# Historic Nowra Bridge repurposing

Project update September 2025

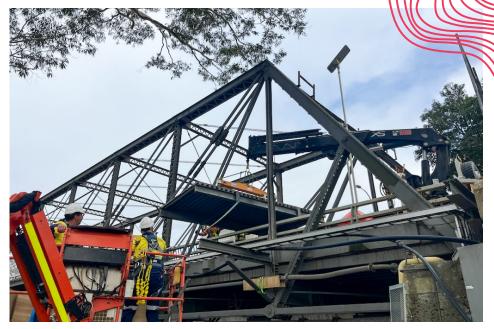
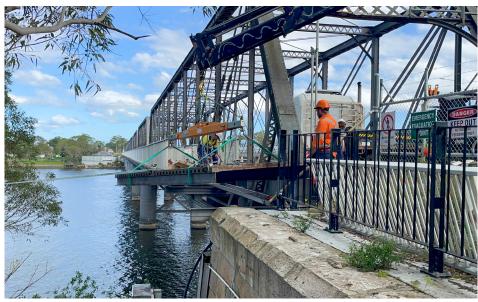
The crew maneuvering a section of the walkway through the truss at the northern end of the bridge.

In May, we successfully trialled an innovative method to remove the cantilever pedestrian walkway which was added to the historic bridge in 1980.

Rather than using traditional methods involving barges and cranes on the water, the team tested a more efficient approach: a crane mounted on a truck carefully maneuvered massive sections of the walkway, each weighing over three tonnes, through the bridge's trusses.

The trial was a success, with crews removing segments from both the northern and southern ends of the bridge without incident. This breakthrough means the entire walkway can now be dismantled directly from the bridge deck, avoiding the need for complex marine operations and delivering significant cost savings to the project.
