# **U-turn detour route for 12.5m Medium Rigid Vehicle (MRV): Victory Parade, and Illoura Street - Northern Interchange, Newcastle Inner City Bypass, in Newcastle, NSW**

## **Traffic and Pedestrian Impact Study**

November 2024

**Project: RP2J – Newcastle Inner City Bypass**

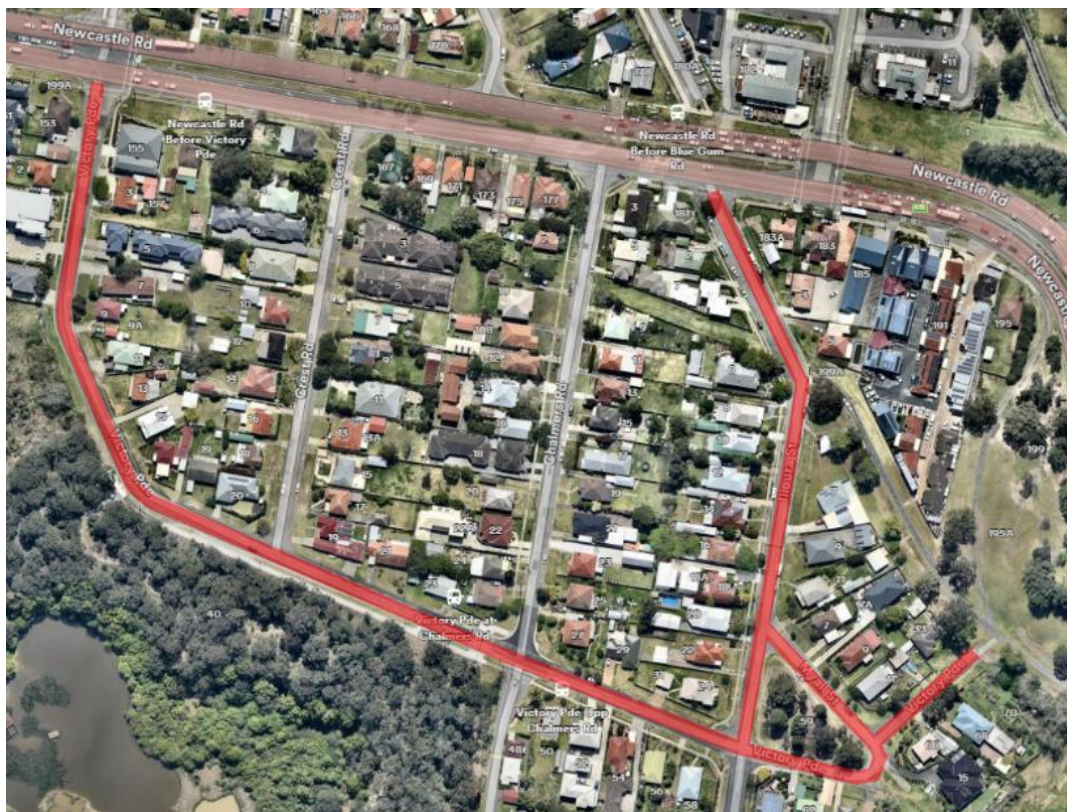
**Figure 2.1: Proposed U-turn detour**  
 (Source: Fulton Hogan)

This report presents the findings of the Traffic and Pedestrian Impact Study, which reviewed the proposed U-turn detour route for a 12.5m long Medium Rigid Vehicle (MRV) (refer to Figure 2.2) on Victory Parade and Illoura Street as part of the Newcastle Inner City Bypass project in Newcastle, NSW (refer to Figure 2.1).

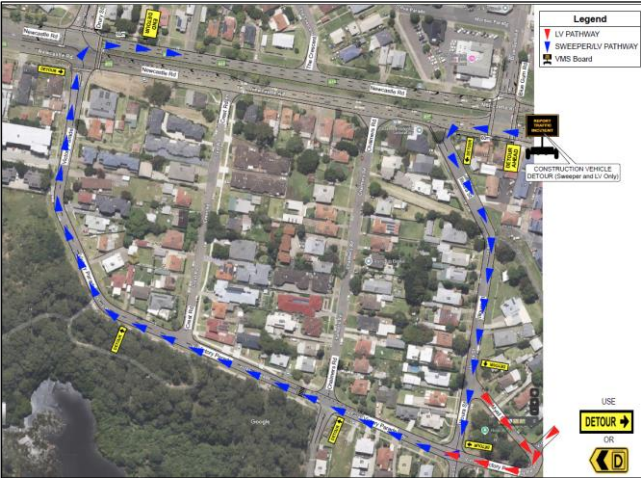
<p><b>Figure 4.1</b></p>

No.	Approximate location	Description of findings
1	Newcastle Road, Illoura Street, and Victory Parade	<p>'DETOUR' (T5-1) sign and 'DETOUR AHEAD' (T1-1) signs are missing on Newcastle Road, Illoura Street, and Victory Parade.</p> <p>In addition, nothing is in place to warn drivers of a detour or to identify the directions and locations for their trucks to leave Newcastle Road.</p> <p>The 'DETOUR' (T5-1) sign should be used along the route to reassure and guide the construction HVs on the detour route.</p> <p><b>Recommended mitigation measures:</b></p> <ul style="list-style-type: none"> <li>Install 'DETOUR AHEAD' (T1-1) and 'DETOUR' (T5-1) signs and repeat the 'DETOUR' (T5-1) signs to reassure and guide the 12.5m long Medium Rigid Vehicle (MRV) along the route of the detour (refer to Figure 4.1).</li> </ul>

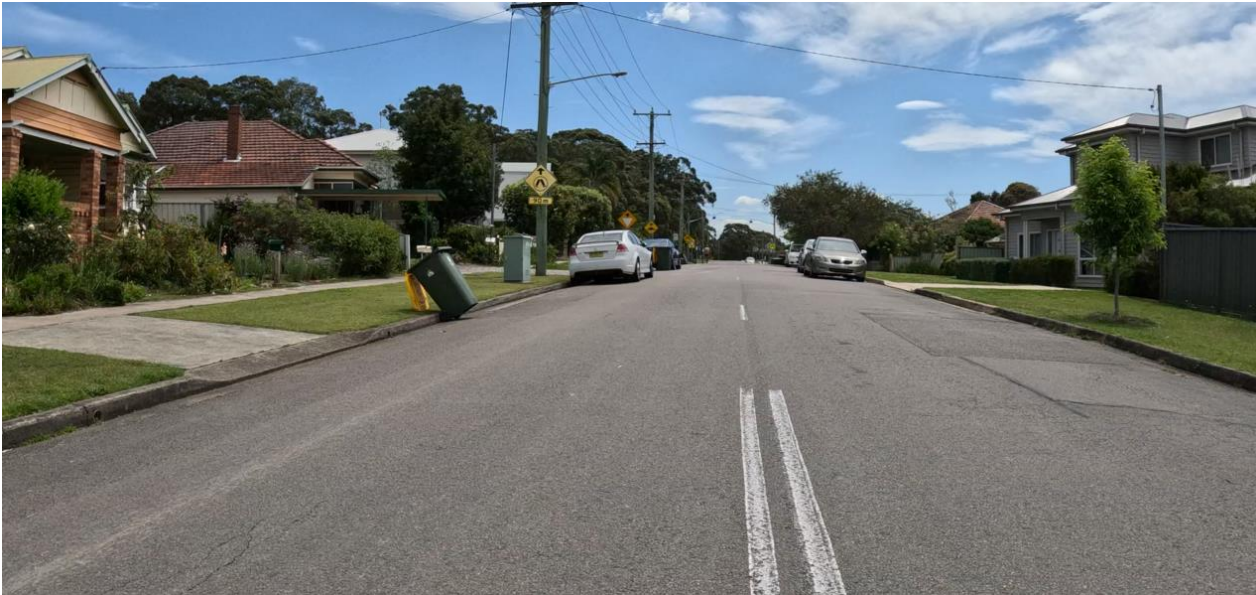
No.	Approximate location	Description of findings
4	Victory Parade / Zebra crossing	<p>The sight distance to the existing Zebra crossing on Victory Parade exceeds 120m (refer to Photo 4.1).</p>

<p><b>Photo 4.1: Victory parade, at <math>\approx</math> 120m before the Zebra crossing</b>          (Photo: Traffic Engineering Centre Pty Ltd)</p> <p>According to Austroads' Guide to Road Design Part 3: Geometric Design, Clause 5.3.2, the Truck Stopping Sight Distance for an operational speed of 50km/h [observed likely to be the case in this 50km/h speed limit zone] is no more than 69m (refer to Table 4.1).</p>

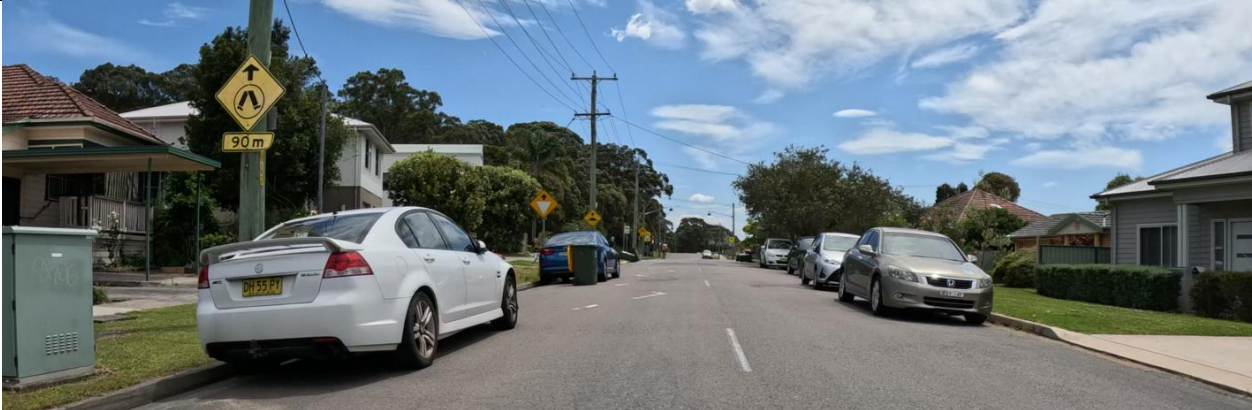
<p><b>Table 4.1: Truck stopping sight distance</b> (Source: Austroads' Guide to Road Design Part 3: Geometric Design, Table 5.5)</p> <p>In addition, at 90m before the Zebra crossing, there is an advance warning sign alerting approaching drivers about the crossing (refer to Photo 4.2), while the crossing itself is also properly signed, with even an addition in the form of 'Give Way' sign (refer to Photo 4.3).</p> <p>The only identified deficiency was the faded 'Zig-zag' line on the approach to the Zebra crossing (refer to Photos 4.2 &amp; 4.4).</p>	Operating speed (km/h)	Single unit trucks, Semi-trailers and B-doubles Based on $d = 0.29$ <sup>(1)</sup>			$R_T = 1.5$ s <sup>(2)</sup>	$R_T = 2.0$ s	$R_T = 2.5$ s	40	38	44	49	50	55	62	69	60	74	82	91	70	96	105	115	80	120	131	142	90	147	160	172	100	–	191	205	110	–	225	241
Operating speed (km/h)	Single unit trucks, Semi-trailers and B-doubles Based on $d = 0.29$ <sup>(1)</sup>																																								
	$R_T = 1.5$ s <sup>(2)</sup>	$R_T = 2.0$ s	$R_T = 2.5$ s																																						
40	38	44	49																																						
50	55	62	69																																						
60	74	82	91																																						
70	96	105	115																																						
80	120	131	142																																						
90	147	160	172																																						
100	–	191	205																																						
110	–	225	241

<p><b>Photo 4.2: Victory parade, at <math>\approx</math> 100m before the Zebra crossing</b>          (Photo: Traffic Engineering Centre Pty Ltd)</p>

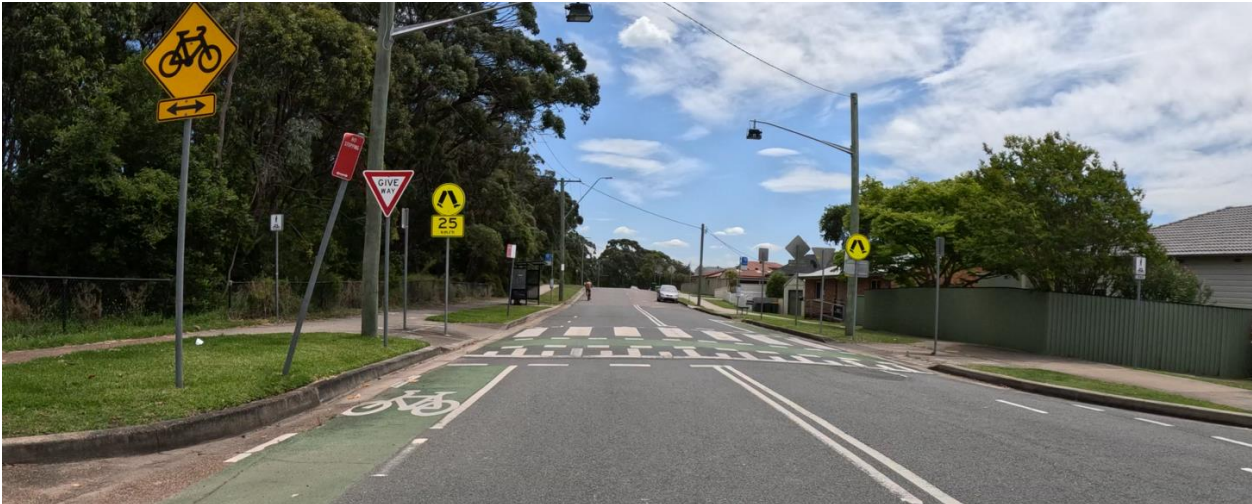
<p><b>Photo 4.3: Victory parade, at the immediate approach to the Zebra crossing</b>          (Photo: Traffic Engineering Centre Pty Ltd)</p>

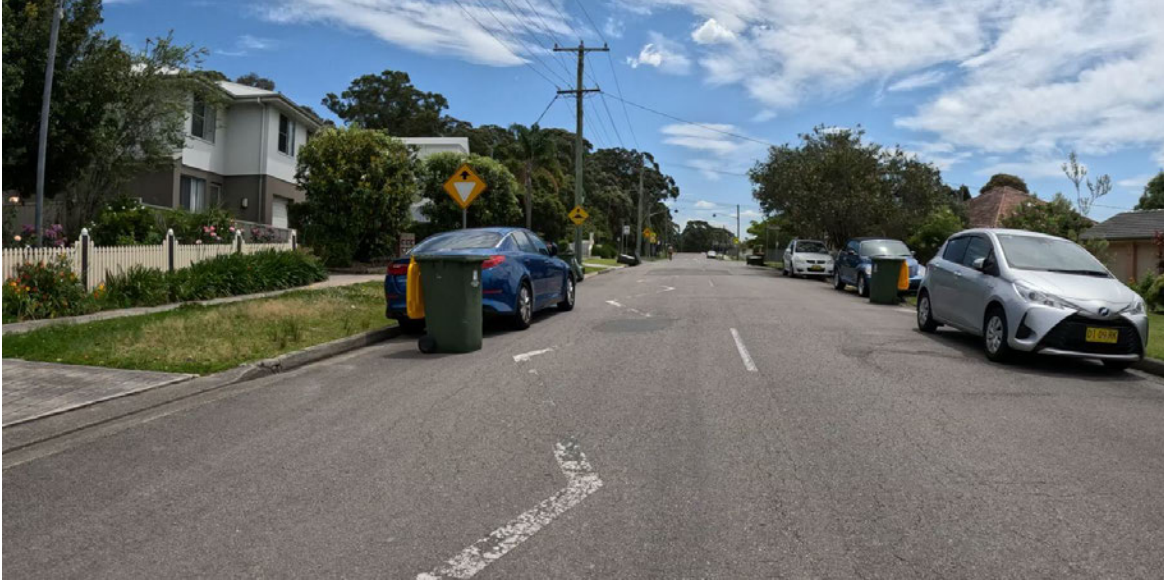
<p><b>Photo 4.4: Victory parade, faded 'Zig-zag' line on approach to the Zebra crossing</b>        (Photo: Traffic Engineering Centre Pty Ltd)</p> <p>Under the condition that the 'Zig-Zag' line is repainted, an increase in traffic of a maximum of 1 to 2 of the 12.5m long Medium Rigid Vehicle (MRV) per peak hour would have no more than minimal impact on the pedestrian amenities and safety along the proposed detour route.</p> <p><b>Recommended mitigation measures:</b></p> <ul style="list-style-type: none"> <li>Repaint the faded 'Zig-Zag' line.</li> </ul>

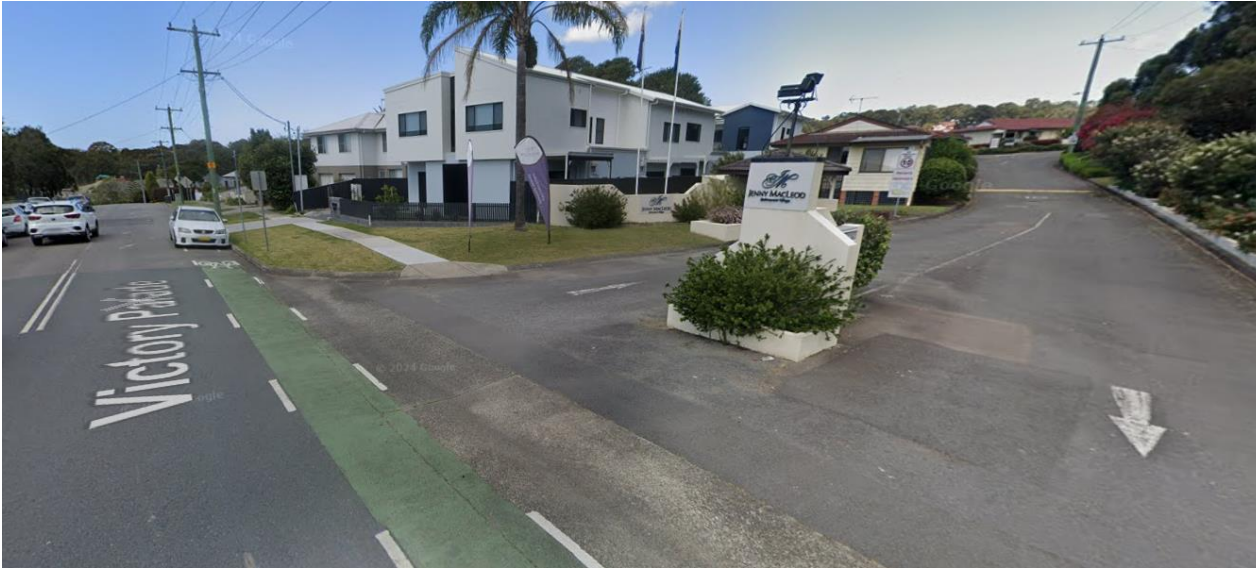
No.	Approximate location	Description of findings
6	Victory Parade, at the intersection with Chalmers Road and the access driveway to the retirement village	<p>The access driveway to a retirement village is located at the intersection with Chalmers Road (refer to Photo 4.7 and Figure 4.3).</p>

<p><b>Photo 4.7: Access driveway to the retirement village, off Victory Parade</b>          (Photo: Streetview)</p>

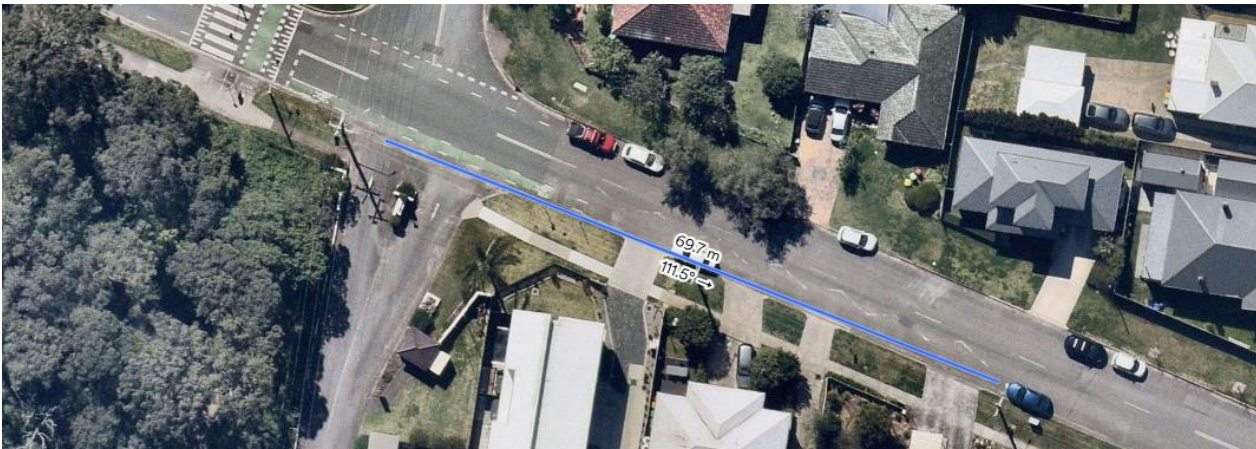
</div> <p><b>Figure 4.4</b>            (Source: nearmap)</p>

No.	Approximate location	Description of findings
6 Cont'd		<p>As observed at the site, in all likelihood and foreseen circumstances, the access driveway and a vehicle on it are visible to a driver on Victory Parade at least 70m before the intersection (refer to Photo 4.8 and Figure 4.4).</p> <div data-bbox="611 430 1865 790">   </div> <p><b>Photo 4.8: Victory parade, at <math>\approx</math> 70m before the intersection with the access driveway to the retirement village</b>            (Photo: Traffic Engineering Centre Pty Ltd)</p> <div data-bbox="611 869 1865 1319">

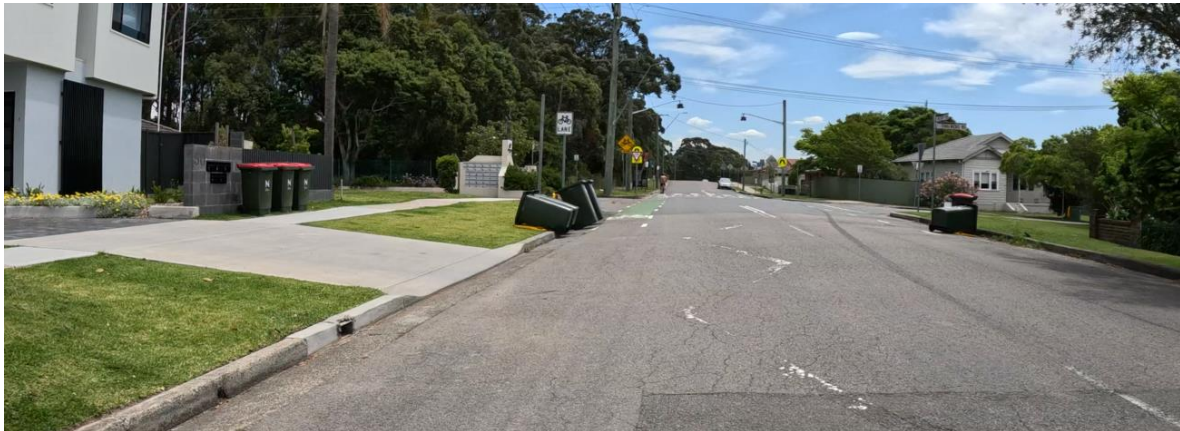
<p><b>Table 4.2: Truck stopping sight distance</b> (Source: Austroads' Guide to Road Design Part 3: Geometric Design, Table 5.5)</p> <p>Furthermore, the closer to the access driveway, the more obvious and visible the access driver is to approaching motorists on the Victory Parade (refer to Photos 4.7 &amp; 4.8).</p>

<p><b>Photo 4.9: Victory parade, on the final approach to the access driveway to the retirement village</b> (Photo: Traffic Engineering Centre Pty Ltd)</p>	Operating speed (km/h)	Single unit trucks, Semi-trailers and B-doubles Based on $d = 0.29$ <sup>(1)</sup>			$R_T = 1.5$ s <sup>(2)</sup>	$R_T = 2.0$ s	$R_T = 2.5$ s	40	38	44	49	50	55	62	69	60	74	82	91	70	96	105	115
Operating speed (km/h)	Single unit trucks, Semi-trailers and B-doubles Based on $d = 0.29$ <sup>(1)</sup>																								
	$R_T = 1.5$ s <sup>(2)</sup>	$R_T = 2.0$ s	$R_T = 2.5$ s																						
40	38	44	49																						
50	55	62	69																						
60	74	82	91																						
70	96	105	115

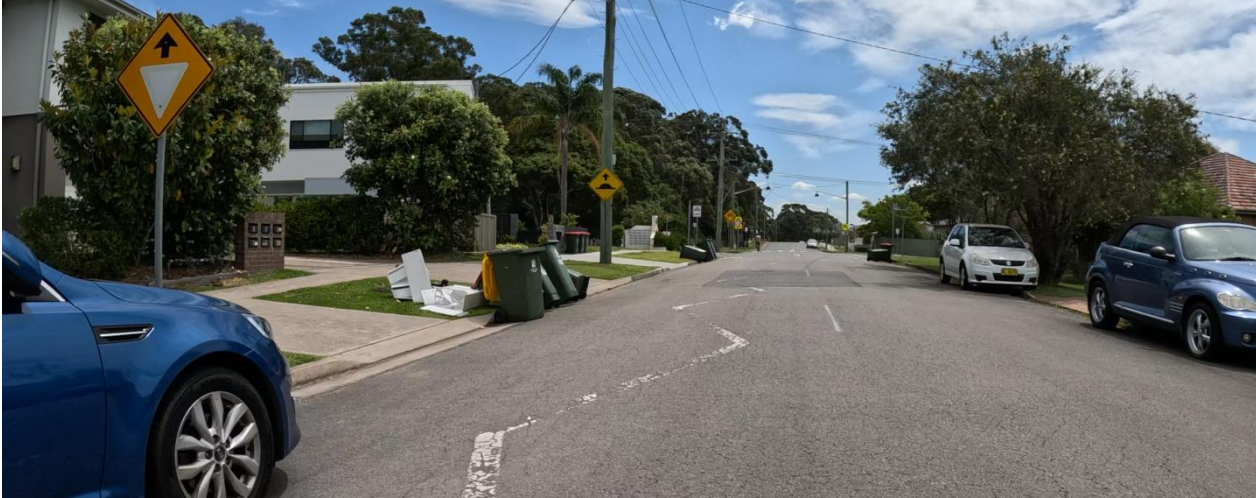
<p><b>Photo 4.10: Victory parade, on the final approach to the access driveway to the retirement village</b>          (Photo: Traffic Engineering Centre Pty Ltd)</p> <p>In addition to the above, and considering Vicory Parade is a bus route, the introduction of only one or two sweepers per peak hour would not, in all likelihood and foreseen circumstances, impact the retirement village residents' safety or amenity.</p>

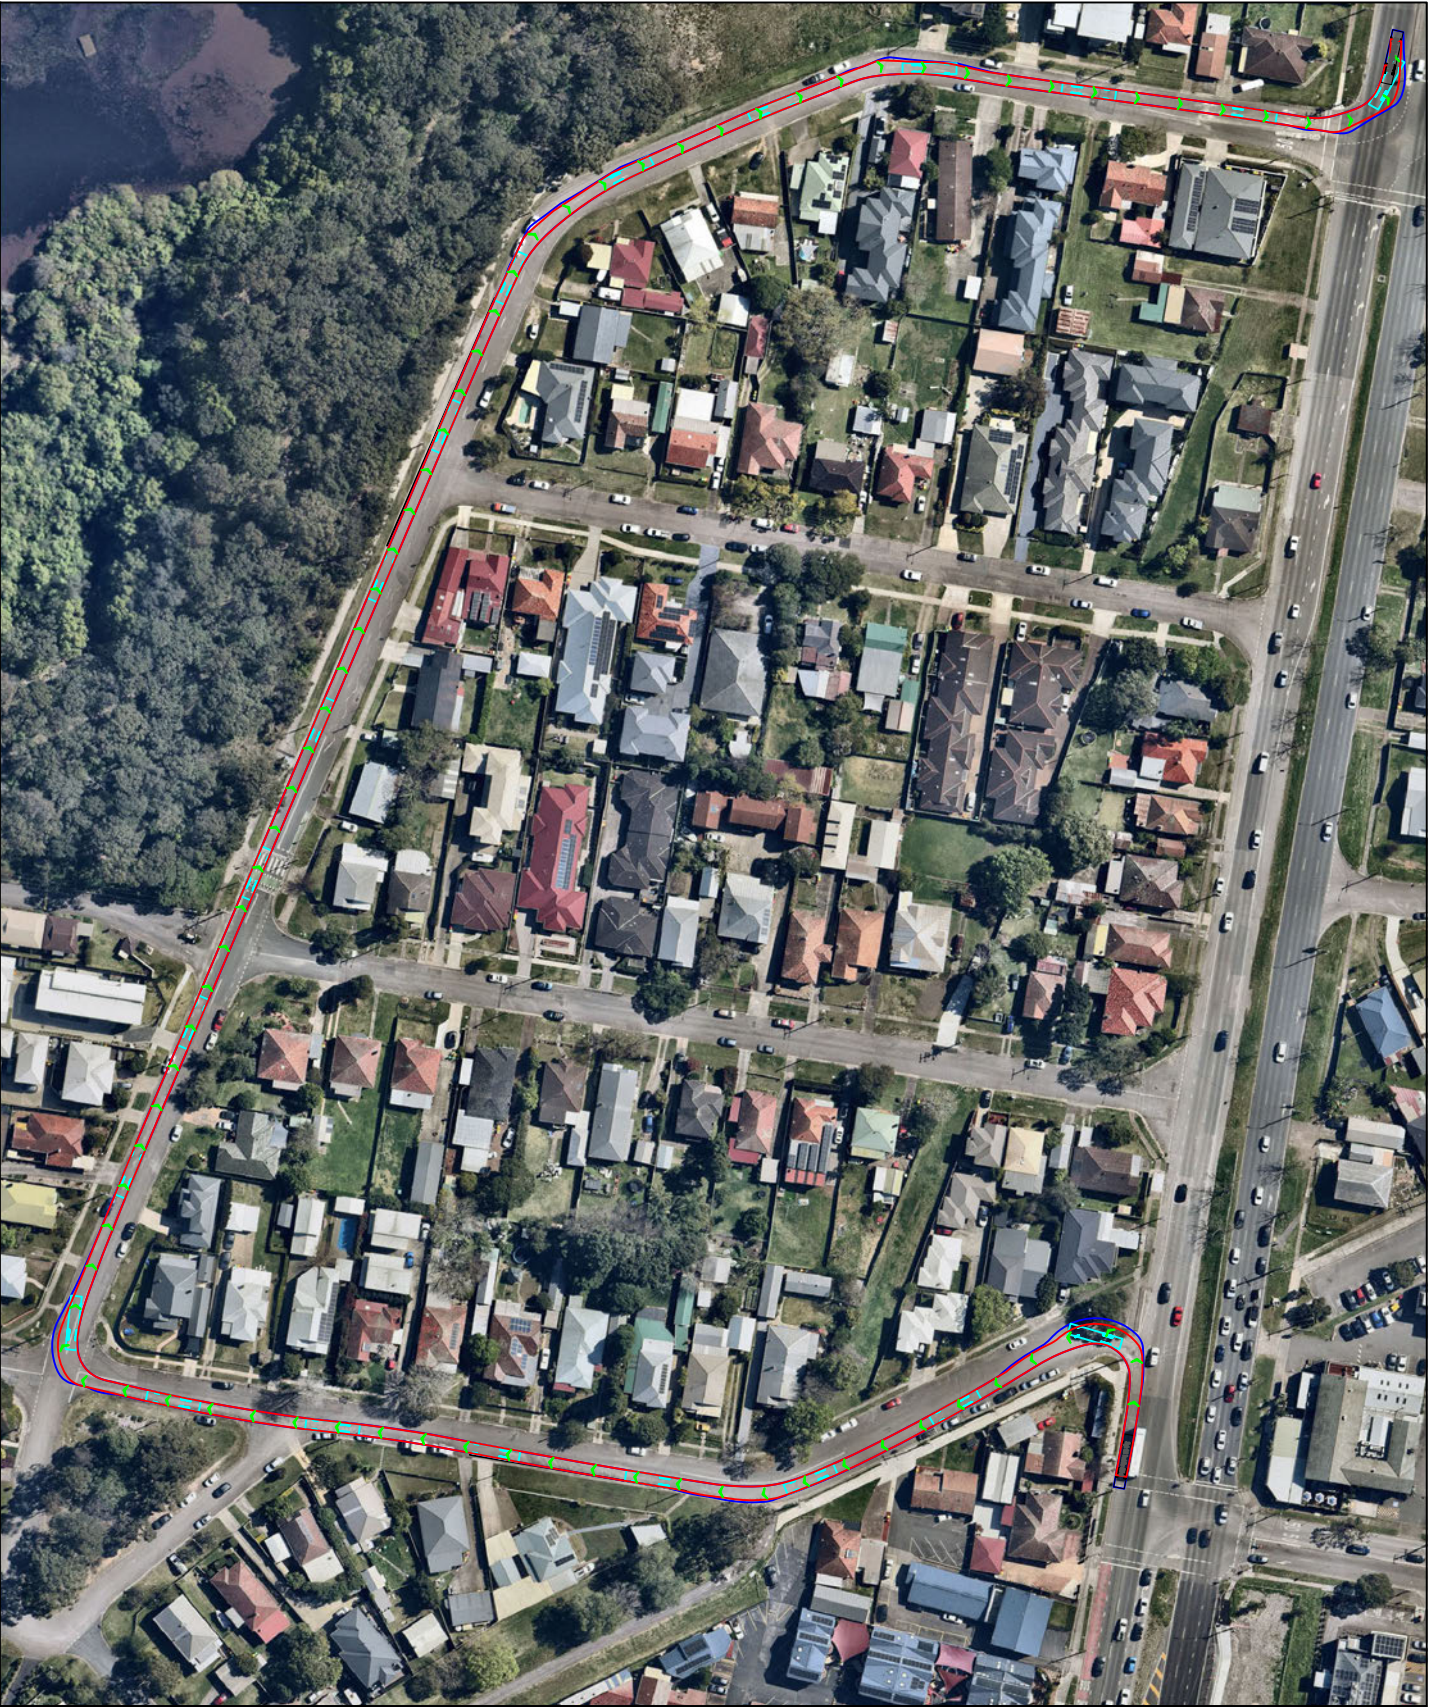
NEWCASTLE INNER BYPASS

No.	Approximate location	Description of findings
2	Newcastle Road, Illoura Street, and Victory Parade  / Swept path analysis	<p>Swept path analysis leads to the conclusion that the proposed U-turn detour route is wide enough to accommodate swept paths of 12.5m long Medium Rigid Vehicle (MRV) (refer to Figure 4.2).</p>   <p><b>Figure 4.2</b></p>

SINGLE UNIT TRUCK—12.5m

Single Unit Truck/Bus (12.5 m)	
Overall Length	12.500m
Overall Width	2.500m
Overall Body Height	4.300m
Min Body Ground Clearance	0.490m
Track Width	2.500m
Lock-to-Lock time	6.005
Curb to Curb Turning Radius	12.500m

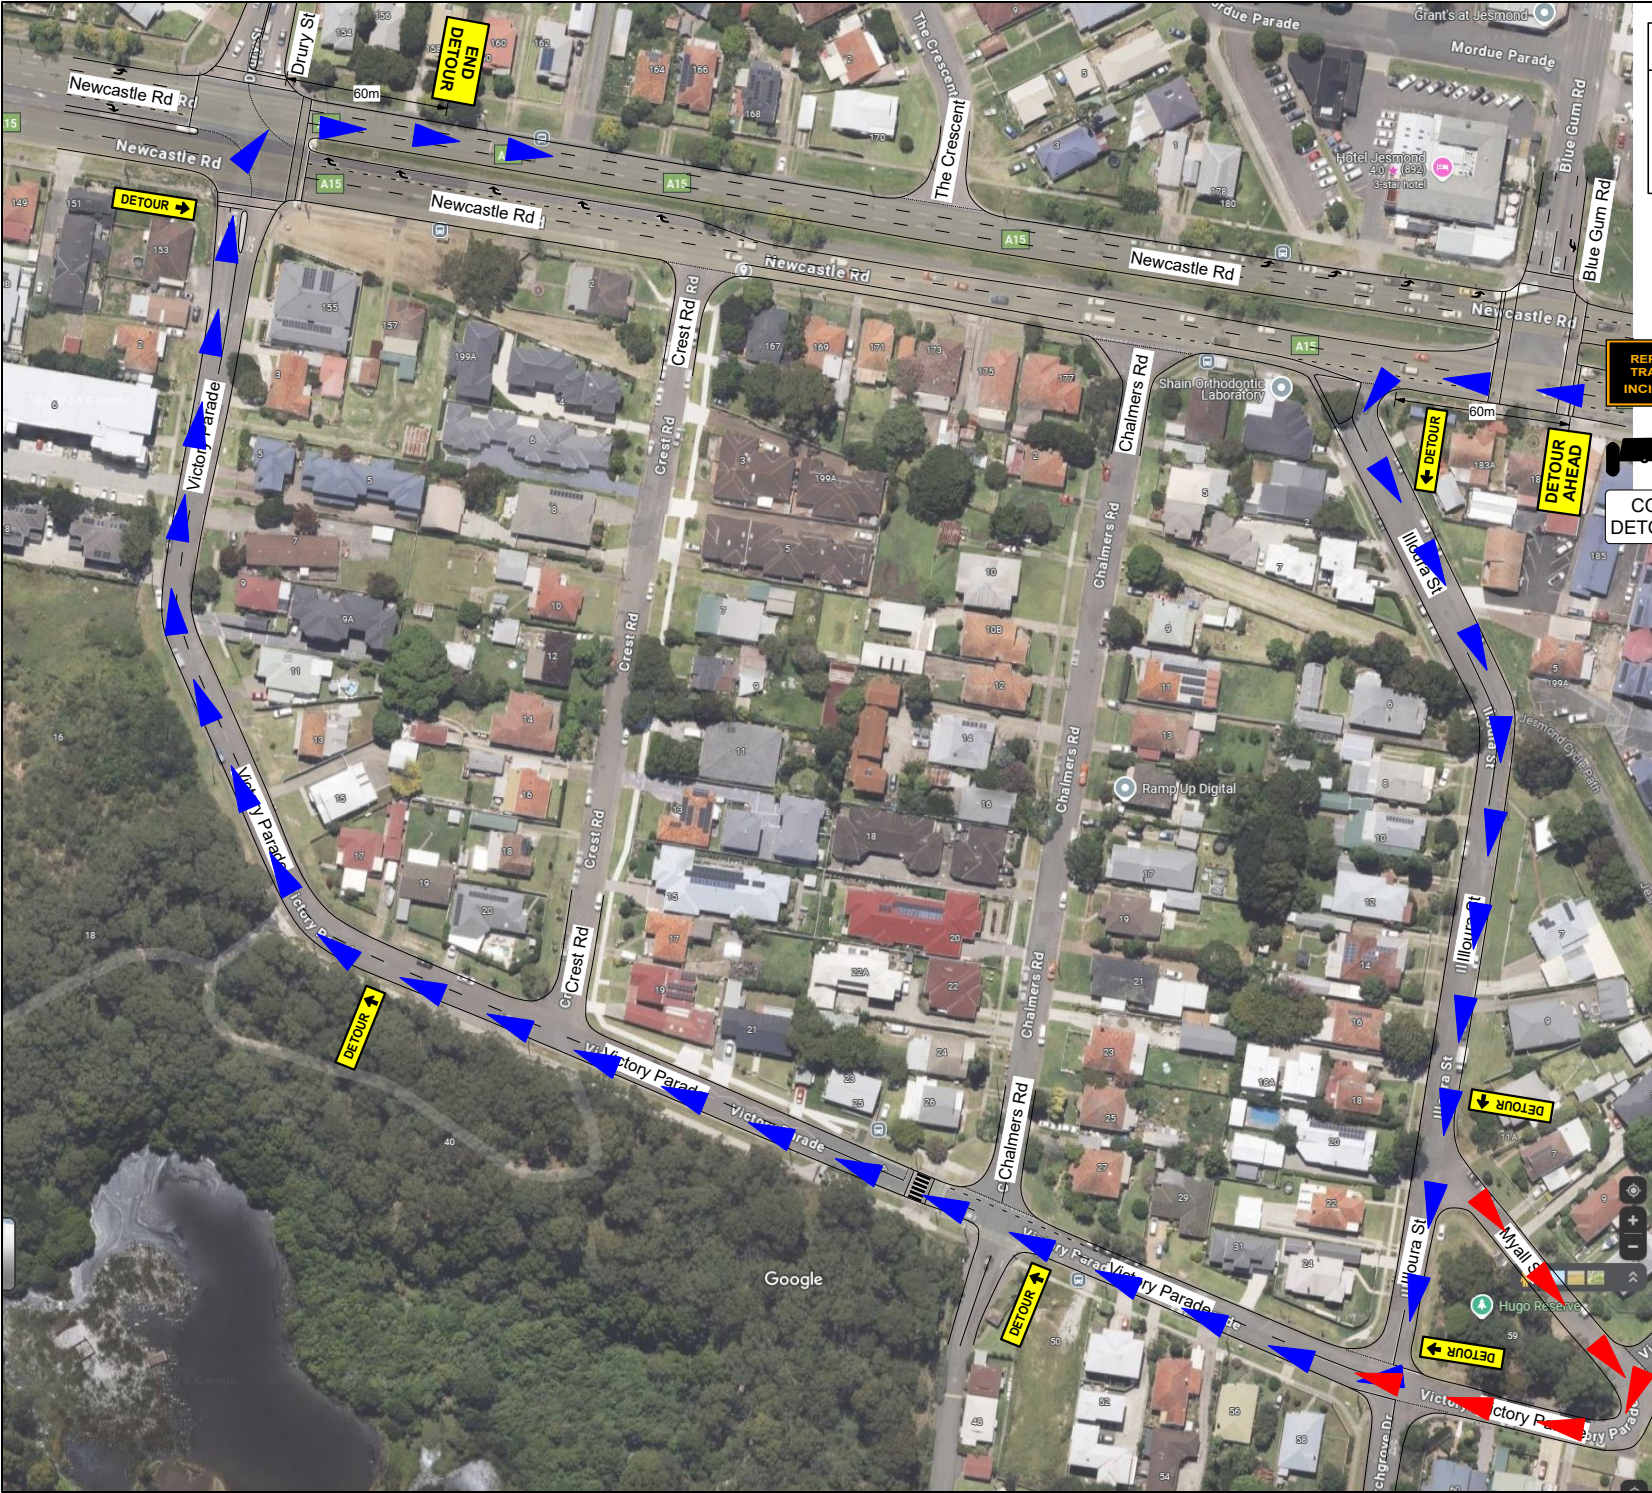
**CONSTRUCTION VEHICLE  
DETOUR (Sweeper and LV Only)**

- ▼ LV PATHWAY
- ▼ SWEEPER/LV PATHWAY
- VMS Board
