# WINDSOR BRIDGE REPLACEMENT PROJECT

**PROJECT NUMBER: 190508**

Salvage Excavation Report - Area 1 – Historical Archaeology

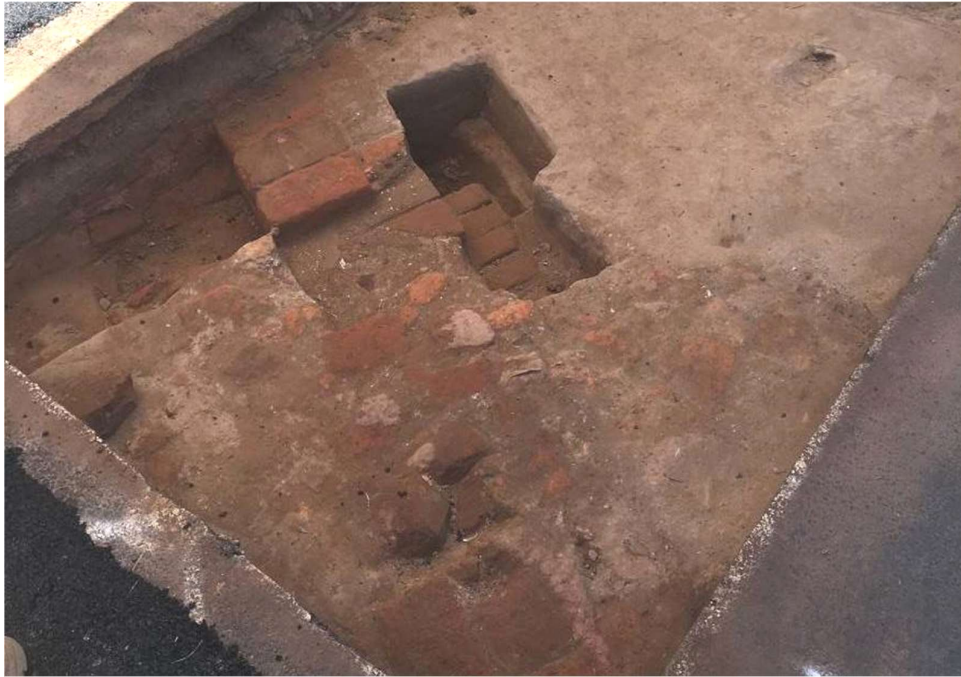
**Figure 3.1** Early 19<sup>th</sup> century brick footing identified beneath George Street (test pit SA 25).

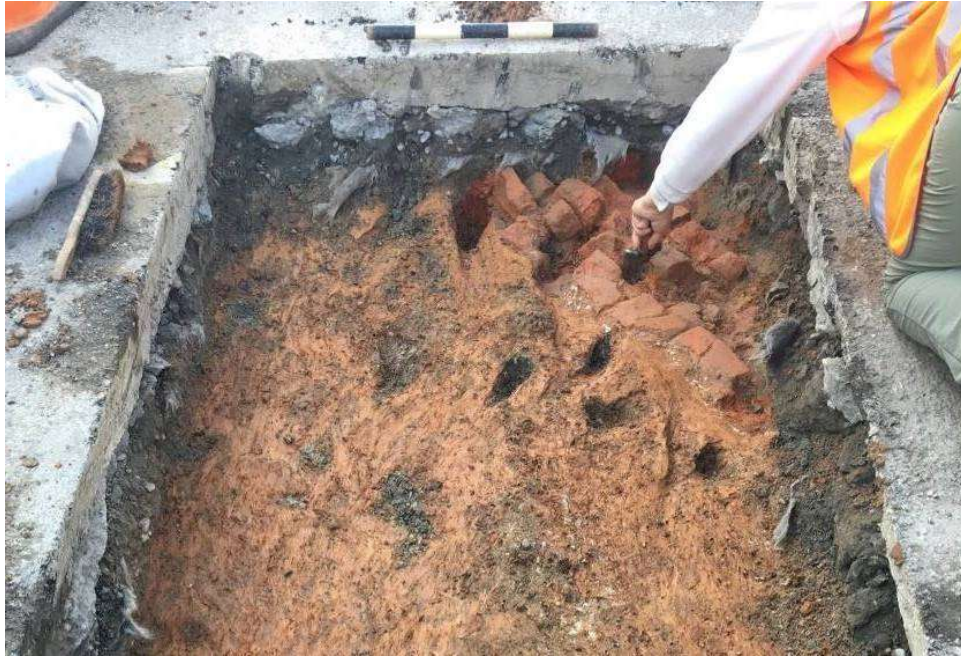
**Figure 3.2** Early 19<sup>th</sup> century box drain identified beneath Old Bridge Street (SA 26).

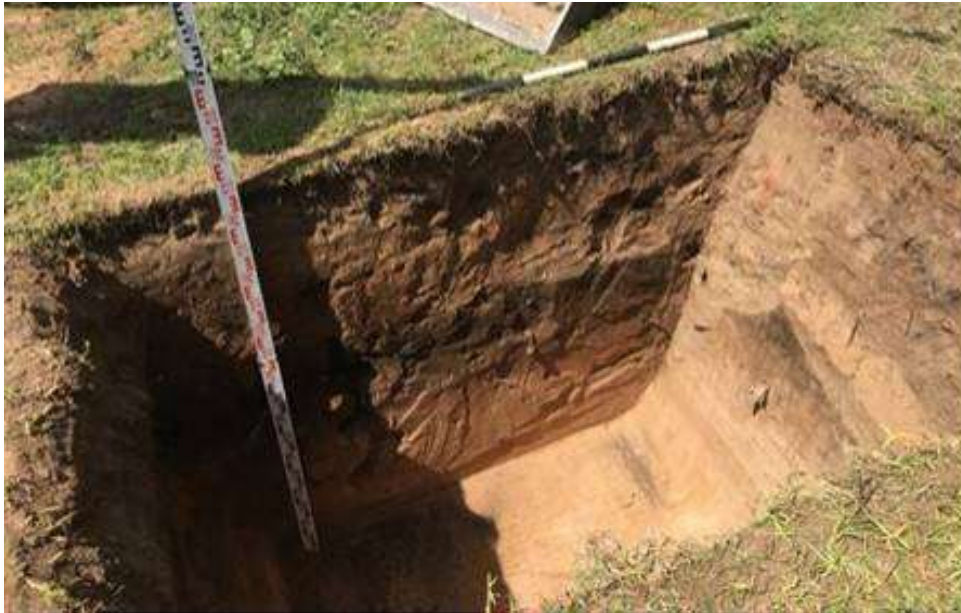
**Figure 3.3** Disturbed historical soil profile within SA 9 in lower Thompson Square (dark undulating band halfway down the profile).

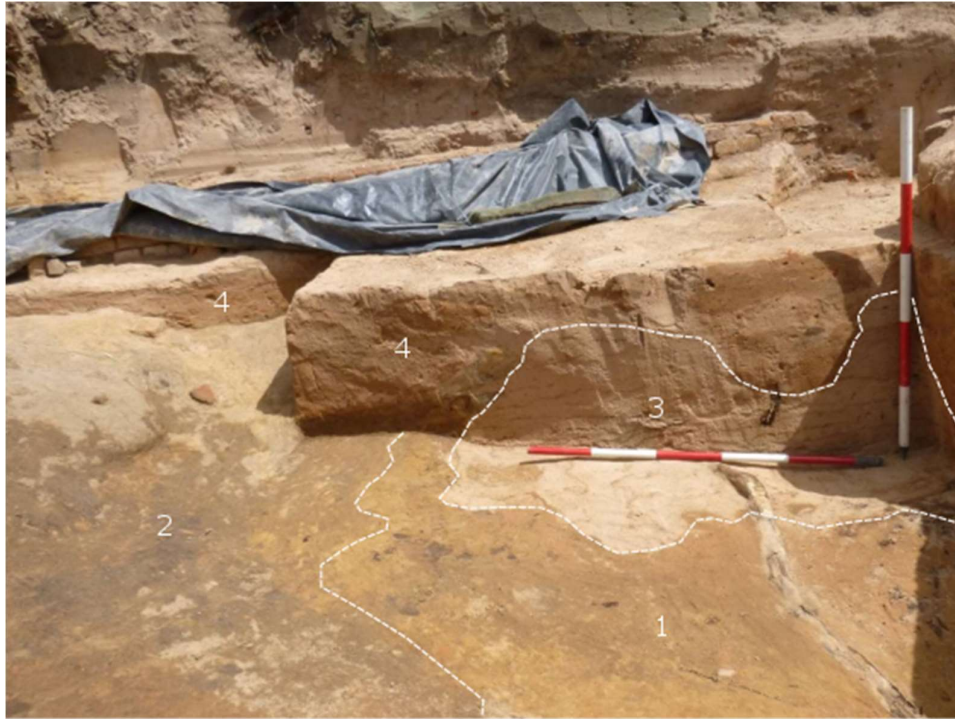
**Figure 5.1** West-facing view of the lower stratigraphy identified in the vicinity of grid square S21/E6. Numbered areas are: 1) indurated clay-rich unit ii (1103); 2) weathered unit ii with historical artefacts on the surface (1364); 3) disturbed unit ii/iv interface; and 4) historical fill deposits. Box drain 1 [1143] is beneath the black plastic in the background. Scales are 1m.

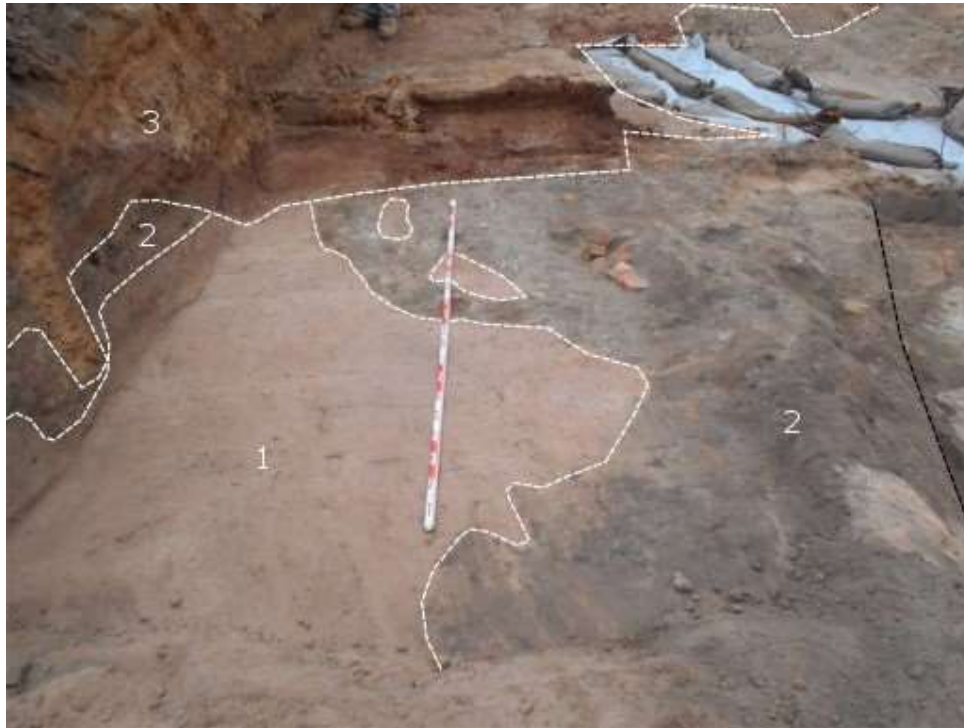
**Figure 5.2** View south across the vicinity of N0/E10 showing: 1) truncated aeolian sand unit iv (1074); 2) Phase 3 drain trench fills, contexts 1111 and 1118; and 3) Phase 5 road fills (1006) and [1034]. The black dashed line indicates the eastern edge of the oviform drain trench and box drain 2 (1047) is covered in the background. Scale is 2m.

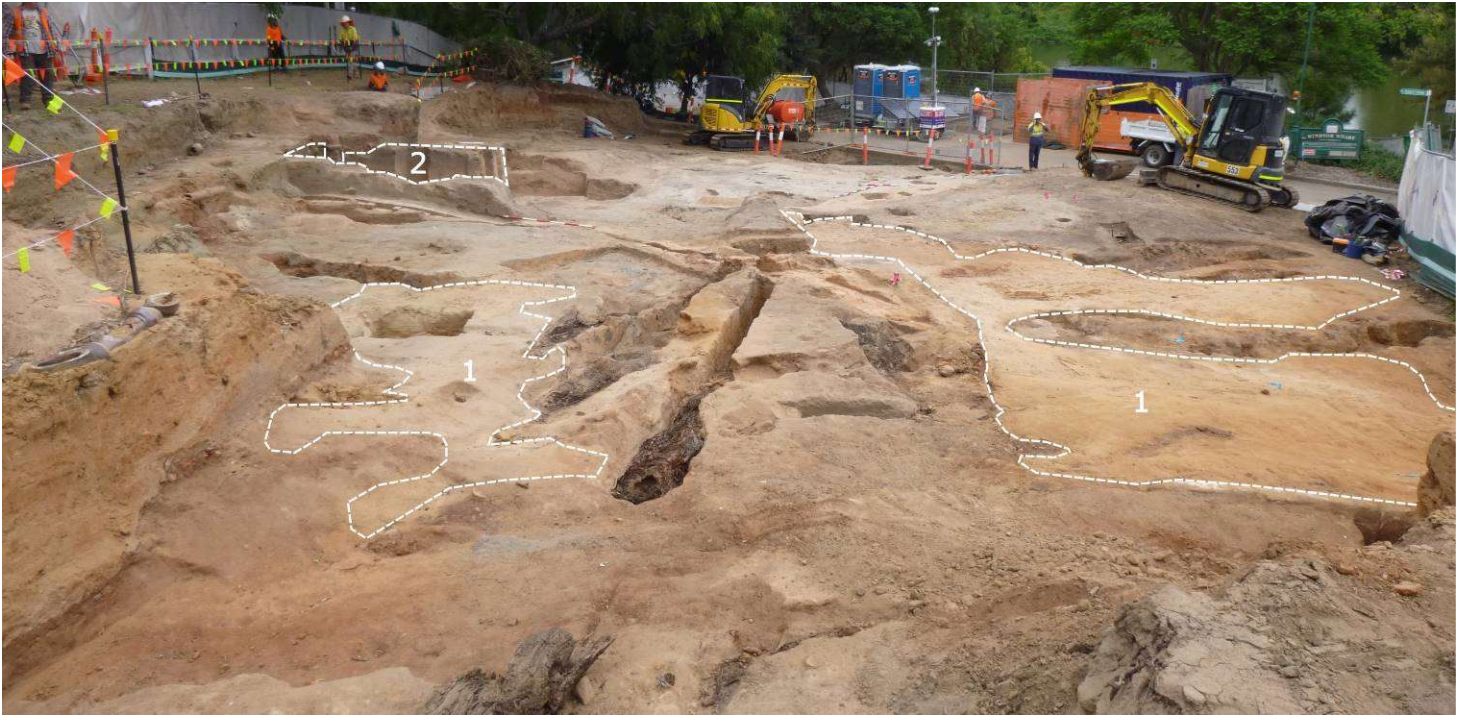
**Figure 5.3** View north-west across the centre of the site from the centre of grid area 1 during mid-excavation showing the truncated and remnant natural sand units present. Numbered areas are: 1) truncated units ii/iii (1103) identified directly below later fill materials; and 2) the area of un-truncated, early historical soil profile (1067/1074). All other areas visible contain historical archaeology and fills dating to phases 3 and 5.

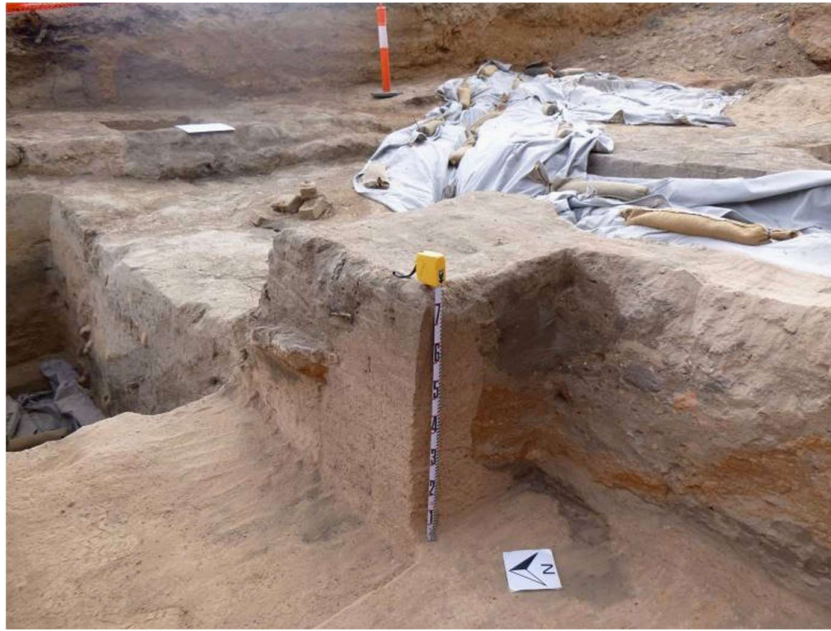
**Figure 5.5** View south-east showing Phase 3 cut and fill disturbance to the Phase 2, context 1067 and 1074 profile. Left of the vertical scale is the north-south oriented trench for the oviform drain (1106) and right of the scale is the more vertical east-west cut (1082) of box drain 2, seen covered in the background.

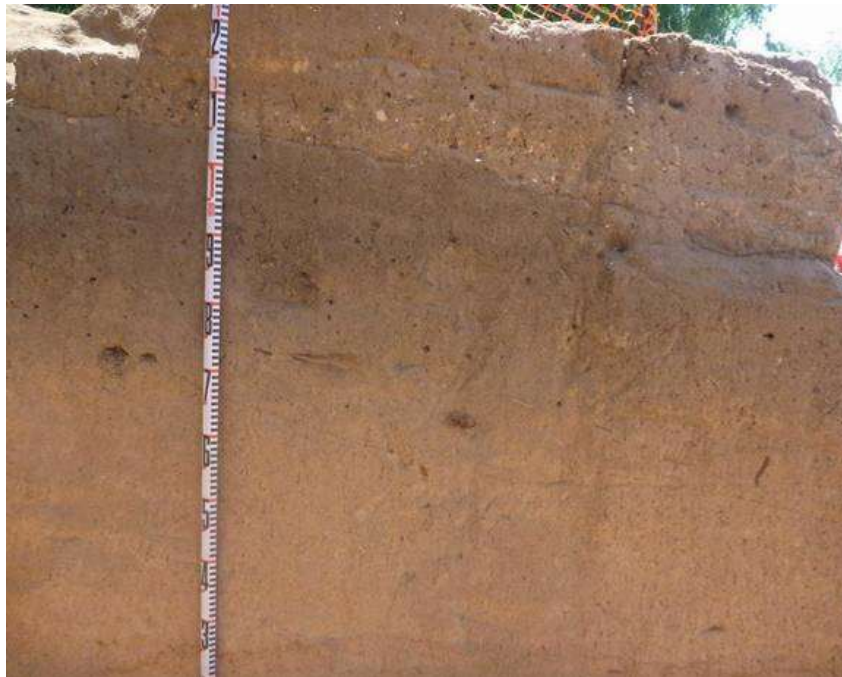
**Figure 5.6** Detail of the natural/early historical topsoil context 1067 (unit v) and the paler, underlying aeolian sand context 1074 (unit iv). Above both and distinguishable from the developed soil profile is 20cm of Phase 3-4 fill deposit context 1014.

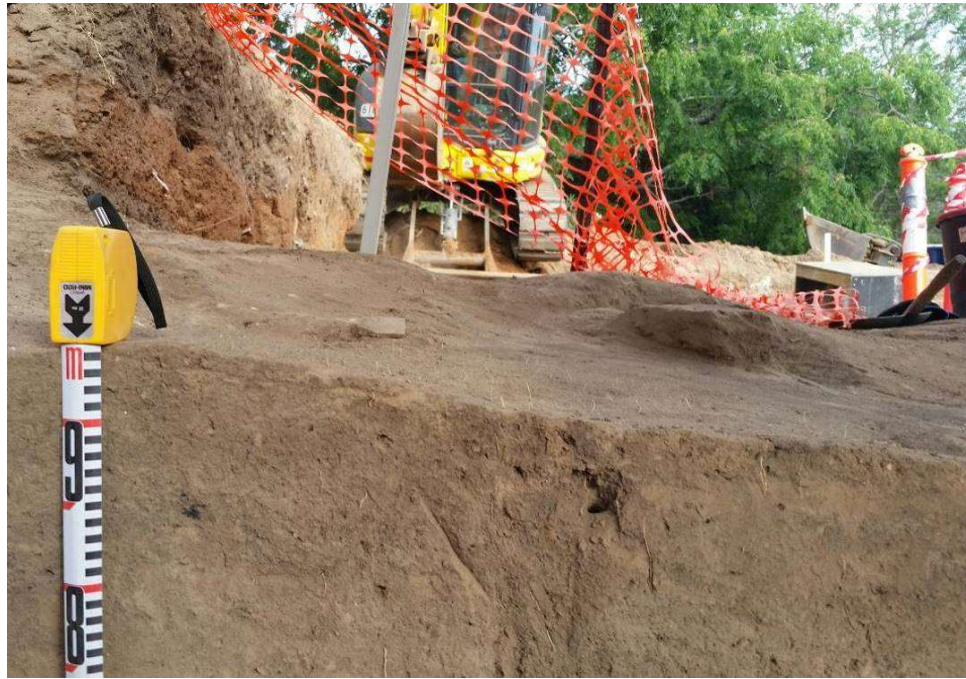
**Figure 5.7** Detail of the profile and surface of topsoil context 1067 with a fragment of colonial ware visible on the surface.

Following removal of the overlying fill deposits, historical artefacts dating to the early colonial period were evident on the surface of context 1067 including locally made (colonial) earthenware and Chinese export porcelain (Figure 5.7). Once identified as an element of Phase 2 and a key culturally bearing deposit of the Aboriginal programme, topsoil 1067 and subsoil 1074 were systematically excavated using 50cm salvage squares based on the site grid. This allowed the team to record in detail any individual historical features and recover 100% of historical artefacts within the excavated deposit. No historical archaeological features such as structural remains or refuse pits were identified within contexts 1067 and 1074 that would suggest direct occupation of the immediate or adjacent area. All recovered artefacts were distributed fairly evenly across the area with no notable concentrations present that might indicate a discrete discard event or localised activity (Figure 5.8).

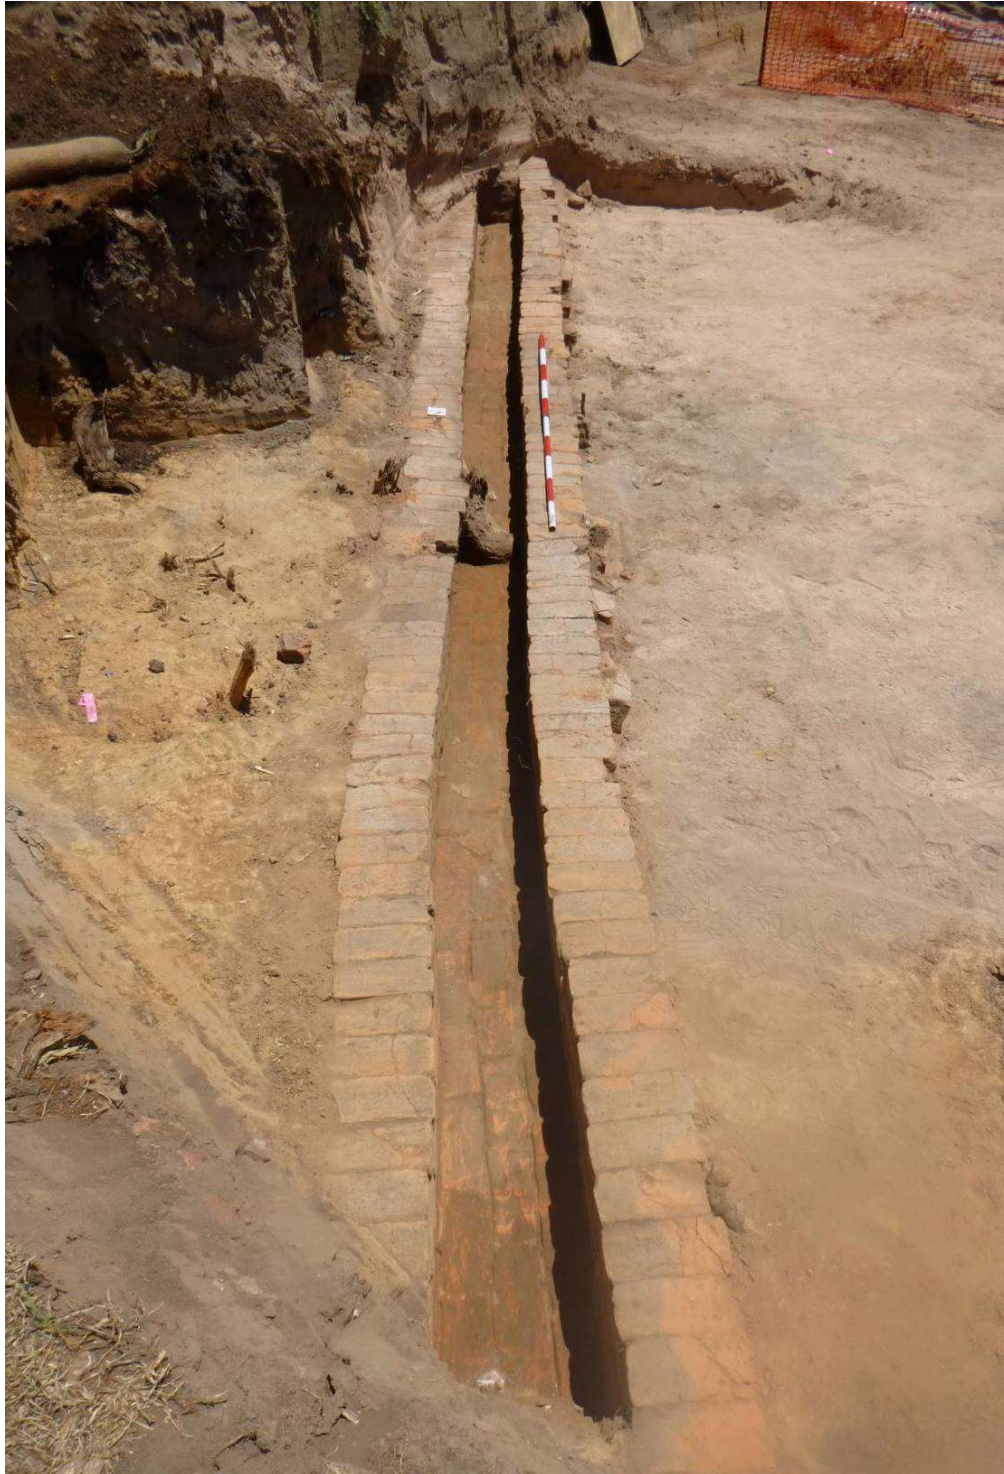
**Figure 5.14** View west along box drain 1 (1143). Levelling fill deposits 1195 and 1147 are seen at left and right respectively.

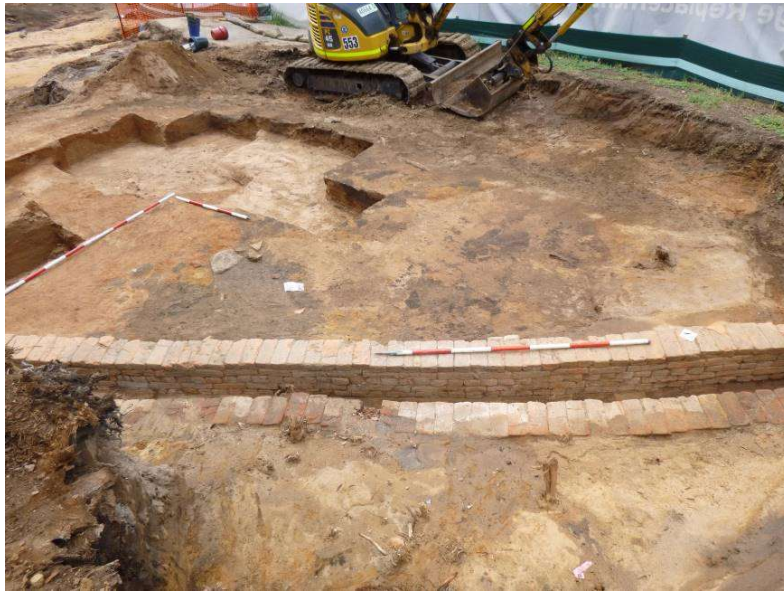
**Figure 5.15** View north across box drain 1 (1143) showing mottled construction-related deposit 1340 and redeposited sand context 1147 (at left). The top of colonial ware feature (1339), consisting of grey sediment, is seen near the right-angled scales at the junction of these two deposits. Disturbed natural unit iii sand (1103) is seen within Aboriginal archaeological salvage squares at top left.

Ten metres of box drain 1 (1143) were subsequently exposed on an east-west alignment against the western edge of excavation between grid northings S19 and S28 (Figure 5.14 and Figure 5.15). The 80cm wide box drain 1 was constructed in English bond using sandstock bricks measuring 10cm by 23cm by 6.5cm in 6 courses, with the sixth stretcher course forming the base of the interior. Bonding was provided by shell lime/sand to mud mortar and traces of a covering of timber boards (1323) remained in place across this sub-surface drain, a feature that was later found to be better preserved over box drain 3, located further north. It was unclear if the timber boards were utilised to prevent the drain becoming a fall hazard if it was constructed on the contemporary ground surface, or if they were to cover the drain before burial. If the latter reason is correct then the use of timber rather than stone slabs for this function may have been to reduce construction costs, as buried timber would be expected to rot and cause the overlying ground to subside. The full extent of the exposed section of box drain 1 and all Phase 3 archaeology present in grid area 1 is presented in Figure 5.13.

A concentrated deposit of shattered colonial ware vessels (1339) (Figure 5.15 and Figure 5.16) was recovered from the interface between context 1340 and the weathered natural context 1364 discussed in Section 5.3.1. Locally made earthenware forms an important element of early colonial material culture studies in Australia. This concentration of six separate vessels comprised the most complete group recovered, from the only secured artefact deposit identified across the entire salvage excavation. This is an indication of the scale of disturbance present, in large part a result of the construction of the Phase 3 drain system itself. This accumulation may differ from the prevailing secondary or even tertiary deposition pattern across the site, as fragments comprising of 20-80% of each vessel were present. This suggests vessels accidentally broken nearby at the time of construction of the drain, or possibly goods in transit between locations were dumped on this spot prior to filling. From the line of grid easting E10 westwards, all Phase 3 deposits were found to have been removed by later Phase 4, 5 and 6 activity, including a service trench and grading and gravel bedding probably associated with Phase 5 road construction.

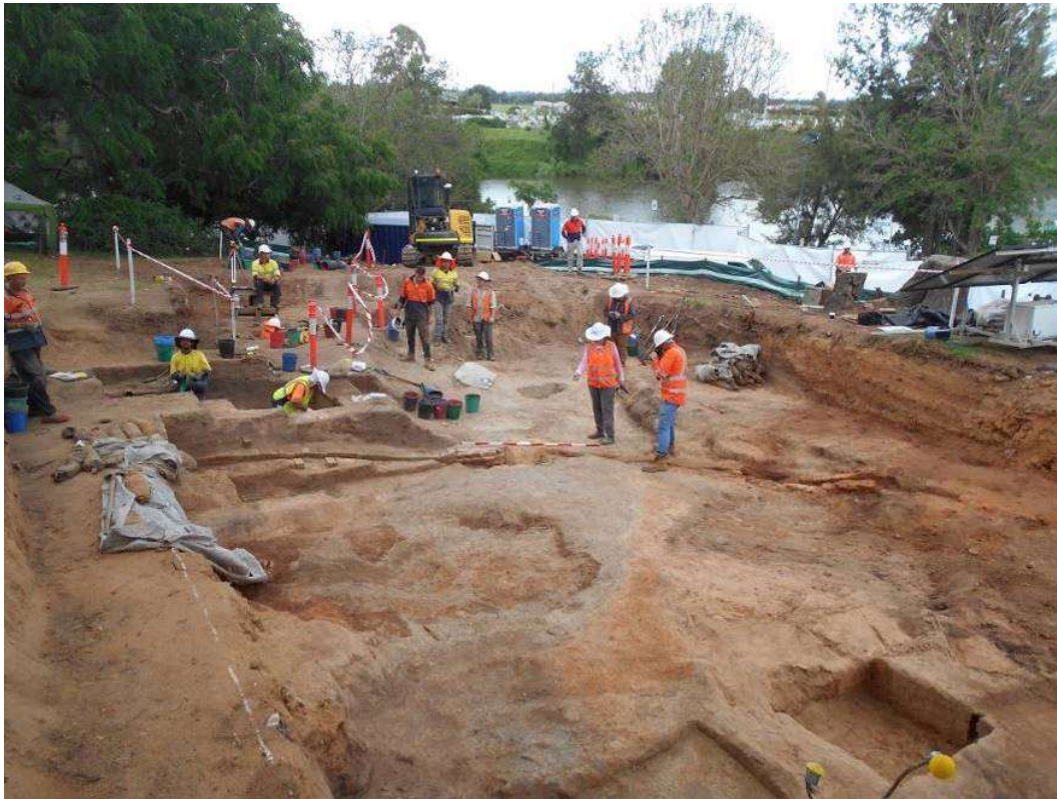
**Figure 5.17** View north through the centre of the salvage excavation showing linear fill deposits running below box drain 2 (1047). The sump connecting the box drain with the oviform drain below is adjacent to the 1m metre scale at centre.

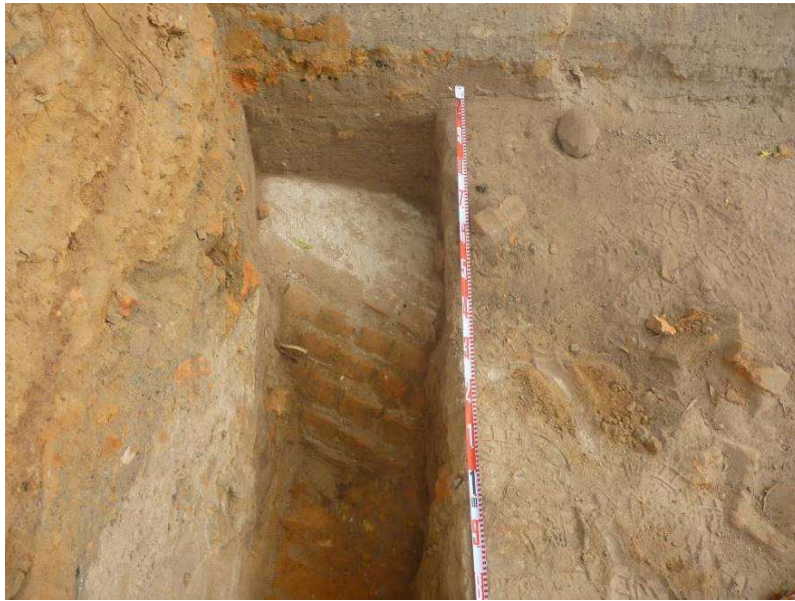
**Figure 5.18** View west showing the crown of the c.1814 oviform drain (1115) exposed within Sondage 2.

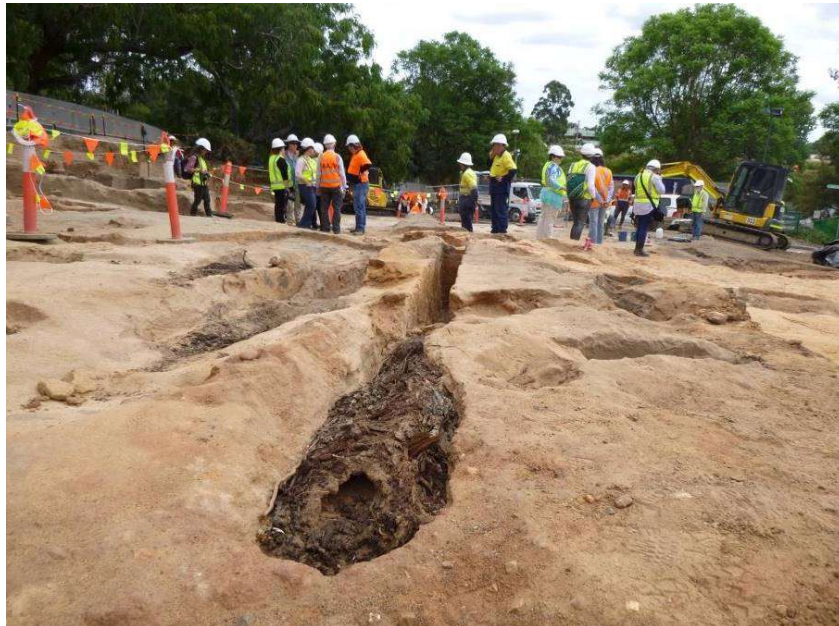
**Figure 5.20** View north-west showing one of timber logs buried within Phase 3 fill deposits laid down for the construction of box drain 2, seen near the figures.

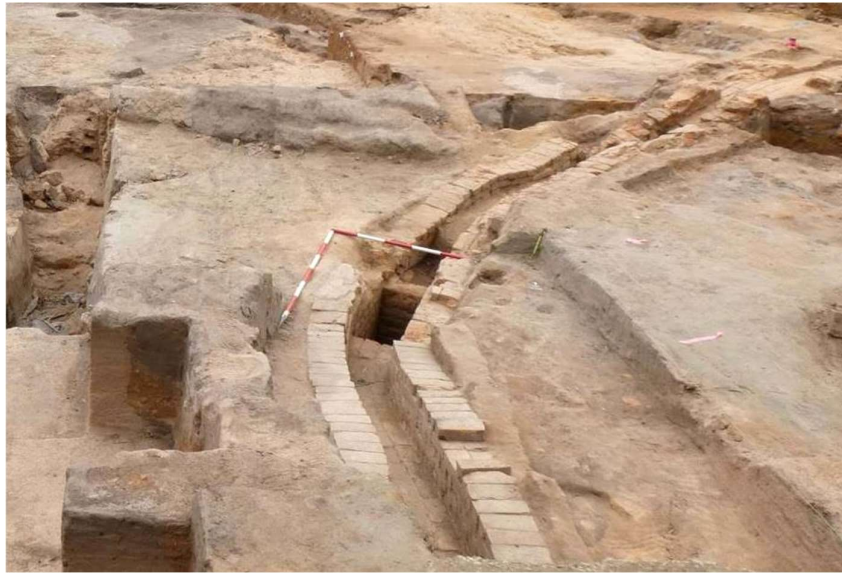
**Figure 5.21** Box drain 2 (1047) with the central shaft framed by the 1m scales. The areas of disturbance to the structure are the result of Phase 5 road construction (top right) and Phase 6 demolition of the Hawkesbury Motor Boat Club (centre surrounding the shaft). The wide trench cut and associated fills of 1047 are seen in the adjacent test excavation squares at lower right.

West of the shaft, a 500cm deep and approximately 2m wide dished construction trench (1082) had been excavated into Phase 2 soils 1067 and 1074 to achieve the required grade toward the west (Figure 5.21). This had been backfilled in conjunction with the main oviform fill deposits (1077, 1078 and 1079) and included a low-density total assemblage of 17 finds from these three separate fill layers. This was largely made up of ceramics (64.7%) with nine separate vessels being represented. As with Phase 2 deposits, Canton decorated Chinese export porcelain (36.4% of MNV) and creamware (27.3% of MNV) were common. Notable finds included an iron cold chisel (from 1079), believed to have been utilised during construction as a brick bolster, and an early gun spall form of gun flint (from 1077), in common usage to the early years of the 19<sup>th</sup> century before this type was superseded by superior English blade flints.<sup>99</sup>

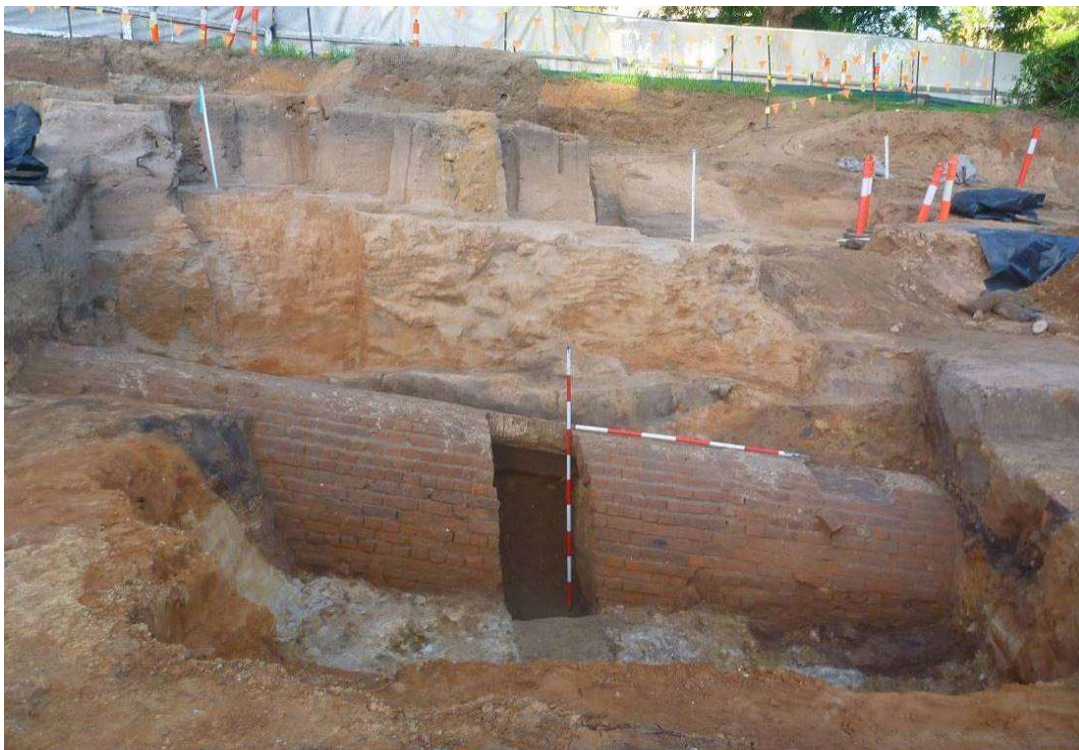
**Figure 5.25** View west showing the oviform drain within the expanded area of Sondage 3. The Phase 6 disturbance cut into the drain is seen at centre by the 2m scale and tertiary clay at base.

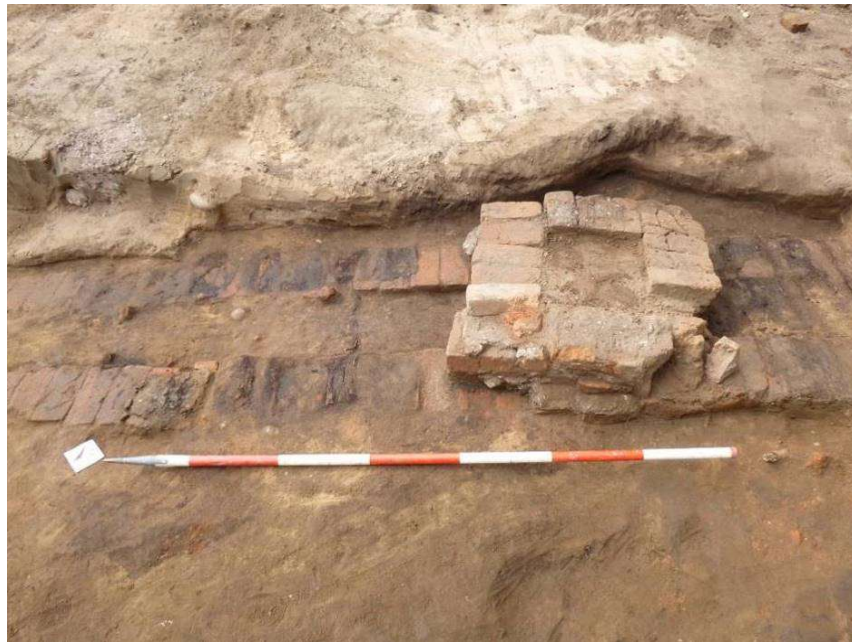
**Figure 5.27** South-east facing view of truncated brick structure 1322 resting on the western end of box drain 3 with timber board covering *in situ*.

At this western end of context 1183 (9.43m AHD), an additional feature was recorded that distinguishes box drain 3 from the other two. In grid square N17/E8, a brick square (1322) measuring 85cm by 85cm was placed over, but not keyed into, the box drain, apparently providing yet another inlet to the main drain from this point or another drain at a higher level. The inlet (1322) had been truncated, once again, by Phase 5 activity which had reduced it to just two courses of *ad-hoc* brickwork. As the pattern of box drain construction indicates that they were generally sunk less than 1m below the remediated surface, this inlet is likely to have originated at the surface and may be the base of one of a number of gully traps added to catch surface runoff and direct it into the main oviform drain.

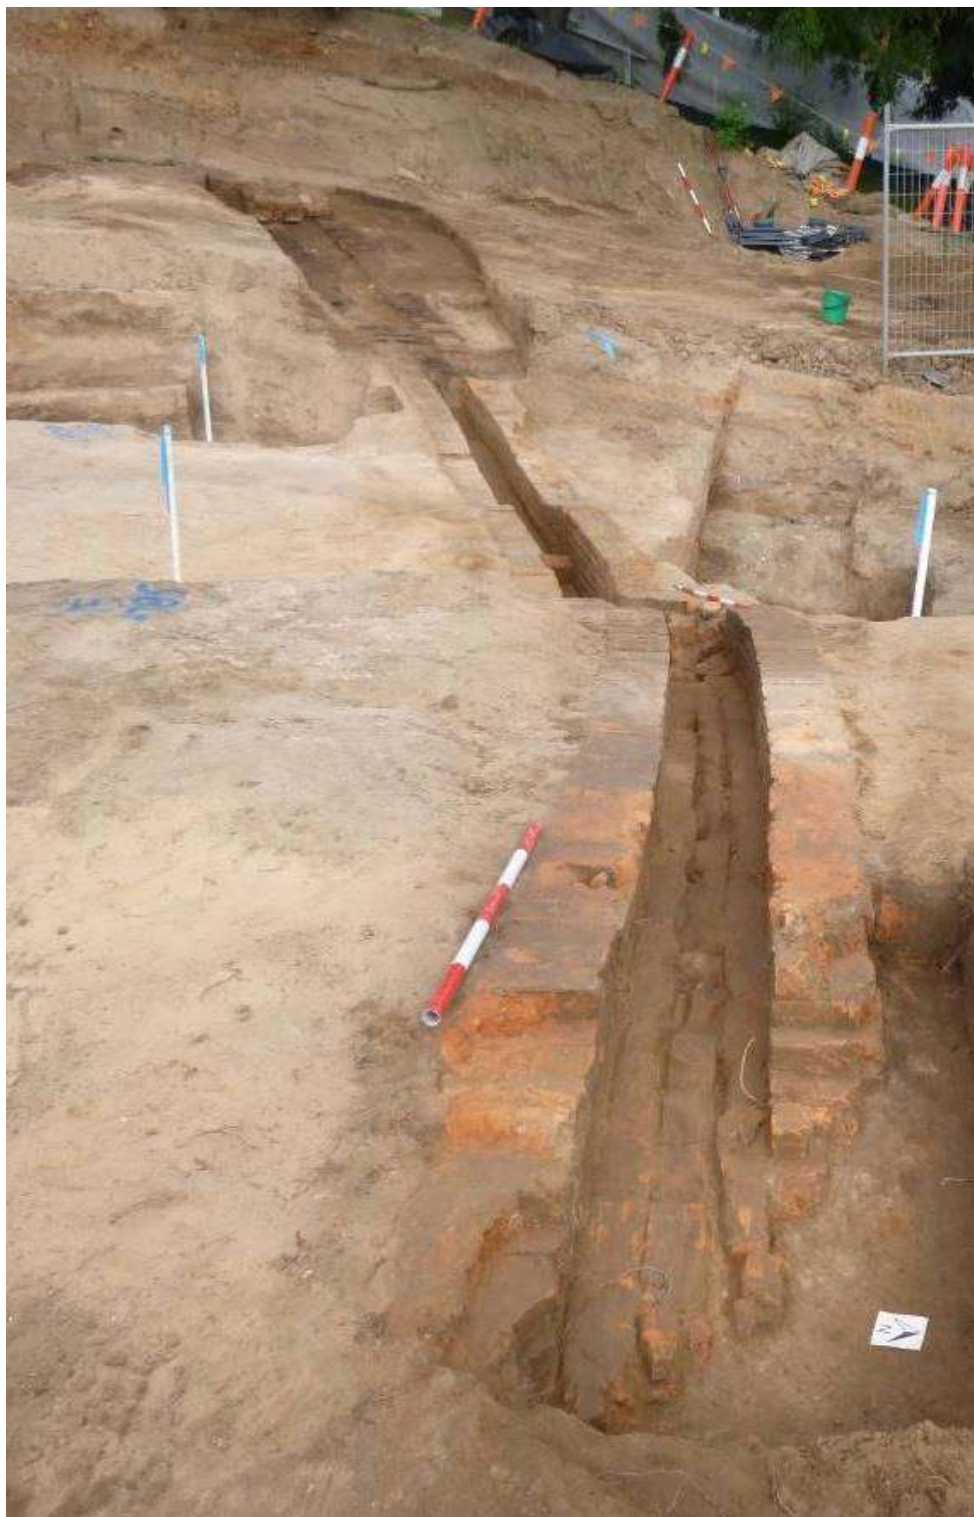
**Figure 5.28** View north-west of box drain 3 (1183) from the truncated eastern end. The two cold chisels seen in Figure 5.26 were recovered from the area next to the 1m scale.

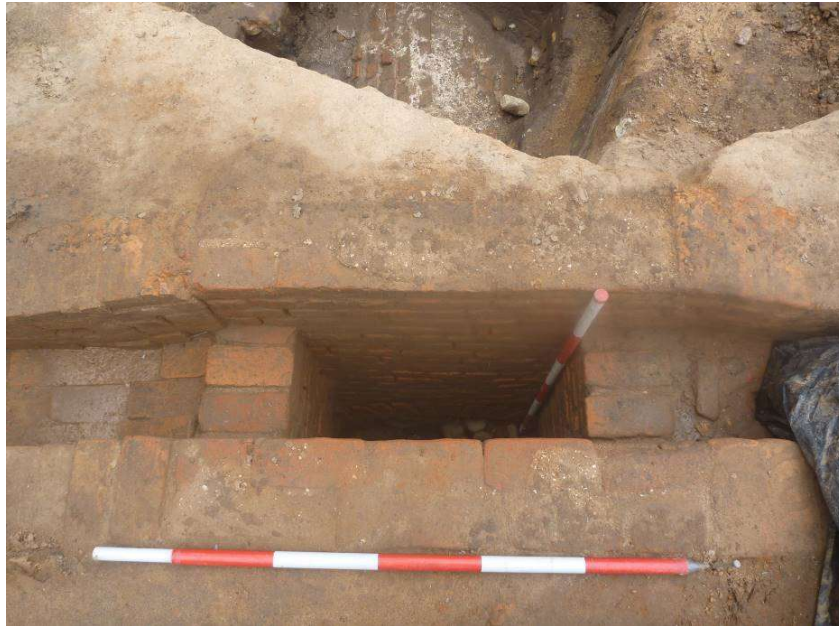
**Figure 5.29** Shaft 1217 of box drain 3 with the oviform drain seen below in Sondage 4. Note the slumping of the drain either side of the shaft. The vertical scales are 1m (horizontal) and 2m (vertical).

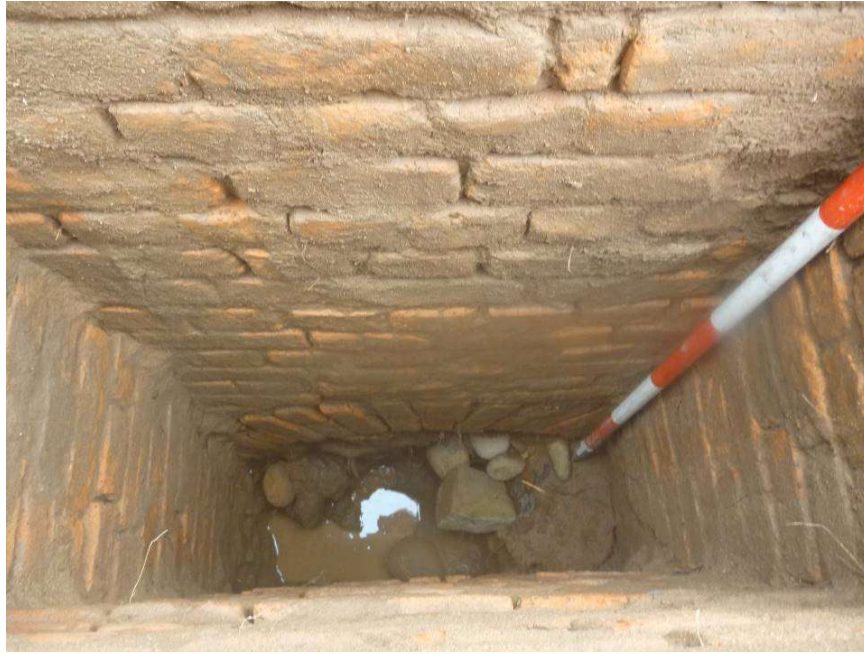
**Figure 5.30** Interior of emptied shaft 1217 with crown arch of the oviform drain visible at base.

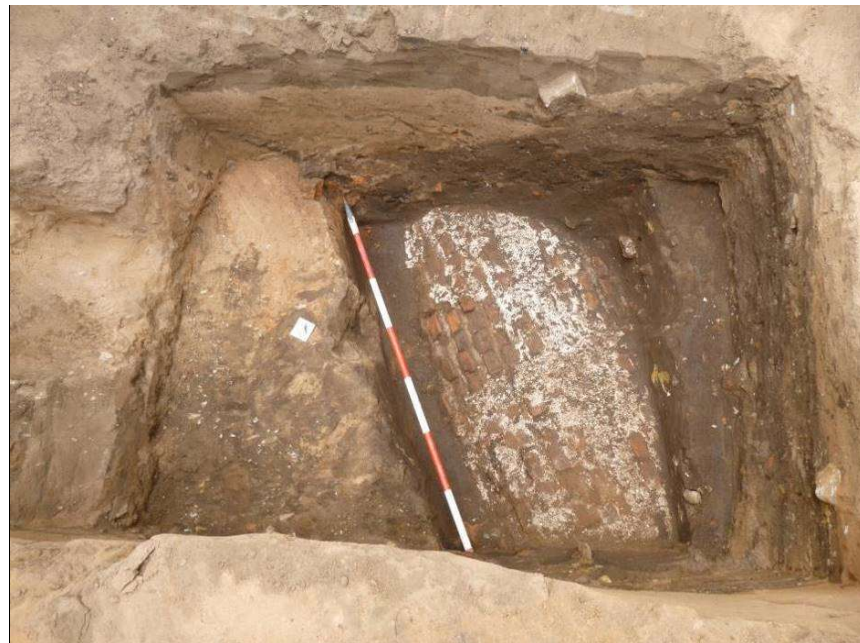
**Figure 5.31** South-facing view of the oviform drain in Sondage 4.

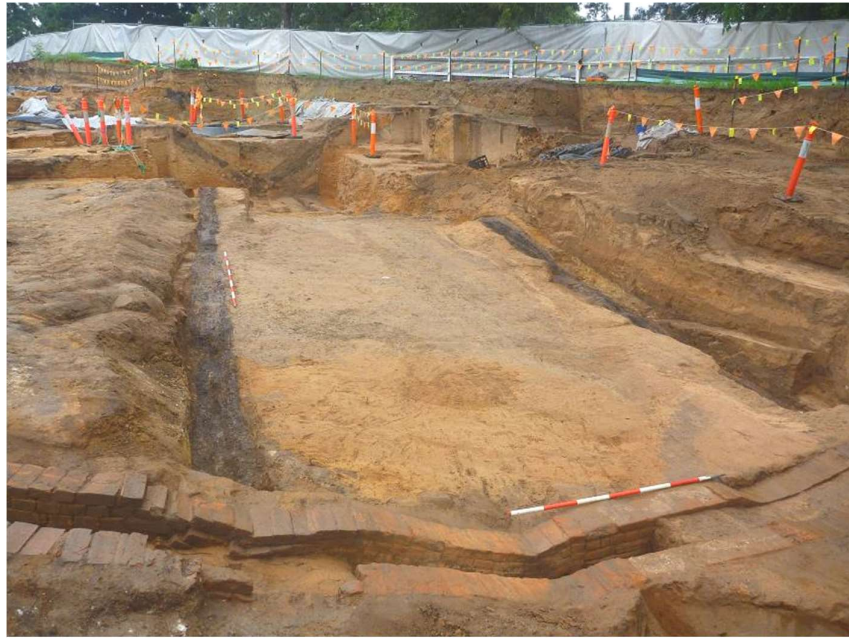
**Figure 5.33** View south-west from box drain 3 along the length of oviform trench 1106, the margins of which are delineated by timber logs 1362 (at right) and 1365 (at left).

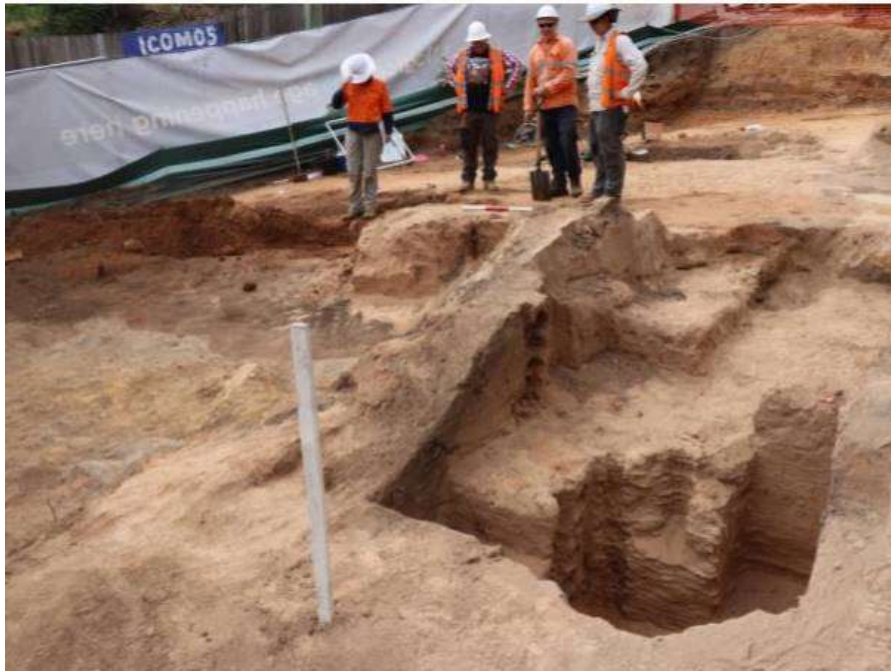
**Figure 5.34 View south-east toward the small strip of brown drain fill 1111/1117 deposited onto a sharp break of slope to the north. The area is pedestalled due to surrounding excavation of the underlying sand units by the Aboriginal team. Widespread disturbance immediately to the east (left) of this strip occurred during Phase 5.**

Almost the entire area east of sondages 3 and 4, was found to have been truncated during phases 3 and 5, removing all trace of any c.1814 ground surface that may have existed prior to construction of the drain system. This truncation began immediately east of Sondage 3, cutting through a small area of overspill of drain system fills 1111 and 1117 centred on S1-N1/E10. Enough of this remnant patch of contexts 1111 and 1117 remained to determine that these fills had been deposited onto a relatively steep 20-25% slope toward the north (**Figure 5.34**). Subsequent excavation to the north-east determined that preservation of the overspill (1119) was more widespread along the north-eastern margin of the drain trench. The continuation of fill material from the trench out onto this area indicates that the overspill remains *in situ*, however no further extent of the above-mentioned slope or historical features remained below this fill, which rested directly on level, truncated and disturbed sandy subsoil 1103, present at the time of construction. This stratigraphy was itself further truncated by extensive Phase 5 disturbance and filling from grid easting E18 to the eastern limit of excavation by Old Bridge Street.

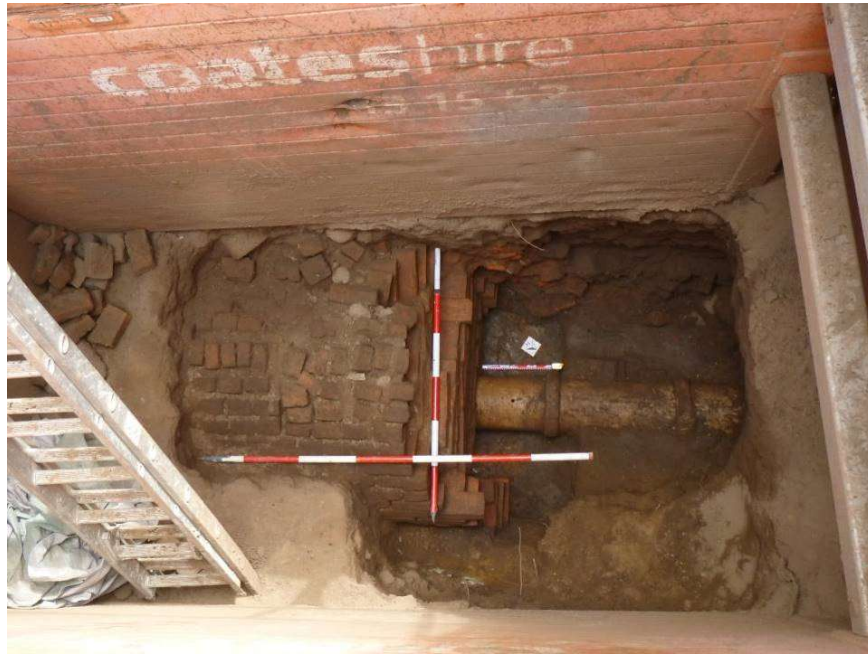
**Figure 5.35** Oviform drain 1115 as seen in Sondage 6 from ground level. The inserted earthenware pipe and headwall are visible at the terminal point. The scale spanning the drain is 1.2 metres in length.

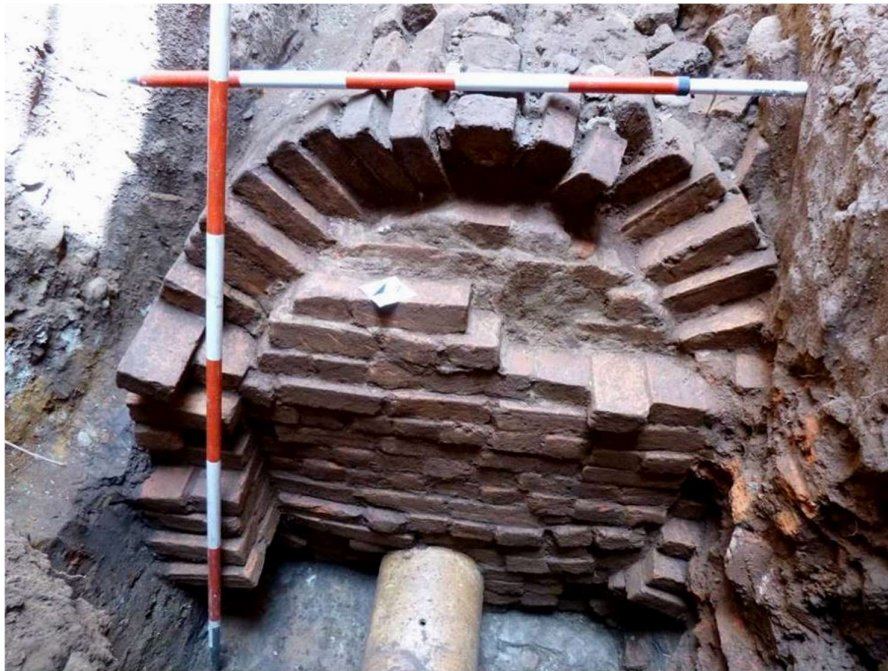
**Figure 5.36** View to the south-east of the stabilising headwall and large earthenware pipe inserted into the base of the oviform drain, constructed here with compact tertiary clay forming the base.

In Sondage 6, 4m to the north, the drain was again identified, however this sondage revealed that the drain had been accessed here at least once before during its operational life. At some stage after its initial construction, the drain had collapsed at this point and had thus become blocked. This collapse was apparent from the slumping of some of the arch headers and soldier bricks towards the north. Part of the western lower wall of the drain had also collapsed in that location. The collapse and consequent blockage had necessitated the excavation and repair of the drain at this point along its course. This repair consisted of the removal of the collapsed bricks, the insertion of a large, 27cm diameter ceramic drain pipe into the mouth of the drain and the construction of a new stabilising headwall to seal the collapse (Figure 5.36). Interestingly, the drain in this location does not form a complete oval, as the lower courses rest on compact tertiary clay at base. A removed section of the inserted pipe confirmed it is of a non-vitreous earthenware fabric more commonly utilised during the mid-19<sup>th</sup> century. However, the dark yellowish patent cement mortar used in the headwall is consistent with a late 19<sup>th</sup> or early 20<sup>th</sup> century date. Given the history of severe flooding in this area, it is likely that the discharge (northern) end of the drain was of necessity rebuilt on more than one occasion due to flood damage.

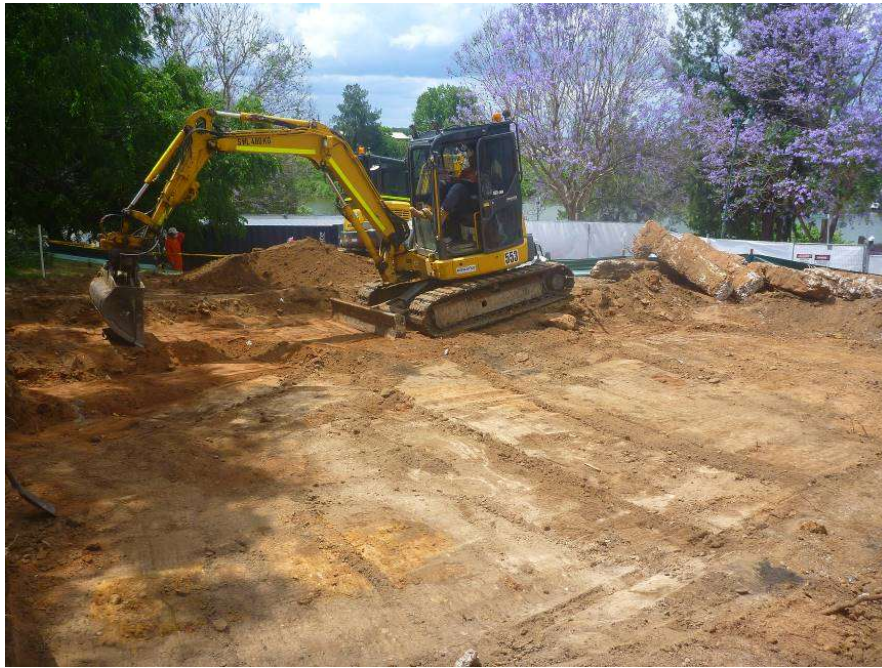
**Figure 5.37** View north showing the initial exposure of the lighter grey-brown Phase 4 fill deposit 1014 that denoted the level of 19<sup>th</sup> century lower Thompson Square.

From 1816 until the construction of Windsor Bridge from 1874, fill 1014 formed the ground surface or near ground surface over at least the area recorded (45m<sup>2</sup>). Over the course of the excavation it was established that deposit 1014 and the upper Phase 3 fill deposits associated with either end of box drain 3 had been truncated during Phase 5 and that further erosion and removal of the deposit had occurred around the site, particularly throughout the eastern half of grid area 2. Numerous cuts and features within deposit 1014 were identified, however few of these contained artefacts of any dating utility and all are considered likely to have been made during Phase 5 on the basis of the site history. Of the 115 artefacts recovered (NISP), the increased presence of printed and semi-vitrified whiteware and bottle glass distinguish this deposit from subsurface Phase 3 deposit 1099 and the assemblages of Phases 2 and 3.

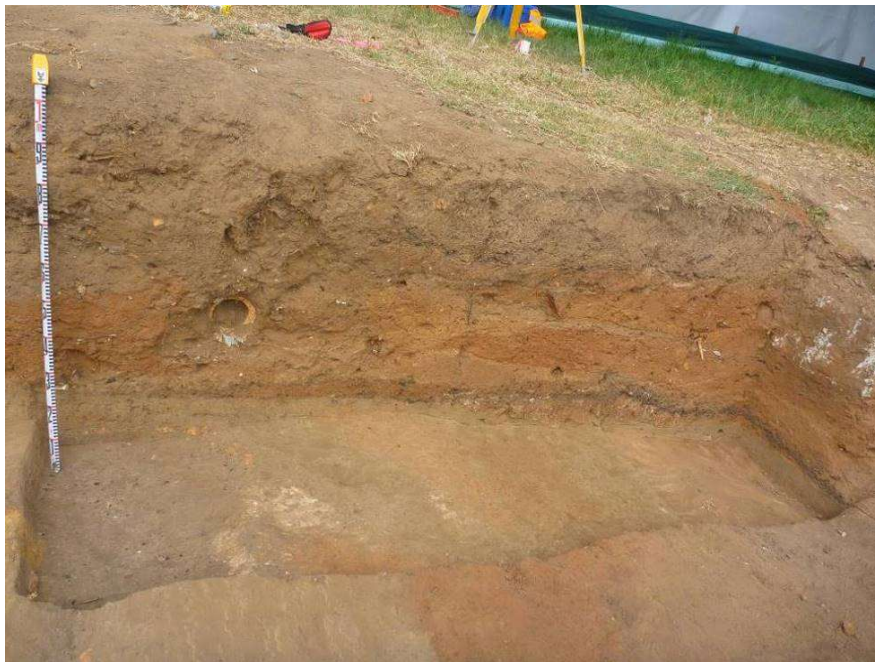
**Figure 5.38** View west showing the initial removal of Phase 4 deposit 1014, seen below the thin line of black foundry waste at right. Phase 2 historical topsoil 1067 is just showing through at left.
