# WINDSOR BRIDGE REPLACEMENT PROJECT

**PROJECT NUMBER: 190508**

Salvage Excavation Report - Area 1 – Historical Archaeology

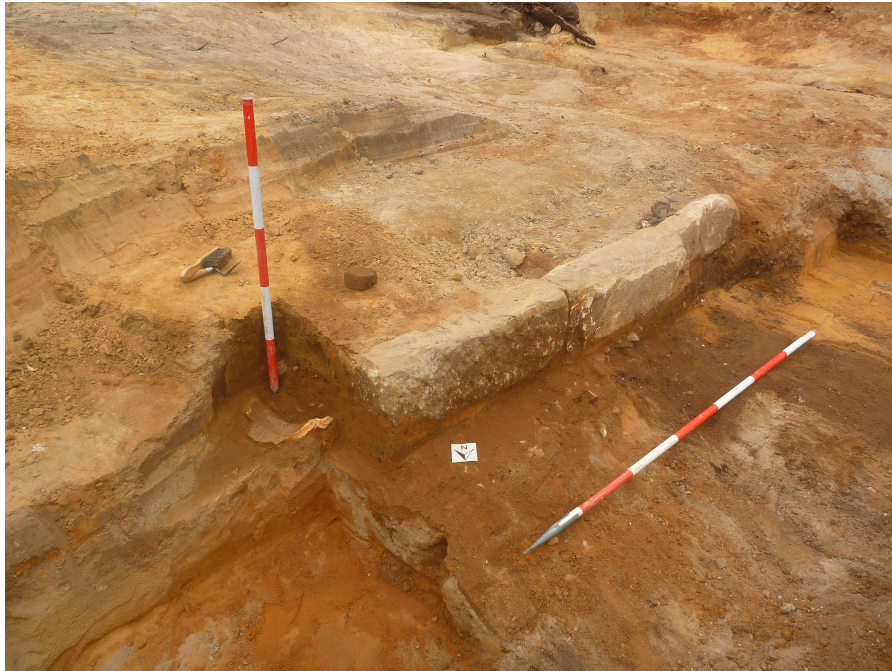
**Figure 5.39** South facing view of sandstone kerbstones or trench lining blocks 1152 for vitreous ceramic pipe 1153.

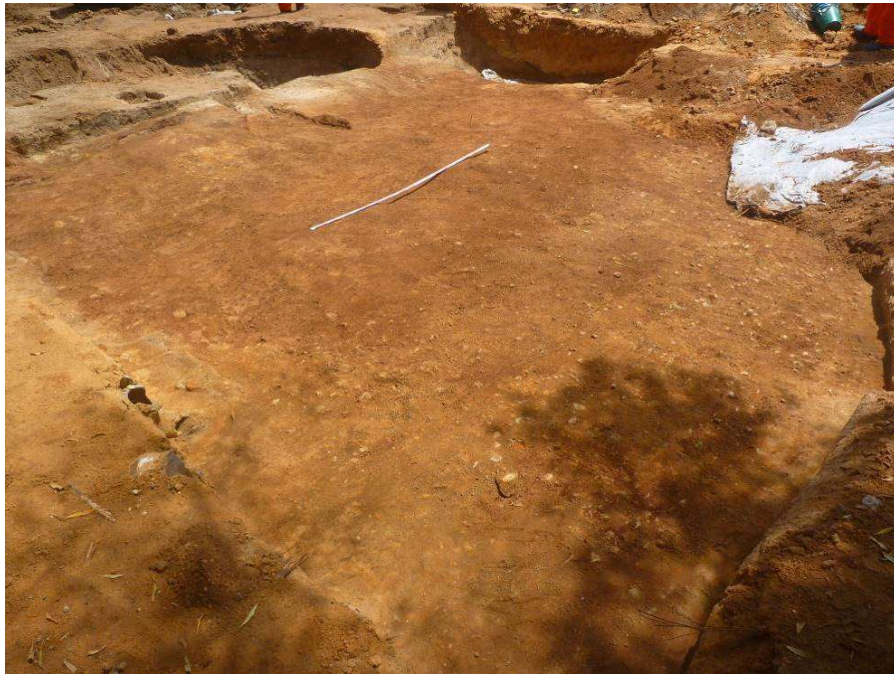
**Figure 5.40** View north over road surface 1045/1034 during excavation.

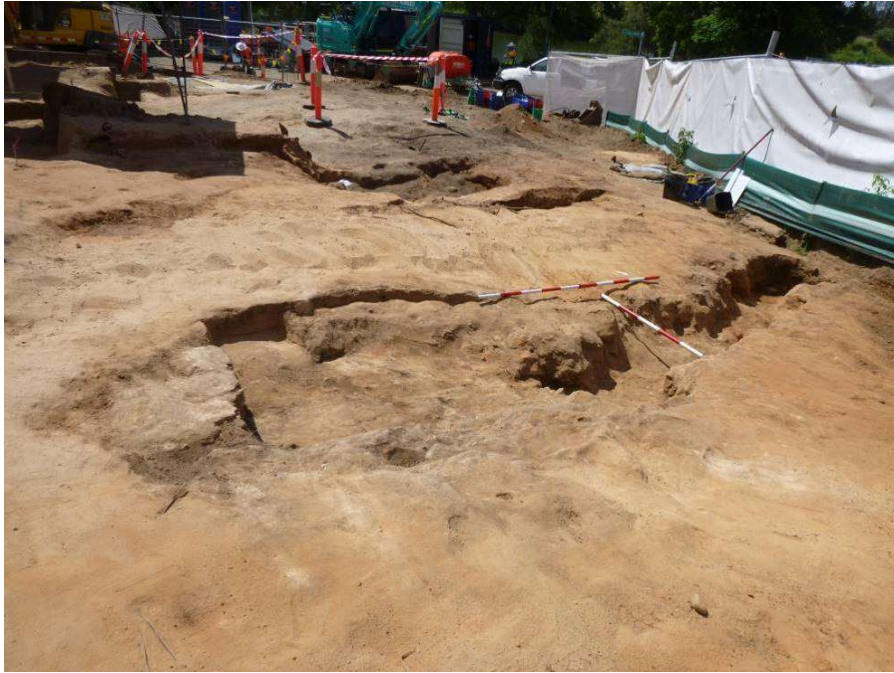
**Figure 5.41** View north of one of several possible scoured out ruts within the lower eastern end of road surface 1046. Fill material is visible to the north in the background

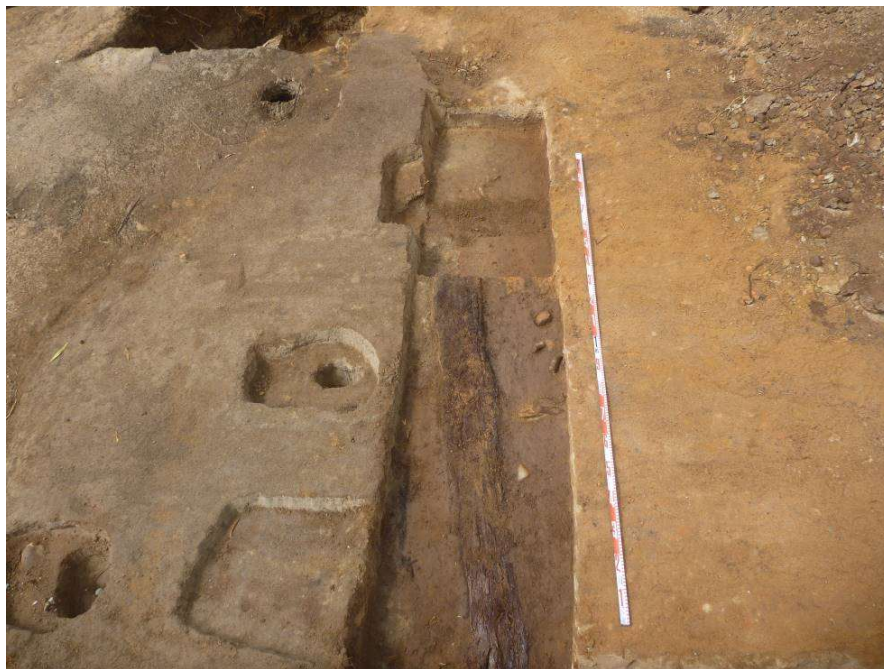
**Figure 5.42** Fenceline postholes 1018 and 1020 and a possible timber fence rail against the northern edge of road cutting 1035 in grid square S2/E4. These features were buried by fill deposit 1006 (right) c. 1934.

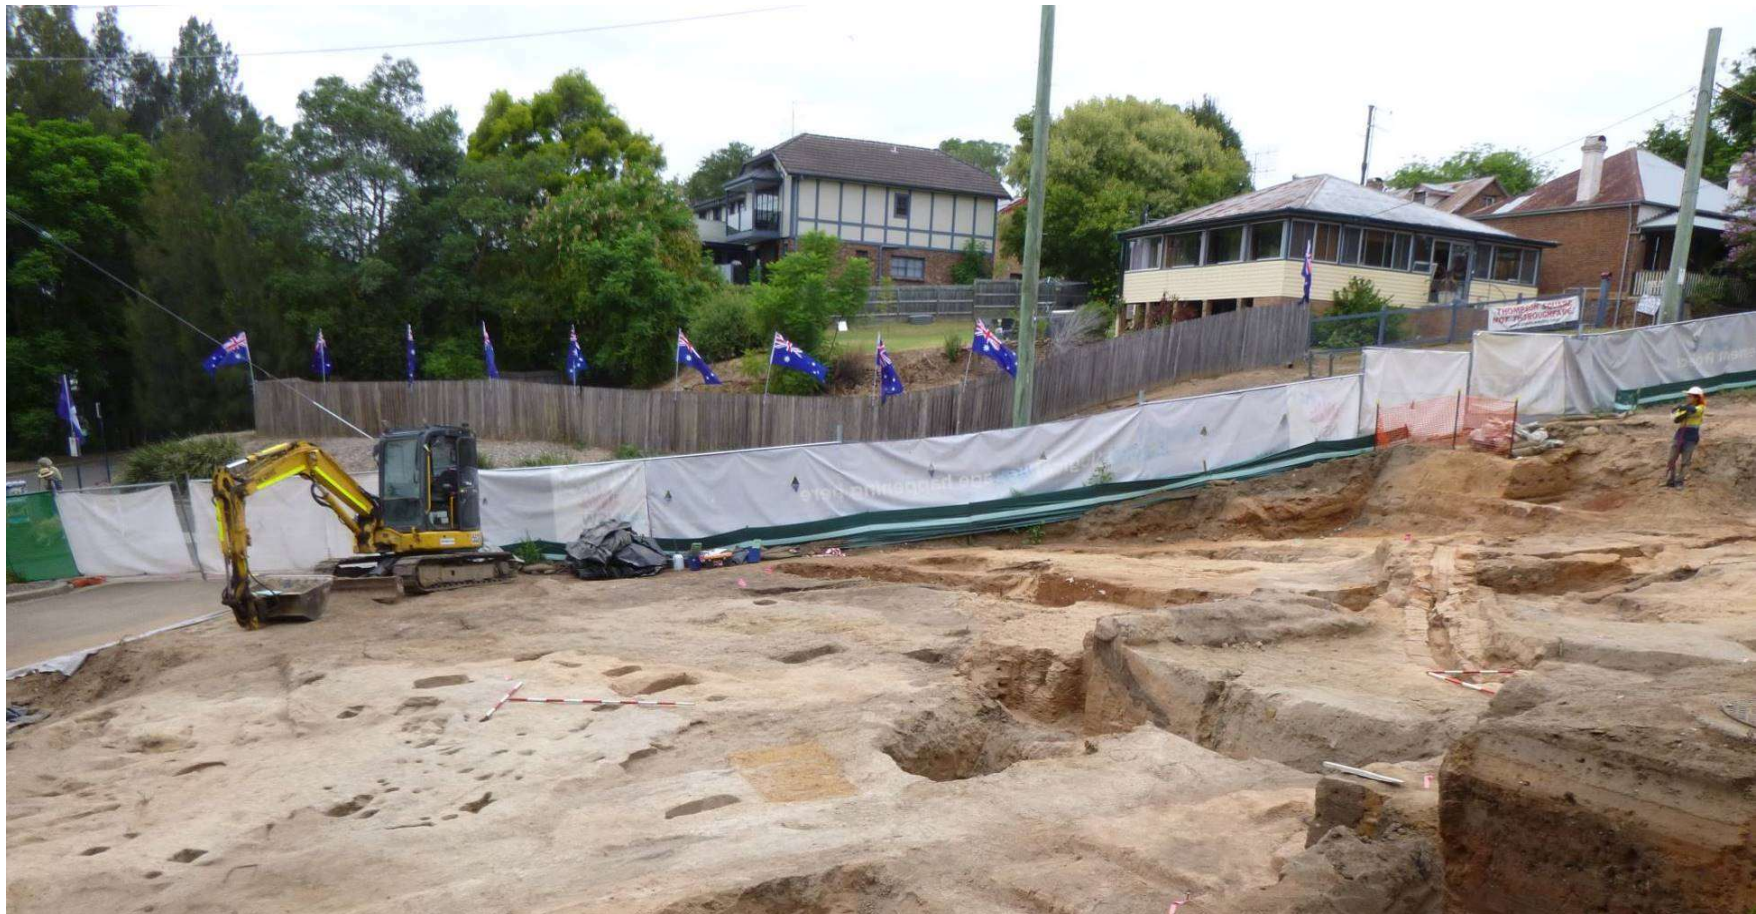
**Figure 5.43** View east over the impacts of Phase 5 in grid area 2. From left are: scattered postholes, shallow cuts and tree roots by the scales; at centre right of the excavator is dark humic bulk material filling the eroded margin of the converging roads; and at right the orange-tan base of road cutting 1035 and truncated box drain 2. From the oviform drain trench edge seen beside box drain 2 it can again be seen that the original terrain was sited at a higher elevation.

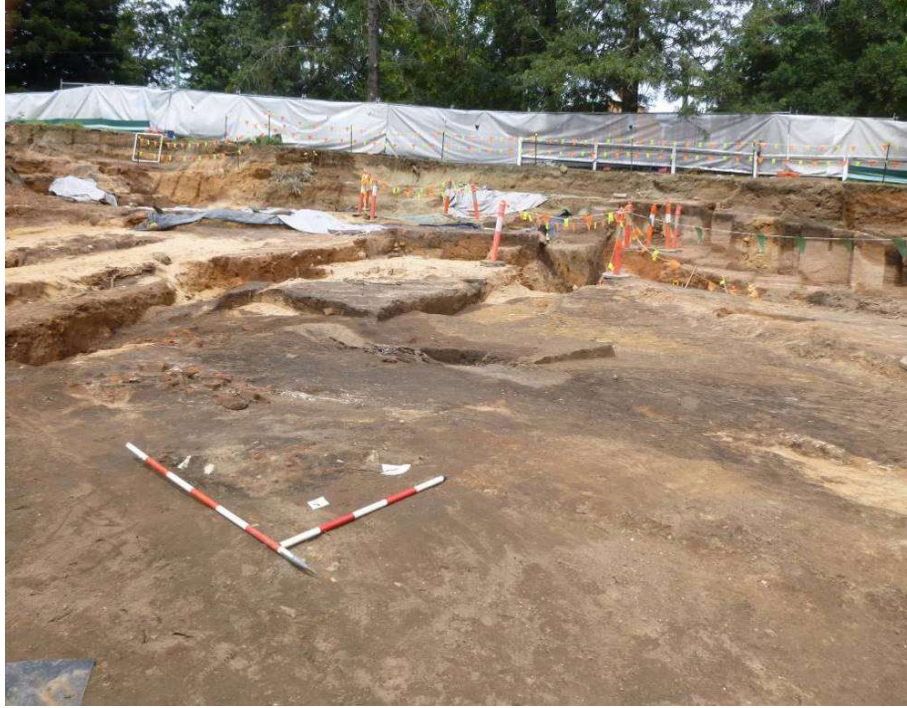
**Figure 5.44** View south-west across Phase 5 disturbance deposits 1229, 1351, 1328 and 1338. This entire area was found to contain late 19<sup>th</sup> century cultural refuse to the truncated natural sand below, including vitrified whiteware and imported stoneware seen framed by the scales.

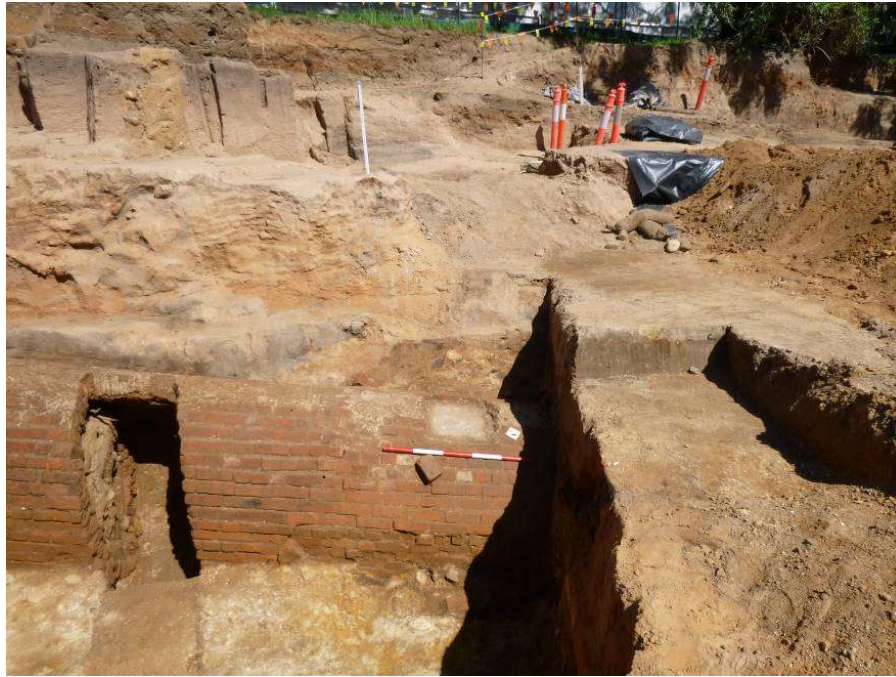
**Figure 5.45** View west showing the impacts of modern Phase 6 pits 1242 and 1264 to the oviform drain. The subsurface line of the 1937 sewer main is seen to be directly below 1242 at left. The third of these pits is seen at top left, with no trench cut visible in the intervening natural sand.

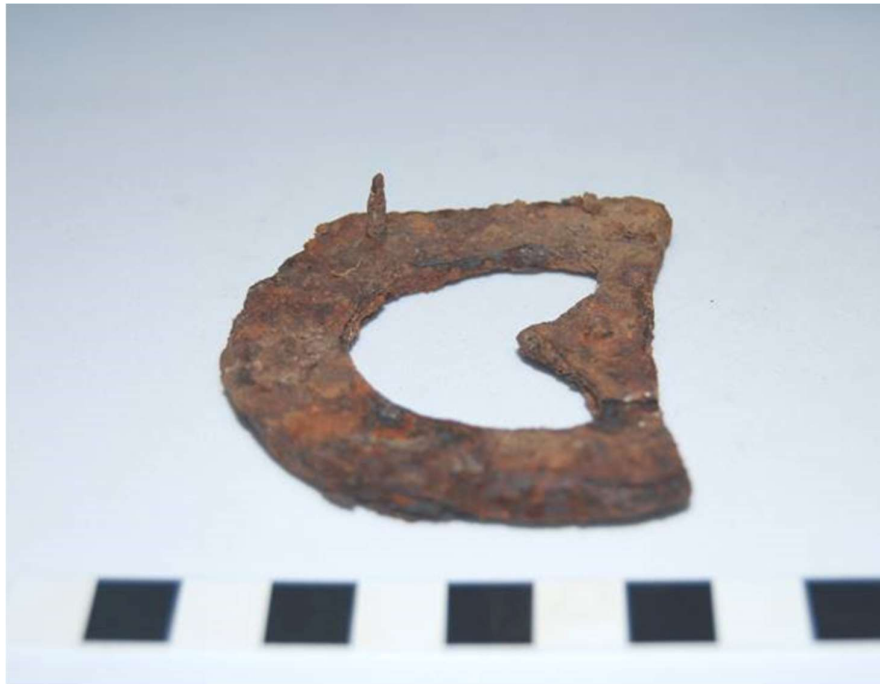
**Figure 6.34** Iron boot heel plate with hobnails recovered from Phase 3 context 1119.

The next most frequent category, clothing, was made up of eight buttons (Table 12) and one iron boot heel-plate with two hobnails in place (Figure 6.34). Of the buttons, six were one-piece copper alloy buttons representing various forms of die-cut and stamped manufacture common to the 18<sup>th</sup> and early 19<sup>th</sup> centuries (Figure 6.35).<sup>141</sup> These lacked decoration of any kind and were fixed to clothing via separate wire shanks attached via a flux to the back of the flat, pressed or domed button. At least four buttons were gilded, a form of decoration that in America is associated with the 'golden' age of buttons after 1820 but which had been perfected in Britain during the late 18<sup>th</sup> century.<sup>142</sup> A single back-plated, gilded and decorated example was recovered with a stamped back plate inscription referencing the gilding and a front face relief depicting nested birds supported by the branch of a tree (Figure 6.36). This style of button, depicting wildfowl or animals in general, was common to hunting or livery jackets during the Georgian period.<sup>143</sup> In addition to these metal buttons, a wooden button mould, formed by turning on a lathe, was recovered from context 1105 that would have originally been faced with bone, mother of pearl or simply used 'as is' (Figure 6.37).

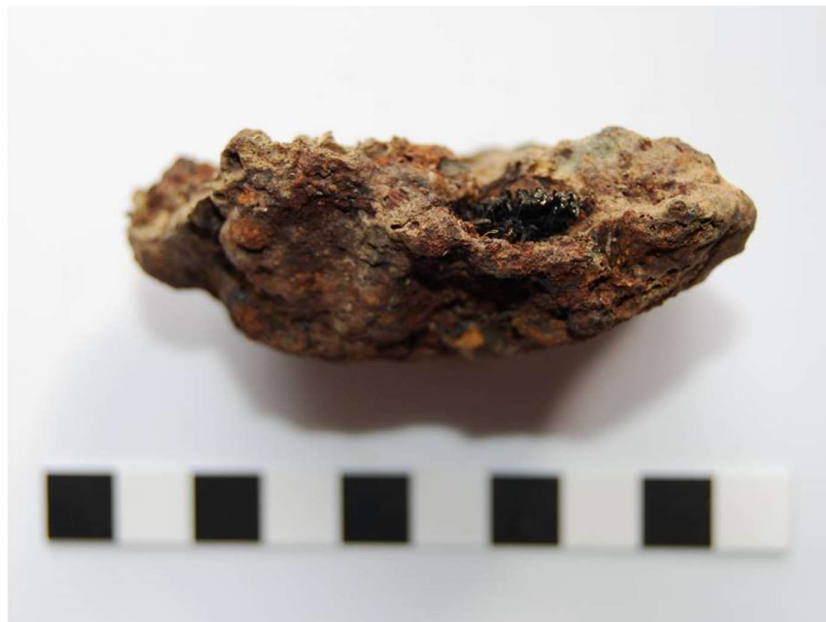
**Figure 6.38** Smithing hearth bottom sample from Phase 3 context 1118.

The Industry activity class included a mass of what is likely to be smithing hearth bottom (the bowled concretion of slag formed at the base of a blacksmith's forge hearth) with characteristic charcoal inclusions, hammerscale and convex base (Figure 6.38). Tools in this class included three hand-wrought cold chisels, one recovered from box drain 2 fill context 1079 and two from box drain 3 fill context 1366. The latter two (Figure 5.26) appear to have been produced from the same length of bar iron, both having matching width and thickness. The example from box drain 2 is slightly thinner and has a bullnose shank. The disposal or loss of these tools near two separate box drains suggests they were utilized in the construction of the Phase 3 drains as bolsters to cut and shape bricks.

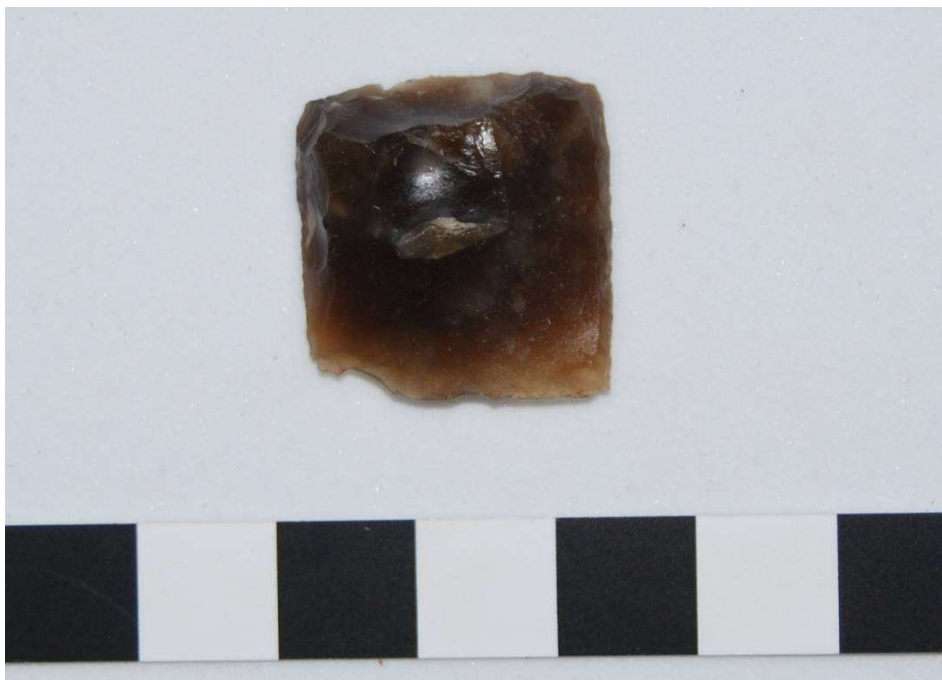
Figure 6.40 Gun spall flint recovered from Phase 3 context 1077.

The firearms activity class is made up of three gun flints, reflecting the evolution of British flints of the late 18<sup>th</sup>-early 19<sup>th</sup> centuries. This included two examples of the less efficient gun spall form, having opposing ventral faces and a single leading edge (Figure 6.40), and from context 1119 a square 'English' blade gunflint with two dorsal arrises (Figure 6.41). The former type is typically associated with the 18<sup>th</sup> century and by c.1810 was largely replaced by the superior, longer-lasting English flint formed from a knapped blade.<sup>145</sup>

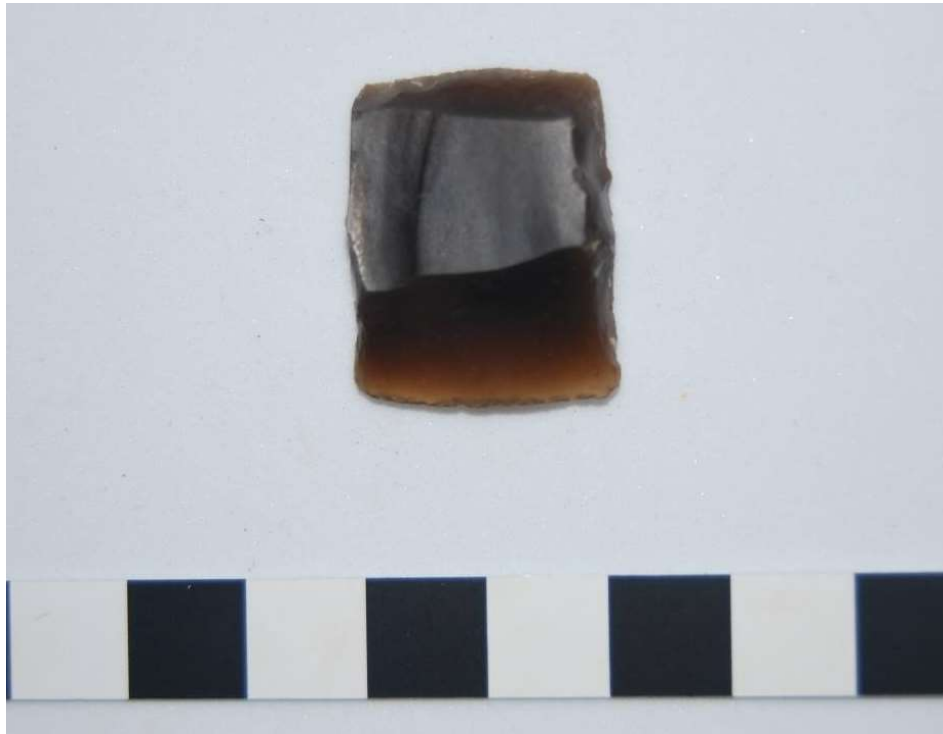
**Figure 6.41** English blade gun flint recovered from Phase 3 context 1119.

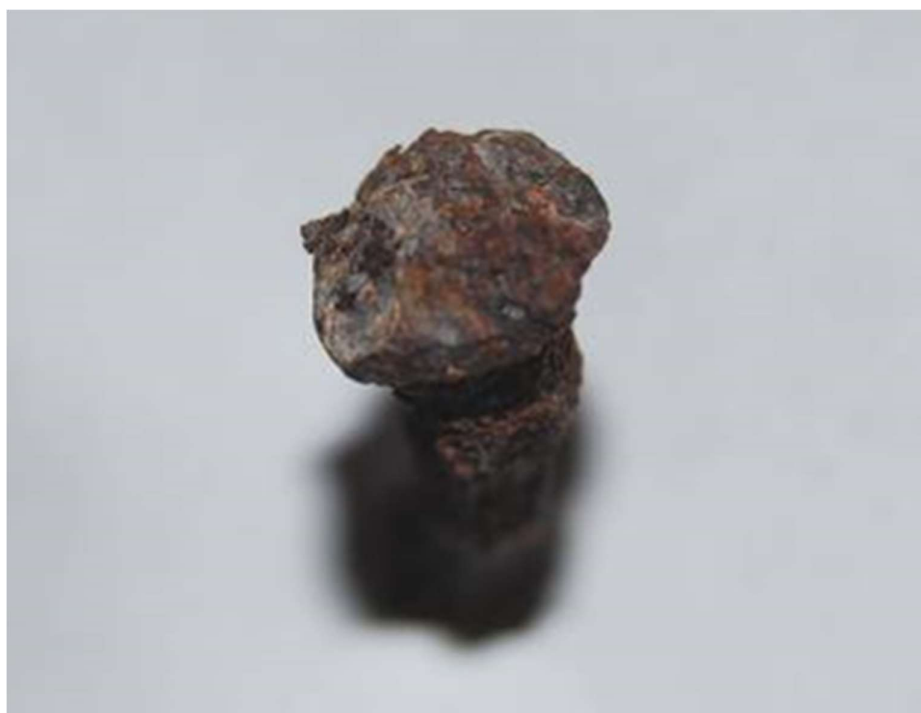
**Figure 6.43** Hand-wrought rose-head nail recovered from Phase 2 context 1067.

Construction materials formed a significant proportion of the finds recovered from phases 2 and 3. Of the total 91 MNV/MNI from Phase 2, 22 were of this class, being iron nails (MNI 18), crown window glass pane fragments (MNI 2) and sandstock brick pieces (MNI 1). Minimum estimated numbers of window glass were arrived at through separation of NISP by colour and thickness. Of the nails, seven were common nails, with clenched nails (MNI 3) being the next most common type. A single flooring brad was present, as well as a large spike, two smaller spikes and three indeterminate nail types. All were hand-wrought and the majority rose-headed (Figure 6.43).

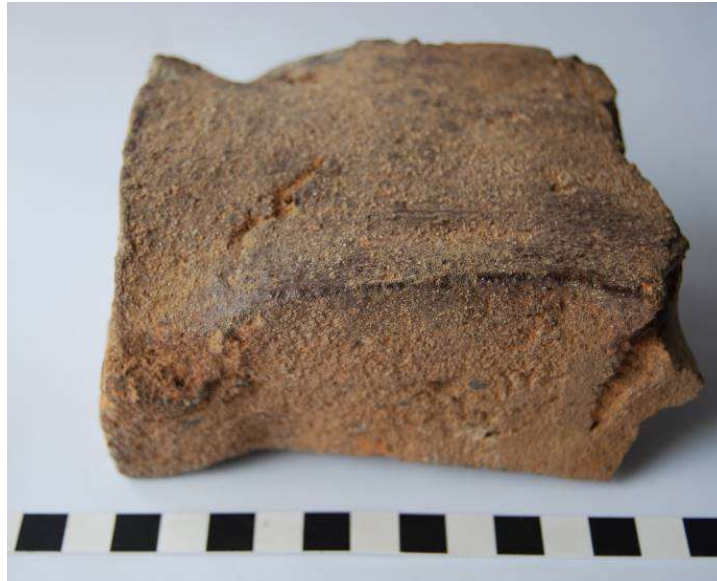
**Figure 6.45** Sandstock brick WBRHS18447 from Phase 3 context 1118.

Within Phase 3 fill deposits, a small number of bricks fragments were identified with adhered mortar, suggesting demolition of prior structures, and brick differing in composition to the drainage system fabric was identified, notably in the case of artefact WBRHS18447 recovered from context 1118; an overfired, yellow-brown brick, distorted from extraction from the mould, with a coarse sand exterior (Figure 6.45). A lump of sandstone was also identified within Sondage 3 fill deposit 1099. This had no evidence of working or shaping but was nonetheless introduced to the site and may have once formed part of a vernacular structure.

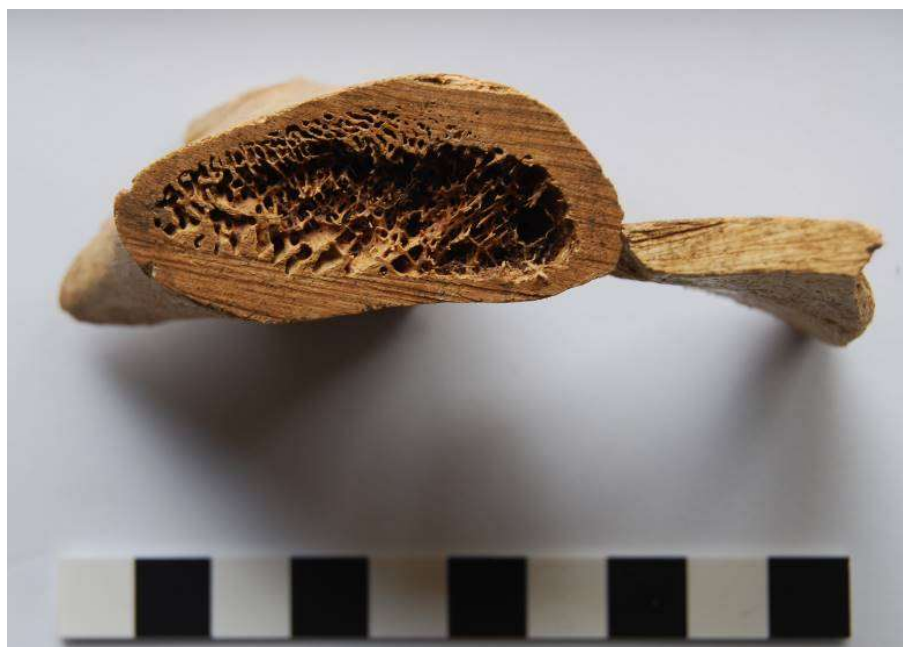
**Figure 6.47** Hacksaw marks on beef wedge and blade cut bones from context 1119.

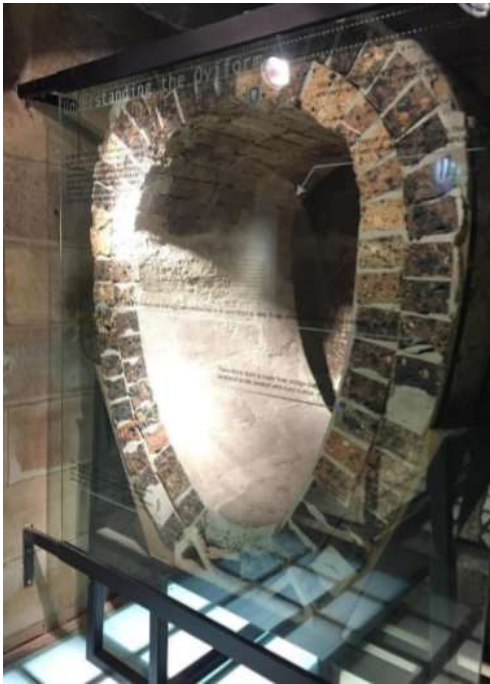
**Figure 7.2** Section of the Tank Stream oviform drain on display in the Sydney GPO.

By the late 1830s, brick barrel drains were a common feature of major public works programs. The style of construction remained a standard until the 1850s after which time civil sewerage and drainage programs employed larger drains with a range of geometries, primarily oviform and elliptical drains. In this regard the principle of the Thompson Square drain is ahead of its time, however the mid-century examples (such as the Tank Stream Channel, Sydney) were generally built in the standard of double skins of stretcher-laid brick and bonded with a strong mortar and provided with an internal sealing layer of patent cement (Figure 7.2).

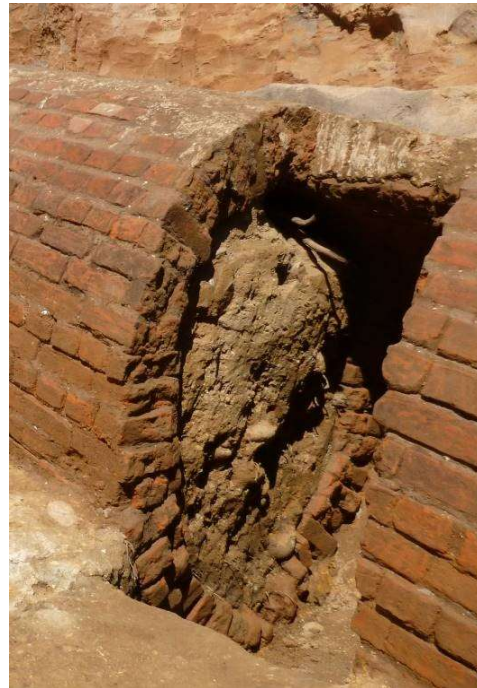
**Figure 7.3** View of the Thompson Square oviform drain showing varied coursing used.

In barrel and oviform drain construction, all courses are usually laid in stretcher bond, with the width of the drain and depth of invert determined by the expected carrying capacity in both dry-weather flow (daily discharge of effluvia without the addition of surface water) and stormwater flow. The invert of the Thompson Square drain is essentially a dish-drain that would not have operated efficiently as a sewer in dry-weather. The use of five different brick segments (stretcher invert, stretcher batter walls, stretcher arch segment from spring-line, header arch and soldier crown course) (Figure 7.1 and Figure 7.3) is a reasonable indication that the structural principles of drain construction were not well understood by the designer. The drain appears to be an attempt to construct an ovoid/ellipsoid drain without the knowledge of the geometry that provided drains of this type with strength and the ability to cope with variable flow regimes. The use of header courses for the vault is more typical of low-arched window and door heads rather than long vaults. The decision to use this form may have been driven by the designer's (in)experience or by an inability to create long sections of formwork that would allow stretcher courses to be constructed. The exemplar for this type of construction appears to be the Lady Macquarie's Road culvert constructed between 1813 and 1816.
