Escalation Sensation

Wooden Escalators at Wynyard
and Town Hall Railway Stations

Historical Report

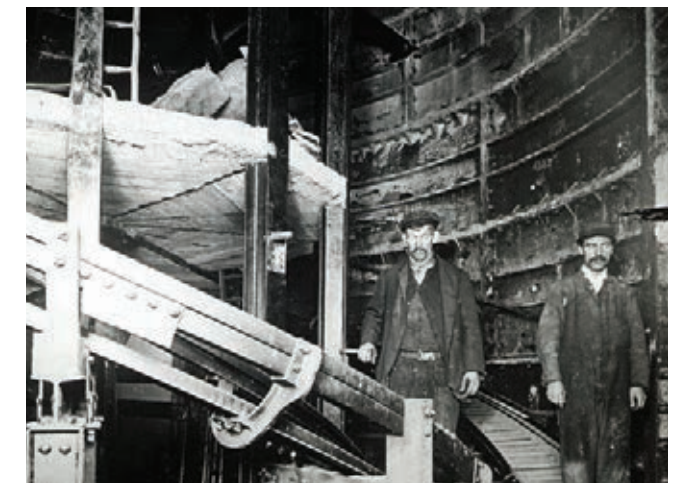
Figure 4: Two workmen stand on the double spiral. (Source: © TfL from the London Transport Museum collection). In March 1993 the remains of this walkway were found at the bottom of the lift shaft in Holloway Station, and are now in the care of London's Transport Museum depot at Acton.

Experimental prototypes were conceived for railway stations such as the first and only 'spiral' Reno escalator installed at London's Holloway Road Station in 1906. This was the earliest moving stair on the London Underground, but operated for just one day before it was deemed unsafe and was removed from service.

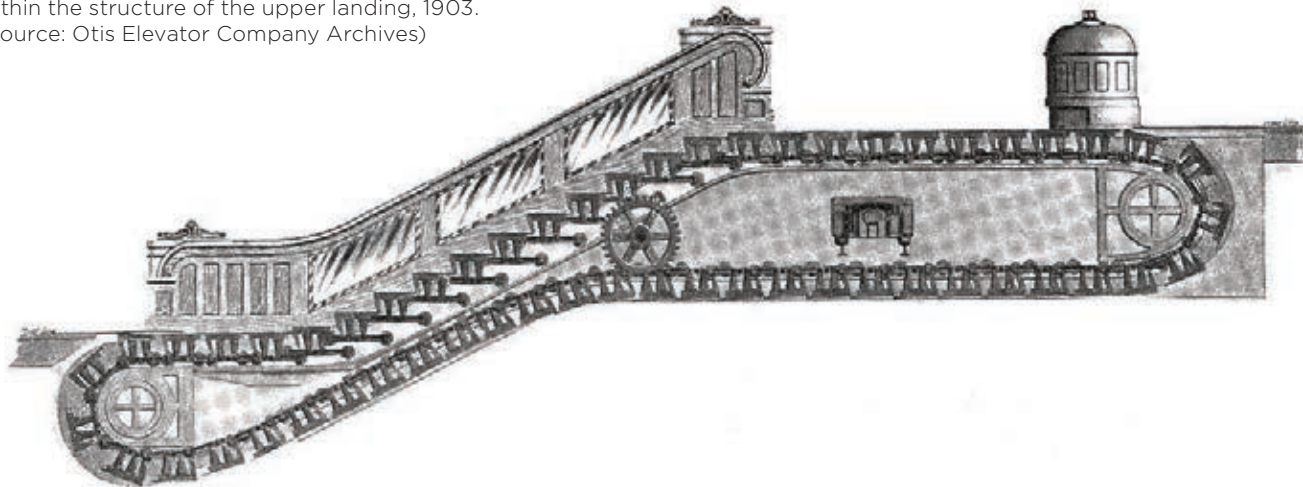
Figure 7: View of an Otis escalator, showing the circuit of steps. The driving mechanism is located within the structure of the upper landing, 1903. (Source: Otis Elevator Company Archives)

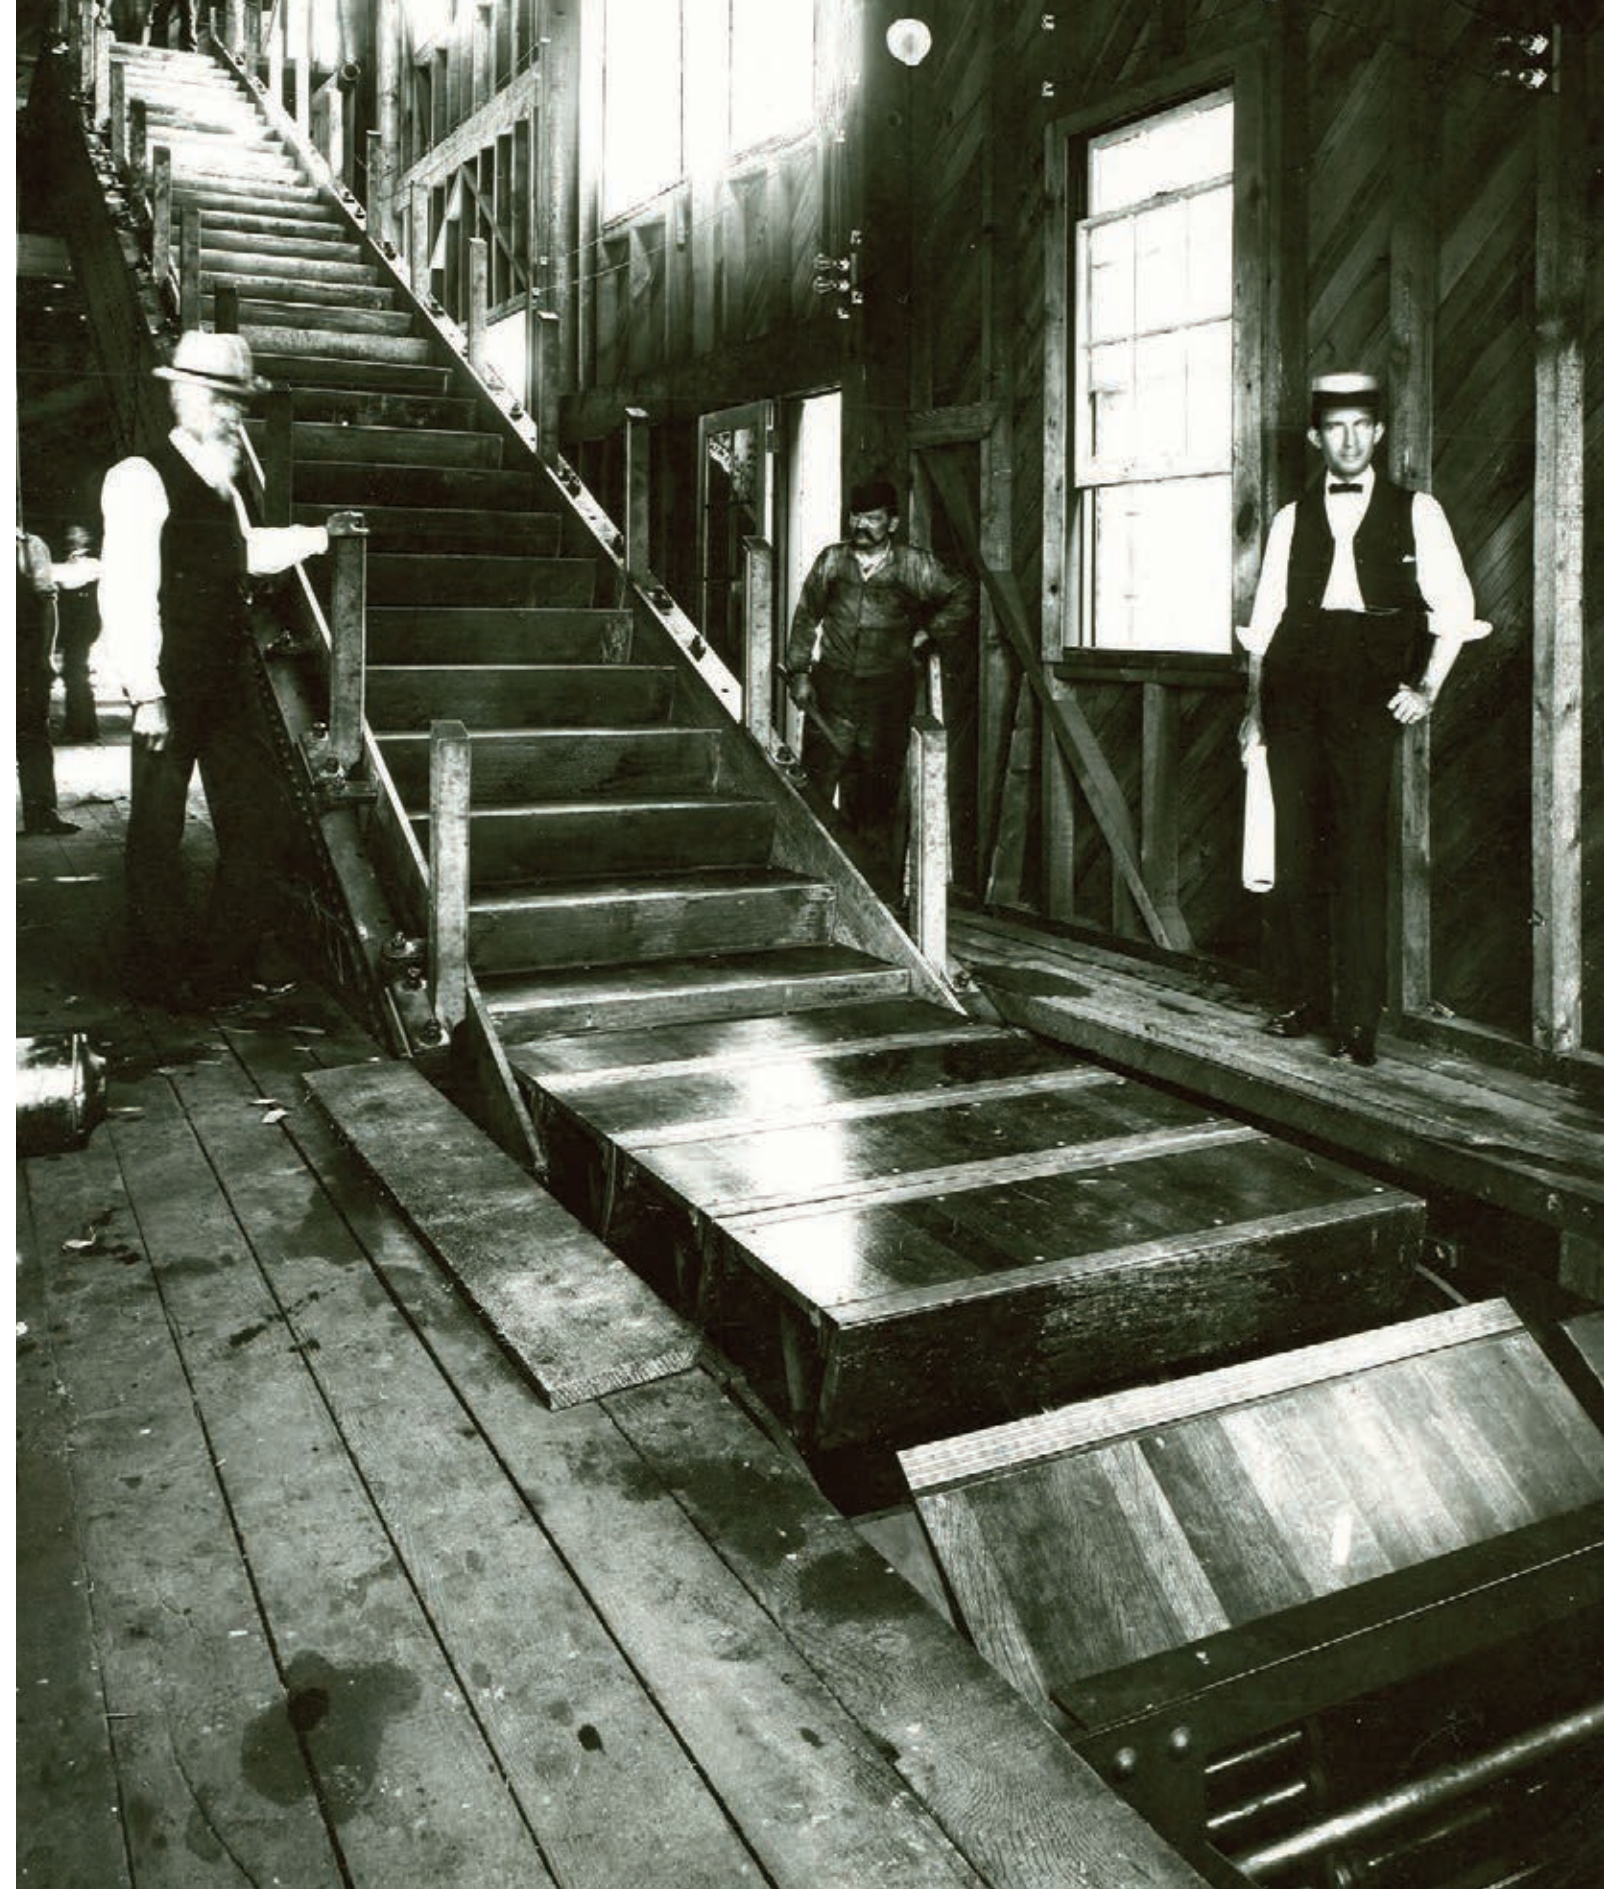
Figure 8: A flat step escalator under construction in Otis factory at Yonkers New York showing the completed treads and risers, 1899. (Source: Otis Elevator Company Archives)

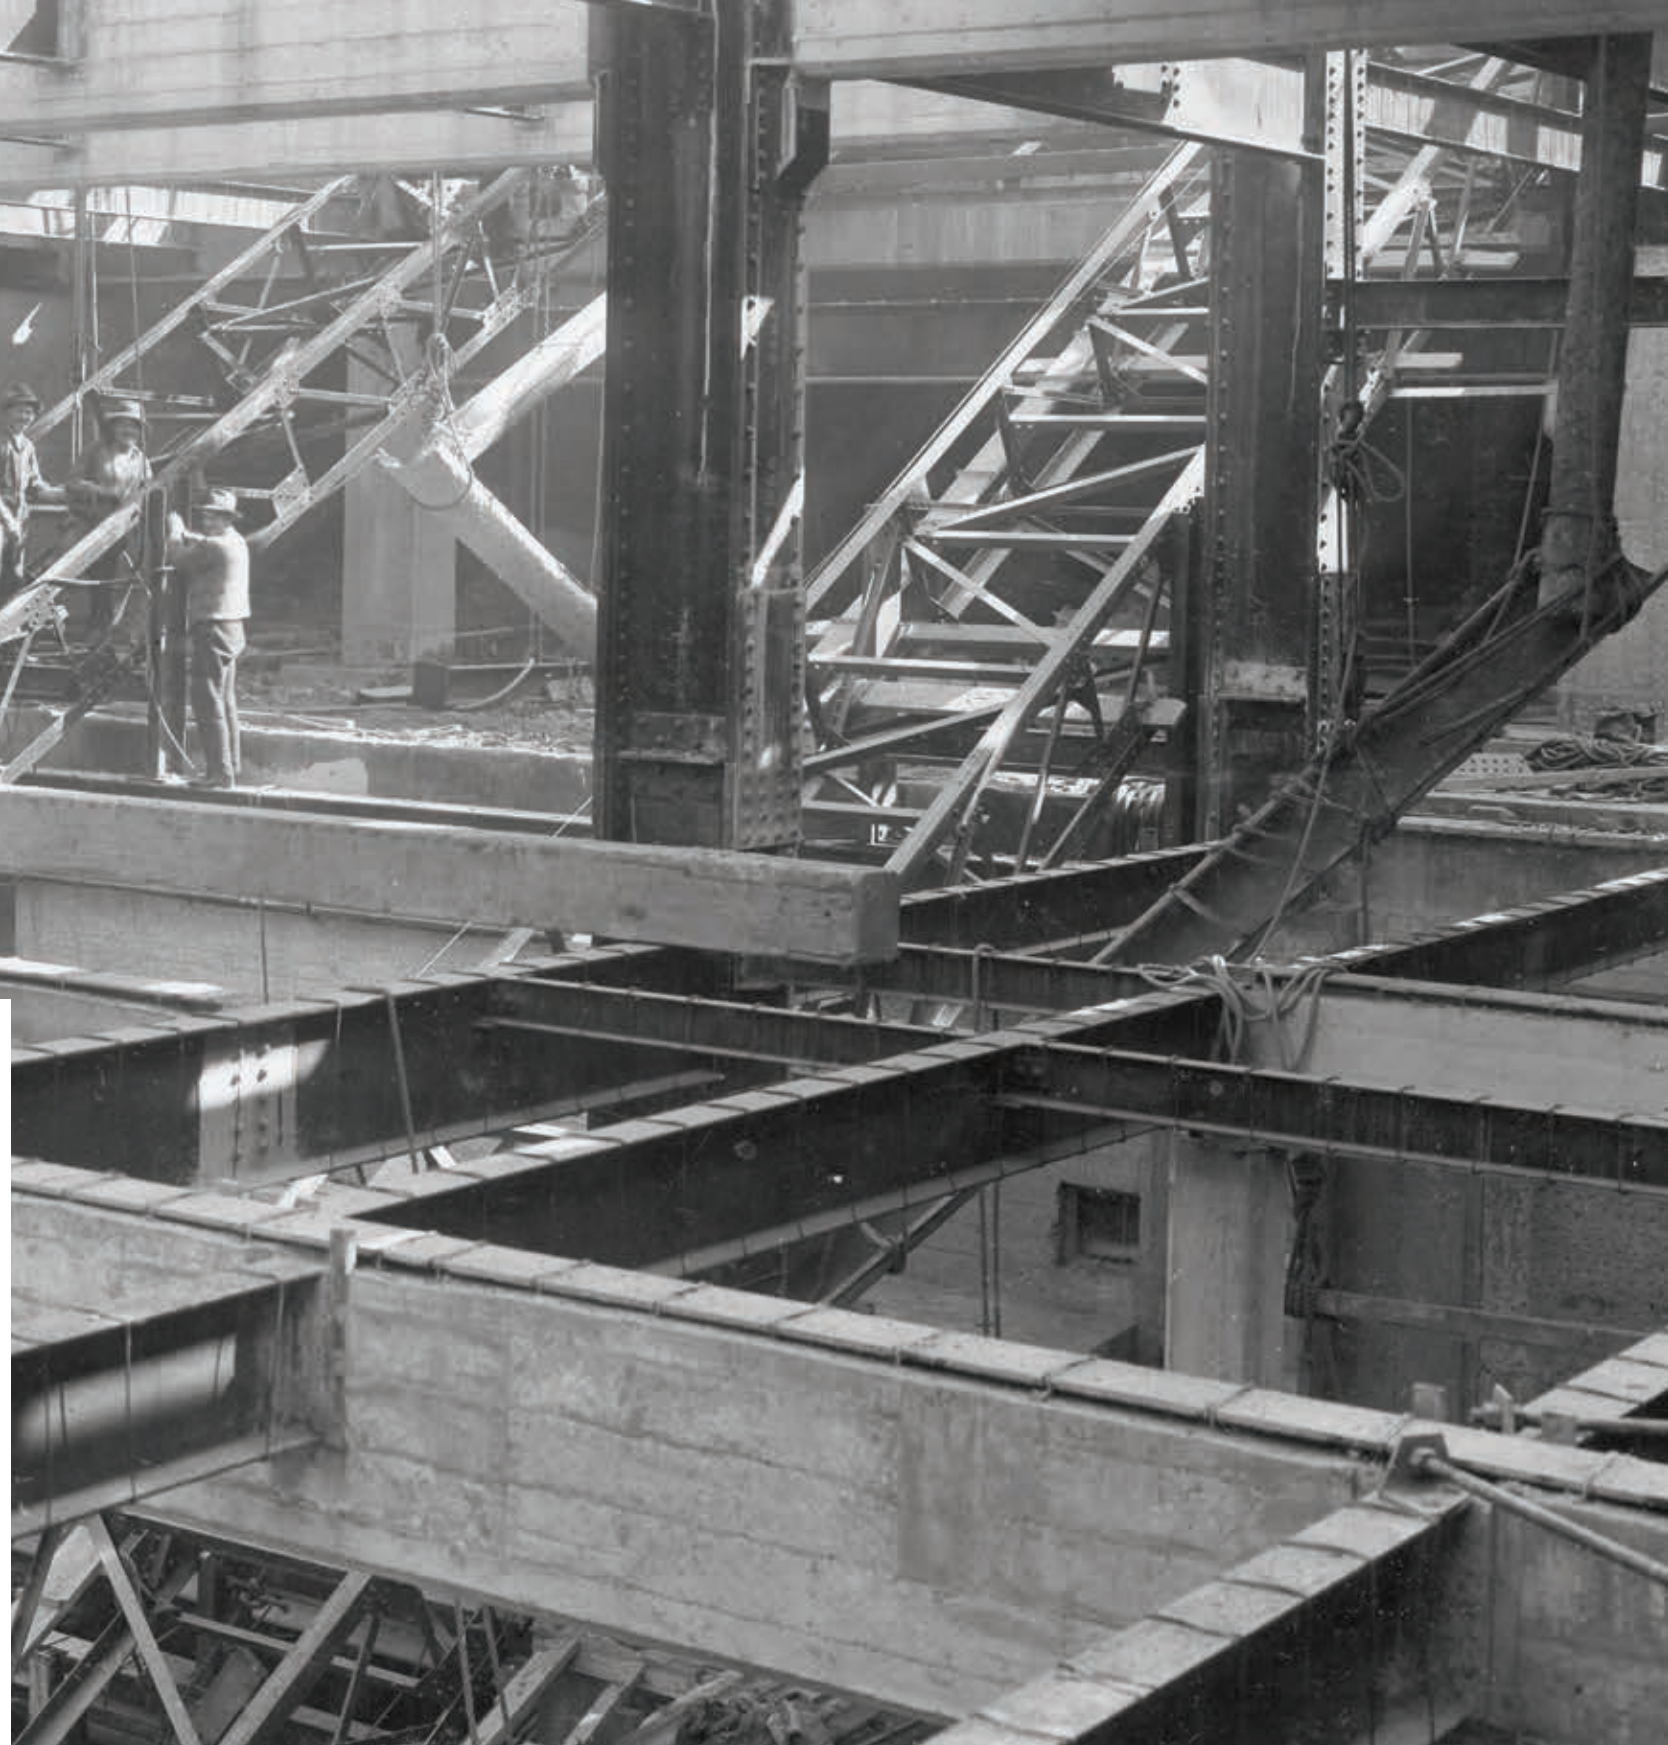
Figure 19: Installing the escalator trusses at Wynyard, August 1930. (Source: Sydney Trains)

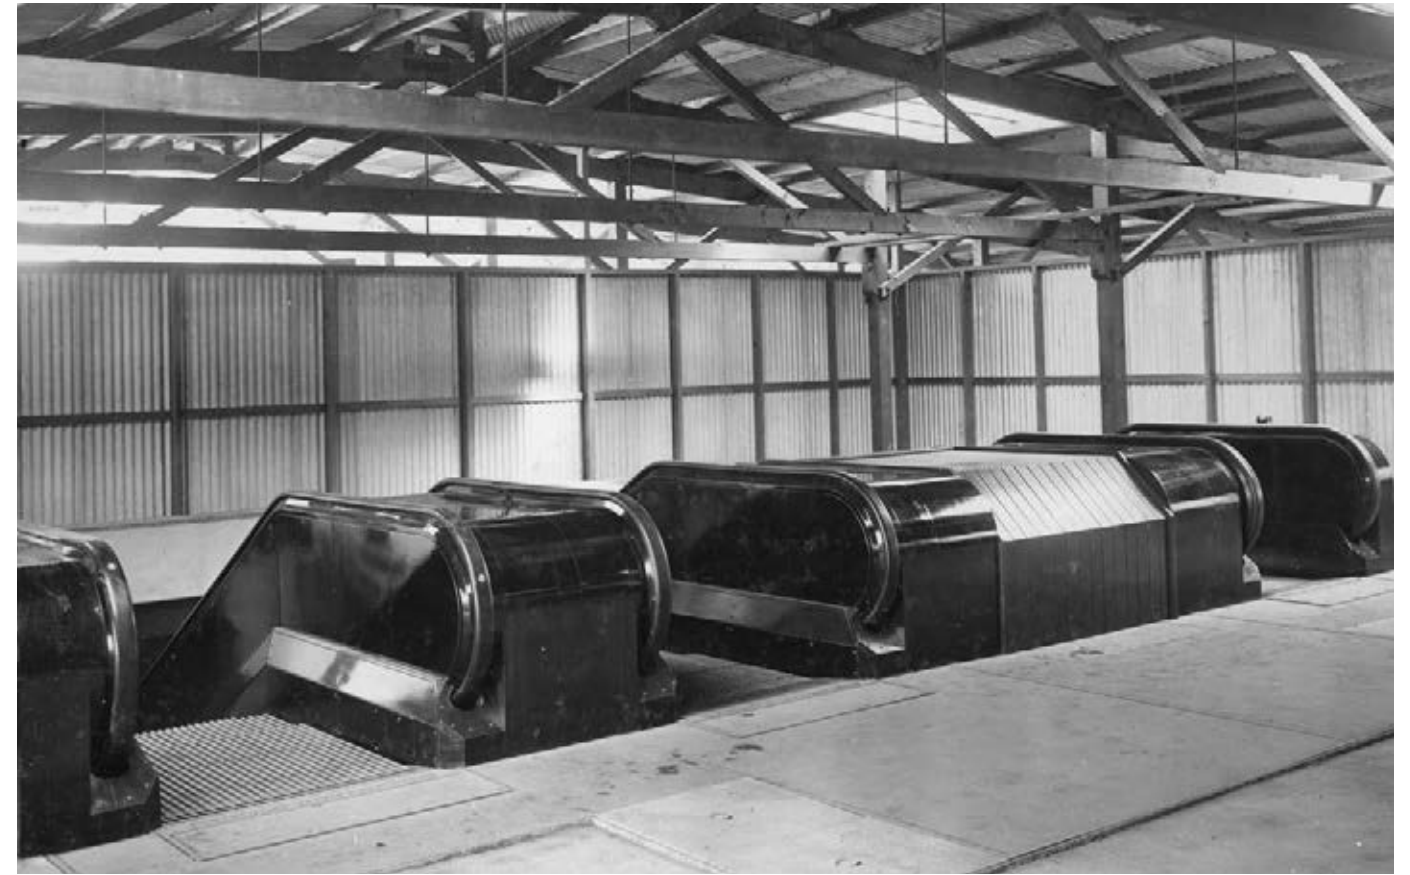
Figure 21: Wynyard Station escalators fully installed and ready for testing in 1931. Note the covered section where future capacity for a fourth escalator was provided. (Source: Sydney Trains)

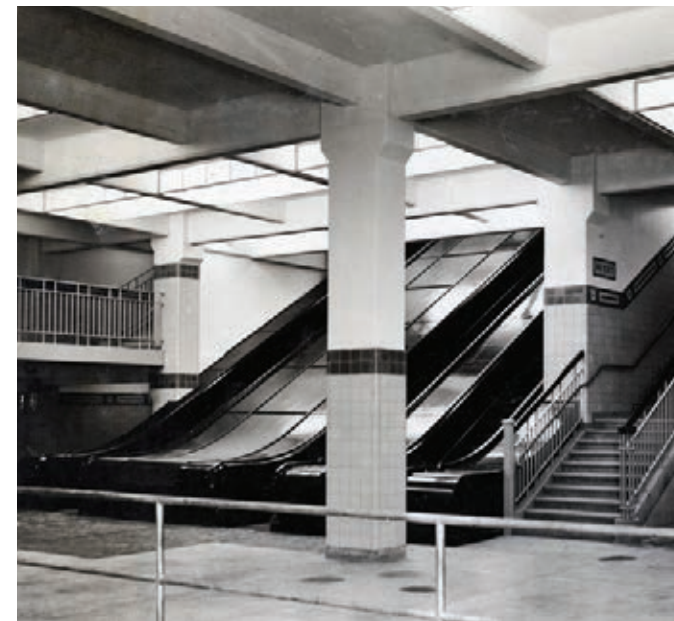
Figure 22: York Street entrance escalators to Wynyard Station just prior to the opening of the station in 1932. The station finishes are now complete. Note the set of stair either side of the escalator bank, which provided extra capacity for peak hours and as a back-up exit in case of emergency. (Source: State Archives and Records NSW 12685_a007_a00704_8722000031r)

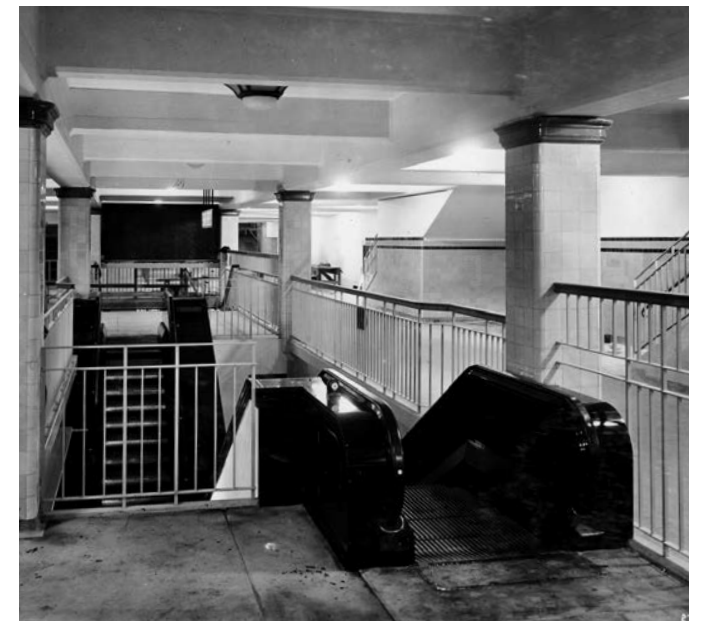
Figure 23: View of the Town Hall escalators from the concourse to platform 6 in a crossover pattern just prior to the station opening in 1932. (Source: State Archives and Records NSW. 12685_a007_a00704_8735000046r)

At Town Hall, escalators were necessary to serve the lowest level of platforms, then being Platform 6. Their rise equalled 11.5 metres. The design could accommodate four escalators, but only two were originally installed in a criss-cross formation. None were installed to access the station or concourse from the street level as it was too shallow.

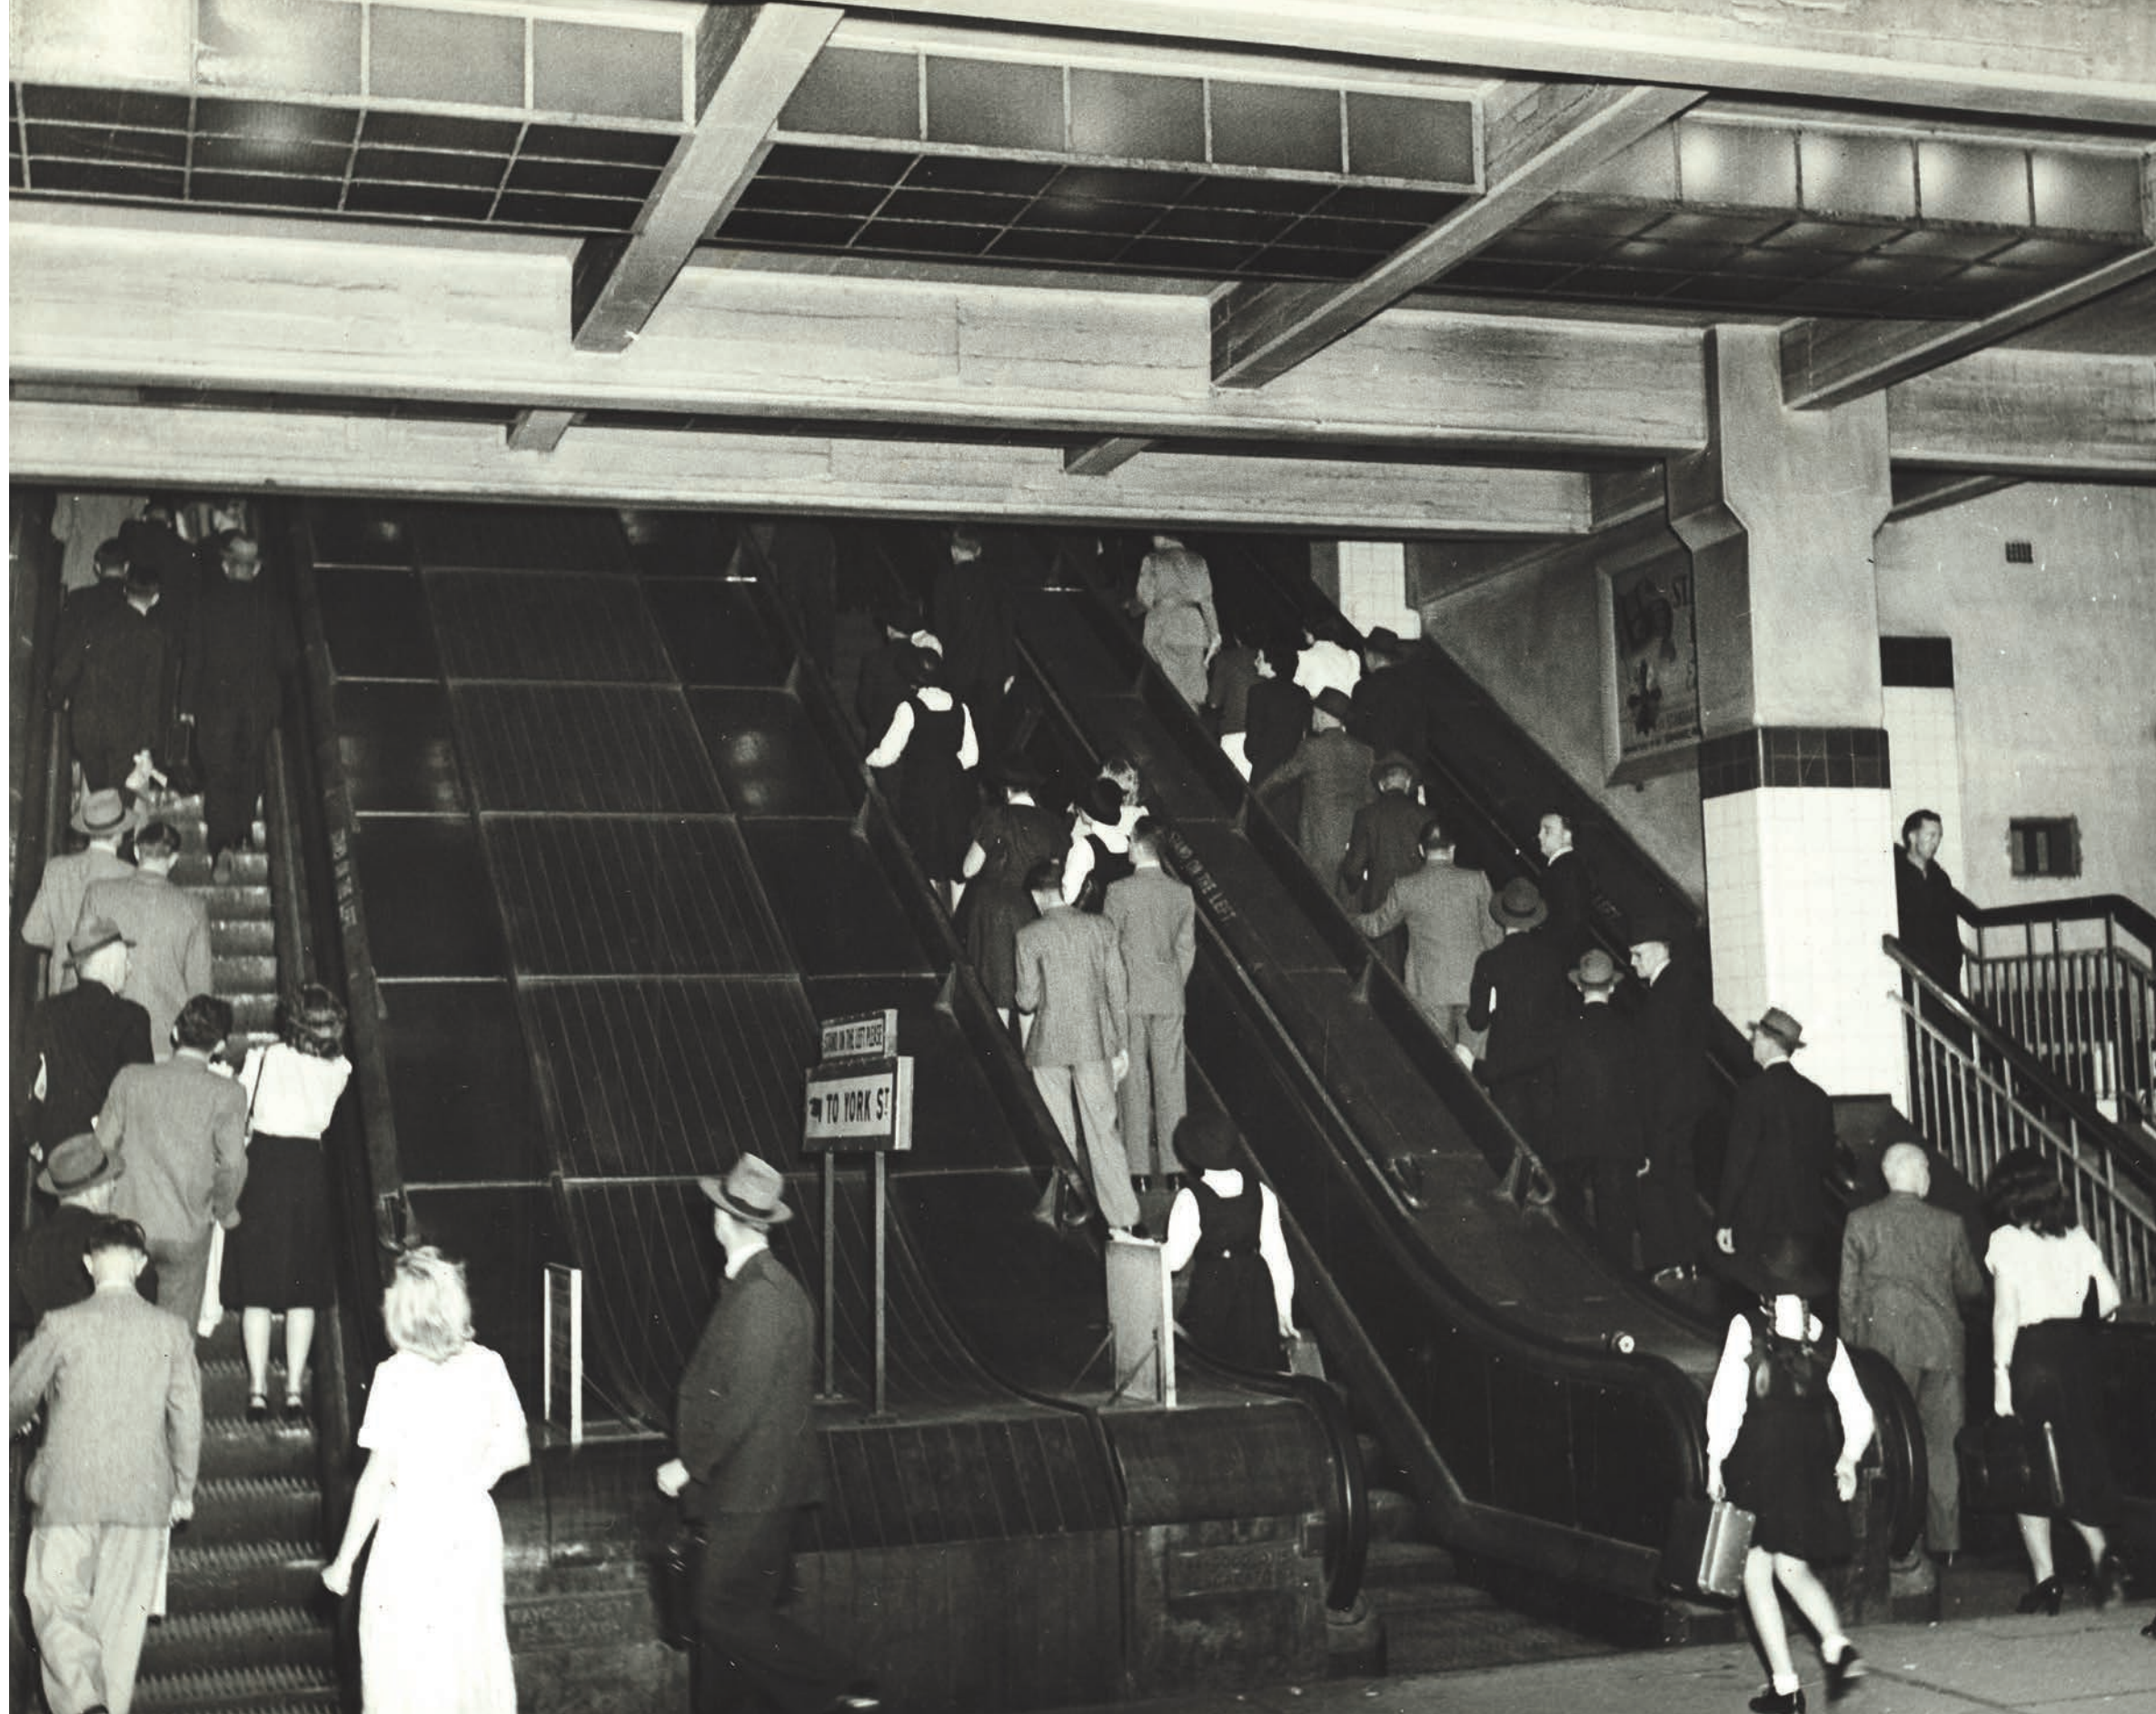
Figure 27: Morning peak hour at Wynyard in 1948. Notice that all three escalators are in the up mode, with those passengers wishing to descend to the concourse doing so via the stairs. (Source: State Archives and Records NSW 17420_a014_a014000661)

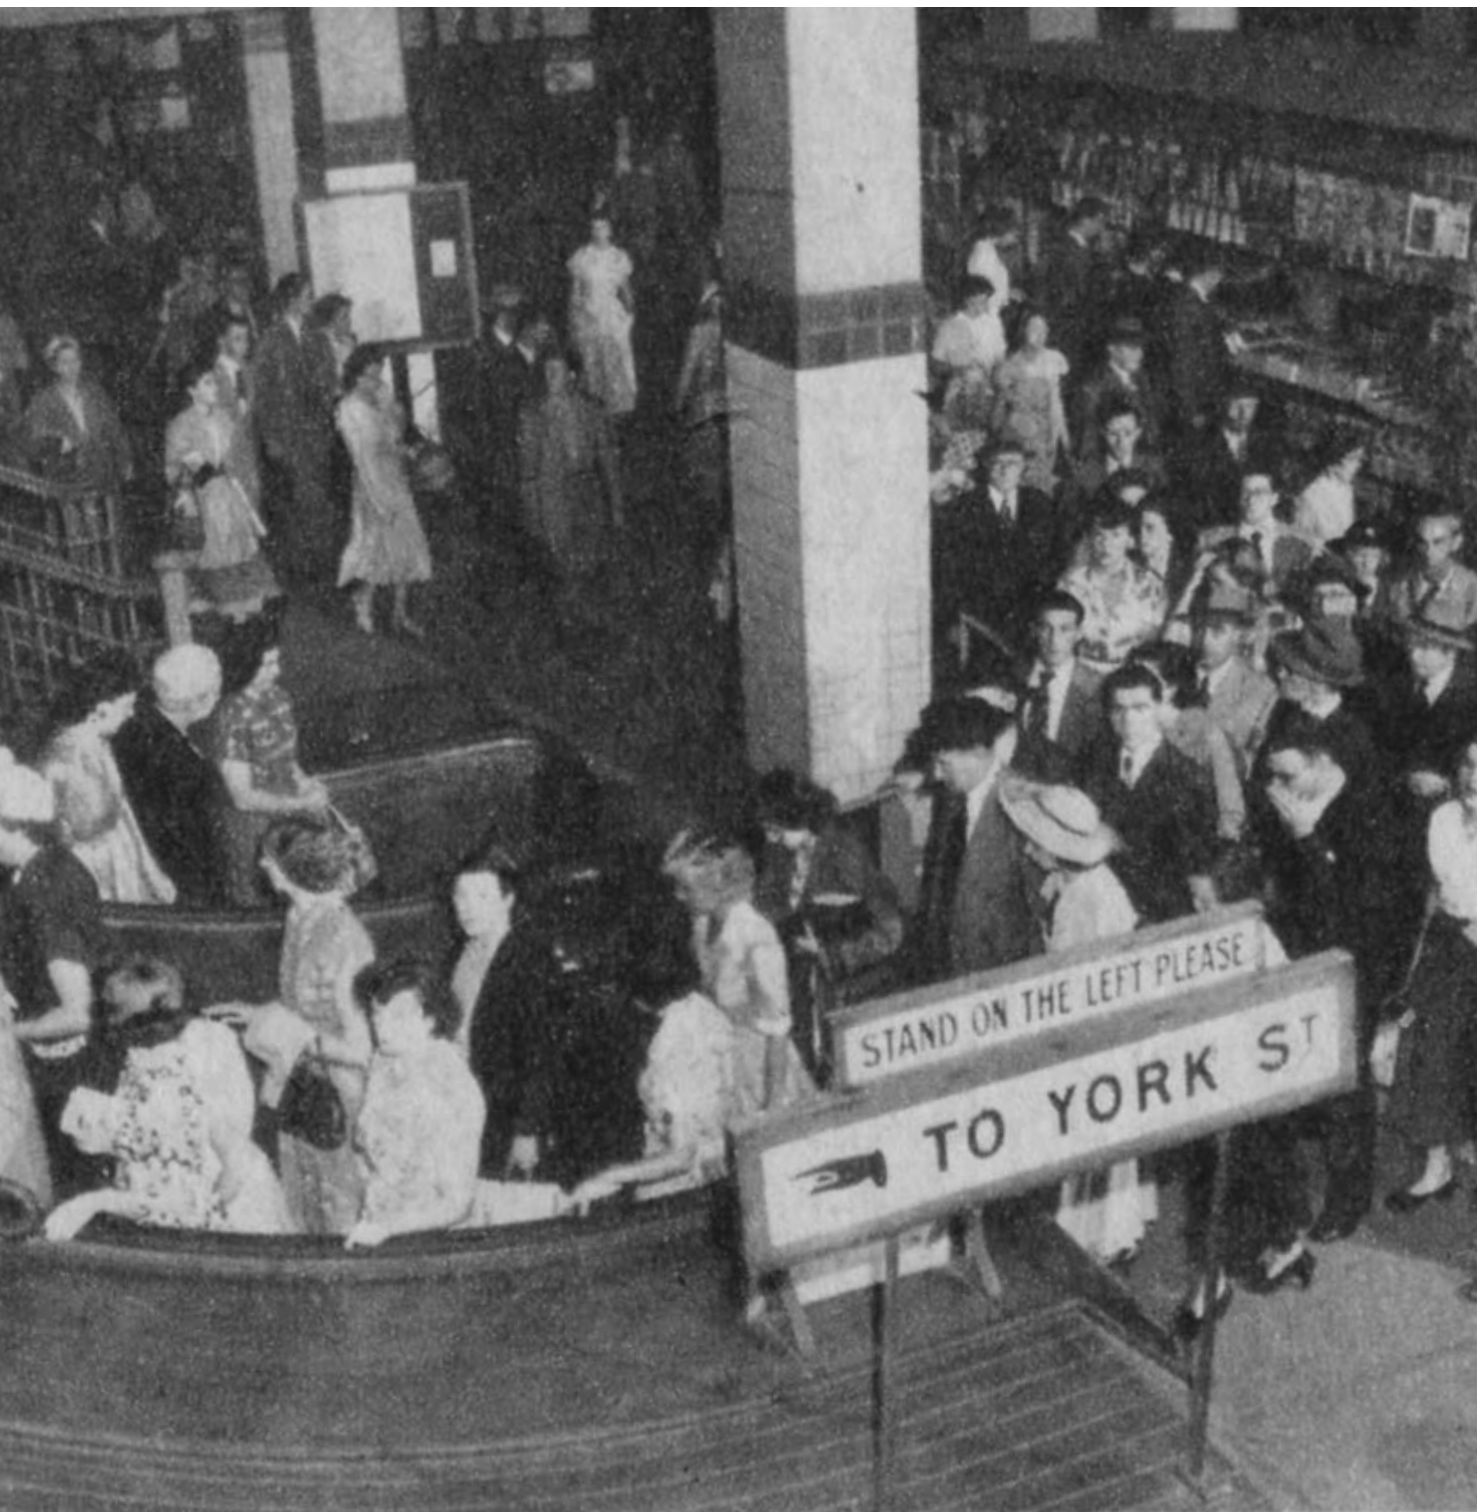
Figure 28: The Wynyard escalators at the morning peak hour in 1953. One escalator is running down, whilst the other two run up to York Street (the escalator on the near side is out of the frame in this photograph). Note the instructions to stand on the left. (Source: John Tipper, Collecting Books and Magazines)

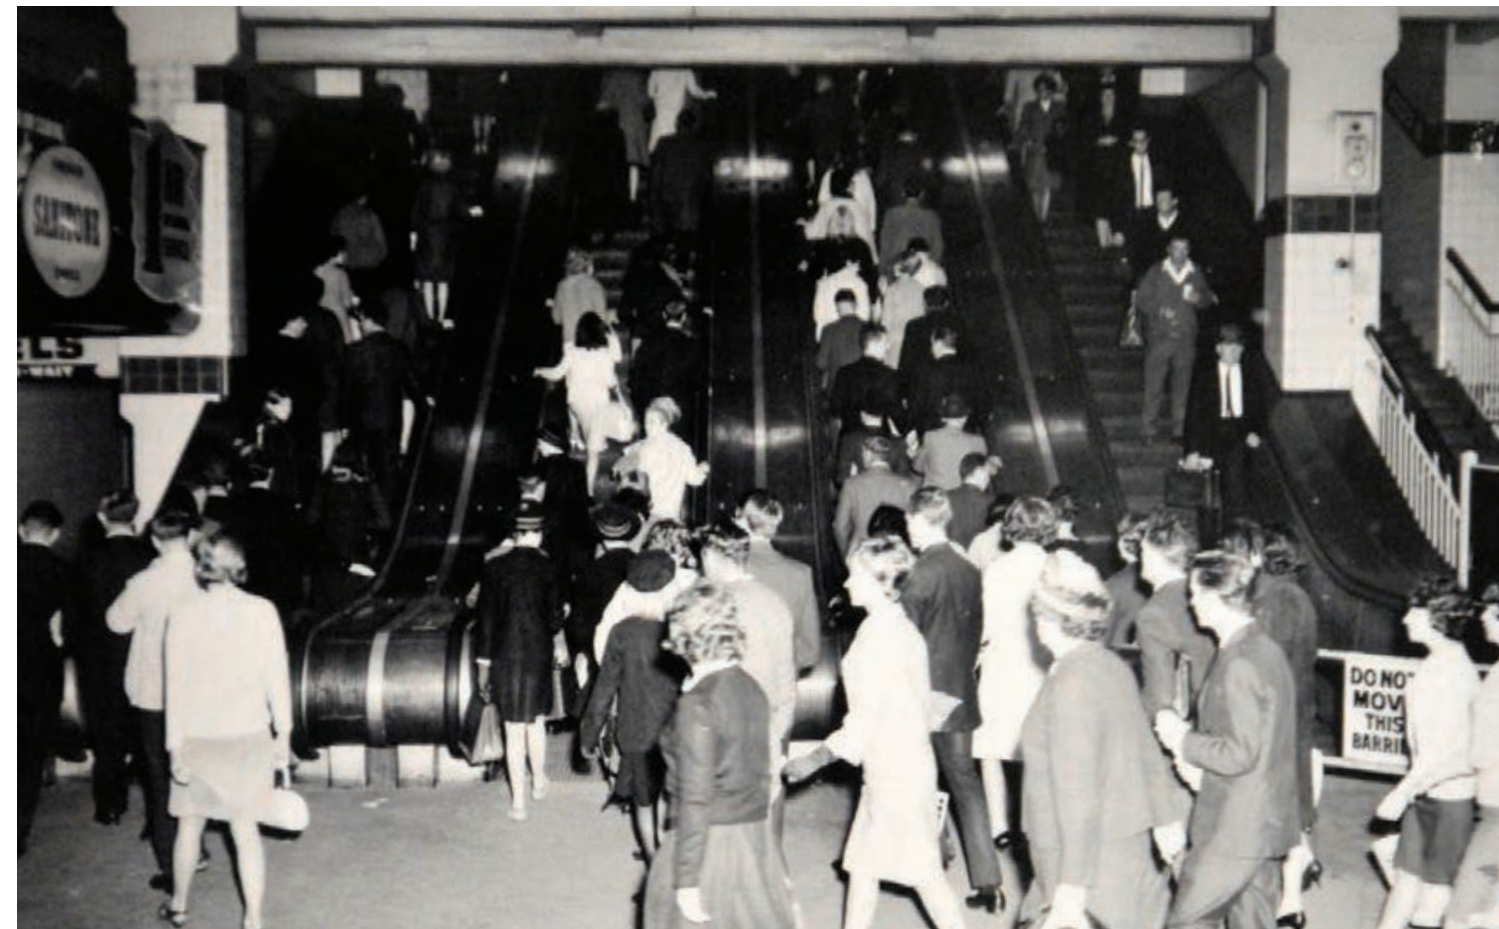
Figure 30: York Street exit in April 1966 showing the new 48SA escalator machines in use. (Source: State Archives and Records)

This work completely replaced the old L-Type escalators with what was from then referred to as 48SA type escalators.

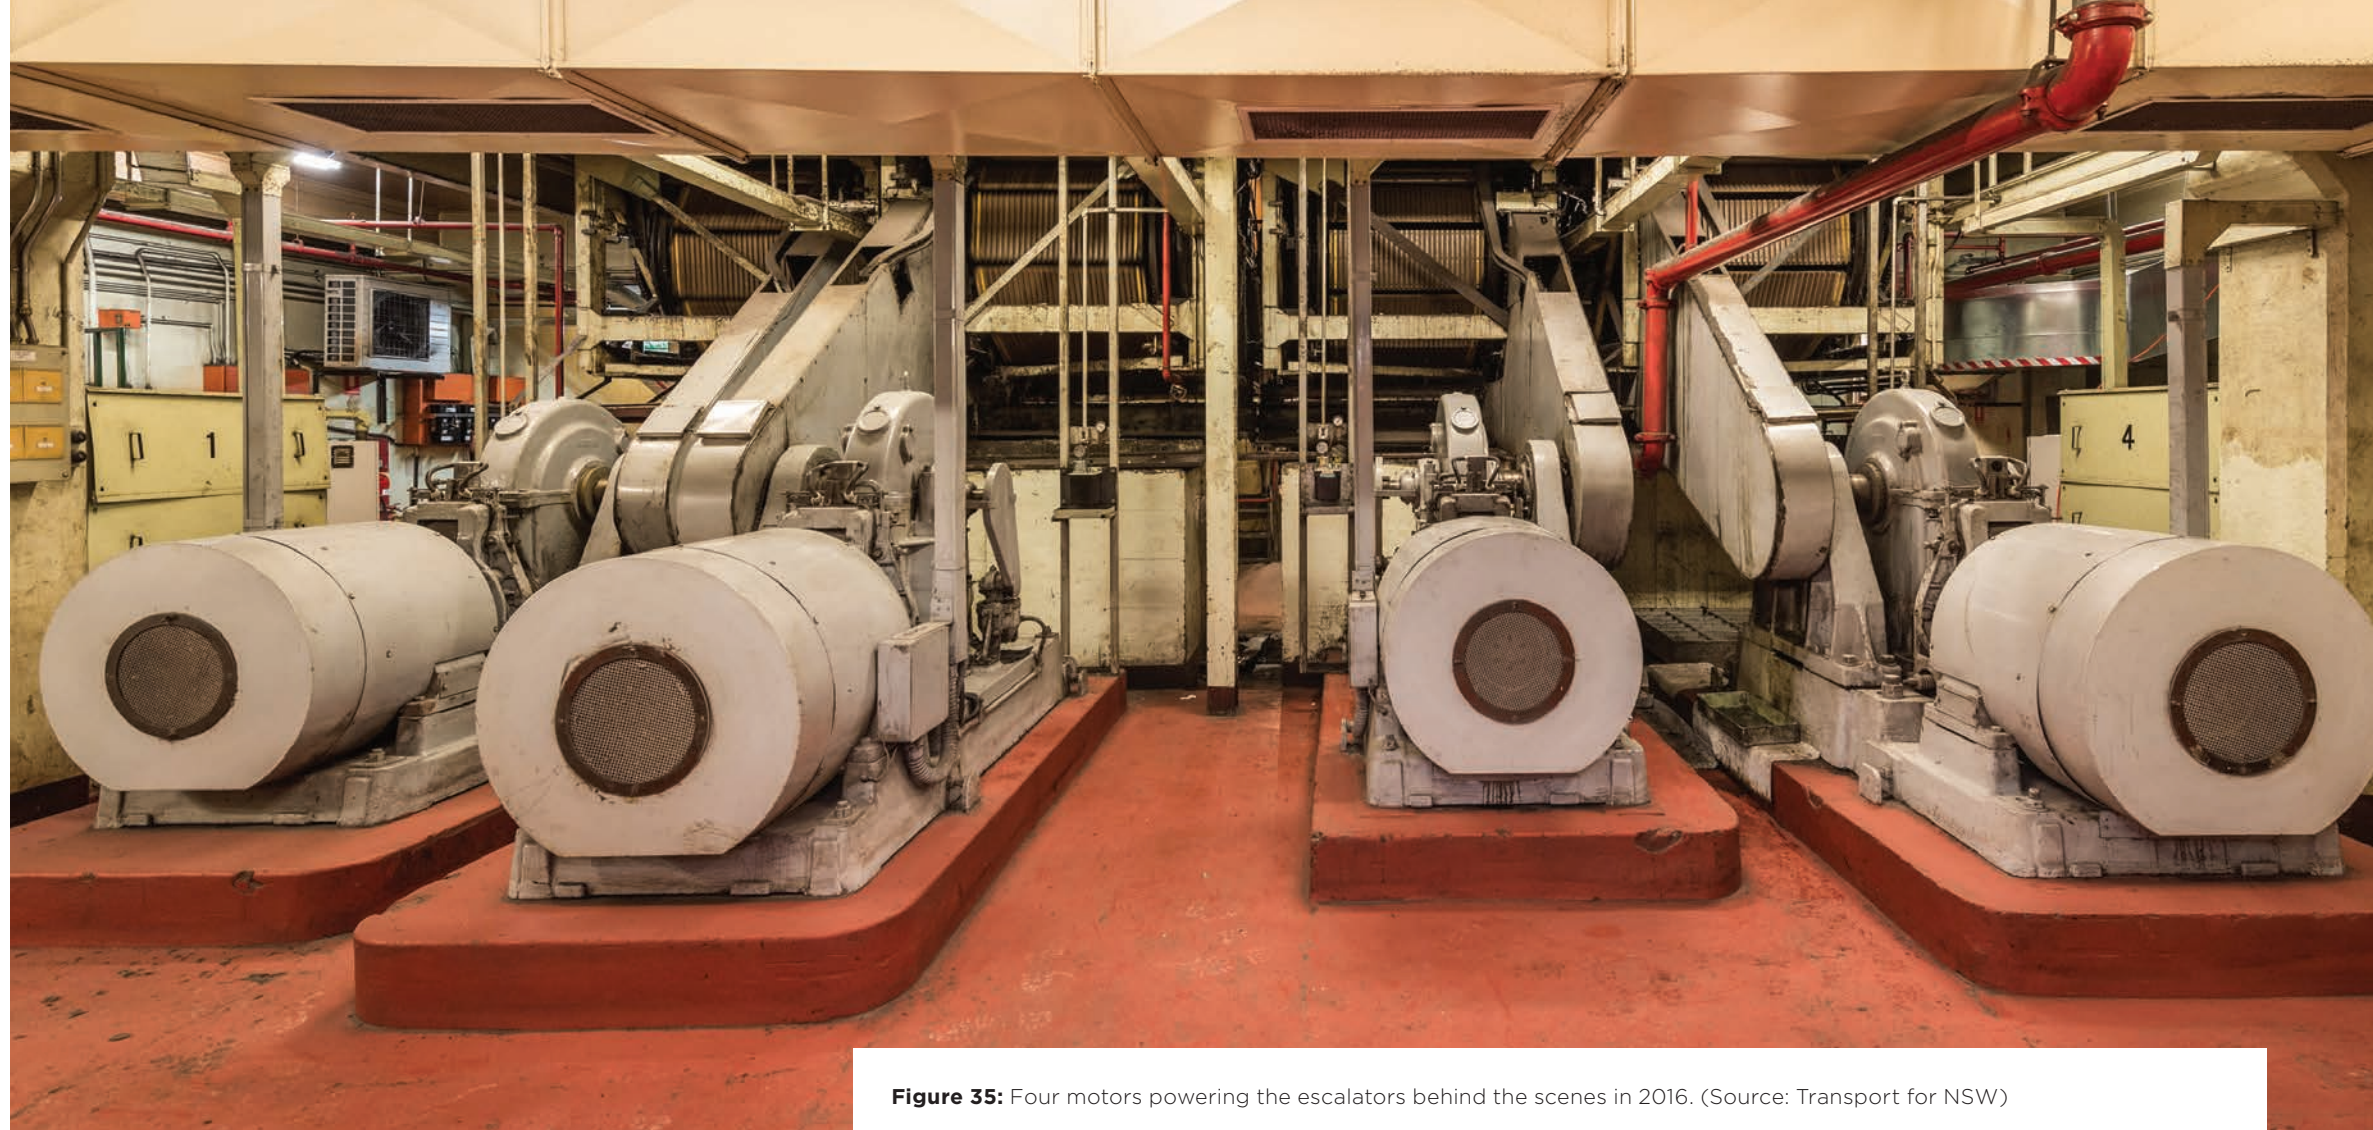
Figure 35: Four motors powering the escalators behind the scenes in 2016. (Source: Transport for NSW)

The day to day maintenance on them was mainly lubrication, keeping the chains lubricated, the gear boxes filled up, cleaning the landing trays underneath. A lot of rubbish and debris comes through the steps, so to reduce any fire hazard they are cleaned daily.⁴⁷

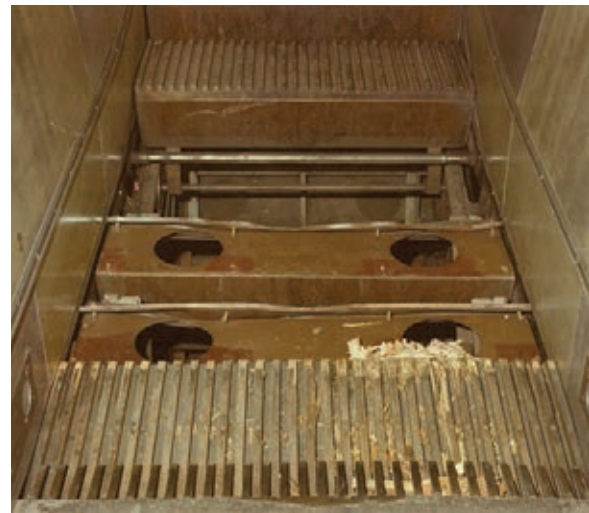
Figure 38: Town Hall escalator under repair in the 1980s. (Source: Sydney Trains)

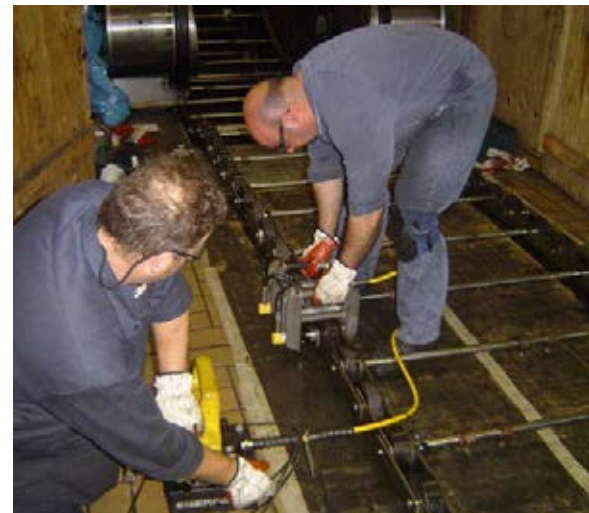
Figure 39: Step chain replacement. (Source: Sydney Trains)

In 1983, 66 steps were replaced at Town Hall on No.1 escalator when it was discovered the steel braces were broken as a result of fatigue, and a major refit was undertaken in 1985 with the step chains at both Town Hall and Wynyard being rebuilt and replaced by railway staff.

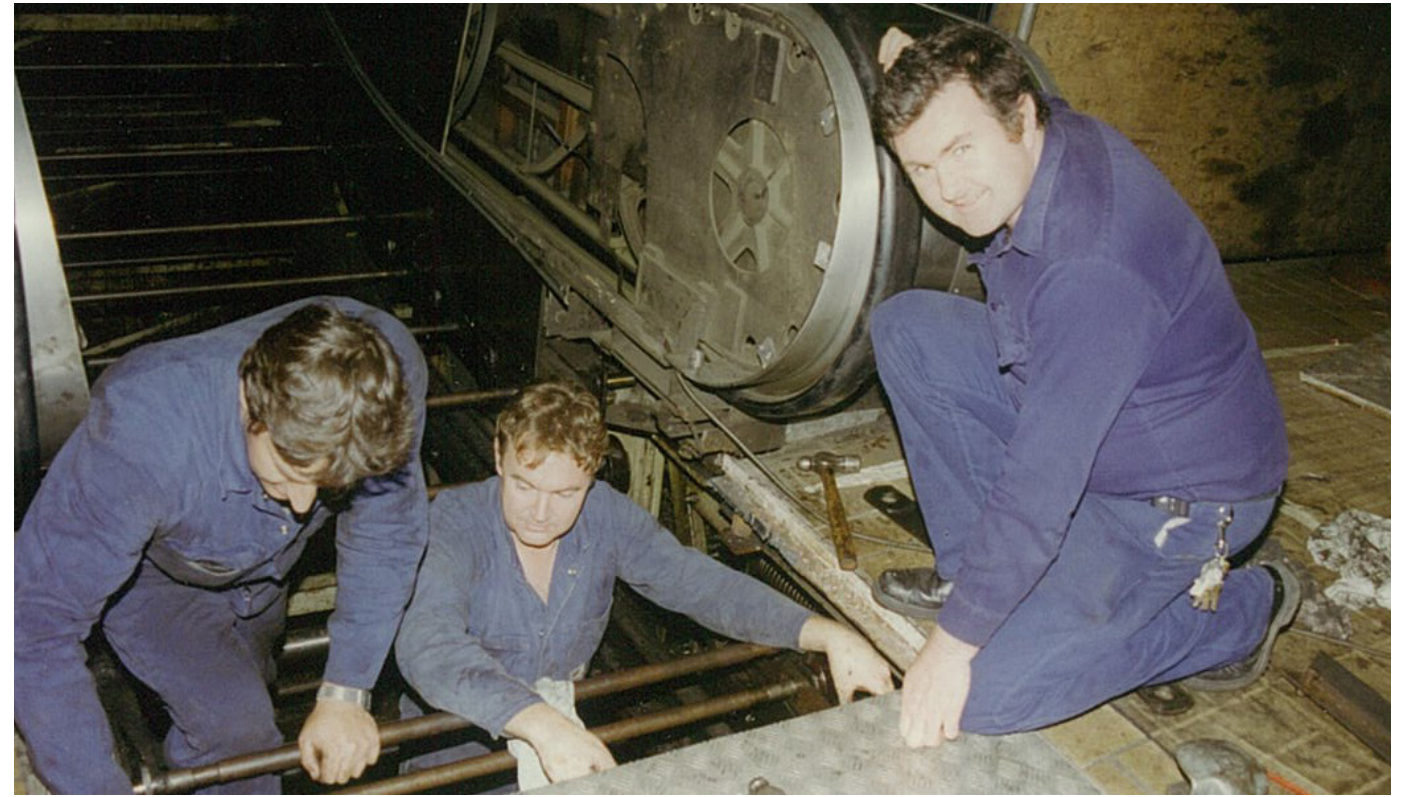
Figure 40: Crew from the Lift and Escalator Section dealing with an urgent escalator problem at Town Hall Station over the Christmas holidays in the 1990s. L-R: Fitters Mal Green, Kevin Taylor and senior foreman Martin King. (Source: Sydney Trains)
