Escalation Sensation

Wooden Escalators at Wynyard
and Town Hall Railway Stations

Historical Report

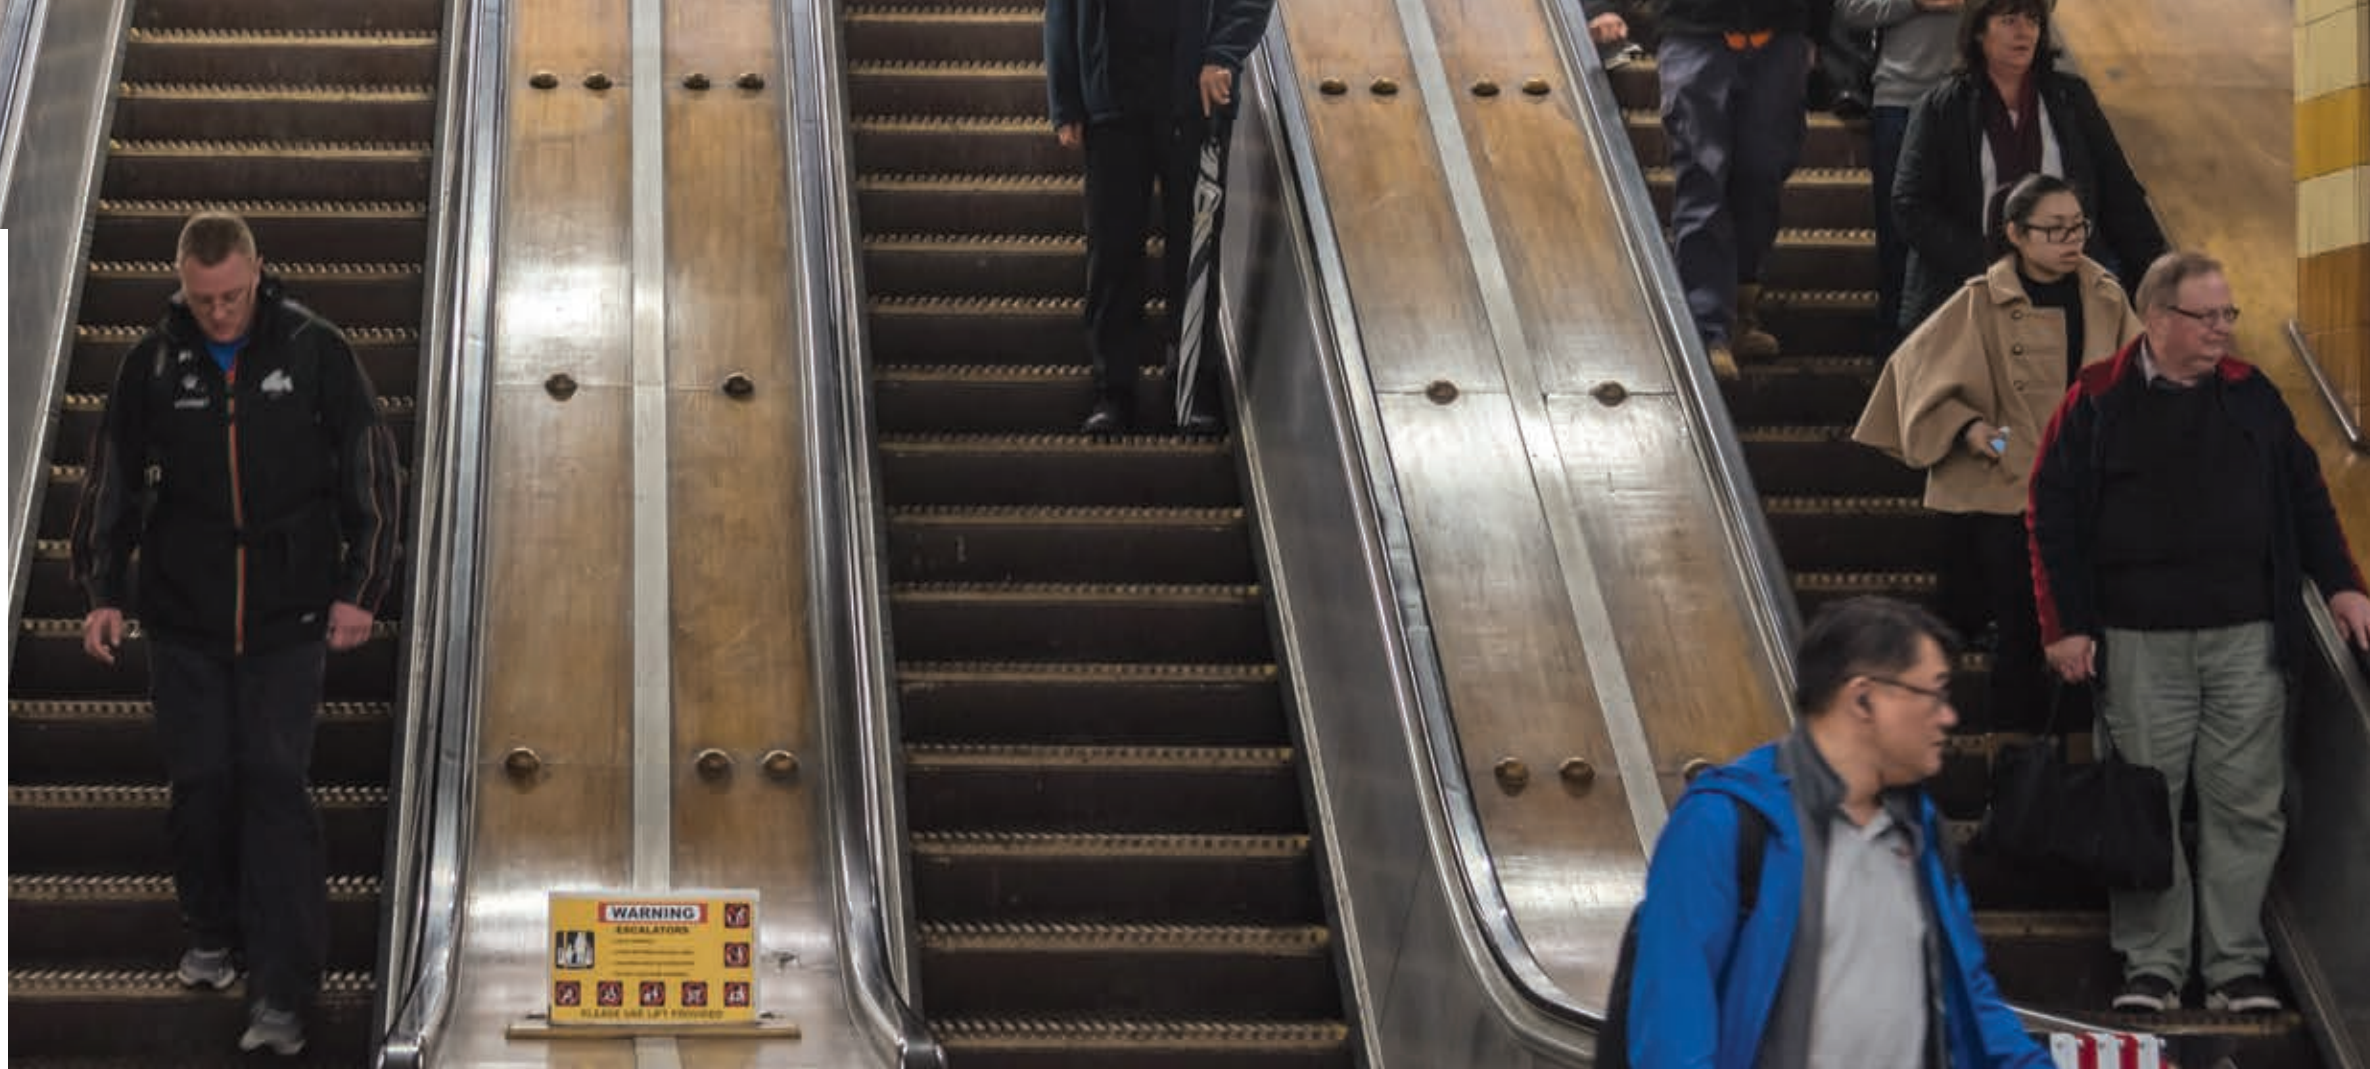
Figure 41: Wynyard Escalators 2016 in the last months of service. The distinctive timber panelling was a well-loved feature of the escalators and an element of the heritage that was included in the interpretation of the new escalators. (Source: Sydney Trains)

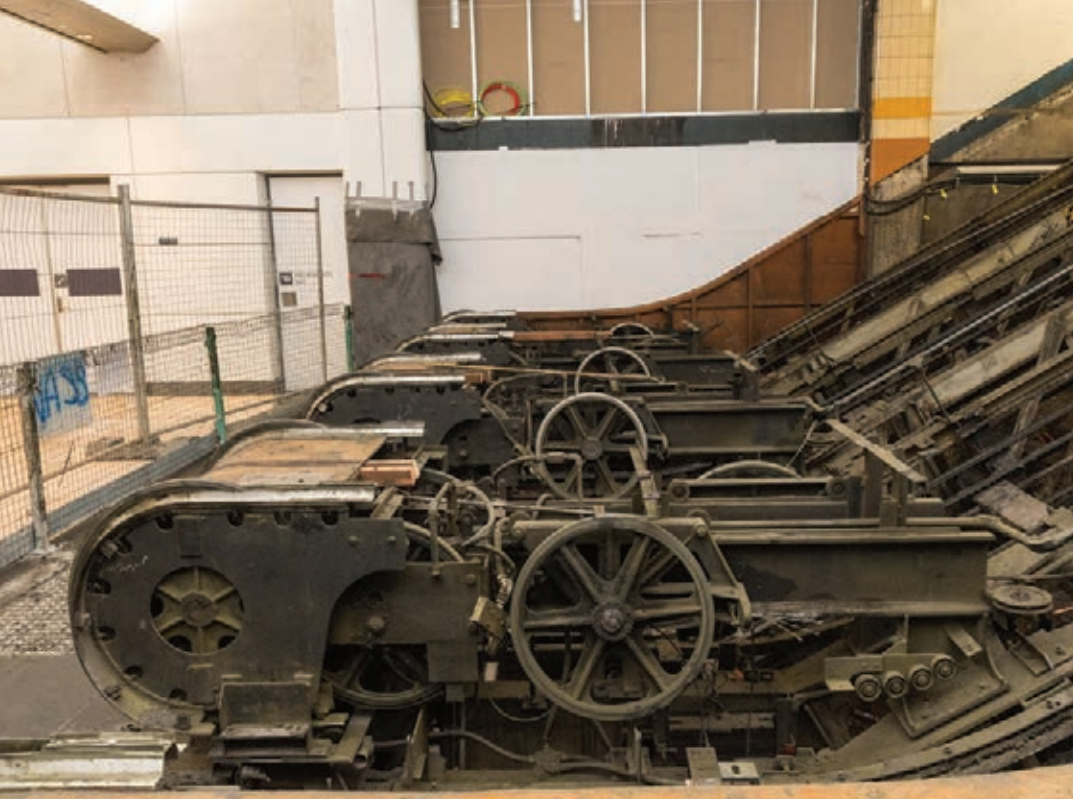
Figure 43: Escalator landings during demolition at Wynyard Station. (Source: Transport for NSW)

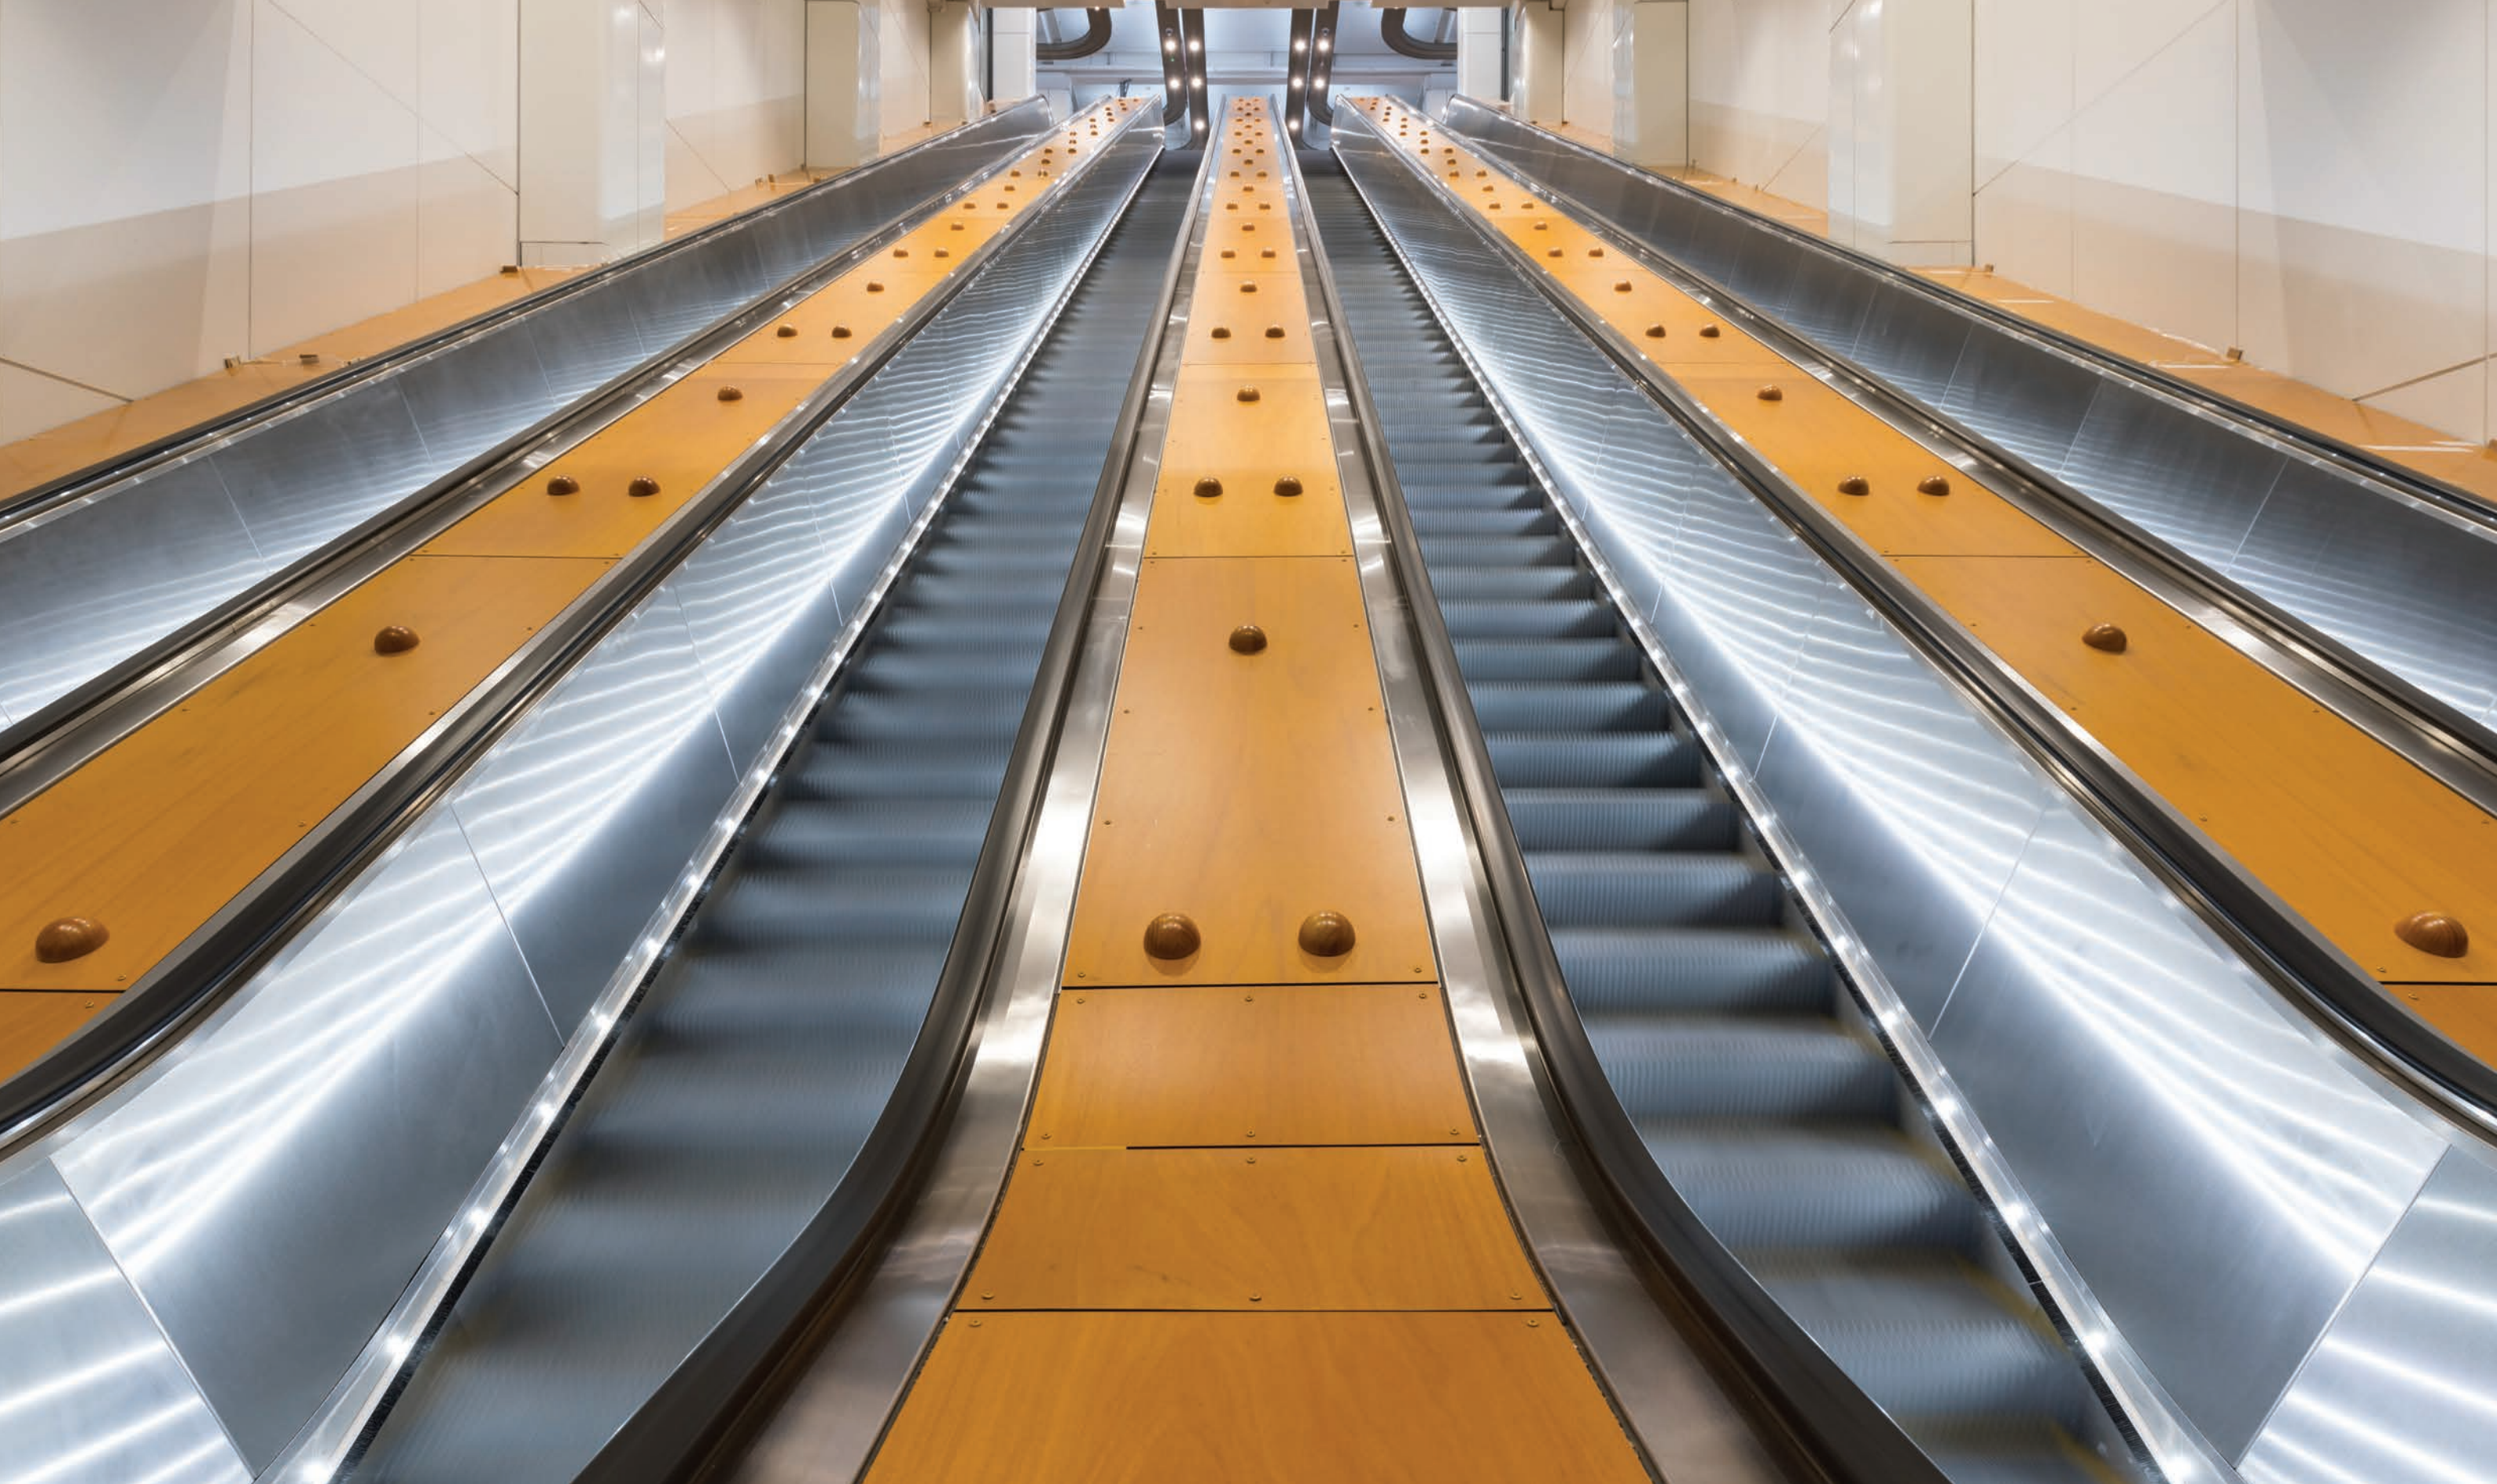
Figure 45: New escalators installed at Wynyard Station in 2017 with metal steps and wood-like decking reminiscent of the historic machines. (Source: Transport for NSW)
