RE: Byron Bay Bus Interchange – ISEPP Consultation

This Statement of Heritage Impact (SOHI) will review the relevant statutory heritage controls, assess the impact of the proposal on the subject property and make recommendations as to the level of impact.

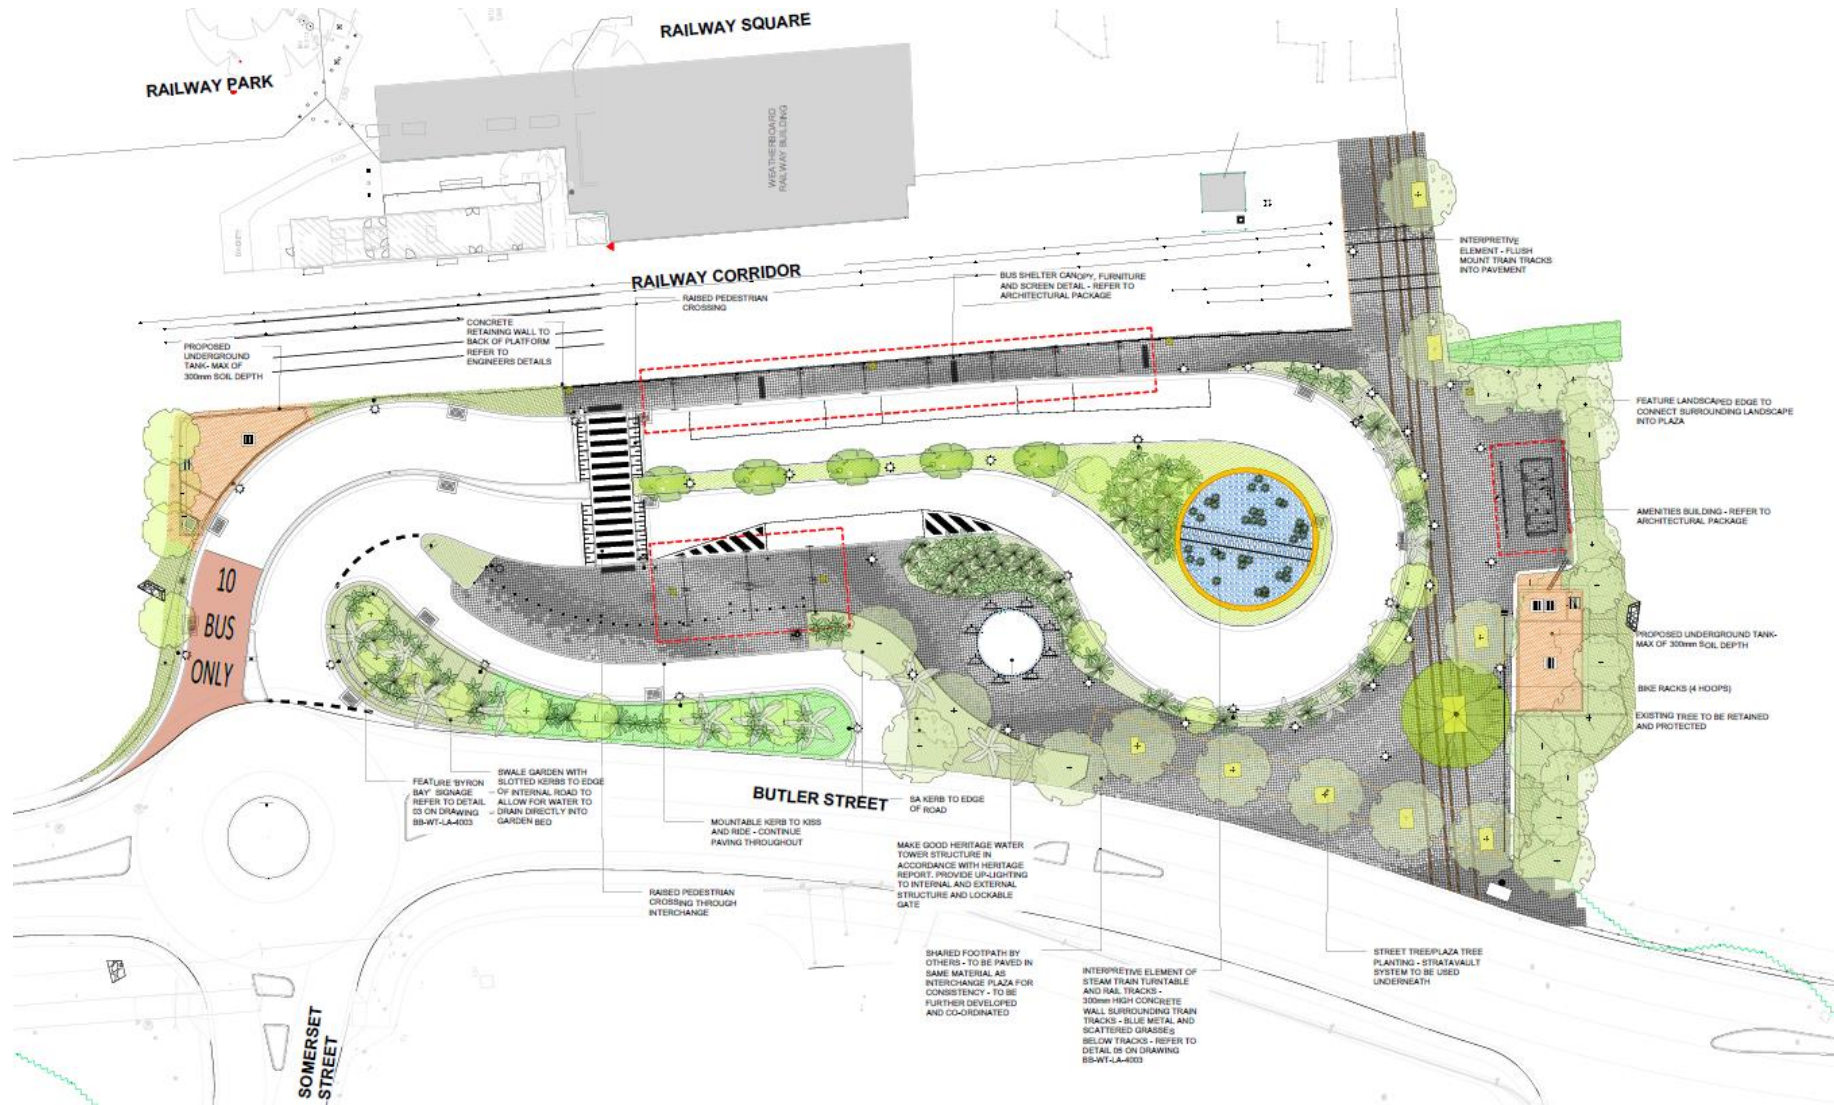
Figure 2: Concept design of proposed interchange (DesignInc 2018)

The concept design of the proposal is provided in Figure 2. Works are expected to commence in early 2019 and expected to take 15 months to complete.

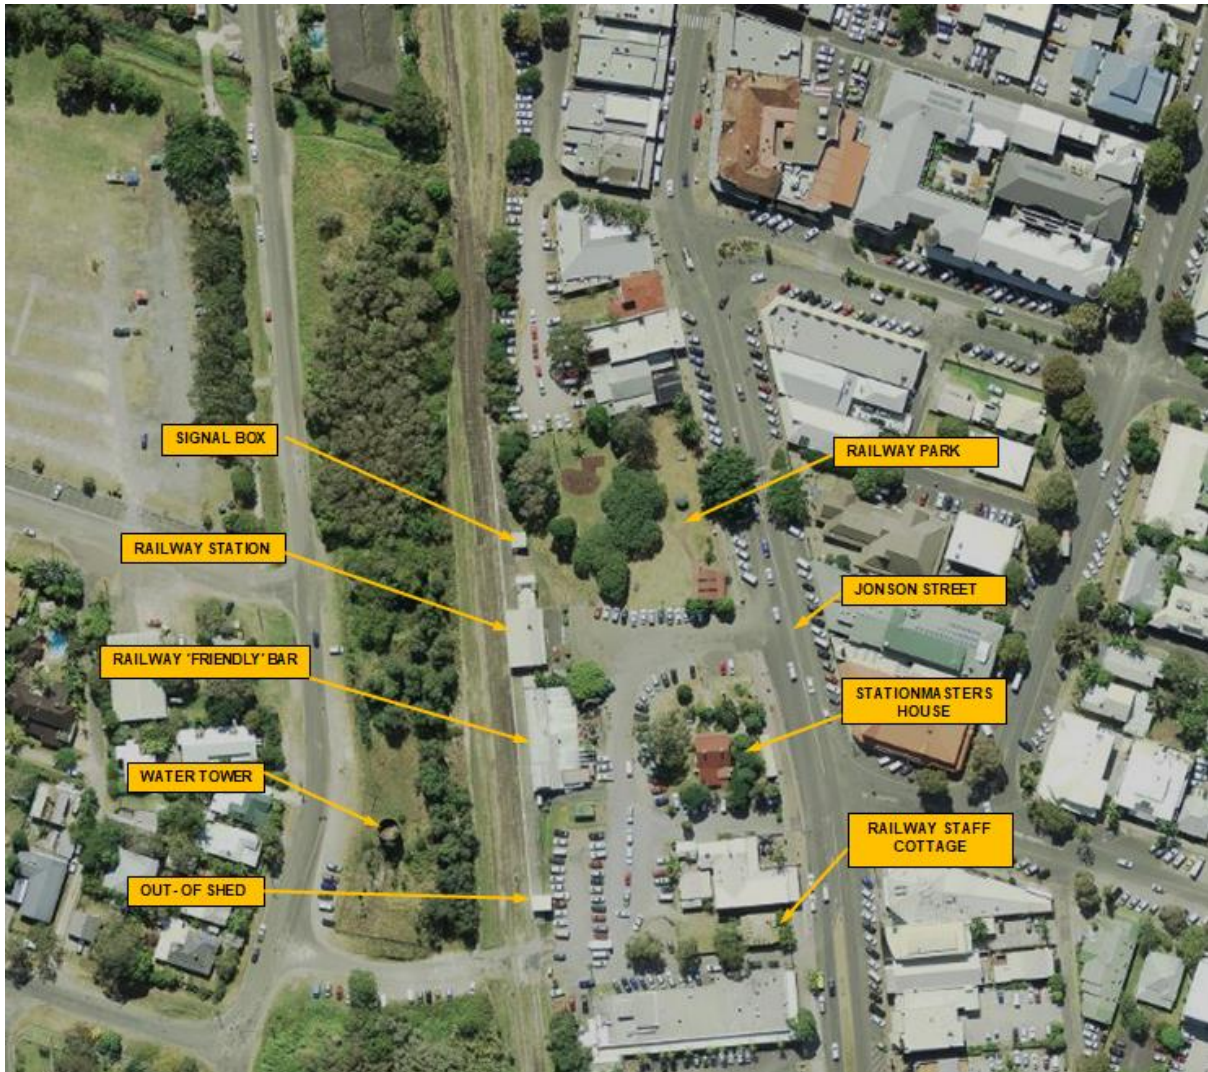
Figure 3. *Aerial Photo indicating the location of the key elements at Byron Bay Railway Station (Source: LPI SIX).*

The site is included on the State Heritage Register (SHR) as *Byron Bay Railway Station and yard group* (Item 01107). The statutory curtilage is contained within Lot 4729, DP1228104 and is shown below in Figure 3.

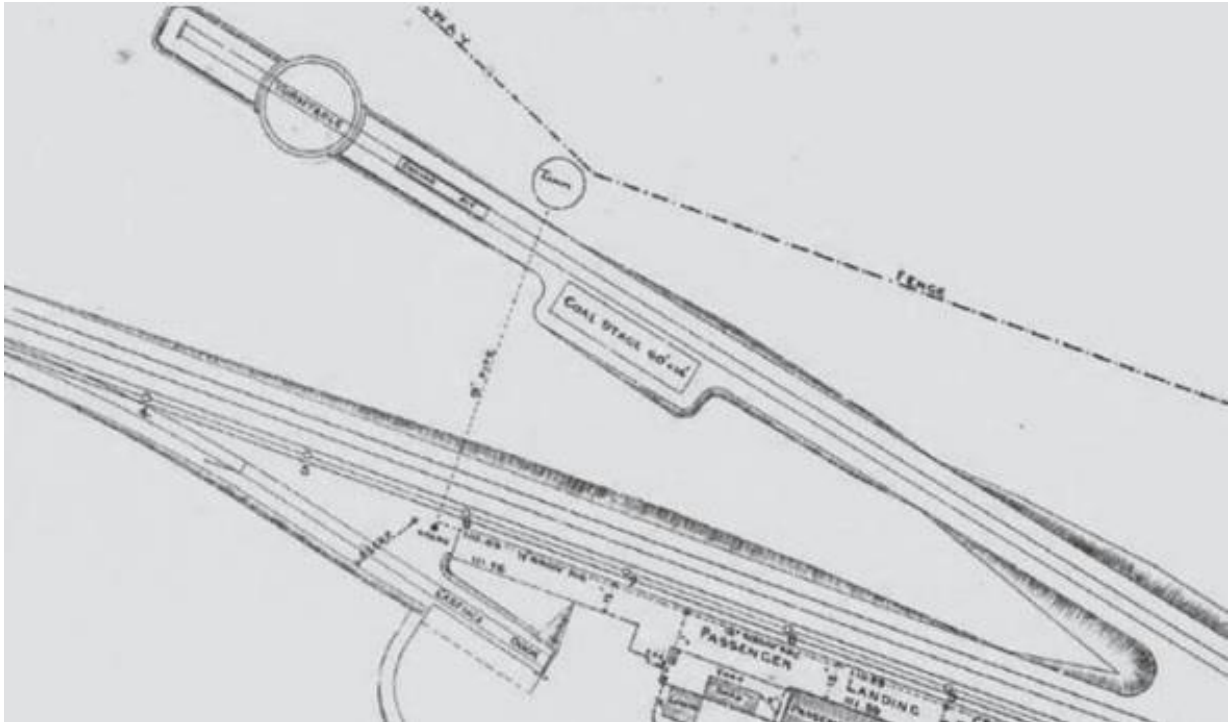
Figure 18. Extract from the General Arrangement plan of 1892, showing the turntable, ash pit and coal stage. (Source: ARHS – reproduced in Weir Phillips; Byron Bay Station and Yard Group Conservation Management Strategy; 2018).

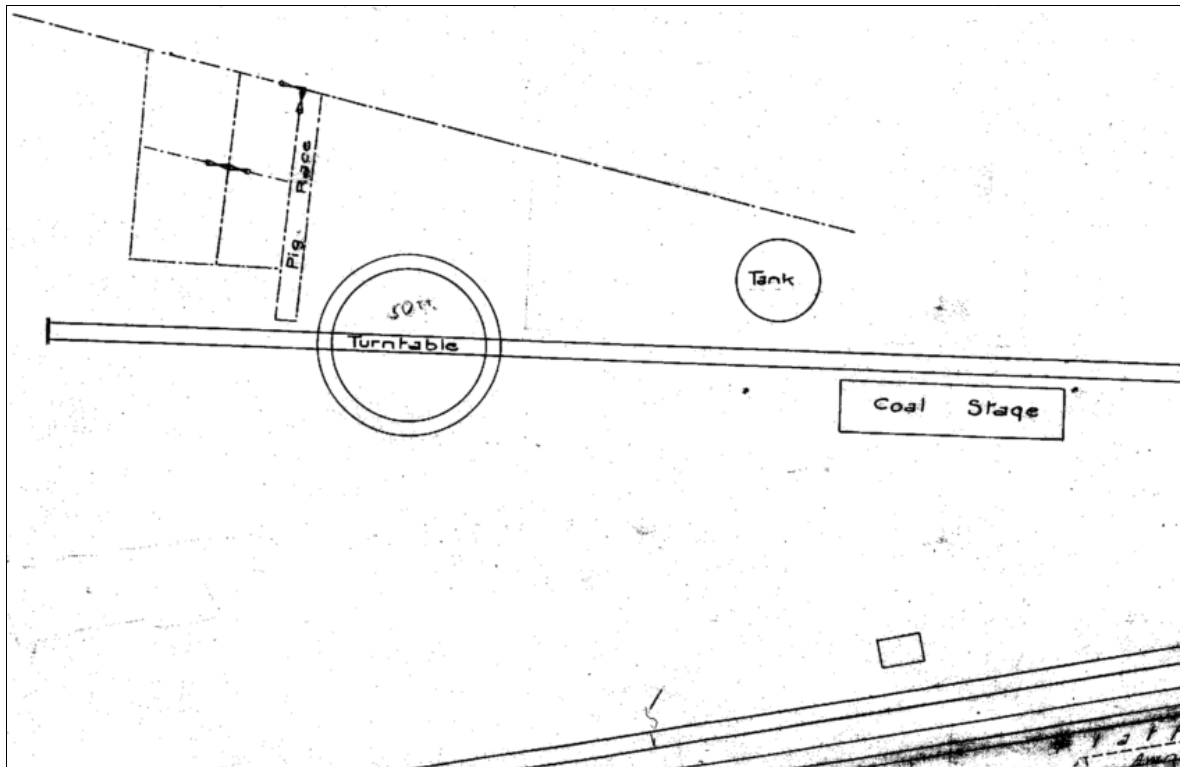
Figure 19. Extract from Byron Bay Station Plan circa 1914, showing the Loco Siding and the layout of water tower, turntable and coal stage. Pig pens and a fenced race are shown on the western side, south of the turntable. (Source: Sydney Trains).

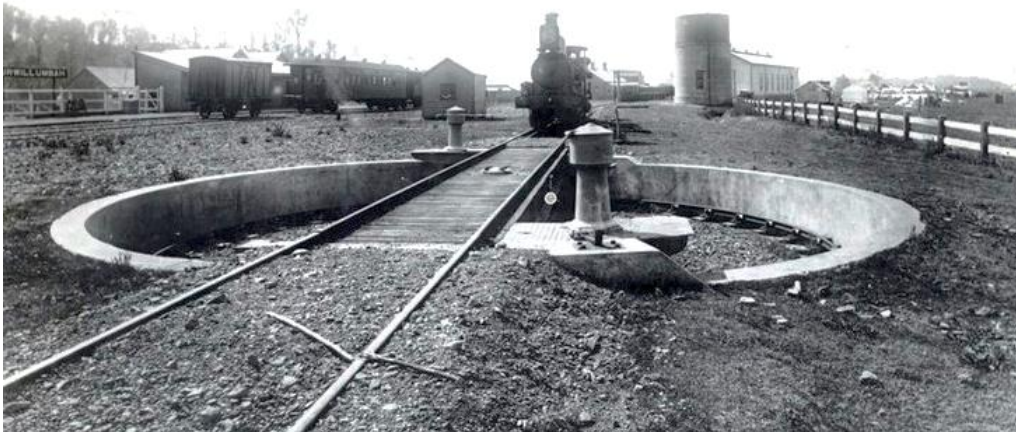
Figure 22. *Murwillumbah railway turntable in 1904, showing the original 40ft turntable arrangement. This turntable, like Byron Bay, was replaced with a larger type in the early twentieth century. (Source: Tweed Library: MUS2015.60).*

The turntable at Byron Bay was initially a 12.2 metre (40 feet) diameter standard locomotive turntable, replaced with a larger 15.2 metre (50 feet) diameter turntable in 1904. Depending upon local conditions, turntables were typically mounted in a pit, approximately 1 metre deep, with brick or concrete side walls. In some cases, the outer wall of the pit was reinforced with concrete.

The turntable was comprised of a pair of fabricated iron plate girders, attached to a central cast iron pivot frame, turning on the pivot mount which was fixed to a concrete footing in the centre of the earthen floored well. The girders carried two heavy timber beams which were fixed to the track. Support wheels attached to the outer ends of the girders ran on a circle of rail fixed to short sleepers.

No photos of the Byron Bay turntable have been identified, however, it was one of several built to the same design along the Lismore to Tweed Railway Line and later replaced with a larger sized turntable in the early twentieth century. The turntable at Byron Bay is believed to have been removed in the 1960s.

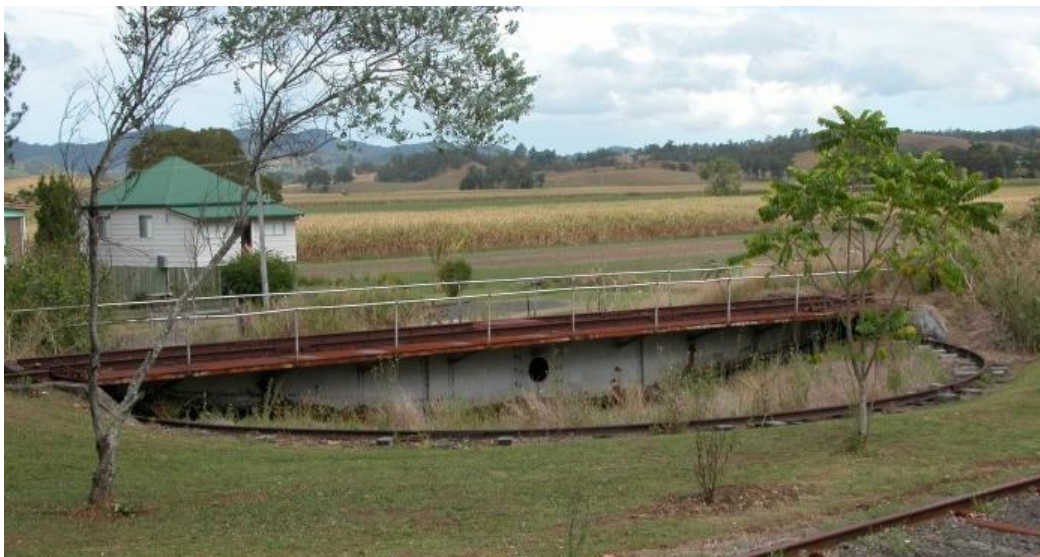
Figure 23. *Murwillumbah's 60ft railway turntable circa 2005. Note the lowered side walls and concrete wings below the railway track at either end. (Source: RailNet).*

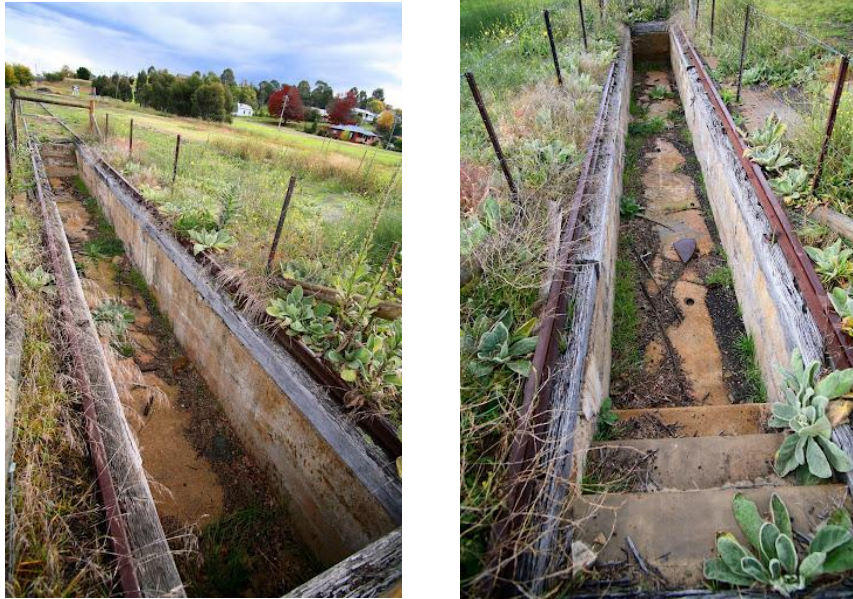
Figure 25. *Ash Pit surviving and exposed at Bombala railway station. (Source: P. Buckley; <http://sydneyrailwaystations.wordpress.com/>).*

Ash pits were provided at every locomotive service point throughout the NSW railway system. Also known as Engine Pits, ash pits were typically a rectangular brick-lined pit located below and between the rails, approximately 6.1m (20 feet) long, 1.2m (3.5 feet) wide and 1.5m (5 feet) deep. One end was usually given steps down from ground level. No photos of the Byron Bay ash pit have been identified. It is believed to have been buried in situ (or removed) in the 1960s.

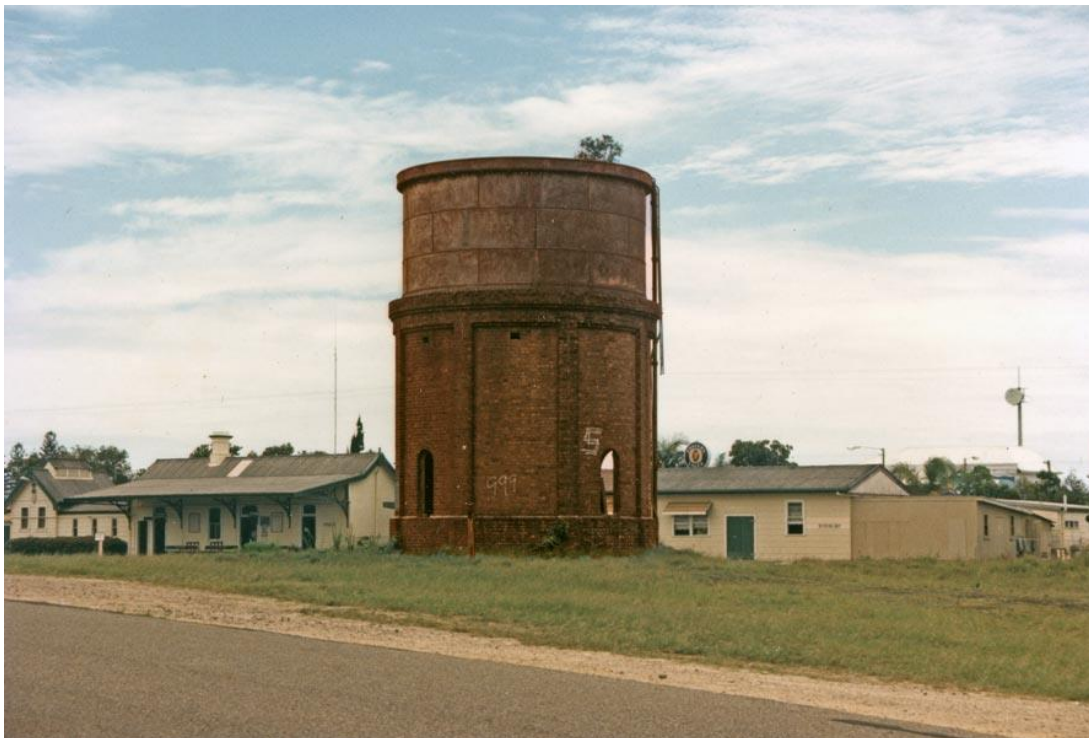
Figure 26. *Byron Bay Railway Station in the 1970s, viewed from the south-western (Butler St) with the water tower in the foreground. Note the cleared and level nature of the Loco Siding area. (Source: EJ Wright Collection – Richmond Tweed Regional Library).*

The Water Tower at Byron Bay was erected in 1894 and comprises a cylindrical wrought-iron (or steel) tank with a capacity of 20,000 gallons standing on a cylindrical brick masonry tank stand. The tank consisted of three rings of riveted plates, each made up of seven panels of curved wrought iron plates. The brick tank stand was provided with windows and a door and provided storage under the tank.

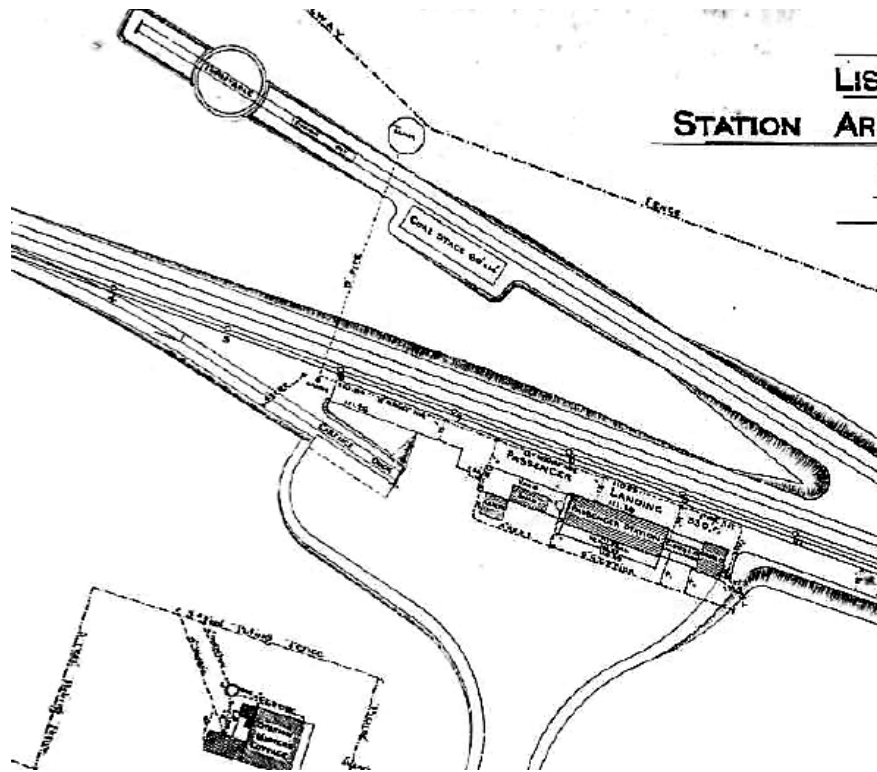
Figure 28. Extract from the General Arrangement plan of 1892, showing the turntable, ash pit, coal stage and 9 inch pipeline to a water column at the south end of the platform (Source: ARHS – reproduced in Weir Phillips; op cit).

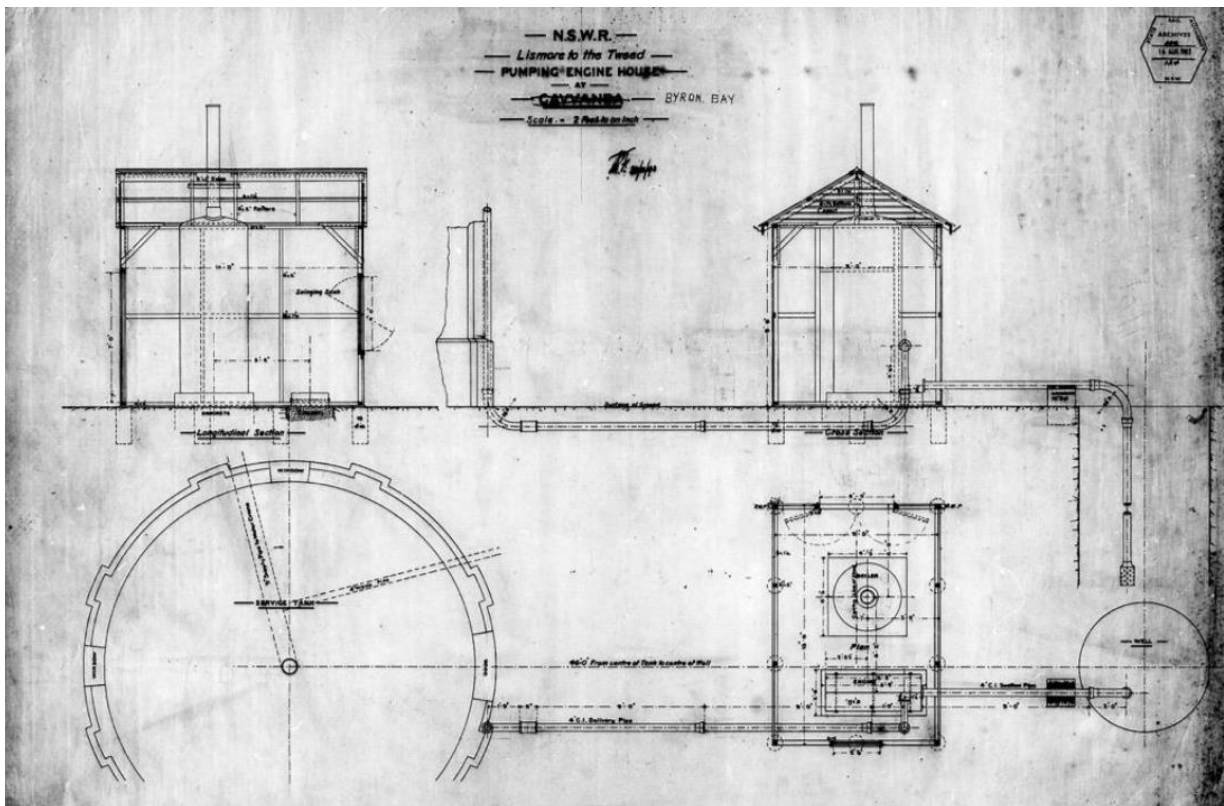
Figure 29. Pumping Engine House at 'Cavvanba' (corrected to "Byron Bay"), circa 1890, showing the water tower supplied from a well via a small steam pumping plant. The plan states that there is 45 feet between the centre of the tank and the centre of the well. (Source: Sydney Trains).

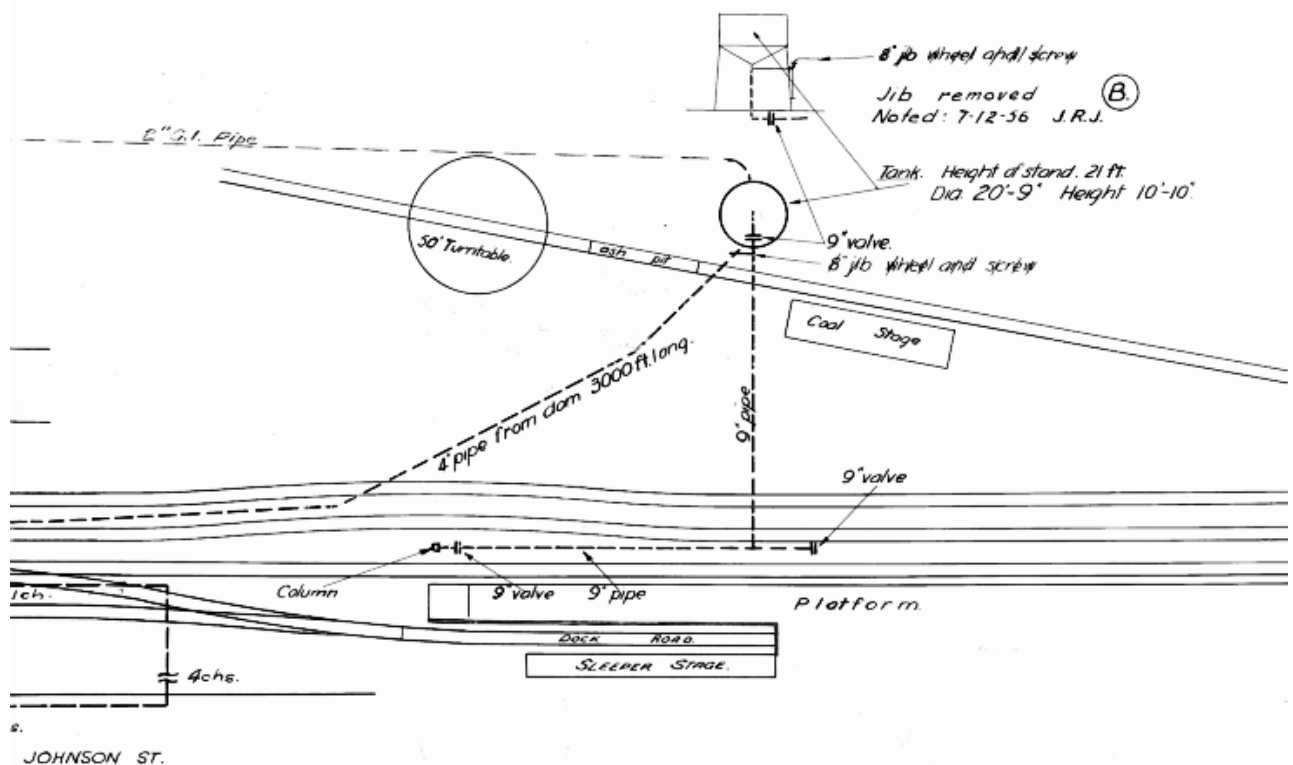
Figure 31. Extract from Byron Bay Water Service Drawing - 3/12/1935, showing the Loco Siding with water tower, turntable, ash pit and coal stage. Note the water supply line to the water column between the tracks at the south end of the station. Also note that supply is now obtained from a 3000 feet long, 4 inch diameter pipe along Carlyle Street from a dam. (Source: Sydney Trains).

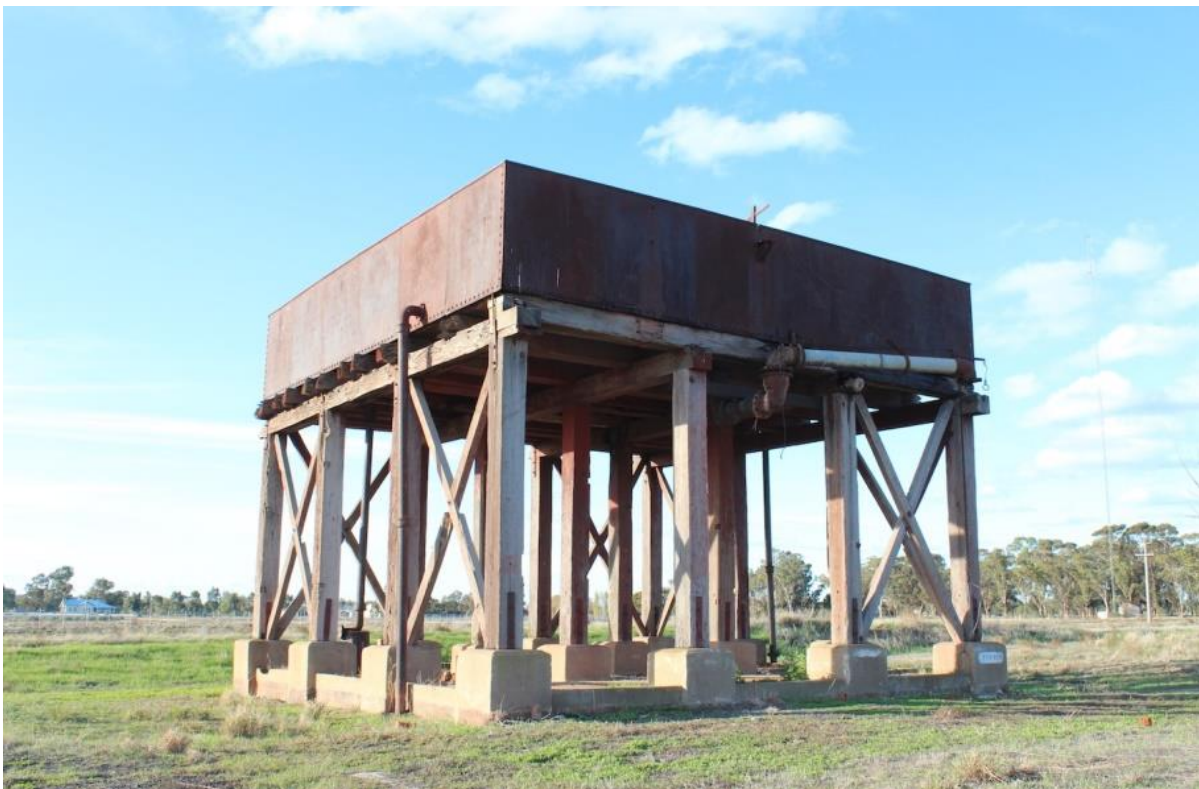
Figure 32. *Early style of metal-plate water tank used on the NSW Railways (Source: Extent Heritage).*

At the end of the 1890s, economic and political circumstances led to a greater emphasis on economy. From 1898 through to 1915, the PWD introduced a more economical design of water tank. Consisting of a steel plate tank on a timber or steel frame, these tanks utilised standardised flanged plates that could be bolted together in various patterns to increase or decrease the holding capacity. The tanks also sat on new 'T' shaped brackets which simplified their attachment to the stands. The sizes of the tanks ranged from 5000 to 15,000 gallons and were installed according to the requirements of the line.

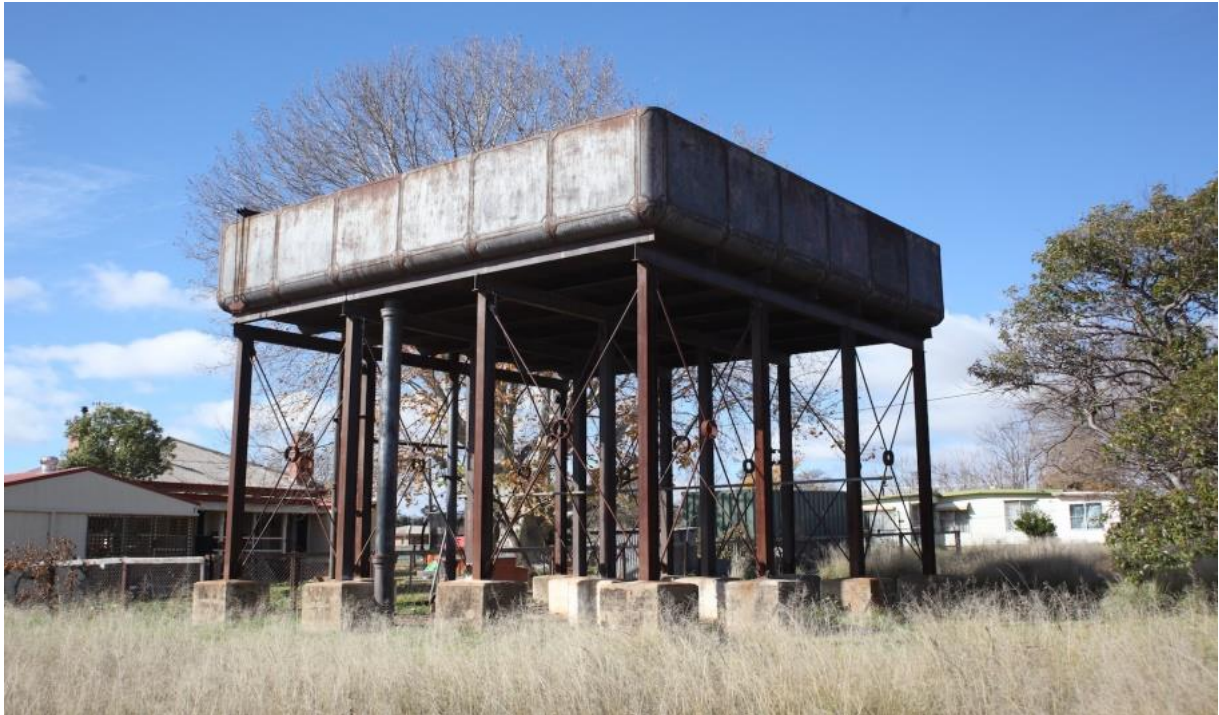
Figure 33. *Later style of metal-plate water tank used on the NSW Railways (Source: Extent Heritage).*

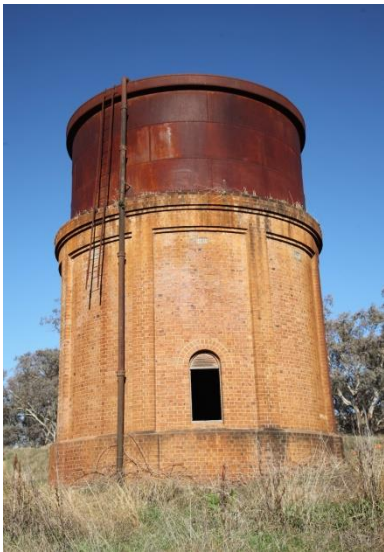
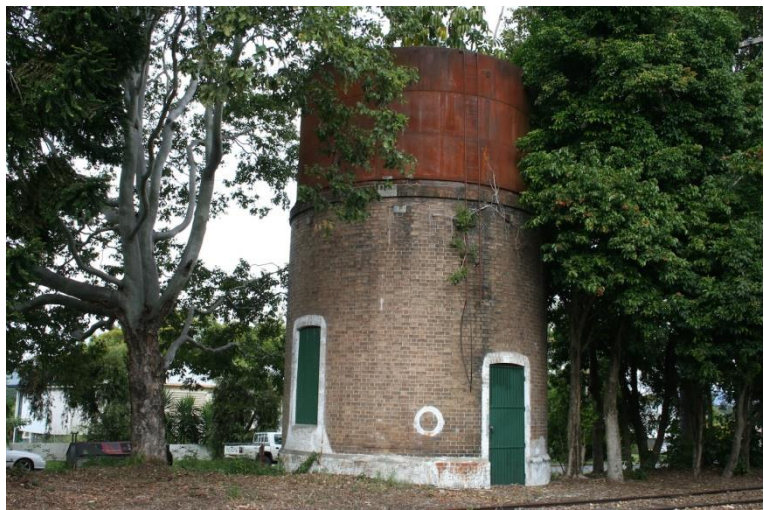
Figure 34. *Meranburn (L) and Murwillumbah (R) are the two surviving railway water tanks of this type (Source: Extent Heritage).*

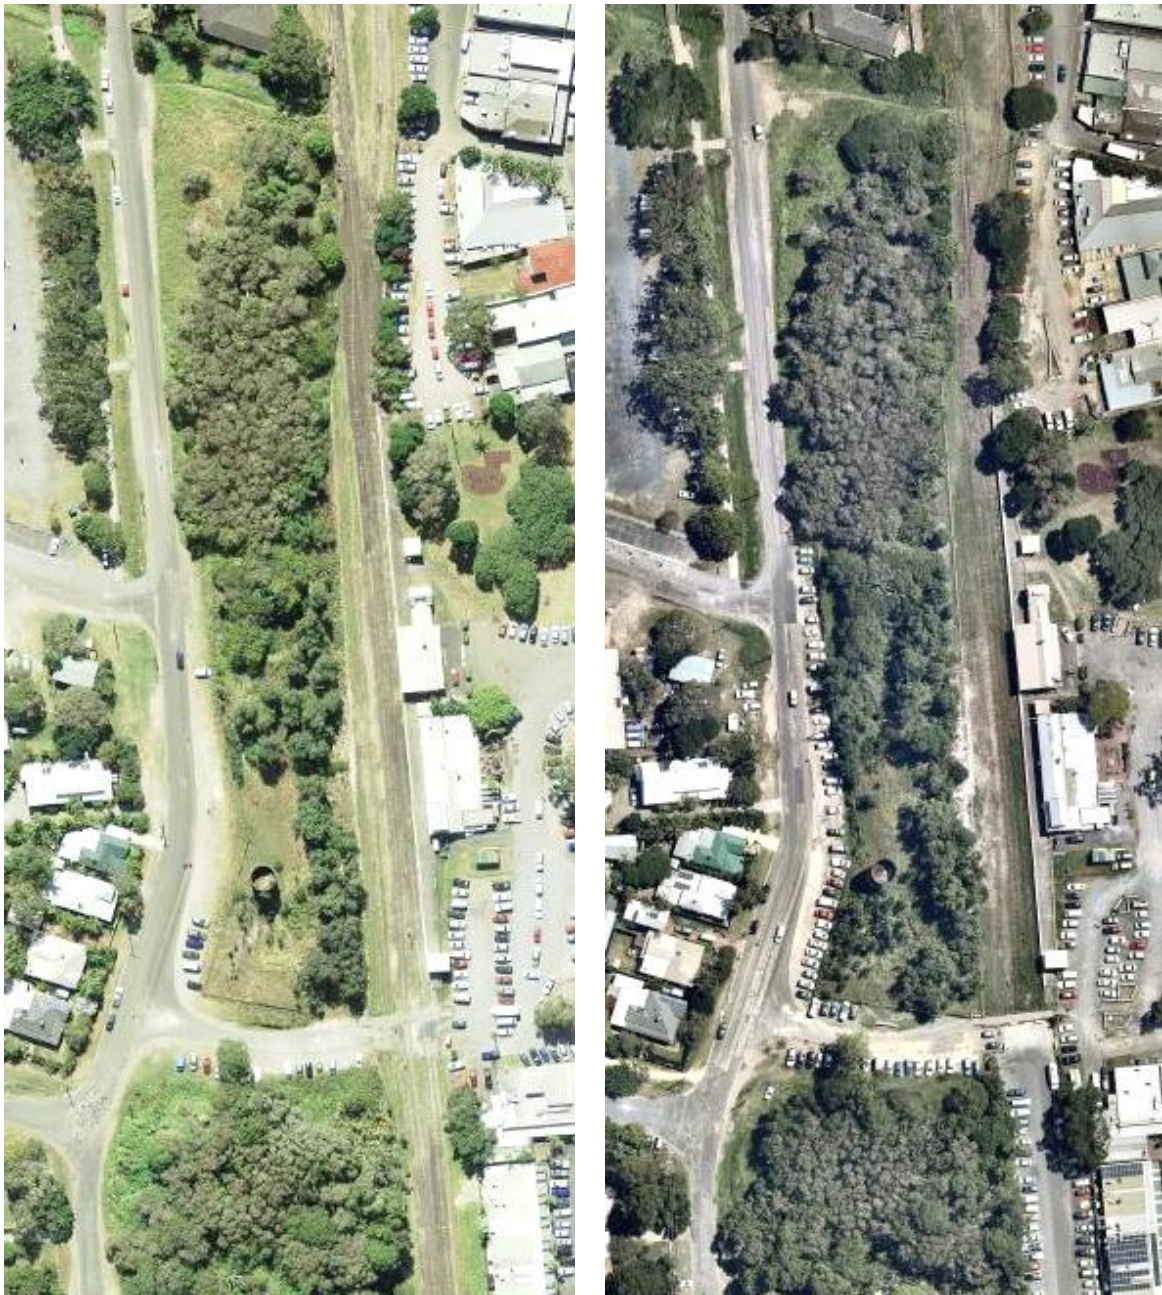
Figure 35. Aerial views of the Loco Siding area, in circa 2012 (left) and 2017 (right). Note the growth of vegetation around the water tower (Sources: LPI Six (l) NearMap (r))

The Loco Siding area is a strip of land on the western side of Byron Bay Railway Station, between the railway tracks and Butler Street. The land is vacant and overgrown with vegetation, the only visible structure being the brick water tower in the south-western corner. The Byron Motor Lodge Motel is located beyond the northern boundary and, to the south, the land is occupied by more substantial native vegetation, merging southwards into the bushland of the Currumbin Swamp.

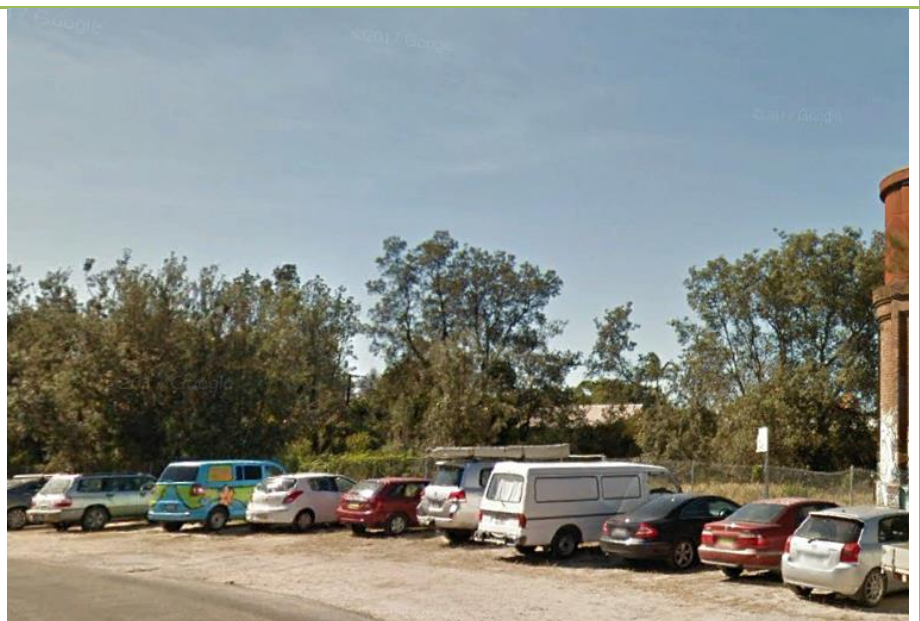
Figure 38. *The informal side road leading to the pedestrian crossing of the railway tracks*

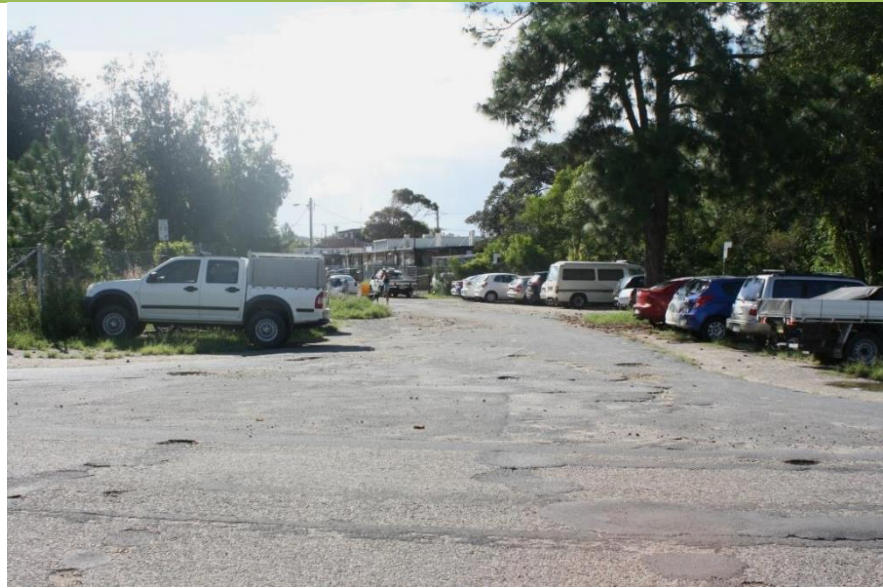
Figure 39. *The area south of the side road is heavily vegetated, low-lying and swampy.*

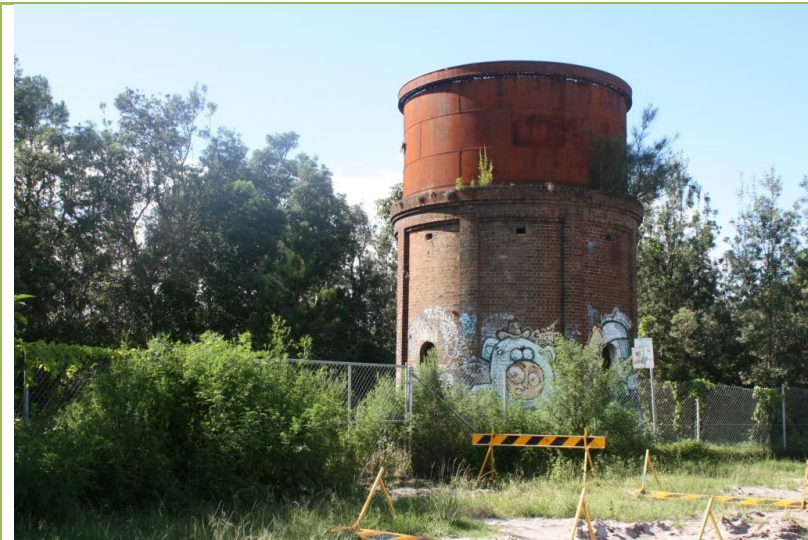
Figure 40. *The Water Tower, seen from Butler Street.*

The former railway water tower is a circular brick tower, 6.5 metres in height, surmounted by a riveted wrought iron water tank of 6.4 metres diameter and 3.3 metres height. The brick tower has expressed pilasters framing eight recessed panels, with a strong, simple cornice around the top. Every second panel features a semi-circular arched opening, each with two rows of brick voussoirs, infilled with wire mesh, with the one on the eastern side larger in dimensions to form a person opening.

The interior of the brick tower is empty, with only the base of the tank and the pipework visible overhead. Exterior pipework is located on the eastern side, with the outlet pipe projecting through the brickwork at approximately 4 metres above ground and the inlet pipe running from ground level up the side of the tower and tank to the top of the tank.

The brickwork is generally in good condition except around the cornice, where vegetation has become established in the mortar of the coping and between bricks. The iron plates of the tank are very corroded, with many pinholes in the sides.

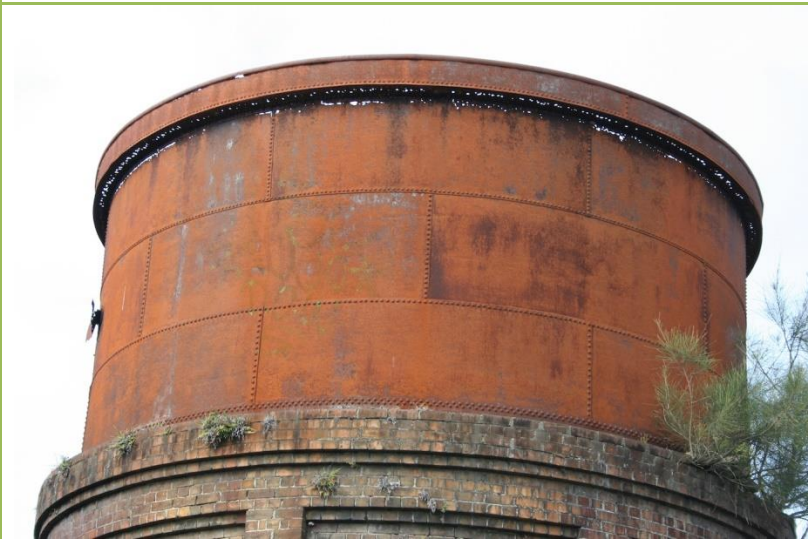
Figure 41. *The Water Tank on the top of the brick tower has some notable corrosion issues*

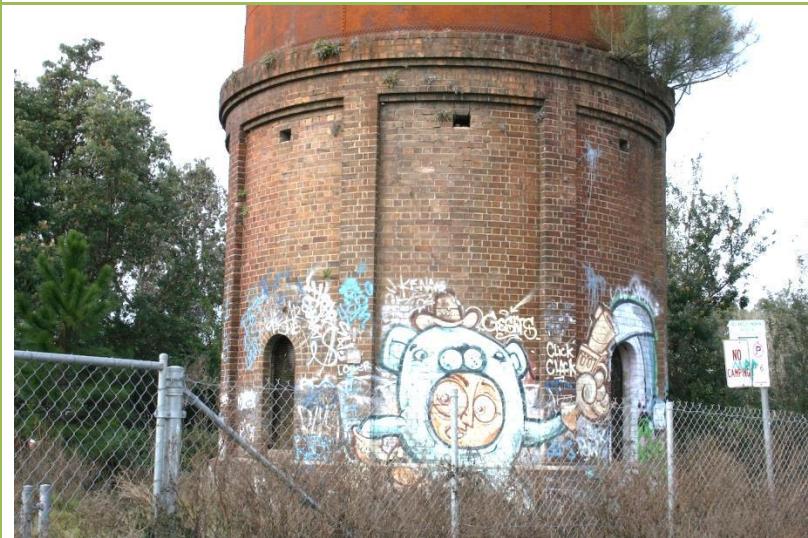
Figure 42. *The brick tower is generally in good condition, except where affected by vegetation and metal corrosion around the top.*

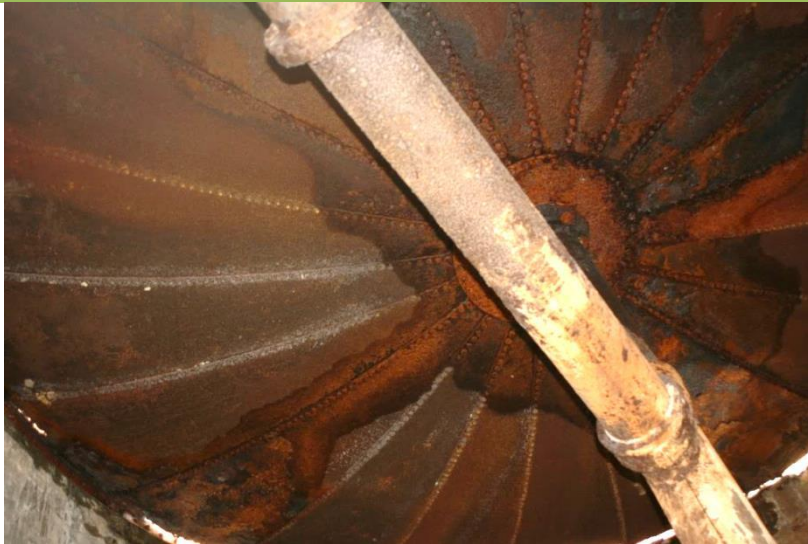
Figure 43. The underside of the water tank and outlet piping viewed from within the brick tower. The tank floor appears to be relatively sound.

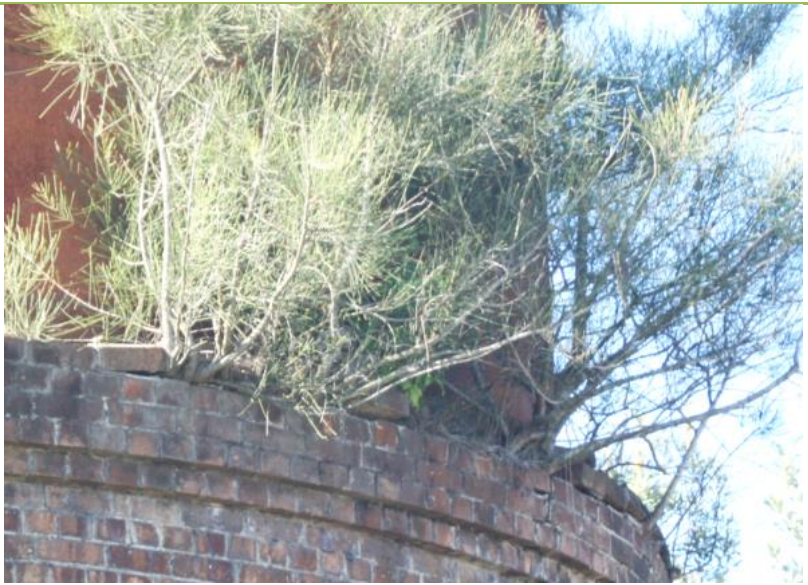
Figure 44. Brickwork around the upper rim is badly affected by vegetation growth.

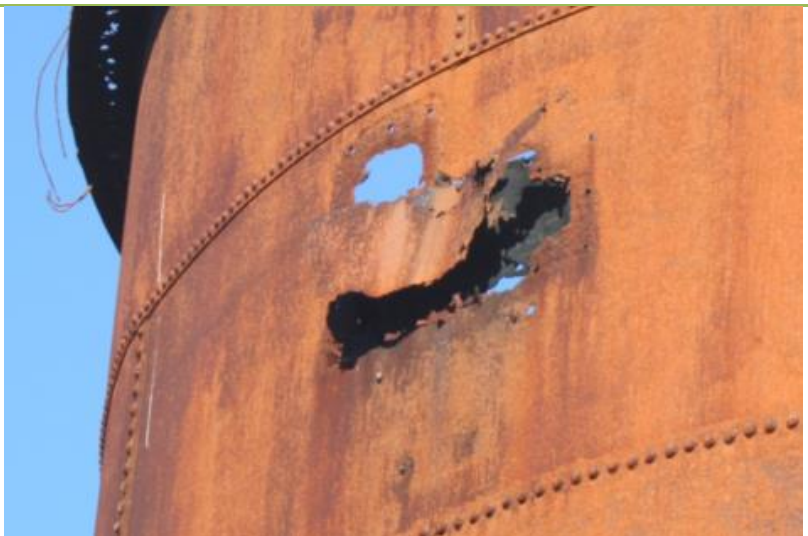
Figure 45. The metal work of the tank already shows evidence of previous corrosion repairs

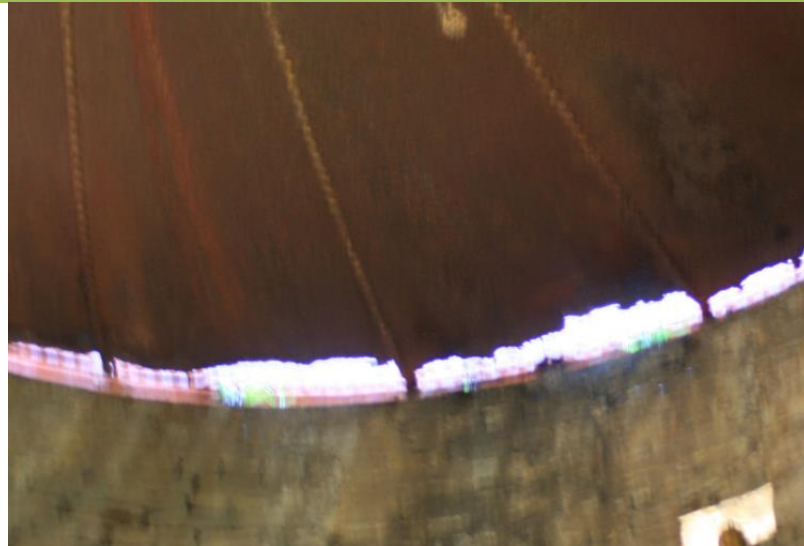
Figure 46. *The floor of the tank has become largely detached from the sides*

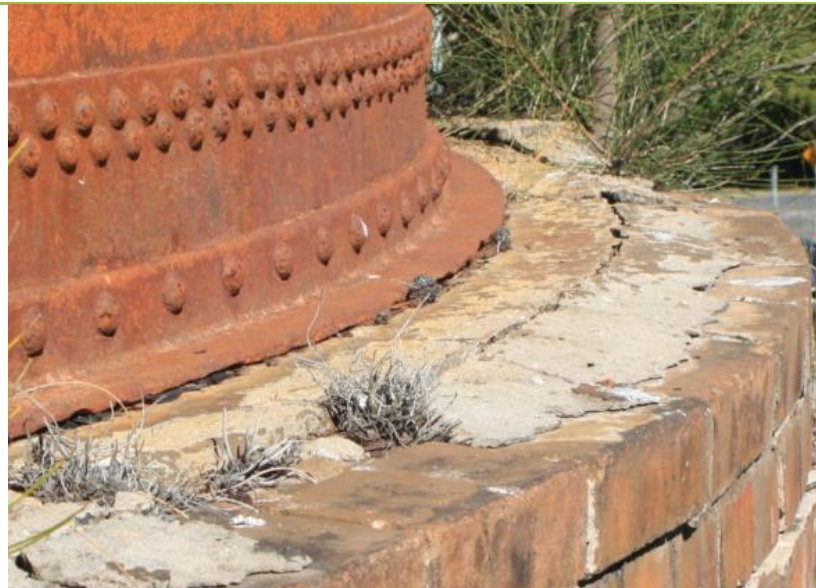
Figure 47. *The lower flange attached to the tank and the rendered coping on the brickwork were designed to shed stormwater but both are in poor condition.*

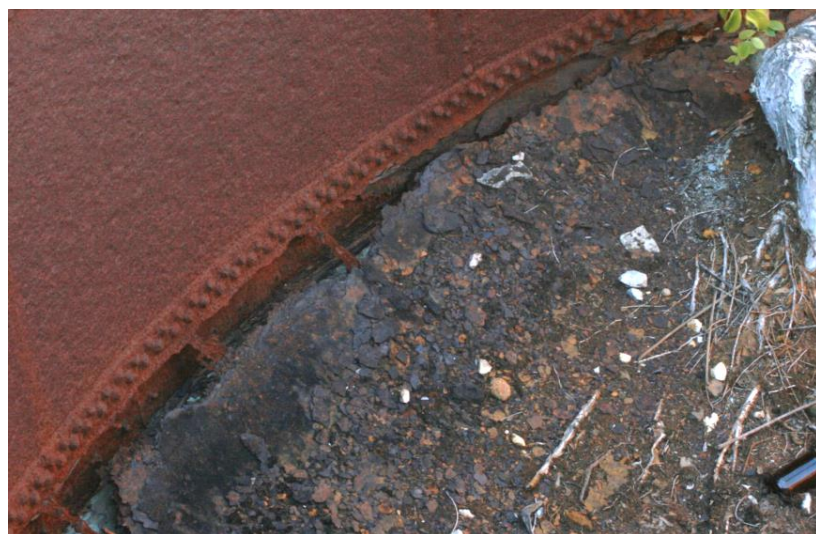
Figure 48. *Viewed from above, the corrosion of the tank floor at the connection to the tank walls is very apparent. There is vegetation growing in the rust and debris on the floor of the tank.*

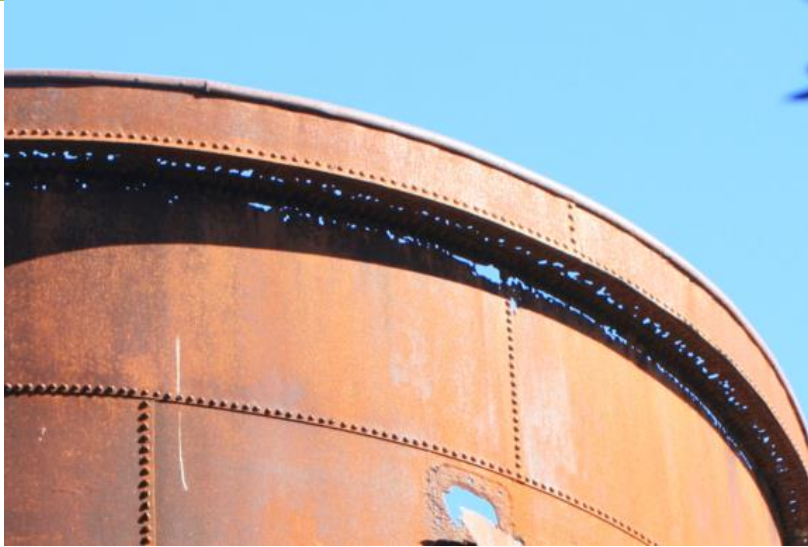
Figure 49. The corrosion of the upper horizontal tank lip appears more advanced than corrosion of the vertical surfaces.

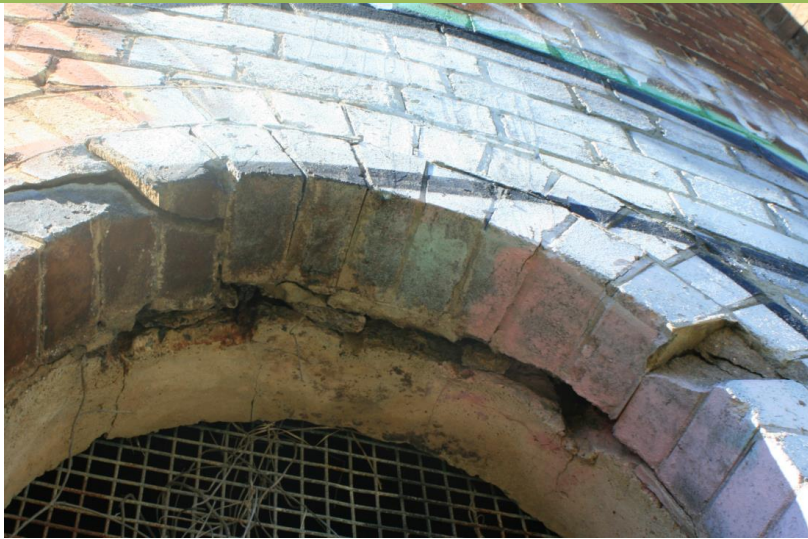
Figure 50. The arch brickwork of the western window has moved and one brick has been crushed.

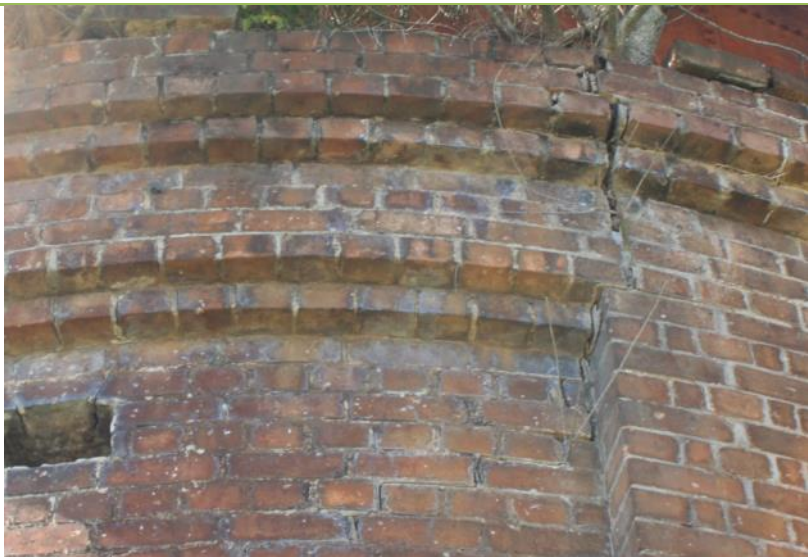
Figure 51. This brickwork crack is moving vertically downwards and is apparent on the inside of the brickwork as well.
