RE: Byron Bay Bus Interchange – ISEPP Consultation

This Statement of Heritage Impact (SOHI) will review the relevant statutory heritage controls, assess the impact of the proposal on the subject property and make recommendations as to the level of impact.

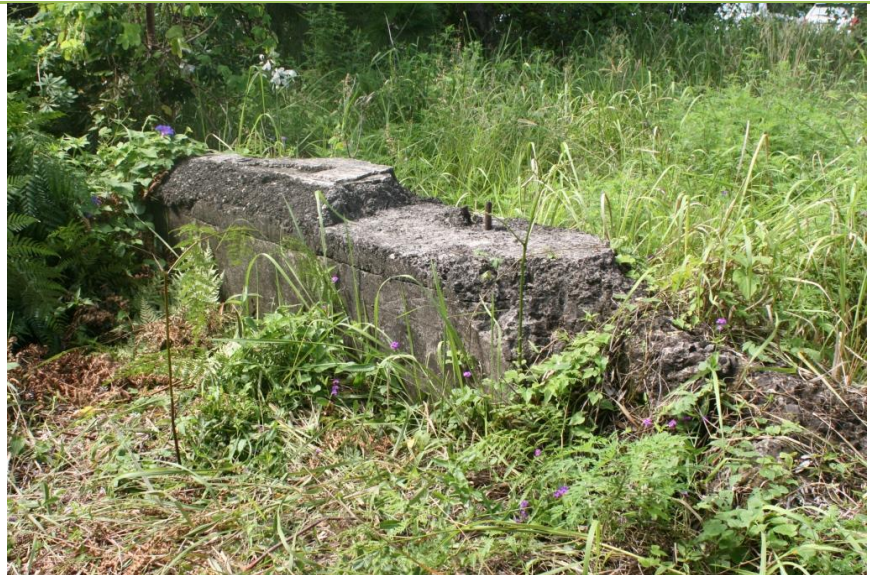
Figure 54. The southern concrete pier has been left standing, with the soil excavated from its southern side to form the present side road. It has been colourfully painted.

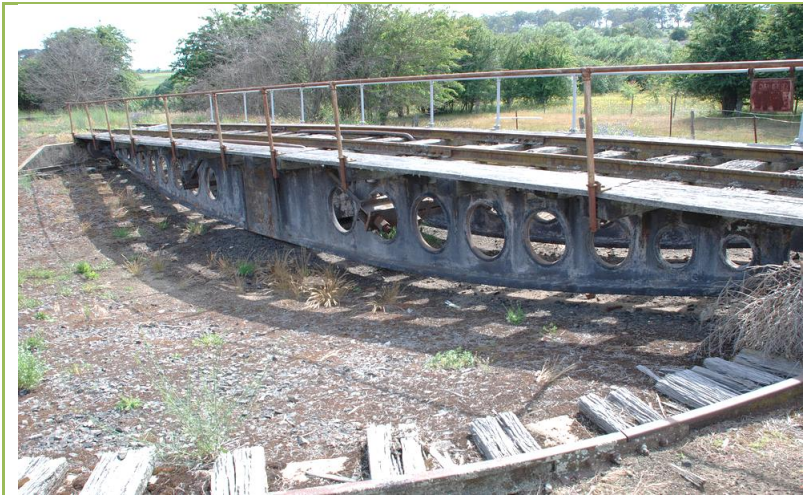
Figure 55. The turntable at Crookwell, NSW demonstrates one of the simplest arrangements (Flickr – J Webb)

The turntable bridge is missing and the pit has been filled with soil to its uppermost level, leaving only a circle of bricks and concrete visible in the ground. (Note that, on some occasions, the pit floor was on ground level, with the track set on an embankment.) Consequently, it is unknown what remains within the pit. Typically, turntable pits had a slightly concave conical concrete floor with the pivot bearing in the centre and an outer circular rail, which may be located on the floor or may be located on a step on the outer wall. Figures 55 – 57 below illustrate different arrangements of turntable pits used within the NSW railway system.

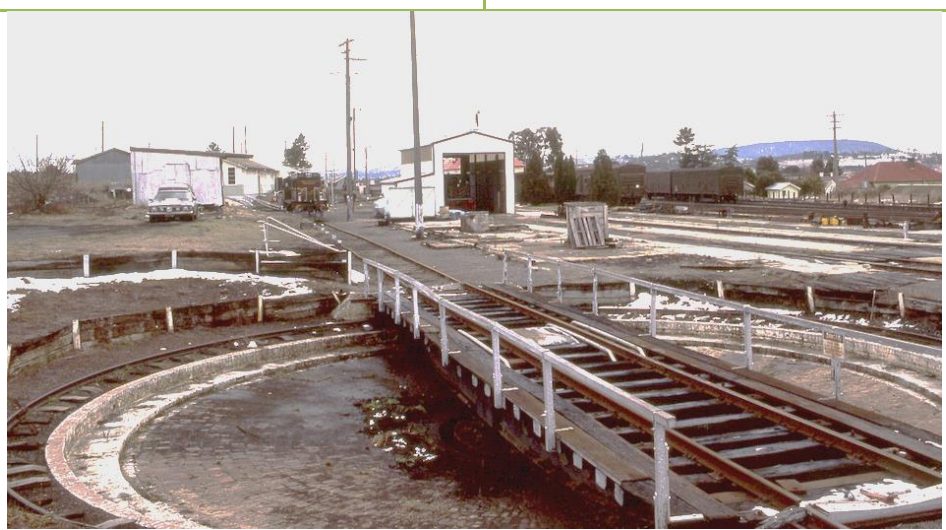
Figure 56. The Turntable at Armidale Station (Flickr – Dermis50)

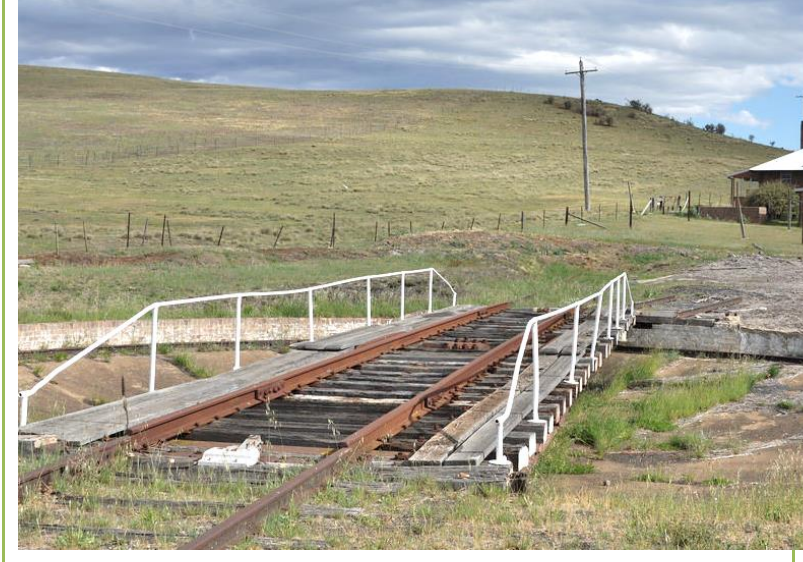
Figure 57. The Turntable at Cooma (Flickr - highplains68)

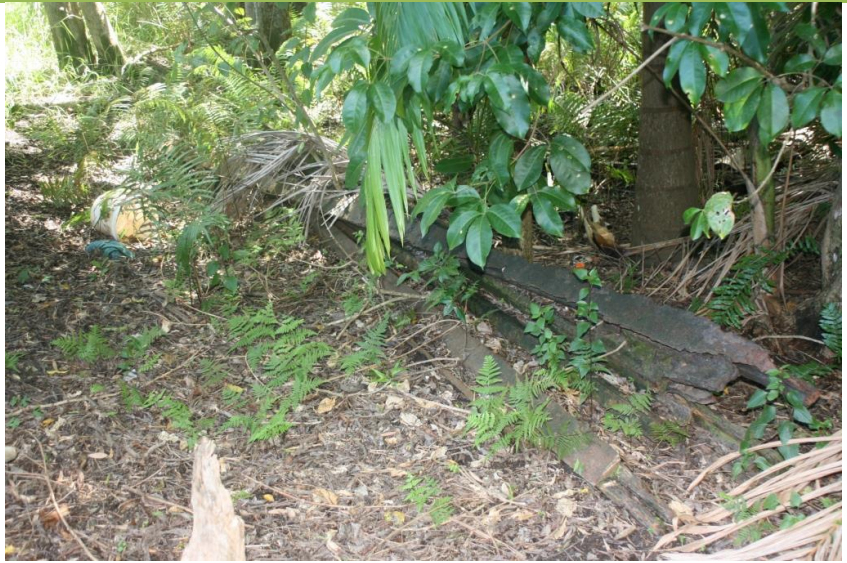
Figure 58. A small pile of old rails lying in the bush, now very corroded.

In the general area of the loco siding, various items of railway origin were noted as scattered artefacts. These included a collection of old rails sitting on the ground, pieces of rail used as fence posts and odd pieces of track furniture. No obvious evidence of the coal stage was observed, nor was evidence of any other structure, such as the stockyards and races or the pump house or well. Local oral history suggests that the well did exist and was visible until the mid-twentieth century; after which it was covered¹¹.

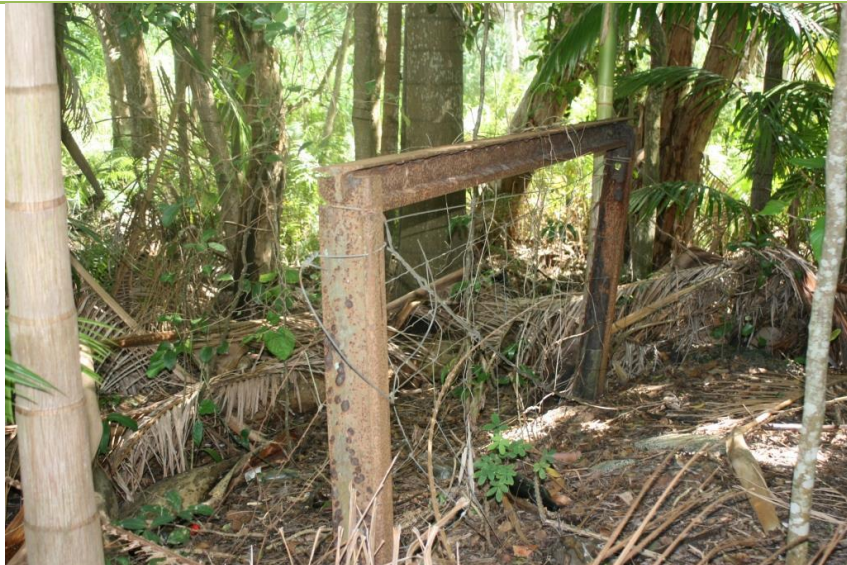
Figure 59. A small section of fencing constructed with pieces of old rail. It is impossible to determine the age and origin of this fence.

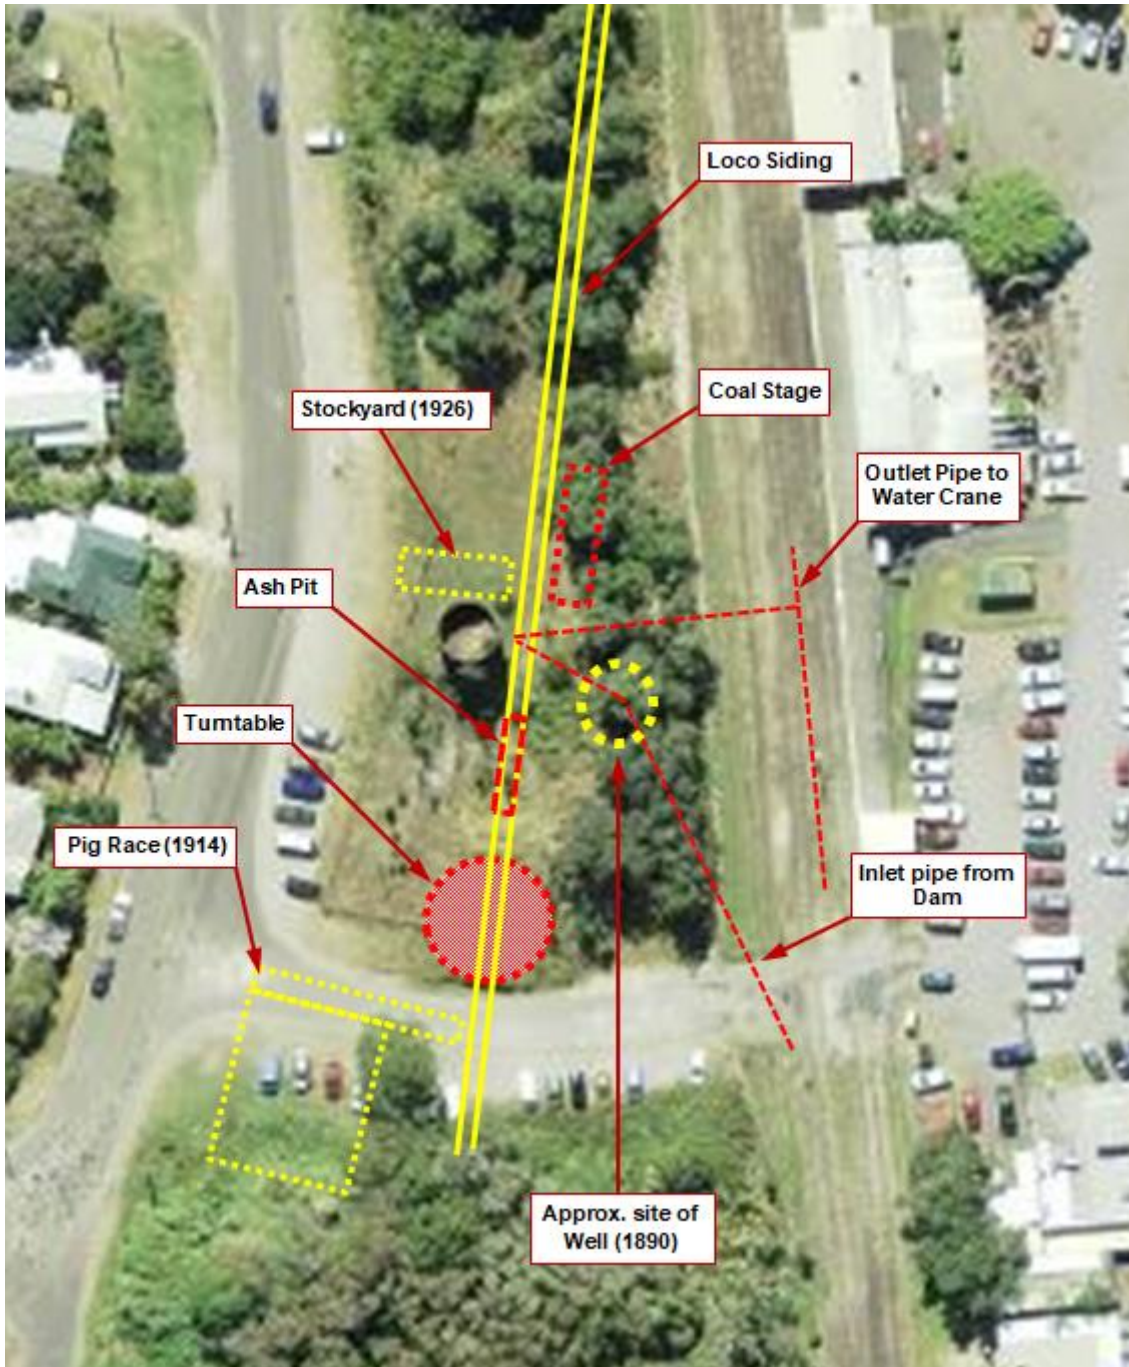
Figure 60. *Overlay plan showing the location of former structures and elements within the Loco Siding area at Byron Bay Railway Station.*

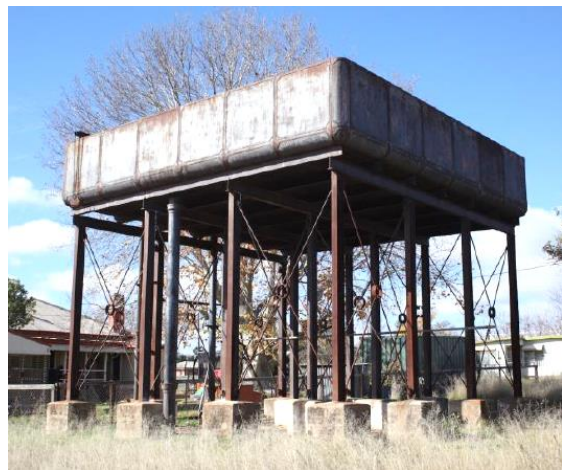
Figure 61. *Early type rectangular railway water tank (l) and the later, more common type of railway water tank (r) (Source: Watering Facilities Report op cit)*

Of these eighteen water towers, most have been demolished following the cessation of the use of steam locomotive engines in the 1960s and the closure of many branch lines. Byron Bay, Murwillumbah and Meranburn are the only three of the type still surviving in NSW, with Murwillumbah the only surviving example of the later, less elaborate type.

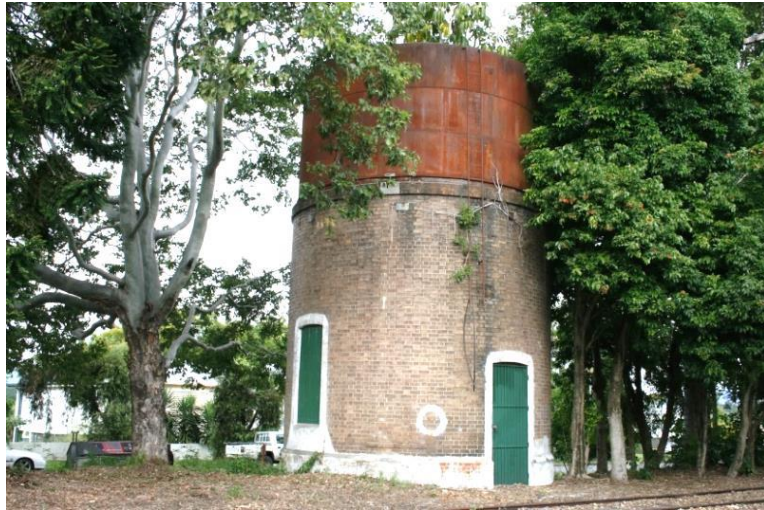
Figure 62. Meranburn (l) and Murwillumbah (r). (Source: Watering Facilities Report op cit)

Consequently, the Byron Bay Water Tower is a rare surviving example of its type. The type was, though, only built in relatively small numbers and cannot be described as representative of railway tanks generally. Of the three survivors of the type, Byron Bay is the most prominent in relation to its urban context, where it is a minor local landmark within the township of Byron Bay. Murwillumbah is located away from the centre of town and is obscured by vegetation. Meranburn is located many kilometres from the nearest township (6 km west of Manildra) in an isolated context.

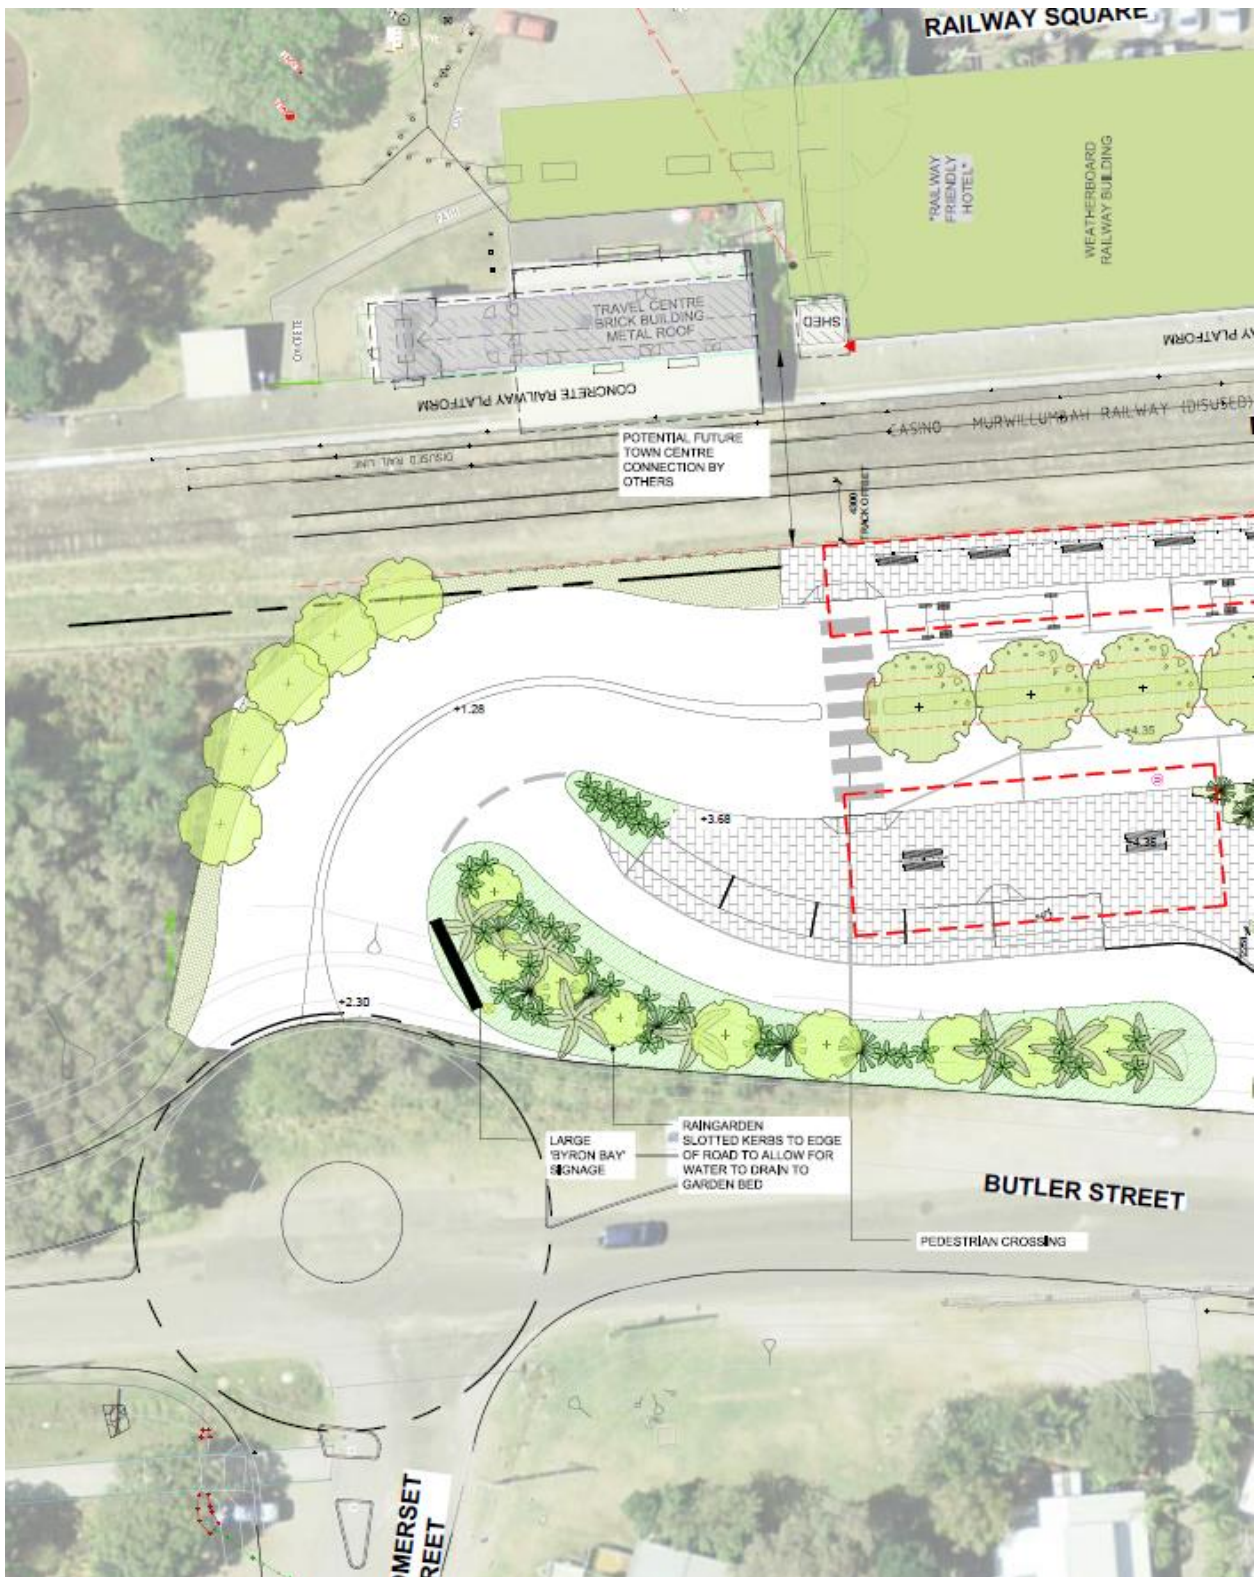
Figure 65. Detail (northern end) of the layout of the proposed Bus Terminal, showing the entry and exits from the Butler St roundabout and the drop-off area (DesignInc - SMEC).

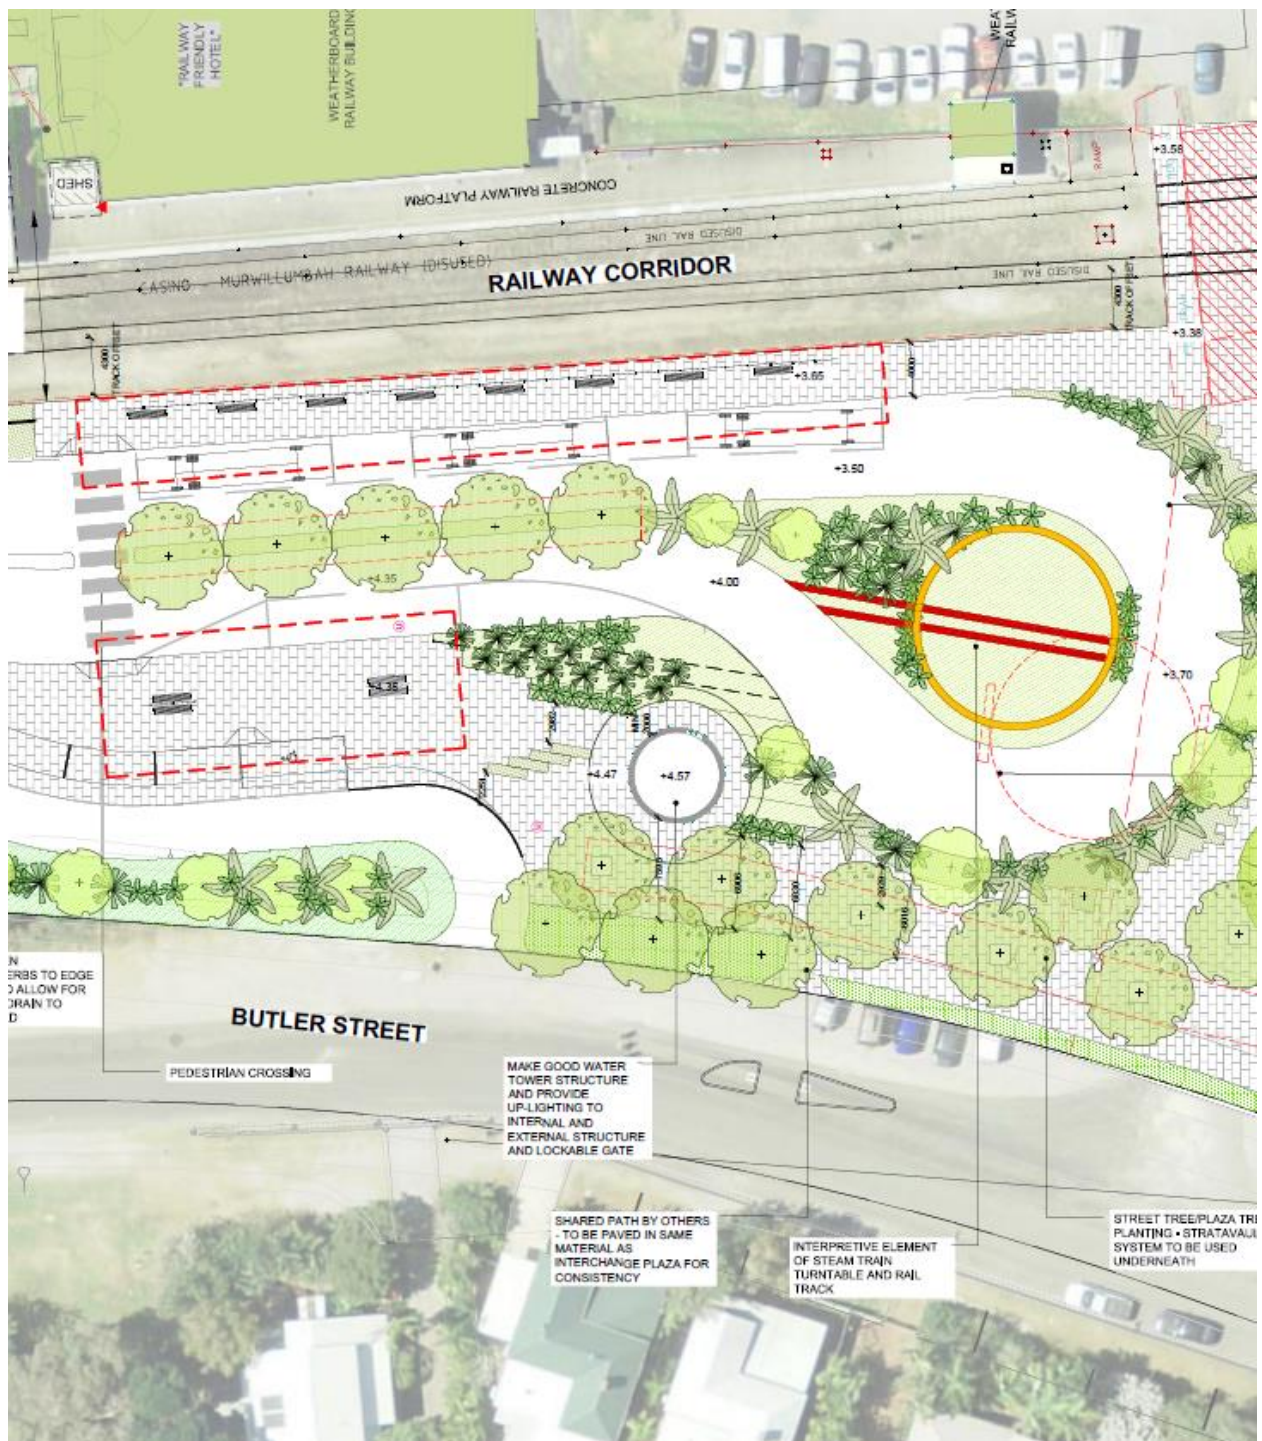
Figure 66. Detail (centre) of the layout of the proposed Bus Terminal, showing the canopies over the paved waiting areas, the roundabout and proposed landscaping and interpretation of the turntable. (DesignInc - SMEC).

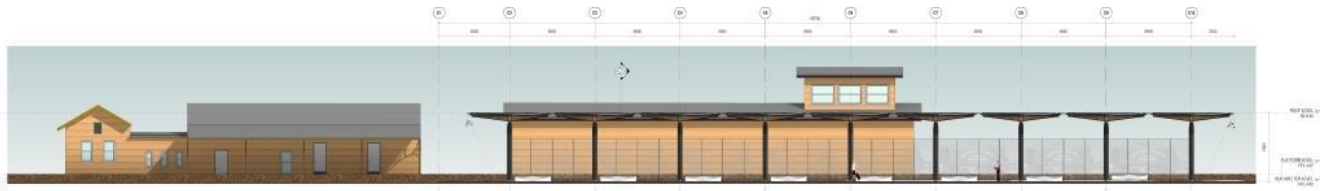
Figure 68. View east from centre of site to railway station (DesignInc - SMEC).

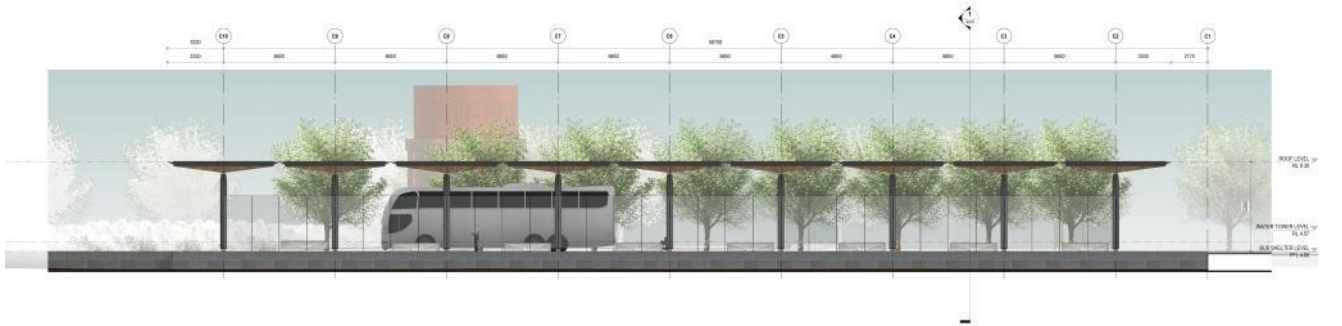
Figure 69. View west from railway station (DesignInc - SMEC).

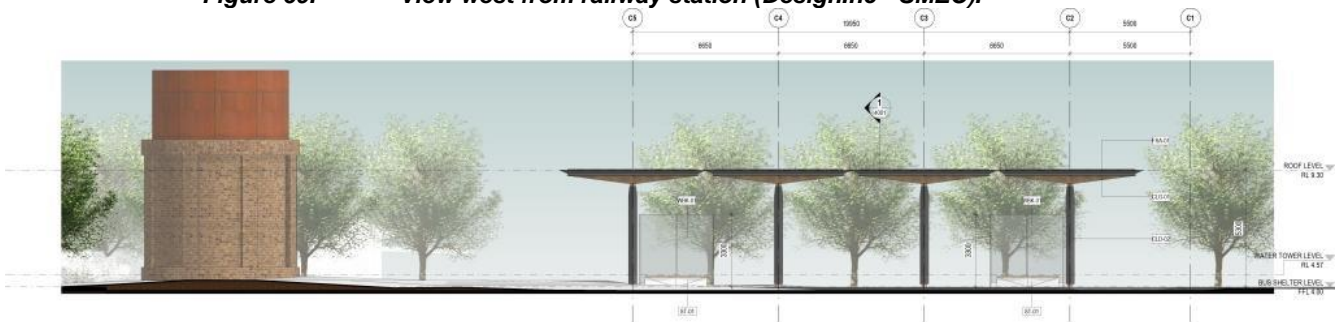
Figure 70. View west from centre of site (DesignInc - SMEC).

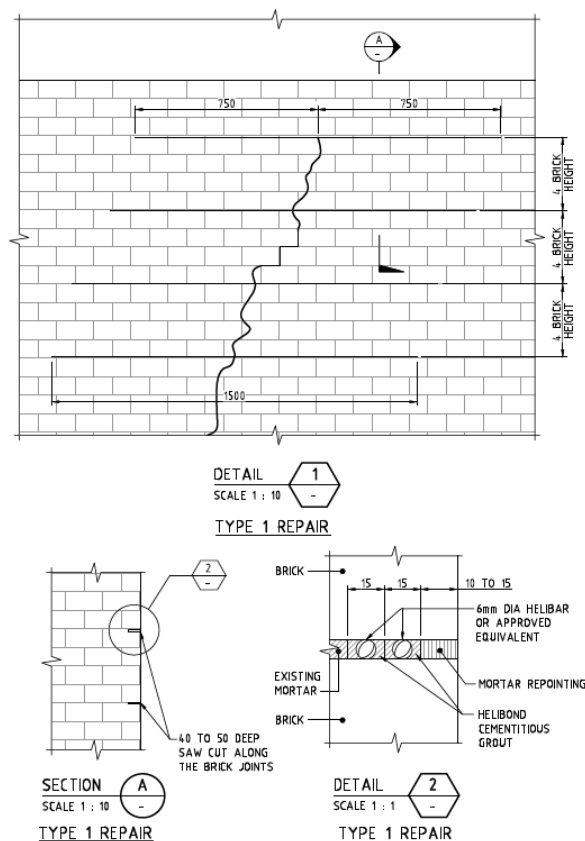
Figure 81. Areas of brickwork requiring crack-stitching (SMEC).
