Transport Access Program: Denistone Station

Statement of Heritage Impact

Report to Transport for NSW

November 2021

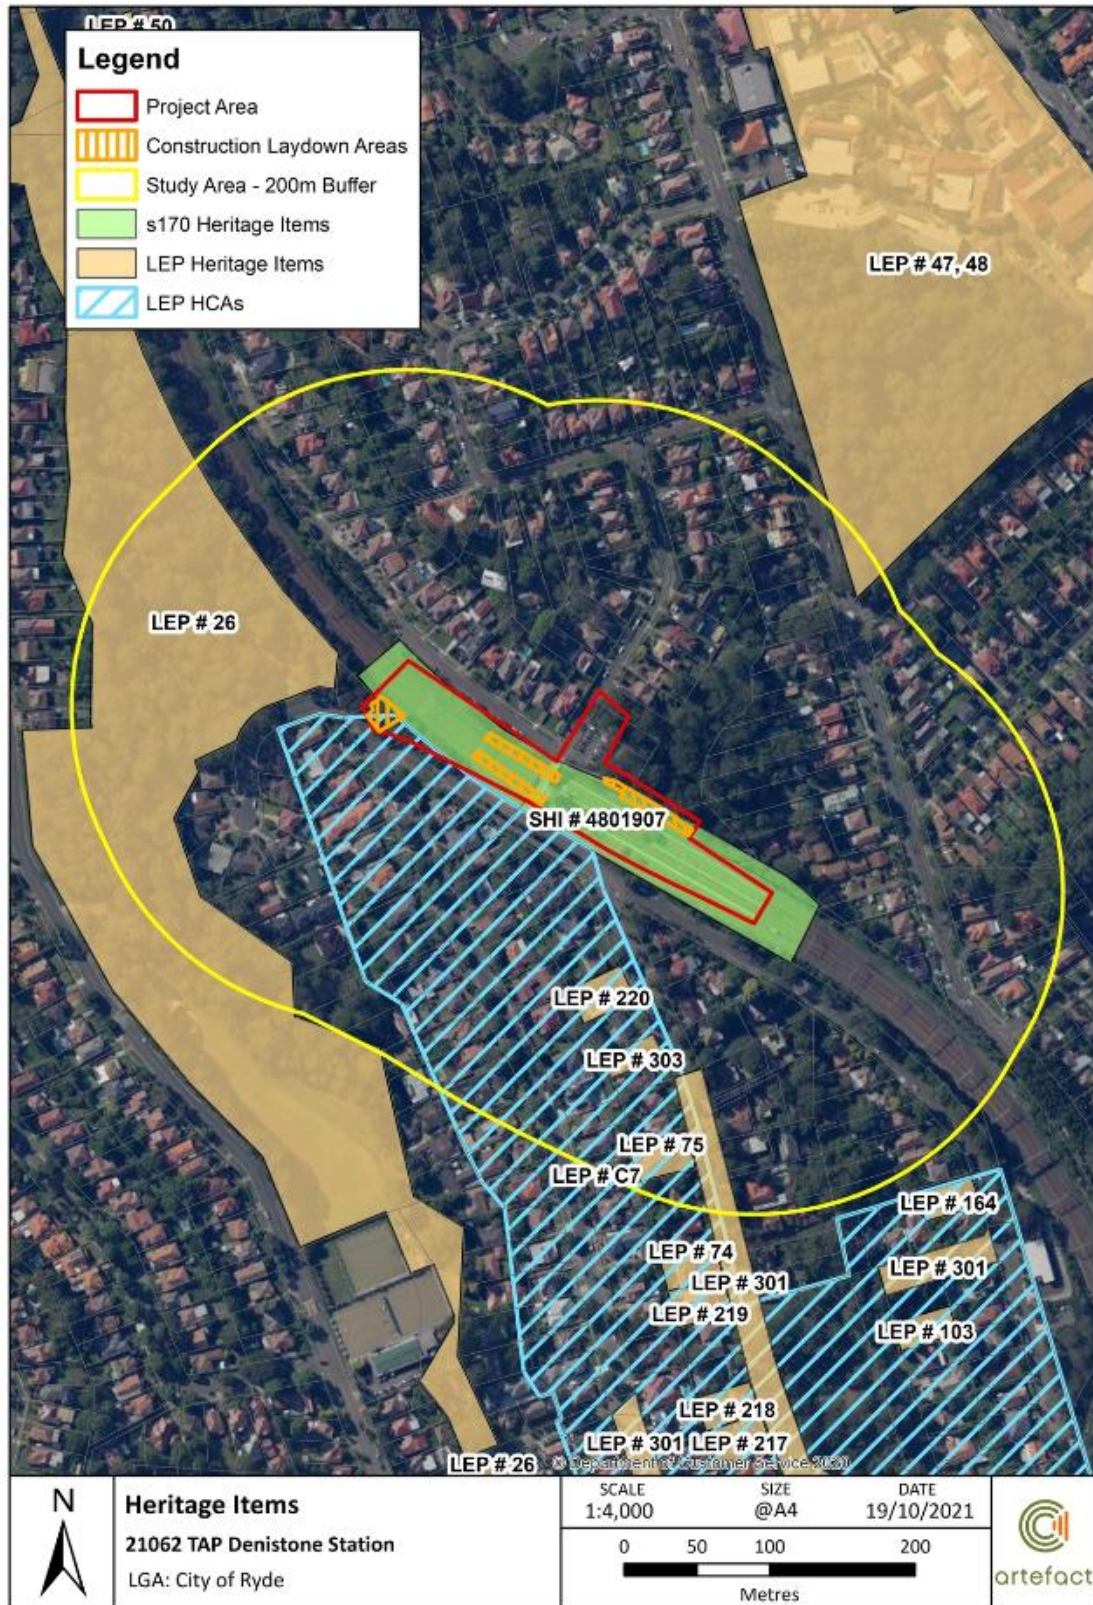
Figure 2: The heritage curtilage of Denistone Station and the statutory heritage items in the vicinity (Source: Artefact 2021)

The relevant statutory and non-statutory heritage listings for Denistone Station and items within its vicinity are listed in the Table 1 below. The listing and curtilage boundaries are detailed in Figure 2 below. Although Denistone Station was nominated for listing on the SHR in 2017, the Station has not been added to the SHR.⁴

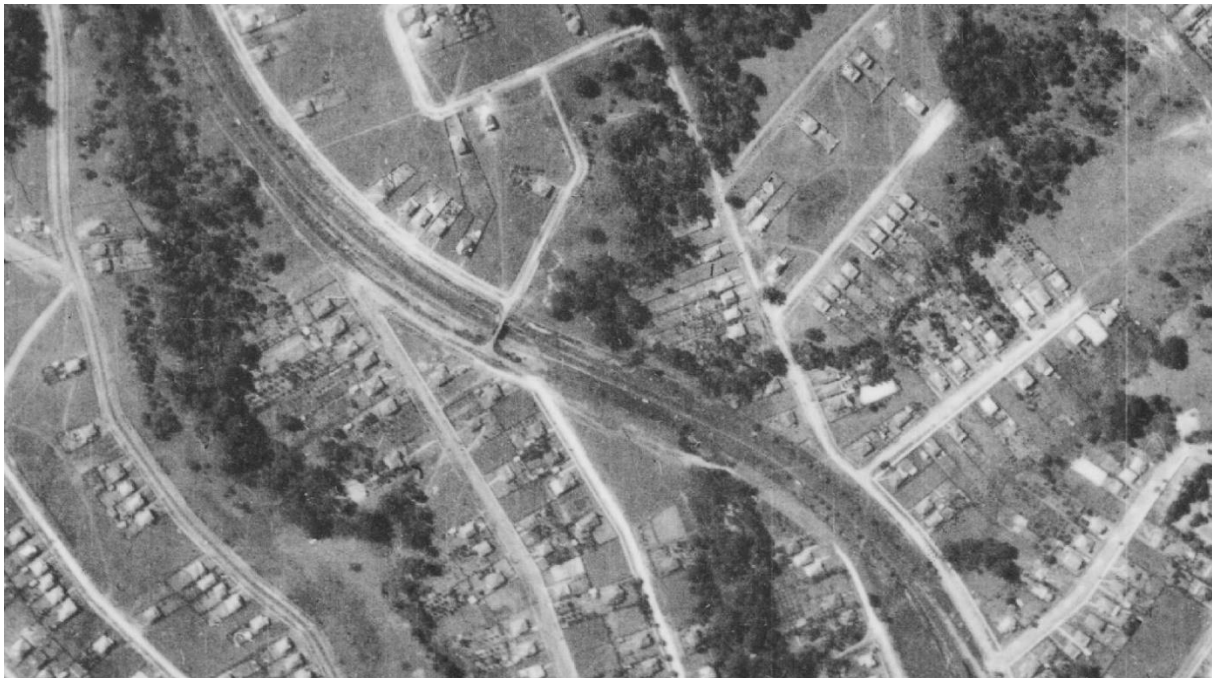
Figure 13: A 1930 aerial photograph showing the cutting for the railway line and an earlier overbridge (Source: NSW Government Spatial Services Historical Imagery Viewer (HAP) 2020, CAC_10_1260.jp2)

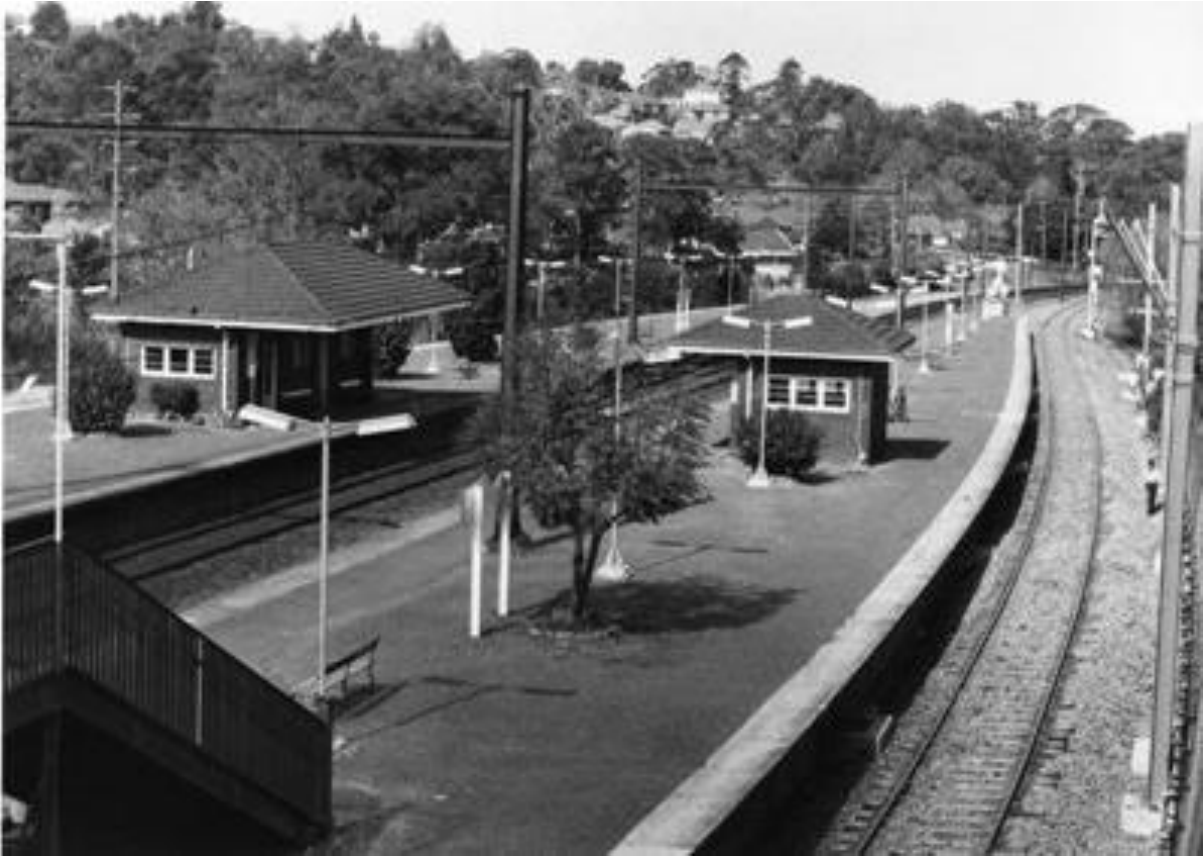
Figure 24: 1978 photograph showing the open third track along Platform 4 (Source: Anonymous 1978 in Heritage NSW 2017)

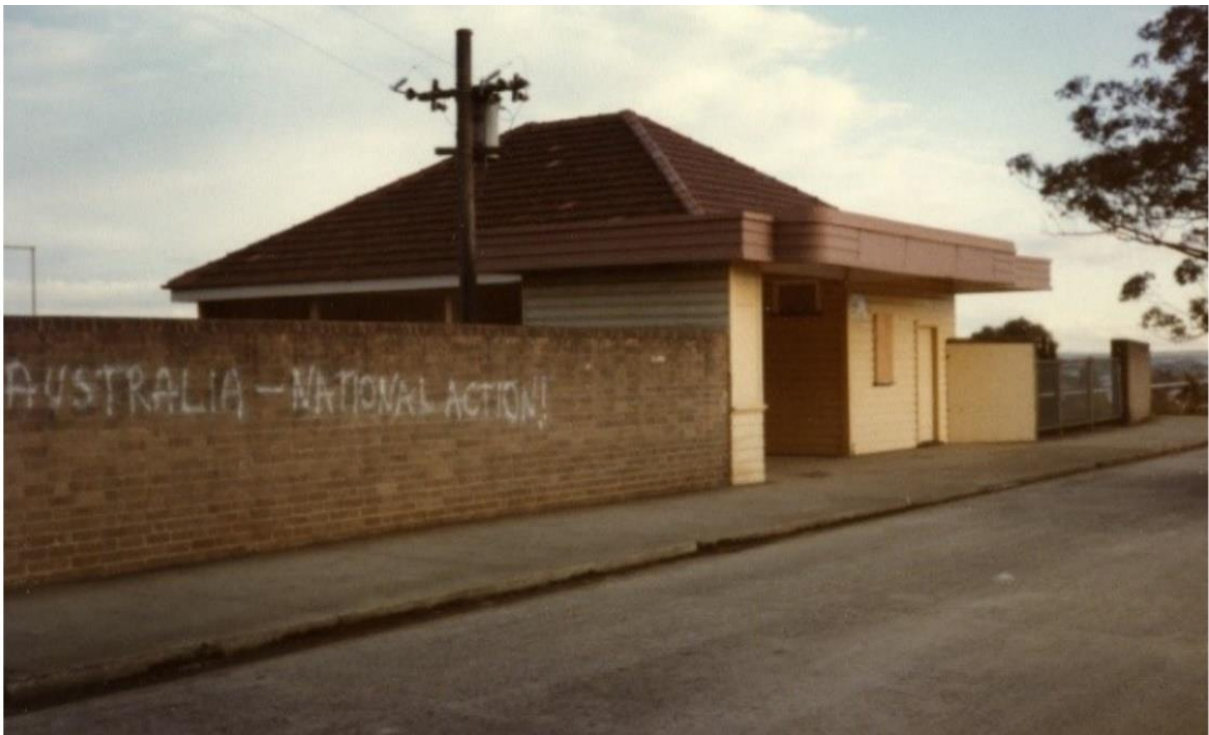
Figure 25: 1984 photograph of the overhead booking office, showing the former awning and bookstall (Source: RailCorp in Arcilla, Gupta and Binkhorst 2019. p. 18)

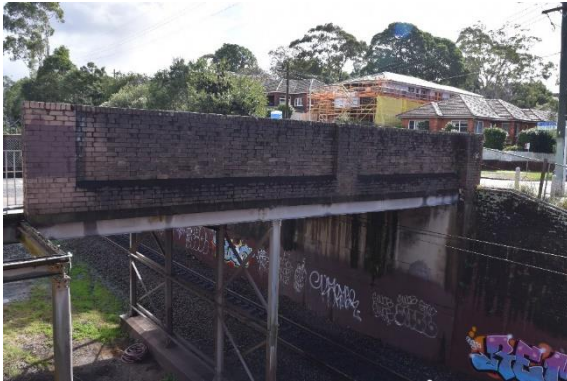
Figure 39: View of the south-eastern side of the overbridge, showing the brick parapet, concrete abutment and steel supports (Source: Artefact 2021)

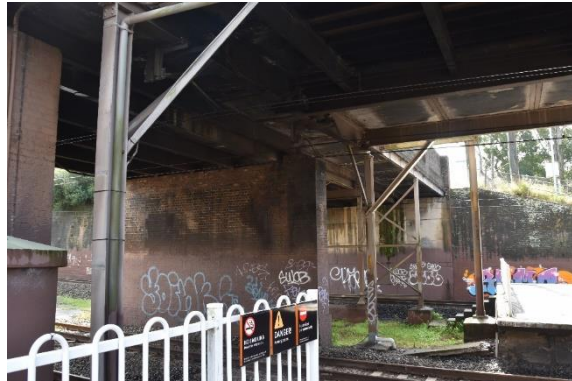
Figure 40: View of the south-eastern side of the overbridge, showing a brick pier and steel supports (Source: Artefact 2021)

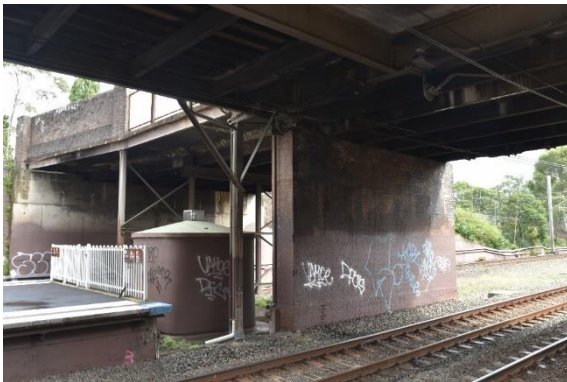
Figure 41: View of the south-western end of the overbridge, showing the brick piers, concrete rendered abutment and steel supports (Source: Artefact 2021)

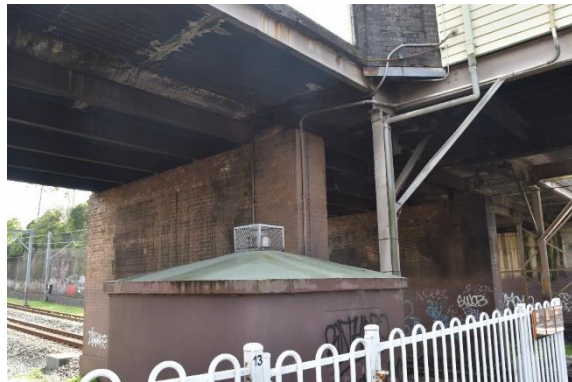
Figure 42: View of the south-western sides of the brick piers and additional steel supports (Source: Artefact 2021)

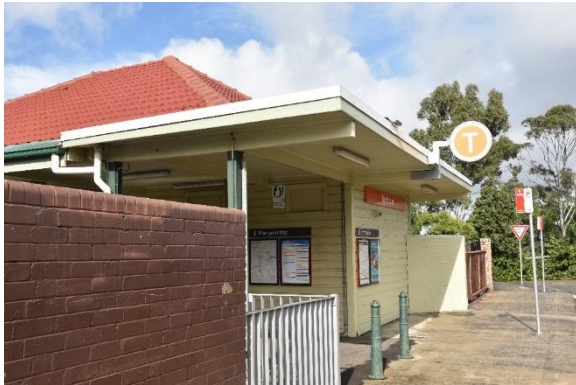
Figure 43: View of the front (north-west) elevation overhead booking office from the overbridge, view south (Source: Artefact 2021)

The overhead booking office is located on the south-eastern side of the overbridge, providing access between the overbridge and footbridge (Figure 43 to Figure 52). The building comprises a 1937 Type 19²⁹ weatherboard overhead booking office with a hipped Marseille tiled roof, the latter of which appears to have been re-tiled in 2018 (Figure 43 to Figure 46). The roof includes tiled hipped roof which extends over the weatherboard building and an L-shaped corrugated metal awning to the north-east and south-east of the main building (Figure 43 to Figure 46). The overhead booking office is supported by steel girders, while the footbridge awning is supported by timber posts (Figure 43 to Figure 46).

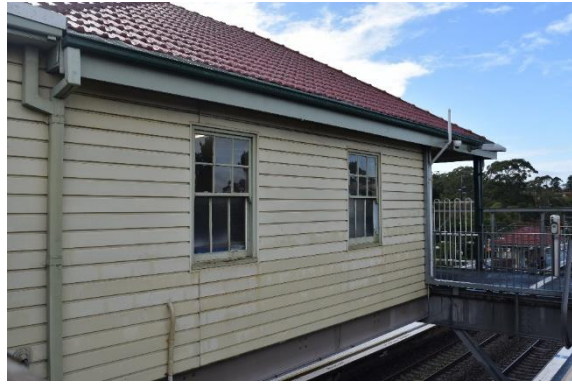
Figure 44: View of the side (south-western) elevation of the overhead booking office from the overbridge, view south (Source: Artefact 2021)

Several of the original weatherboards appear to have been removed and replaced with acrylic composite cladding on all elevations aside from the north-western elevation, which appears to have been replaced or covered with metal cladding (Figure 43 to Figure 46). The recladding has resulted in the removal or covering of original openings on the front (south-eastern) and side (north-eastern) elevations, including ticket windows and doors (Figure 15, Figure 25 and Figure 40). Only one ticket window remains on the north-eastern elevation, but the original framing has been replaced with an aluminium frame and security roller, while the c.1945 clerestory windows along the north-eastern elevation have been infilled (Figure 43 to Figure 45). The original double-hung timber-framed sashed windows along the south-western elevation have been retained, likely with the original glazing intact (Figure 44).

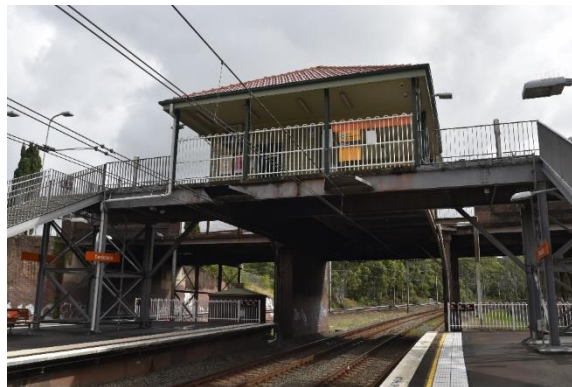
Figure 47: View of the extant steel supports from the former bookstall, view west (Source: Artefact 2021)

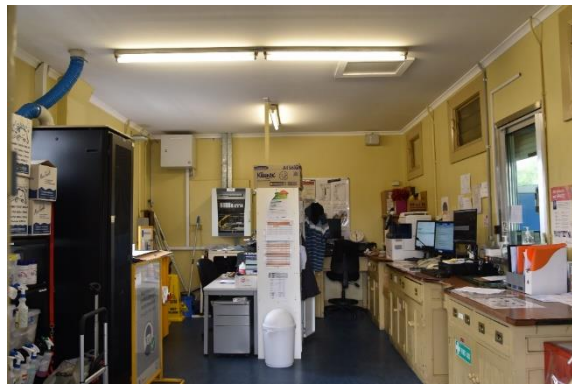
Figure 48: View of the interior of the overhead booking office, view north-west (Source: Artefact 2021)

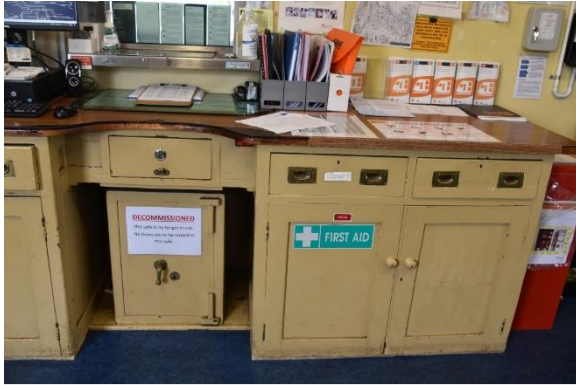
Figure 49: View of the original timber counter and safe, view north-east (Source: Artefact 2021)

Internally, the original configuration has been partially retained through the retention of the 1937 L-shaped timber counter, which demonstrates the location of the original ticket windows, as well as the original safe, and a portion of the original partition wall at the north-western end of the building (Figure 48 to Figure 50). Although the original doorway on the north-western elevation has been covered, the door appears to be intact behind boarding internally (Figure 48). The doorway in the south-eastern elevation has been retained, but the door has been replaced with a plain timber door and aluminium screen (Figure 51). The glazing in one of the louvred clerestory windows along the north-eastern elevation has been retained (Figure 52).

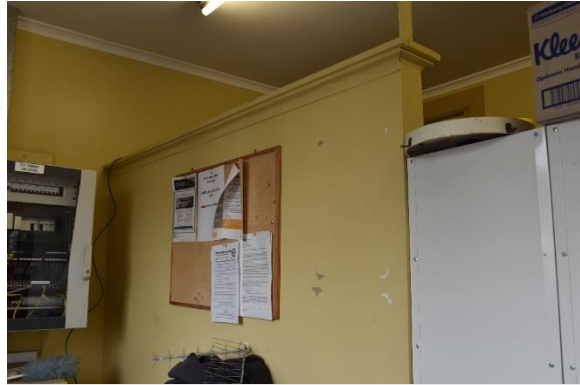
Figure 50: View of the retained portion of an original partition at the north-western end of the office, view north (Source: Artefact 2021)

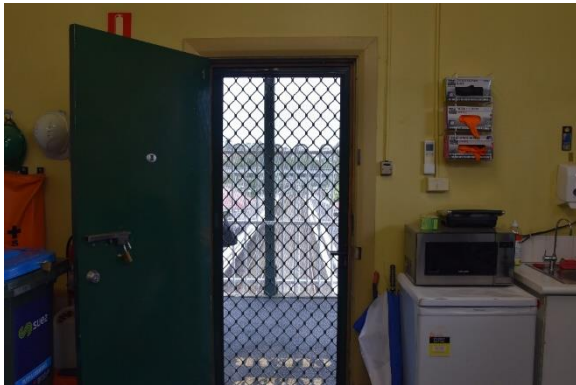
Figure 51: View of the doorway in the south-eastern elevation, view south-east (Source: Artefact 2021)

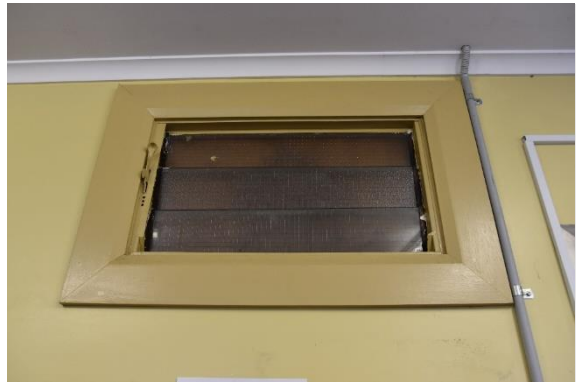
Figure 52: View of the c.1945 clerestory window along the north-eastern elevation, view north-east (Source: Artefact 2021)

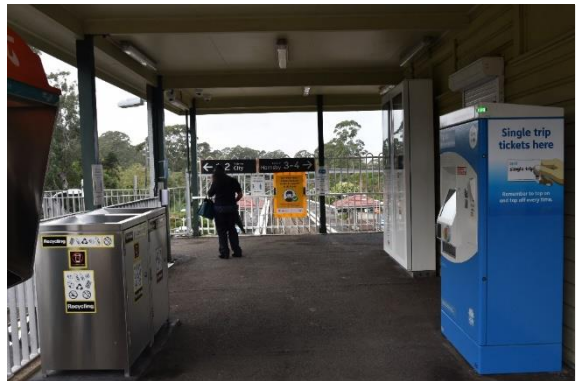
Figure 57: An original Newell post and handrail (Source: Artefact 2021)

The footbridge, constructed in 1937, provides access to the two island platforms (Figure 53 to Figure 58). The footbridge comprises a steel footbridge and two staircases leading to the platforms with concrete treads and decking supported by a steel truss frame structure (Figure 55 to Figure 58). The concrete treads exhibit minor localised modifications. The footbridge has retained the majority of the original cast-iron newel posts with star detail, and steel balustrading, comprising steel panels of flattop rectangular palisade balustrades which have been painted with micaceous paint (Figure 57). A section of the original balustrading has been replaced with steel loop-top fencing along the south-eastern side of the footbridge, while a sympathetic style of balustrading has been installed in the area of the former bookstall (Figure 53 and Figure 58). The steel trellis (support), the timber footings and steel bolts are all that remains of the former bookstall (Figure 58). The original handrails, with rounded terminations and the foot of the stairs and curved terminations at the top of the stairs, are also extant (Figure 57). The surface of the concourse is levelled with asphalt and c.1990s heritage style bollards

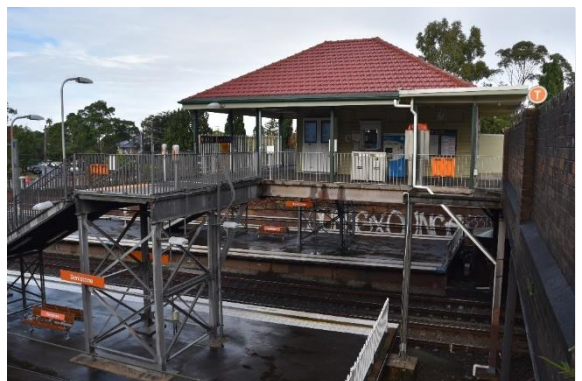
Figure 58: The steel support structure of the footbridge and staircase (Source: Artefact 2021)

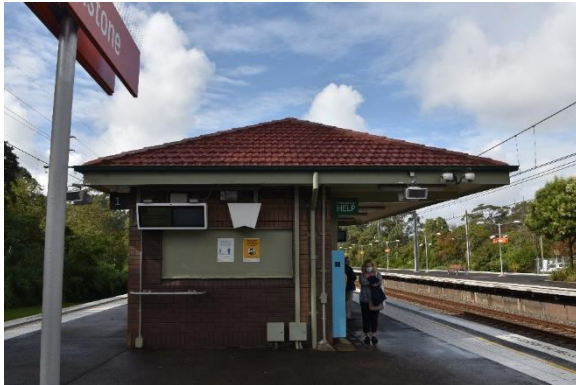
Figure 60: The cantilevered awning along the south-western elevation of the Conveniences Building, view south-east (Source: Artefact 2021)

The station platform building on Platform 1/2 is a 1937 face-brick Conveniences Building with a hipped roof laid in Marseille terracotta tiles (Figure 59 to Figure 76). The walls comprise stretcher-bonded red brick cavity walls with soldier-coursed brickwork at the ground level, as a string course and at the top of the two engaged piers flanking the opening on the north-eastern side of the building (Figure 59 to Figure 66). The engaged piers and steel brackets support the cantilevered north-eastern end of the hipped roof, which forms an awning over the north-eastern entrance (Figure 59 to Figure 62). The side (north-western) and front (south-western) elevations of the building exhibit boarded-up windows with soldier-coursed lintels and chamfered sills, the timber framing to these windows appears to have been retained (Figure 59 to Figure 66). The rear (north-eastern) windows retain their original timber framing and later twentieth-century glazing (Figure 59 to Figure 66). The building utilises similar materials, details and form to the Shelter Shed on Platform 3/4, both of which exhibit an Inter-War Railway Domestic design, inspired by Functionalist Inter-War housing (see Section 4.3.5). An original, but disused, bubbler sits along the south-western elevation of the building (Figure 61).

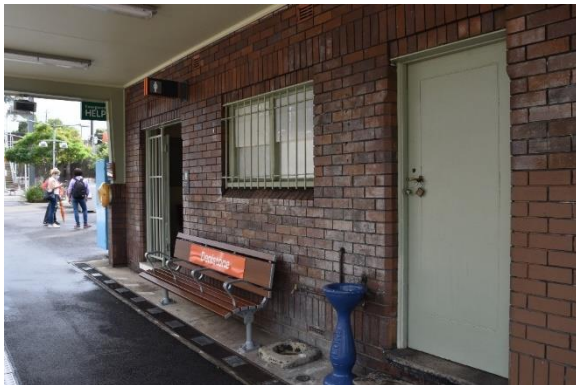
Figure 62: The south-eastern elevation of the Conveniences Building on Platform 1/2, view north-west (Source: Artefact 2021)

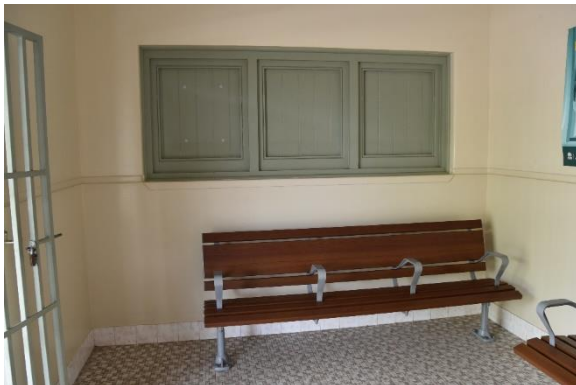
Figure 68: The ceiling of the waiting room, view north-west (Source: Artefact 2021)

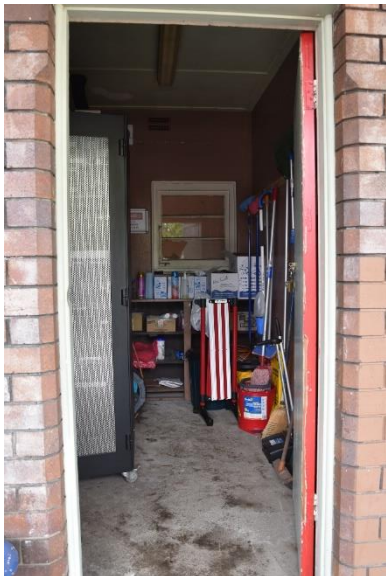
Figure 74: The ceiling of the storeroom in the Conveniences Building, view north-east (Source: Artefact 2021)

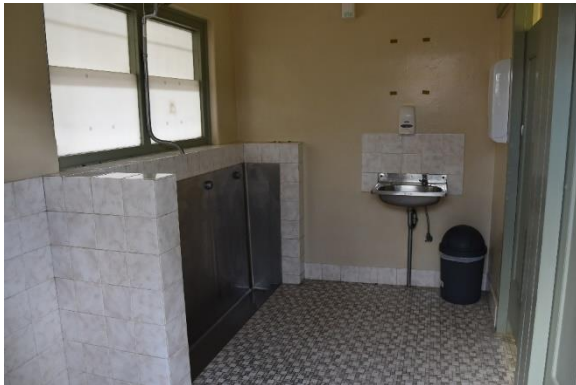
Figure 76: The original stalls of the men's bathroom in the Conveniences Building, view north (Source: Artefact 2021)

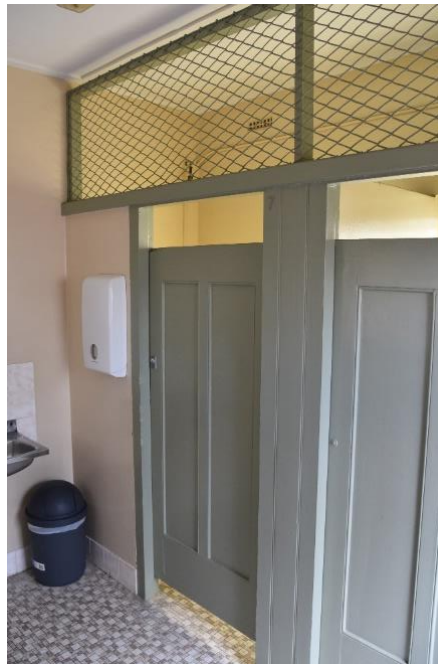
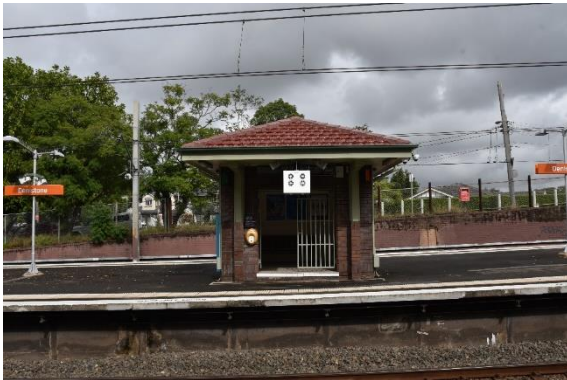
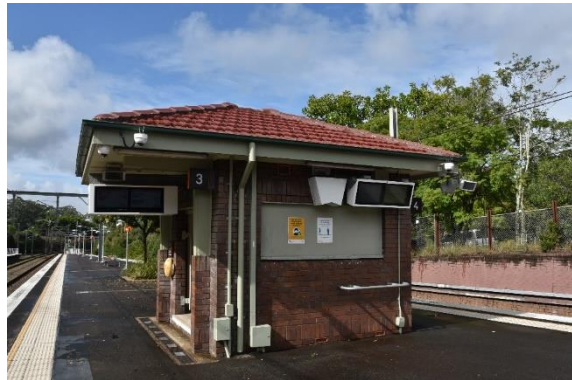
The station platform building on Platform 3/4 is a small 1937 face-brick Type 13 Shelter Shed with a hipped roof laid in Marseille terracotta tiles (Figure 77 to Figure 80). The walls comprise stretcher-bonded red brick cavity walls with soldier-coursed brickwork at the ground level, as a string course and at the top of the two engaged piers flanking the opening on the north-eastern side of the building (Figure 77 to Figure 79). The engaged piers and steel brackets support the cantilevered north-eastern end of the hipped roof, which forms an awning over the wide entrance (Figure 78). The side elevations of the building include infilled windows with soldier-coursed lintels and chamfered sills (Figure 78). Modern signage and services have been fixed to the external elevations of the building (Figure 77 to Figure 79). The design of the building is austere, with similar form, materials and details to the Platform 1/2 building, demonstrating the Inter-War Railway Domestic style of Denistone Station, inspired by Functionalist Inter-War housing.

Figure 77: The front (north-eastern) elevation of the Shelter Shed on Platform 3/4, view south-west (Source: Artefact 2021)

Figure 78: The north-western elevation of the Shelter Shed on Platform 3/4, view south-east (Source: Artefact 2021)

Figure 79: The rear (south-western) elevation of the Shelter Shed on Platform 3/4, view north-west (Source: Artefact 2021)

Station Building (Shelter Shed), Type 13	The building is generally in good condition aside from efflorescence visible on the brickwork. The temporary infilling of the windows has deteriorated and is in fair condition.	Good

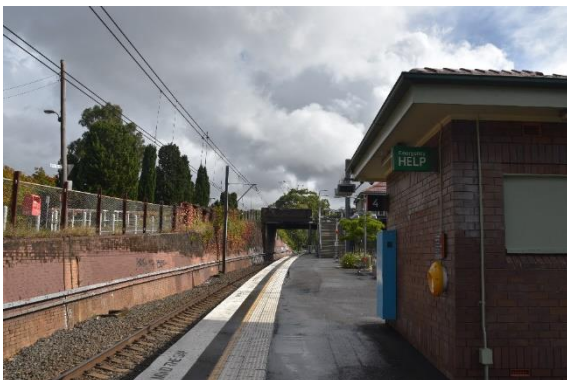
The Shelter Shed exhibits one room, providing bench seating for passengers along three walls (Figure 80). The walls are rendered and display a relief moulded dado course, while the ceiling comprises timber battened fibrous plaster and a timber quad moulded cornice (Figure 80). The internal sides of the windows are infilled but retain the original timber-framing (Figure 80). The tiled floor and skirting appear to date to two phases in the second half of the twentieth century (Figure 80). The 1937 drawings demonstrate that the flooring was originally timber and the seating a curved in-built timber seat, both of which have since been replaced (Figure 80).

Figure 80: The interior of the Shelter Shed on Platform 3/4, view south-west (Source: Artefact 2021)

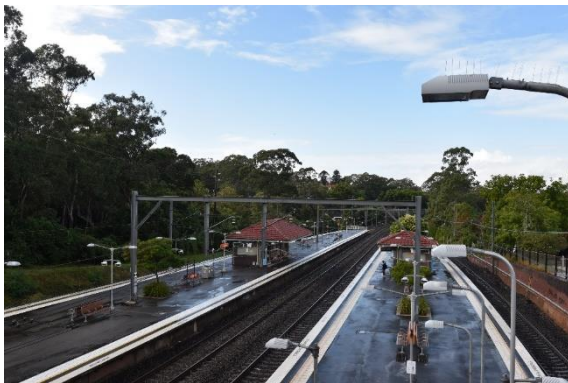
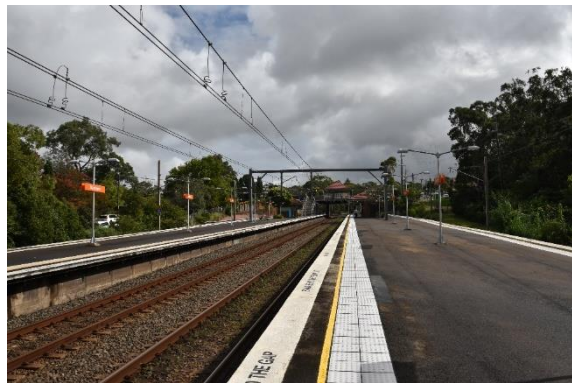
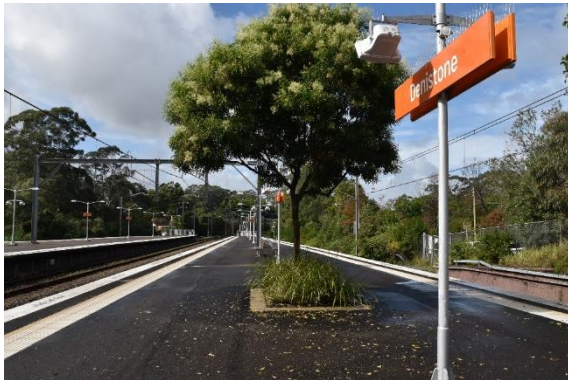
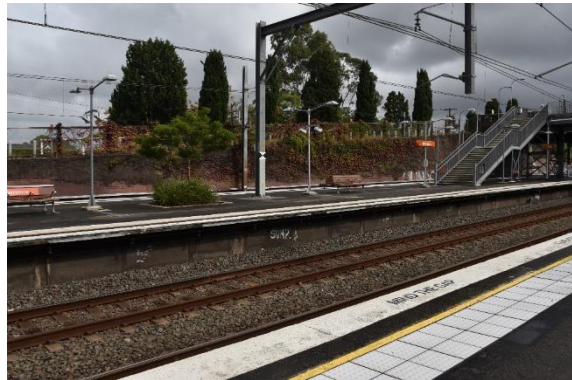
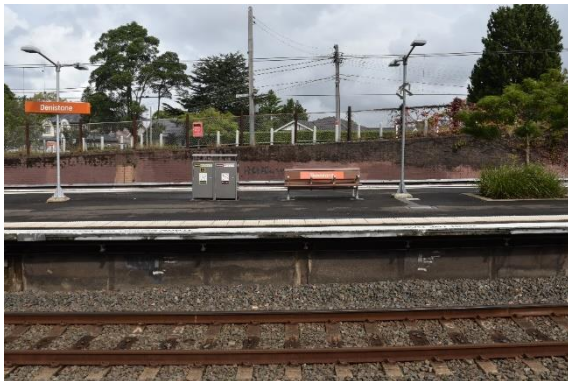
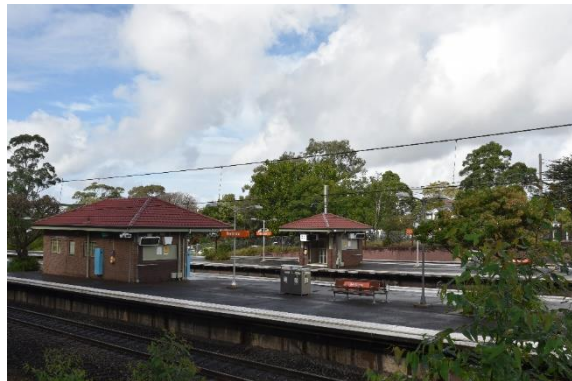
Figure 14, Figure 17 and Figure 19). The existing faces of all platforms comprise steel rail post and shuttered concrete (Figure 81 to Figure 88). Although some studies claim that original 1930s brick faces may have been retained behind the concrete facing on Platforms 2 and 3, the *Heritage*

Platforms Conservation Management Strategy assesses Platforms 2 and 3 as intact original 1930s steel rail post and shuttered concrete platforms (Figure 81 to Figure 88).³⁰

Figure 81: The platforms from the staircase on Platform 3/4, view south-east (Source: Artefact 2021)

Figure 82: The platforms from the staircase on Platform 3/4, view south-east (Source: Artefact 2021)

Figure 83: The view along Platform 3/4, view south-east (Source: Artefact 2021)

Figure 84: The north-eastern side of Platform 1/2 from Platform 3/4, view west (Source: Artefact 2021)

Figure 85: The north-eastern side of Platform 1/2 from Platform 3/4, view south-west (Source: Artefact 2021)

Figure 86: The north-eastern side of Platform 3/4 from East Parade, view west (Source: Artefact 2021)

Component	Assessment	Grading
Platforms	The surfaces of the platform are in good condition, although the steel straps along the concrete facing are missing in some areas and the concrete is stained. The garden beds are in good condition, with concrete edging and plantings of healthy native trees and grasses.	Good - Fair
Retaining Walls	The walls appear to be in good condition other than the application of anti-graffiti coating and vegetation growth on the south-western wall, while there is graffiti and efflorescence on the north-eastern wall.	Good - Fair
Signal Box	The steel elements are in good condition, although the prefabricated elements have partially deteriorated.	Good - Fair
Signal/Communications box	The signal/communications box has been painted and appears to have no defects.	Good

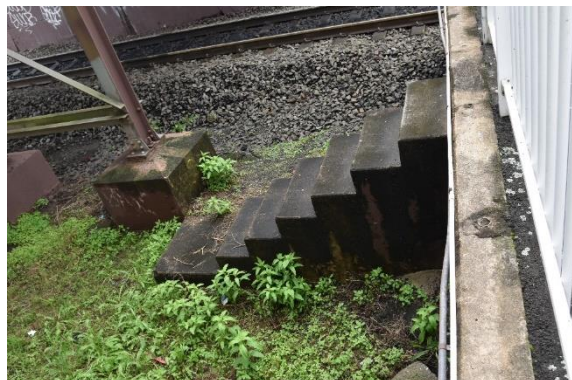
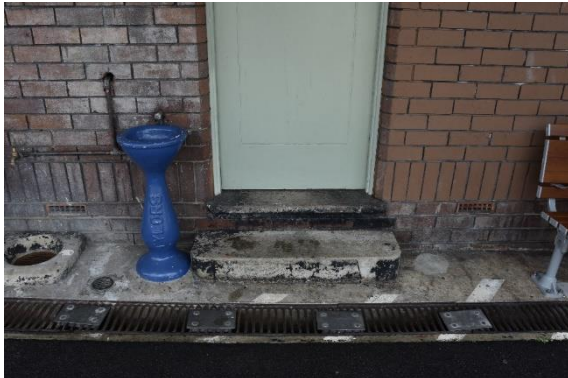
Both Platforms 1/2 and 3/4 exhibit a small platform building, drains, double-headed lights, signage, garden beds, benches and bins (Figure 81 to Figure 88). The garden beds comprise square concrete edging which is flush with the asphalt surface, are planted with native trees and grasses. The garden beds appear to have been upgraded in the 1990s to early 2000s (Figure 81 to Figure 86). The 1930s cast iron grated drains along the bases of the front elevations of the platform buildings are demonstrative of a short-lived policy in the 1930s that required the platform surfaces to slope down away from the tracks (Figure 89 to Figure 90). The bins and benches comprise standard railway designs dating to the twenty-first century.

Figure 89: The grated drain along the front elevation of the Conveniences Building on Platform 1/2, view north-east (Source: Artefact 2021)

Figure 90: The grated drain is visible along the front elevation of the Shelter Shed on Platform 3/4, view south-east (Source: Artefact 2021)

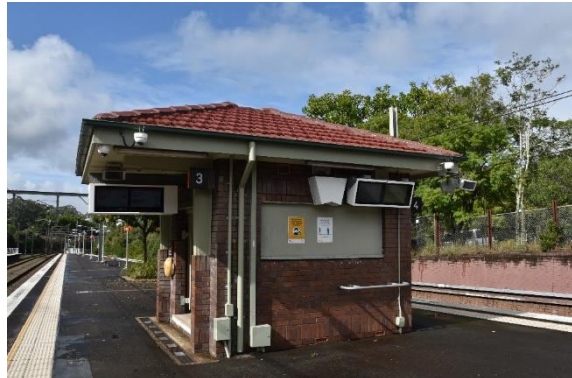
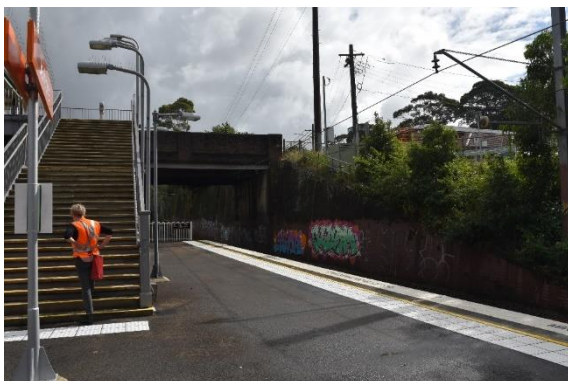
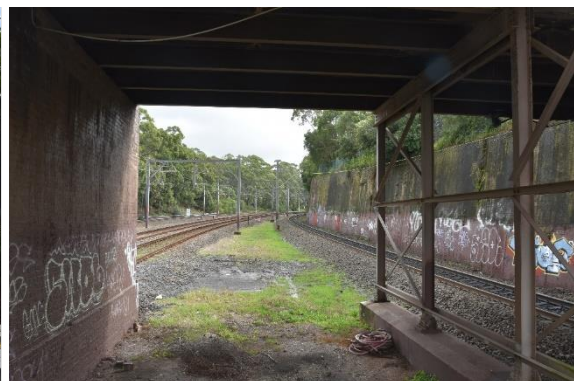
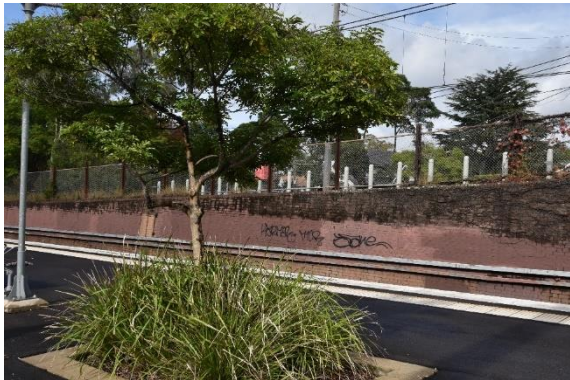
Brick retaining walls line the cutting for the railway line (Figure 91 to Figure 94). Although a 1937 has previously been established for the brick retaining walls, historical aerials indicate that the widening of the railway cutting, and therefore the construction of the existing retaining walls, was not undertaken until sometime between 1943 and 1955 (Figure 17 and Figure 18). The retaining walls form the sides of the railway corridor in the area of Denistone Station. The walls are at their highest point in the location of the overbridge and fall towards the south-eastern end of the station (Figure 91 to Figure 94). The retaining walls continue for over 50 metres to the north-east of the station (Figure 92). The north-eastern wall has been covered in graffiti, while the south-western wall has been coated in an anti-graffiti paint and vegetation has grown along it, hiding the severity of the brick wall (Figure 91 to Figure 94). A GST has been attached along the length of the south-western retaining wall (Figure 91 to Figure 92).

Figure 91: The north-eastern retaining wall from Platform 1/2, view north (Source: Artefact 2021)

Figure 92: The north-eastern retaining wall to the north of the station from the end of Platform 1/2, view north-west (Source: Artefact 2021)

Figure 93: The southern end of the south-western retaining wall from Platform 3/4, view north (Source: Artefact 2021)

Figure 94: The south-western retaining wall from the footbridge, view south (Source: Artefact 2021)

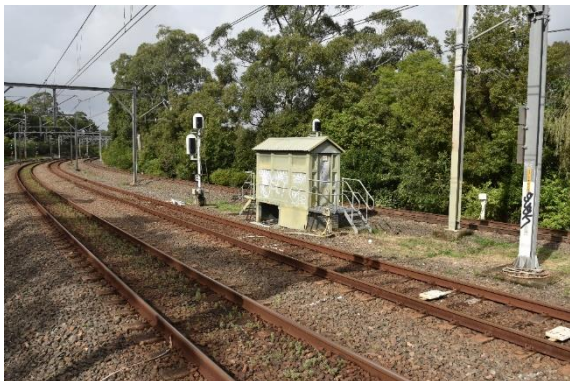
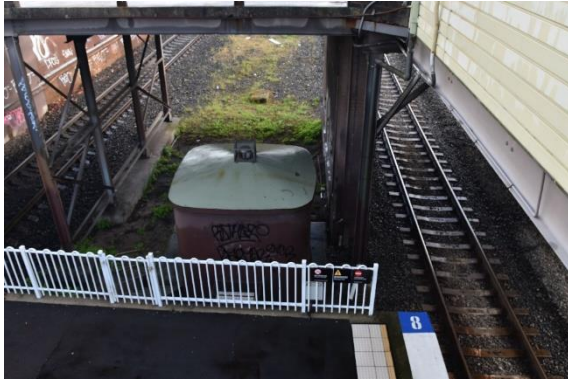
A signal/communications box, dating to the late twentieth century, is located to the north-west of the north-western end of Platform 1/2 (Figure 96 and Figure 97). The signal/communications box appears to be constructed from plastic with an aluminium cage over the signal light at the top of the box (Figure 96 and Figure 97).

Figure 96: The signal/communications box as viewed from the footbridge on Platform 3/4, view north-west (Source: Artefact 2021)

Figure 97: The signal/communications box as viewed from the Platform 1/2, view west (Source: Artefact 2021)
