TRANSPORT FOR NSW

DECEMBER 2021

# OPTIONS TO REDUCE KOALA VEHICLE STRIKE ALONG HEATHCOTE ROAD, NEAR DEADMANS CREEK

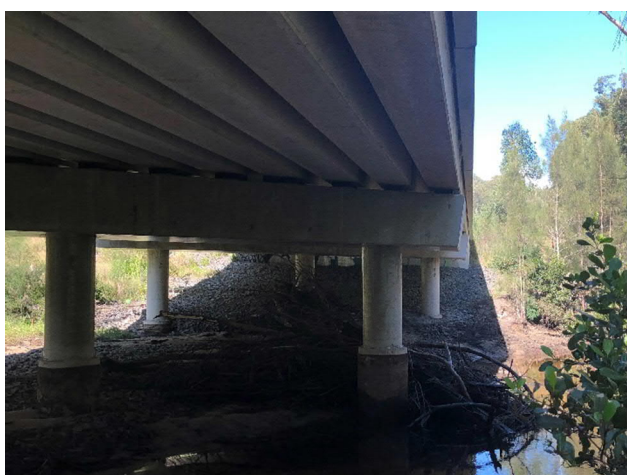
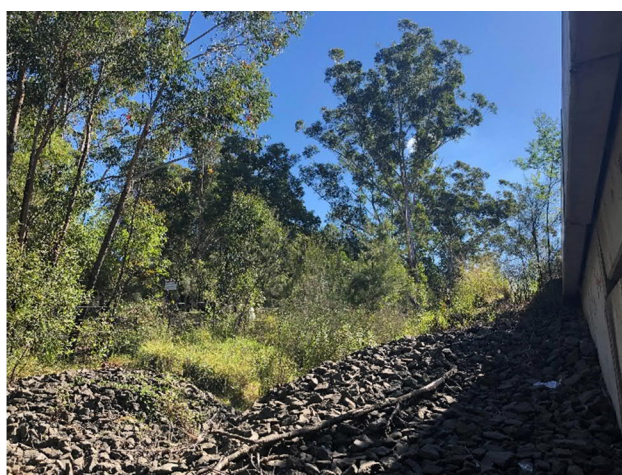
Photo 3.1 The multi-span concrete bridge that crosses Deadmans Creek (L) and the rip-rap scour protection that surrounds the bridge abutments and creek banks (R)

The central section of the study area contains the Deadmans Creek Bridge which crosses the tidally influenced Deadmans Creek. It is a multi-span concrete bridge and provides some fauna connectivity under Heathcote Road. Camera traps placed under the bridge in March 2021 have shown use of the bridge underpass by Deer, Eastern Grey Kangaroos, Swamp Wallabies, Red-necked Wallabies, Foxes and Black Rats. However, the connectivity for the koala underneath the bridge is limited by the amount of scour protection on the creek banks which reduces its suitability for the species.

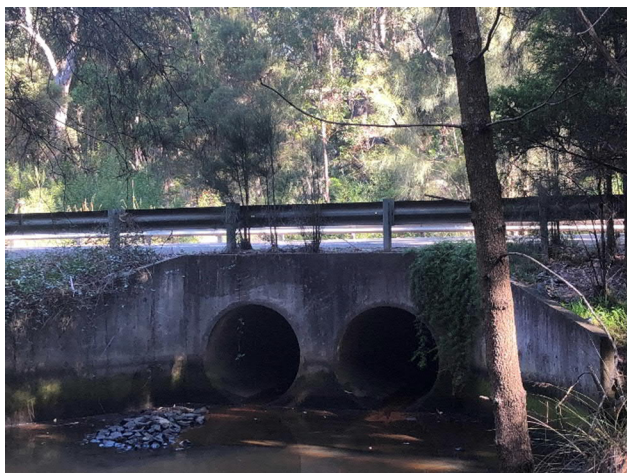
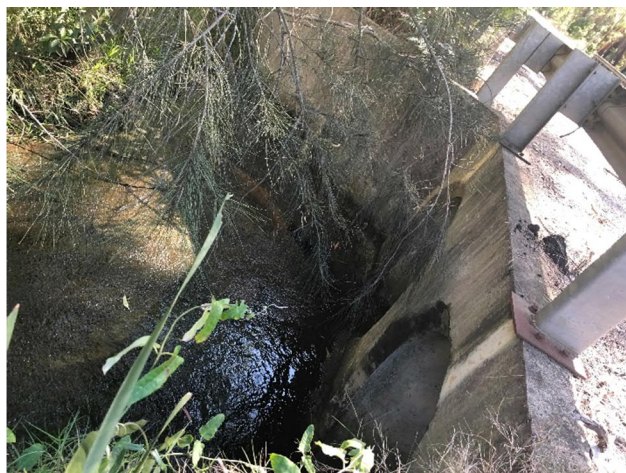
Photo 3.2 The twin-cell concrete pipe drainage culvert that crosses underneath Heathcote Road. The northern cell contains water most of the time (L) while the southern cell typically contains less water (R)

About 200 metres to the north-west of Deadmans Creek Bridge is a twin-cell 950 mm diameter concrete pipe drainage culvert that crosses under Heathcote Road. This is in the low-lying section of the study area and connects to Deadmans Creek in the north. It is tidally influenced, usually contains water and forms part of the “coastal wetlands” and “proximity area for Coastal Wetlands” under the Coastal Management SEPP 2018. Fauna connectivity for terrestrial species in this location is limited due to the tidal presence of water in the culverts and relatively small culvert size (950mm) which many terrestrial species will avoid because it is too wet and dark. The vegetation in this location is Swamp Oak Floodplain Forest (EEC, BC Act), which is more extensive on the north-eastern side of Heathcote Road.

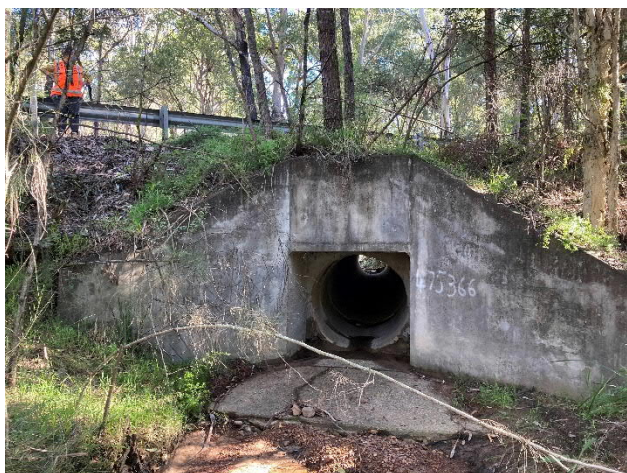
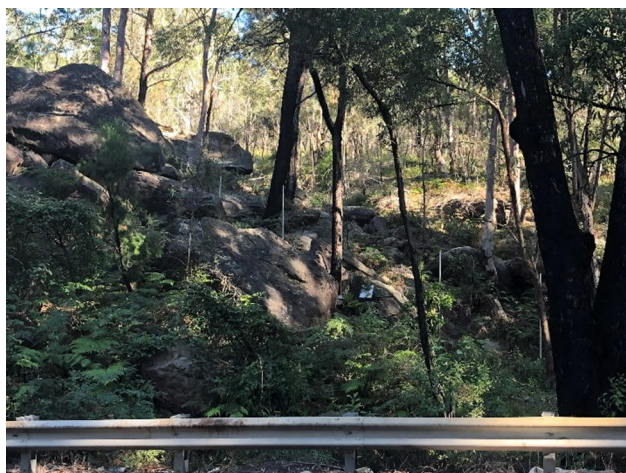
Photo 3.3 Single-cell concrete pipe drainage culvert that crosses under Heathcote Road on the northern side (L) and connects to Defence land on the southern side (R). ‘W’-beam safety barrier is also present in this section of the study area

About 470 metres to the north-west of Deadmans Creek Bridge is a reinforced single-cell 1500 mm diameter concrete pipe drainage culvert that crosses under Heathcote Road, connecting Defence land. This is the beginning of the elevated section of the study area and connects to the bend in Deadmans Creek to the north. Due to the gentle slope and elevation, it contains less water than the culverts closer to the bridge and is likely dry most of the time. Fauna connectivity for terrestrial species in this location is moderate but somewhat limited by the relatively small size and darkness of the culvert. The vegetation in this location is sandstone enriched dry sclerophyll forest with the canopy dominated by *Eucalyptus pilularis* (Blackbutt), *Eucalyptus punctata* (Grey Gum) and *Angophora costata* (Smooth-barked Apple).

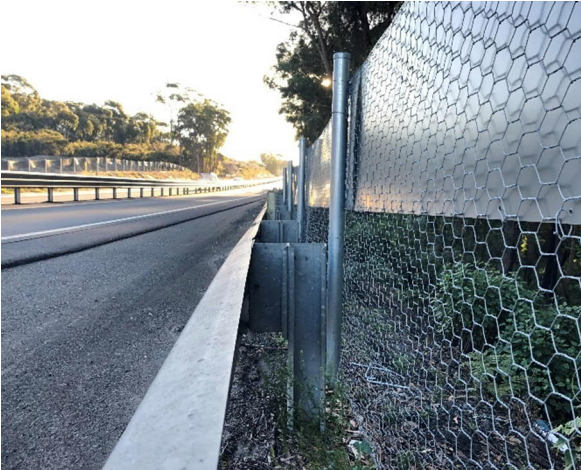
<p>Photo 4.1 Example fauna fence for Koalas installed behind ‘W’ beam safety barrier on Picton Road</p>

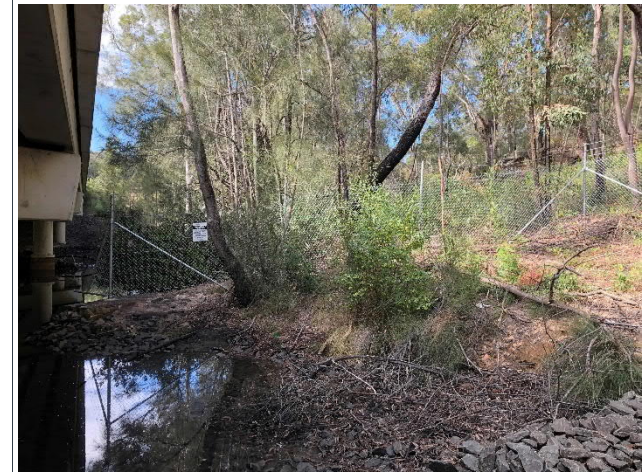
Photo 4.2 Newly installed Defence fence at Deadmans Creek. This may require modification or replacement for Option 2 to be effective. Image courtesy of TfNSW

- A section of Defence fencing (~260 metres) would need to be replaced or modified (while meeting Defence controlled access fencing requirements) along its current alignment.

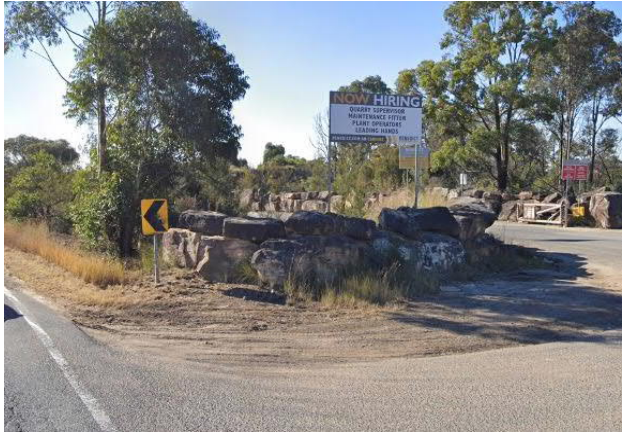
<p>Photo 4.4 View of Quarry entrance</p>

OPTION 4 – EXTENSION OF FENCING	PHOTOS
<p><b>Option 4 description:</b></p> <ul style="list-style-type: none"> <li>— Extension of fencing along Heathcote Road up to the Quarry entrance.</li> <li>— This can be applied to any of the options and if applied to Option 2, Defence fencing would be used (some of which may need to be replaced or modified (while meeting Defence controlled access fencing requirements) along its current alignment.</li> </ul> <p><b>Constructability:</b> Tie fencing into rock cuttings or equivalent geographical barrier</p> <p><b>Fencing cost:</b> 2.2 kilometres @ \$100 p/m = approximately <b>\$220,000</b> (not including geo-tech, surveyors, clearing contractors if required, other investigations or the other costs required by the relevant Option this is applied to).</p> <p><b>Extent of clearing:</b> The removal of approximately 1.33 hectares of native vegetation would be required to achieve a 3 metre buffer either side of the new fence. This in addition to the vegetation removal required by the relevant Option this is applied to.</p> <p><b>Maintenance requirements:</b> Can implement TfNSW Routine Maintenance specification if applied with Option 1 or Option 3.</p> <p><b>Land tenure:</b> If applied with Option 1 and Option 3 = TfNSW and Quarry tenure and if applied with Option 2 = TfNSW, Defence and Quarry tenure.</p> <p><b>Effectiveness:</b> Long, uninterrupted sections of fauna fencing are most effective when used in conjunction with crossing structures such as bridges.</p> <p><b>Ecological consideration:</b> Minimises direct impacts to Coastal SEPP areas.</p>

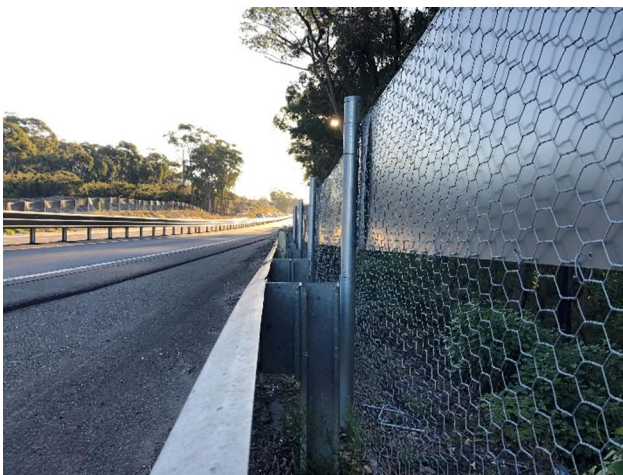
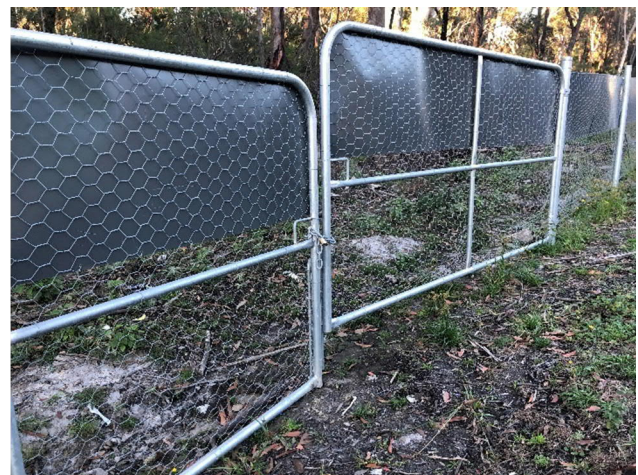
Photo 4.5 Example of koala fencing along Picton Road in Sydney's south-west. The photo on the right shows a break in koala fence to provide vehicle access. The gap underneath the gate is ~500 mm, which fauna can easily navigate their way under. Gaps underneath gates need to be minimised as much as possible

Other important considerations include fence height, mesh size and whether the fence needs to be buried to prevent burrowing animals such as wombats from digging underneath it. Fencing for species that climb (e. g. koalas) may need a band of sheet metal at the top that prevents them from climbing over. Inevitably, fencing along roads will need breaks in it to allow vehicles to access the road, such as at intersecting roads or property access points. Where these occur, effort must be made to prevent animals from accessing the road, such as the use of gates, grids across the intersecting road, or fencing that is run up the intersecting road for a few hundred metres.

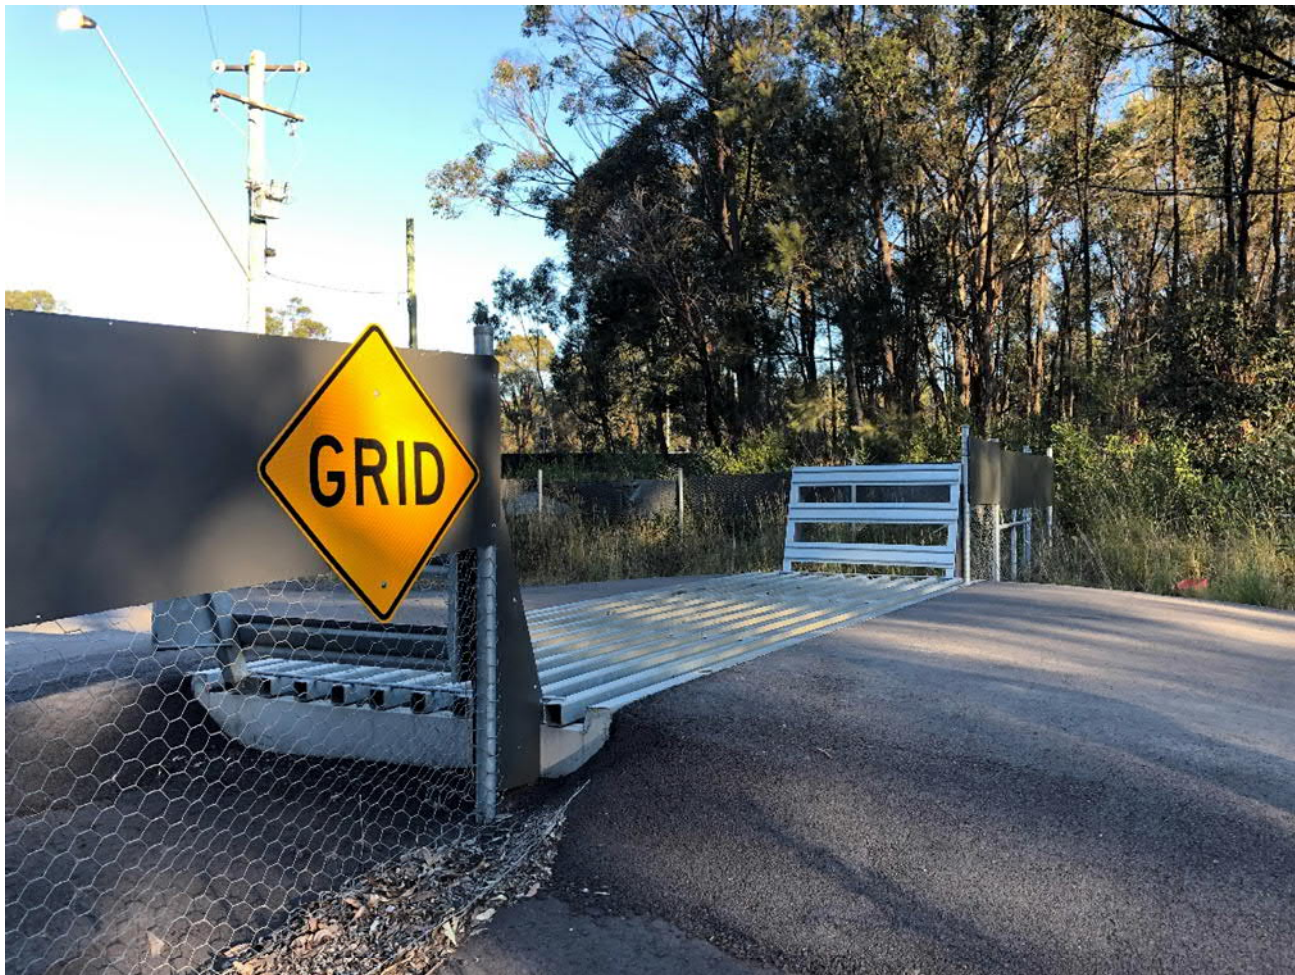
Photo 4.6 Example of a koala grid along Picton Road, where there is a break in continuous fencing for residential access

Koala grids can be installed when there is a break in long, continuous fauna fencing (e.g. residential access or local road) and they are a modified cattle grid. Koala grids can maintain the flow of human traffic while potentially preventing egress onto road corridors by koalas. While there is limited data demonstrating their success, koala grids installed on a road in the Lismore Local Government Area reportedly prevented koala roadkill over a 6-year period (DPIE, 2020b).

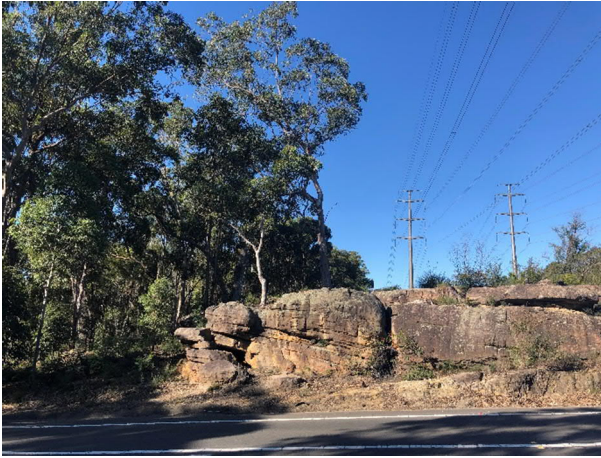
Photo B.1 PCT 1789 Moderate condition – regrowth under the powerline in the east of the study area

The occurrence of this vegetation type within the study area is illustrated in Figure 3.1 with photographic representation provided in Photo B.1 to Photo B.4. An overview of floristic and structural composition is presented in Table B.1. A general description is provided below.

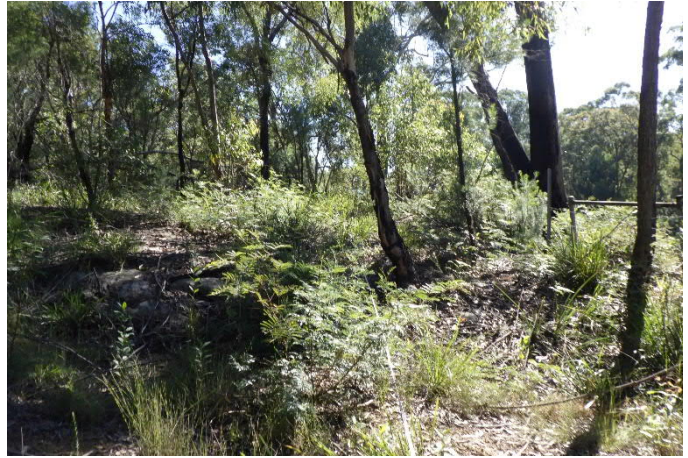
Photo B.2 PCT 1789 High condition – Q1 adjoining Holsworthy Defence base on the western side of Heathcote Road.

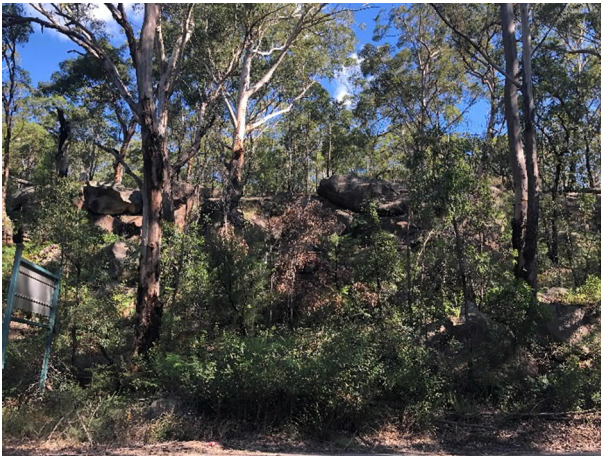
Photo B.3 PCT 1789 High condition – on the western side of Heathcote Road in the west of the study area

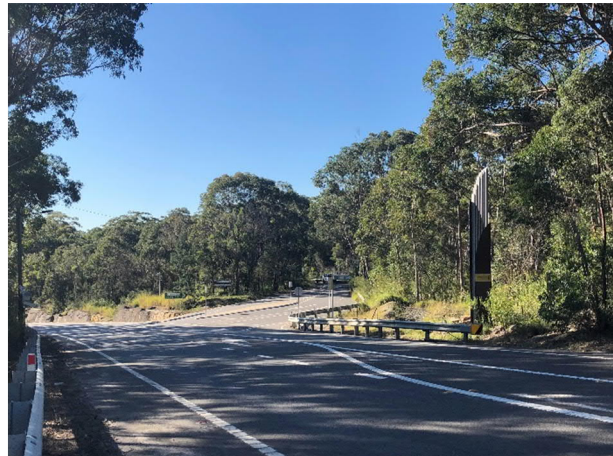
Photo B.4 PCT 1789 High condition – at the intersection of St George Crescent and Heathcote Road (western side is high condition)

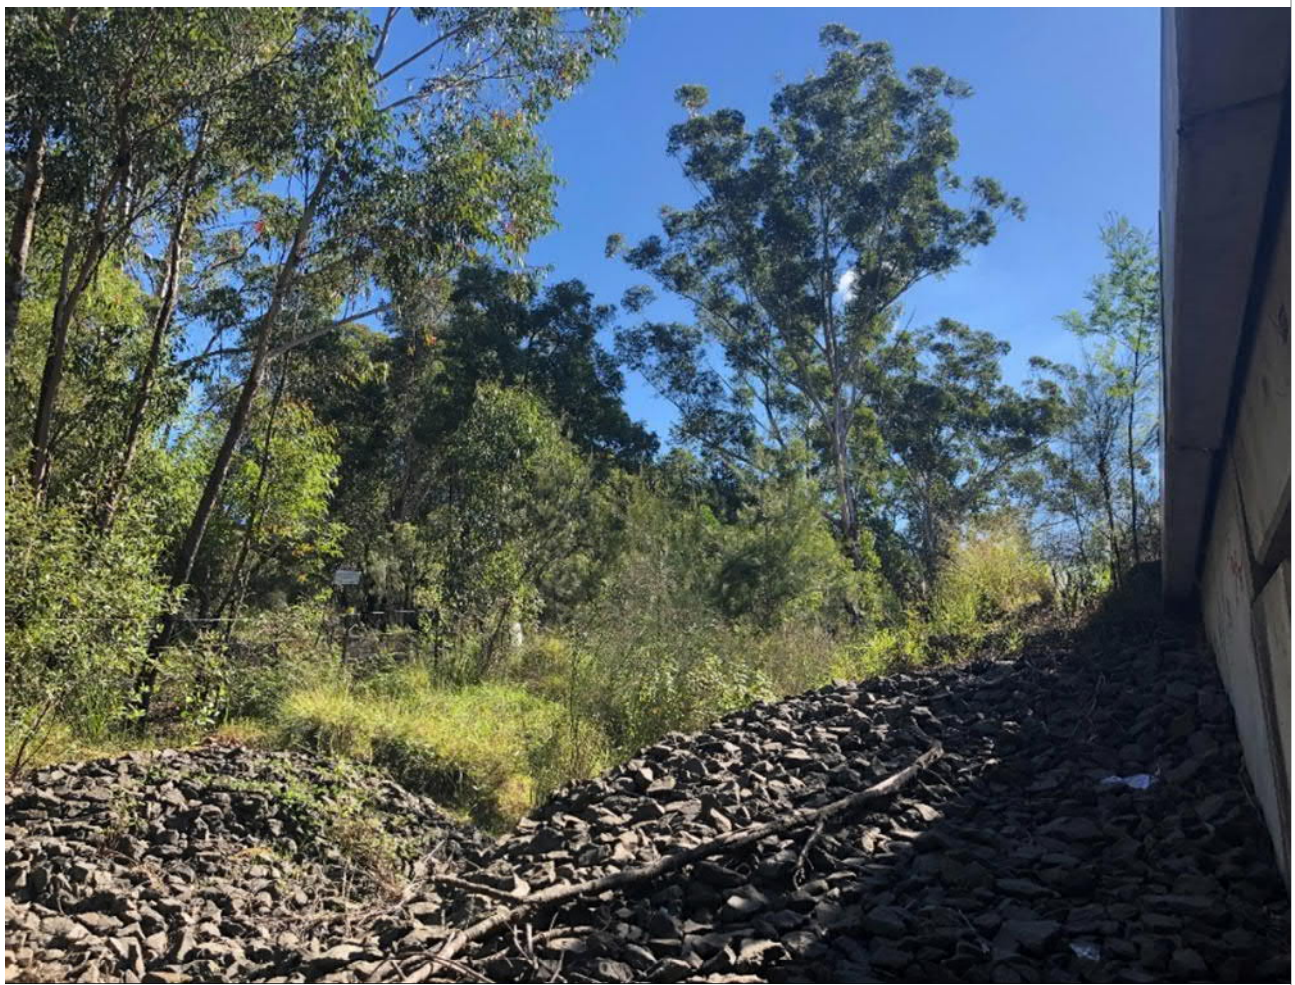
Photo B.7 Miscellaneous ecosystem – Exotic grassland near Deadmans Creek Bridge

This non-native vegetation type consists of exotic forbs and grasses. The grassland that occurs on the road verges is the old bridge location and is regularly slashed as part of routine maintenance associated with Heathcote Road. The distribution of the exotic grassland is shown in Figure 3.1. Photographic representation is provided in Photo B.7 below. Overall, this vegetation formed 0.66 hectares within the study area.
