NSW Site Auditor Scheme

Site Audit Statement

Site audit statement no. 0503-2006-R

Address	**Part of the Tarago Station Rail Corridor**	
	Tarago NSW	Postcode **2580**

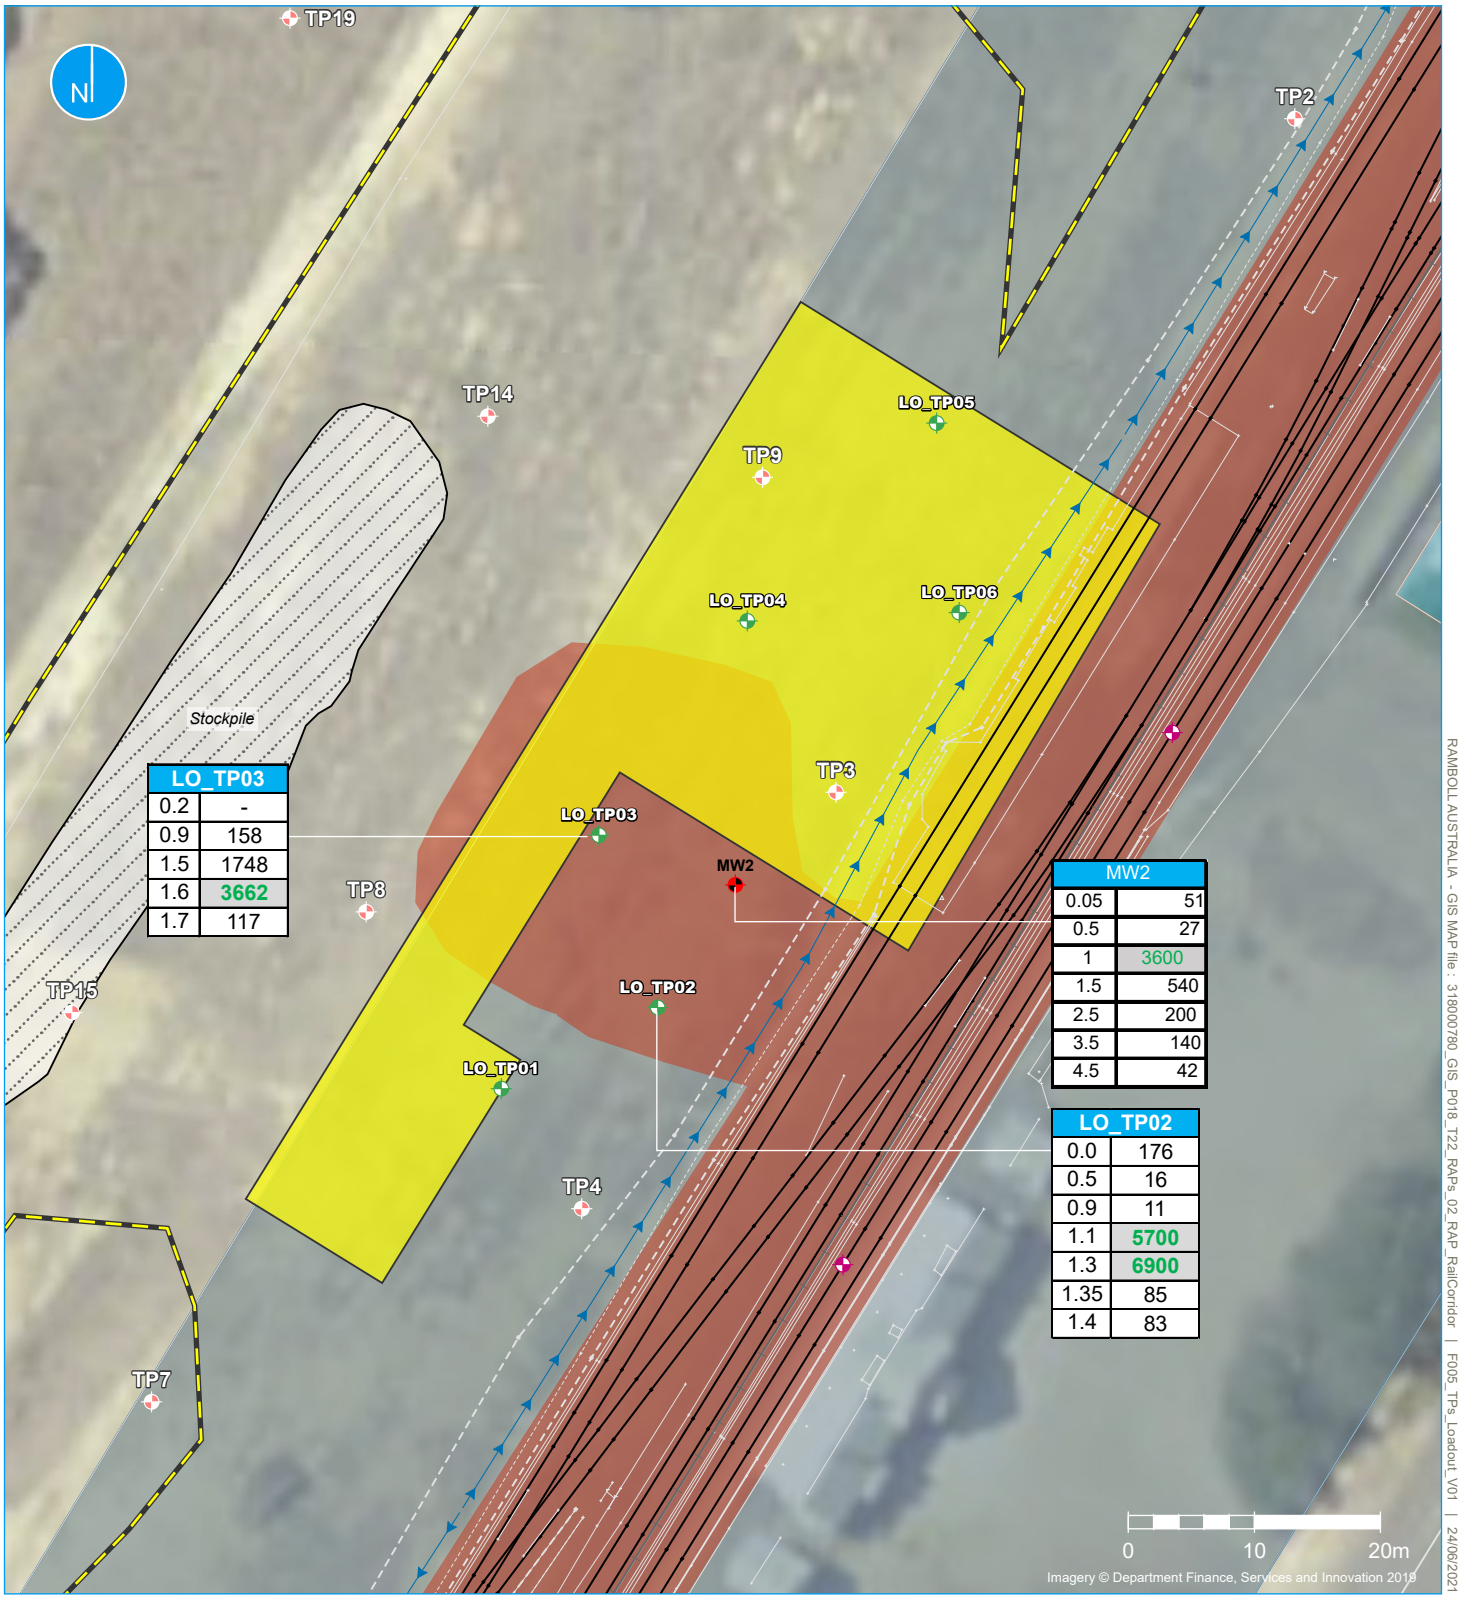
Figure 2ci | Loadout complex sampling locations

Results indicated that lead contamination was present at depth beneath a clay capping layer approximately 1 m thick. During test pitting completed in August 2020, foreign material (i.e. plastic, metal, wire and glass) was noted at LO_TP03 and LO_TP05 at depths consistent with elevated lead concentrations. The highest lead concentration was reported at LO_TP02 at 1.3 m bgl.

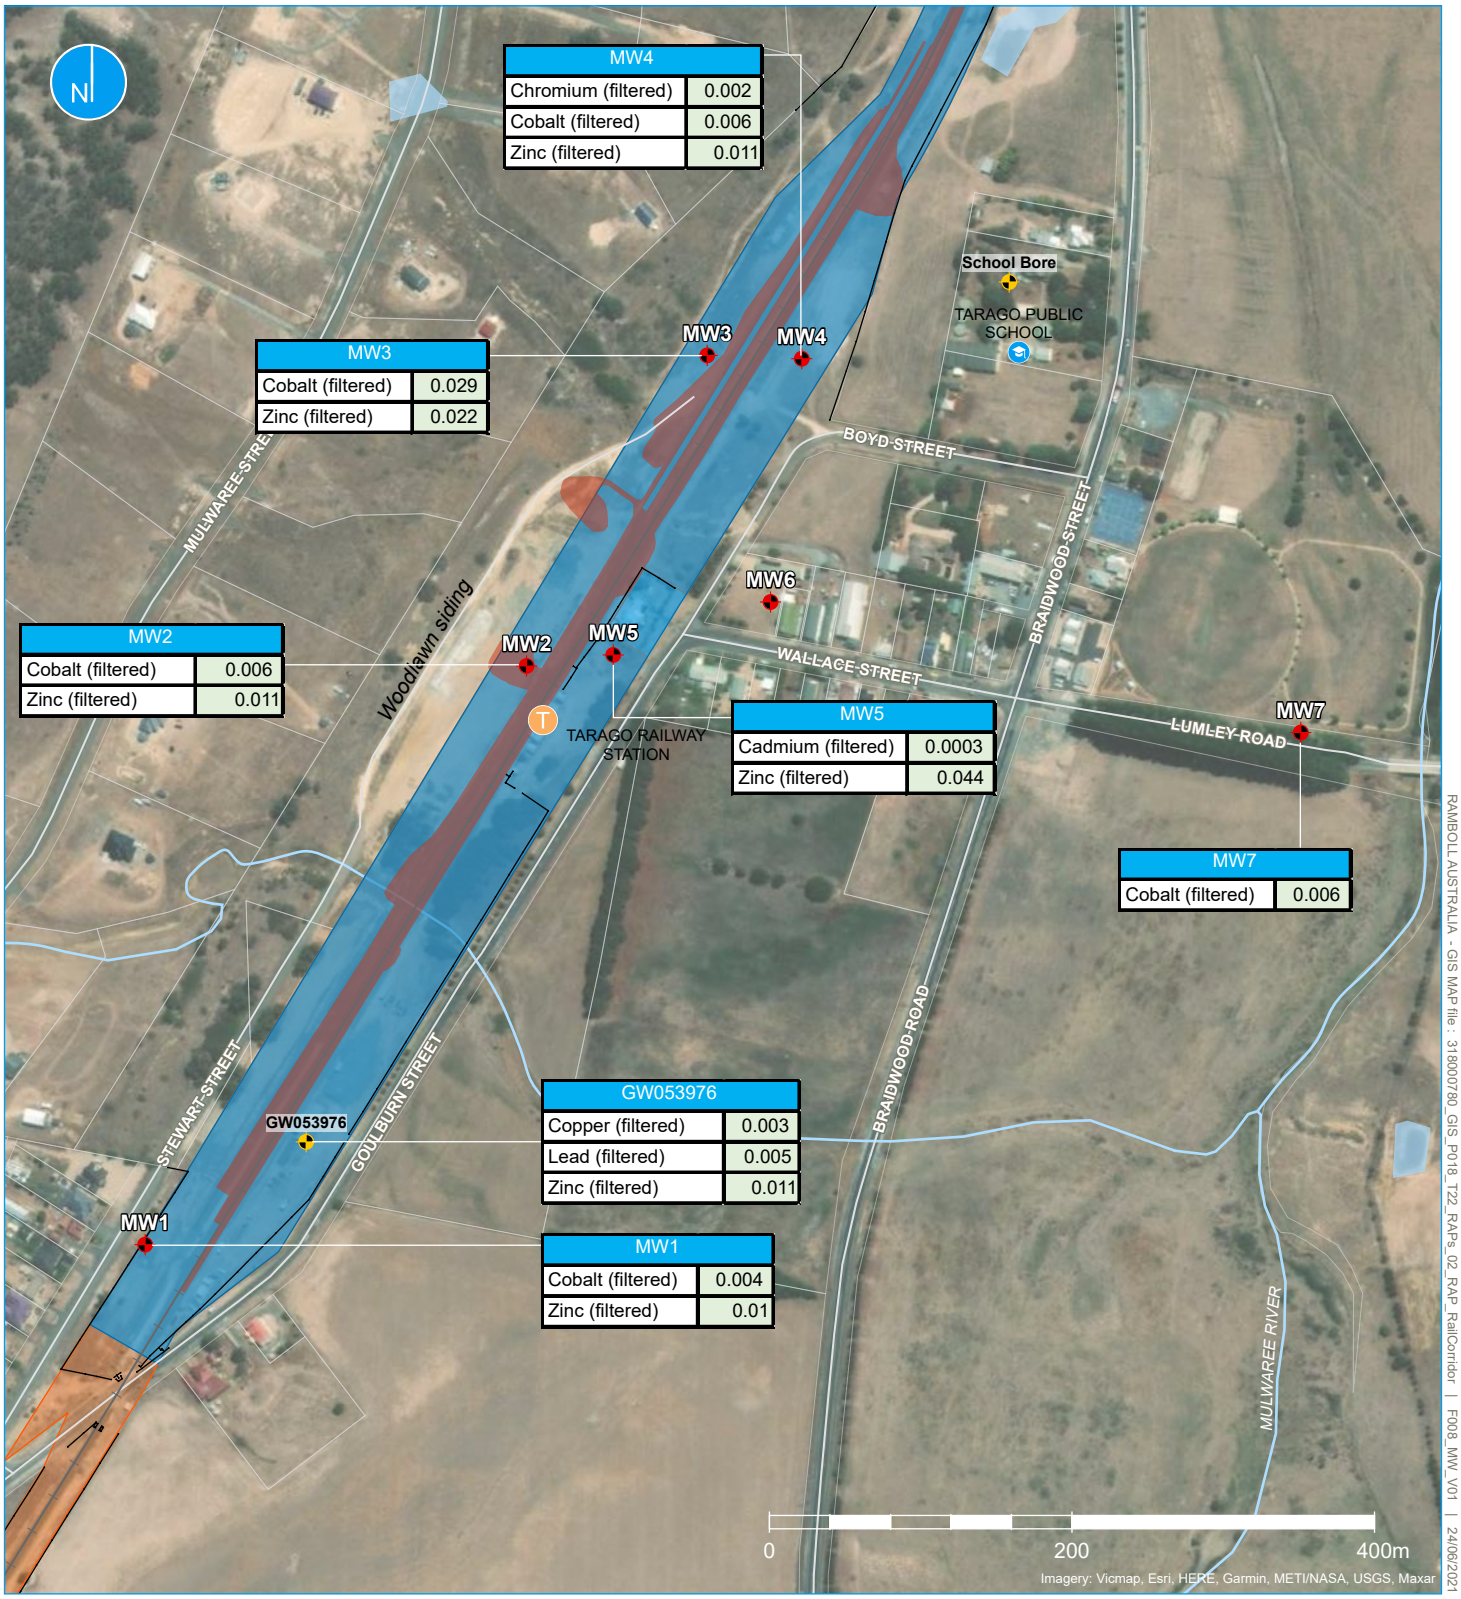
Figure 5 | Groundwater monitoring well locations

Contaminant (mg/L)	> ANZG 2018 Freshwater Ecosystems
Cadmium (filtered)	0.0002
Chromium (filtered)	0.001
Cobalt (filtered)	0.0014
Lead (filtered)	0.0034
Zinc (filtered)	0.008
