Condition Report

Balls Head Coal Loader

Waverton, NSW

Date of Issue: 5th March, 2018
Issue No: 5
Status: Final - Amended
Project No: 17204

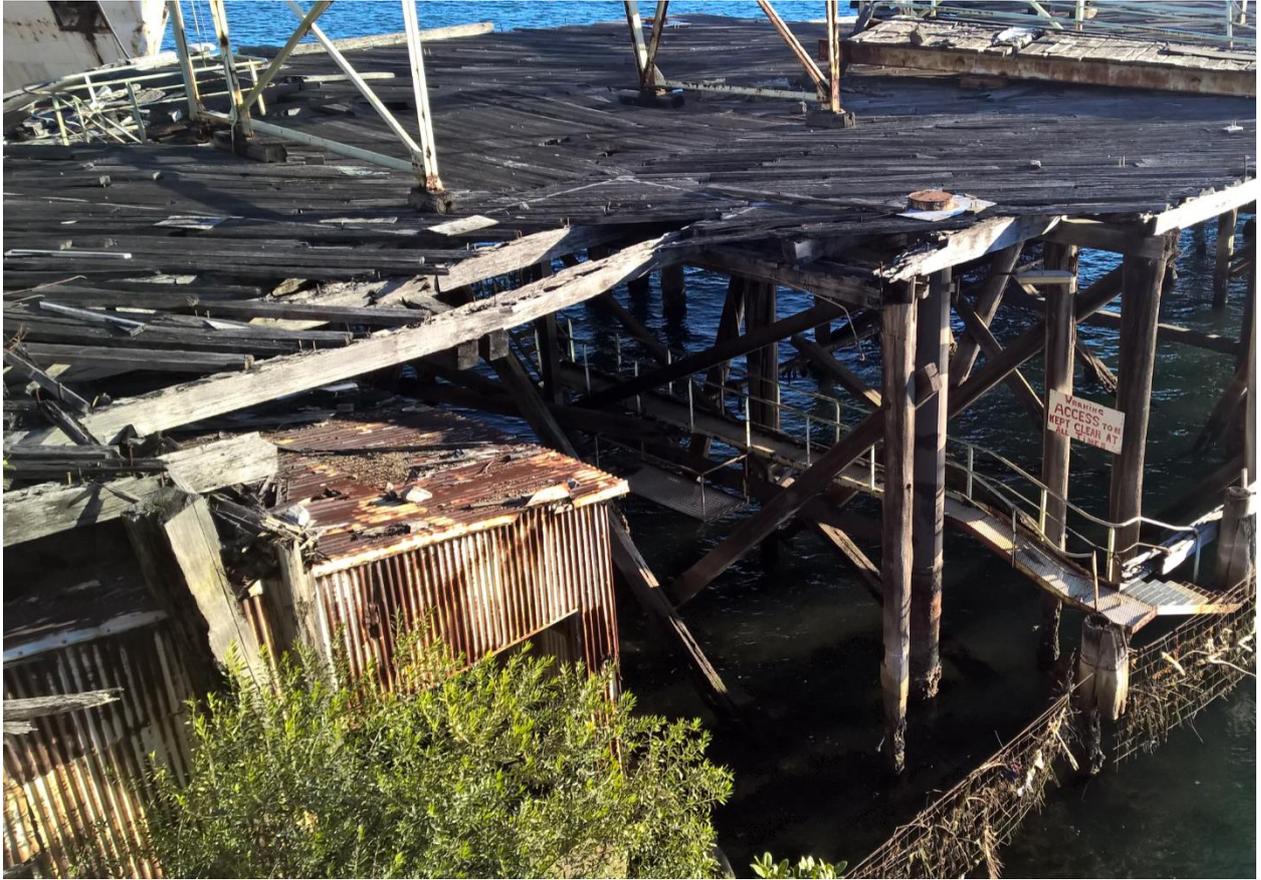
Figure 16: Photo taken July 2017 above pump house.

Based on the current condition of the pump house we consider that the pump house structure is likely to be fragile and may remain intact for 5 to 10 years. The southwest corner of the pump house is not expected to last beyond 5 years. In addition the slab supporting the southwest corner is disintegrating and is not expected to last beyond 5 years.

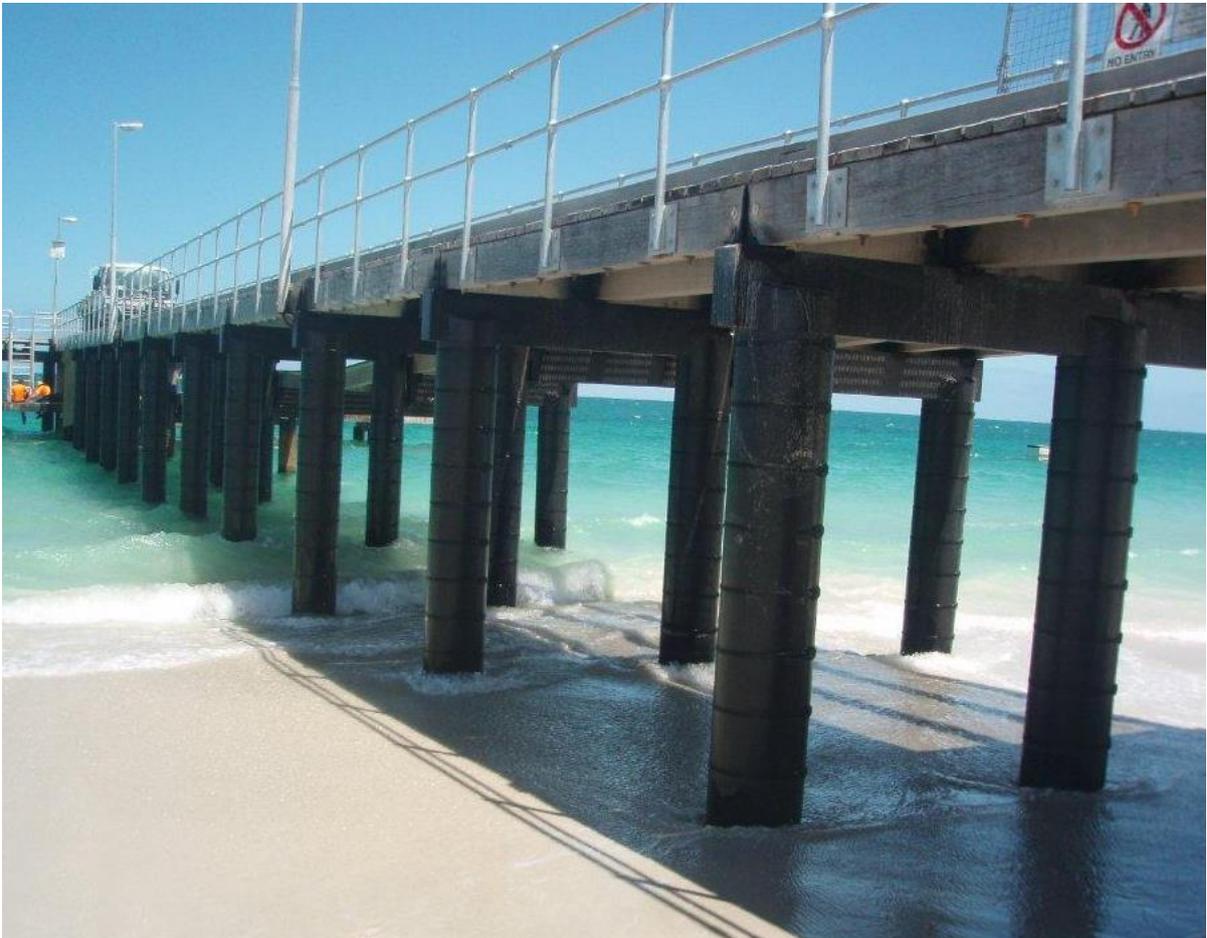
Figure 17: Example of plastic polyethylene wrapping of piles. Photo from Google images.

The piles can be protected from corrosion in the tidal zone by applying a new protective wrap. The wrap would extend up to the bulge visible on the piles, and roughly 2m below the low-water line. Ideally the wrap would extend above the bulge to protect this splash zone, however this is difficult to achieve with a wrap.

The wrap consists of grease tape wrapped around the piles, and a black polyethylene plastic wrap to hold and protect the tape. The plastic is secured with black plastic straps.

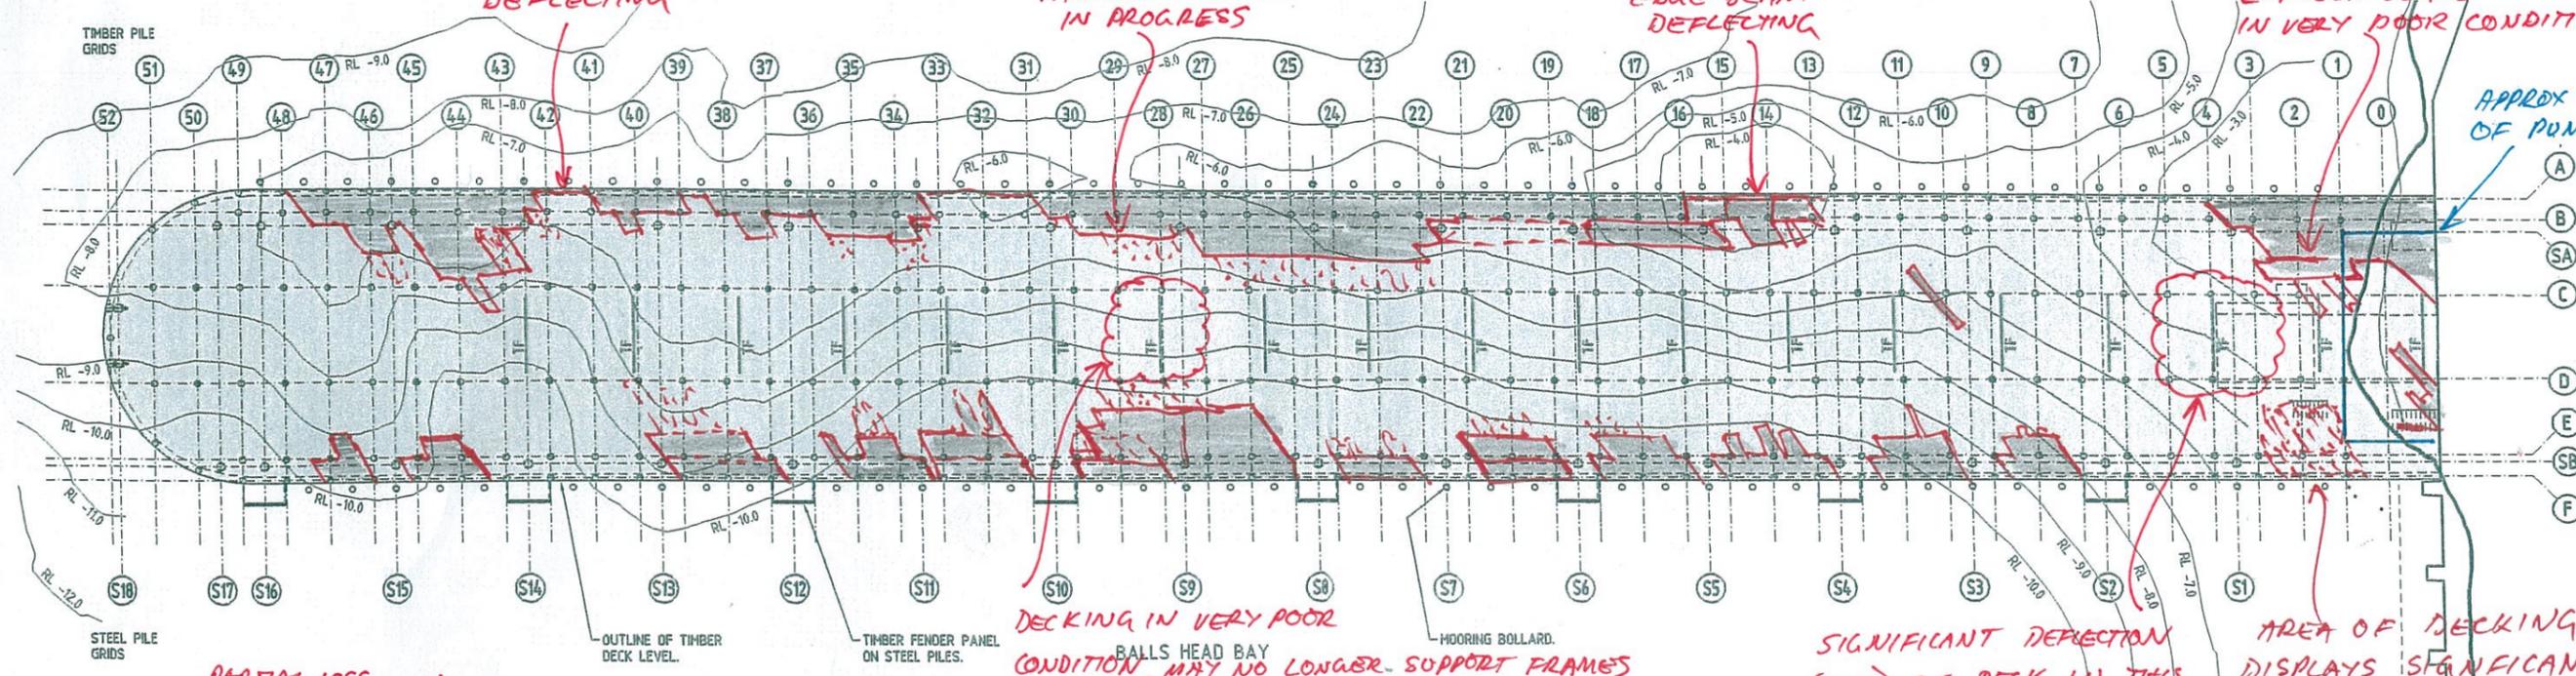
DETERIORATION OF STRUCTURE

X - PILES MARKED AS SUCH WERE NOT PRESENT OR HAD SNAPPED AT TIME OF REVIEW. (2013)
