Project No: SHBC/NORTH/22 Report No: SHBC/NORTH/PAR/B

PRELIMINARY ARBORICULTURAL REPORT

Sydney Harbour Bridge Cycleway Northern Access Milsons Point

23rd May 2022
Revision B

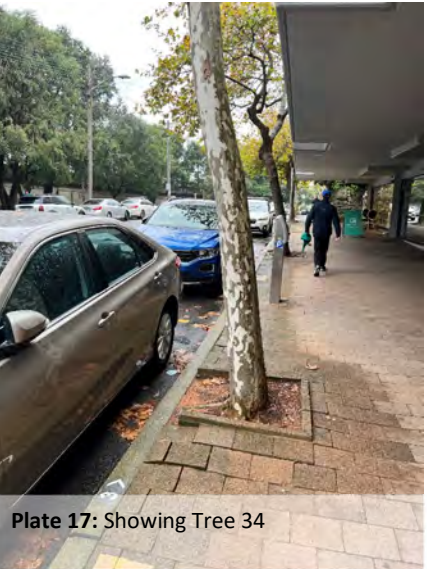
Plate 17: Showing Tree 34

| Tree No. | Species | DBH comb. (mm) | Height (m) | Radial Crown Spread (m) | Health Rating | Structural Rating | Comments | Age Class | ULE (years) | L/Sign | Retention Value | Radial TPZ (m) | Radial SRZ (m) |
|---|---|---|---|---|---|---|---|---|---|---|---|---|---|
| 34 | <i>Planantus x acerifolius</i> (London Plane Tree) | 200 | 13 | 7 | Good | Good | | Semi-mature | 15-40 | Low | Consider for Removal | 2.4 | 1.7 |
