## Graphitisation Investigation

### Windsor Bridge

<b>Prepared for:</b> Roads & Traffic Authority NSW 110 George St Parramatta NSW 2150		<b>Contact:</b> Peter Ton <b>Phone:</b> (02) 8837 0843 <b>Mob:</b> (0407) 295 624
<b>Date:</b> July 13 <sup>th</sup> , 2011	<b>Job Number:</b> 2739	<b>Report Number:</b> C11231 <b>Rev:</b> Original

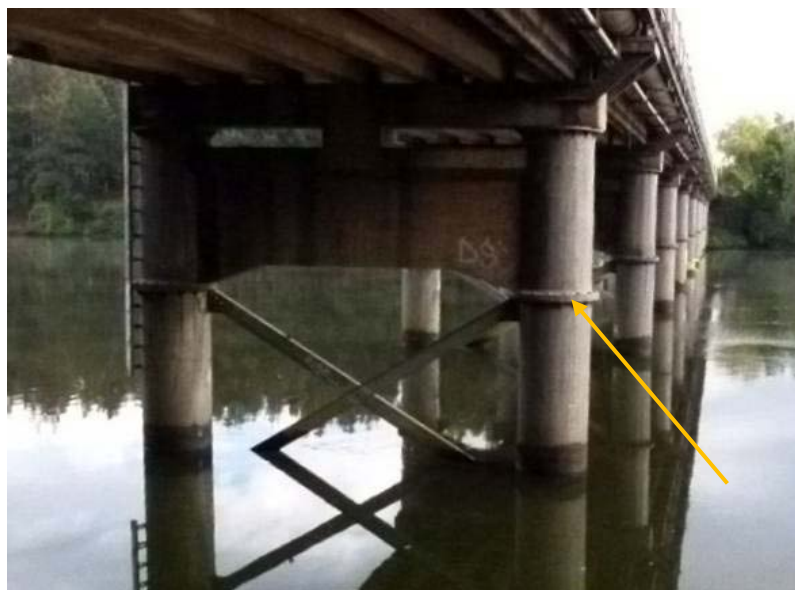
View of above water part of bridge pier showing lower flange used as reference level for recording height on piers

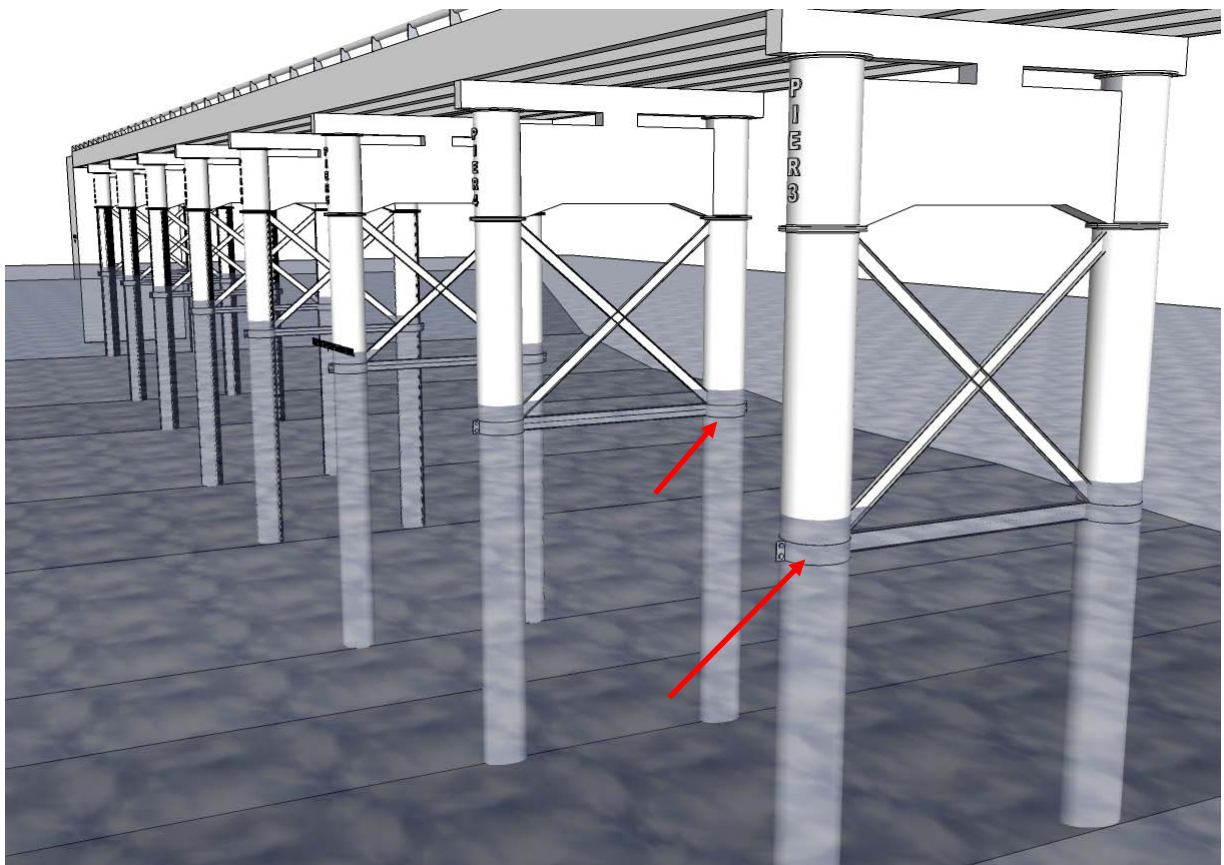
**Figure 1** Sketch Showing General Arrangement of Piers

There is diagonal bracing in the atmospheric zone with a tie-beam located at approximately the low water mark, as indicated in Figure 1. The tidal range is of the order of 1 metre.

Note that the cross bracing at present is fixed to the columns by means of cleats at the top, with the cleats having been riveted onto the cast iron columns. However at the base, the bracing is secured by means of collars clamped around the columns, at the bottom of the tidal range (see arrows in Figure 1).

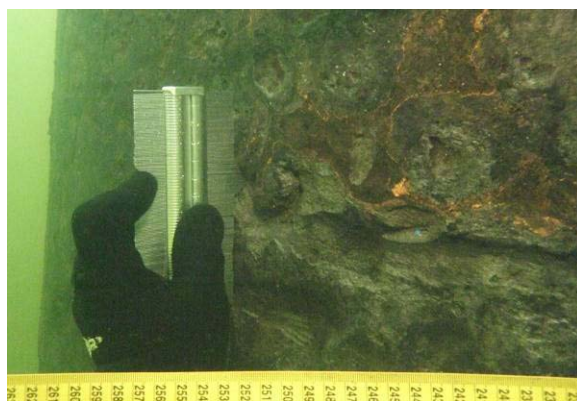
It should be noted that in addition to the core samples taken, the divers also measured the depth of graphitisation by excavating through the graphitised layer. This frequently showed depths of graphitisation in excess of 20mm, so that the residual cast iron thickness will be less than 10 mm and perhaps, in some instances, negligible.

Measuring depth of graphitisation – diver pushing pins of profile gauge into excavation through graphite layer

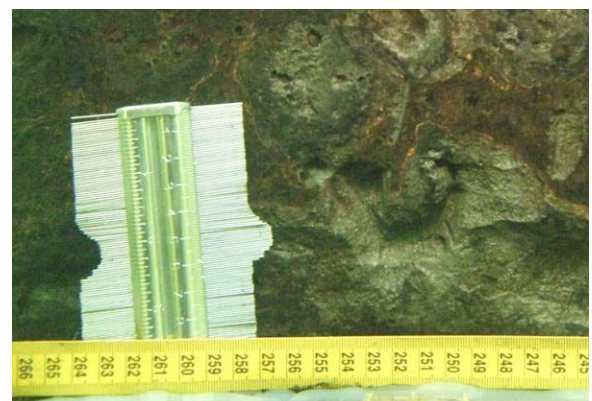
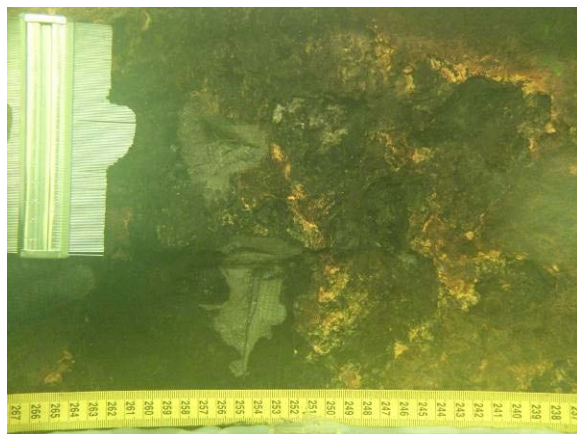
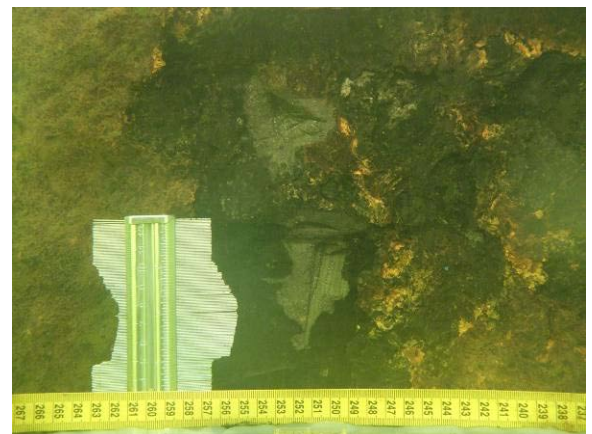
Profile gauge withdrawn from excavation allows depth of graphitisation to be measured
