## **Roads and Maritime Services**

14.2166.0502-0016

### **Windsor Bridge Rehabilitation Design of Viewing Platform Condition Assessment and Rehabilitation Options**

December 2019

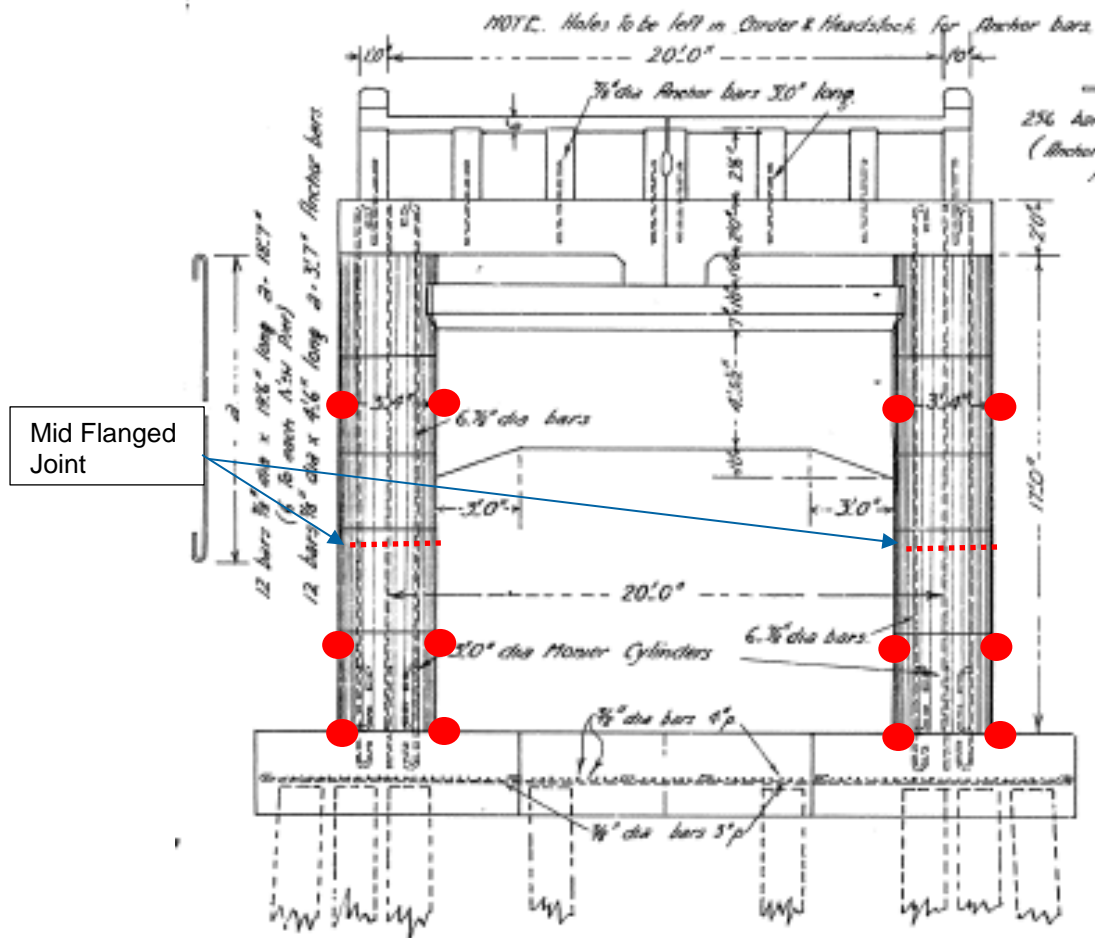
**Figure 6: Pier 1 column wall thickness measurement locations**

The nominated steel thickness measurement locations are shown as red dots in Figure 6 below.

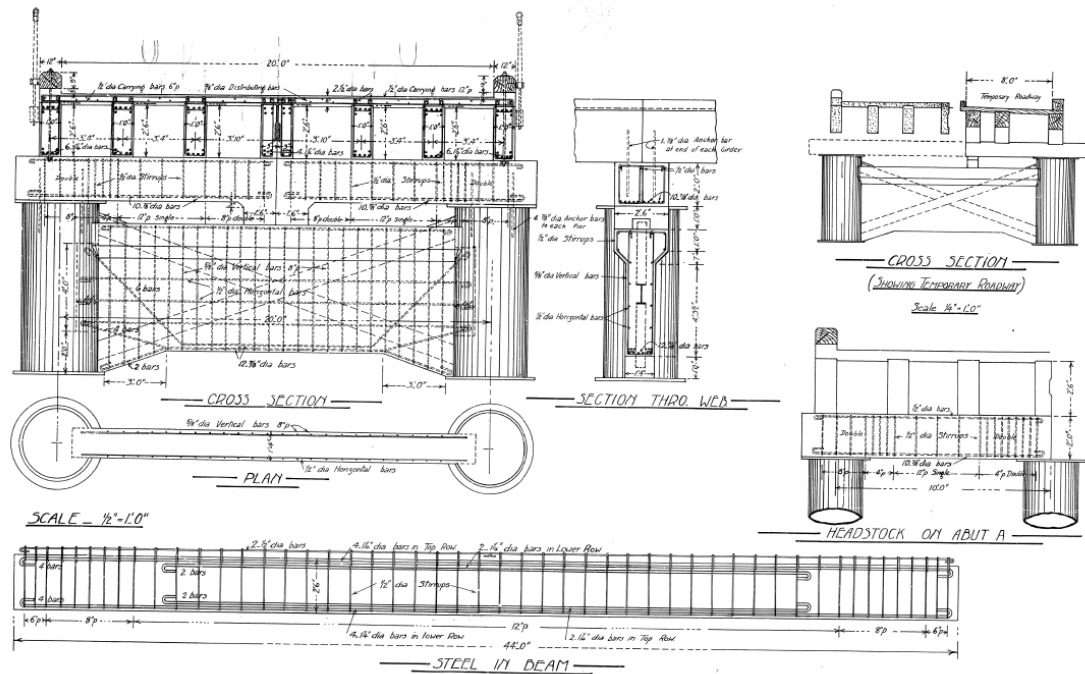
**Figure 17 Department of Public Works NSW (Drawing 0182 492BC0104 Sheet 2 of 19)**

One of the existing reinforcement drawing (Drawing 0182 492BC0104 Sheet 2 of 19 by the Department of Public Works) suggests that the reinforcement in concrete elements may be electrically continuous within the elements, but not across the elements. However, Drawings also suggest that reinforcement from the left part of the Headstock did not continue to the right part, i.e, they were constructed in two halves.

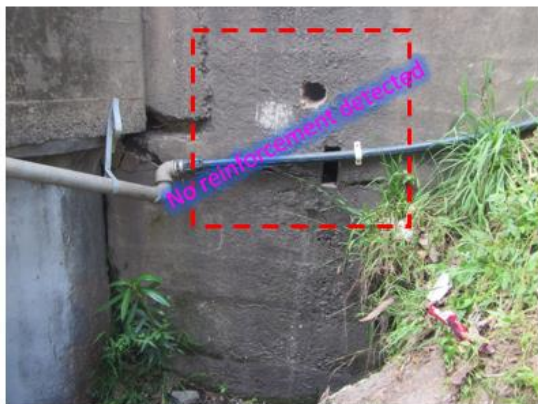
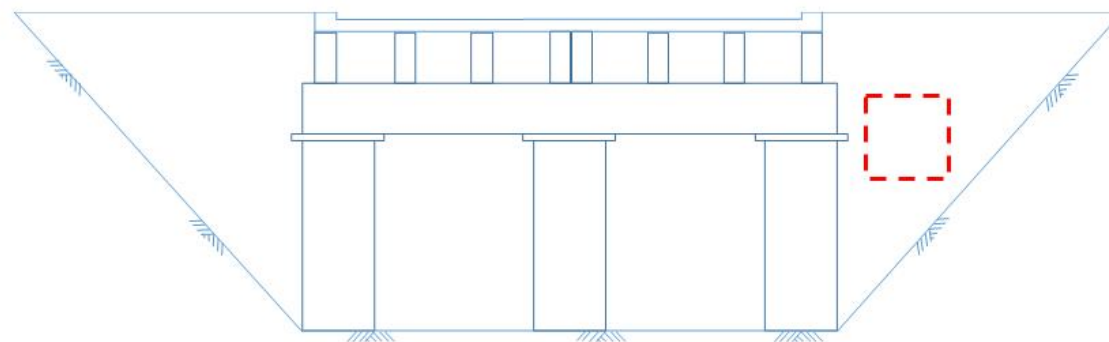
## Abutment Wing Wall (West Side)

**Photo 3 West side Wingwall Breakout B1**

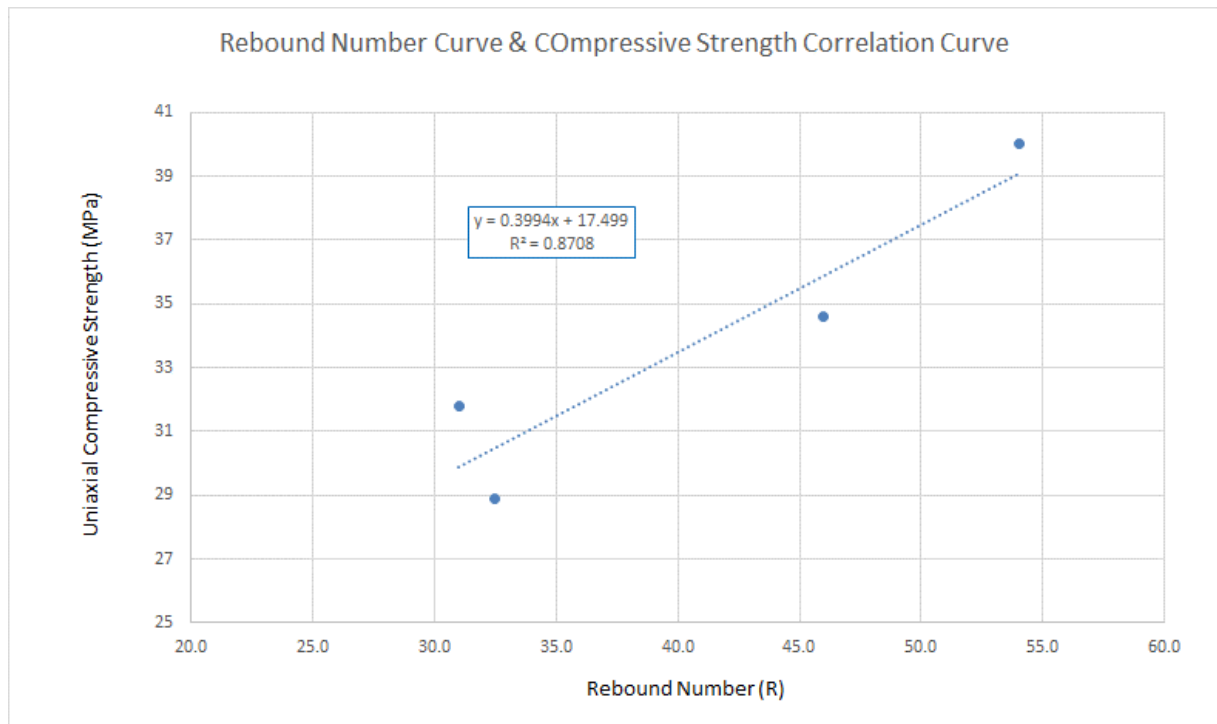
Location	Mean Rebound Number	Uniaxial Compressive strength Test (MPa)
Pier 1 Headstock Core 2	29	32.5
Pier 1 Headstock Core 1	31	23.0
Pier 1 Headstock Core 3	40	54.0
Girder 1 North End West Face Core 1	32	31.0
Girder 1 North End West Face Core 2	35	46.0
Girder 7 North End East Face Core 3	31	50.0

Note: Although we were looking for  $r^2$  value  $>0.9$  for correlation, a value of 0.87 is still considered to be an indication of a sensible correlation presence.

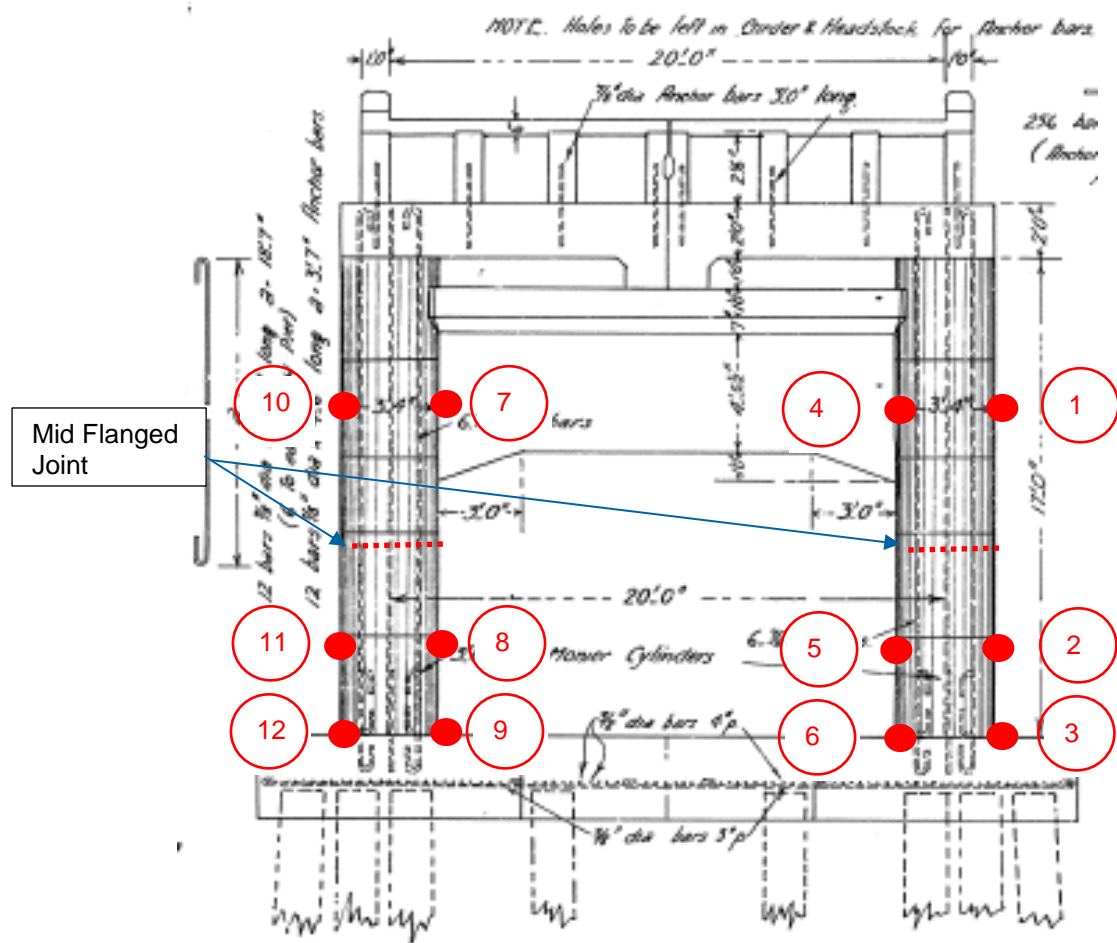
## Appendix K – Pier Wall Thickness Survey Results

Pier	Location ID	Side	Location	Thickness (mm)			
				1	2	3	Mean
Pier 1 East	1	East	Top	-	-	-	-
	2	East	Middle	30	28	-	29
	3	East	Bottom	25.1	-	-	25
	4	West	Top	-	-	-	-
	5	West	Middle	30	32	-	31
	6	West	Bottom	24	25	24.5	25
Pier 1 West	7	East	Top	-	-	-	-
	8	East	Middle	25	26	24	25
	9	East	Bottom	22	22	23	22
	10	West	Top	-	-	-	-
	11	West	Middle	24	22	26	24
	12	West	Bottom	26	26	23	25
