Safety Investigation Report

Electric Shock Occurrence

Intersection of Ultimo Road and George Streets Sydney

Prepared for The Secretary
Transport for NSW
2 August 2018

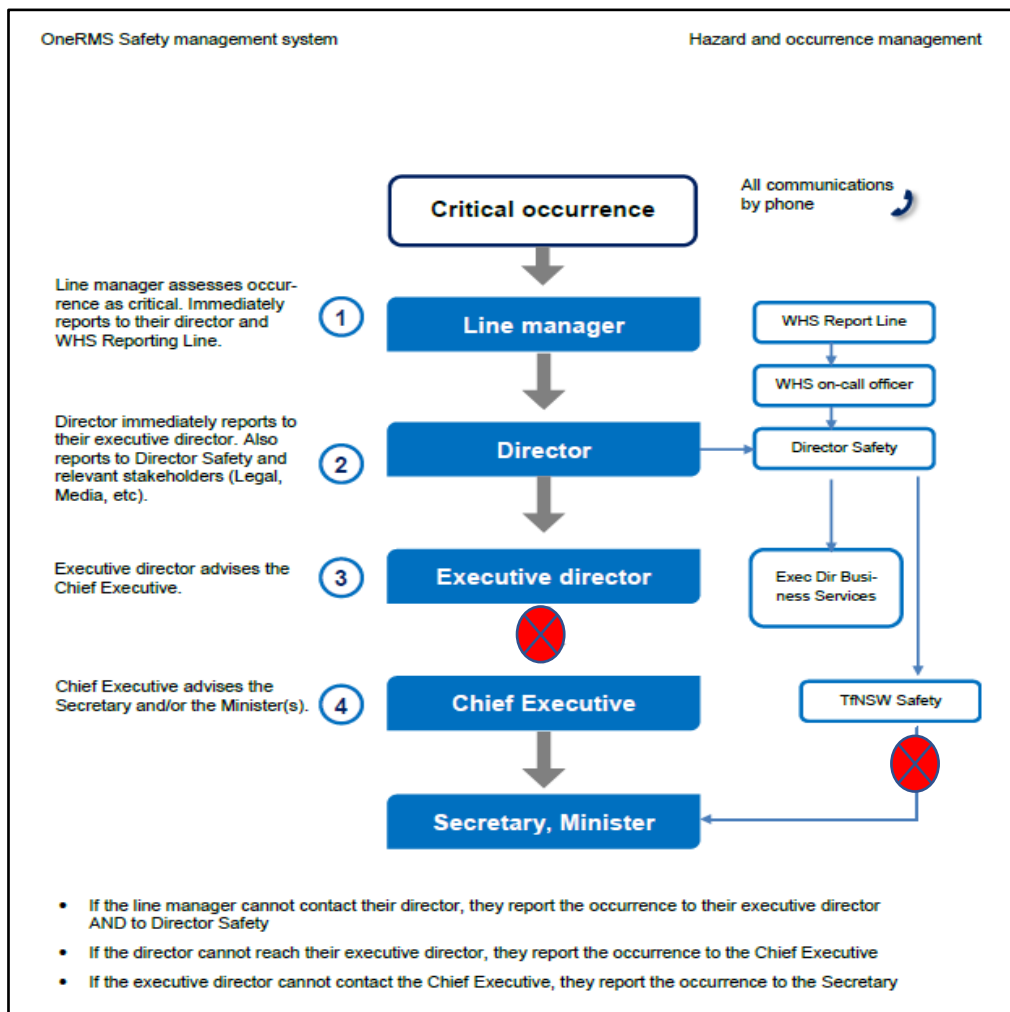
Image 8: RMS Escalation Procedure 10 June 2018

It was not relayed to the Chief Executive RMS and the occurrence was not presented, as a critical occurrence, to the TfNSW Director Safety, Quality, Environment and Risk. Subsequently the situation occurred where information was not distributed prior to media awareness.

The information path and the blockage points appear below in image 8.

The investigation is aware of work in progress to address incident reporting and notification protocols within the transport cluster, through the Transport Cluster Leadership Committee. This is expected to further strengthen obligations related to reporting and escalation.

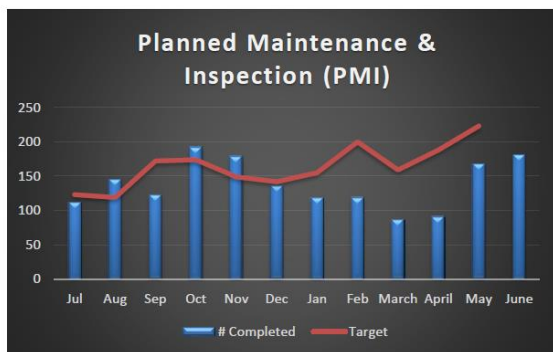
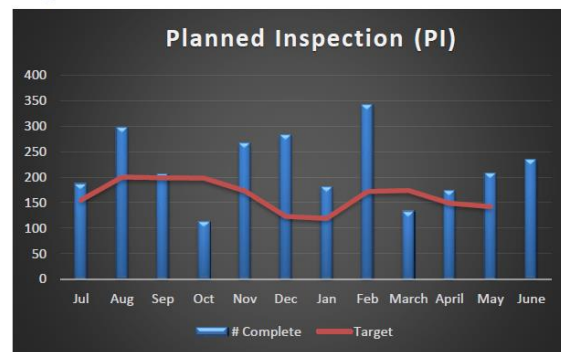
Image 10: LT JV Performance Charts

The following performance graphs were embedded within this document¹⁶. It was stated that this was meant to reflect the asset inspections conducted by the LT JV. The investigation was unable to obtain any measure of compliance from this document.
