Tarago Station
C/-
Tarago Railway Station, Goulburn Street
Tarago NSW 2580

Tarago Railway Station, Goulburn Street, Tarago NSW Internal Dust Removal Report

Date 12/10/2020

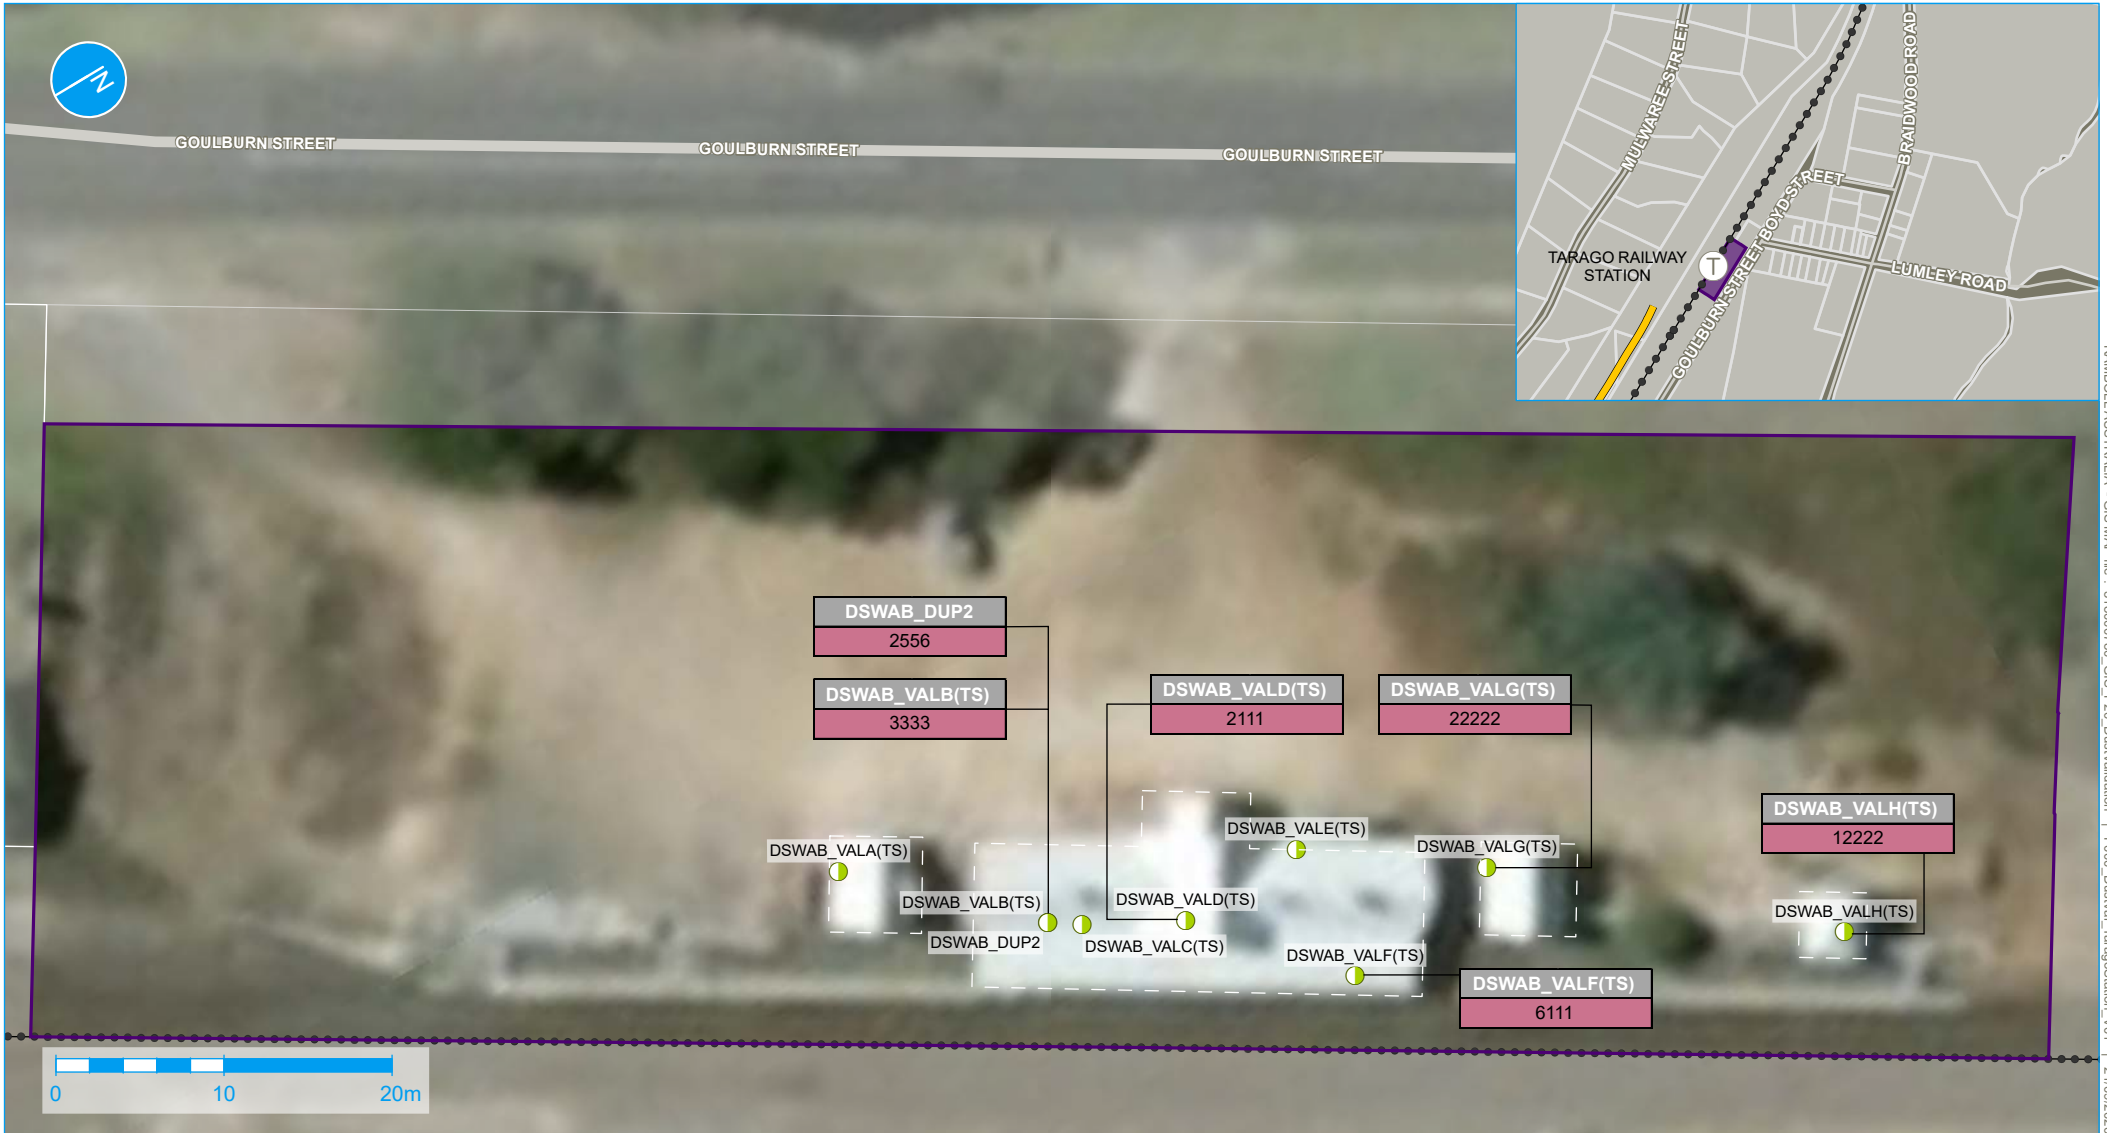
Attachment 1 – Site Figure

This report describes the removal of dust from readily accessible spaces (excluding ceiling cavities) and the risk associated with lead in these areas following dust removal. A site figure is presented as **Attachment 1**.
