## STATEMENT of HERITAGE IMPACT

**Proposal:** Adaptive re-use of the former Tank Annex building 22 to provide a storage facility with building and site conservation works to suit Transport Heritage NSW

**Client: Transport Heritage NSW**

David Scobie Architects Pty Ltd  
Architects & Heritage Consultants

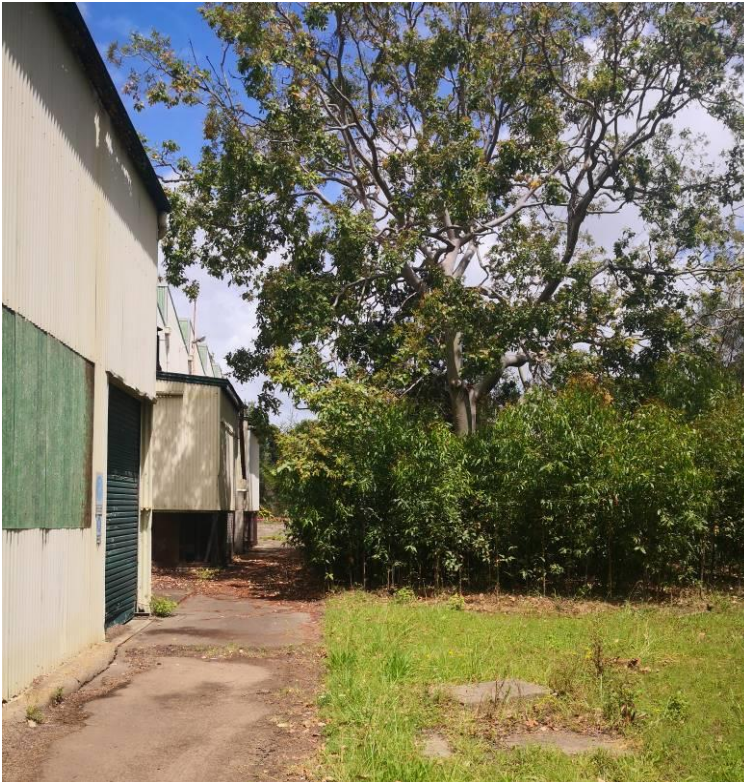
**Figure 10** View of the first and larger tree to the western part on the North side which will be retained and protected. The missing section of roadway will be constructed north of the tree.

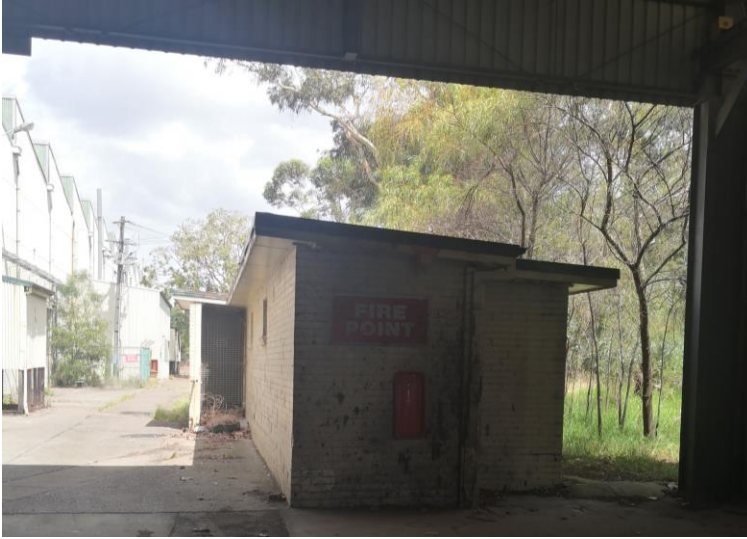
**Figure 13** View of the second toilet block – to be retained subject to approval from the NSW Fire Brigade for the required access road
