# Sydney Ferry Fleet Engineering Assessment

Transport for NSW (TfNSW)

**Report No.:** 2023-9359, Rev. 2

**Date:** 2023-06-09

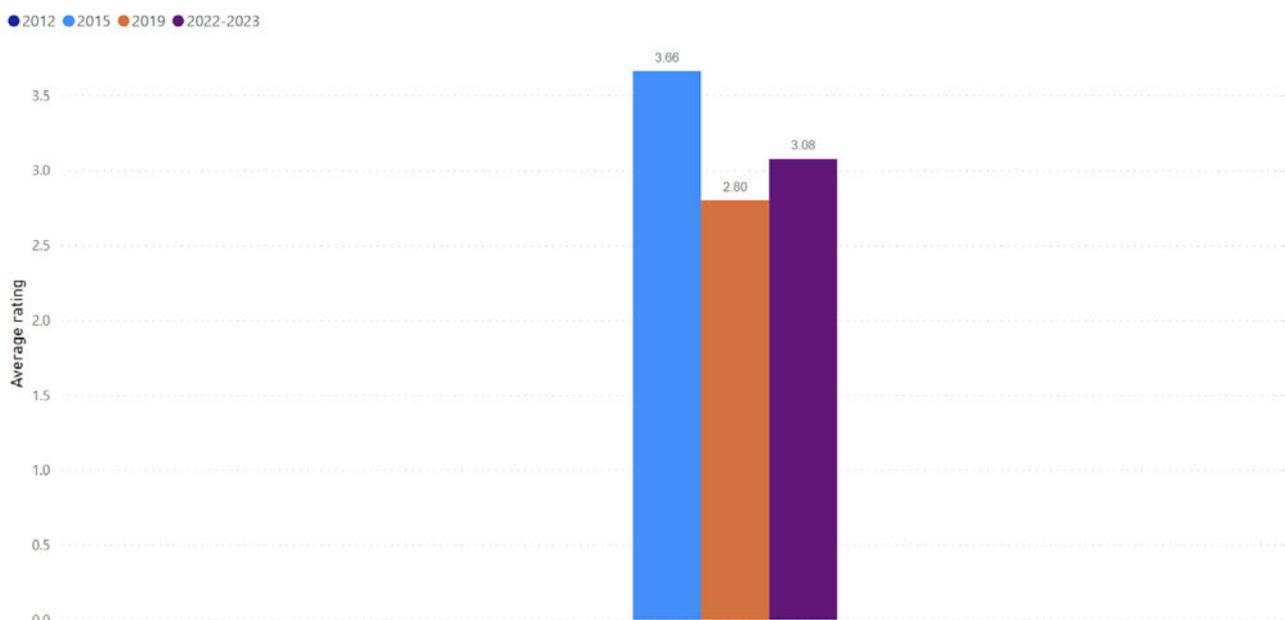
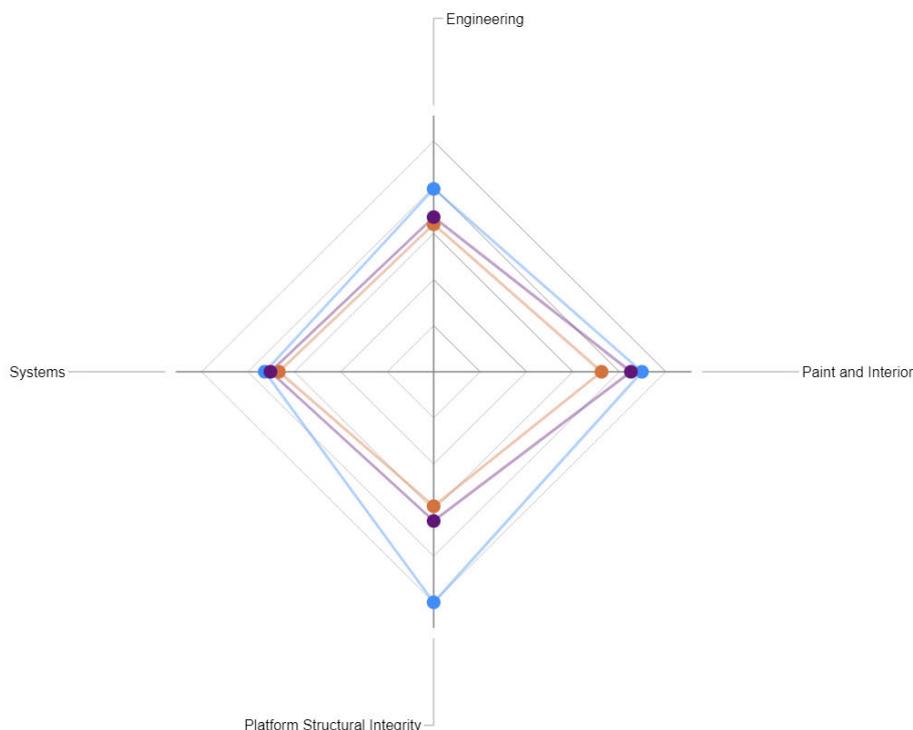
Figure 6.2.2 – Overall rating comparison between 2015, 2019 and 2022-23

Overall and since 2015, vessel *Freshwater* has declined in condition. For 2022-23 there has been an improvement in condition from 2019 with some significant and incremental improvements across all categories (**Engineering, Platform Structural Integrity, Paint and Interior and Systems**).

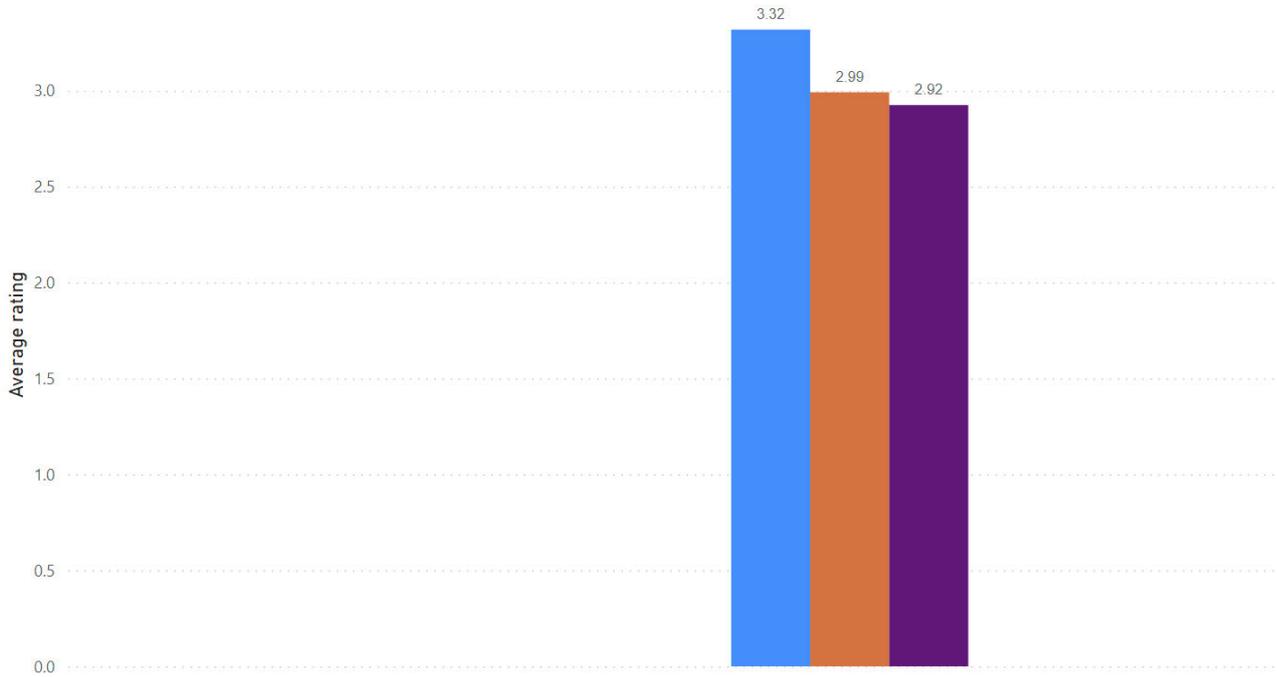
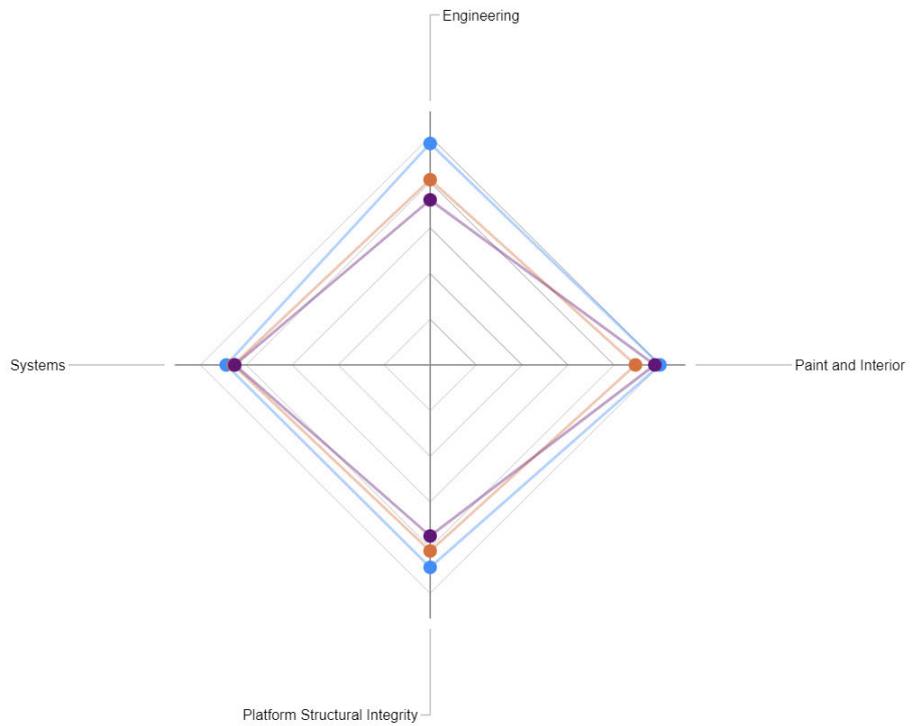
**Figure 6.2.4** – Overall rating comparison between 2015, 2019 and 2022-23

Overall and since 2015, vessel *Collaroy* has declined in condition. For 2022-23 there has been an improvement in condition from 2019 with an improvement in the **Paint and Interior** category. A decline was seen across categories **Engineering** and **Platform Structural Integrity**. **Systems** remained steady.

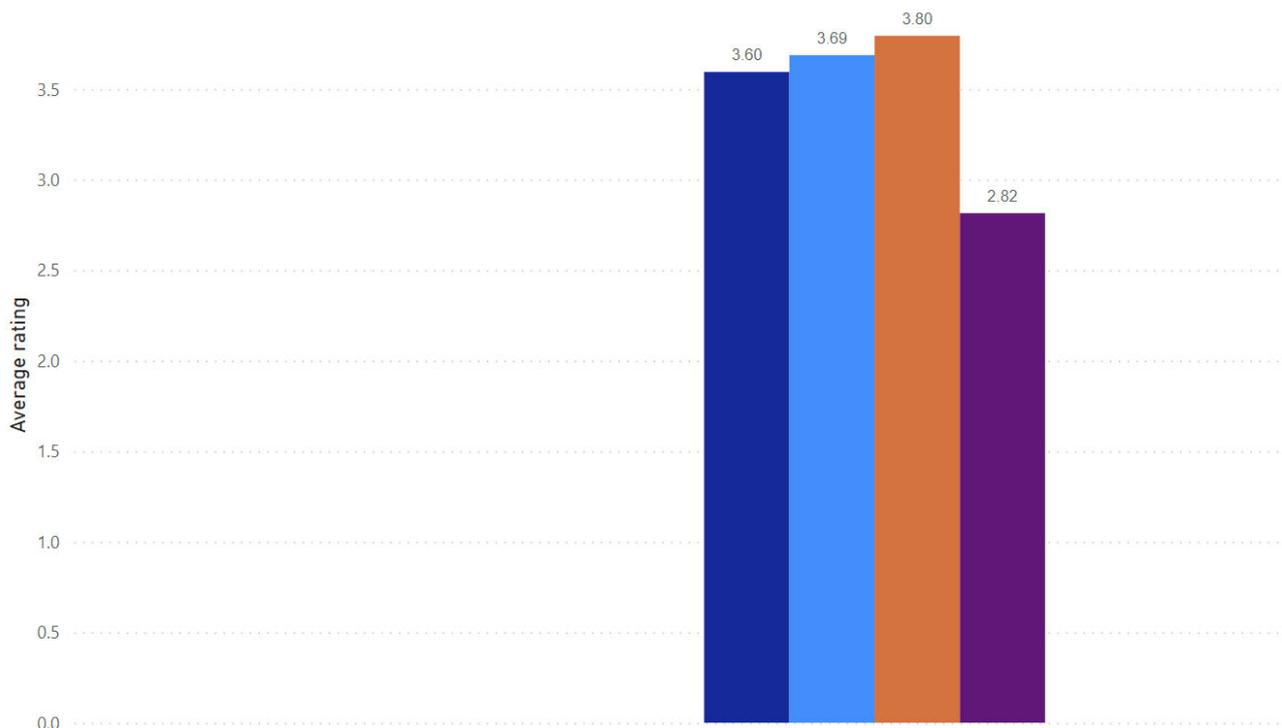
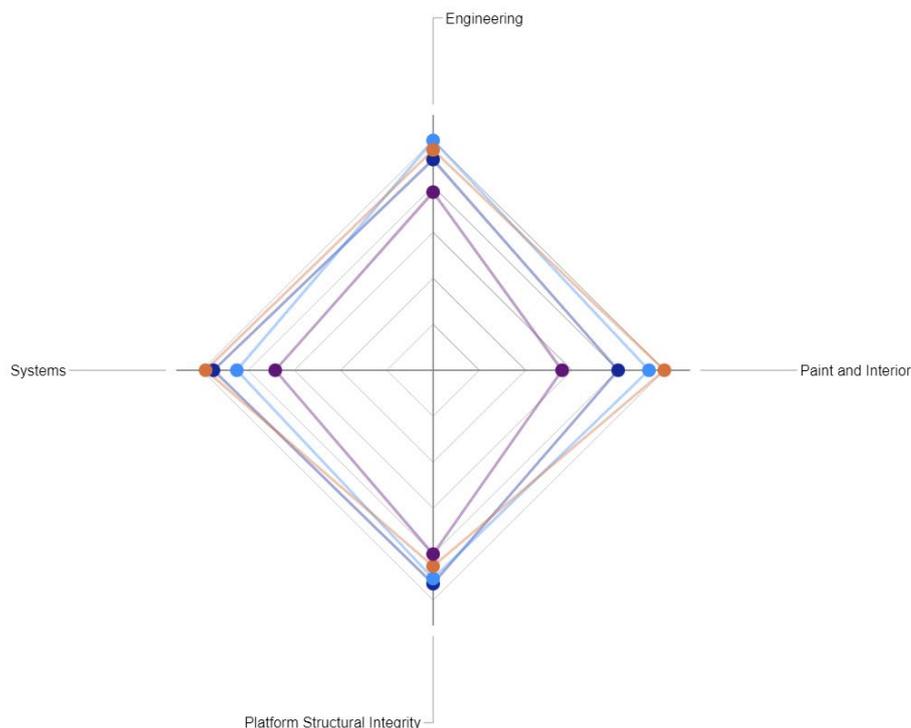
**Figure 6.3.1** – Overall rating comparison between 2012, 2015, 2019 and 2022-23

Until 2022-23, vessel *Alexander* had improved in overall condition. For 2022-23 there has been a decline in condition from 2019 with significant declines across all categories (**Engineering, Platform Structural Integrity, Paint and Interior and Systems**). The biggest declines were in **Paint and Interior** and **Systems**.

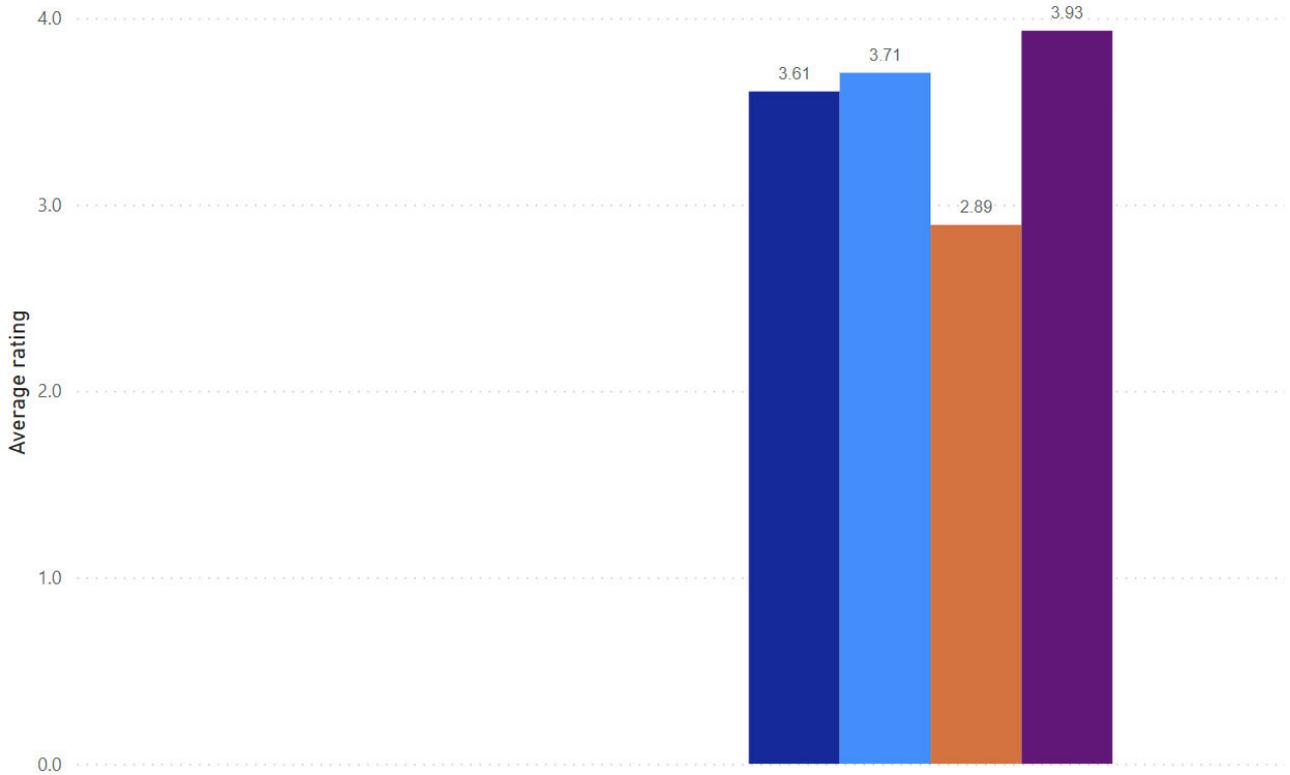
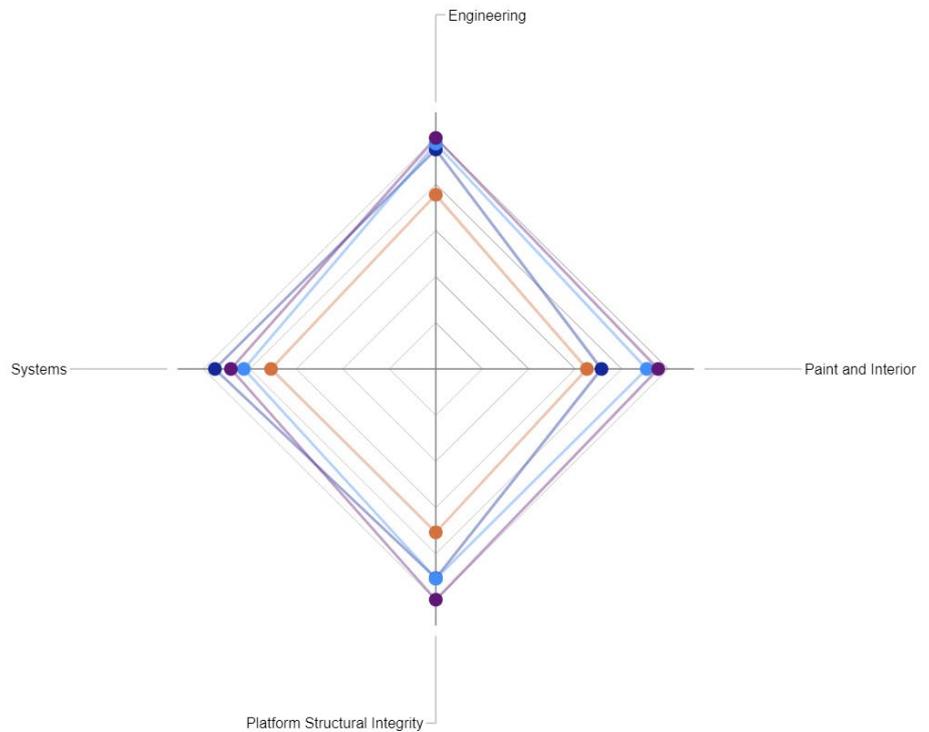
**Figure 6.3.3** – Overall rating comparison between 2012, 2015, 2019 and 2022-23

In 2022-23, vessel *Borrowdale* has recorded its best condition since Fleet Assessments commenced. For 2022-23 there has been an improvement in condition from 2019 (2015 and 2012) with significant increases across all categories (**Engineering, Platform Structural Integrity, Paint and Interior and Systems**). The biggest increases were in **Paint and Interior** and **Platform Structural Integrity**.

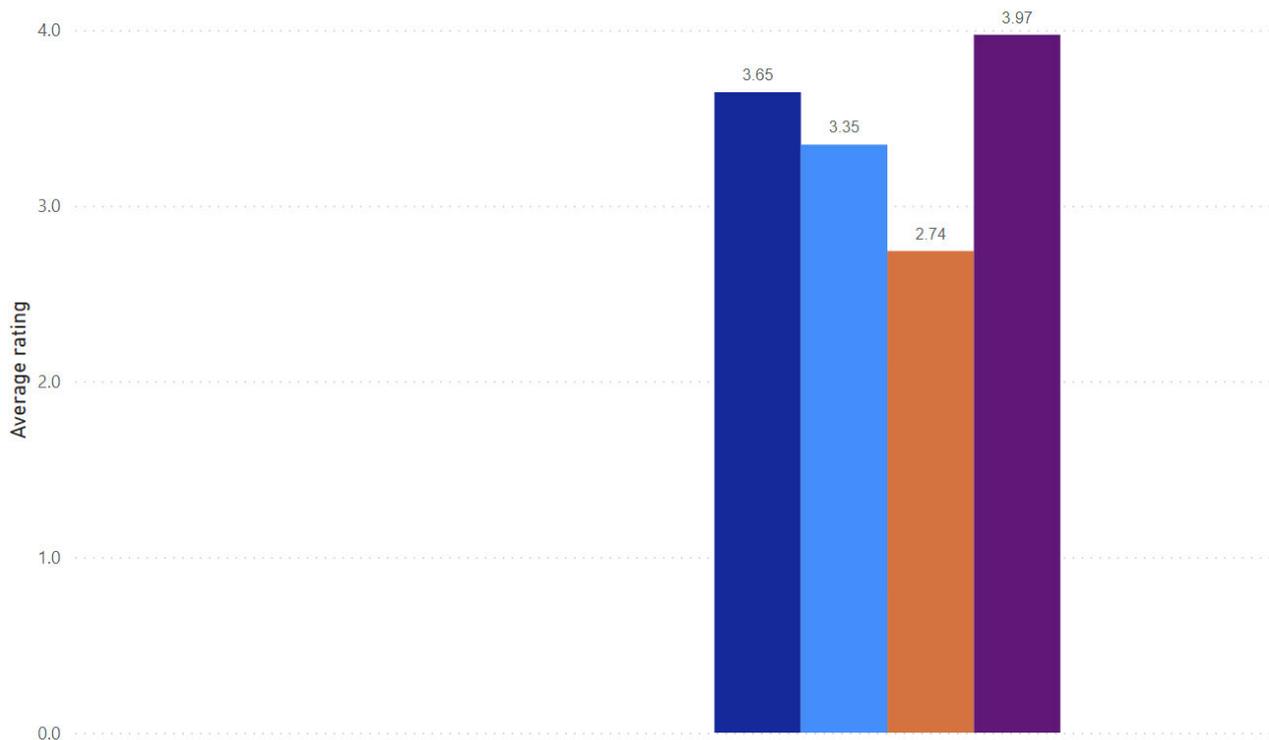
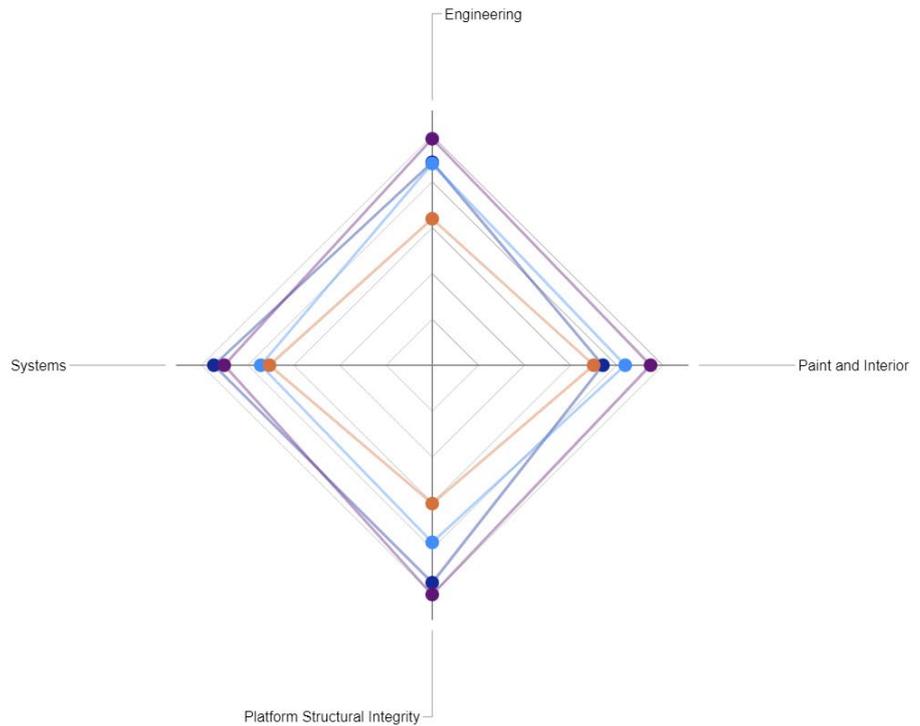
**Figure 6.3.5** – Overall rating comparison between 2012, 2015, 2019 and 2022-23

In 2022-23, vessel *Charlotte* has recorded its best condition since Fleet Assessments commenced. Prior to this its condition was in a constant decline. For 2022-23 there has been an improvement in condition from 2019 (2015 and 2012) with significant increases across all categories (**Engineering, Platform Structural Integrity, Paint and Interior and Systems**). The biggest increases were in **Engineering** and **Platform Structural Integrity**.

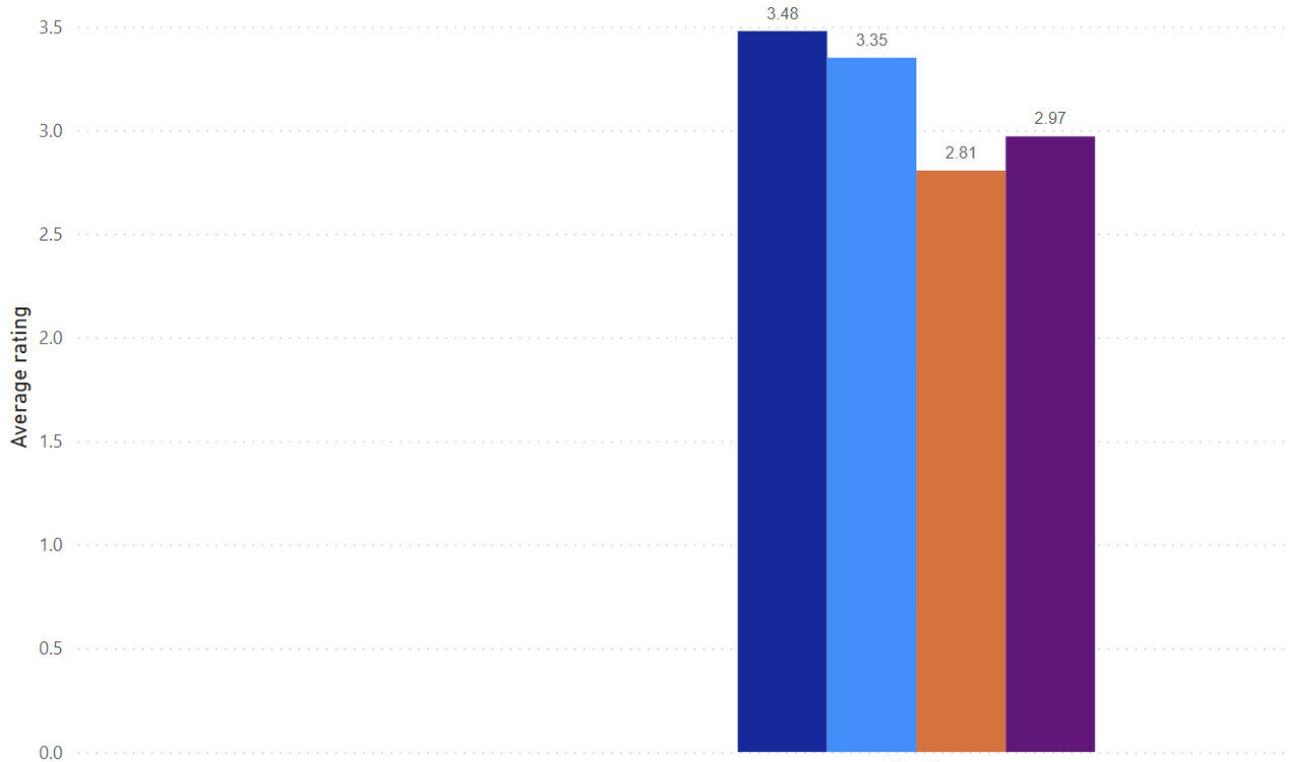
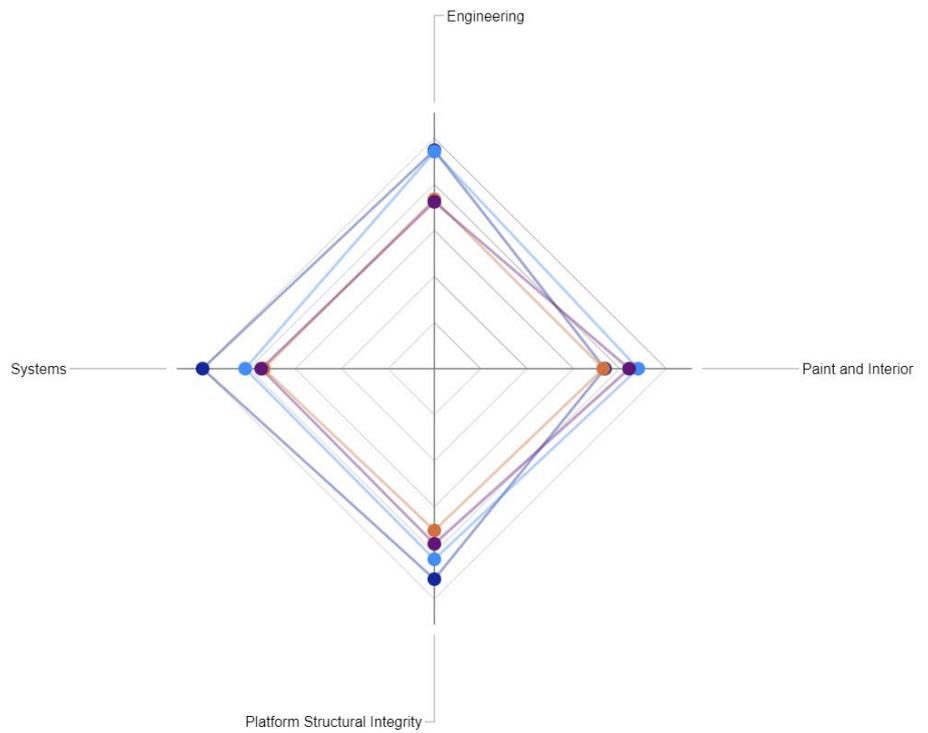
**Figure 6.3.7 – Overall rating comparison between 2012, 2015, 2019 and 2022-23**

Since 2012, vessel *Fishburn* has declined in overall condition. For 2022-23 there has been an improvement in condition from 2019 with an improvement in the **Paint and Interior** and **Platform Structural Integrity** categories. **Engineering** and **Systems** remained steady.

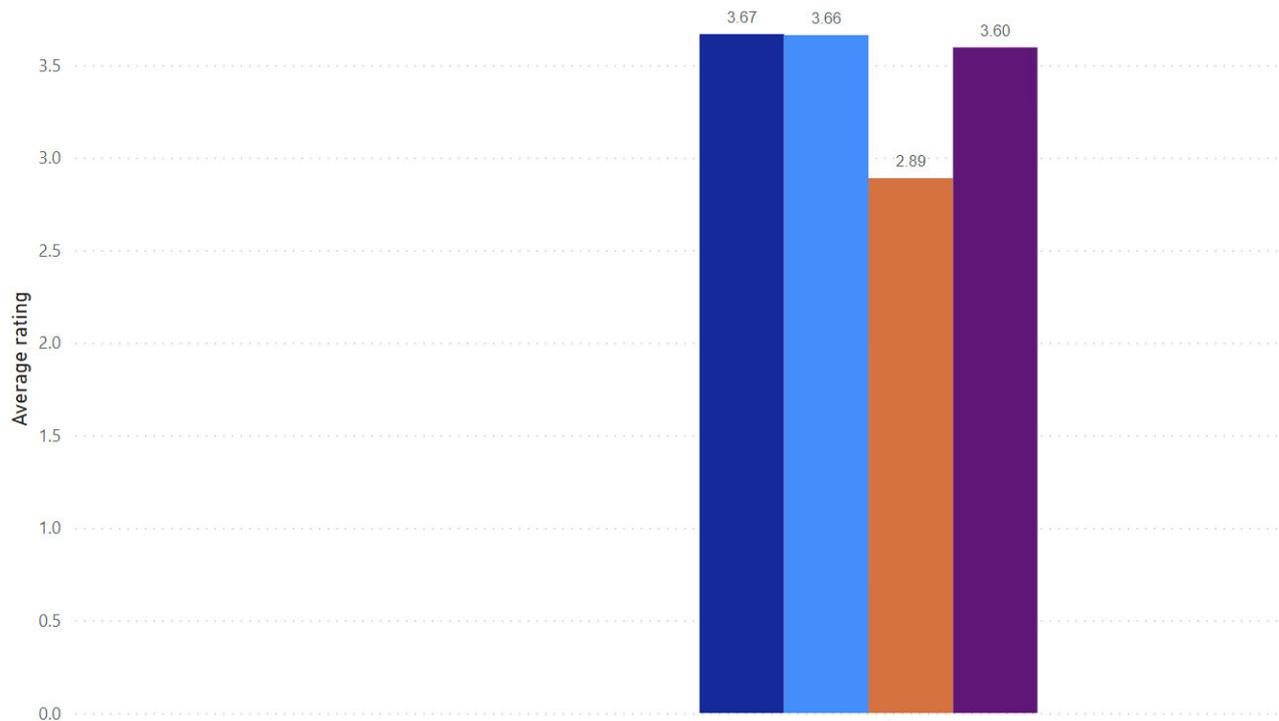
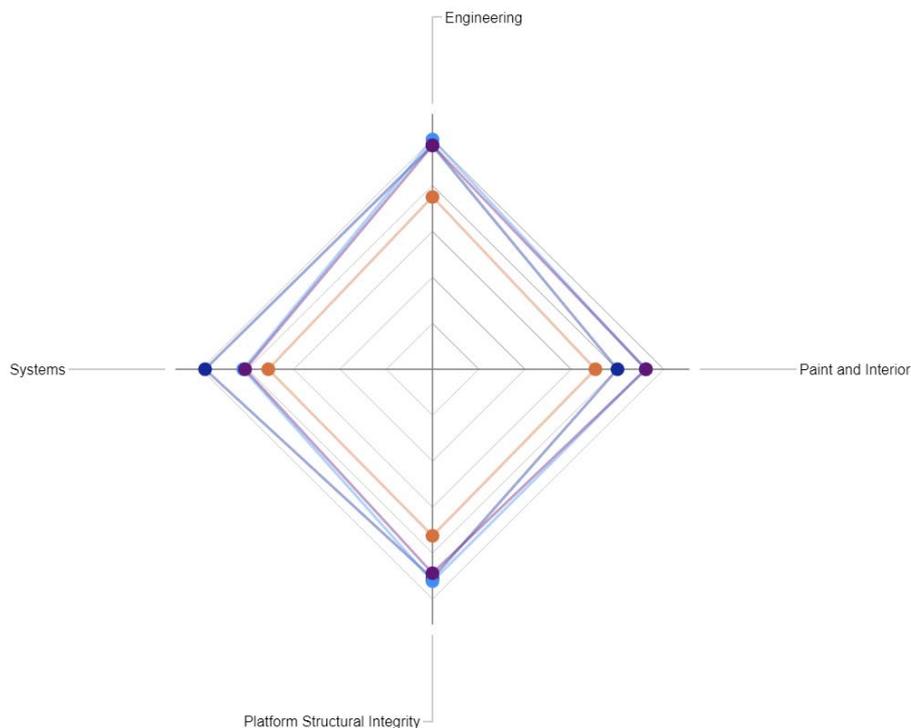
Figure 6.3.9 – Overall rating comparison between 2012, 2015, 2019 and 2022-23

In 2022-23, vessel *Friendship* has recorded results similar to (but marginally less than) those from 2012 and 2015. For 2022-23 there has been an improvement in condition from 2019 with significant increases across all categories (**Engineering, Platform Structural Integrity, Paint and Interior and Systems**). The biggest increases were in **Engineering** and **Paint and Interior**.

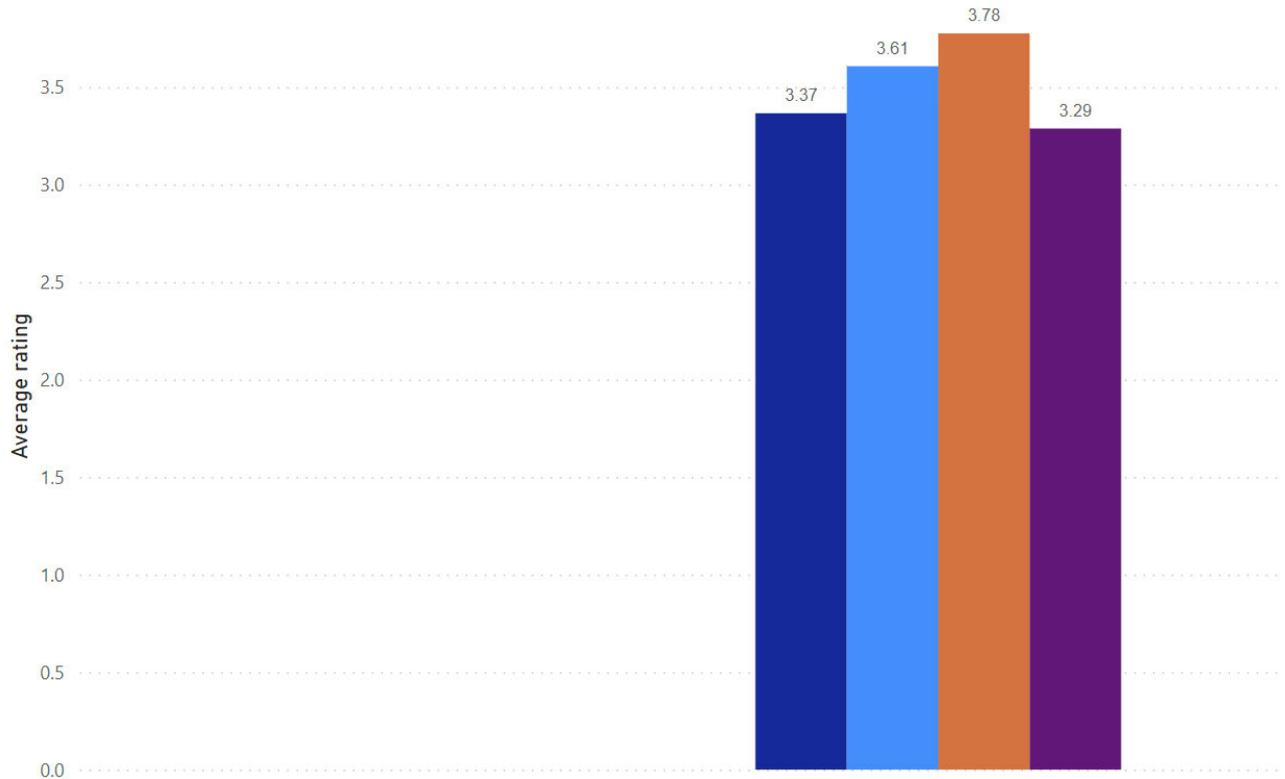
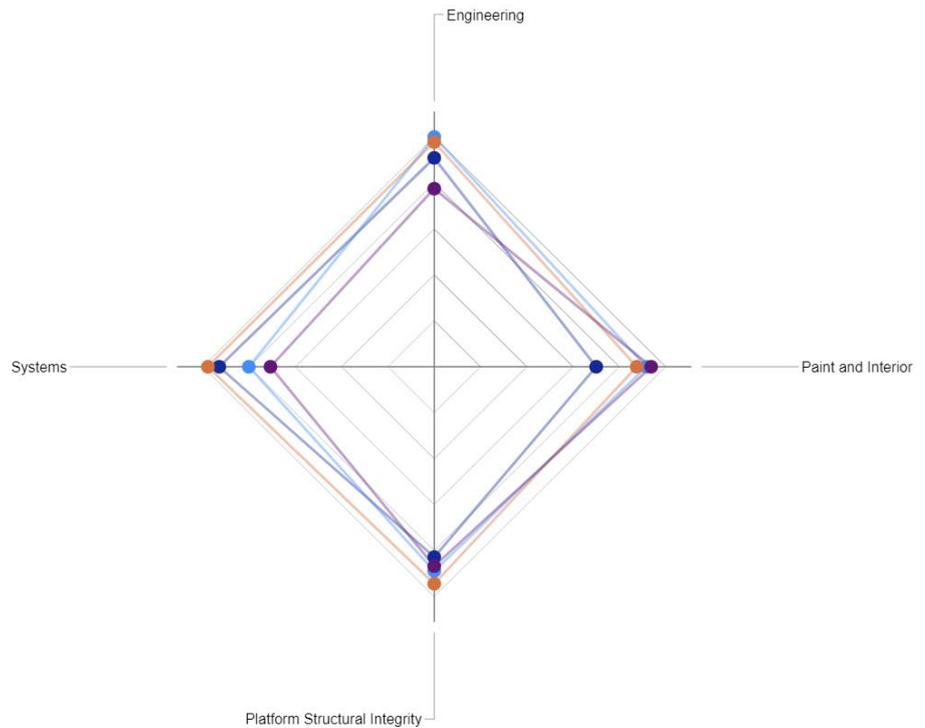
**Figure 6.3.11** – Overall rating comparison between 2012, 2015, 2019 and 2022-23

Since 2012, vessel *Golden Grove* had improved in overall condition. For 2022-23 there has been a decline in condition from 2019 (and 2012 and 2015) with a decline seen in the **Platform Structural Integrity**, **Engineering** and **Systems** categories. **Paint and Interior** improved from 2019.

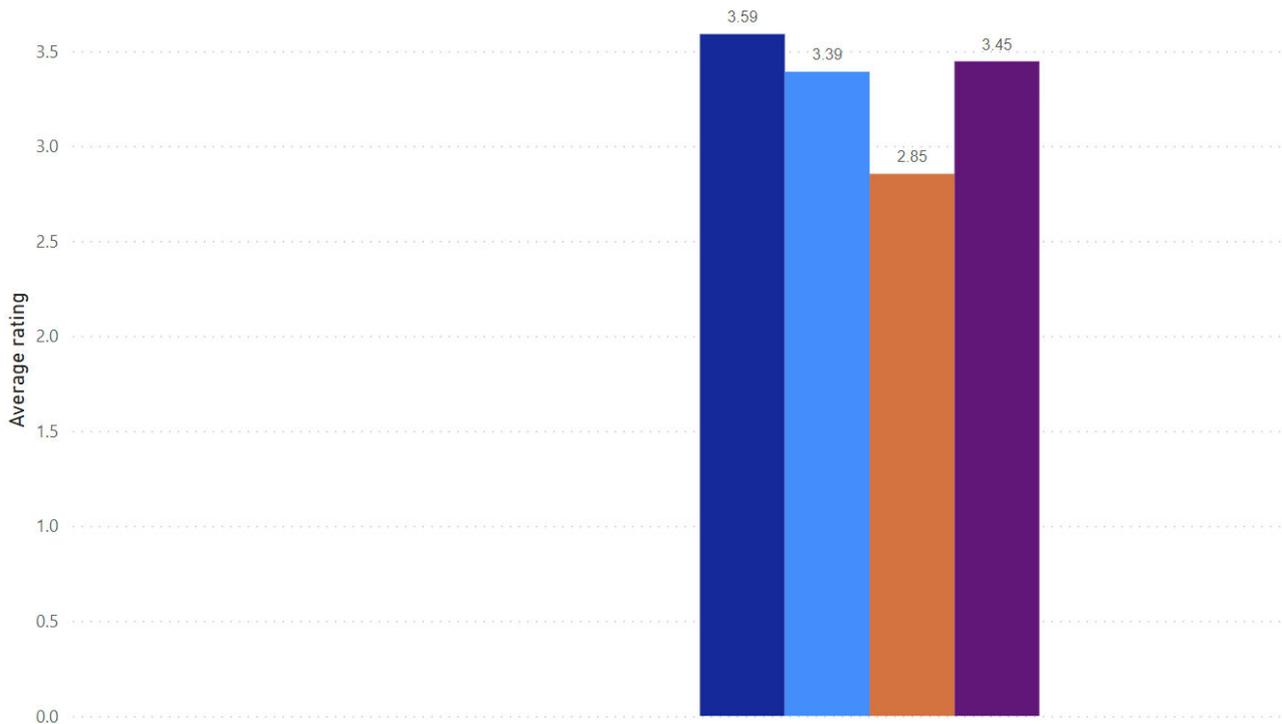
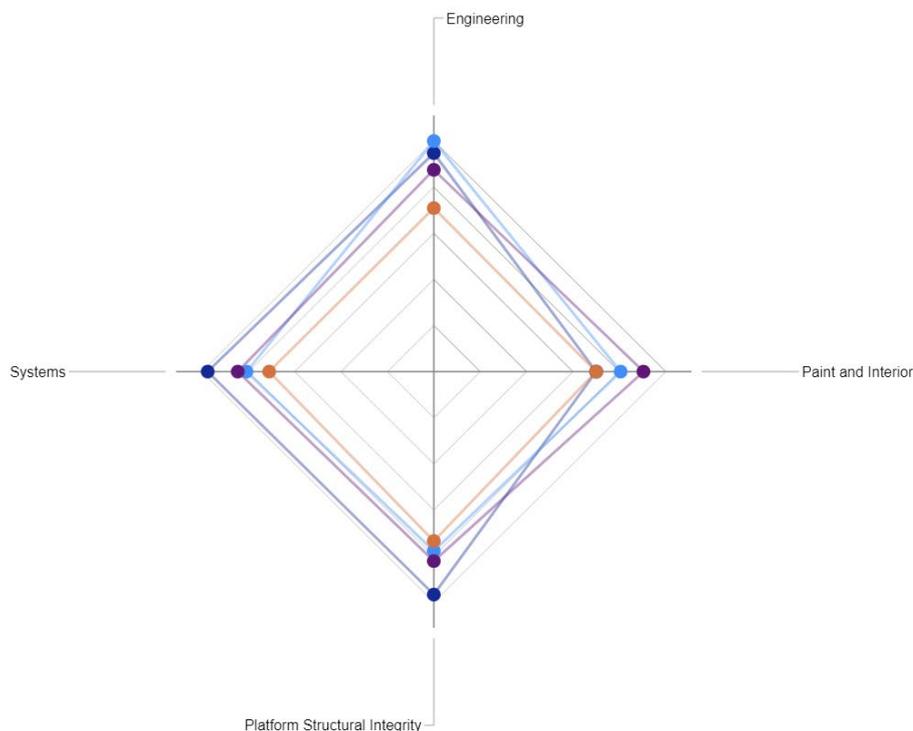
**Figure 6.3.13** – Overall rating comparison between 2012, 2015, 2019 and 2022-23

In 2022-23, vessel *Scarborough* has recorded results similar to those from 2012 and 2015. For 2022-23 there has been an improvement in condition from 2019 and 2015 with significant increases across all categories (**Engineering, Platform Structural Integrity, Paint and Interior and Systems**). The biggest increases were in **Engineering and Paint and Interior**.

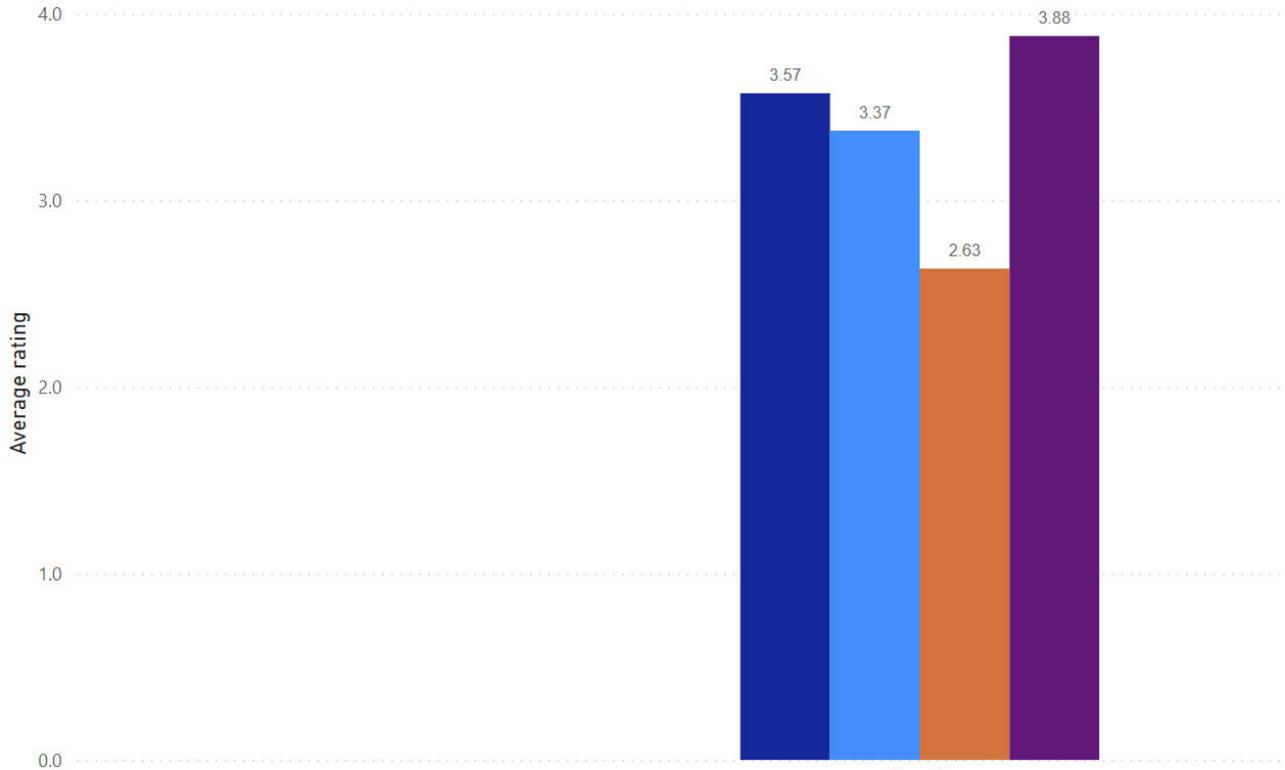
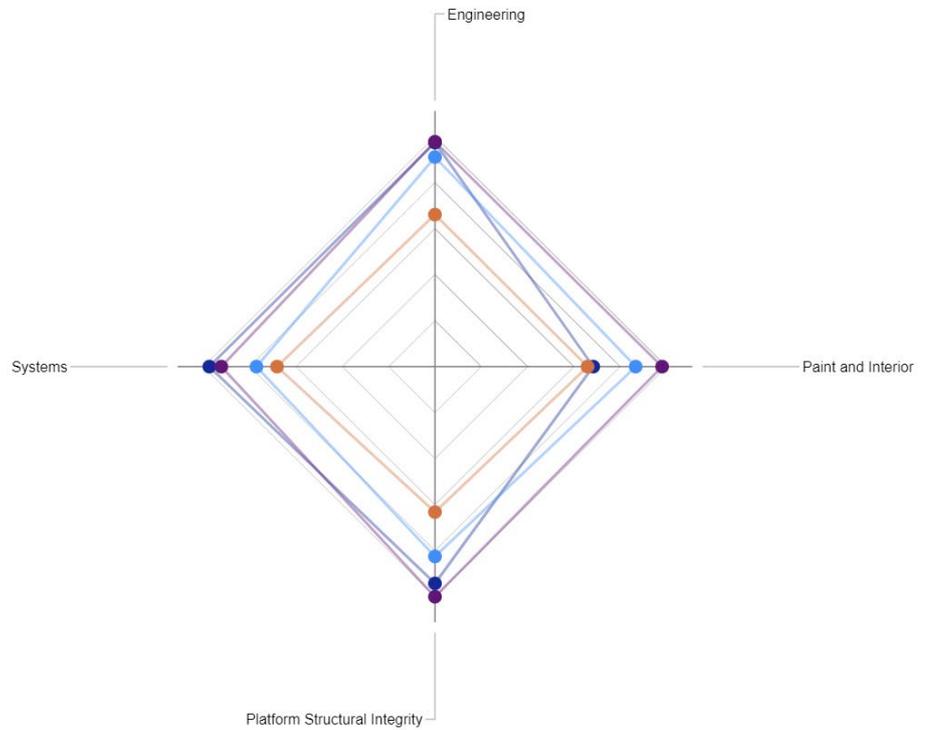
**Figure 6.3.15** – Overall rating comparison between 2012, 2015, 2019 and 2022-23

In 2022-23, vessel *Sirius* has recorded its best condition since Fleet Assessments commenced. Prior to this its condition was in a constant decline. For 2022-23 there has been an improvement in condition from 2019 (2015 and 2012) with significant increases across all categories (**Engineering, Platform Structural Integrity, Paint and Interior and Systems**). The biggest increases were in **Paint and Interior** and **Platform Structural Integrity**.

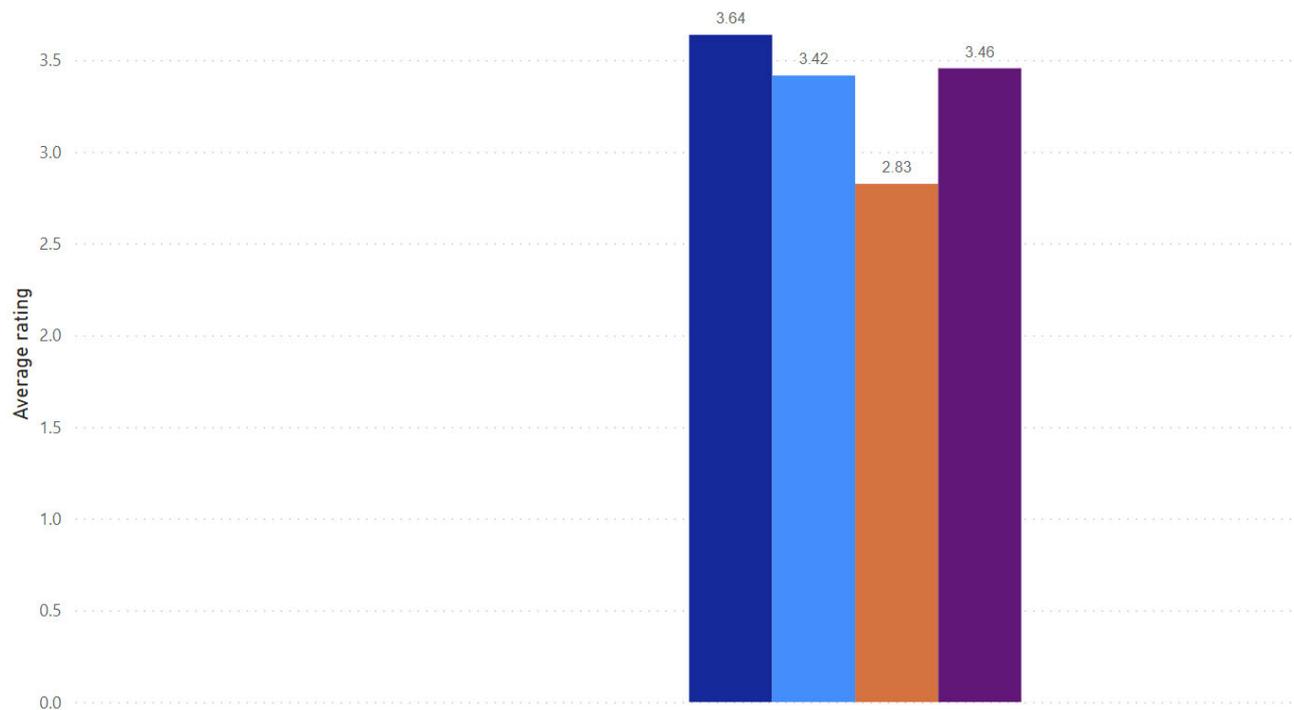
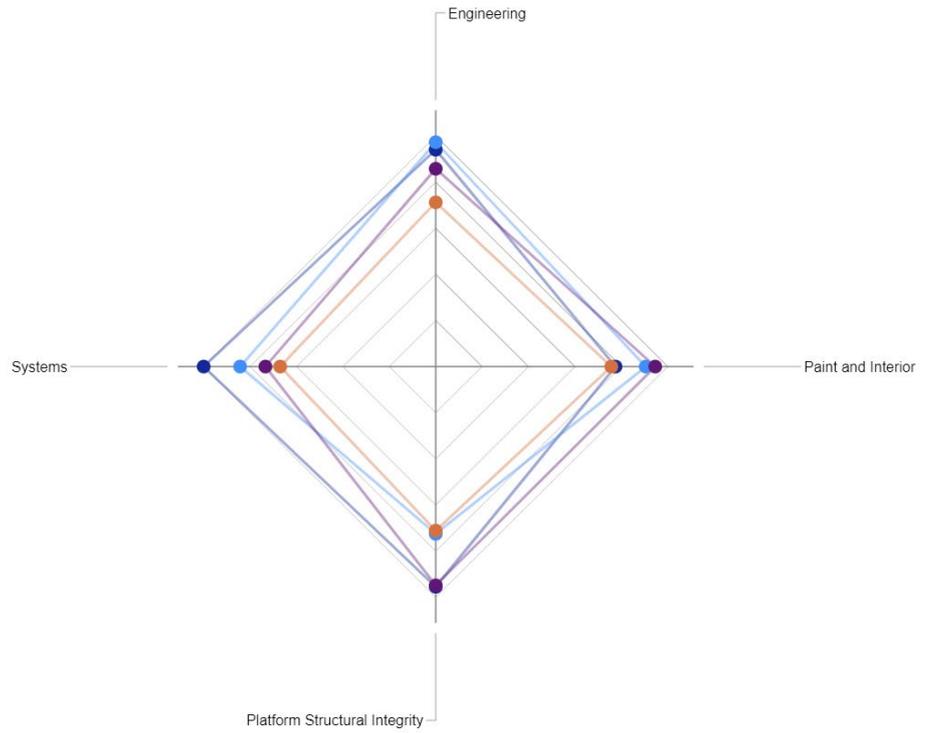
**Figure 6.3.17** – Overall rating comparison between 2012, 2015, 2019 and 2022-23

In 2022-23, vessel *Supply* has recorded results similar to those from 2012 and 2015. For 2022-23 there has been an improvement in condition from 2019 and 2015 with significant increases across all categories (**Engineering, Platform Structural Integrity, Paint and Interior** and **Systems**). The biggest increases were in **Platform Structural Integrity** and **Paint and Interior**.

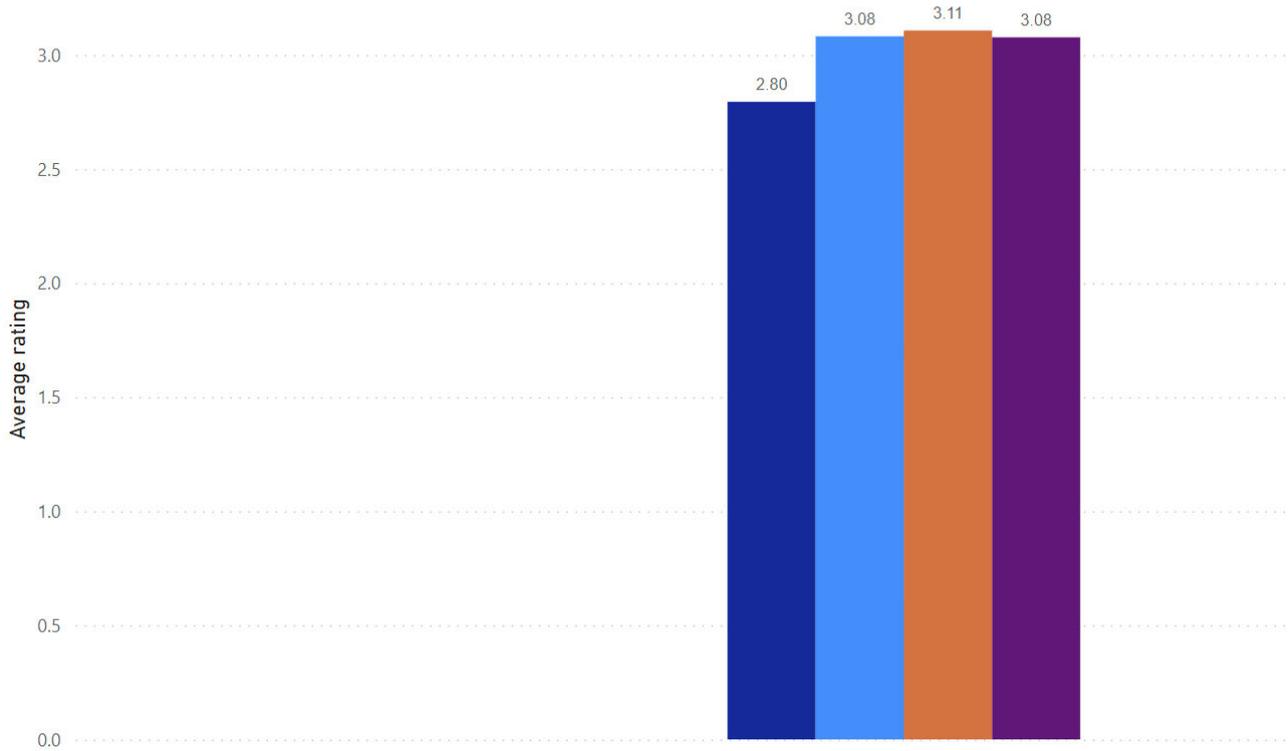
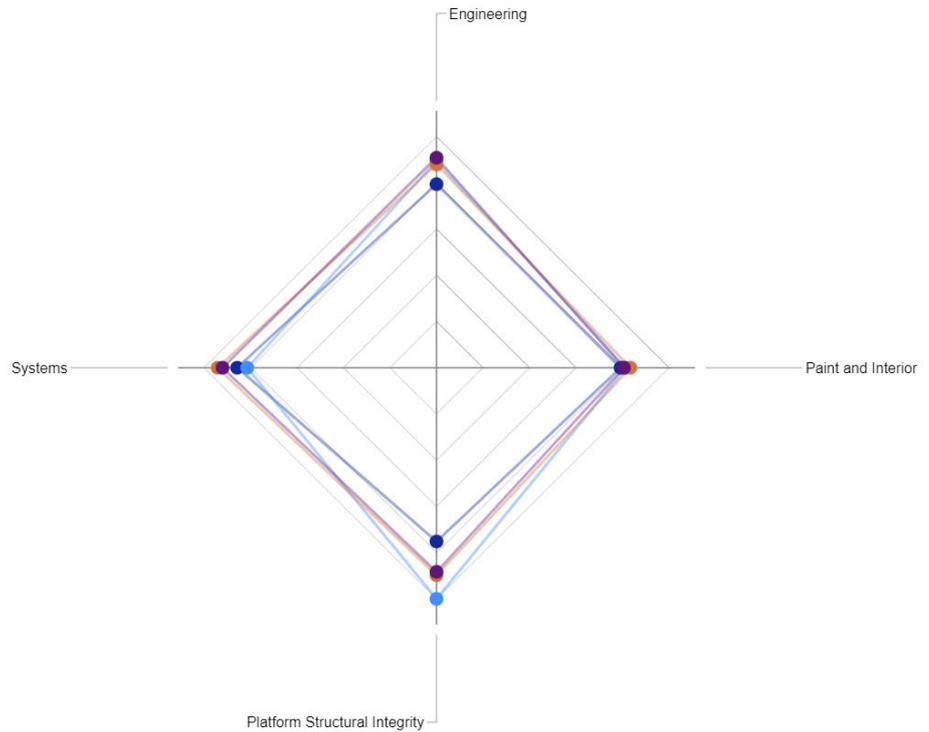
**Figure 6.4.1** – Overall rating comparison between 2012, 2015, 2019 and 2022-23

The overall condition of *Betty Cuthbert* has remained stable since the 2015 assessment. For 2022-23, all categories remain steady from the 2019 assessment.

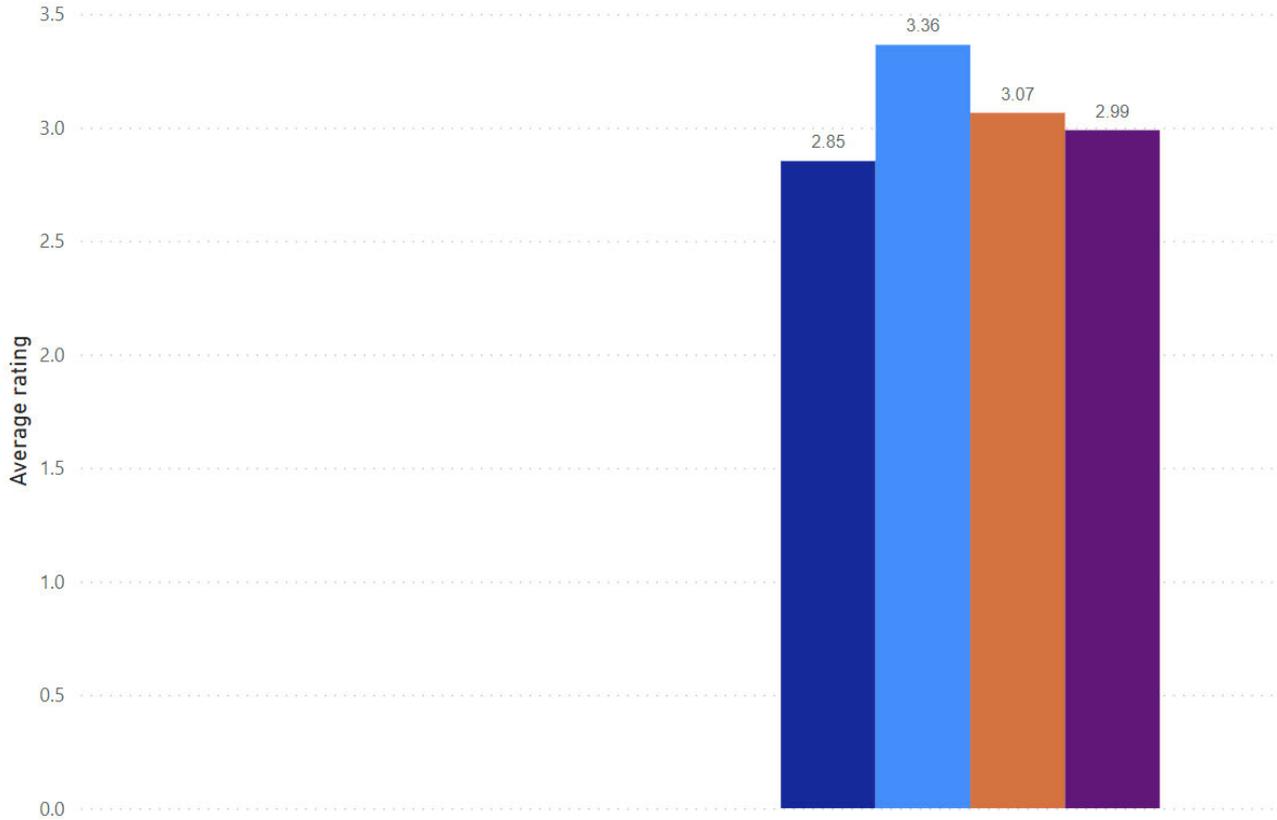
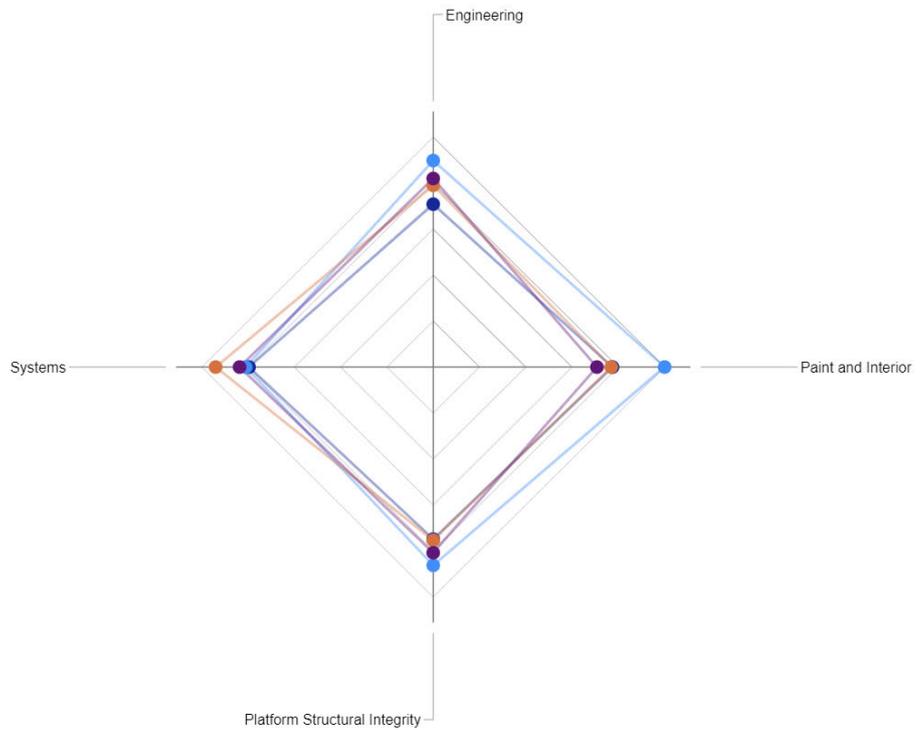
**Figure 6.4.3** – Overall rating comparison between 2012, 2015, 2019 and 2022-23

For 2022-23 there has been a decline in the overall condition of vessel *Dawn Fraser* since 2015. There has been a decline across categories **Systems** and **Paint and Interior**. **Engineering** and **Platform Structural Integrity** have remained steady since 2019.
