# Sydney Ferry Fleet Engineering Assessment

Transport for NSW (TfNSW)

**Report No.:** 2023-9359, Rev. 2

**Date:** 2023-06-09

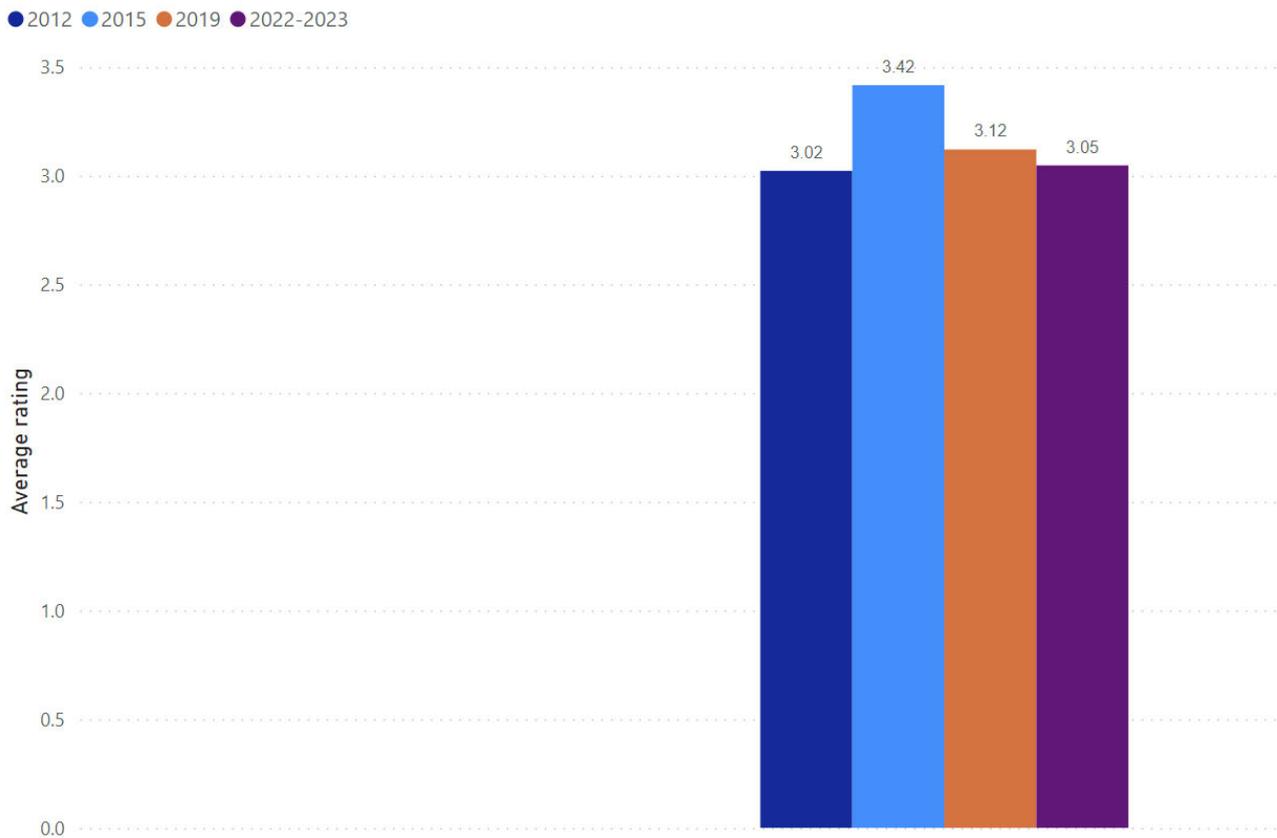
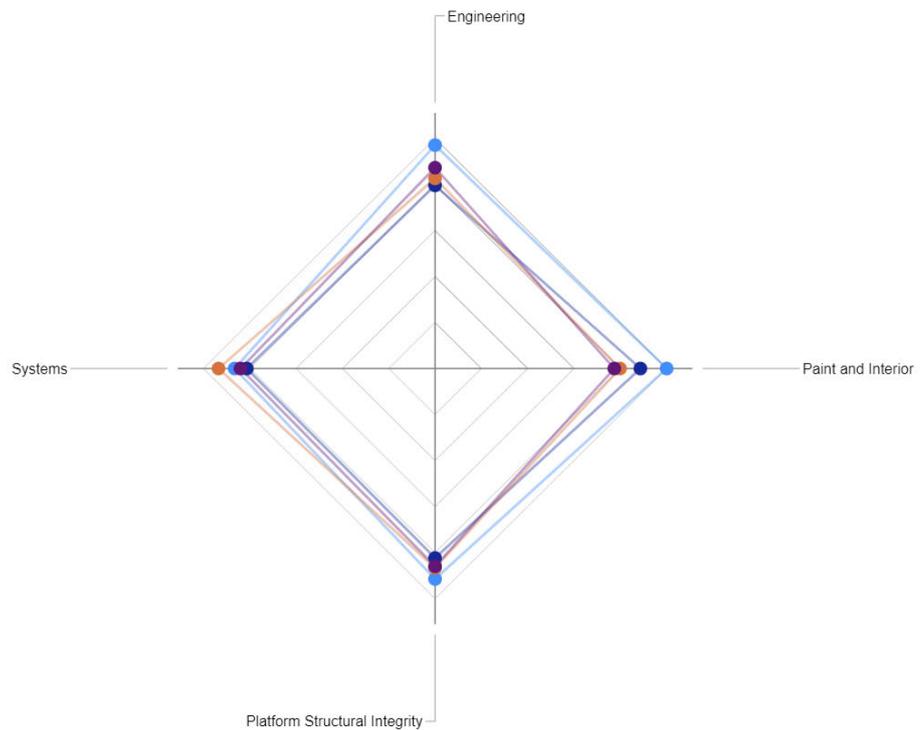
**Figure 6.4.5** – Overall rating comparison between 2012, 2015, 2019 and 2022-23

For 2022-23 there has been a decline in the overall condition of vessel *Evonne Goolagong* since 2015. From 2019 there has been a decline in the category **Systems**. **Engineering**, **Paint and Interior** and **Platform Structural Integrity** have remained steady since 2019.

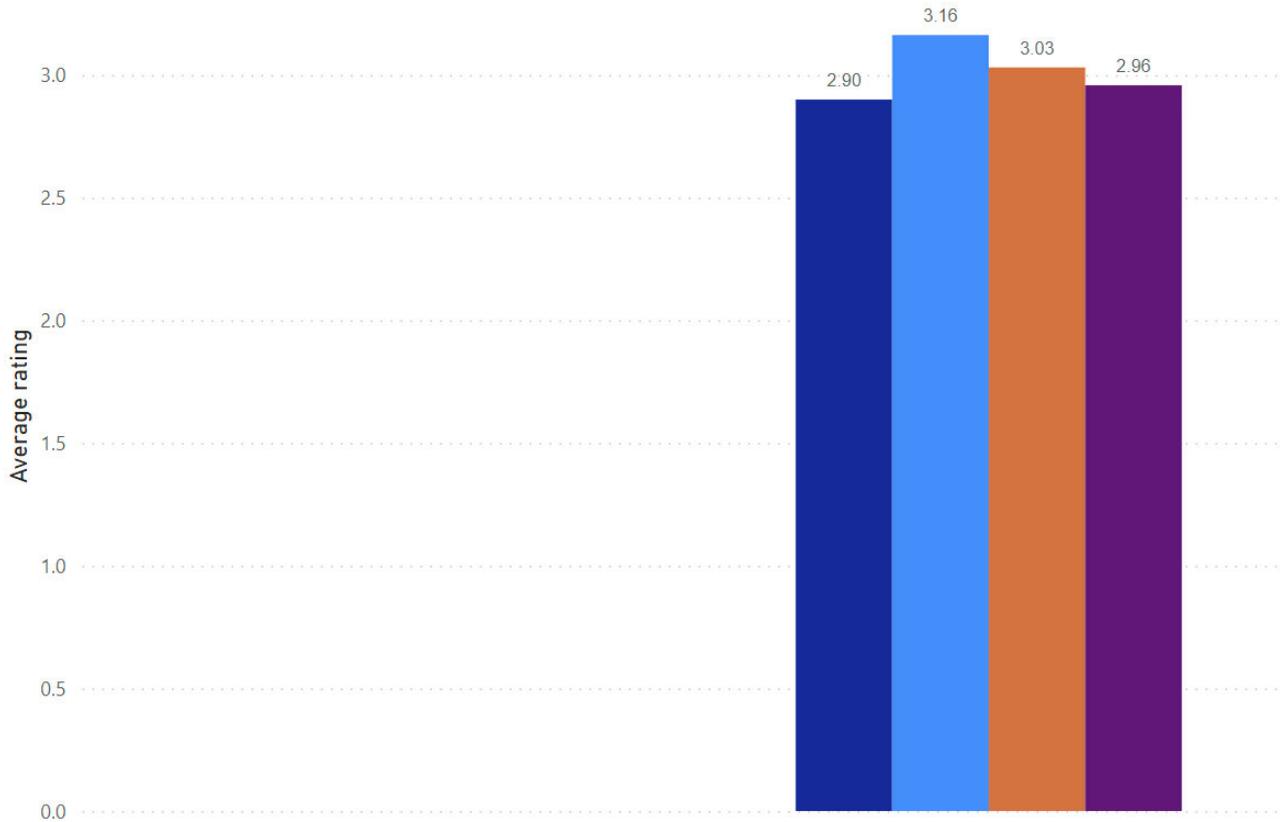
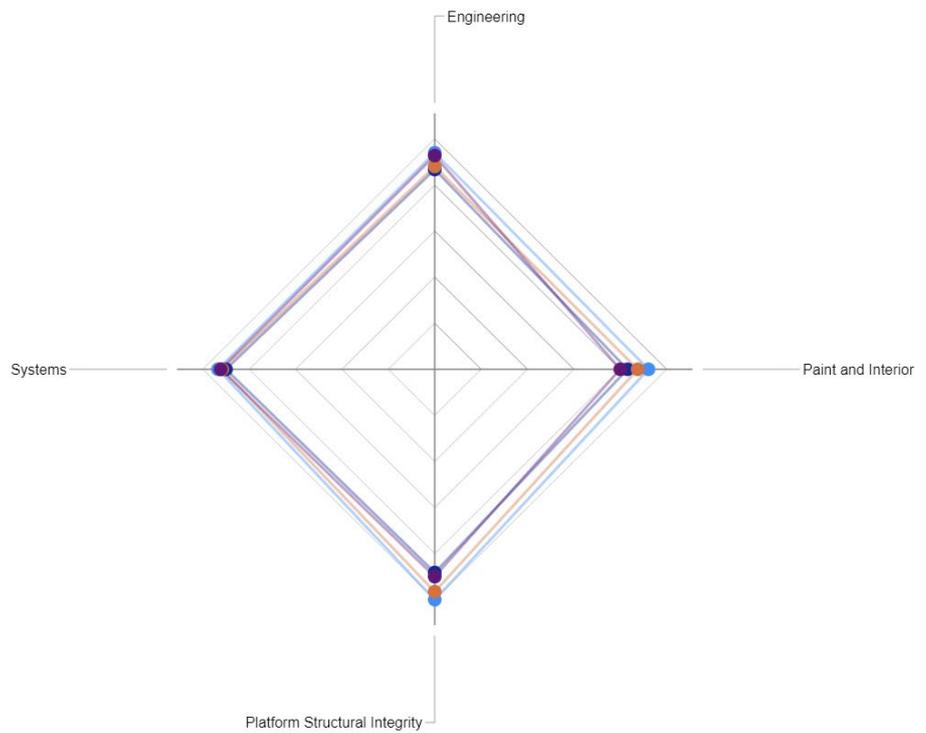
**Figure 6.4.7** – Overall rating comparison between 2012, 2015, 2019 and 2022-23

For 2022-23 there has been a decline in the overall condition of vessel *Marjorie Jackson* since 2015. From 2019 there has been a decline in the categories **Paint and Interior** and **Platform Structural Integrity**. **Engineering** and **Systems** have remained steady since 2019.

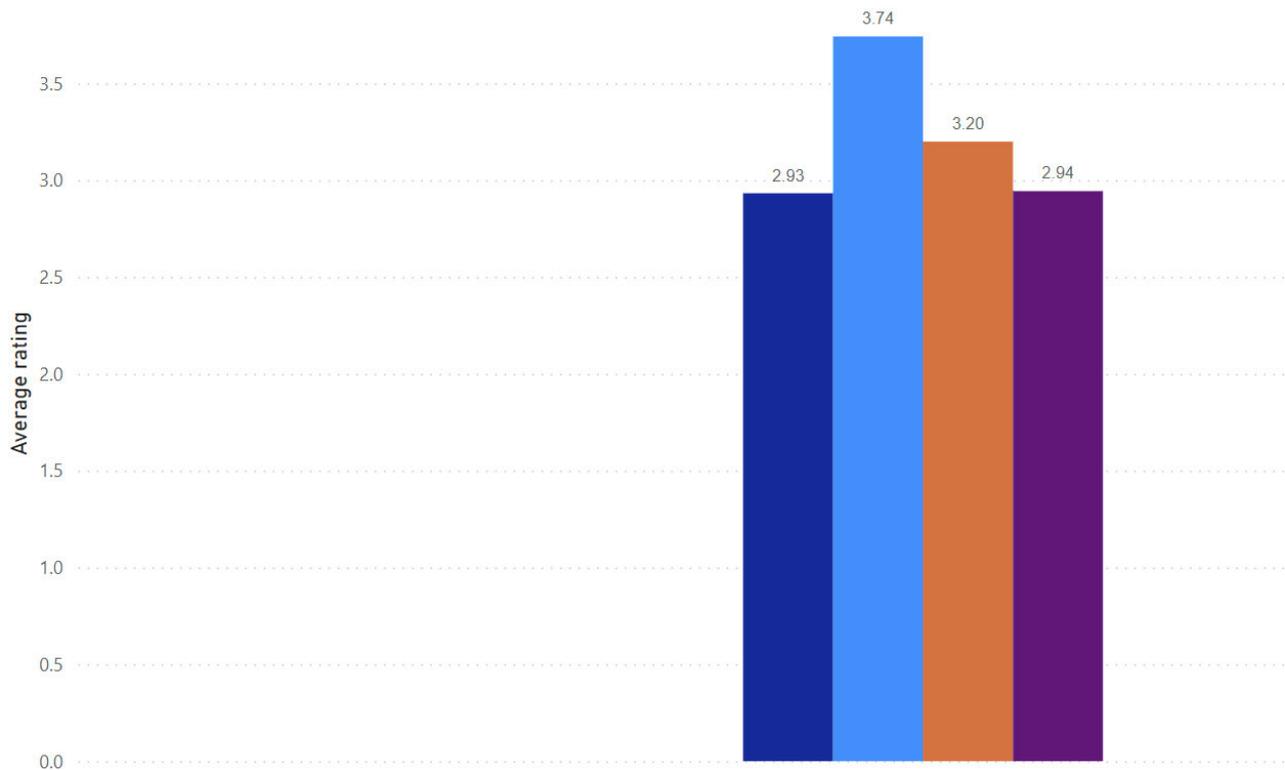
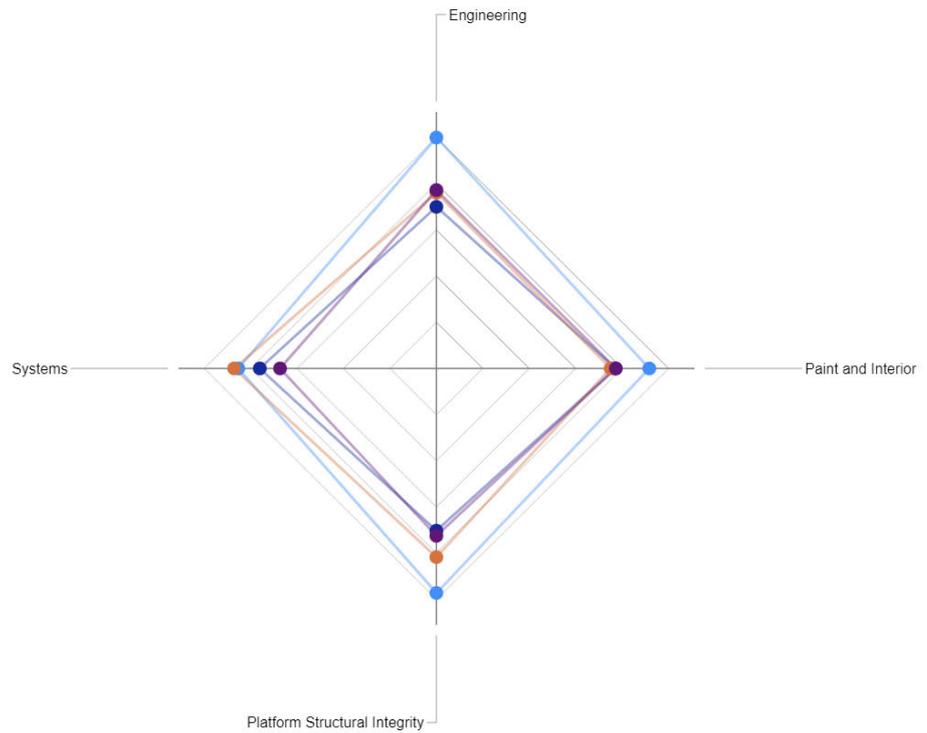
**Figure 6.4.9** – Overall rating comparison between 2012, 2015, 2019 and 2022-23

For 2022-23 there has been a decline in the overall condition of vessel *Marlene Matthews* since 2015. From 2019 there has been a decline in the categories **Systems** and **Platform Structural Integrity**. **Engineering** and **Paint and Interior** have remained steady since 2019.

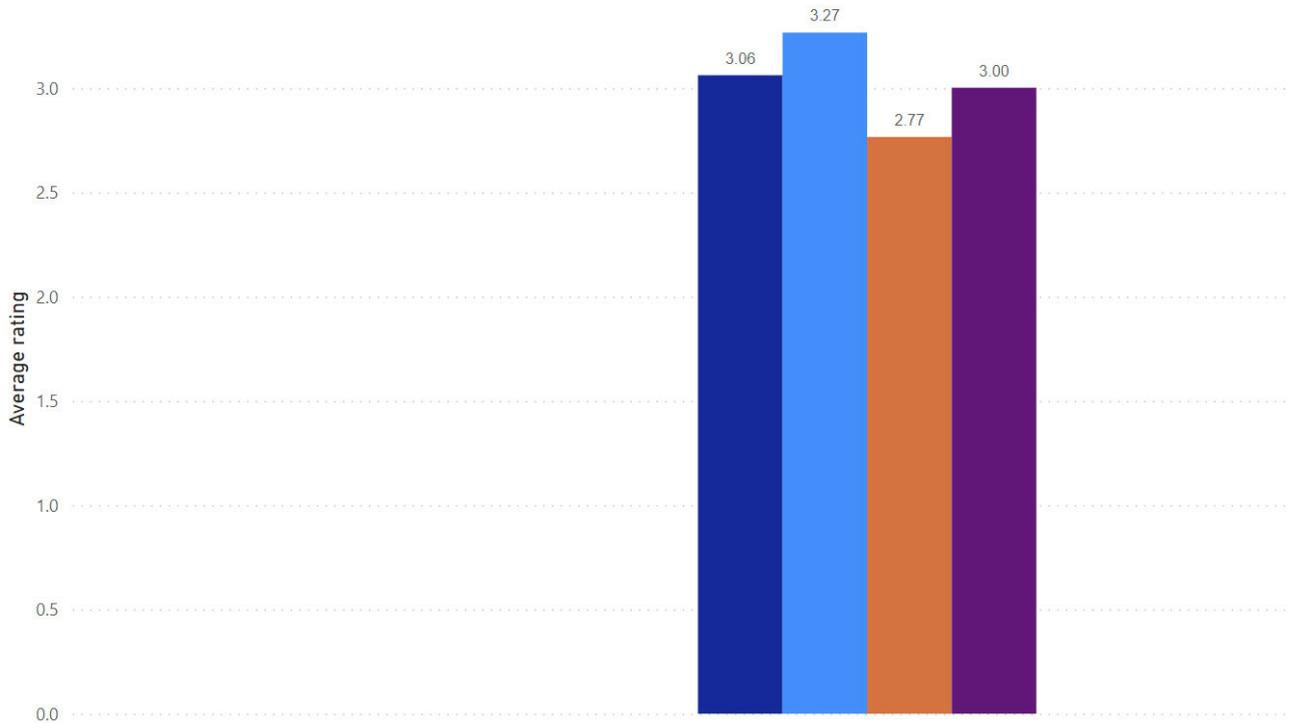
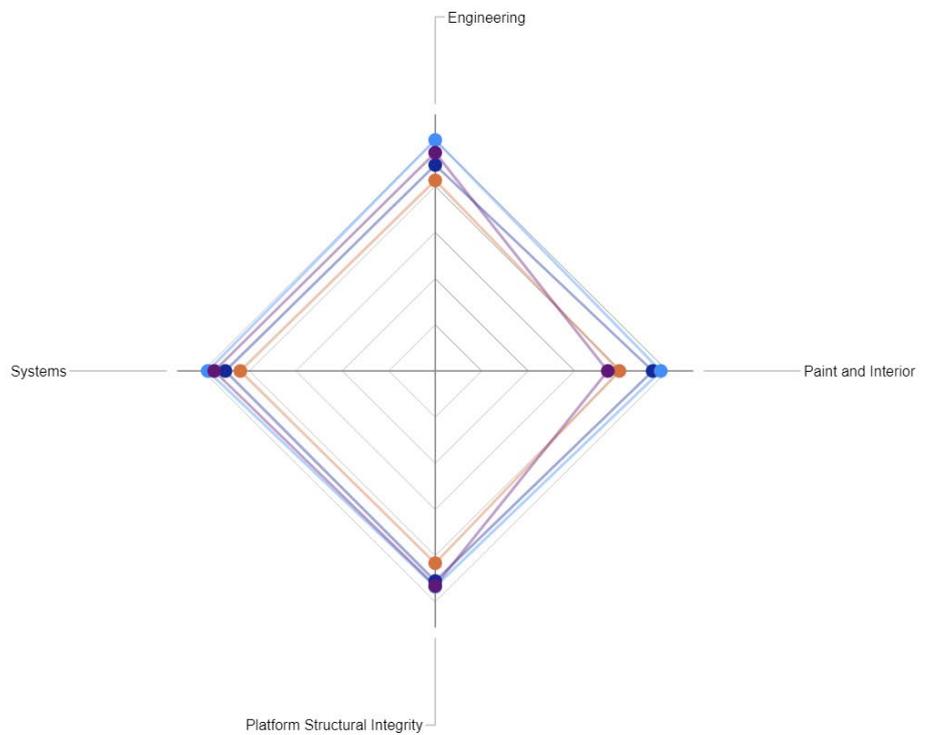
**Figure 6.4.11** – Overall rating comparison between 2012, 2015, 2019 and 2022-23

For 2022-23 there has been an improvement in the overall condition of vessel *Nicole Livingstone*. From 2019 there has been a significant improvement in the categories **Systems, Engineering** and **Platform Structural Integrity**. **Paint and Interior** have remained steady since 2019.

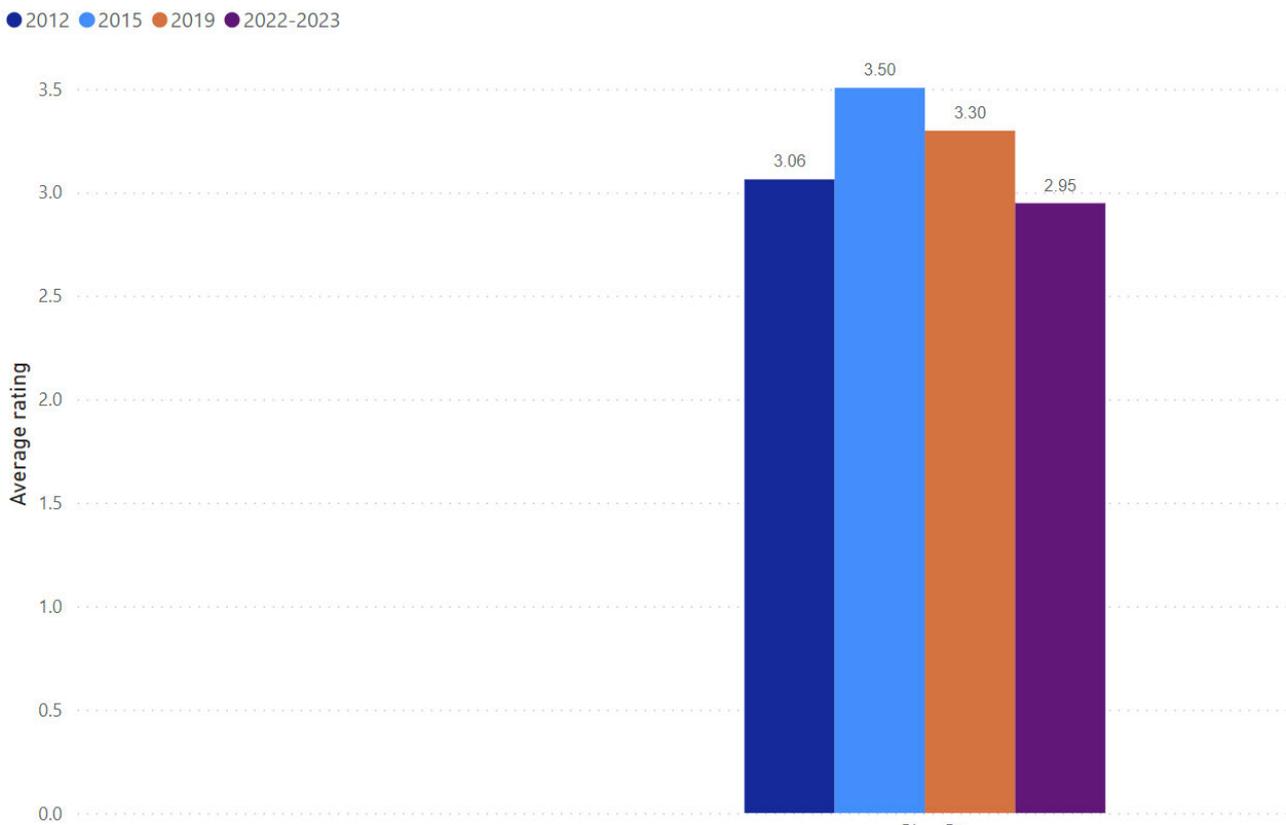
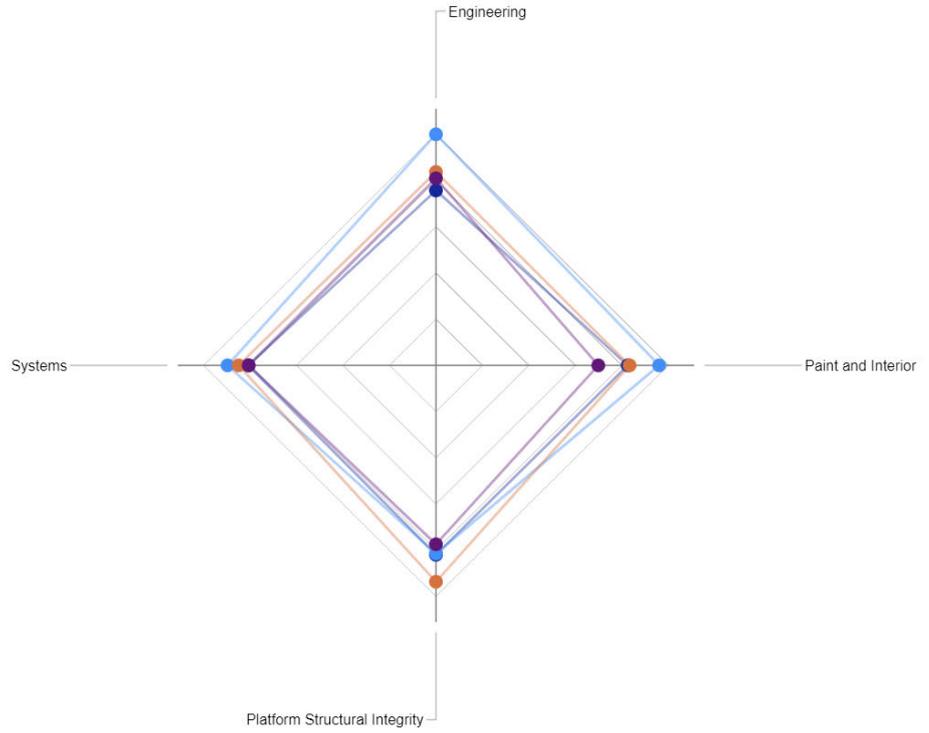
Figure 6.4.13 – Overall rating comparison between 2012, 2015, 2019 and 2022-23

For 2022-23 there has been a decline in the overall condition of vessel *Shane Gould* since 2015. From 2019 there has been a decline in the categories **Paint and Interior** and **Platform Structural Integrity**. **Engineering** and **Systems** have remained steady since 2019.

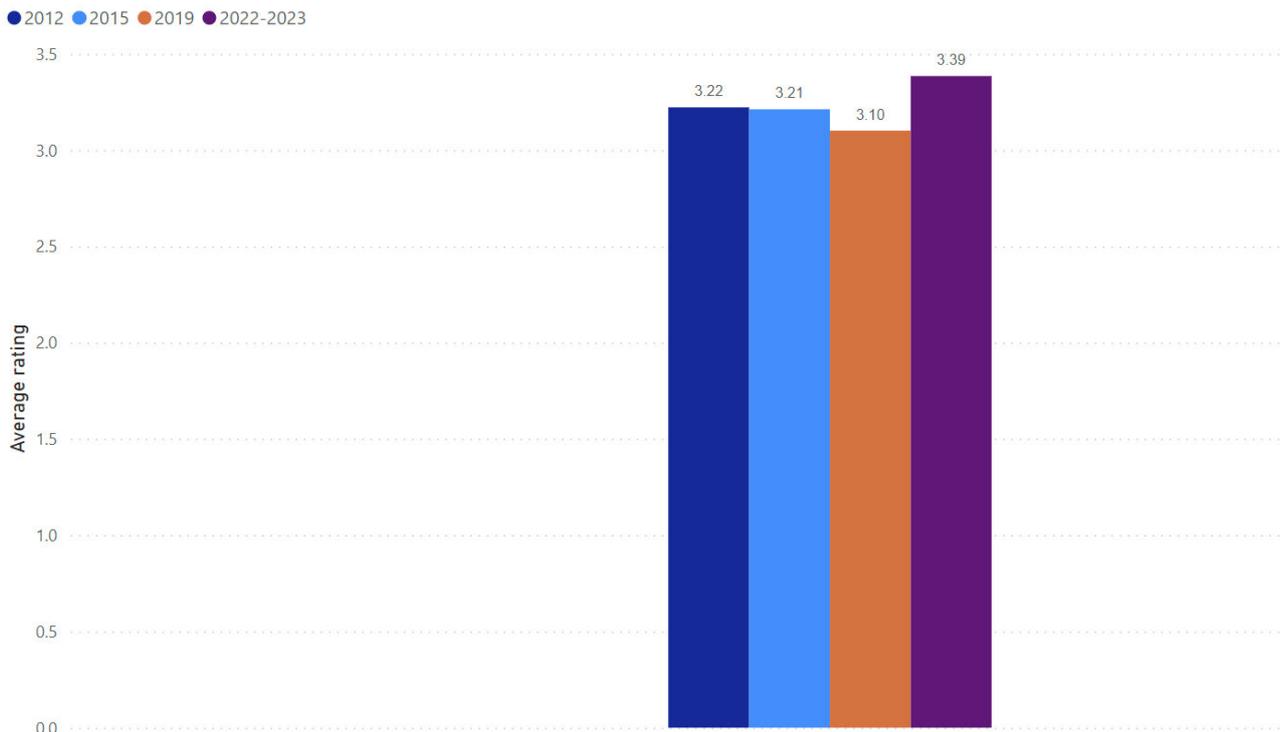
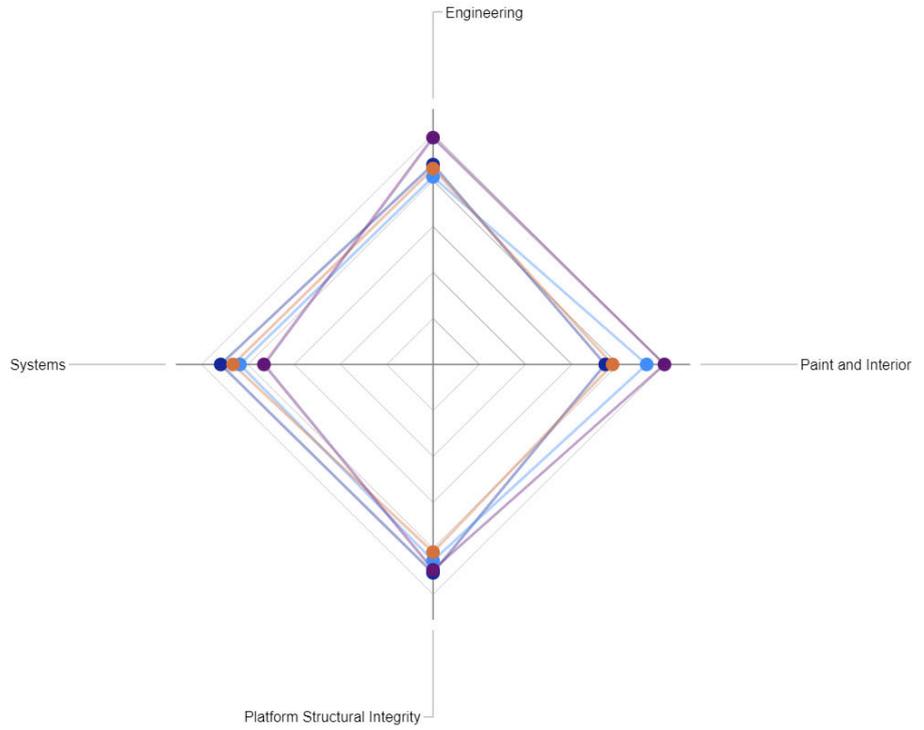
**Figure 6.5.1** – Overall rating comparison between 2012, 2015, 2019 and 2022-23

In 2022-23, vessel *Pam Burridge* has recorded its best overall condition since Fleet Assessments commenced (despite an overall decline in condition since 2012). For 2022-23 there has been an improvement in condition from 2019 with significant improvements across **Engineering, Platform Structural Integrity** and **Paint and Interior** categories. A decline was seen across category **Systems**.

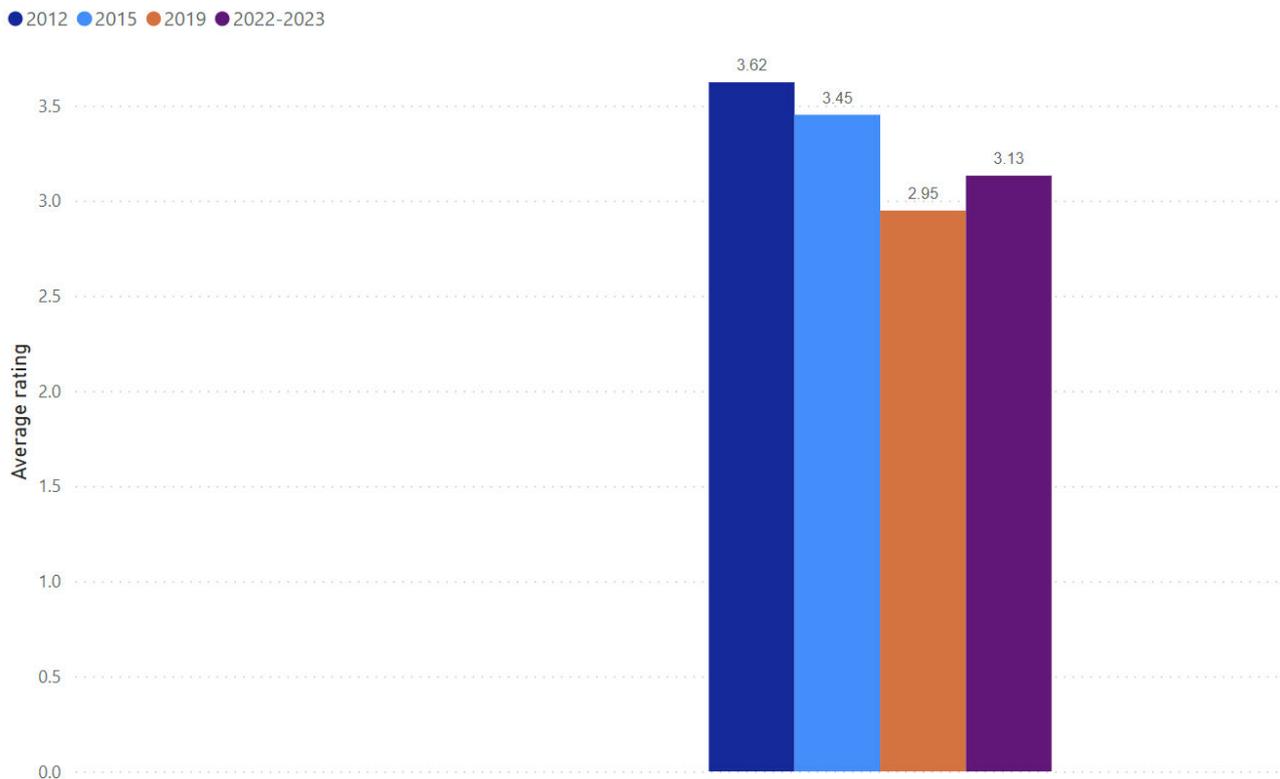
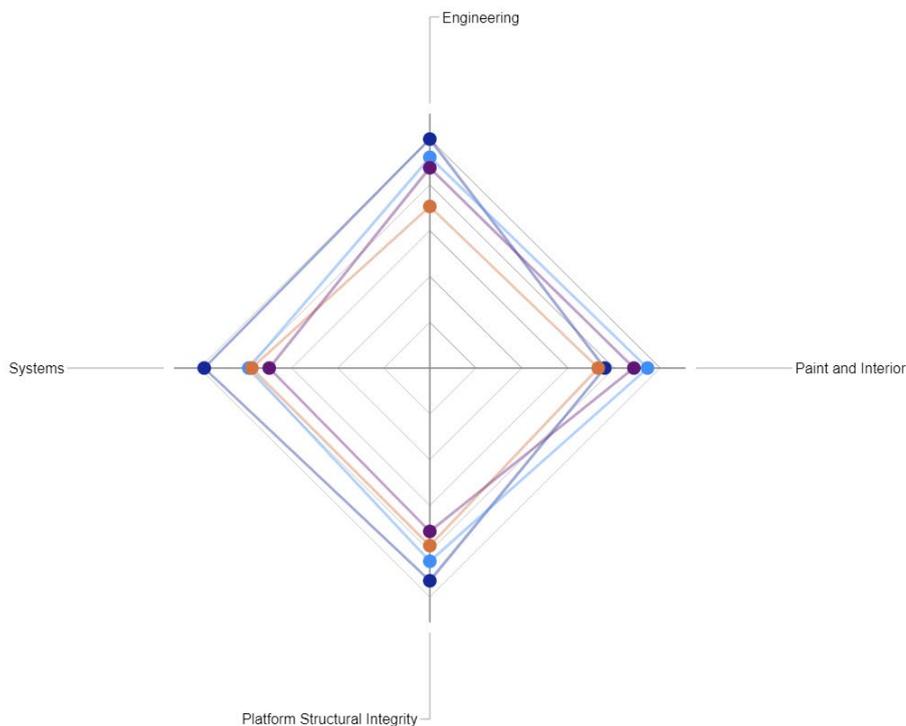
**Figure 6.6.1** – Overall rating comparison between 2012, 2015, 2019 and 2022-23

Overall and since 2012, vessel *Louise Sauvage* has declined in condition. For 2022-23 there has been an improvement in condition from 2019 with significant improvements across **Engineering** and **Paint and Interior** categories. Declines were seen across categories **Platform Structural Integrity** and **Systems**.

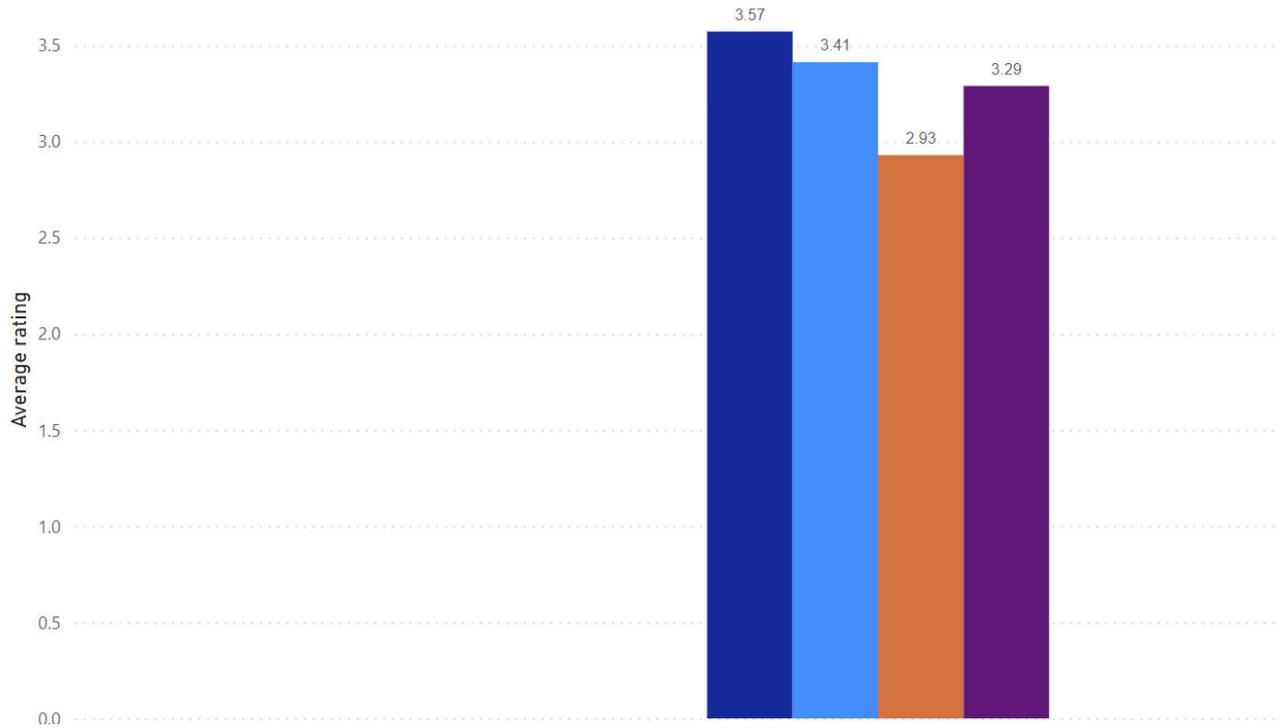
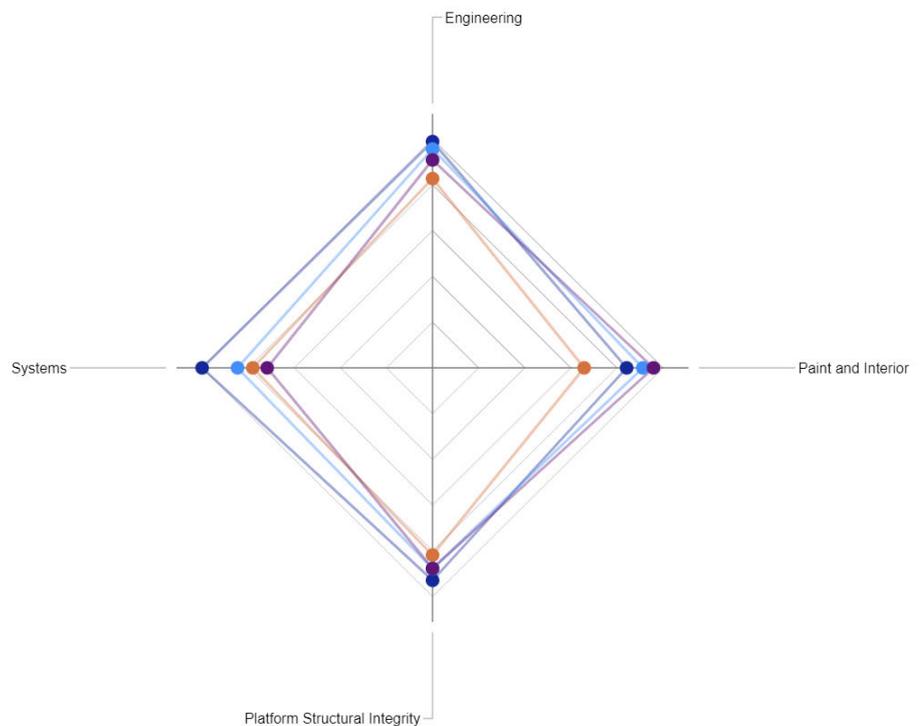
**Figure 6.6.3** – Overall rating comparison between 2012, 2015, 2019 and 2022-23

Overall and since 2012, vessel *SuperCat 4* has declined in condition. For 2022-23 there has been an improvement in condition from 2019 with significant improvements across **Engineering, Platform Structural Integrity and Paint and Interior** categories. A decline was seen across category **Systems**.

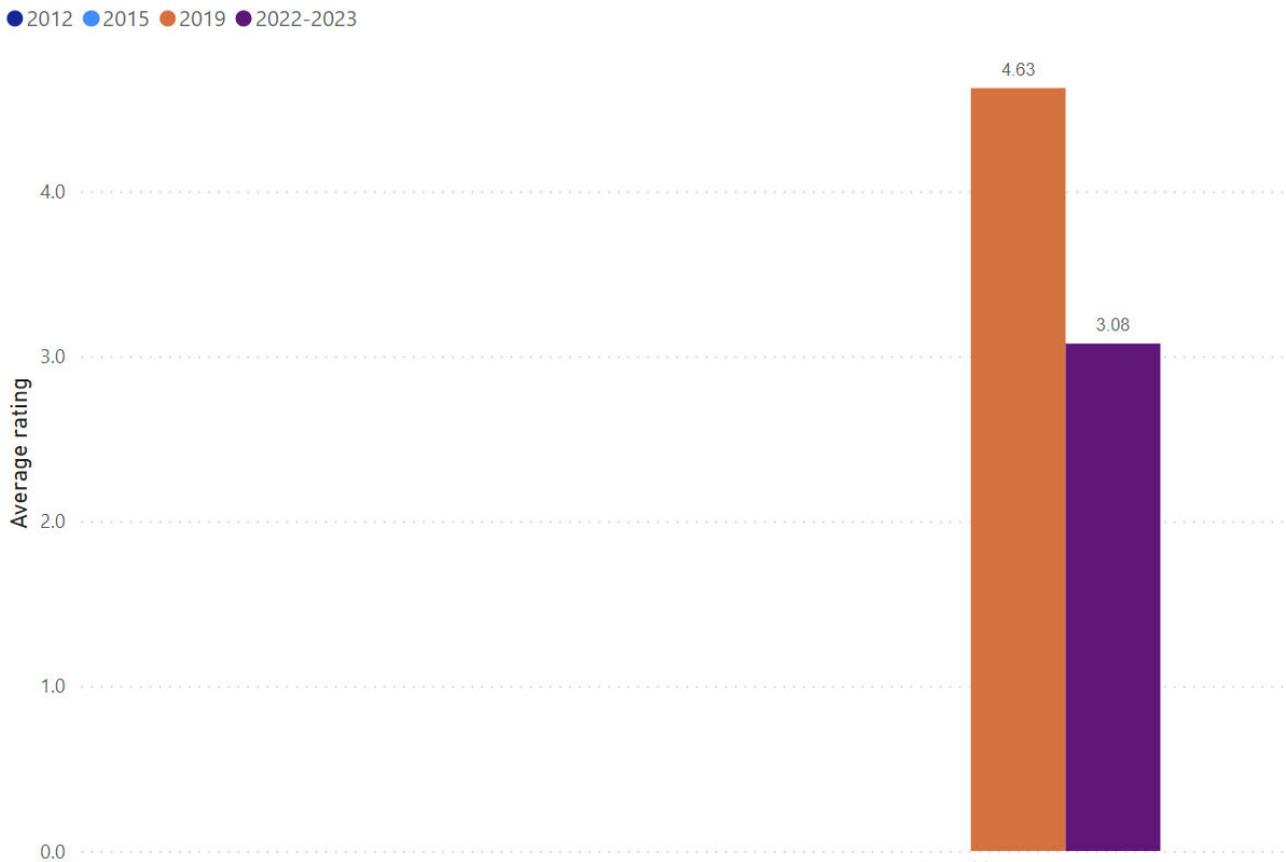
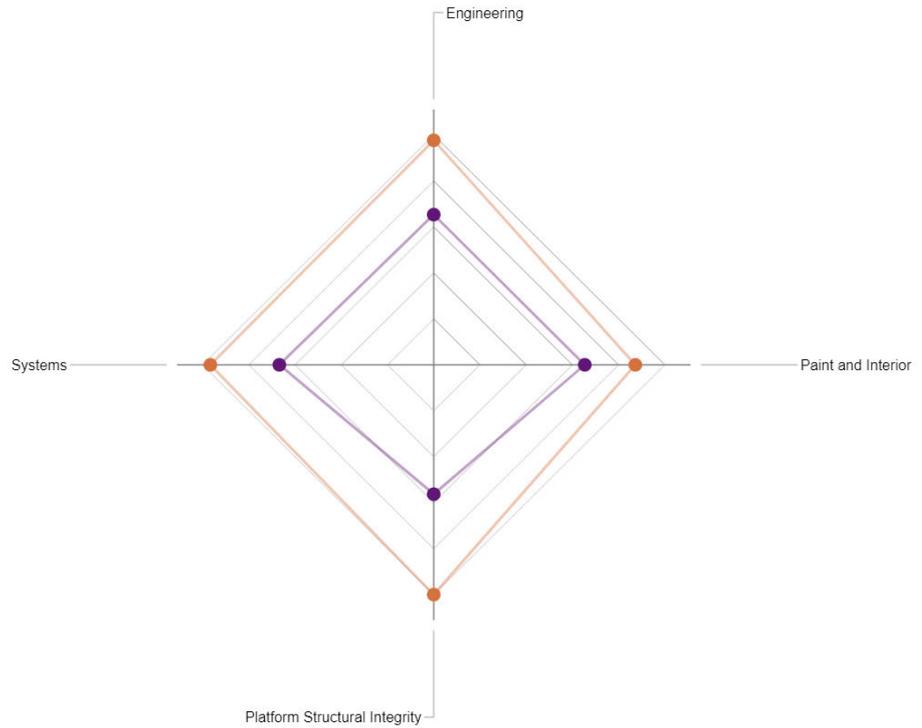
Figure 6.7.1 – Overall rating comparison between 2019 and 2022-23

For 2022-23 there has been a decline in the condition of *Catherine Hamlin* from 2019. There has been a significant decline across all categories (**Engineering, Platform Structural Integrity, Systems and Paint and Interior**). The most significant has been in **Engineering and Platform Structural Integrity**.

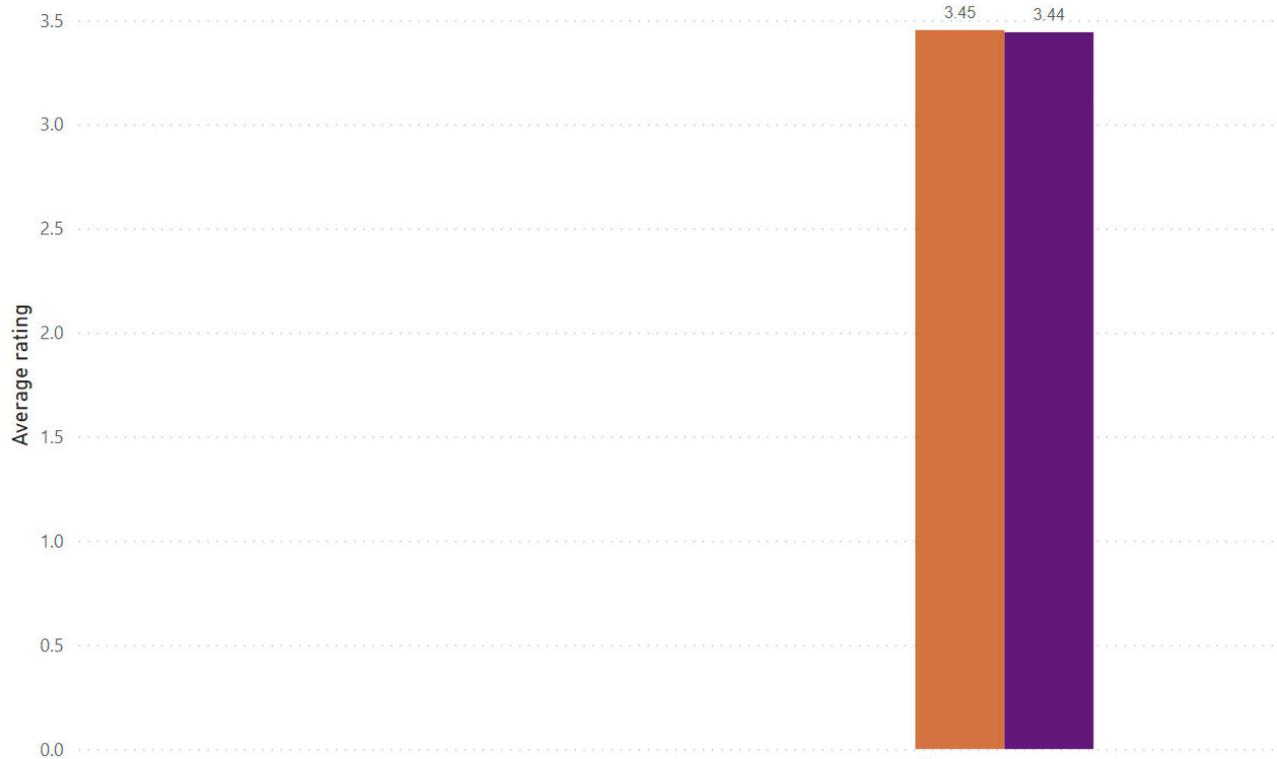
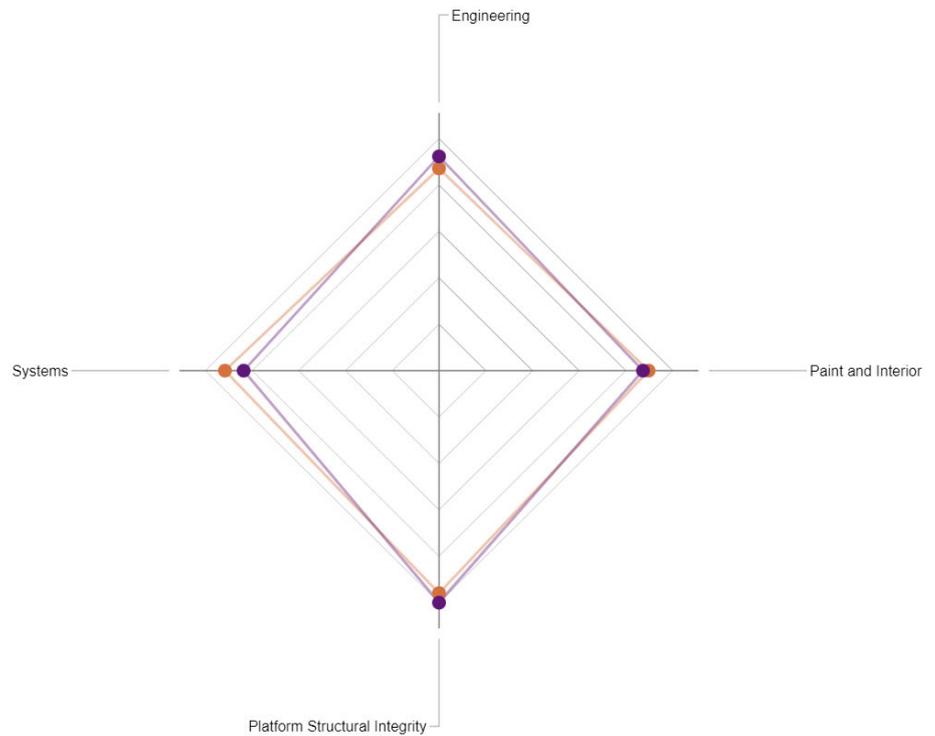
Figure 6.7.3 – Overall rating comparison between 2019 and 2022-23

For 2022-23 there has no significant overall change in the condition of *Fred Hollows*. When compared to 2019, there has been a stable result across categories **Engineering**, **Platform Structural Integrity** and **Paint and Interior**. There was a decline in condition of category **Systems**.

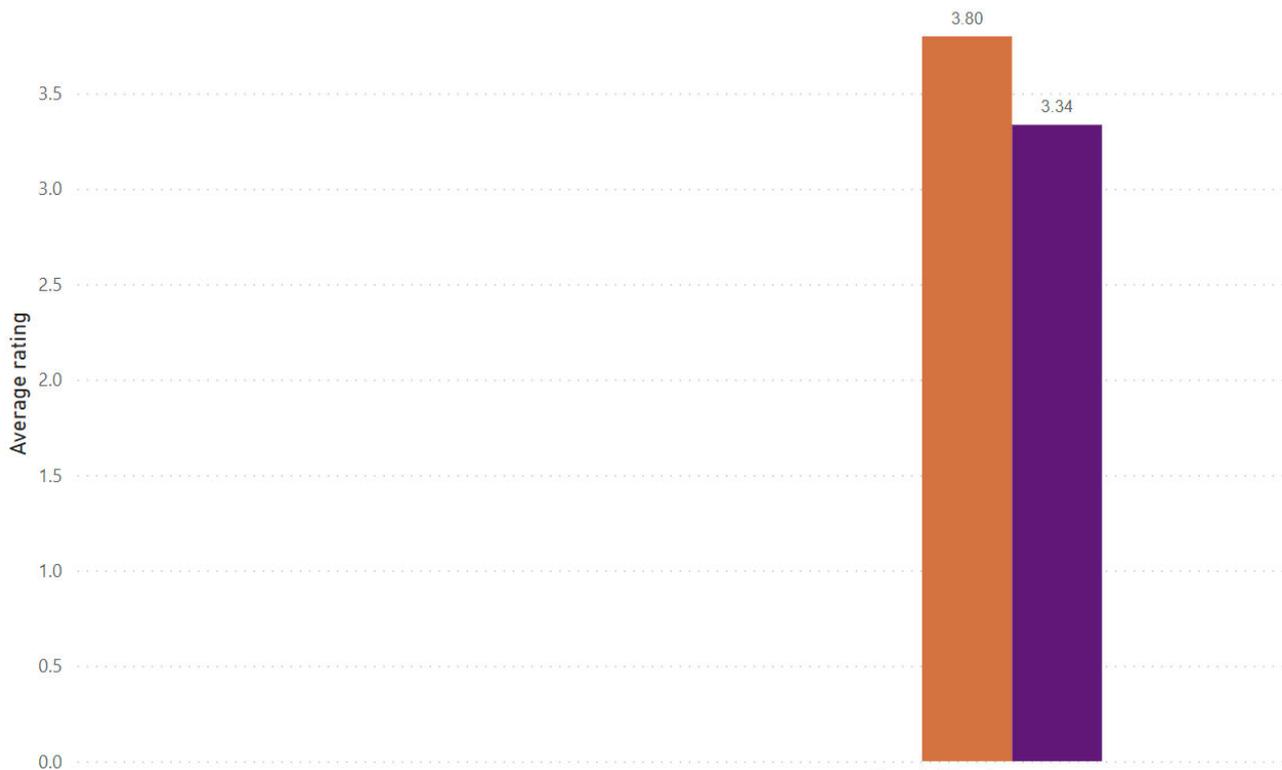
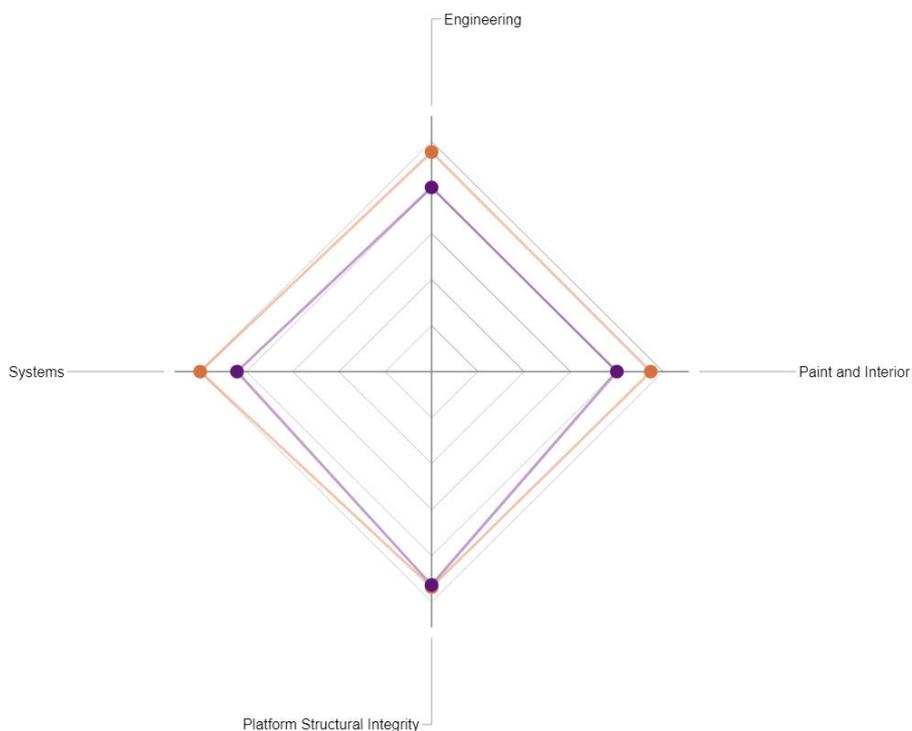
**Figure 6.7.5** – Overall rating comparison between 2019 and 2022-23

For 2022-23 there has been a decline in the condition of *Victor Chang* from 2019. There has been a significant decline across categories **Engineering**, **Systems** and **Paint and Interior**. **Platform Structural Integrity** remained steady.

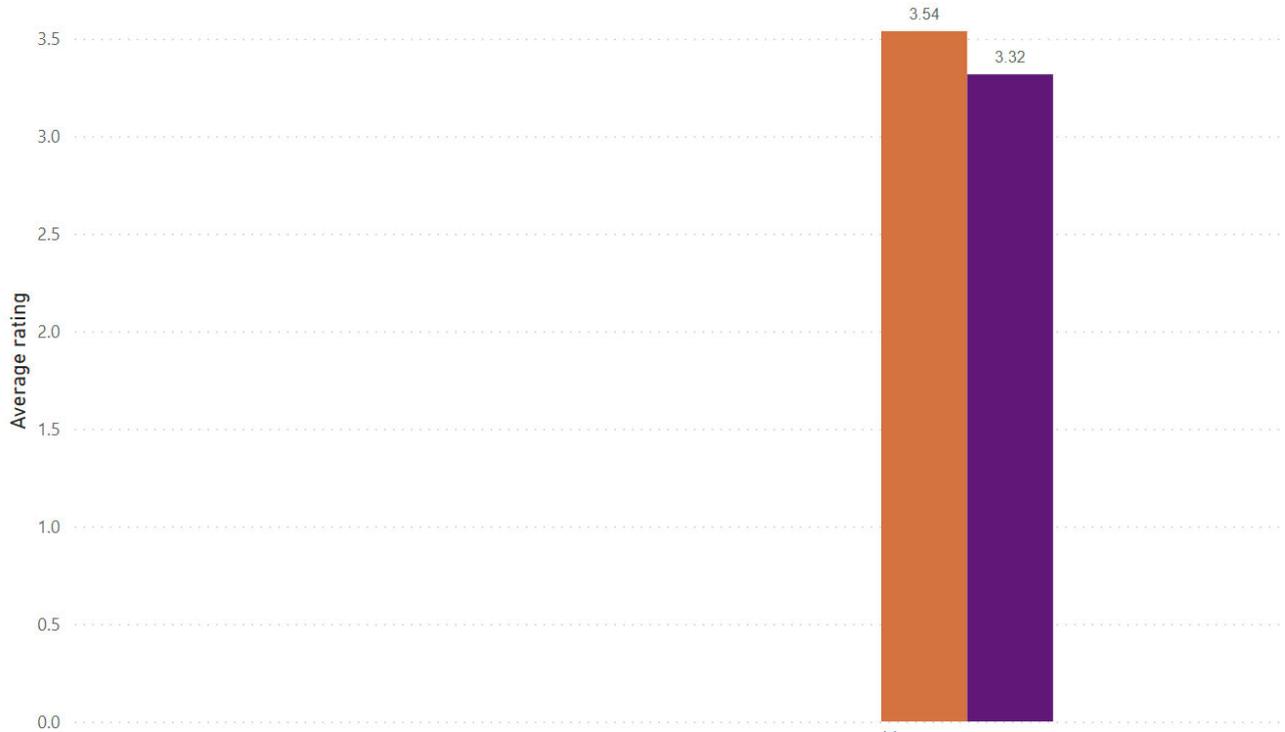
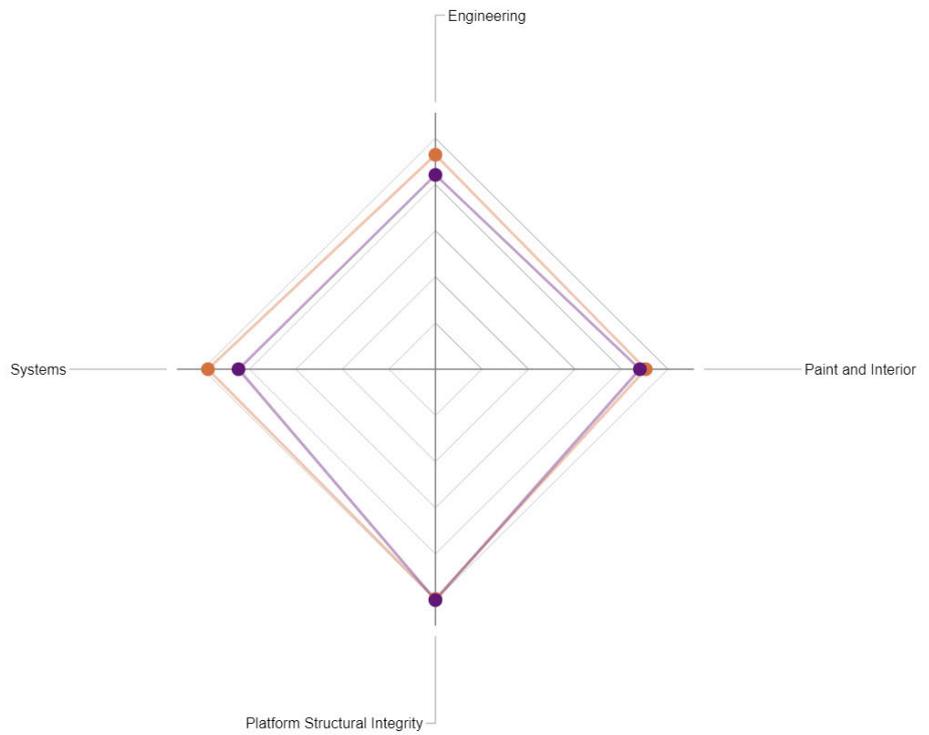
**Figure 6.7.7 – Overall rating comparison between 2019 and 2022-23**

For 2022-23 there has been a decline in the condition of *Pemulwuy* from 2019. There has been a significant decline across categories **Engineering** and **Systems**. **Platform Structural Integrity** and **Paint and Interior** remained steady.

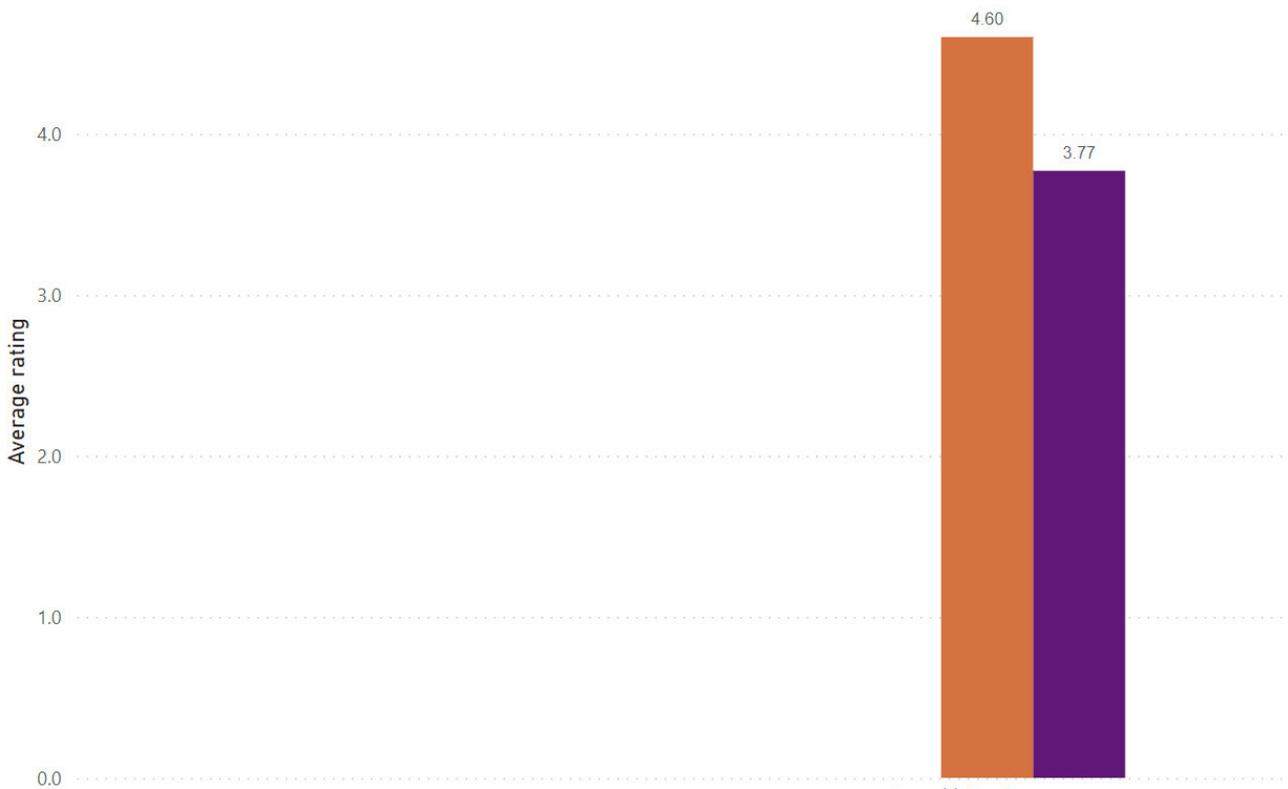
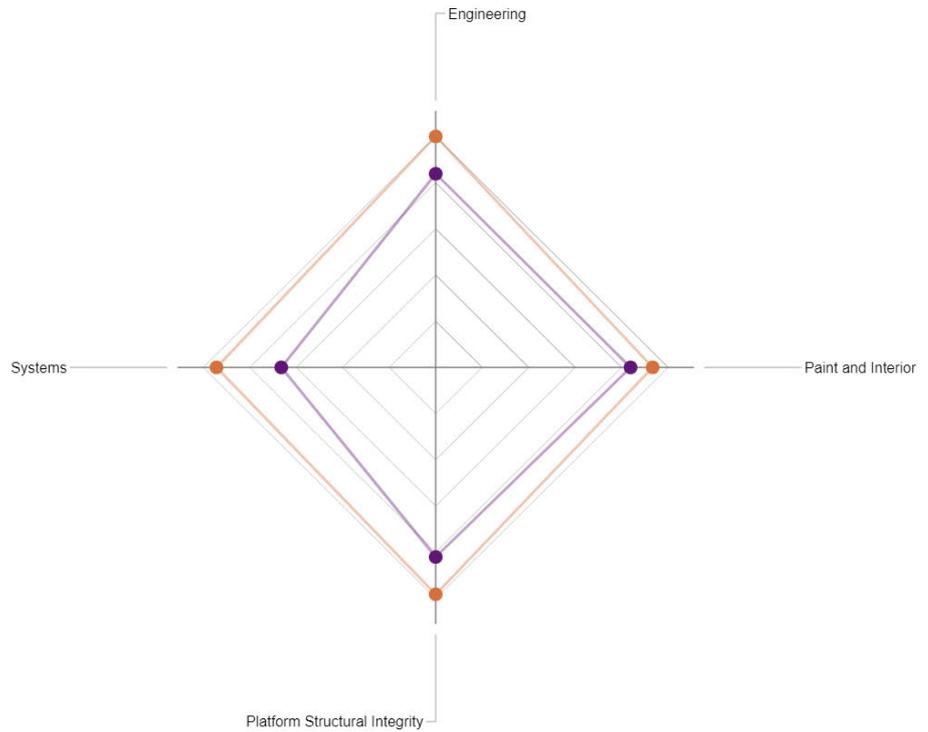
Figure 6.7.9 – Overall rating comparison between 2019 and 2022-23

For 2022-23 there has been a decline in the condition of *Bungaree* from 2019. There has been a significant decline across all categories (**Engineering, Platform Structural Integrity, Systems and Paint and Interior** categories). The most significant has been in **Engineering and Paint and Interior**.
