# Sydney Ferry Fleet Engineering Assessment

Transport for NSW (TfNSW)

**Report No.:** 2023-9359, Rev. 2

**Date:** 2023-06-09

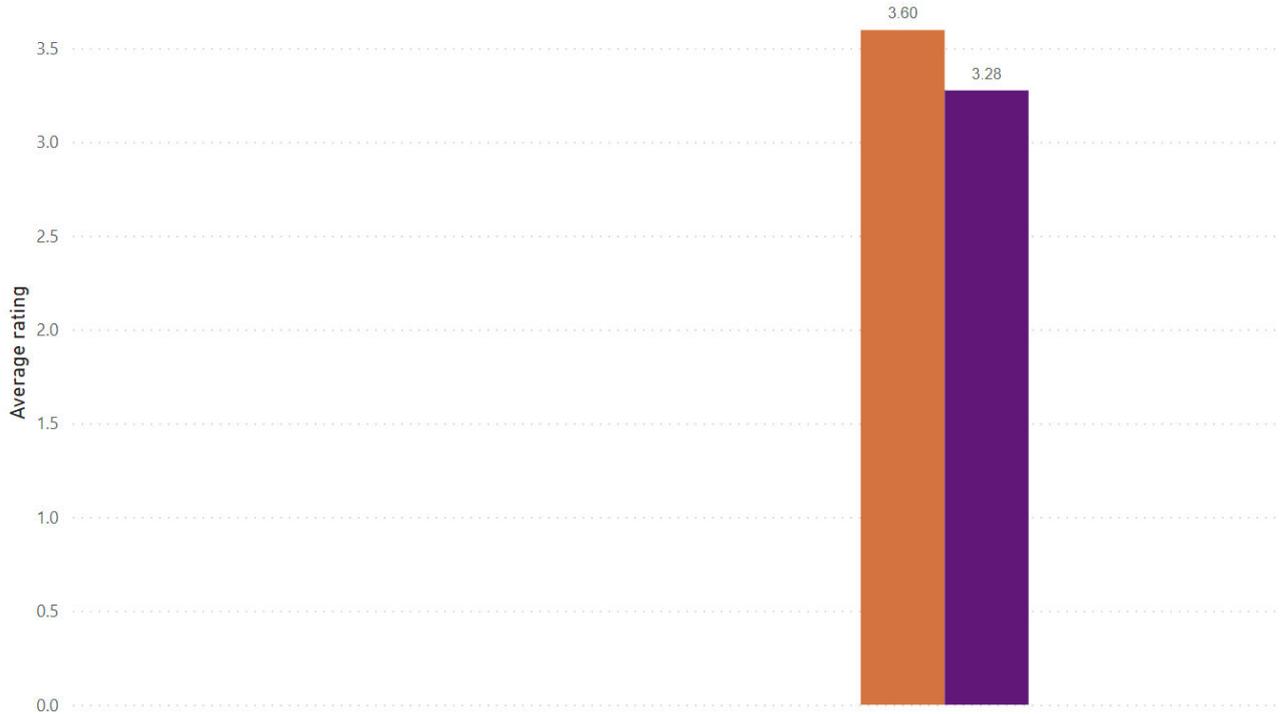
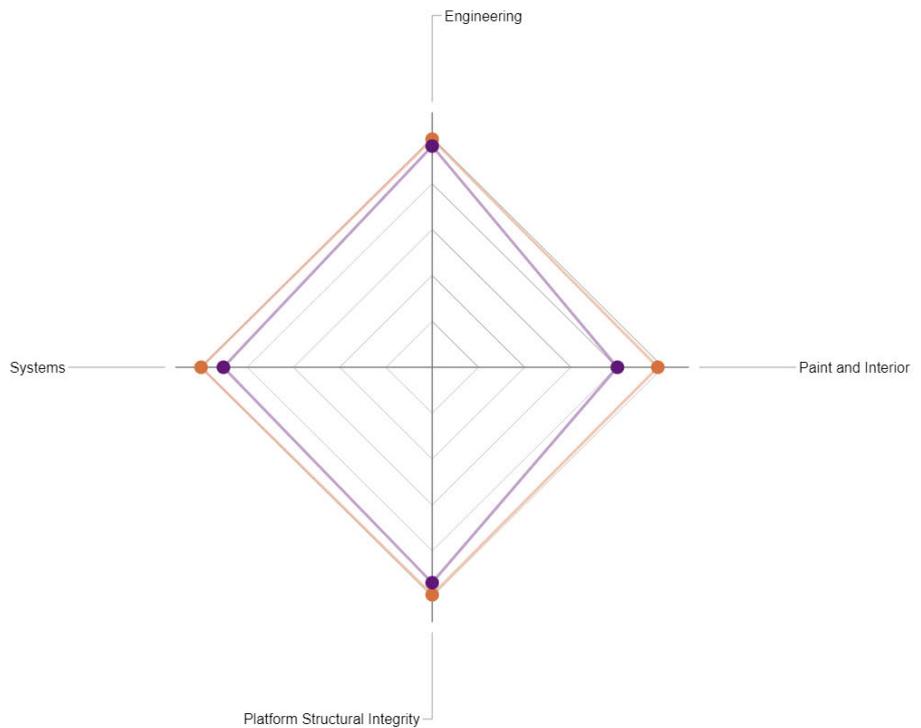
**Figure 6.7.11 – Overall rating comparison between 2019 and 2022-23**

For 2022-23 there has been a decline in the condition of *May Gibbs* from 2019. There has been a significant decline across categories **Systems** and **Paint and Interior**. **Platform Structural Integrity** and **Engineering** remained steady.

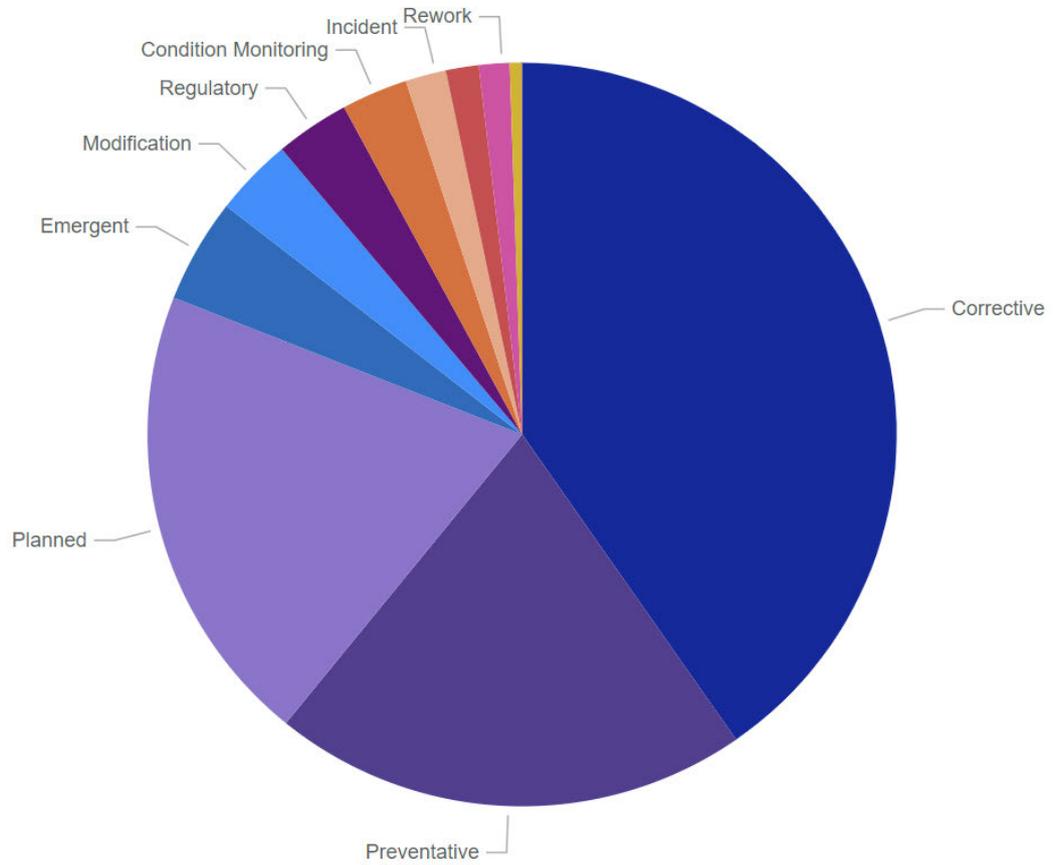
**Figure 7.1** – Breakdown of Fleet work order categories

In comparison with deep sea shipping the expected ratio between preventive and corrective maintenance is typically 80%/20%. The ratio between preventive and corrective maintenance across the Sydney Ferry Fleet is 21%/40%. As such, a considerable amount of additional preventative maintenance should be carried out.

A higher percentage of corrective maintenance is expected for the Fleet considering the wear and tear in public areas but there should be a potential to increase the ratio of preventative maintenance across the Fleet.

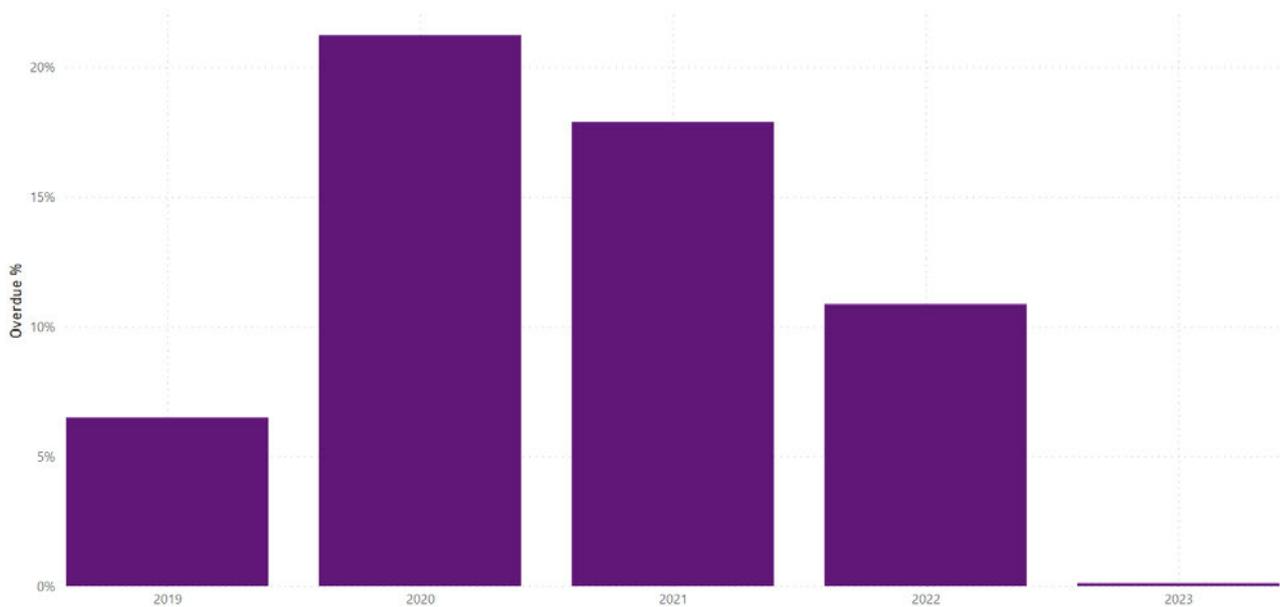
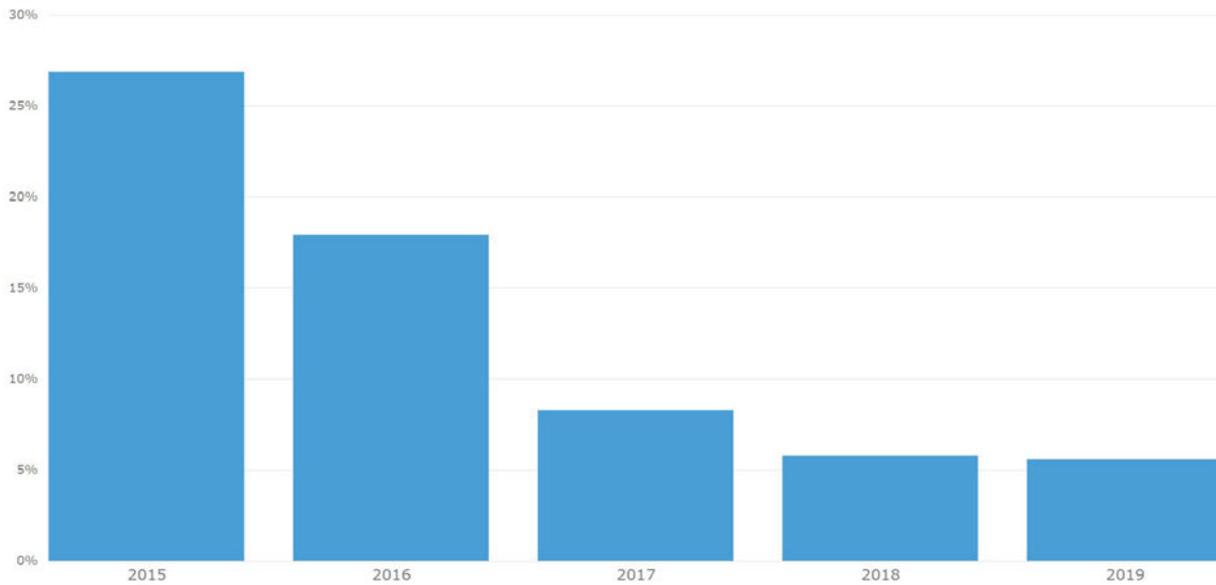
Figure 7.2 shows that there were a significant number of overdue work orders in 2020 (21%) but this percentage has been decreasing in both 2021 and 2022. Data for 2023 is up until January so it is considered non-representational for 2023.

As a comparison and as shown in Figure 7.3, there was an improvement in overdue work orders at the end of the 2015-2019 period. This trend did not continue into the 2019-2023 period with the aforementioned rise of overdue orders in 2020. By 2022, the overdue work orders were still higher than those across 2017-2019.

There should be an increased effort to reduce the number of overdue work orders to be in-line with historical averages (<10%).

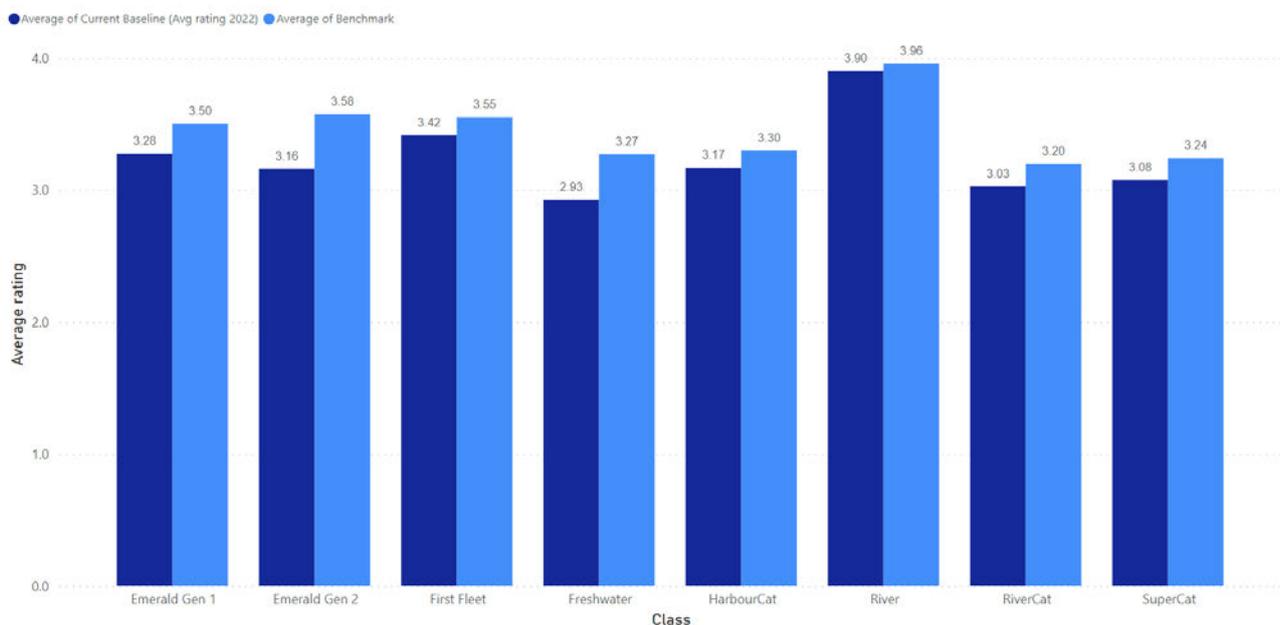
**Figure 10.1** – Baseline (2022-23) vs benchmark values across the eight vessel Classes.

Figure 10.1 highlights the Baseline (current Fleet condition for 2022-23) compared with the benchmark if all items rated **1 – Poor** and **2 – Below average** were improved to a score of **3 – Average**. This would be the result if all identified defects were rectified to at least a **3 – Average** quality level.

Both the Emerald Generation 2 Class and Freshwater Class have the largest gap between the baseline and benchmark. The River Class and First Fleet Class have the smallest gap.
