JBS&G 64627 – 154,525

L007 (Interim Audit Advice Tarago Woodlawn Siding Rev 0)

L007 Interim Audit Advice (0503-2303-007) – Tarago Woodlawn Siding NSW – Remedial Options Assessment Tarago Rail Corridor

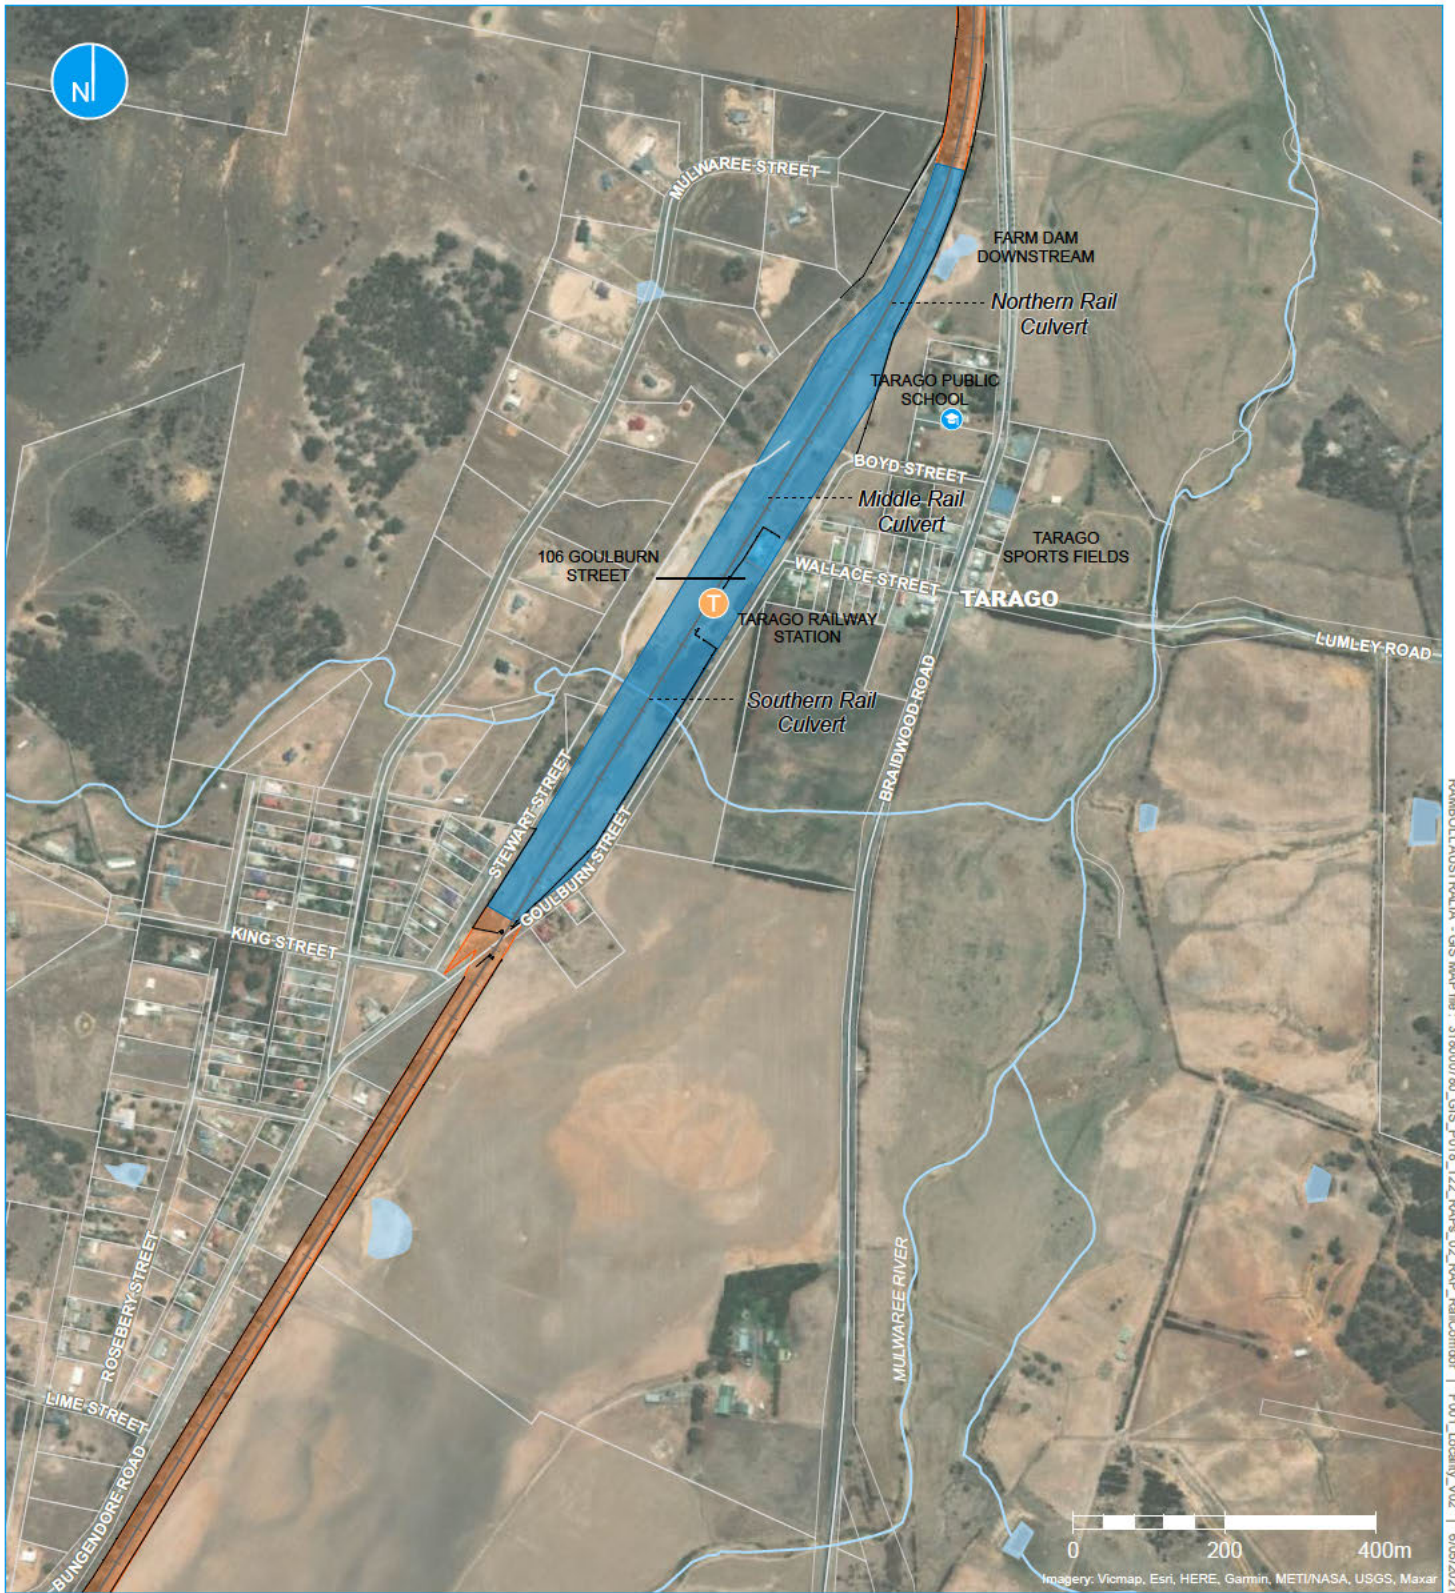
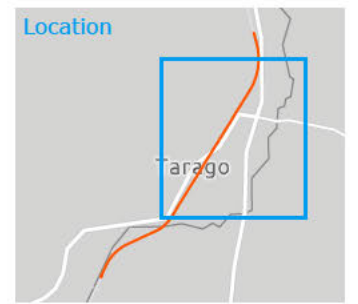
Figure 1 | Locality Plan

Within the rail corridor, ballast within the rail siding, loop line, main line and adjacent soils have been identified as being contaminated with lead. The location and extent of the site are shown in Figures 1 and 2, in Attachment 2.

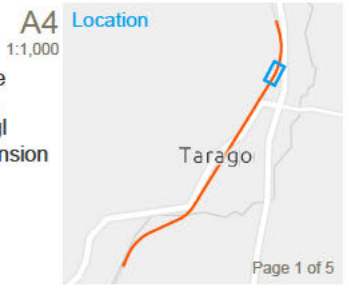
Figure 2a | Site Plan

The proposed remediation extent is shown in Figures 2a-2e, Attachment 2.
