STRATEGIC ENVIRONMENTAL  
AND ENGINEERING CONSULTING

our reference: 22000129-R-02  
your reference:

14 June 2022

### **Review of Surface and Ground Water Quality: Windsor Bridge**

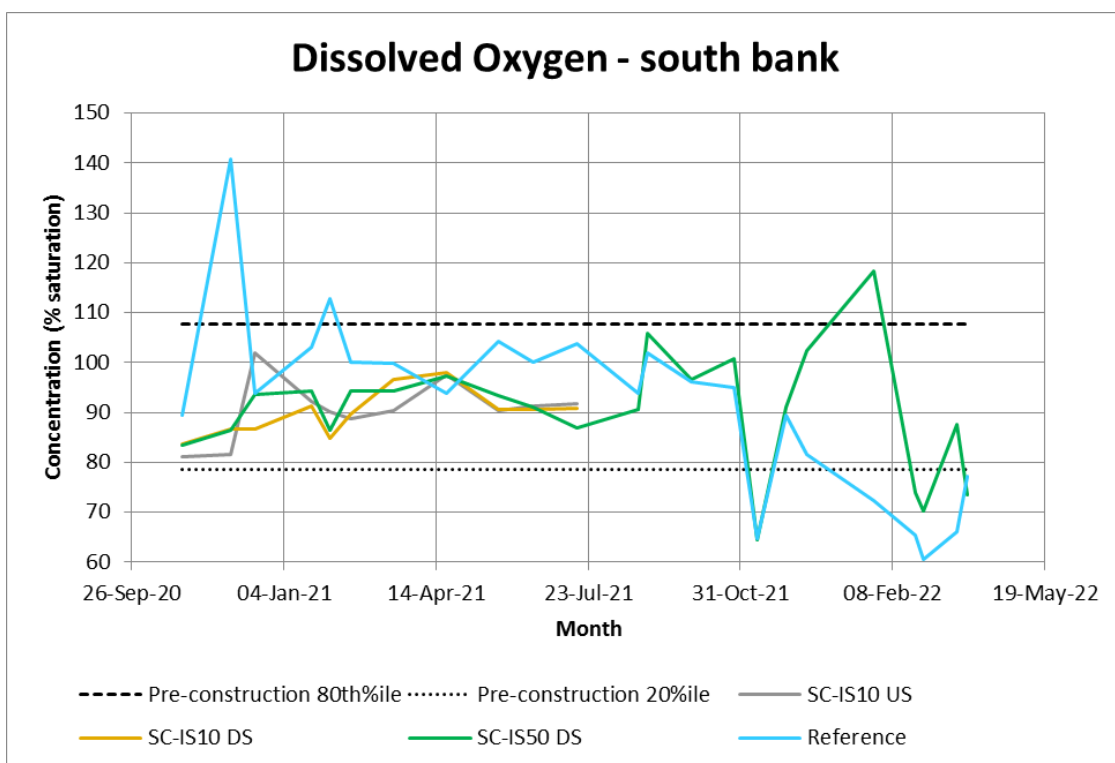
Figure 9: Plot of Dissolved Oxygen at the south bank locations, post construction.

Dissolved oxygen was generally within the SSTVs. Values dropped below the SSTVs at the north bank between February and March however this trend also occurred at

the reference site indicating that it is unlikely that the project was the cause for the observed change in dissolved oxygen levels.

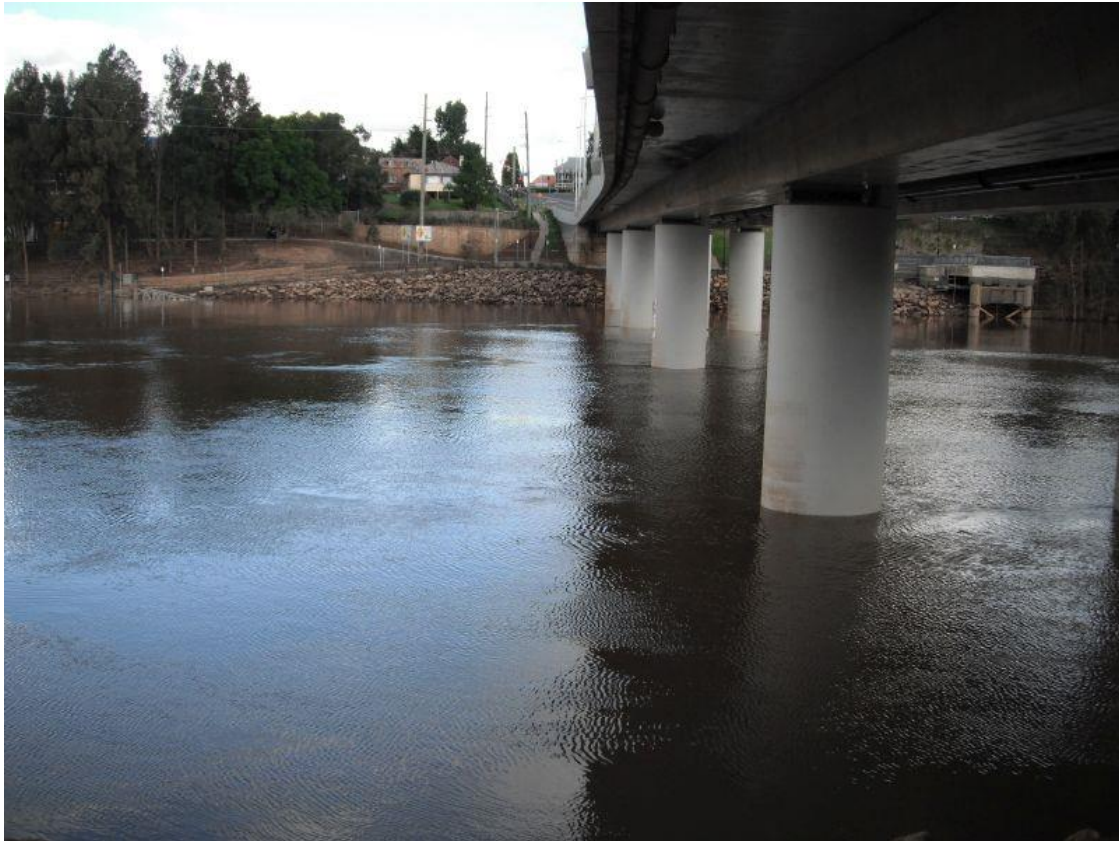
ongoing to repair and maintain an adequate level of groundcover after the recent flood events.

**Figure 20: Under bridge looking south.**

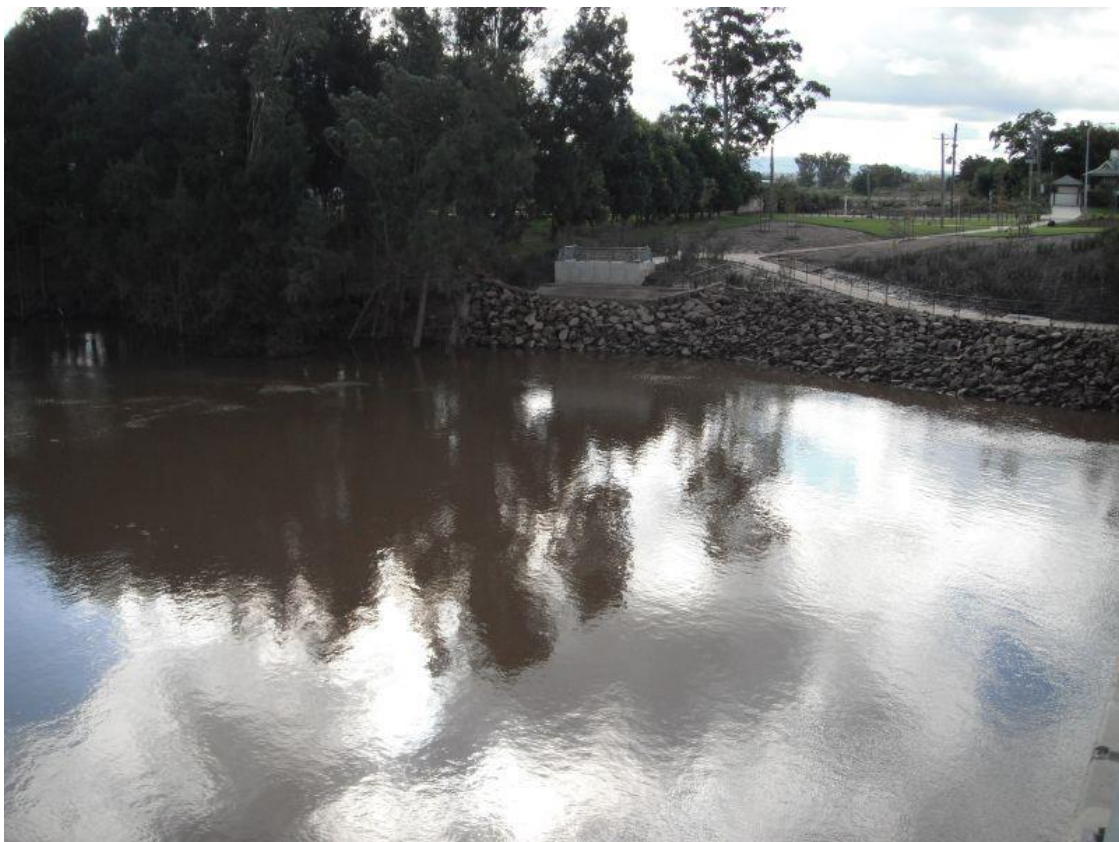
**Figure 21: Looking north to the old bridge abutment.**
