Sydney Trains Environmental Management System Site Environmental Management Plan (SEMP)

Project / Program Details	
Project/Program Name	Bld Refurb RRR Bldg Mittagong
Project/Program No	P.0078604
Scope of Works	<p>Railway Refreshment Room (RRR) Building at Mittagong Railway Station is a two storey building with brick external wall and a slate hipped roof and is Heritage listed (SHR#01195).</p> <p>The building is old and require repair works.</p> <p>This scope of work is to:</p> <ul style="list-style-type: none"> - Repair/reconstruction works on chimney stacks as per Heritage Architect documentation and TTW Engineering design. - Replacement of windows on the 1st floor as per Heritage Architect documentation and TTW Engineering design. - Repair of crack on external wall on the end of corridor on the 1st floor as per Heritage Architect documentation and TTW Engineering design. - Replacement of roof gutters with larger capacity OG gutters as per Heritage Architect documentation. - Minor repair works on roof structure including replacing cracked or damaged roof slates as per Heritage Architect documentation. - Additional 2 downpipes to the platform side of RRR building and relocation of

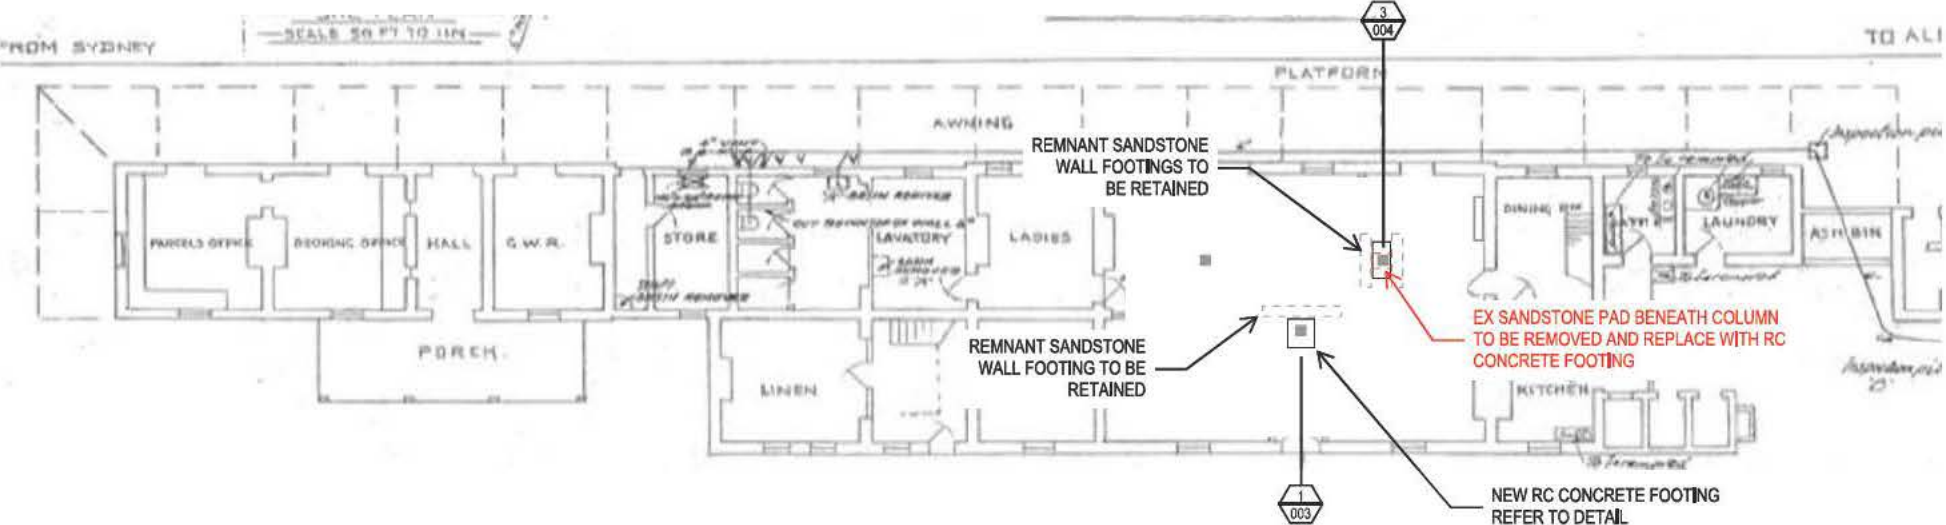
GROUND FLOOR PLAN

- TIMBER FLOORING TO BE REPLACED
- TIMBER BEAM (UNDER) TO BE REPLACED

REFER TO DRAWING SK-01-002 FOR TIMBER MEMBER SCHEDULE.

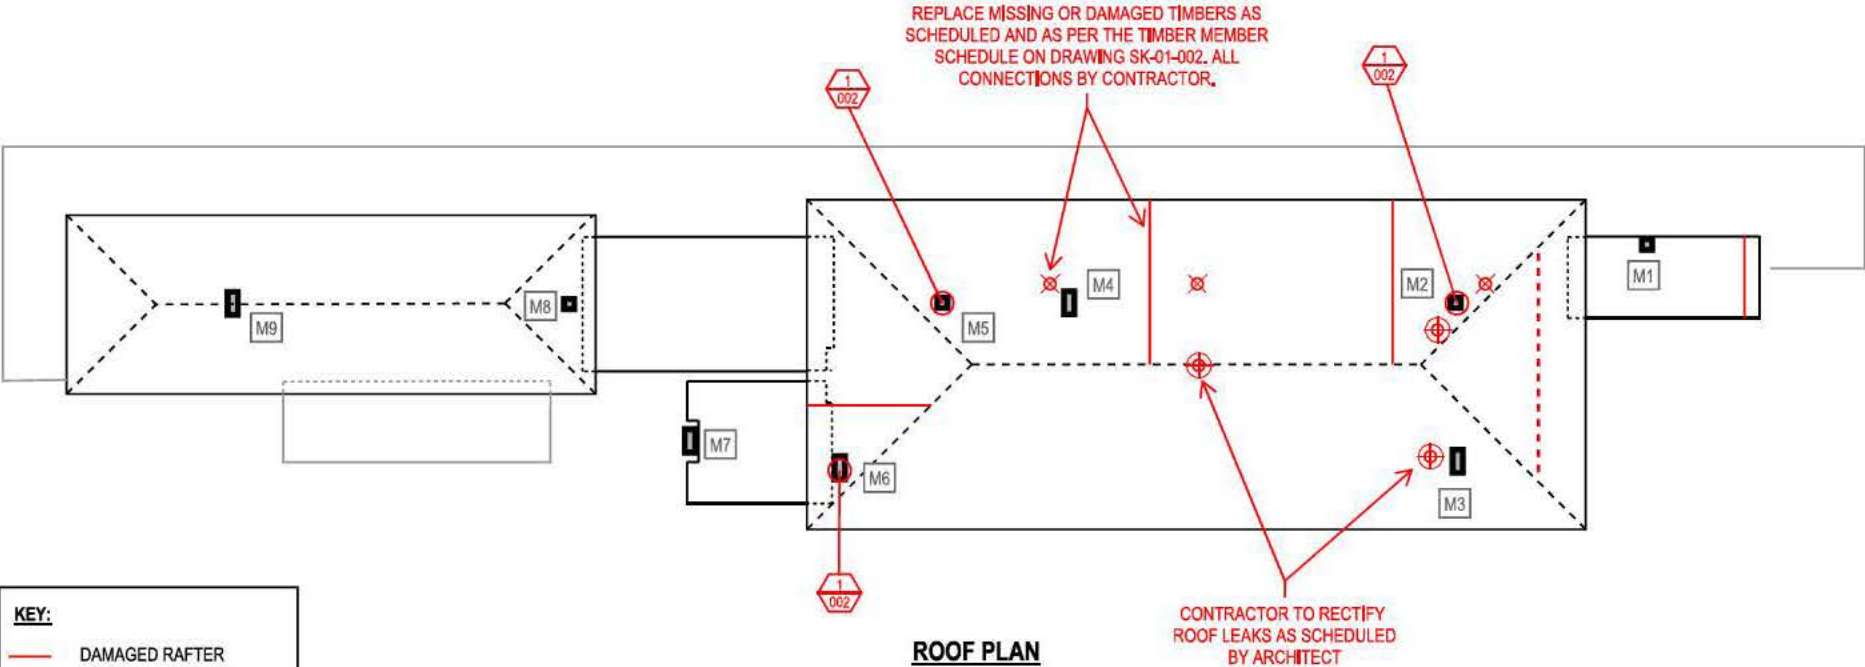
- DAMAGED RAFTER
- MISSING UNDERPURLIN
- MISSING ROOFING STRUT
- CHIMNEY NUMBER (PER CONDITION REPORT)
- APPROXIMATE LOCATION OF ROOF LEAKS

1. REFER TO DRAWING SK-00-000 FOR GENERAL NOTES.
2. ALL REMEDIATION WORKS ARE SHOWN IN RED.

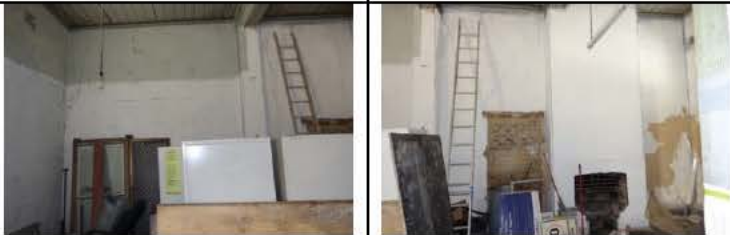
Space/Element	Description	Condition		Recommendations	Urgency
Wall, South	As N

Following damp remediation works/actions repair damaged plaster	C+ Timing based on reuse
Wall, East
