Sydney Trains Environmental Management System Site Environmental Management Plan (SEMP)

Project / Program Details		
Project/Program Name	Petersham Terminus Street Building works (Internal)	
Project/Program No	P.0091011.03	
Scope of Works	Heritage maintenance works including; Internal refurbishment works to bring the building to a 'warm shell', as per heritage approvals.	
What is the cost of the scope of works?	<input type="checkbox"/> Routine maintenance - any value <input checked="" type="checkbox"/> Capital investment - less than \$5 million <input type="checkbox"/> Capital investment - more than \$5 million	
Location	Petersham – 5.540 km	
Attach applicable Environmental Work Method Statement (EWMS)	EWMS Number	EWMS Title
	EMS-03-EW-0299	Station Refresh
Is any of the proposed work outside of the EWMS' scope?	<input checked="" type="checkbox"/> No: Continue to next question <input type="checkbox"/> Yes:

SCHEDULE OF WORKS – FORMER PETERSHAM STATION BUILDING INTERIOR CONSERVATION – ISSUE E – 26 May 2025

Hazardous Building Materials Management Plan

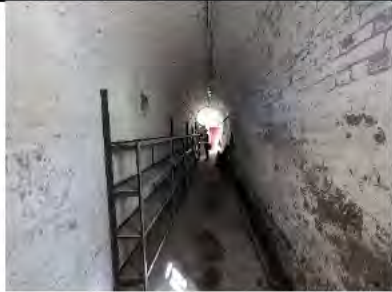
ELEMENT	CONDITION & DESCRIPTION OF DEFECTS	PROPOSED WORK / METHODOLOGY / OCP ARCHITECTS COMMENT	PHOTOGRAPHS
5.04: ROOM LG1 – VERANDAH UNDERCROFT/ STORE			
Note: refer to and allow for works as per “Generally above in 5.02” (beyond itemized elements below)			
LG1.01 Walls and Ceiling	Condition: Fair Painted brickwork. Evidence of significant rising damp.	<ul style="list-style-type: none"> • Clean ceiling and walls, including removal of loose limewash using washing down. • Allow to limewash walls – min. two coats.. • Hold Point: sample of lime wash (min. 1 square metre).

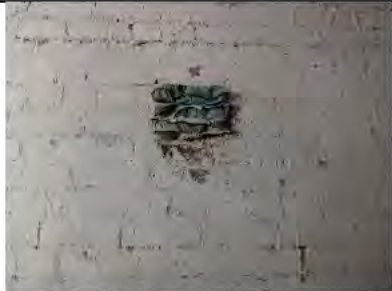
LG1.02 Wall Vents	Condition: Poor Wall vents are rusted and have been blocked with sandbags, blocking ventilation in the space.	<ul style="list-style-type: none"> • Existing vents : Clean and vermin mesh as per Generally Above 5.02.18. • New vents : As per Generally Above 5.02.18.

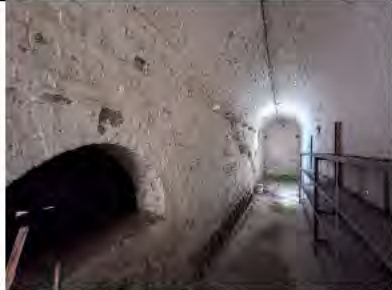
ELEMENT	CONDITION & DESCRIPTION OF DEFECTS	PROPOSED WORK / METHODOLOGY / OCP ARCHITECTS COMMENT	PHOTOGRAPHS
LG1.03 Floor	Condition: Good Later concrete slab with little heritage significance. Evidence of damp with water pooling.	<ul style="list-style-type: none"> Remove debris. Clean floors, drains and any sumps.

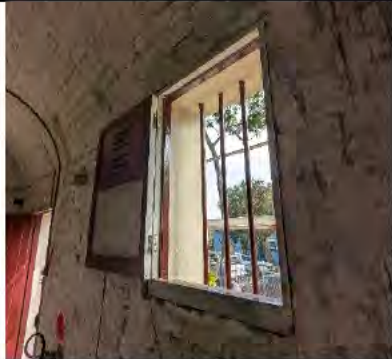
LG1.05 Doors and Windows	Condition: Good Crudely detailed door frame.	<ul style="list-style-type: none"> Clean and repaint window sashes according to proposed colour scheme. Reconstruct window frames and repaint according to proposed colour scheme. Repaint windows and frames internally and externally (as per Item 1.10.) Repaint door as per 5.02.09, 5.02.10 and provide new mortise lock as per 5.02.12.

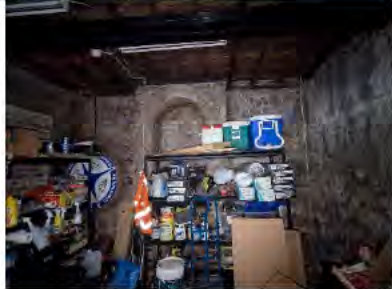
ELEMENT	CONDITION & DESCRIPTION OF DEFECTS	PROPOSED WORK / METHODOLOGY / OCP ARCHITECTS COMMENT	PHOTOGRAPHS
5.06: ROOM LG3 – STORE			
Note: refer to and allow for works as per “Generally above in 5.02” (beyond itemized elements below)			
LG3.01 Ceiling (underside of floor structure)	Condition: Good	<ul style="list-style-type: none"> No conservation works required at this stage. Clean ceiling.

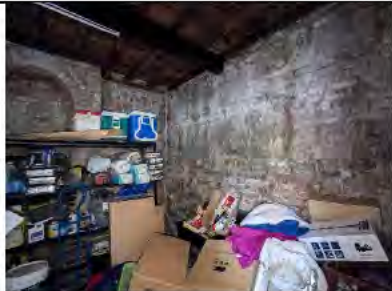
LG3.02 Walls	Condition: Fair Evidence of significance rising damp.	<ul style="list-style-type: none"> Clean walls, including removal of loose limewash including removal using washing down. Note: Clean walls with appropriate solution to remove mould and biological growth (As per Item 5.02.04). Allow to limewash walls – Min. two coats. Note: Monitor damp on walls for the next 18 months to determine effectiveness of recent roof repair works on falling damp issues. (Refer to Item 5.02.03.) Further works may need to be considered at a later stage, including to address rising damp. (Refer to Item 5.02.03.)

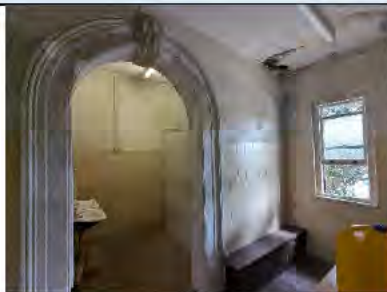
ELEMENT	CONDITION & DESCRIPTION OF DEFECTS	PROPOSED WORK / METHODOLOGY / OCP ARCHITECTS COMMENT	PHOTOGRAPHS
5.07: G1 & G2 – GENTS' LAVATORY			
Note: refer to and allow for works as per “Generally above in 5.02” (beyond itemized elements below)			
G1.01 Ceiling	Condition: Poor Evidence of significant water damage and mould growth.	<ul style="list-style-type: none"> Remove ceiling and replace with waterproof plasterboard (e.g. Villaboard). Paint finish as 5.02.05 - 4 coat acrylic Allow for new access hatch for over-ceiling maintenance (refer to 5.02.07).

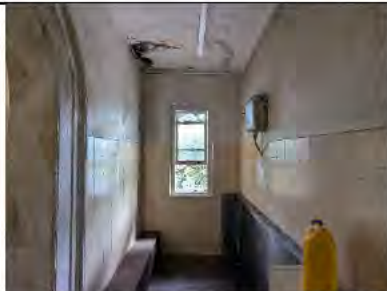
G1.02 Walls	Condition: Fair Extensive black mould	<ul style="list-style-type: none"> Clean walls with appropriate solution to remove mould and biological growth. (Refer to 5.02.04) Monitor damp on walls for the during works to determine effectiveness of recent roof repair works on falling damp issues. (refer to Item 5.02.03) Further works may need to be considered at a later stage, including to address rising damp. (refer to 5.02.03) Allow to clean, check damp levels and, if acceptable, repaint to match existing as per Item 5.02.09. Accept tiles as are. Clean tiles. Paint walls and paint out conduits. Non-heritage partition walls and wall tiles may be removed if required for adaptive re-use. This is shown on drawings.

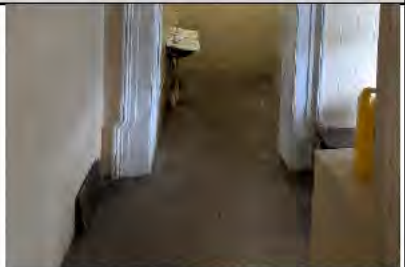
ELEMENT	CONDITION & DESCRIPTION OF DEFECTS	PROPOSED WORK / METHODOLOGY / OCP ARCHITECTS COMMENT	PHOTOGRAPHS
G1.04 Floor	Condition: Fair	<ul style="list-style-type: none"> Clean floor tiles. Remove floor coverings and inspect concrete below. HOLD POINT: Assume asbestos content when removing floor coverings. Investigate and proceed with caution as per Work Health & Safety regulations and as per the <i>Hazardous Building Materials Management Plan</i> prepared for Petersham Railway Station, particularly Section 6.4.1. No further work at this work at this stage.

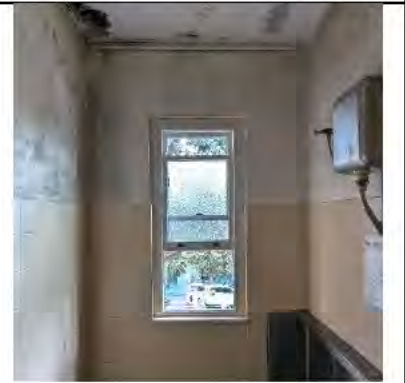
G1.05 Doors and Windows	Condition: Good	<ul style="list-style-type: none"> Windows: no conservation works required at this stage – clean only. Doors: address doors and door hardware as per 5.02.09, 5.02.10 and 5.02.12.

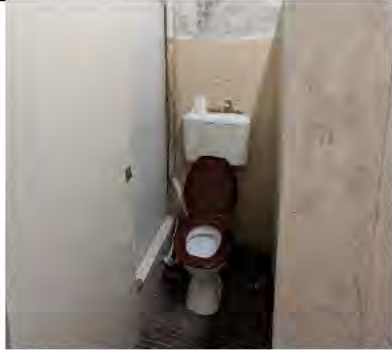
ELEMENT	CONDITION & DESCRIPTION OF DEFECTS	PROPOSED WORK / METHODOLOGY / OCP ARCHITECTS COMMENT	PHOTOGRAPHS
G1.06 Bathroom fixtures	Condition: fair	<ul style="list-style-type: none"> • Allow for general cleaning • Provide a new cistern. • Provide new working tap to bathroom sink with a hot / cold lever. • Provide new seat to toilet. • Provide new shower and taps to shower. • Ensure that all hydraulics are in working order.

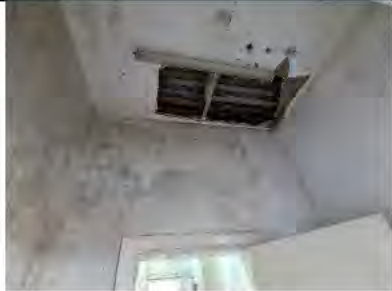
5.08: G3 – GENTS' LAVATORY			
Note: refer to and allow for works as per "Generally above in 5.02" (beyond itemized elements below)			
G3.01 Ceiling	Condition: Poor Evidence of water damage and mould growth. Missing sections of plasterboard.	<ul style="list-style-type: none"> • Remove ceiling and replace with waterproof plasterboard (e.g. Villaboard). • Paint finish as 5.02.05 – 4 coat acrylic • Allow for new access hatch for over-ceiling maintenance. (Refer to Item 5.02.07.)

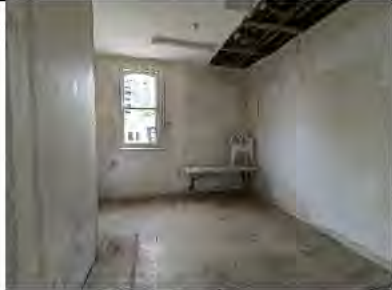
ELEMENT	CONDITION & DESCRIPTION OF DEFECTS	PROPOSED WORK / METHODOLOGY / OCP ARCHITECTS COMMENT	PHOTOGRAPHS
G3.02 Walls	Condition: Poor Cracks on south wall. Extensive black mould. Rising damp along platform wall.	<ul style="list-style-type: none"> Monitor damp on walls for the next 18 months to determine effectiveness of recent roof repair works on falling damp issues. Further works may need to be considered at a later stage, including to address rising damp along the platform edge. (Refer to Item 5.02.03.) Cracks should be investigated by Structural Engineer once building has been allowed to dry. (Refer to Item 5.02.22.) Allow for new plasterboard wall lining on partition wall and paint as per 5.02.09 above (Note: may need to be removed if required for adaptive re-use). Allow to clean, check damp levels and, if acceptable, repaint to match existing as per Item 5.02.09.

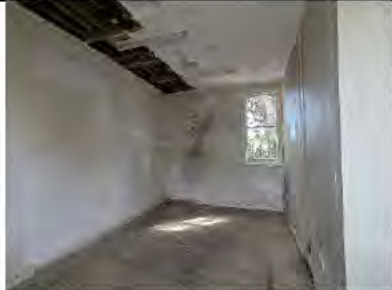
G3.03 Floor	Condition: Fair Concrete slab possibly contributing to rising damp.	<ul style="list-style-type: none"> Remove vinyl and inspect concrete below. Remove floor coverings and inspect concrete below. HOLD POINT: Assume asbestos content when removing floor coverings. Investigate and proceed with caution as per Work Health & Safety regulations and as per the <i>Hazardous Building Materials Management Plan</i> prepared for Petersham Railway Station, particularly Section 6.4.1. No further work at this work at this stage.

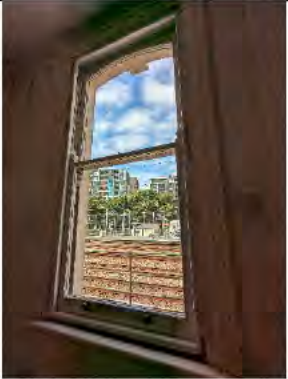
ELEMENT	CONDITION & DESCRIPTION OF DEFECTS	PROPOSED WORK / METHODOLOGY / OCP ARCHITECTS COMMENT	PHOTOGRAPHS
G3.04 Doors and Windows	Condition: Good	<ul style="list-style-type: none"> Windows: check window hardware, ensure operation and repaint. (As per Item 5.02.09.) Doors: address doors and door hardware as per 5.02.09, 5.02.10 and 5.02.12.

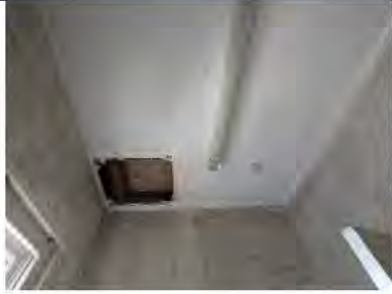
5.09: G4/G5 – GENTS' LAVATORY			
Note: refer to and allow for works as per “Generally above in 5.02” (beyond itemized elements below)			
G4.01 Ceilings	Condition: Poor Severe water damage, sections of missing lining, extensive black mould.	<ul style="list-style-type: none"> Remove ceiling and replace with waterproof plasterboard (e.g. Villaboard). Allow for new access hatch for over-ceiling maintenance. (Refer to Item 5.02.07.)

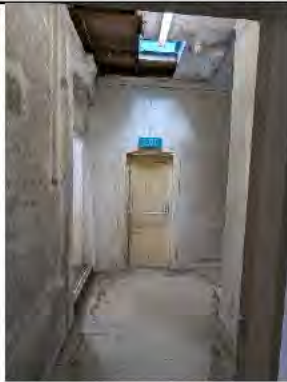
ELEMENT	CONDITION & DESCRIPTION OF DEFECTS	PROPOSED WORK / METHODOLOGY / OCP ARCHITECTS COMMENT	PHOTOGRAPHS
G4.02 Walls	Condition: Fair Damp detected on external walls.	<ul style="list-style-type: none"> • Clean walls with appropriate solution to remove mould and biological growth. (Refer to Item 5.02.04.) • Monitor damp on walls for the next 18 months to determine effectiveness of recent roof repair works on falling damp issues. Further works may need to be considered at a later stage, including to address rising damp along the platform edge. (refer to Item 5.02.01) • Cracks should be investigated by Structural Engineer once building has been allowed to dry. (Refer to Item 5.02.22) • Allow to clean, check damp levels and, if acceptable, repaint to match existing as per Item 5.02.09.

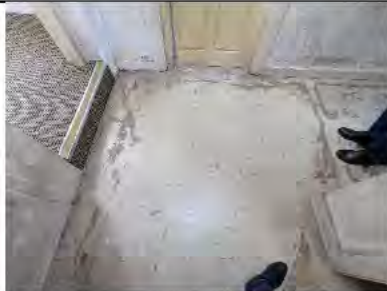
G4.03 Floors	Condition: Fair Concrete slab possibly contributing to rising damp.	<ul style="list-style-type: none"> • Remove vinyl and inspect concrete below. <ul style="list-style-type: none"> - HOLD POINT: Assume asbestos content when removing floor coverings. Investigate and proceed with caution as per Work Health & Safety regulations and as per the <i>Hazardous Building Materials Management Plan</i> prepared for Petersham Railway Station, particularly Section 6.4.1. - No further work at this work at this stage.

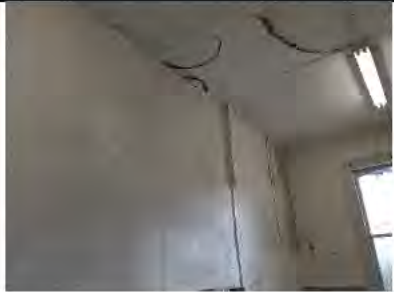
5.10: G6 – KITCHEN			
Note: refer to and allow for works as per “Generally above in 5.02” (beyond itemized elements below)			
G6.01 Ceiling	Condition: Poor Evidence of extensive water damage, sections of missing plasterboard	<ul style="list-style-type: none"> Remove Masonite ceiling and provide new Villaboard ceiling. Set and paint ceiling. (Refer to Item 5.02.05.) Allow to install new access hatch for over-ceiling maintenance. (Refer to Item 5.02.07.)

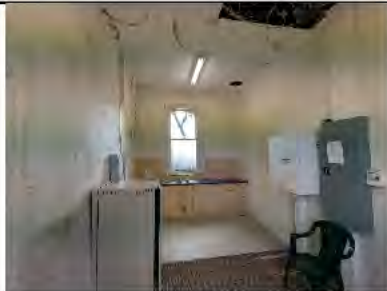
ELEMENT	CONDITION & DESCRIPTION OF DEFECTS	PROPOSED WORK / METHODOLOGY / OCP ARCHITECTS COMMENT	PHOTOGRAPHS
G6.02 Walls	Condition: Poor Severe water damage, sections of missing lining, extensive black mould.	<ul style="list-style-type: none"> Remove plasterboard wall linings. Clean walls with appropriate solution to remove mould and biological growth. (Refer to Item 5.02.04.) Monitor damp on walls for the next 18 months to determine effectiveness of recent roof repair works on falling damp issues. (Refer to Item 5.02.03.) Further works may need to be considered at a later stage, including to address rising damp. (Refer to Item 5.02.03.) Allow to clean, check damp levels and, if acceptable, repaint to match existing as per Item 5.02.09. Western wall: allow to remove bowed Masonite panels in the middle section of the wall, to be repaired with new Masonite sheets. Paint finish.

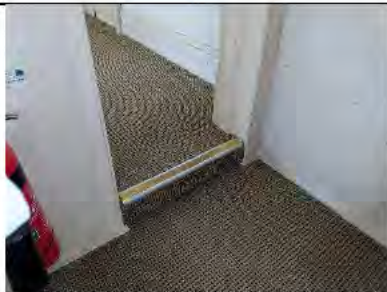
G6.03 Floors	Condition: Inaccessible – timber floor could not be inspected due to carpet and vinyl coverings.	<ul style="list-style-type: none"> Remove floor coverings (vinyl and carpet coverings) to allow for inspection of floorboards and sub-floor structure. <ul style="list-style-type: none"> HOLD POINT: Assume asbestos content when removing floor coverings. Investigate and proceed with caution as per Work Health & Safety regulations and as per the <i>Hazardous Building Materials Management Plan</i> prepared for Petersham Railway Station, particularly Section 6.4.1. Sand and apply tung oil on floorboards – Allow 10% floorboard replacement with 150mm T&G hardwood boards. Retain existing access hatch in existing position. Add 2 recessed finger brass pulls to hatch. (Refer to Item 5.02.15.)

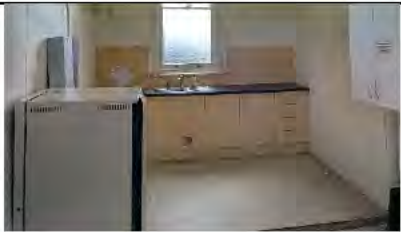
G6.05 Fixtures		<ul style="list-style-type: none"> Clean and sand kitchen units and apply a low-gloss Danish-style finish . Remove cupboards containing electrical meter / circuit breaker and IT / communications services.

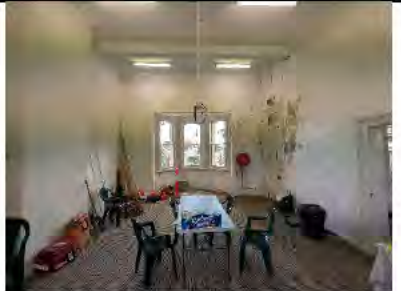
5.11: G7 – GENERAL WAITING ROOM			
Note: refer to and allow for works as per “Generally above in 5.02” (beyond itemized elements below)			
G7.01 Ceiling	Condition: Poor	<ul style="list-style-type: none"> Reinstate lath and plaster ceiling. (As per Item and 5.02.06.) Allow to install new access hatch for over-ceiling maintenance. (Refer to Item 5.02.07.) Remove redundant/obsolete fixtures. Repaint as per 5.02.09 above.

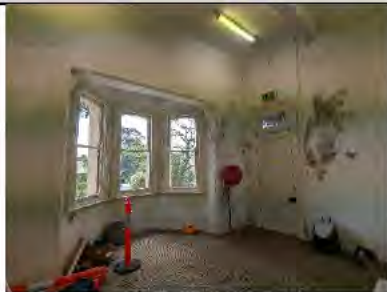
ELEMENT	CONDITION & DESCRIPTION OF DEFECTS	PROPOSED WORK / METHODOLOGY / OCP ARCHITECTS COMMENT	PHOTOGRAPHS
G7.02 Walls	Condition: Poor Walls are damp and mouldy. Cracks above northern windows. Evidence of falling damp on the north side and rising damp on south side of the room.	<ul style="list-style-type: none"> • Clean walls with appropriate solution to remove mould and biological growth. (Refer to Item 5.02.04) • Monitor damp on walls for the next 18 months to determine effectiveness of recent roof repair works on falling damp issues. (Refer to Item 5.02.03.) • Further works may need to be considered at a later stage, including to address rising damp. (Refer to Item 5.02.03.) • Cracks should be investigated by Structural Engineer once building has been allowed to dry (refer to Item 5.02.22.) • Allow to clean, check damp levels and, if acceptable, repaint to match existing as per Item 5.02.09. • Reinstate fireplace opening and mantle. Refer to 'Appendix A – Architectural Drawings,' drawing no. 07. • Allow to clean, check damp levels and, if acceptable, repaint to match existing as per Item 5.02.09.

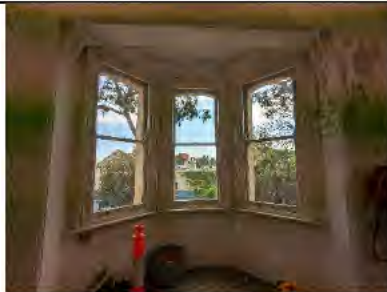
G7.03 Doors		<ul style="list-style-type: none"> • Remove recent off-shelf interior doors to the western and eastern sides of the room, leaving the door frames and architraves intact. Repaint door frames and architrave. • Address doors and door hardware as per 5.02.09, 5.02.10 and 5.02.12. 	
G7.04 Windows		<ul style="list-style-type: none"> • Addressed in previous conservation works. • Check hardware, ensure operation and repaint. (As per Item 5.02.09.) • Windows require finishing. (Refer to Item 5.02.09.)

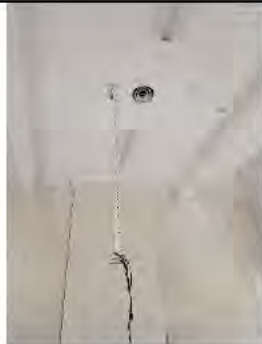
G7.06 Lighting / Electrical	Condition: Intrusive	<ul style="list-style-type: none"> Remove projector.

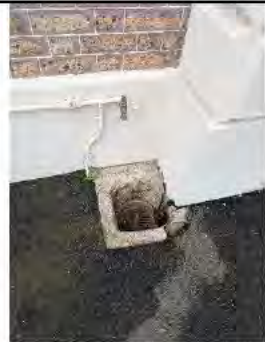
ELEMENT	CONDITION & DESCRIPTION OF DEFECTS	PROPOSED WORK / METHODOLOGY / OCP ARCHITECTS COMMENT	PHOTOGRAPHS
5.12: G8 – VERANDAHS			
Addressed in external conservation works.			
ELEMENT	CONDITION & DESCRIPTION OF DEFECTS	PROPOSED WORK / METHODOLOGY / OCP ARCHITECTS COMMENT	PHOTOGRAPHS
G8.01 Drain		<ul style="list-style-type: none"> Provide grate to cover drain to southern verandah and install flush with platform (at top level of drain opening).

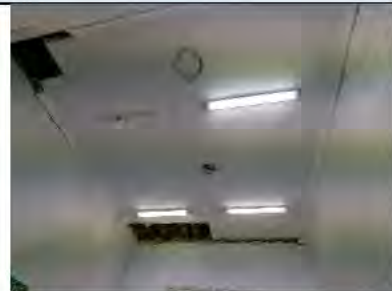
ELEMENT	CONDITION & DESCRIPTION OF DEFECTS	PROPOSED WORK / METHODOLOGY / OCP ARCHITECTS COMMENT	PHOTOGRAPHS
5.13: G9 – STORE			
Note: refer to and allow for works as per “Generally above in 5.02” (beyond itemized elements below)			
G9.01 Ceiling	Condition: Poor	<ul style="list-style-type: none"> Salvage and restore lath and plaster ceiling, augment with new laths 30% (Refer to Item 5.02.05 and 5.02.06.) Allow to install new access hatch for over-ceiling maintenance. (Refer to Item 5.02.07.) Remove redundant/obsolete fixtures. Repaint as per 5.02.09 section above.

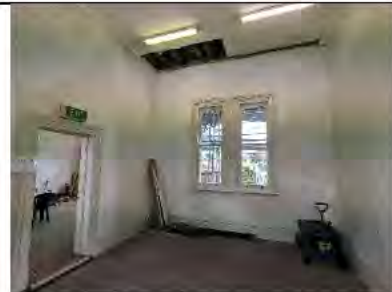
G9.02 Walls	Condition: Fair	<ul style="list-style-type: none"> Clean walls with appropriate solution to remove mould and biological growth. (Refer to Item 5.02.04.) Monitor damp on walls for the next 18 months to determine effectiveness of recent roof repair works on falling damp issues. (Refer to Item 5.02.03.) Further works may need to be considered at a later stage, including to address rising damp. (Refer to Item 5.02.03.) Cracks should be investigated by Structural Engineer once building has been allowed to dry. (Refer to Item 5.02.22.) Allow to clean, check damp levels and, if acceptable, repaint to match existing as per Item 5.02.09.

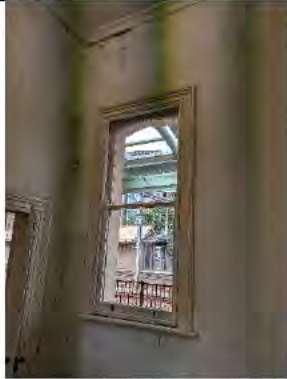
ELEMENT	CONDITION & DESCRIPTION OF DEFECTS	PROPOSED WORK / METHODOLOGY / OCP ARCHITECTS COMMENT	PHOTOGRAPHS
G9.03 Windows and Doors	Condition: Good	<ul style="list-style-type: none"> Windows: check hardware, ensure operation and repaint. (As per Item 5.02.09) Doors: address doors and door hardware as per 5.02.09, 5.02.10 and 5.02.12.

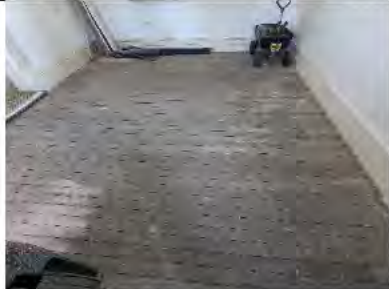
G9.05 Floors	Condition: Fair	<ul style="list-style-type: none"> Allow for sanding and tung oil application on floorboards – Allow 100% floorboard replacement with 150mm T&G hardwood boards. Allow to install new access hatch for sub-floor maintenance. (Refer to Item 5.02.15)

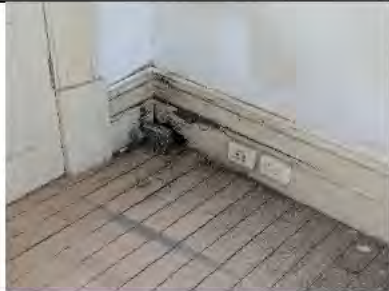
G9.06 Skirting	Condition: Fair	<ul style="list-style-type: none"> Joinery Shop to make up new skirting, and fit and spice in and repaint skirting to match existing – Allow 30% replacement in hardwood to match existing. (Refer to 5.02.09)

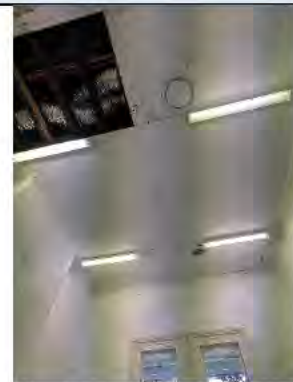
ELEMENT	CONDITION & DESCRIPTION OF DEFECTS	PROPOSED WORK / METHODOLOGY / OCP ARCHITECTS COMMENT	PHOTOGRAPHS
5.14: G10 – STATION MASTER'S OFFICE			
Note: refer to and allow for works as per “Generally above in 5.02” (beyond itemized elements below)			
G10.01 Ceiling	Condition: Poor	<ul style="list-style-type: none"> Reinstate lath and plaster 100% of ceiling. (Refer to Item 5.02.05 and 5.02.06.) Allow to install new access hatch for over-ceiling maintenance. (Refer to Item 5.02.07.) Remove redundant/obsolete fixtures. Repaint as per 5.02.09 above.

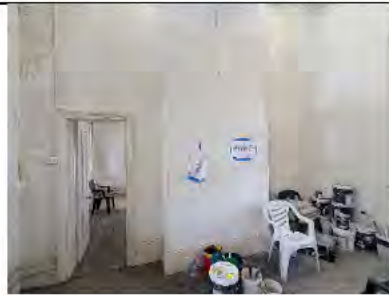
G10.02 Walls	Condition: Fair. Evidence of falling damp to all walls and rising damp on southern (platform wall).	<ul style="list-style-type: none"> Clean walls with appropriate solution to remove mould and biological growth. (Refer to Item 5.02.04.) Monitor damp on walls for the next 18 months to determine effectiveness of recent roof repair works on falling damp issues. (Refer to Item 5.02.03.) Further works may need to be considered at a later stage, including to address rising damp. (Refer to Item 5.02.03.) Cracks should be investigated by Structural Engineer once building has been allowed to dry. (Refer to Item 5.02.22.) Allow to clean, check damp levels and, if acceptable, repaint to match existing as per Item 5.02.09.

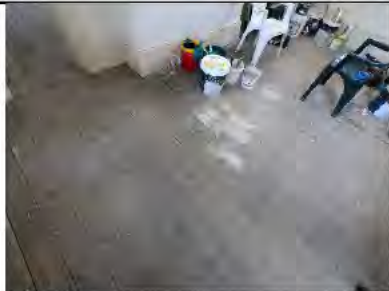
ELEMENT	CONDITION & DESCRIPTION OF DEFECTS	PROPOSED WORK / METHODOLOGY / OCP ARCHITECTS COMMENT	PHOTOGRAPHS
G10.03 Floor	Condition: Fair	<ul style="list-style-type: none"> Allow for sanding and tung oil application on floorboards. – Allow 10% floorboard replacement with 150mm T&G hardwood boards. Allow to install new access hatch for sub-floor maintenance. (Refer to Item 5.02.15.)

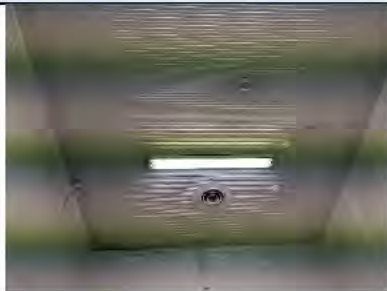
ELEMENT	CONDITION & DESCRIPTION OF DEFECTS	PROPOSED WORK / METHODOLOGY / OCP ARCHITECTS COMMENT	PHOTOGRAPHS
5.15: G11 – ENTRANCE			
Note: refer to and allow for works as per “Generally above in 5.02” (beyond itemized elements below)			
G11.01 Ceiling	Condition: Fair	<ul style="list-style-type: none"> Retain ripple-iron ceiling: <ul style="list-style-type: none"> Carefully strip and allow to repaint with 4 coats of low-gloss enamel to match existing. Allow to patch original moulded plaster cornice (allow for 20%). Air conditioning outlets to be removed and hole in ceiling repaired. Ceiling access hatch to be accepted as is. Allow to paint as per 5.02.09 above.

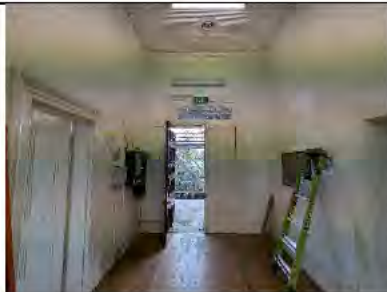
G11.02 Walls	Condition: Fair	<ul style="list-style-type: none"> Monitor damp on walls for the next 18 months to determine effectiveness of recent roof repair works on falling damp issues. (Refer to Item 5.02.03.) Further works may need to be considered at a later stage, including to address rising damp. (Refer to Item 5.02.03.) Cracks should be investigated by Structural Engineer once building has been allowed to dry. (Refer to Item 5.02.22.) Allow to clean, check damp levels, patch and repaint to match existing. Allow for 30% lime plaster patching (skim coat gypsum and plaster).

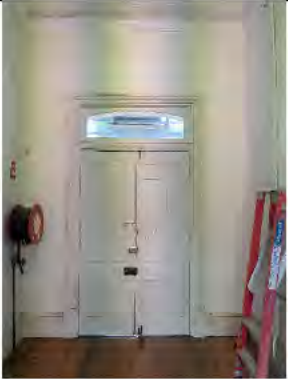
ELEMENT	CONDITION & DESCRIPTION OF DEFECTS	PROPOSED WORK / METHODOLOGY / OCP ARCHITECTS COMMENT	PHOTOGRAPHS
G11.03 Doors	Condition: Good.	<ul style="list-style-type: none"> Remove recent off-shelf interior door to the eastern side of the room, leaving the door frame and architrave intact and repaint. Doors: address doors and door hardware as per 5.02.09, 5.02.10 and 5.02.12.

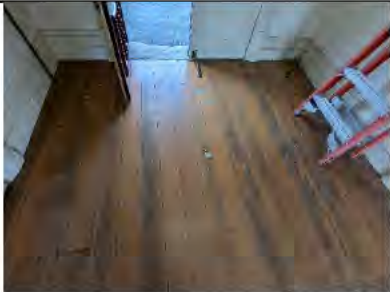
G11.03 Floors	Condition: Good.	<ul style="list-style-type: none"> Allow for sanding and tung oil application on floorboards. – Allow 10% floorboard replacement with 150mm T&G hardwood boards. Allow to install new access hatch for sub-floor maintenance. (Refer to Item 5.02.15.) Allow to clean and repaint skirting.

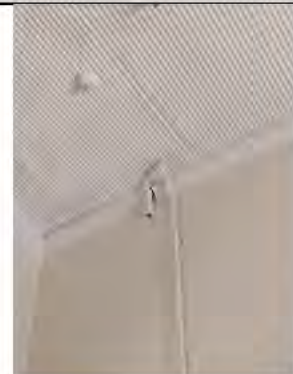
ELEMENT	CONDITION & DESCRIPTION OF DEFECTS	PROPOSED WORK / METHODOLOGY / OCP ARCHITECTS COMMENT	PHOTOGRAPHS
G11.04 Lighting / Electrical	Condition: Intrusive.	<ul style="list-style-type: none"> Allow to remove all intrusive, modern, deteriorated fluorescent lighting. Accept wall-mounted conduits as are, with the exception of conduits that can be deemed redundant from a visual examination – such conduits are to be removed.

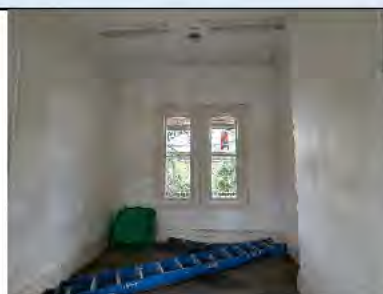
5.16: G12 – BOOKING OFFICE			
Note: refer to and allow for works as per “Generally above in 5.02” (beyond itemized elements below)			
G12.01 Ceiling	Condition: Poor	<ul style="list-style-type: none"> Remove Masonite ceiling and reinstate lath and plaster ceiling. (Refer to Item 5.02.05 and 5.02.06.) Ceiling hatch and access ladder: <ul style="list-style-type: none"> Allow to remove existing ceiling hatch and associated access ladder. Allow to provide and install a new access hatch in the same position as the current ceiling hatch, for over-ceiling maintenance. (Refer to Item 5.02.07.) Allow to adjust existing aperture to suit new ladder system. Contractor to provide shop drawing (Hold Point). Allow to provide and install a new retractable access ladder to the new ceiling hatch, similar to AM-BOSS Commercial Series Pull-Down Access Ladder, with extended ladder handrails. New ladder system to be compliant with relevant building standards and Transport NSW codes. (Ladder handrails to extend between 900mm-1100mm above the platform landing).

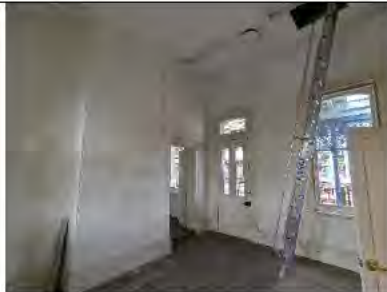
ELEMENT	CONDITION & DESCRIPTION OF DEFECTS	PROPOSED WORK / METHODOLOGY / OCP ARCHITECTS COMMENT	PHOTOGRAPHS
		<ul style="list-style-type: none"> - (Note: new ceiling hatch and access ladder may need to be removed and relocated if required at adaptive re-use stage). • Remove redundant/obsolete fixtures. • Repaint as per 5.02.09 above. 	
G12.02 Walls	Condition: Fair Cracks above northern windows	<ul style="list-style-type: none"> • Clean walls with appropriate solution to remove mould and biological growth. (Refer to Item 5.02.04.) • Monitor damp on walls for the next 18 months to determine effectiveness of recent roof repair works on falling damp issues. (Refer to Item 5.02.03.) • Further works may need to be considered at a later stage, including to address rising damp. (Refer to Item 5.02.03.) • Cracks should be investigated by Structural Engineer once building has been allowed to dry. (Refer to Item 5.02.22.) • Allow to clean, check damp levels and, if acceptable, repaint to match existing as per Item 5.02.09. • Refresh of fireplace hearth.

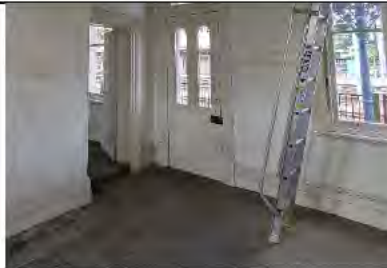
G12.03 Floors	Condition: Fair	<ul style="list-style-type: none"> • Allow for sanding and tung oil application on floorboards. – Allow 10% floorboard replacement with 150mm T&G hardwood boards. • Retain existing access hatch in existing position. Add 2 recessed finger brass pulls to hatch. (Refer to Item 5.02.15.)

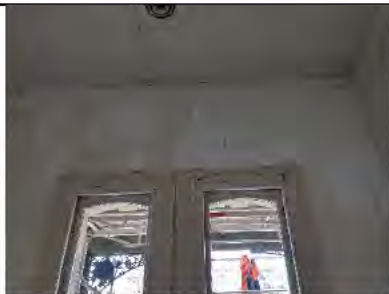
G12.05 Doors and Windows	Condition: Good	<ul style="list-style-type: none"> Windows: check hardware, ensure operation and repaint. (As per Item 5.02.09.) Doors: address doors and door hardware as per 5.02.09, 5.02.10 and 5.02.12.

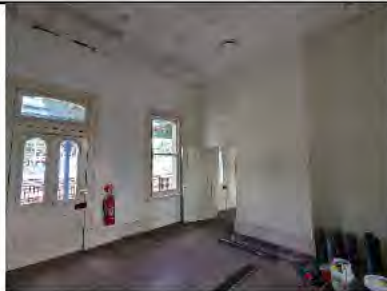
ELEMENT	CONDITION & DESCRIPTION OF DEFECTS	PROPOSED WORK / METHODOLOGY / OCP ARCHITECTS COMMENT	PHOTOGRAPHS
G13.02 Walls	Condition: Poor Evidence of falling damp on north wall and rising damp along south wall. Plaster/ render along top of the wall is chipped/ missing. Large crack above the south door.	<ul style="list-style-type: none"> • Clean walls with appropriate solution to remove mould and biological growth. (Refer to Item 5.02.04) • Monitor damp on walls for the next 18 months to determine effectiveness of recent roof repair works on falling damp issues. (Refer to Item 5.02.03.) • Further works may need to be considered at a later stage, including to address rising damp. (Refer to Item 5.02.03.) • Cracks should be investigated by Structural Engineer once building has been allowed to dry. (Refer to Item 5.02.22.) • Allow to clean, check damp levels and, if acceptable, repaint to match existing as per Item 5.02.09. • Reinstate fireplace. • Refresh of fireplace hearth.

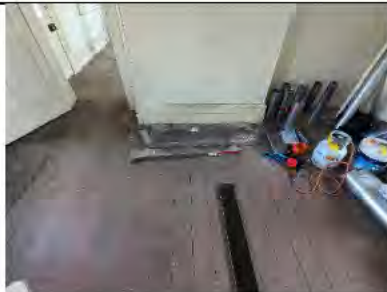
G13.03 Floors	Condition: Good	<ul style="list-style-type: none"> • Allow for sanding and tung oil application on floorboards. – Allow 10% floorboard replacement with 150mm T&G hardwood boards. • Allow to install new access hatch for sub-floor maintenance. (Refer to Item 5.02.15.)

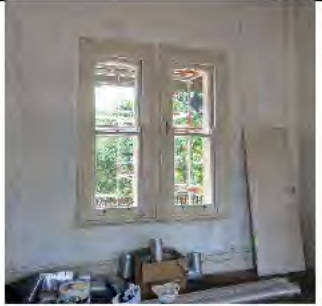
ELEMENT	CONDITION & DESCRIPTION OF DEFECTS	PROPOSED WORK / METHODOLOGY / OCP ARCHITECTS COMMENT	PHOTOGRAPHS
G13.05 Doors and Windows	Condition: Good	<ul style="list-style-type: none"> Windows: check window hardware, ensure operation and repaint. (As per Item 5.02.09.) Doors: address doors and door hardware as per 5.02.09, 5.02.10 and 5.02.12.

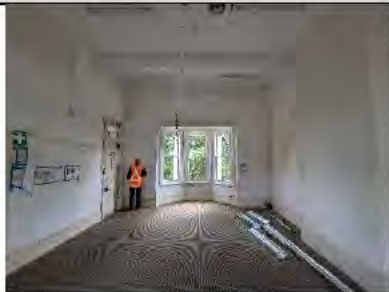
ELEMENT	CONDITION & DESCRIPTION OF DEFECTS	PROPOSED WORK / METHODOLOGY / OCP ARCHITECTS COMMENT	PHOTOGRAPHS
G14.02 Walls	Condition: Poor Cracking and missing render surrounding northern bay window. Rising damp along southern wall.	<ul style="list-style-type: none"> • Clean walls with appropriate solution to remove mould and biological growth. (Refer to Item 5.02.04.) • Monitor damp on walls for the next 18 months to determine effectiveness of recent roof repair works on falling damp issues. (Refer to Item 5.02.03.) • Further works may need to be considered at a later stage, including to address rising damp. (Refer to Item 5.02.03.) • Cracks should be investigated by Structural Engineer once building has been allowed to dry (Refer to Item 5.02.22.) • Allow to clean, check damp levels and, if acceptable, repaint to match existing as per Item 5.02.09.

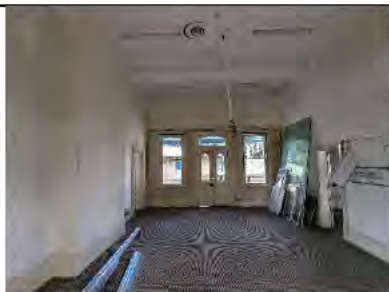
G14.03 Floors	Condition: Inaccessible – timber floor could not be inspected due to carpet	<ul style="list-style-type: none"> • Remove floor coverings to allow for inspection of floorboards and sub-floor structure. <ul style="list-style-type: none"> - HOLD POINT: Assume asbestos content when removing floor coverings. Investigate and proceed with caution as per Work Health & Safety regulations and as per the <i>Hazardous Building Materials Management Plan</i> prepared for Petersham Railway Station, particularly Section 6.4.1. • Allow for sanding and tung oil application on floorboards. – Allow 10% floorboard replacement with 150mm T&G hardwood boards. • Allow to install new access hatch for sub-floor maintenance. (Refer to Item 5.02.15)

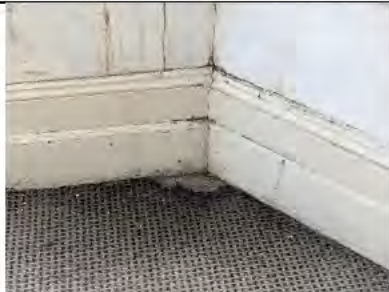
G14.04 Skirting	Condition: Fair	<ul style="list-style-type: none"> • Reconstruct and replace skirting along Northern wall to match existing.

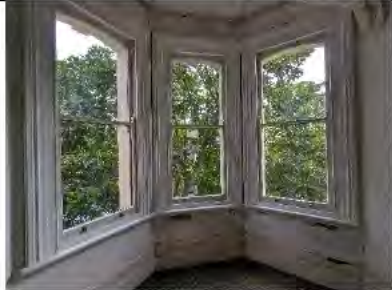
ELEMENT	CONDITION & DESCRIPTION OF DEFECTS	PROPOSED WORK / METHODOLOGY / OCP ARCHITECTS COMMENT	PHOTOGRAPHS
G14.05 Doors and Windows	Condition: Fair	<ul style="list-style-type: none"> Remove and dispose of glazed panels and applied framing from Southern door to platform. Reconstruct framing over Northern Bay window. Windows: check hardware, ensure operation and repaint. (As per Item 5.02.09.) Remove recent off-shelf interior door to the eastern side of the room, leaving the door frame and architrave intact and repaint. Doors: address doors and door hardware as per 5.02.09, 5.02.10 and 5.02.12.

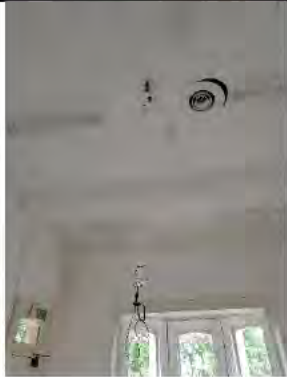
G14.06 Lighting / Electrical	Condition: Intrusive	<ul style="list-style-type: none"> Remove projector.

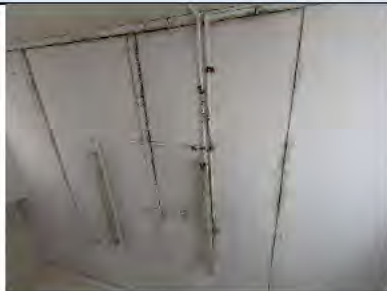
ELEMENT	CONDITION & DESCRIPTION OF DEFECTS	PROPOSED WORK / METHODOLOGY / OCP ARCHITECTS COMMENT	PHOTOGRAPHS
5.19: G15 & G16 – LADIES' LAVATORY			
Note: refer to and allow for works as per “Generally above in 5.02” (beyond itemized elements below)			
G15.01 Ceiling	Condition: Poor Evidence of damp. The lighting is in poor condition.	<ul style="list-style-type: none"> Remove Masonite ceilings and replace with waterproof plasterboard (e.g. Villaboard). Allow to add new scotia moulded plaster cornices to ceilings (75mm). Allow to install new access hatch for over-ceiling maintenance. (Refer to Item 5.02.07) Remove redundant/obsolete fixtures. Repaint as per 5.02.09 above.

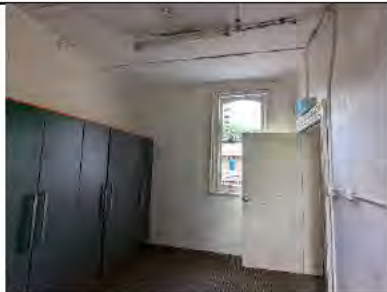
G15.02 Walls	Condition: Fair Large crack in the eastern masonry dividing wall.	<ul style="list-style-type: none"> Clean walls, including tilework, with appropriate solution to remove mould and biological growth. (Refer to Item 5.02.04) Monitor damp on walls for the next 18 months to determine effectiveness of recent roof repair works on falling damp issues. (Refer to Item 5.02.03.) Further works may need to be considered at a later stage, including to address rising damp. (Refer to Item 5.02.03.) Cracks should be investigated by Structural Engineer once building has been allowed to dry. (Refer to Item 5.02.22.) Allow to clean walls and repaint to match existing walls, as per Item 5.02.09.

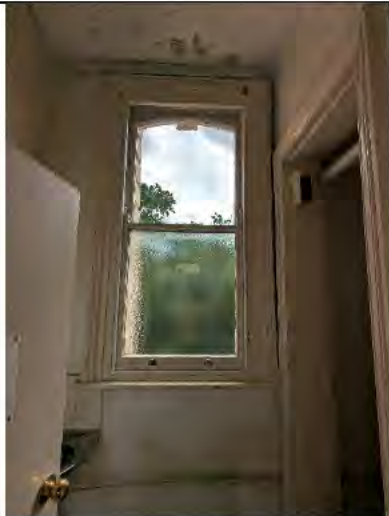
ELEMENT	CONDITION & DESCRIPTION OF DEFECTS	PROPOSED WORK / METHODOLOGY / OCP ARCHITECTS COMMENT	PHOTOGRAPHS
G15.03 Doors		<ul style="list-style-type: none"> Doors: address doors and door hardware as per 5.02.09, 5.02.10 and 5.02.12. 	
G15.04 Windows		<ul style="list-style-type: none"> Check hardware, ensure operation and repaint. (Refer to Item 5.02.09.)

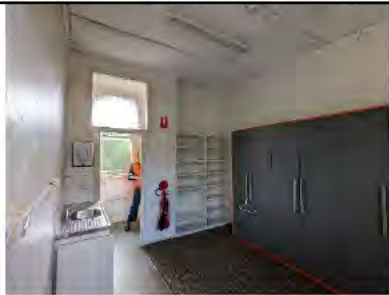
G15.05 Floors	Condition: Inaccessible – timber floor could not be inspected due to carpet	<ul style="list-style-type: none"> Remove floor coverings (lino and carpet) to allow for inspection of floorboards and sub-floor structure. <ul style="list-style-type: none"> HOLD POINT: Assume asbestos content when removing floor coverings. Investigate and proceed with caution as per Work Health & Safety regulations and as per the <i>Hazardous Building Materials Management Plan</i> prepared for Petersham Railway Station, particularly Section 6.4.1. Allow for sanding and tung oil application on floorboards – allow 10% floorboard replacement with 150mm T&G hardwood boards. Allow to install new access hatch for sub-floor maintenance. (Refer to Item 5.02.15.)

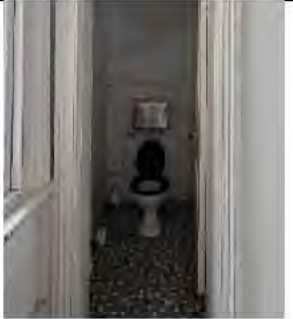
ELEMENT	CONDITION & DESCRIPTION OF DEFECTS	PROPOSED WORK / METHODOLOGY / OCP ARCHITECTS COMMENT	PHOTOGRAPHS
G15.06 Kitchenette and bathroom fixtures	Condition: Fair	<ul style="list-style-type: none"> General cleaning and ensure all hydraulics are in working order. Reconnect water to taps. Hot water system: <ul style="list-style-type: none"> Remove existing defunct hot water system, including associated wiring and connections, from under counter in kitchenette. Provide new laminated chipboard base to interior of kitchenette cupboard where missing. Provide and fit a new Rheem Steller stainless steel 50 litre storage unit, type 4A1050. Note: Check kilowatt rating – min. 4.8 KW unit Note: Size – 400mm diameter, 700mm high To be fitted with a 0.7mm copper tray with min. 70mm upturn around all 4 sides. Drain to stack using copper pipework. Remove any redundant/obsolete hydraulic fixtures. Bathroom sink: provide new working tap, similar to that in the kitchenette. Provide new seat to toilet.

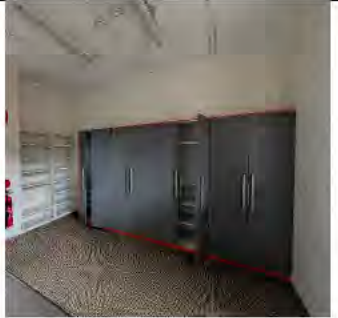
G15.07 Other fixtures		<ul style="list-style-type: none"> Built-in shelving unit to northern wall – retain in-situ and repaint. Storage unit to eastern wall – carefully remove storage unit from room, to be re-used elsewhere (e.g. in new extension or off-site).

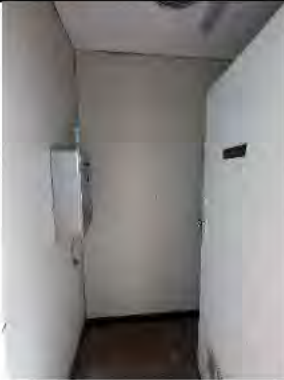
G17.02 Walls	Condition: Good.	<ul style="list-style-type: none"> Fabric is of little heritage value – No conservation works required at this stage. Allow for new plasterboard wall lining on partition wall or remove it if required for adaptive re-use. Allow to clean, check damp levels and, if acceptable, repaint to match existing as per Item 5.02.09.

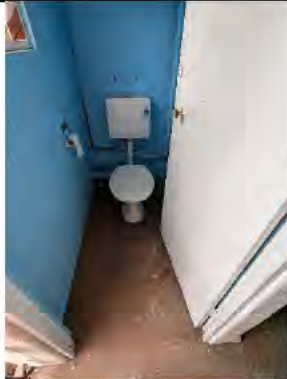
ELEMENT	CONDITION & DESCRIPTION OF DEFECTS	PROPOSED WORK / METHODOLOGY / OCP ARCHITECTS COMMENT	PHOTOGRAPHS
G17.03 Bathroom fixtures and hygiene facilities	Condition: Fair.	<ul style="list-style-type: none"> General cleaning and ensure all hydraulics are in working order. Remove any redundant/obsolete hydraulic fixtures.

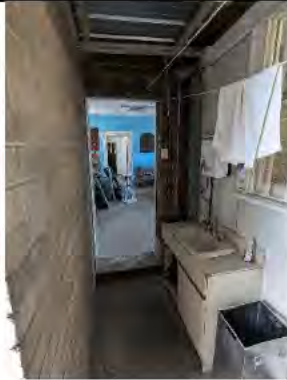
G17.04 Floor	Condition: Good.	<ul style="list-style-type: none"> Fabric is of little heritage value - no conservation works required at this stage.

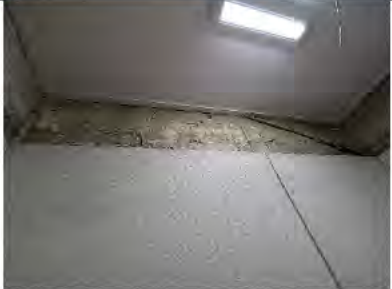
5.21: G20 & G21 – LAVATORY AND STORES			
Note: refer to and allow for works as per “Generally above in 5.02” (beyond itemized elements below)			
G20.01 Ceiling	Condition: Fair.	<ul style="list-style-type: none"> Fabric is of little heritage value - No conservation works required at this stage. Replace ceiling lining with Villaboard. Remove redundant/obsolete fixtures. Repaint as per 5.02.09 above.

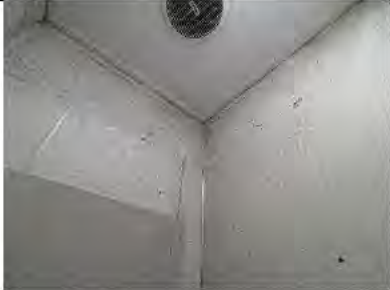
ELEMENT	CONDITION & DESCRIPTION OF DEFECTS	PROPOSED WORK / METHODOLOGY / OCP ARCHITECTS COMMENT	PHOTOGRAPHS
G20.02 Walls	Condition: Fair. Evidence of historic damage from damp which may have been addressed by roof repairs.	<ul style="list-style-type: none"> Fabric is of little heritage value. Remove loose paint, patch and repaint to match existing. (As per Item 5.02.09.)

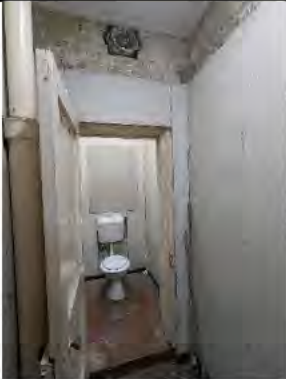
G20.03 Floor	Condition: Good.	<ul style="list-style-type: none"> Fabric is of little heritage value - No conservation works required at this stage.

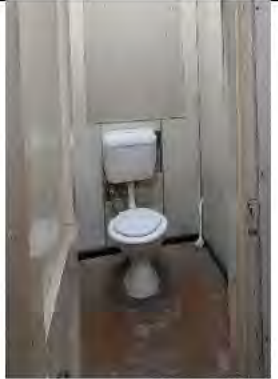
ELEMENT	CONDITION & DESCRIPTION OF DEFECTS	PROPOSED WORK / METHODOLOGY / OCP ARCHITECTS COMMENT	PHOTOGRAPHS
G20.04 Toilet fixtures	Condition: Fair.	<ul style="list-style-type: none"> General cleaning and ensure all hydraulics are in working order. Remove any redundant/obsolete hydraulic fixtures.

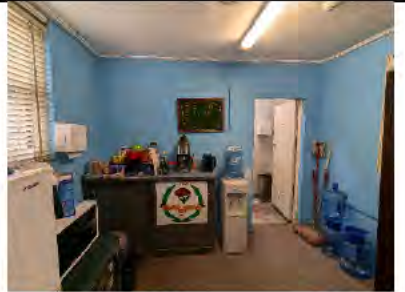
G22.02 Walls	Condition: Good.	<ul style="list-style-type: none"> Fabric is of little heritage value – No conservation works required at this stage. Allow for new plasterboard wall lining on partition wall. Allow to clean, check damp levels and, if acceptable, repaint to match existing as per Item 5.02.09.

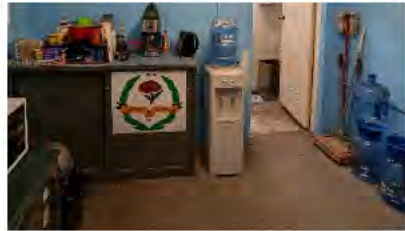
G22.03 Floors	Condition: Inaccessible – Floor could not be inspected due to carpet	<ul style="list-style-type: none"> Remove floor coverings to allow for inspection.

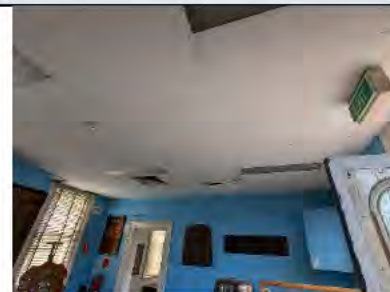
5.23: G23 – POST AND TELEGRAPH OFFICE			
Note: refer to and allow for works as per “Generally above in 5.02” (beyond itemized elements below)			
G23.01 Ceiling	Condition: Fair.	<ul style="list-style-type: none"> Fabric is of little heritage value - No conservation works required at this stage. Patch and repaint Gyprock ceiling lining – Allow 20% replacement to match existing. Earlier ceiling above not visible – inspect when possible. Remove redundant/obsolete fixtures. Repaint as per 5.02.09 above.

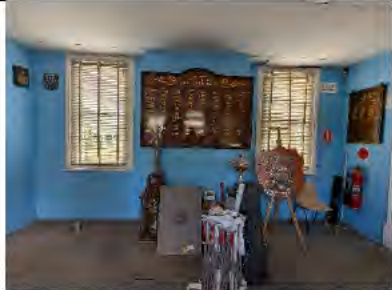
ELEMENT	CONDITION & DESCRIPTION OF DEFECTS	PROPOSED WORK / METHODOLOGY / OCP ARCHITECTS COMMENT	PHOTOGRAPHS
G23.02 Walls	Condition: Good.	<ul style="list-style-type: none"> Fabric is of little heritage value. Allow for new wall lining on partition wall or remove it if required for adaptive re-use. Allow to clean, patch and repaint to match existing as per Item 5.02.09.

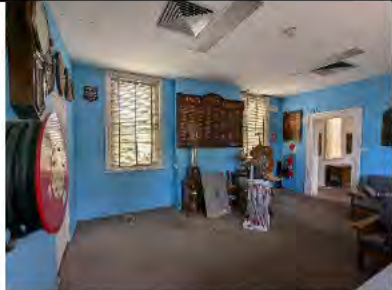
G23.03 Floor	Condition: Good.	<ul style="list-style-type: none"> Fabric is of little heritage value - No conservation works required at this stage. Replace carpet to match existing. Remove floor coverings to allow for inspection of floorboards. <ul style="list-style-type: none"> HOLD POINT: Assume asbestos content when removing floor coverings. Investigate and proceed with caution as per Work Health & Safety regulations and as per the <i>Hazardous Building Materials Management Plan</i> prepared for Petersham Railway Station, particularly Section 6.4.1.

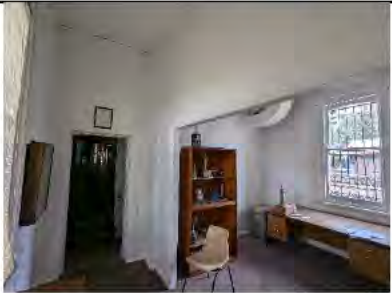
G24.02 Walls	Condition: Good.	<ul style="list-style-type: none"> Fabric is of little heritage value. Allow for new wall lining on partition wall or remove it if required for adaptive re-use. Allow to clean, patch and repaint to match existing as per Item 5.02.09.

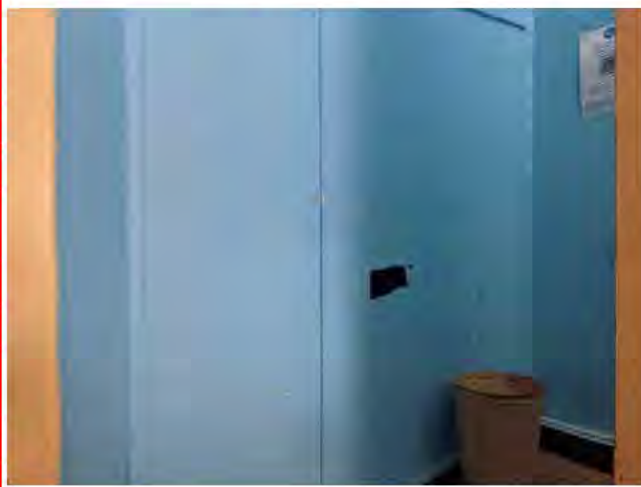
Item Number	1	Reinspection Date	Apr-27
Survey Level	Basement		
Building	Building 1 Old Petersham Station		
Room	Basement		
Item Location and Description	Staircase walls - Fibre cement sheet		
Sample Number	Previously Sampled: 003		
Sample Status	Positive		
Hazardous Material / Asbestos Content	Chrysotile / Amosite		
Risk Assessment	9	Priority Rating	Very Low
Recommendations	Remove under non-friable conditions.

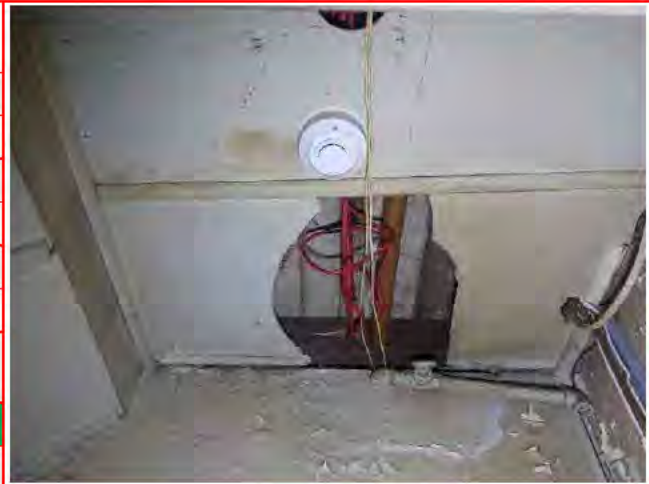
Item Number	4	Reinspection Date	Apr-27
Survey Level	Basement		
Building	Building 1 Old Petersham Station		
Room	Basement, Room under stairs		
Item Location and Description	Ceiling - Fibre cement sheet		
Sample Number	Previously Sampled: 003		
Sample Status	Positive		
Hazardous Material / Asbestos Content	Chrysotile / Amosite		
Risk Assessment	7	Priority Rating	Very Low
Recommendations	Remove under non-friable conditions.

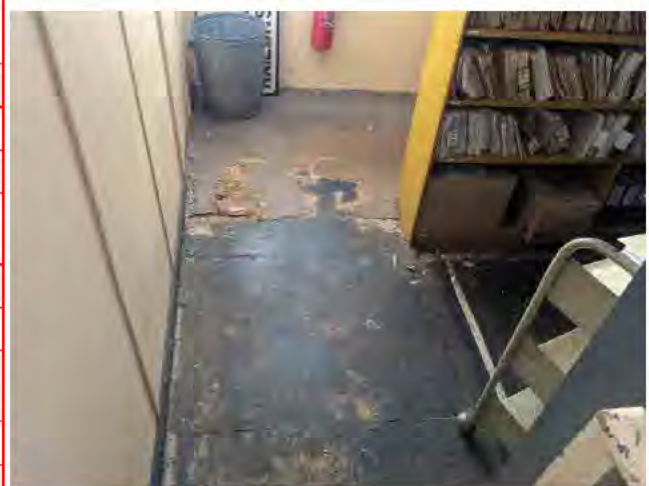
Item Number	5	Reinspection Date	-
Survey Level	Basement		
Building	Building 1 Old Petersham Station		
Room	Basement, throughout		
Item Location and Description	Floor covering - Bituminous membrane		
Sample Number	P2100299-OHMS-41911		
Sample Status	Negative		
Hazardous Material / Asbestos Content	No asbestos detected		
Risk Assessment	-	Priority Rating	-
Recommendations	No action required

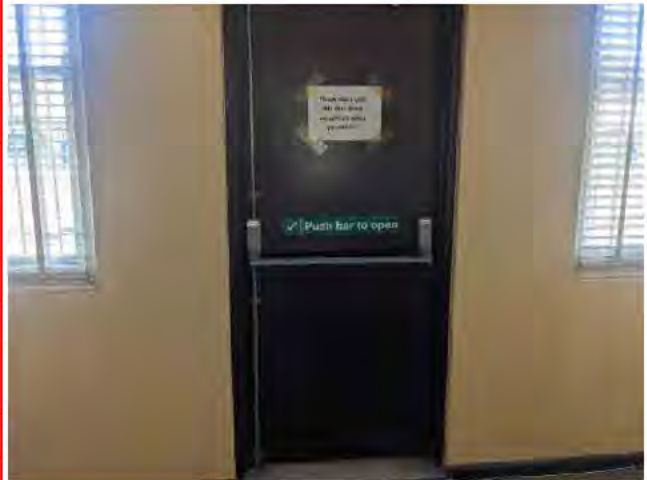
Item Number	6	Reinspection Date	-
Survey Level	1st Floor		
Building	Building 1 Old Petersham Station		
Room	Board room		
Item Location and Description	Emergency exit door - Fire door core		
Sample Number	P2100299-Visual inspection		
Sample Status	Negative		
Hazardous Material / Asbestos Content	Presumed		
Risk Assessment	-	Priority Rating	-
Recommendations	No action required

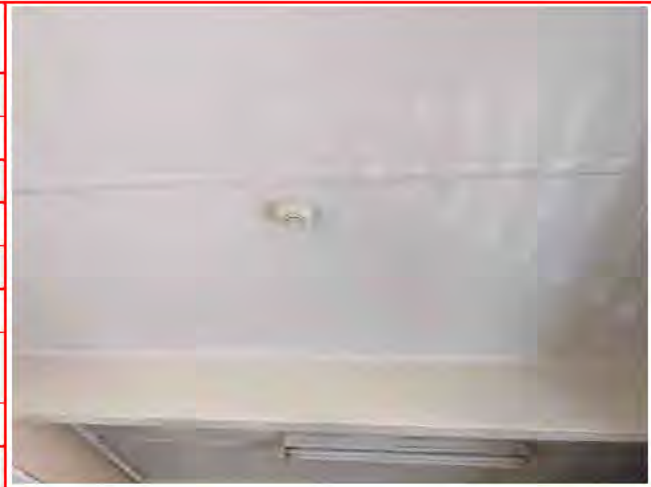
Item Number	7	Reinspection Date	-
Survey Level	1st Floor		
Building	Building 1 Old Petersham Station		
Room	Board room and Store		
Item Location and Description	Ceiling - Paper Product		
Sample Number	P2100299-OHMS-41905		
Sample Status	Negative		
Hazardous Material / Asbestos Content	No asbestos detected		
Risk Assessment	-	Priority Rating	-
Recommendations	No action required

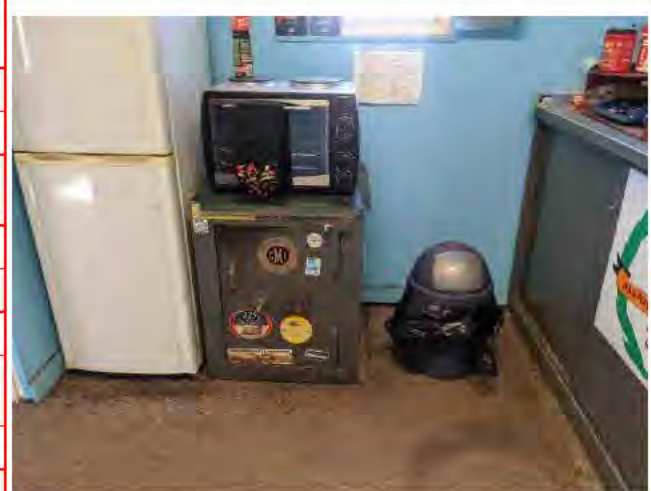
Item Number	8	Reinspection Date	-
Survey Level	1st Floor		
Building	Building 1 Old Petersham Station		
Room	Board Room, Office, Kitchen and Trophy room		
Item Location and Description	Safe - Insulation		
Sample Number	P2100299-Visual inspection		
Sample Status	Negative		
Hazardous Material / Asbestos Content	Presumed		
Risk Assessment	-	Priority Rating	-
Recommendations	No action required

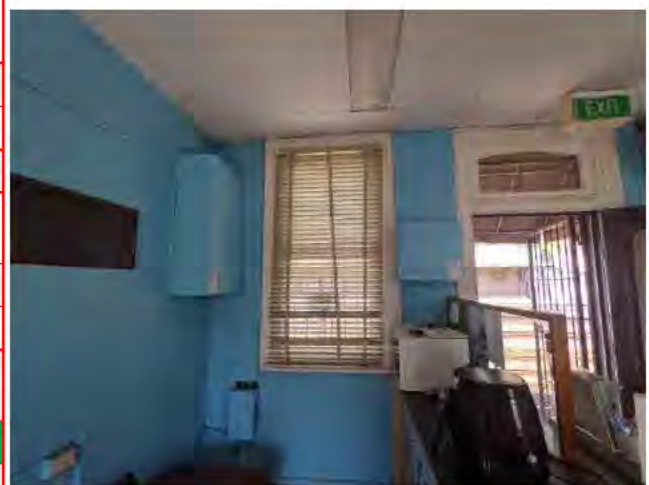
Item Number	10	Reinspection Date	Apr-27
Survey Level	1st Floor		
Building	Building 1 Old Petersham Station		
Room	Entry room		
Item Location and Description	Electrical board - Bituminous backing board		
Sample Number	P2100299-OHMS-41906		
Sample Status	Positive		
Hazardous Material / Asbestos Content	Chrysotile		
Risk Assessment	5	Priority Rating	Very Low
Recommendations	Label and manage in-situ (non-friable).

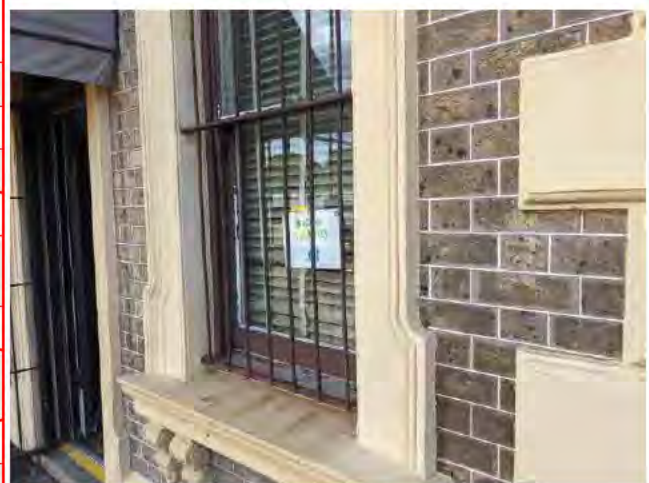
Item Number	11	Reinspection Date	-
Survey Level	1st Floor		
Building	Building 1 Old Petersham Station		
Room	External		
Item Location and Description	Windows - Window caulking		
Sample Number	Previously Sampled: OHMS-41915		
Sample Status	Negative		
Hazardous Material / Asbestos Content	No asbestos detected		
Risk Assessment	-	Priority Rating	-
Recommendations	No action required

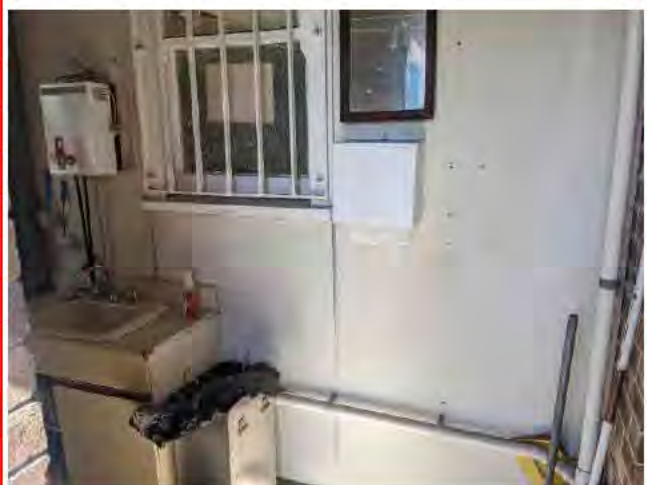
Item Number	13	Reinspection Date	Apr-27
Survey Level	1st Floor		
Building	Building 1 Old Petersham Station		
Room	External, Kitchen		
Item Location and Description	South Wall - Fibre cement sheet		
Sample Number	P2100299-OHMS-41907		
Sample Status	Positive		
Hazardous Material / Asbestos Content	Chrysotile		
Risk Assessment	8	Priority Rating	Very Low
Recommendations	Encapsulate, label and manage in-situ (non-friable).
