Sydney Trains Environmental Management System Site Environmental Management Plan (SEMP)

Project / Program Details		
Project/Program Name	Petersham Terminus Street Building works (Internal)	
Project/Program No	P.0091011.03	
Scope of Works	Heritage maintenance works including; Internal refurbishment works to bring the building to a 'warm shell', as per heritage approvals.	
What is the cost of the scope of works?	<input type="checkbox"/> Routine maintenance - any value <input checked="" type="checkbox"/> Capital investment - less than \$5 million <input type="checkbox"/> Capital investment - more than \$5 million	
Location	Petersham – 5.540 km	
Attach applicable Environmental Work Method Statement (EWMS)	EWMS Number	EWMS Title
	EMS-03-EW-0299	Station Refresh
Is any of the proposed work outside of the EWMS' scope?	<input checked="" type="checkbox"/> No: Continue to next question <input type="checkbox"/> Yes:

SCHEDULE OF WORKS – FORMER PETERSHAM STATION BUILDING INTERIOR CONSERVATION – ISSUE E – 26 May 2025

Hazardous Building Materials Management Plan

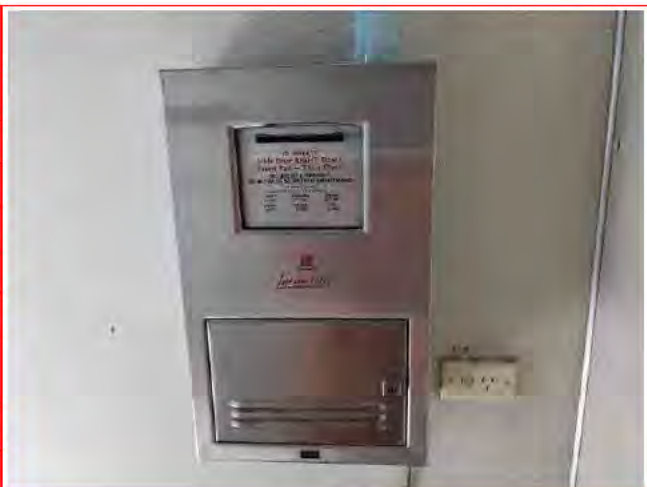
Item Number	14	Reinspection Date	-
Survey Level	1st Floor		
Building	Building 1 Old Petersham Station		
Room	Female toilet		
Item Location and Description	Incinerator - Insulation		
Sample Number	P2100299-Visual inspection		
Sample Status	Negative		
Hazardous Material / Asbestos Content	Presumed		
Risk Assessment	-	Priority Rating	-
Recommendations	No action required

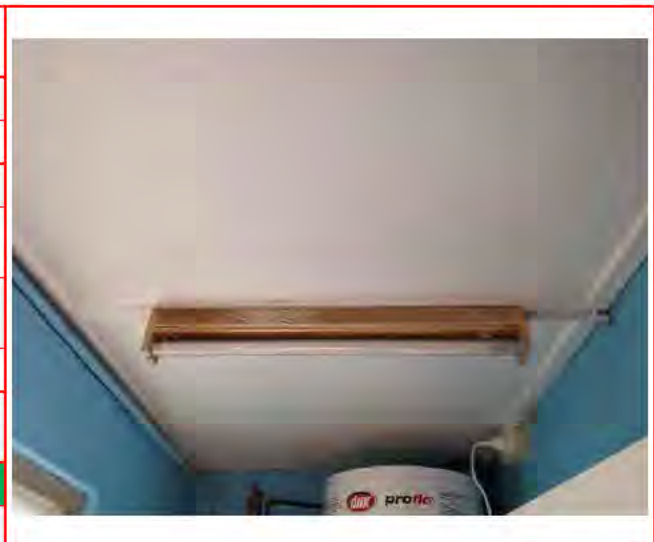
Item Number	17	Reinspection Date	Apr-27
Survey Level	1st Floor		
Building	Building 1 Old Petersham Station		
Room	Male toilet		
Item Location and Description	Ceiling lining - Fibre cement sheet		
Sample Number	Previously Sampled: OHMS-41907		
Sample Status	Positive		
Hazardous Material / Asbestos Content	Chrysotile		
Risk Assessment	4	Priority Rating	Very Low
Recommendations	Label and manage in-situ (non-friable).

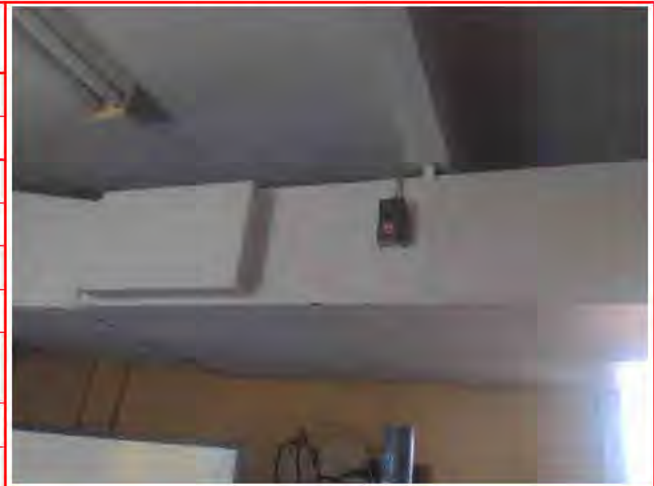
Item Number	18	Reinspection Date	-
Survey Level	1st Floor		
Building	Building 1 Old Petersham Station		
Room	Storage room		
Item Location and Description	Ducting - Insulating Board		
Sample Number	P2100299-Visual inspection		
Sample Status	Negative		
Hazardous Material / Asbestos Content	Presumed		
Risk Assessment	-	Priority Rating	-
Recommendations	No action required

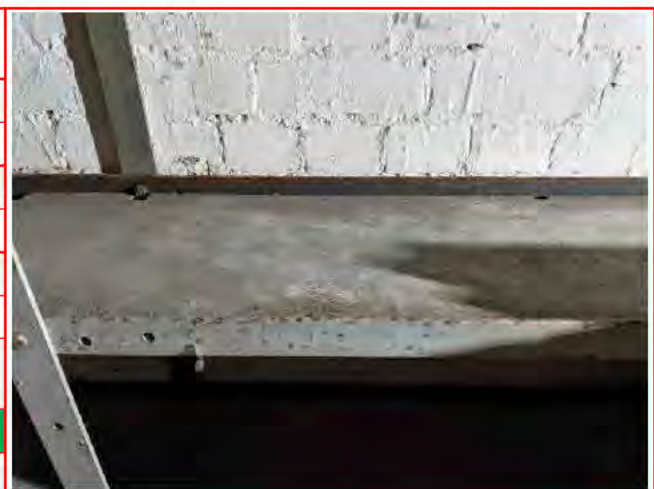
Item Number	20	Reinspection Date	Apr-27
Survey Level	Basement		
Building	Original Petersham Station		
Room	Basement, Undercroft		
Item Location and Description	Shelves - Fibre cement sheet		
Sample Number	Previously Sampled: 011		
Sample Status	Positive		
Hazardous Material / Asbestos Content	Chrysotile		
Risk Assessment	8	Priority Rating	Very Low
Recommendations	Remove under non-friable conditions.

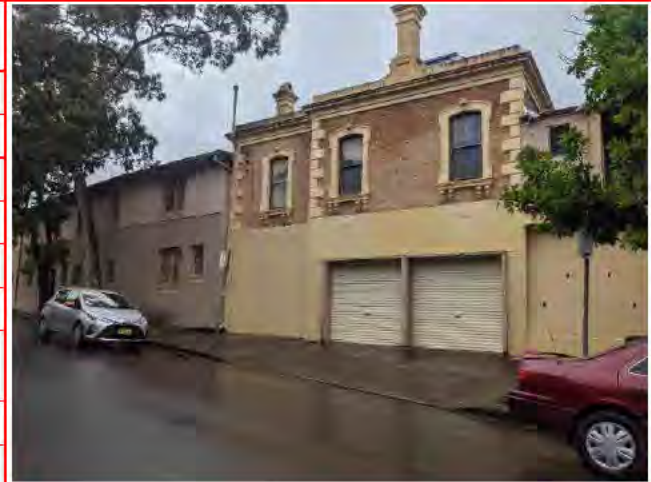
Item Number	21	Reinspection Date	-
Survey Level	Basement		
Building	Original Petersham Station		
Room	External		
Item Location and Description	Gable Ends - Fibre cement sheet		
Sample Number	-		
Sample Status	Negative		
Hazardous Material / Asbestos Content	Presumed		
Risk Assessment	-	Priority Rating	-
Recommendations	No action required

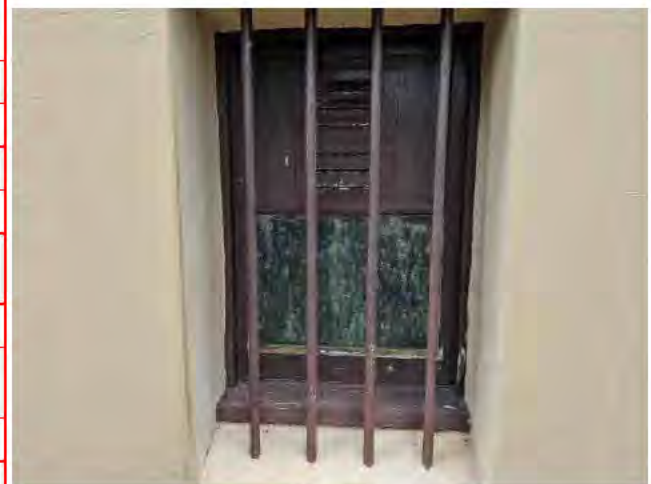
Item Number	22	Reinspection Date	-
Survey Level	1st Floor		
Building	Original Petersham Station		
Room	Exterior		
Item Location and Description	Window - Window caulking		
Sample Number	Previously Sampled: OHMS-41915		
Sample Status	Negative		
Hazardous Material / Asbestos Content	No asbestos detected		
Risk Assessment	-	Priority Rating	-
Recommendations	No action required

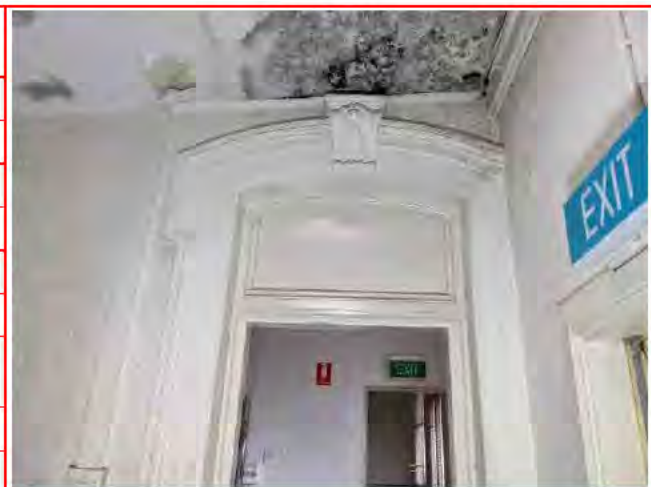
Item Number	23	Reinspection Date	-
Survey Level	1st Floor		
Building	Original Petersham Station		
Room	Kitchen		
Item Location and Description	Door infill		
Sample Number	P2100299-Visual inspection		
Sample Status	Negative		
Hazardous Material / Asbestos Content	Presumed No asbestos detected		
Risk Assessment	-	Priority Rating	-
Recommendations	No action required

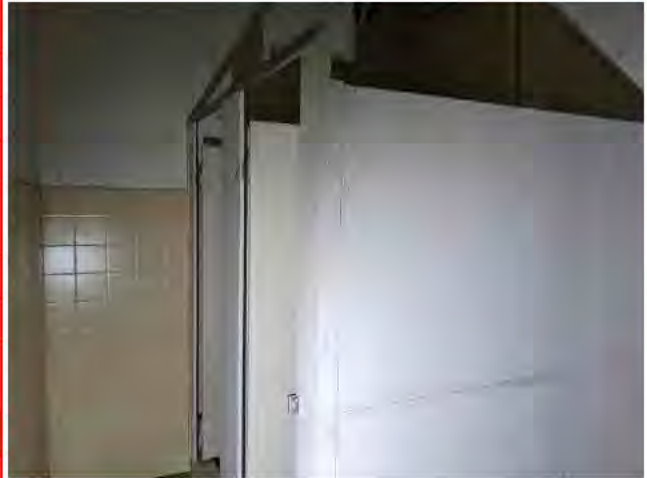
Item Number	24	Reinspection Date	Apr-27
Survey Level	1st Floor		
Building	Original Petersham Station		
Room	Male Toilet		
Item Location and Description	Partitions - Compressed cement sheet		
Sample Number	Previously Sampled: 007		
Sample Status	Positive		
Hazardous Material / Asbestos Content	Chrysotile		
Risk Assessment	6	Priority Rating	Very Low
Recommendations	Label and manage in-situ (non-friable).

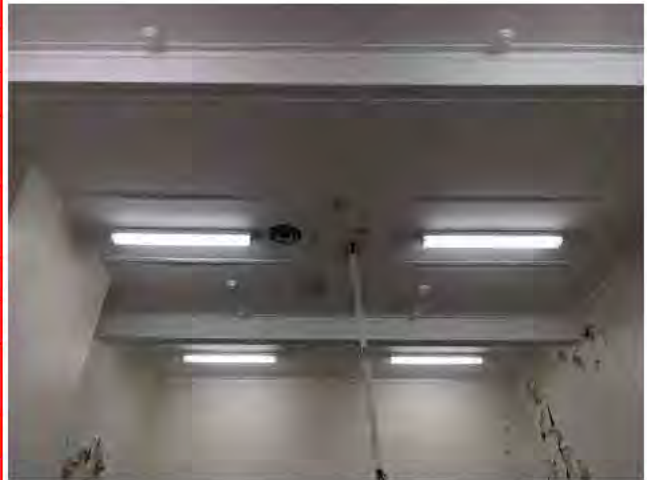
Item Number	26	Reinspection Date	Apr-27
Survey Level	1st Floor		
Building	Original Petersham Station		
Room	Rooms No.2 East, No.4 East, No.2 West & No.5 West		
Item Location and Description	Ceiling linings - Fibre cement sheet		
Sample Number	P2100299-OHMS-41917		
Sample Status	Positive		
Hazardous Material / Asbestos Content	Chrysotile		
Risk Assessment	12	Priority Rating	Low
Recommendations	Encapsulate, label and manage in-situ (non-friable).

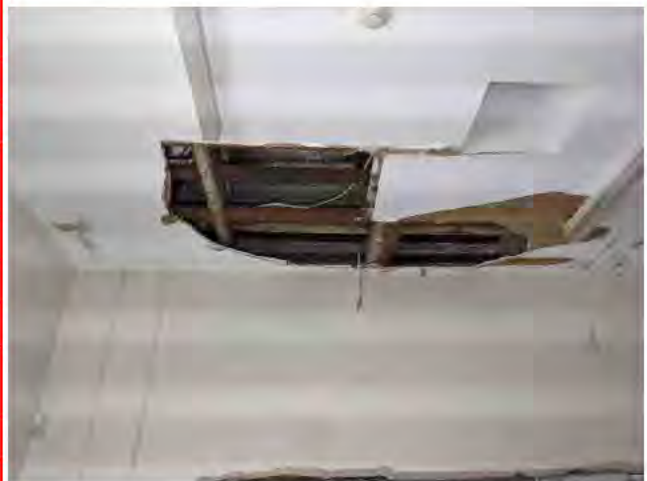
Item Number	27	Reinspection Date	-
Survey Level	1st Floor		
Building	Original Petersham Station		
Room	Unisex Toilet, Male & Female Toilet		
Item Location and Description	Ceiling		
Sample Number	P2100299-Visual inspection		
Sample Status	Negative		
Hazardous Material / Asbestos Content	No asbestos detected		
Risk Assessment	-	Priority Rating	-
Recommendations	No action required

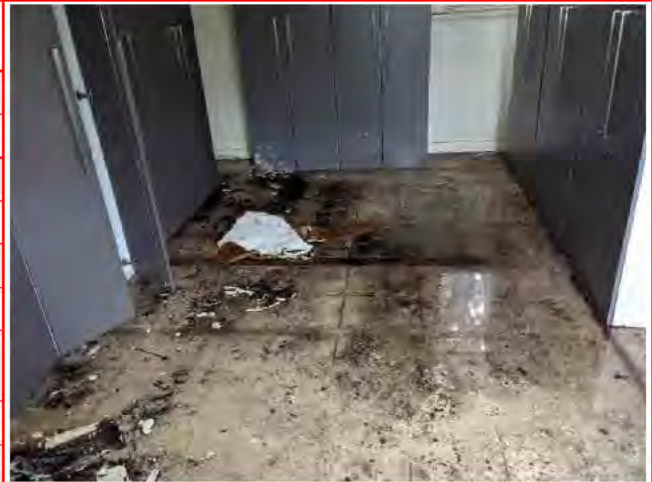
Item Number	28	Reinspection Date	-
Survey Level	1st Floor		
Building	Original Petersham Station		
Room	Western most Office area		
Item Location and Description	Floor - Vinyl floor tiles		
Sample Number	P2100299-OHMS-41922		
Sample Status	Negative		
Hazardous Material / Asbestos Content	No asbestos detected		
Risk Assessment	-	Priority Rating	-
Recommendations	No action required

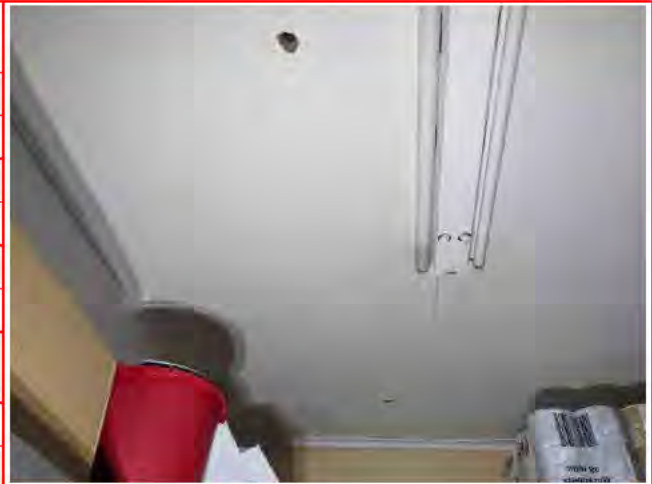
Item Number	29	Reinspection Date	-
Survey Level	Basement		
Building	Building 1 Old Petersham Station		
Room	Basement		
Item Location and Description	Ceiling (White paint)		
Sample Number	L24		
Sample Status	Previously Sampled		
Hazardous Material / Asbestos Content	Positive Swab		
Risk Assessment	-	Priority Rating	-
Recommendations	Manage in-situ.

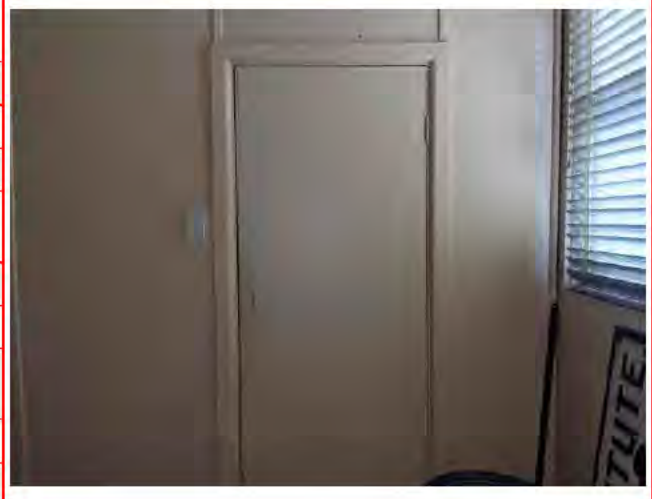
Item Number	30	Reinspection Date	-
Survey Level	Basement		
Building	Building 1 Old Petersham Station		
Room	Basement		
Item Location and Description	Walls (Peach with green undercoat paint)		
Sample Number	OHMS-41901		
Sample Status	Previously Sampled		
Hazardous Material / Asbestos Content	Positive Swab		
Risk Assessment	-	Priority Rating	-
Recommendations	Manage in-situ.

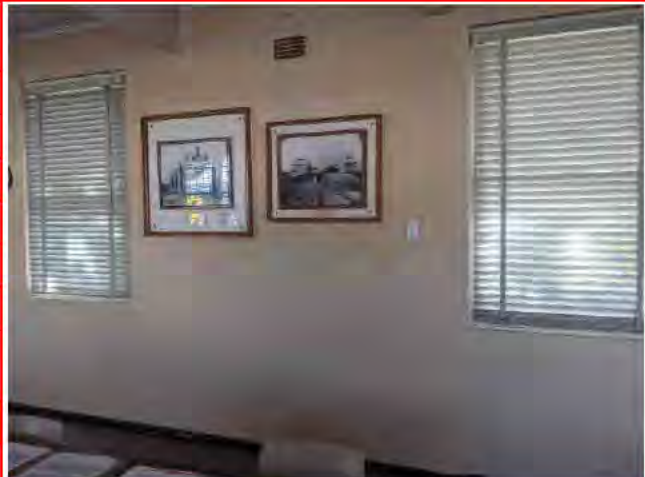
Item Number	32	Reinspection Date	-
Survey Level	1st Floor		
Building	Building 1 Old Petersham Station		
Room	Board room		
Item Location and Description	Walls (Peach paint)		
Sample Number	OHMS-41901		
Sample Status	Previously Sampled		
Hazardous Material / Asbestos Content	Lead Containing Paint		
Risk Assessment	10	Priority Rating	Medium
Recommendations	Encapsulate with non-lead based paint

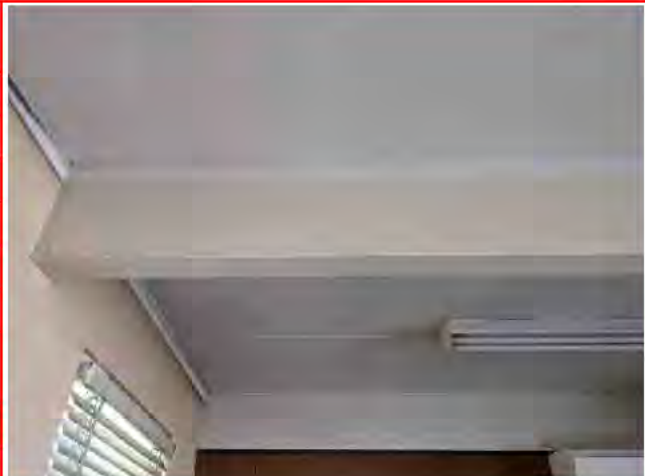
Item Number	33	Reinspection Date	-
Survey Level	1st Floor		
Building	Building 1 Old Petersham Station		
Room	Board room & Store		
Item Location and Description	Ceiling beams (Cream paint)		
Sample Number	OHMS-41904		
Sample Status	Sampled		
Hazardous Material / Asbestos Content	Lead Containing Paint		
Risk Assessment	4	Priority Rating	Very Low
Recommendations	Manage in-situ.

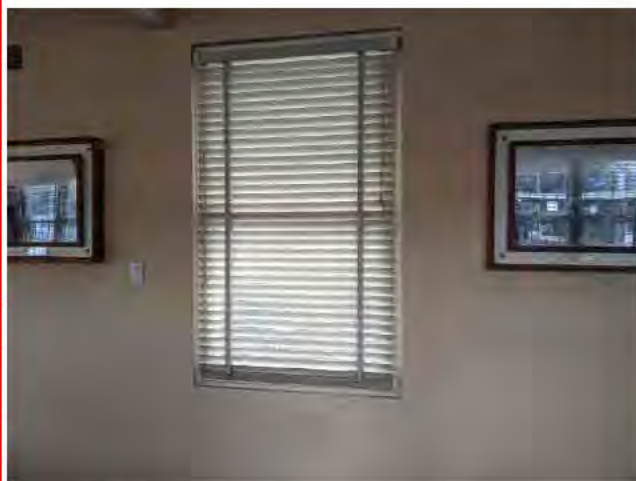
Item Number	34	Reinspection Date	-
Survey Level	1st Floor		
Building	Building 1 Old Petersham Station		
Room	Board room and Storage room		
Item Location and Description	Window frames and Timber Trim (White paint)		
Sample Number	L22		
Sample Status	Previously Sampled		
Hazardous Material / Asbestos Content	Positive Swab		
Risk Assessment	-	Priority Rating	-
Recommendations	Encapsulate with non-lead based paint

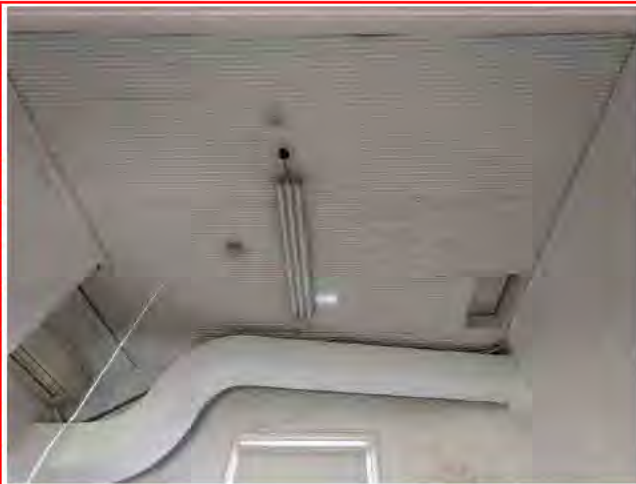
Item Number	35	Reinspection Date	-
Survey Level	1st Floor		
Building	Building 1 Old Petersham Station		
Room	Ceiling space		
Item Location and Description	Settled Dust		
Sample Number	Visual inspection		
Sample Status	Strongly Presumed		
Hazardous Material / Asbestos Content	Lead Contaminated Dust		
Risk Assessment	-	Priority Rating	Low
Recommendations	Remove in accordance with legislation.

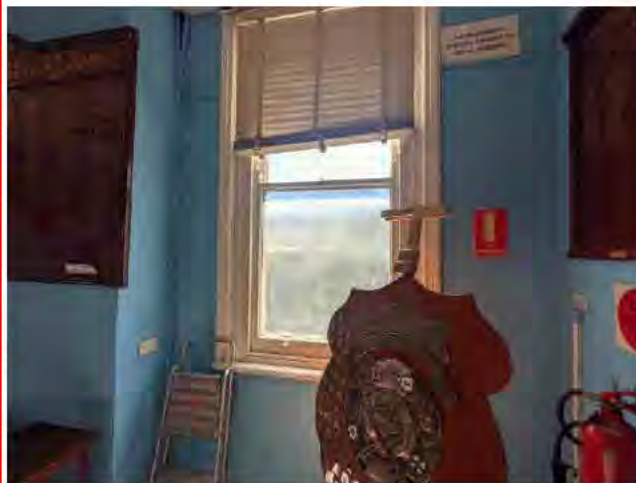
Item Number	36	Reinspection Date	-
Survey Level	1st Floor		
Building	Building 1 Old Petersham Station		
Room	Entry Foyer, Office, Kitchen, Trophy room Basement		
Item Location and Description	Door and window frames (White paint)		
Sample Number	L24		
Sample Status	Previously Sampled		
Hazardous Material / Asbestos Content	Positive Swab		
Risk Assessment	-	Priority Rating	-
Recommendations	Manage in-situ.

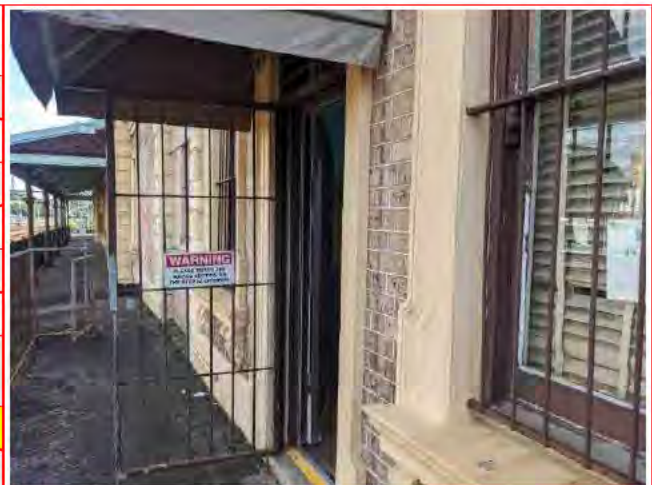
Item Number	40	Reinspection Date	-
Survey Level	1st Floor		
Building	Building 1 Old Petersham Station		
Room	External		
Item Location and Description	Entry door (Brown paint)		
Sample Number	OHMS-41910		
Sample Status	Sampled		
Hazardous Material / Asbestos Content	Lead Containing Paint		
Risk Assessment	5	Priority Rating	Low
Recommendations	Encapsulate with non-lead based paint

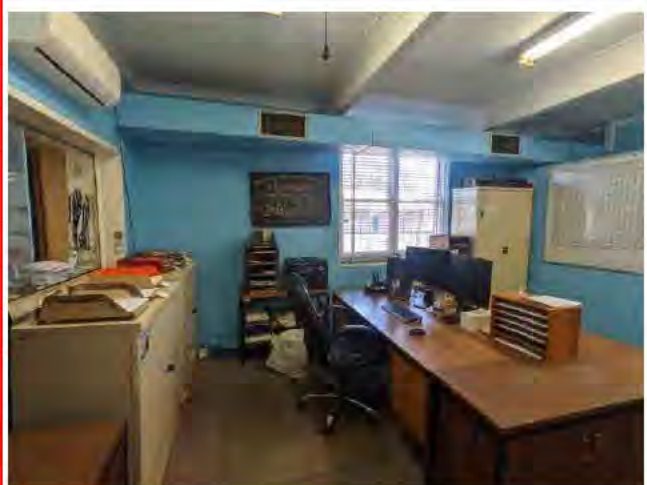
Item Number	43	Reinspection Date	-
Survey Level	1st Floor		
Building	Building 1 Old Petersham Station		
Room	Main Entry, Office, Kitchen, Stairs and Male Toilets		
Item Location and Description	Walls (Blue paint)		
Sample Number	L23		
Sample Status	Previously Sampled		
Hazardous Material / Asbestos Content	Positive Swab		
Risk Assessment	-	Priority Rating	Very Low
Recommendations	Encapsulate with non-lead based paint

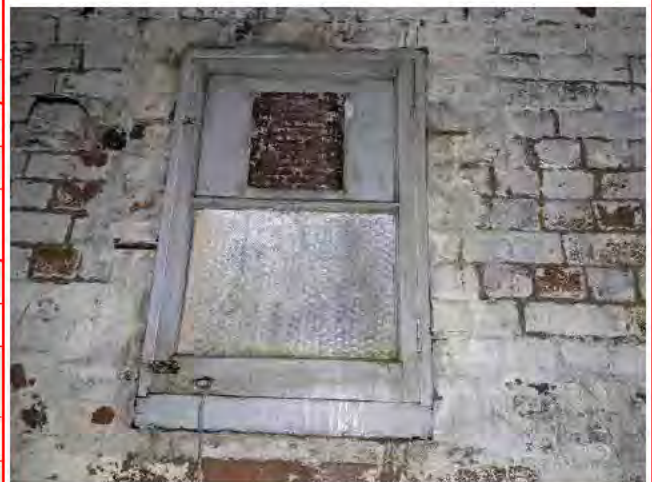
Item Number	49	Reinspection Date	-
Survey Level	Basement		
Building	Original Petersham Station		
Room	Basement, Undercroft		
Item Location and Description	Windows (Grey with white undercoat paint)		
Sample Number	L38		
Sample Status	Previously Sampled		
Hazardous Material / Asbestos Content	Positive Swab		
Risk Assessment	-	Priority Rating	-
Recommendations	Encapsulate with non-lead based paint

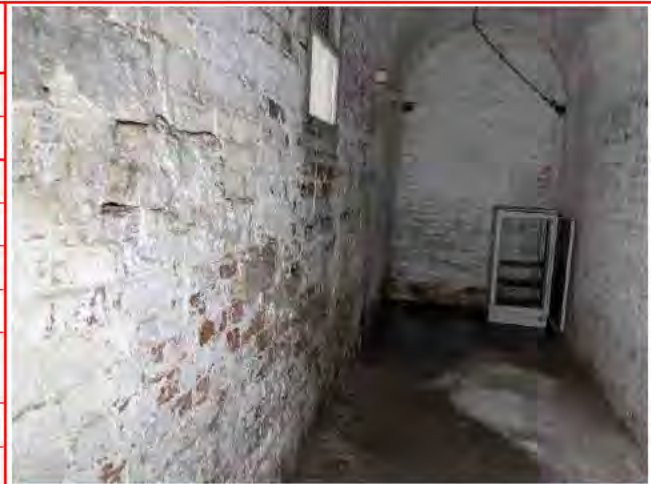
Item Number	50	Reinspection Date	-
Survey Level	Basement		
Building	Original Petersham Station		
Room	Basement, Undercroft		
Item Location and Description	Walls (White paint)		
Sample Number	OHMS-41924		
Sample Status	Sampled		
Hazardous Material / Asbestos Content	No Lead Detected		
Risk Assessment	-	Priority Rating	-
Recommendations	No action required (no lead)

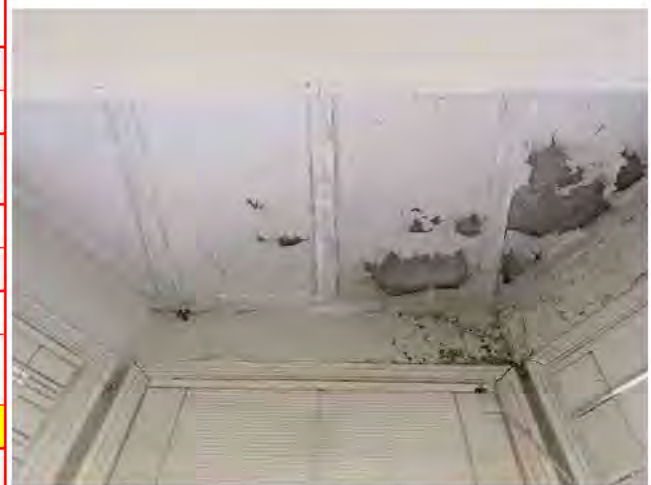
Item Number	52	Reinspection Date	-
Survey Level	1st Floor		
Building	Original Petersham Station		
Room	All office rooms, Entry foyer, Toilet and Bathroom		
Item Location and Description	Original ceilings (White paint)		
Sample Number	OHMS-41918		
Sample Status	Sampled		
Hazardous Material / Asbestos Content	Lead Containing Paint		
Risk Assessment	7	Priority Rating	Low
Recommendations	Remove in accordance with legislation (industrial applications).

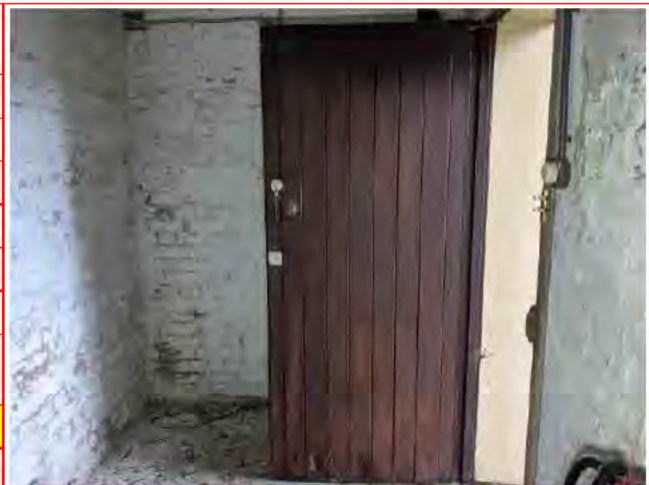
Item Number	55	Reinspection Date	-
Survey Level	1st Floor		
Building	Original Petersham Station		
Room	Exterior		
Item Location and Description	Entry door (Brown paint)		
Sample Number	OHMS-41910		
Sample Status	Previously Sampled		
Hazardous Material / Asbestos Content	Lead Containing Paint		
Risk Assessment	8	Priority Rating	Low
Recommendations	Manage in-situ.

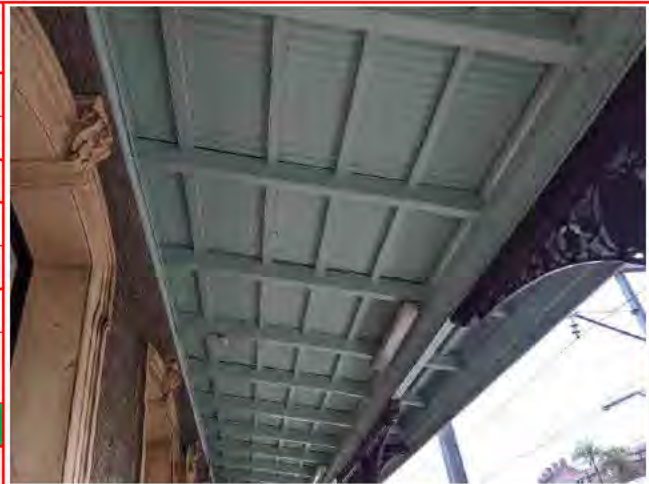
Item Number	57	Reinspection Date	-
Survey Level	1st Floor		
Building	Original Petersham Station		
Room	External, Awning		
Item Location and Description	Timber work (Green paint)		
Sample Number	OHMS-41923		
Sample Status	Sampled		
Hazardous Material / Asbestos Content	Lead Containing Paint		
Risk Assessment	4	Priority Rating	Very Low
Recommendations	Manage in-situ.

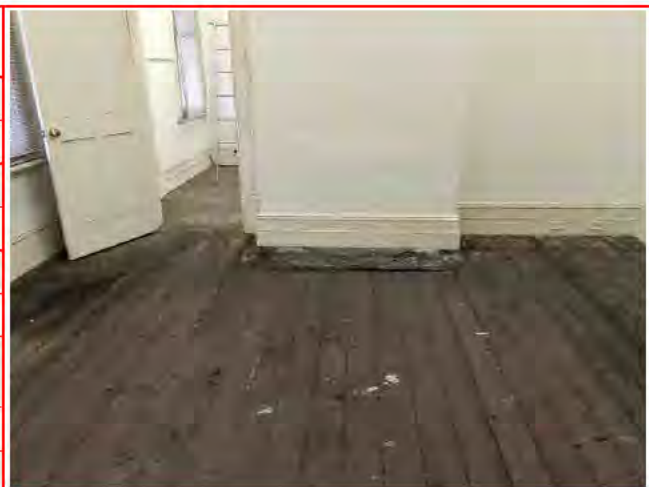
Item Number	58	Reinspection Date	-
Survey Level	1st Floor		
Building	Original Petersham Station		
Room	Internal, Office rooms		
Item Location and Description	Former fire place stone		
Sample Number	OHMS-41920		
Sample Status	Sampled		
Hazardous Material / Asbestos Content	No Lead Detected		
Risk Assessment	-	Priority Rating	-
Recommendations	No action required (no lead)

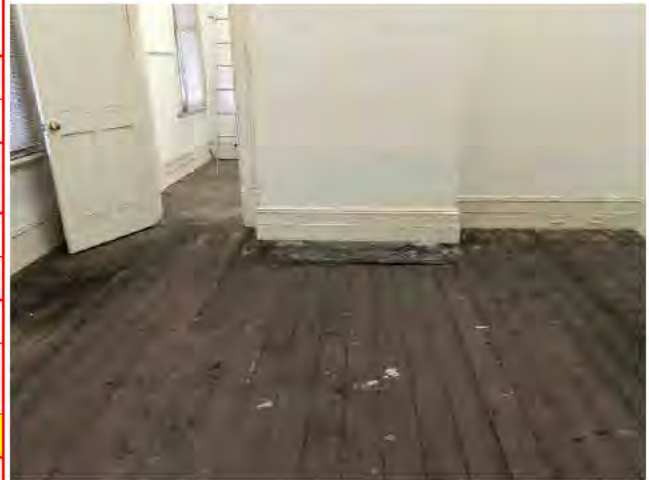
Item Number	59	Reinspection Date	-
Survey Level	1st Floor		
Building	Original Petersham Station		
Room	Office rooms, Lunch room, toilet and Bathroom		
Item Location and Description	Timber skirting (White paint)		
Sample Number	OHMS-41919		
Sample Status	Sampled		
Hazardous Material / Asbestos Content	Lead Containing Paint		
Risk Assessment	8	Priority Rating	Low
Recommendations	Manage in-situ.

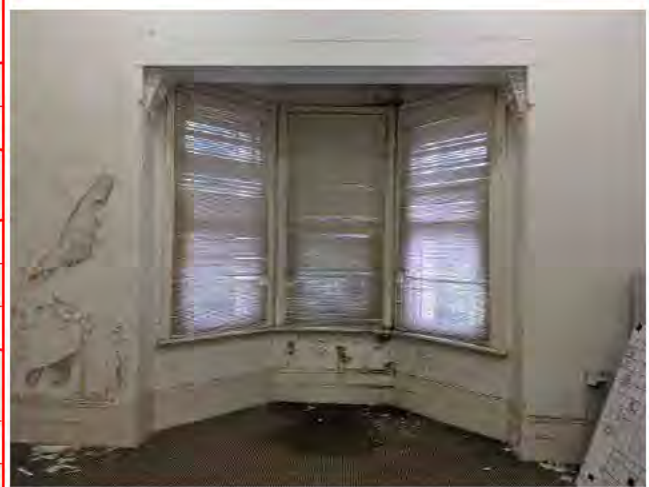
Item Number	60	Reinspection Date	-
Survey Level	1st Floor		
Building	Original Petersham Station		
Room	Office rooms, Lunch room, toilet and Bathroom		
Item Location and Description	Window frames (White paint)		
Sample Number	L28		
Sample Status	Previously Sampled		
Hazardous Material / Asbestos Content	Positive Swab		
Risk Assessment	-	Priority Rating	-
Recommendations	Manage in-situ.

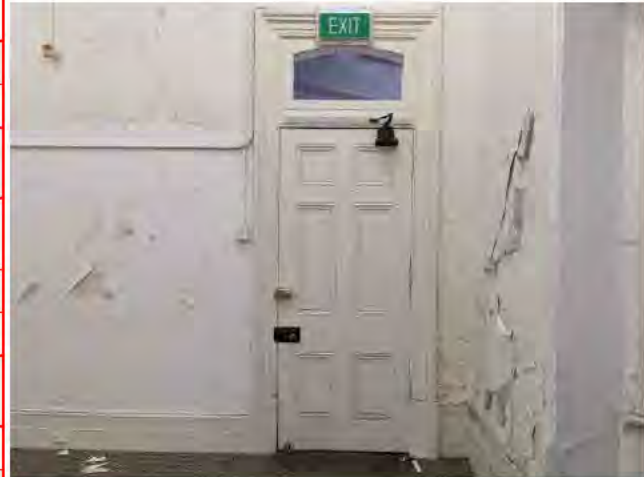
Item Number	61	Reinspection Date	-
Survey Level	1st Floor		
Building	Original Petersham Station		
Room	Office rooms, Lunch room, toilet and Bathroom		
Item Location and Description	Door and Door frames (White paint)		
Sample Number	L28		
Sample Status	Previously Sampled		
Hazardous Material / Asbestos Content	Positive Swab		
Risk Assessment	-	Priority Rating	-
Recommendations	Manage in-situ.

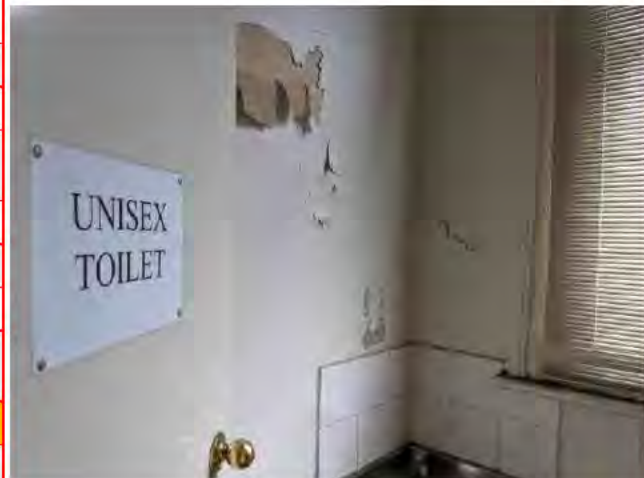
Item Number	62	Reinspection Date	-
Survey Level	1st Floor		
Building	Original Petersham Station		
Room	Unisex Toilet, Male Toilet and Female Toilet		
Item Location and Description	Walls and Ceiling		
Sample Number	OHMS-41916		
Sample Status	Sampled		
Hazardous Material / Asbestos Content	Lead Containing Paint		
Risk Assessment	11	Priority Rating	Medium
Recommendations	Remove in accordance with legislation (industrial applications).

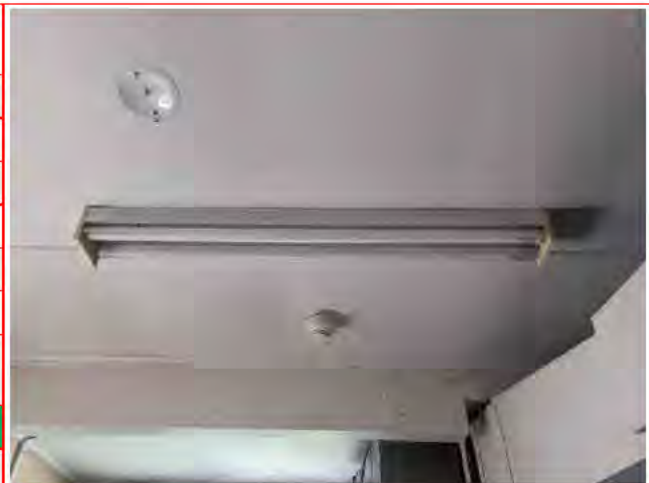
Item Number	65	Reinspection Date	-
Survey Level	1st Floor		
Building	Building 1 Old Petersham Station		
Room	Board room and Storage room		
Item Location and Description	Light fitting		
Sample Number	-		
Sample Status	Positive		
Hazardous Material / Asbestos Content	PCB		
Risk Assessment	-	Priority Rating	Very Low
Recommendations	Confirm status or remove.

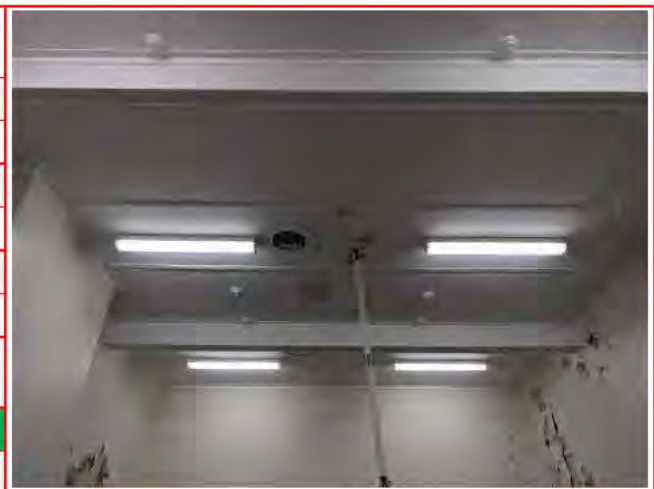
Item Number	67	Reinspection Date	-
Survey Level	Ground Floor		
Building	Original Petersham Station		
Room	Internal		
Item Location and Description	Flourescent lights		
Sample Number	-		
Sample Status	Positive		
Hazardous Material / Asbestos Content	PCB		
Risk Assessment	-	Priority Rating	Very Low
Recommendations	Confirm status or remove.

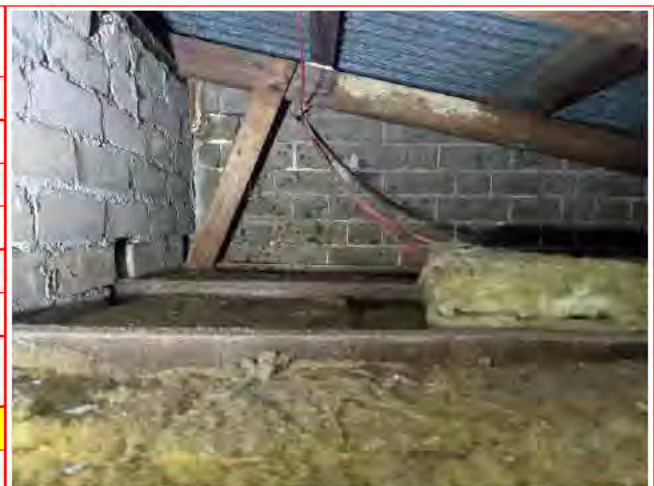
Item Number	68	Reinspection Date	-
Survey Level	1st Floor		
Building	Building 1 Old Petersham Station		
Room	Ceiling space		
Item Location and Description	Insulation Batts		
Sample Number	-		
Sample Status	Presumed		
Hazardous Material / Asbestos Content	SMF		
Risk Assessment	-	Priority Rating	Low
Recommendations	Manage in-situ.

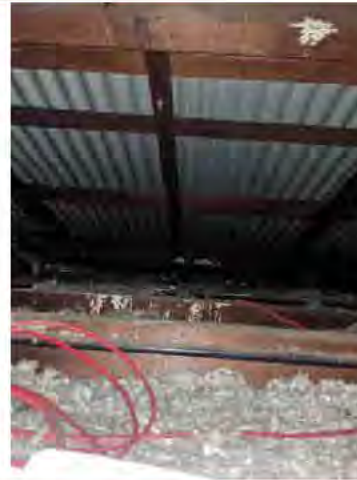
Item Number	69	Reinspection Date	-
Survey Level	1st Floor		
Building	Building 1 Old Petersham Station		
Room	Ceiling space		
Item Location and Description	Insulation		
Sample Number	OHMS-41913		
Sample Status	Presumed		
Hazardous Material / Asbestos Content	SMF		
Risk Assessment	-	Priority Rating	Low
Recommendations	Manage in-situ.

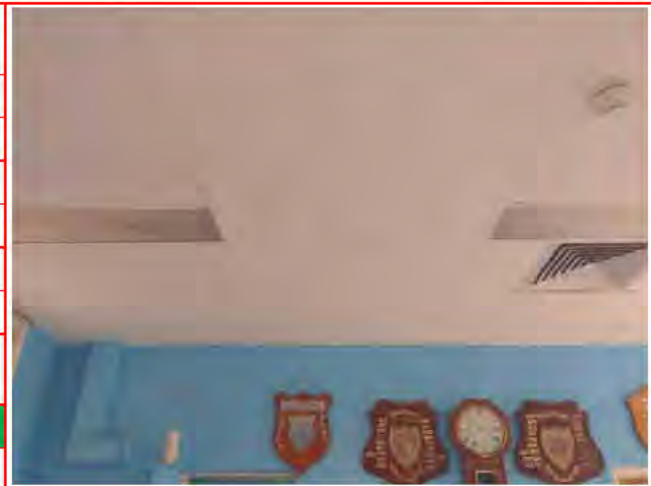
Item Number	70	Reinspection Date	-
Survey Level	1st Floor		
Building	Building 1 Old Petersham Station		
Room	Main Entry		
Item Location and Description	Ceiling tiles		
Sample Number	Visual inspection		
Sample Status	Presumed		
Hazardous Material / Asbestos Content	SMF		
Risk Assessment	-	Priority Rating	Very Low
Recommendations	Manage in-situ.

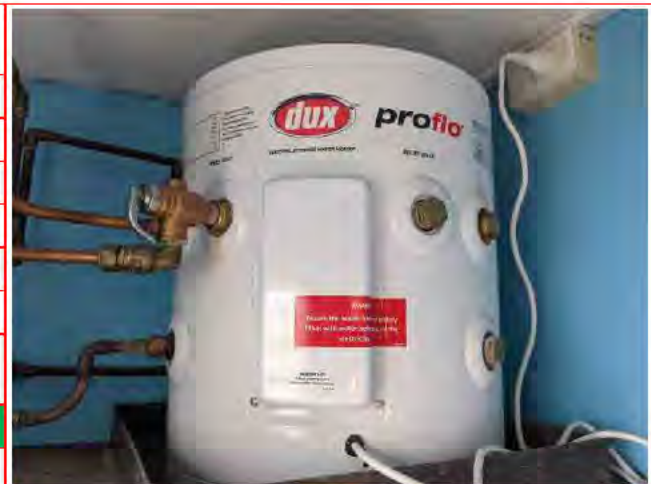
Item Number	71	Reinspection Date	-
Survey Level	1st Floor		
Building	Building 1 Old Petersham Station		
Room	Male toilet		
Item Location and Description	Hot Water Heater		
Sample Number	Visual inspection		
Sample Status	Presumed		
Hazardous Material / Asbestos Content	SMF		
Risk Assessment	-	Priority Rating	Very Low
Recommendations	Manage in-situ.

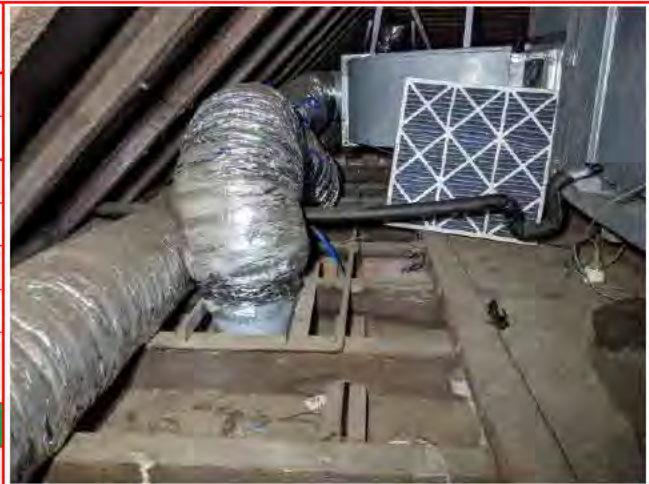
Item Number	72	Reinspection Date	-
Survey Level	1st Floor		
Building	Original Petersham Station		
Room	Ceiling space		
Item Location and Description	Flexible A/C ducting		
Sample Number	-		
Sample Status	Presumed		
Hazardous Material / Asbestos Content	SMF		
Risk Assessment	-	Priority Rating	Very Low
Recommendations	Manage in-situ

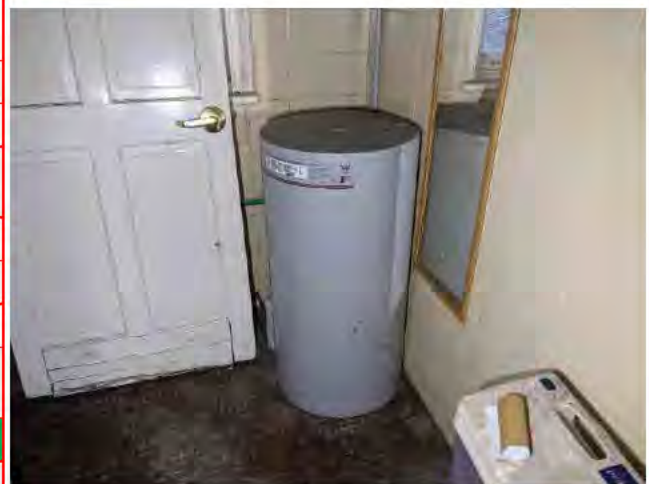
Item Number	73	Reinspection Date	-
Survey Level	1st Floor		
Building	Original Petersham Station		
Room	Unisex Toilet, Female Toilet and Lunch room		
Item Location and Description	Hot Water Heater		
Sample Number	Visual inspection		
Sample Status	Presumed		
Hazardous Material / Asbestos Content	SMF		
Risk Assessment	-	Priority Rating	Very Low
Recommendations	Manage in-situ.
