Appendix H – Nowra Bridge adaptive reuse strategic options report

Nowra Bridge (BN713) over the Shoalhaven River

Adaptive Reuse Strategic Options

November 2023

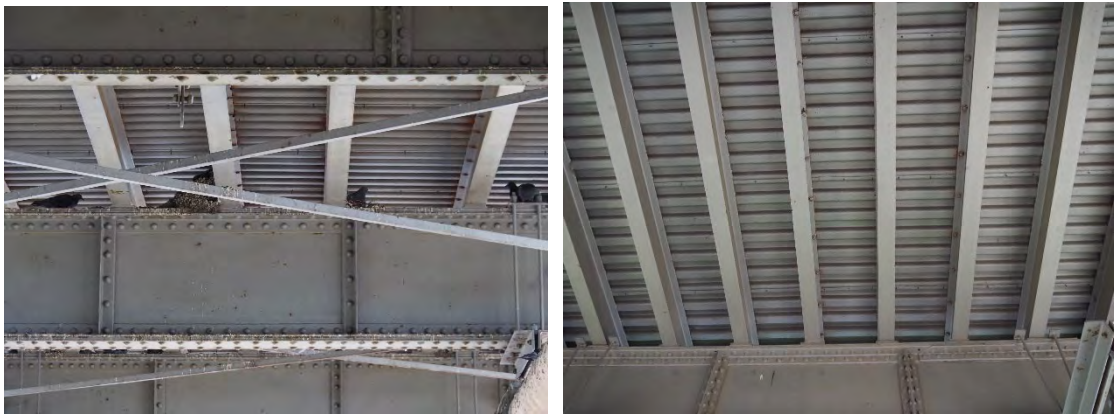
Figure 3-2 Soffit span 9 (Source: FBE)

The overall rating has been assessed as **“good”** by TfNSW.

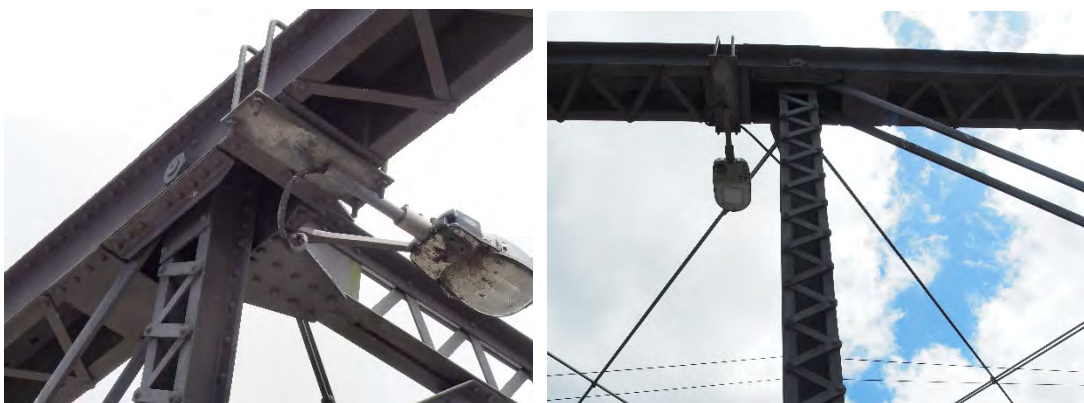
Figure 3-10 Bridge Lighting (Source: FBE)

Two overhead lights are generally provided per truss situated on the eastern side of the truss and overhanging slightly towards the carriageway.

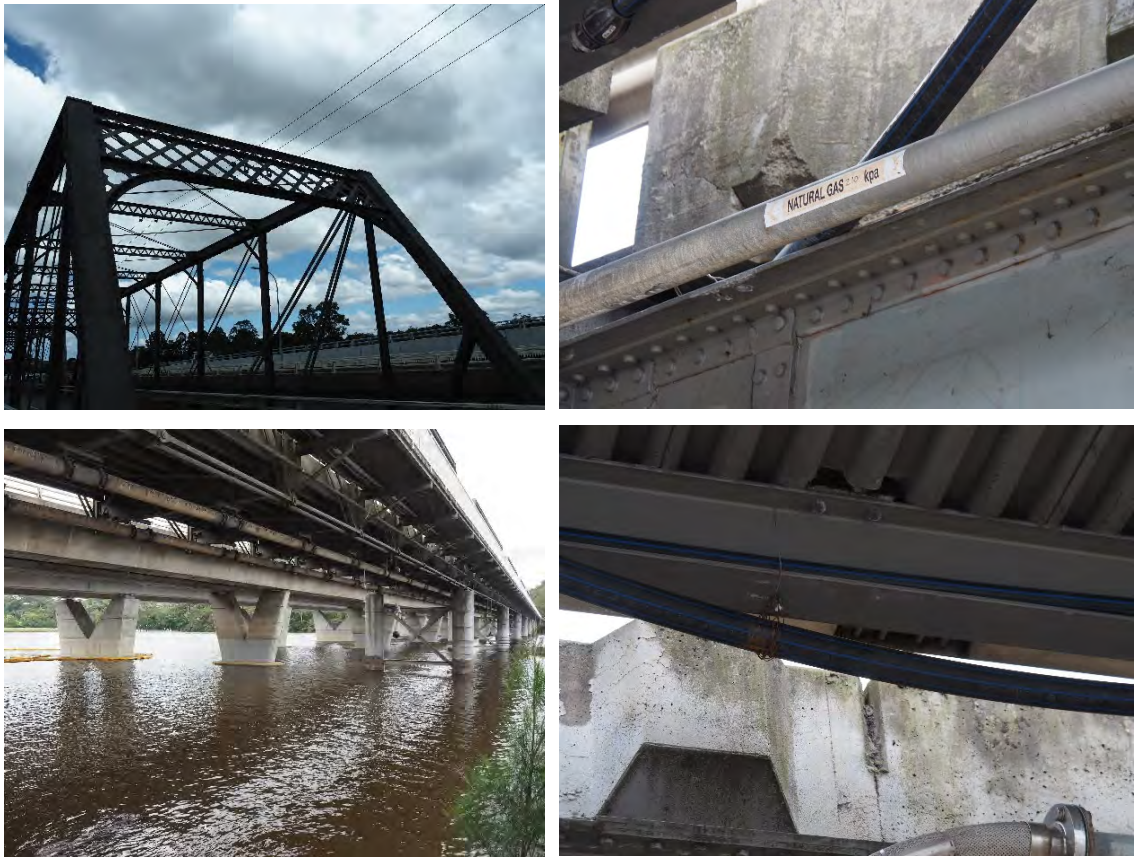
Figure 3-11 Utilities located on the bridge (Source: FBE)

Several utilities are located on the bridge, and the utility search results are summarised in Table 6-1. It should be noted that some of the assets may have already been relocated to the new bridge (TfNSW to confirm).

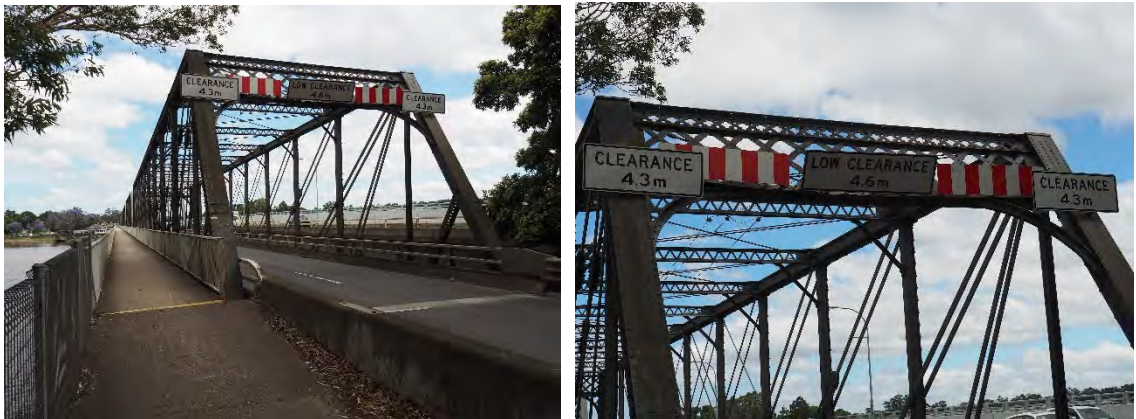
Figure 3-12 Northern end of the bridge (existing signage) (Source: FBE)

Low clearance signs are located on the Abutment A end of the bridge. At the time of writing, these signs were planned to be removed.

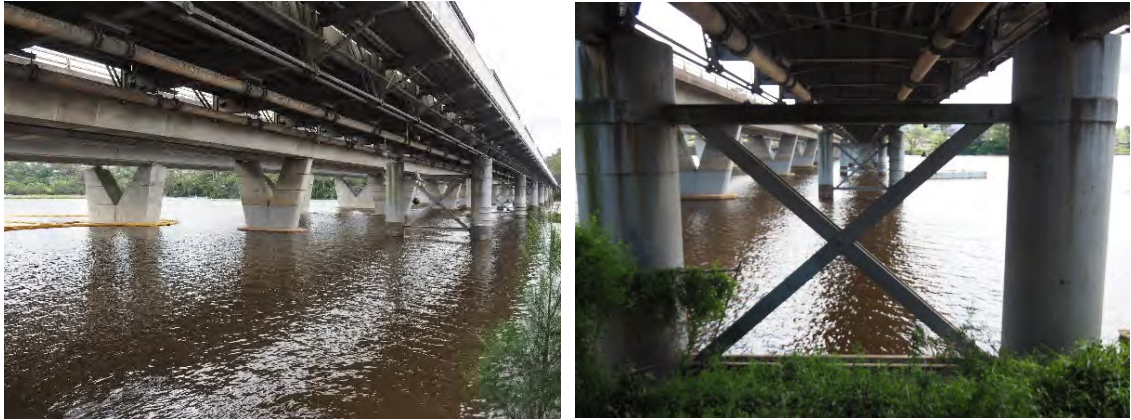
Figure 3-13 Bridge piers (Source: FBE)

The bridge is supported by eight piers, each consisting of two cast iron caissons manufactured locally in Australia. The caissons were recently repainted. The Cathodic Protection (CP) protects the piers from further graphitisation and appears to function successfully. The most recent structural assessment has found that the piers have adequate capacity.

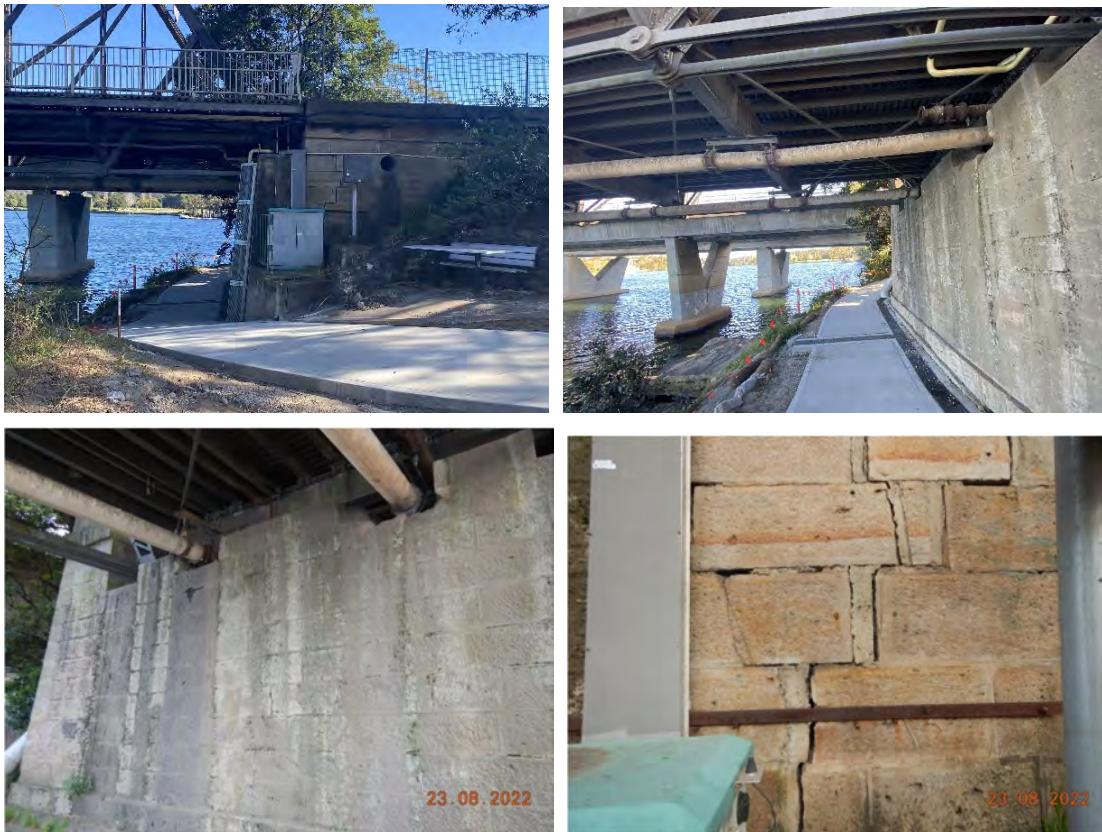
Figure 3-14 Abutment A - Sydney end (Source: FBE and TfNSW)

The northern abutment of the bridge retains much of its original form and fabric, constructed from dressed sandstone blocks set on concrete footings supported by timber piles. The sandstone extends to wing walls on both sides of the abutment. A minor shift at the eastern face has been stabilised with steel strapping. Some of the upper stonework has been displaced due to the installation of pipes under the bridge. Road drainage is integrated into the wing walls, managed by spoon drains on the eastern side and a large-diameter pipe that reroutes water across the western side.

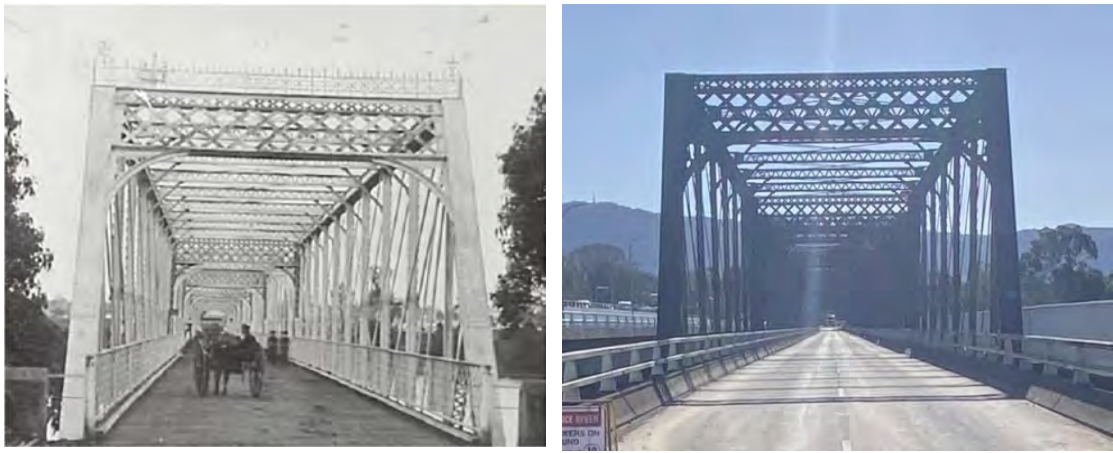
Figure 4-10 LHS: LHS Early Photo of Entry Portal, RHS: Entry Portal as currently exists (Source: Shoalhaven Historical Society, FBE)

In the design of the Nowra Bridge, the architect chose to enhance its appearance with decorative elements. These included three-leaf cutouts in the corner plates, four-leaf cutouts over the lattice truss, and cast iron rosettes at lattice bracing connection points. Originally, each portal featured non-structural vertical cresting decorations adorned with four-leaf cutouts and spear points. However, these embellishments and rosettes no longer exist today.

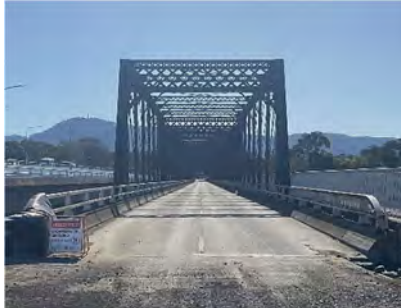
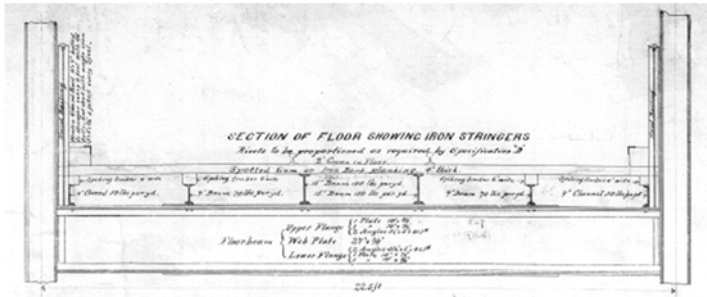
Figure 4-14 Left: Bridge in current form Right: DMR WAE Bridge Deck (Source: FBE, DMR)

The present deck is not original and holds no particular engineering or aesthetic significance. The modified New Jersey kerb, featuring RHS steel rails, is considered Intrusive, even though it was necessary to meet current design standards for the bridge's operation. Its appearance differs significantly from the original lattice barrier present when the bridge was built.
