CAPTAINS FLAT RAIL CORRIDOR ENVIRONMENTAL MANAGEMENT PLAN

Project name **Captains Flat Rail Corridor Contamination Management**
Project no. **318001025**
Recipient **Transport for New South Wales**
Document type **Environmental Management Plan**
Report ref. **318001025-03**
Description **The report describes environmental management procedures to minimise risks from contaminated soil within the rail corridor at Captains Flat.**

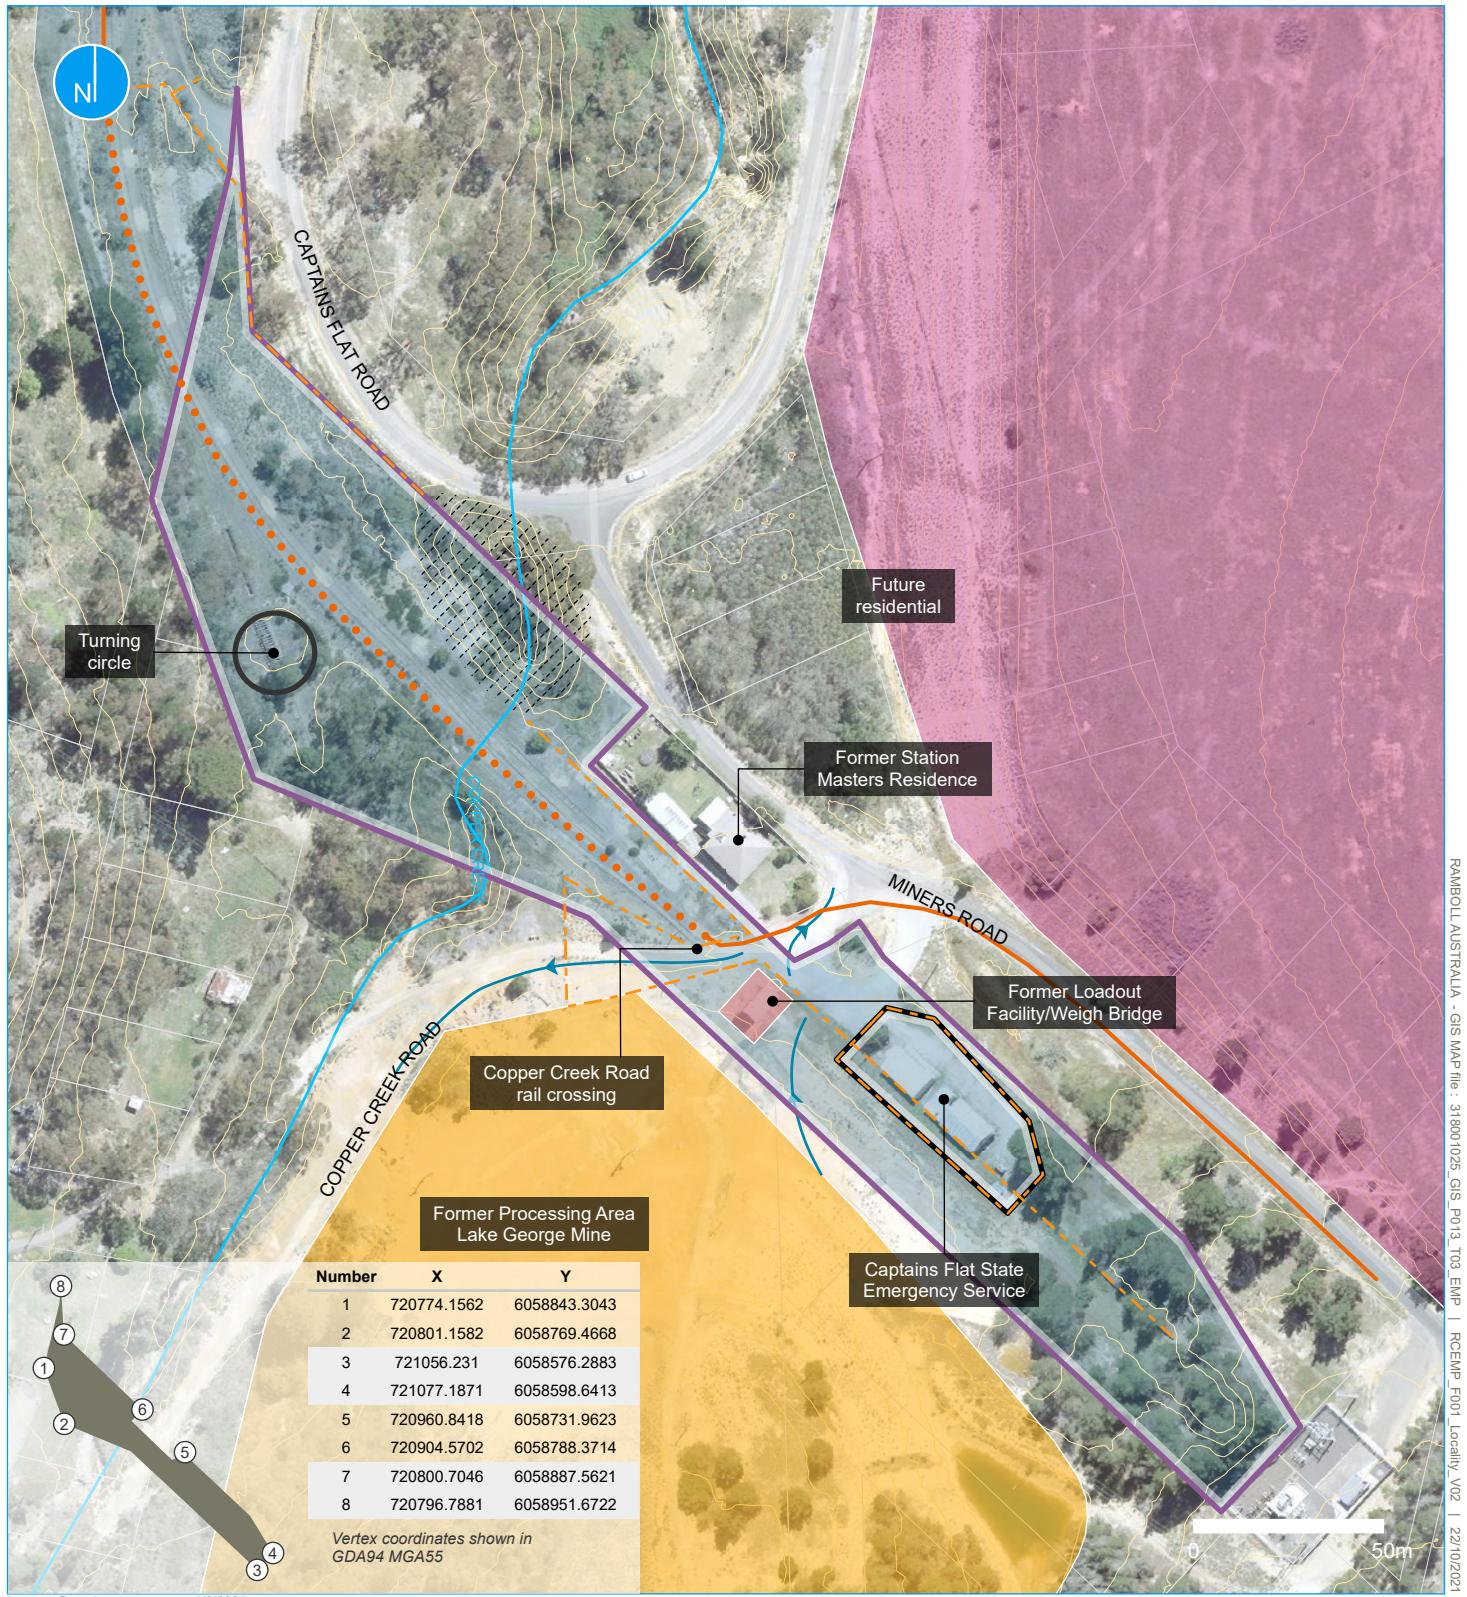
Figure 1 | Locality Plan
Captains Flat Rail Corridor Environmental Management Plan

- [Purple line] Site boundary
- [Black line with square] Captains Flat SES Station
- [Pink shaded area] Northern Tailings Dump
- [Red shaded area] Onsite source
- [Yellow shaded area] Offsite source
- [Dotted orange line] Former heritage trail
- [Solid orange line] Remaining heritage trail
- [Light blue shaded area] Rail corridor
- [Black line] Rail
- [Blue arrow] Run off
- [Blue line] Copper Creek (Ecological receptor)
- [Yellow lines] Contours 2m

Site topography is characterised by a moderate north facing slope intersected by a moderate – steep gully directing Copper Creek which flows north-east to the Molonglo River. Copper Creek passes beneath the rail line through a culvert and an area of apparent fill. Topographical contours are presented on **Figure 1 and 2, Appendix 1**.
