WATERFALL WAY

Pacific Highway to Dorrigo

Road safety review

SEPTEMBER 2014

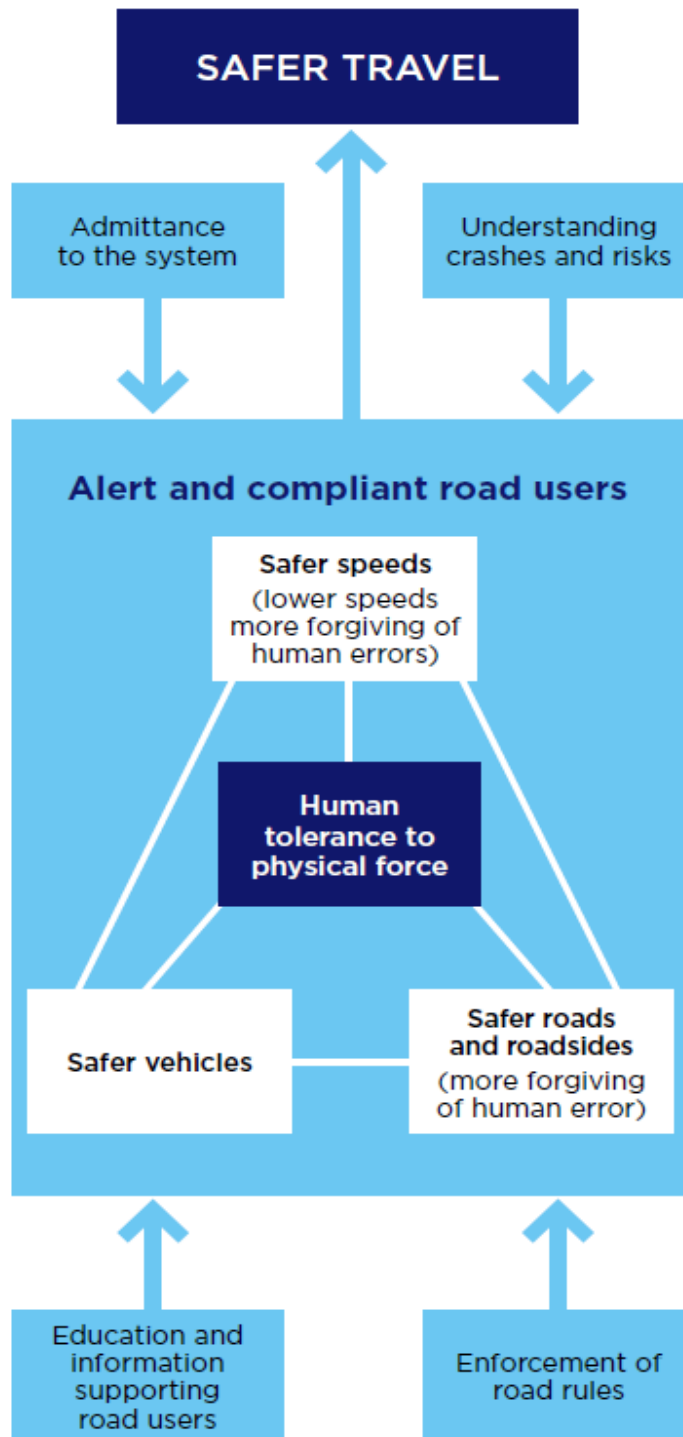
Figure 2: Diagram of the Safe System approach

The Safe System approach is adopted in highway route safety reviews. This approach recognises that a highway is a system with many inputs: the vehicle, the driver and the road environment. The Safe System approach aims to promote safe travel, yet recognises that drivers will make mistakes. However these mistakes should not result in serious injury or death. The system aims to provide a roadside environment that responds to driver error and reduces the occurrence and severity of road crashes. Figure 2 is a representation of the Safe System approach.

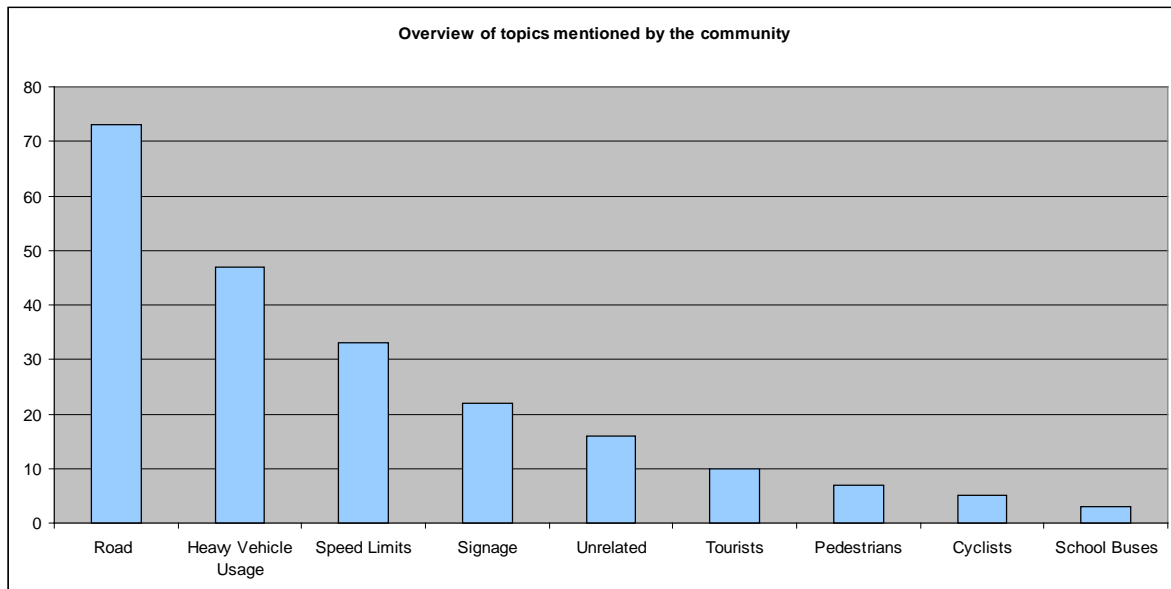
Figure 3: Overview of main topics mentioned during the feedback process

Submissions made by the community and feedback provided at the community workshops focused on road safety along the 40 kilometre stretch of Waterfall Way from the Pacific Highway to Tyringham Street, Dorrigo. The main areas of focus for the community, shown in Figure 3, were road conditions, heavy vehicle usage and speed limits.

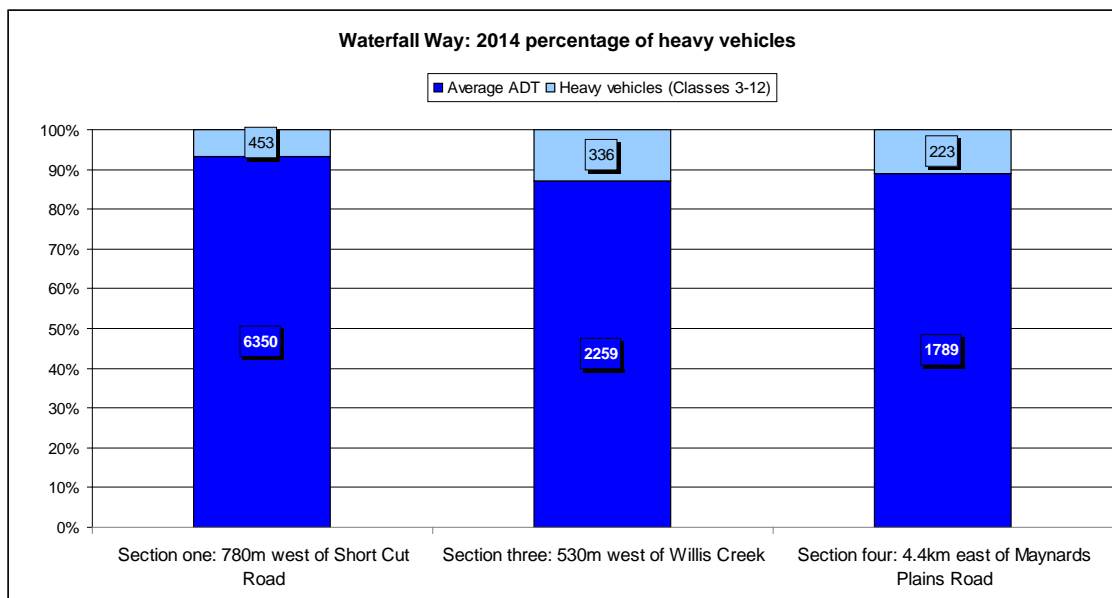
Figure 5 shows the total number of vehicles using Waterfall Way, and the percentage of heavy vehicles in the three sections of Waterfall Way.

Figure 5: 2014 - Percentage of heavy vehicles on three sections of Waterfall Way

- Section one (Pacific Highway to Bellinghen): 6350 with 453 heavy vehicles
- Section three (Bellinghen to Thora): 2259 with 336 heavy vehicles
- Section four (Thora to Dorrigo): 1789 with 223 heavy vehicles.

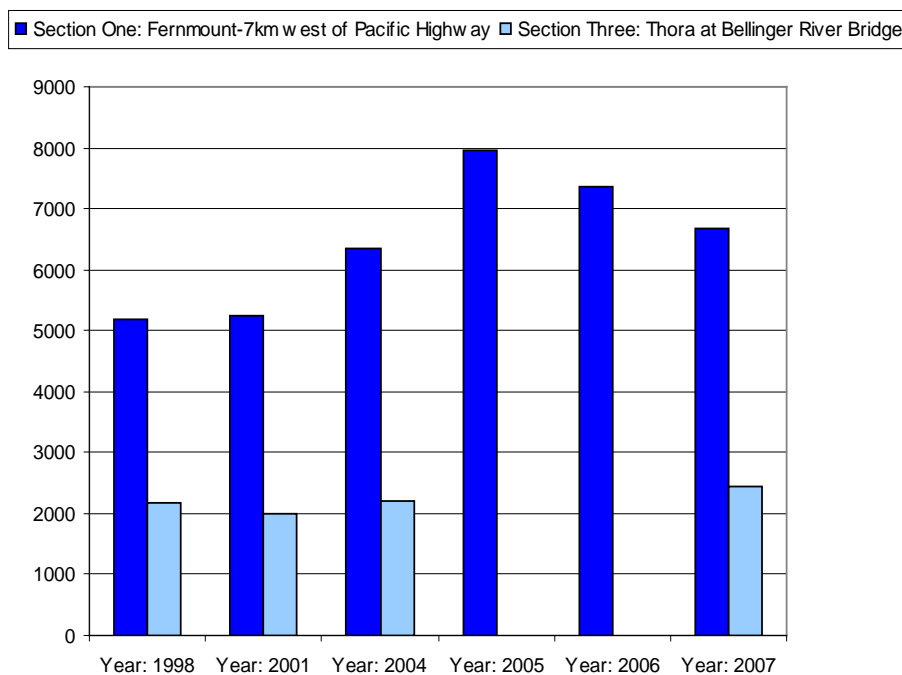
Figure 6 shows a graph of the Annual Average Daily Traffic (AADT) volumes at Fernmount, which is located in section one and Thora, located between sections three and four. It is noted that at Thora there were no traffic data available for years 2005 and 2006.

Figure 6: Annual traffic volumes for a six year period (1998 – 2007)

Location	1998	2001	2004	2005	2006	2007
Section One: Fernmount	5179	5244	6341	7963	7357	6687
Section Three: Thora	2190	2001	2198	NA	NA	2455

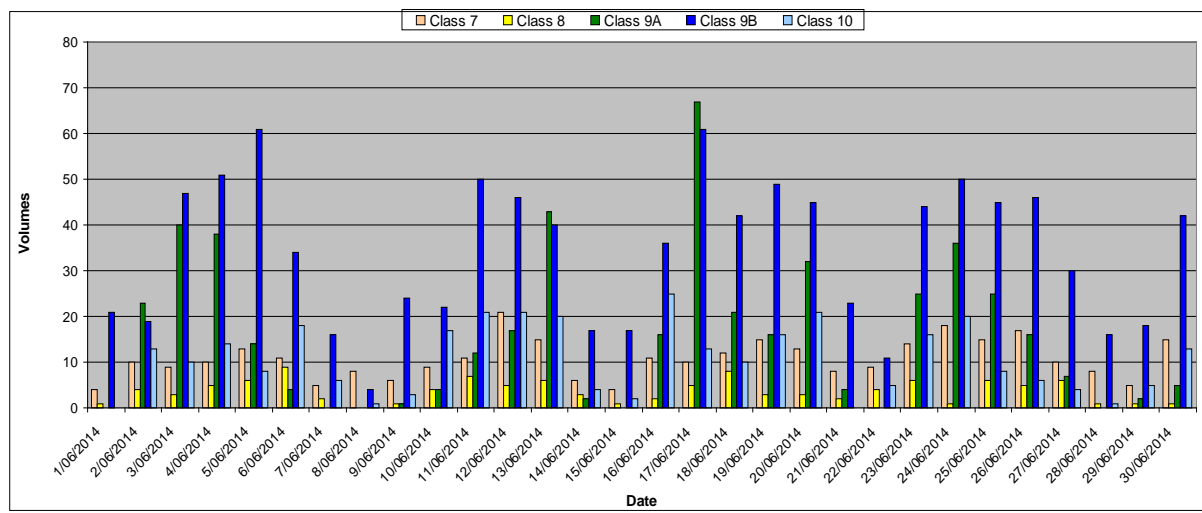
From Average Daily Traffic (ADT) data received during June 2014, an analysis of the type of heavy vehicles and number of heavy vehicles using the road, 780 metres west of Short Cut Road, are shown in Figure 7.

Figure 7: West of Short Cut Road, heavy vehicle volumes/day – classes 7 to 10

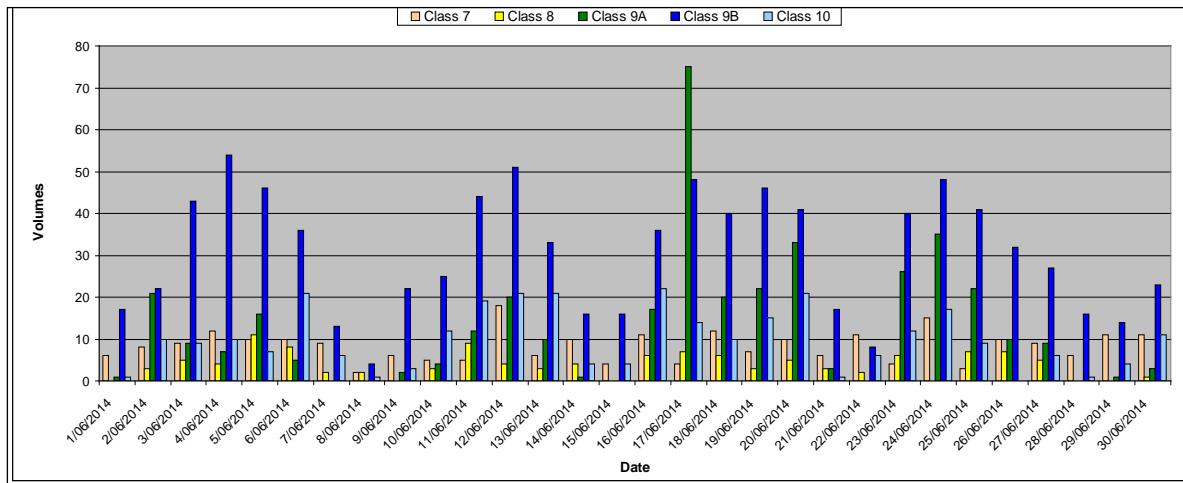
From Average Daily Traffic (ADT) data received during June 2014, an analysis of the type of heavy vehicles and number of heavy vehicles using the road, 530 metres west of Wills Creek, are shown in Figure 8.

Figure 8: 530 metres west of Wills Creek, heavy vehicle volumes/day

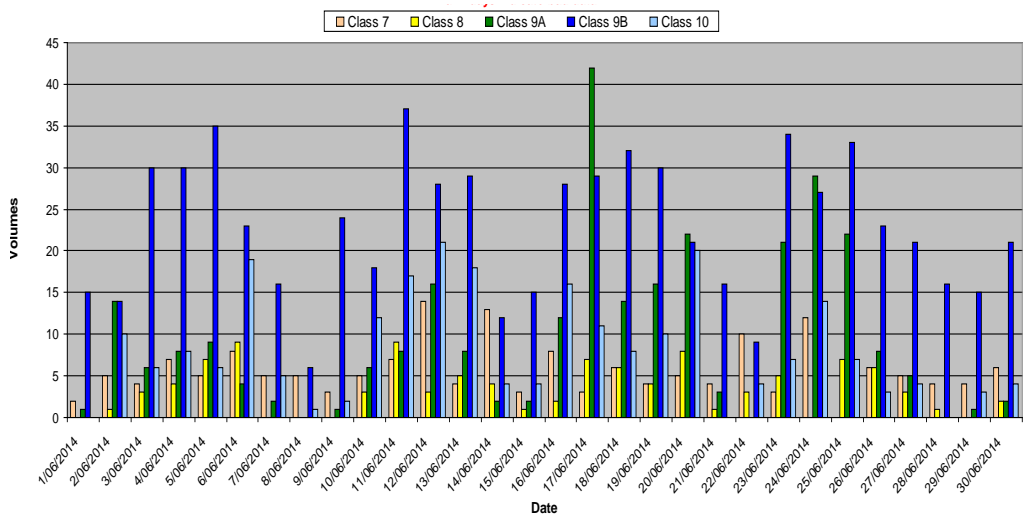
The Average Daily Traffic for heavy vehicles is shown in Figure 9. The speed limit at this location is 100km/h and the daily average mean speed for Classes 3 to 12 was 55km/h, with classes 9A and 9B recording an average speed of 46km/h and 42km/h respectively.

Figure 9: East of Maynards Plains Road, heavy vehicles/day – classes 7 to 10

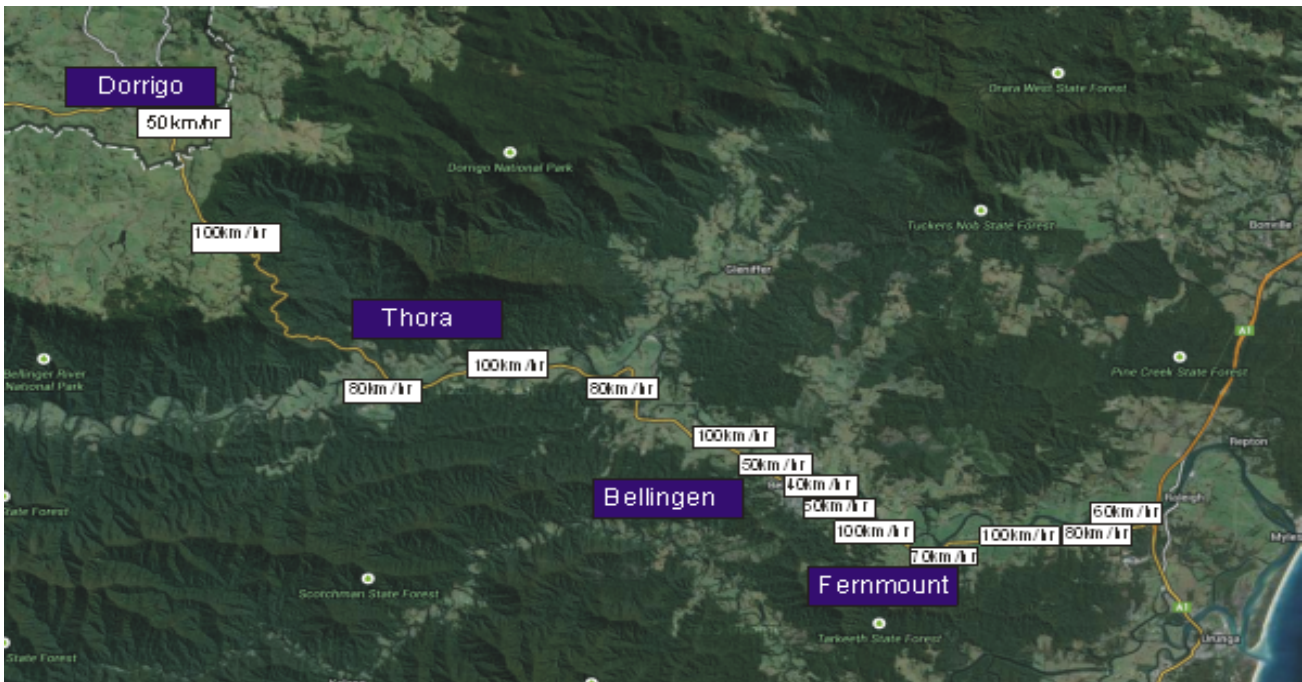
The existing speed zones along Waterfall Way are indicated on the map below, in Figure 10. It should be noted that these are permanent speed zones and represent fourteen changes in zones between the Pacific Highway and Dorrigo.

It is acknowledged that there are also a number of temporary speed zones, predominantly relating to road works that have not been included in the diagram below that may also impact on travel times for motorists.

In addition a 60km/h truck and bus speed zone exists in the Gordonville Cutting area, west of Bellingen.

Figure 10: Indicative location of the speed zone changes along Waterfall Way

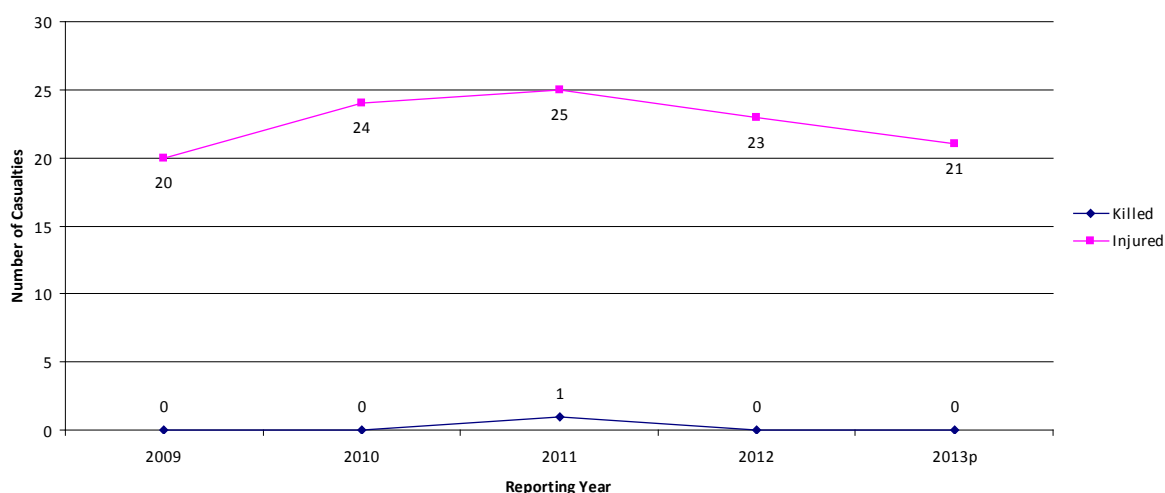
Figure 11 shows details of the casualty crashes for five years from 2009 to 2013 in which 81 casualty crashes on Waterfall Way were recorded. In the 81 casualty crashes, 114 casualties were reported, one person was killed and 113 people were injured.

Figure 11: Casualty crashes/reporting year

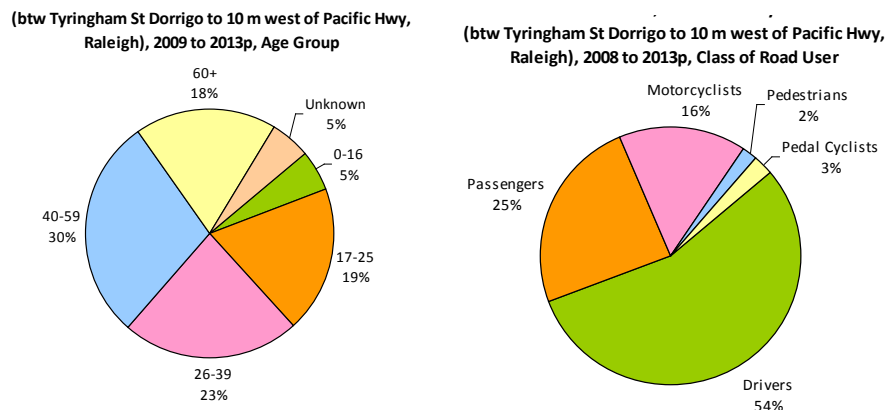
Data gathered for the five year period are highlighted in Figure 13.

Figure 13: Graphs showing age group and gender of reported casualties

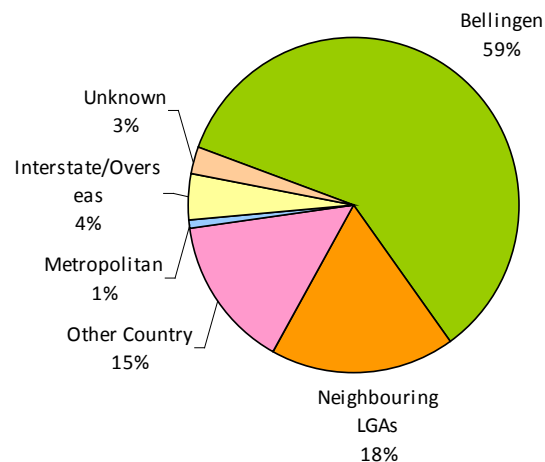
Analysis of the crash data shows a majority of drivers and riders involved in crashes on Waterfall Way were residents of Bellingen Shire Council (59 per cent) or from the neighbouring local government area of Coffs Harbour and Nambucca (18 per cent). Refer to Figure 14.

Figure 14: Graphs showing residence of casualty crashes

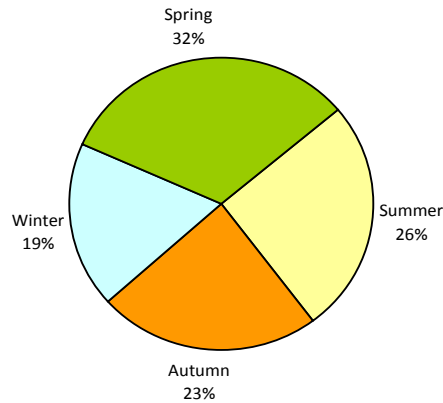
Summer and spring months accounted for the highest number of casualty crashes. Refer to Figure 15.

Figure 15: Graphs showing the time of year crashes occurred

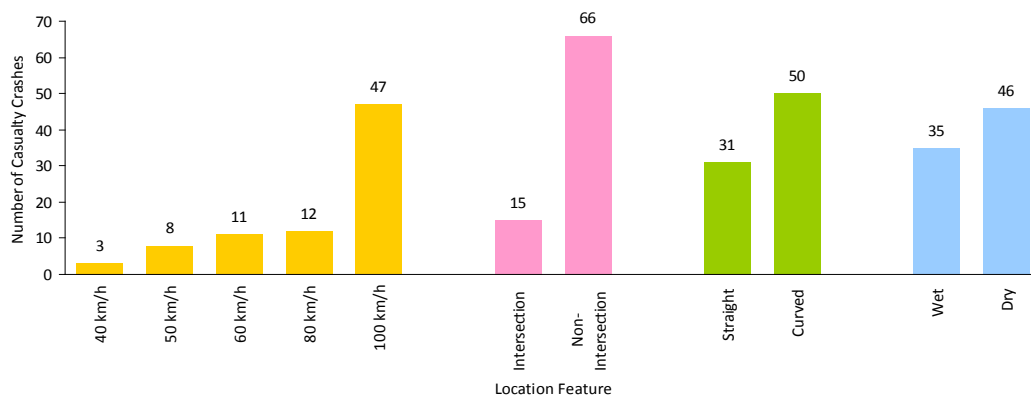
Figure 16 shows features of where crashes occurred. Over half of the crashes occurred in speed zones signposted at 100km/h or more (58 per cent).

Over half occurred on curved lengths of Waterfall Way (62 per cent).

Over two in every five crashes occurred on a wet road surface (46 per cent), which is higher than other country roads (21 per cent).

Figure 16: Graphs showing location features of casualty crashes
