## 3.2 Test Trench 2: Car Park, Thompson Square

Windsor Bridge Replacement Project 14020		
European Test Excavation	Test Trench 2	
Scale: 1:25	Ⓢ N	Plan No: 1

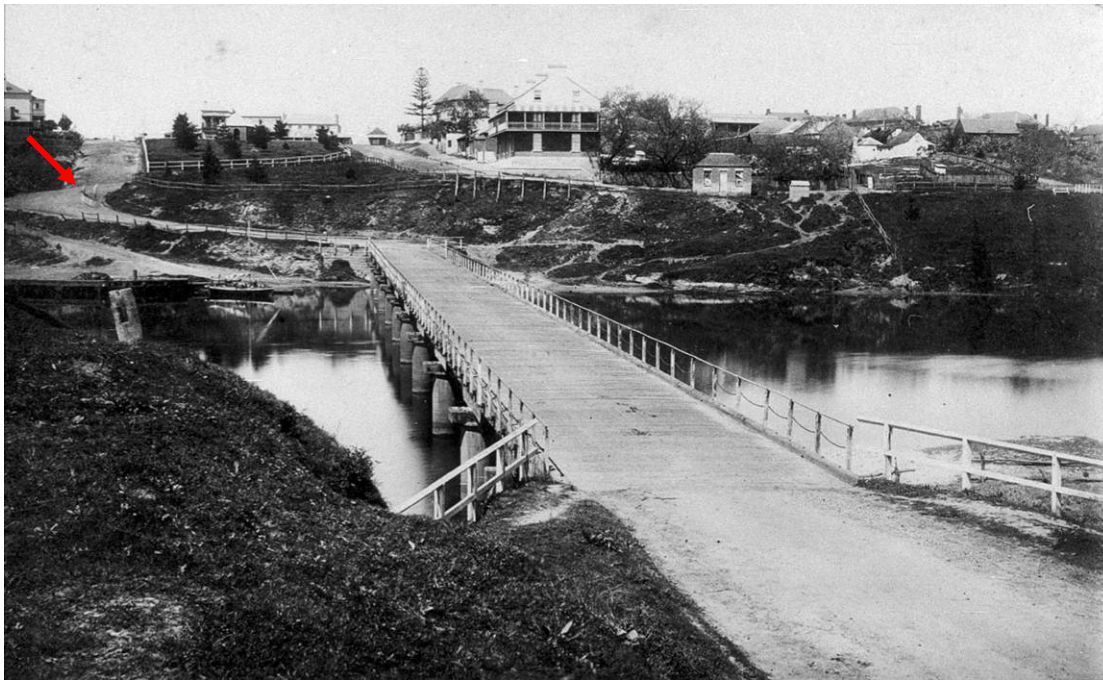
*Plate 25: View of Thompson Square that shows the c. 1855 road extension to Bridge Street and the point where it met the 1876 road to the wharf (source: NSW State Library).*

The “cutting” is the sloping cut that can be seen in the excavation that removed the old trees and plants and possibly a building that stood in the way of the new road. The carting probably was for the dark brown silty soil that was used to form the level base for the new road and that covers the entire area of the excavation [057]. What is missing is the macadamizing - the paved surface.

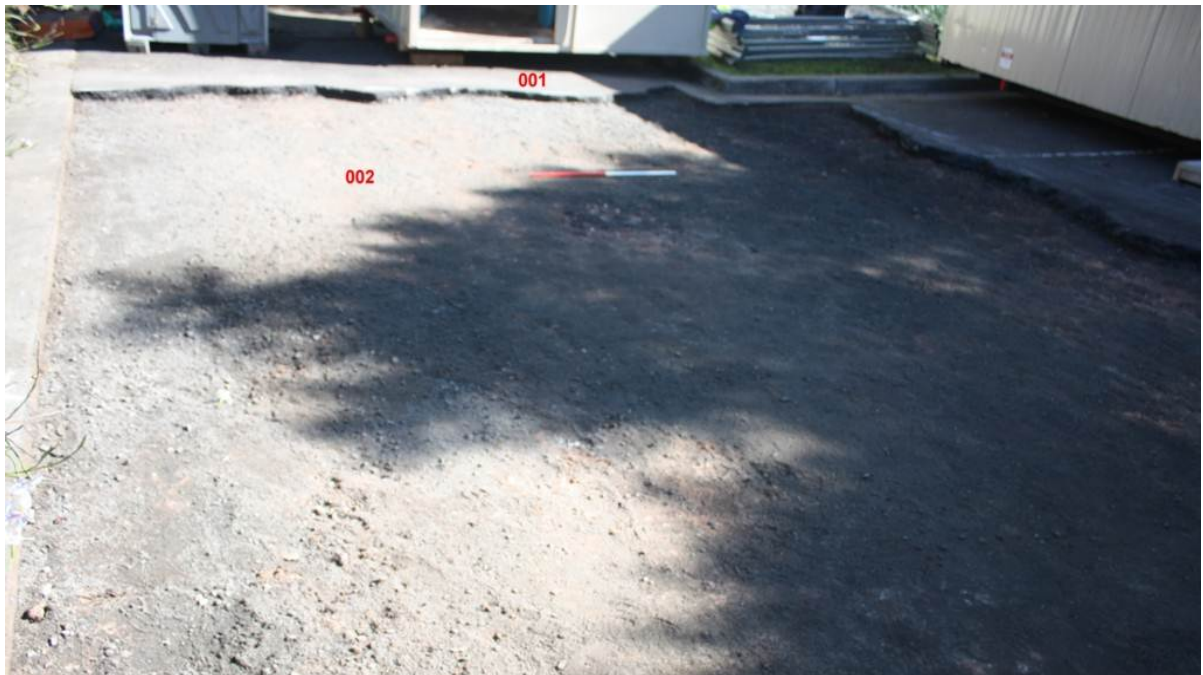
Plate 28: Test Trench 2, removal of the present car park surface revealing the underlying blue metal; scale one metre.

The upper portion of Test Trench 2 was similar to that found in Test Trench 1. The entire excavation area was covered with bitumen up to 50 mm deep [001]; this is the present surface in use. It was laid over a thin deposit of blue metal [002] and below the blue metal was up to 300 mm of compacted sandstone rubble [005]. This was the same deposit found under the present road in Test Trench 1 [051]. A cement kerb and gutter ran along the southern side of the trench at the edge of the reserve [004, 005]. The presence of the blue metal [002] here across the surface of the trench, similar to that found under the kerb and gutter in Test Trench 1 [054] suggests that the car park is later than the last surfacing of Old Bridge Road and comparable in date to the kerbing and guttering found around the reserve, probably from the mid-1970s onwards.

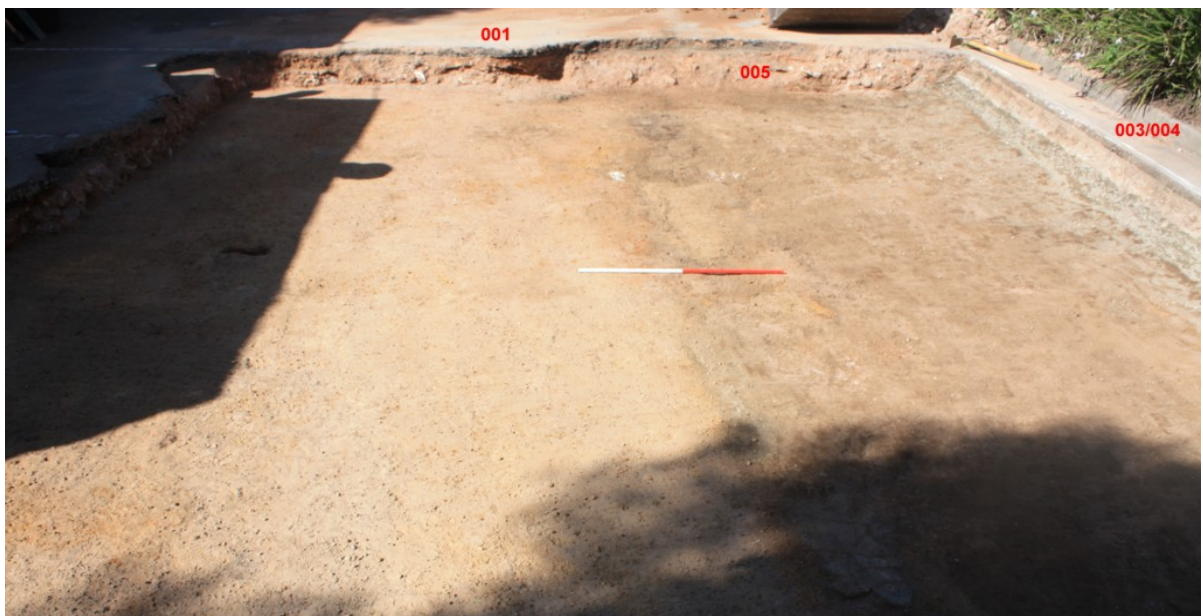
Plate 29: Test Trench 2, view east showing the depth of sandstone rubble lying under the road in the section; scale one metre

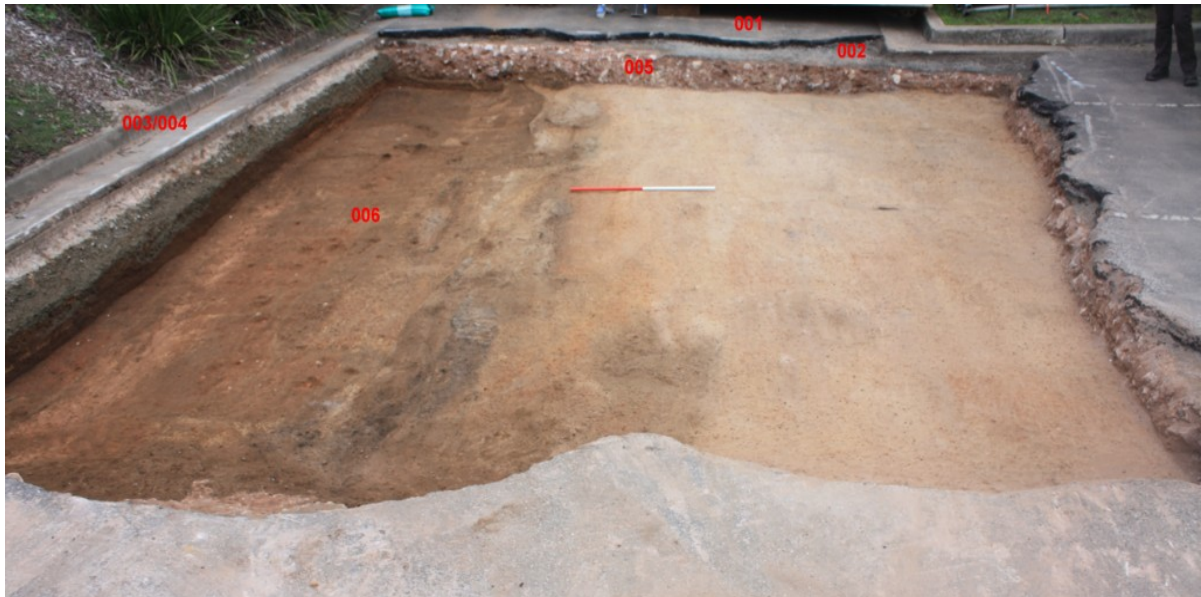
Plate 30: Test Trench 2, view west showing the cut [006] along the southern side of the trench; scale one metre.

Removing the sandstone rubble revealed a flat surface across the entire trench and along the southern side a wide cut up to 2.8 metres wide (Plate 30). This cut ran the full east-west length of the trench [006]. It narrowed slightly at the western end of the trench.

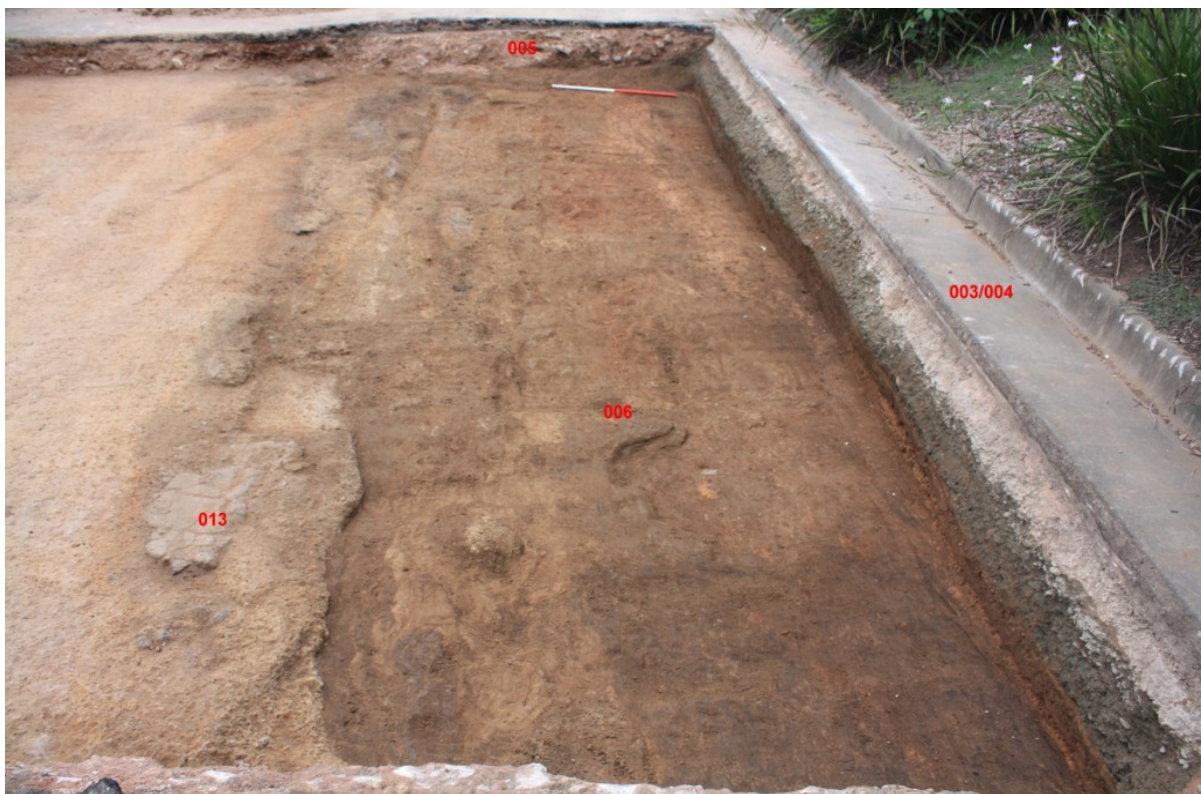
Plate 31: Test Trench 2, view east showing the cut [006]; scale one metre.

The long, straight cut [006] had been made into an existing surface [008]. The cut appears to have been a paved path or road; remnants of bitumen surfacing survived along the northern side of the cut and at the western end in a shallow depression [013]. Some of this bitumen was mixed with the loam and compacted clay that had been used to fill the cut [007]. In the section at the eastern end of the trench there appears to have been a post-hole cut into the filling material [036].

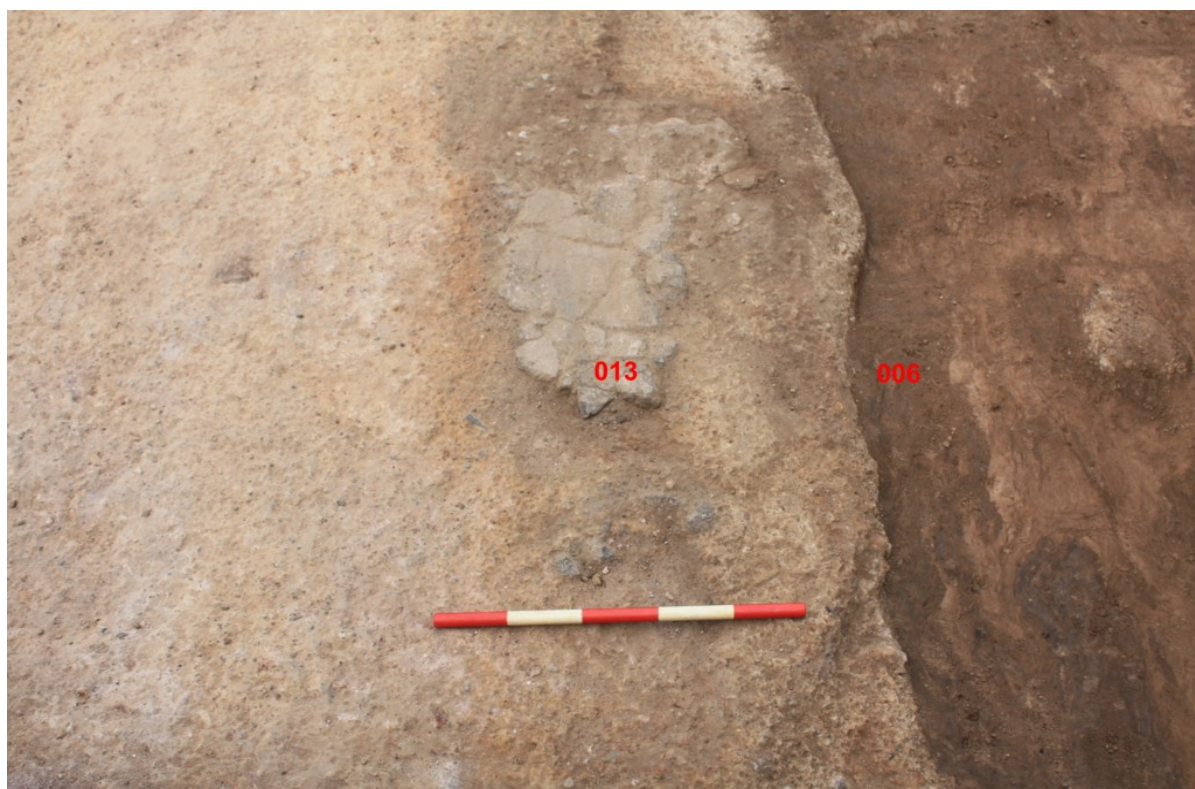
Plate 32: Test Trench 2, remnant bitumen surface on the northern side of the cut for a path [006], view east; scale 500 millimetres.

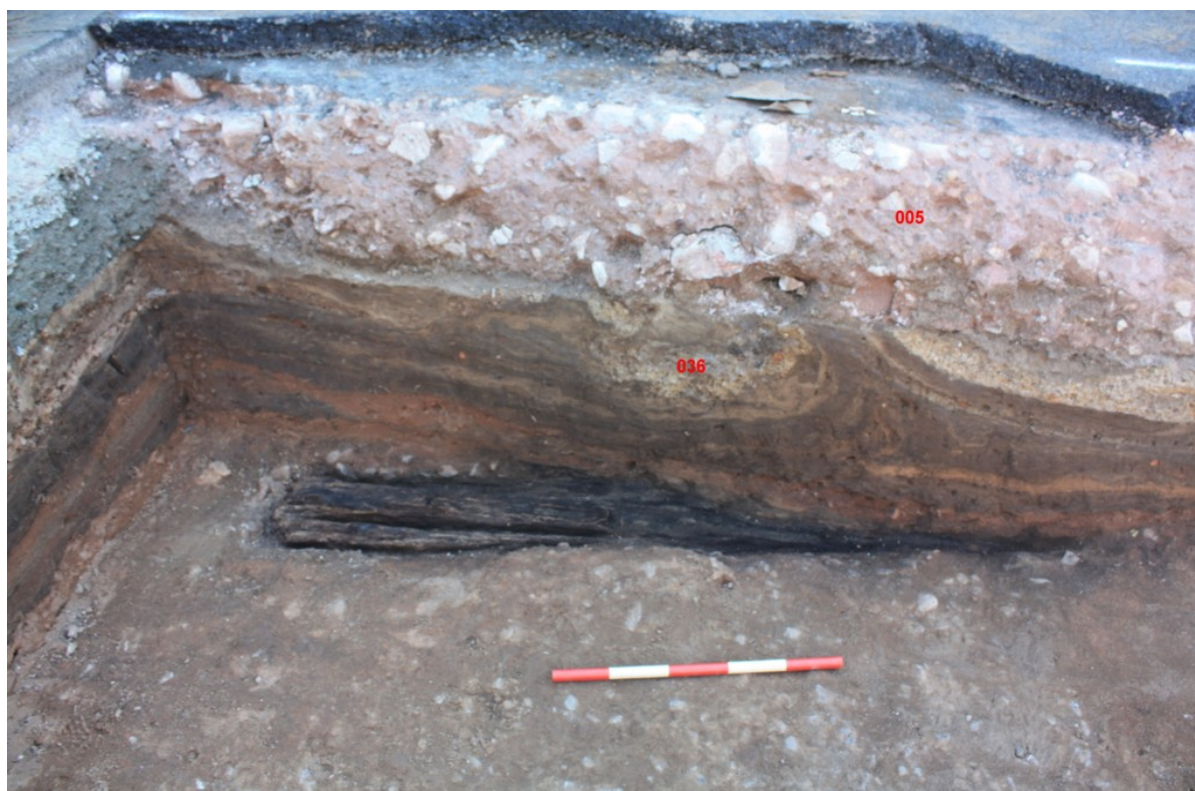
Plate 33: Test Trench 2, view west showing what appears to have been a post-hole [036] cut into the fill that surfaced the cut; scale 500 mm.

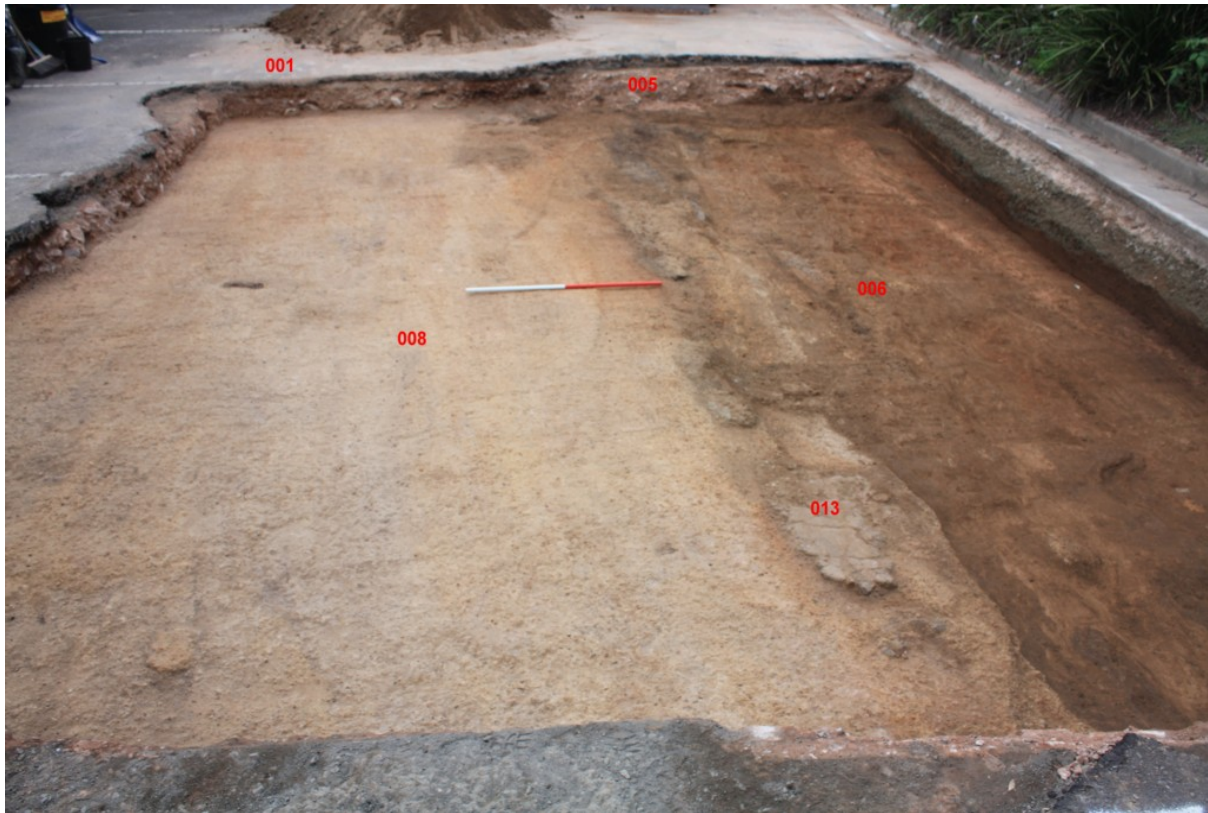
*Plate 34: Test Trench 2, view east showing the road surface [008] with the cut made into the southern side [006]; scale one metre.*

The existing surface [008] in which this cut had been made encompassed the remainder of the trench and extended beyond it to the north, east and west. The surface was made by heavily compacting clay using ironstone gravel to give strength and make it impervious. The surface was approximately 40 mm thick.

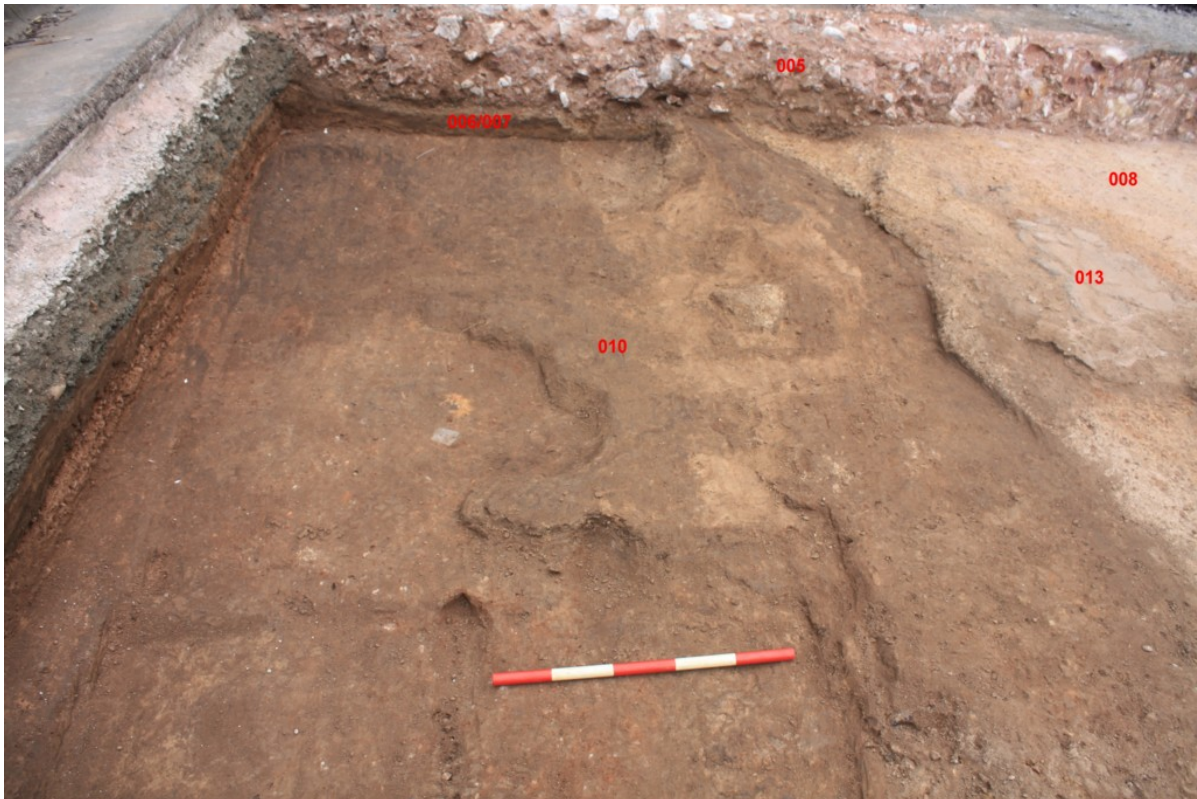
*Plate 35: Test Trench 2, view west showing remnants of the compacted silty soil [013] that was used to support the hard paved surface [008] here exposed in the cut [006/007] along the southern side of the trench; scale 500 mm.*

The hard surface [008] was founded on a deposit of fill or bedding material [010] that extended across the entire trench. The cut on the southern side of the trench [006] had been excavated into this material removing some and leaving portions of the compacted material intact. This flat compacted bedding was made with silt, red and orange sand, some gravel, small pieces of both early and later nineteenth century brick and some blue metal [010]. The inclusions appear to have been to create a textured surface that would grip the new hard surface.

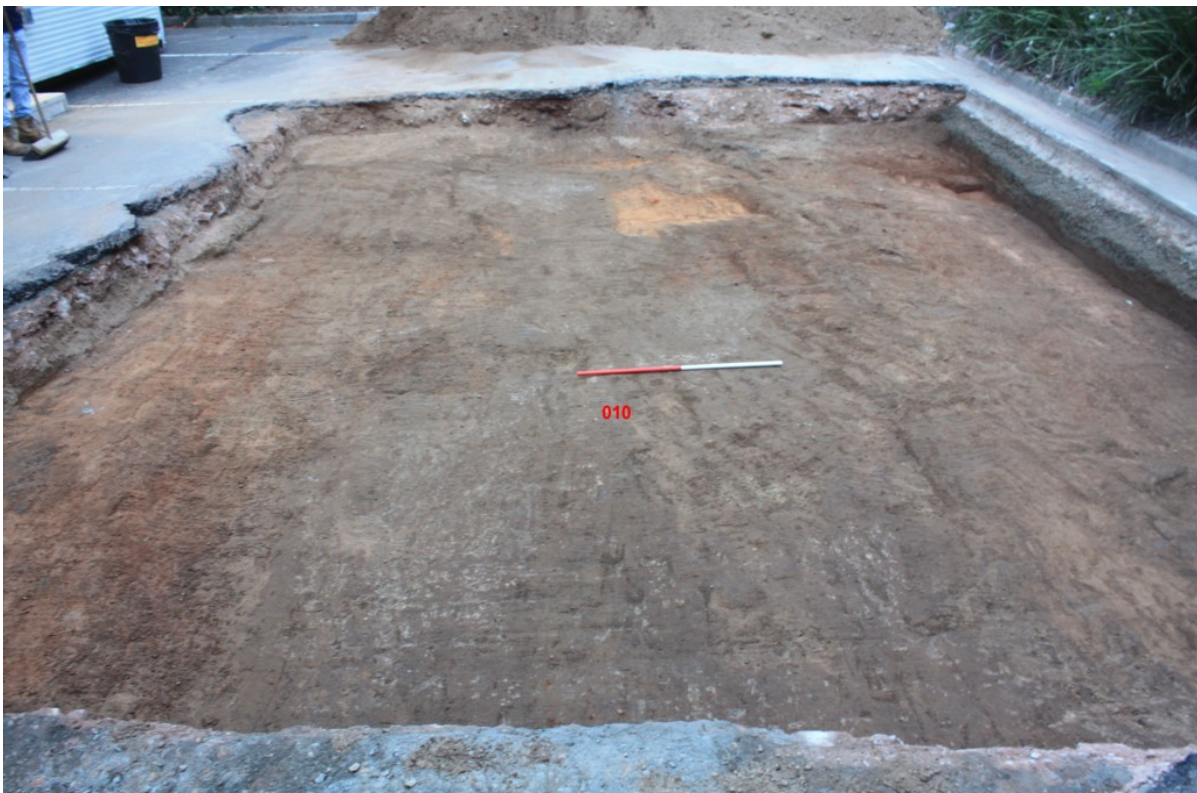
*Plate 36: Test Trench 2, view east showing the compacted silty soil [010] that formed the base for the hard paved surface [008]; scale one metre*

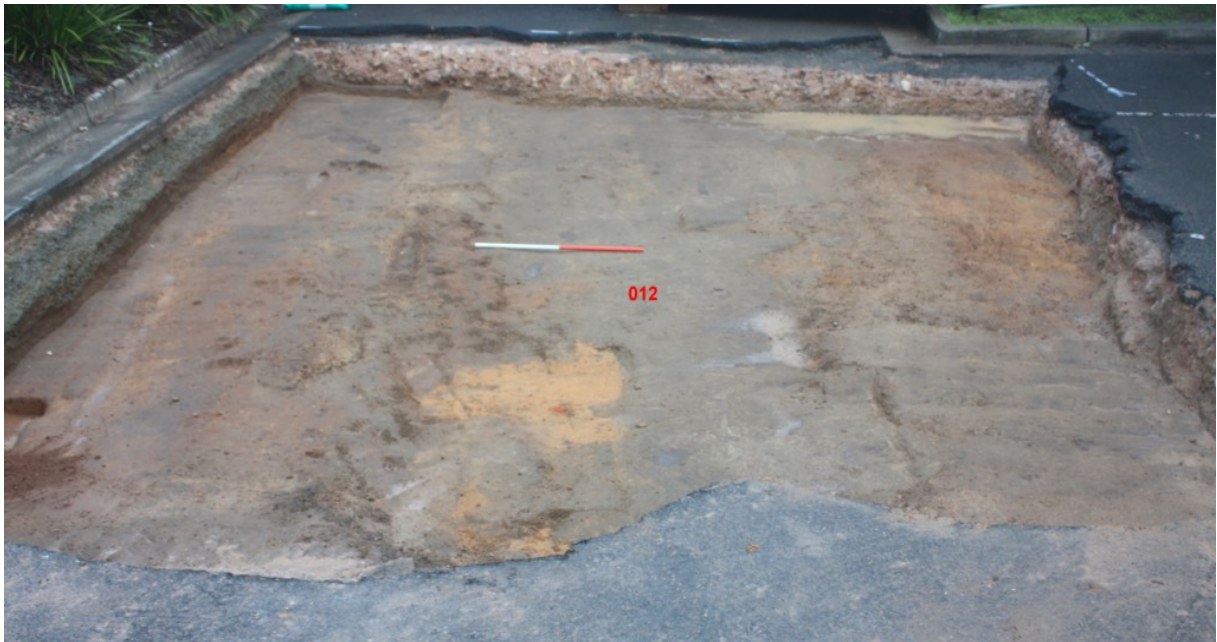
*Plate 37: Test Trench 2, view west showing the sandy silt [012] that lay under the bedding material [010] for the hard paved surface [008]; scale one metre*

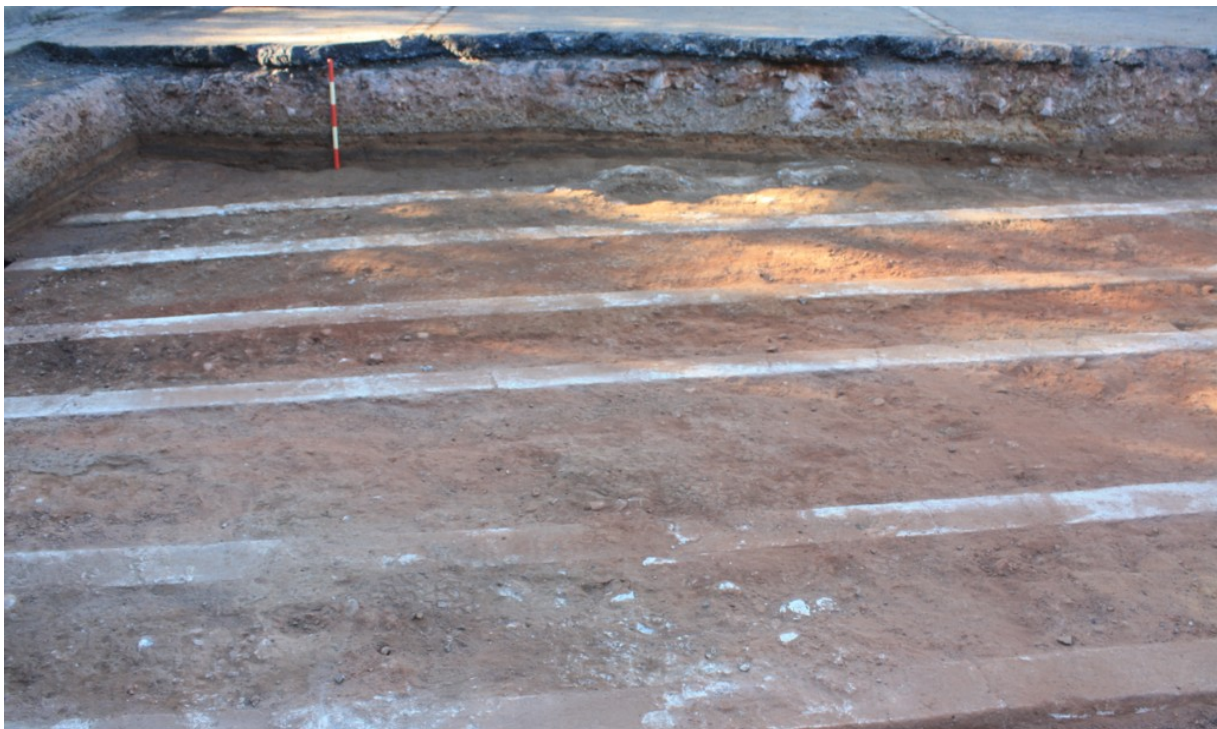
*Plate 38: Test Trench 2, view north showing in section the layers of fill that produced a hard flat and slightly sloping surface; scale 500 millimetres.*

The layering of these two principal deposits with some lensing produced a clean flat surface that sloped gradually to the west best seen in the sections.

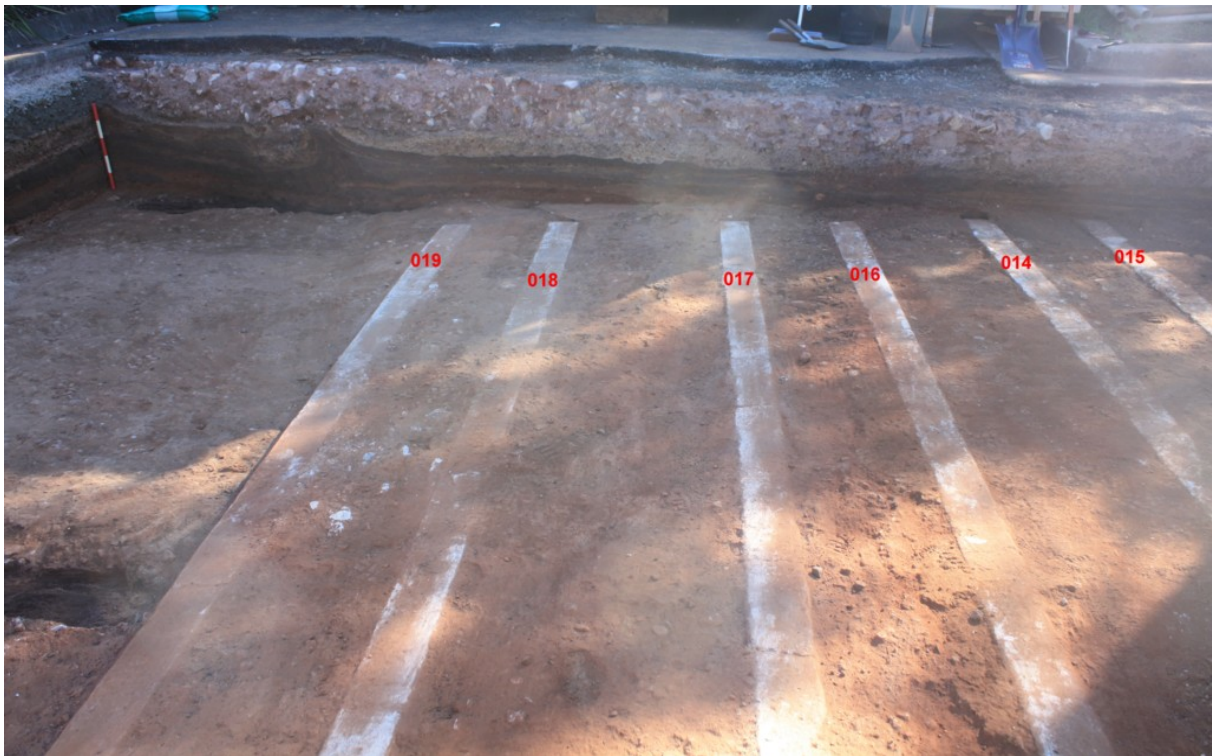
Plate 39: Test Trench 2, view west showing the six poured concrete beams [014-019]; scale 500 millimetres.

The removal of this clean silty material [012] revealed a number of features across the entire trench. Under the majority of the trench, from the northern side were five poured concrete beams [014-019] that extended across the entire east-west length (Plate 38). A similar sixth beam [015] was found just on the boundary of the trench in the north-western corner [015].

The beams continued beyond the eastern end of the test trench but at the western end several of the beams ended with small semi-circular holes that supported timber posts, possibly form work for the pour [025,034, 035]. The northernmost beam [015] was not fully encompassed within the trench to observe whether it had a similar feature. The fourth beam within the trench [018] had a smaller hole for a stake or post [032] that was in conjunction with a piece of sheet metal [026]. The southernmost of these beams [019] also differed; there was a square post-hole on the southern side of the beam [031]. It was compacted with a circular stake hole within it. There was a similar small stake hole [033] close to the fourth beam [017].

Of these six beams most were between 300-400 mm apart from the adjoining beams; the exception was between the two southernmost [018, 019] and the next to the north [017]. The difference in spacing here was 700 mm; there was no obvious reason for the different spacing.

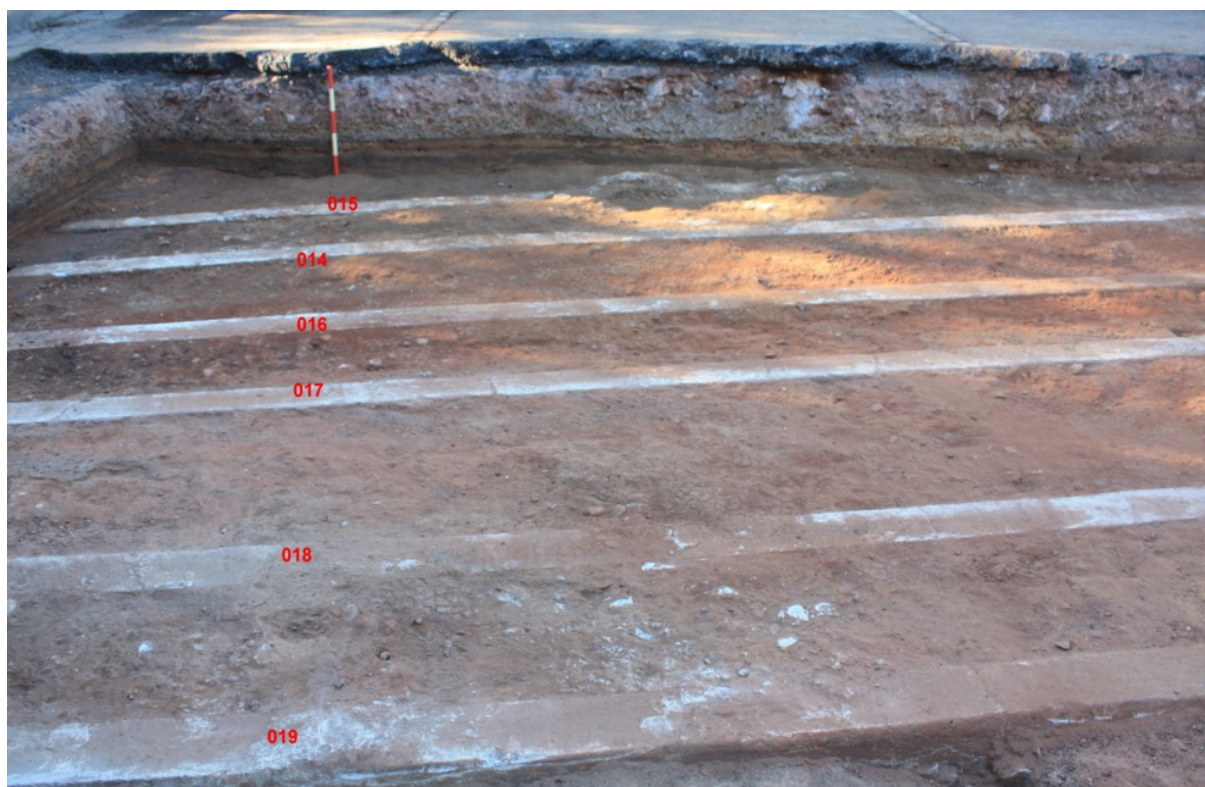
*Plate 40: Test Trench 2, view north showing the same six beams; scale 500 millimetres.*

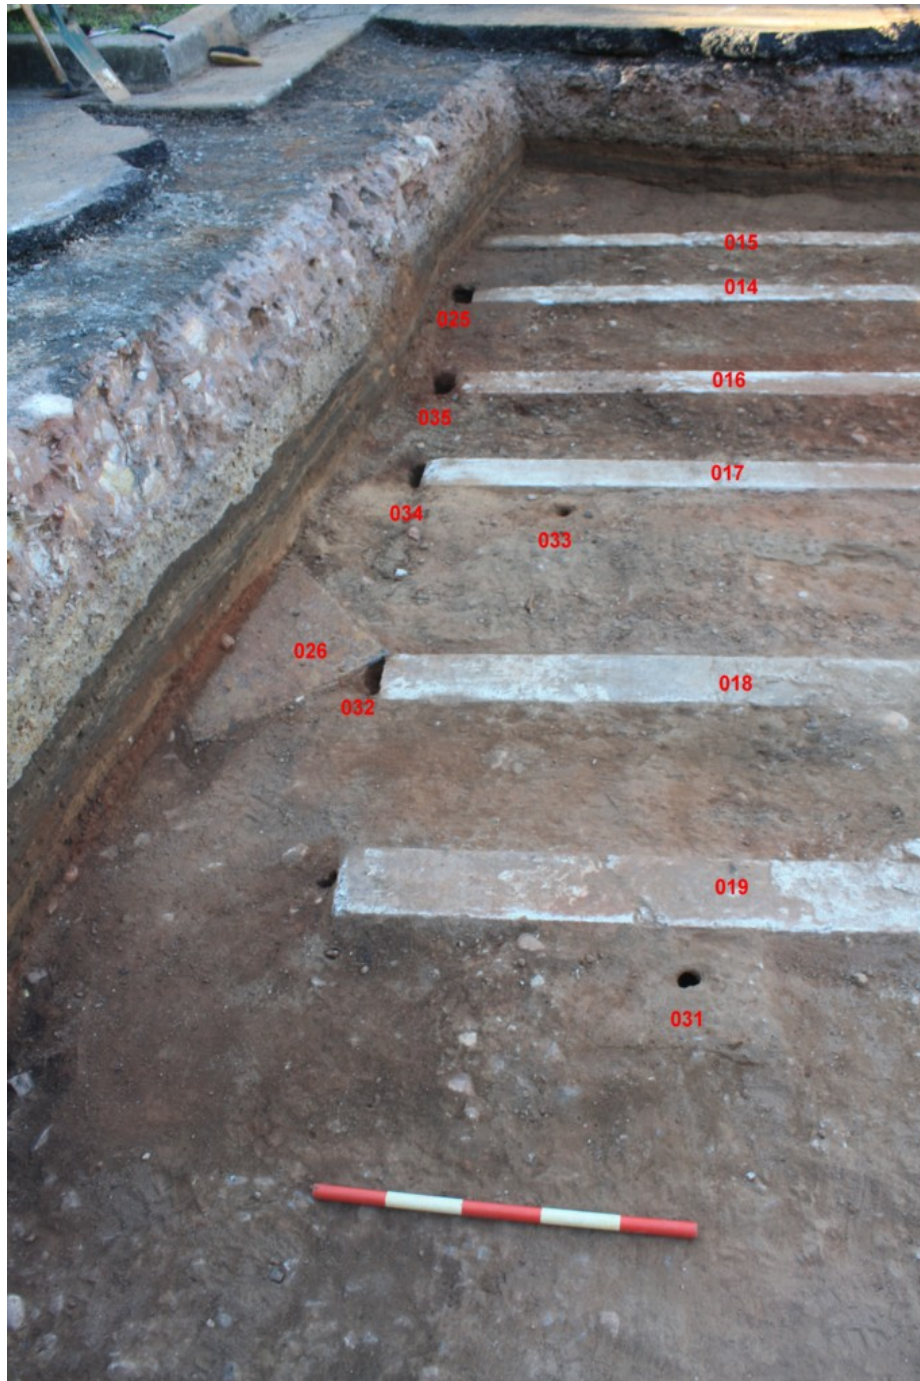
*Plate 41: Test Trench 2, view north showing the post and stake holes at the ends of each beam and the two smaller stake holes next to two of the beams; scale 500 millimetres*

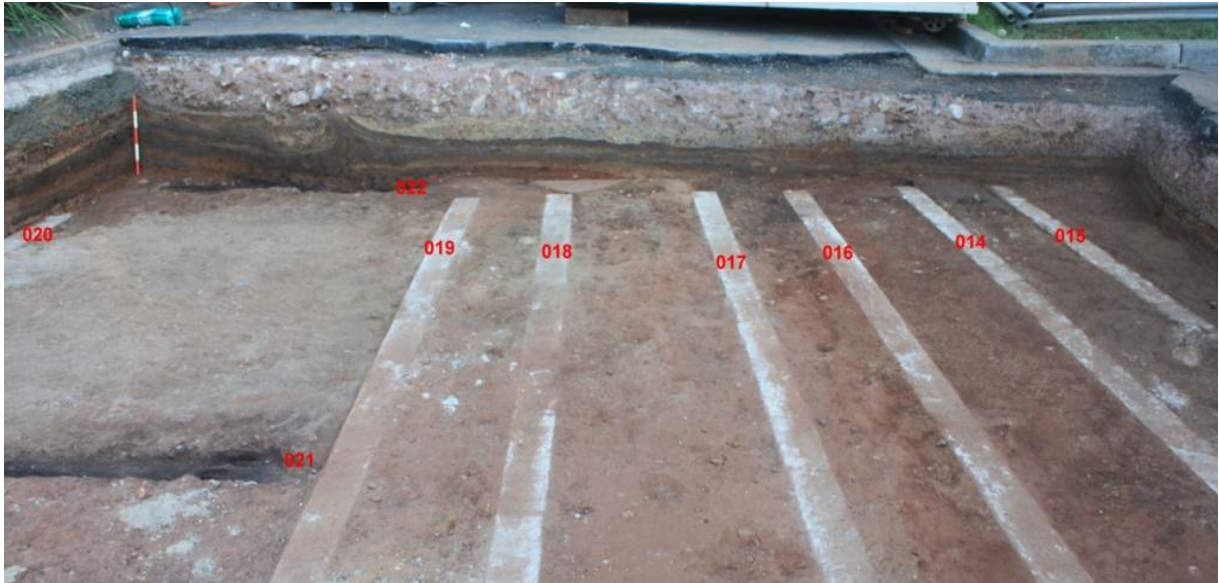
*Plate 42: Test Trench 2, view west showing all the concrete beams and one of the timber plates, the second [024] is in the shade at the end of the trench; scale one metre.*

On the southern side of the trench was another concrete beam [020]; this was separated from the main group by 2.1 metres. The reason for the separation is unknown but two timber beams or plates were found spanning the gap in the space between this beam and the larger group, but not touching the concrete beams on either side; they were separated by approximately 200 mm. As well, the two timber plates [021, 022] were separated from each other by a space of approximately three metres.

One particular feature of all the concrete beams and the timber plates is that they were placed on a slight angle from north-east to south-west.

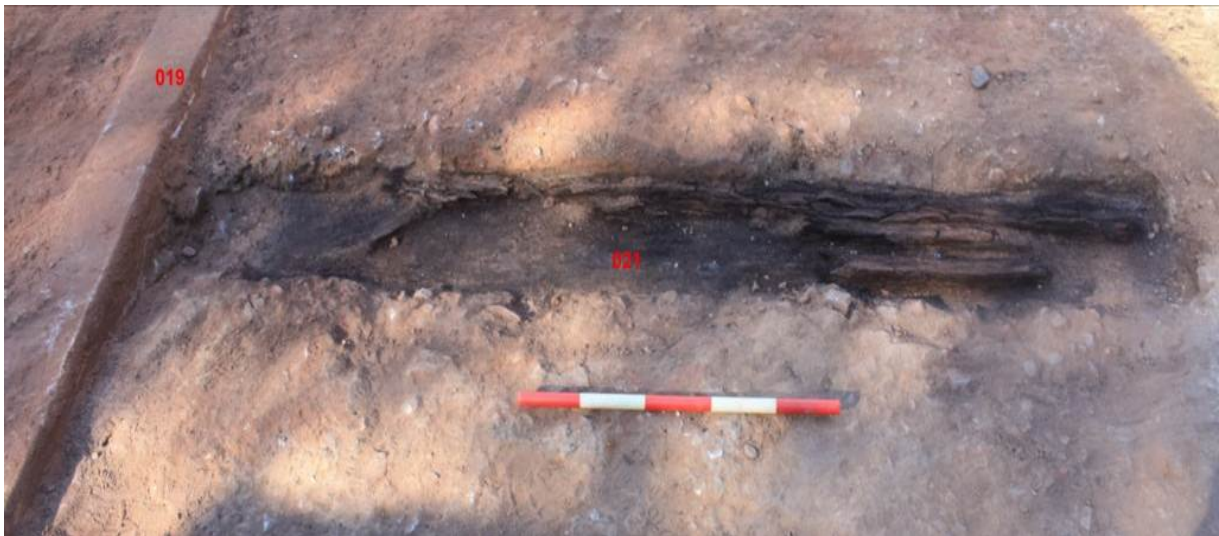
*Plate 43: Test Trench 2, view east (above) showing the timber plate in the body of the trench [021] and at the western end (below); scale 500 millimetres*

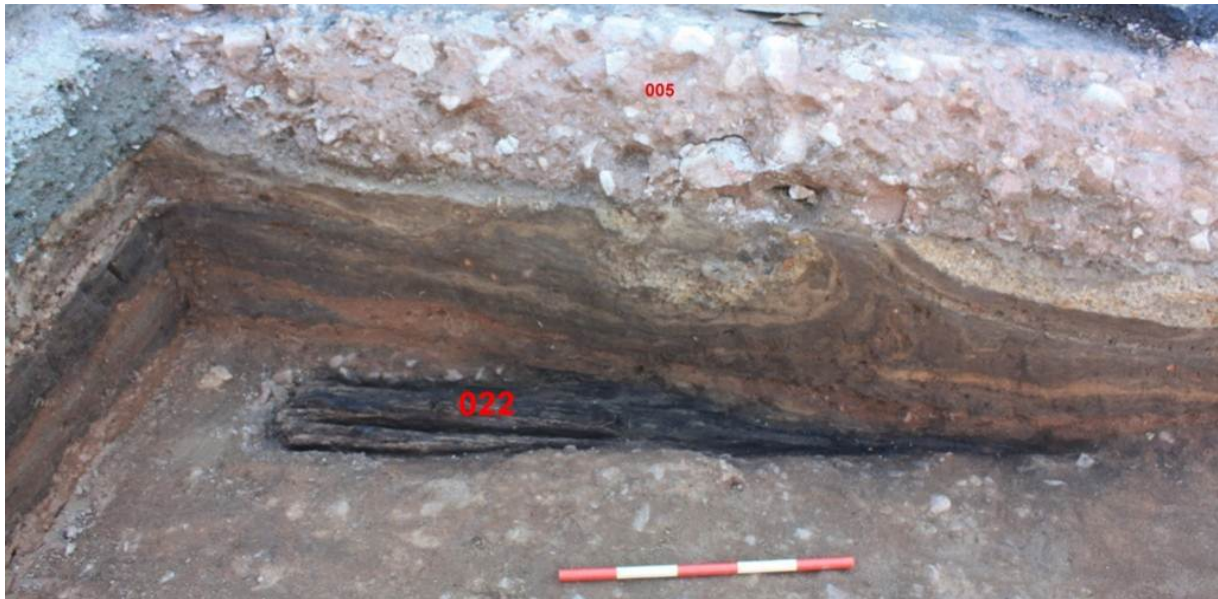
*Plate 44: The timber plate in the section at the western end of the Test Trench 2.*

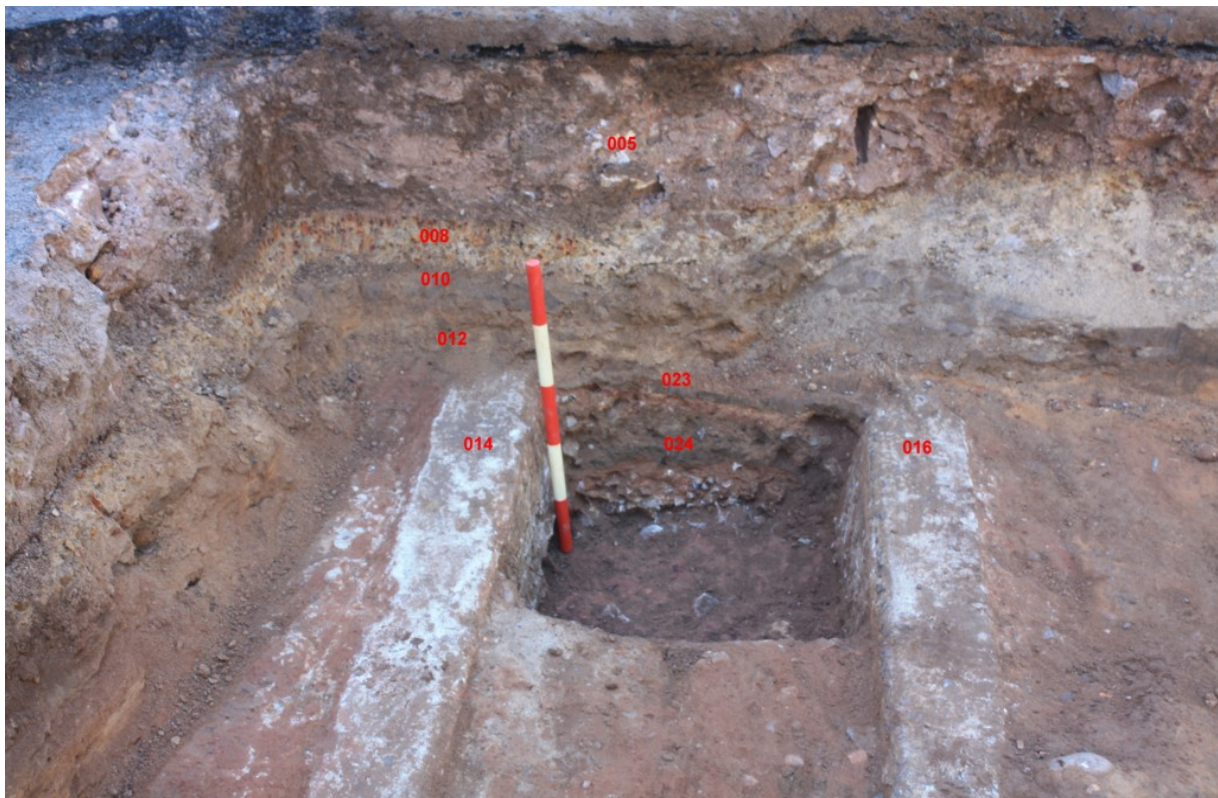
*Plate 45: Test Trench 2, view east in the north-western corner of the trench showing the compacted fill into which the concrete beams had been placed; scale 500 millimetres.*

The concrete beams and the timber plates had been placed in a deposit of fill [024] that comprised large pieces of blue metal, stone rubble, loam and clay. It was 300 mm deep had been compacted very hard to stabilise these elements. Between the six concrete beams on the northern side of the trench [014-019] the rubble had been topped with a thin slurry of cement [023]. This slurry was not found at the southern end of the trench between the widely spaced beams and the timber plates.

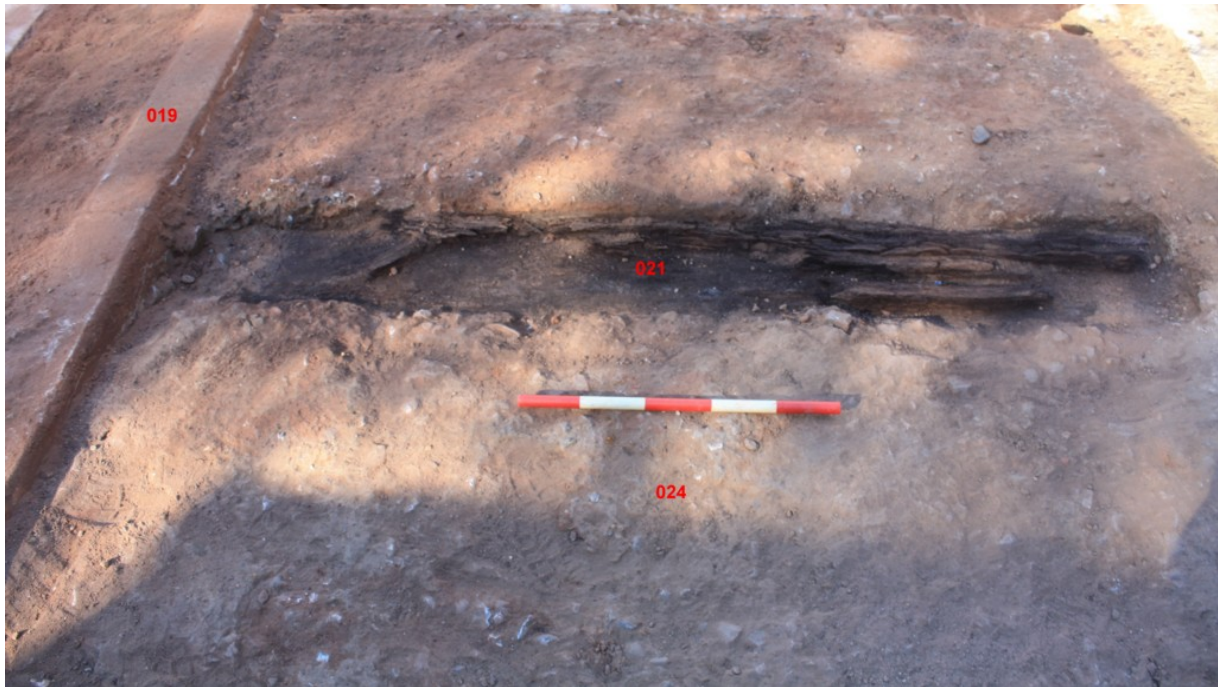
*Plate 46: Test Trench 2, view east showing the hard compacted fill [024] between the beams and timber plates on the southern side of the trench; scale 500 millimetres*

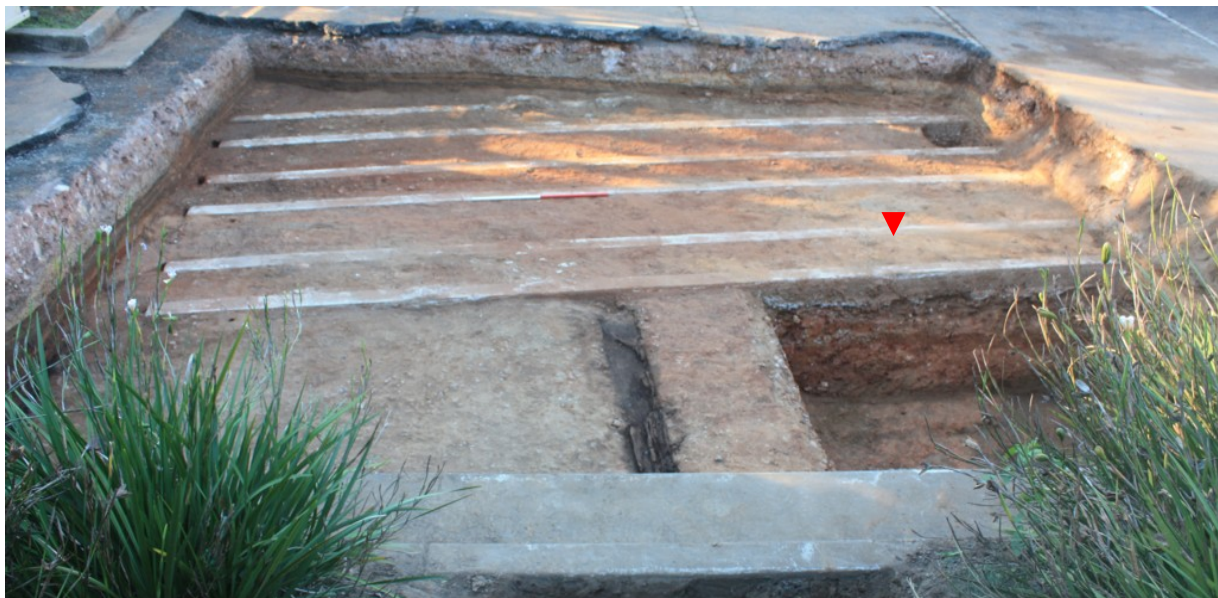
*Plate 47: Test Trench 2, view north showing the position of the test pit (indicated by arrow) used to take the excavation to the required depth while preserving the features uncovered in the body of the excavation; scale one metre.*

In order to preserve these features the excavation was limited from this point to a test pit in the south-eastern corner between the two concrete beams [019, 020] and beyond the timber plate [021]. In this pit measuring approximately 2.0 x 2.5 metres the excavation was taken to the depth of 1.5 metres, the depth required for the proposed bridge construction.

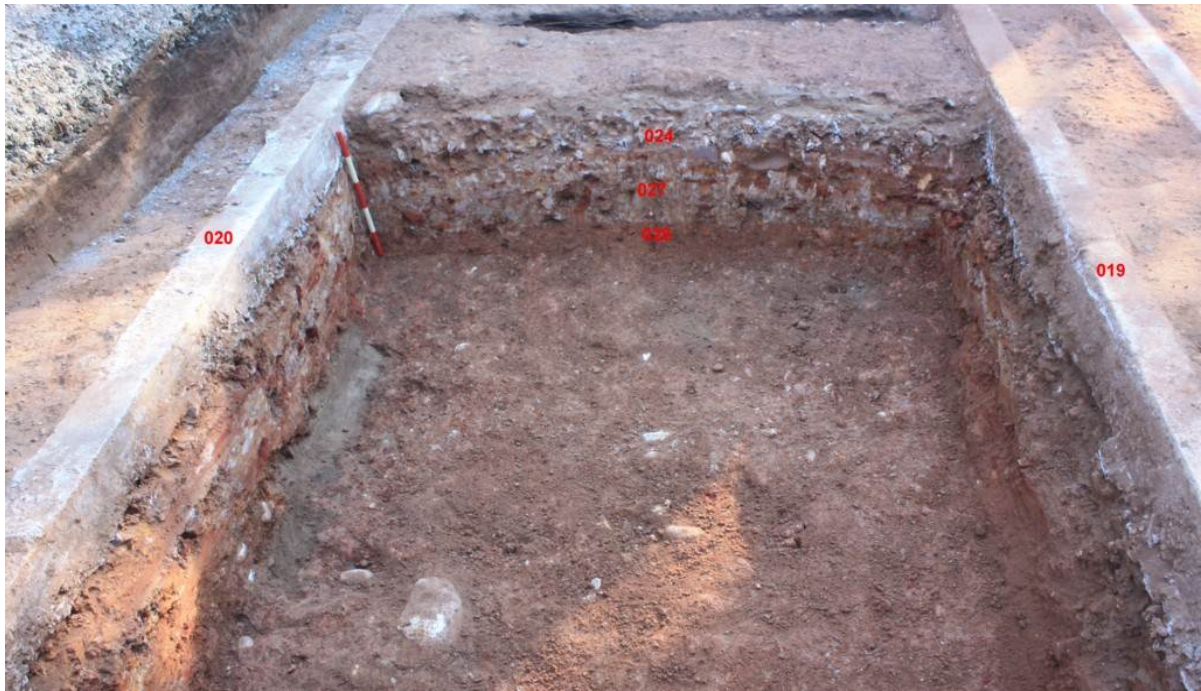
*Plate 48: Test Trench 2, view west showing the section in the small test pit with the fill layers [027, 028] below the packing for the beams [024]; scale 500 millimetres*

Immediately below the hard packing [024] used to stabilise the concrete beams were several layers of fill used to raise and level the site prior to the introduction of the beams. The first of these layers, below the packing fill, was a deposit of mixed white and orange clay up to a

There was considerable evidence for the extensive scope of work that went into creating the new approach to the bridge. Large quantities of fill were brought to the site to raise its level [027, 028]; this is confirmed by archival sources. The concrete beams found throughout the trench [014-020] appear to have been used to stabilise the slope and create a firm base for the new road. Evidence remained of their construction, post holes from what appears to be some kind of form work at the western ends of each beam [025, 035, 034, 026, 032, 031, 033] and small stakes. There is not enough evidence to determine why they were widely spaced on the southern side and for what purpose the timber plates [021, 022] that stretched between them served; certainly both plates and concrete beams were part of the one program of work. They were all bedded in the same compacted deposit of rubble [024].
