## 3.2 Test Trench 2: Car Park, Thompson Square

Windsor Bridge Replacement Project 14020		
European Test Excavation	Test Trench 2	
Scale: 1:25	Ⓢ N	Plan No: 1

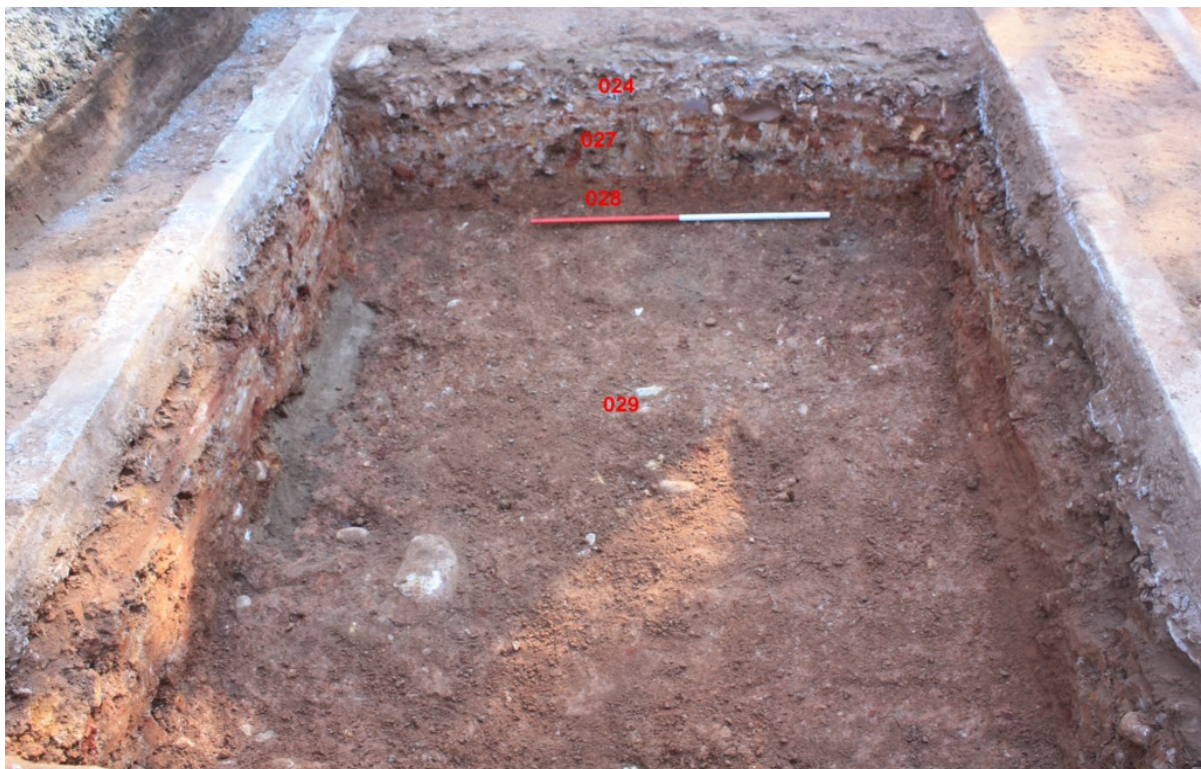
*Plate 49: Test Trench 2, view west showing the compacted stone and soil layer [029]; scale one metre.*

Below the two fill layers [027, 028] was a compacted deposit that comprised loam, some red clay, and a large quantity of rounded stones and small gravel [029]; it was up to 250 mm in depth but this was at its deepest point. It filled a sloping cut below and so the middle section was considerably deeper than the sides (south and north). It was impossible to determine from the small excavation area whether this was a fill deposit or an older road surface.

What is more difficult to interpret are the layers found at the base of the smaller test pit excavated in the south-eastern corner of the large trench. The deposit with numerous rounded pebbles and gravel [029] could be the surface of the older road to the bridge or a deposit common to Thompson Square. The survey plan of the early 1870s for the proposed bridge records that the surface of the square close to the river was composed of earth with rounded pebbles. Whether this surface is a contained feature or common to the square is impossible to determine from the area available. Similarly, the deposit below [030] is also impossible to interpret other than it appears to be introduced soil and that it has been cut and shaped, possibly for the surface above it or for a purpose no longer evident because of the excavation made into it. It is also impossible to determine if it is a unique feature or a widely spread surface.

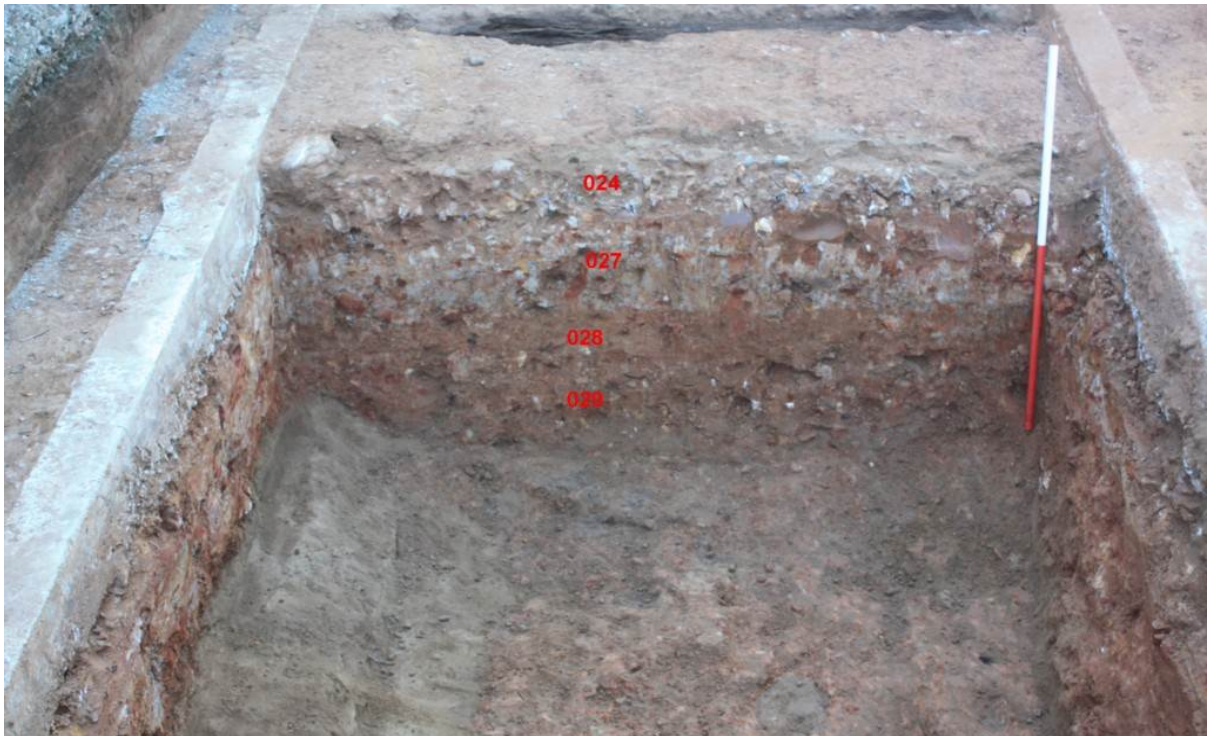
*Plate 50: Test Trench 2, view west showing the stone and clay fill in section filling in the sloping cut below it; scale one metre.*

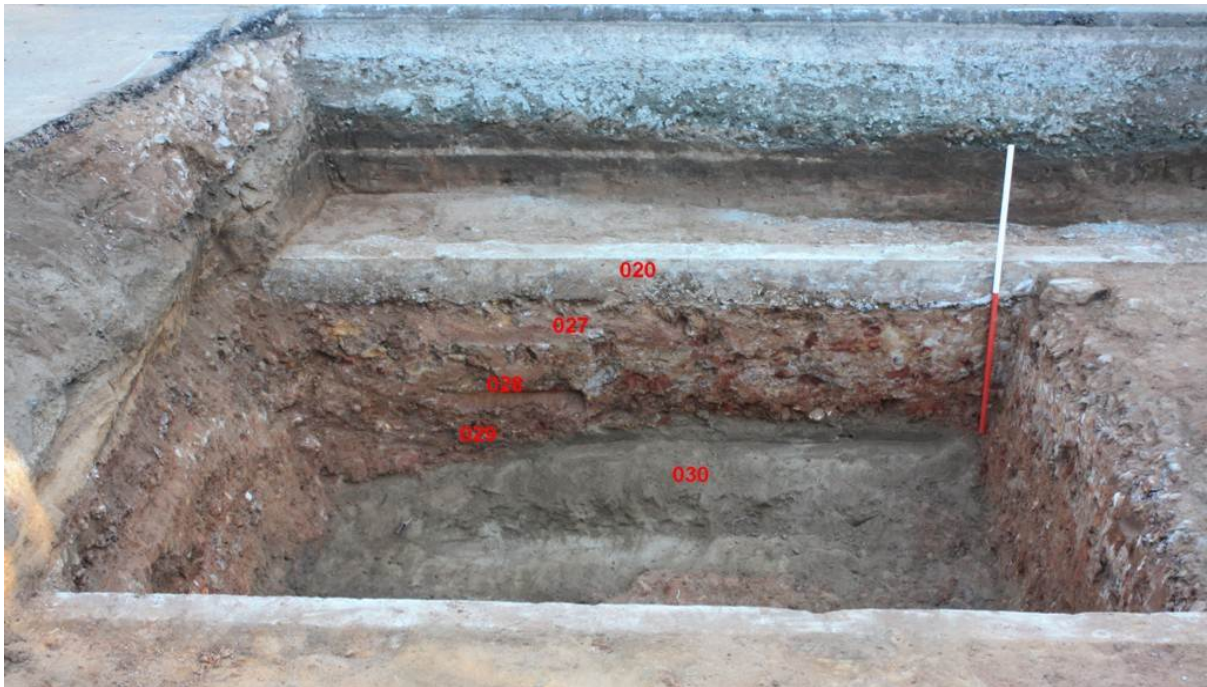
*Plate 51: Test Trench 2, view south showing the sloping silty soil [030] cut into a step at the base of the test pit; the slope to the east is evident here: scale one metre.*

Below this deposit was a distinctive fine, silty green/grey coloured loam. It was completely sterile of inclusions or artefacts. It may originally have been a level deposit but appears to have been cut in a step on the southern side of the trench leaving a thin deposit across the base of the trench that was missing in parts [030]. It also substantially sloped down to the east. There was insufficient evidence to determine what this material had been used for or when it was deposited here. Below it could be seen the top of a new deposit [037] apparently red clay. At this point the excavation had reached the 1.5 metre depth that is proposed for excavation of the new bridge and the investigation was terminated here.

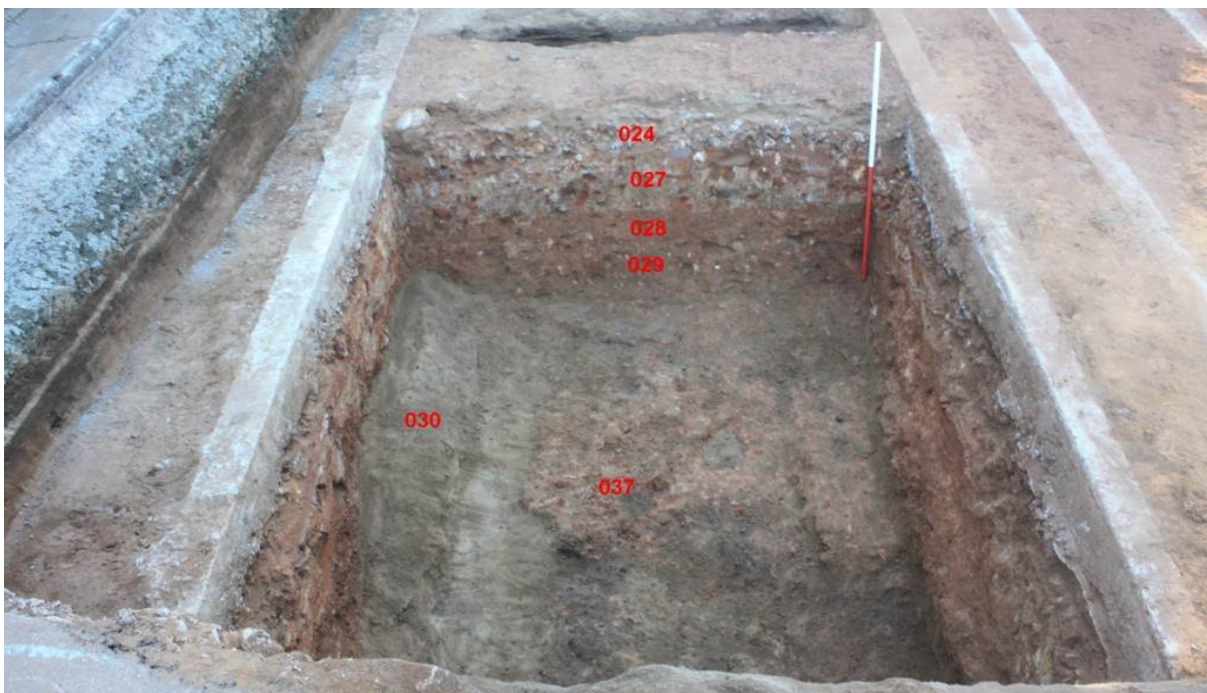
*Plate 52: Test Trench 2, view east showing the sloping soil [030] at the base of the trench and the clay underlying it [037]; scale one metre*

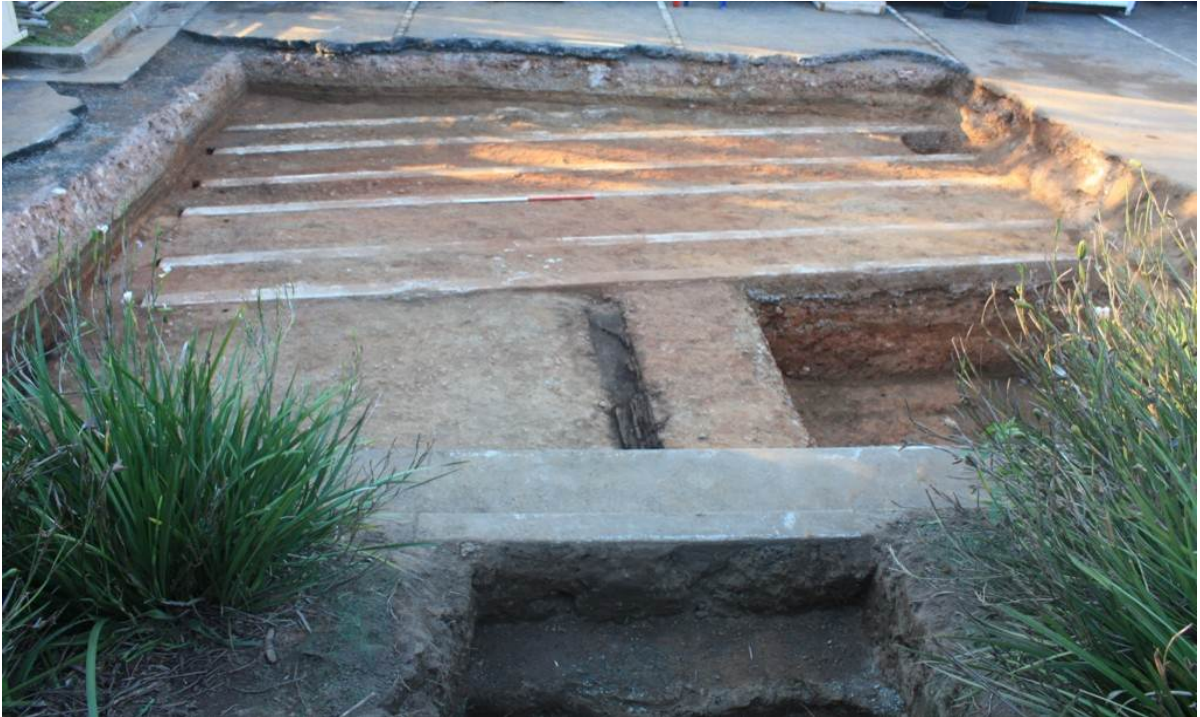
*Plate 53: Test Trench 2, view north showing the main Test Trench 2 and the smaller test pit within it to its final depth; in the foreground is the base of the pit made in the reserve.*

After this work was completed a small test pit was put into the side of the reserve adjoining the car park to determine if there was a distinct stratigraphic profile here and, if so, whether it could be related to the information recorded in Test Trench 2. A 1.5 metre trench was cut into the side of the reserve for this purpose.

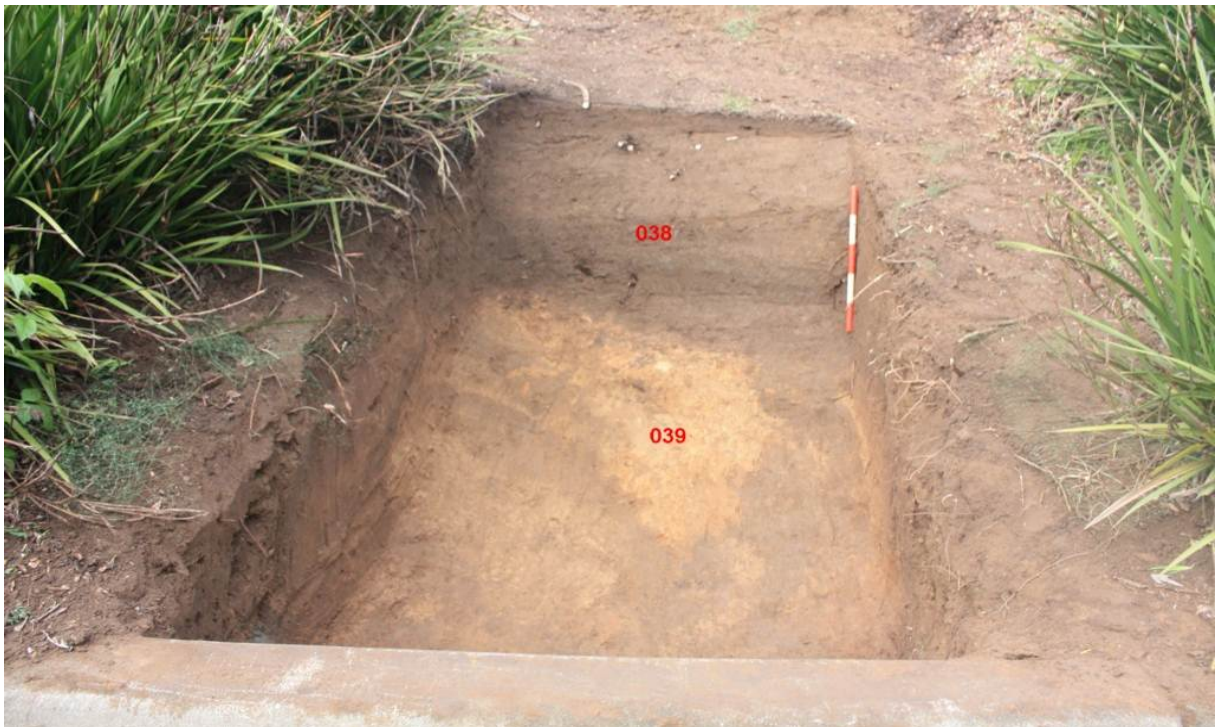
*Plate 54: Test Trench 2, view south showing the soil and clay in the excavation into the reserve; scale 500 millimetres.*

The excavation in the reserve revealed no connection to the test trench in the car park. All that was found in this smaller trench was introduced topsoil in lenses to a depth of 800 mm [038] lying above yellow clay [039] that extended at least to the 1.5 metre depth required for the bridge excavation. The deposits sloped down to the north.
