Windsor Bridge Replacement

Noise and vibration Addendum

Heritage Advice on Noise Reduction Mitigation measures

Windsor Bridge Replacement Project

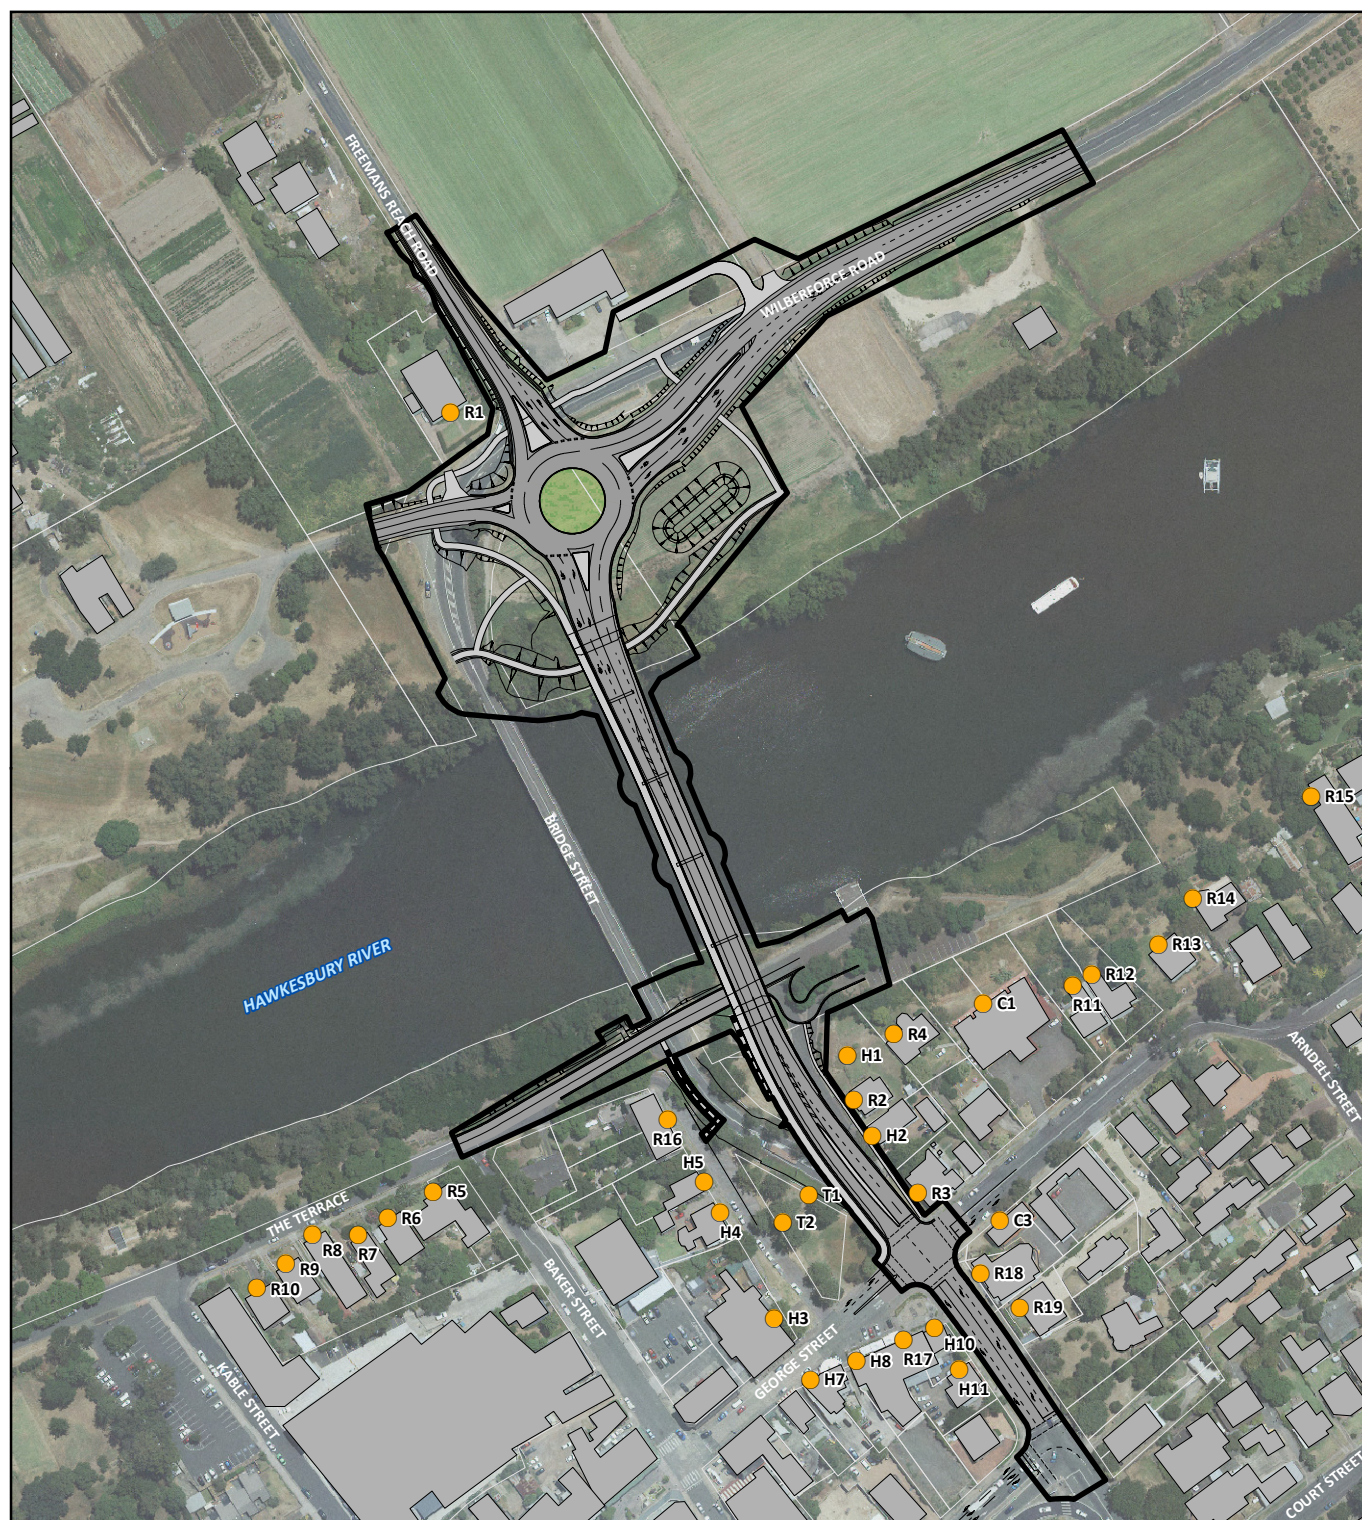
Figure 1-1 | Receivers

The study area comprises a mixture of residential and commercial receivers, many of which are buildings or items with local and/or State heritage significance. The closest residential receivers identified for the project are shown in **Table 1-1**. Additional properties were identified during the exhibition and submission phase of the EIS and have been included in the assessment of noise sensitive receivers for the revised proposal. These properties were previously identified in the EIS Noise and Vibration Working paper as commercial premises and are listed in **Table 1-1** as R16, R17, R18, and R19. **Table 1-2** presents the detail of the revised list of commercial and non residential receivers for the project. The receiver locations revised are shown in **Figure 1-1**.

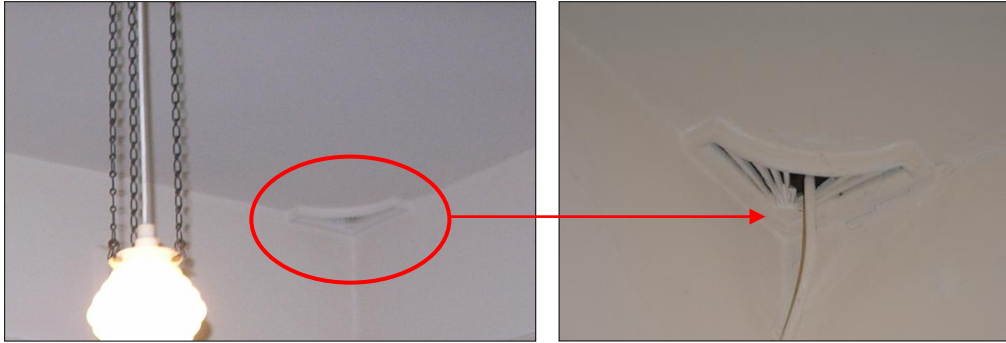
The ventilation system ducts / cabling can be placed within the roof cavity with only minimum required opening for the ducting registers in the ceilings. Consultation should be undertaken

with an appropriately qualified Heritage Architect in order to establish the locations for ducting registers. Images of an example of traditional corner ceiling vent from a house in Alexandria have been provided below for reference. New detailing should not imitate this example but be a simple version of the traditional ceiling vent.

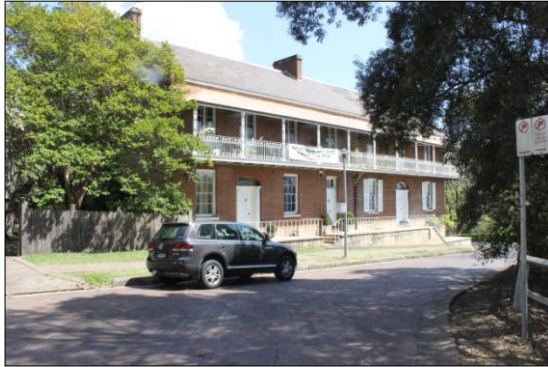
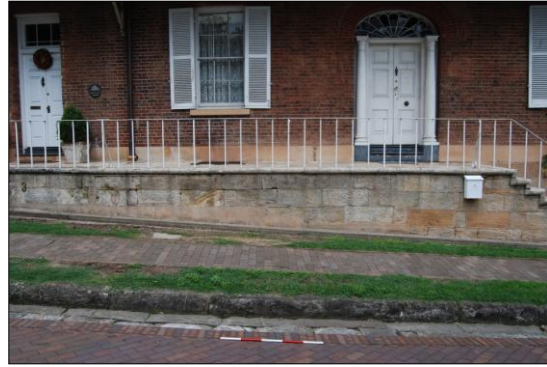
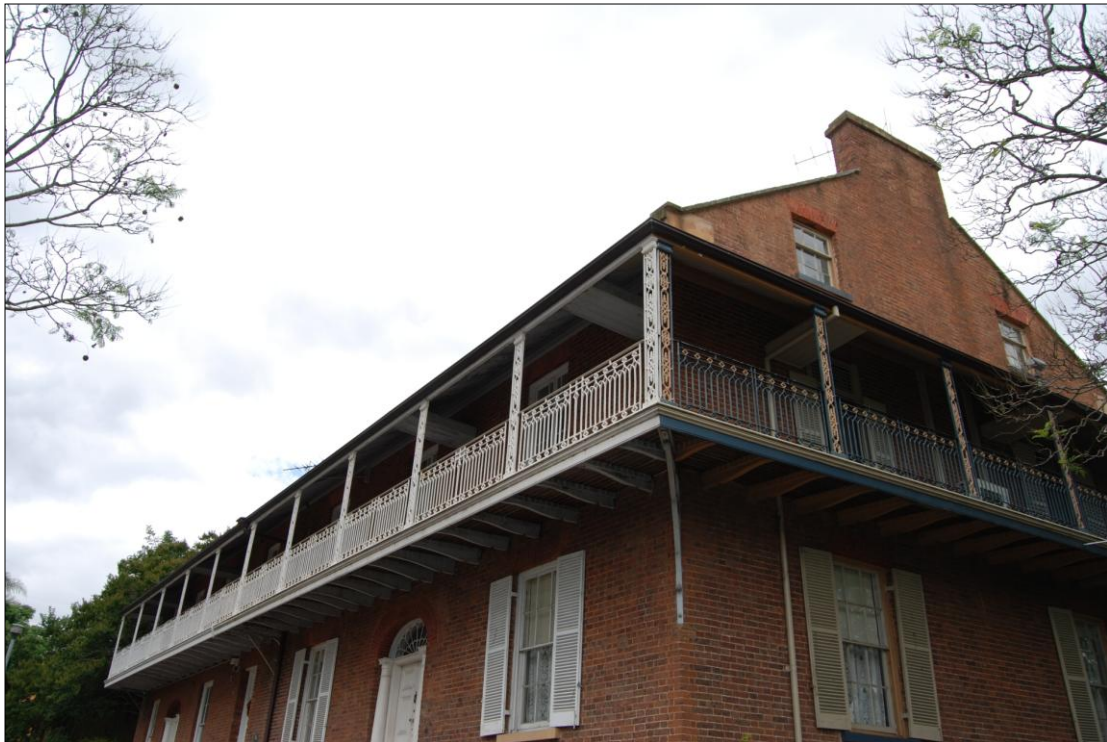
Views of the Doctors House at 1-3 Thompson Square, Windsor

All of the buildings that are considered in this report feature timber joinery characteristic of their construction periods and architectural styles. While the Victorian terrace style buildings at 1-3 Thompson Square (The Doctors House) and at 64-68 George Street (former Hawkesbury Stores) appear to have intact window and door joinery, the joinery at the original hall section of the former School of Arts Building (14 Bridge Street) may have been replaced with matching joinery with the front projecting bay windows being later additions. Notwithstanding, the joinery of these buildings is considered significant and any architectural noise treatment should maintain their external appearance. Any treatment therefore should be made from the interiors.

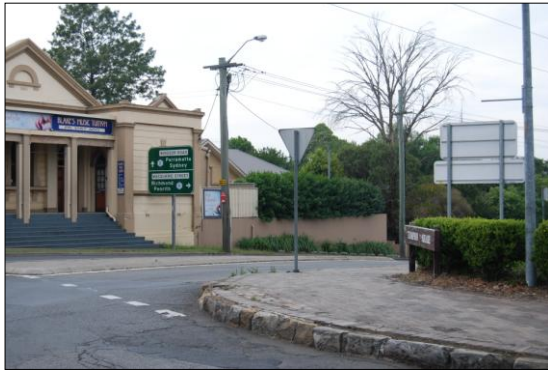
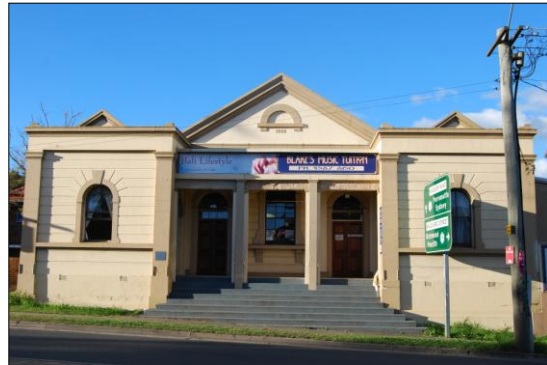
Views of the former School of Arts at 14 Bridge Street, Windsor

Recommendations for architectural noise treatment that were made for 10 Bridge Street will also be applicable for these buildings. Similar architectural noise treatment should also be applied to the former School of Arts Building at 14 Bridge Street.

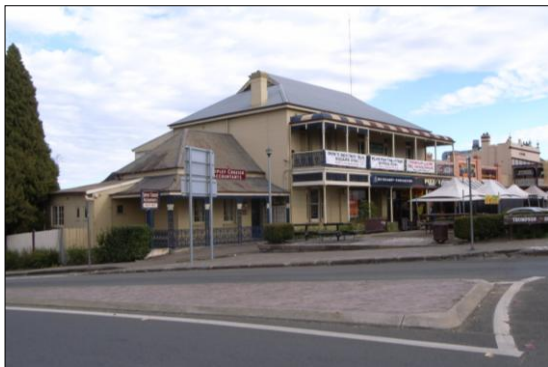
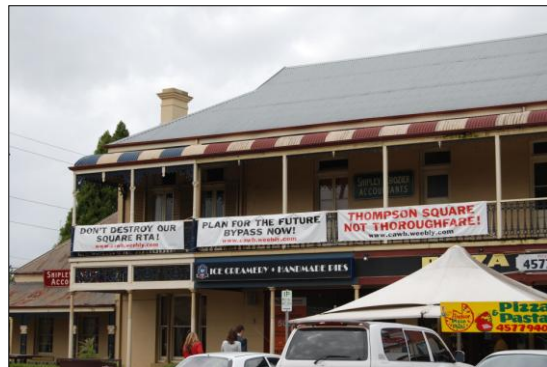
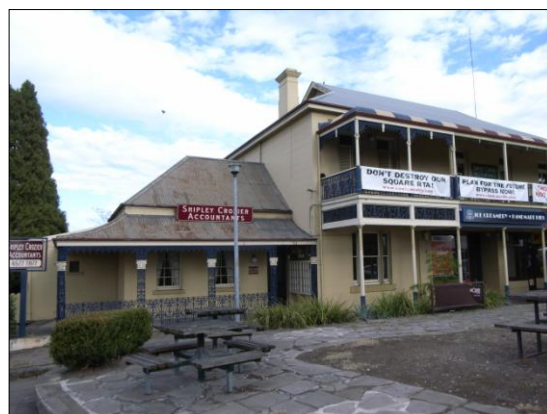
***Views of the former Hawkesbury Stores at 64-68 George Street, Windsor***

Similarly, the upper floor rooms facing George Street feature four (4) windows (2 to each room). All windows are operable and should be retained in operational condition. The profile of the existing glazing bars of the timber joinery (both French doors and windows) is very fine with a deep section that would allow insertion of a second custom made frame.
