L001 Interim Audit Advice (0503-2006-001) – Tarago

Andrew Lau of JBS&G Australia Pty Ltd (JBS&G), was engaged on the 16 April 2020 by John Holland Rail Pty Ltd (John Holland, the client) to conduct a site audit at land that falls within the Goulburn – Bombala rail corridor at Tarago, and is part of the Tarago Station Rail Corridor, Tarago, NSW 2580. The site is identified as Part of Lot 22 DP1202608, occupying an area of approx. 7.7 ha ('the site'). The site is owned by Transport for NSW (TfNSW) and is zoned RU2 "rural landscape". The location of the site and the extent of the site area are shown in Figures 1 – 3, included in **Attachment 2**.

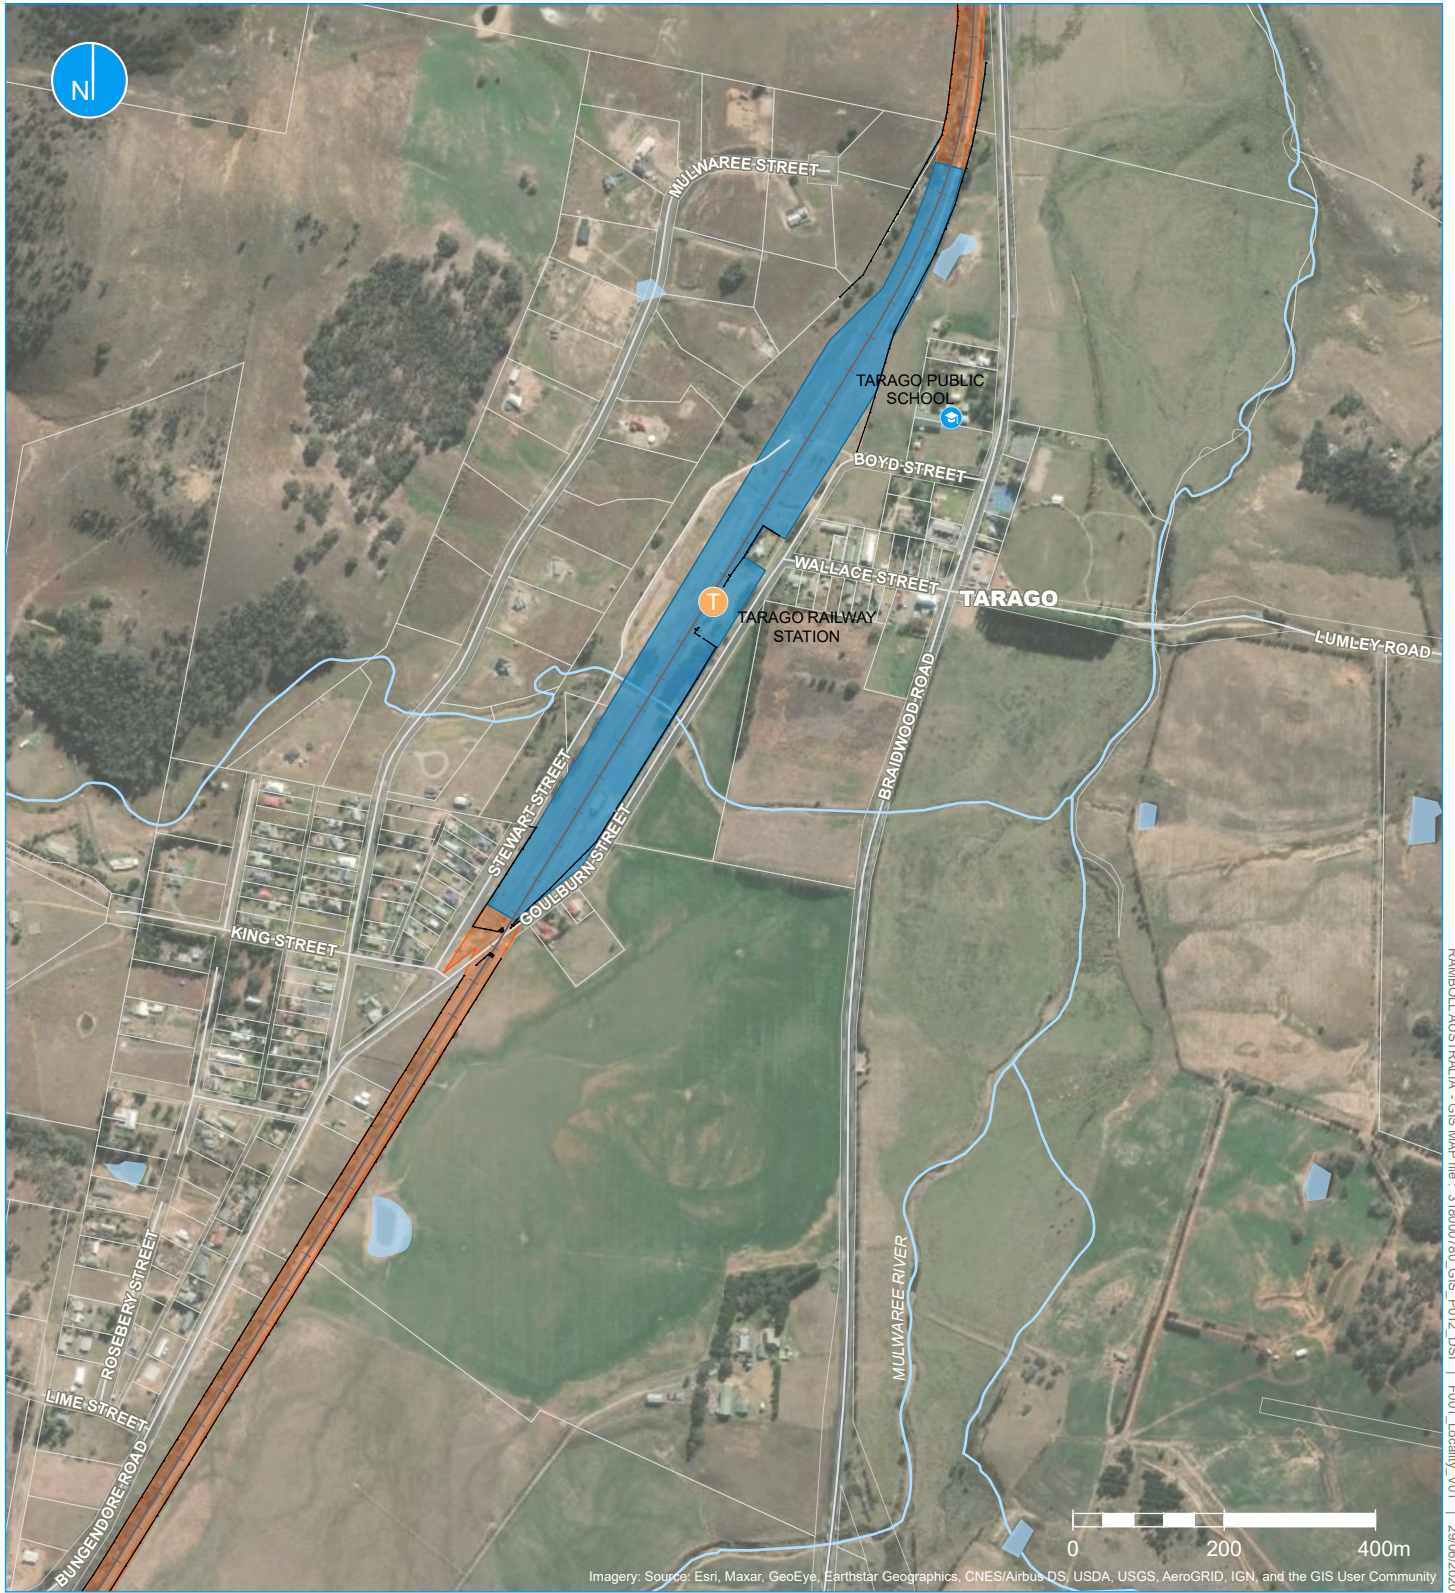
Figure 1 | Locality Plan

- Legend**
- Site boundary
 - Rail corridor
 - Rail corridor fence

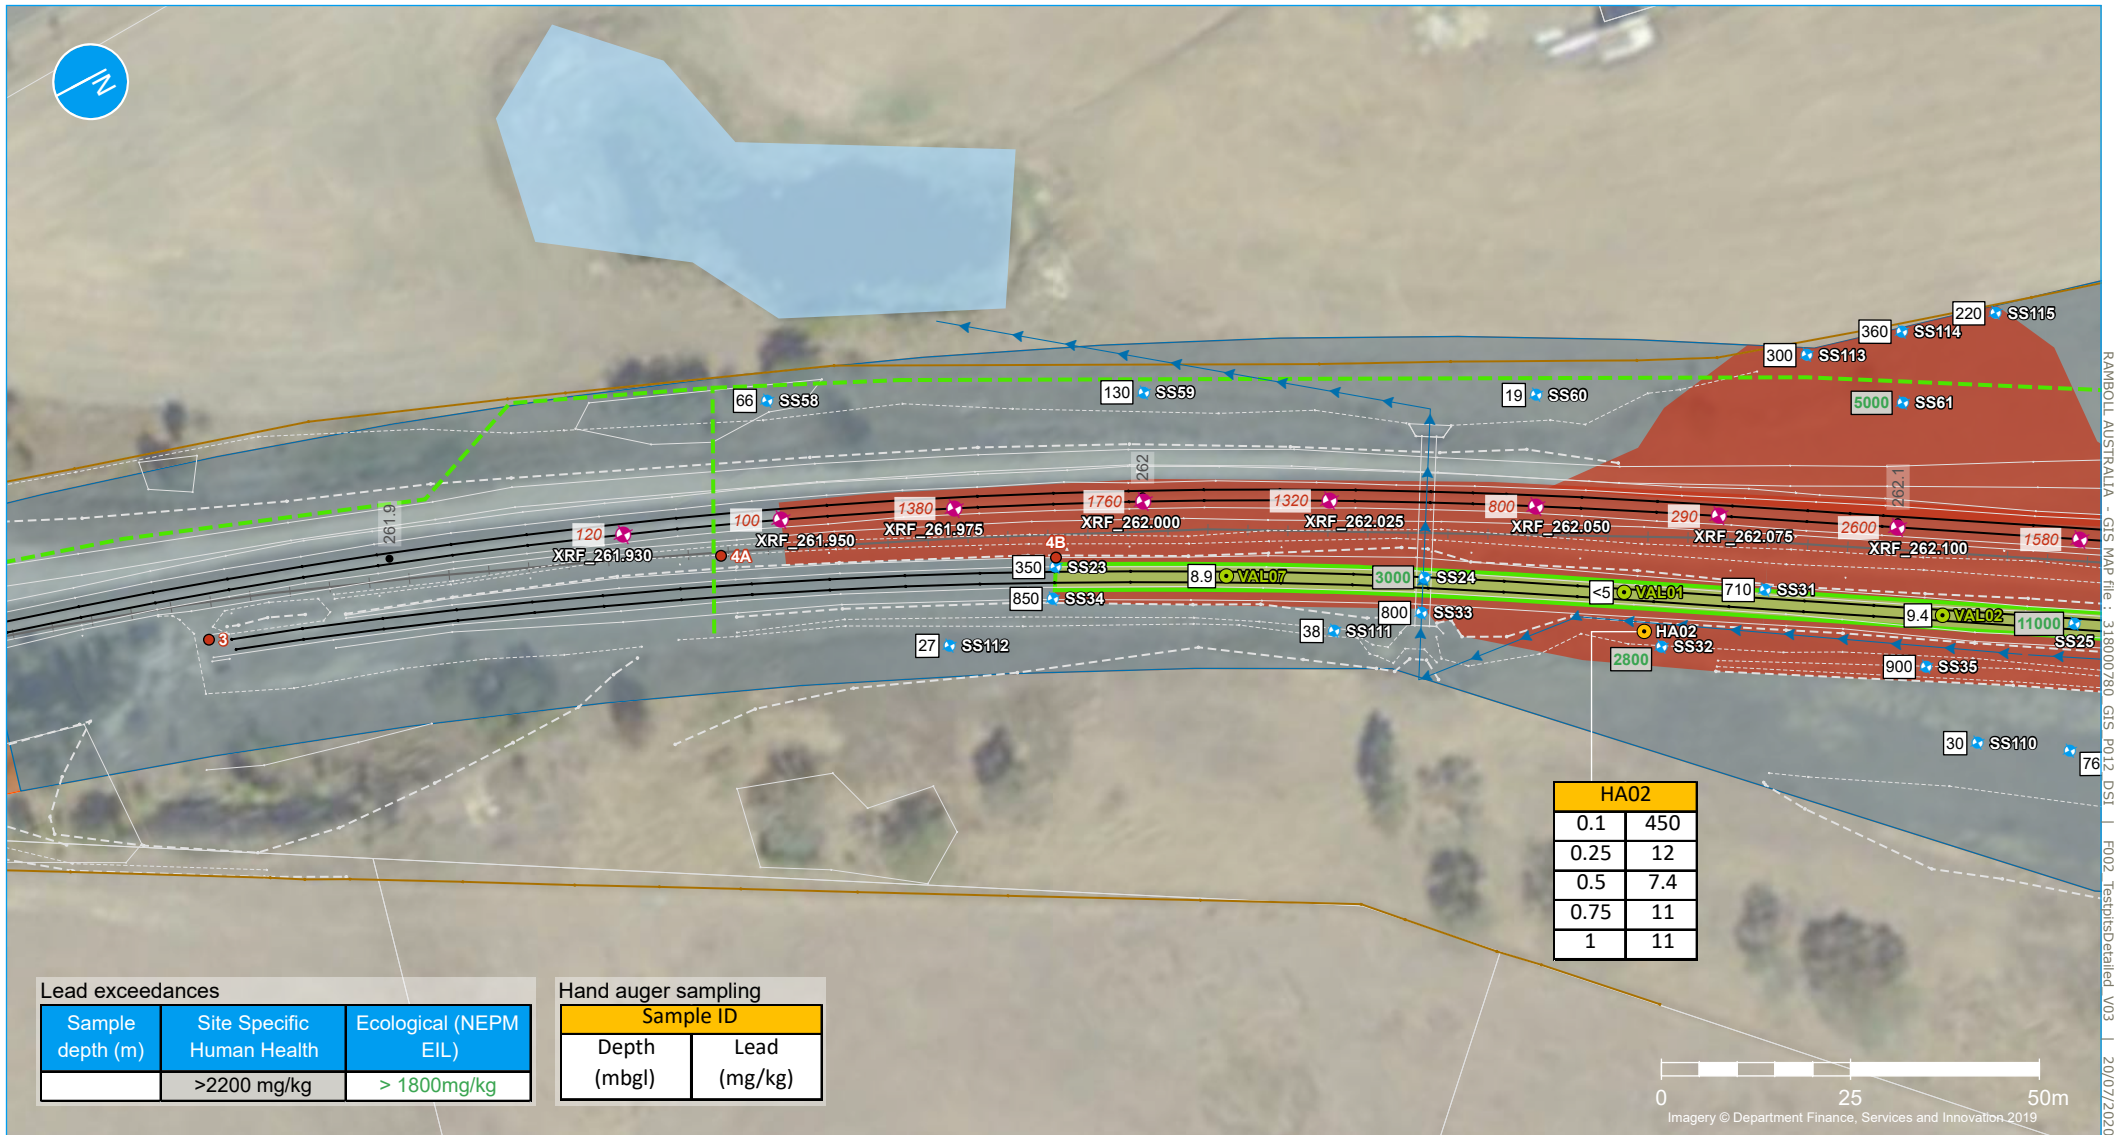
Figure 2a | Site Plan

- Site boundary
- Rail corridor fence
- 0.1km chainage point
- Signal trench (approximate)
- Surface water flow (indicative)
- Survey lines
- Rail track
- Top of bank
- Bottom of bank
- Other elements
- X-Ray fluorescence sampling (Ramboll 2019, 2020)
- Previous sampling location (McMahon)
- Shallow soil (Ramboll 2019)
- Hand auger (Ramboll 2019)
- 1200 Lead concentration for XRF sample (mg/kg)
- Validation sample (Ramboll 2019)
- Lead impacted area
- Area of excavation during loop extension (no further excavation proposed)

Note: X-Ray fluorescence sampling results were conservatively assessed against a management threshold of 1200 mg/kg Pb to mitigate uncertainty associated with these.
Data relating to impacts on private properties has not been presented to maintain privacy for affected parties. Data for TP1 – TP9 and TP15 from the Woodlawn siding is presented in Appendix 3, Table H2 – H3. Data for TP1 – TP20 from the Loadout Complex Footprint is presented in Appendix 3, Table 7.

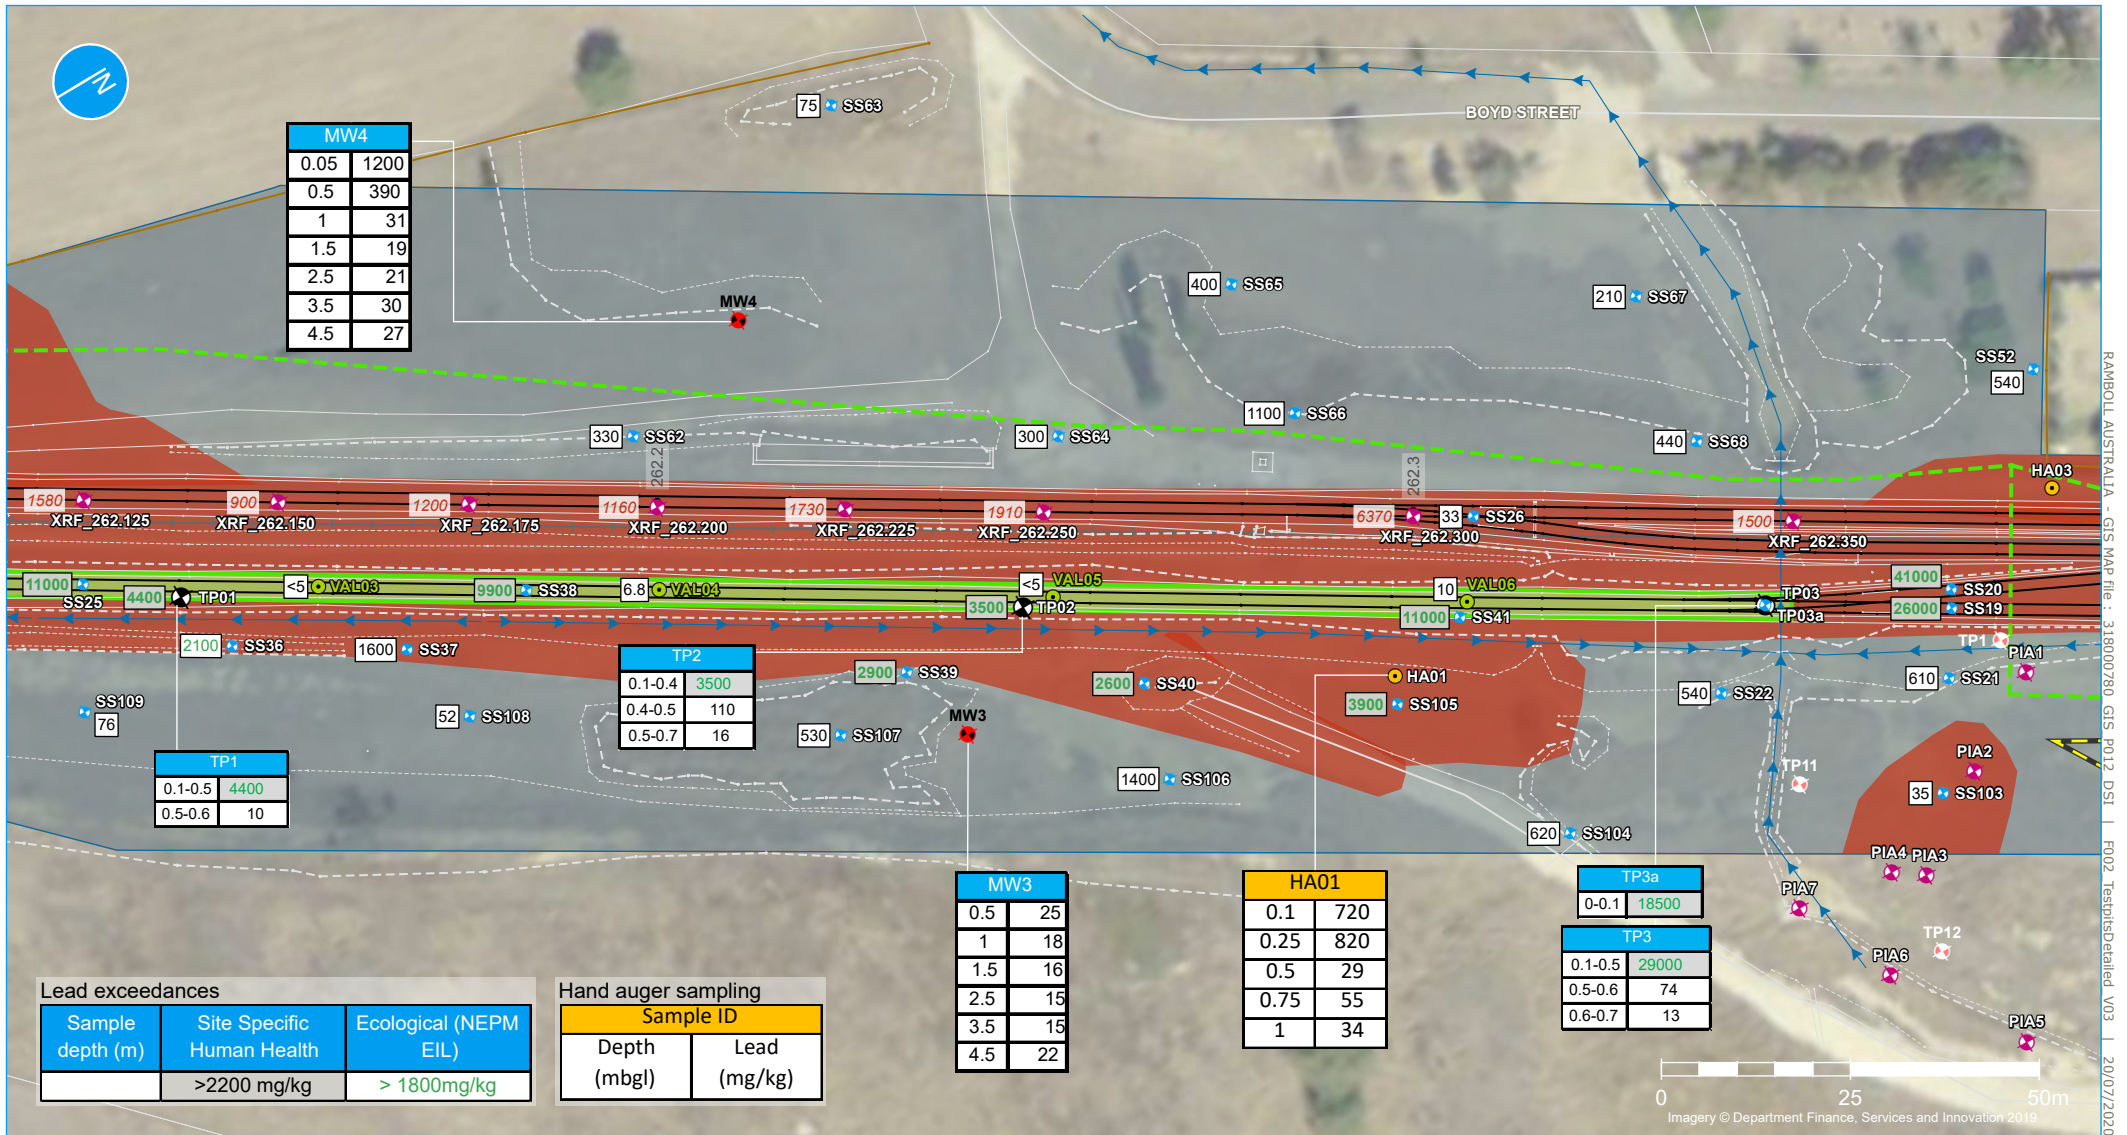
Figure 2b | Site Plan

- Site boundary
 - Rail corridor fence
 - 0.1km chainage point
 - Signal trench (approximate)
 - Surface water flow (indicative)
 - Survey lines
 - Rail track

- Top of bank
 - Bottom of bank
 - Other elements
 - ◆ X-Ray fluorescence sampling (Ramboll 2019, 2020)
 - ◆ Shallow soil (Ramboll 2019)
 - ⊕ Test pit (Ramboll 2019)

- Hand auger (Ramboll 2019)
 - ◆ 1200 Lead concentration for XRF sample (mg/kg)
 - Validation sample (Ramboll 2019)
 - ◆ Groundwater monitoring location
 - ◆ Test pit (loadout complex)

- Lead impacted area
 - Area of excavation during loop extension (no further excavation proposed)
 - Former loadout road (approximate)
- Note: X-Ray fluorescence sampling results were conservatively assessed against a management threshold of 1200 mg/kg Pb to mitigate uncertainty associated with these.
Data relating to impacts on private properties has not been presented to maintain privacy for affected parties. Data for TP1 – TP9 and TP15 from the Woodlawn siding is presented in Appendix 3, Table H2 – H3. Data for TP1 – TP20 from the Loadout Complex Footprint is presented in Appendix 3, Table 7.

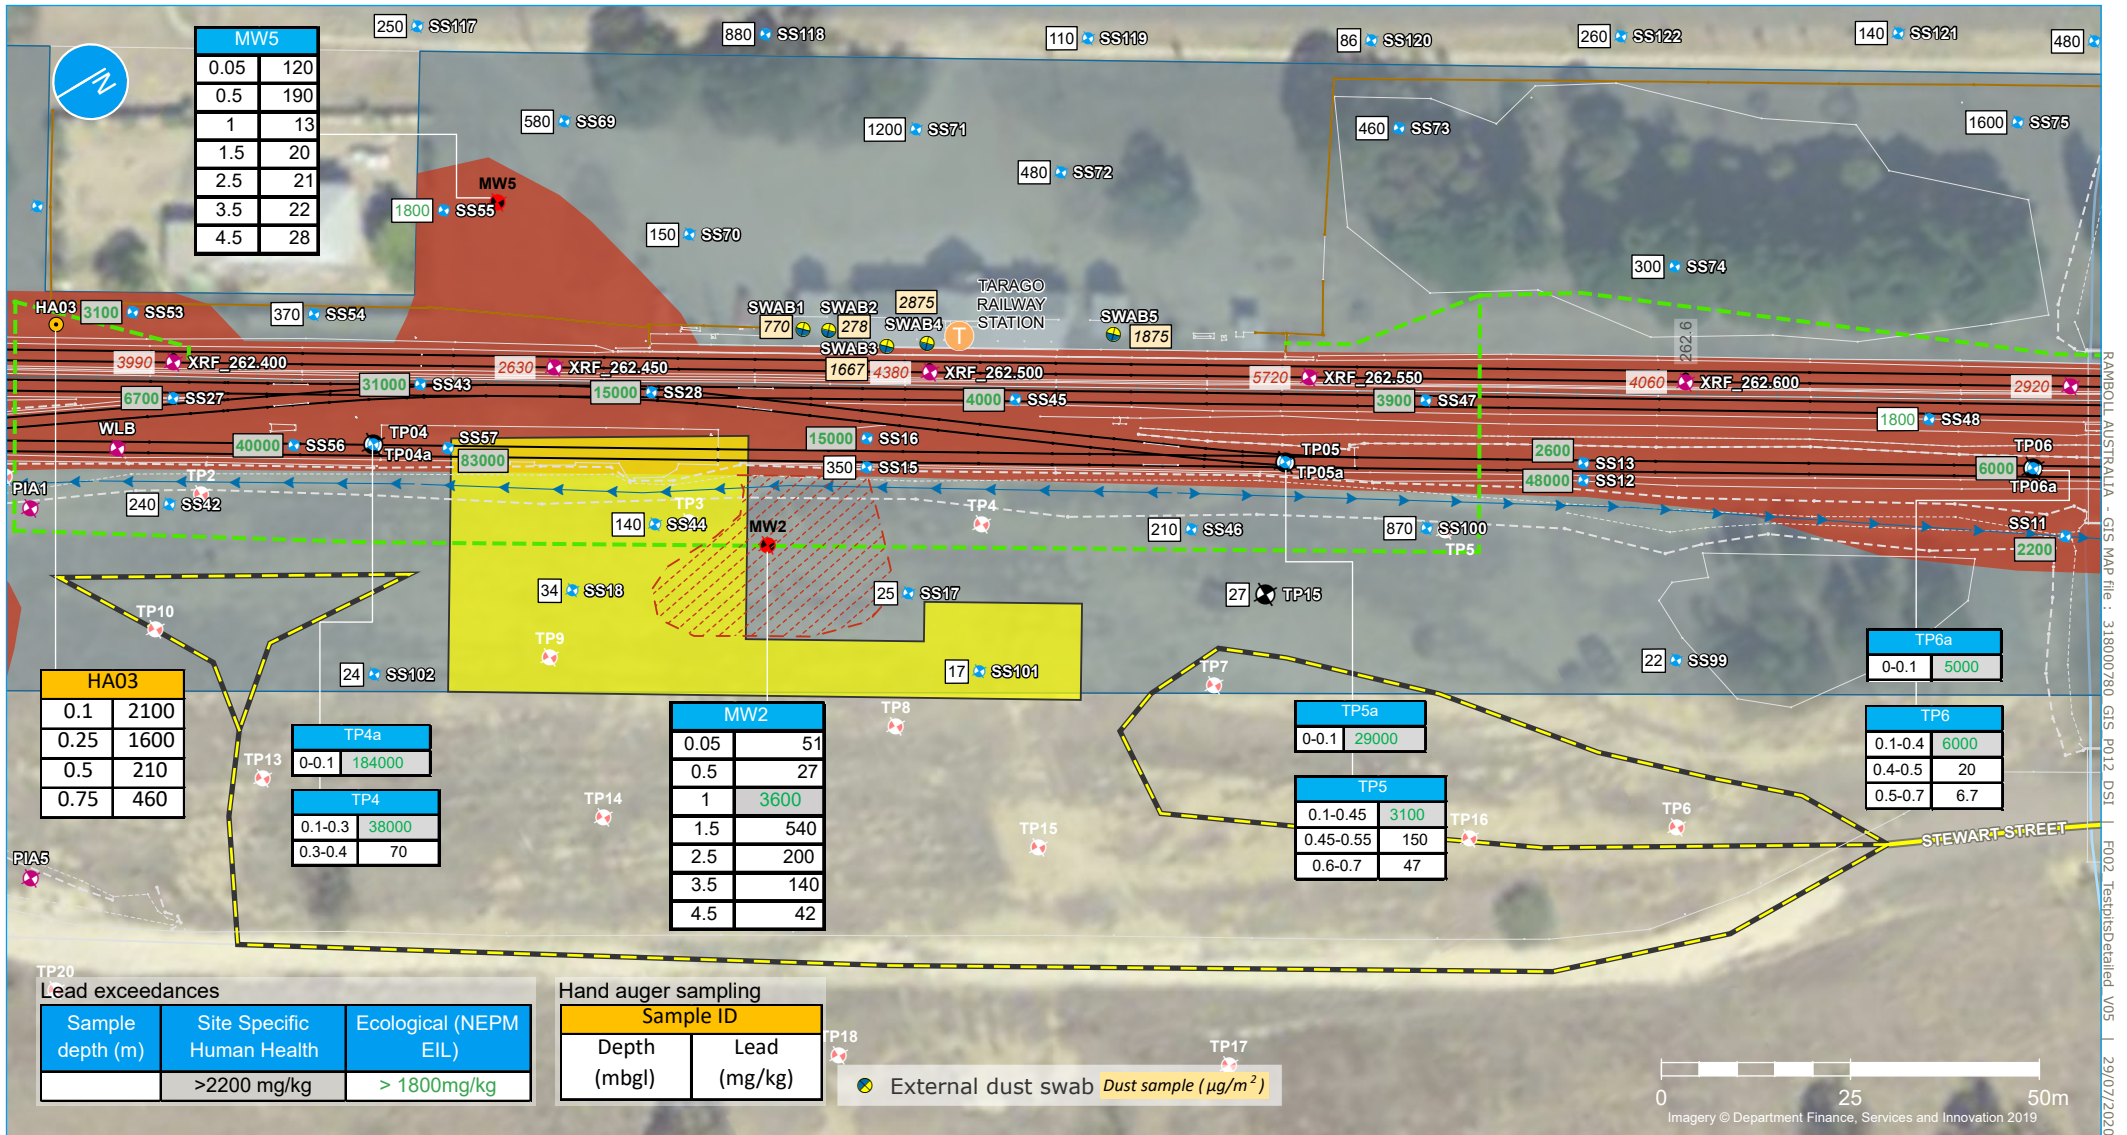
Figure 2c | Site Plan

Note: X-Ray fluorescence sampling results were conservatively assessed against a management threshold of 1200 mg/kg Pb to mitigate uncertainty associated with these.
Data relating to impacts on private properties has not been presented to maintain privacy for affected parties. Data for TP1 – TP9 and TP15 from the Woodlawn siding is presented in Appendix 3, Table H2 – H3. Data for TP1 – TP20 from the Loadout Complex Footprint is presented in Appendix 3, Table 7.

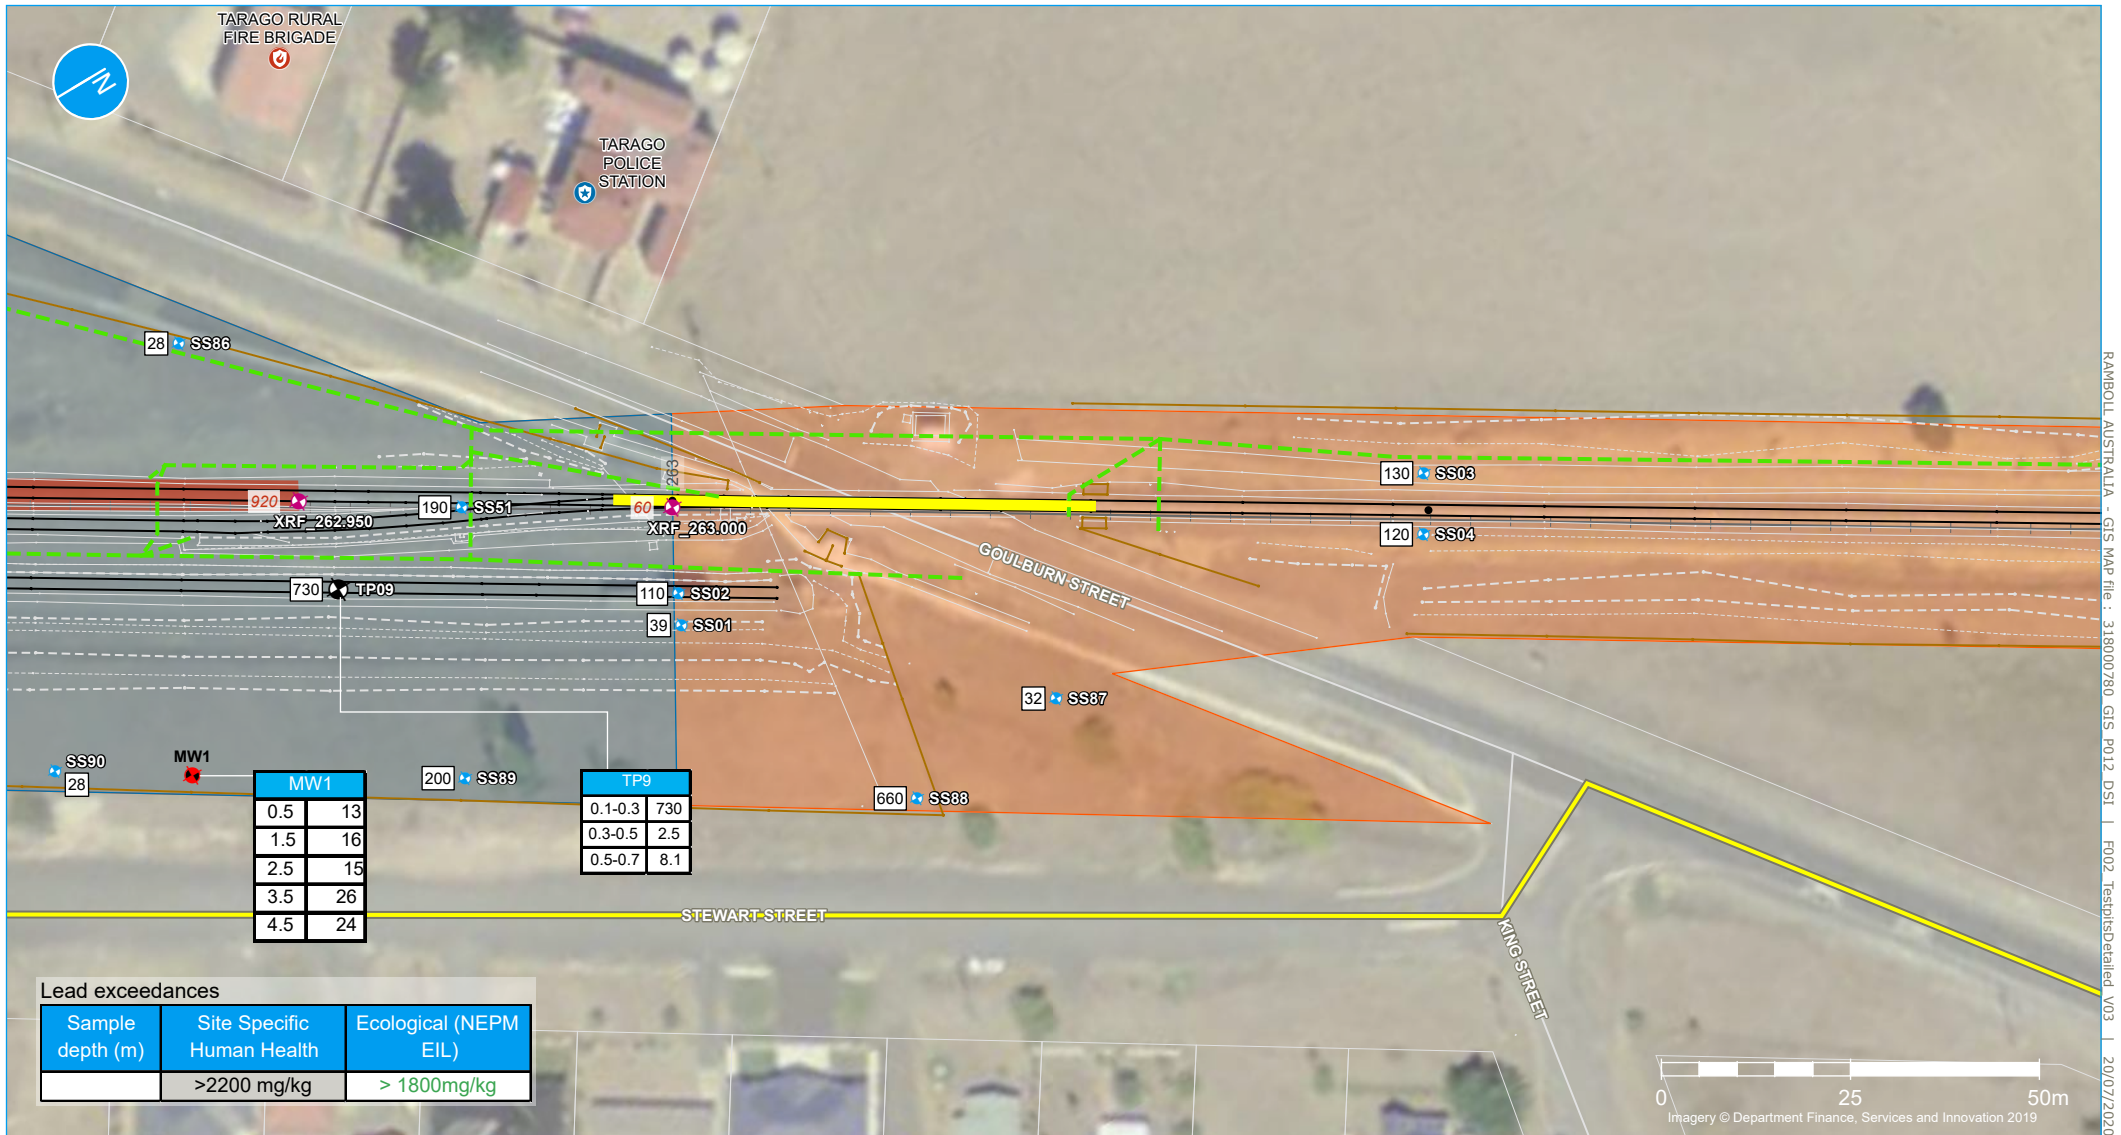
Figure 2e | Site Plan

- Site boundary
- Rail corridor fence
- Rail track
- Top of bank
- Bottom of bank
- Other elements
- X-Ray fluorescence sampling (Ramboll 2019, 2020)
- Shallow soil (Ramboll 2019)
- Test pit (Ramboll 2019)
- Lead concentration for XRF sample (mg/kg)
- Groundwater monitoring location
- Lead impacted area
- Haul route
- 0.1km chainage point
- Goulburn Street level crossing
- Signal trench (approximate)
- Surface water flow (indicative)

*Note: X-Ray fluorescence sampling results were conservatively assessed against a management threshold of 1200 mg/kg Pb to mitigate uncertainty associated with these.
Data relating to impacts on private properties has not been presented to maintain privacy for affected parties. Data for TP1 – TP9 and TP15 from the Woodlawn siding is presented in Appendix 3, Table H2 – H3. Data for TP1 – TP20 from the Loadout Complex Footprint is presented in Appendix 3, Table 7.*
