Document type
Remedial Options Assessment

TARAGO RAIL CORRIDOR REMEDIAL OPTIONS ASSESSMENT

Project name **Tarago Rail Corridor**
 Project no. **318000780**
 Recipient **John Holland Rail**
 Document Type **Report**
 Report ref. **318000780-T22-01**
 Description **Ramboll has prepared a remedial options
assessment for contamination at or originating
from the rail corridor at Tarago.**

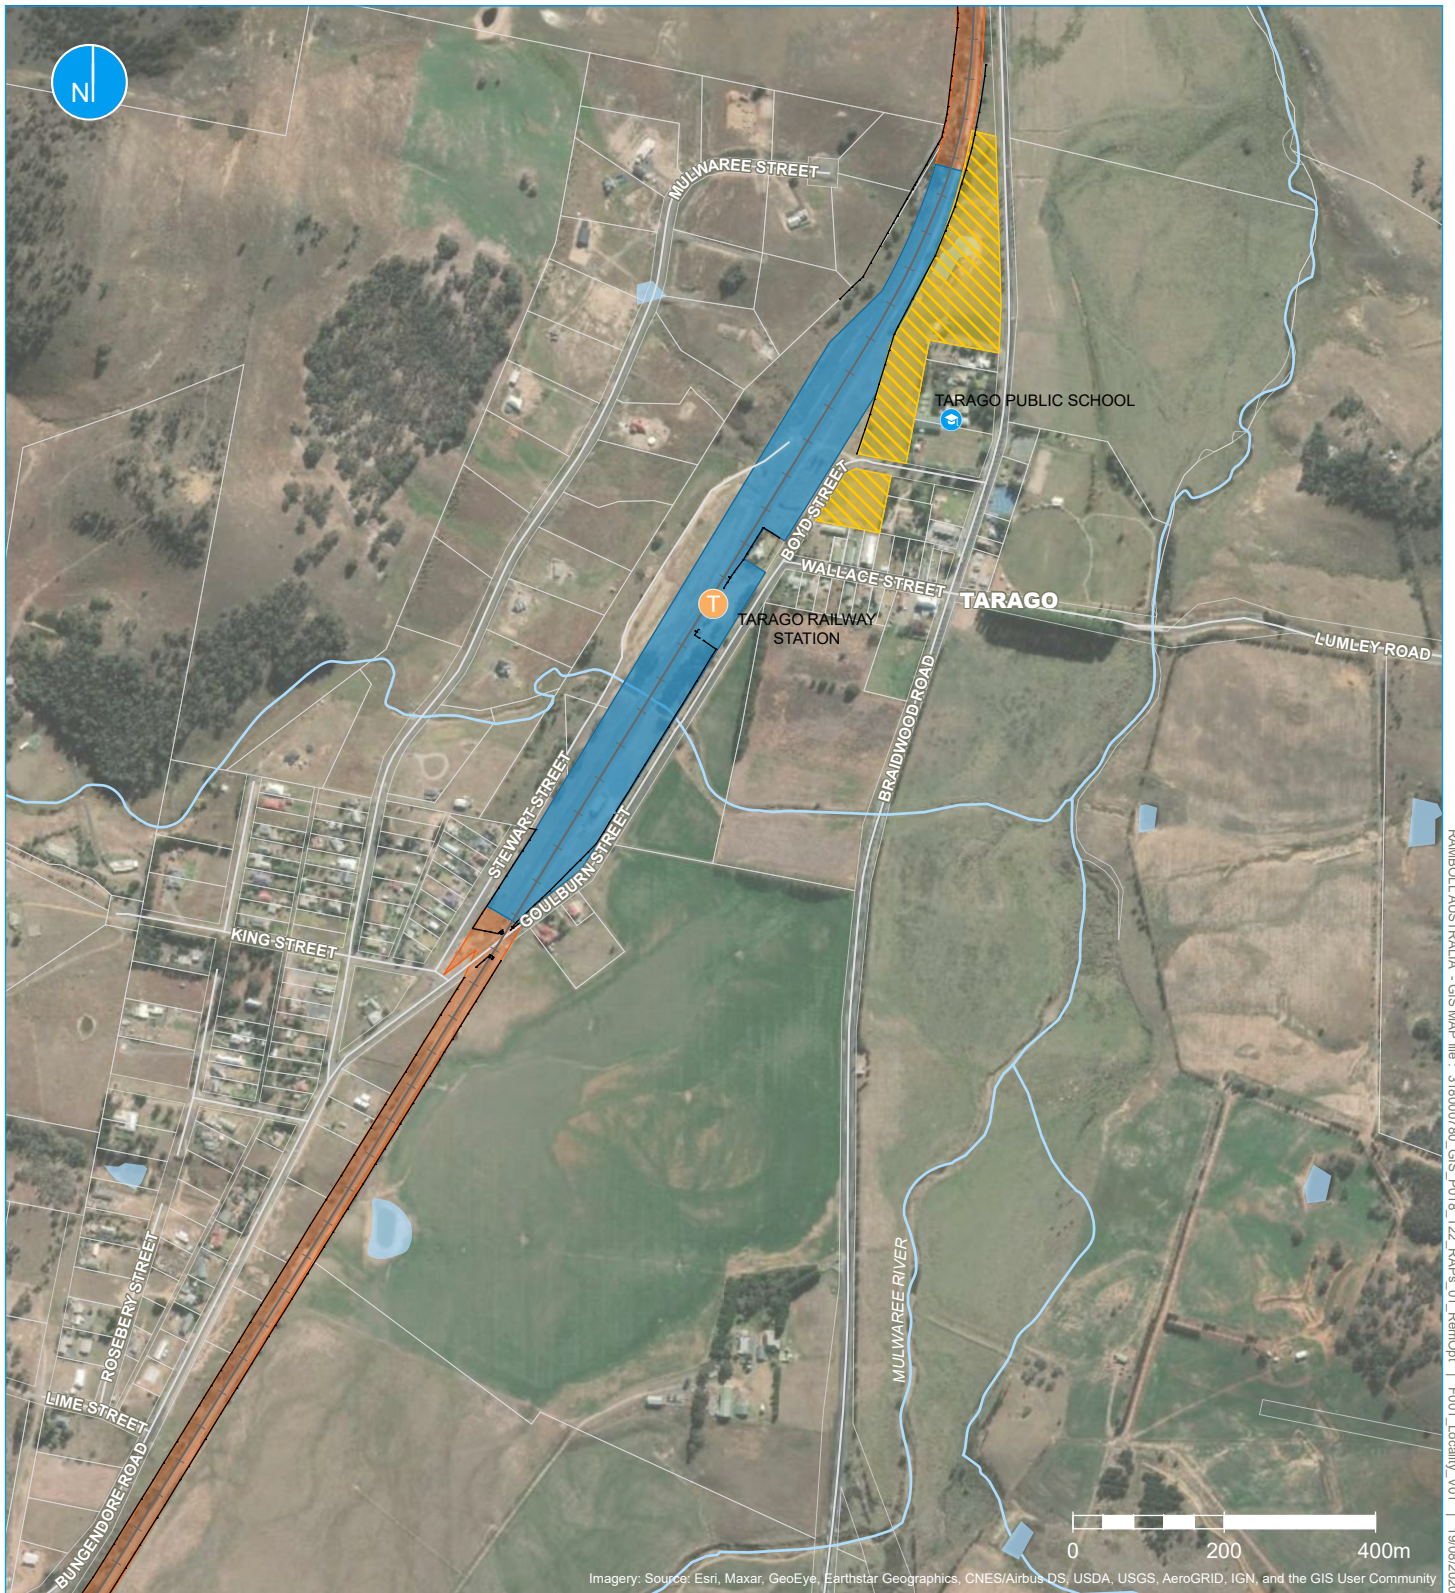
Figure 1 | Locality Plan

- Site boundary
- Area of offsite impact
- Rail corridor
- Rail corridor fence

Ramboll Australia Pty Ltd (Ramboll) was commissioned by John Holland Rail (JHR or the client) to prepare a Remedial Action Plan (RAP) for contamination within or originating from the Goulburn – Bombala rail corridor at Tarago, NSW. The rail corridor at Tarago is shown on **Figure 1, Appendix 1** and is here-in referred to as the site.

Surface water and sediment in drainage lines onsite forms part of the 20,500 m² described above. Tier 2 risk assessment for offsite surface water and sediment impacts is occurring. Properties where remediation of offsite surface water and sediment is required based on tier 1 risk assessment are presented on **Figure 1, Appendix 1**.

The remediation required onsite is defined in **Section 8** and on **Figures 2a – 2e, Appendix 1**. Additionally, remedial options have been considered for offsite areas as defined on **Figure 1, Appendix 1** based on tier 1 risk assessment however further site specific (tier 2) risk assessment is being completed to define remedial requirements.
