JBS&G 62556 - 147,001 L02 (Interim Advice 0503 2303-001) Rev 0

# L02 Interim Audit Advice (0503-2303-02) – Tarago Rail Corridor – Interim (Pre Remediation) Monitoring Requirements

Andrew Lau of JBS&G Australia Pty Ltd (JBS&G), was engaged on the 16 April 2020 by Transport for NSW (TfNSW, the client) to conduct a site audit at land that falls within the Goulburn – Bombala rail corridor at Tarago, NSW, 2580. The site is identified as Part of Lot 22 DP1202608, occupying an area of approx. 7.7 ha ('the site'). The site is owned by TfNSW and is zoned RU2 "rural landscape". The location of the site and the extent of the site area are shown in Figures 1 - 3, included in **Attachment 2**.

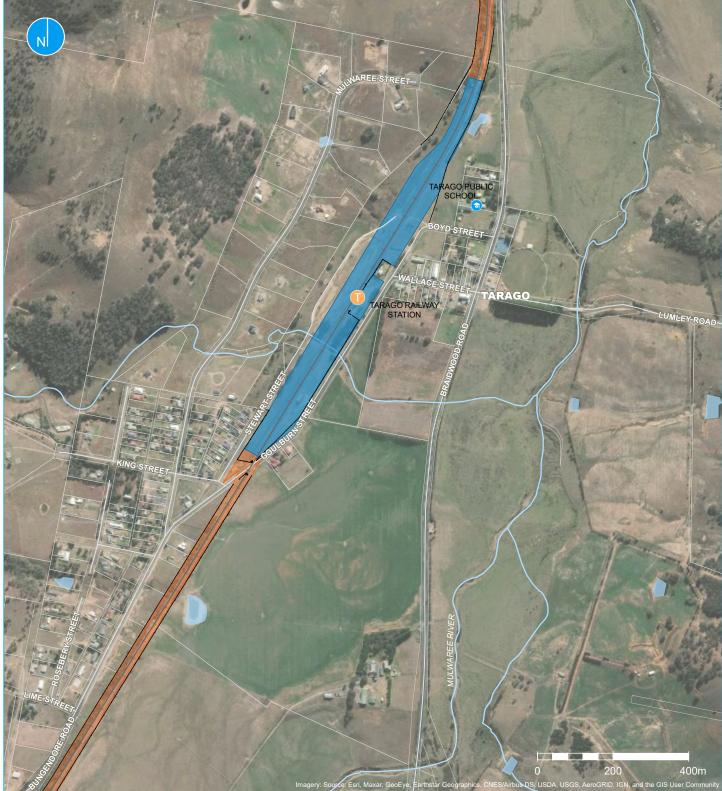
Site boundary Rail corridor Rail corridor fence

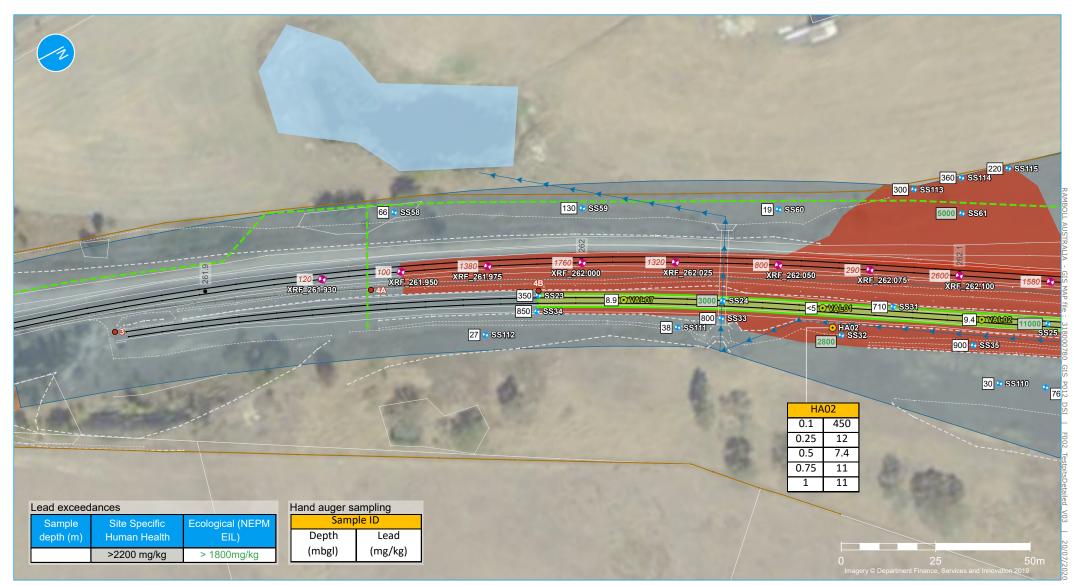
- Site boundary
- Rail corridor fence
- 0.1km chainage point
- ---- Signal trench (approximate)
- ----- Surface water flow (indicative)
- Survey lines
- ------Rail track
- ----- Top of bank
- Bottom of bank
  - Other elements
- X-Ray fluorescence sampling (Ramboll 2019, 2020)
- Previous sampling location (McMahon)
- Shallow soil (Ramboll 2019)
- Hand auger (Ramboll 2019)
- 1200 Lead concentration for XRF sample (mg/kg)
- Validation sample (Ramboll 2019)

Lead impacted area Area of excavation during loop extension (no further excavation proposed)

Note: X-Ray fluorescence sampling results were conservatively assessed against a management threshold of 1200 mg/kg Pb to mitigate uncertainty associated with these.

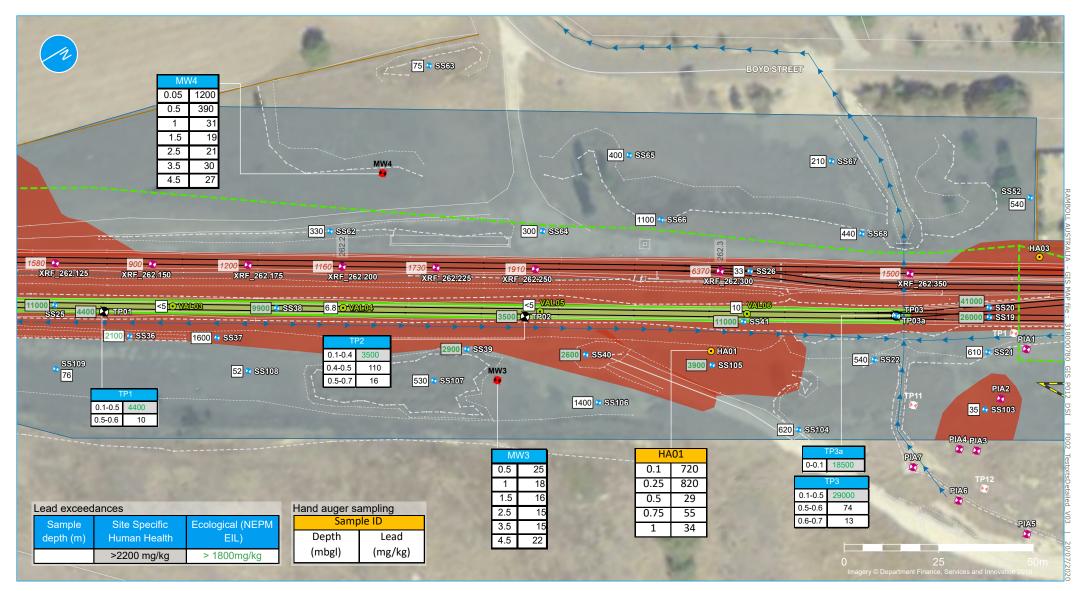
- Site boundary
  Rail corridor fence
- 0.1km chainage point
- ---- Signal trench (approximate)
- ----- Surface water flow (indicative)
- Survey lines ——— Rail track
- ---- Top of bank
- Bottom of bank
  - Other elements
- X-Ray fluorescence sampling (Ramboll 2019, 2020)
- Shallow soil (Ramboll 2019)
- Test pit (Ramboll 2019)
- Hand auger (Ramboll 2019)
- 1200 Lead concentration for XRF sample (mg/kg)
- Validation sample (Ramboll 2019)
- Groundwater monitoring location
- Test pit (loadout complex)

- Lead impacted area
- Area of excavation during loop extension (no further excavation
- proposed)
- Former loadout road (approximate)

Note: X-Ray fluorescence sampling results were conservatively assessed against a management threshold of 1200 mg/kg Pb to mitigate uncertainty associated with these.

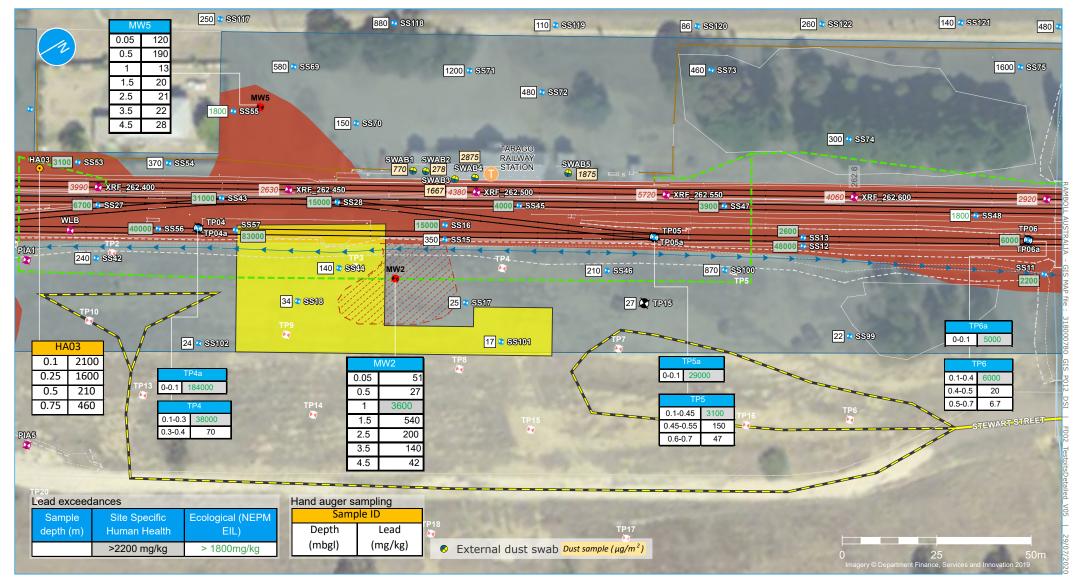
- Site boundary Rail corridor fence
- 0.1km chainage point
- Signal trench (approximate)
- Surface water flow (indicative)
- Survey lines Rail track Top of bank
  - Bottom of bank
    - Other elements
- X-Ray fluorescence sampling (Ramboll 2019, 2020) •
- ٠ Shallow soil (Ramboll 2019)
- $\bullet$ Test pit (Ramboll 2019)
- Hand auger (Ramboll 2019)
- Lead concentration for XRF sample (mg/kg) 1200
- ۲ Groundwater monitoring location
- \* Test pit (loadout complex)

Haul route

Note: X-Ray fluorescence sampling results were conservatively assessed against a management threshold of 1200 mg/kg Pb to mitigate uncertainty associated with these.

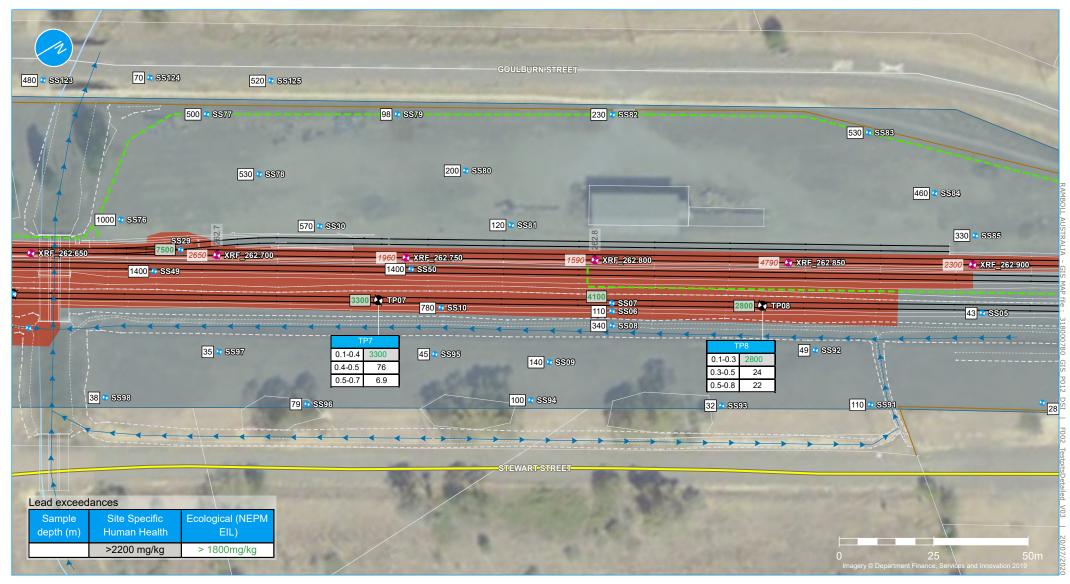
- Site boundary
- Rail corridor fence
- 0.1km chainage point
- Signal trench (approximate)
- Surface water flow (indicative)
- Survey lines
- Rail track
  - Top of bank
  - Bottom of bank Other elements
- X-Ray fluorescence sampling (Ramboll 2019, 2020) •
- Shallow soil (Ramboll 2019) ٠
- Test pit (Ramboll 2019)
- 1200 Lead concentration for XRF sample (mg/kg)

Lead impacted area Haul route

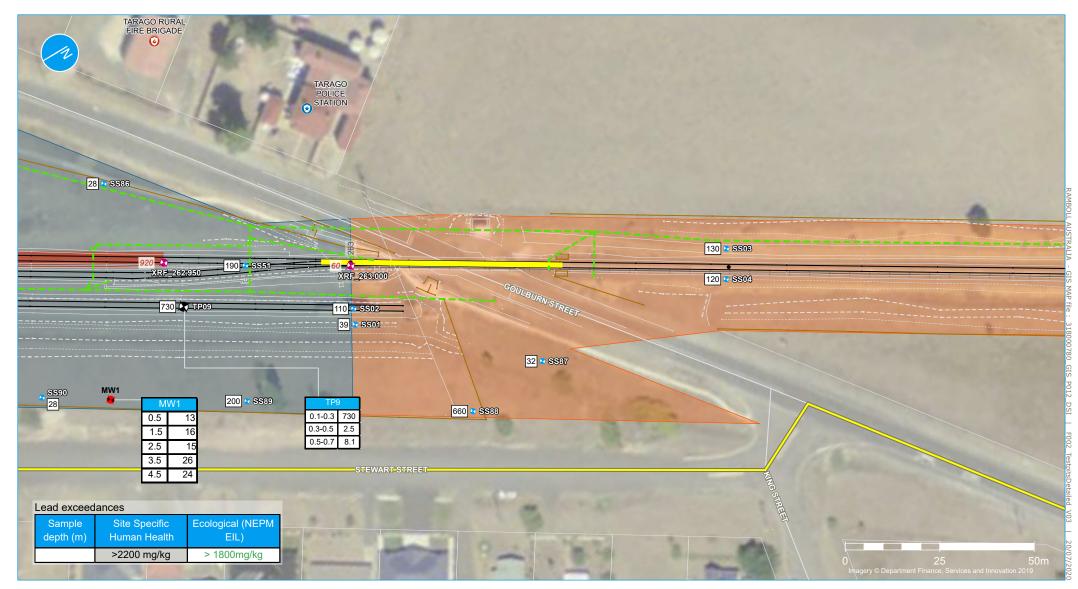
- Site boundary Rail corridor fence 0.1km chainage point •
- Goulburn Street level crossing
- Signal trench (approximate)
- Surface water flow (indicative)  $\rightarrow$
- Survey lines Rail track
- Top of bank
- Bottom of bank
