# ANNUAL NSW SPEED CAMERA PERFORMANCE REVIEW

NSW Centre for Road Safety

JULY 2012

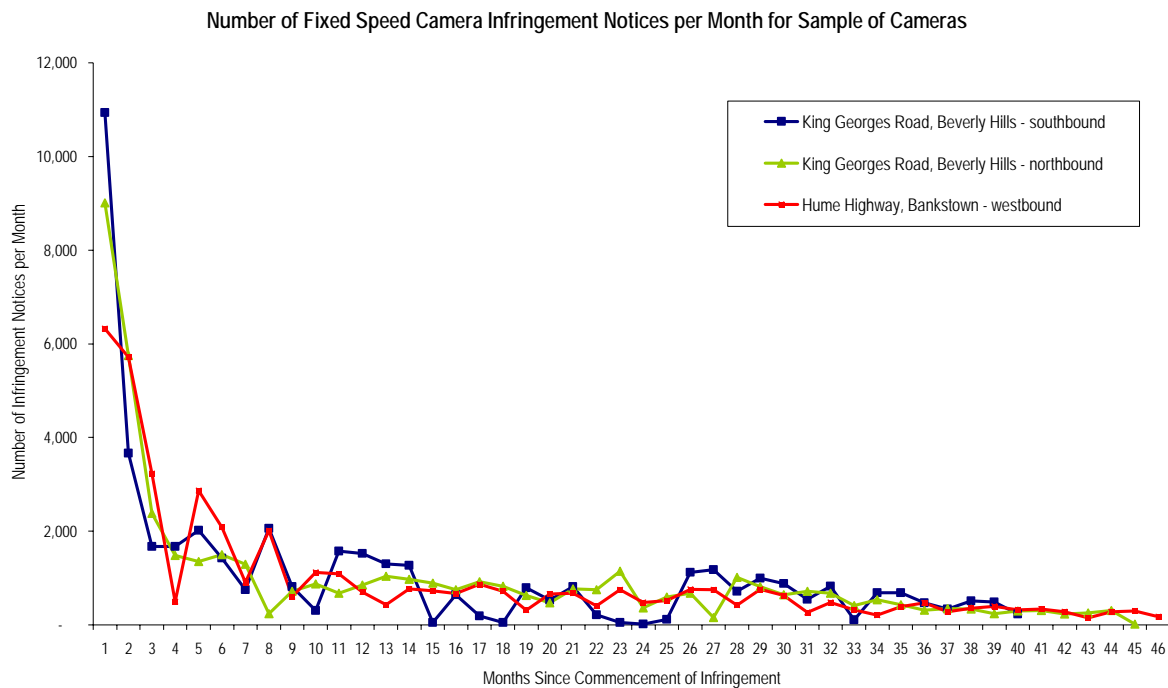
Figure 1: Example of trend in speed camera infringements over time.

Speed cameras are used to change driver behaviour, which can be measured by changes in infringements over time. An example of this trend is illustrated in Figure 1 which depicts the number of infringements per month since the commencement of enforcement at three high profile fixed speed camera locations. This pattern shows an initial high number of infringements followed by a rapid and sustained decrease in infringements as drivers modify their behaviour which is reflected in a reduction in crashes over time.

Appendix C contains this type of infringement graph for every fixed speed camera location. Infringement numbers follow this trend at many locations however in some locations the initial few years of infringement volumes are missing because data for pre July 2004 is not currently published on the Office of State Revenue website. The Centre for Road Safety is currently collating this information and it will be available for future reporting.

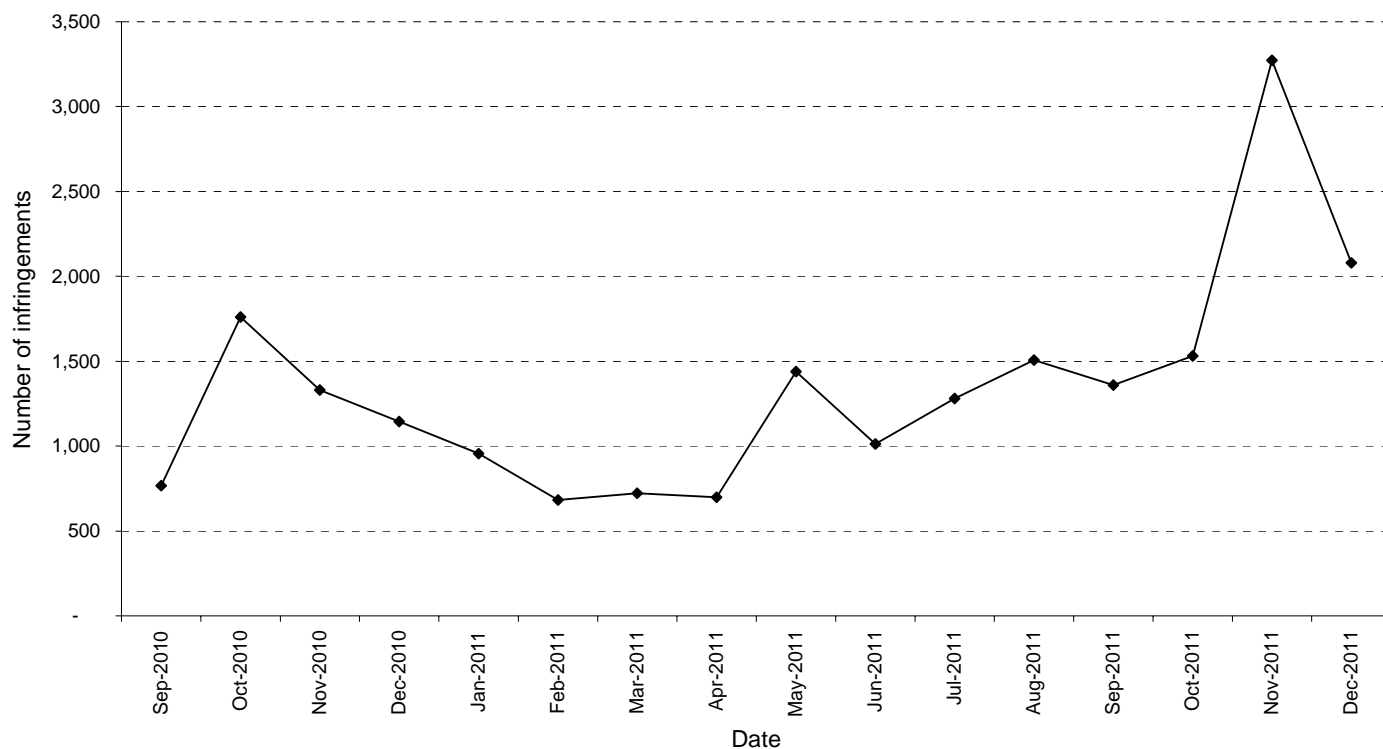
Mobile speed camera program infringement data

In 2011 there were a total of 16,544 infringements resulting in a total fine revenue of \$2.58 million from mobile speed camera enforcement.

Since the program commenced, the number of sites available for use and the number of sites used each month has increased over time as ongoing assessments to identify suitable enforcement sites are completed. However, all selected sites are within the 142 locations published on the website. There are two months where there are peaks in infringement volumes. An increase in infringements usually comes when mobile speed cameras are enforcing in less frequently used locations or locations that have not been used before. In both May 2011 and November 2011 there were increases in the number of sites used for enforcement in those months. In the months following the use of new sites, the number of infringements decreased or stabilised. This trend is to be anticipated; for example fixed speed enforcement follows the same type of pattern, with the difference being that fixed speed cameras are in the same place 24/7 meaning that reductions in infringements are more consistent.

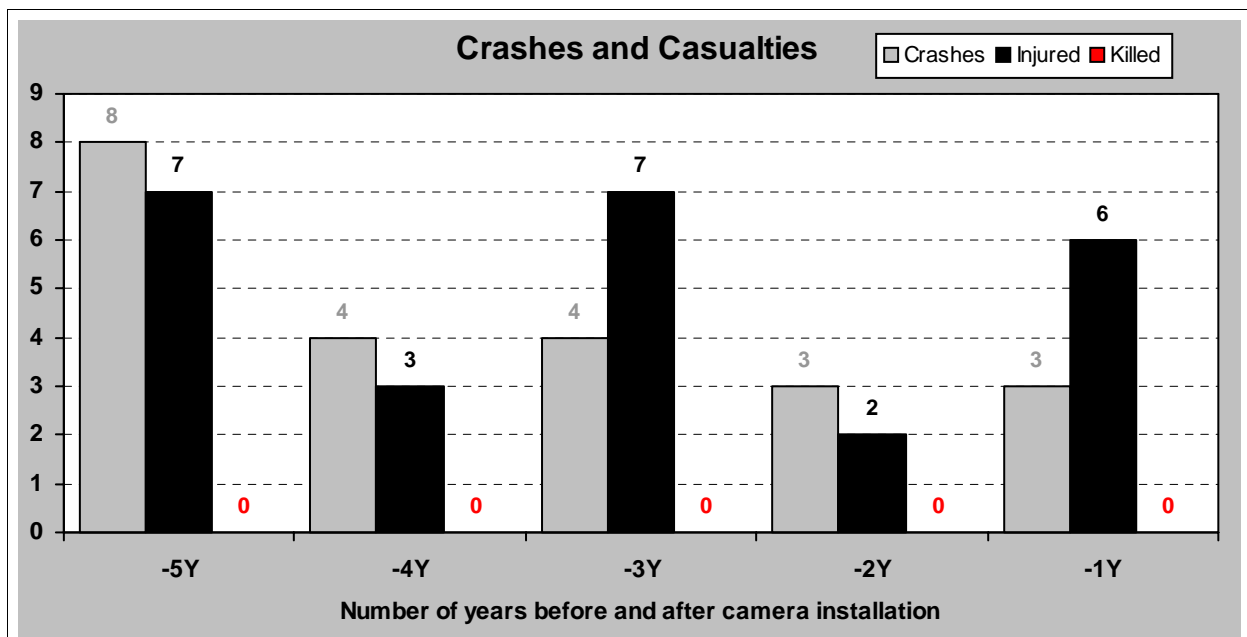
In the 223 day period from installation to the end of 2011, there were 0 crashes resulting in 0 injuries and 0 fatalities.

This represents a 100 per cent reduction in the yearly average number of crashes and a 100 per cent reduction in the yearly average number of casualties at this intersection in the period after installation until the end of 2011.

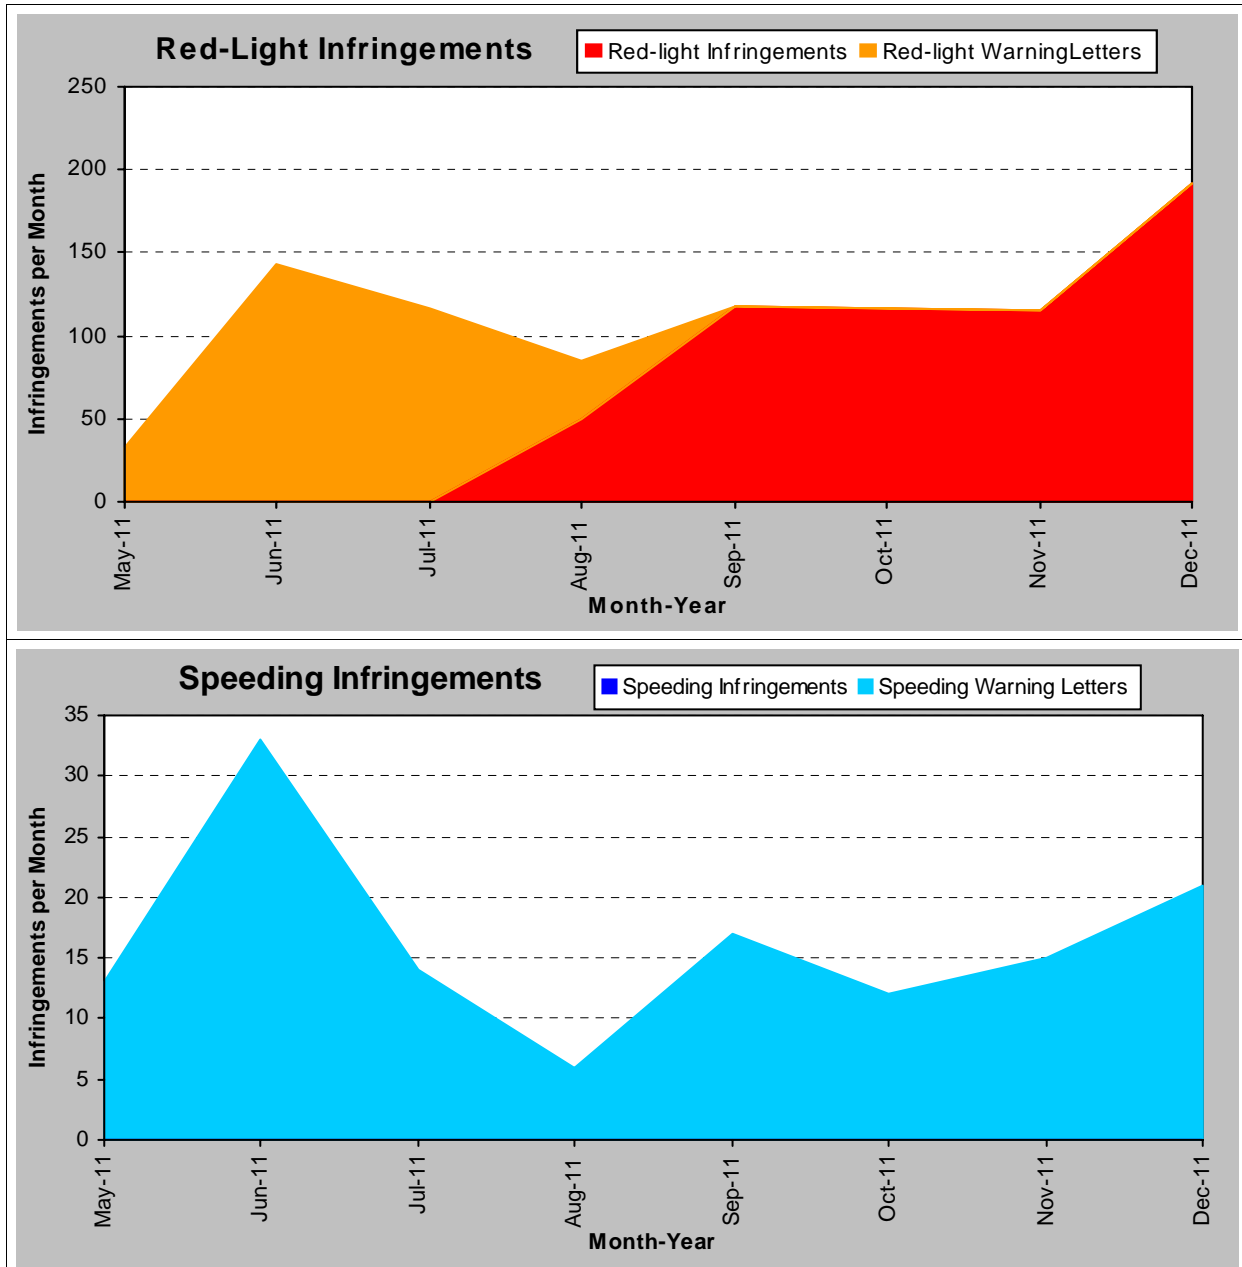
## Infringements at safety camera location

The graph below details the number of warning letters and infringements issued at this intersection since the camera began operating.

Roadworks and camera maintenance may influence the number of infringements issued.

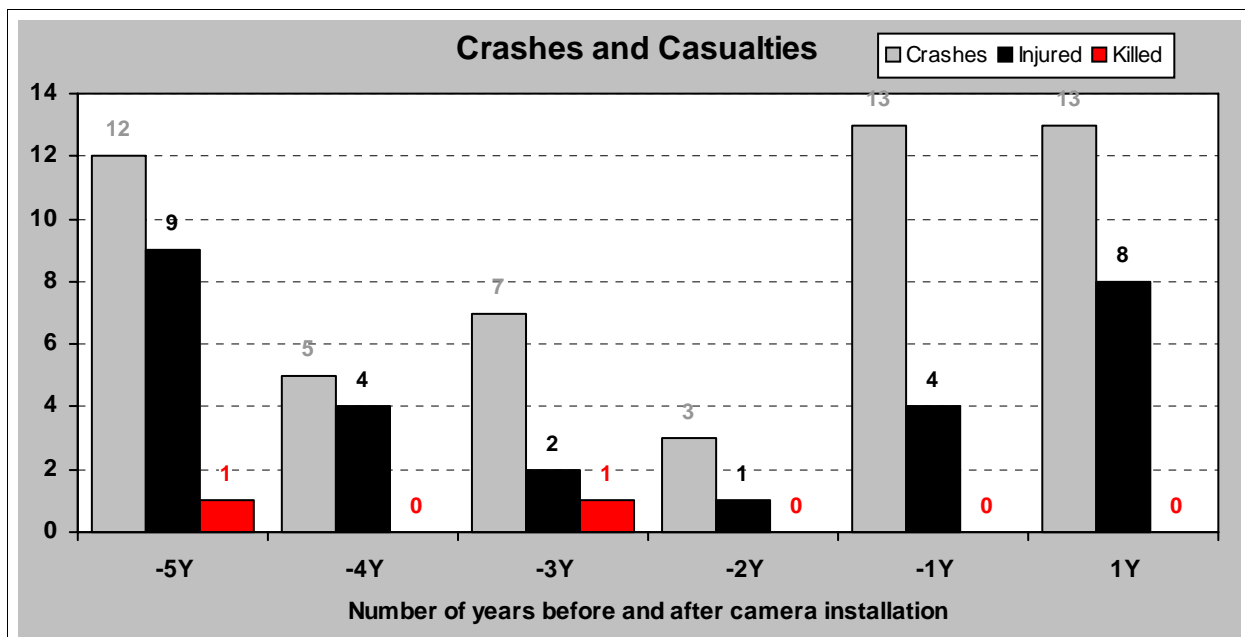
This represents a 33 per cent increase in the yearly average number of crashes and a 66 per cent increase in the yearly average number of casualties at this intersection in the period after installation until the end of 2011.

Provisional crash data shows there were 10 crashes resulting in 10 casualties at this intersection in 2011.

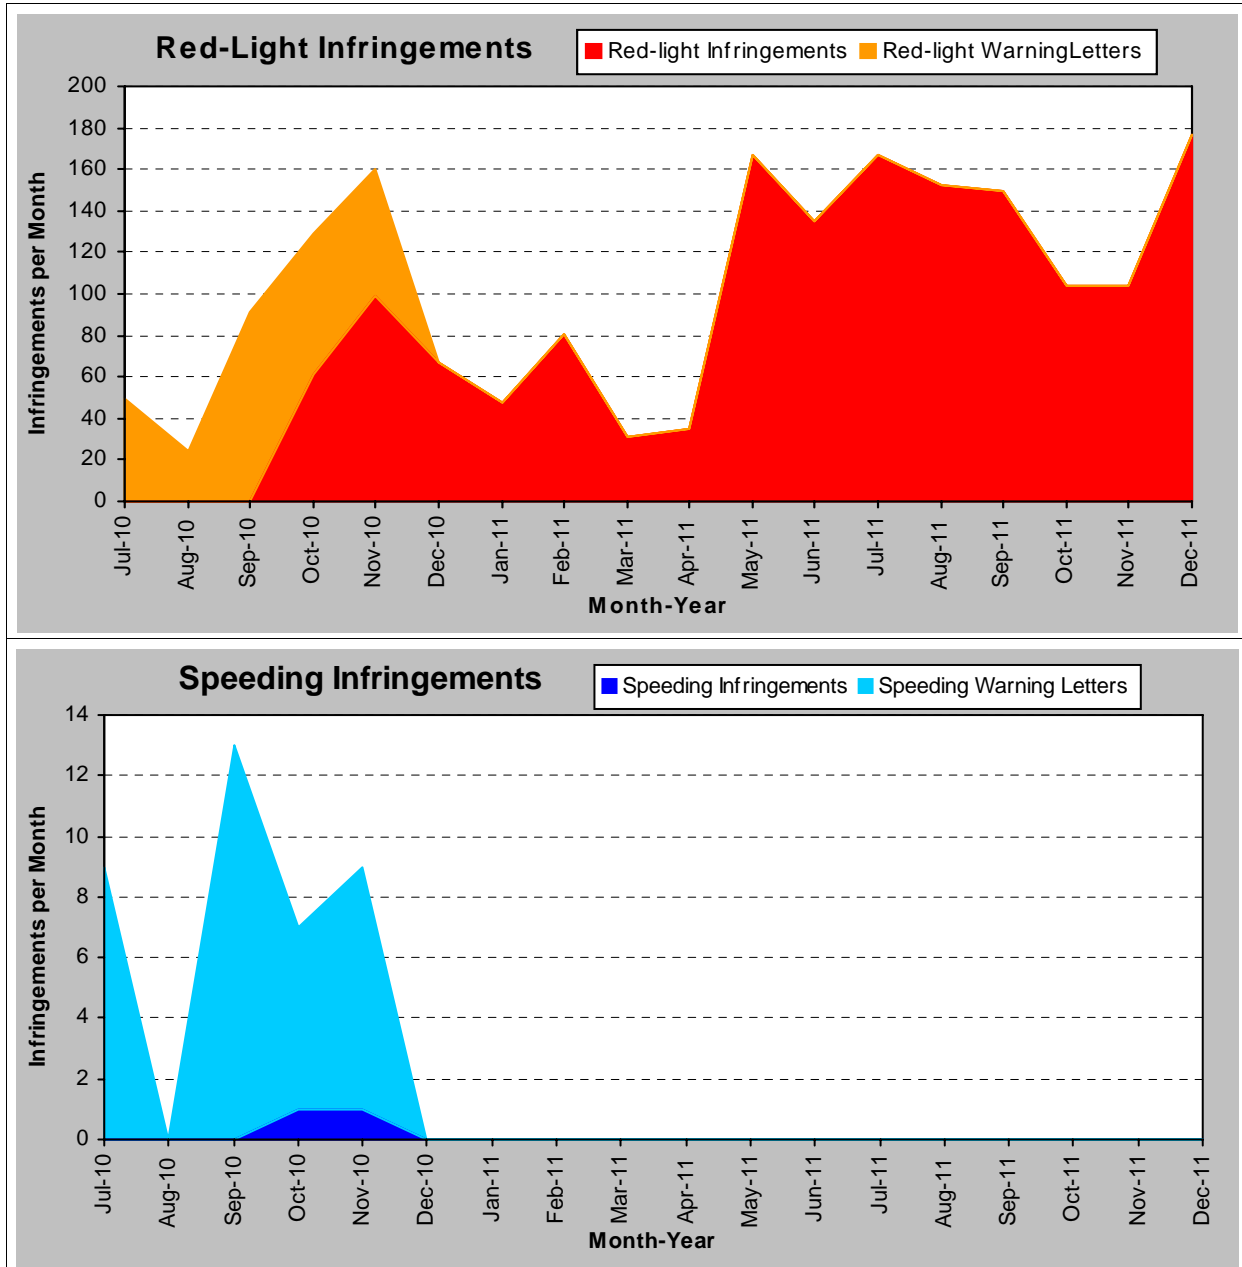
## Infringements at safety camera location

The graph below details the number of warning letters and infringements issued at this intersection since the camera began operating. The graph also shows the trend in infringements at this location.

Roadworks and camera maintenance may influence the number of infringements issued.

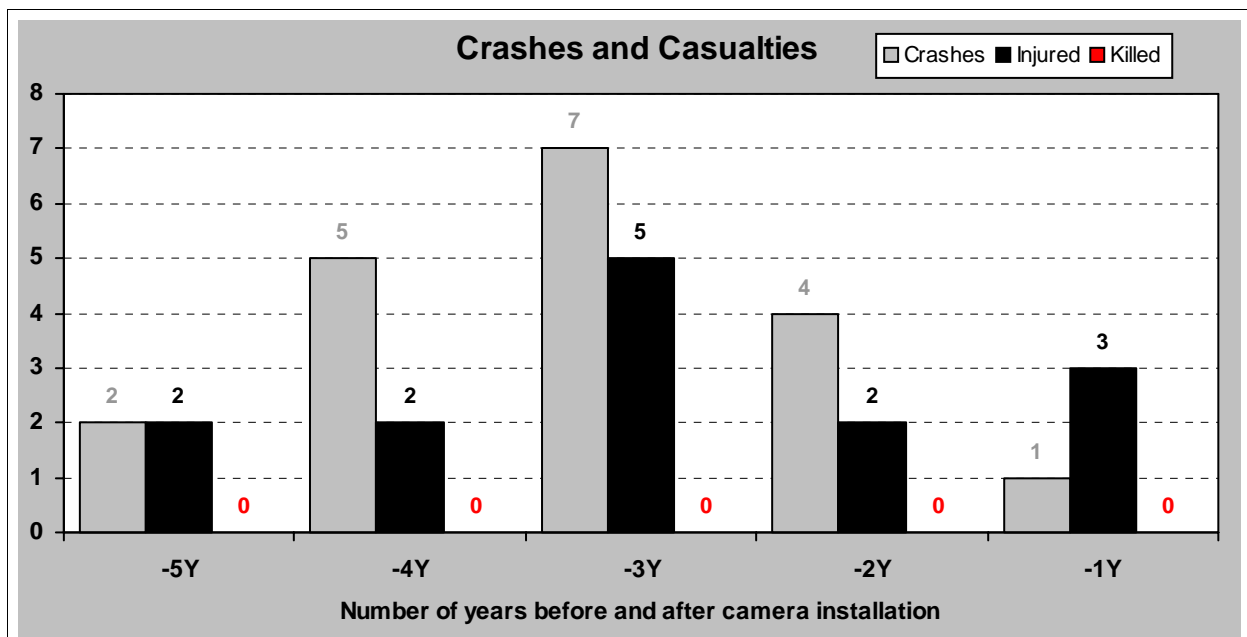
In the 291 day period from installation to the end of 2011, there were 5 crashes resulting in 4 injuries and 0 fatalities.

This represents a 65 per cent increase in the yearly average number of crashes and a 79 per cent increase in the yearly average number of casualties at this intersection in the period after installation until the end of 2011.

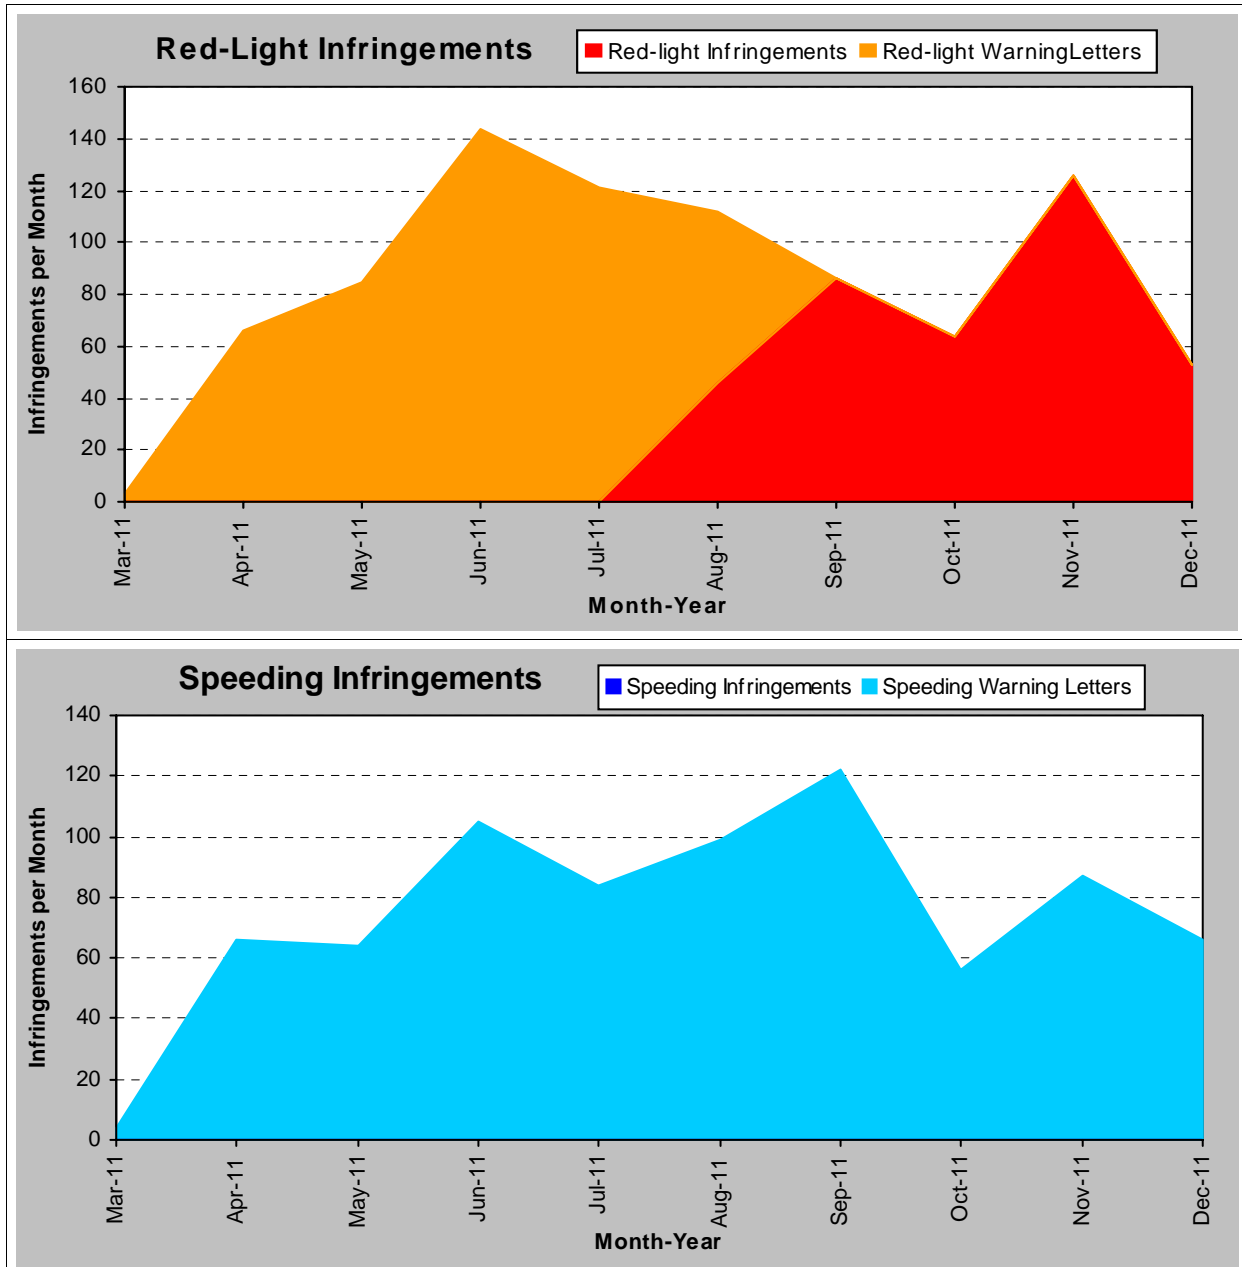
## Infringements at safety camera location

The graph below details the number of warning letters and infringements issued at this intersection since the camera began operating.

Roadworks and camera maintenance may influence the number of infringements issued.

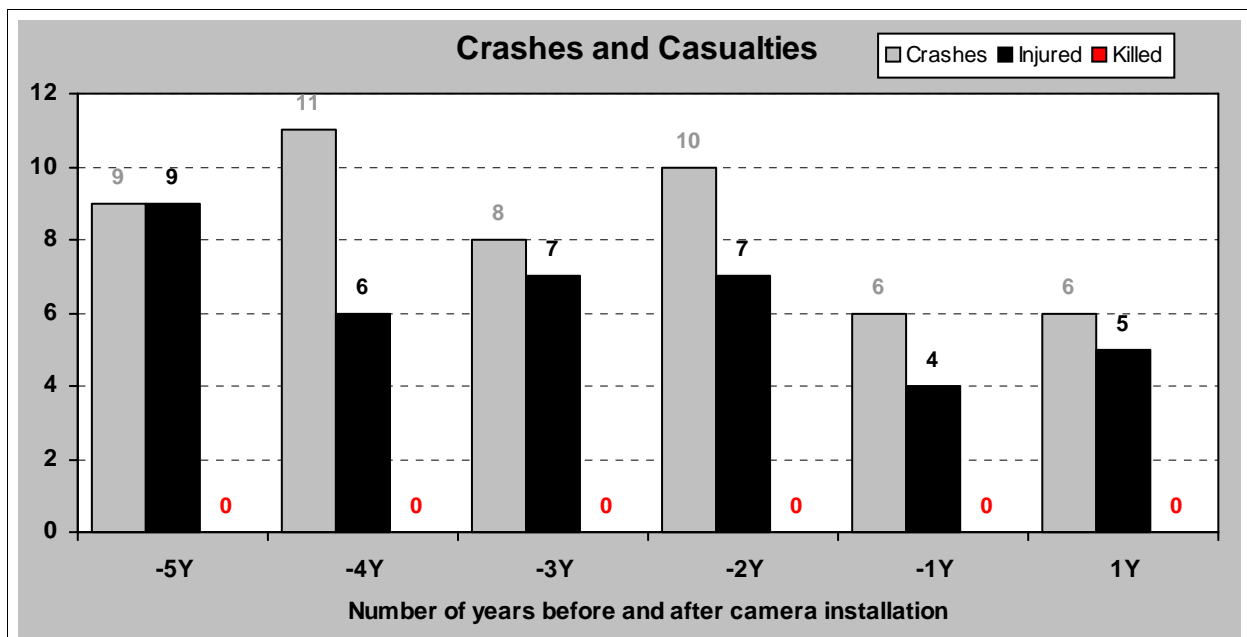
This represents a 46 per cent reduction in the yearly average number of crashes and a 27 per cent reduction in the yearly average number of casualties at this intersection in the period after installation until the end of 2011.

Provisional crash data shows there were 5 crashes resulting in 6 casualties at this intersection in 2011.

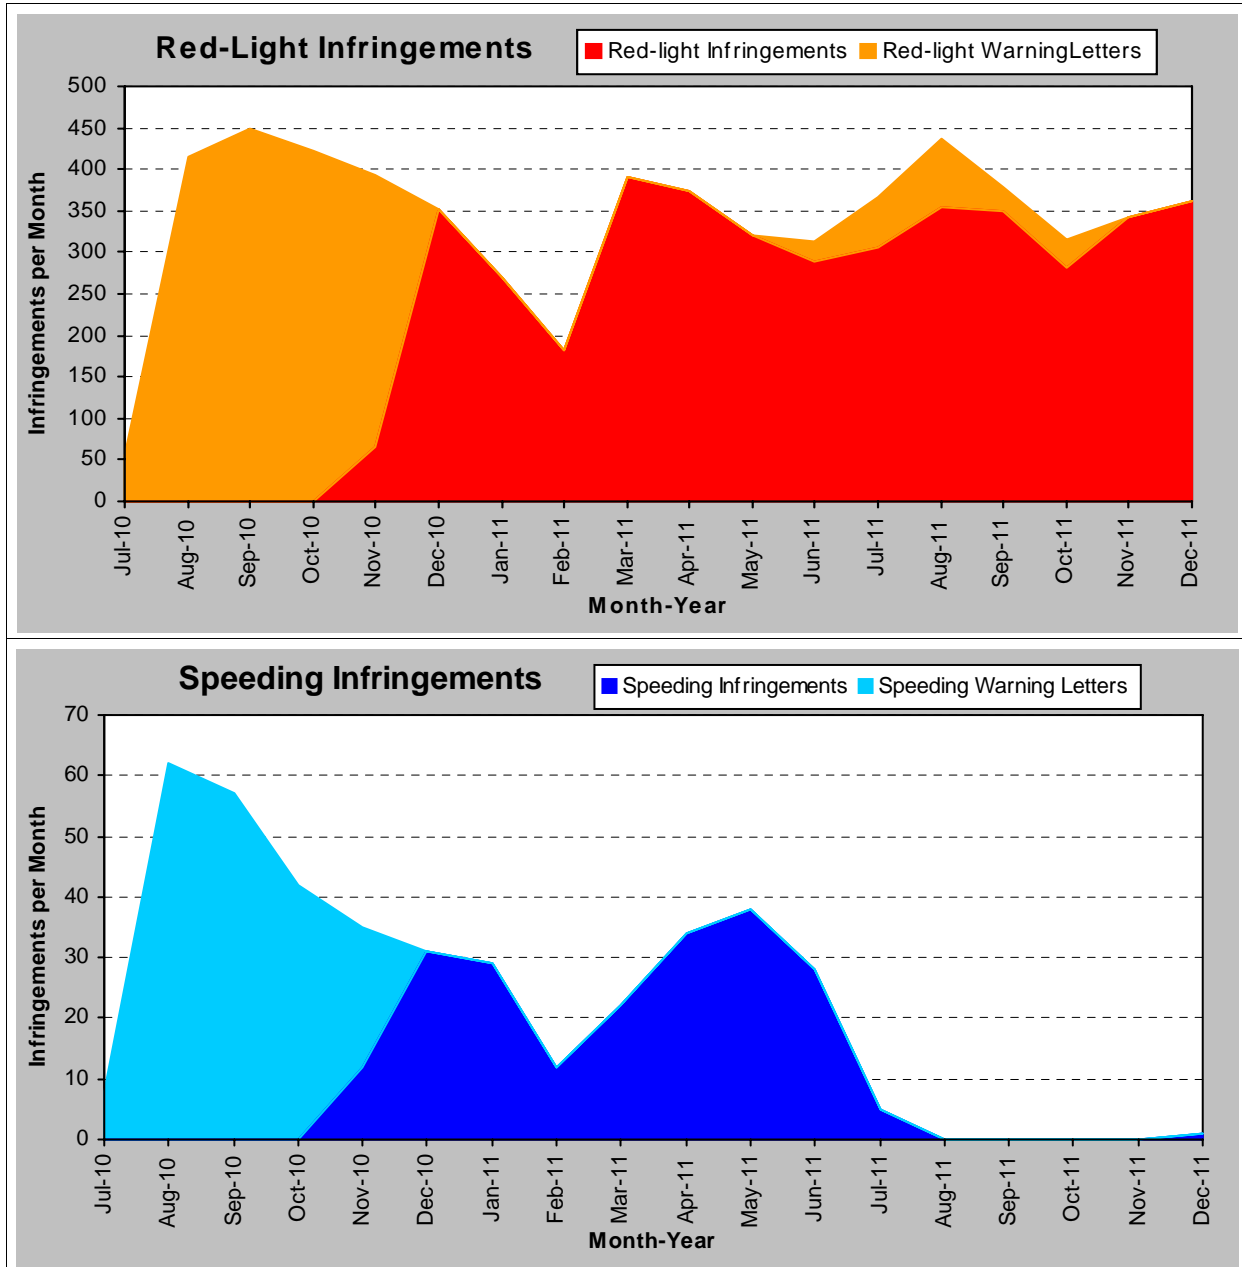
## Infringements at safety camera location

The graph below details the number of warning letters and infringements issued at this intersection since the camera began operating. The graph also shows the trend in infringements at this location.

Roadworks and camera maintenance may influence the number of infringements issued.

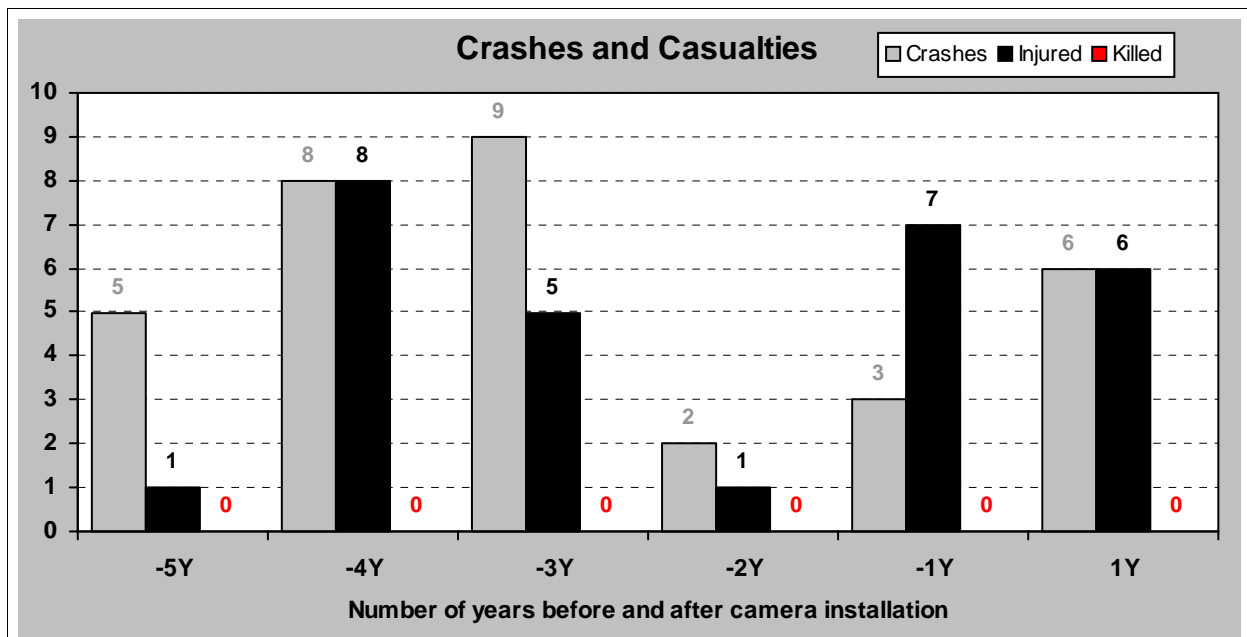
This represents a 6 per cent increase in the yearly average number of crashes and a 30 per cent increase in the yearly average number of casualties at this intersection in the period after installation until the end of 2011.

Provisional crash data shows there were 6 crashes resulting in 6 casualties at this intersection in 2011.

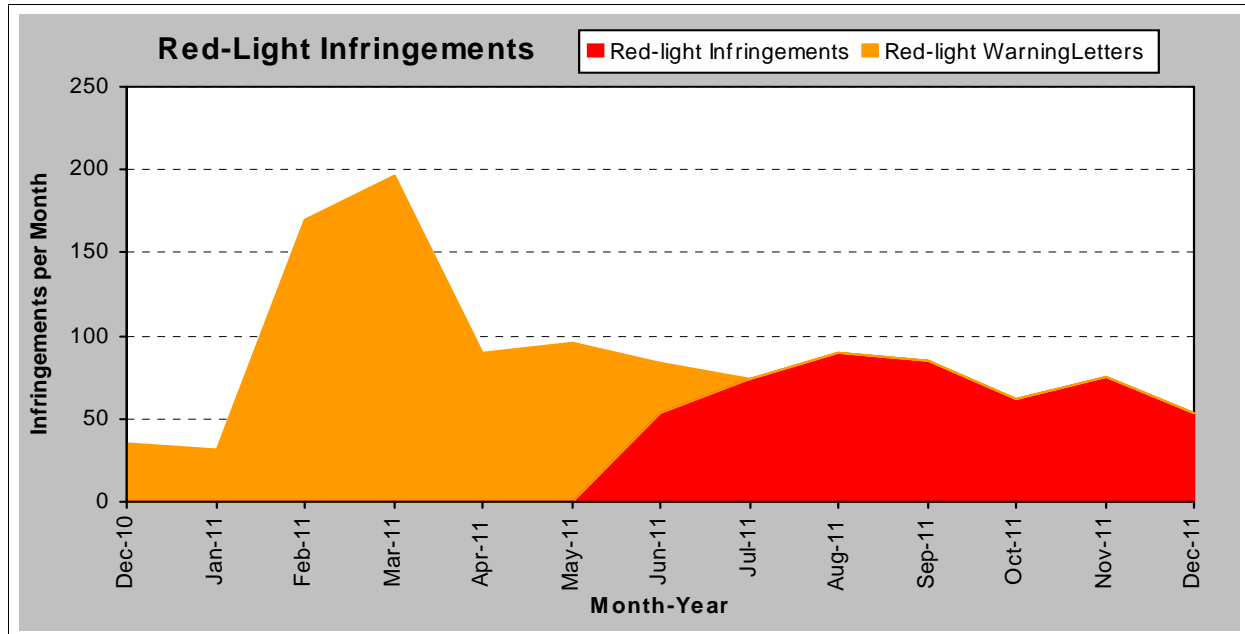
## Infringements at safety camera location

The graph below details the number of warning letters and infringements issued at this intersection since the camera began operating.

Roadworks and camera maintenance may influence the number of infringements issued.

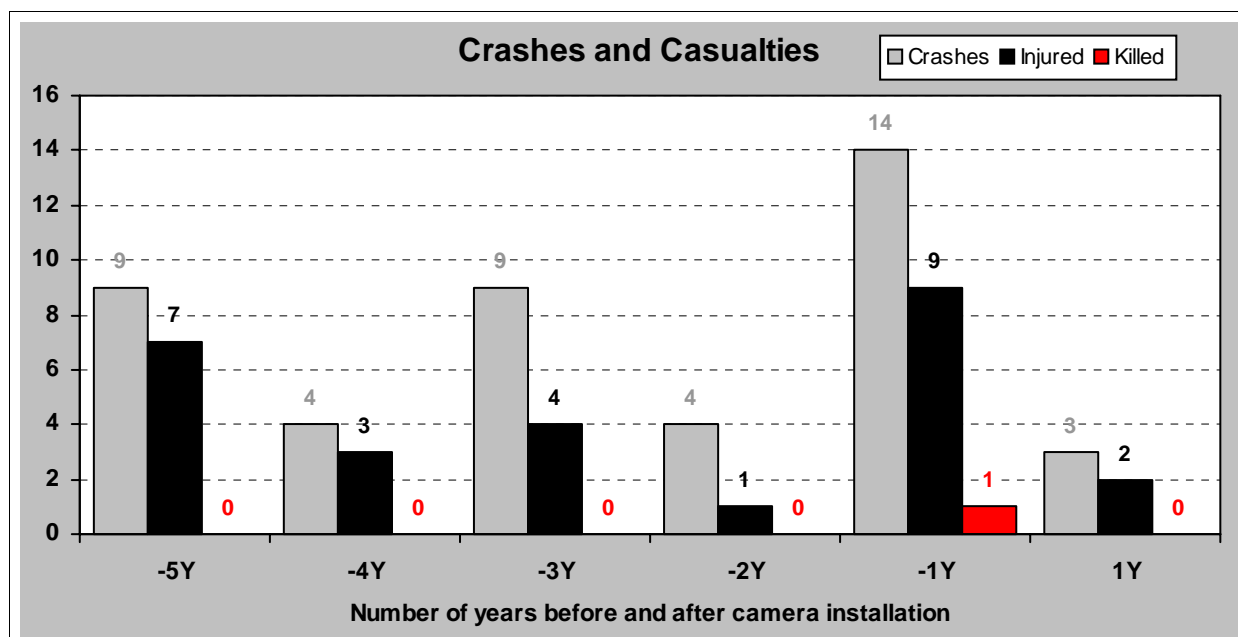
This represents a 72 per cent reduction in the yearly average number of crashes and a 70 per cent reduction in the yearly average number of casualties at this intersection in the period after installation until the end of 2011.

Provisional crash data shows there were 2 crashes resulting in one casualty at this intersection in 2011.

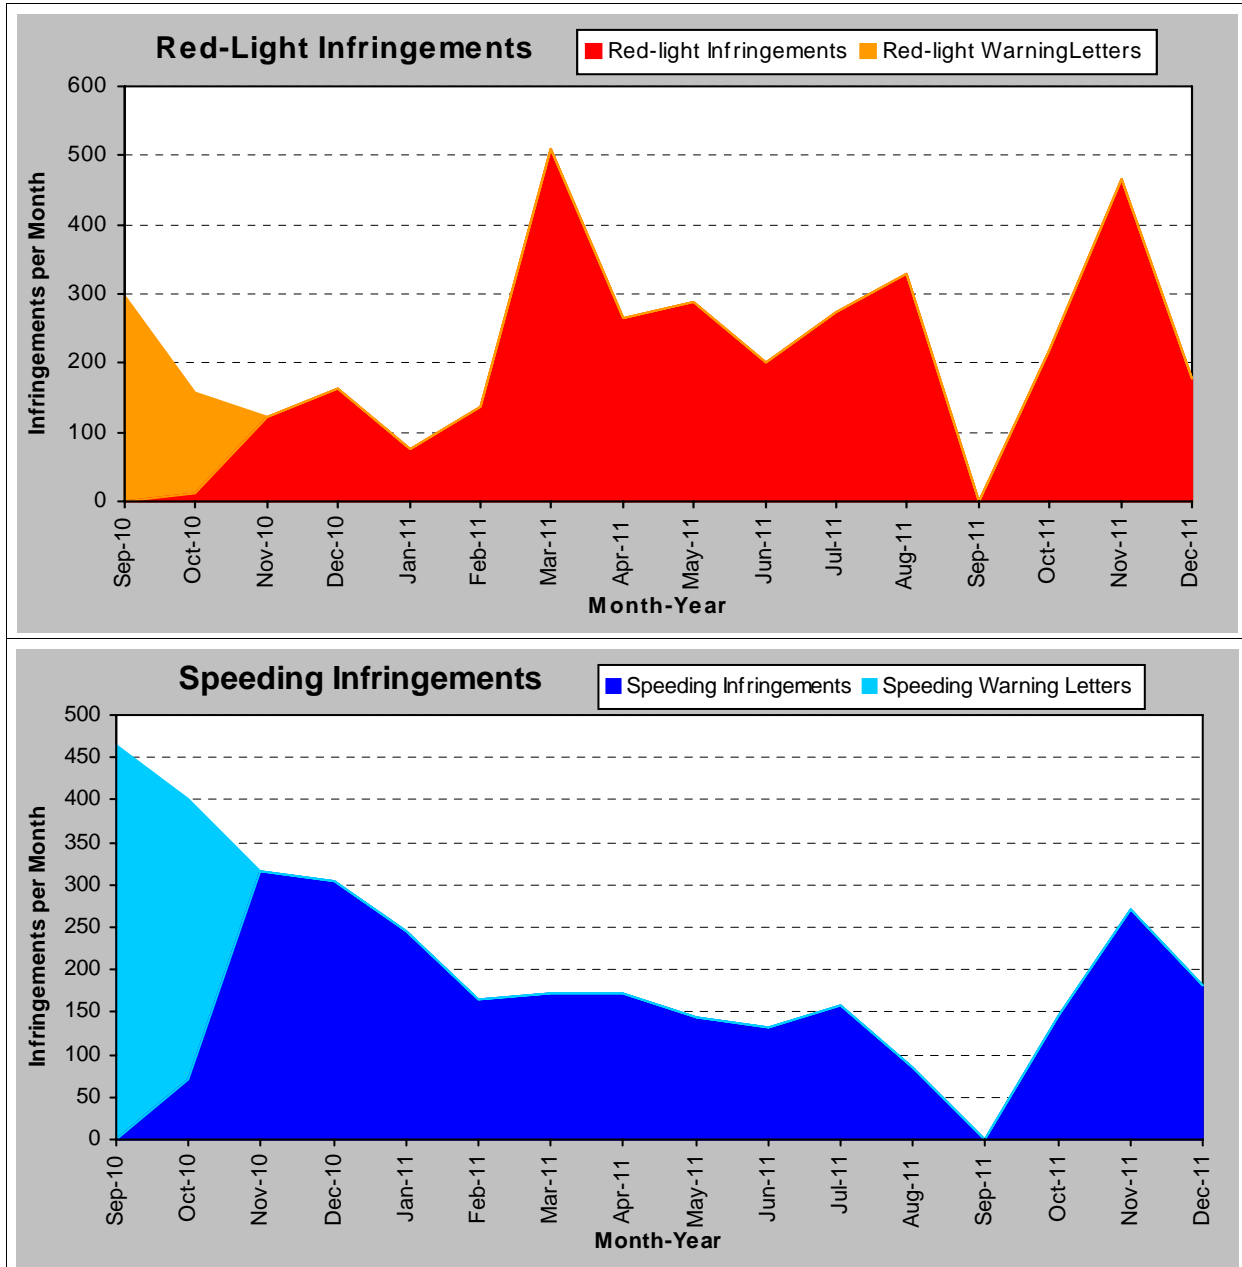
## Infringements at safety camera location

The graph below details the number of warning letters and infringements issued at this intersection since the camera began operating. The graph also shows the trend in infringements at this location.

Roadworks and camera maintenance may influence the number of infringements issued.

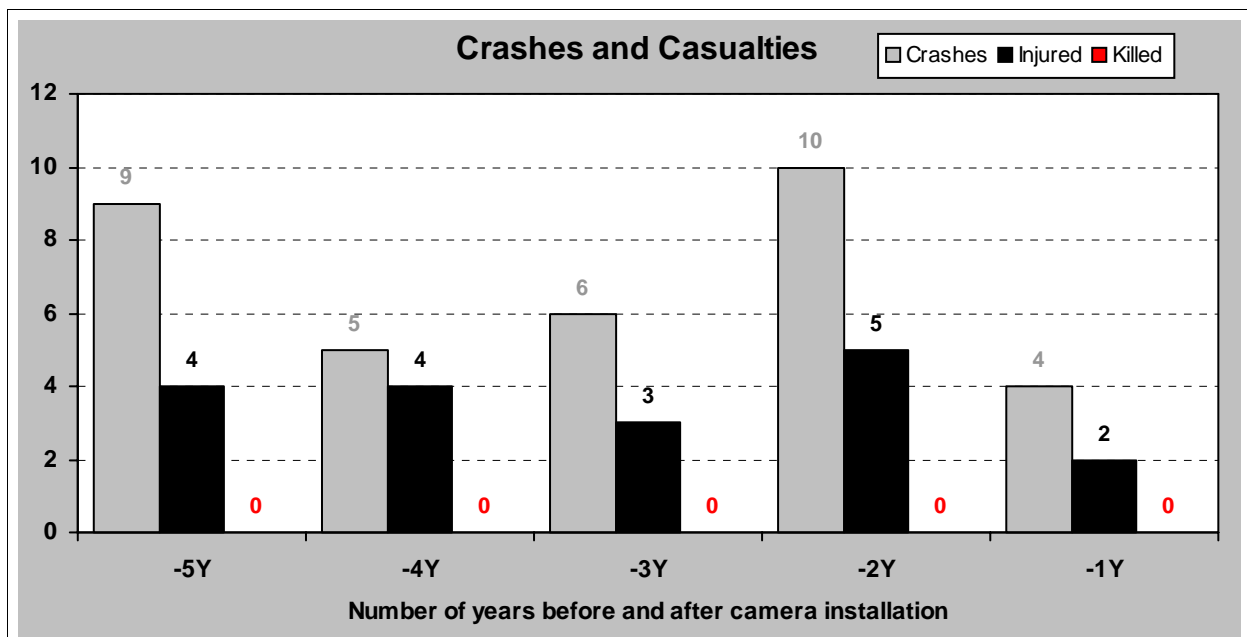
In the 186 day period from installation to the end of 2011, there was 1 crash resulting in 1 injury and 0 fatalities.

This represents a 71 per cent reduction in the yearly average number of crashes and a 45 per cent reduction in the yearly average number of casualties at this intersection in the period after installation until the end of 2011.

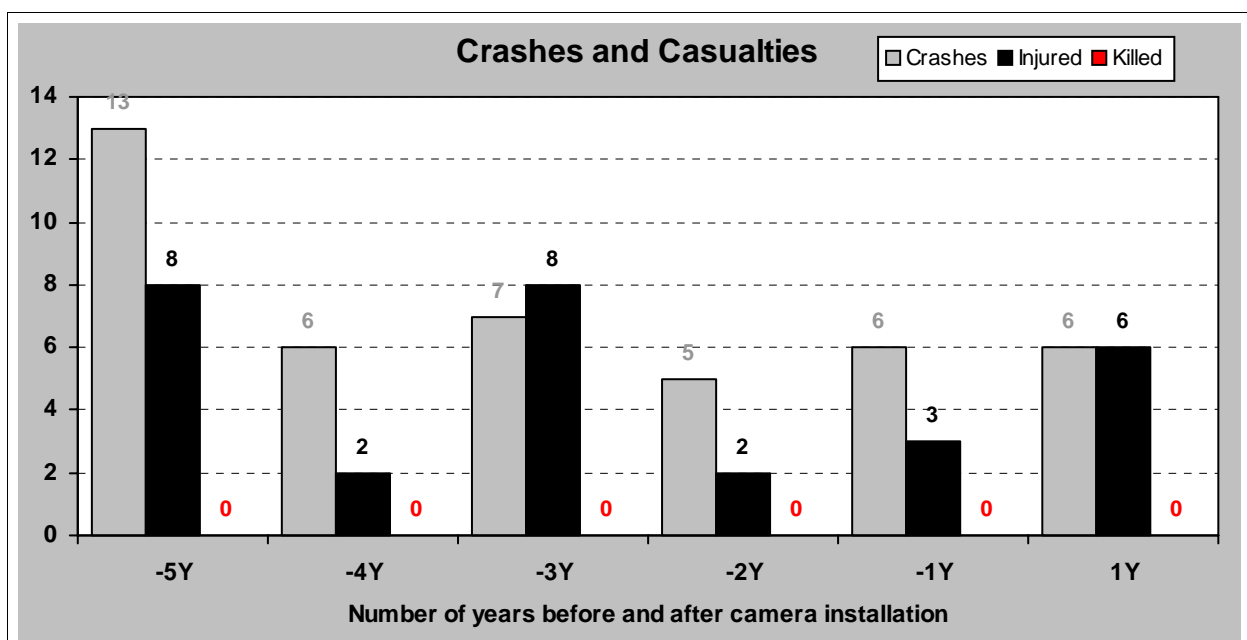
This represents a 14 per cent increase in the yearly average number of crashes and a 117 per cent increase in the yearly average number of casualties at this intersection in the period after installation until the end of 2011.

Provisional crash data shows there were 10 crashes resulting in 13 casualties at this intersection in 2011.

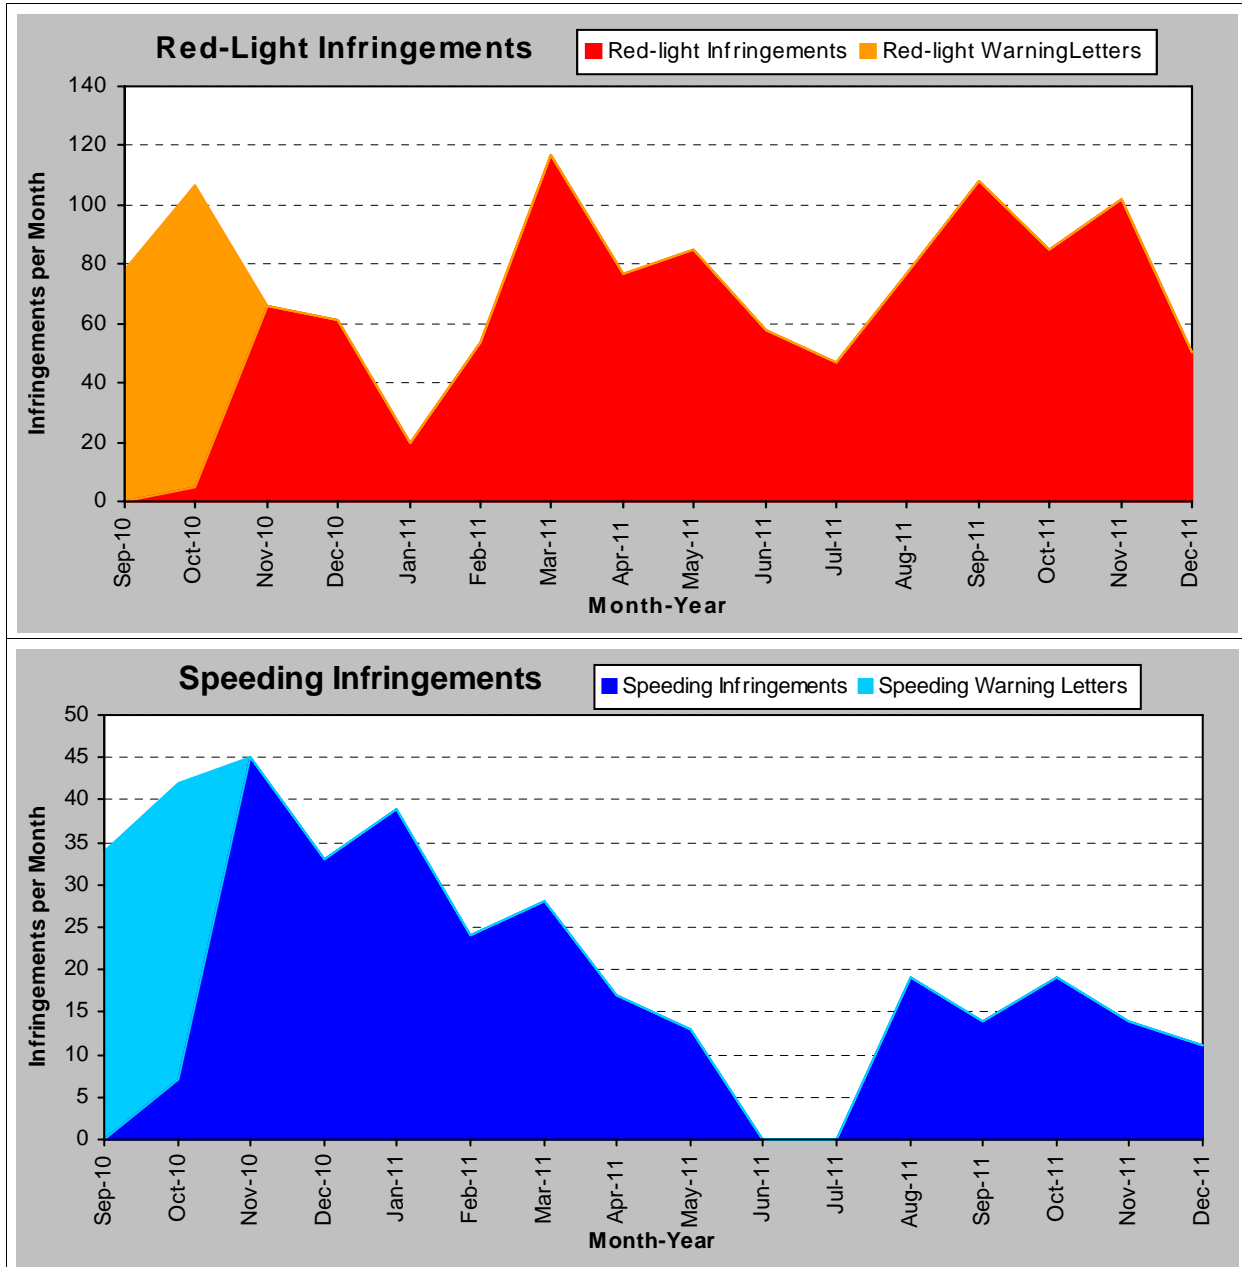
## Infringements at safety camera location

The graph below details the number of warning letters and infringements issued at this intersection since the camera began operating. The graph also shows the trend in infringements at this location.

Roadworks and camera maintenance may influence the number of infringements issued.

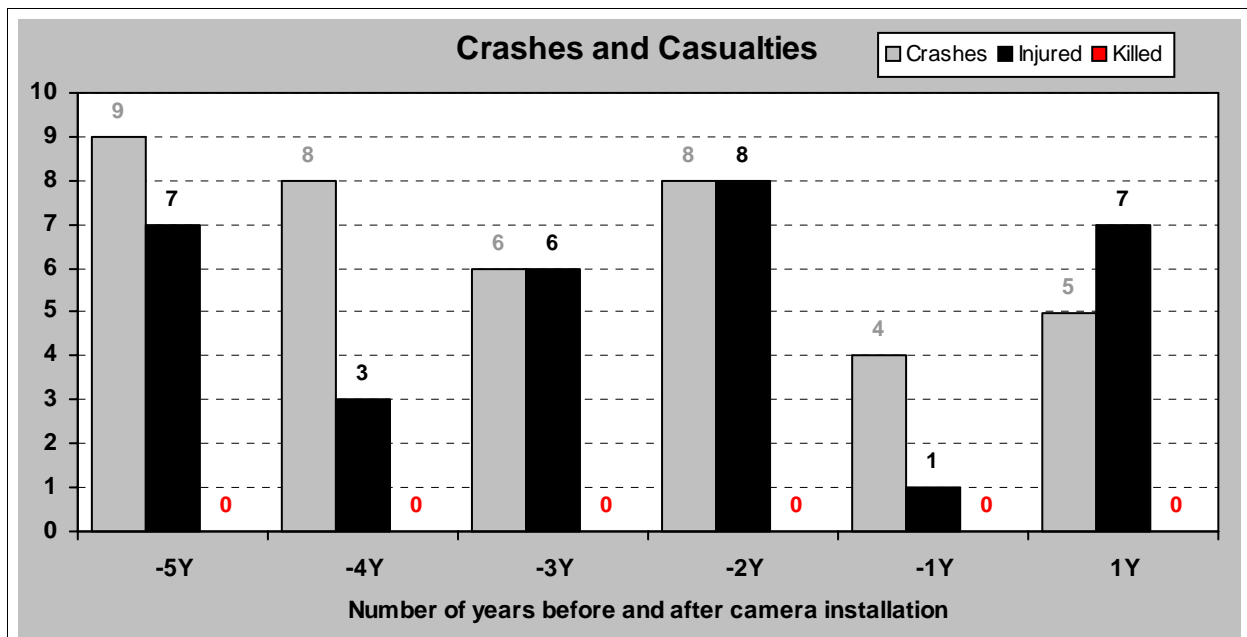
This represents a 32 per cent reduction in the yearly average number of crashes and a 34 per cent increase in the yearly average number of casualties at this intersection in the period after installation until the end of 2011.

Provisional crash data shows there were 5 crashes resulting in 7 casualties at this intersection in 2011.

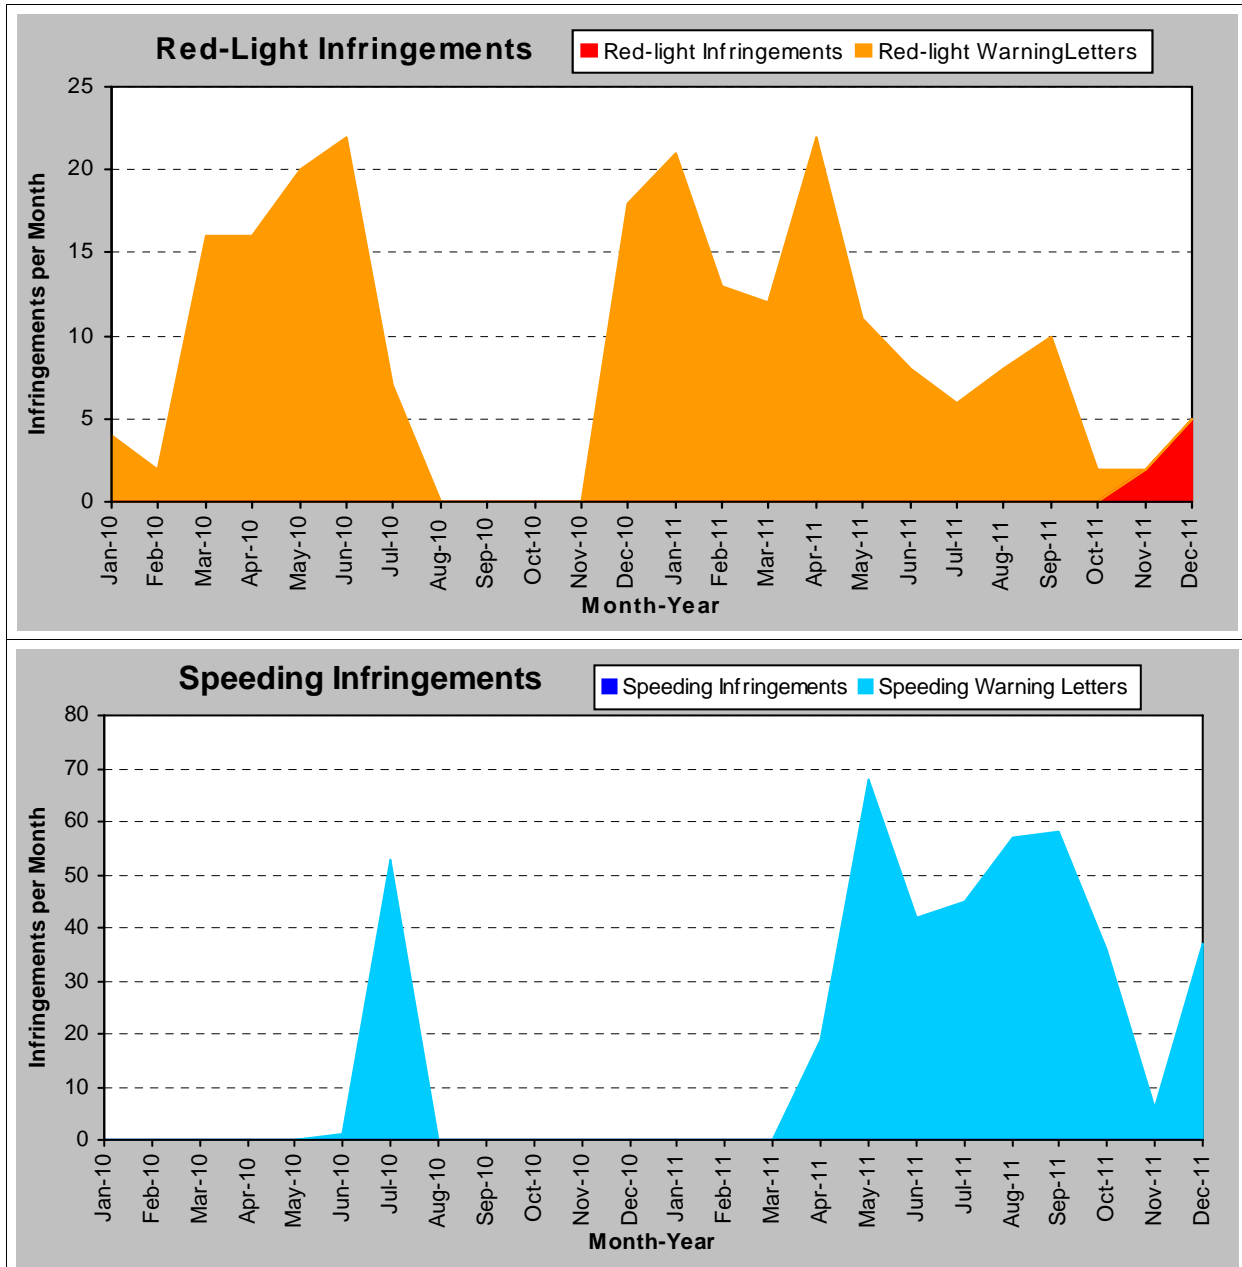
## Infringements at safety camera location

The graph below details the number of warning letters and infringements issued at this intersection since the camera began operating.

Roadworks and camera maintenance may influence the number of infringements issued.
