# ANNUAL NSW SPEED CAMERA PERFORMANCE REVIEW

NSW Centre for Road Safety

JULY 2012

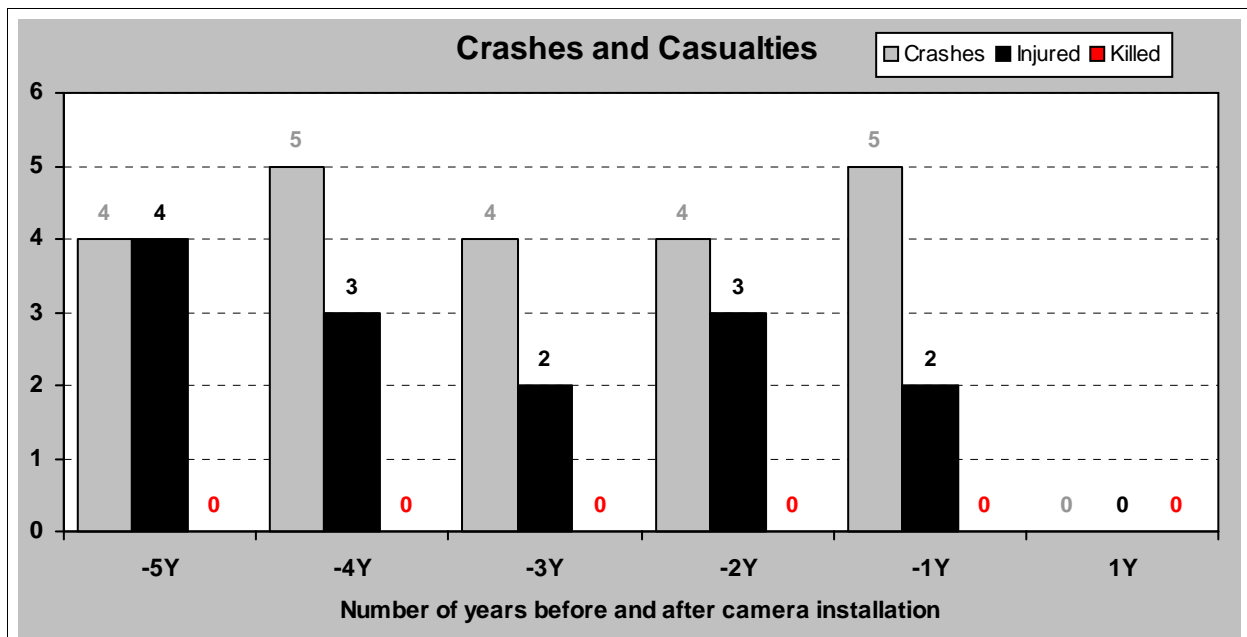
This represents a 100 per cent reduction in the yearly average number of crashes and a 100 per cent reduction in the yearly average number of casualties at this intersection in the period after installation until the end of 2011.

Provisional crash data shows there were crashes resulting in casualties at this intersection in 2011.

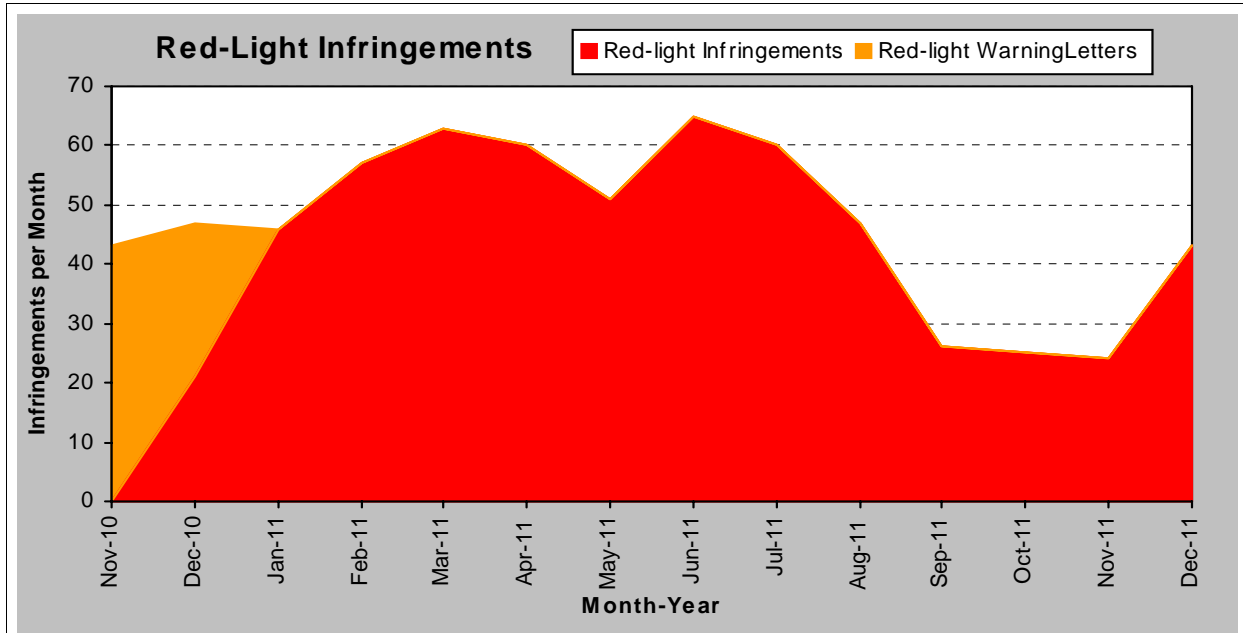
## Infringements at safety camera location

The graph below details the number of warning letters and infringements issued at this intersection since the camera began operating. The graph also shows the trend in infringements at this location.

Roadworks and camera maintenance may influence the number of infringements issued.

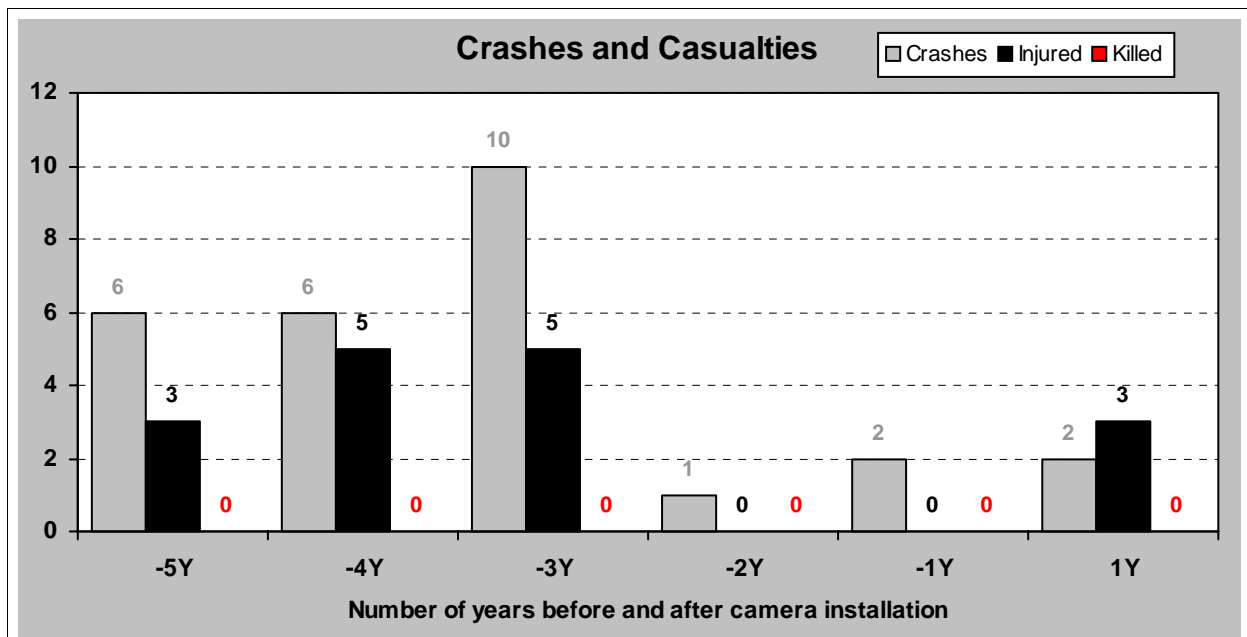
This represents a 68 per cent reduction in the yearly average number of crashes and a 7 per cent reduction in the yearly average number of casualties at this intersection in the period after installation until the end of 2011.

Provisional crash data shows there were 2 crashes resulting in 3 casualties at this intersection in 2011.

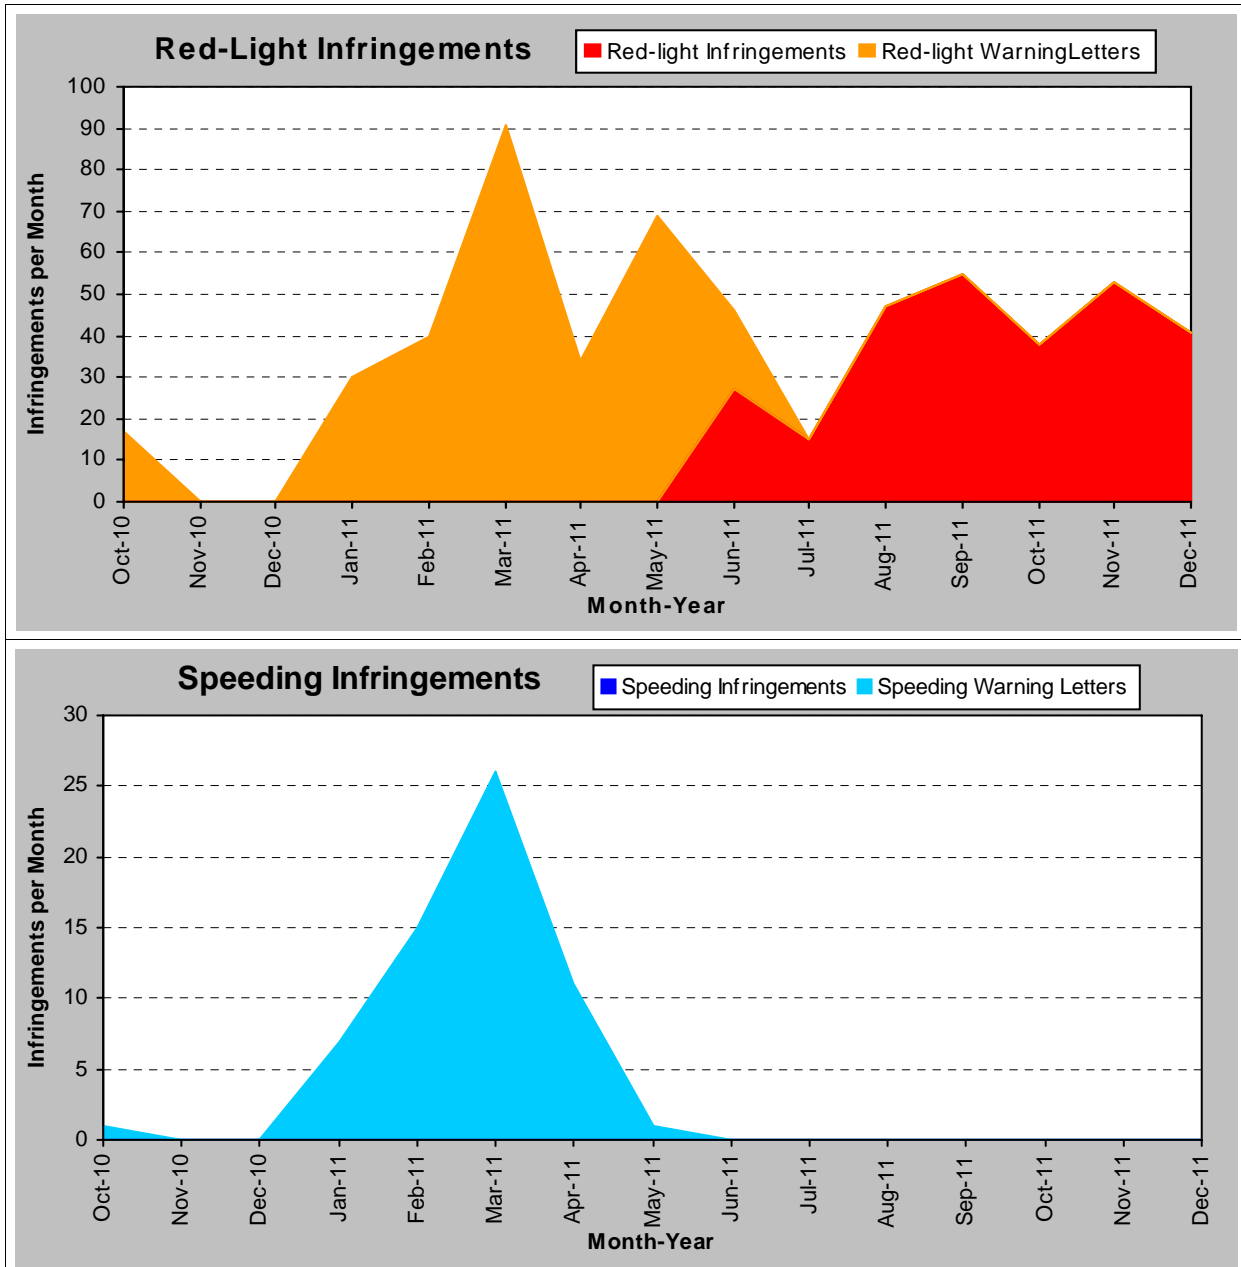
## Infringements at safety camera location

The graph below details the number of warning letters and infringements issued at this intersection since the camera began operating.

Roadworks and camera maintenance may influence the number of infringements issued.

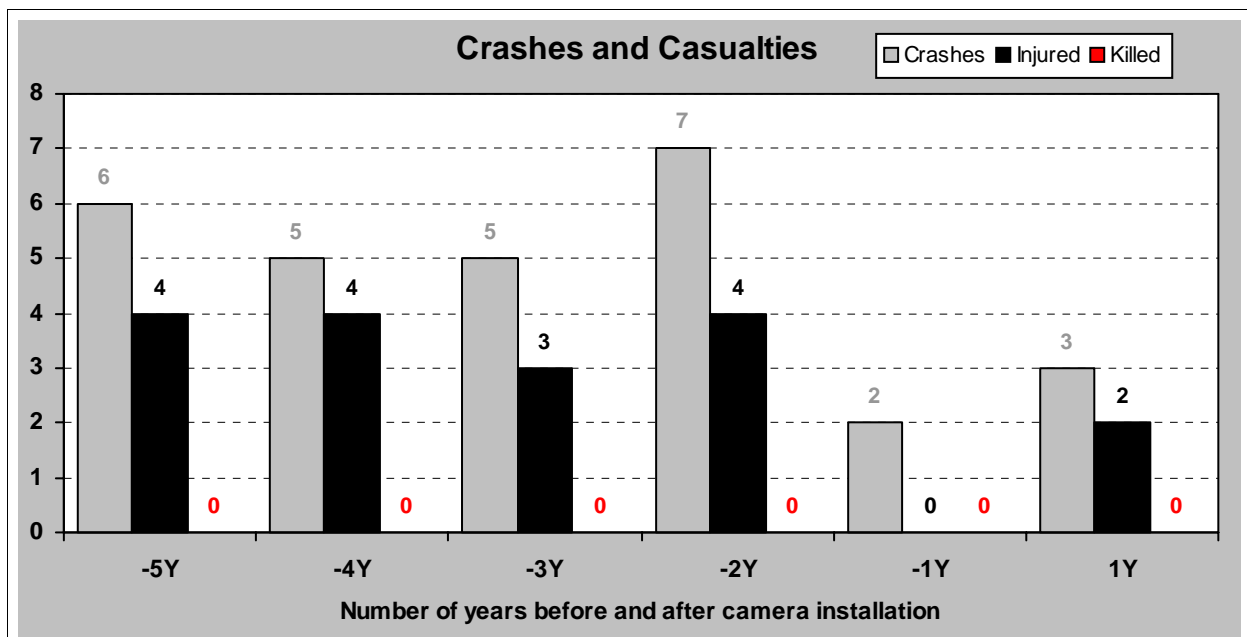
This represents a 47 per cent reduction in the yearly average number of crashes and a 41 per cent reduction in the yearly average number of casualties at this intersection in the period after installation until the end of 2011.

Provisional crash data shows there were 3 crashes resulting in 2 casualties at this intersection in 2011.

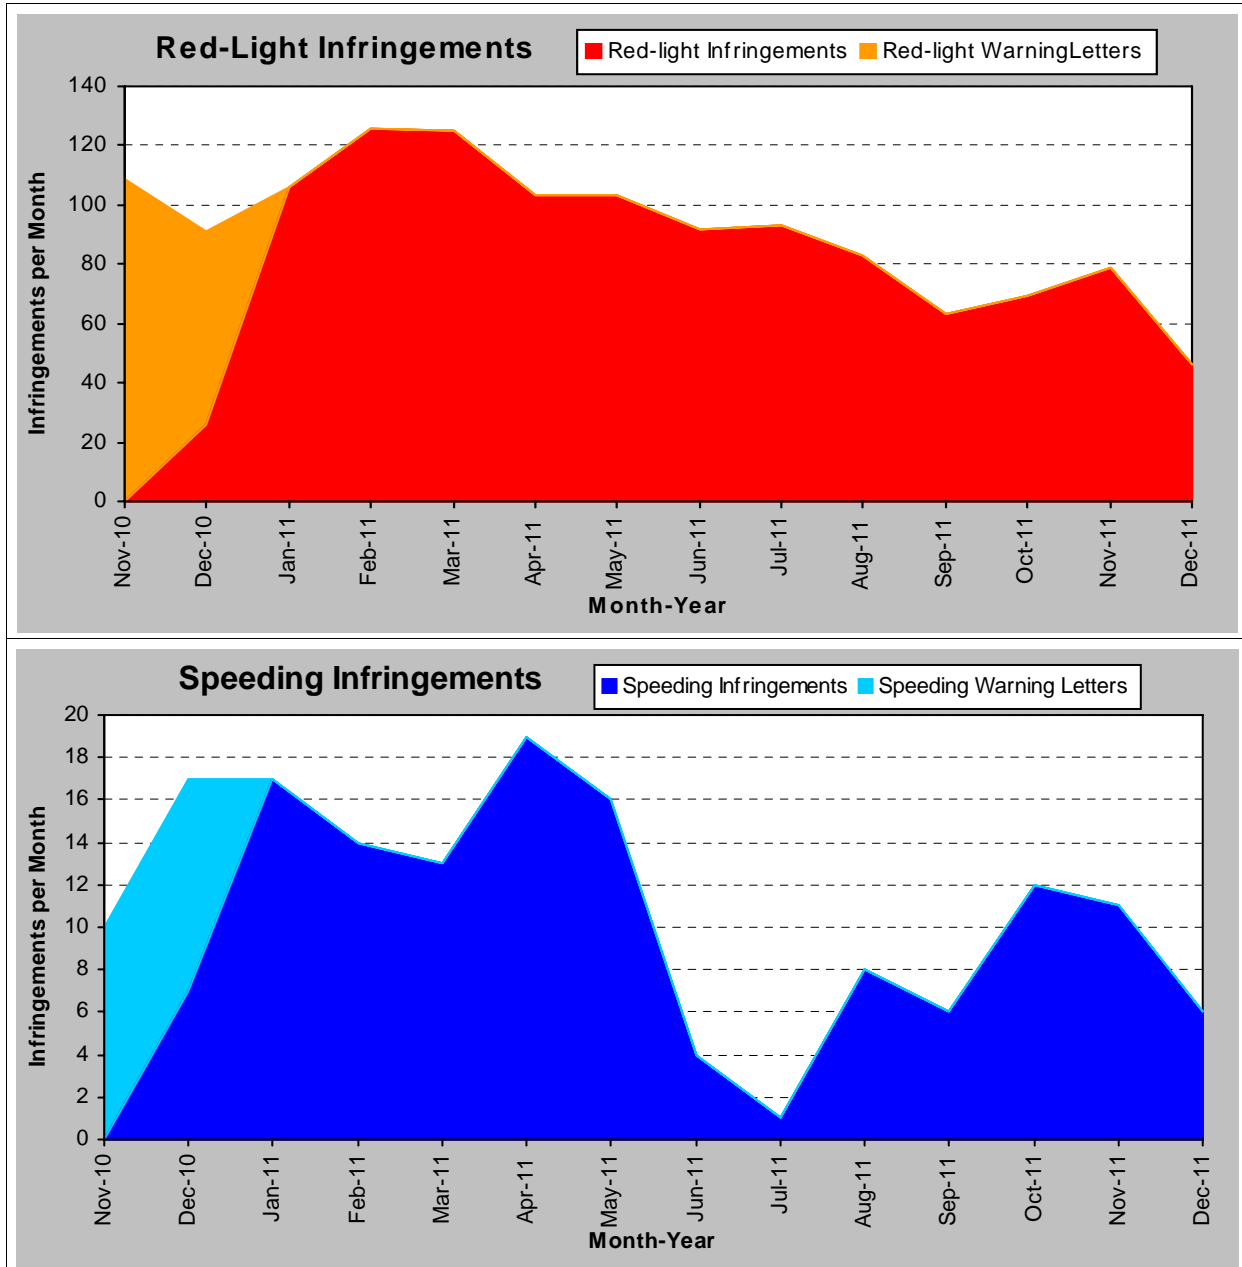
## Infringements at safety camera location

The graph below details the number of warning letters and infringements issued at this intersection since the camera began operating. The graph also shows the trend in infringements at this location.

Roadworks and camera maintenance may influence the number of infringements issued.

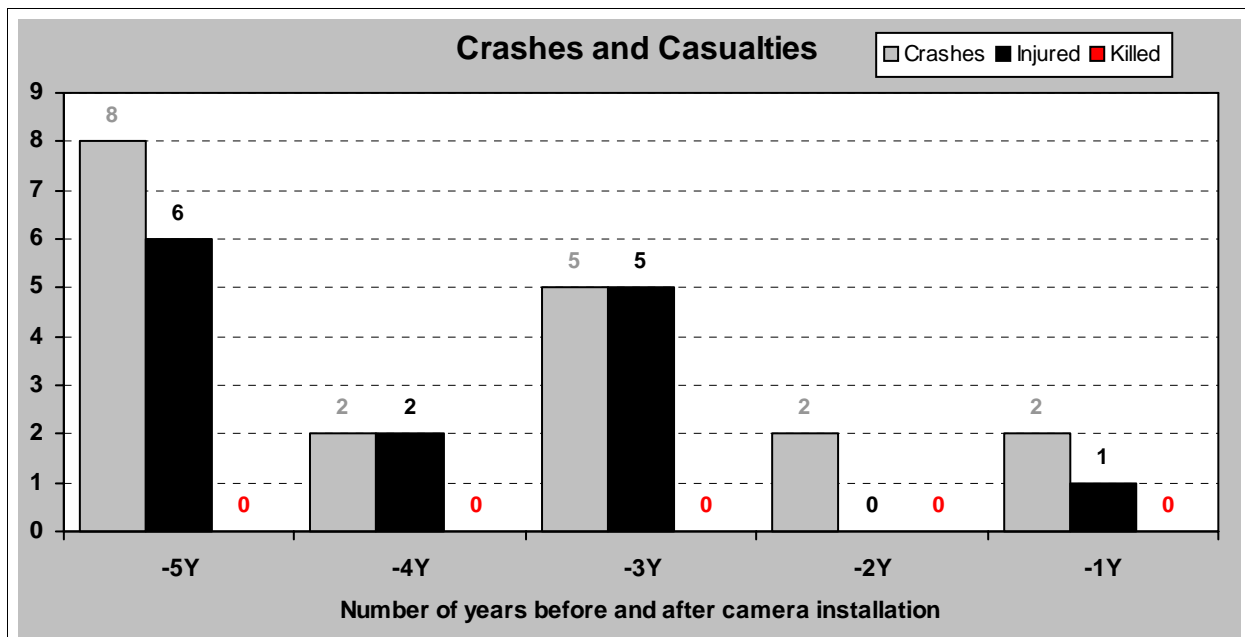
In the 188 day period from installation to the end of 2011, there were 4 crashes resulting in 4 injuries and 0 fatalities.

This represents a 104 per cent increase in the yearly average number of crashes and a 178 per cent increase in the yearly average number of casualties at this intersection in the period after installation until the end of 2011.

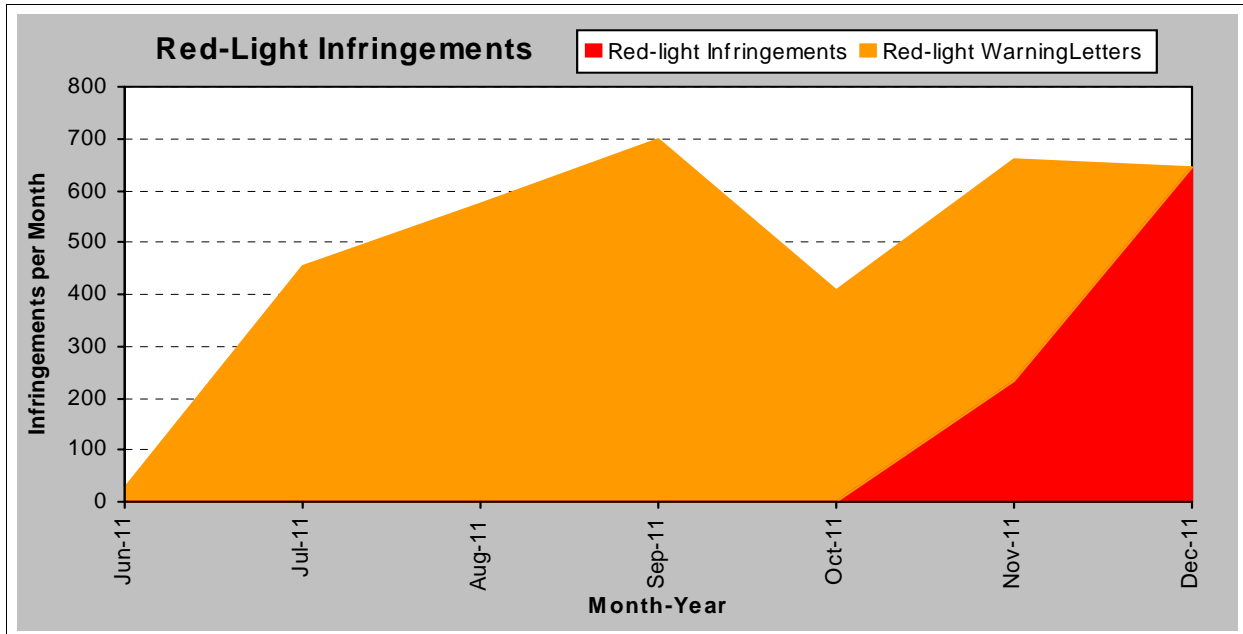
The graph below details the number of warning letters and infringements issued at this intersection since the camera began operating.

Roadworks and camera maintenance may influence the number of infringements issued.

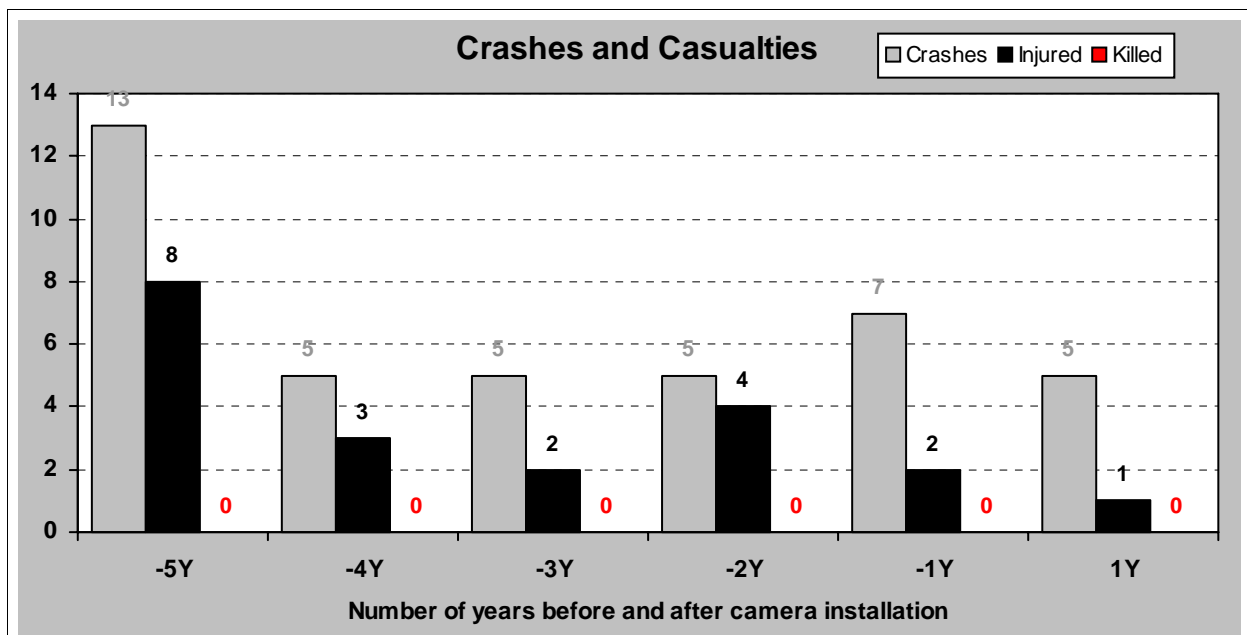
This represents a 46 per cent reduction in the yearly average number of crashes and an 80 per cent reduction in the yearly average number of casualties at this intersection in the period after installation until the end of 2011.

Provisional crash data shows there were 5 crashes resulting in one casualty at this intersection in 2011.

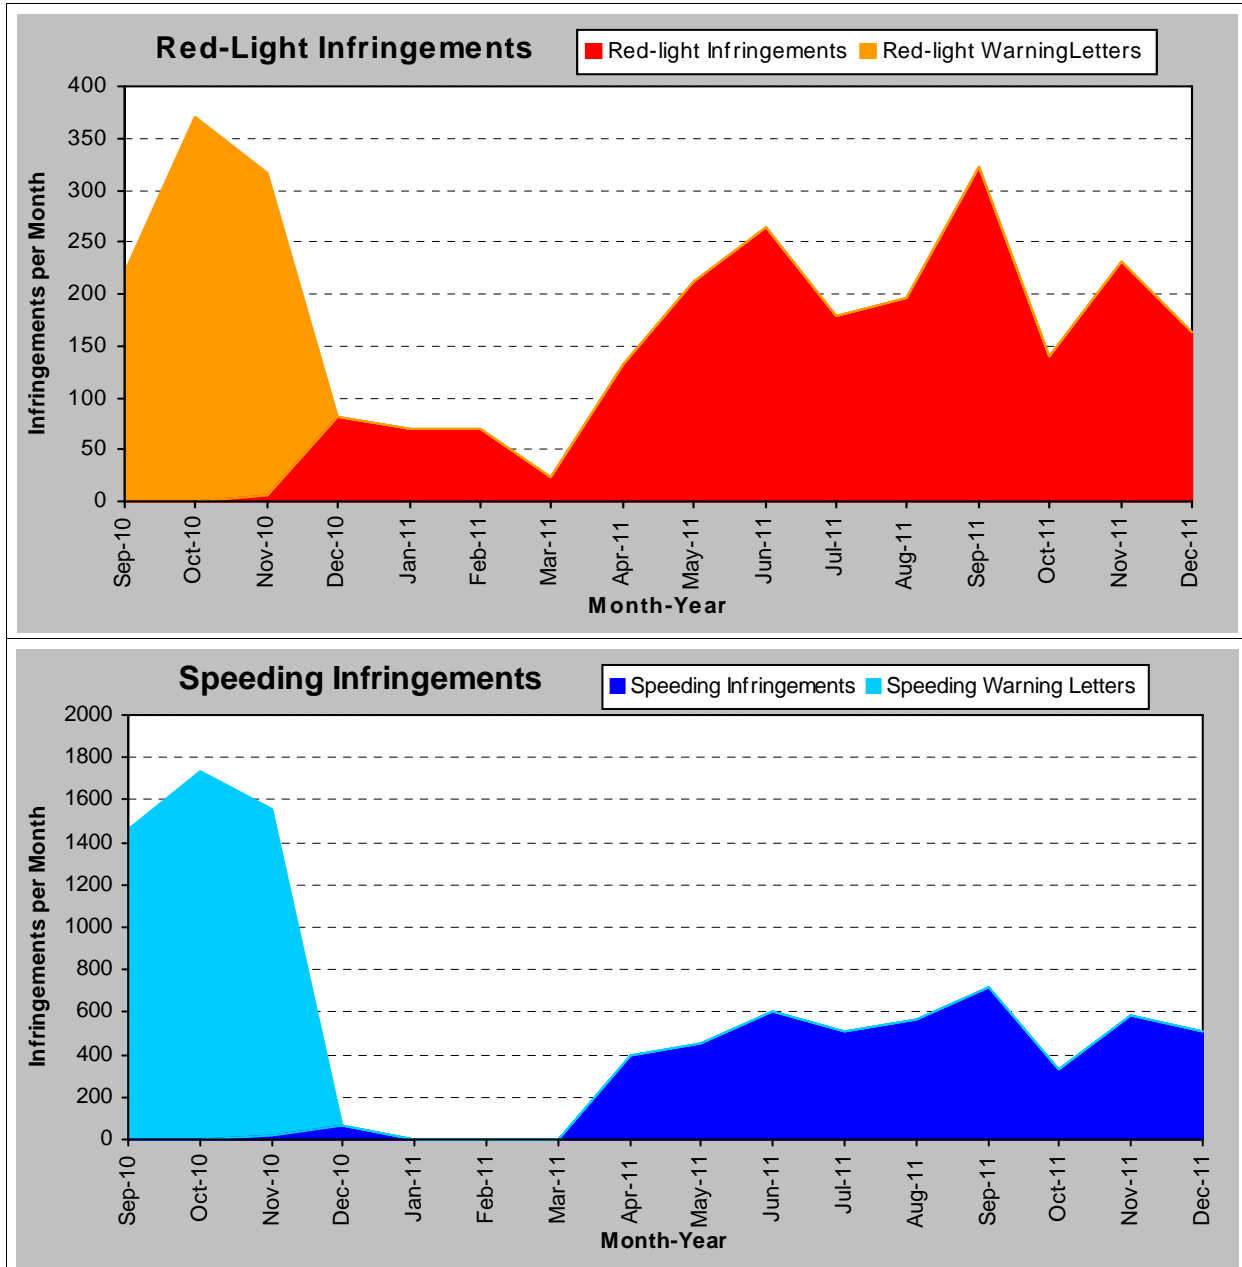
## Infringements at safety camera location

The graph below details the number of warning letters and infringements issued at this intersection since the camera began operating. The graph also shows the trend in infringements at this location.

Roadworks and camera maintenance may influence the number of infringements issued.

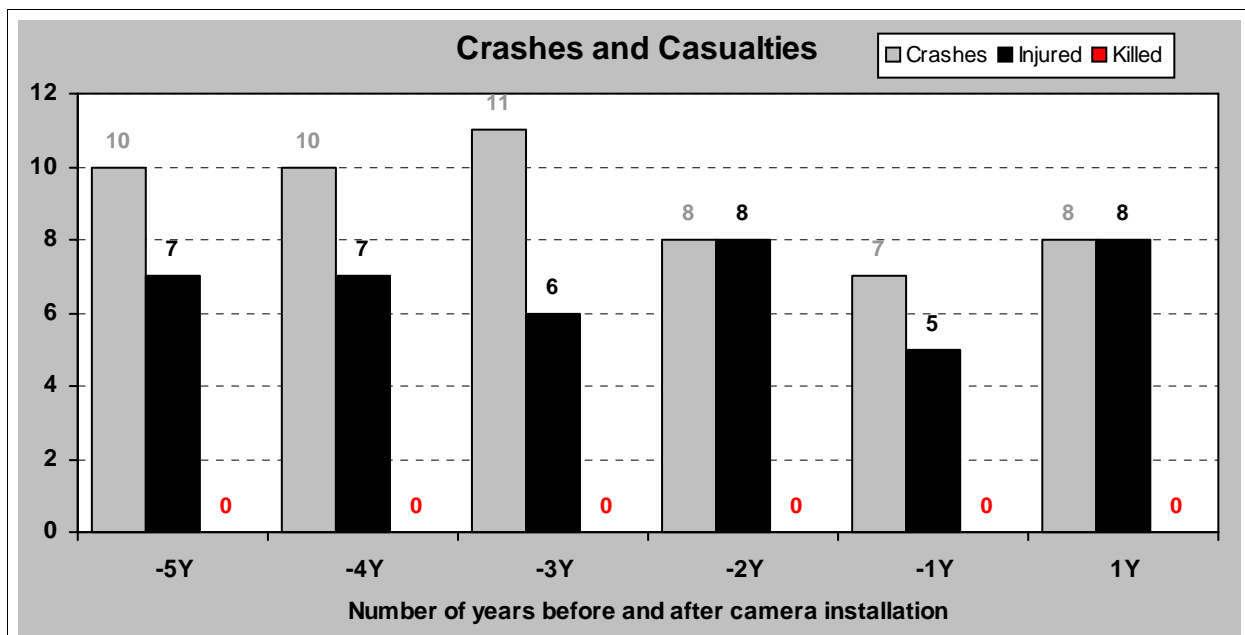
This represents a 14 per cent reduction in the yearly average number of crashes and a 9 per cent increase in the yearly average number of casualties at this intersection in the period after installation until the end of 2011.

Provisional crash data shows there were 8 crashes resulting in 7 casualties at this intersection in 2011.

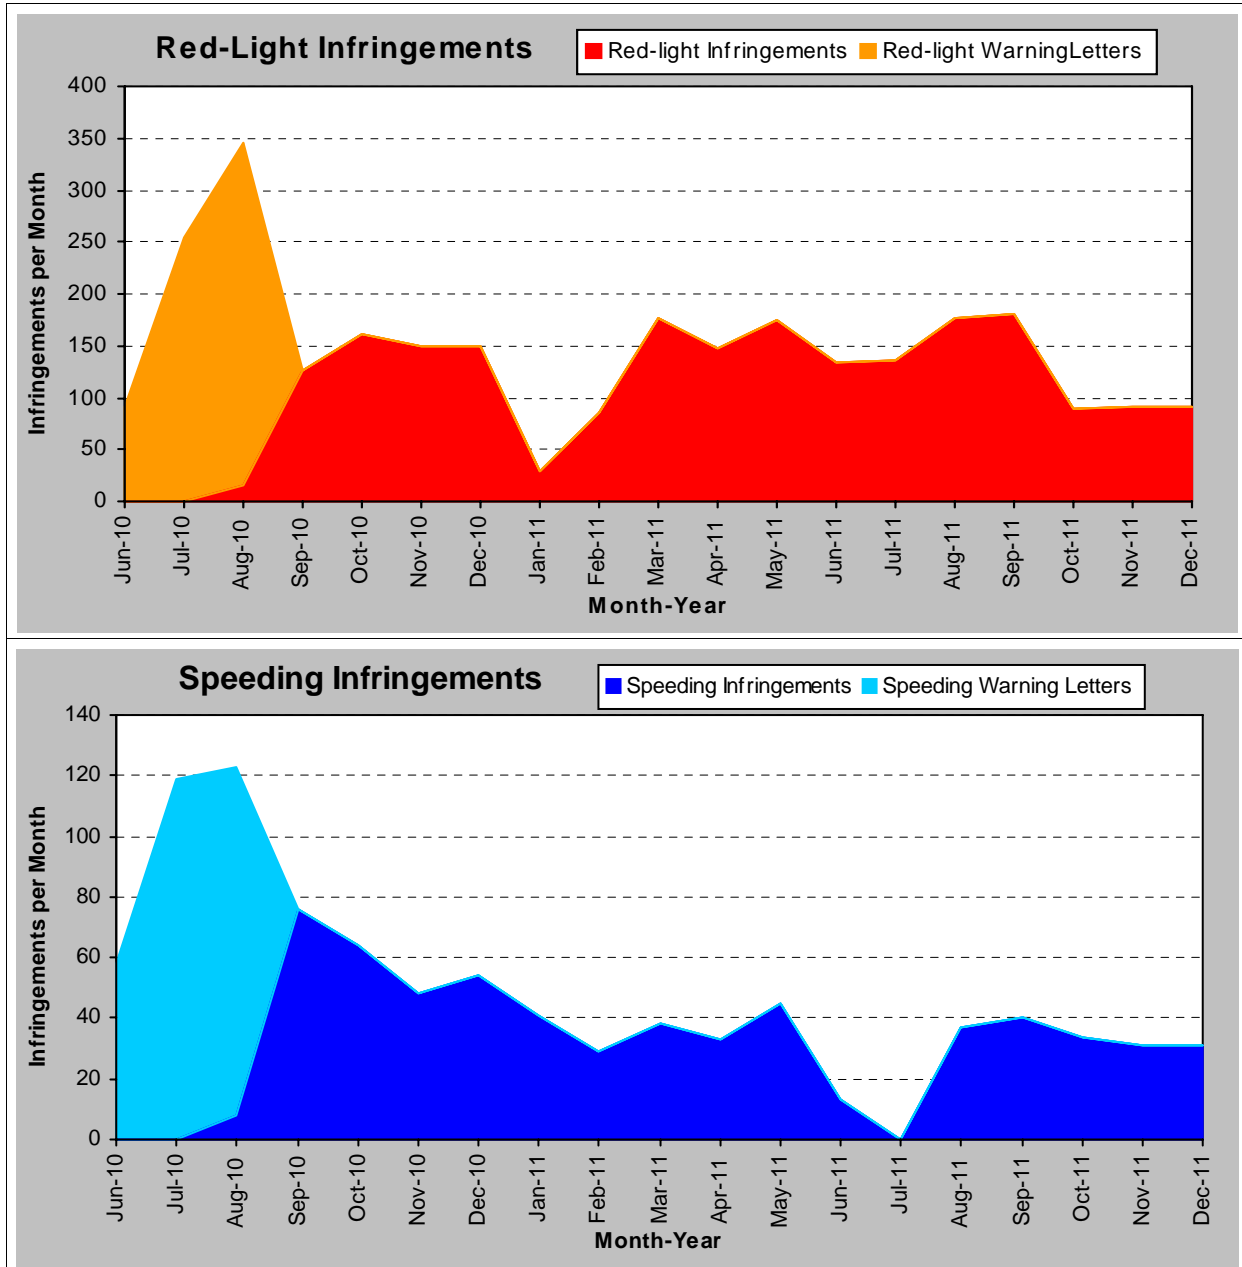
## Infringements at safety camera location

The graph below details the number of warning letters and infringements issued at this intersection since the camera began operating. The graph also shows the trend in infringements at this location.

Roadworks and camera maintenance may influence the number of infringements issued.

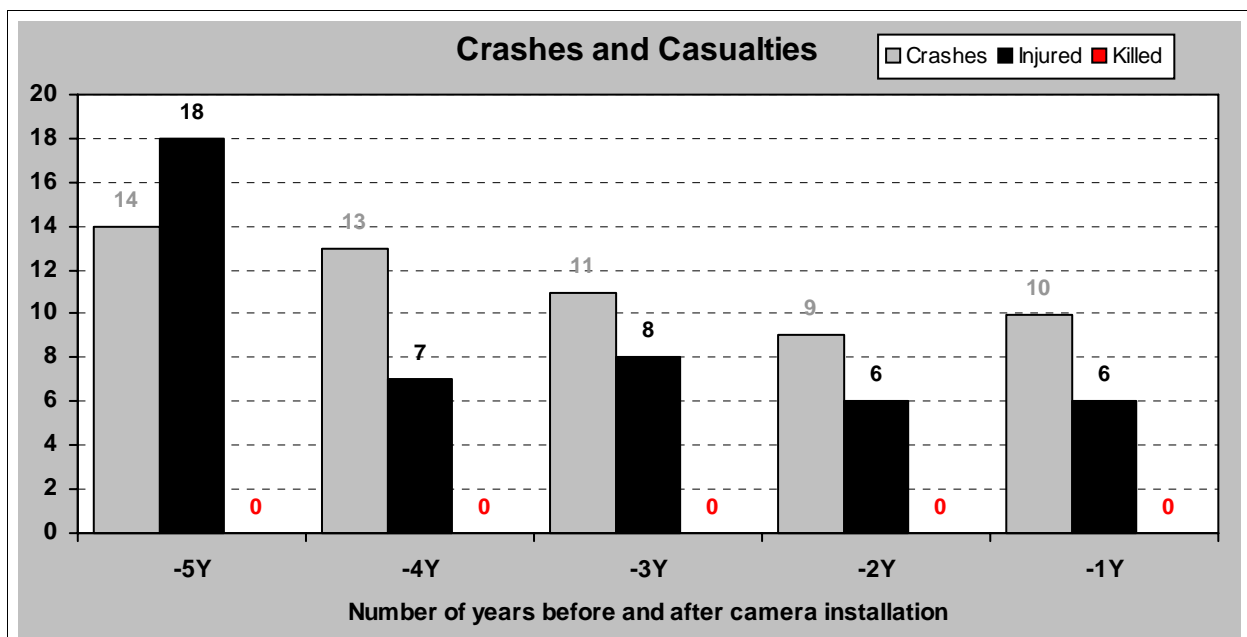
In the 237 day period from installation to the end of 2011, there were 3 crashes resulting in 1 injury and 0 fatalities.

This represents a 59 per cent reduction in the yearly average number of crashes and an 83 per cent reduction in the yearly average number of casualties at this intersection in the period after installation until the end of 2011.

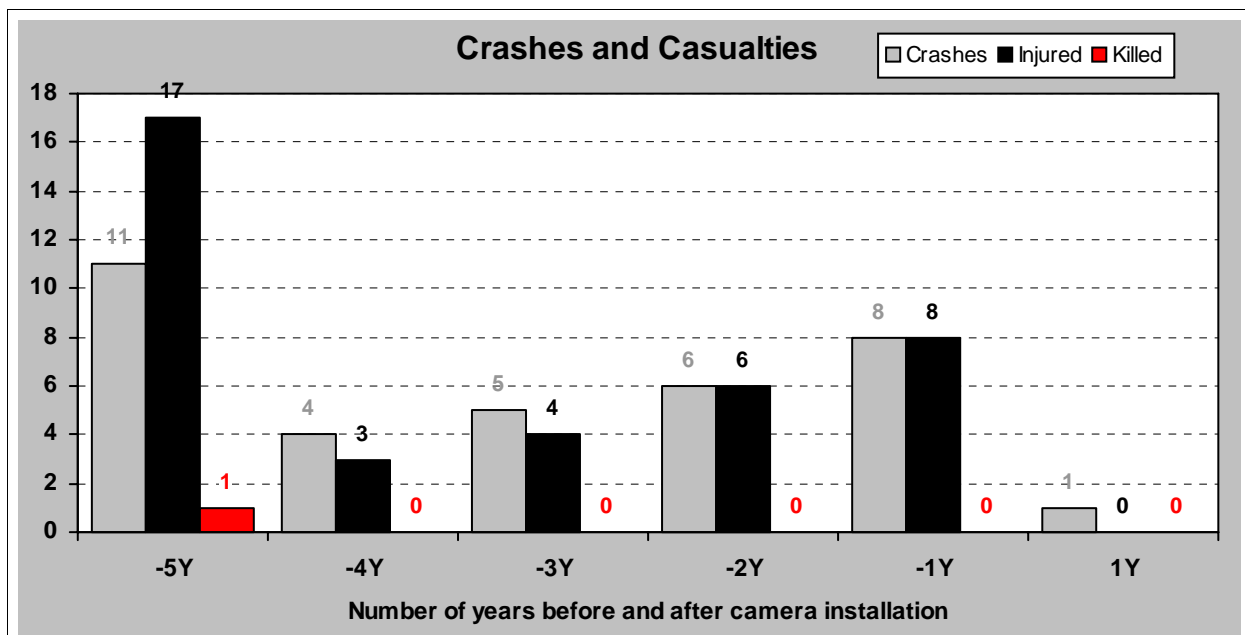
This represents a 61 per cent reduction in the yearly average number of crashes and an 83 per cent reduction in the yearly average number of casualties at this intersection in the period after installation until the end of 2011.

Provisional crash data shows there were 4 crashes resulting in 2 casualties at this intersection in 2011.

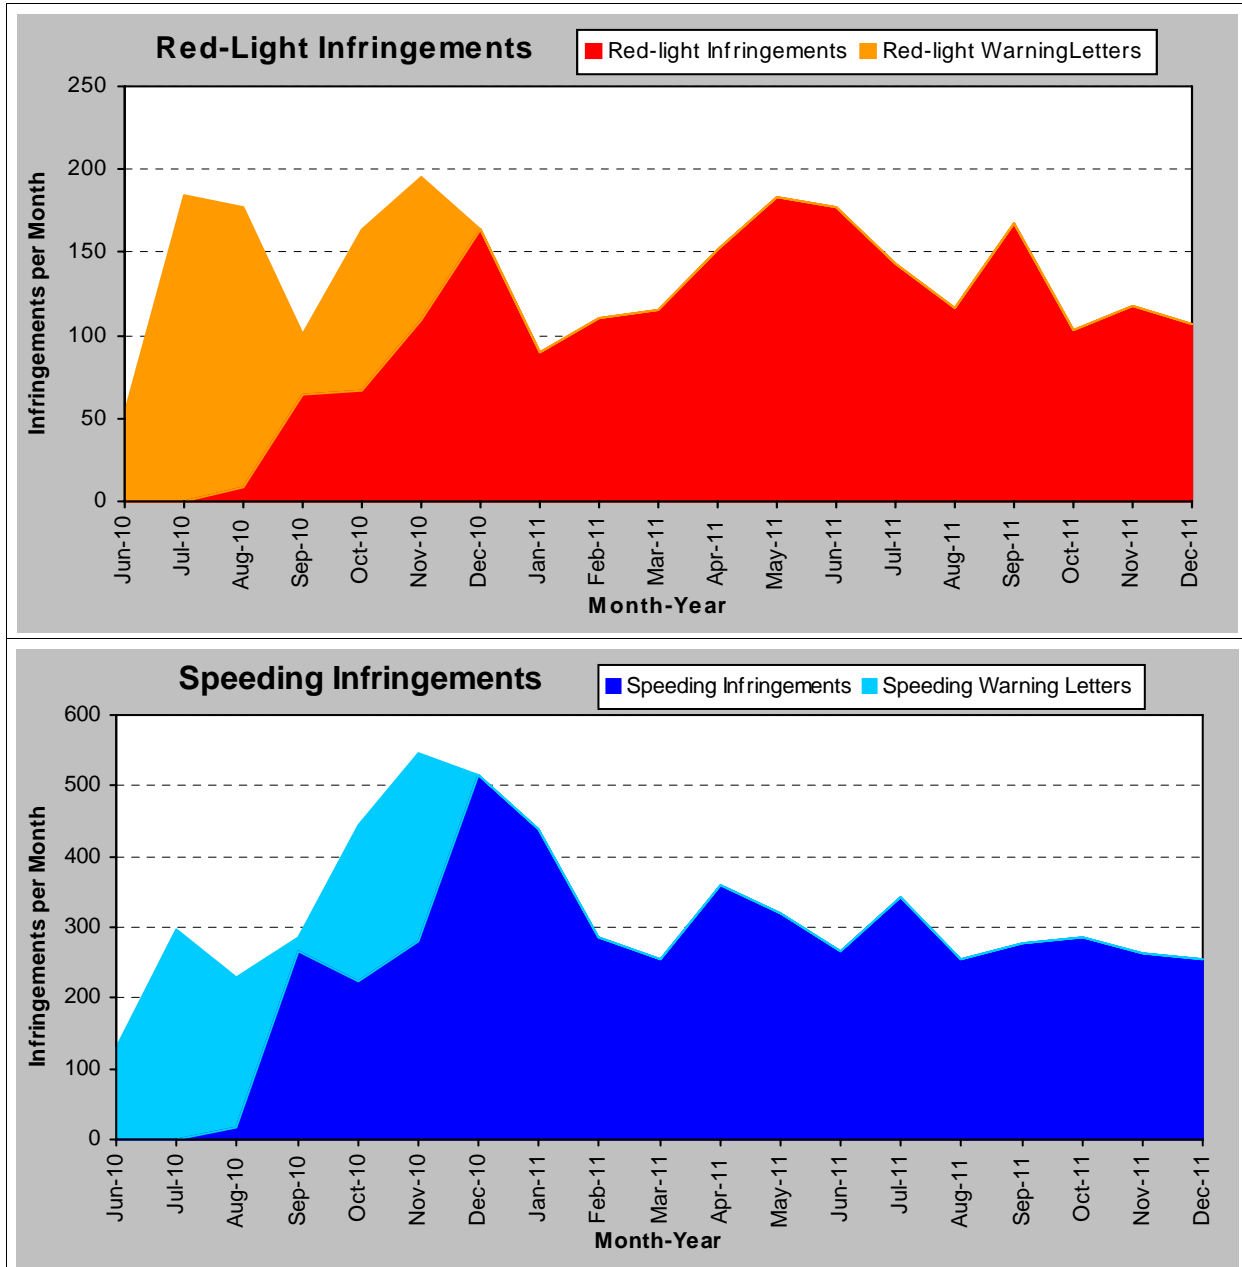
## Infringements at safety camera location

The graph below details the number of warning letters and infringements issued at this intersection since the camera began operating. The graph also shows the trend in infringements at this location.

Roadworks and camera maintenance may influence the number of infringements issued.

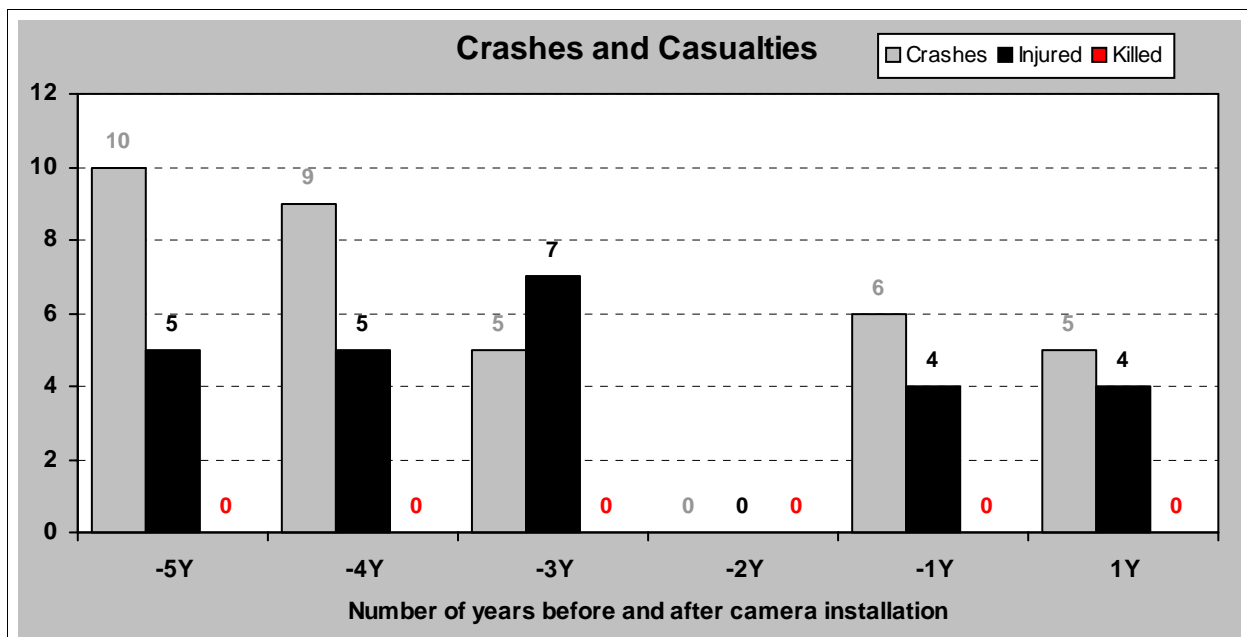
This represents a 31 per cent reduction in the yearly average number of crashes and a 21 per cent reduction in the yearly average number of casualties at this intersection in the period after installation until the end of 2011.

Provisional crash data shows there were 5 crashes resulting in 4 casualties at this intersection in 2011.

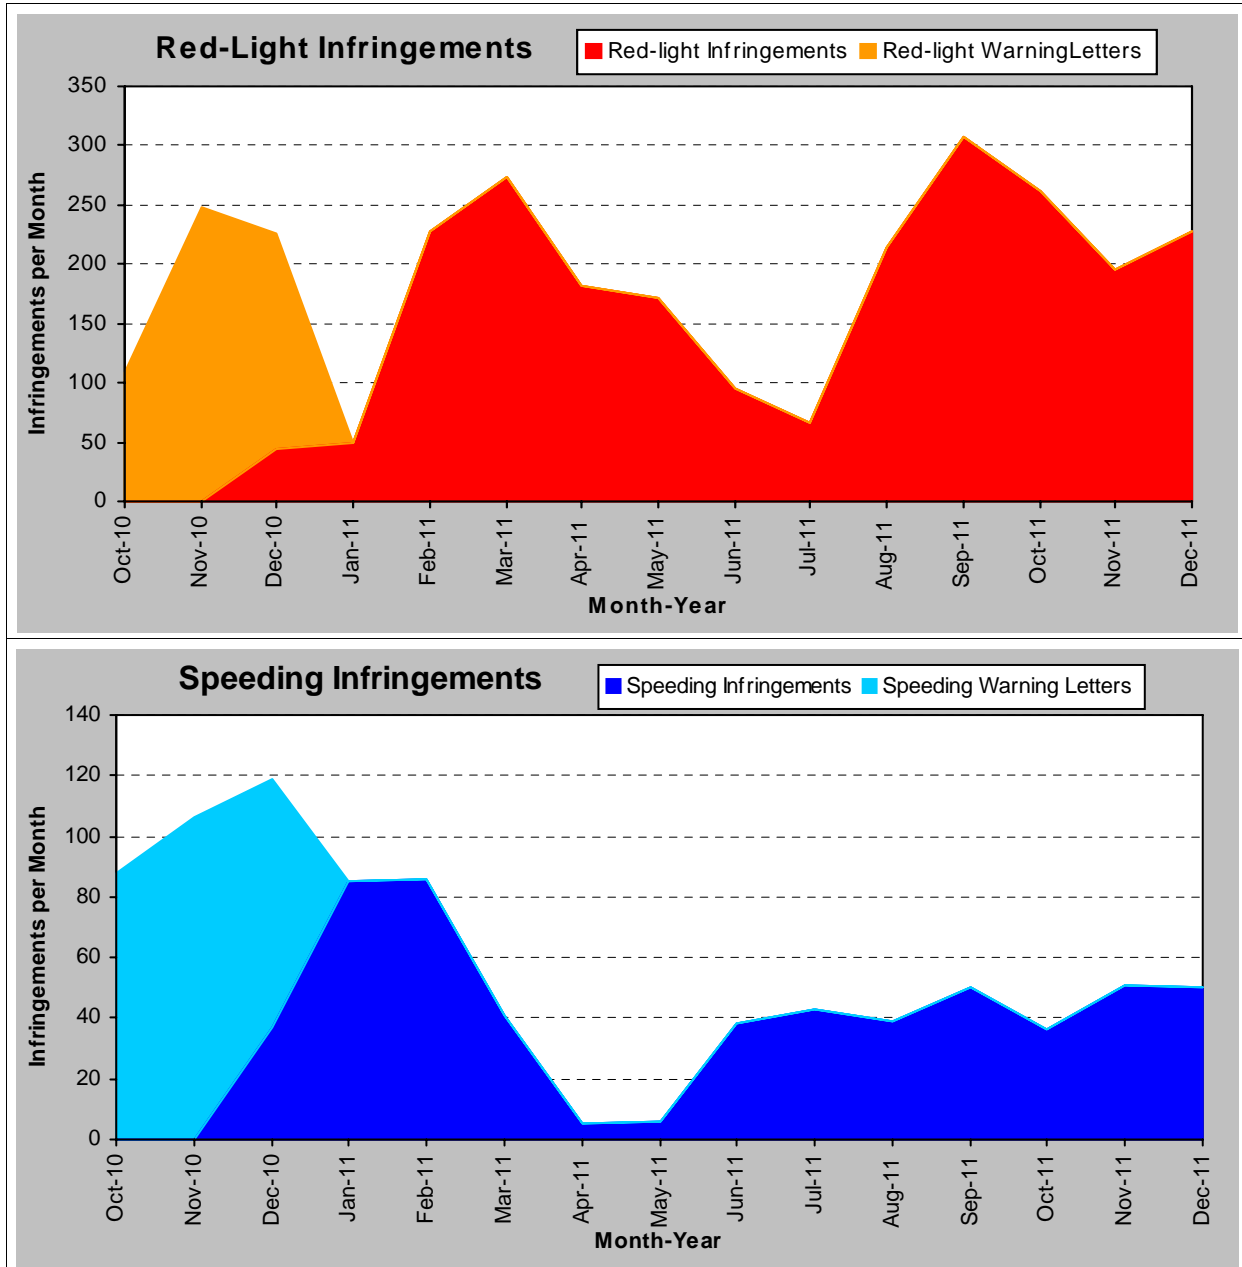
## Infringements at safety camera location

The graph below details the number of warning letters and infringements issued at this intersection since the camera began operating. The graph also shows the trend in infringements at this location.

Roadworks and camera maintenance may influence the number of infringements issued.

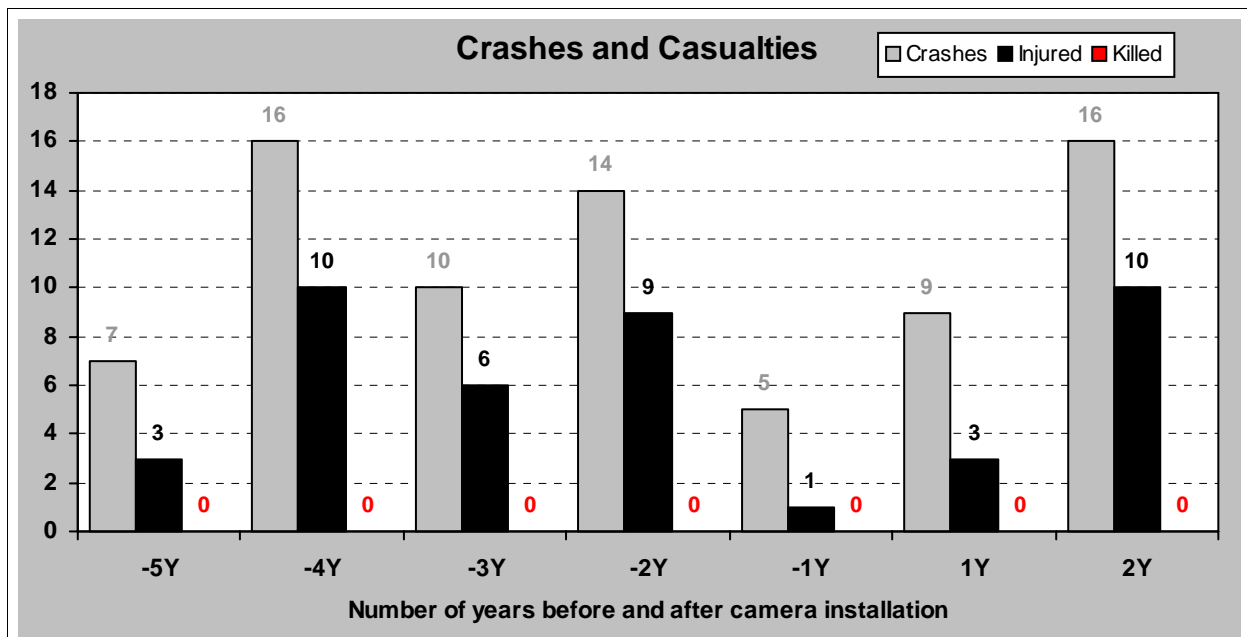
This represents an 18 per cent increase in the yearly average number of crashes and a 10 per cent increase in the yearly average number of casualties at this intersection in the period after installation until the end of 2011.

Provisional crash data shows there were 15 crashes resulting in 9 casualties at this intersection in 2011.

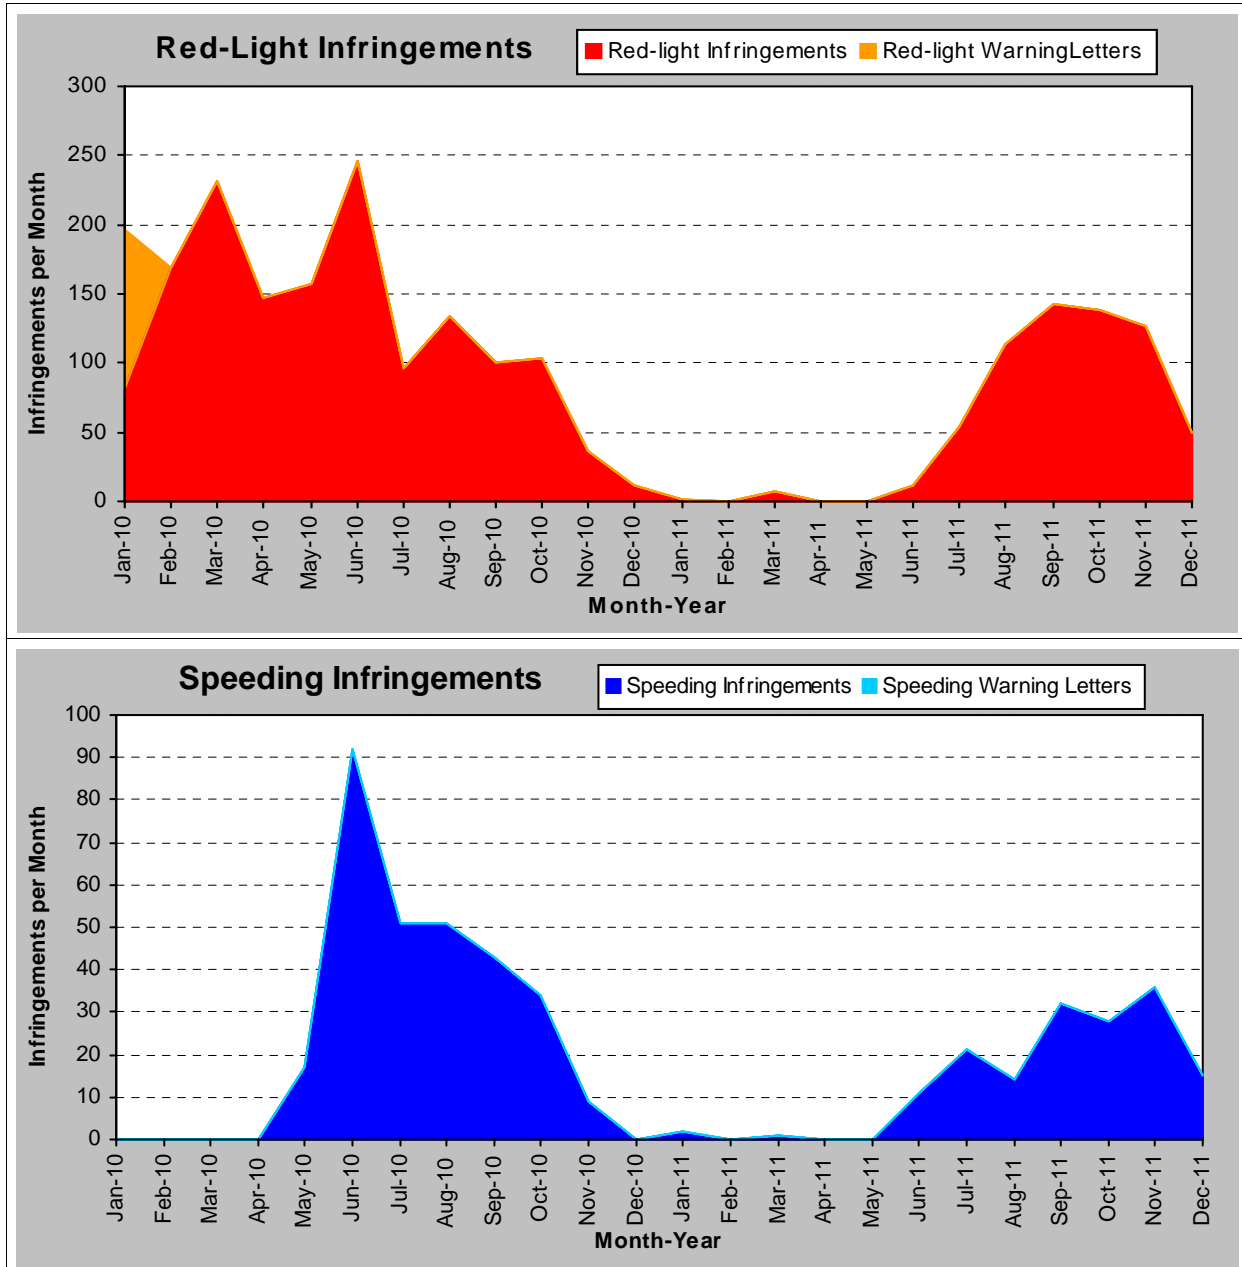
## Infringements at safety camera location

The graph below details the number of warning letters and infringements issued at this intersection since the camera began operating. The graph also shows the trend in infringements at this location.

Roadworks and camera maintenance may influence the number of infringements issued.

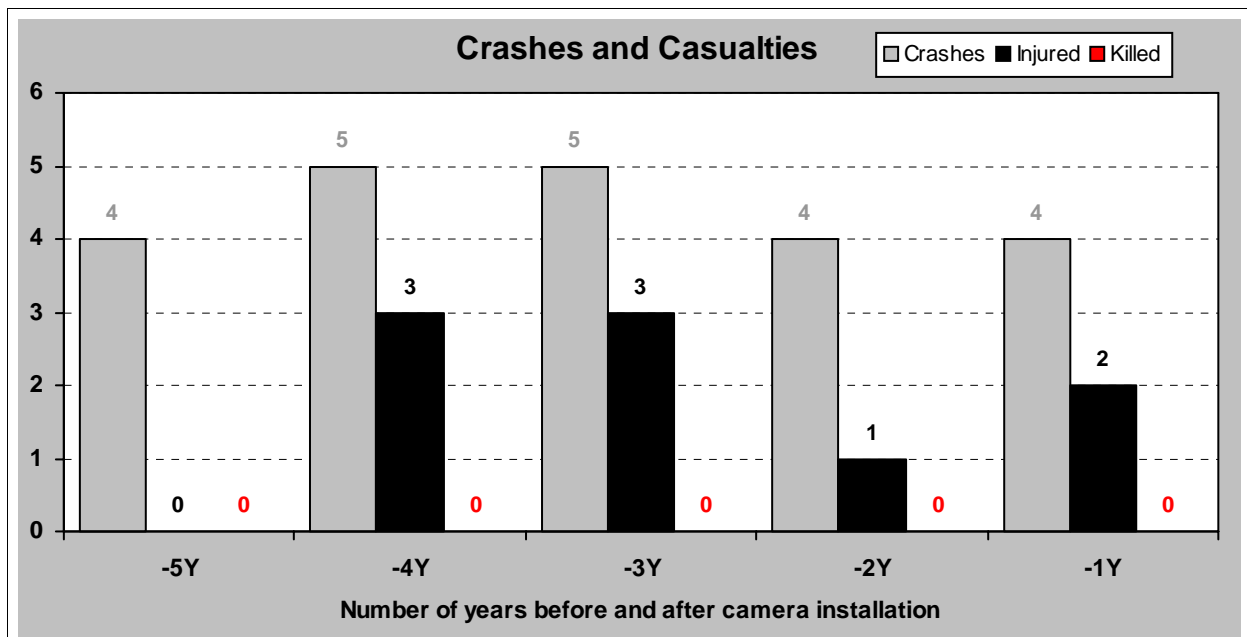
In the 268 day period from installation to the end of 2011, there were 3 crashes resulting in 2 injuries and 0 fatalities.

This represents a 7 per cent reduction in the yearly average number of crashes and a 51 per cent increase in the yearly average number of casualties at this intersection in the period after installation until the end of 2011.
