# ANNUAL NSW SPEED CAMERA PERFORMANCE REVIEW

NSW Centre for Road Safety

JULY 2012

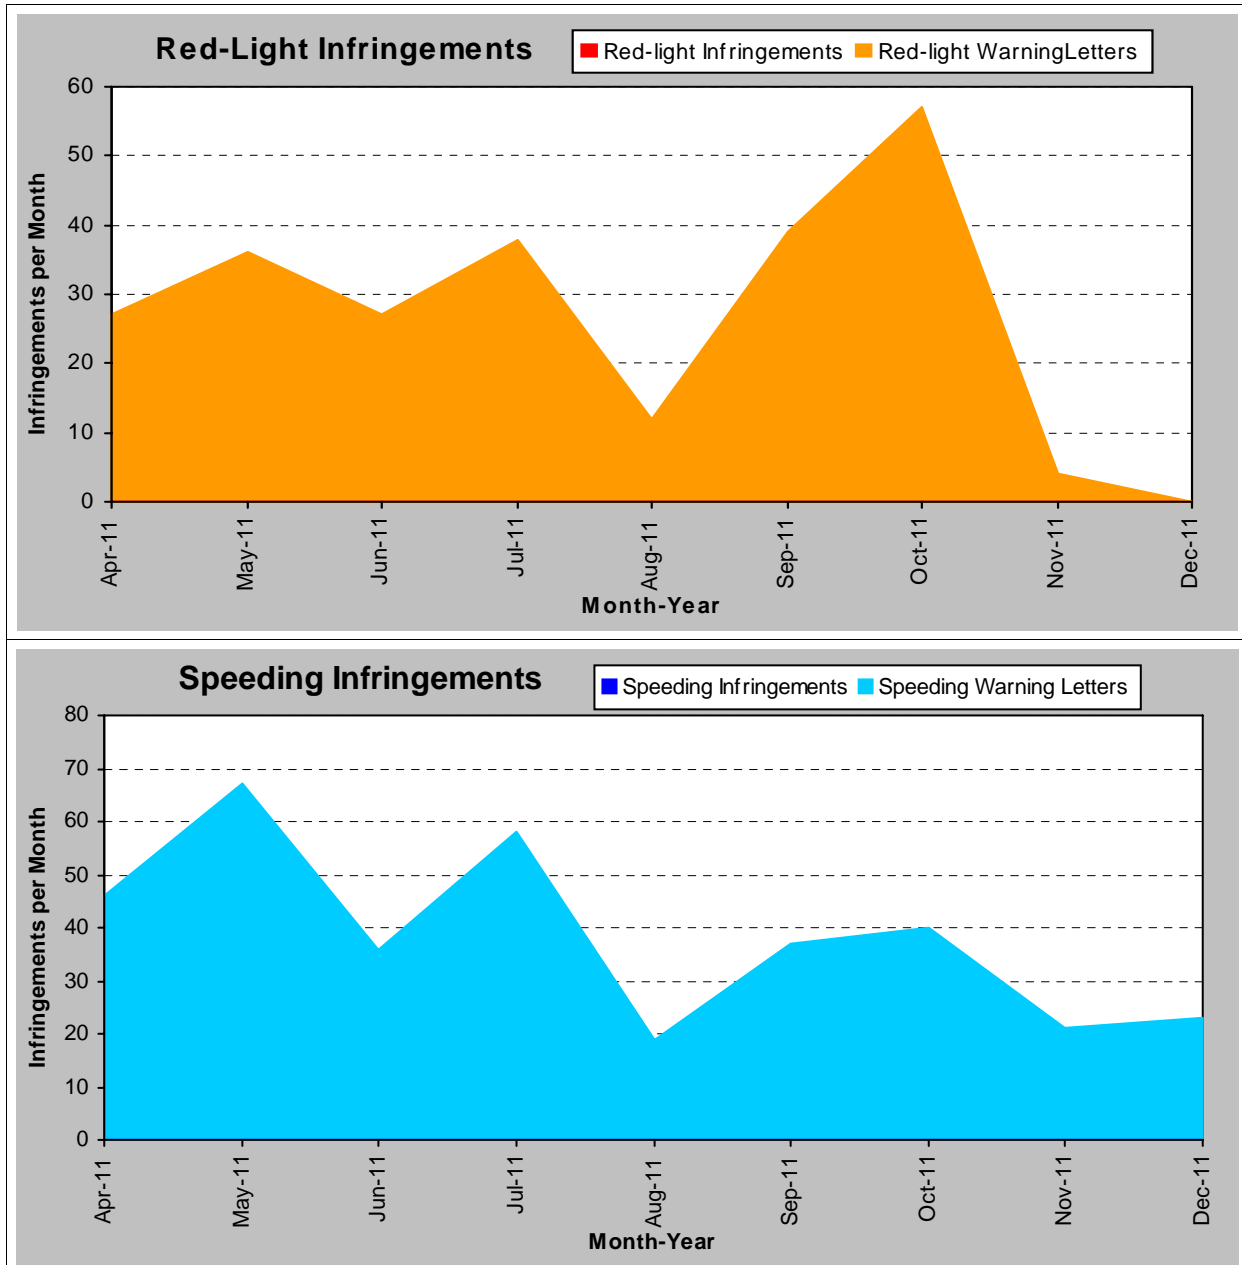
## Infringements at safety camera location

The graph below details the number of warning letters and infringements issued at this intersection since the camera began operating.

Roadworks and camera maintenance may influence the number of infringements issued.

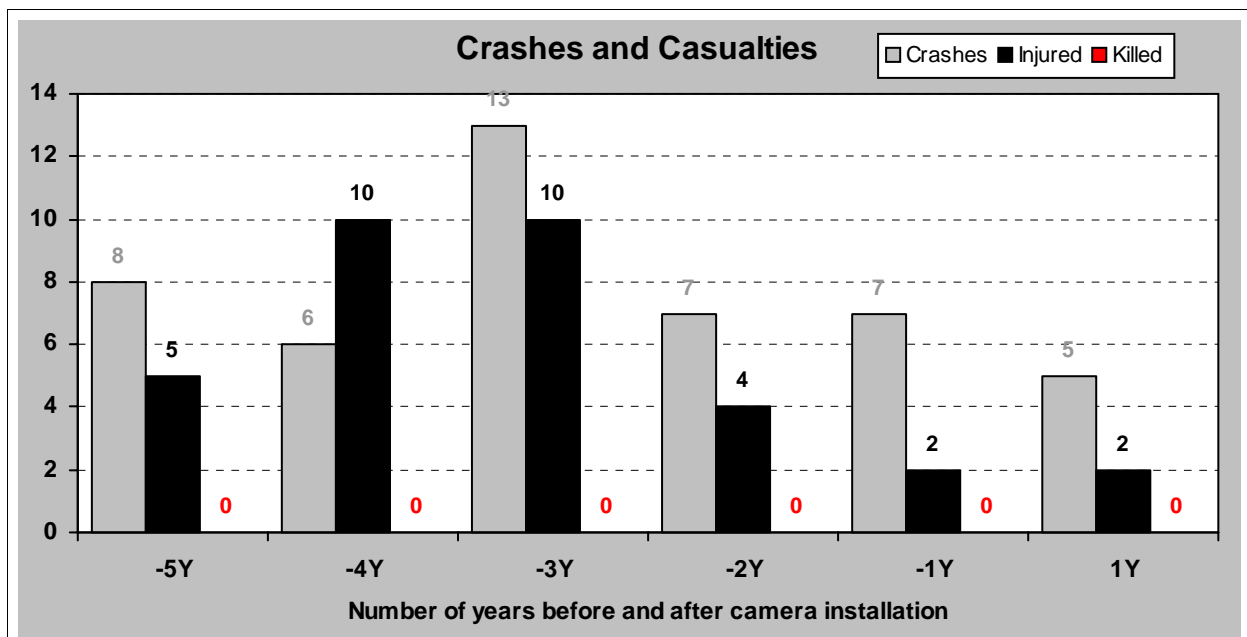
This represents a 51 per cent reduction in the yearly average number of crashes and a 74 per cent reduction in the yearly average number of casualties at this intersection in the period after installation until the end of 2011.

Provisional crash data shows there were 4 crashes resulting in 2 casualties at this intersection in 2011.

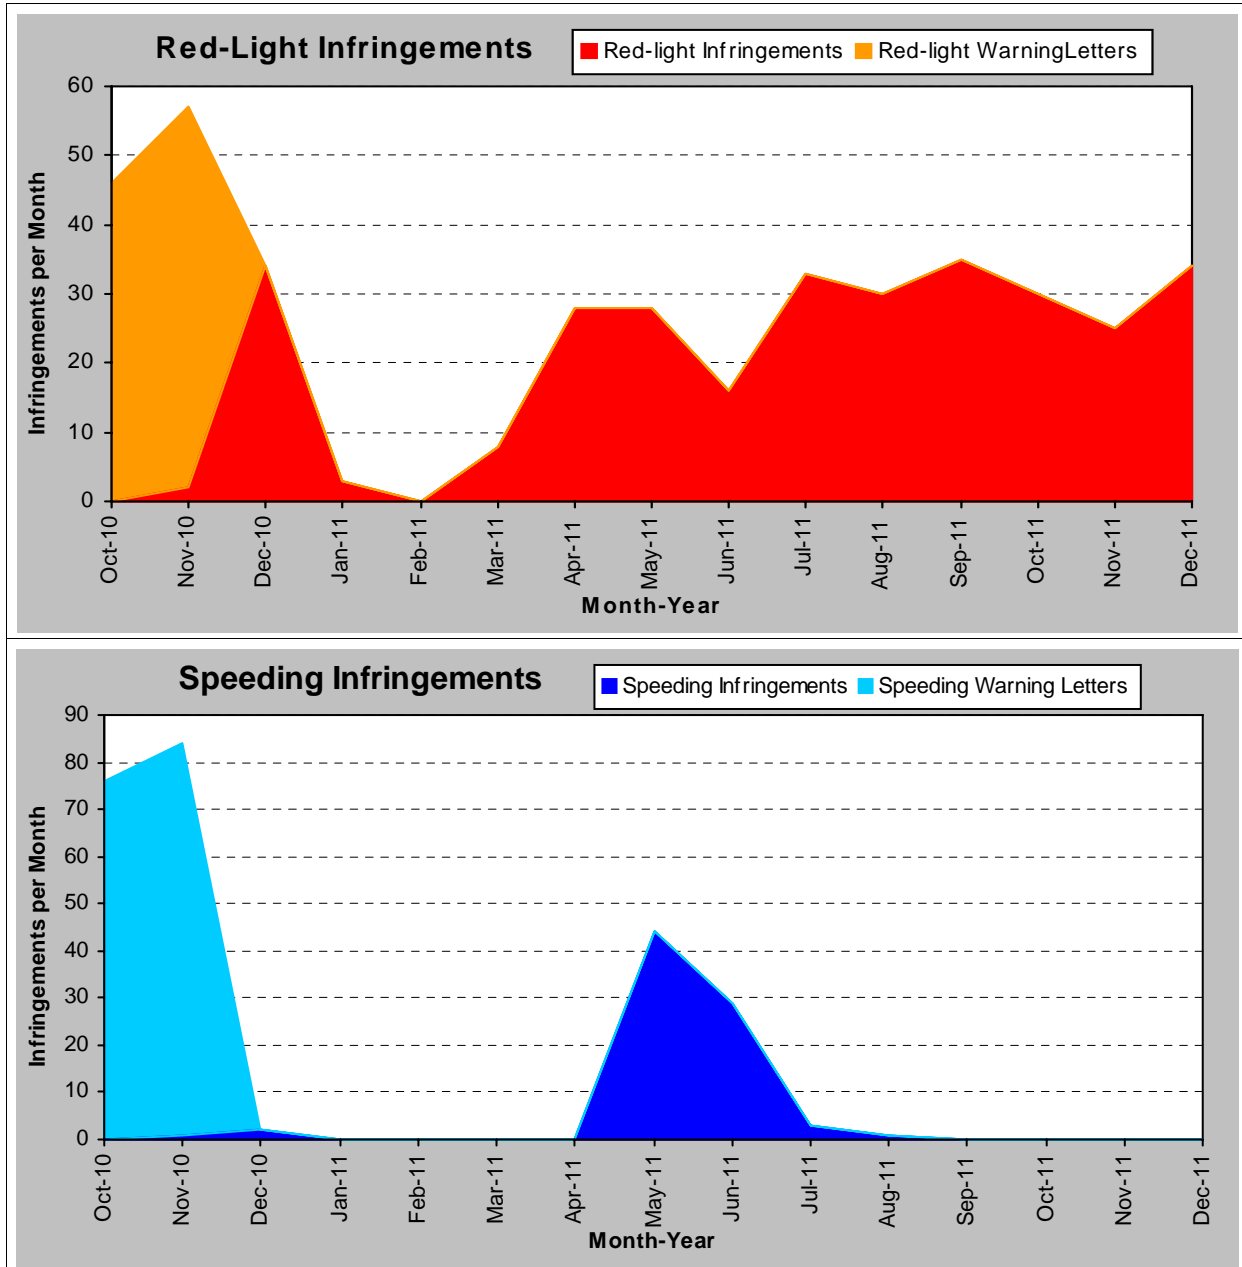
## Infringements at safety camera location

The graph below details the number of warning letters and infringements issued at this intersection since the camera began operating. The graph also shows the trend in infringements at this location.

Roadworks and camera maintenance may influence the number of infringements issued.

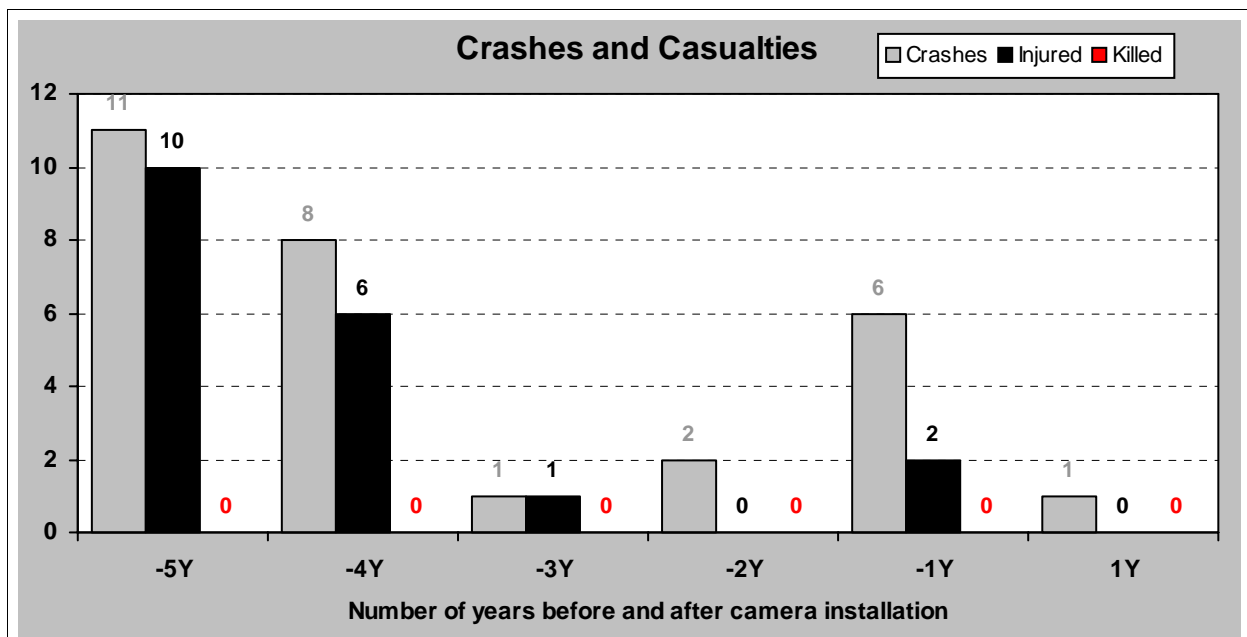
This represents a 53 per cent reduction in the yearly average number of crashes and a 59 per cent reduction in the yearly average number of casualties at this intersection in the period after installation until the end of 2011.

Provisional crash data shows there were 5 crashes resulting in 3 casualties at this intersection in 2011.

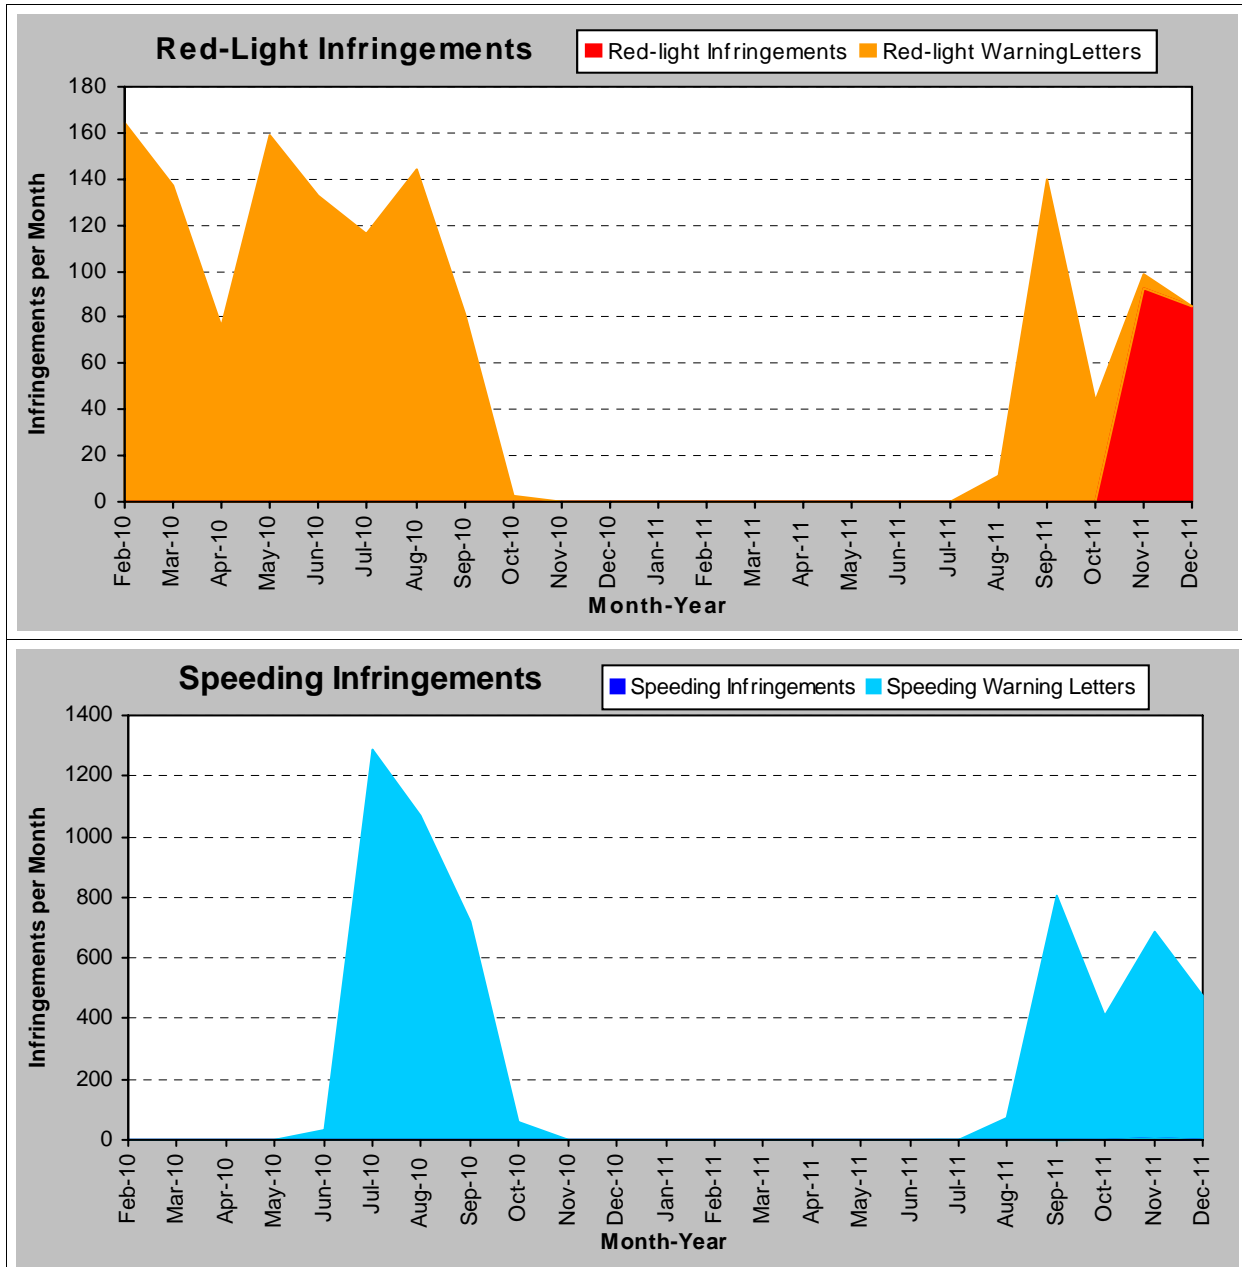
## Infringements at safety camera location

The graph below details the number of warning letters and infringements issued at this intersection since the camera began operating.

Roadworks and camera maintenance may influence the number of infringements issued.

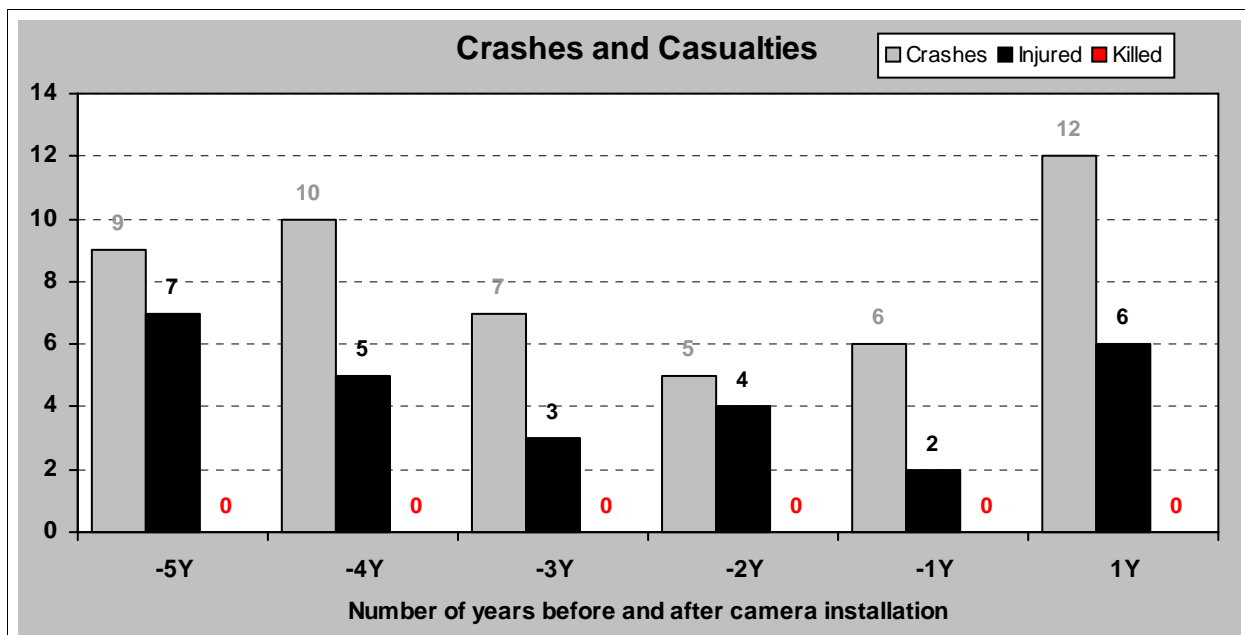
This represents a 31 per cent increase in the yearly average number of crashes and a 15 per cent increase in the yearly average number of casualties at this intersection in the period after installation until the end of 2011.

Provisional crash data shows there were 7 crashes resulting in 4 casualties at this intersection in 2011.

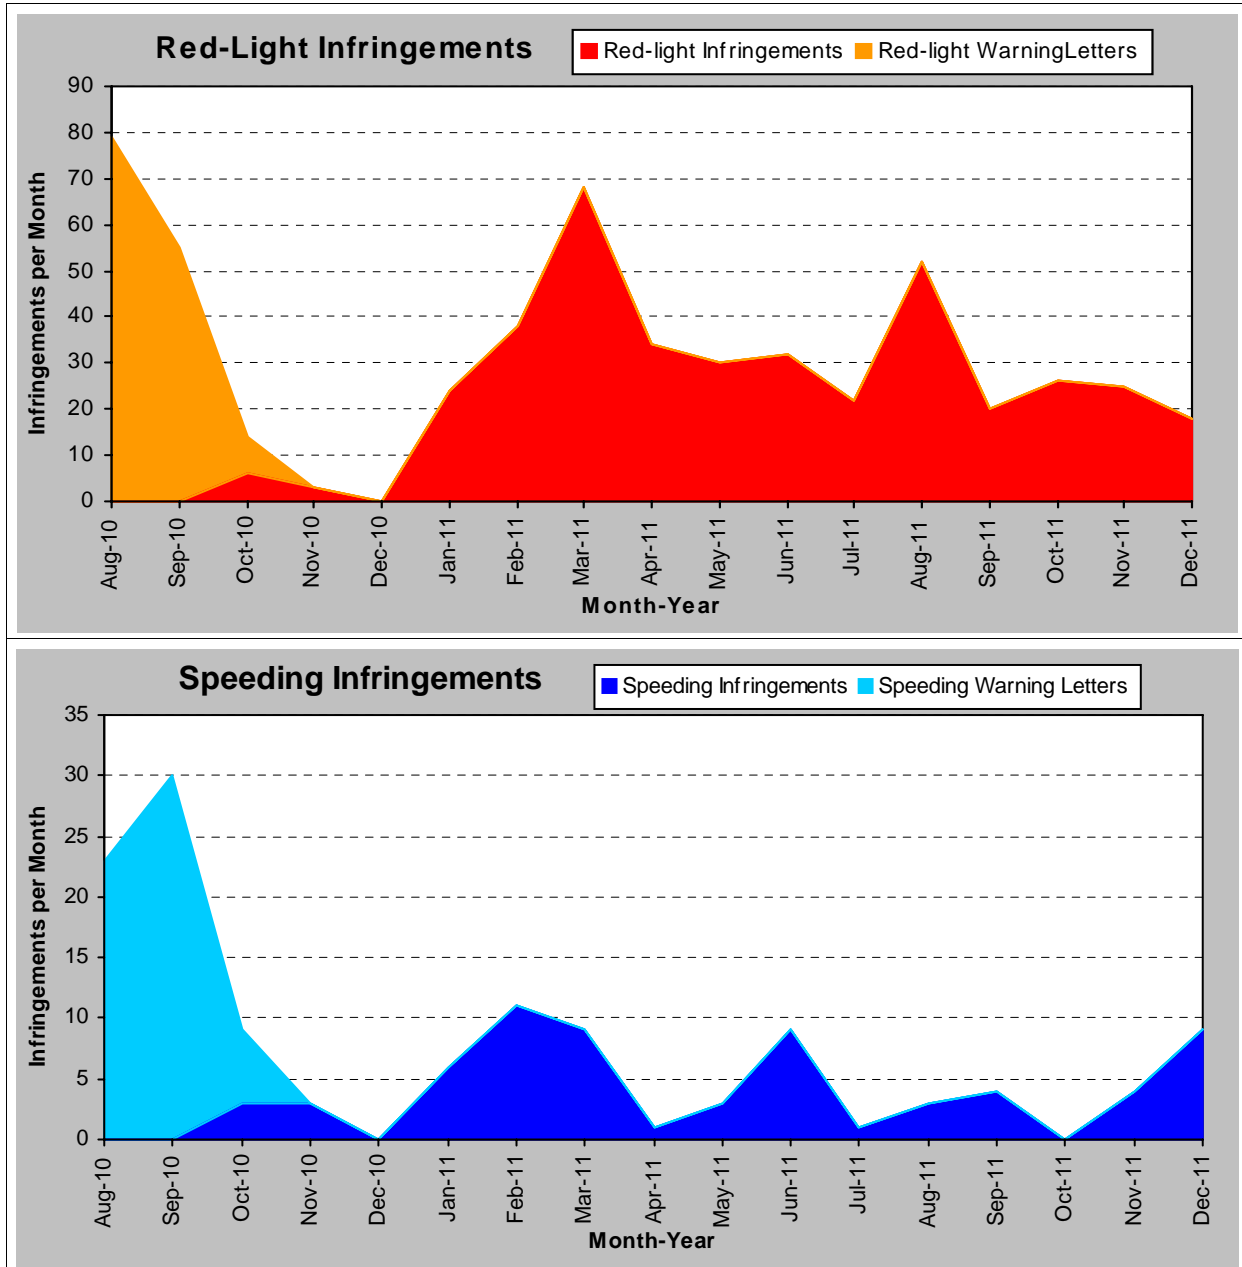
## Infringements at safety camera location

The graph below details the number of warning letters and infringements issued at this intersection since the camera began operating. The graph also shows the trend in infringements at this location.

Roadworks and camera maintenance may influence the number of infringements issued.

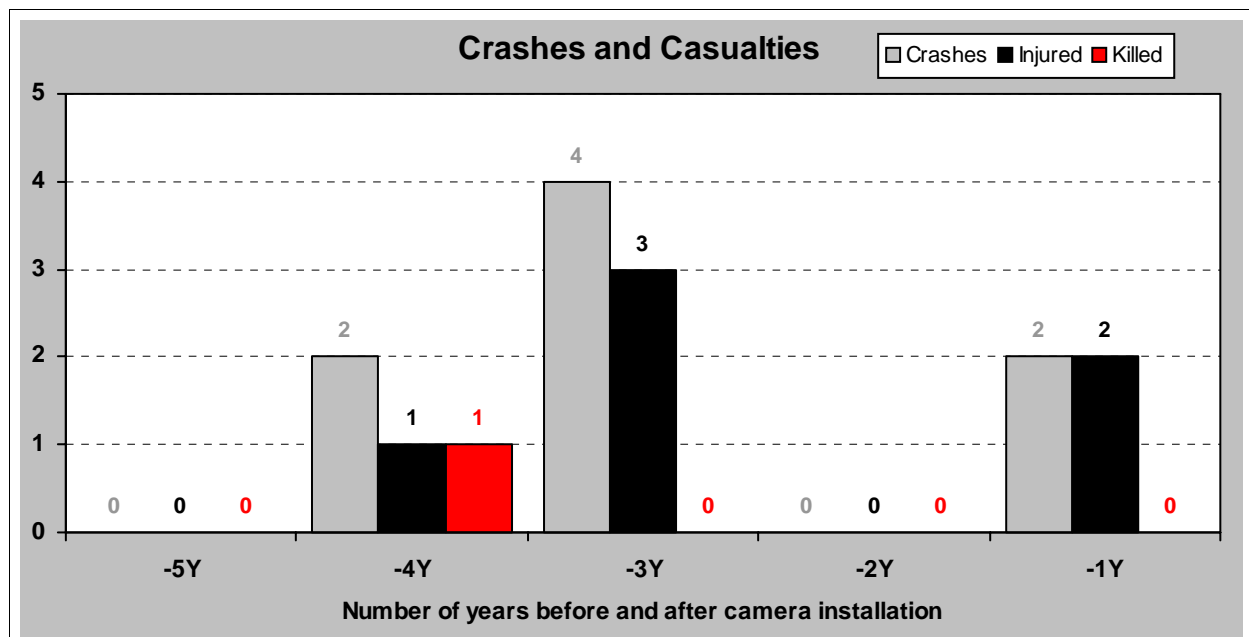
In the 258 day period from installation to the end of 2011, there were 0 crashes resulting in 0 injuries and 0 fatalities.

This represents a 100 per cent reduction in the yearly average number of crashes and a 100 per cent reduction in the yearly average number of casualties at this intersection in the period after installation until the end of 2011.

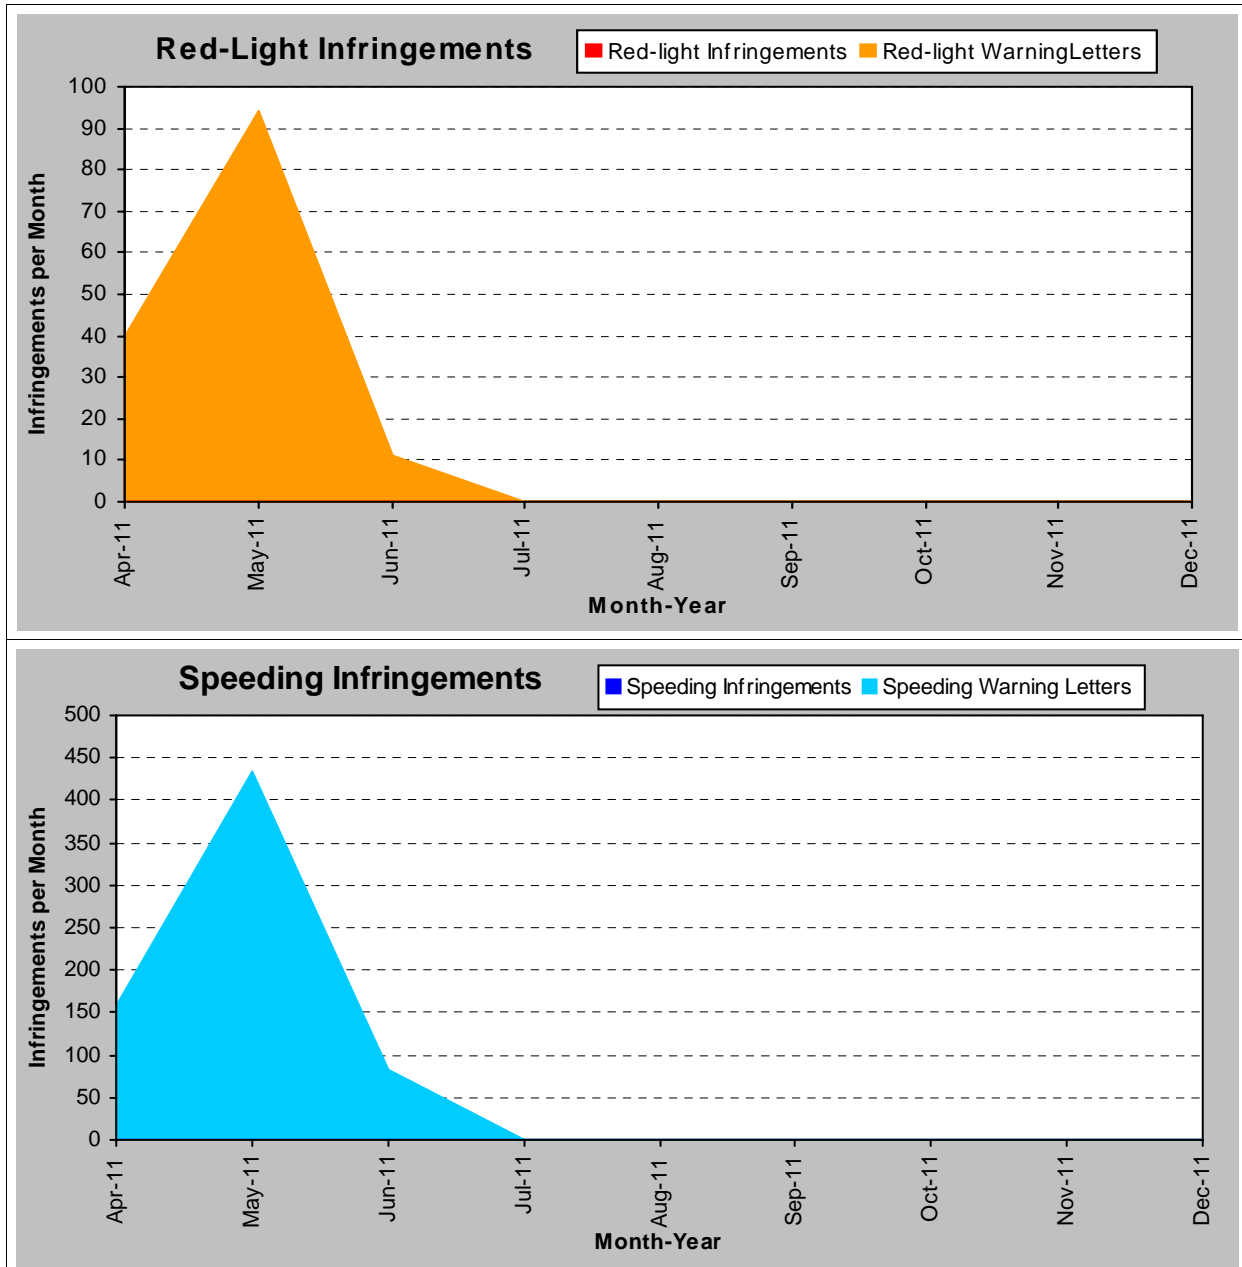
## Infringements at safety camera location

The graph below details the number of warning letters and infringements issued at this intersection since the camera began operating.

Roadworks and camera maintenance may influence the number of infringements issued.

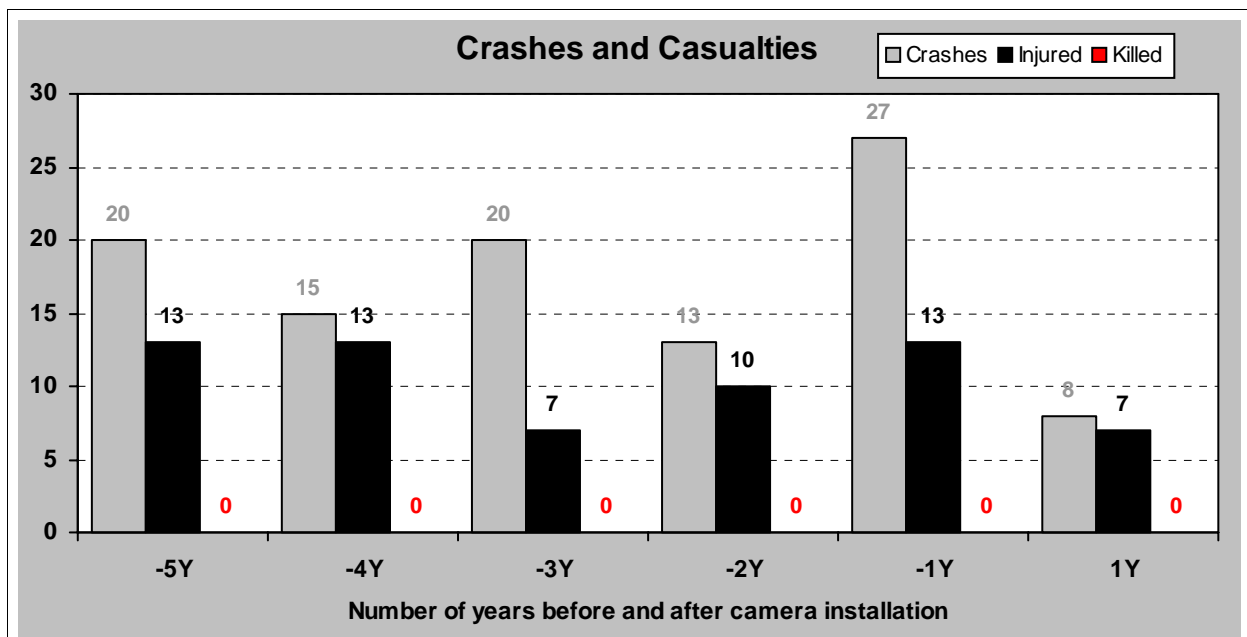
This represents a 57 per cent reduction in the yearly average number of crashes and a 47 per cent reduction in the yearly average number of casualties at this intersection in the period after installation until the end of 2011.

Provisional crash data shows there were 7 crashes resulting in 7 casualties at this intersection in 2011.

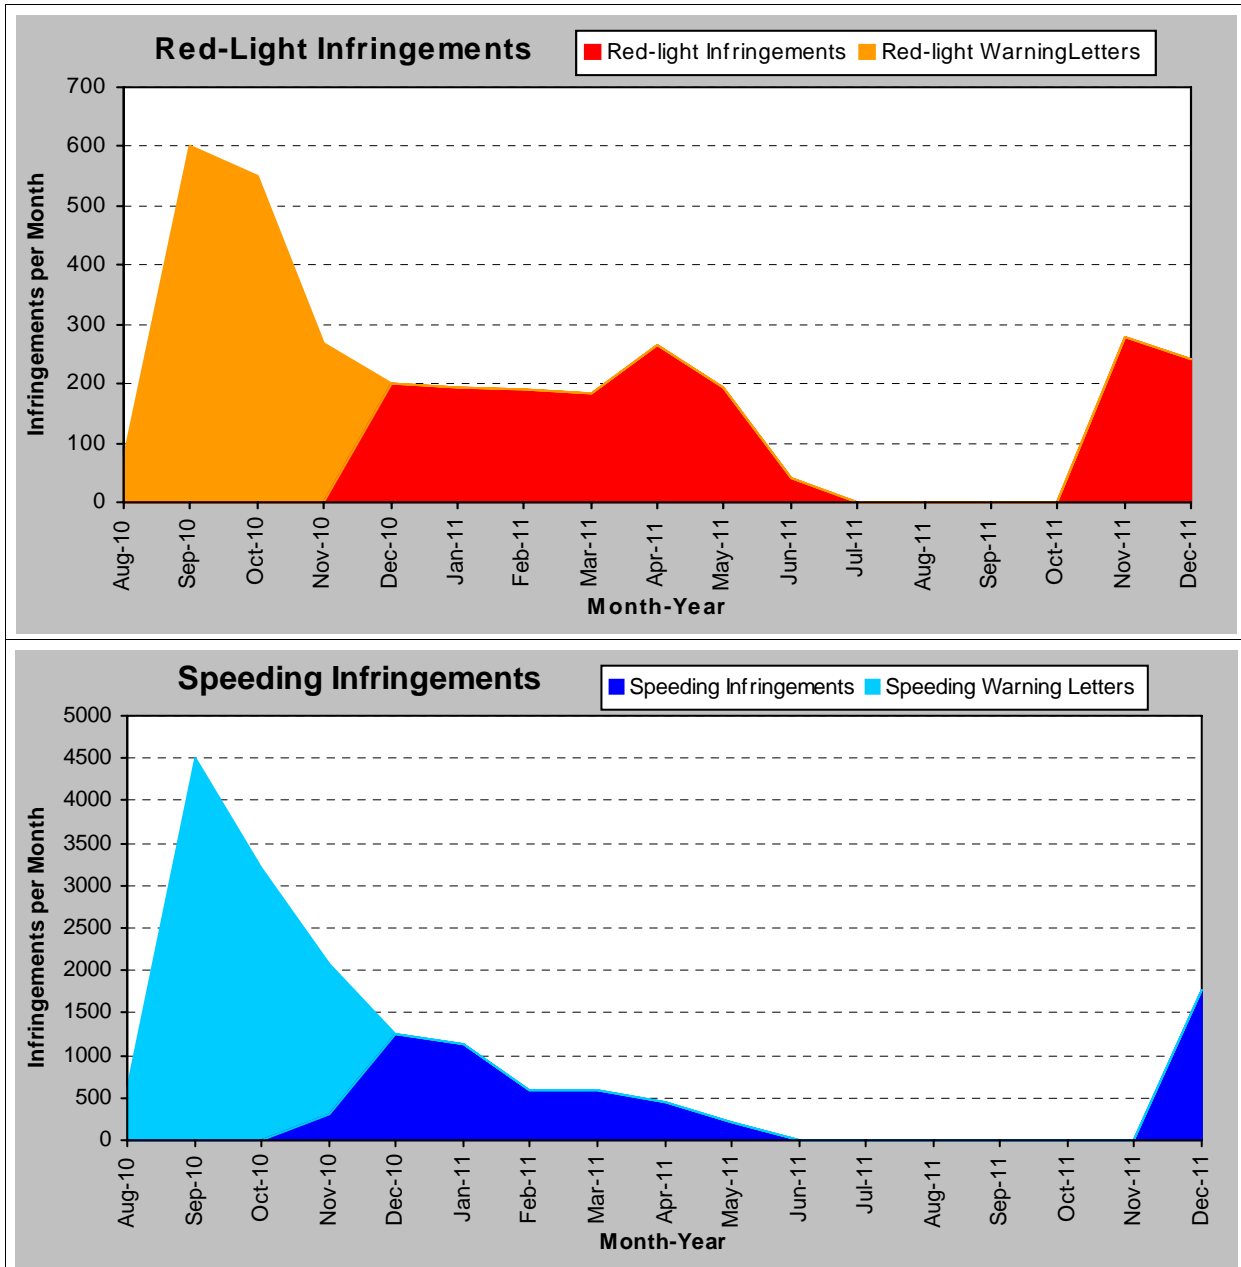
## Infringements at safety camera location

The graph below details the number of warning letters and infringements issued at this intersection since the camera began operating. The graph also shows the trend in infringements at this location.

Roadworks and camera maintenance may influence the number of infringements issued. This location was impacted by major civil works between June and November 2011.

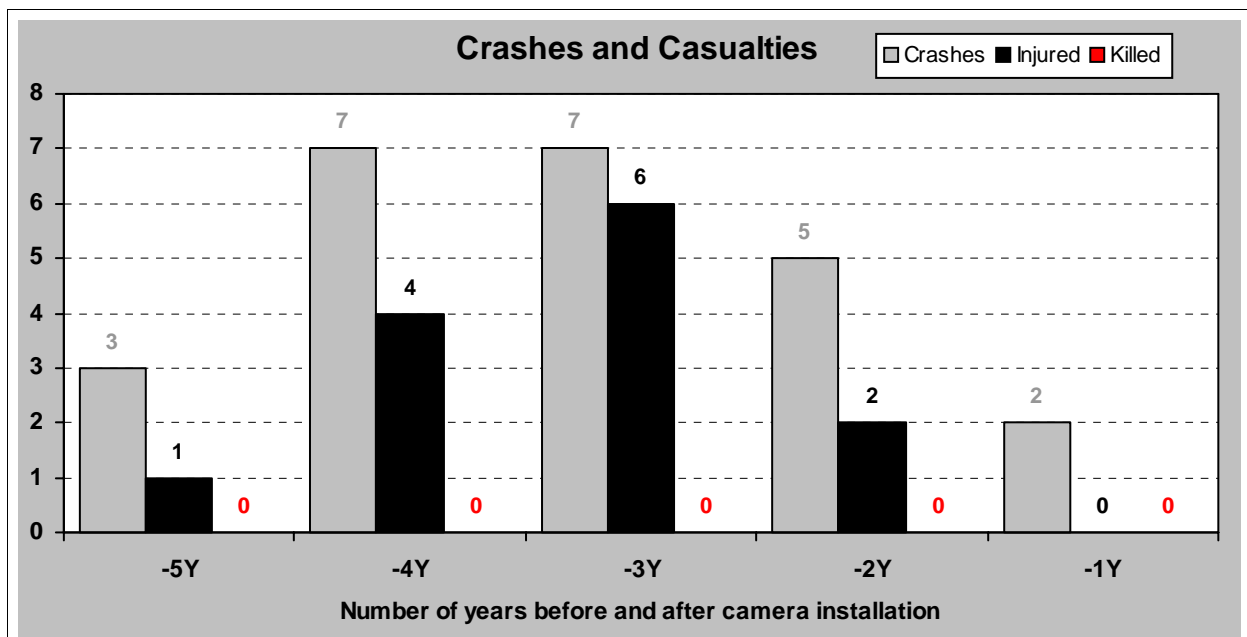
In the 188 day period from installation to the end of 2011, there were 3 crashes resulting in 1 injury and 0 fatalities.

This represents a 21 per cent increase in the yearly average number of crashes and a 25 per cent reduction in the yearly average number of casualties at this intersection in the period after installation until the end of 2011.

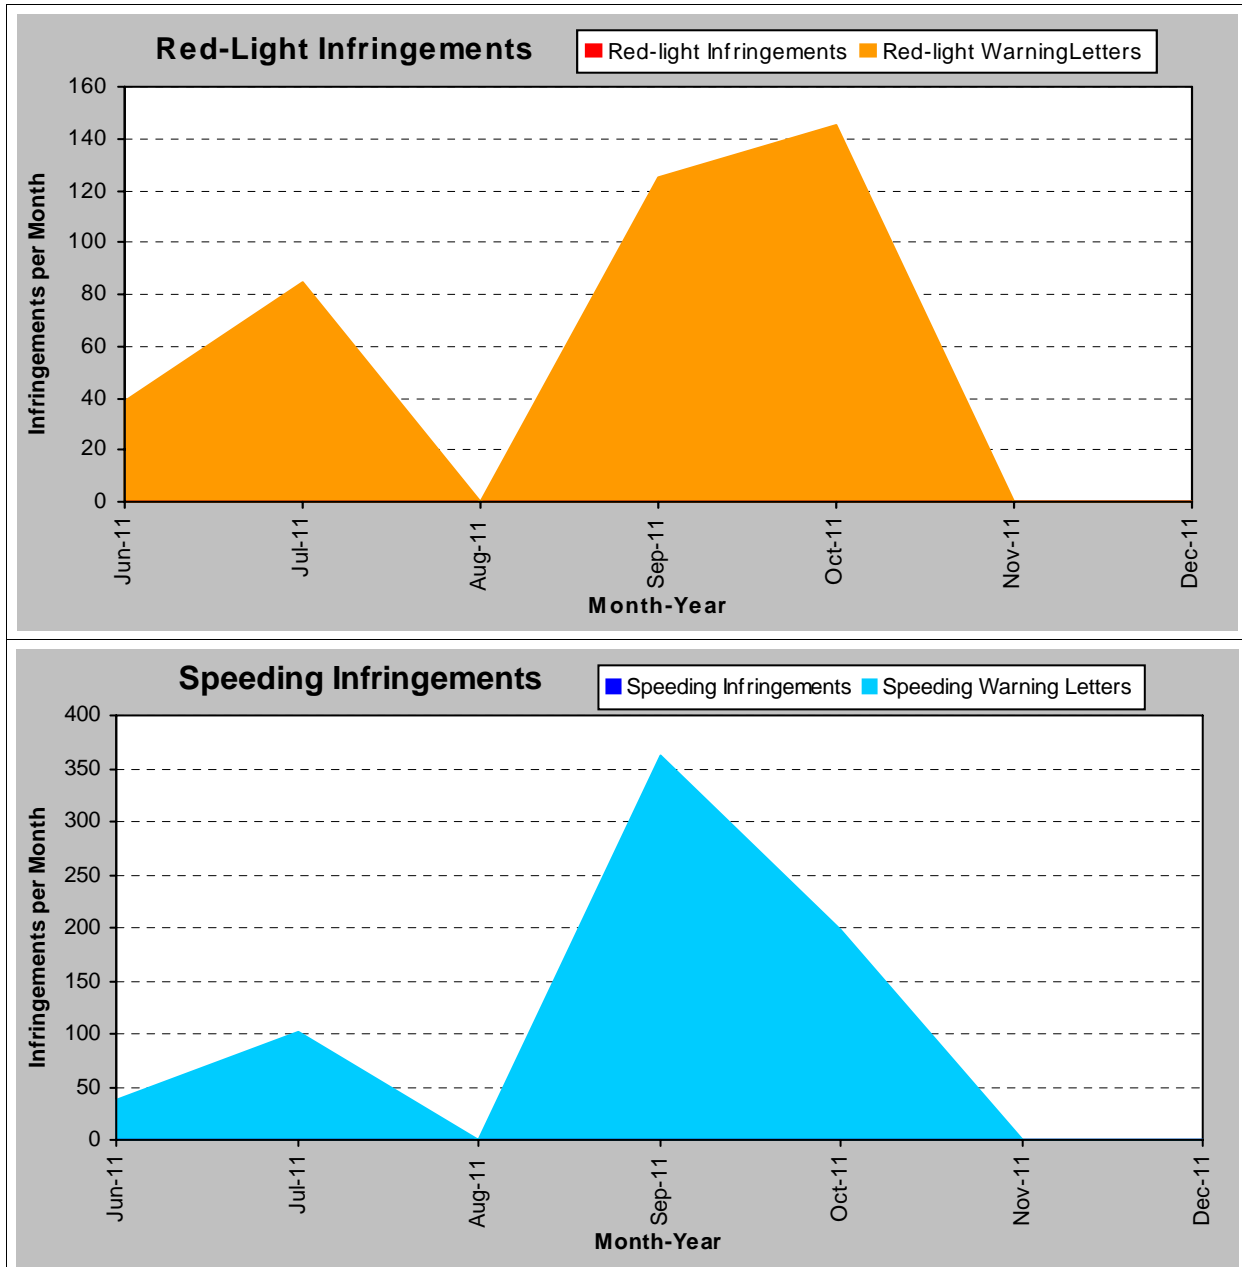
## Infringements at safety camera location

The graph below details the number of warning letters and infringements issued at this intersection since the camera began operating.

Roadworks and camera maintenance may influence the number of infringements issued.

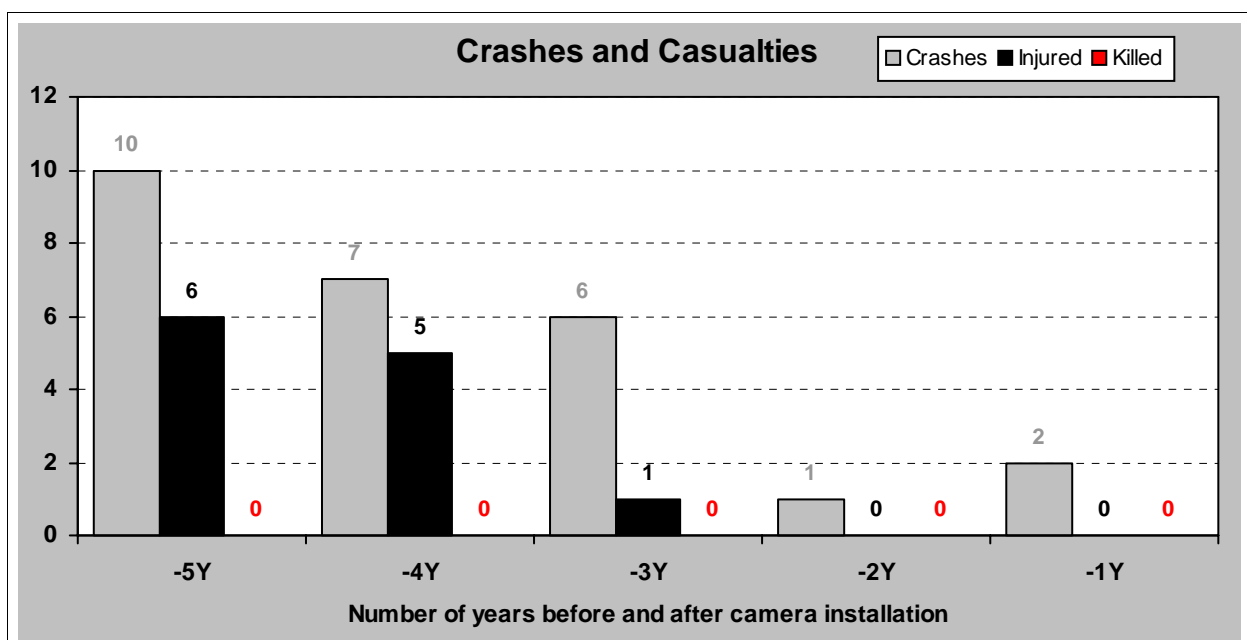
In the 268 day period from installation to the end of 2011, there were 2 crashes resulting in 1 injury and 0 fatalities.

This represents a 48 per cent reduction in the yearly average number of crashes and a 43 per cent reduction in the yearly average number of casualties at this intersection in the period after installation until the end of 2011.

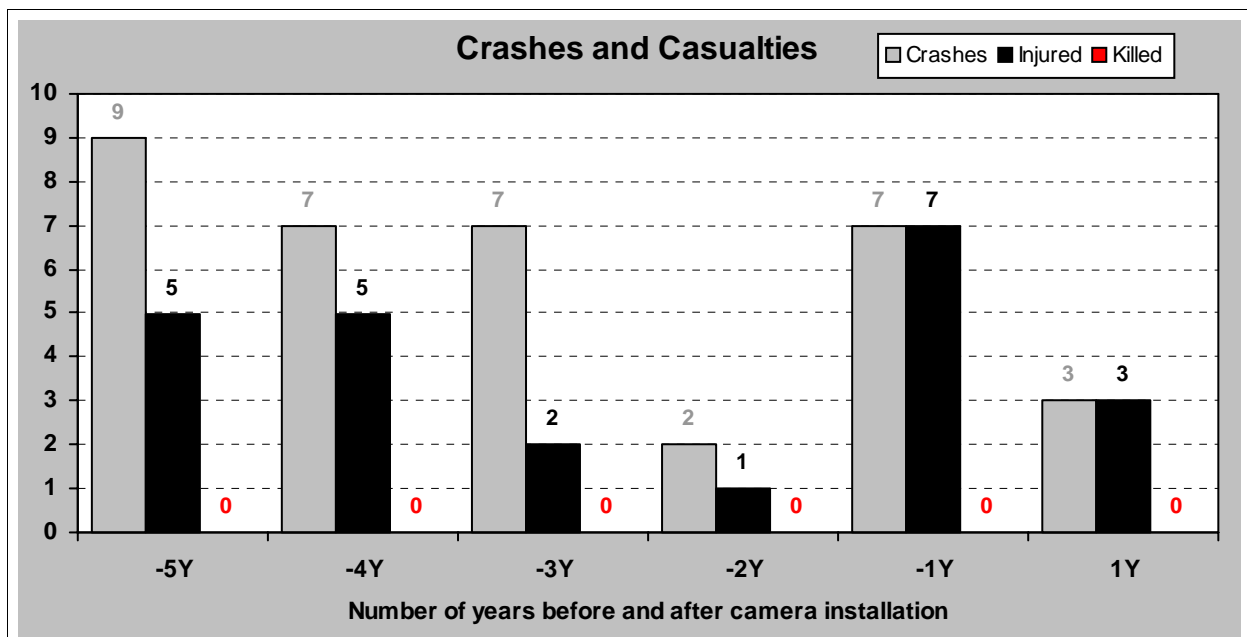
This represents a 36 per cent reduction in the yearly average number of crashes and a 39 per cent reduction in the yearly average number of casualties at this intersection in the period after installation until the end of 2011.

Provisional crash data shows there were 5 crashes resulting in 3 casualties at this intersection in 2011.

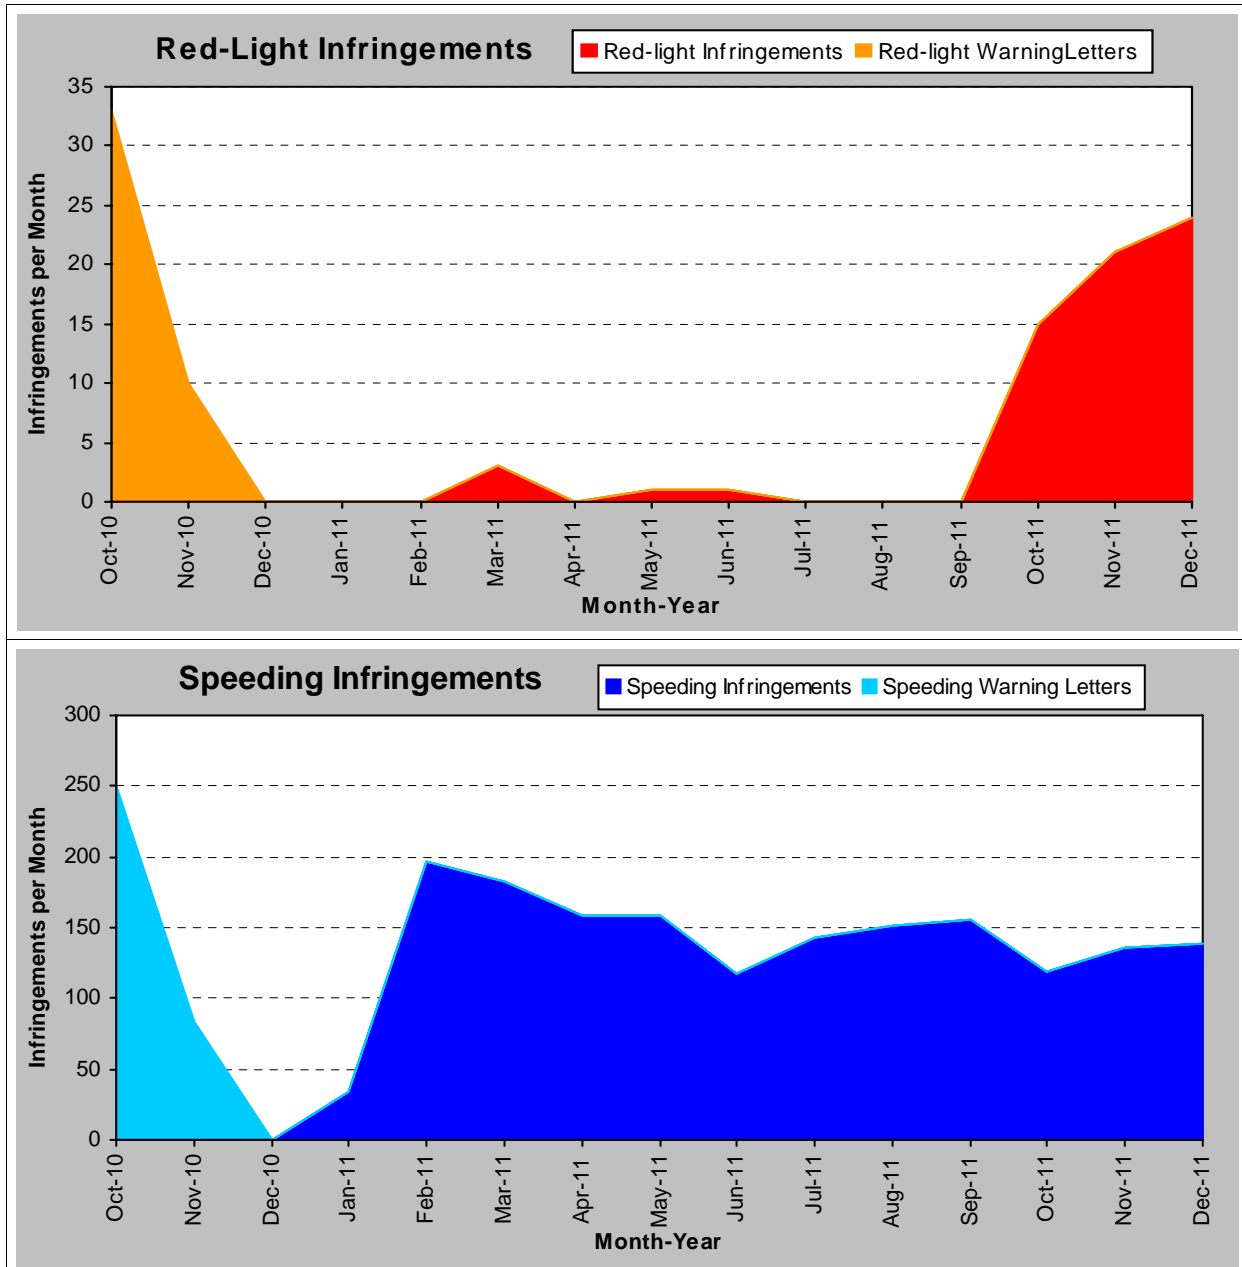
The graph below details the number of warning letters and infringements issued at this intersection since the camera began operating.

Roadworks and camera maintenance may influence the number of infringements issued.

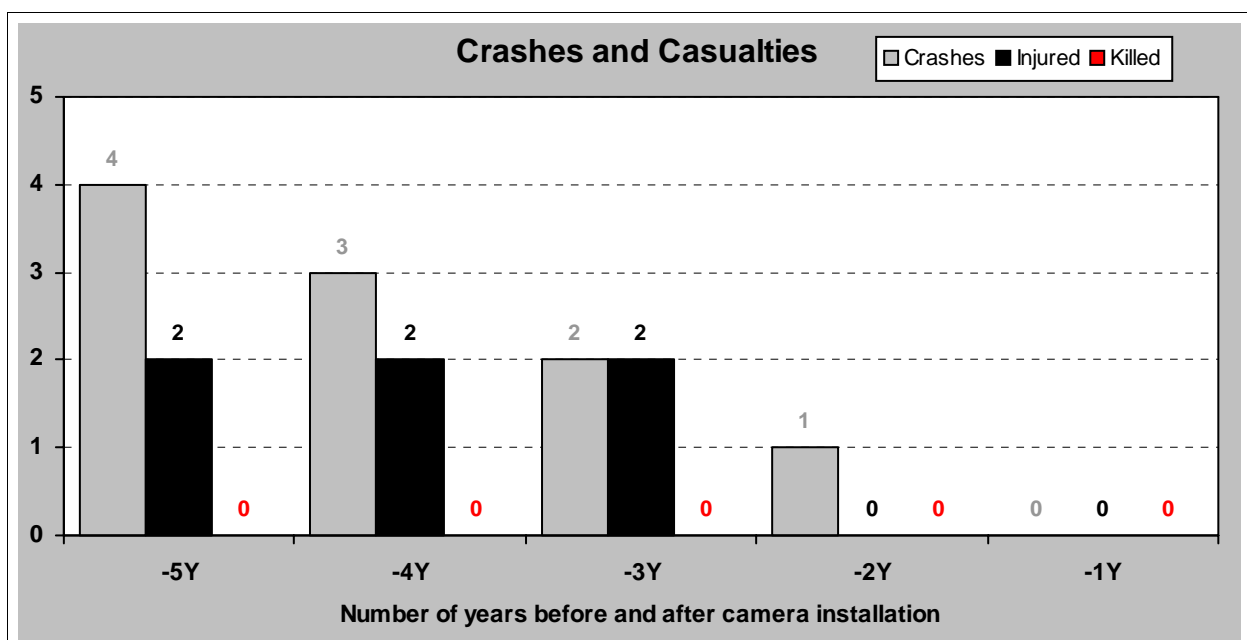
In the 258 day period from installation to the end of 2011, there were 3 crashes resulting in 3 injuries and 0 fatalities.

This represents a 112 per cent increase in the yearly average number of crashes and a 254 per cent increase in the yearly average number of casualties at this intersection in the period after installation until the end of 2011.

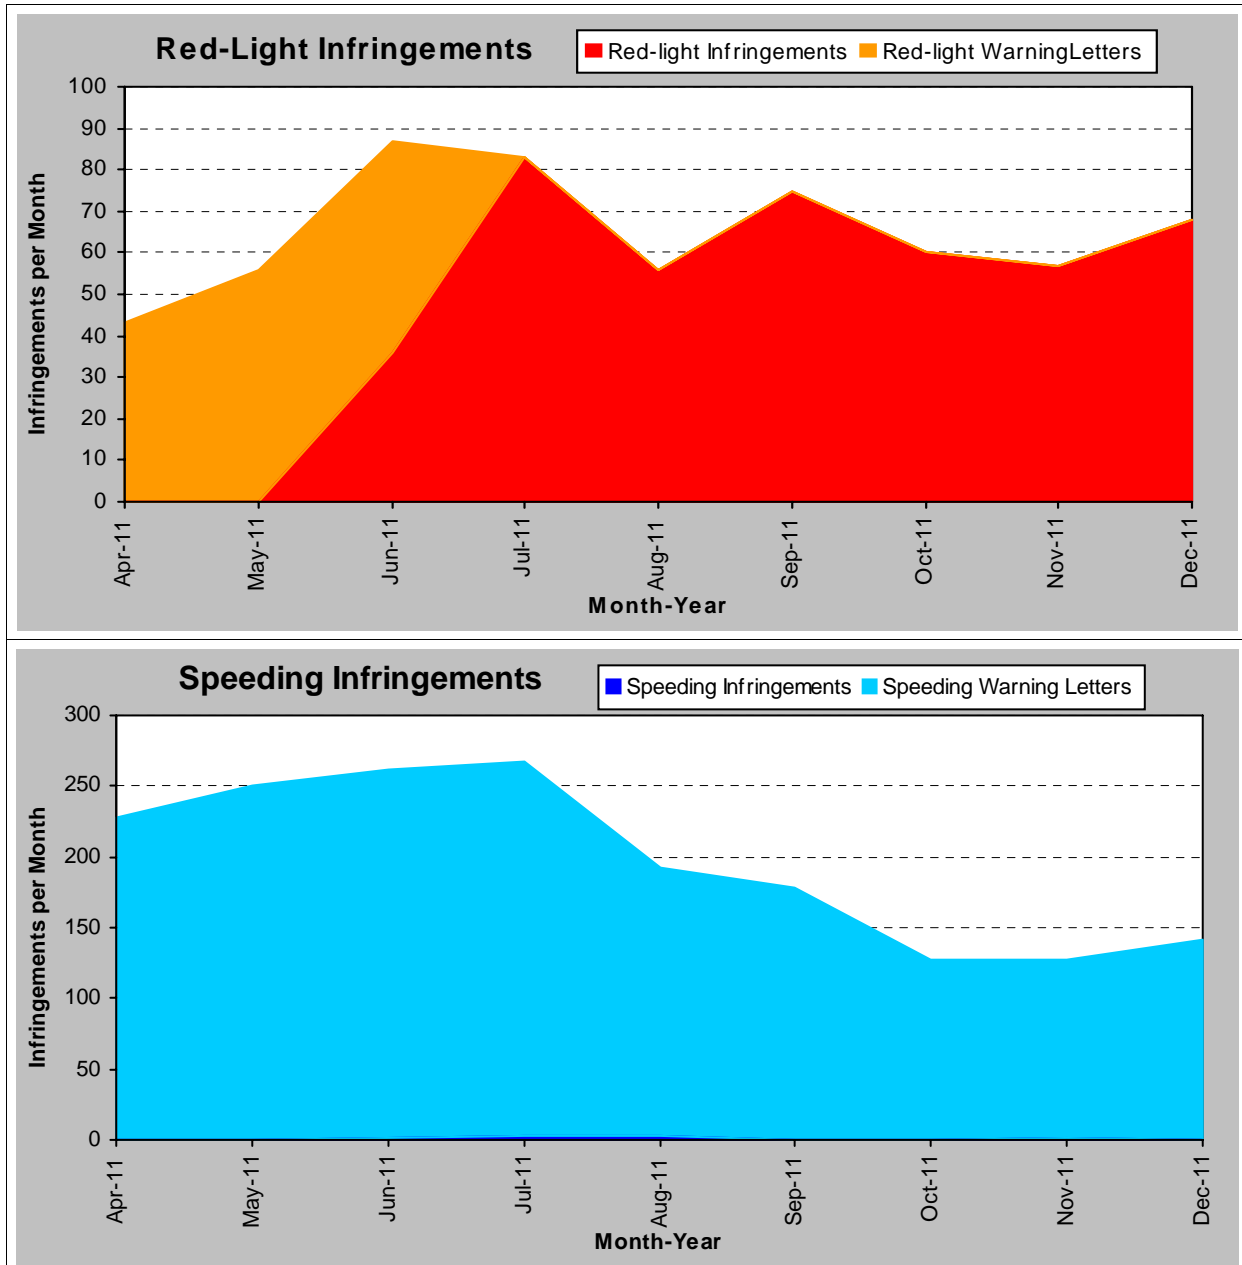
The graph below details the number of warning letters and infringements issued at this intersection since the camera began operating.

Roadworks and camera maintenance may influence the number of infringements issued.
