# ANNUAL NSW SPEED CAMERA PERFORMANCE REVIEW

NSW Centre for Road Safety

JULY 2012

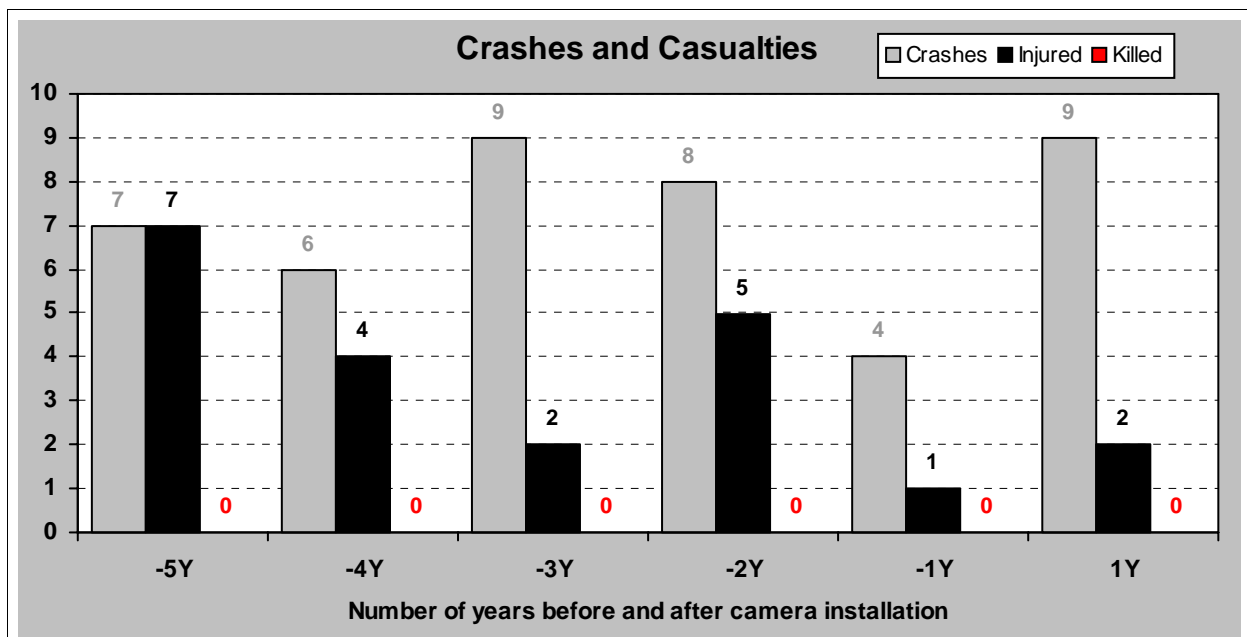
This represents a 29 per cent increase in the yearly average number of crashes and a 54 per cent reduction in the yearly average number of casualties at this intersection in the period after installation until the end of 2011.

Provisional crash data shows there were 8 crashes resulting in 2 casualties at this intersection in 2011.

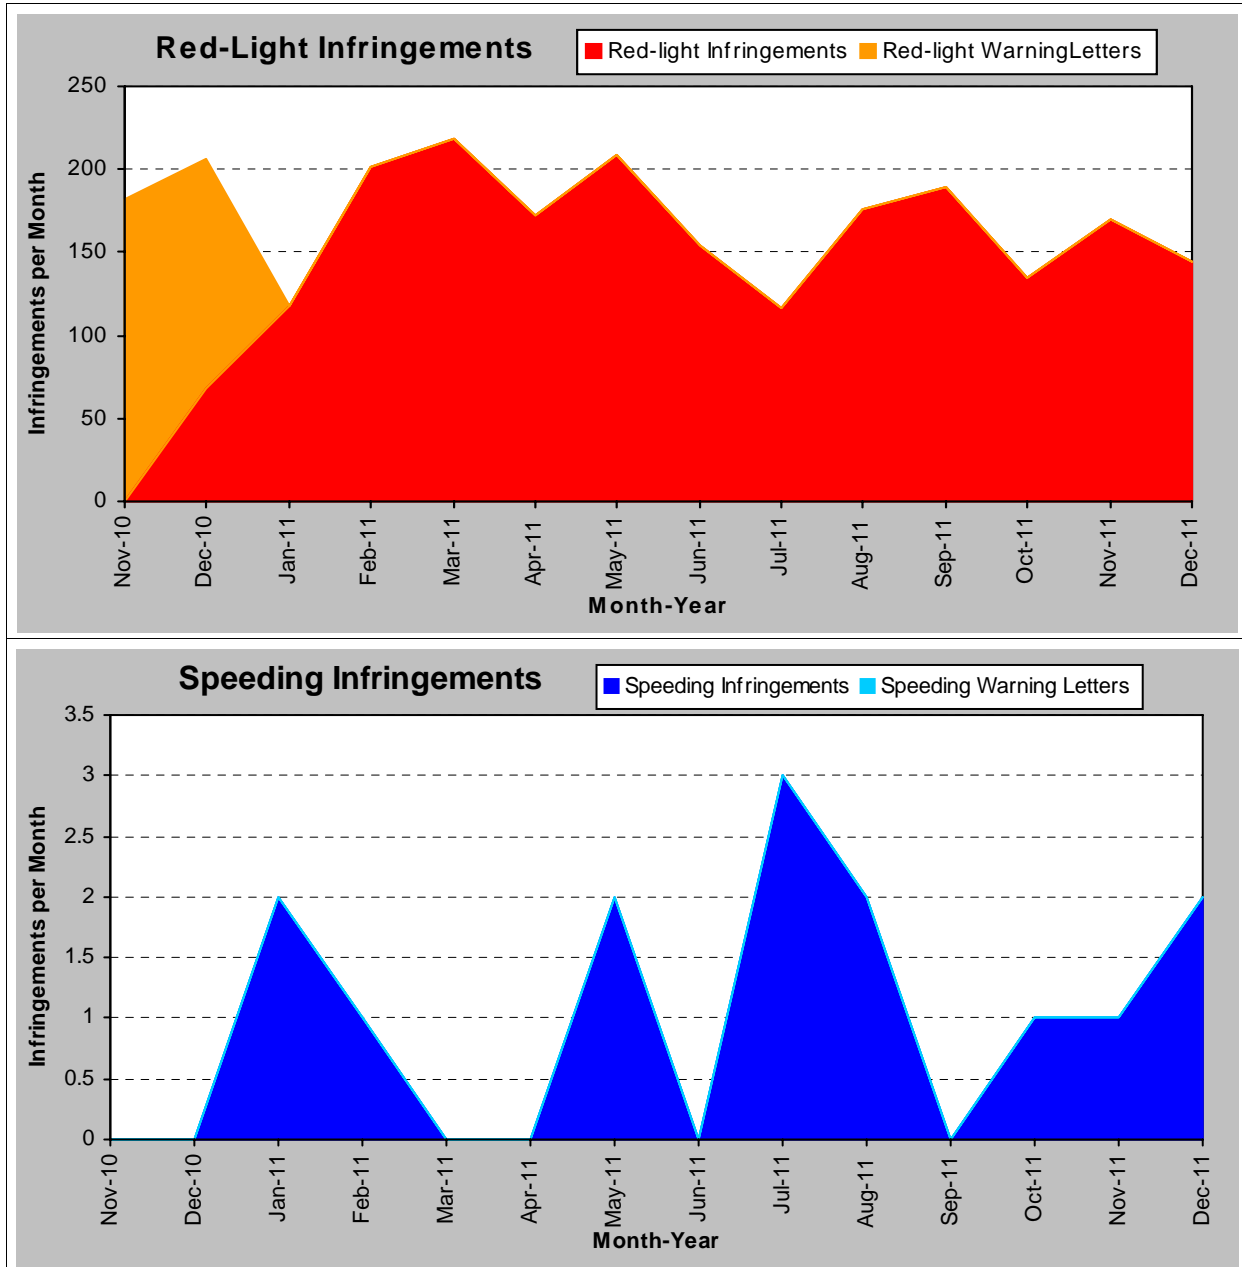
The graph below details the number of warning letters and infringements issued at this intersection since the camera began operating. The graph also shows the trend in infringements at this location.

Roadworks and camera maintenance may influence the number of infringements issued.

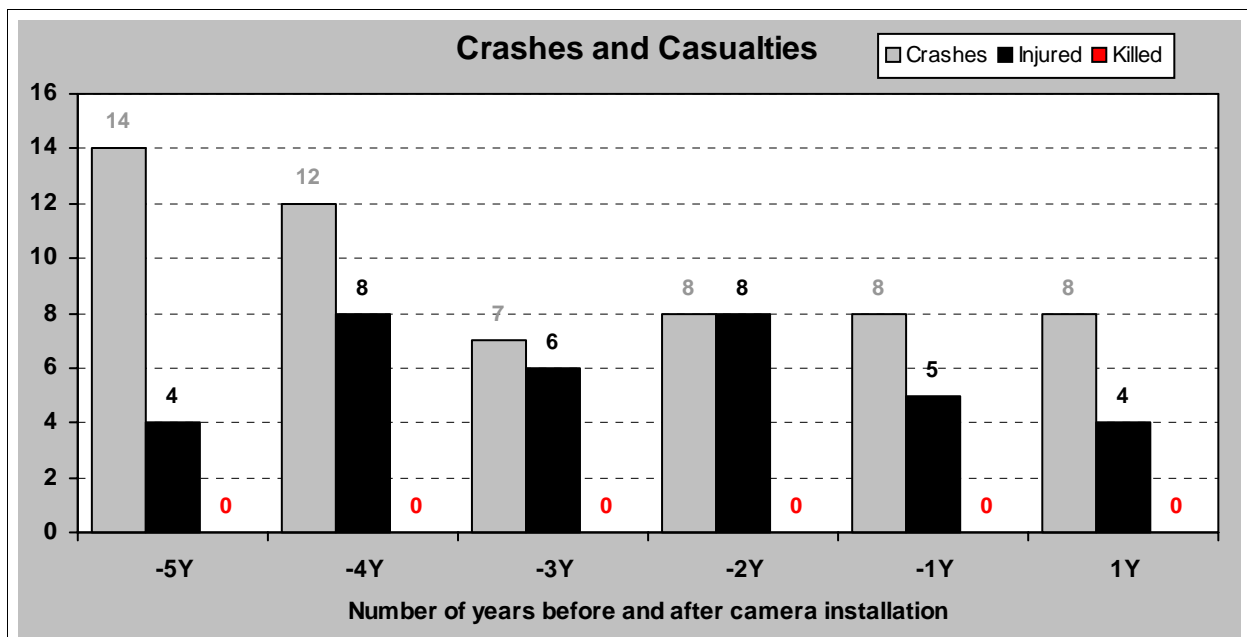
This represents a 1 per cent increase in the yearly average number of crashes and a 2 per cent reduction in the yearly average number of casualties at this intersection in the period after installation until the end of 2011.

Provisional crash data shows there were 8 crashes resulting in 5 casualties at this intersection in 2011.

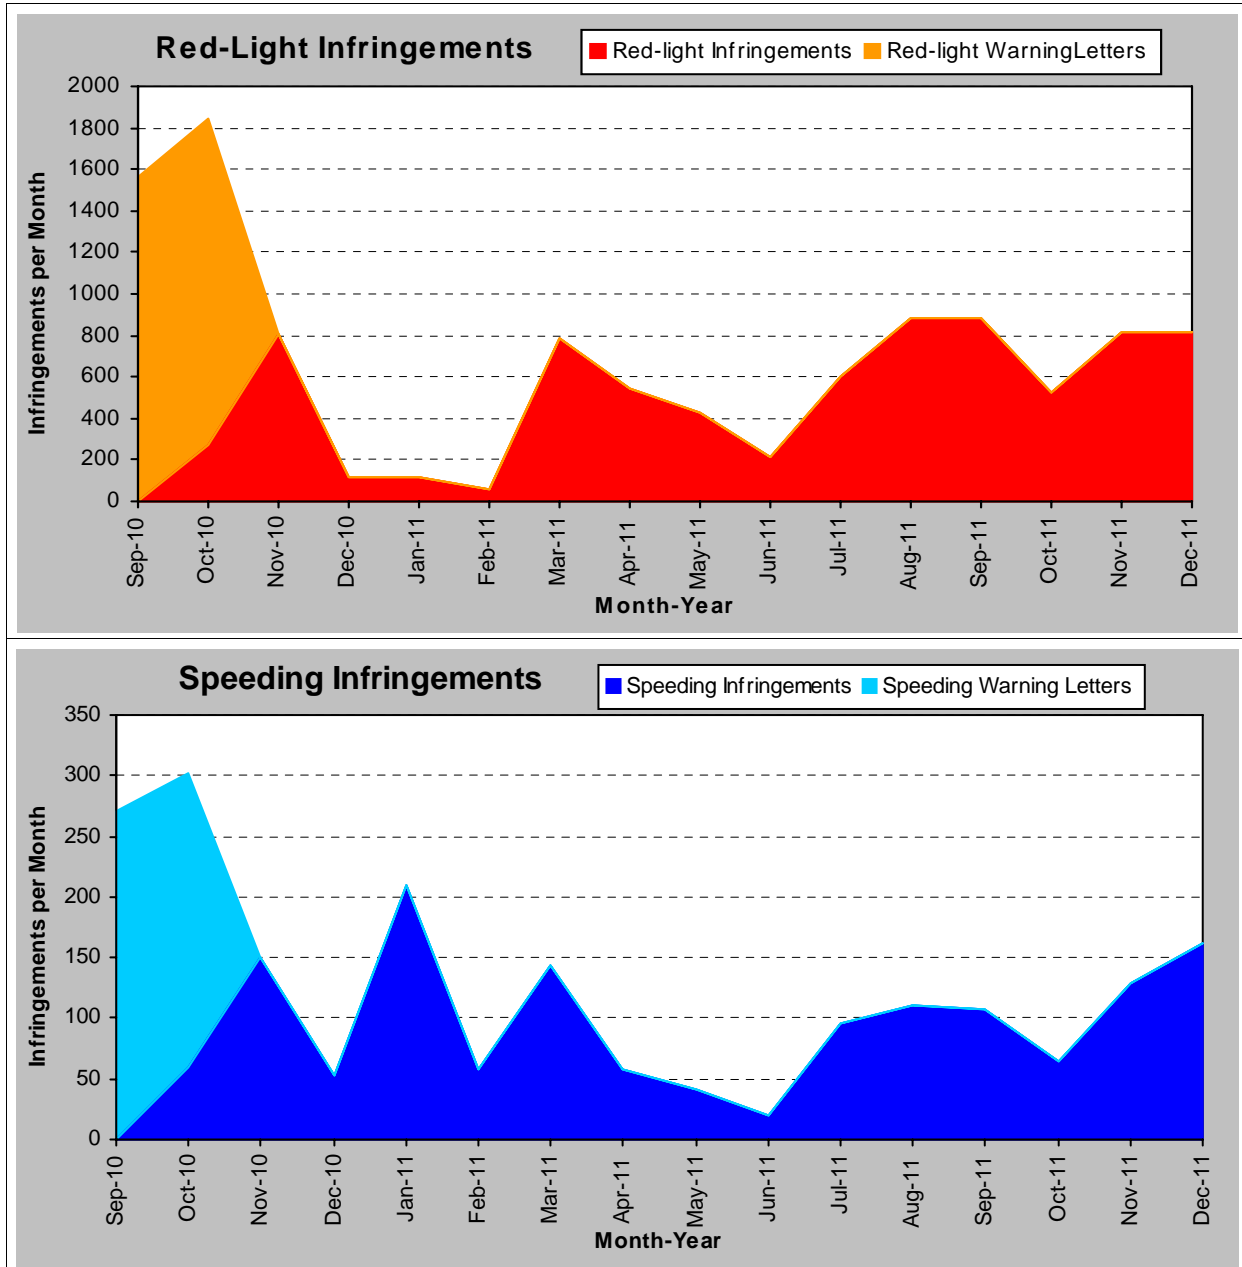
The graph below details the number of warning letters and infringements issued at this intersection since the camera began operating. The graph also shows the trend in infringements at this location.

Roadworks and camera maintenance may influence the number of infringements issued.

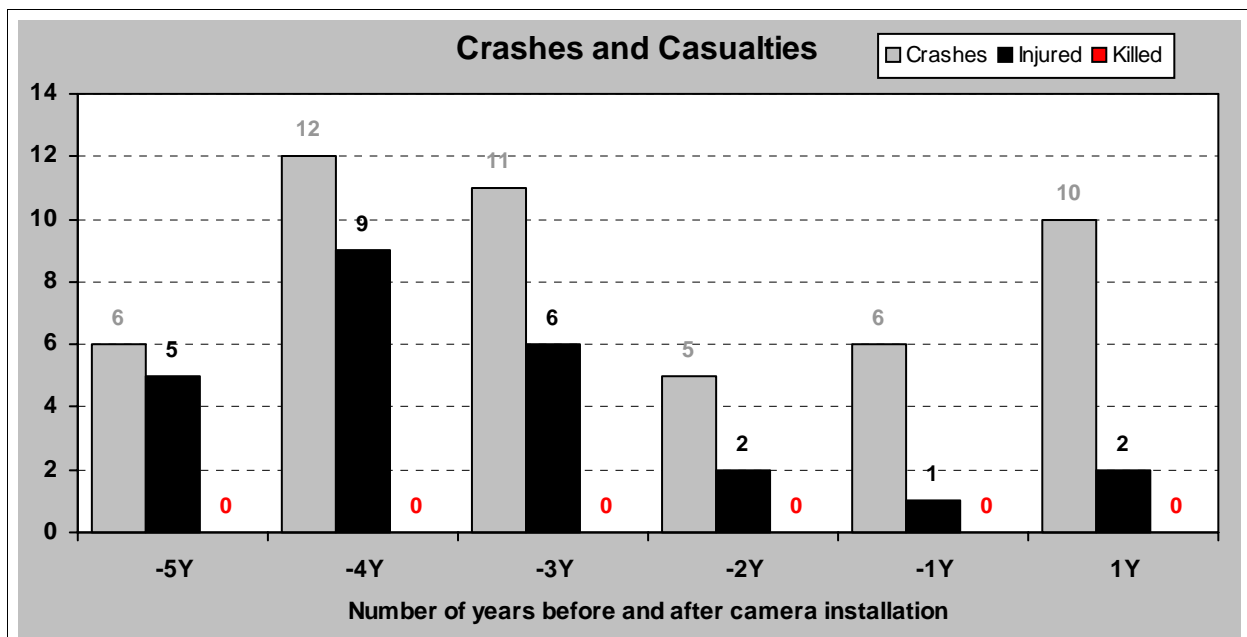
This represents a 10 per cent increase in the yearly average number of crashes and a 62 per cent reduction in the yearly average number of casualties at this intersection in the period after installation until the end of 2011.

Provisional crash data shows there were 8 crashes resulting in 2 casualties at this intersection in 2011.

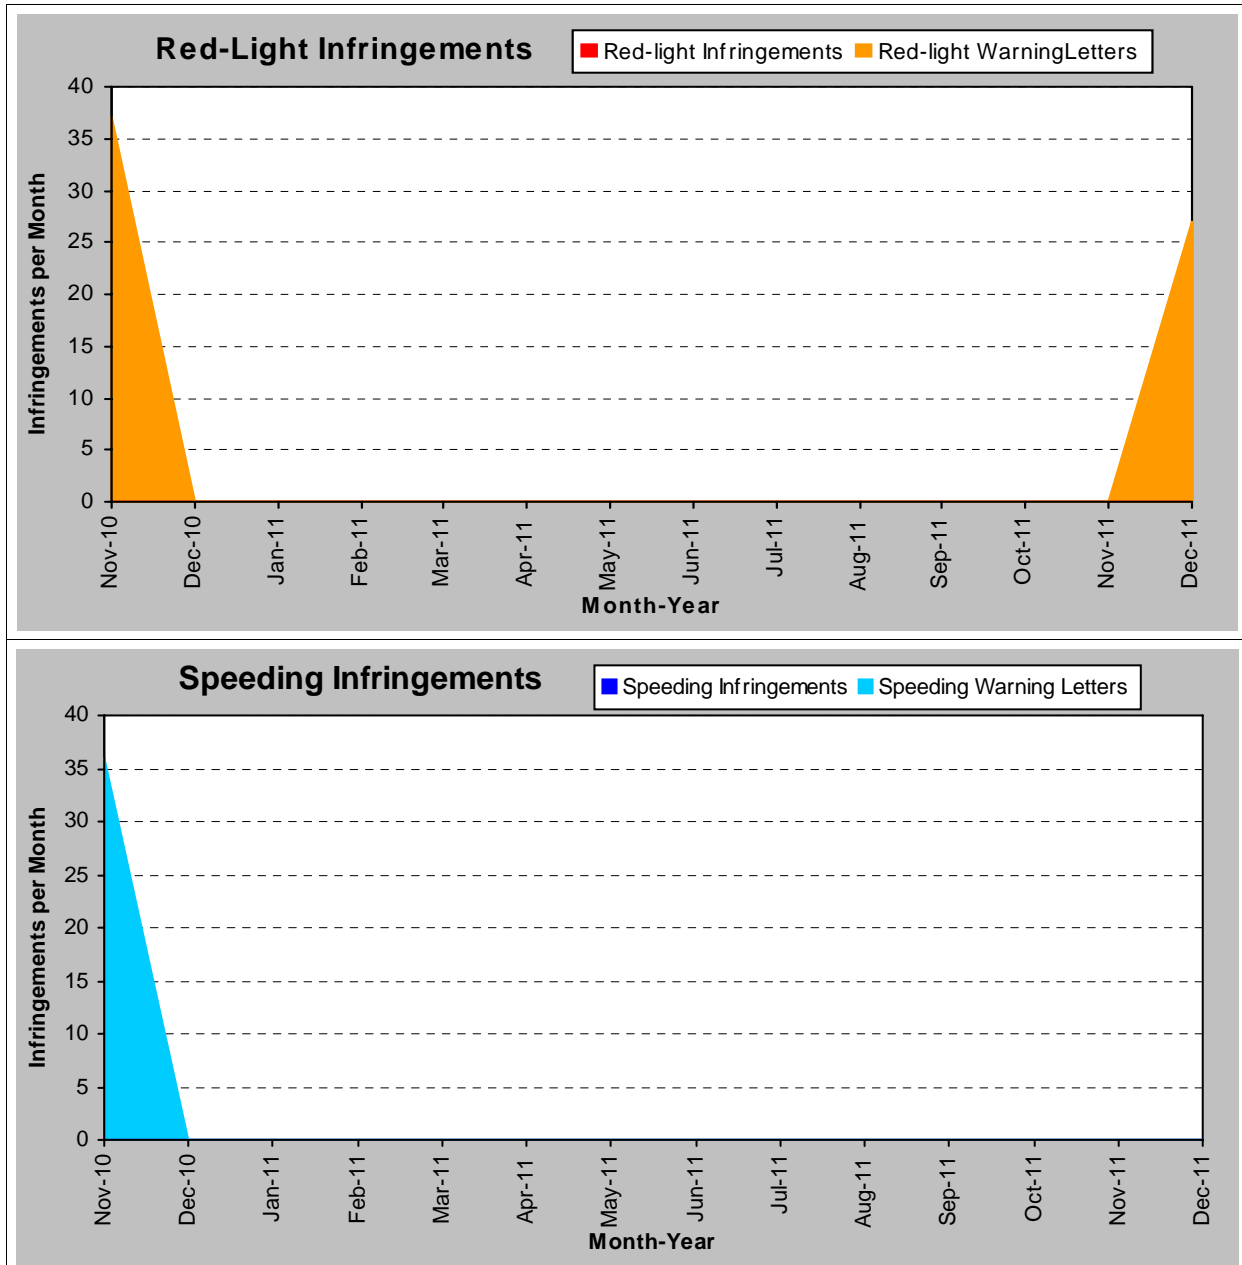
The graph below details the number of warning letters and infringements issued at this intersection since the camera began operating.

Roadworks and camera maintenance may influence the number of infringements issued.

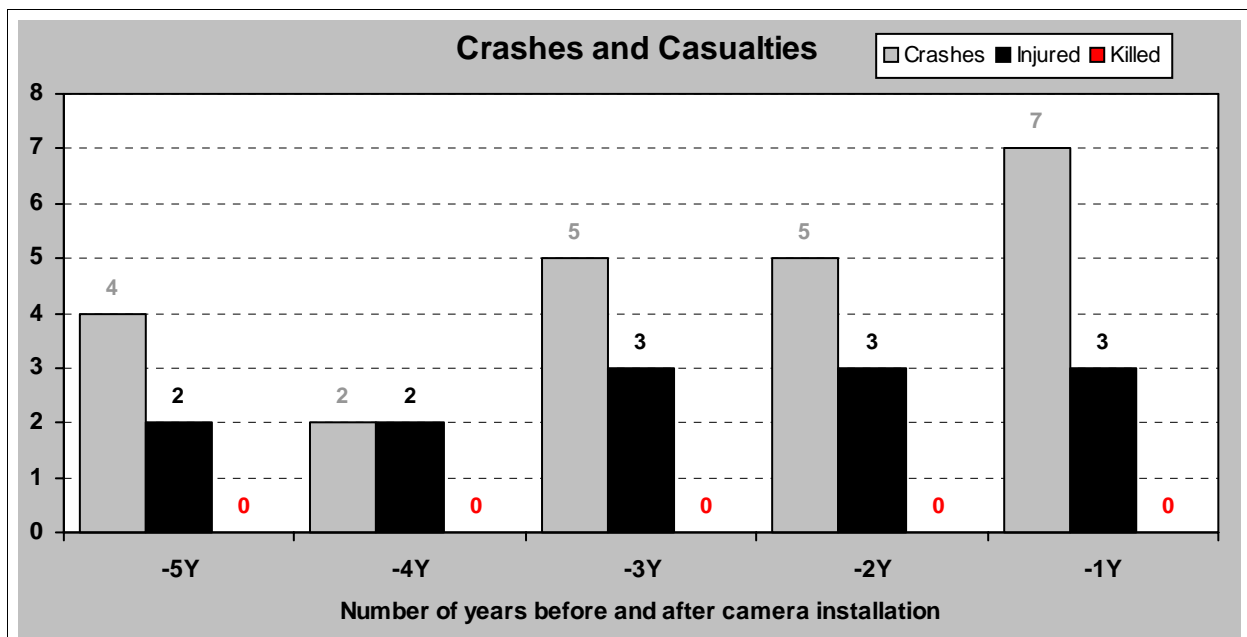
In the 200 day period from installation to the end of 2011, there were 8 crashes resulting in 4 injuries and 0 fatalities.

This represents a 218 per cent increase in the yearly average number of crashes and a 181 per cent increase in the yearly average number of casualties at this intersection in the period after installation until the end of 2011.

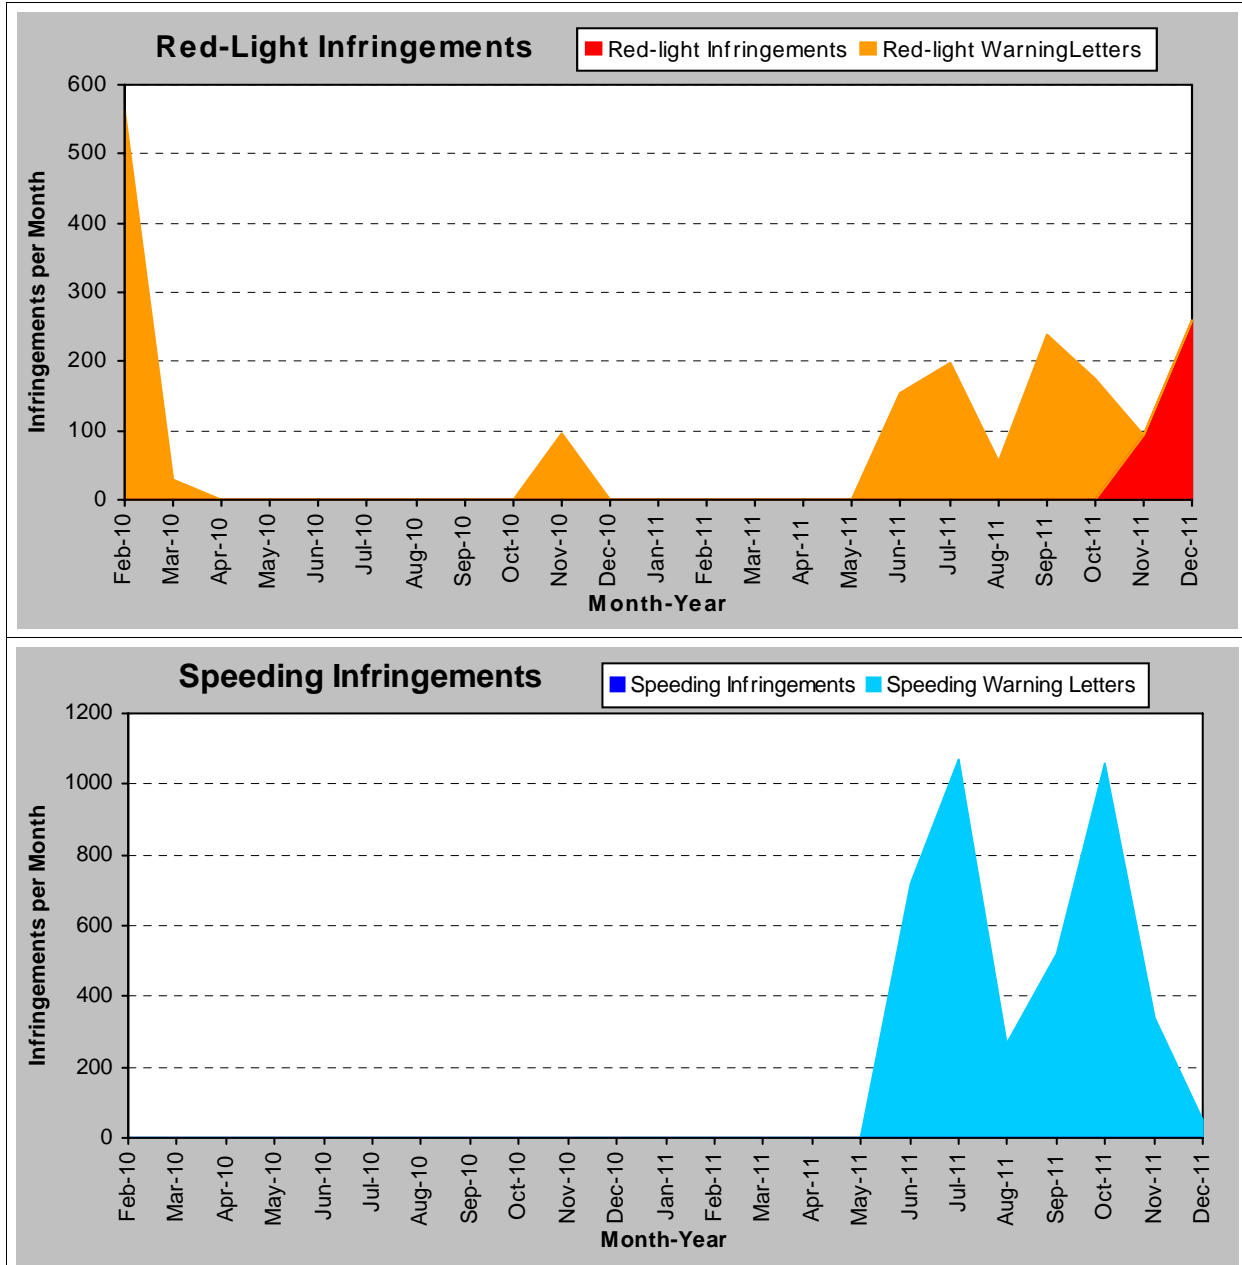
The graph below details the number of warning letters and infringements issued at this intersection since the camera began operating.

Roadworks and camera maintenance may influence the number of infringements issued.

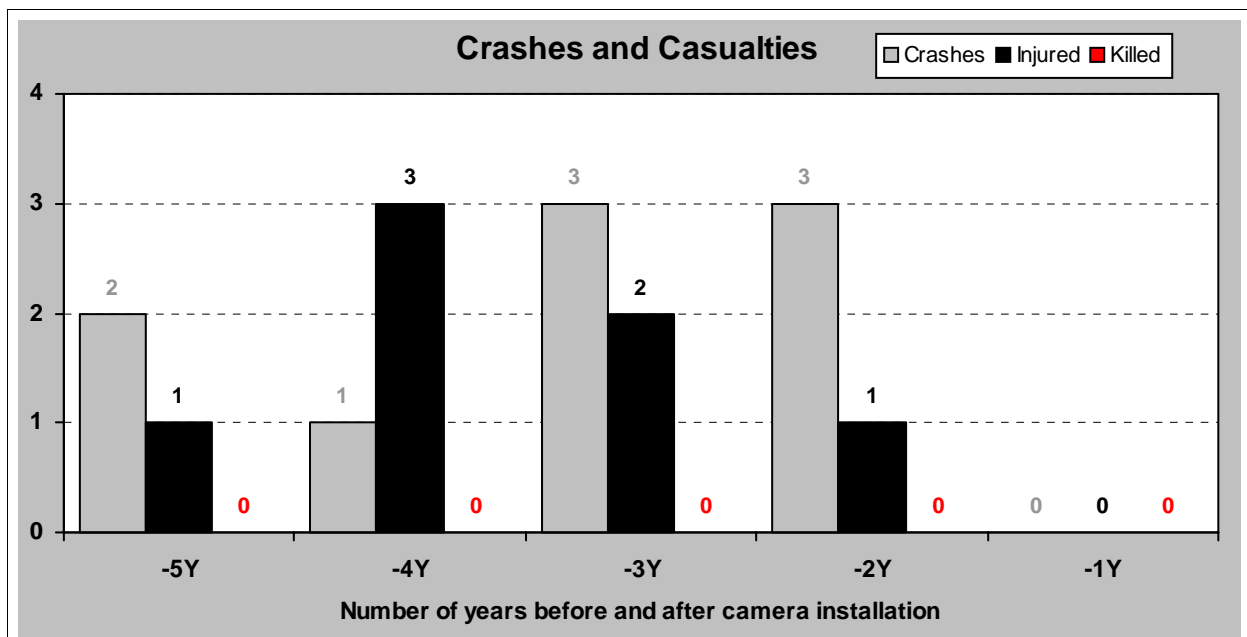
In the 188 day period from installation to the end of 2011, there were 0 crashes resulting in 0 injuries and 0 fatalities.

This represents a 100 per cent reduction in the yearly average number of crashes and a 100 per cent reduction in the yearly average number of casualties at this intersection in the period after installation until the end of 2011.

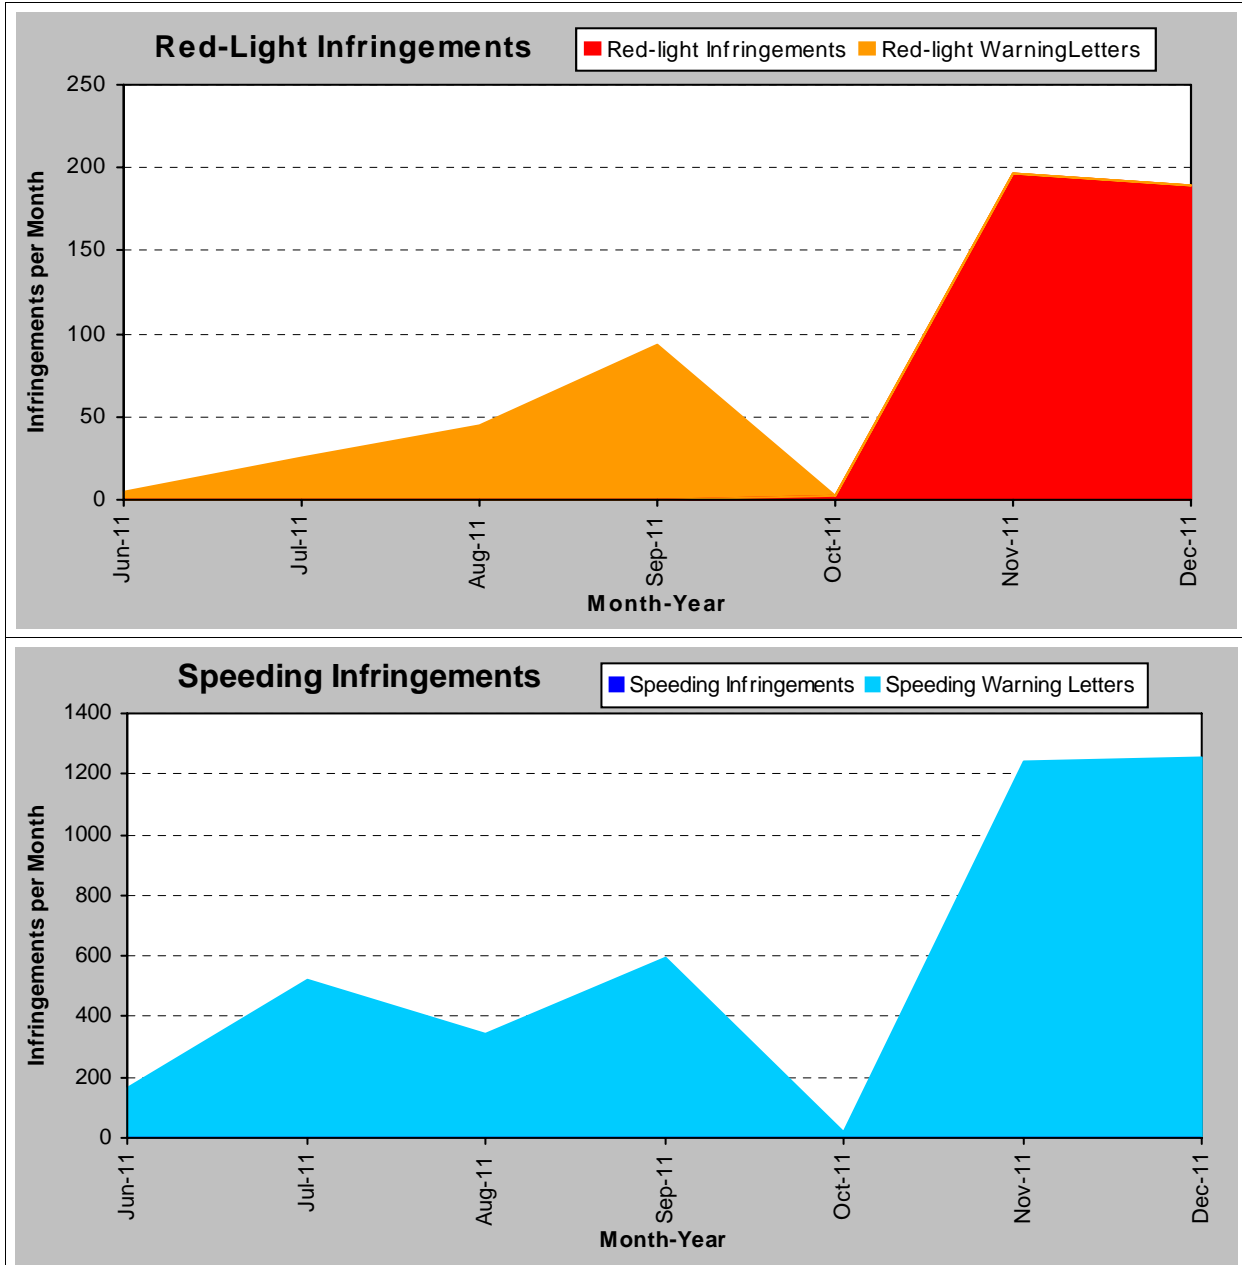
The graph below details the number of warning letters and infringements issued at this intersection since the camera began operating.

Roadworks and camera maintenance may influence the number of infringements issued.

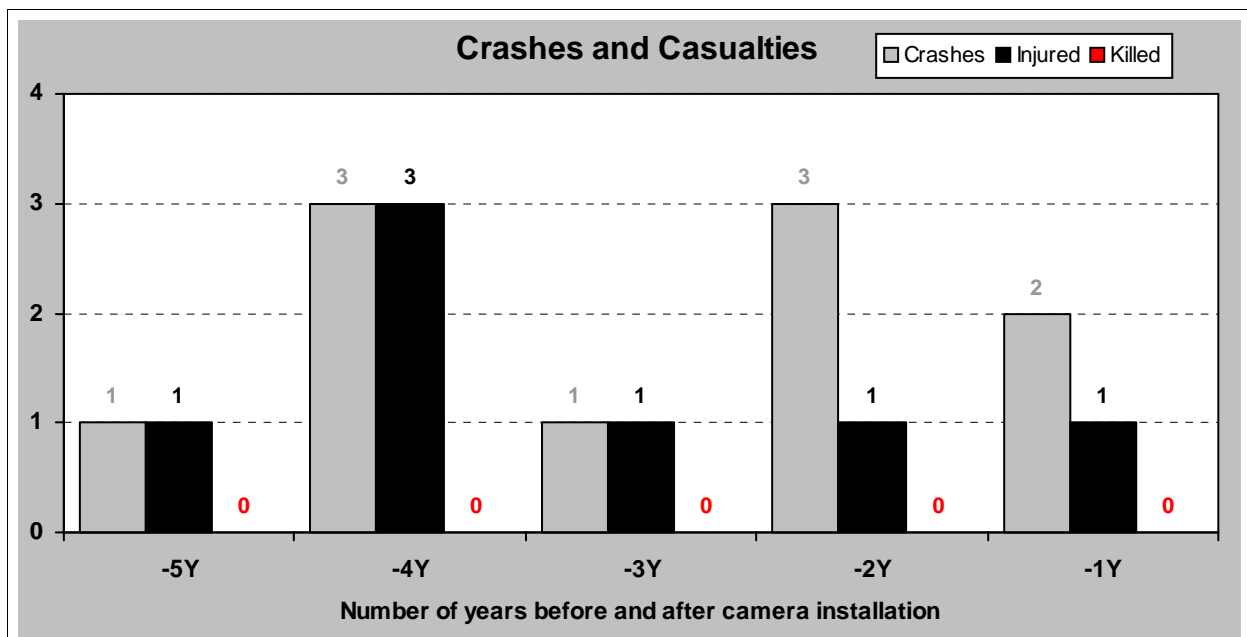
In the 188 day period from installation to the end of 2011, there were 0 crashes resulting in 0 injuries and 0 fatalities.

This represents a 100 per cent reduction in the yearly average number of crashes and a 100 per cent reduction in the yearly average number of casualties at this intersection in the period after installation until the end of 2011.

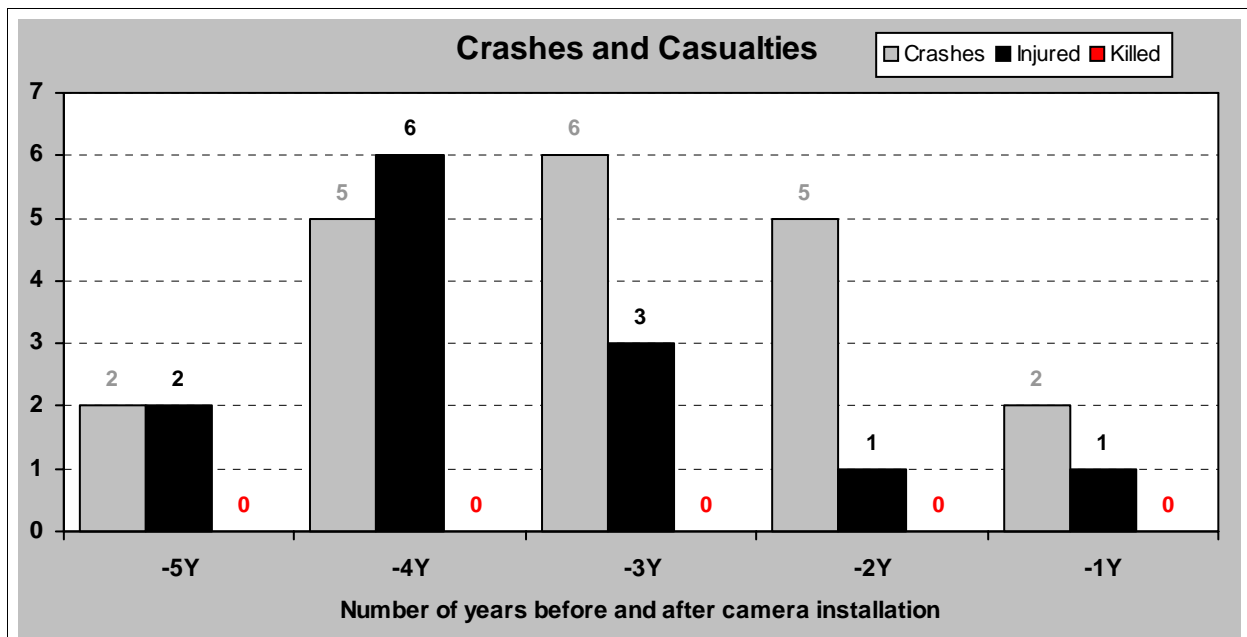
In the 186 day period from installation to the end of 2011, there were 2 crashes resulting in 5 injuries and 0 fatalities.

This represents a 2 per cent reduction in the yearly average number of crashes and a 278 per cent increase in the yearly average number of casualties at this intersection in the period after installation until the end of 2011.

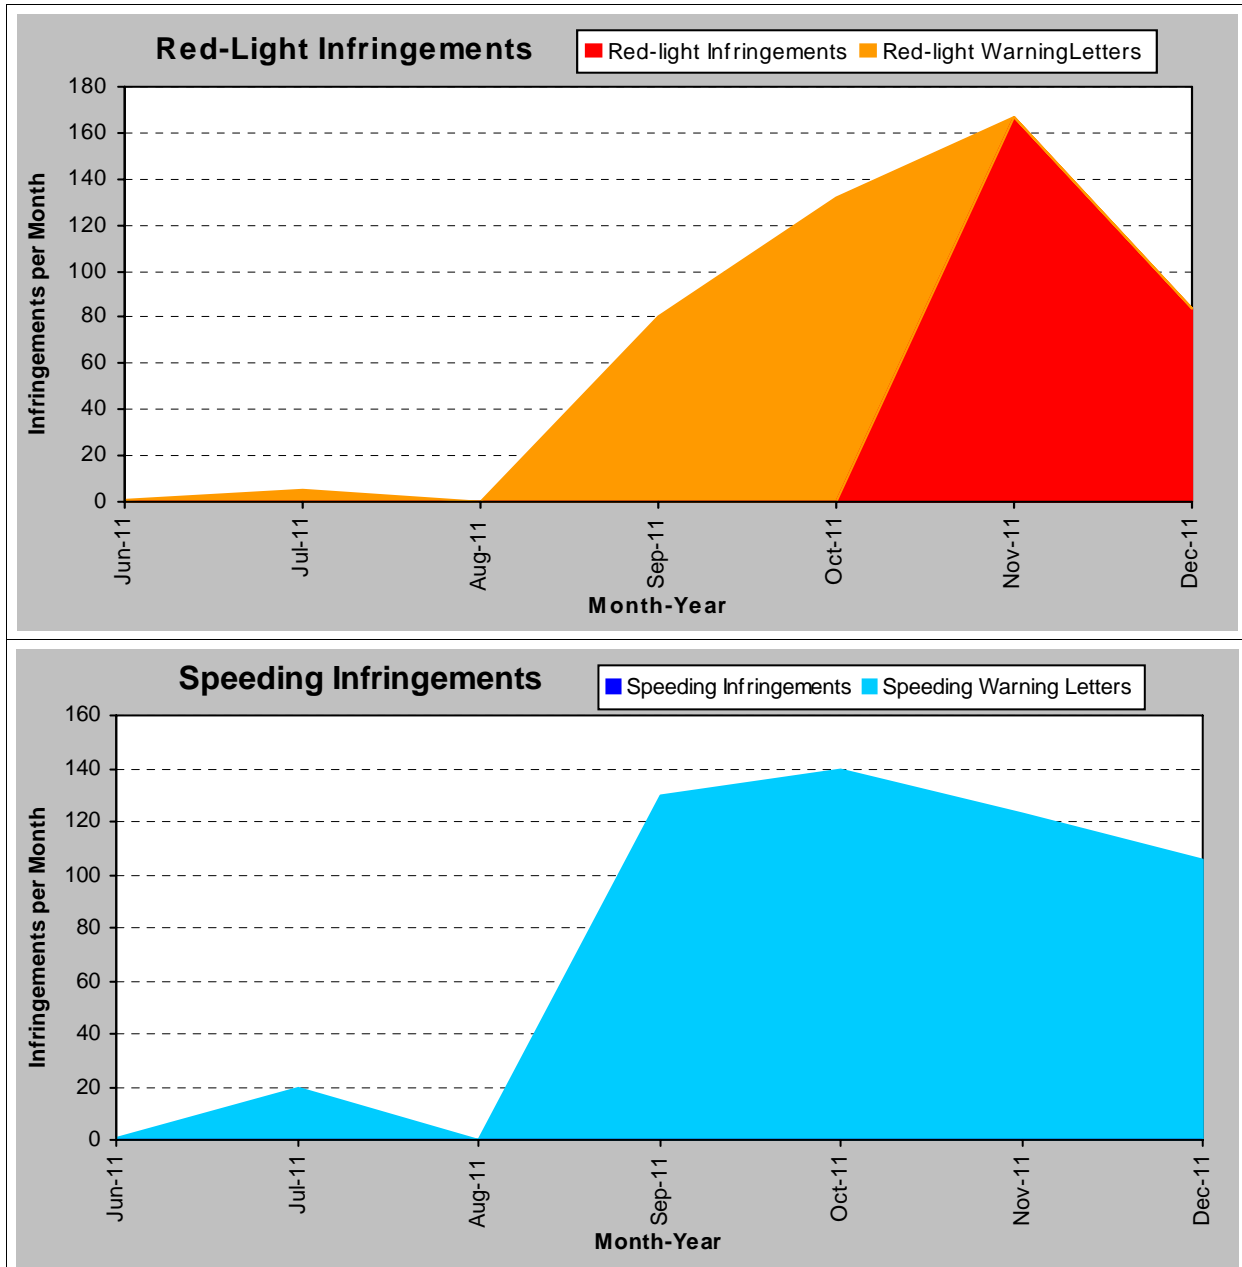
The graph below details the number of warning letters and infringements issued at this intersection since the camera began operating.

Roadworks and camera maintenance may influence the number of infringements issued.

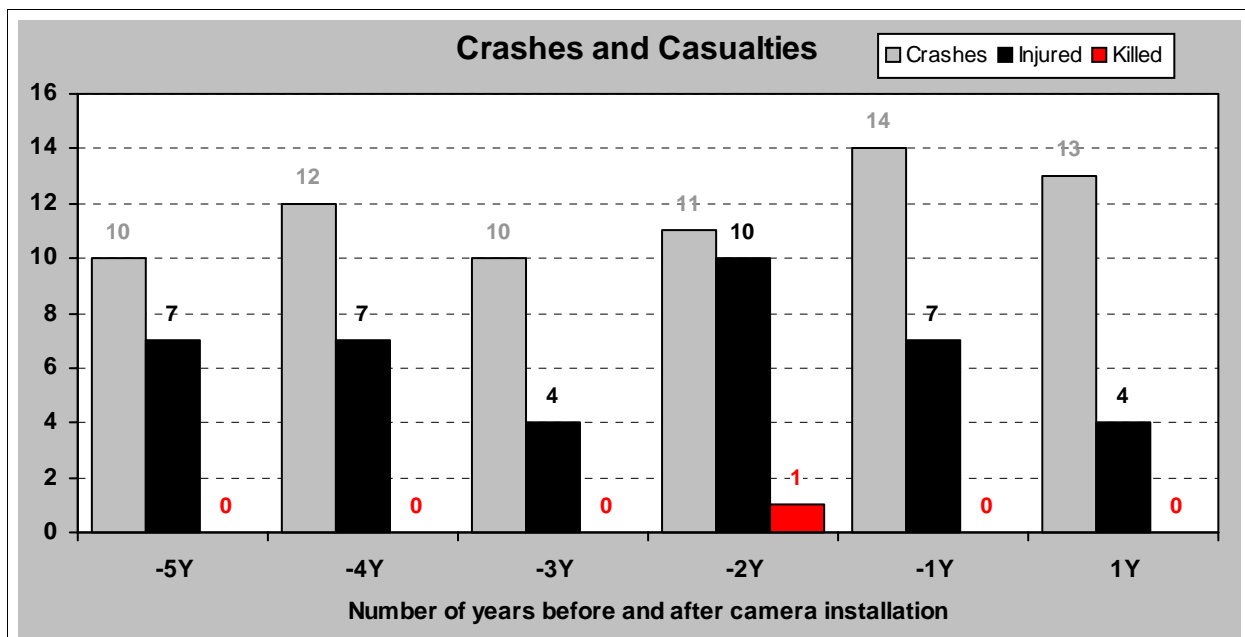
This represents a 19 per cent increase in the yearly average number of crashes and a 29 per cent reduction in the yearly average number of casualties at this intersection in the period after installation until the end of 2011.

Provisional crash data shows there were 14 crashes resulting in 6 casualties at this intersection in 2011.

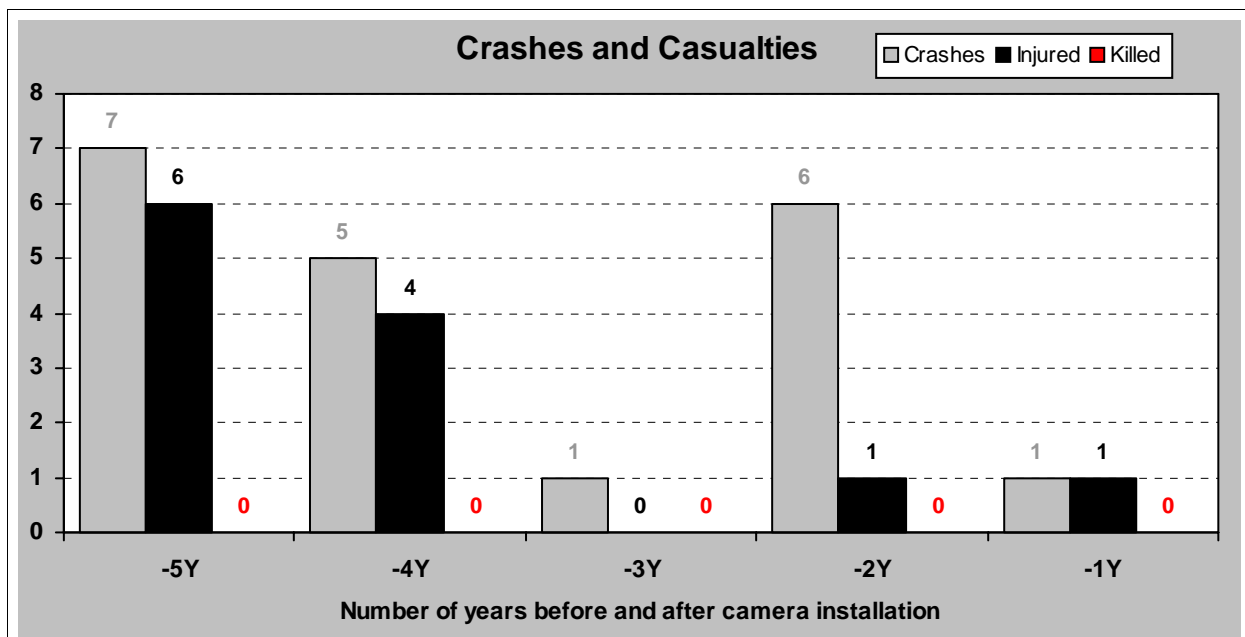
In the 289 day period from installation to the end of 2011, there were 3 crashes resulting in 3 injuries and 0 fatalities.

This represents a 5 per cent reduction in the yearly average number of crashes and a 58 per cent increase in the yearly average number of casualties at this intersection in the period after installation until the end of 2011.

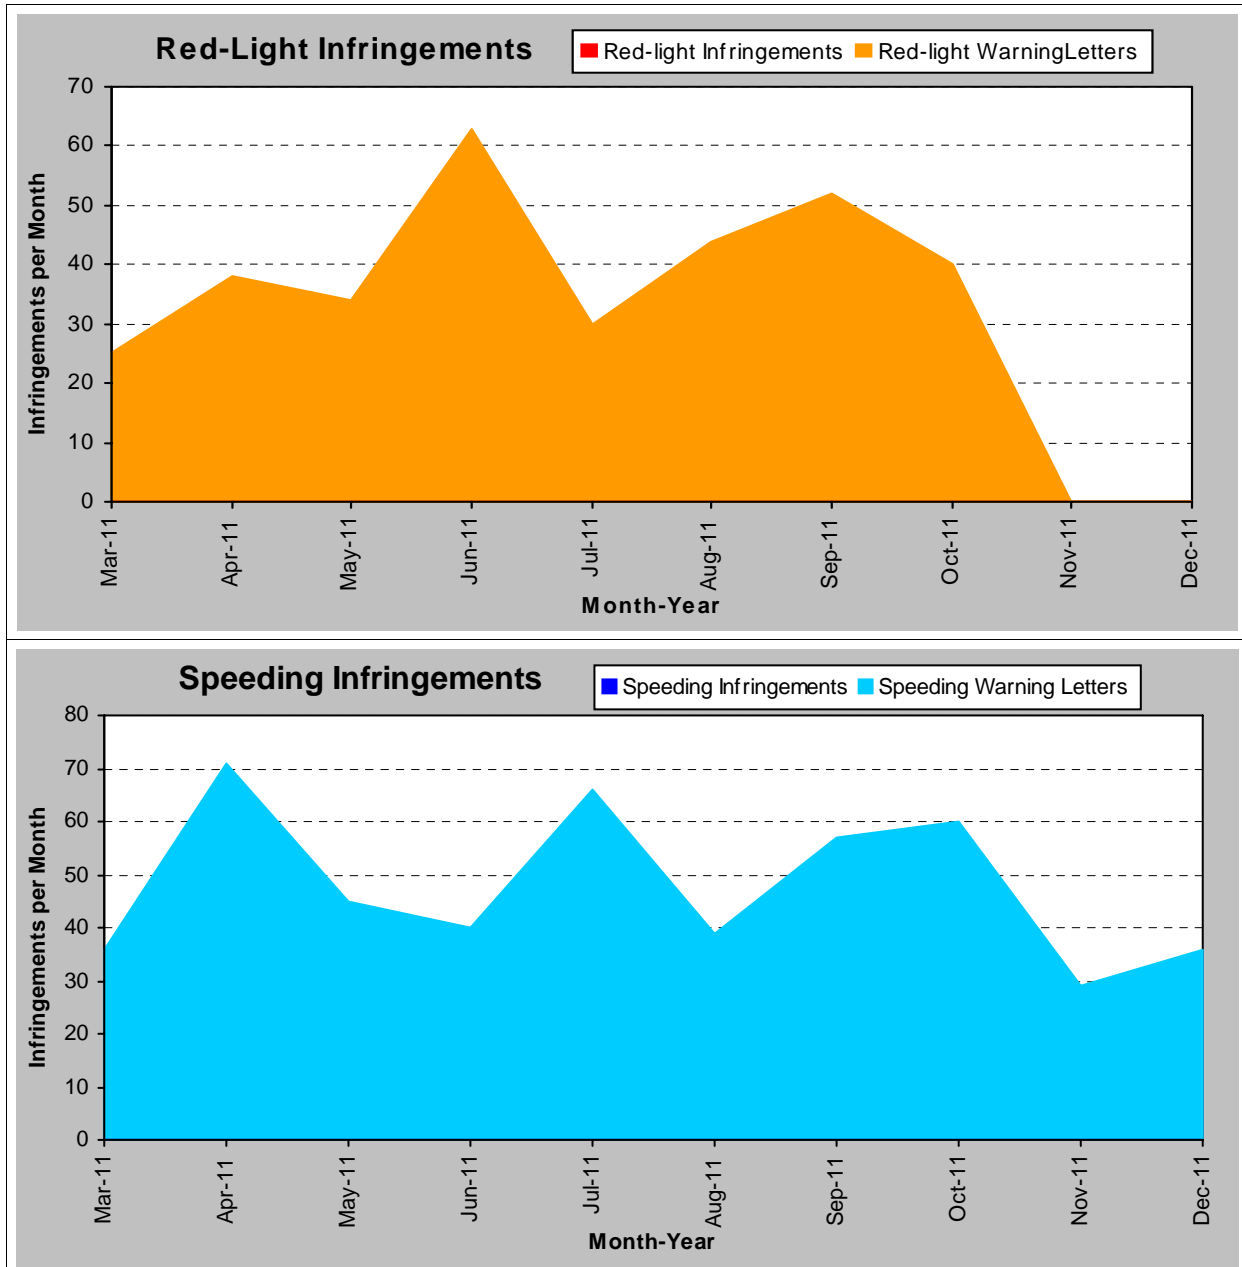
The graph below details the number of warning letters and infringements issued at this intersection since the camera began operating.

Roadworks and camera maintenance may influence the number of infringements issued.

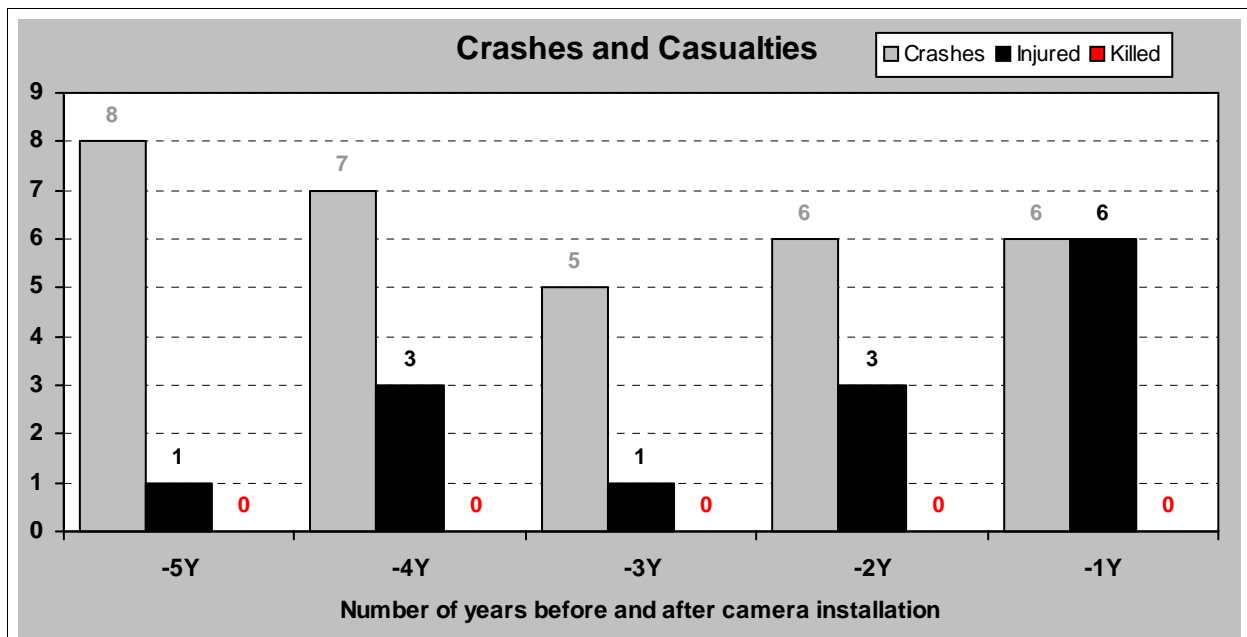
In the 186 day period from installation to the end of 2011, there was 1 crash resulting in 1 injury and 0 fatalities.

This represents a 69 per cent reduction in the yearly average number of crashes and a 30 per cent reduction in the yearly average number of casualties at this intersection in the period after installation until the end of 2011.

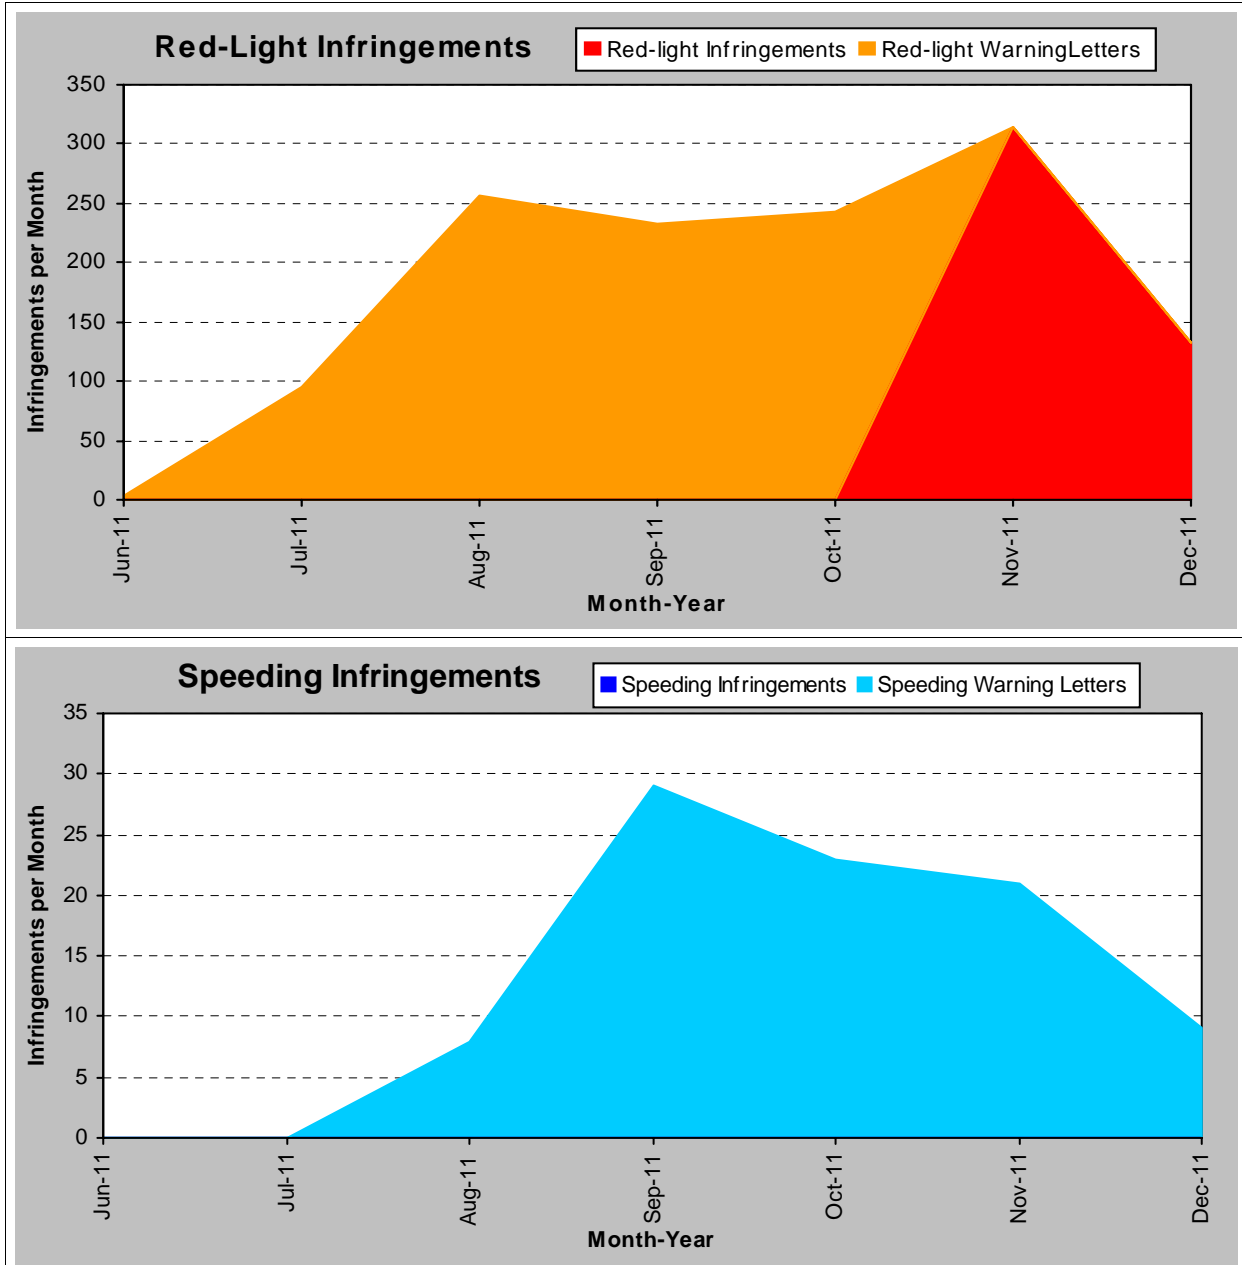
The graph below details the number of warning letters and infringements issued at this intersection since the camera began operating.

Roadworks and camera maintenance may influence the number of infringements issued.

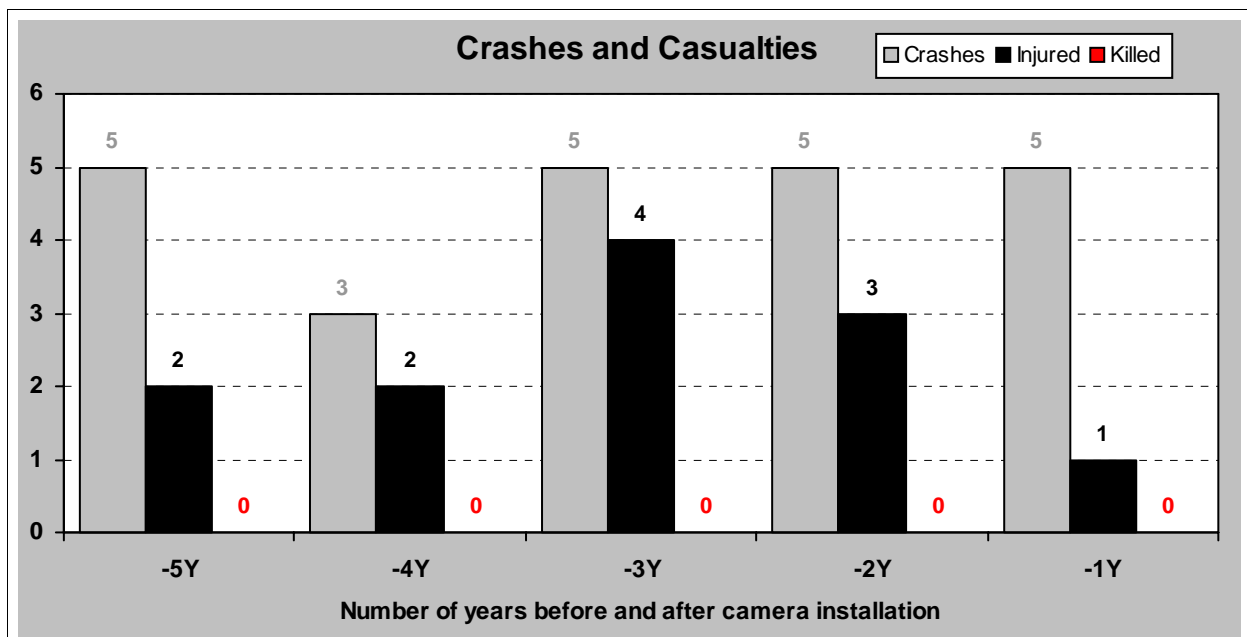
In the 265 day period from installation to the end of 2011, there were 2 crashes resulting in 2 injuries and 0 fatalities.

This represents a 40 per cent reduction in the yearly average number of crashes and a 15 per cent increase in the yearly average number of casualties at this intersection in the period after installation until the end of 2011.
