# ANNUAL NSW SPEED CAMERA PERFORMANCE REVIEW

NSW Centre for Road Safety

JULY 2012

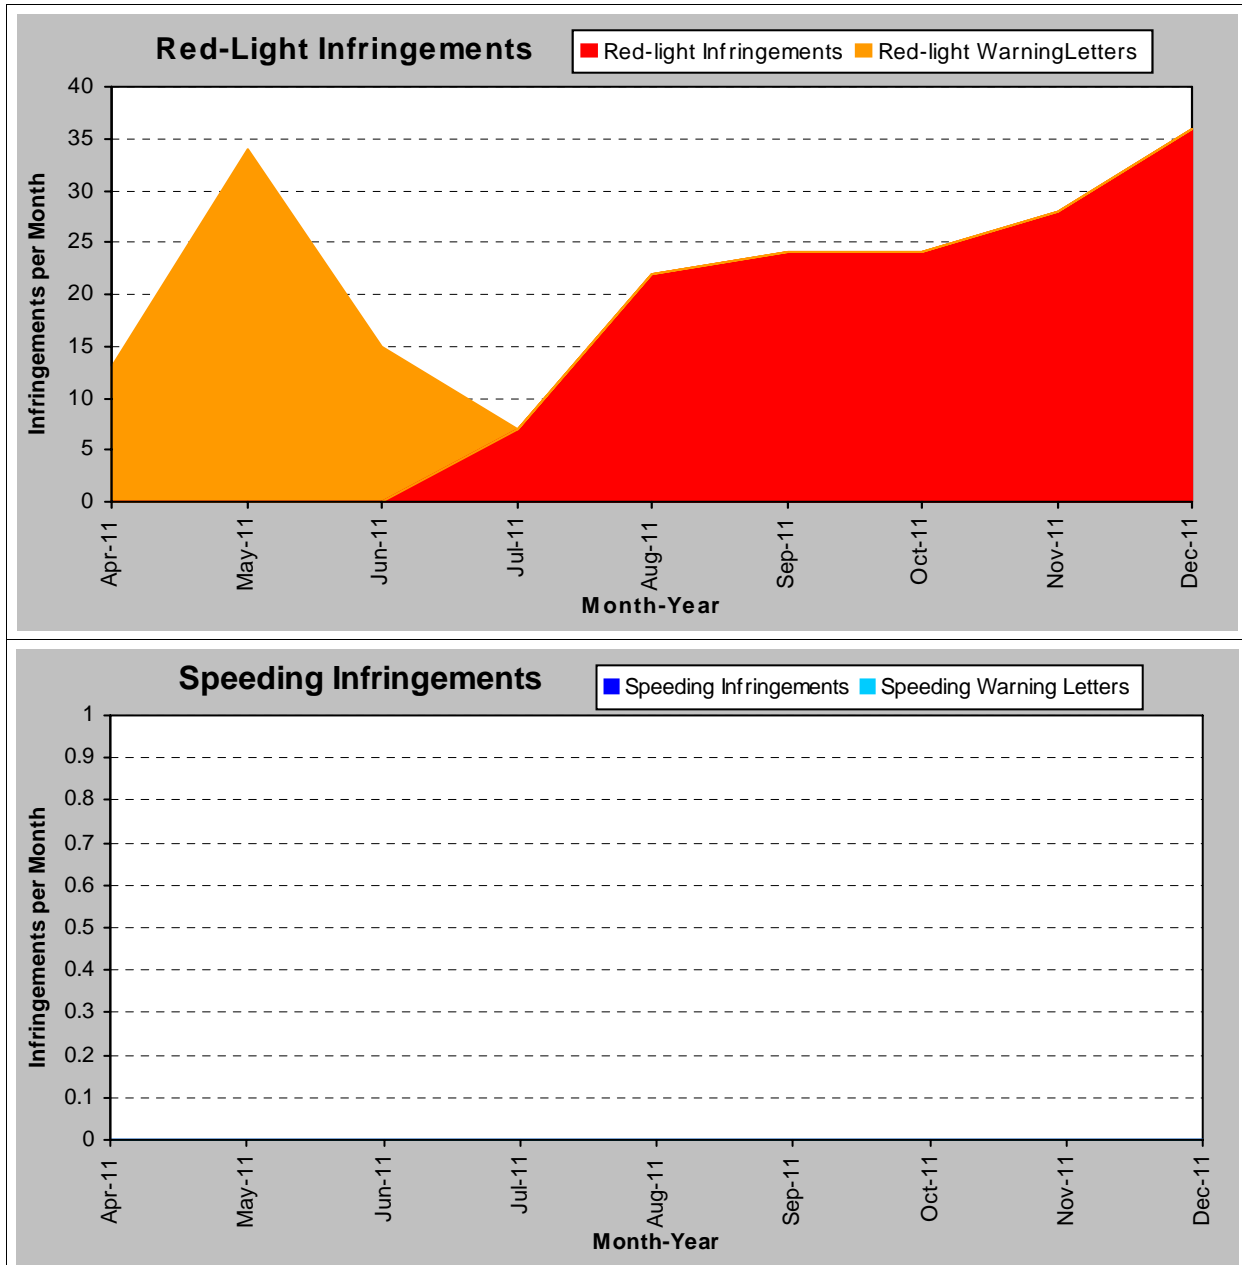
The graph below details the number of warning letters and infringements issued at this intersection since the camera began operating.

Roadworks and camera maintenance may influence the number of infringements issued.

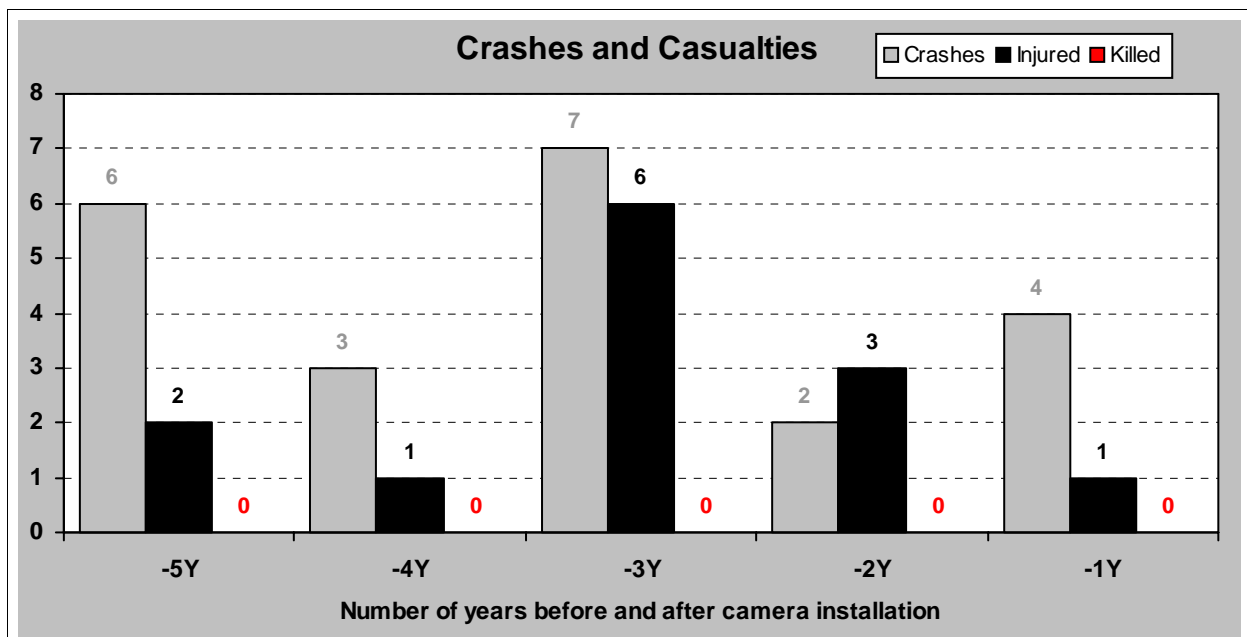
In the 188 day period from installation to the end of 2011, there was 1 crash resulting in 0 injuries and 0 fatalities.

This represents a 56 per cent reduction in the yearly average number of crashes and a 100 per cent reduction in the yearly average number of casualties at this intersection in the period after installation until the end of 2011.

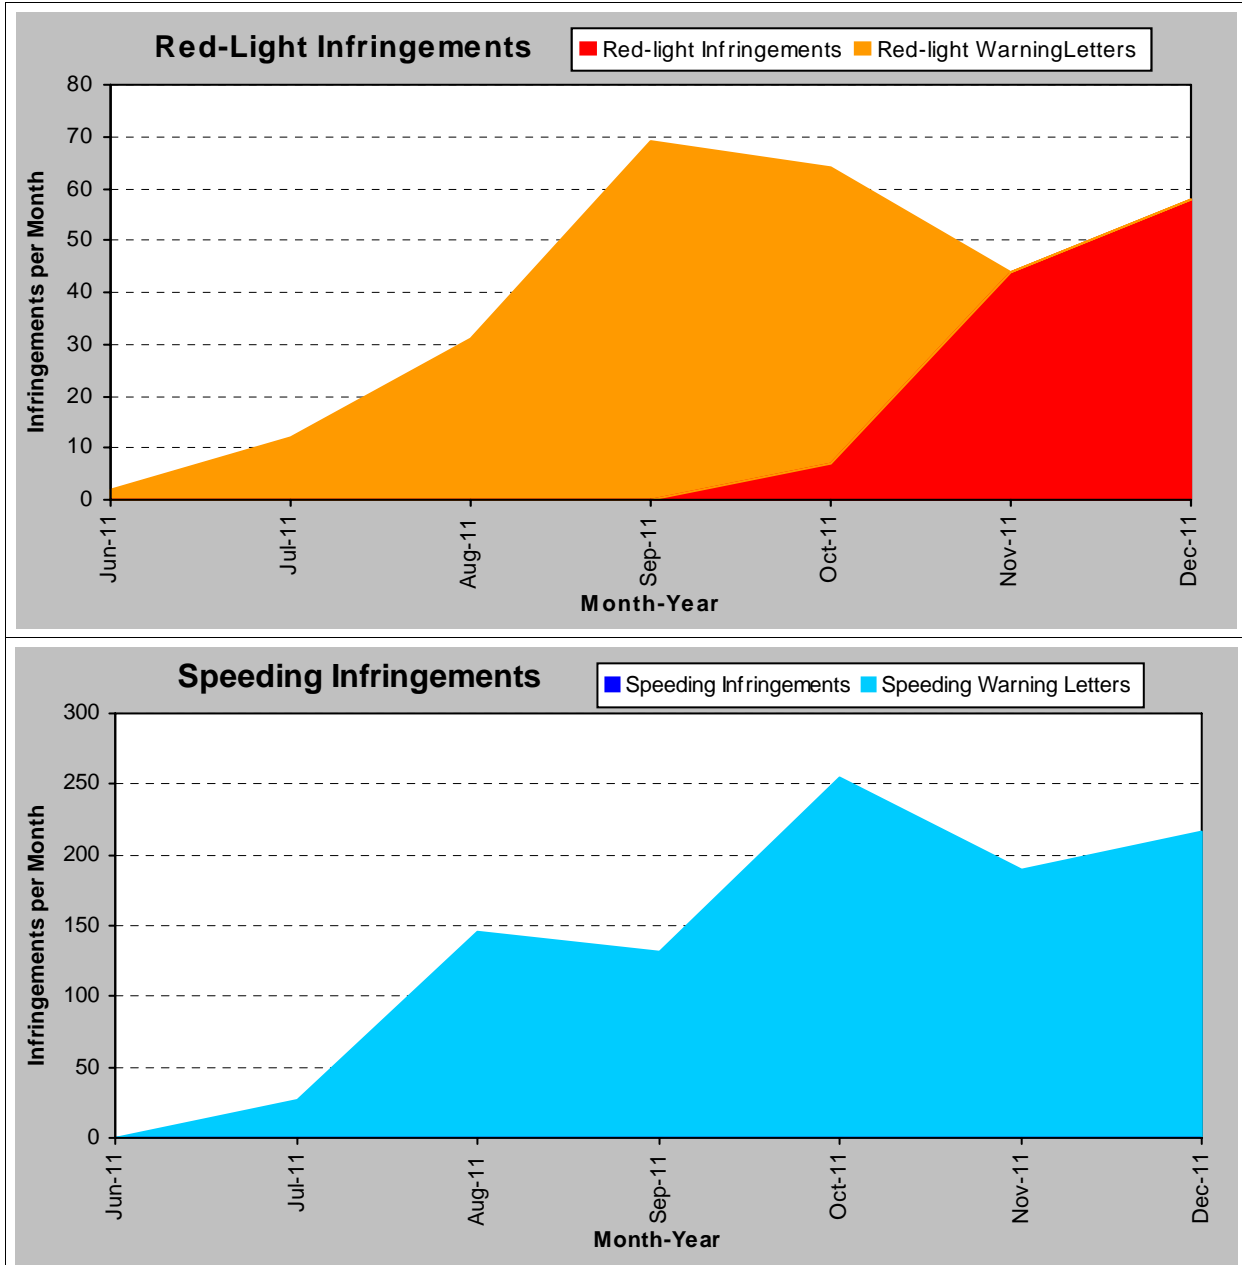
The graph below details the number of warning letters and infringements issued at this intersection since the camera began operating.

Roadworks and camera maintenance may influence the number of infringements issued.

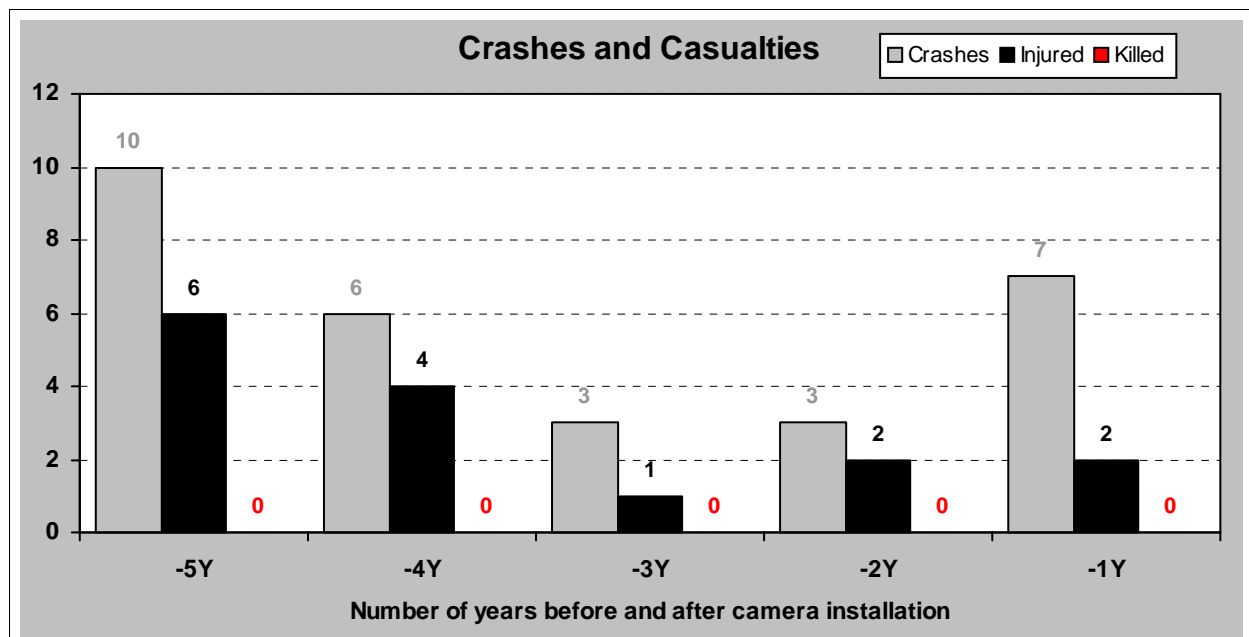
In the 200 day period from installation to the end of 2011, there were 0 crashes resulting in 0 injuries and 0 fatalities.

This represents a 100 per cent reduction in the yearly average number of crashes and a 100 per cent reduction in the yearly average number of casualties at this intersection in the period after installation until the end of 2011.

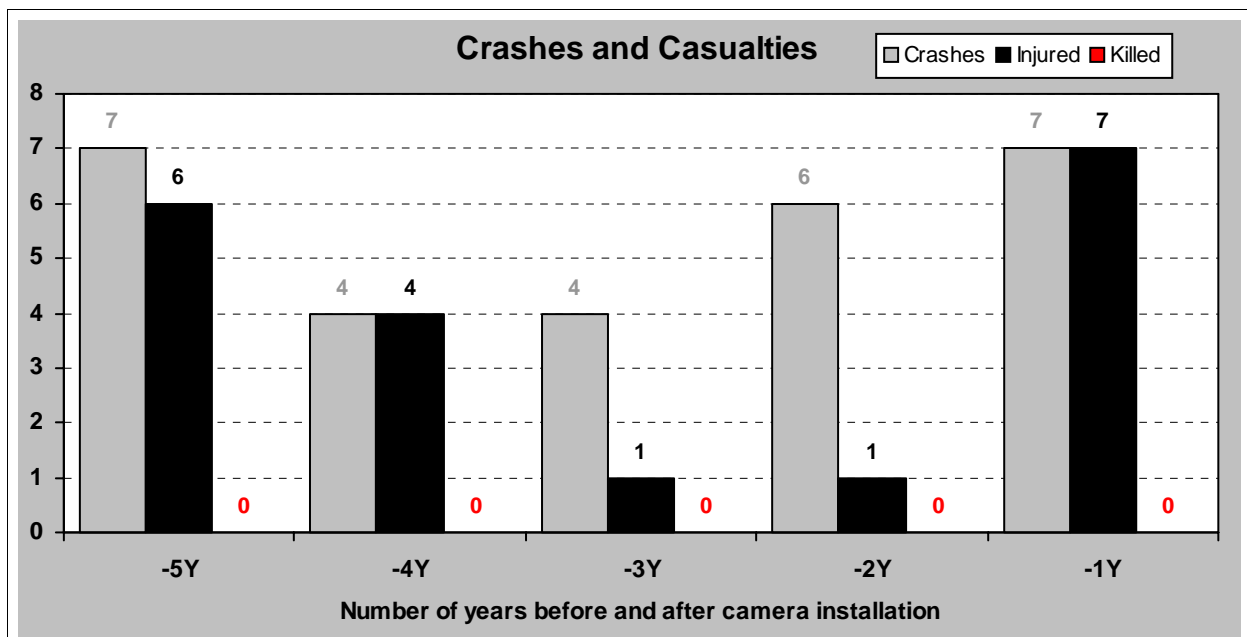
In the 213 day period from installation to the end of 2011, there was 1 crash resulting in 1 injury and 0 fatalities.

This represents a 69 per cent reduction in the yearly average number of crashes and a 55 per cent reduction in the yearly average number of casualties at this intersection in the period after installation until the end of 2011.

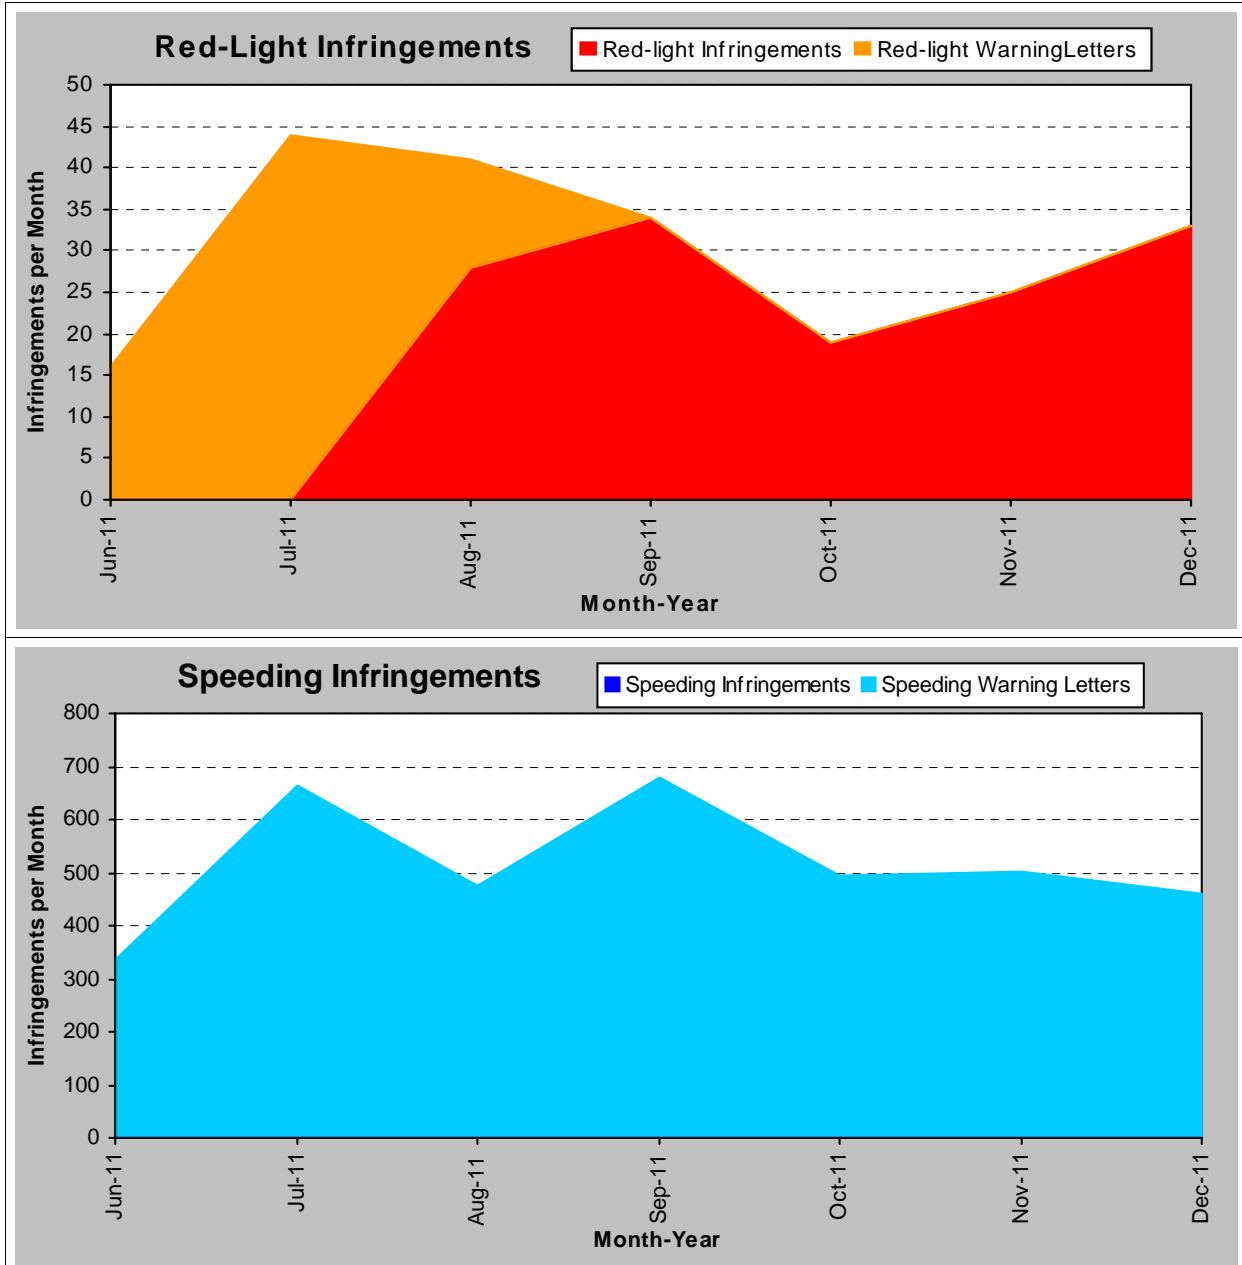
### Infringements at safety camera location

The graph below details the number of warning letters and infringements issued at this intersection since the camera began operating.

Roadworks and camera maintenance may influence the number of infringements issued.

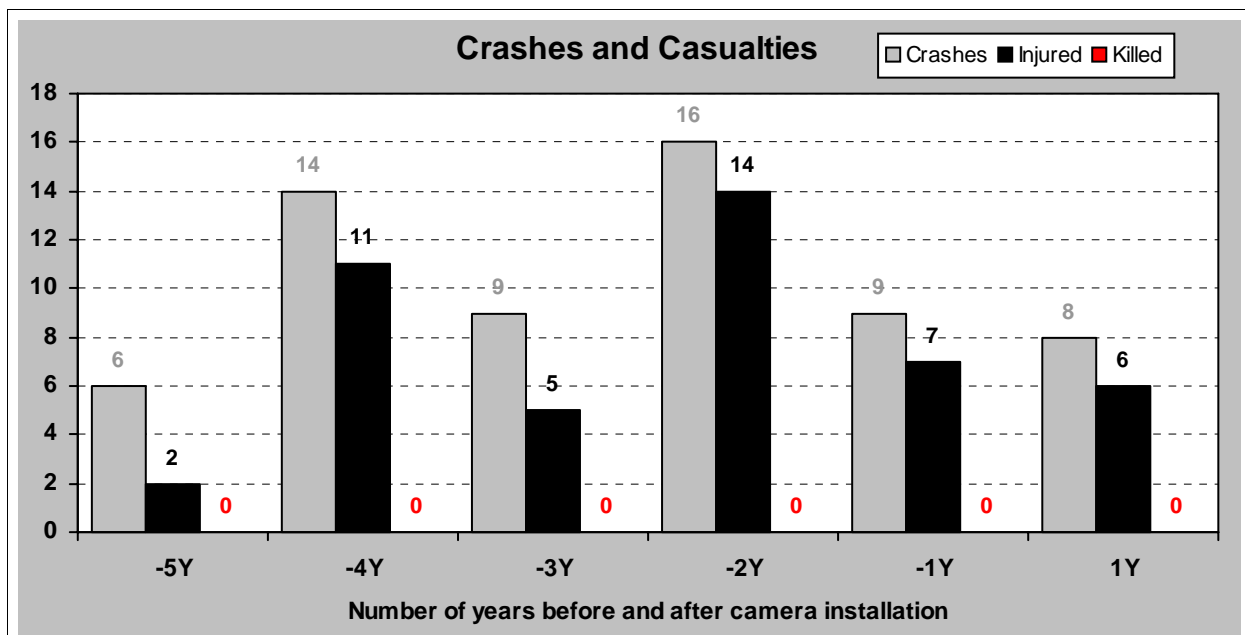
This represents a 20 per cent reduction in the yearly average number of crashes and a 26 per cent reduction in the yearly average number of casualties at this intersection in the period after installation until the end of 2011.

Provisional crash data shows there were 9 crashes resulting in 6 casualties at this intersection in 2011.

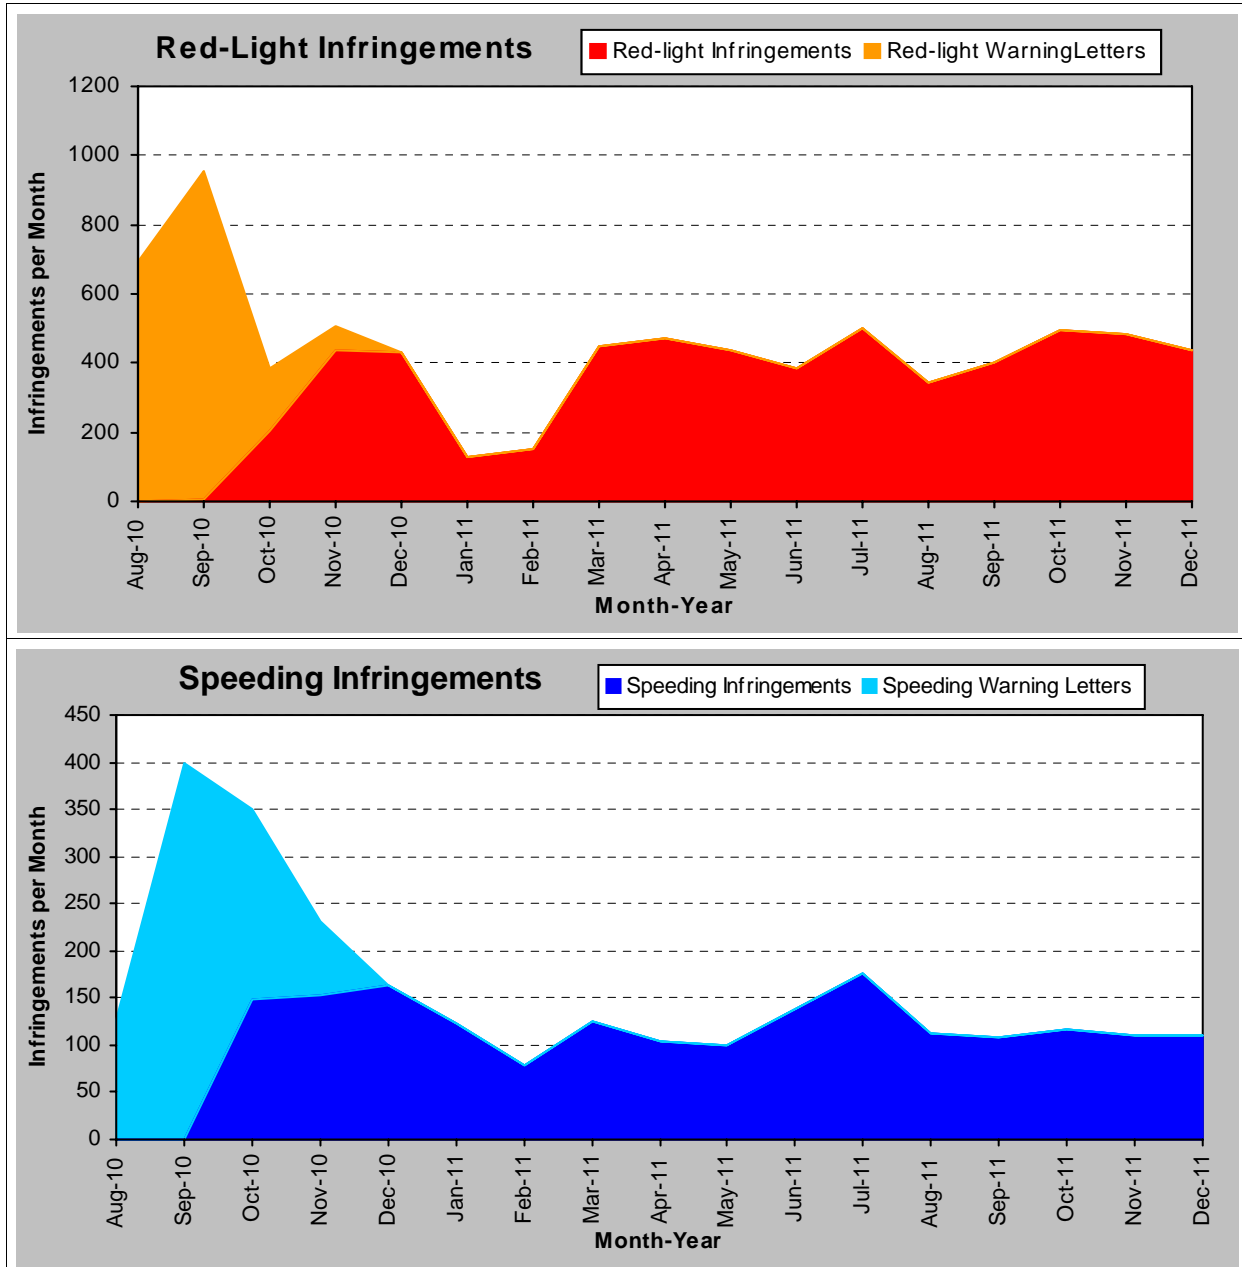
## Infringements at safety camera location

The graph below details the number of warning letters and infringements issued at this intersection since the camera began operating. The graph also shows the trend in infringements at this location.

Roadworks and camera maintenance may influence the number of infringements issued.

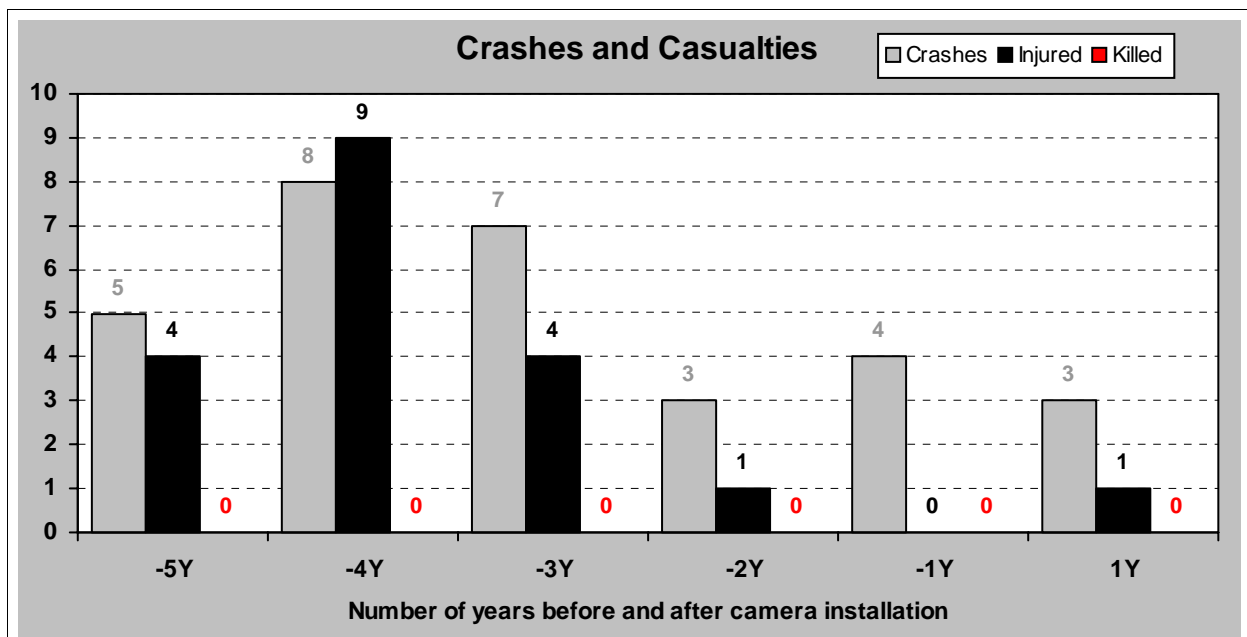
This represents a 42 per cent reduction in the yearly average number of crashes and a 56 per cent reduction in the yearly average number of casualties at this intersection in the period after installation until the end of 2011.

Provisional crash data shows there were 3 crashes resulting in one casualty at this intersection in 2011.

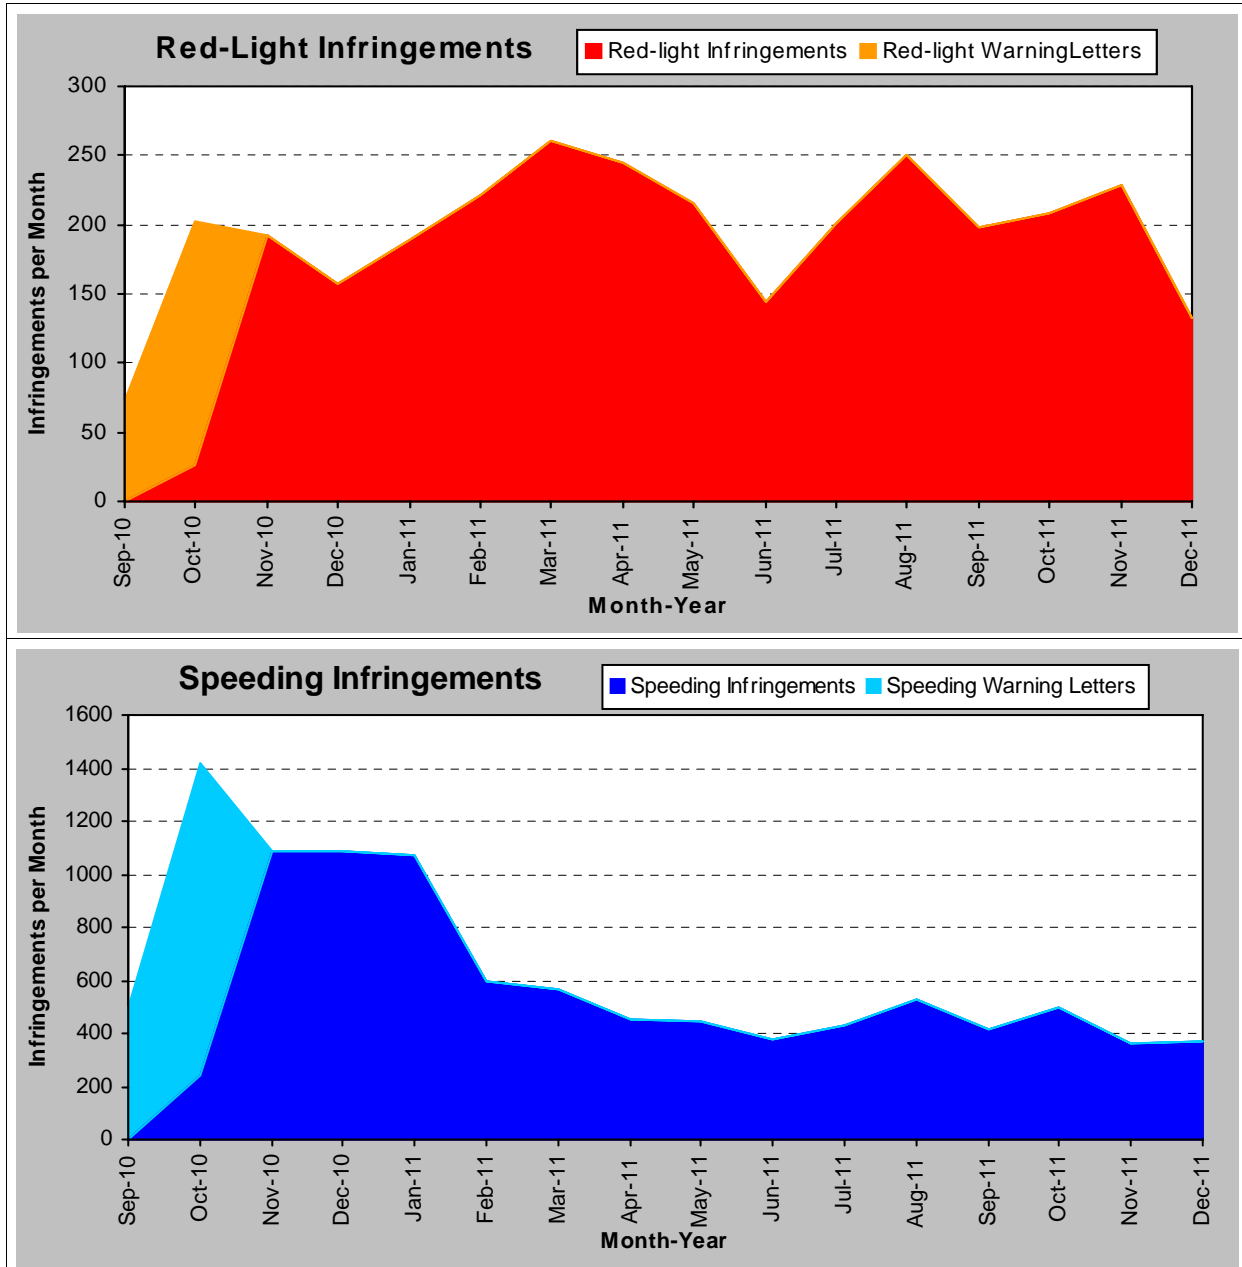
## Infringements at safety camera location

The graph below details the number of warning letters and infringements issued at this intersection since the camera began operating. The graph also shows the trend in infringements at this location.

Roadworks and camera maintenance may influence the number of infringements issued.

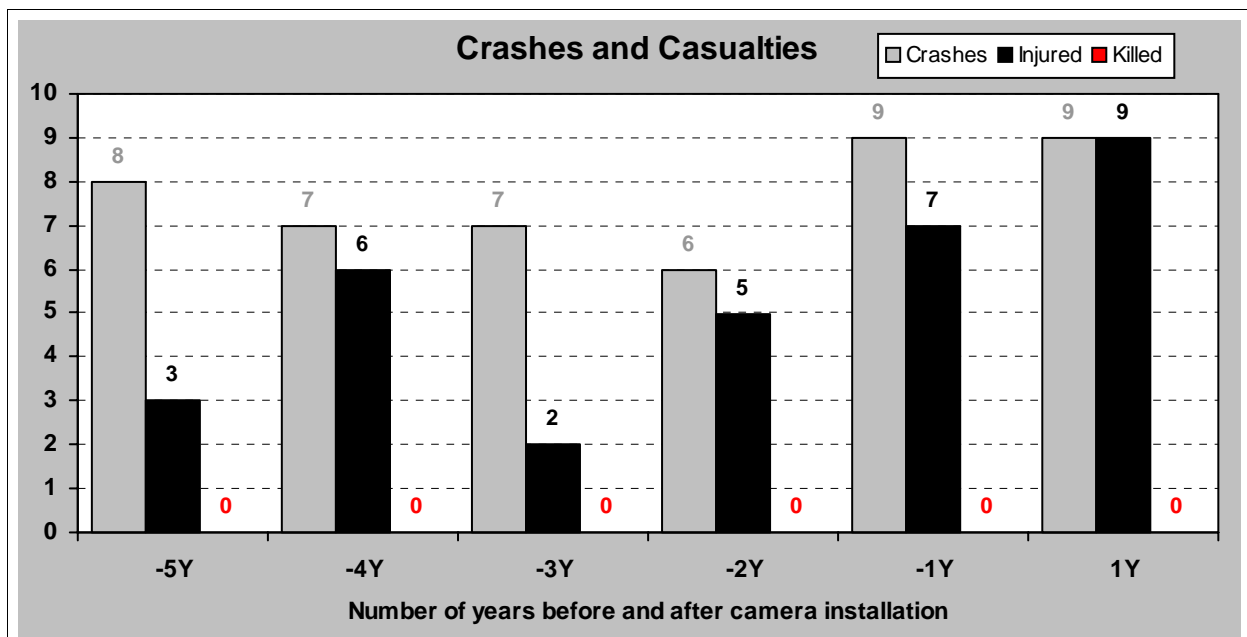
This represents a 14 per cent increase in the yearly average number of crashes and a 67 per cent increase in the yearly average number of casualties at this intersection in the period after installation until the end of 2011.

Provisional crash data shows there were 7 crashes resulting in 8 casualties at this intersection in 2011.

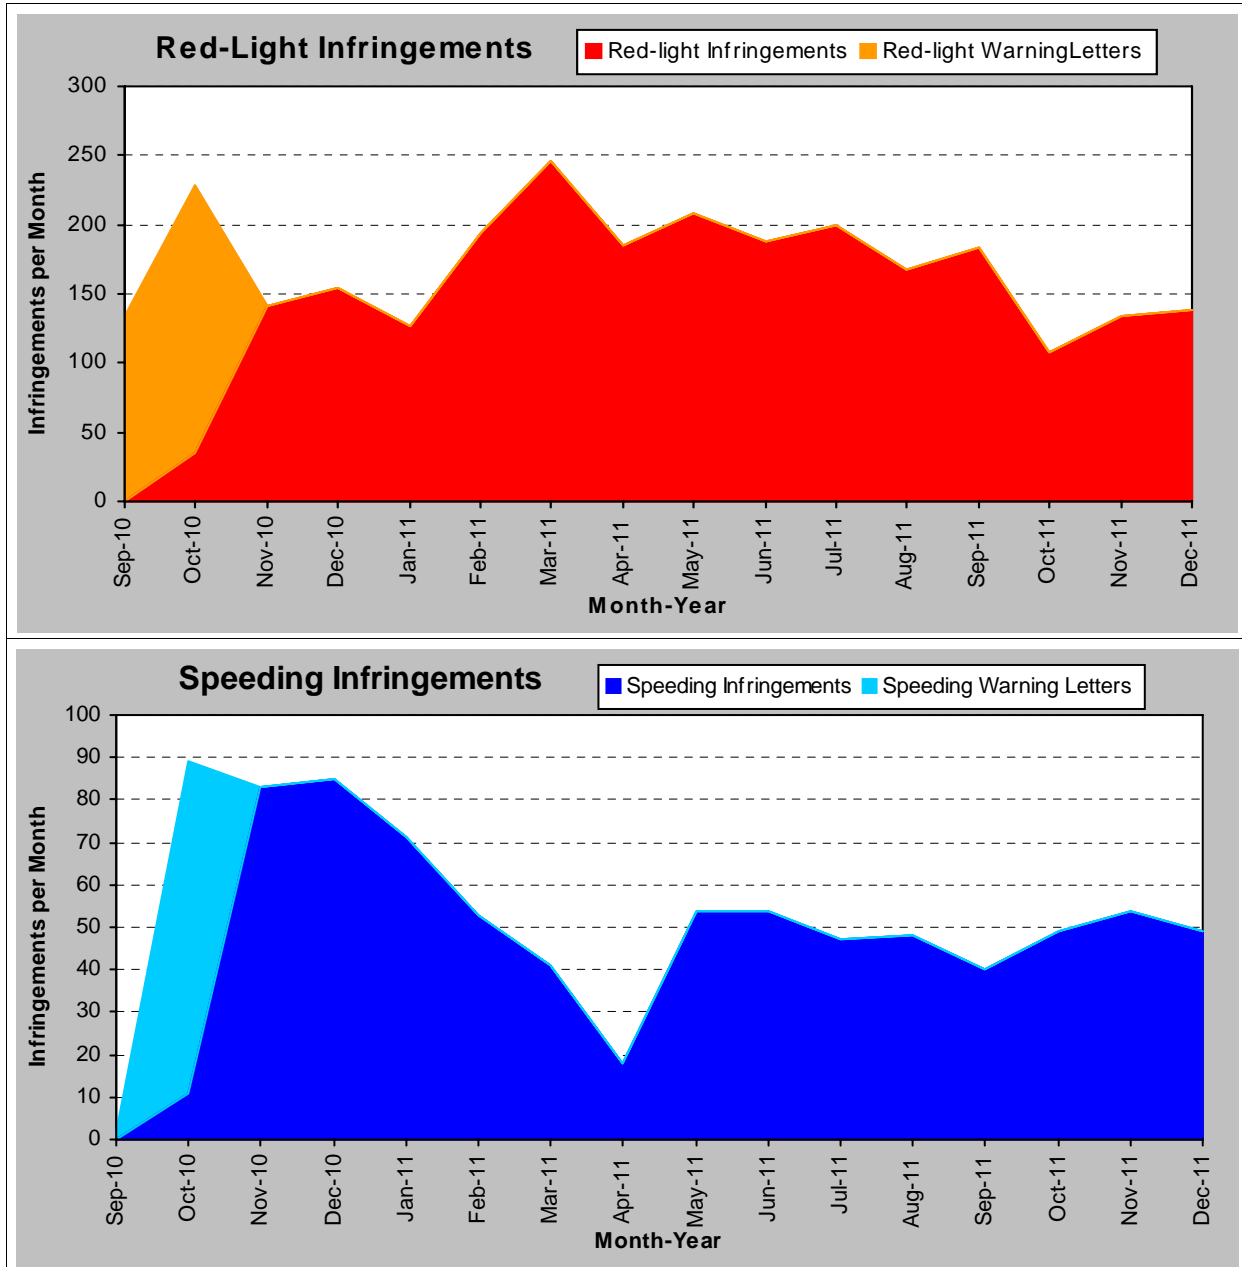
## Infringements at safety camera location

The graph below details the number of warning letters and infringements issued at this intersection since the camera began operating. The graph also shows the trend in infringements at this location.

Roadworks and camera maintenance may influence the number of infringements issued.

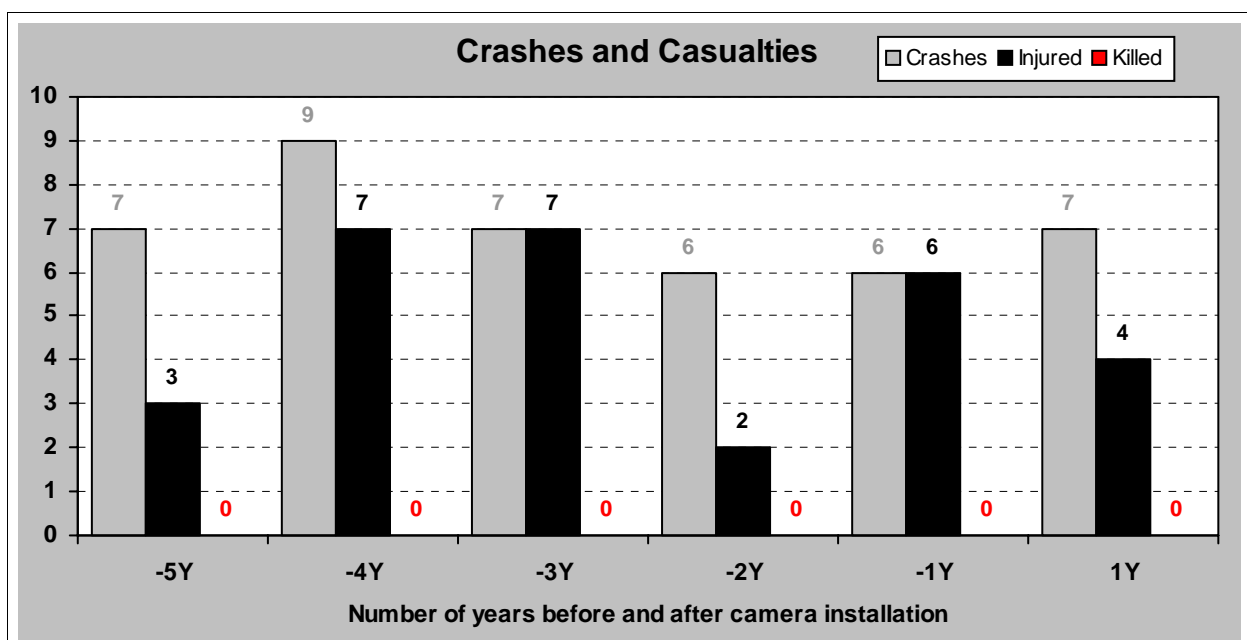
This represents a 6 per cent reduction in the yearly average number of crashes and an 18 per cent reduction in the yearly average number of casualties at this intersection in the period after installation until the end of 2011.

Provisional crash data shows there were 7 crashes resulting in 5 casualties at this intersection in 2011.

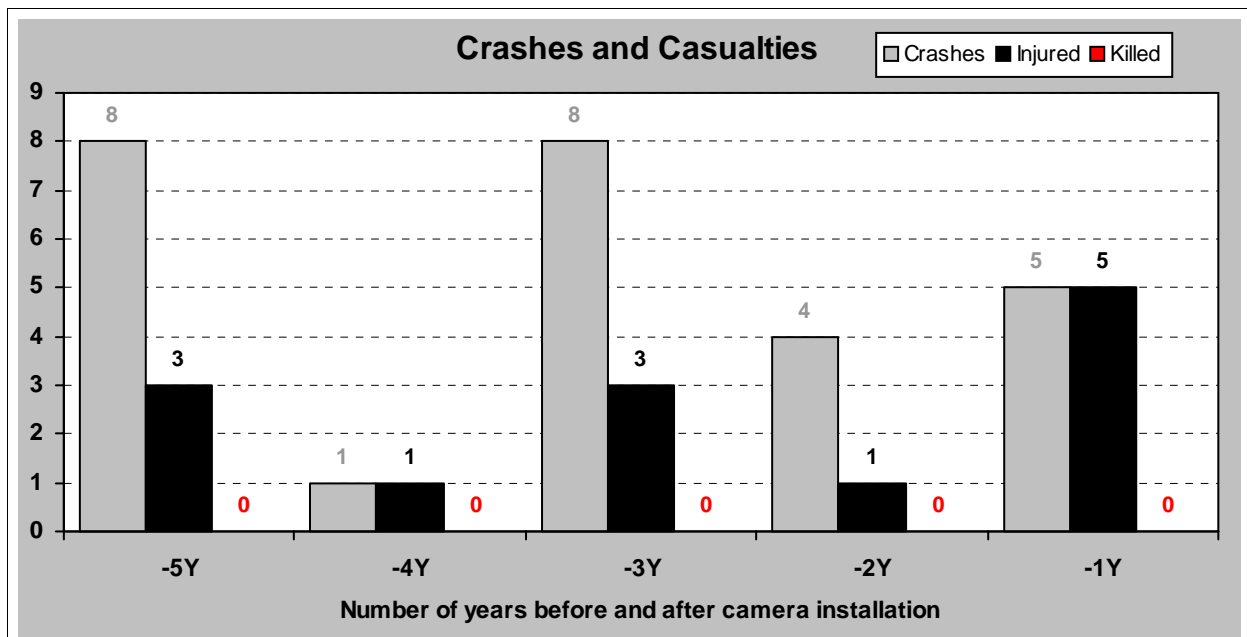
In the 200 day period from installation to the end of 2011, there was 1 crash resulting in 0 injuries and 0 fatalities.

This represents a 65 per cent reduction in the yearly average number of crashes and a 100 per cent reduction in the yearly average number of casualties at this intersection in the period after installation until the end of 2011.

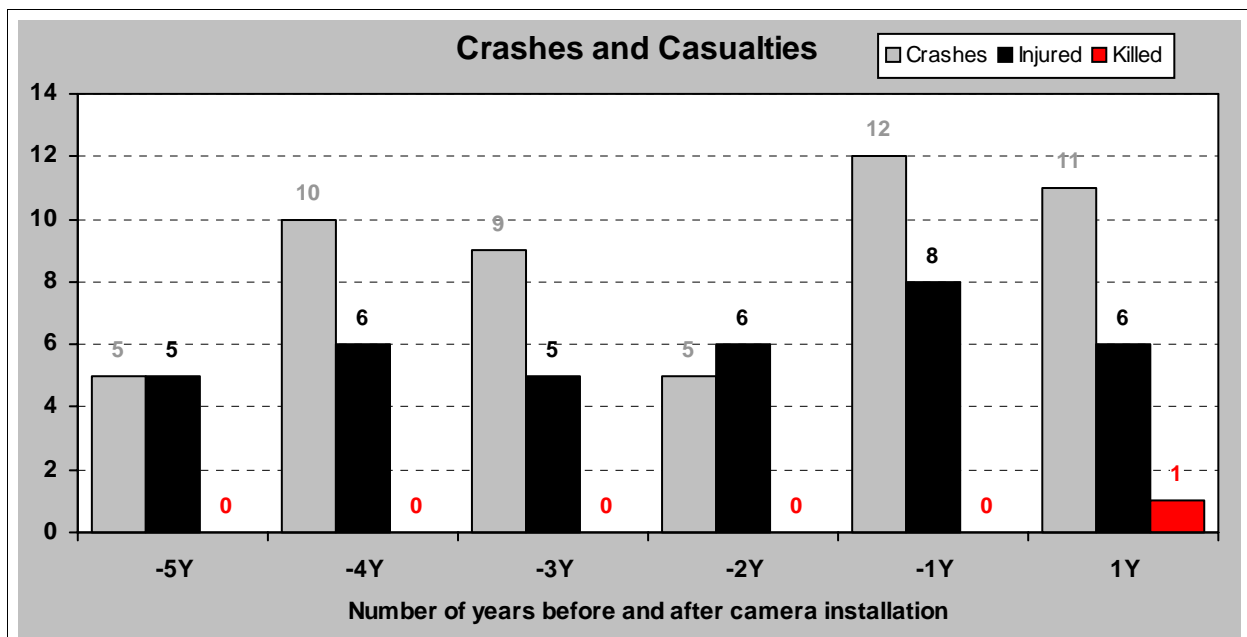
This represents a 35 per cent increase in the yearly average number of crashes and a 13 per cent increase in the yearly average number of casualties at this intersection in the period after installation until the end of 2011.

Provisional crash data shows there were 11 crashes resulting in 7 casualties at this intersection in 2011.

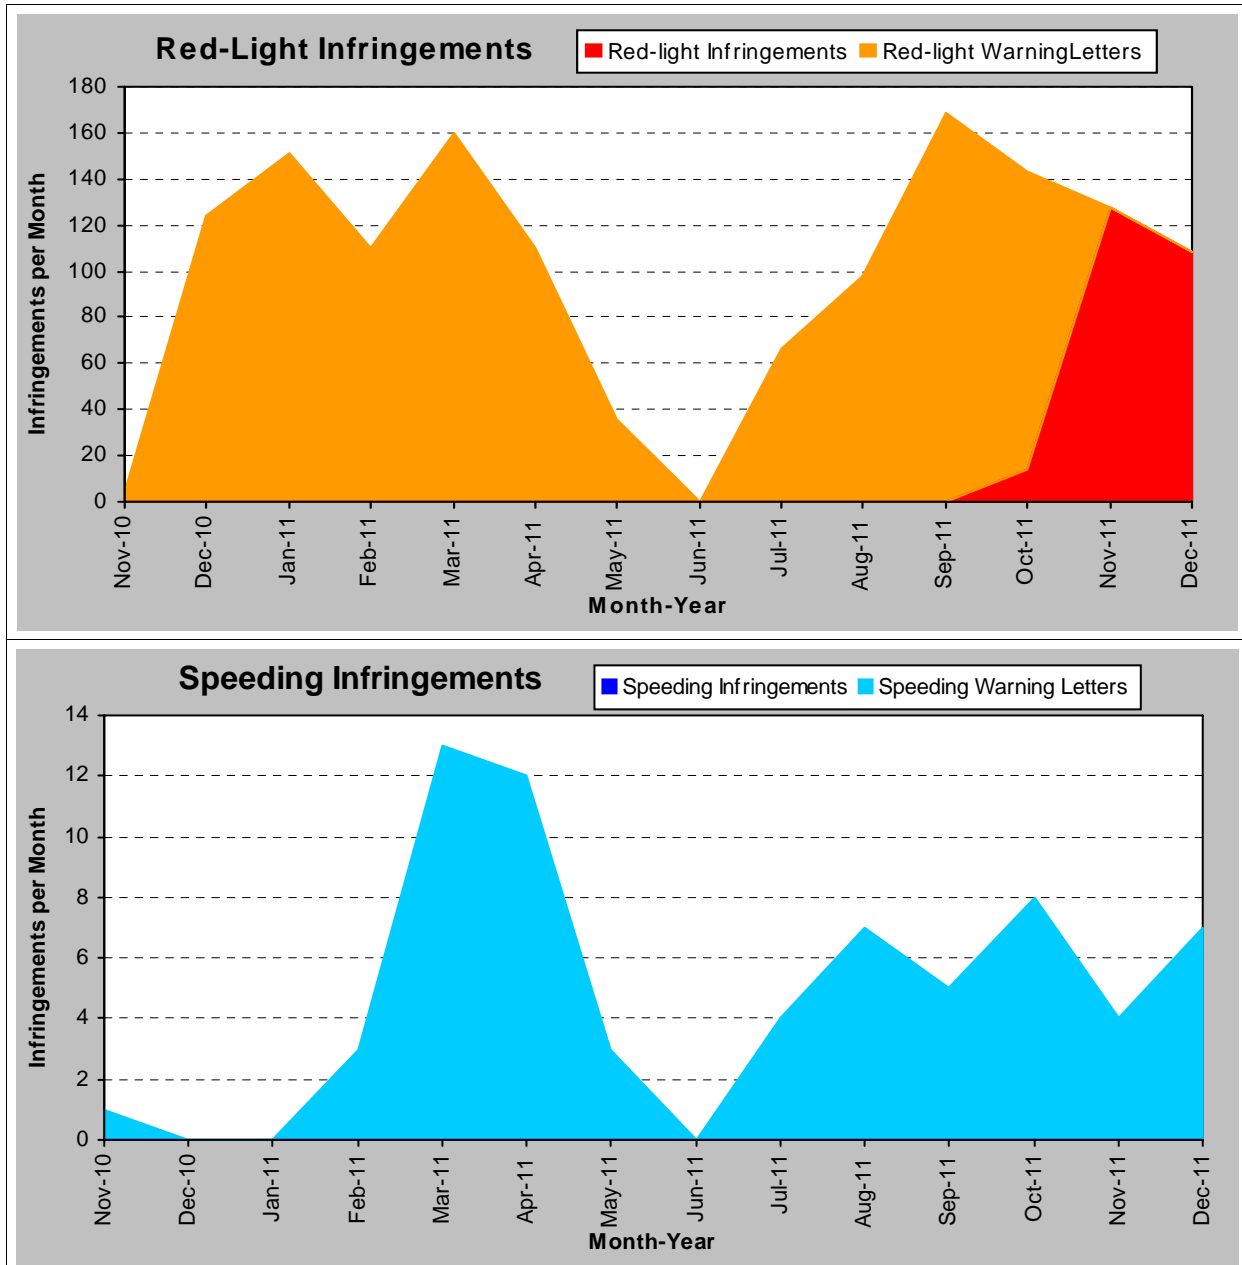
## Infringements at safety camera location

The graph below details the number of warning letters and infringements issued at this intersection since the camera began operating.

Roadworks and camera maintenance may influence the number of infringements issued.

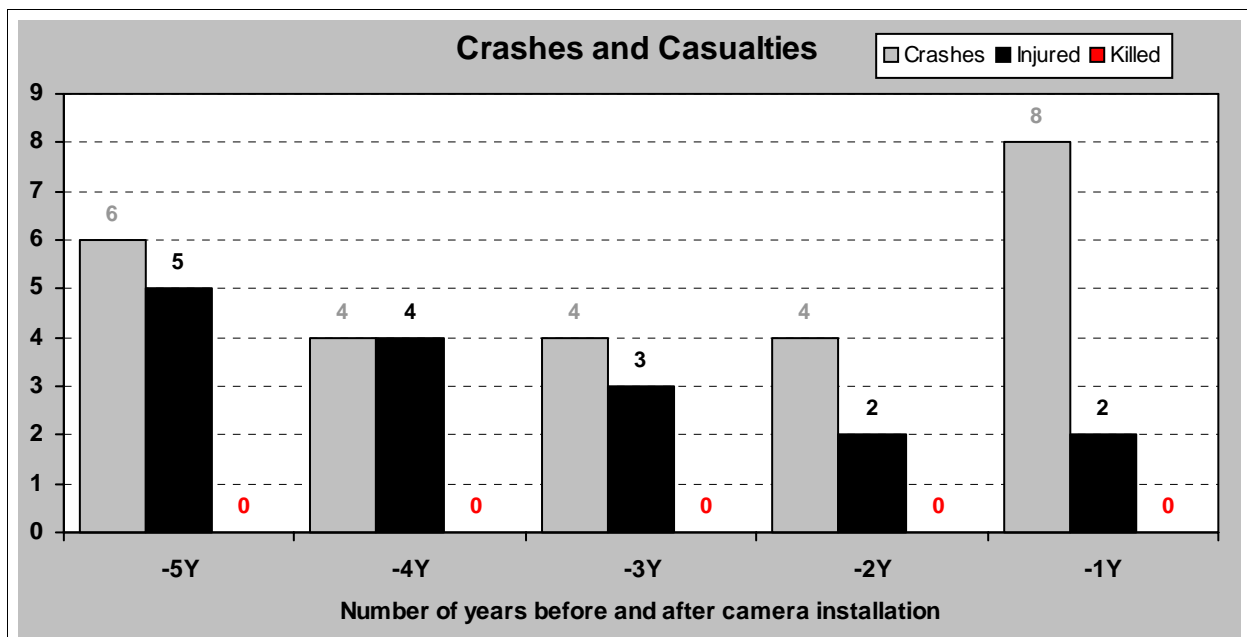
In the 265 day period from installation to the end of 2011, there was 1 crash resulting in 0 injuries and 0 fatalities.

This represents a 73 per cent reduction in the yearly average number of crashes and a 100 per cent reduction in the yearly average number of casualties at this intersection in the period after installation until the end of 2011.

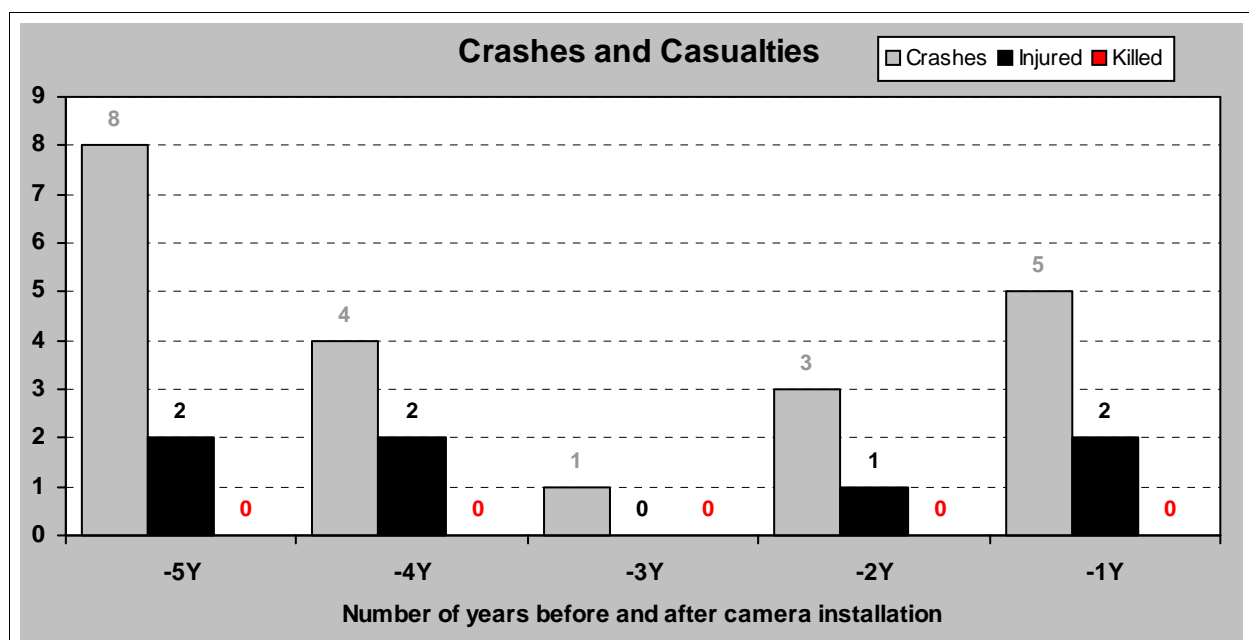
In the 233 day period from installation to the end of 2011, there were 4 crashes resulting in 4 injuries and 0 fatalities.

This represents a 49 per cent increase in the yearly average number of crashes and a 348 per cent increase in the yearly average number of casualties at this intersection in the period after installation until the end of 2011.

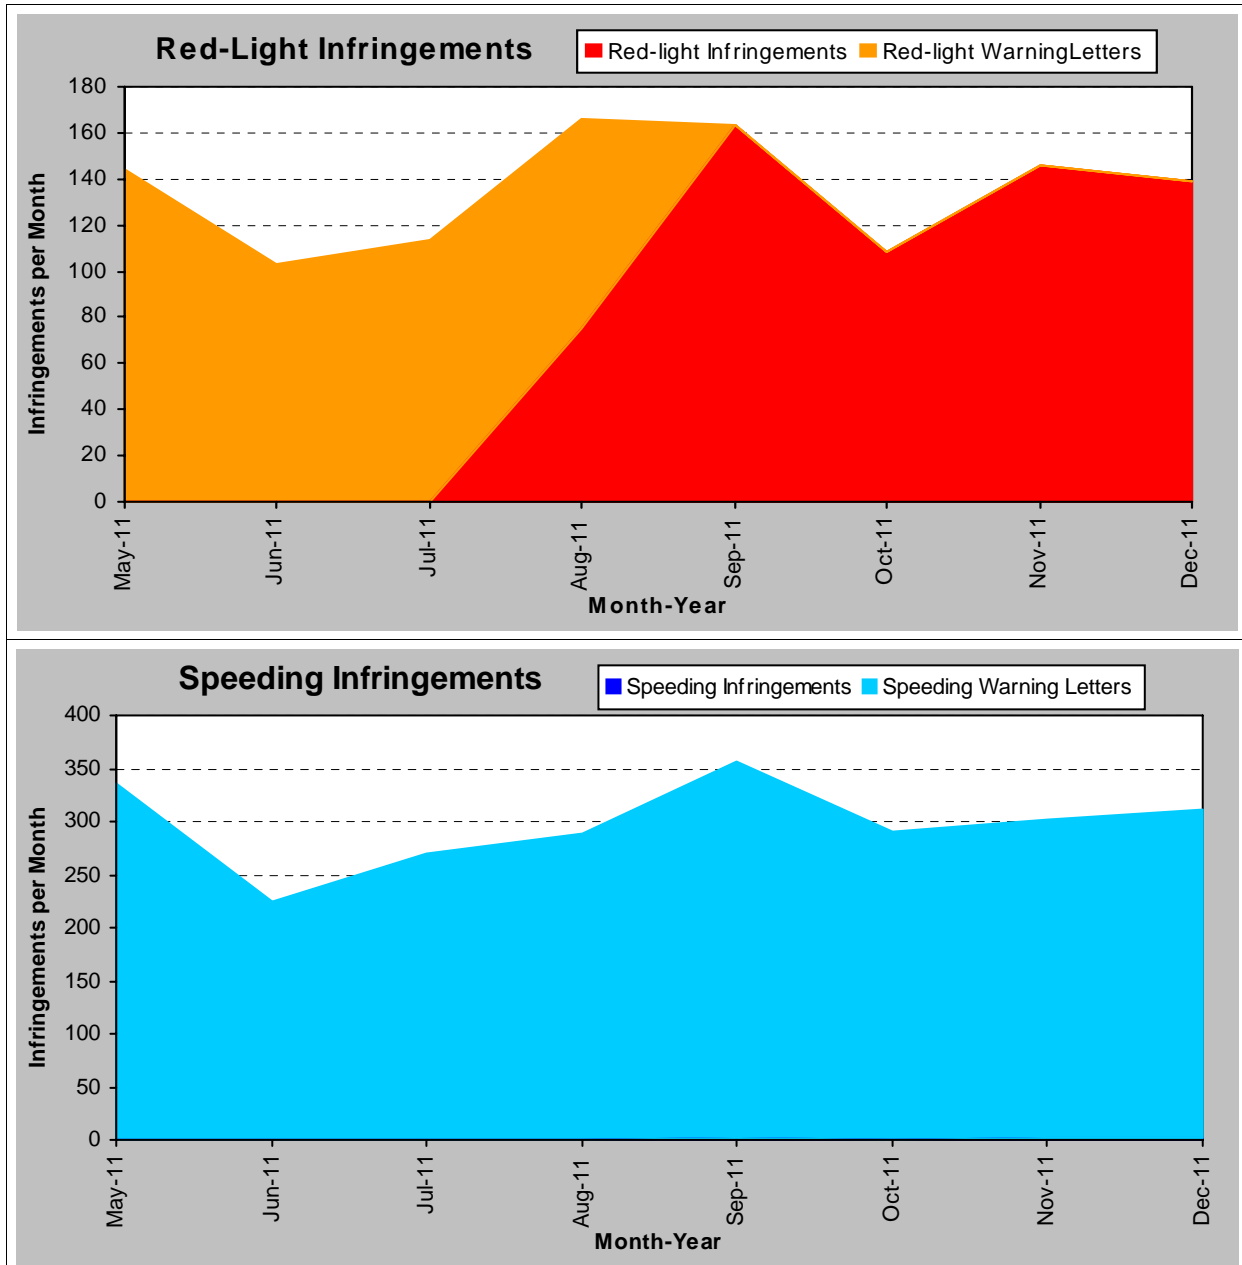
## Infringements at safety camera location

The graph below details the number of warning letters and infringements issued at this intersection since the camera began operating.

Roadworks and camera maintenance may influence the number of infringements issued.
