# ANNUAL NSW SPEED CAMERA PERFORMANCE REVIEW

NSW Centre for Road Safety

JULY 2012

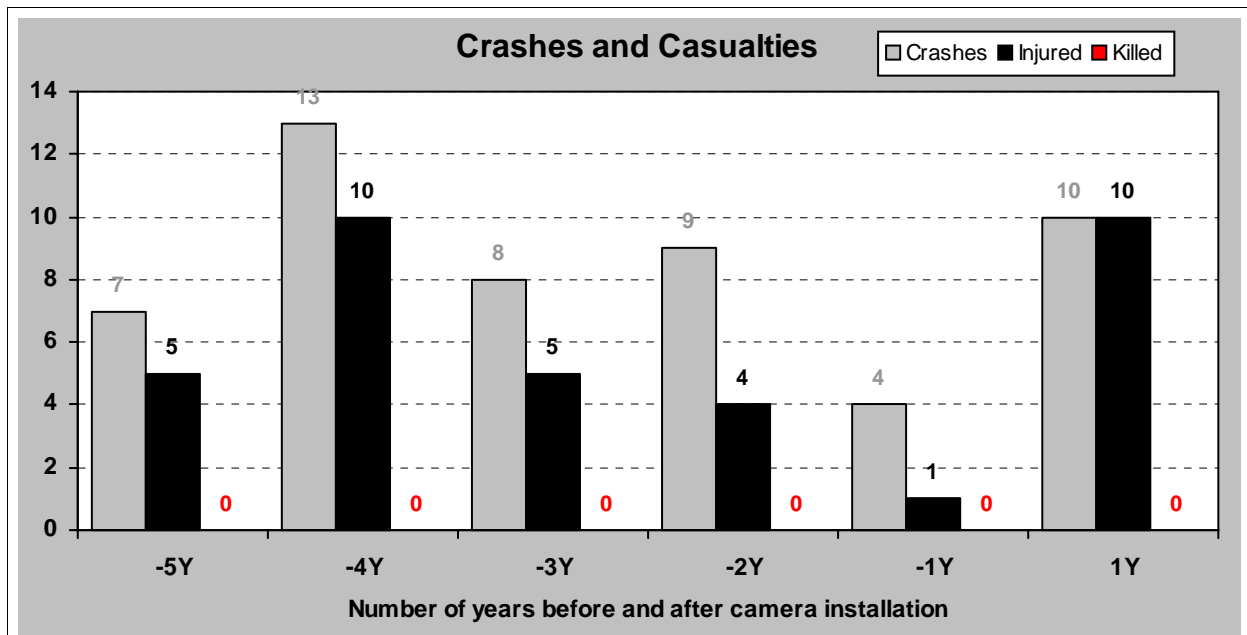
This represents a 3 per cent reduction in the yearly average number of crashes and a 46 per cent increase in the yearly average number of casualties at this intersection in the period after installation until the end of 2011.

Provisional crash data shows there were 5 crashes resulting in 2 casualties at this intersection in 2011.

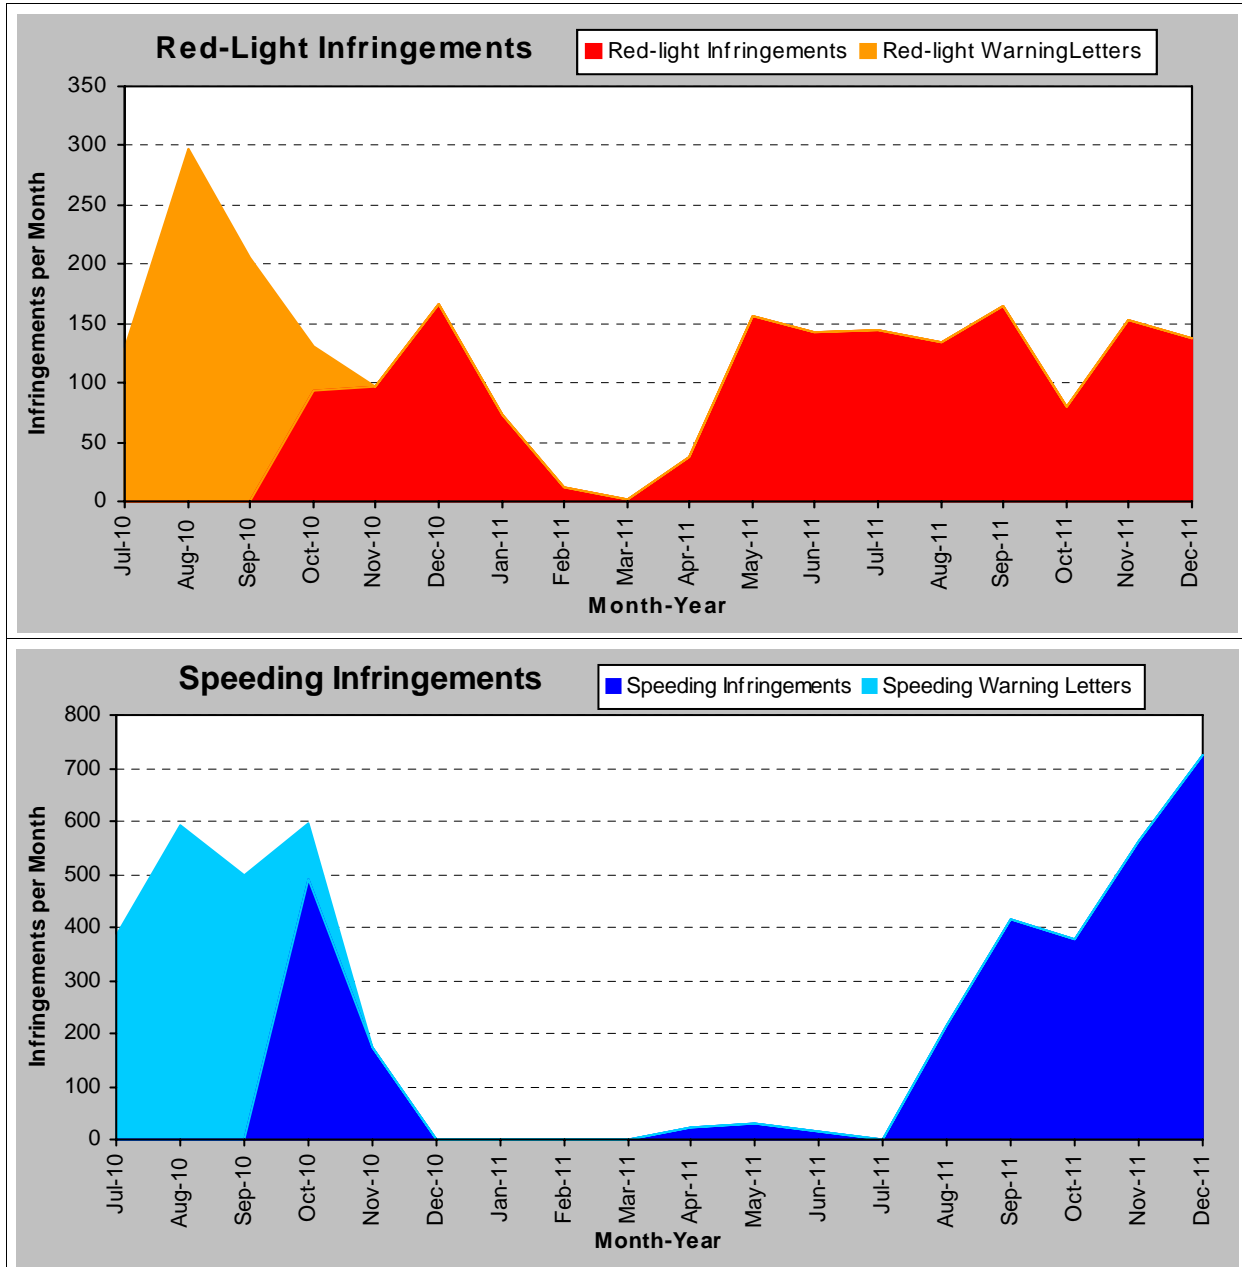
## Infringements at safety camera location

The graph below details the number of warning letters and infringements issued at this intersection since the camera began operating. The graph also shows the trend in infringements at this location.

Roadworks and camera maintenance may influence the number of infringements issued.

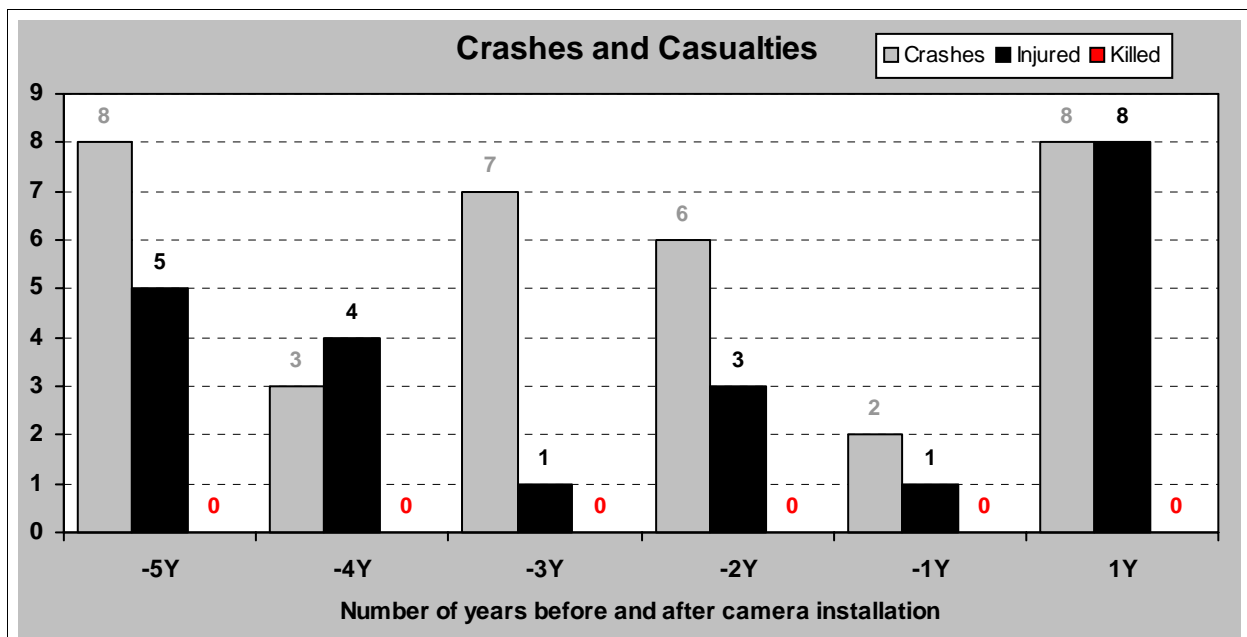
This represents a 76 per cent increase in the yearly average number of crashes and a 172 per cent increase in the yearly average number of casualties at this intersection in the period after installation until the end of 2011.

Provisional crash data shows there were 10 crashes resulting in 7 casualties at this intersection in 2011.

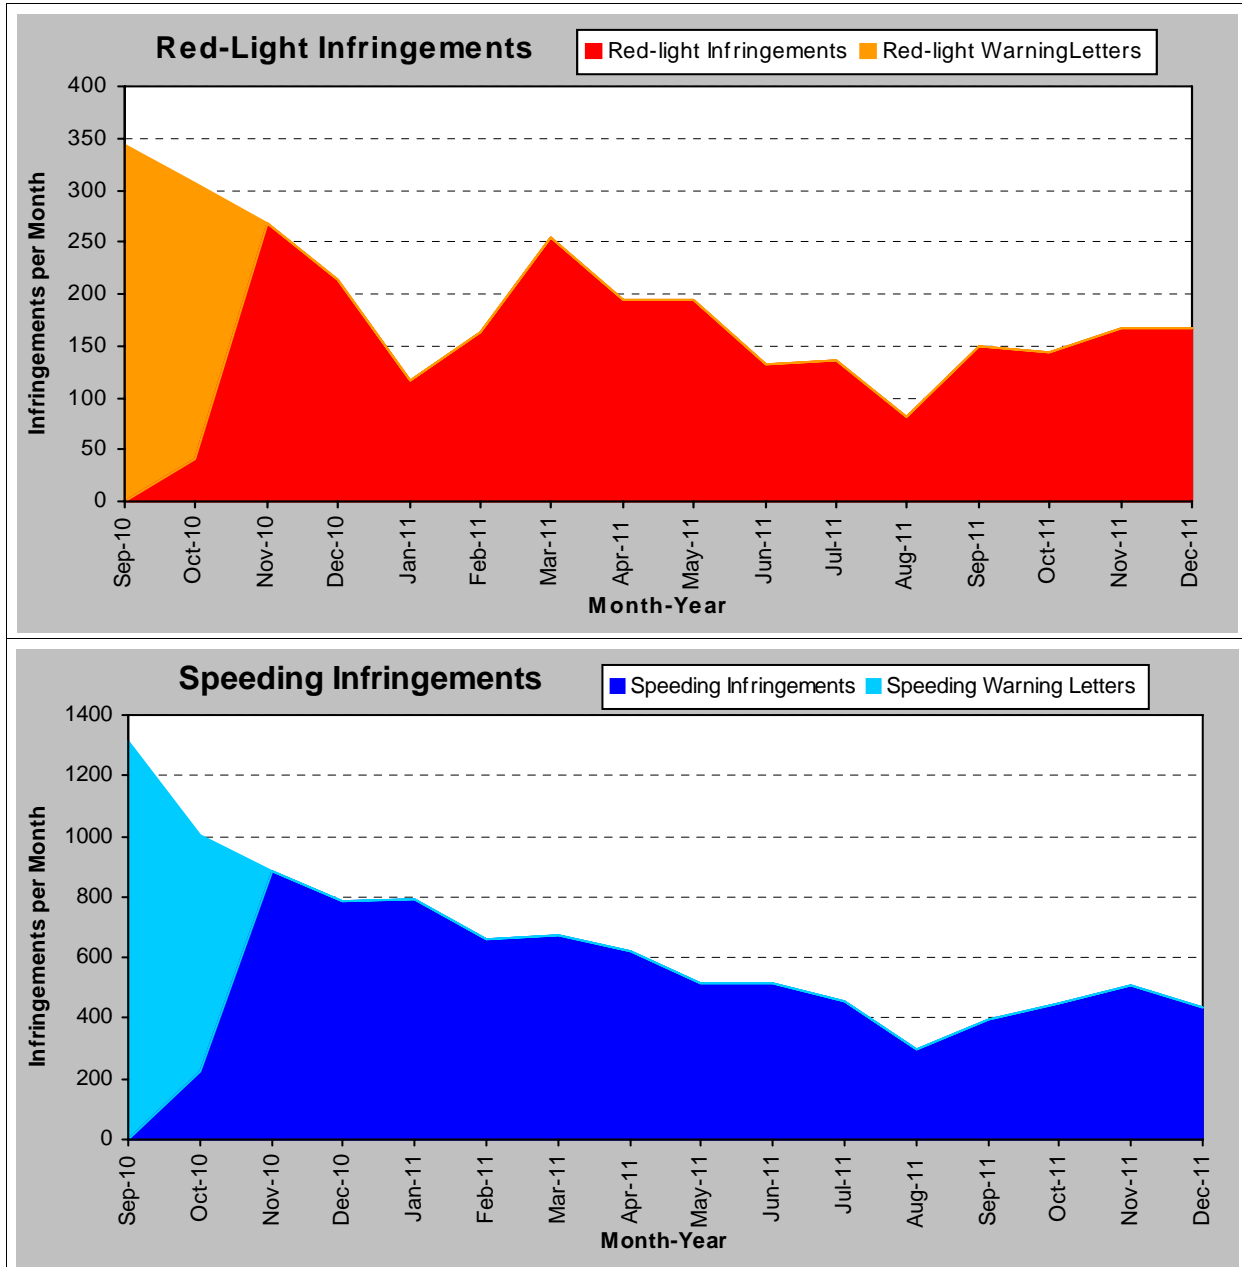
## Infringements at safety camera location

The graph below details the number of warning letters and infringements issued at this intersection since the camera began operating. The graph also shows the trend in infringements at this location.

Roadworks and camera maintenance may influence the number of infringements issued.

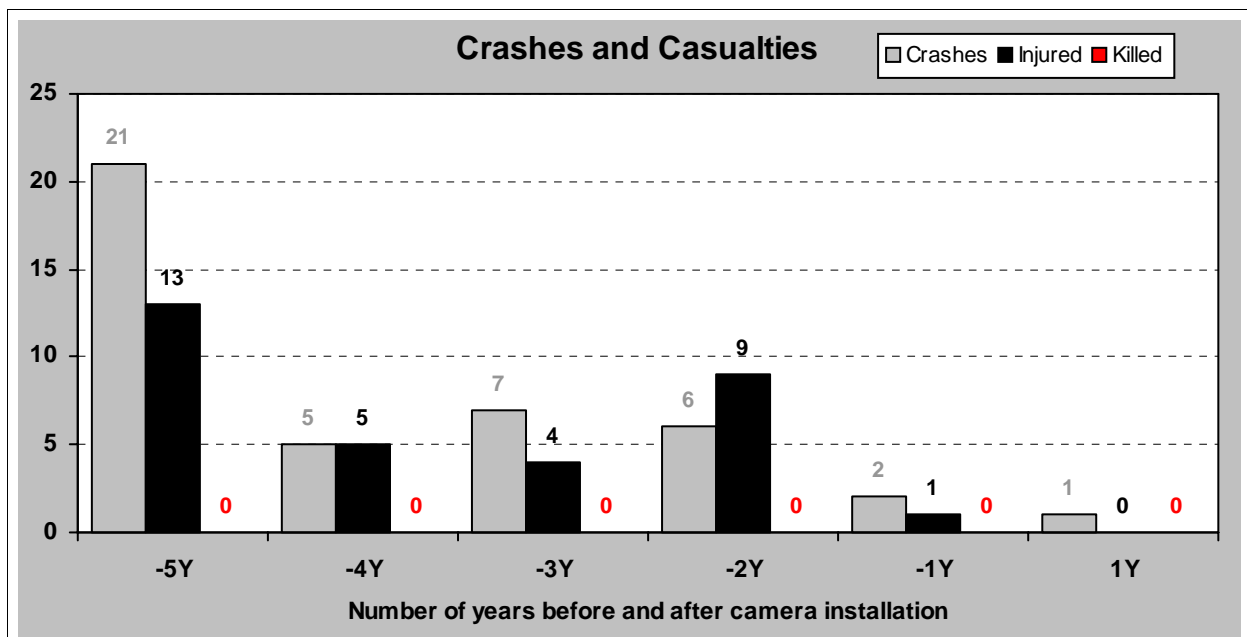
This represents an 84 per cent reduction in the yearly average number of crashes and a 100 per cent reduction in the yearly average number of casualties at this intersection in the period after installation until the end of 2011.

Provisional crash data shows there were 2 crashes resulting in 0 casualties at this intersection in 2011.

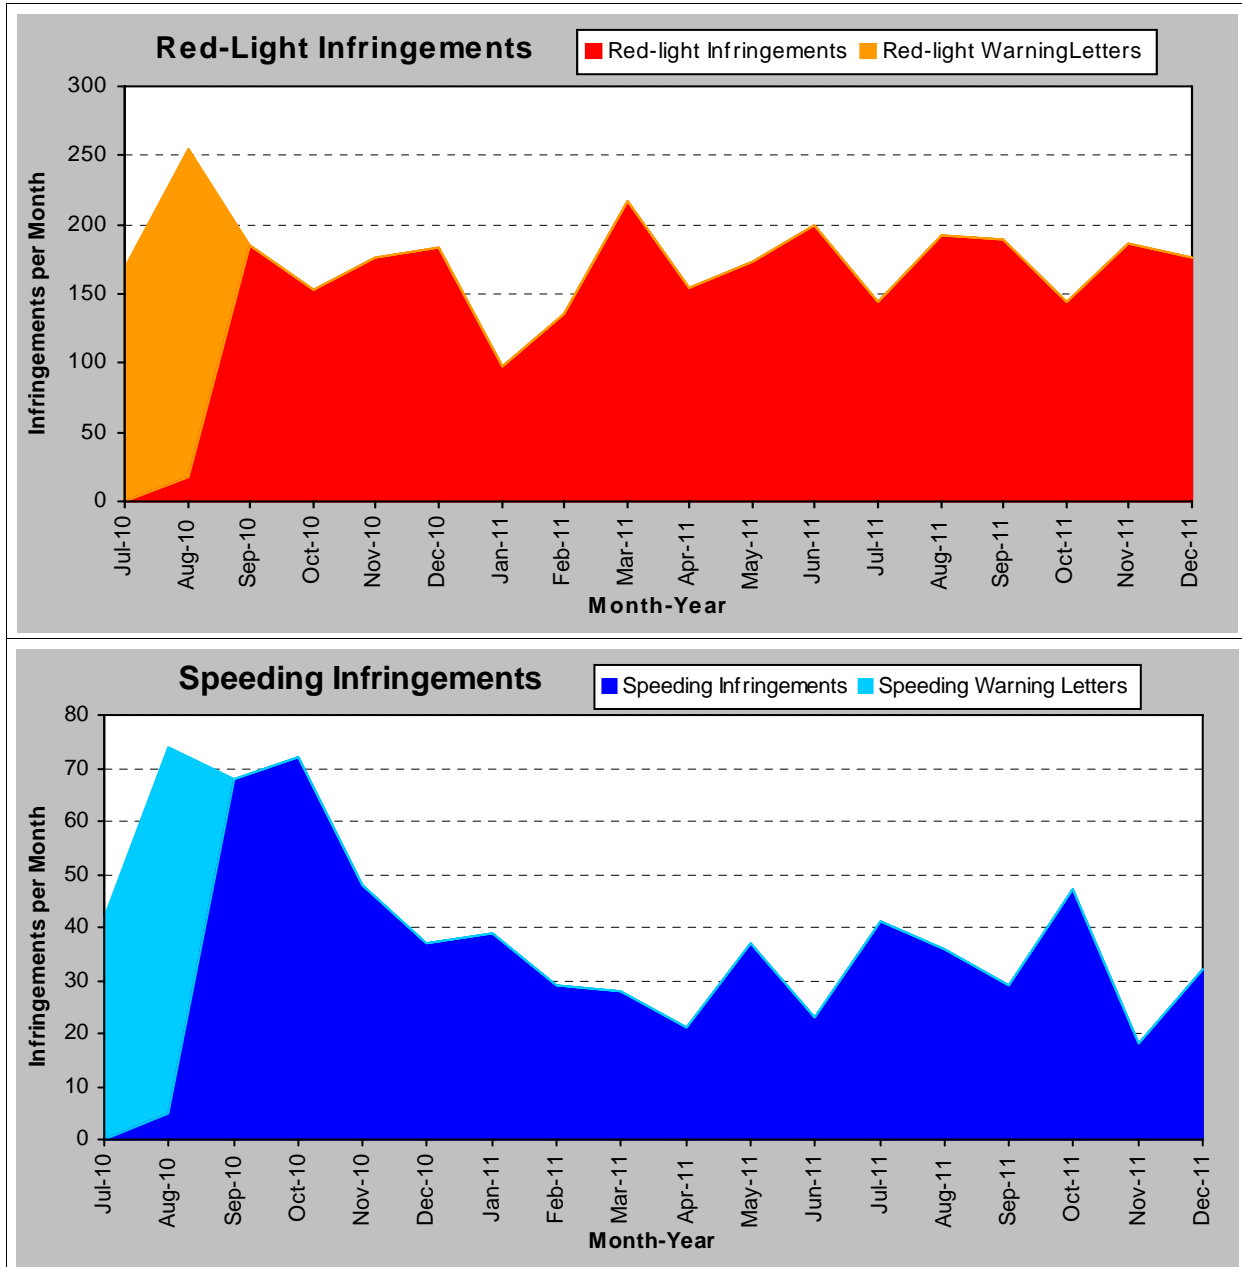
## Infringements at safety camera location

The graph below details the number of warning letters and infringements issued at this intersection since the camera began operating. The graph also shows the trend in infringements at this location.

Roadworks and camera maintenance may influence the number of infringements issued.

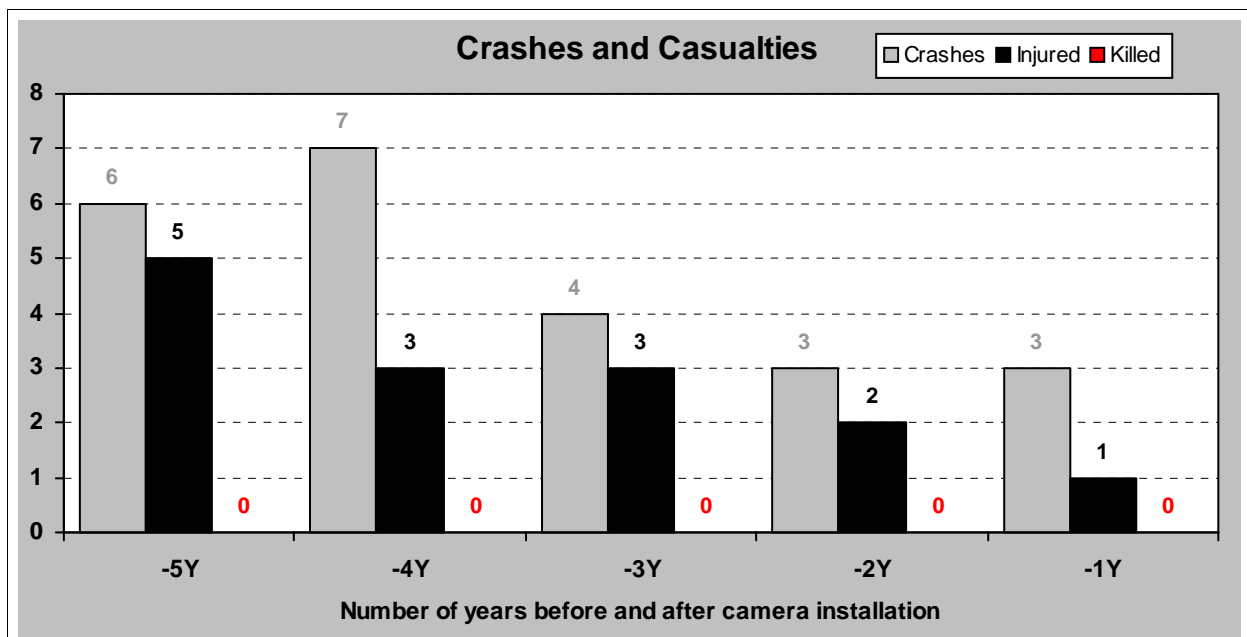
In the 291 day period from installation to the end of 2011, there were 4 crashes resulting in 2 injuries and 0 fatalities.

This represents a 9 per cent increase in the yearly average number of crashes and a 10 per cent reduction in the yearly average number of casualties at this intersection in the period after installation until the end of 2011.

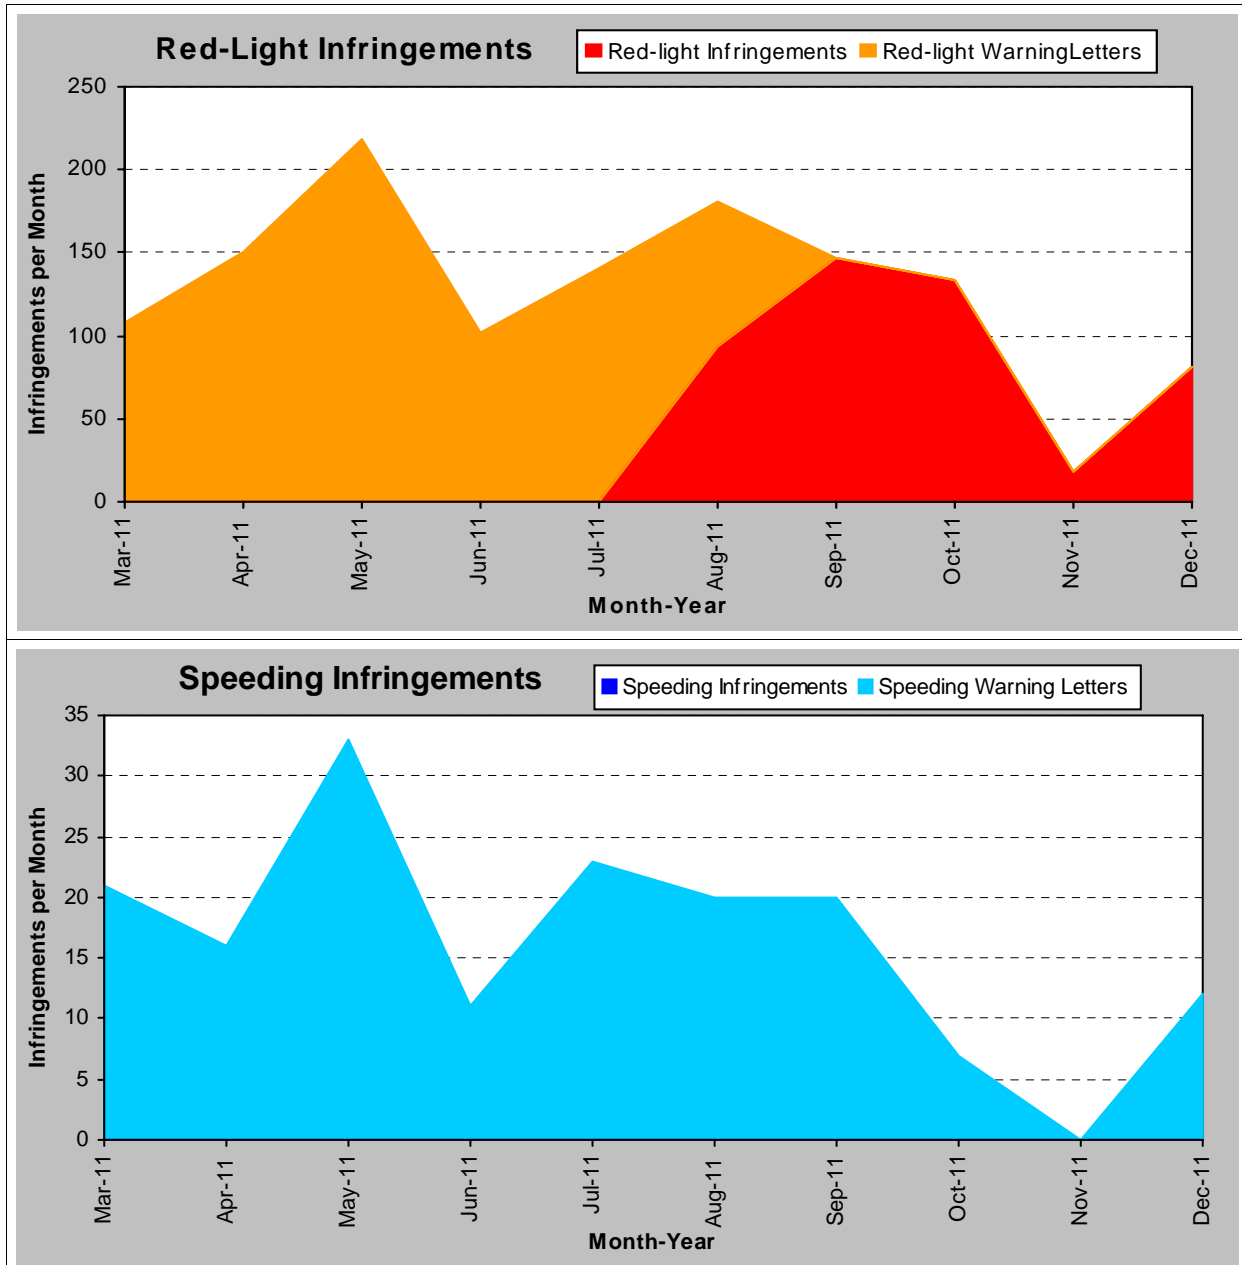
## Infringements at safety camera location

The graph below details the number of warning letters and infringements issued at this intersection since the camera began operating.

Roadworks and camera maintenance may influence the number of infringements issued.

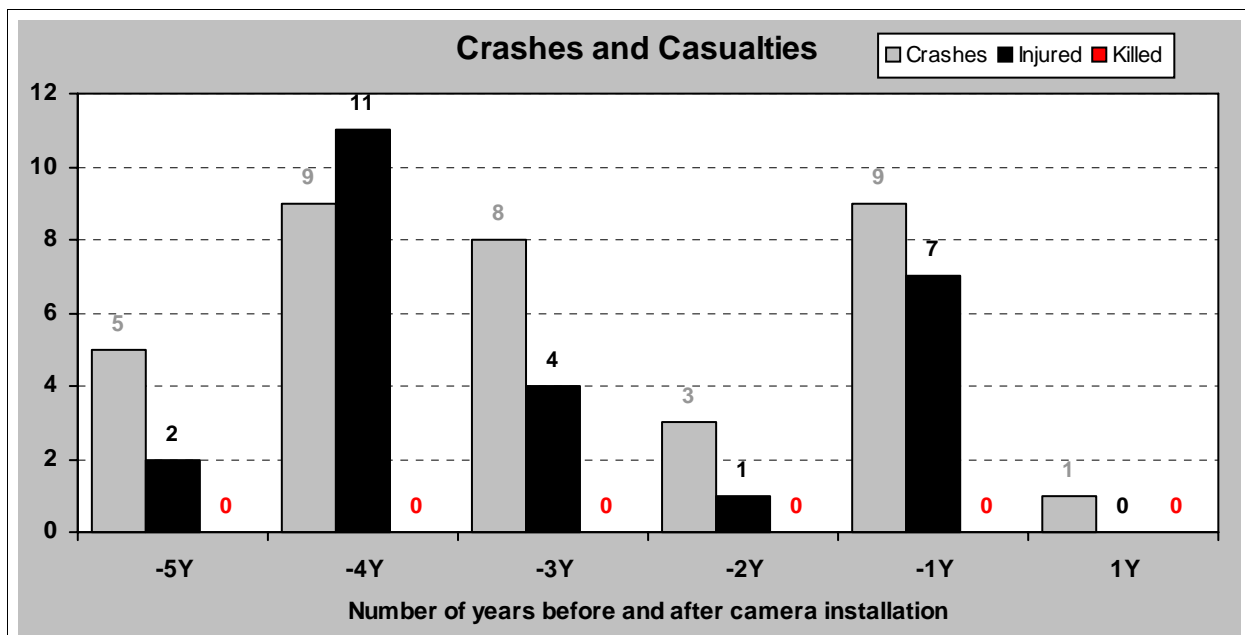
This represents a 79 per cent reduction in the yearly average number of crashes and a 100 per cent reduction in the yearly average number of casualties at this intersection in the period after installation until the end of 2011.

Provisional crash data shows there were 2 crashes resulting in 0 casualties at this intersection in 2011.

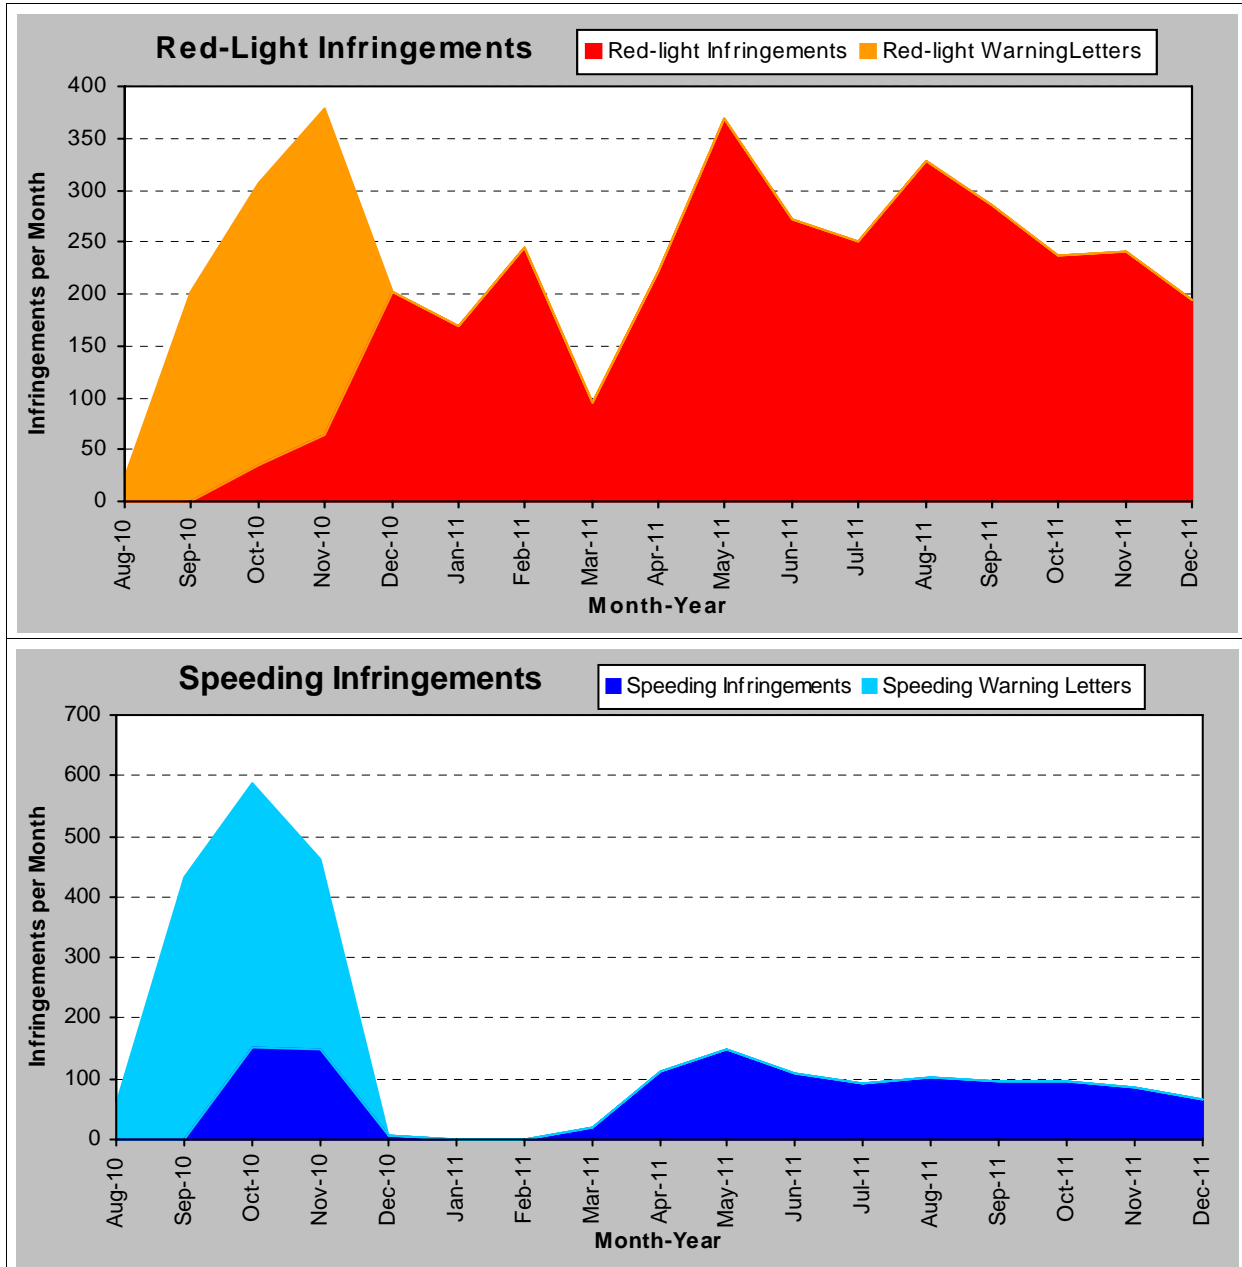
The graph below details the number of warning letters and infringements issued at this intersection since the camera began operating. The graph also shows the trend in infringements at this location.

Roadworks and camera maintenance may influence the number of infringements issued.

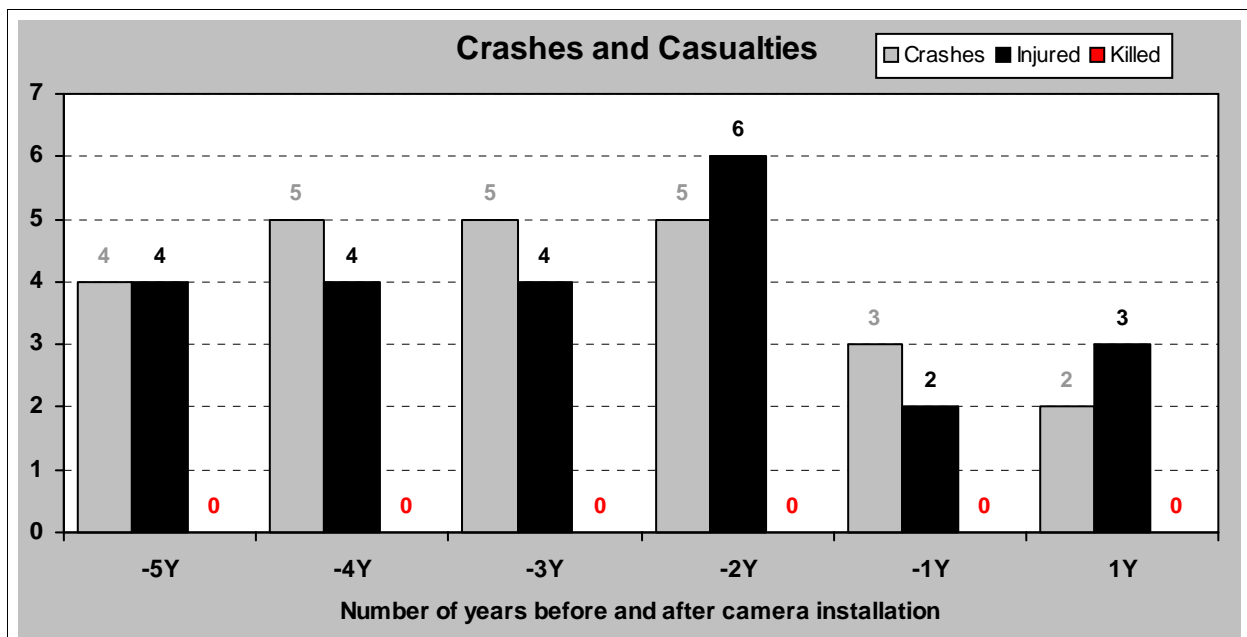
This represents a 57 per cent reduction in the yearly average number of crashes and a 28 per cent reduction in the yearly average number of casualties at this intersection in the period after installation until the end of 2011.

Provisional crash data shows there were 2 crashes resulting in 3 casualties at this intersection in 2011.

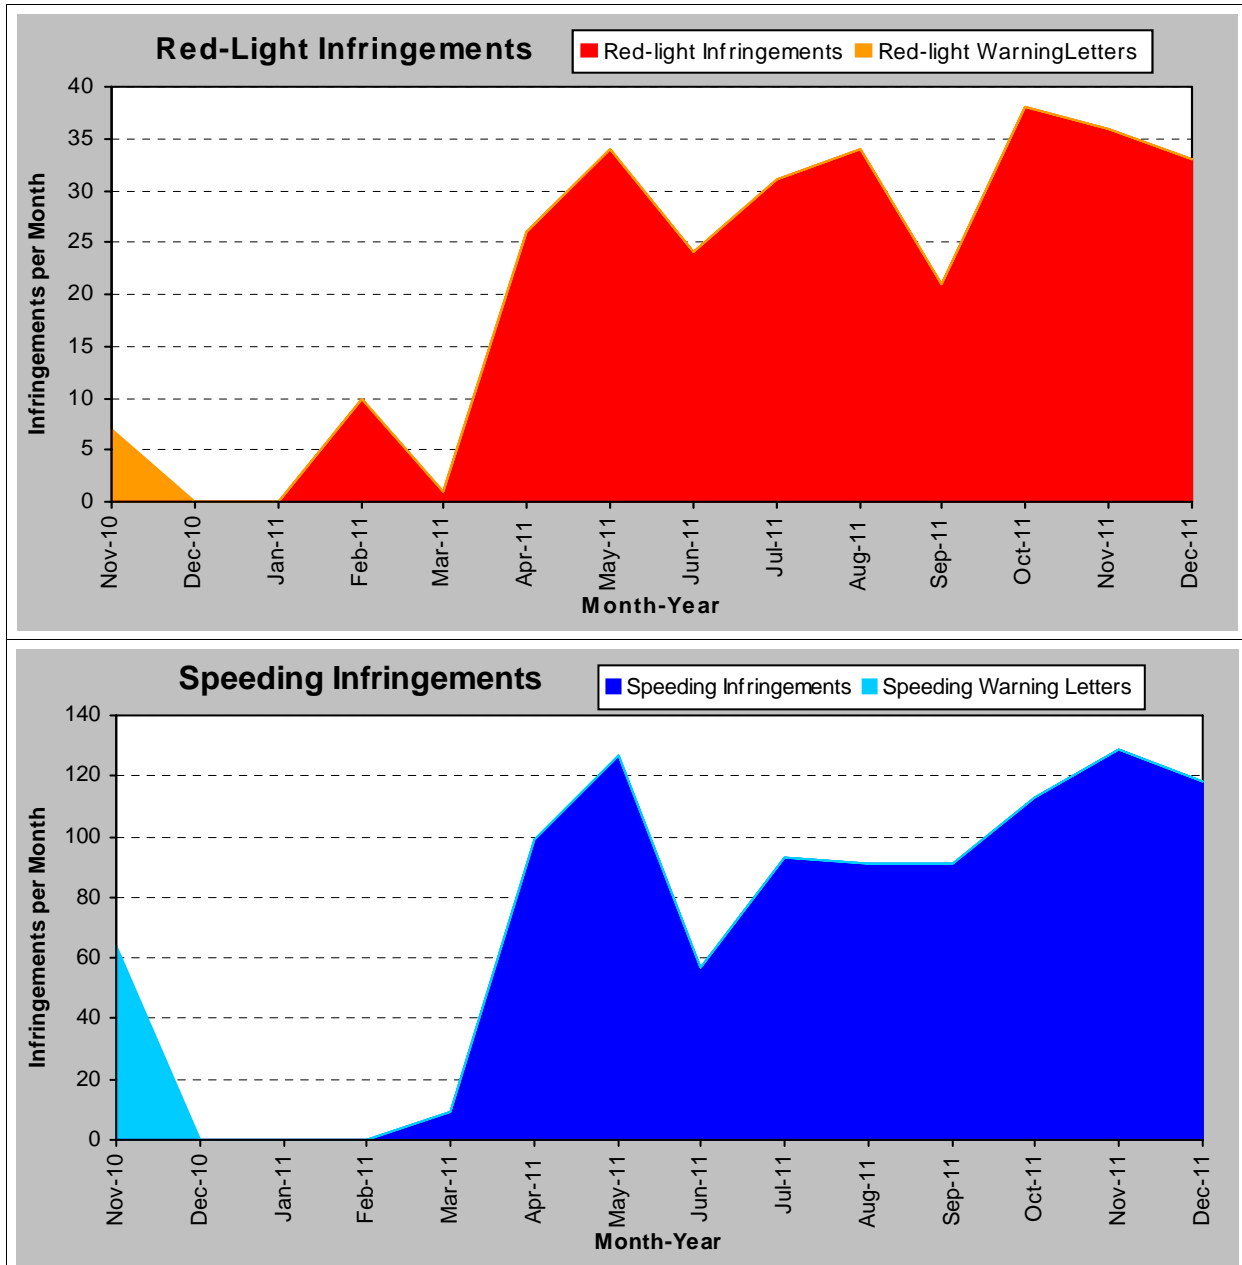
The graph below details the number of warning letters and infringements issued at this intersection since the camera began operating.

Roadworks and camera maintenance may influence the number of infringements issued.

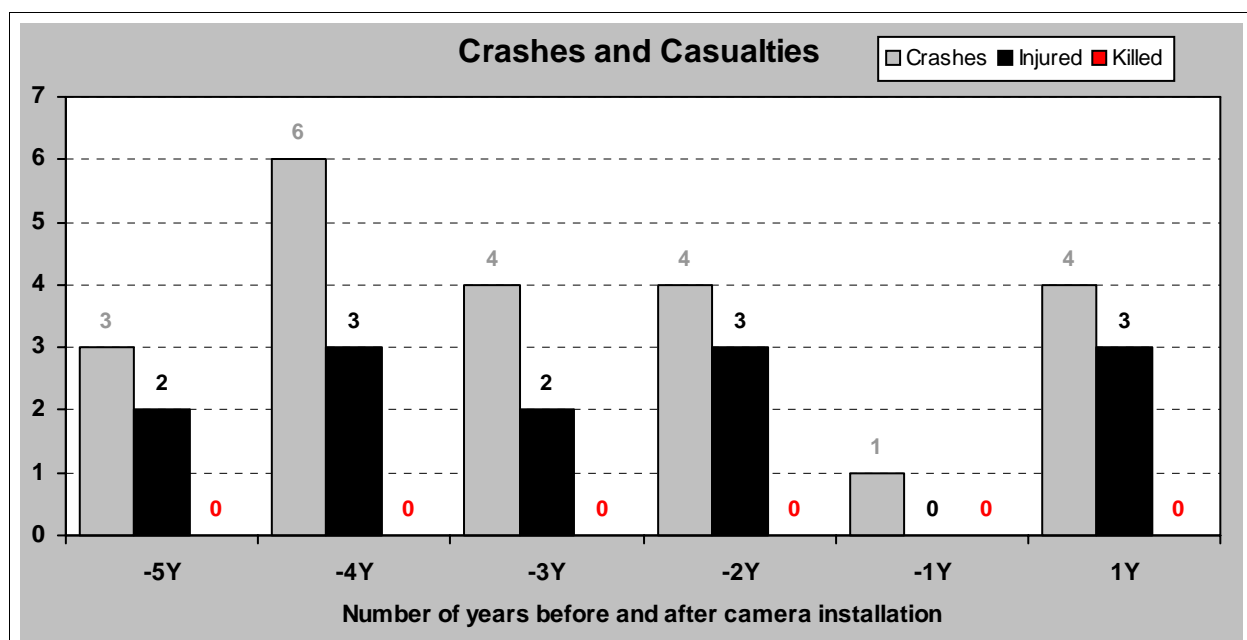
This represents a 6 per cent increase in the yearly average number of crashes and a 43 per cent increase in the yearly average number of casualties at this intersection in the period after installation until the end of 2011.

Provisional crash data shows there were 4 crashes resulting in 3 casualties at this intersection in 2011.

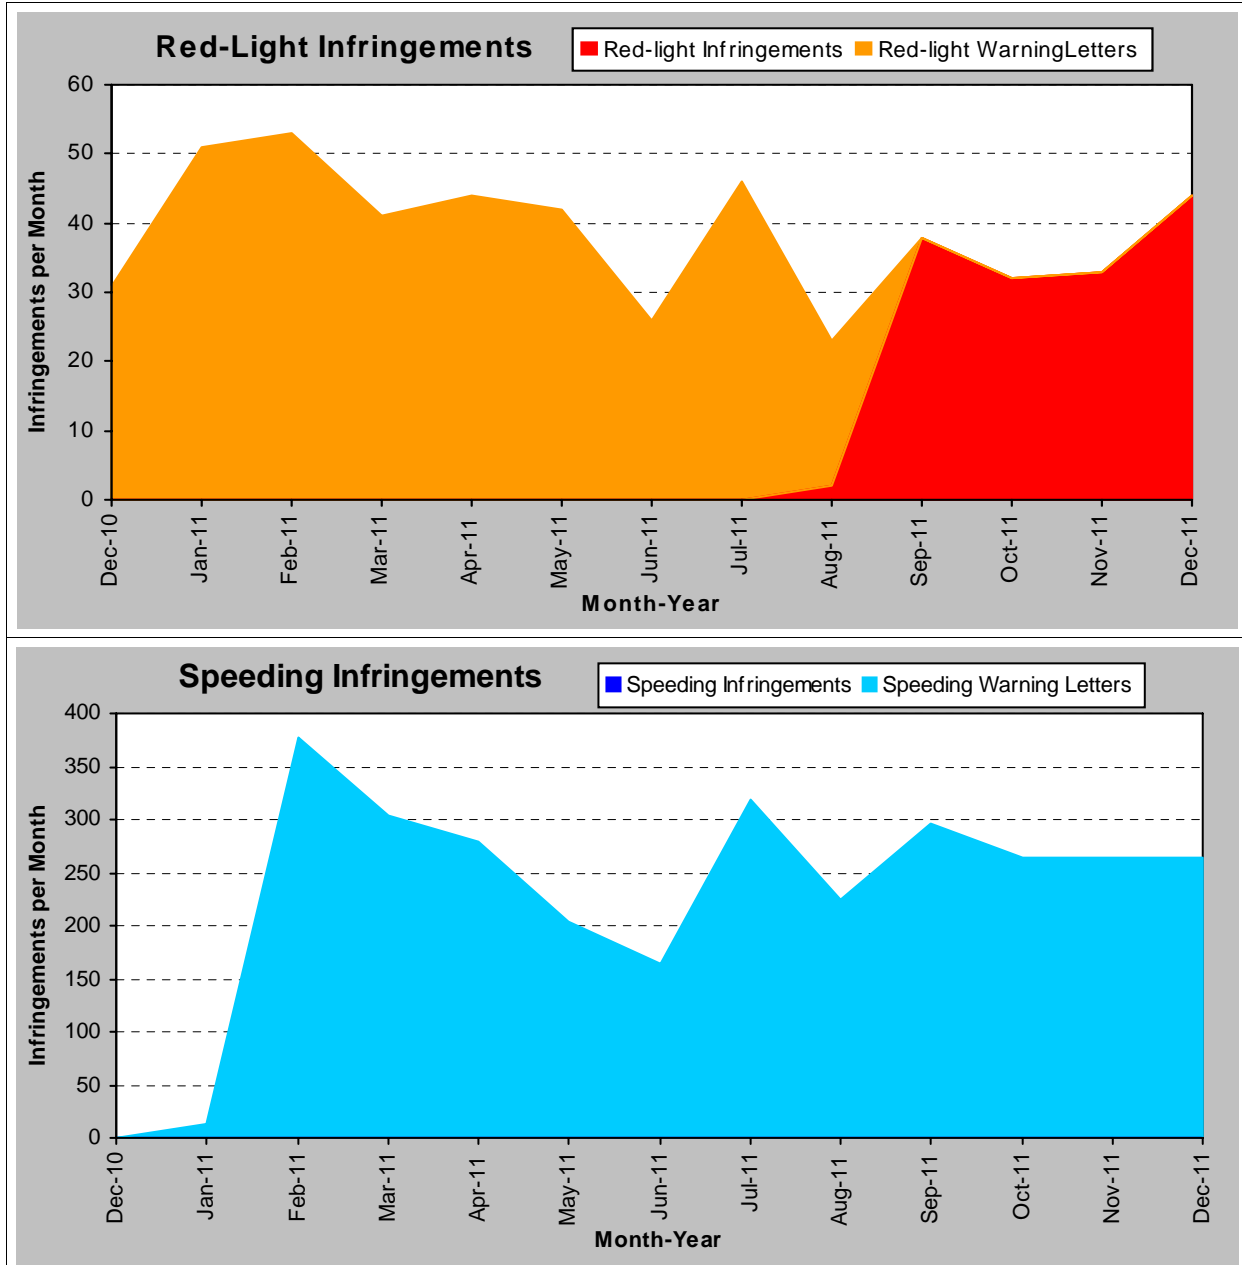
The graph below details the number of warning letters and infringements issued at this intersection since the camera began operating.

Roadworks and camera maintenance may influence the number of infringements issued.

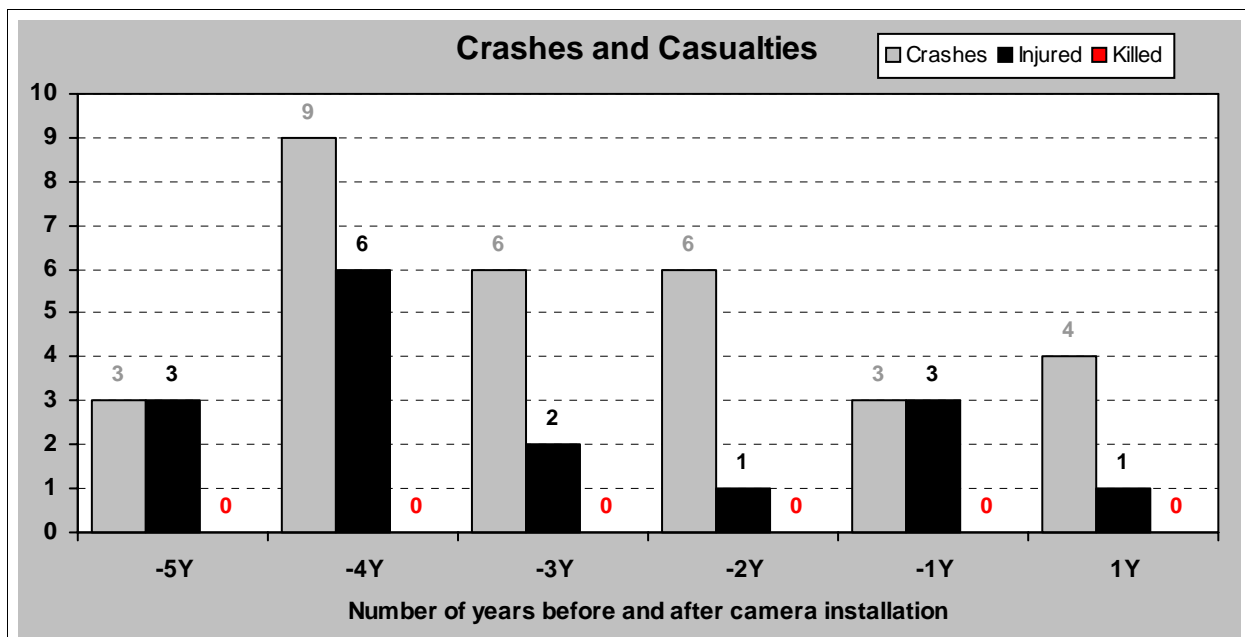
This represents a 2 per cent reduction in the yearly average number of crashes and a 41 per cent reduction in the yearly average number of casualties at this intersection in the period after installation until the end of 2011.

Provisional crash data shows there were 6 crashes resulting in 2 casualties at this intersection in 2011.

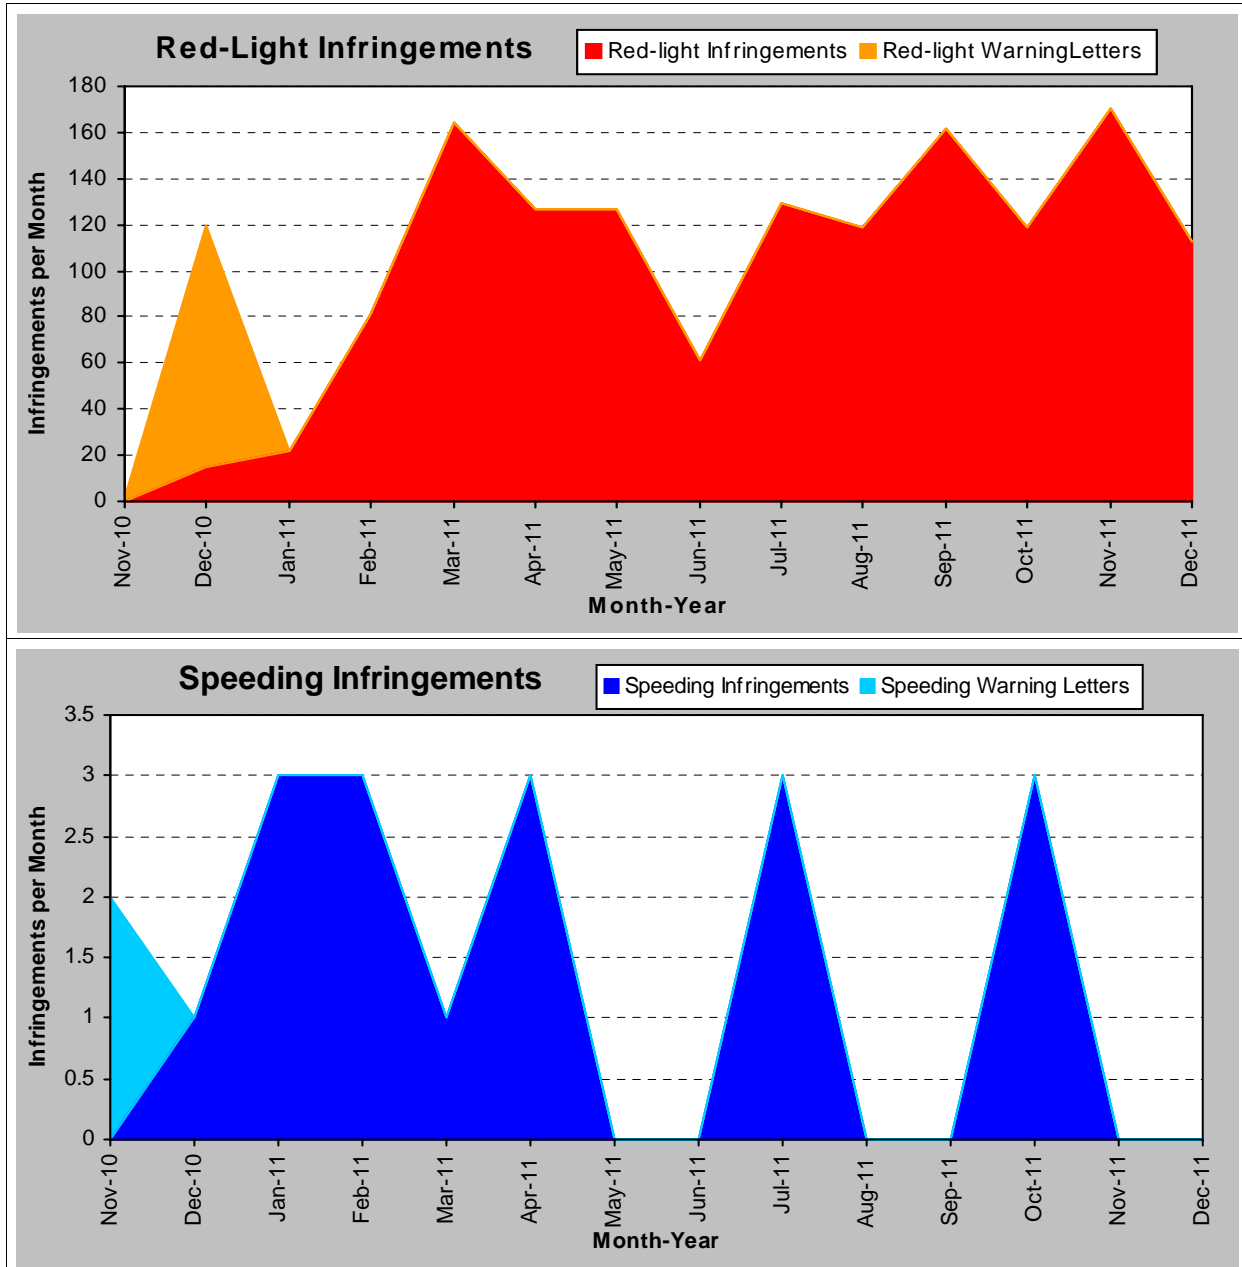
The graph below details the number of warning letters and infringements issued at this intersection since the camera began operating. The graph also shows the trend in infringements at this location.

Roadworks and camera maintenance may influence the number of infringements issued.

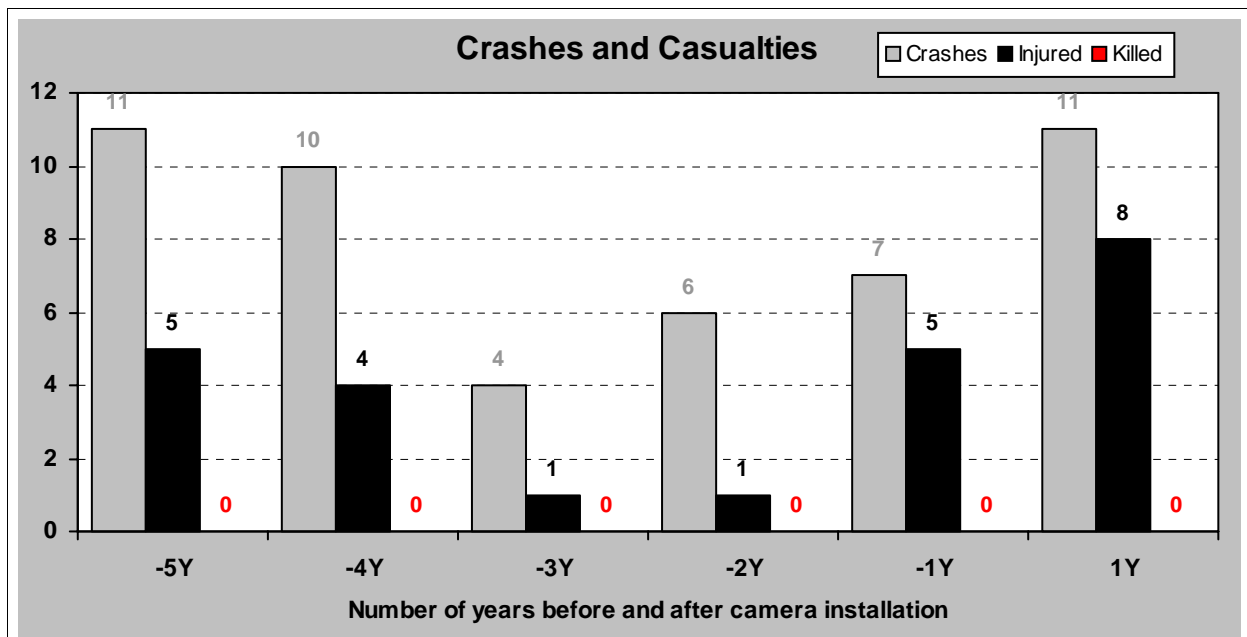
This represents a 38 per cent increase in the yearly average number of crashes and a 139 per cent increase in the yearly average number of casualties at this intersection in the period after installation until the end of 2011.

Provisional crash data shows there were 10 crashes resulting in 7 casualties at this intersection in 2011.

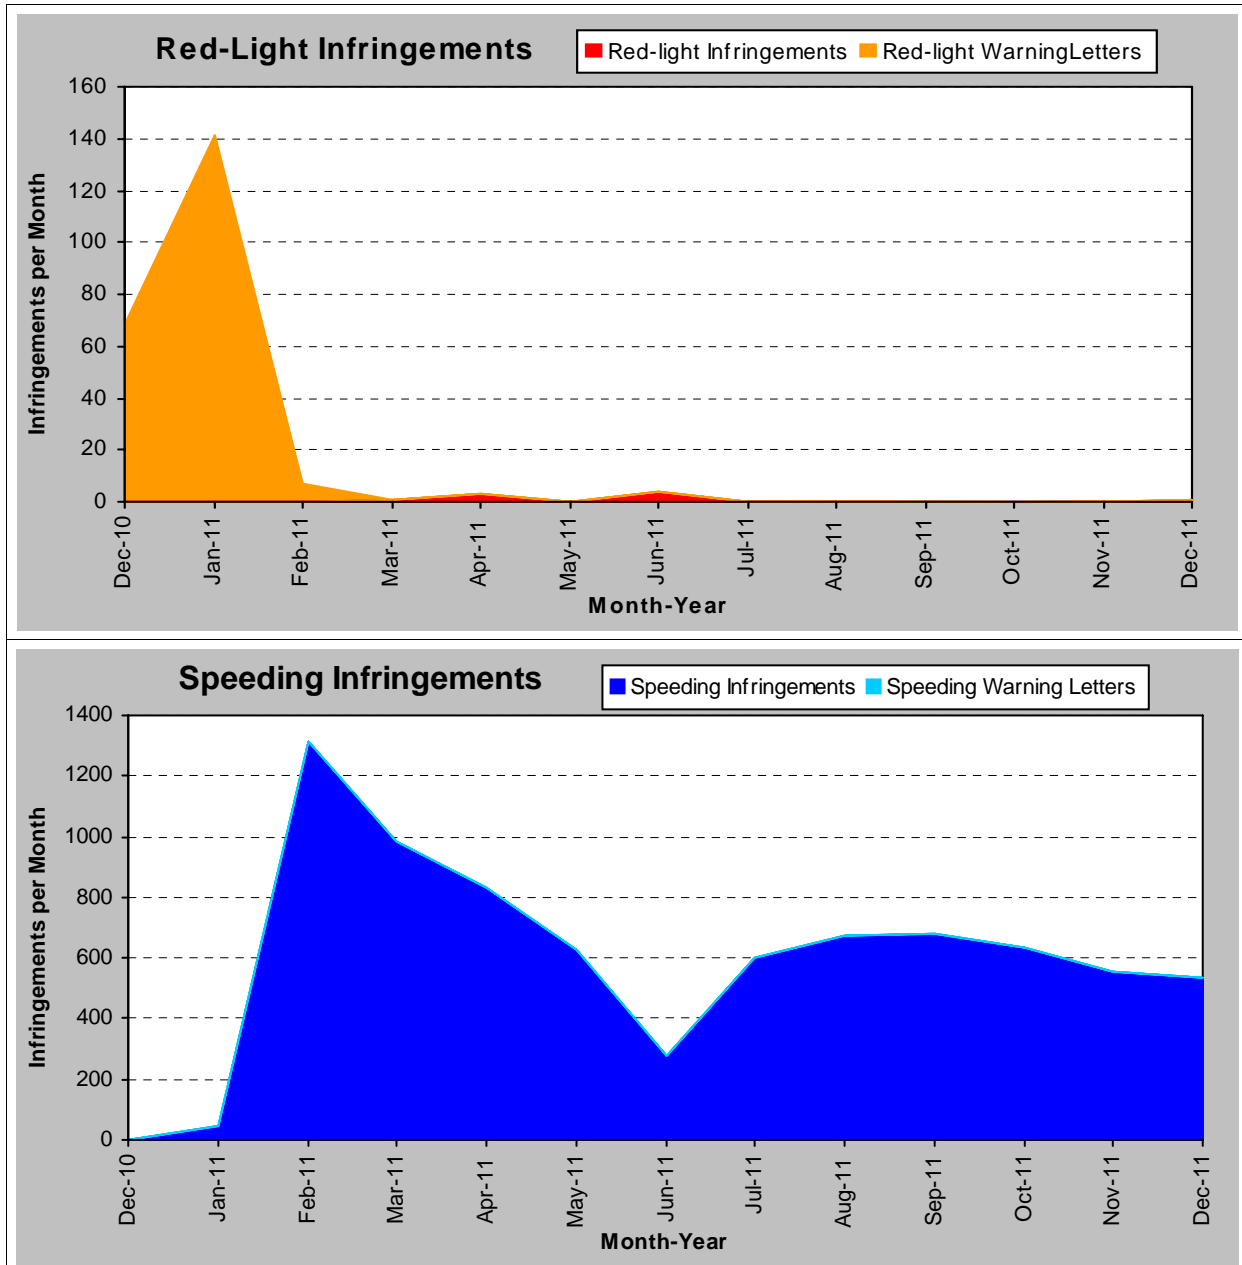
The graph below details the number of warning letters and infringements issued at this intersection since the camera began operating.

Roadworks and camera maintenance may influence the number of infringements issued.
