# ANNUAL NSW SPEED CAMERA PERFORMANCE REVIEW

NSW Centre for Road Safety

JULY 2012

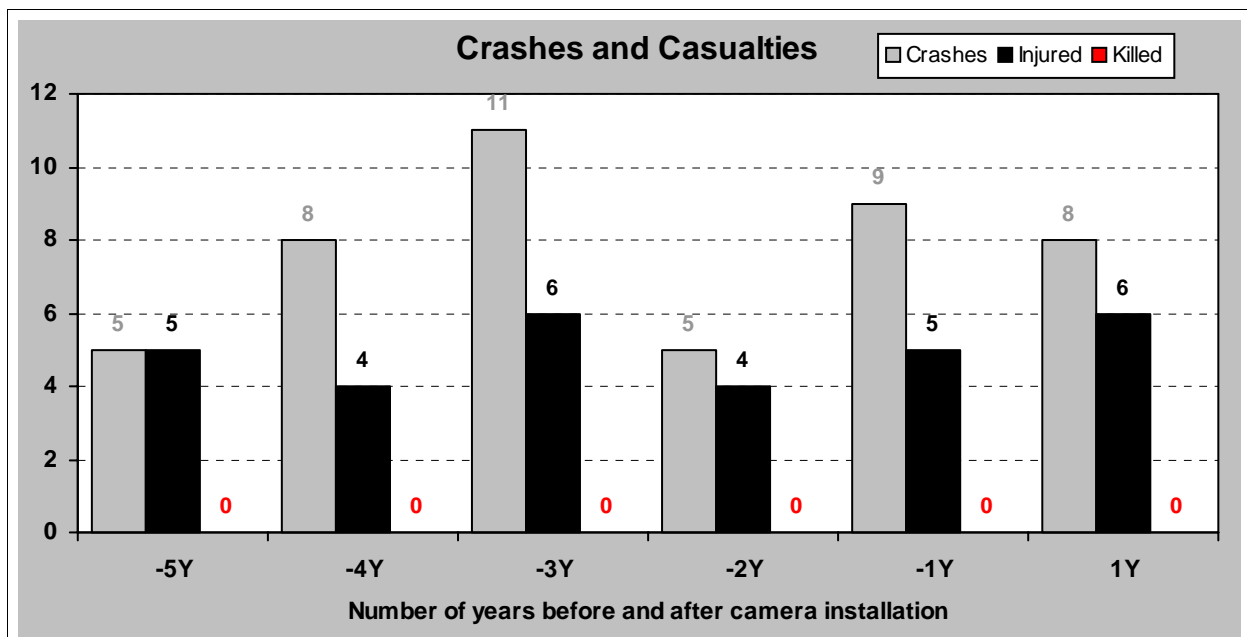
This represents a 1 per cent reduction in the yearly average number of crashes and a 4 per cent increase in the yearly average number of casualties at this intersection in the period after installation until the end of 2011.

Provisional crash data shows there were 8 crashes resulting in 5 casualties at this intersection in 2011.

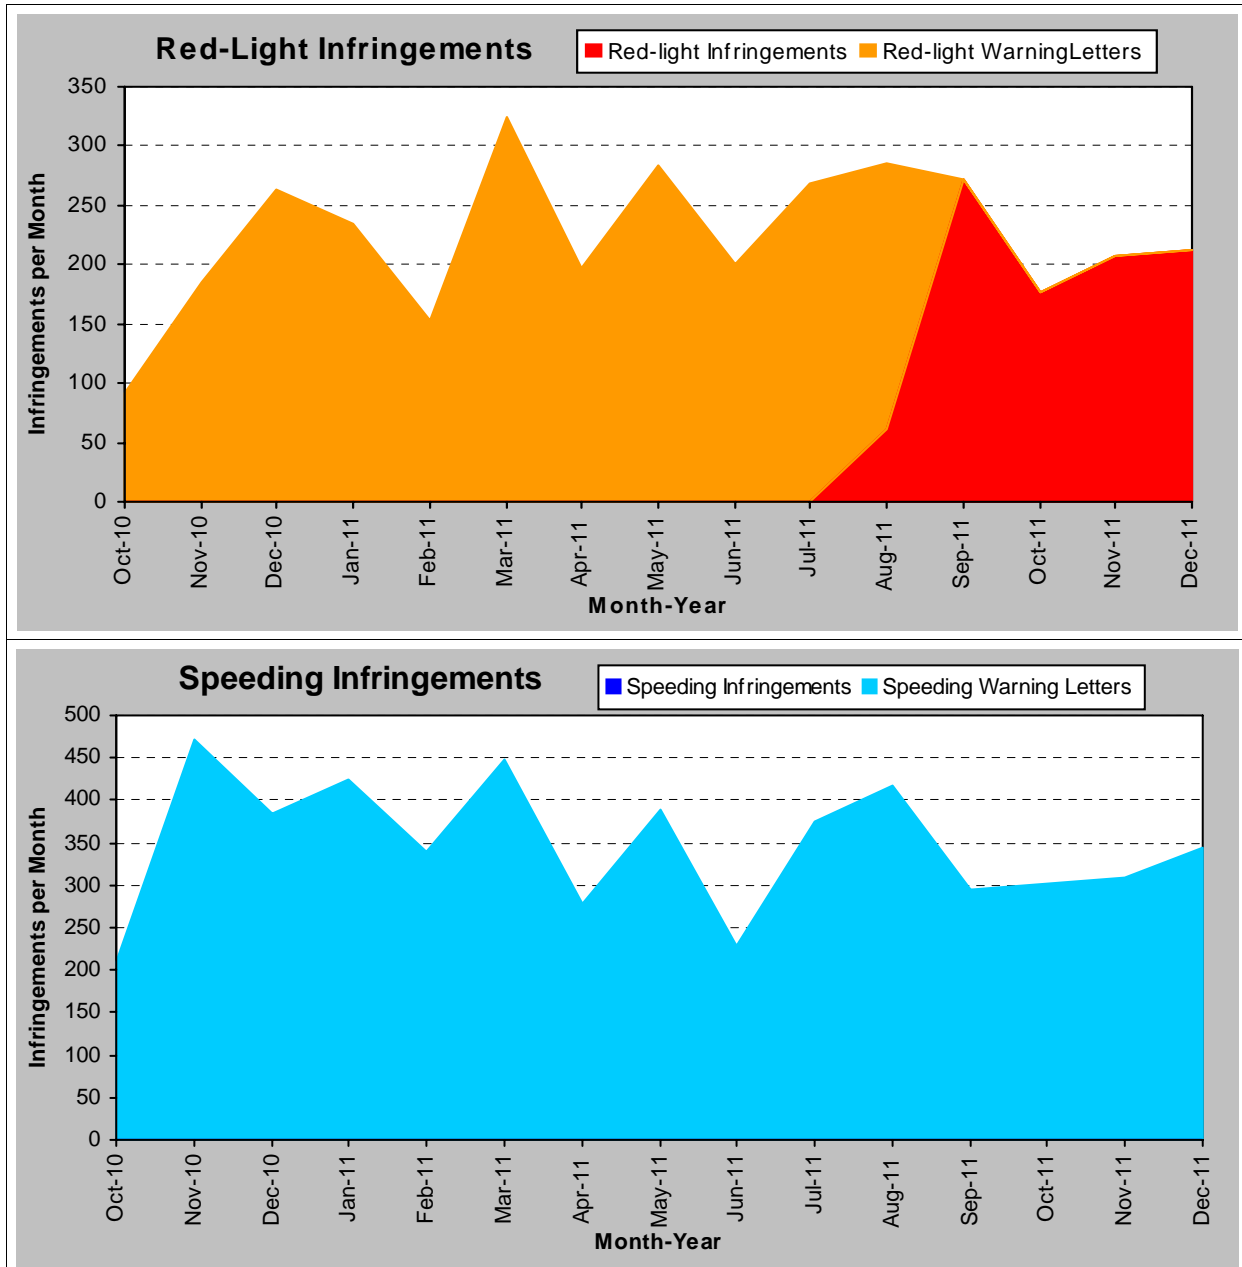
The graph below details the number of warning letters and infringements issued at this intersection since the camera began operating.

Roadworks and camera maintenance may influence the number of infringements issued.

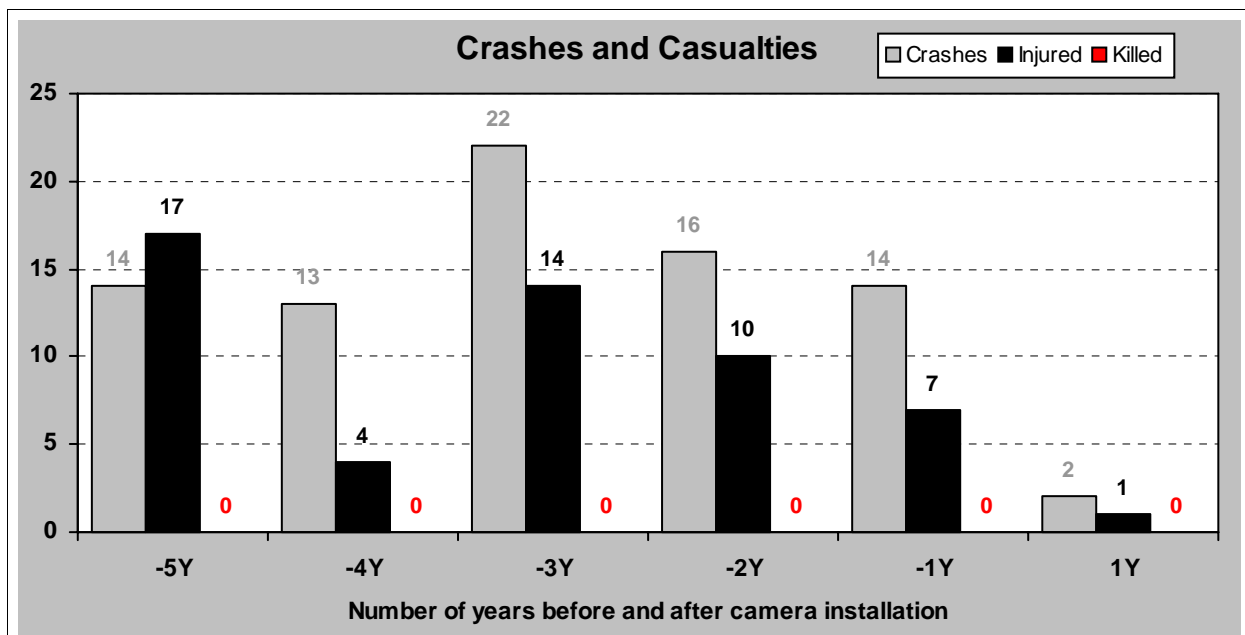
This represents a 75 per cent reduction in the yearly average number of crashes and a 68 per cent reduction in the yearly average number of casualties at this intersection in the period after installation until the end of 2011.

Provisional crash data shows there were 5 crashes resulting in 5 casualties at this intersection in 2011.

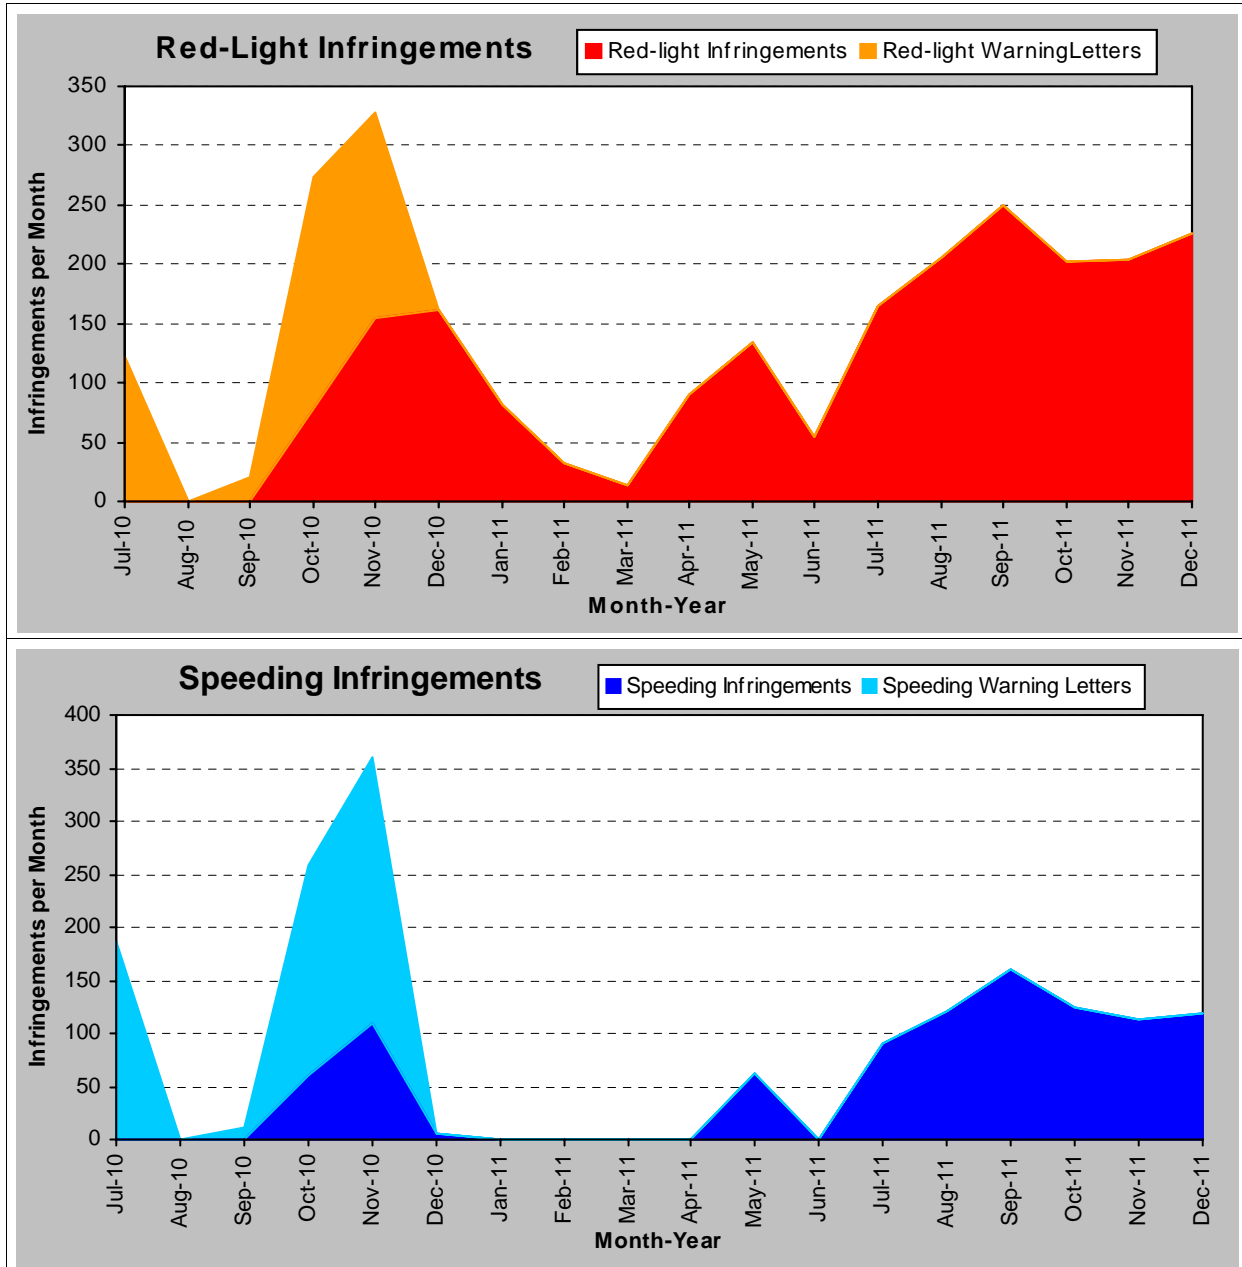
The graph below details the number of warning letters and infringements issued at this intersection since the camera began operating. The graph also shows the trend in infringements at this location.

Roadworks and camera maintenance may influence the number of infringements issued.

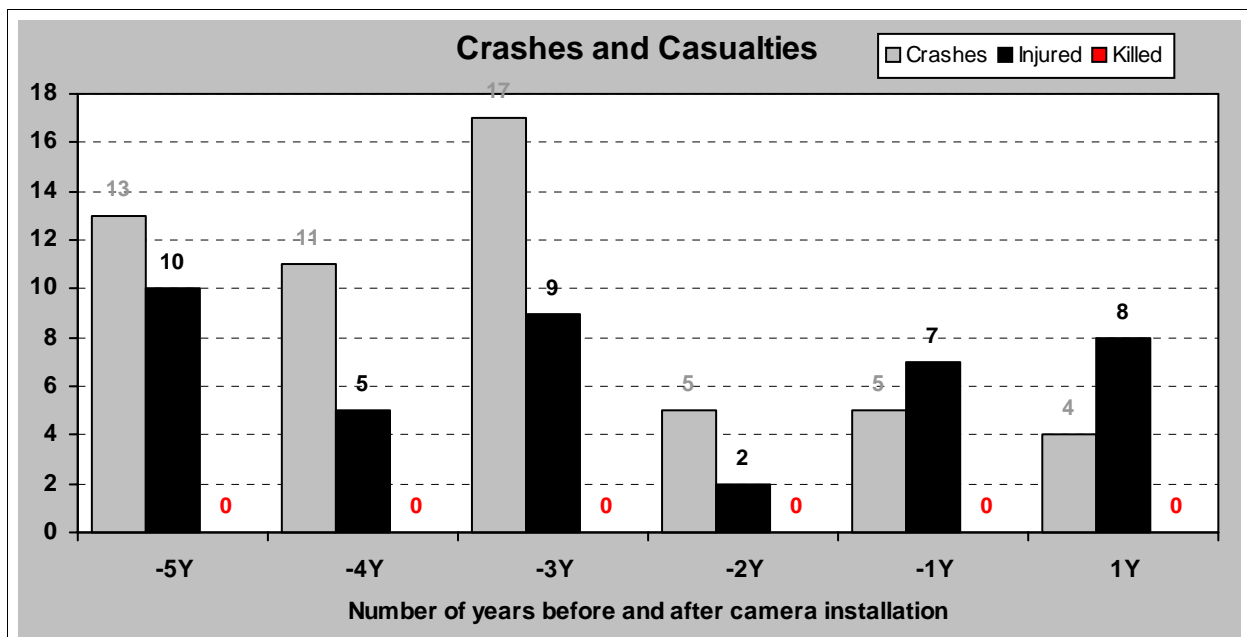
This represents a 48 per cent reduction in the yearly average number of crashes and a 20 per cent reduction in the yearly average number of casualties at this intersection in the period after installation until the end of 2011.

Provisional crash data shows there were 6 crashes resulting in 6 casualties at this intersection in 2011.

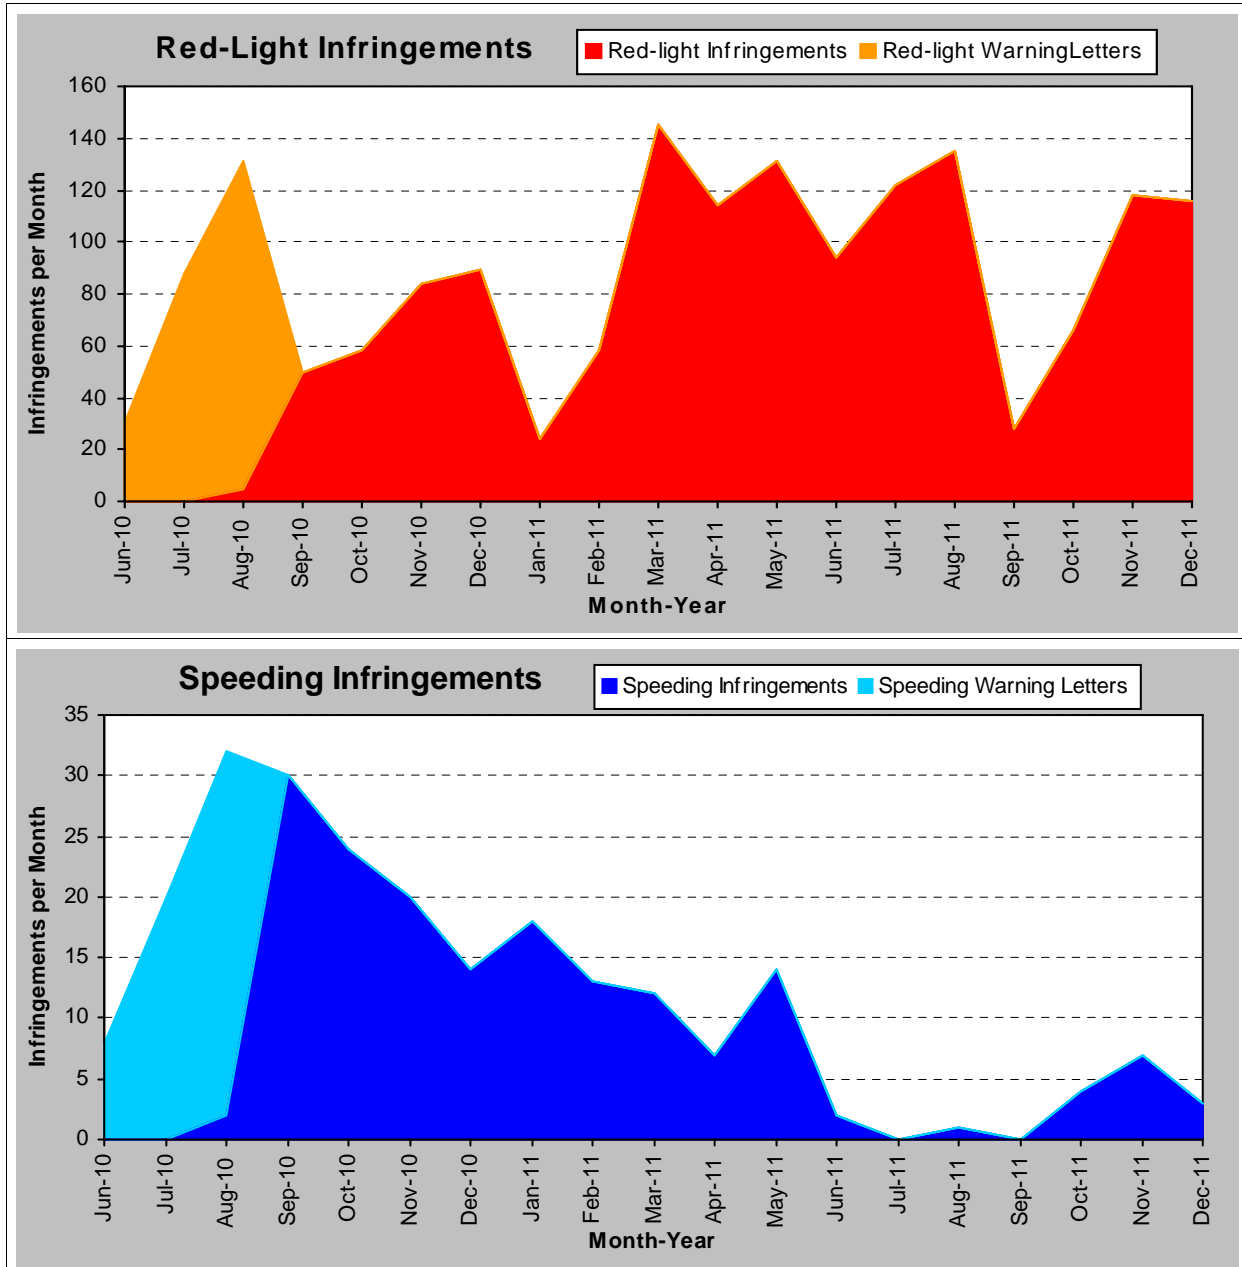
The graph below details the number of warning letters and infringements issued at this intersection since the camera began operating. The graph also shows the trend in infringements at this location.

Roadworks and camera maintenance may influence the number of infringements issued.

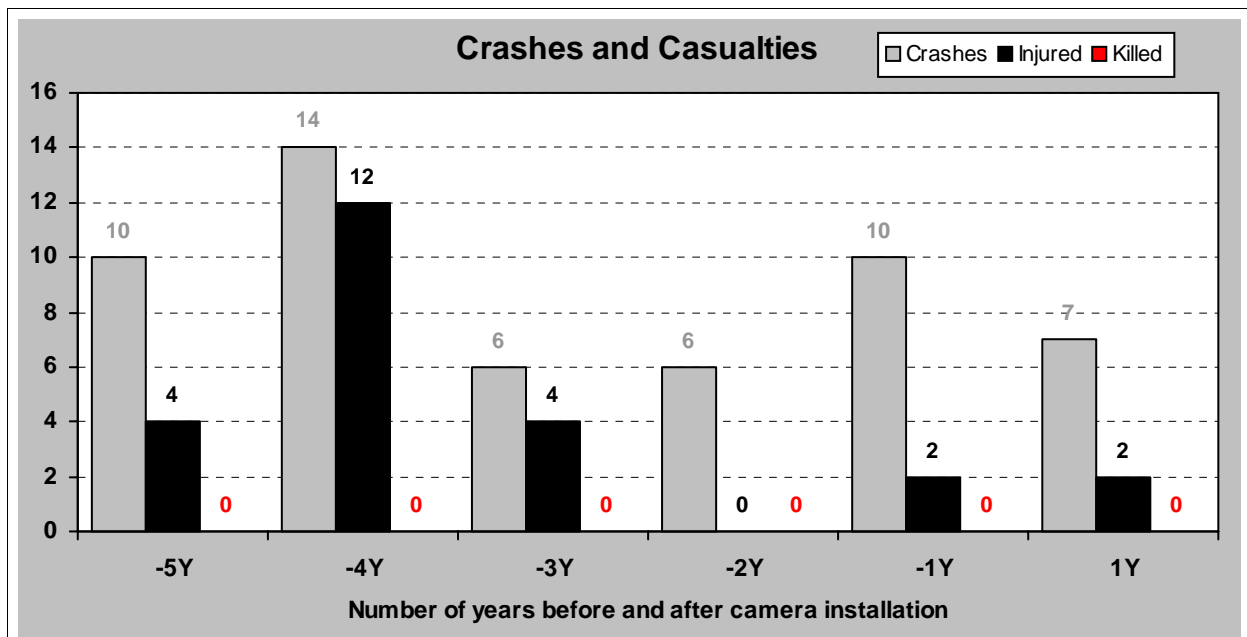
This represents a 43 per cent reduction in the yearly average number of crashes and a 66 per cent reduction in the yearly average number of casualties at this intersection in the period after installation until the end of 2011.

Provisional crash data shows there were 4 crashes resulting in 2 casualties at this intersection in 2011.

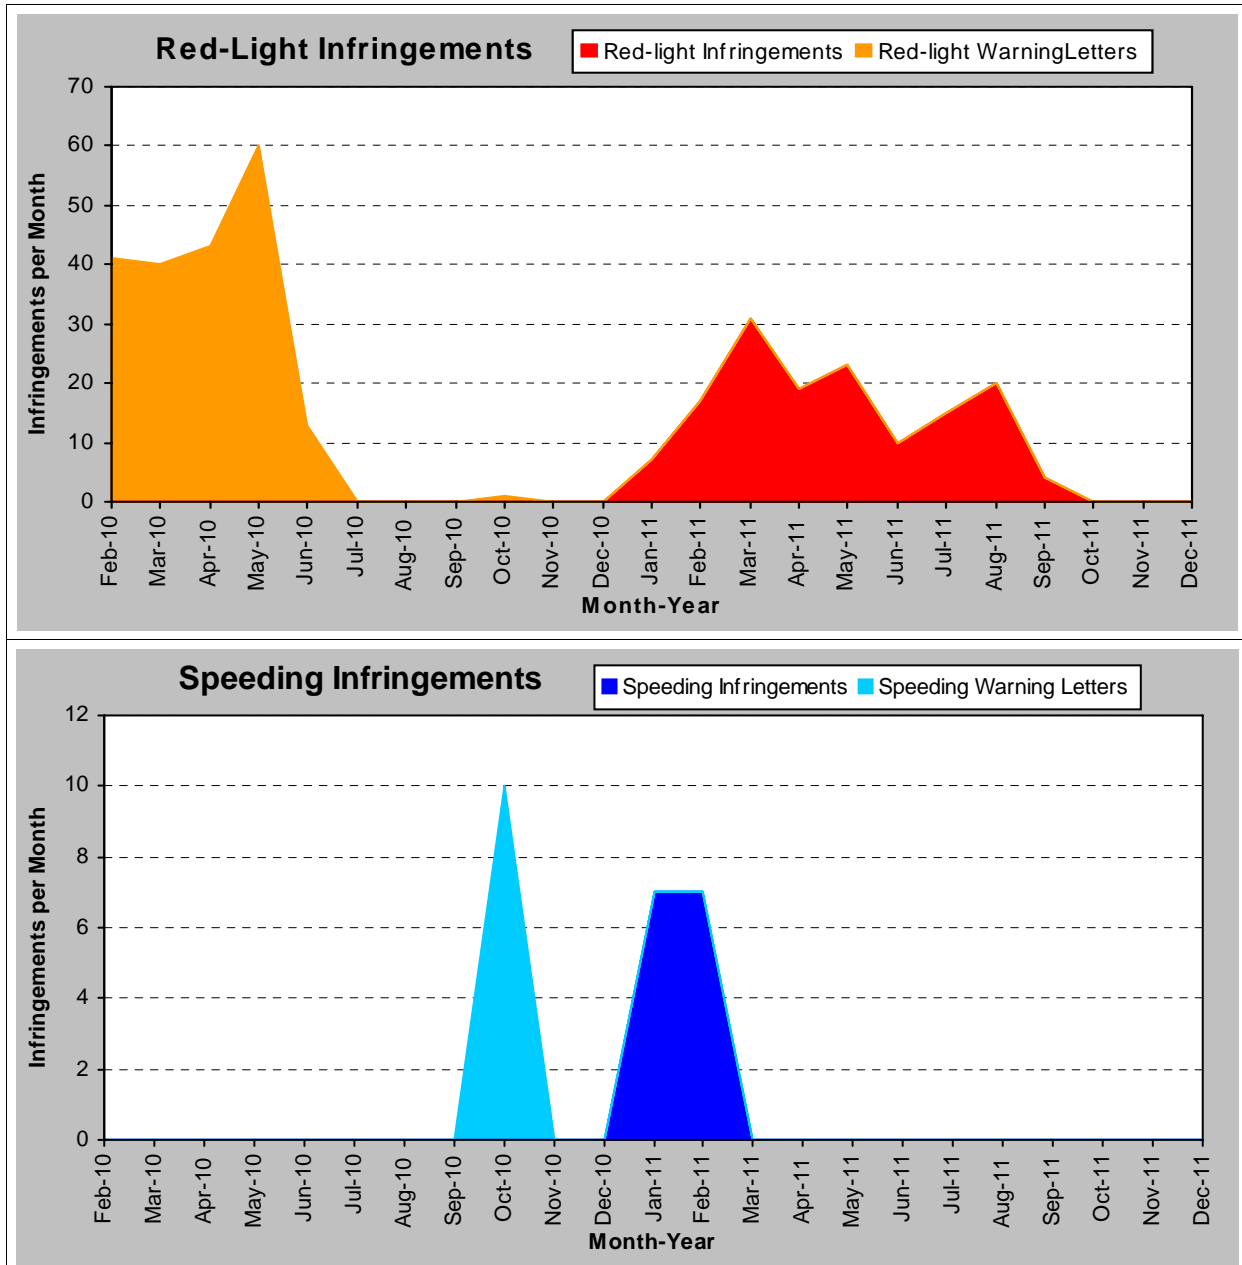
The graph below details the number of warning letters and infringements issued at this intersection since the camera began operating.

Roadworks and camera maintenance may influence the number of infringements issued.

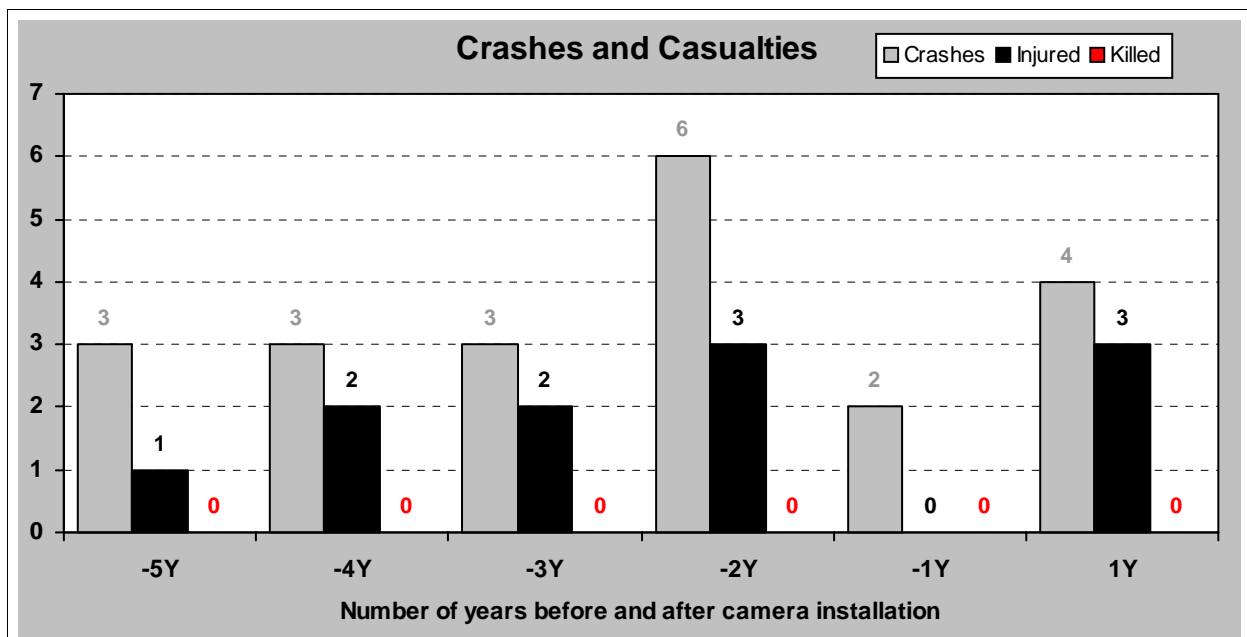
This represents a 28 per cent increase in the yearly average number of crashes and a 64 per cent increase in the yearly average number of casualties at this intersection in the period after installation until the end of 2011.

Provisional crash data shows there were 5 crashes resulting in 3 casualties at this intersection in 2011.

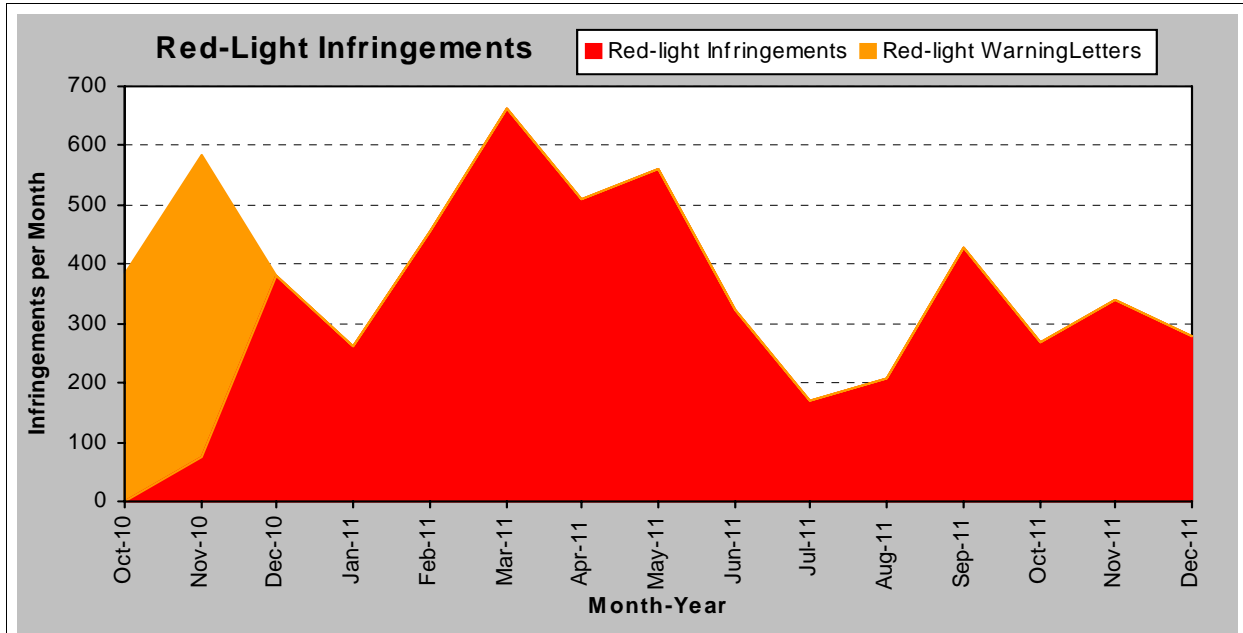
The graph below details the number of warning letters and infringements issued at this intersection since the camera began operating. The graph also shows the trend in infringements at this location.

Roadworks and camera maintenance may influence the number of infringements issued.

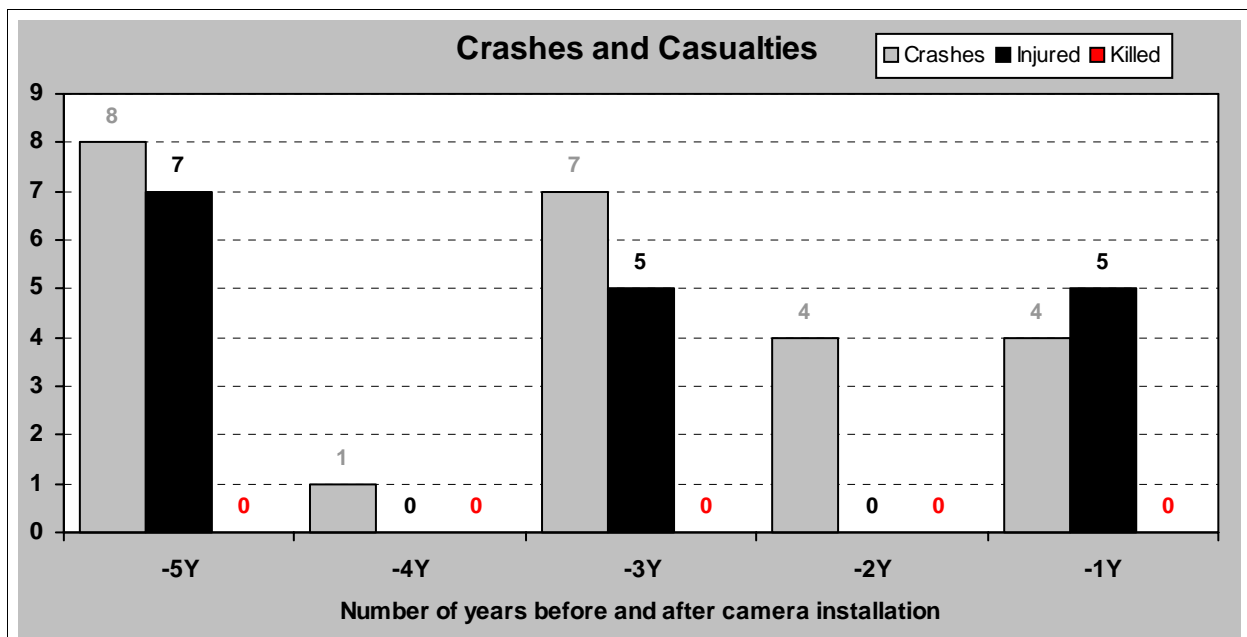
In the 194 day period from installation to the end of 2011, there was 1 crash resulting in 0 injuries and 0 fatalities.

This represents a 61 per cent reduction in the yearly average number of crashes and a 100 per cent reduction in the yearly average number of casualties at this intersection in the period after installation until the end of 2011.

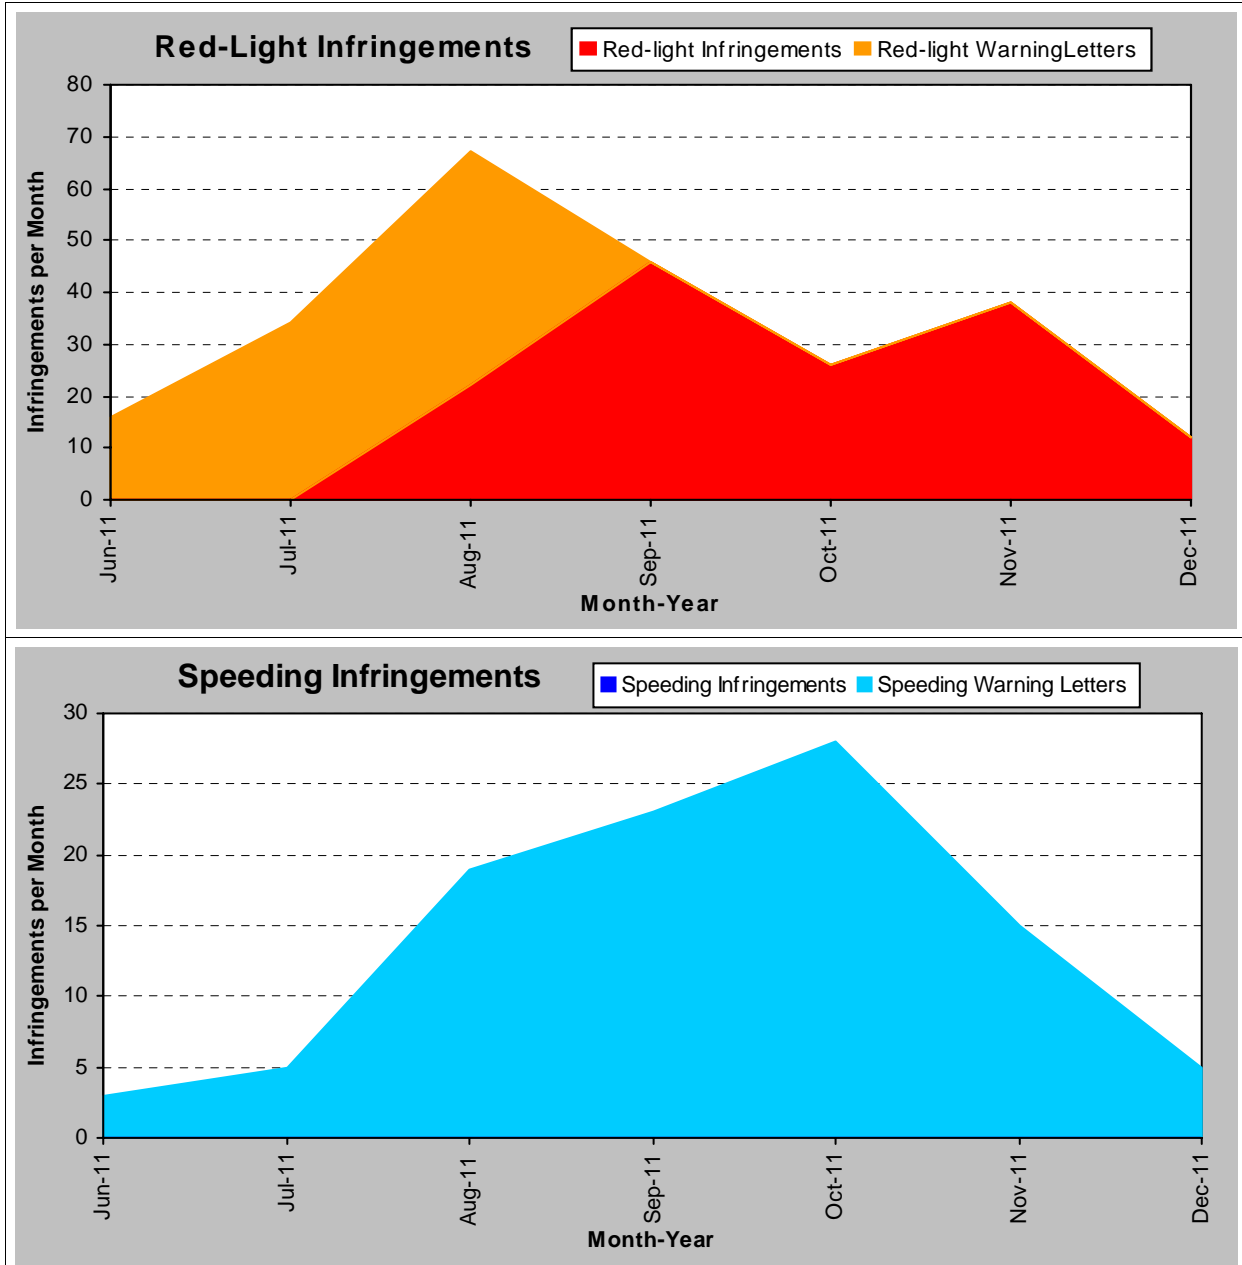
The graph below details the number of warning letters and infringements issued at this intersection since the camera began operating.

Roadworks and camera maintenance may influence the number of infringements issued.

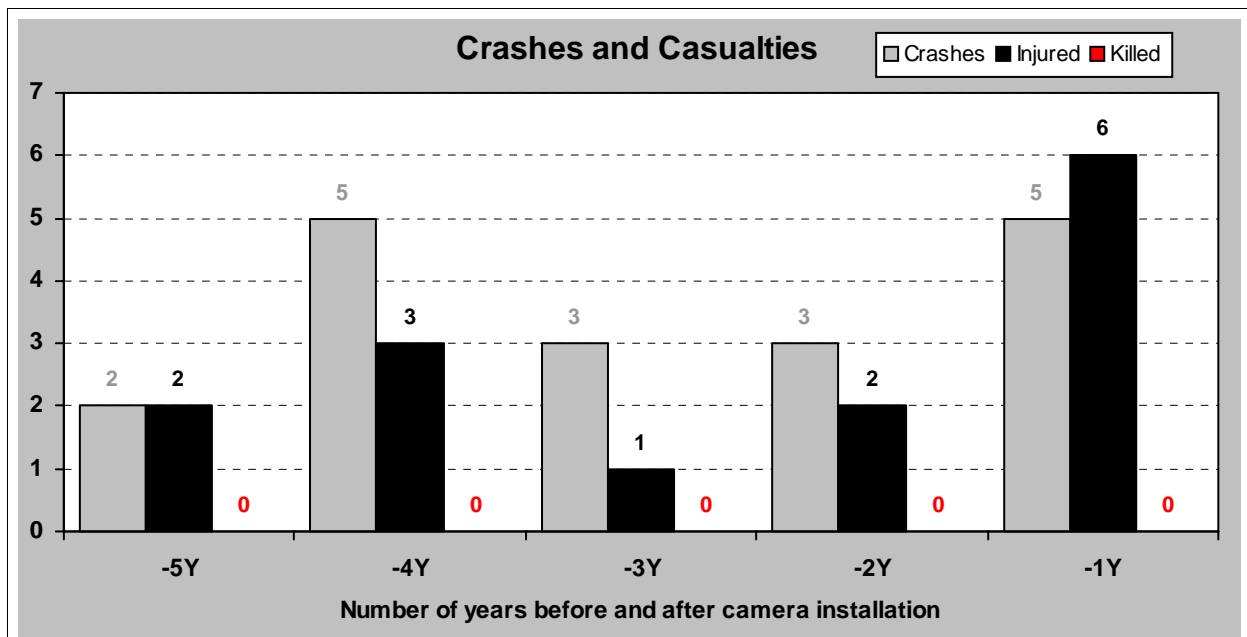
In the 205 day period from installation to the end of 2011, there was 1 crash resulting in 1 injury and 0 fatalities.

This represents a 51 per cent reduction in the yearly average number of crashes and a 36 per cent reduction in the yearly average number of casualties at this intersection in the period after installation until the end of 2011.

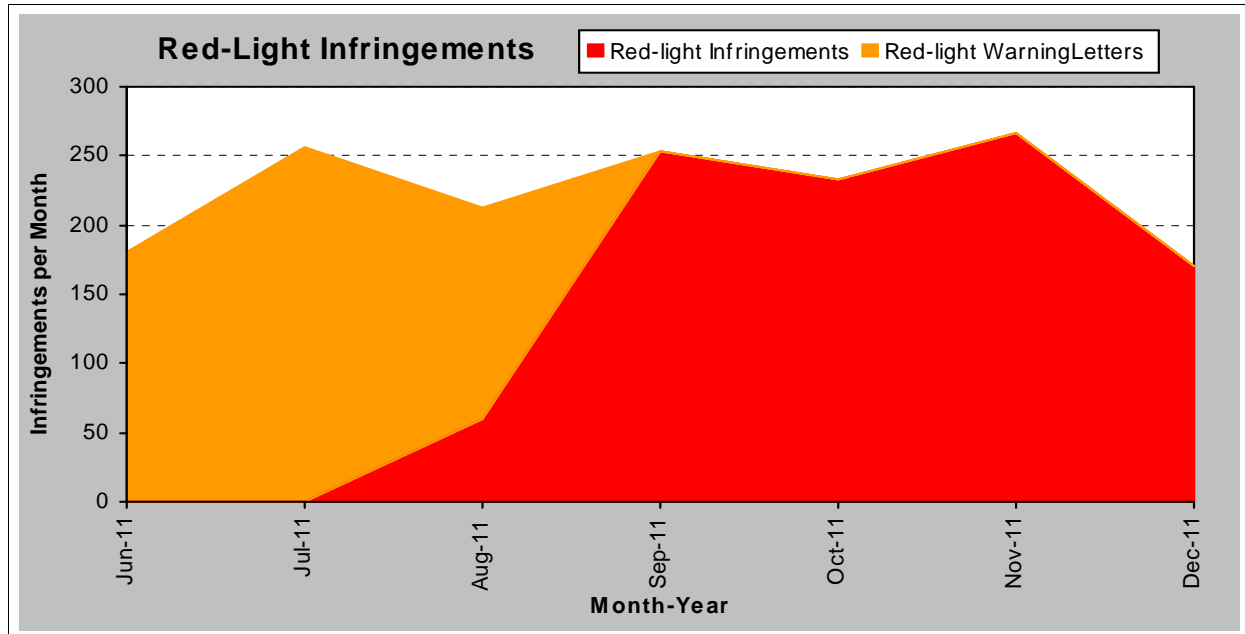
The graph below details the number of warning letters and infringements issued at this intersection since the camera began operating.

Roadworks and camera maintenance may influence the number of infringements issued.

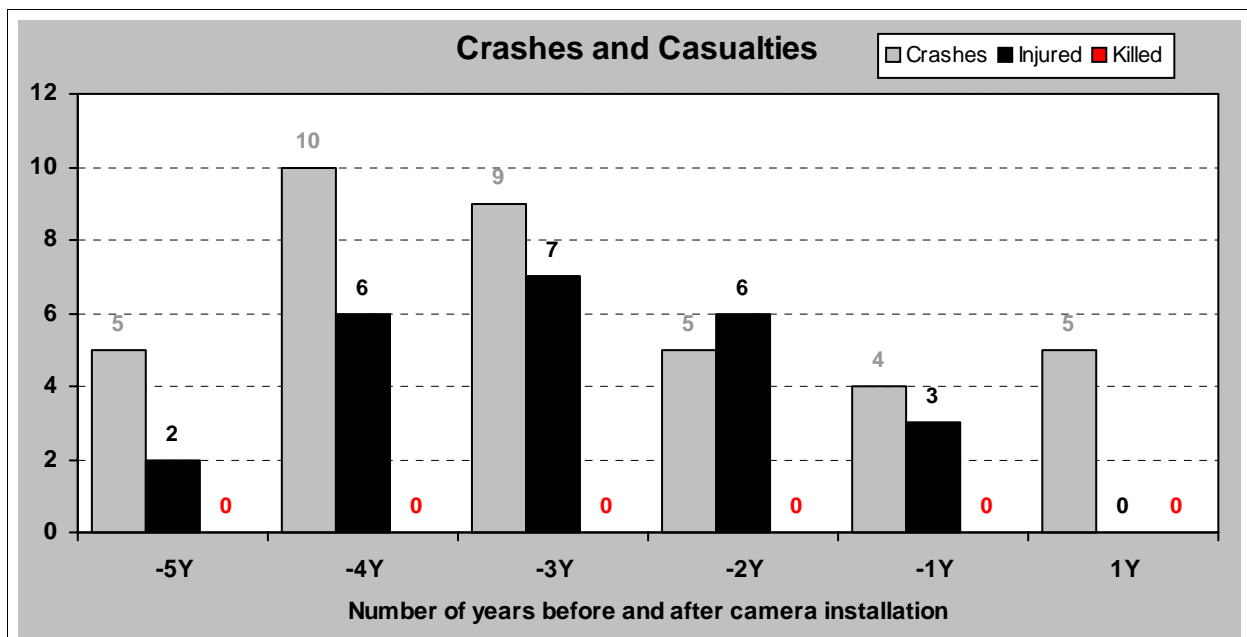
This represents a 7 per cent reduction in the yearly average number of crashes and a 63 per cent reduction in the yearly average number of casualties at this intersection in the period after installation until the end of 2011.

Provisional crash data shows there were 7 crashes resulting in 2 casualties at this intersection in 2011.

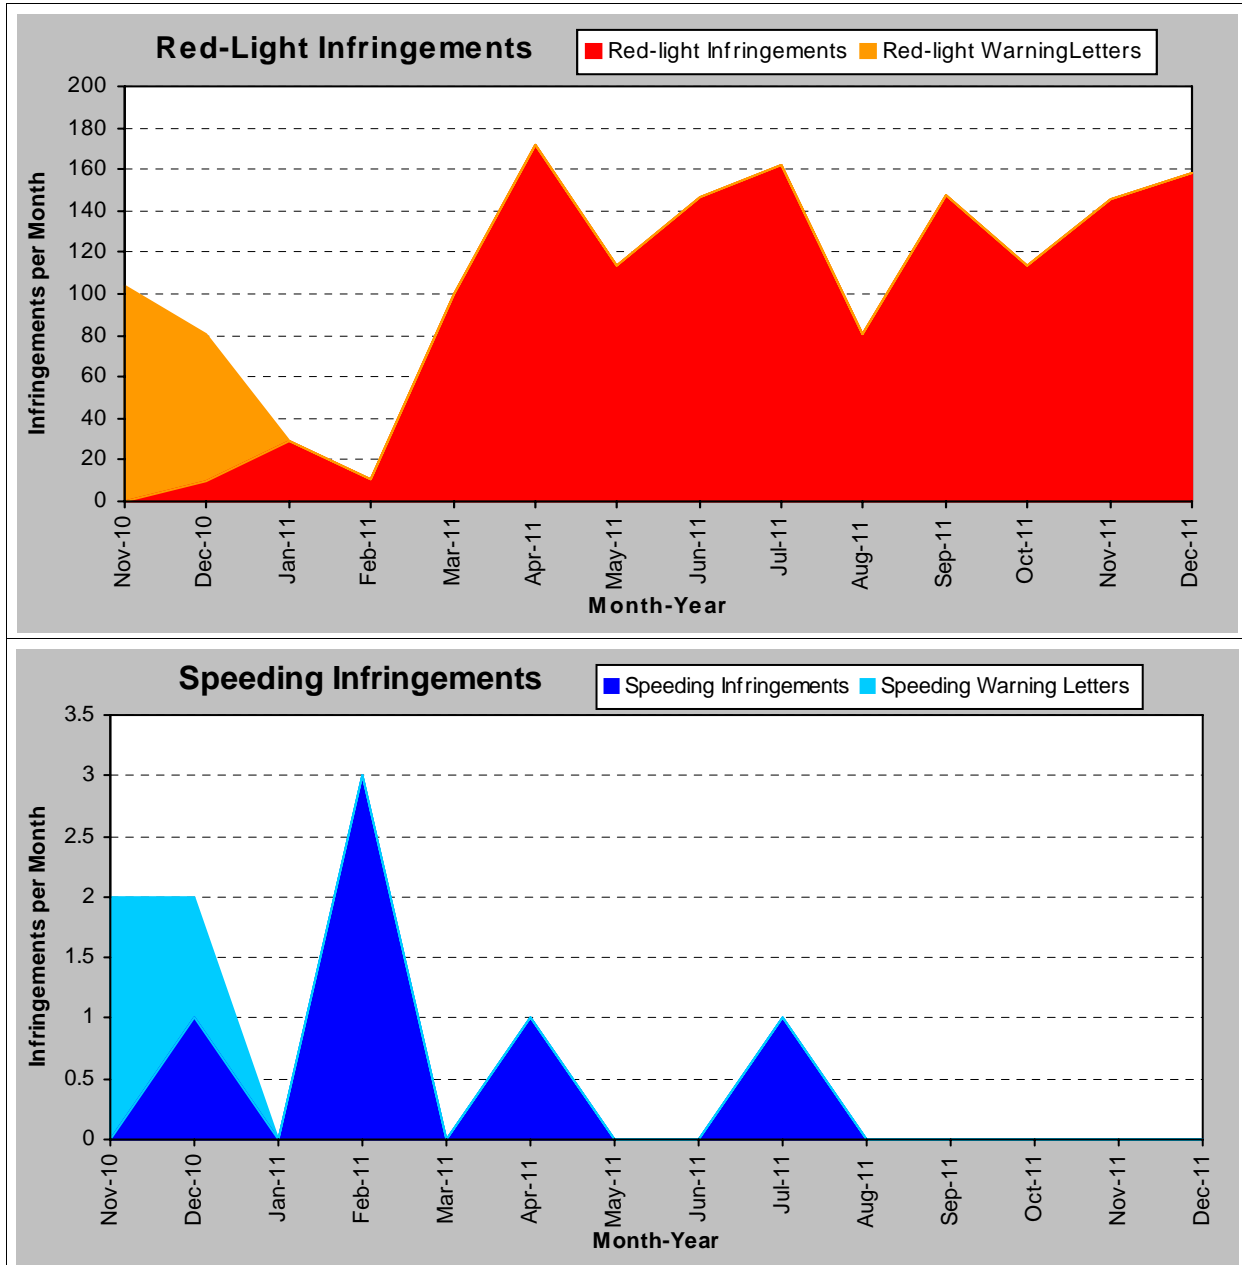
The graph below details the number of warning letters and infringements issued at this intersection since the camera began operating. The graph also shows the trend in infringements at this location.

Roadworks and camera maintenance may influence the number of infringements issued.

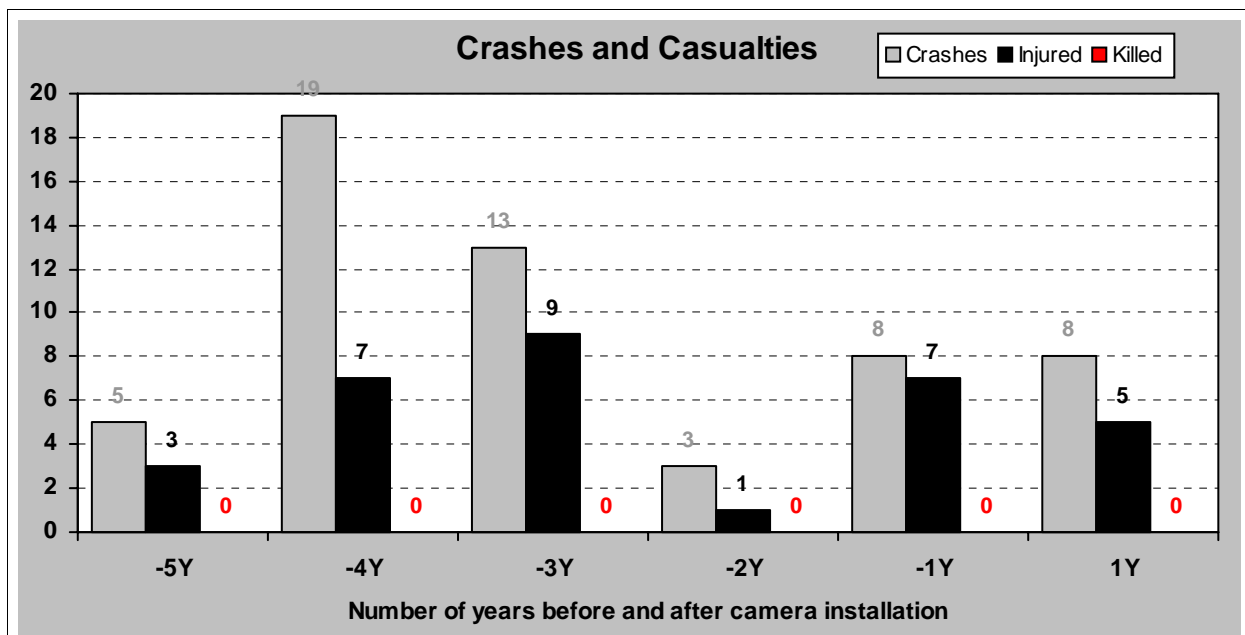
This represents a 27 per cent reduction in the yearly average number of crashes and a 22 per cent reduction in the yearly average number of casualties at this intersection in the period after installation until the end of 2011.

Provisional crash data shows there were 6 crashes resulting in 5 casualties at this intersection in 2011.

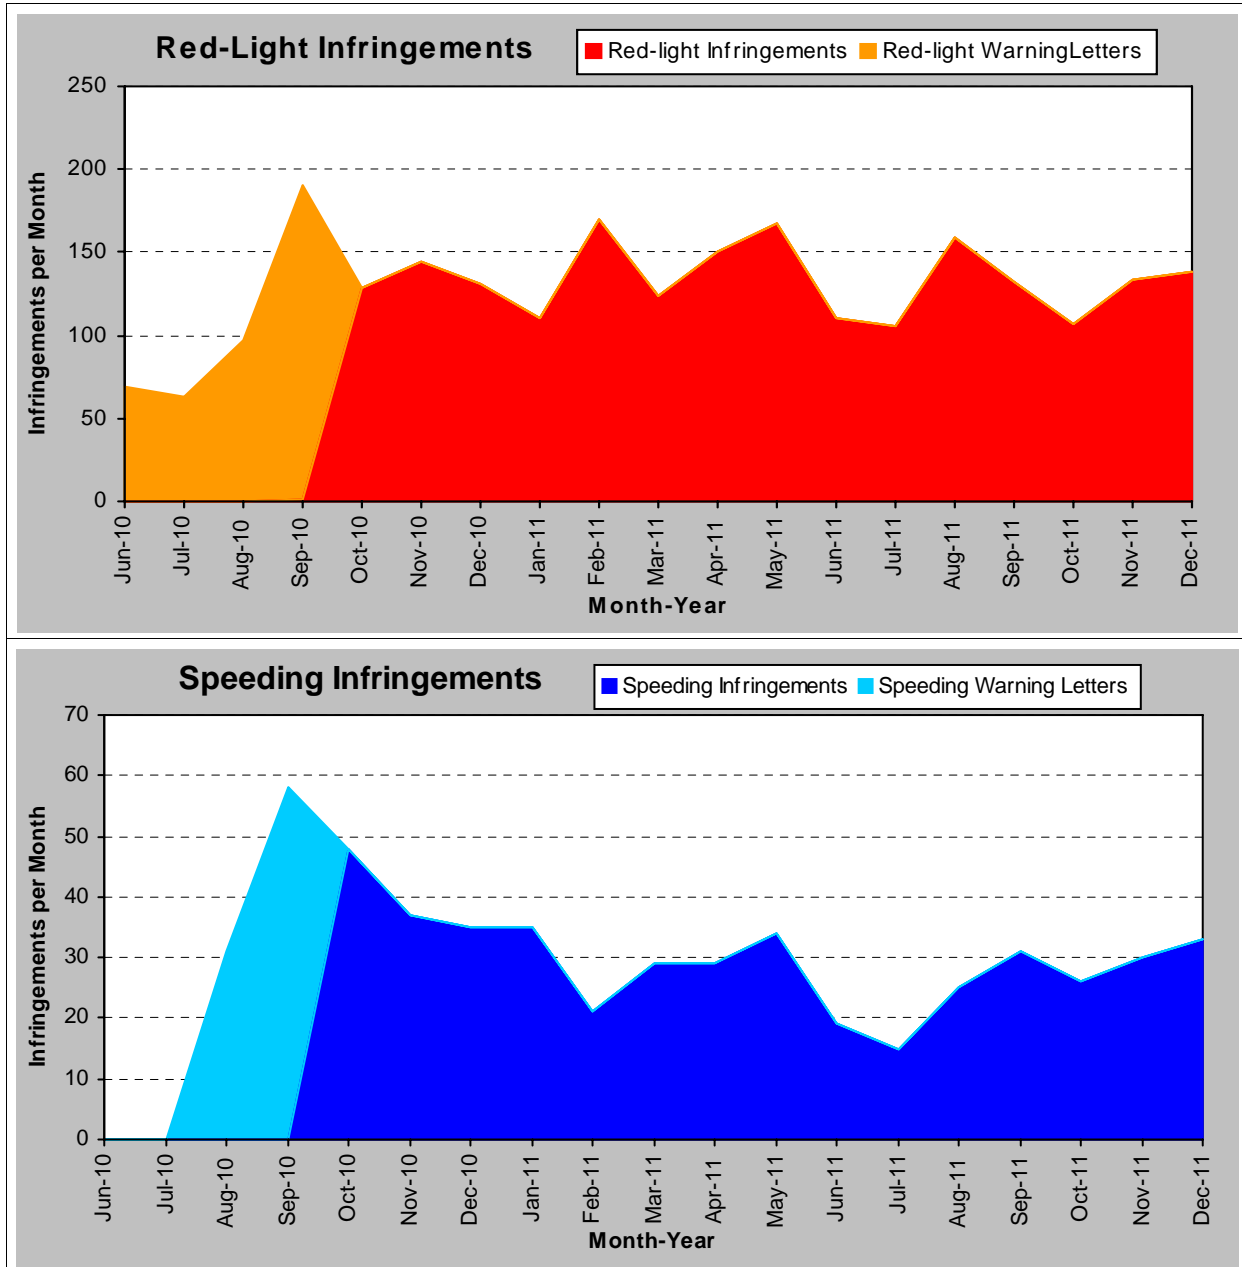
The graph below details the number of warning letters and infringements issued at this intersection since the camera began operating. The graph also shows the trend in infringements at this location.

Roadworks and camera maintenance may influence the number of infringements issued.

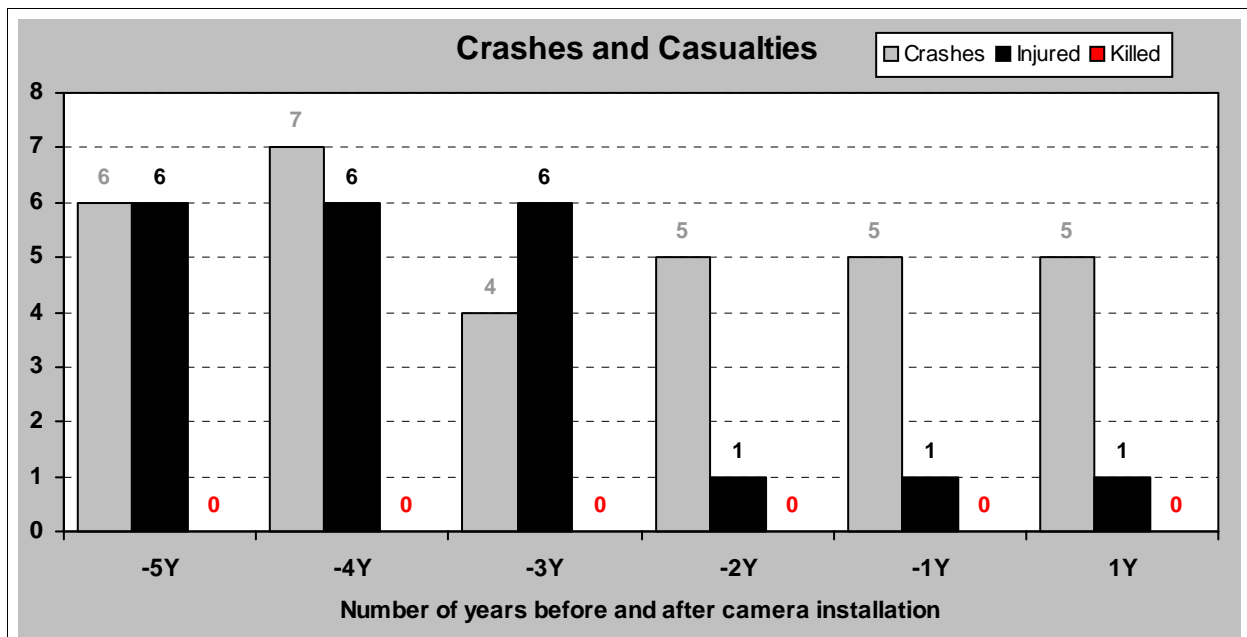
This represents an 11 per cent reduction in the yearly average number of crashes and a 60 per cent reduction in the yearly average number of casualties at this intersection in the period after installation until the end of 2011.

Provisional crash data shows there were 6 crashes resulting in 2 casualties at this intersection in 2011.
