# ANNUAL NSW SPEED CAMERA PERFORMANCE REVIEW

NSW Centre for Road Safety

JULY 2012

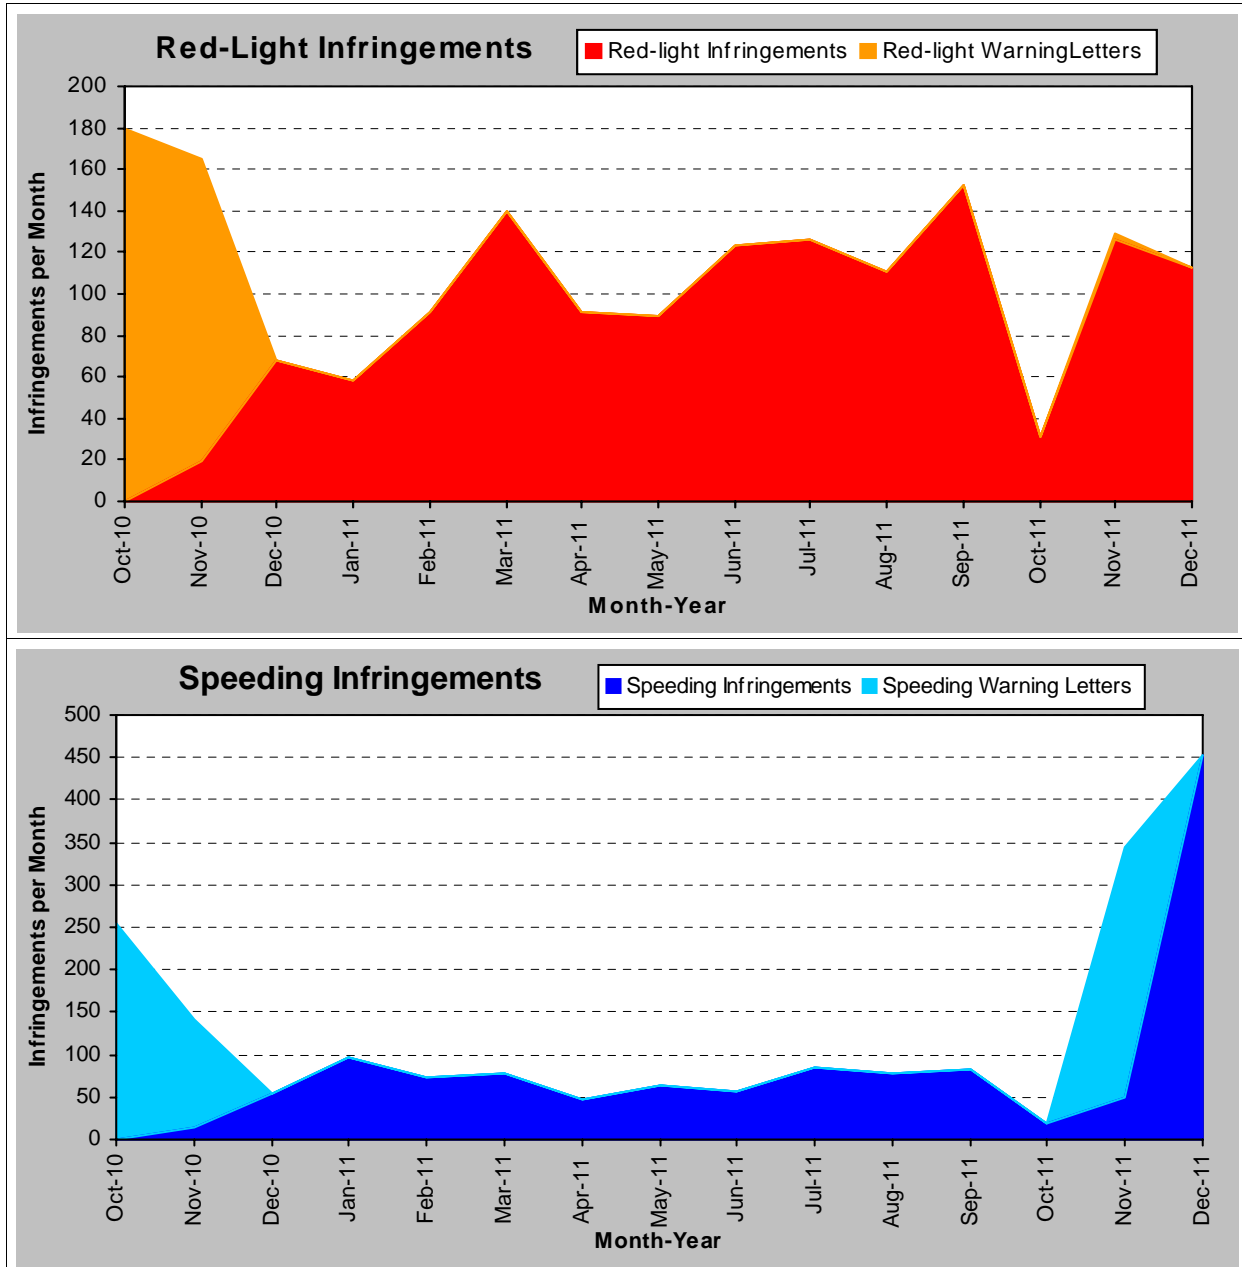
The graph below details the number of warning letters and infringements issued at this intersection since the camera began operating. The graph also shows the trend in infringements at this location.

Roadworks and camera maintenance may influence the number of infringements issued.

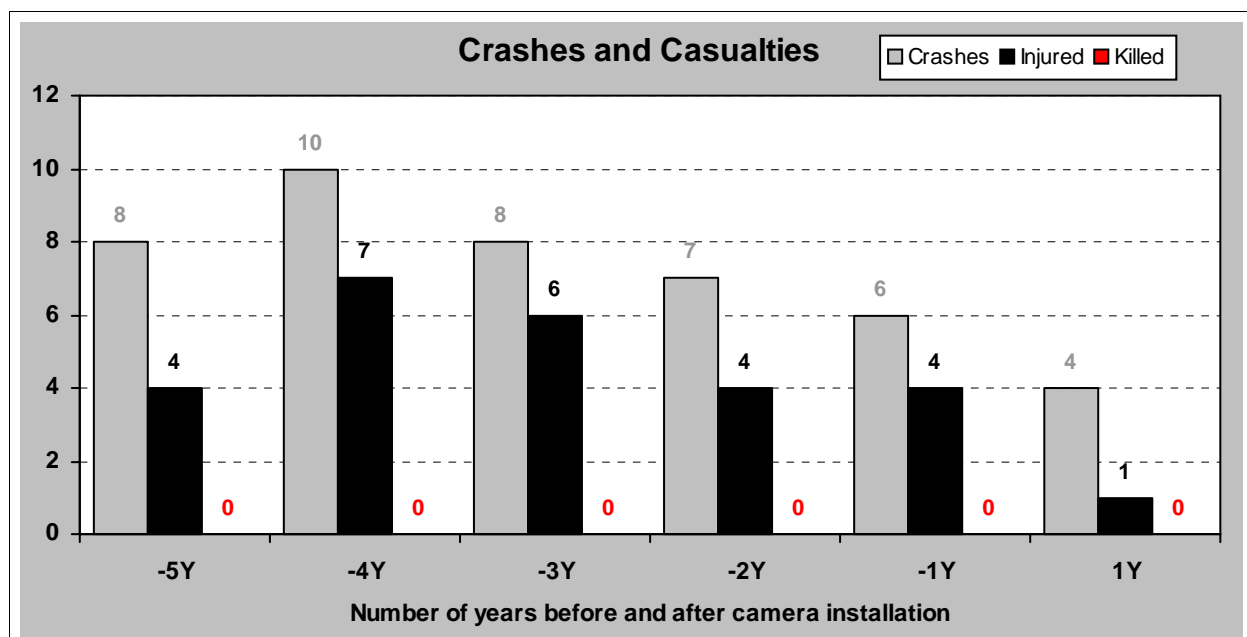
This represents a 32 per cent reduction in the yearly average number of crashes and a 47 per cent reduction in the yearly average number of casualties at this intersection in the period after installation until the end of 2011.

Provisional crash data shows there were 7 crashes resulting in 4 casualties at this intersection in 2011.

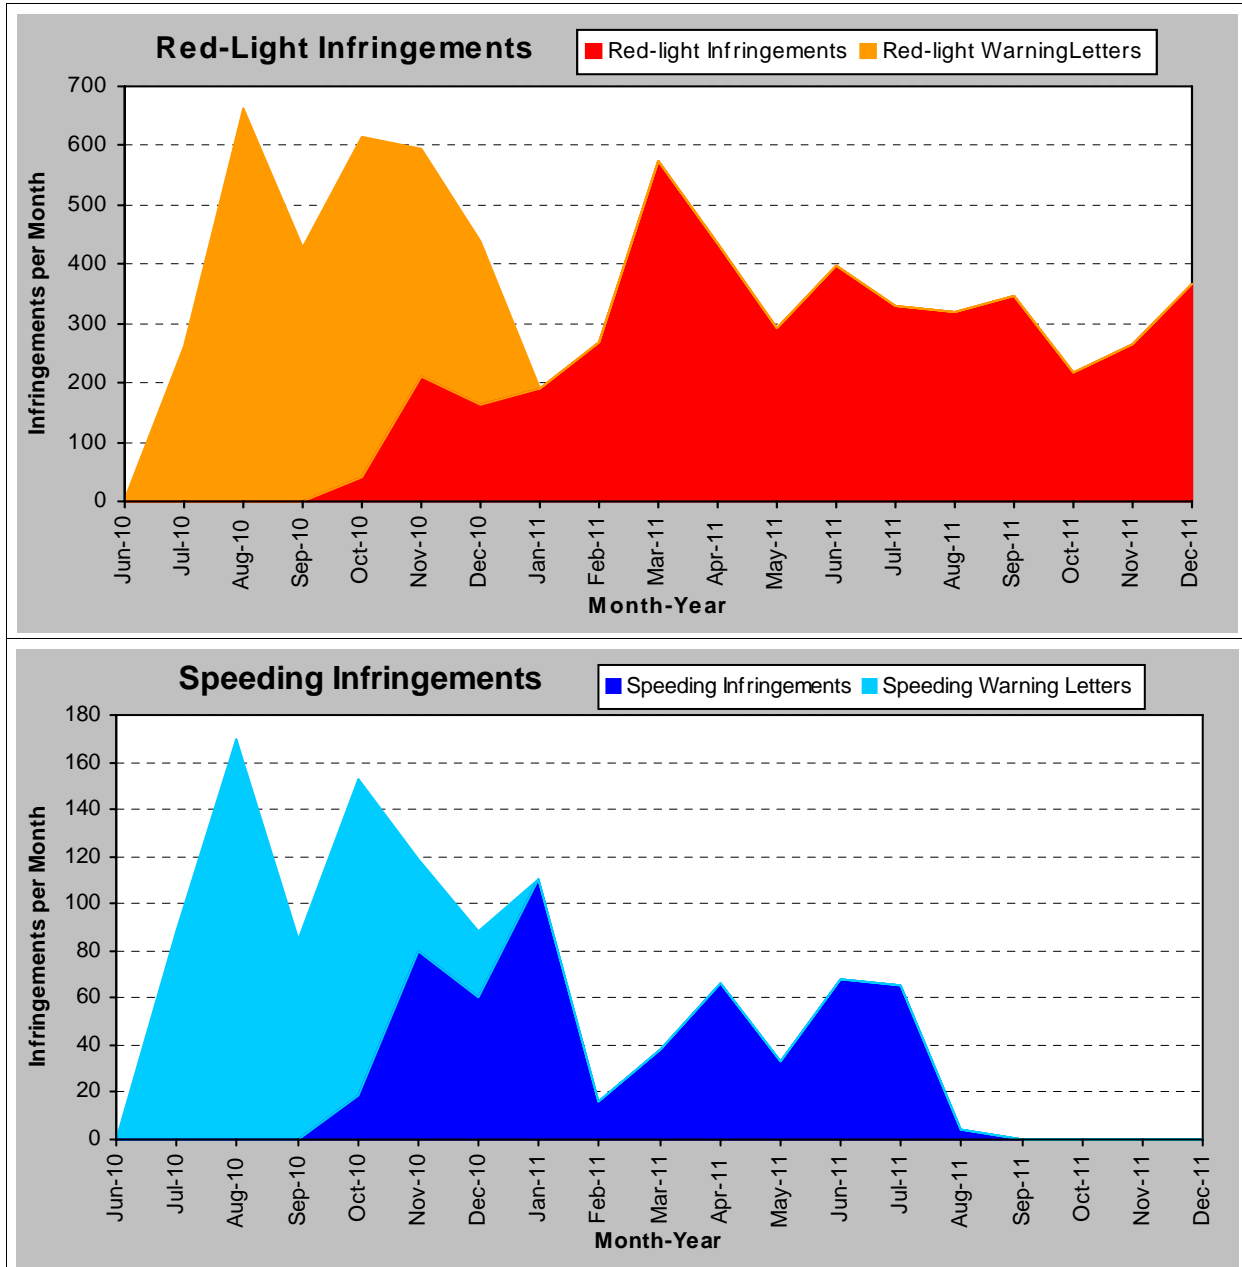
## Infringements at safety camera location

The graph below details the number of warning letters and infringements issued at this intersection since the camera began operating. The graph also shows the trend in infringements at this location.

Roadworks and camera maintenance may influence the number of infringements issued.

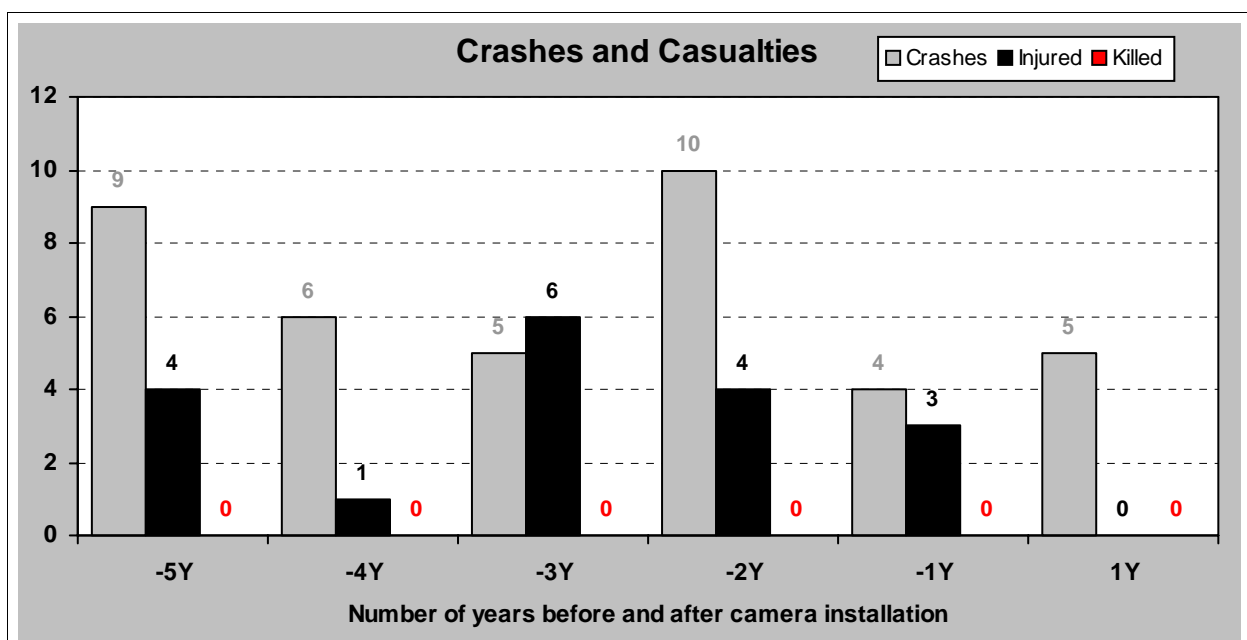
This represents a 39 per cent reduction in the yearly average number of crashes and a 100 per cent reduction in the yearly average number of casualties at this intersection in the period after installation until the end of 2011.

Provisional crash data shows there were 3 crashes resulting in 0 casualties at this intersection in 2011.

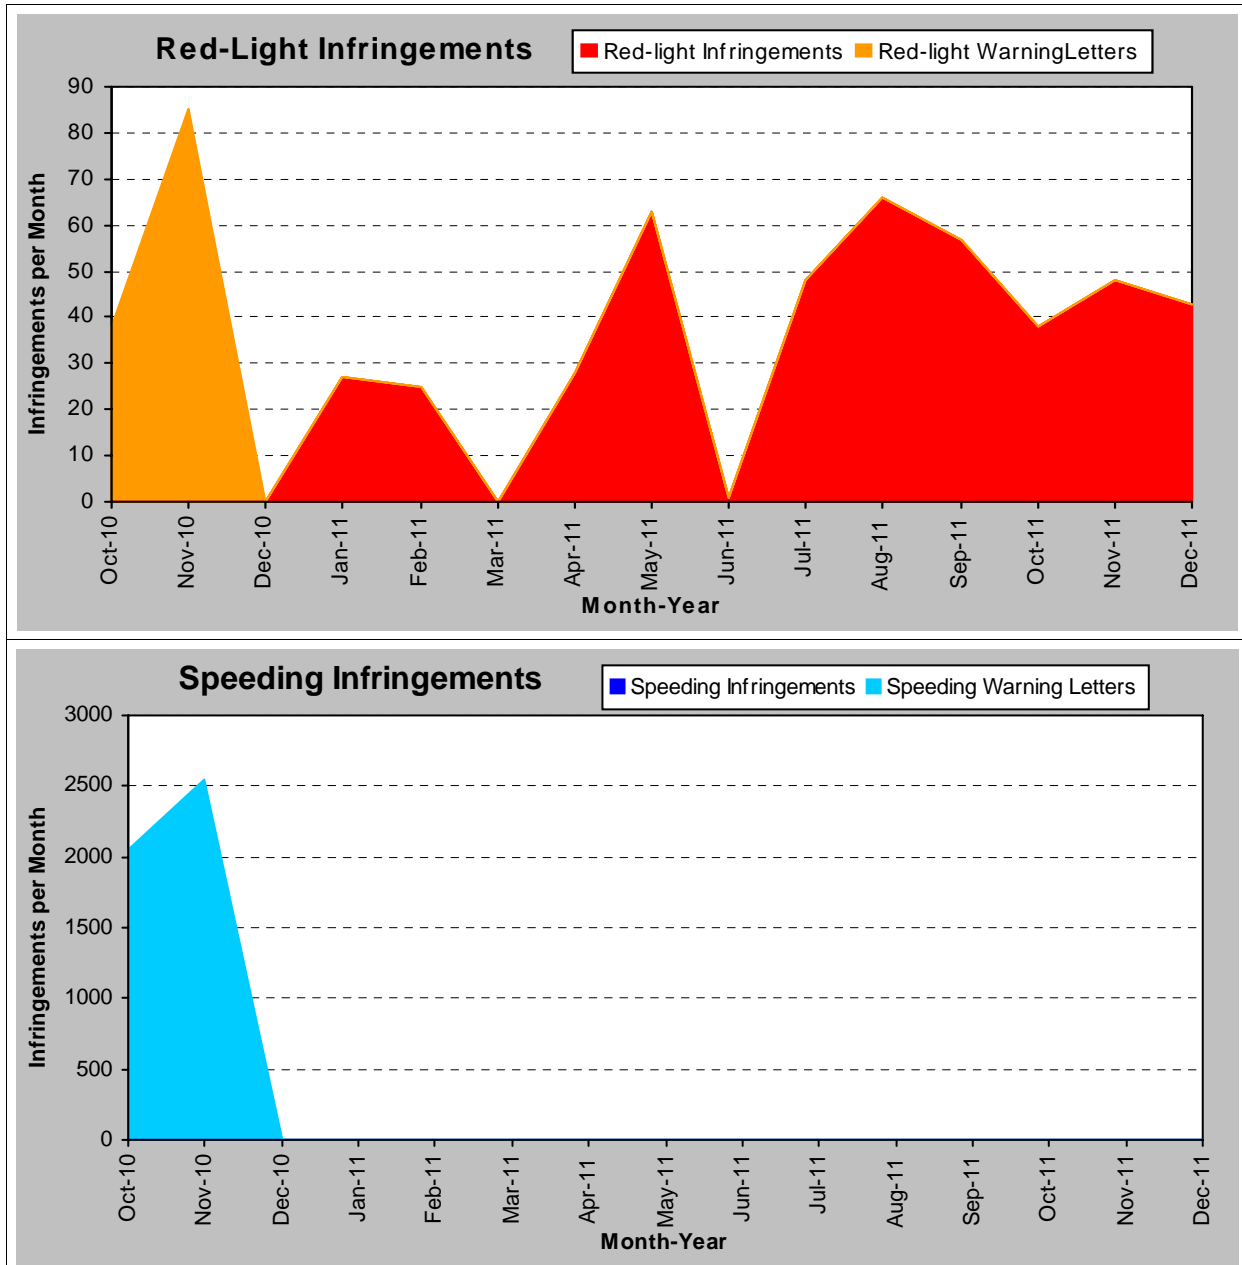
## Infringements at safety camera location

The graph below details the number of warning letters and infringements issued at this intersection since the camera began operating.

Roadworks and camera maintenance may influence the number of infringements issued.

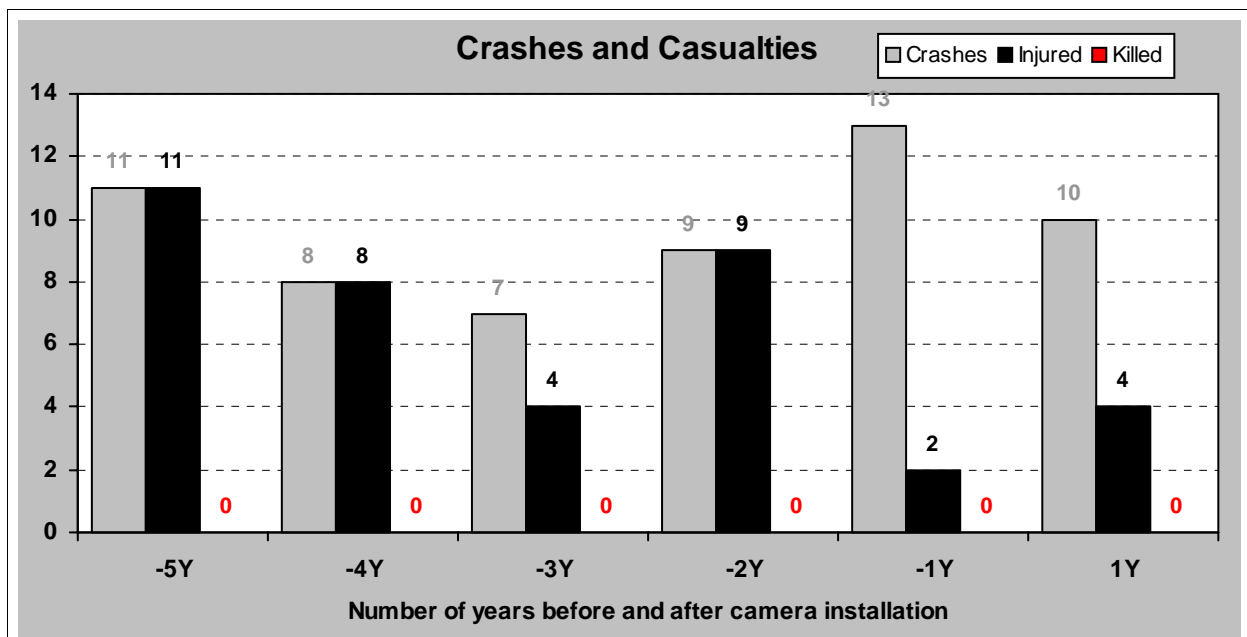
This represents a 16 per cent increase in the yearly average number of crashes and an 18 per cent reduction in the yearly average number of casualties at this intersection in the period after installation until the end of 2011.

Provisional crash data shows there were 14 crashes resulting in 7 casualties at this intersection in 2011.

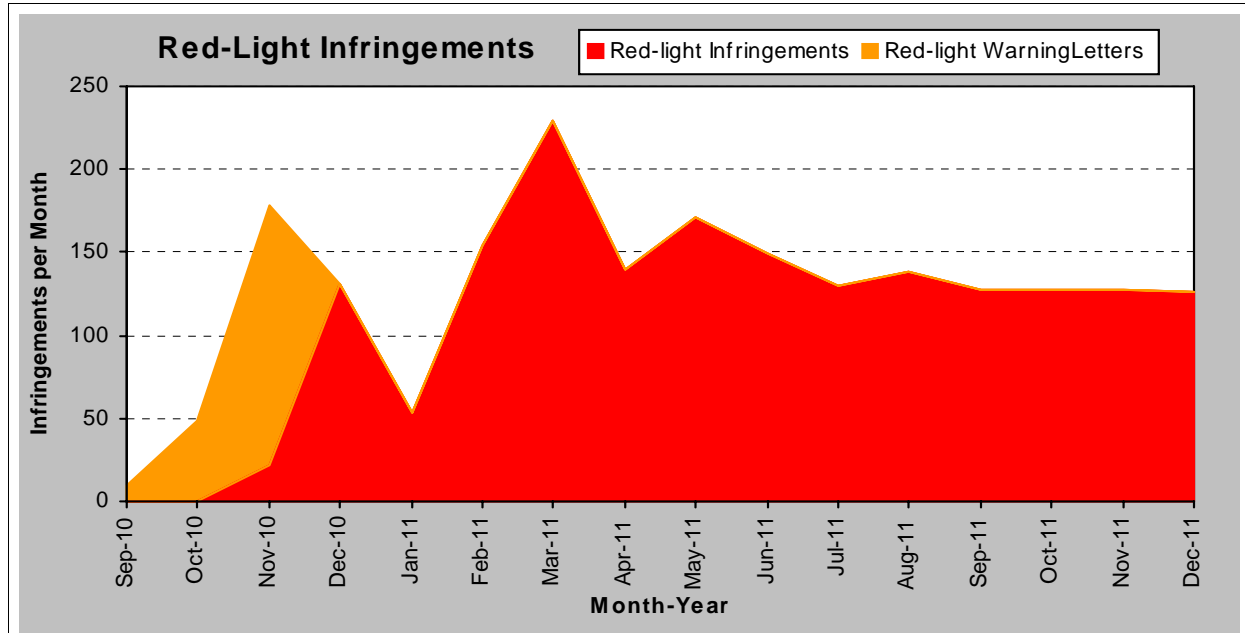
## Infringements at safety camera location

The graph below details the number of warning letters and infringements issued at this intersection since the camera began operating. The graph also shows the trend in infringements at this location.

Roadworks and camera maintenance may influence the number of infringements issued.

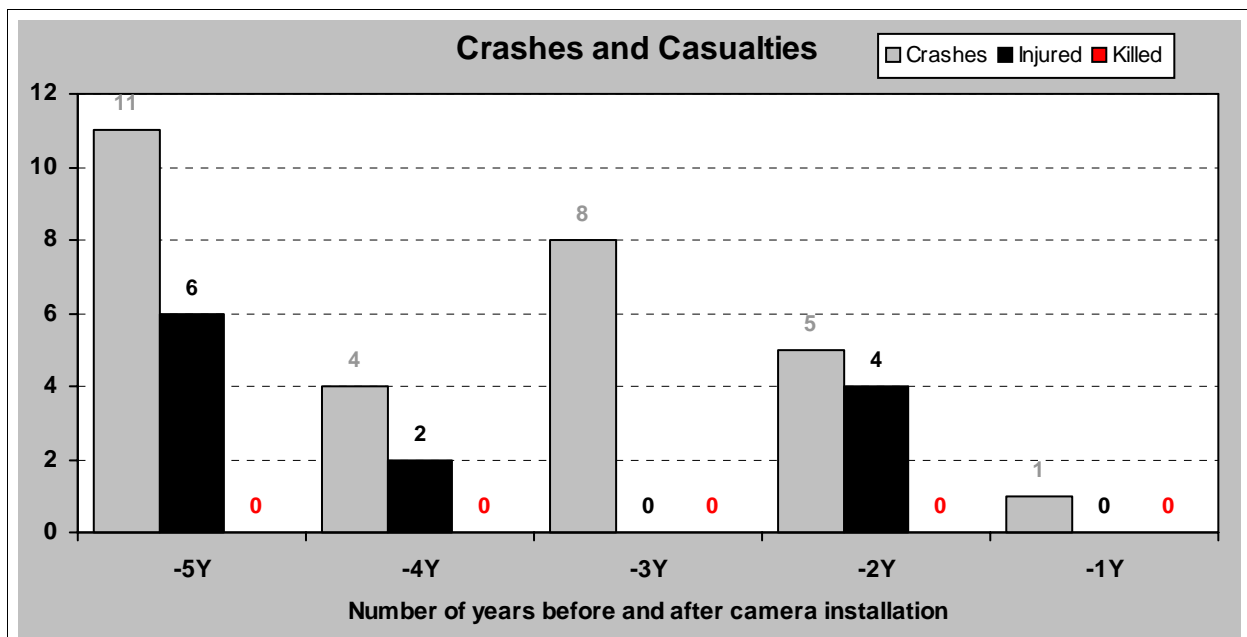
In the 188 day period from installation to the end of 2011, there were 2 crashes resulting in 0 injuries and 0 fatalities.

This represents a 33 per cent reduction in the yearly average number of crashes and a 100 per cent reduction in the yearly average number of casualties at this intersection in the period after installation until the end of 2011.

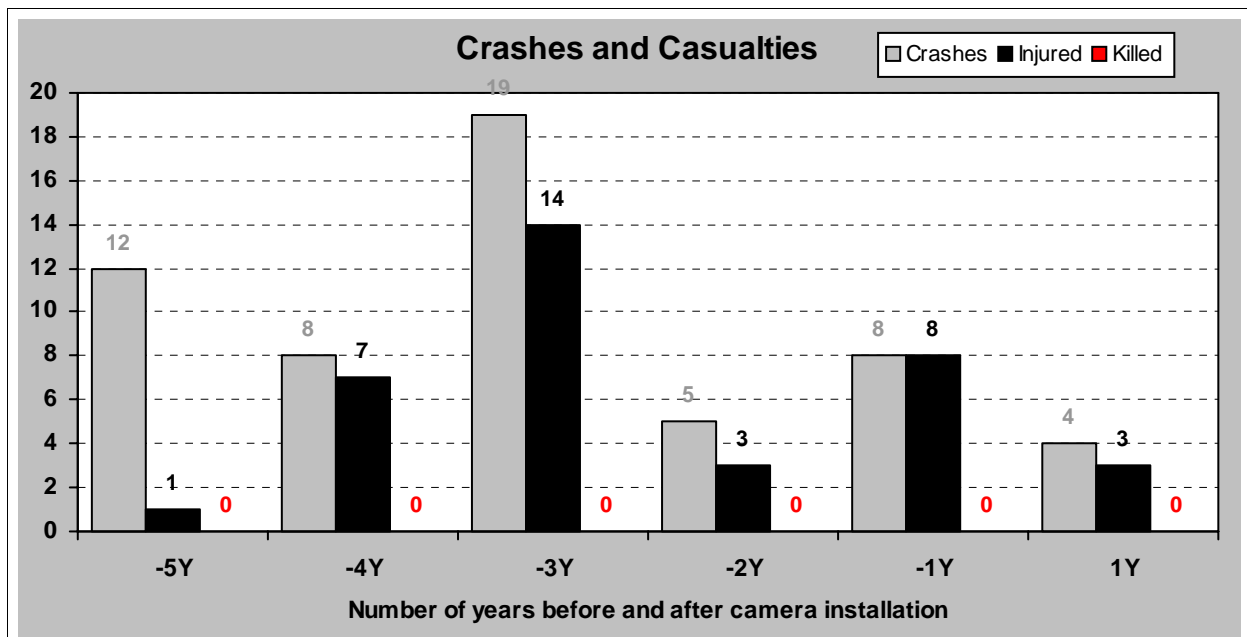
This represents a 62 per cent reduction in the yearly average number of crashes and a 50 per cent reduction in the yearly average number of casualties at this intersection in the period after installation until the end of 2011.

Provisional crash data shows there were 5 crashes resulting in 4 casualties at this intersection in 2011.

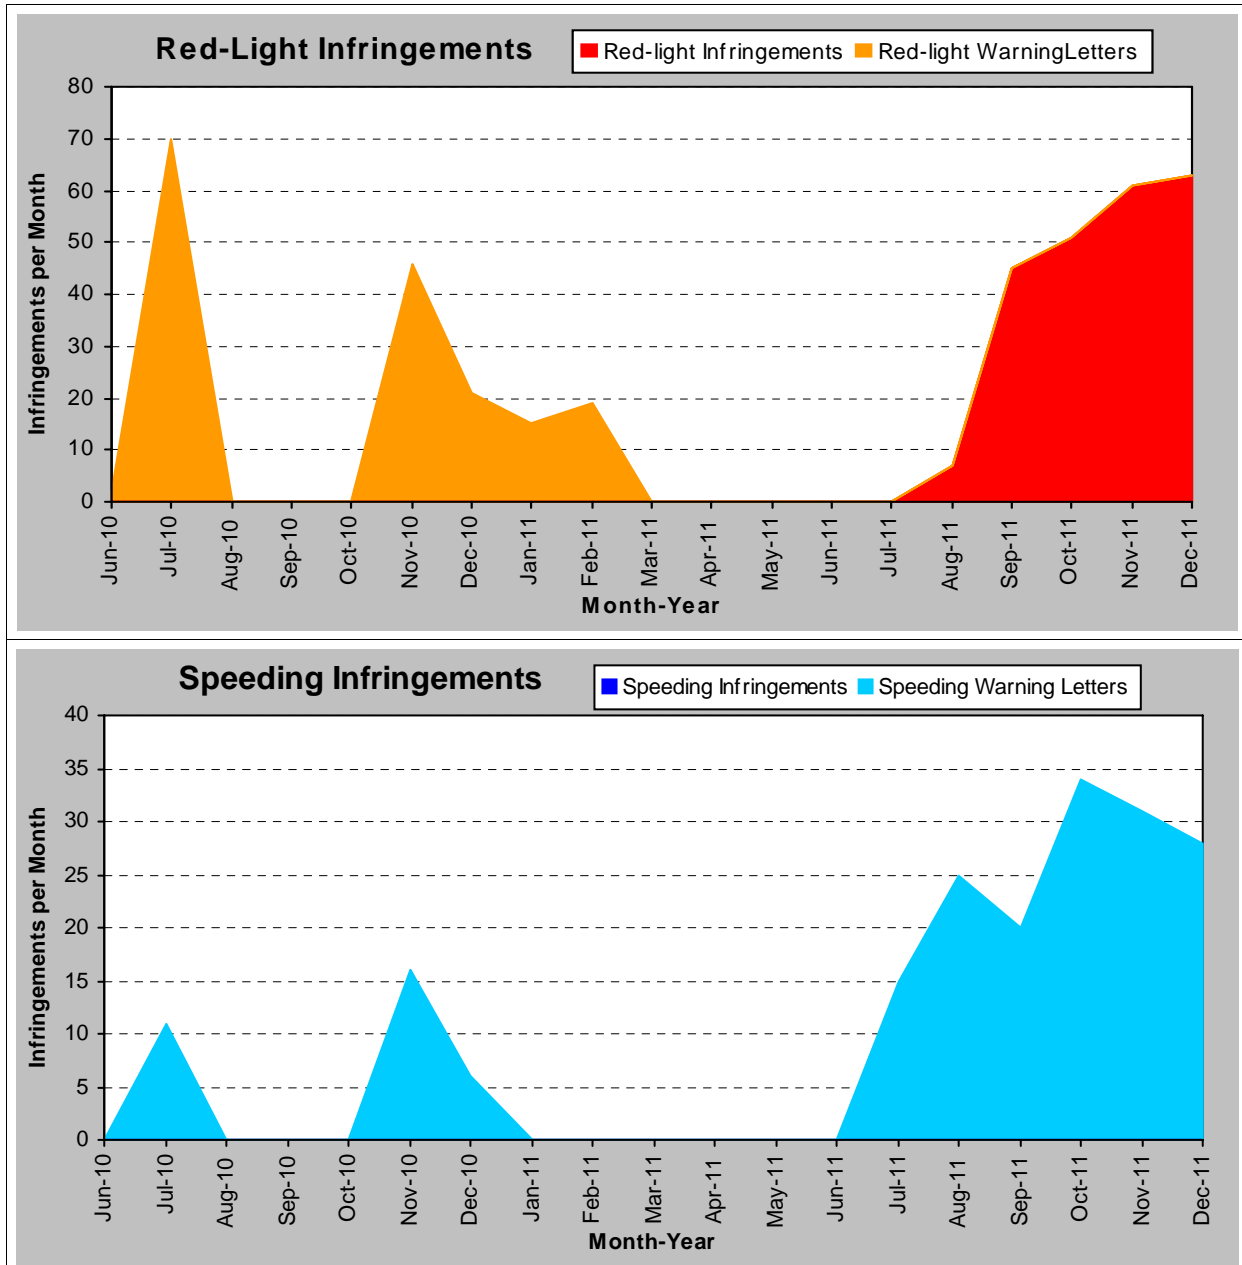
## Infringements at safety camera location

The graph below details the number of warning letters and infringements issued at this intersection since the camera began operating.

Roadworks and camera maintenance may influence the number of infringements issued.

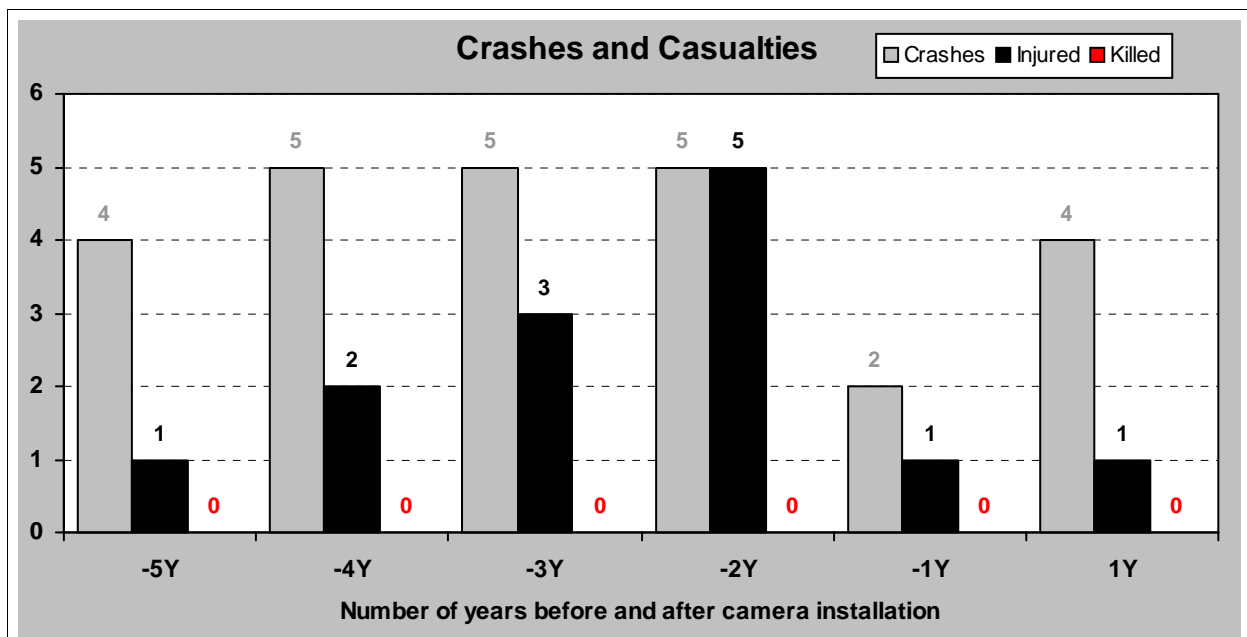
This represents a 16 per cent reduction in the yearly average number of crashes and a 63 per cent reduction in the yearly average number of casualties at this intersection in the period after installation until the end of 2011.

Provisional crash data shows there were 4 crashes resulting in one casualty at this intersection in 2011.

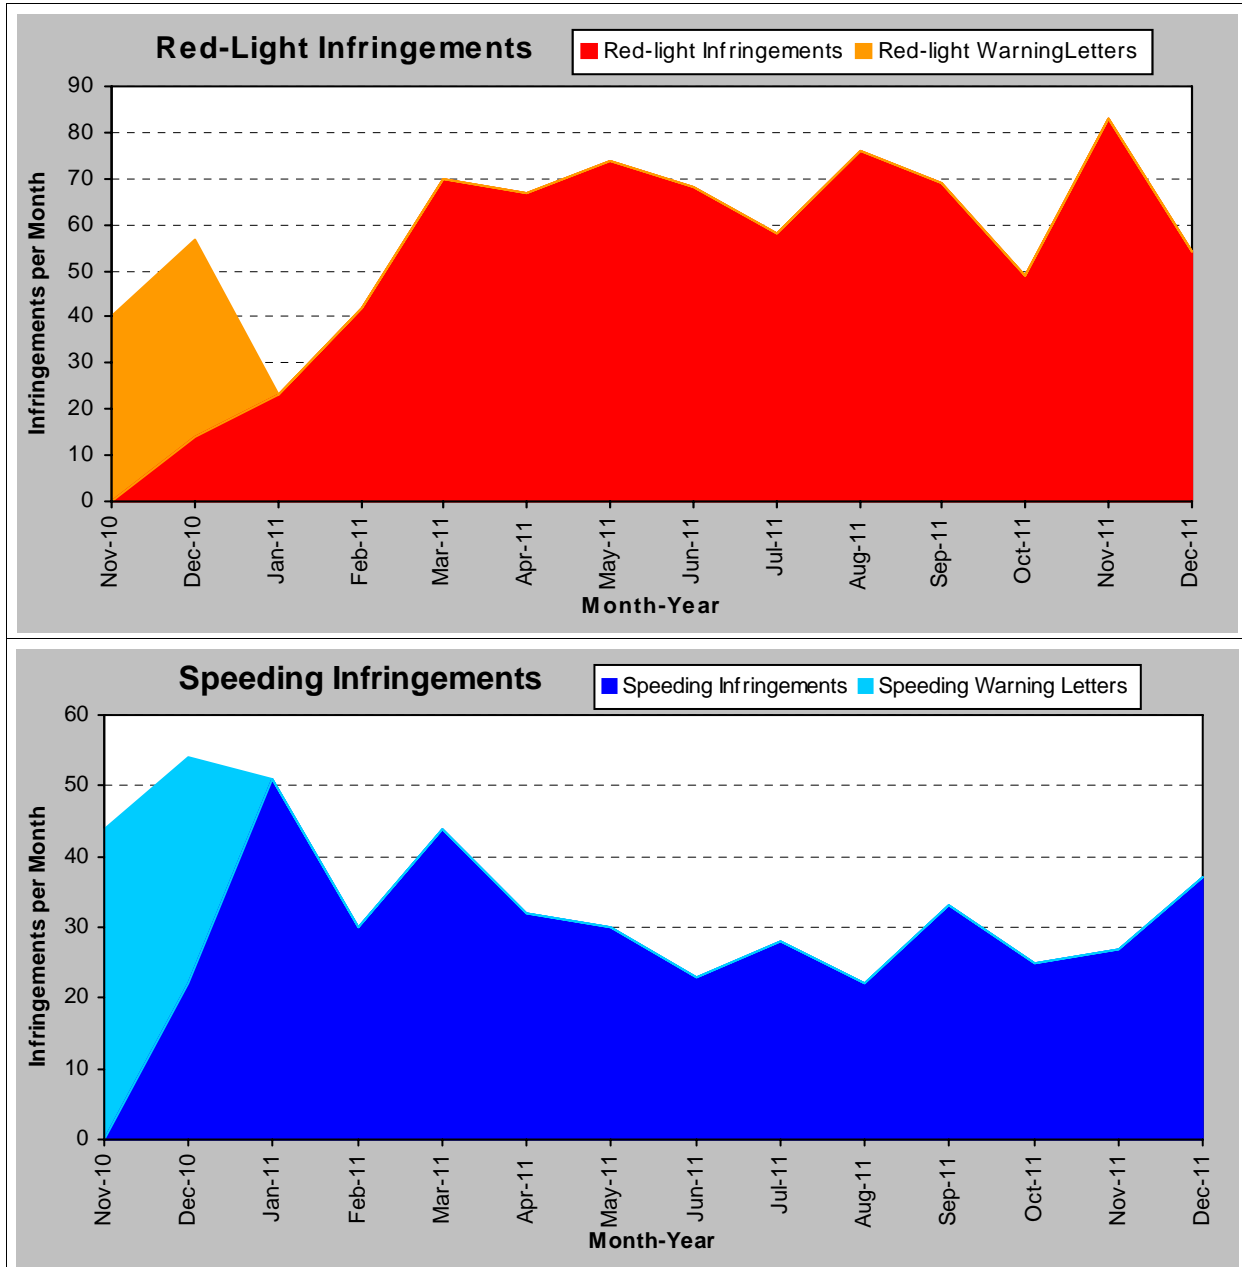
## Infringements at safety camera location

The graph below details the number of warning letters and infringements issued at this intersection since the camera began operating. The graph also shows the trend in infringements at this location.

Roadworks and camera maintenance may influence the number of infringements issued.

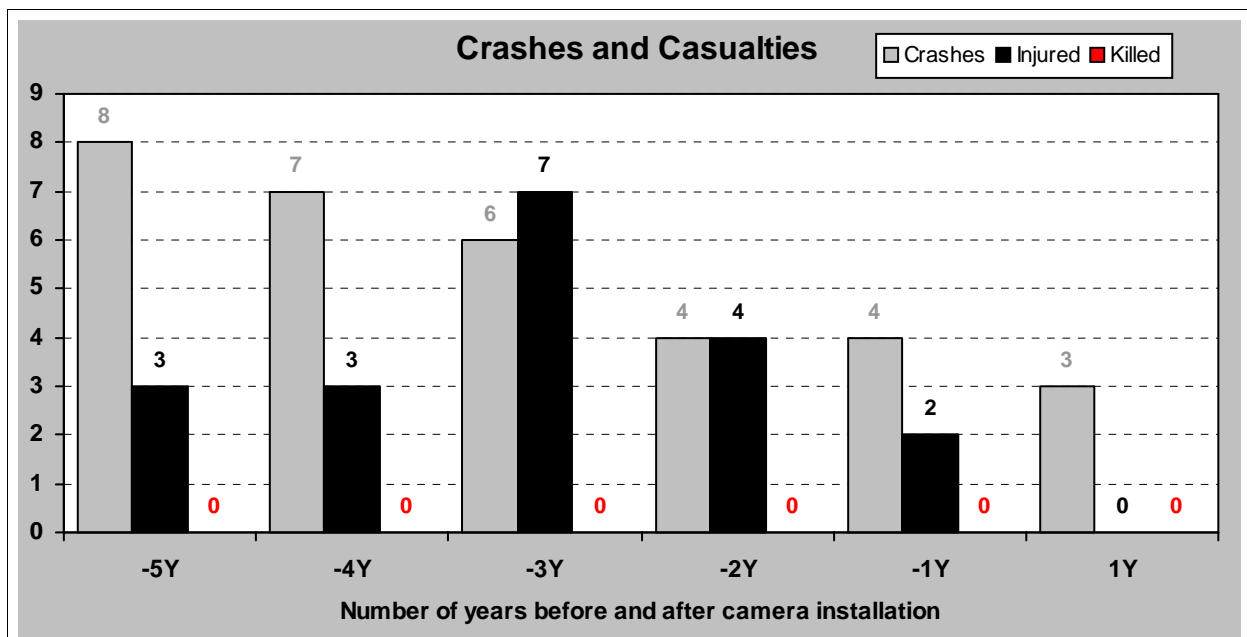
This represents a 39 per cent reduction in the yearly average number of crashes and a 100 per cent reduction in the yearly average number of casualties at this intersection in the period after installation until the end of 2011.

Provisional crash data shows there were 4 crashes resulting in 0 casualties at this intersection in 2011.

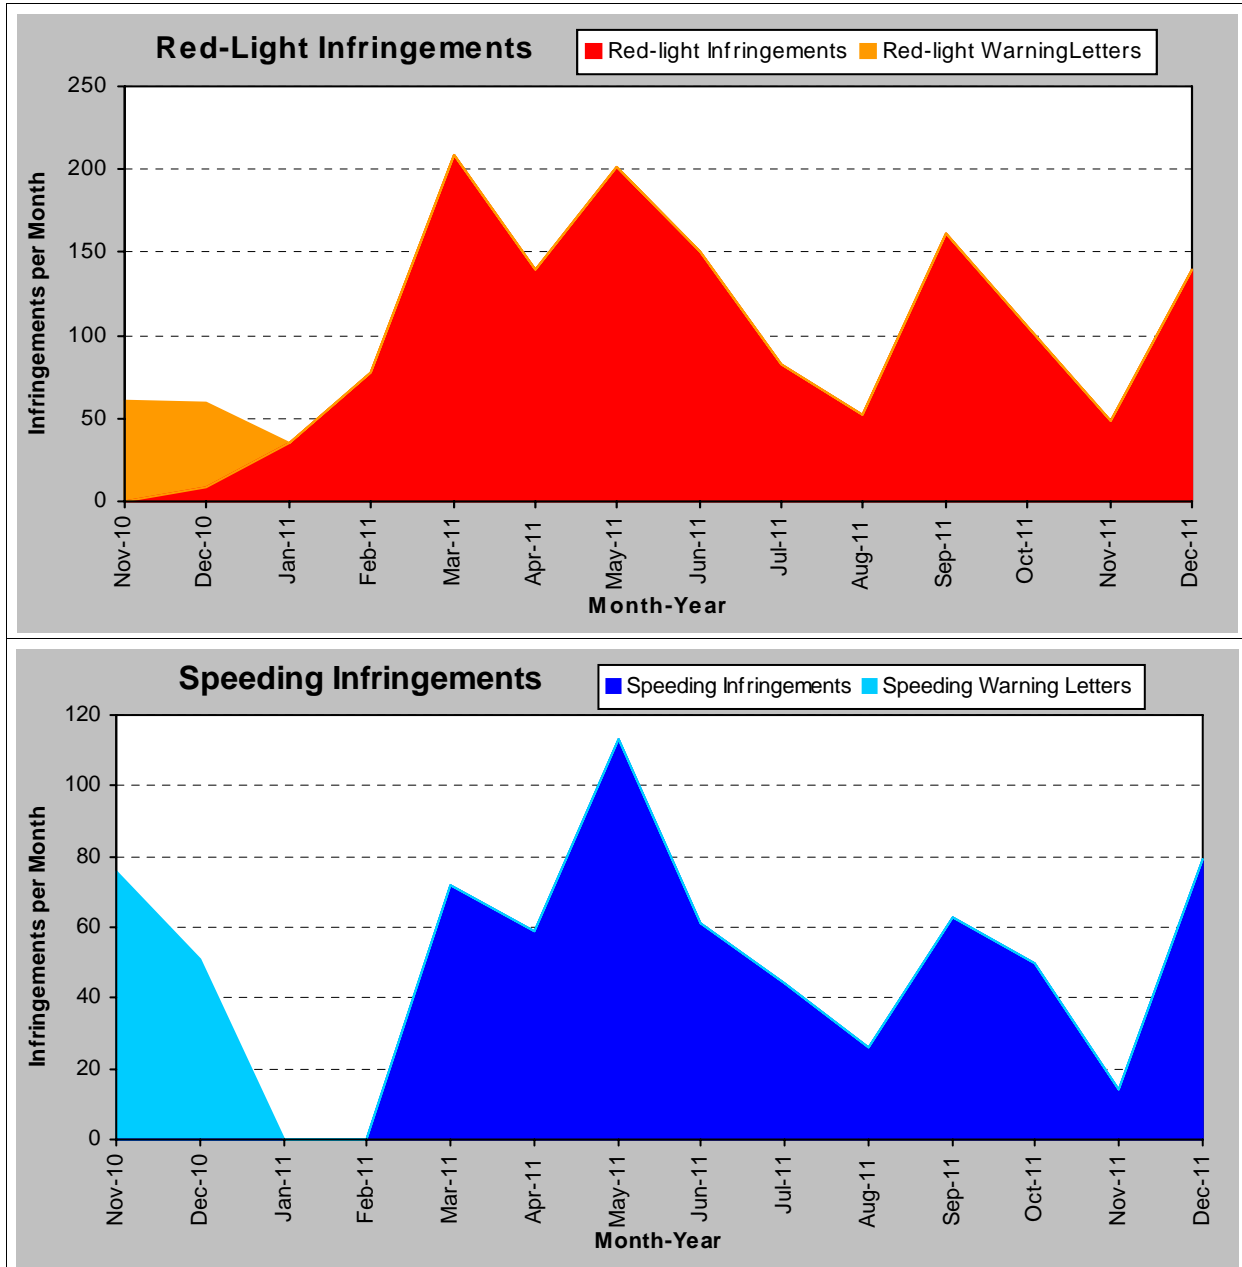
## Infringements at safety camera location

The graph below details the number of warning letters and infringements issued at this intersection since the camera began operating. The graph also shows the trend in infringements at this location.

Roadworks and camera maintenance may influence the number of infringements issued.

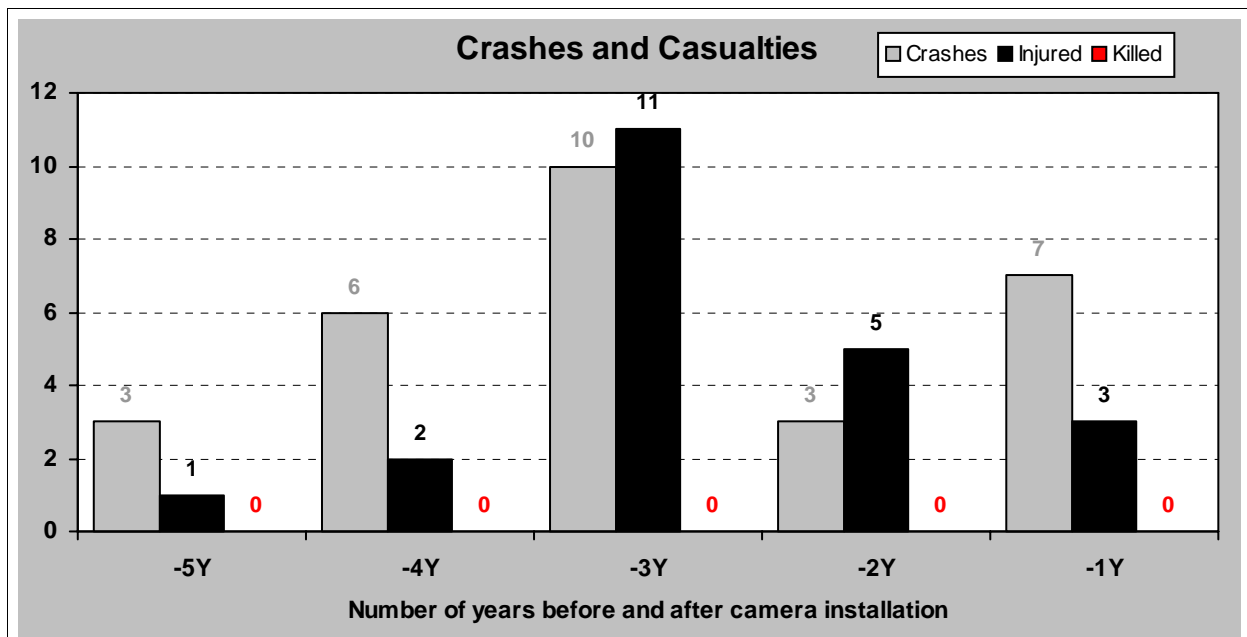
In the 269 day period from installation to the end of 2011, there were 3 crashes resulting in 2 injuries and 0 fatalities.

This represents a 30 per cent reduction in the yearly average number of crashes and a 38 per cent reduction in the yearly average number of casualties at this intersection in the period after installation until the end of 2011.

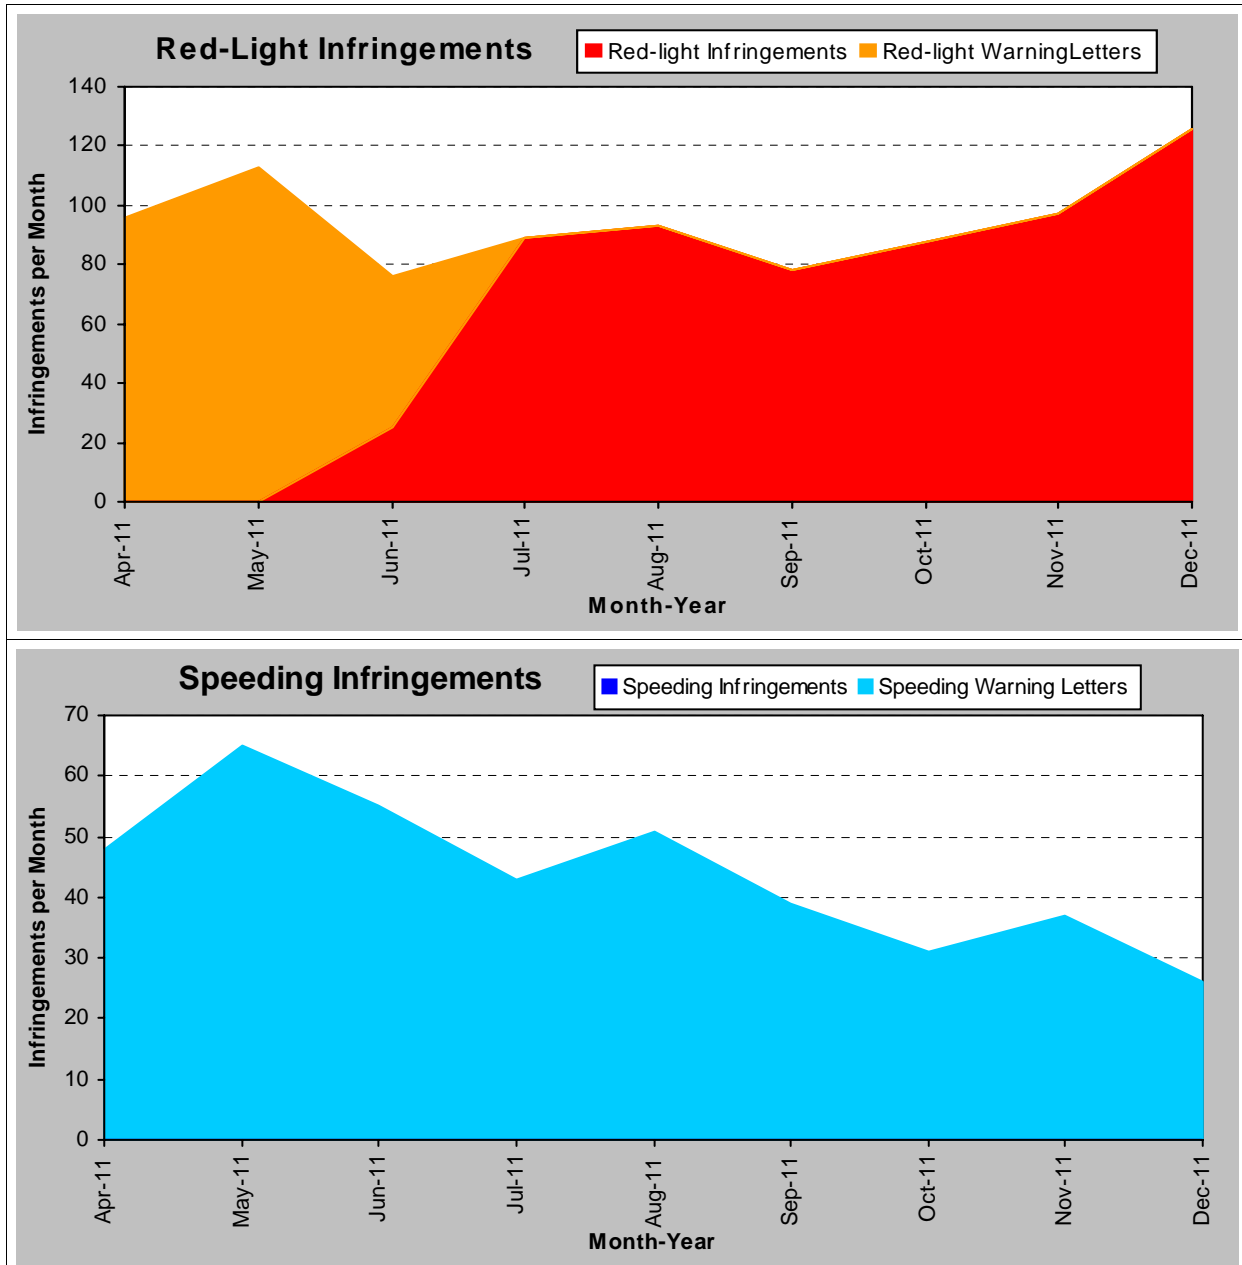
## Infringements at safety camera location

The graph below details the number of warning letters and infringements issued at this intersection since the camera began operating.

Roadworks and camera maintenance may influence the number of infringements issued.

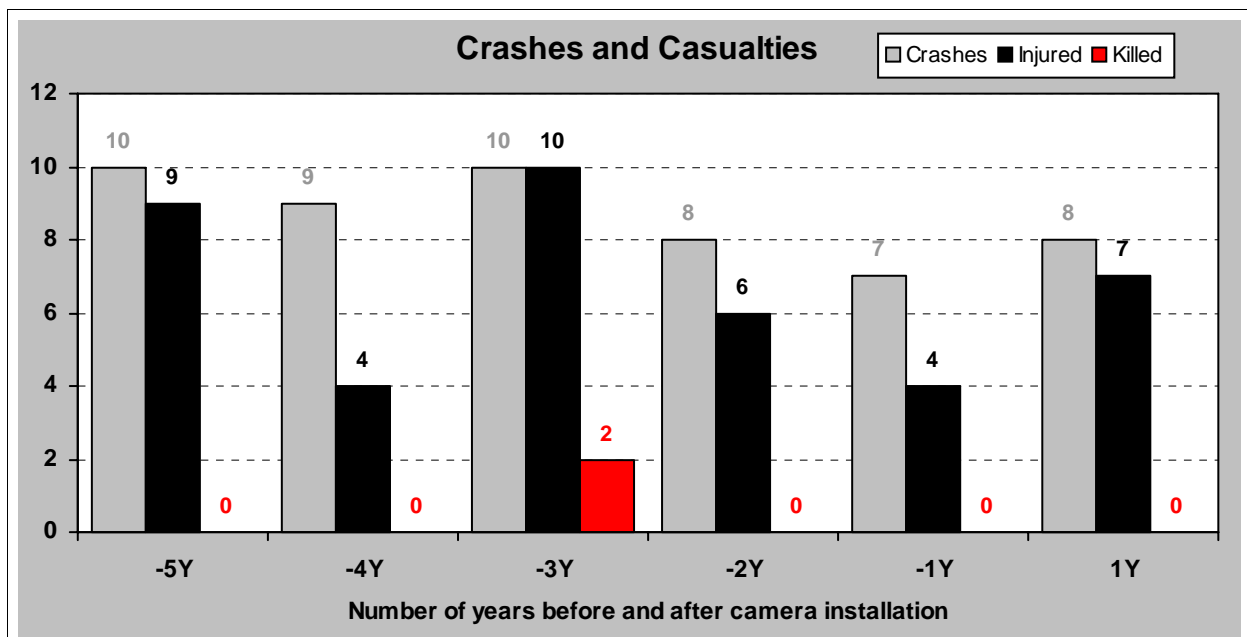
This represents a 7 per cent increase in the yearly average number of crashes and a 13 per cent reduction in the yearly average number of casualties at this intersection in the period after installation until the end of 2011.

Provisional crash data shows there were 11 crashes resulting in 8 casualties at this intersection in 2011.

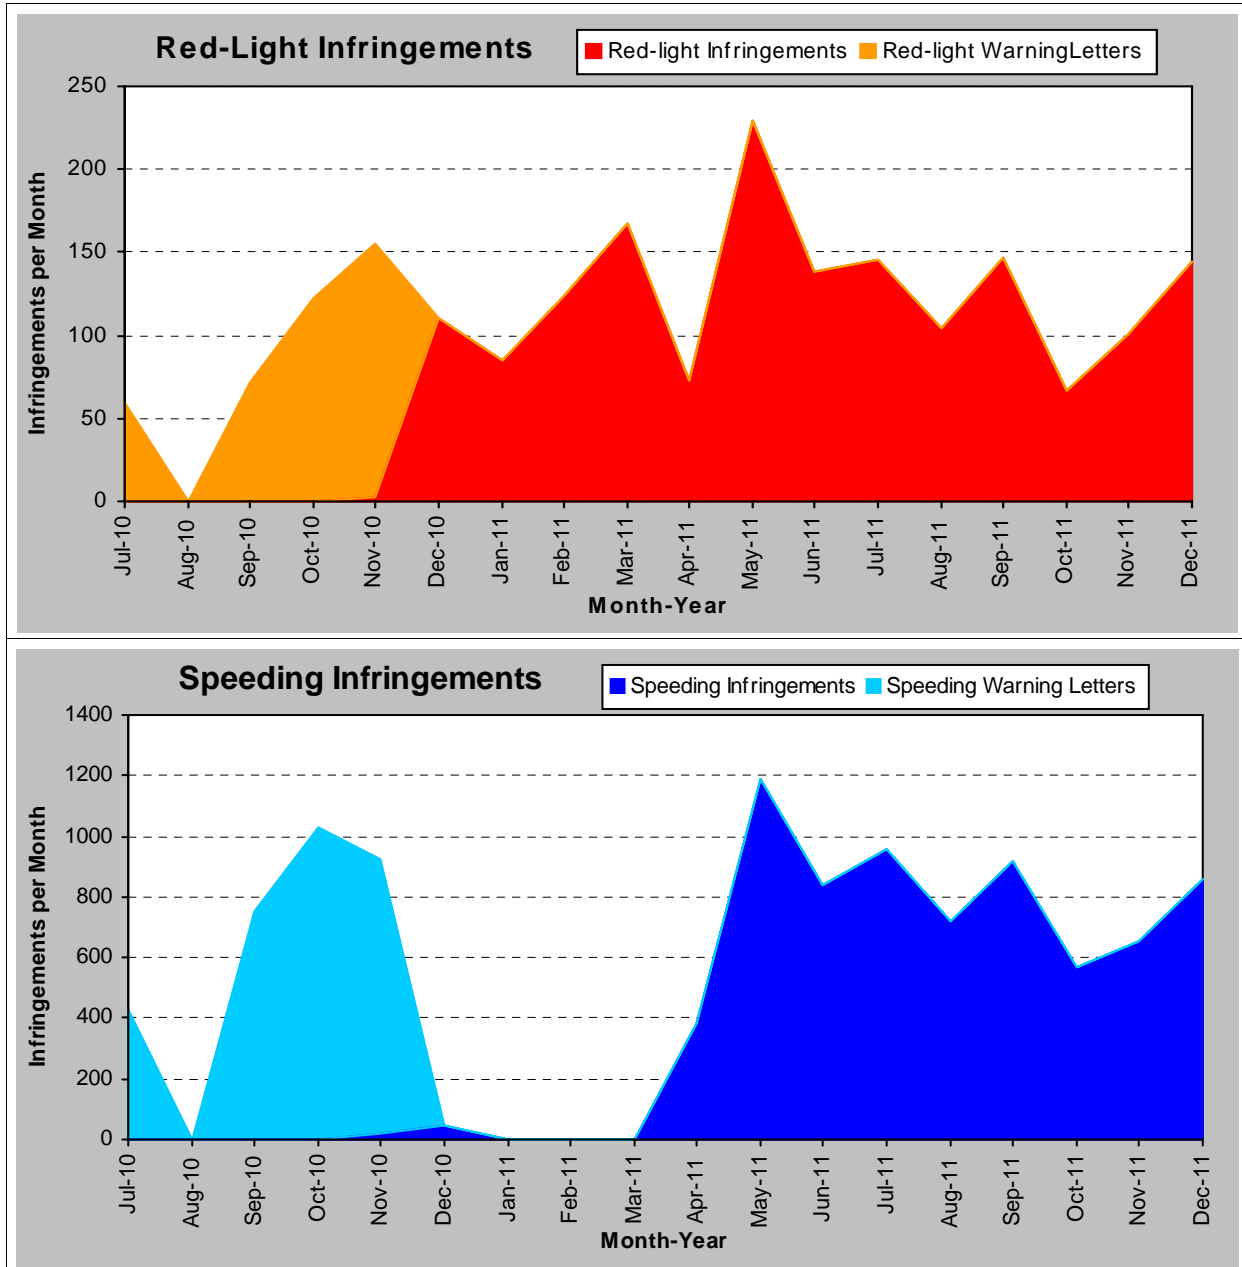
## Infringements at safety camera location

The graph below details the number of warning letters and infringements issued at this intersection since the camera began operating. The graph also shows the trend in infringements at this location.

Roadworks and camera maintenance may influence the number of infringements issued.

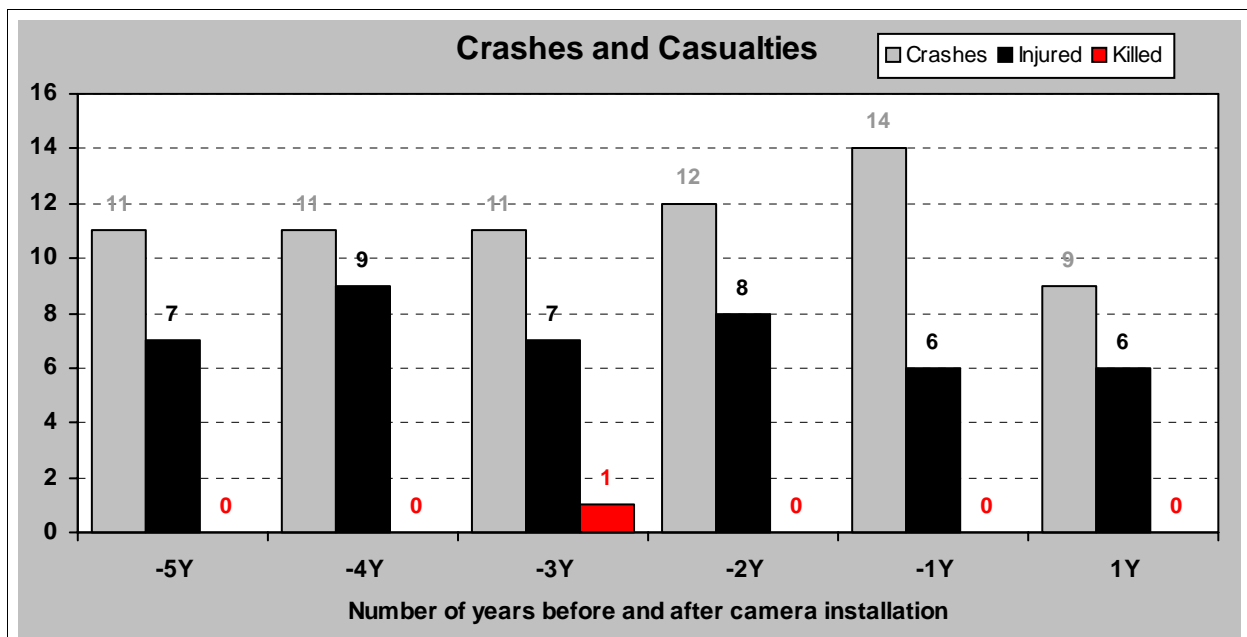
This represents a 27 per cent reduction in the yearly average number of crashes and a 5 per cent increase in the yearly average number of casualties at this intersection in the period after installation until the end of 2011.

Provisional crash data shows there were 10 crashes resulting in 12 casualties at this intersection in 2011.
