# ANNUAL NSW SPEED CAMERA PERFORMANCE REVIEW

NSW Centre for Road Safety

JULY 2012

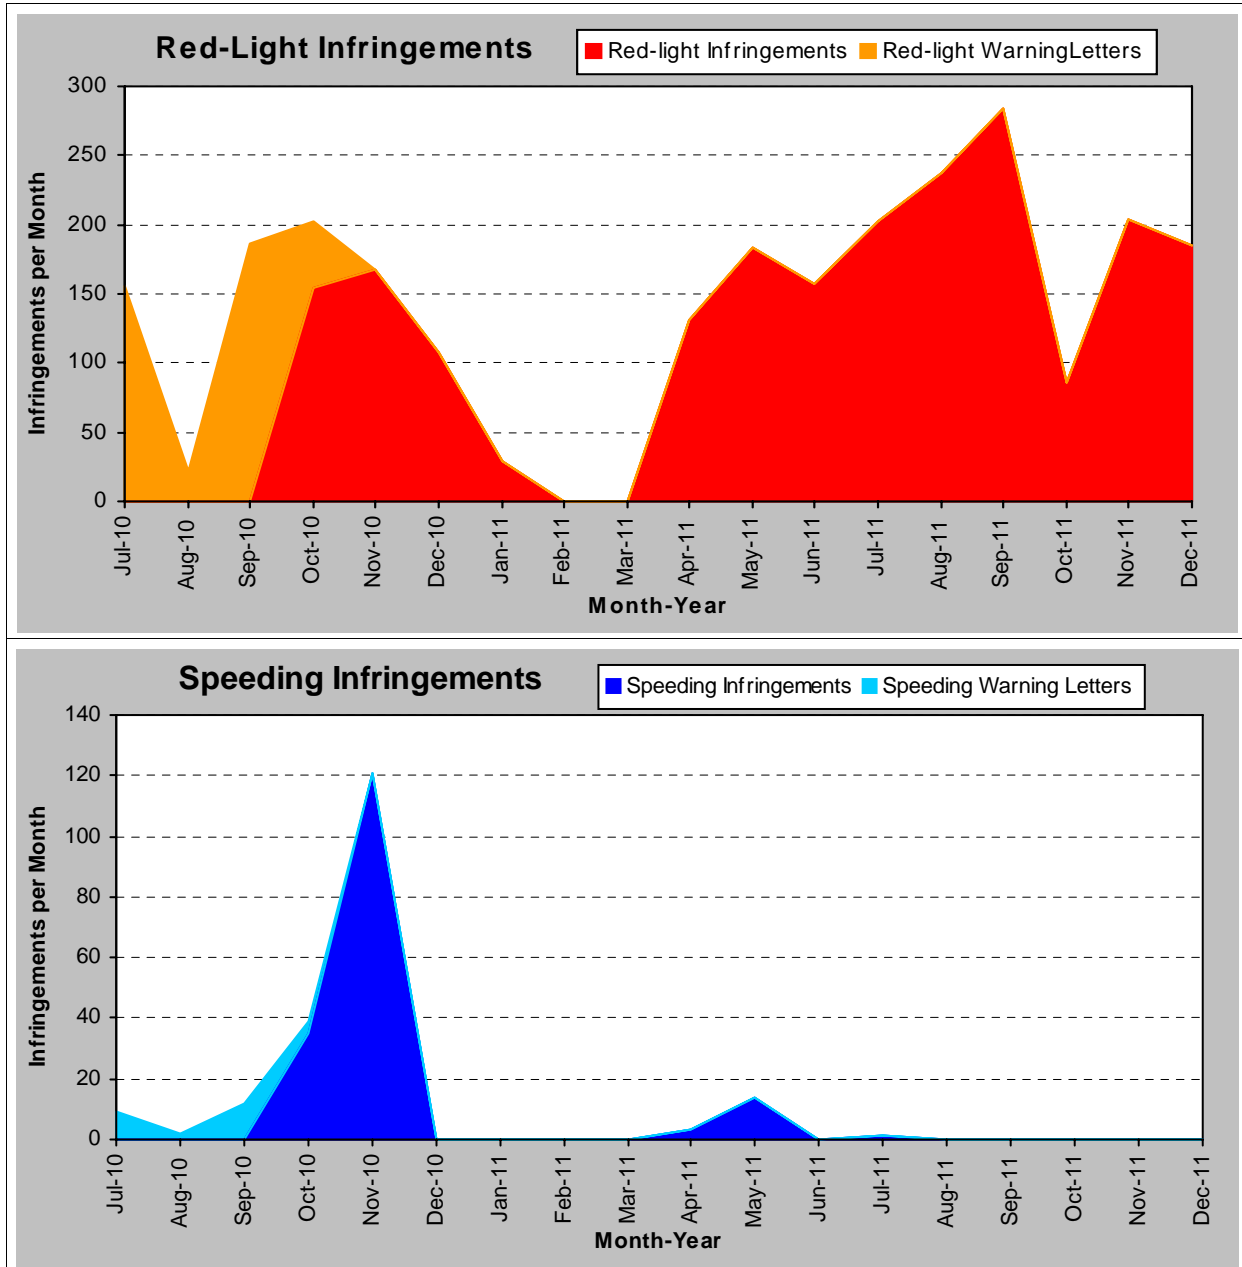
## Infringements at safety camera location

The graph below details the number of warning letters and infringements issued at this intersection since the camera began operating. The graph also shows the trend in infringements at this location.

Roadworks and camera maintenance may influence the number of infringements issued.

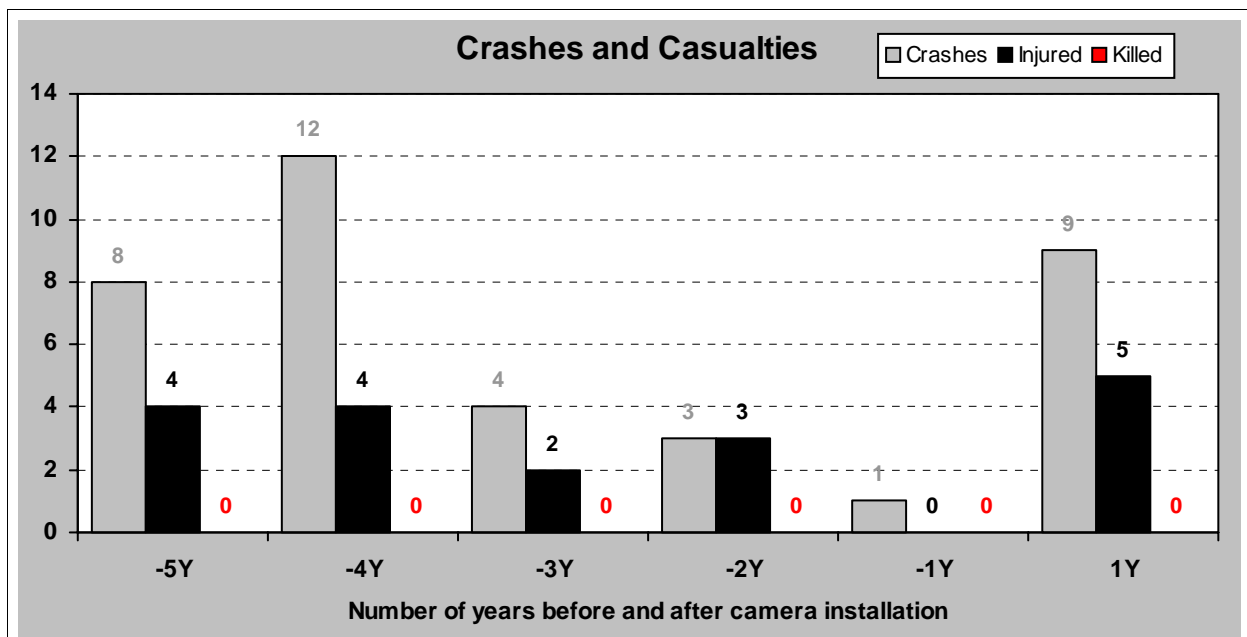
This represents a 54 per cent increase in the yearly average number of crashes and an 84 per cent increase in the yearly average number of casualties at this intersection in the period after installation until the end of 2011.

Provisional crash data shows there were 9 crashes resulting in 5 casualties at this intersection in 2011.

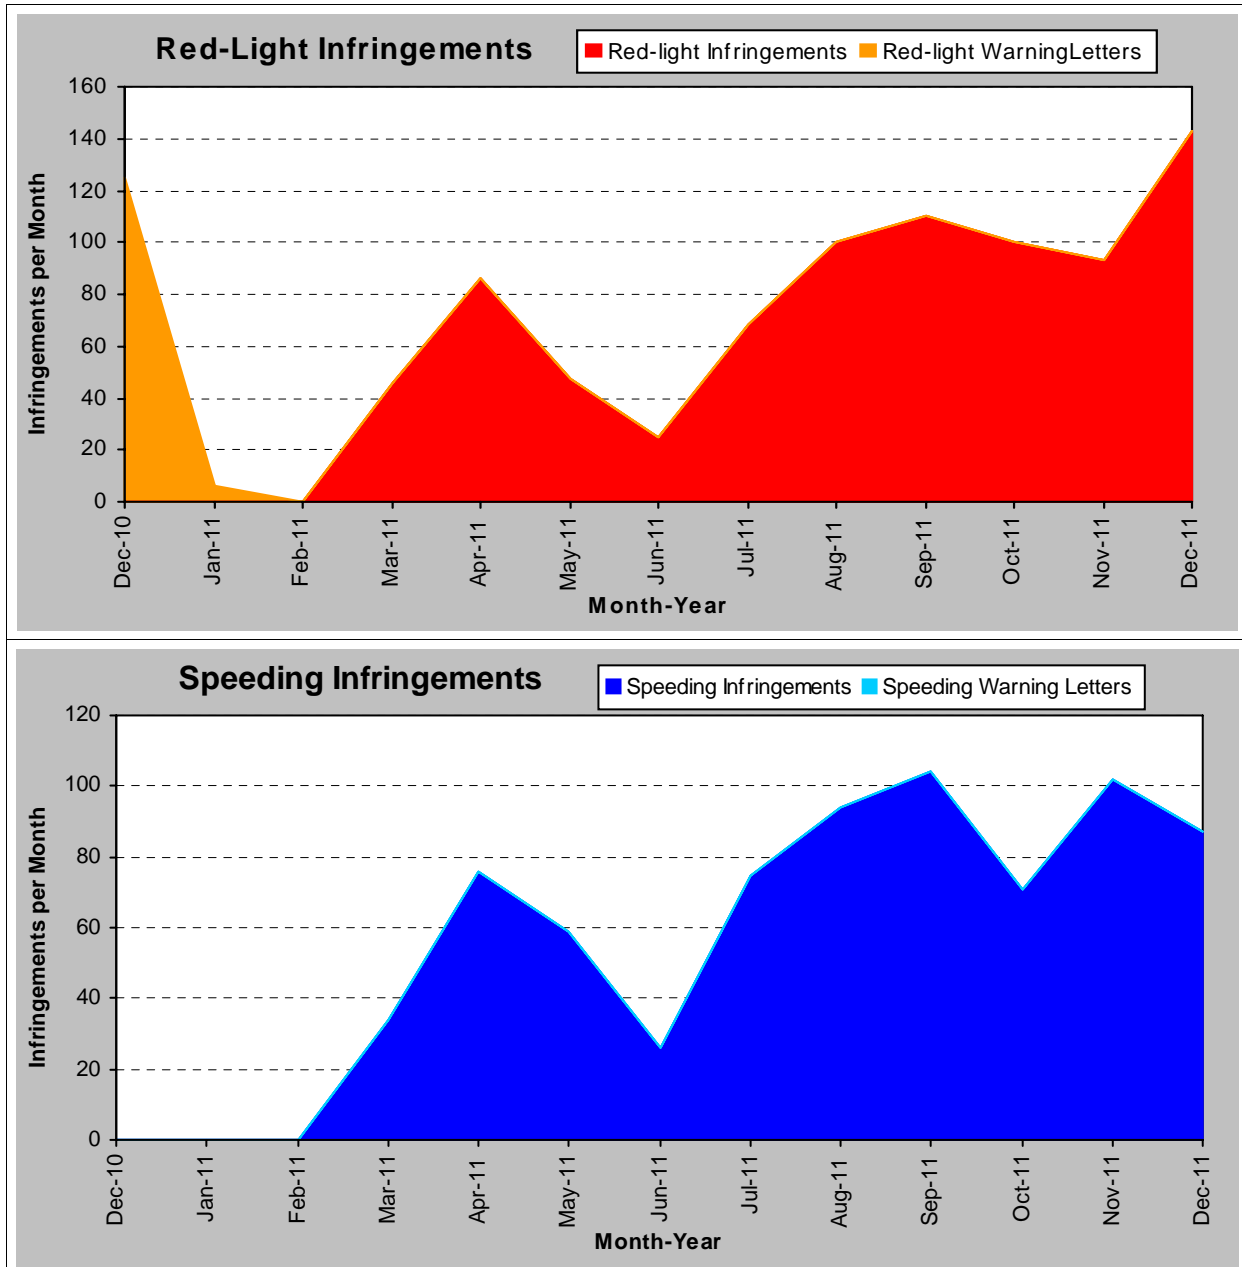
## Infringements at safety camera location

The graph below details the number of warning letters and infringements issued at this intersection since the camera began operating.

Roadworks and camera maintenance may influence the number of infringements issued.

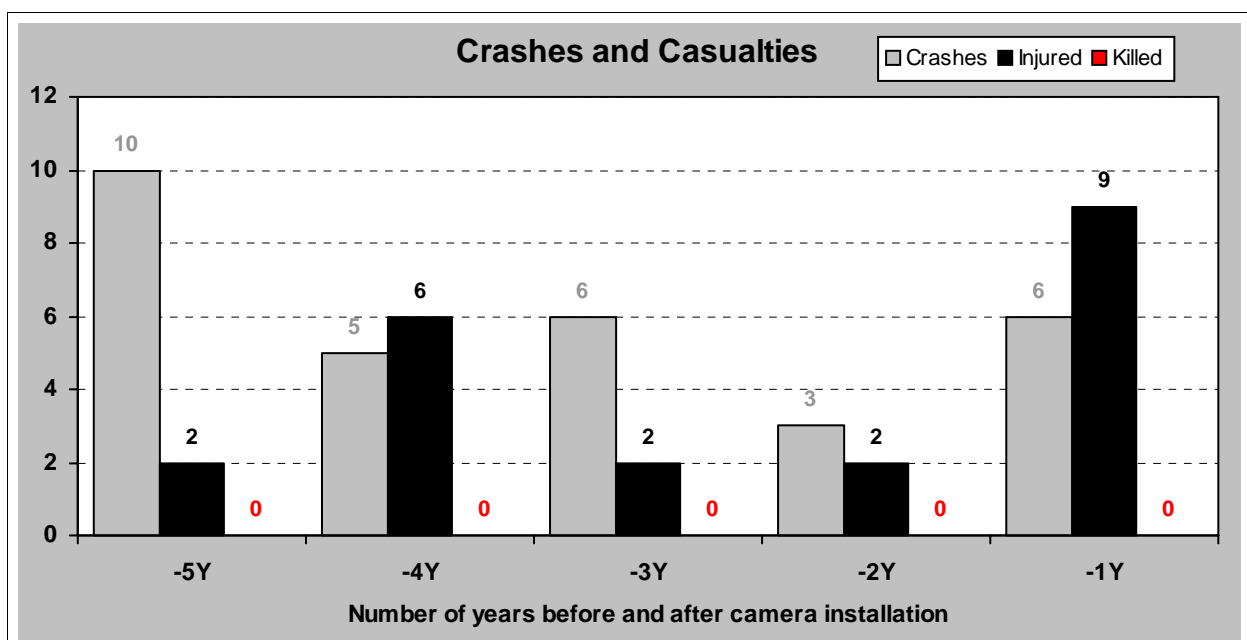
In the 205 day period from installation to the end of 2011, there was 1 crash resulting in 0 injuries and 0 fatalities.

This represents a 70 per cent reduction in the yearly average number of crashes and a 100 per cent reduction in the yearly average number of casualties at this intersection in the period after installation until the end of 2011.

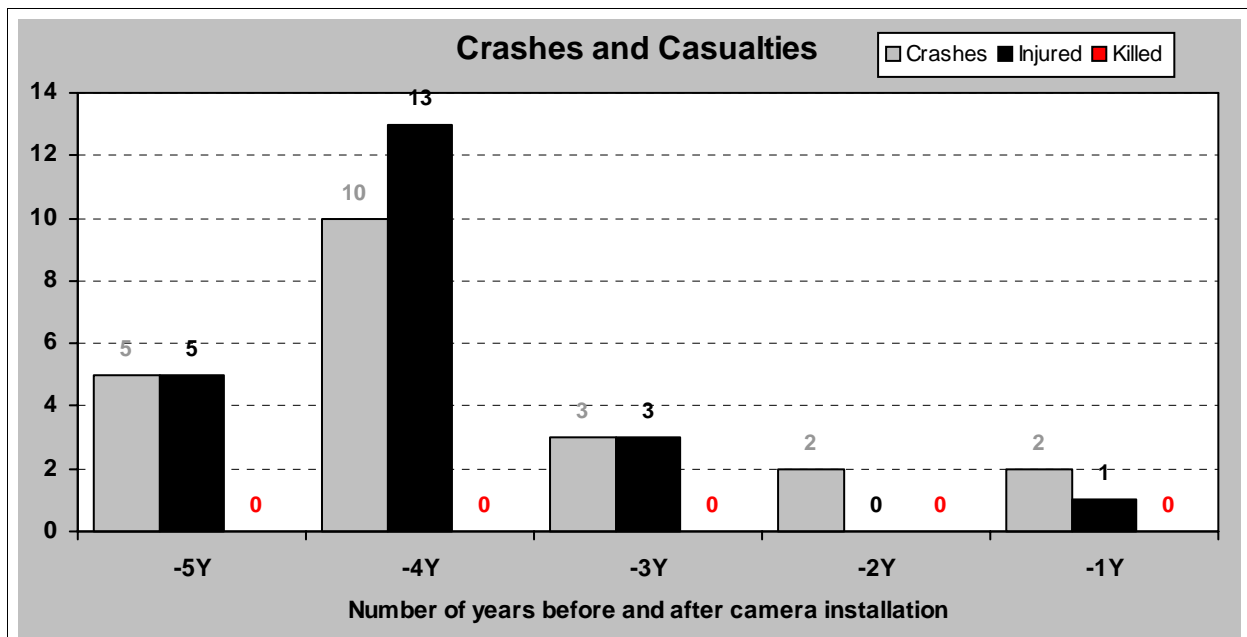
In the 264 day period from installation to the end of 2011, there was 1 crash resulting in 1 injury and 0 fatalities.

This represents a 69 per cent reduction in the yearly average number of crashes and a 69 per cent reduction in the yearly average number of casualties at this intersection in the period after installation until the end of 2011.

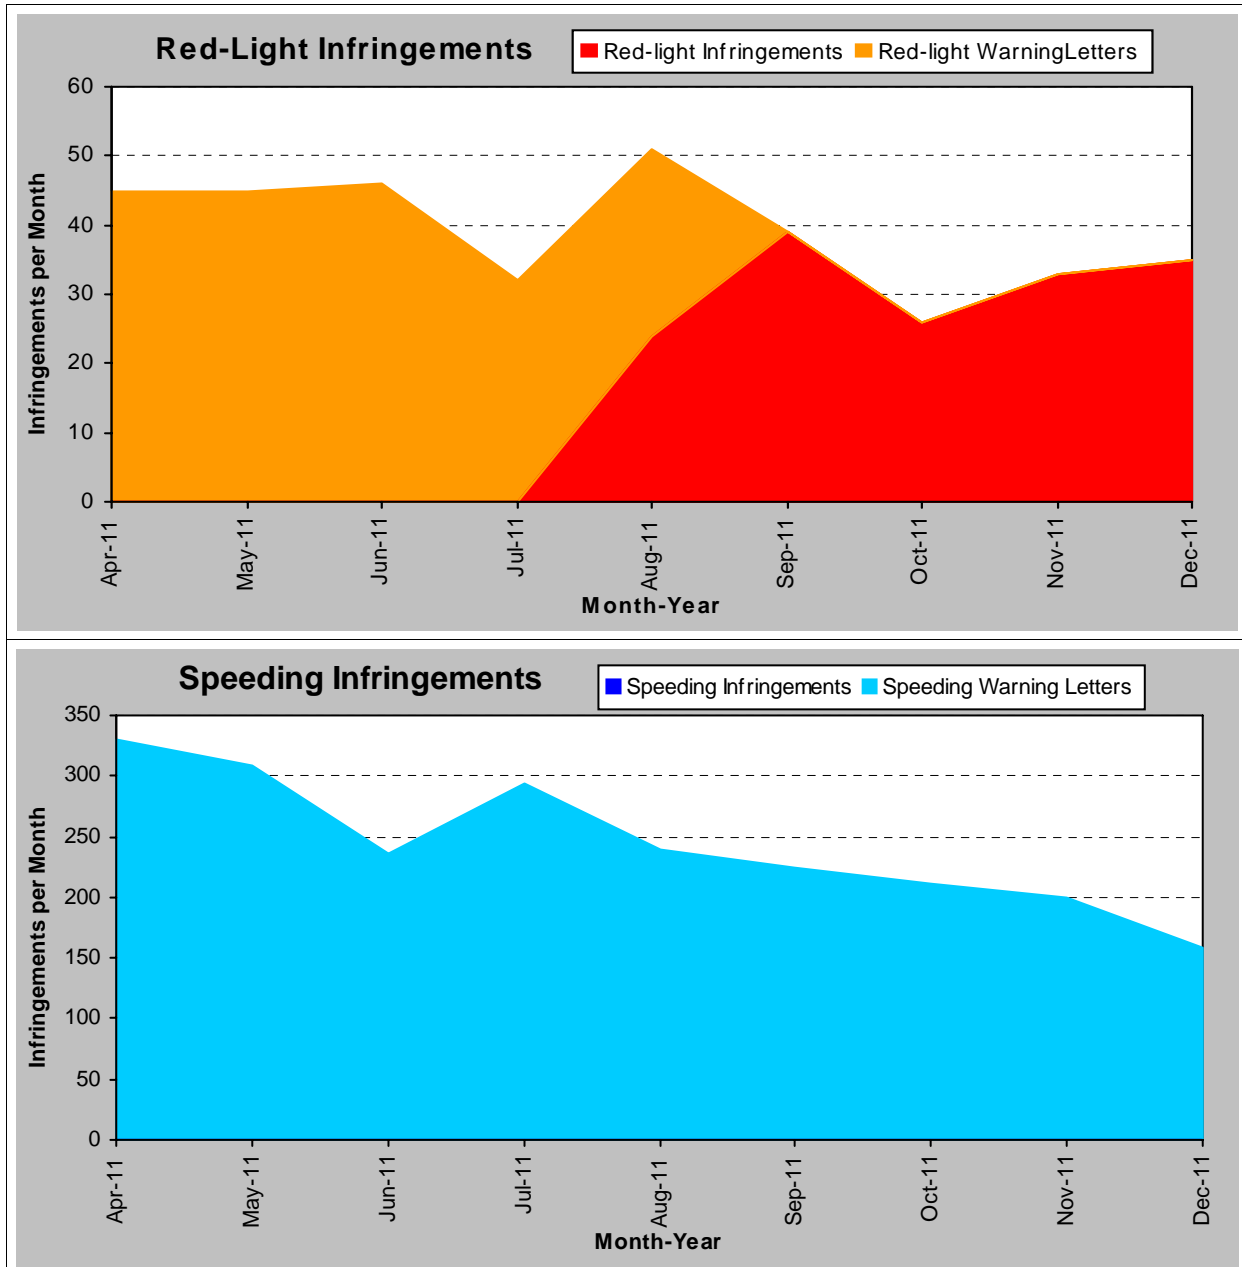
## Infringements at safety camera location

The graph below details the number of warning letters and infringements issued at this intersection since the camera began operating.

Roadworks and camera maintenance may influence the number of infringements issued.

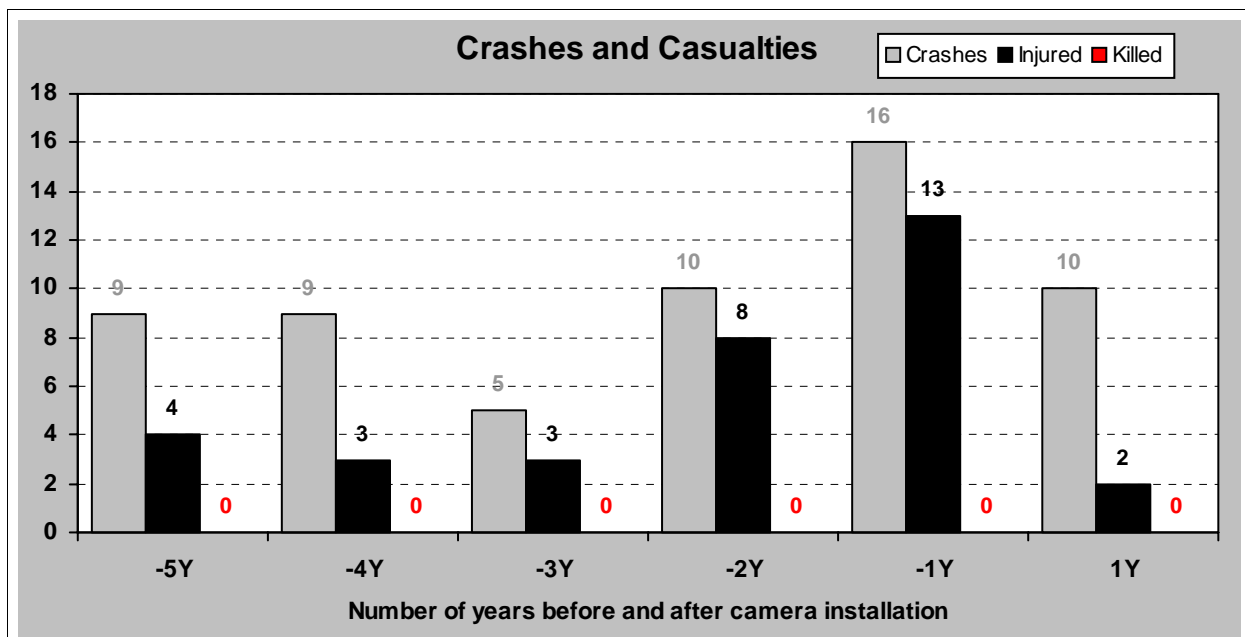
This represents a 1 per cent reduction in the yearly average number of crashes and a 71 per cent reduction in the yearly average number of casualties at this intersection in the period after installation until the end of 2011.

Provisional crash data shows there were 10 crashes resulting in one casualty at this intersection in 2011.

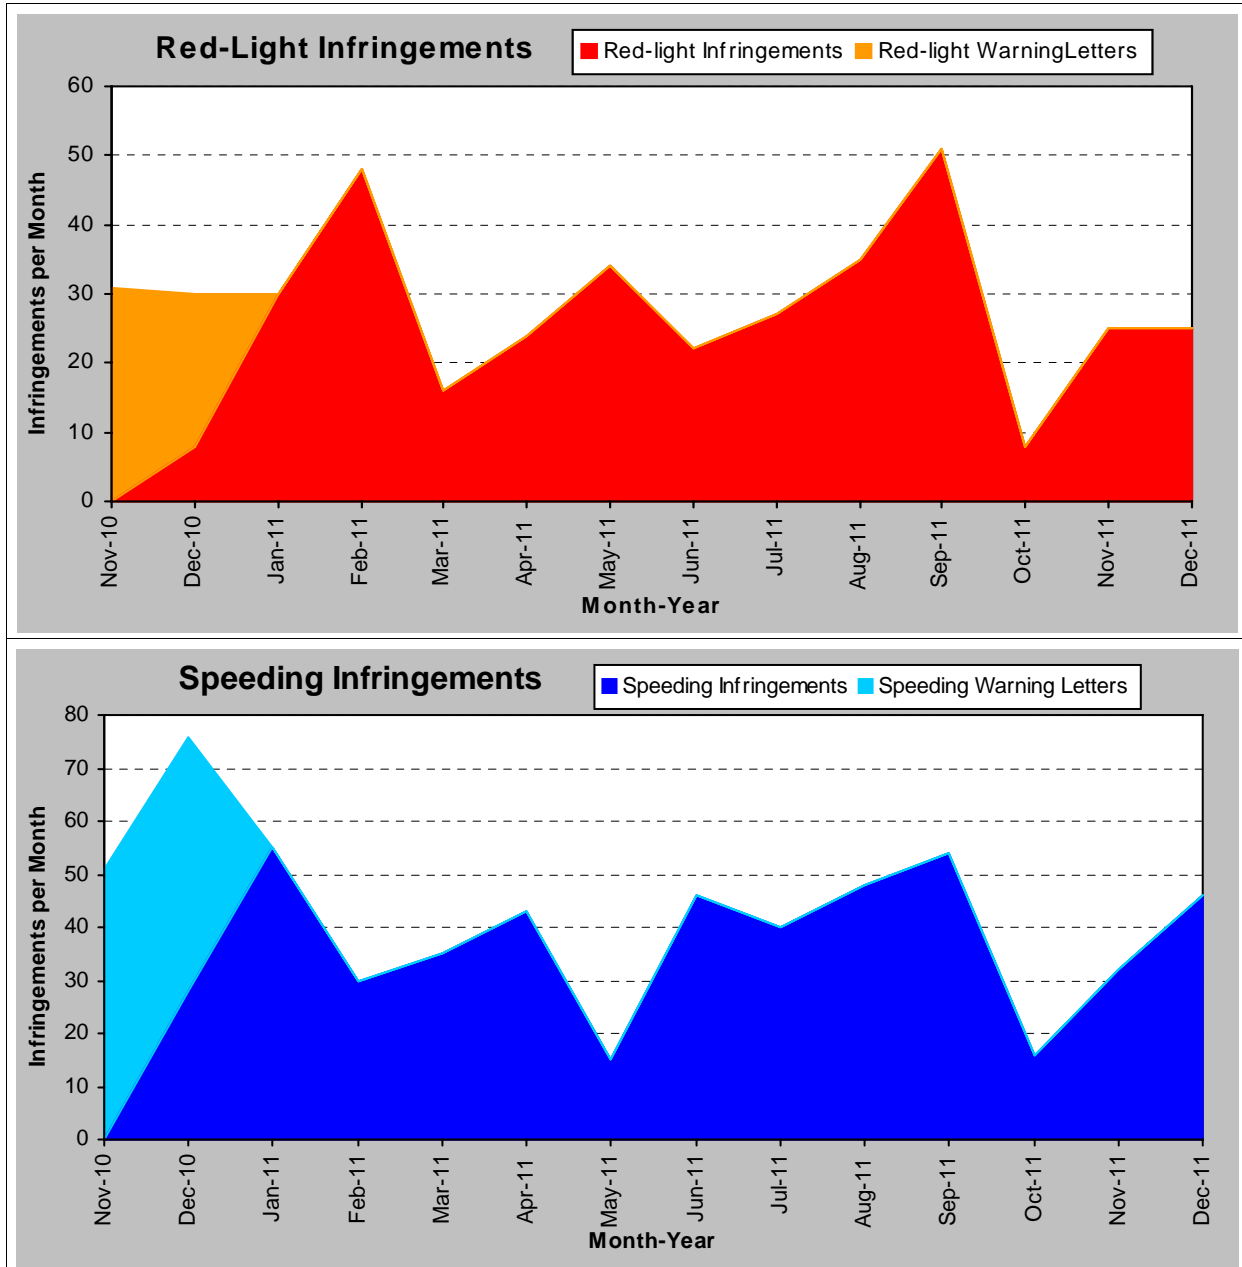
## Infringements at safety camera location

The graph below details the number of warning letters and infringements issued at this intersection since the camera began operating. The graph also shows the trend in infringements at this location.

Roadworks and camera maintenance may influence the number of infringements issued.

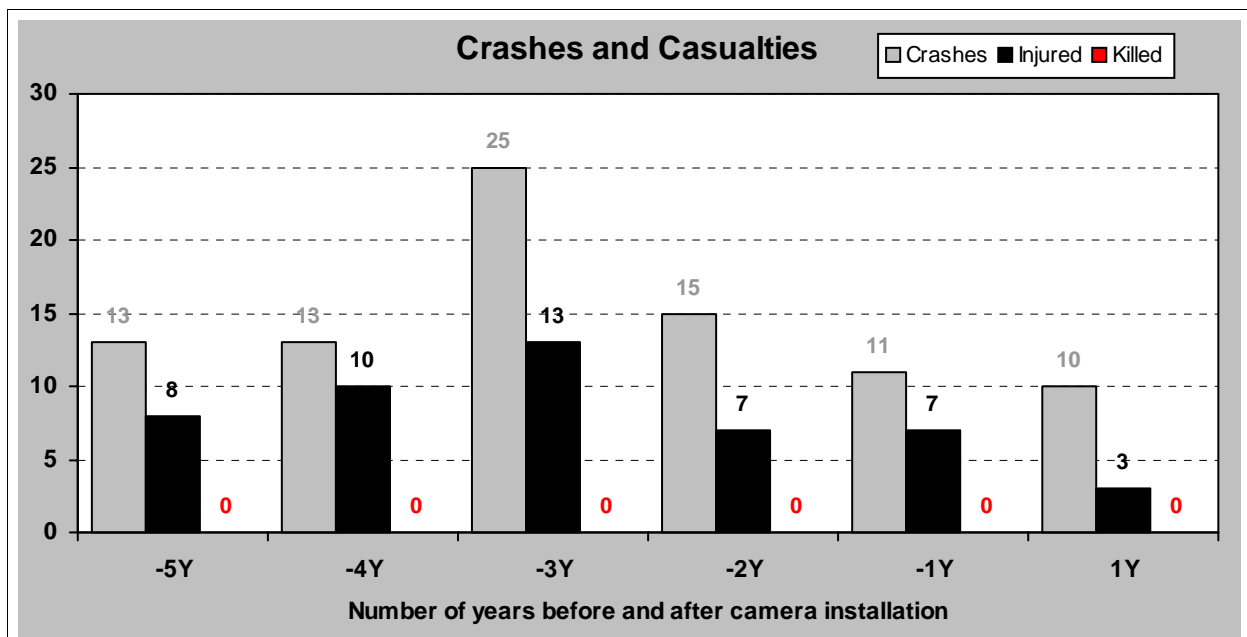
This represents a 27 per cent reduction in the yearly average number of crashes and a 48 per cent reduction in the yearly average number of casualties at this intersection in the period after installation until the end of 2011.

Provisional crash data shows there were 13 crashes resulting in 6 casualties at this intersection in 2011.

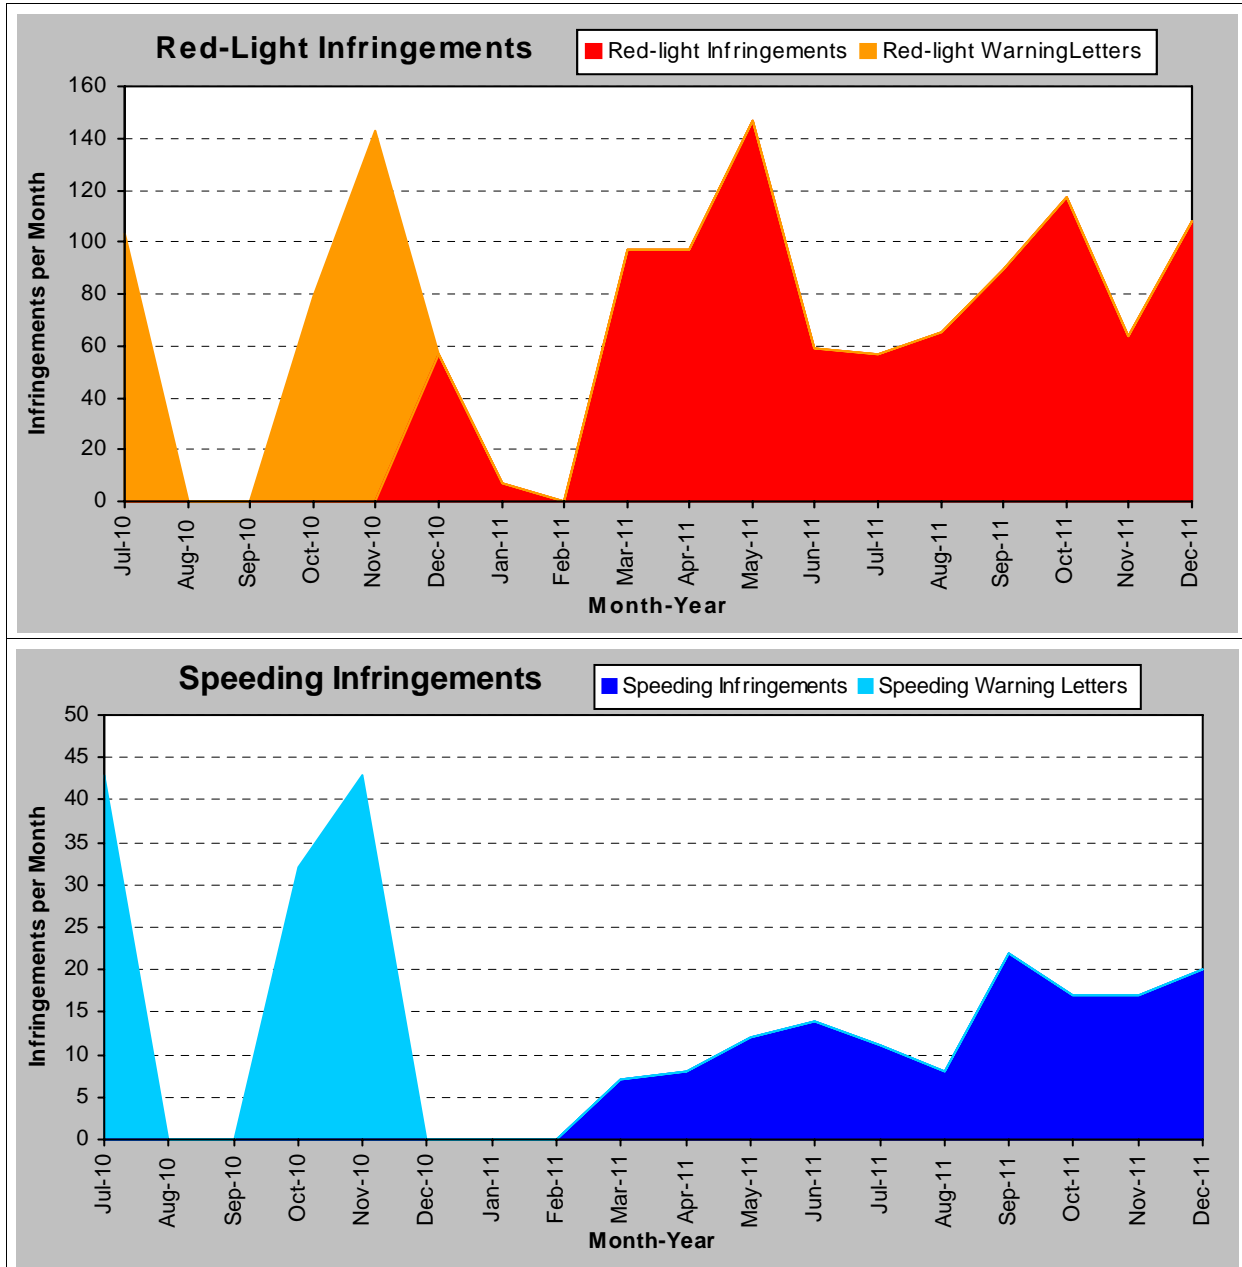
The graph below details the number of warning letters and infringements issued at this intersection since the camera began operating. The graph also shows the trend in infringements at this location.

Roadworks and camera maintenance may influence the number of infringements issued.

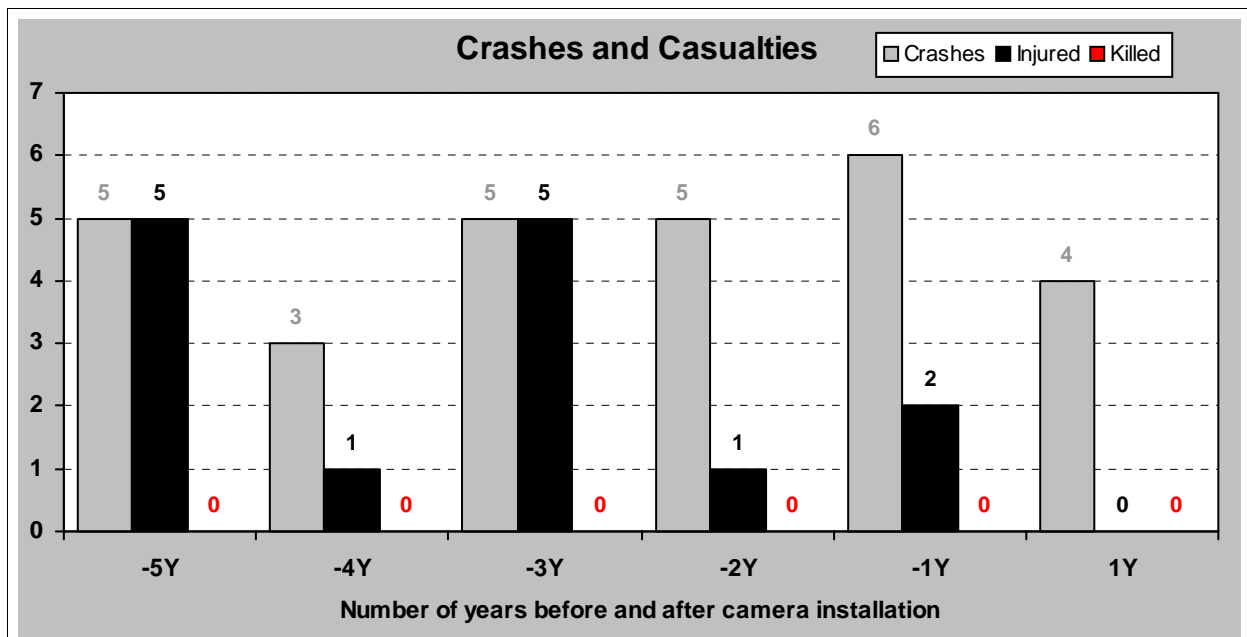
This represents a 1 per cent reduction in the yearly average number of crashes and a 72 per cent reduction in the yearly average number of casualties at this intersection in the period after installation until the end of 2011.

Provisional crash data shows there were 5 crashes resulting in one casualty at this intersection in 2011.

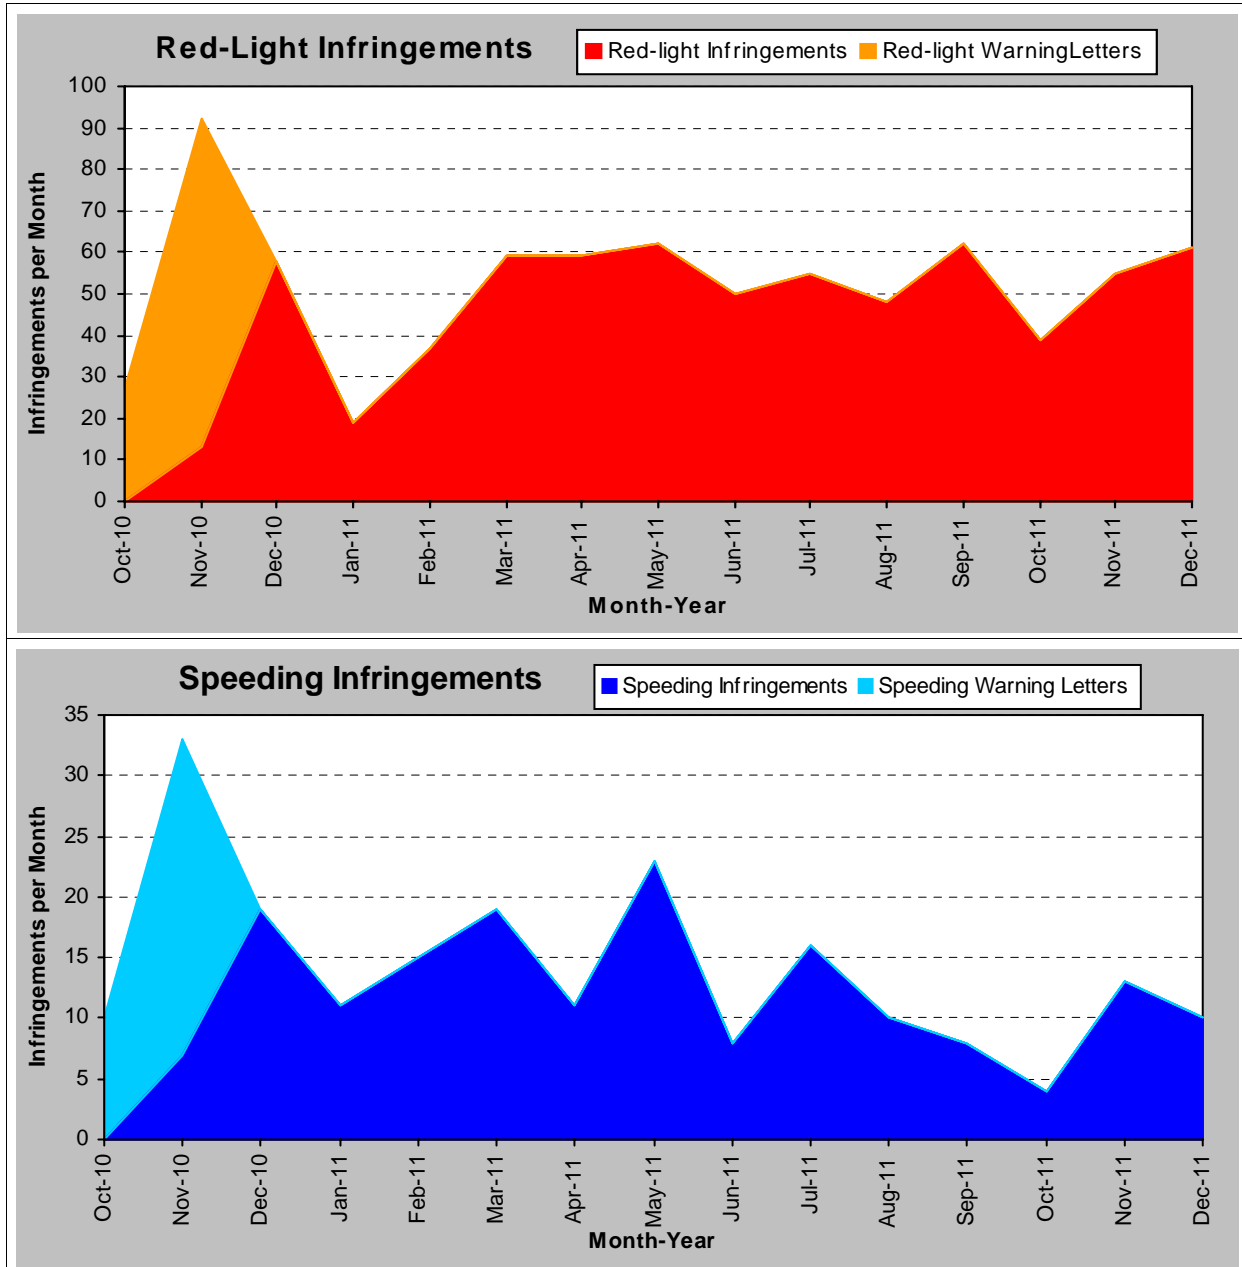
## Infringements at safety camera location

The graph below details the number of warning letters and infringements issued at this intersection since the camera began operating. The graph also shows the trend in infringements at this location.

Roadworks and camera maintenance may influence the number of infringements issued.

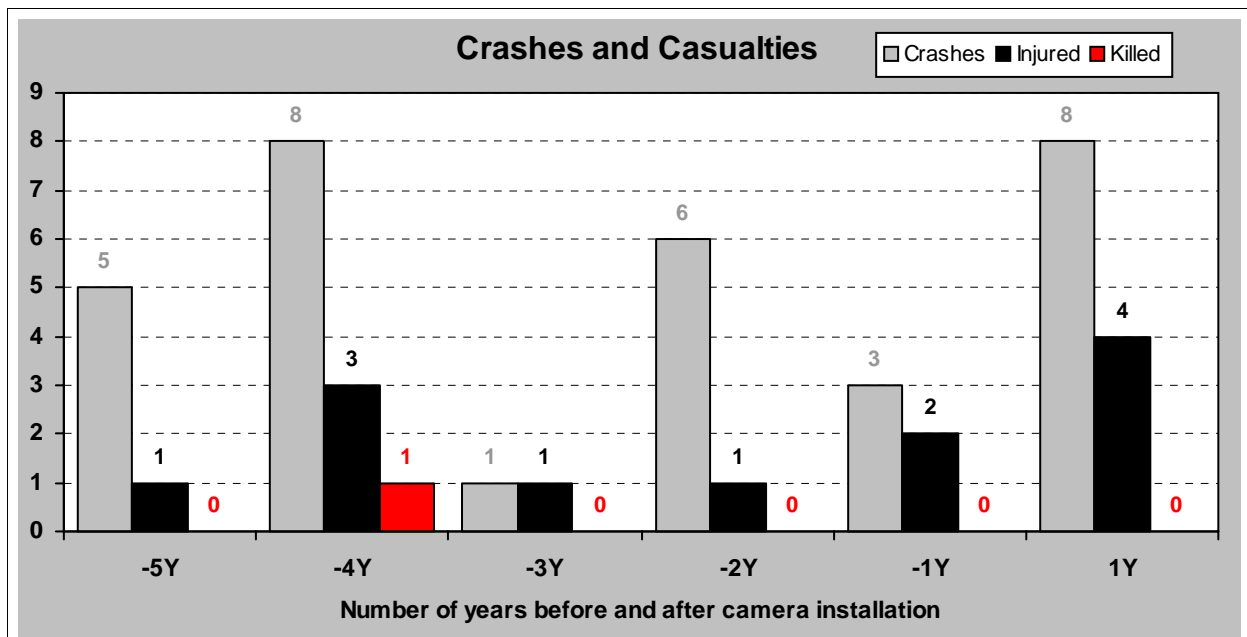
This represents a 29 per cent increase in the yearly average number of crashes and a 65 per cent increase in the yearly average number of casualties at this intersection in the period after installation until the end of 2011.

Provisional crash data shows there were 5 crashes resulting in 4 casualties at this intersection in 2011.

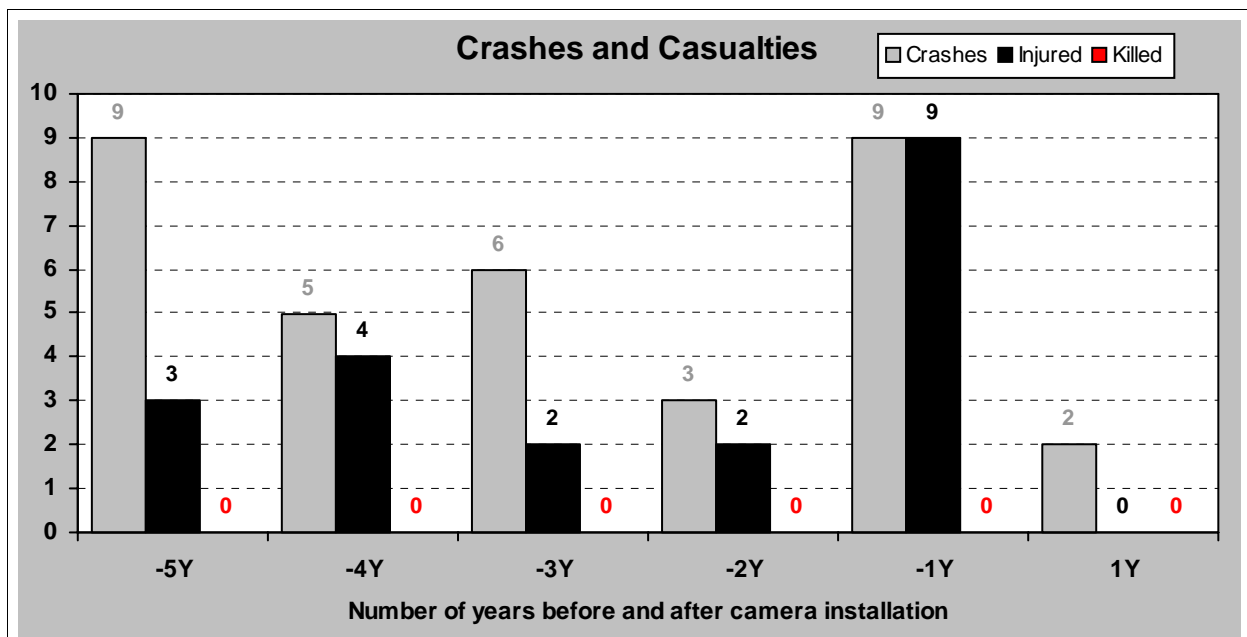
This represents a 70 per cent reduction in the yearly average number of crashes and a 100 per cent reduction in the yearly average number of casualties at this intersection in the period after installation until the end of 2011.

Provisional crash data shows there were 2 crashes resulting in 0 casualties at this intersection in 2011.

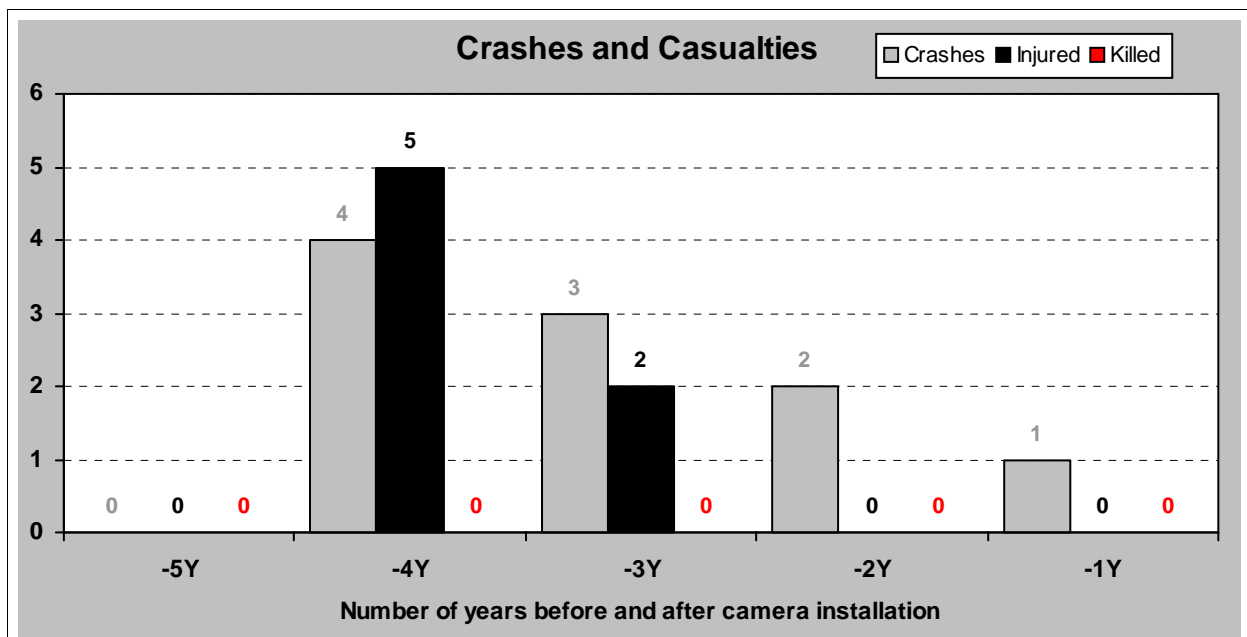
In the 228 day period from installation to the end of 2011, there were 4 crashes resulting in 1 injury and 0 fatalities.

This represents a 220 per cent increase in the yearly average number of crashes and a 14 per cent increase in the yearly average number of casualties at this intersection in the period after installation until the end of 2011.

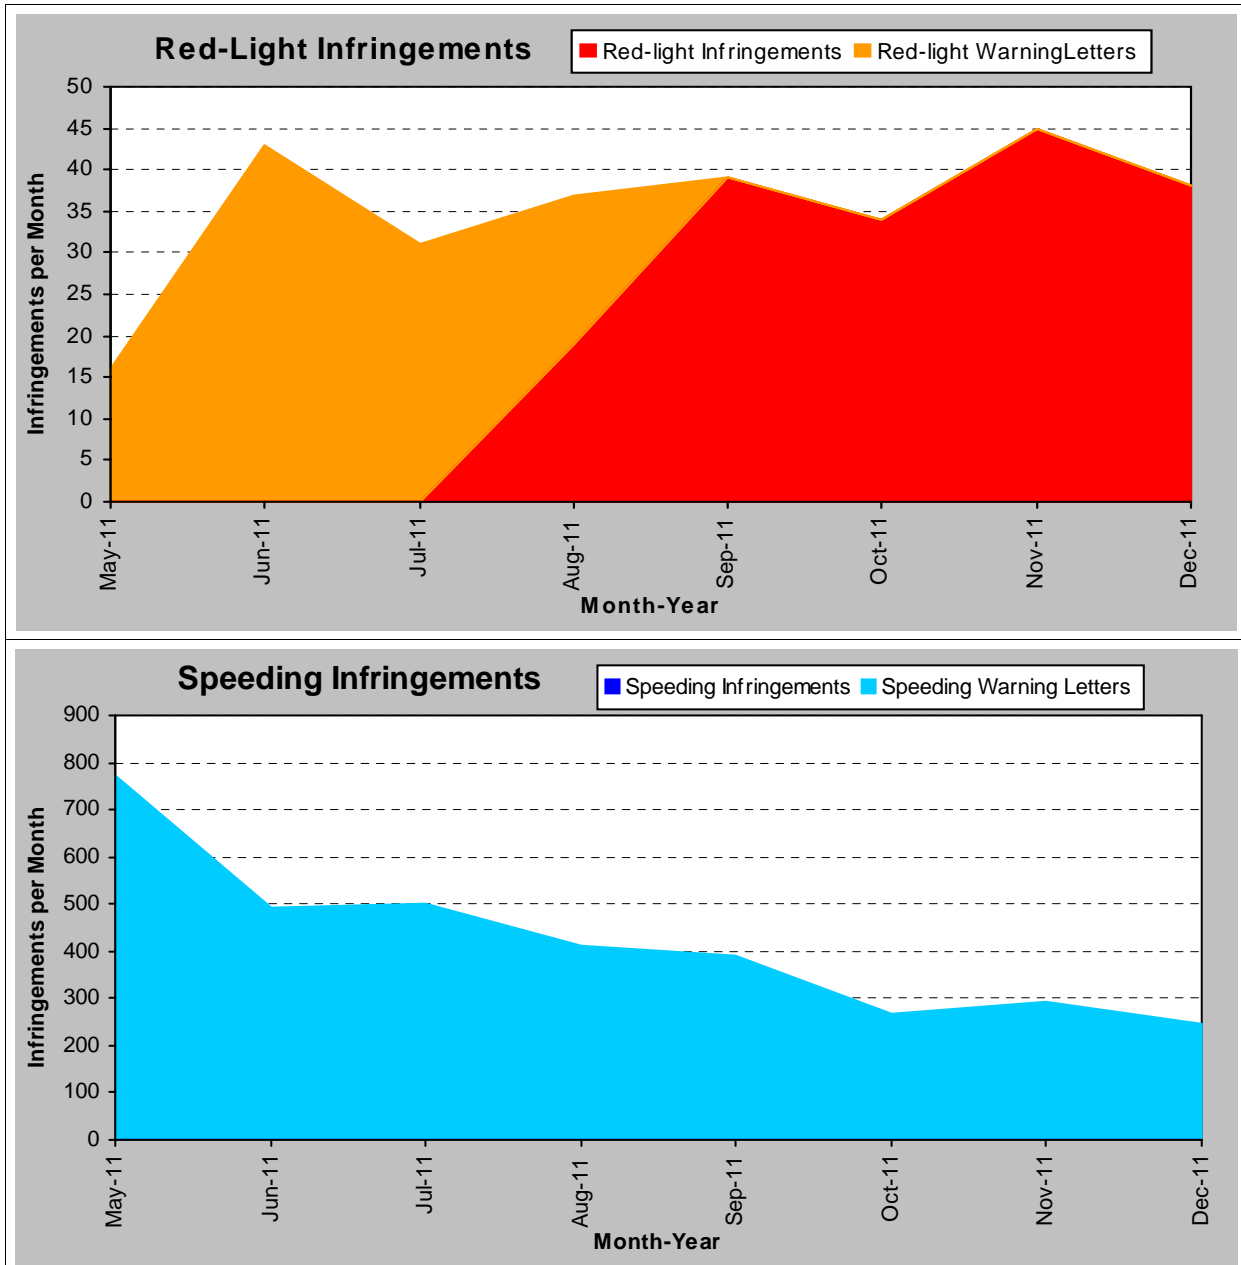
## Infringements at safety camera location

The graph below details the number of warning letters and infringements issued at this intersection since the camera began operating.

Roadworks and camera maintenance may influence the number of infringements issued.

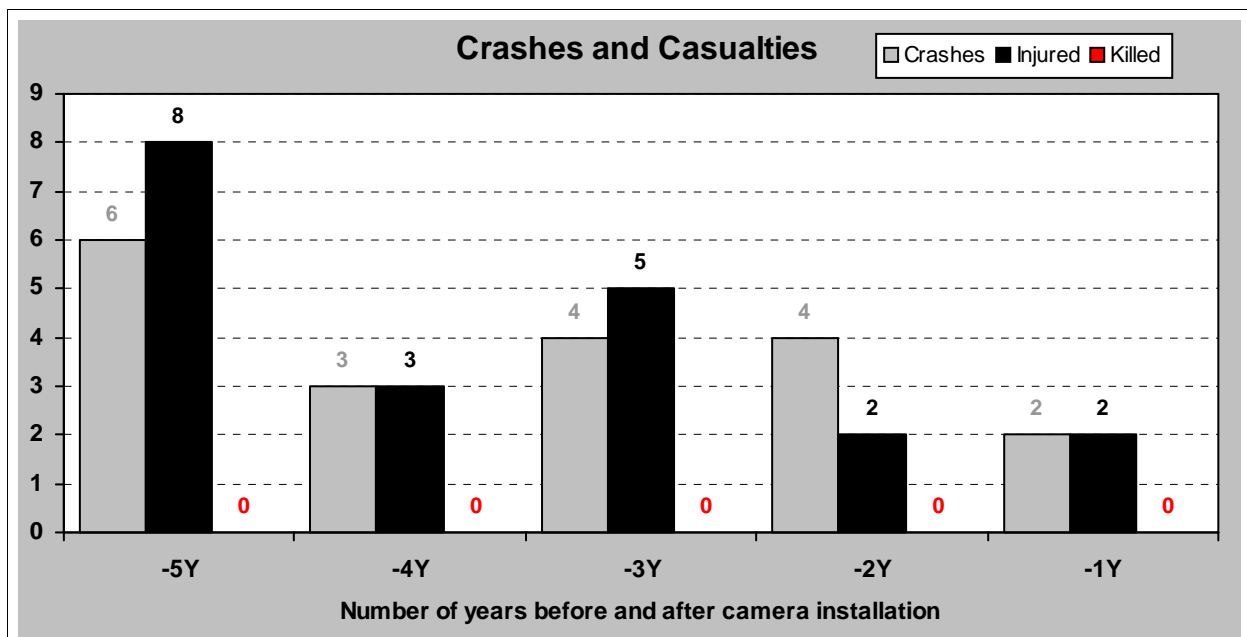
In the 257 day period from installation to the end of 2011, there were 4 crashes resulting in 0 injuries and 1 fatality.

This represents a 50 per cent increase in the yearly average number of crashes and a 64 per cent reduction in the yearly average number of casualties at this intersection in the period after installation until the end of 2011.

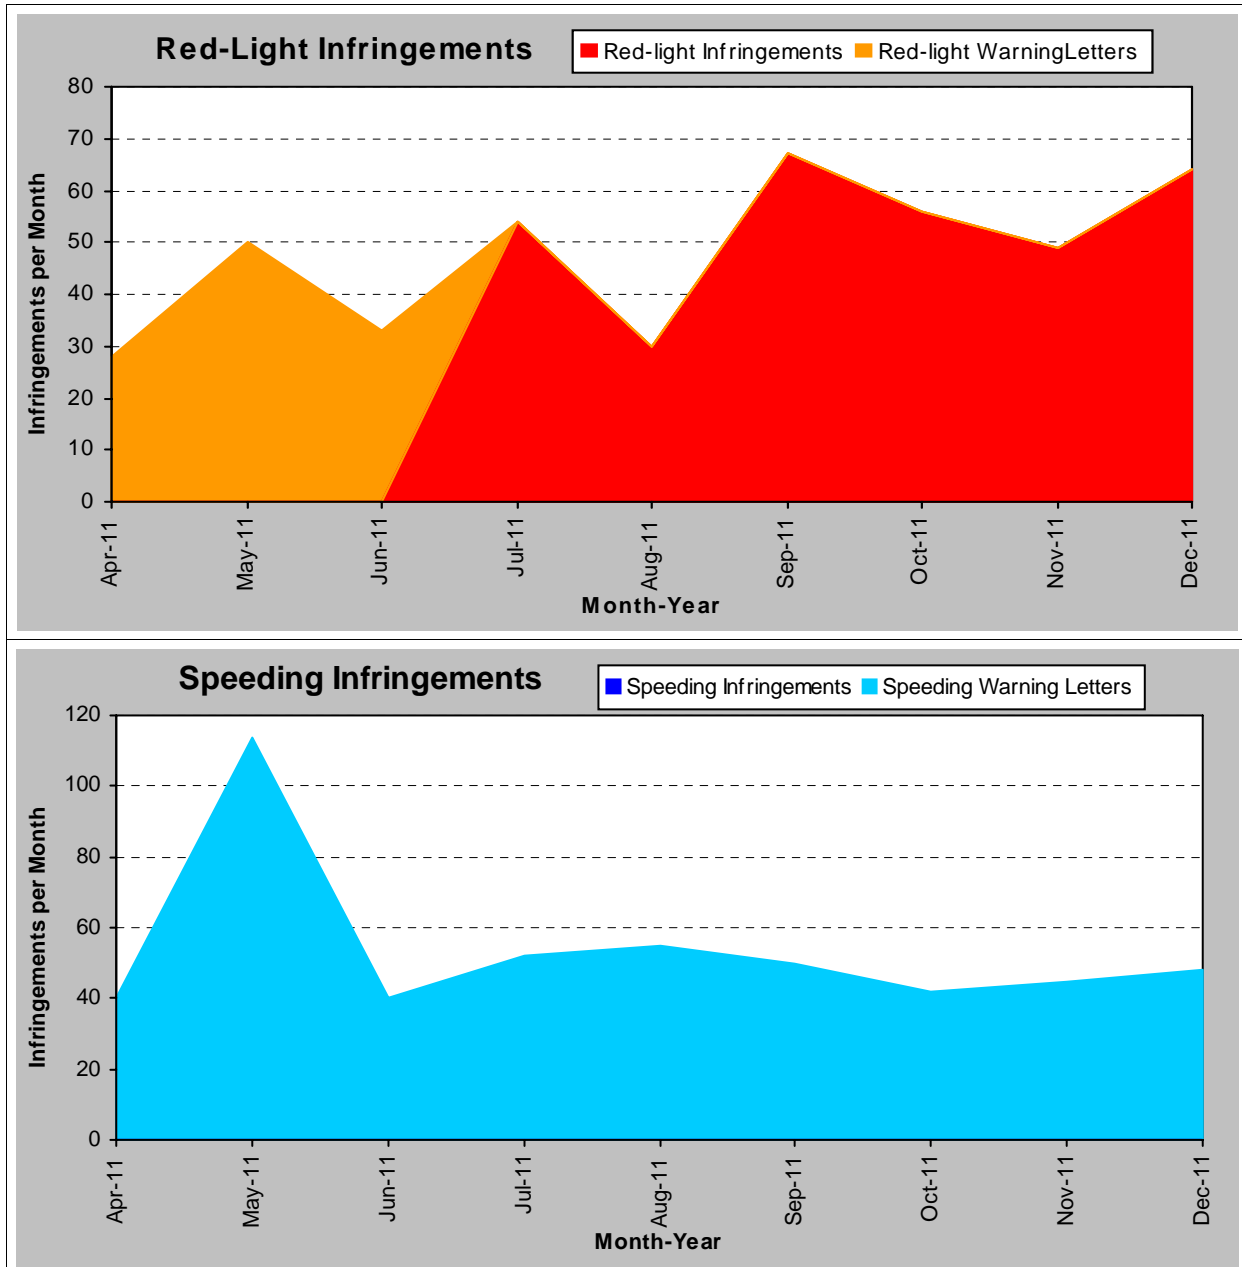
## Infringements at safety camera location

The graph below details the number of warning letters and infringements issued at this intersection since the camera began operating.

Roadworks and camera maintenance may influence the number of infringements issued.

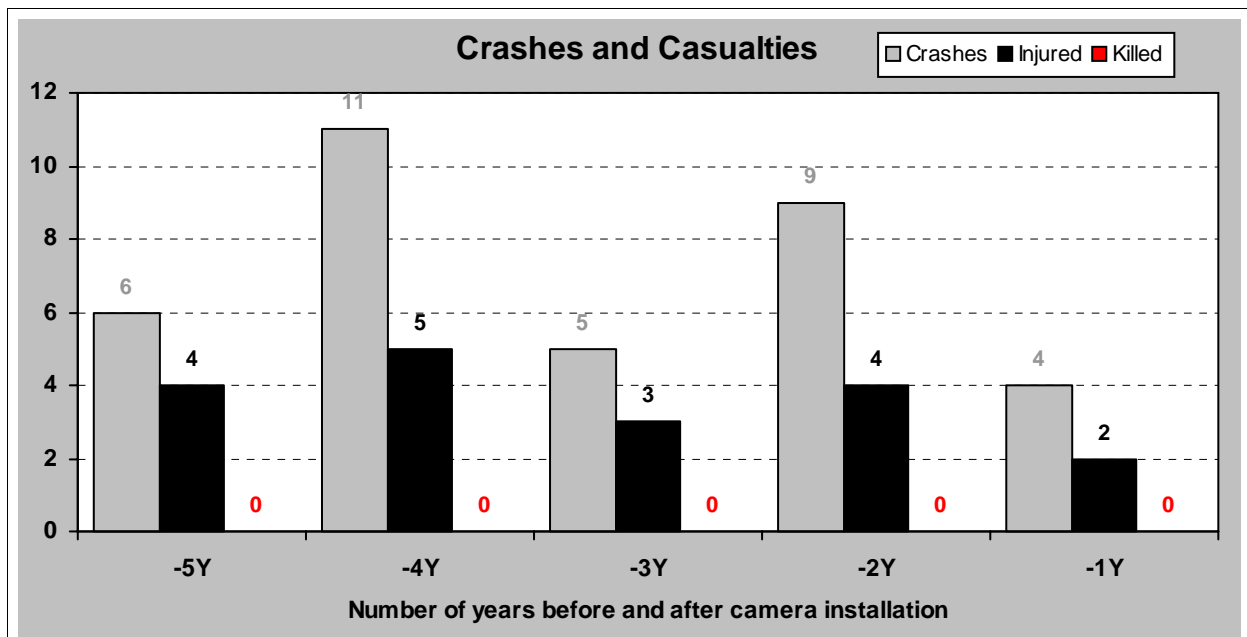
In the 201 day period from installation to the end of 2011, there were 5 crashes resulting in 2 injuries and 0 fatalities.

This represents a 30 per cent increase in the yearly average number of crashes and a 1 per cent increase in the yearly average number of casualties at this intersection in the period after installation until the end of 2011.
