# ANNUAL NSW SPEED CAMERA PERFORMANCE REVIEW

NSW Centre for Road Safety

JULY 2012

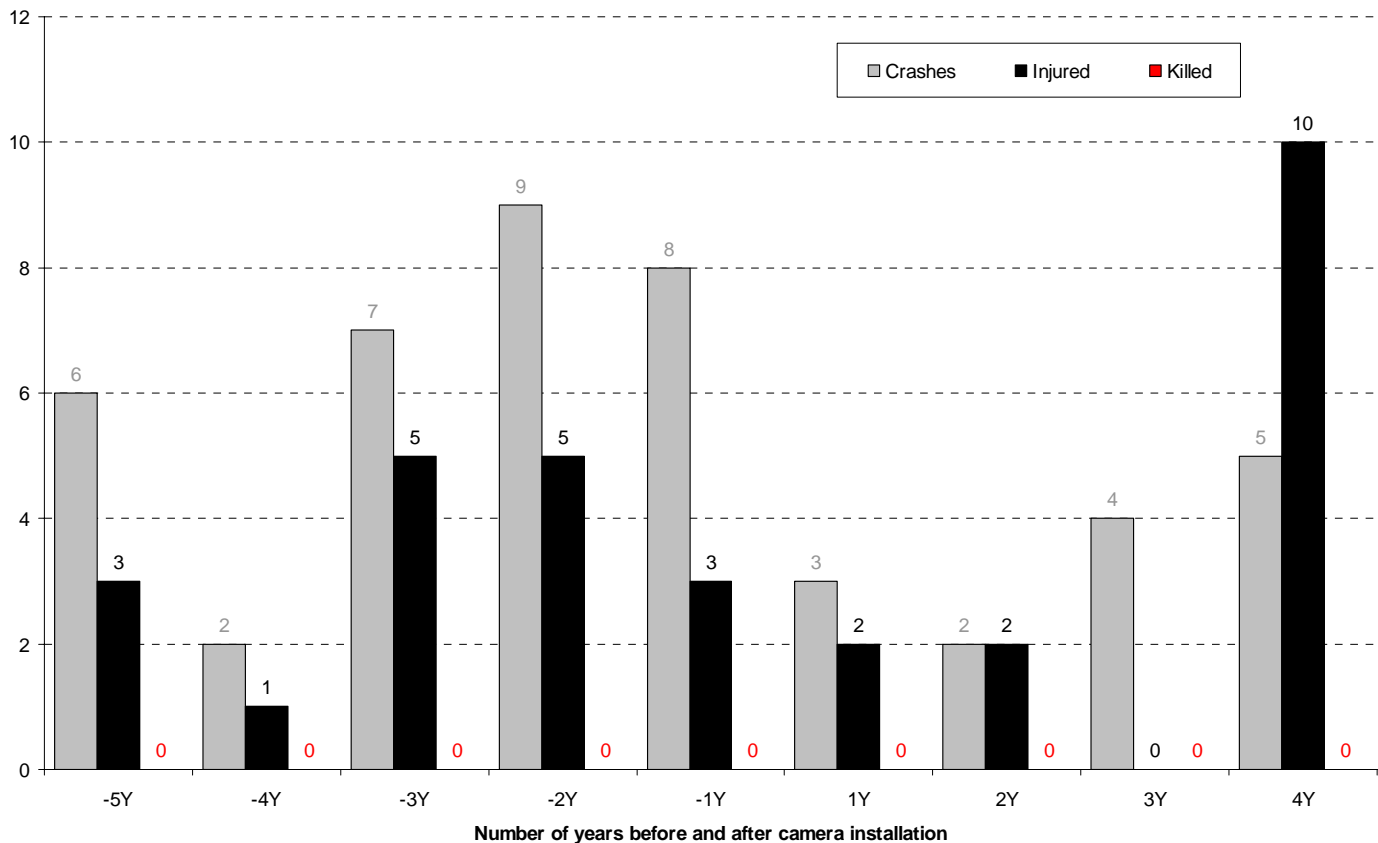
### Crashes at fixed speed camera location

Five years before – May 2002 to May 2007 - Totals				
Fatality Persons	Injury Persons	Casualty Persons	Crashes	Casualty Cost (\$M)
0	17	17	32	1.938
After (most recent four year period) – 2007 to 2011 - Totals				
Fatality Persons	Injury Persons	Casualty Persons	Crashes	Casualty Cost (\$M)
0	14	14	14	1.596

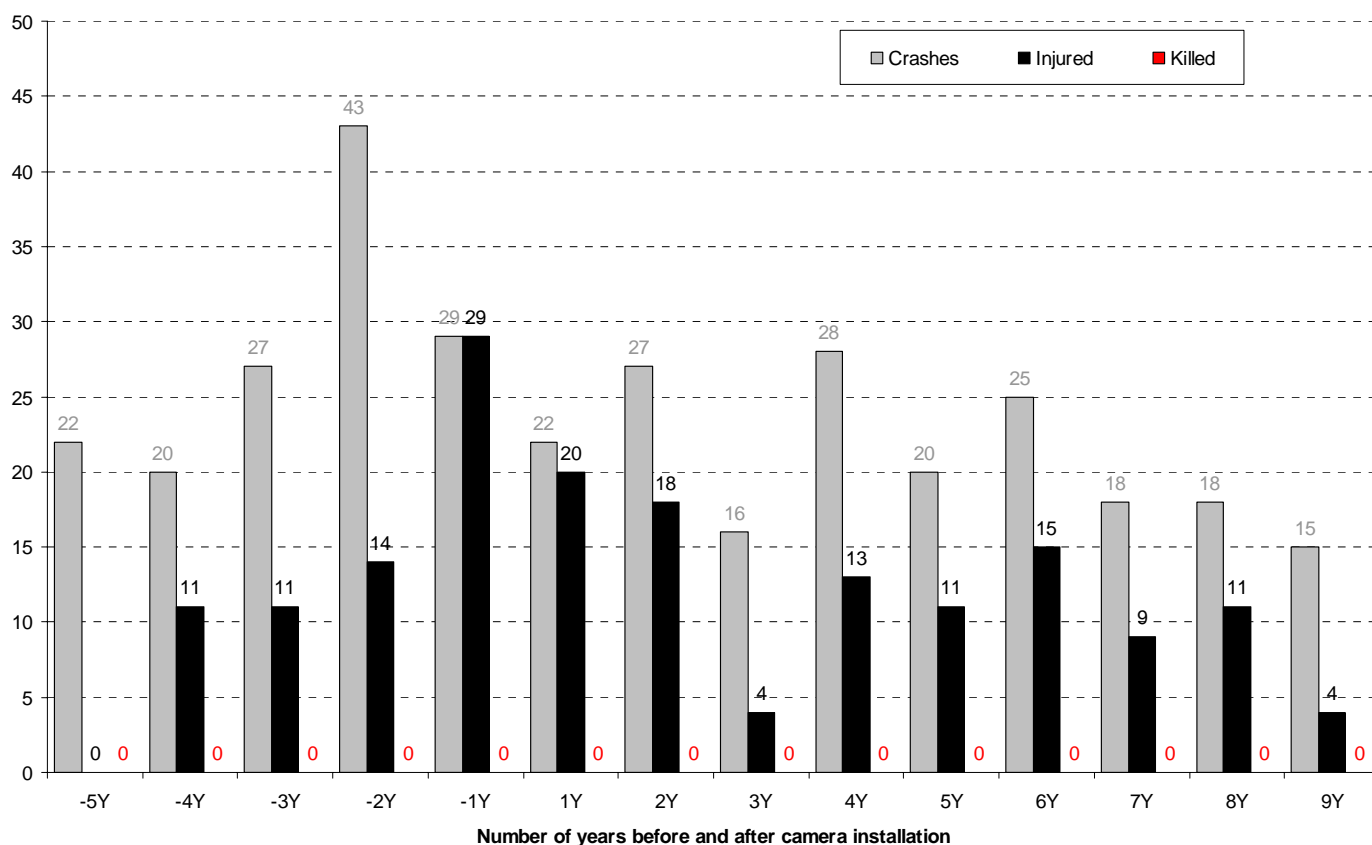
### Crashes at fixed speed camera location

Five years before – Feb 1997 to Feb 2002 - Totals				
Fatality Persons	Injury Persons	Casualty Persons	Crashes	Casualty Cost (\$M)
0	79	79	141	9.006
After (most recent five year period) – 2006 to 2011 - Totals				
Fatality Persons	Injury Persons	Casualty Persons	Crashes	Casualty Cost (\$M)
0	50	50	96	5.7

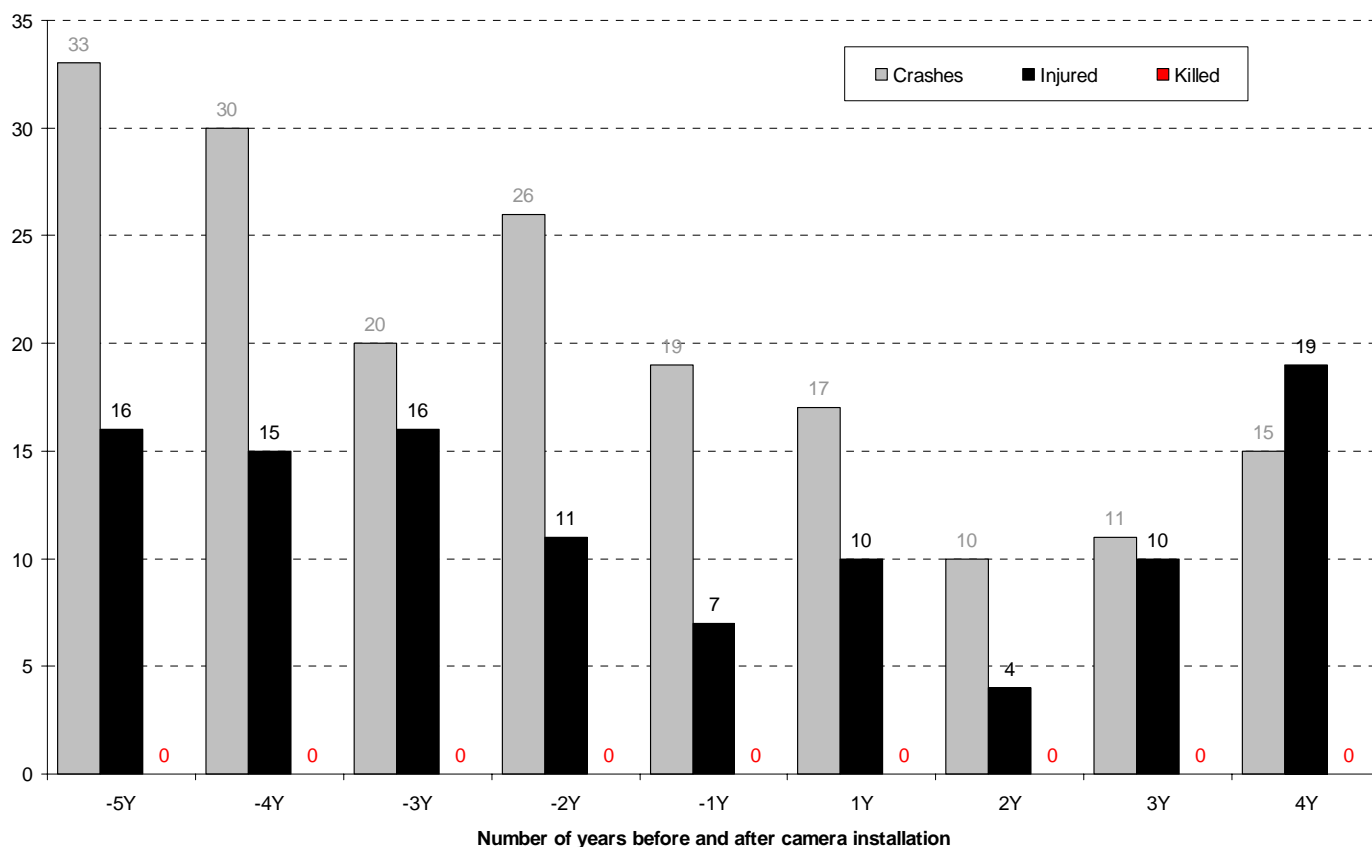
### Crashes at fixed speed camera location

Five years before – Apr 2002 to Apr 2007 - Totals				
Fatality Persons	Injury Persons	Casualty Persons	Crashes	Casualty Cost (\$M)
0	65	65	128	7.41
After (most recent four year period) – 2007 to 2011 - Totals				
Fatality Persons	Injury Persons	Casualty Persons	Crashes	Casualty Cost (\$M)
0	43	43	53	4.902

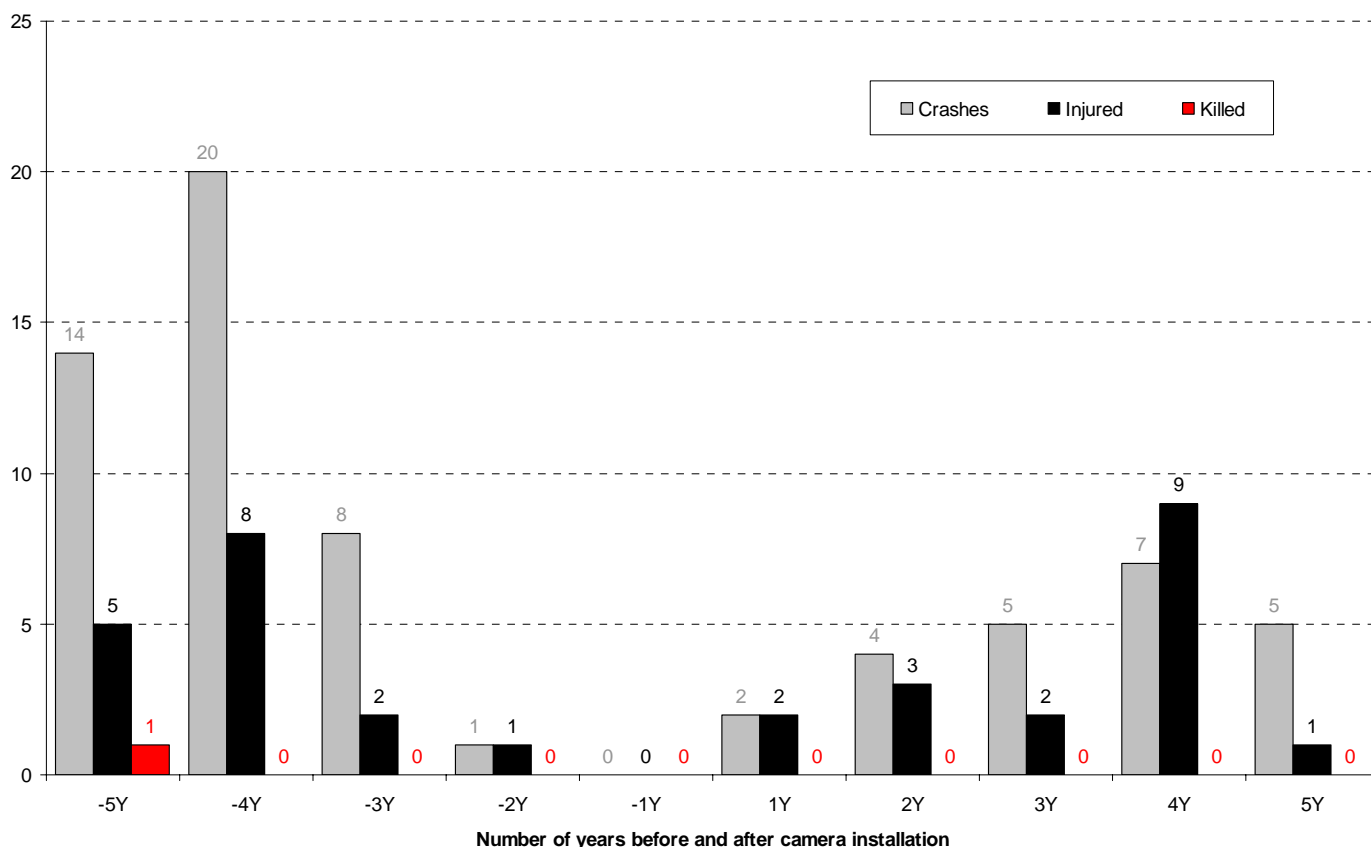
### Crashes at fixed speed camera location

Five years before – Jan 2001 to Jan 2006 - Totals				
Fatality Persons	Injury Persons	Casualty Persons	Crashes	Casualty Cost (\$M)
1	16	17	43	7.658
After (most recent five year period) – 2006 to 2011 - Totals				
Fatality Persons	Injury Persons	Casualty Persons	Crashes	Casualty Cost (\$M)
0	17	17	23	1.938

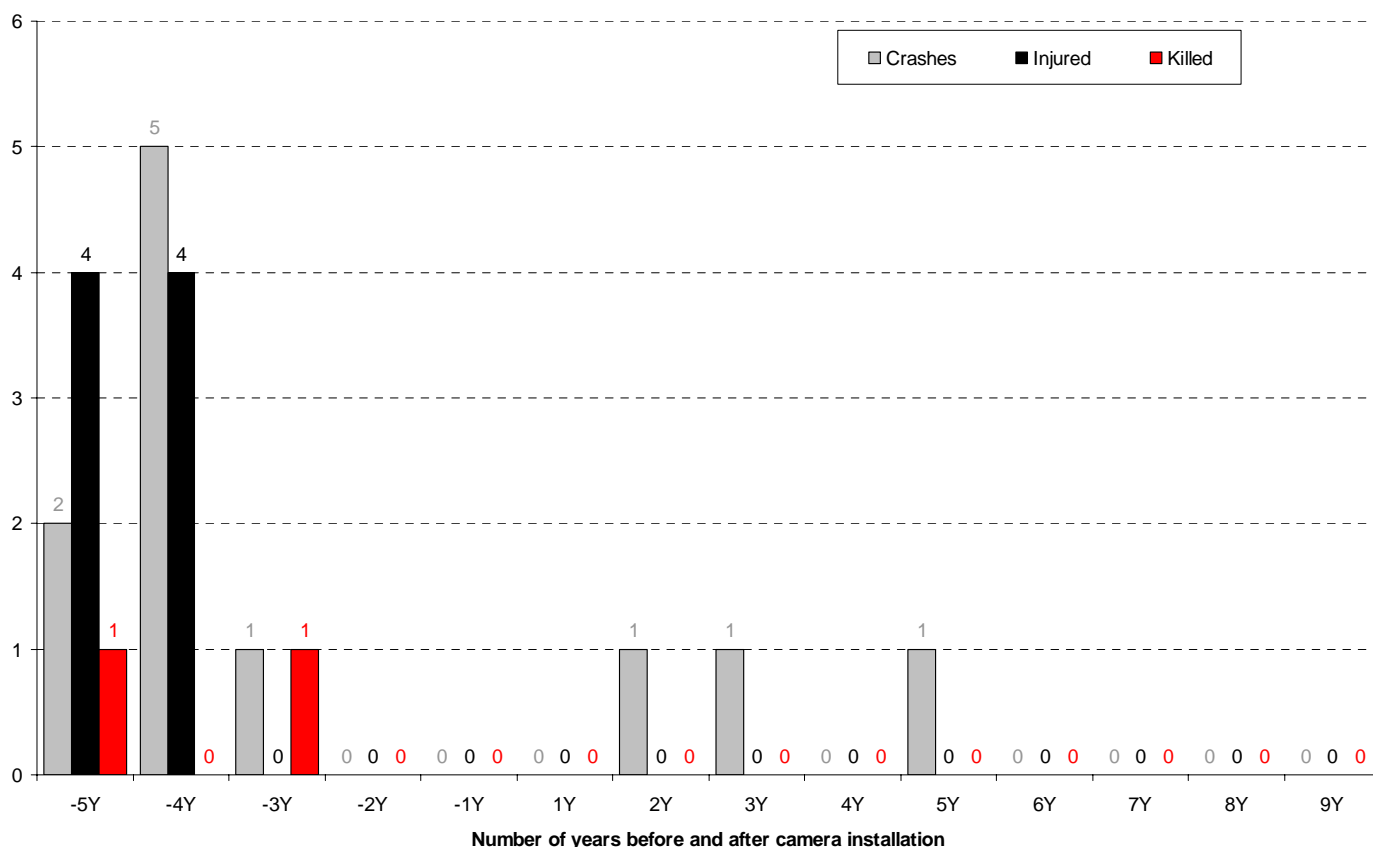
### Crashes at fixed speed camera location

Five years before – Jun 1998 to Jun 2003 - Totals				
Fatality Persons	Injury Persons	Casualty Persons	Crashes	Casualty Cost (\$M)
2	8	10	8	12.58
After (most recent five year period) – 2006 to 2011 - Totals				
Fatality Persons	Injury Persons	Casualty Persons	Crashes	Casualty Cost (\$M)
0	0	0	1	0

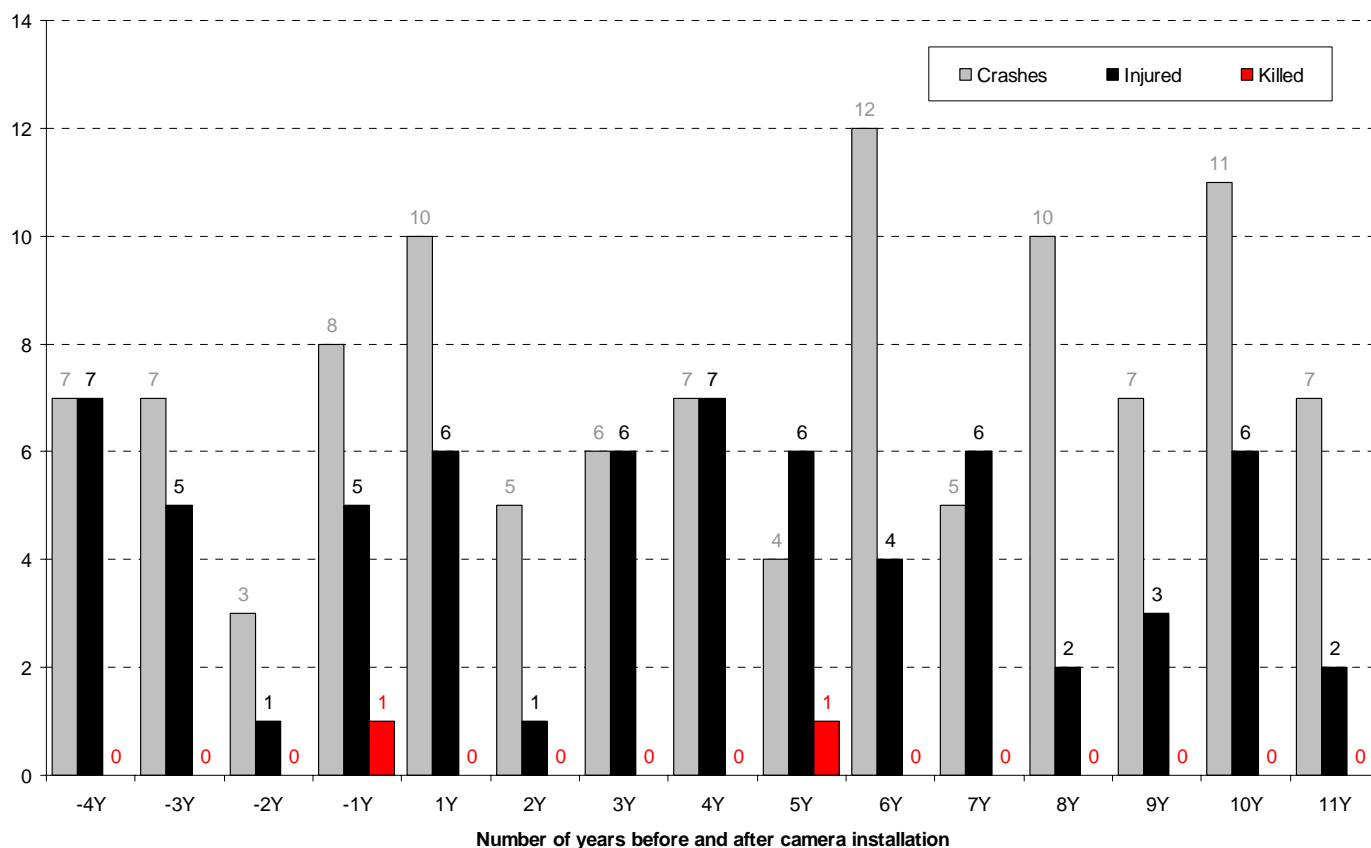
### Crashes at fixed speed camera location

Four year before – Mar 1996 to Mar 2000 (No data available for 1995) - Totals				
Fatality Persons	Injury Persons	Casualty Persons	Crashes	Casualty Cost (\$M)
1	18	19	25	7.886
After (most recent five year period) – 2006 to 2011 - Totals				
Fatality Persons	Injury Persons	Casualty Persons	Crashes	Casualty Cost (\$M)
0	19	19	40	2.166

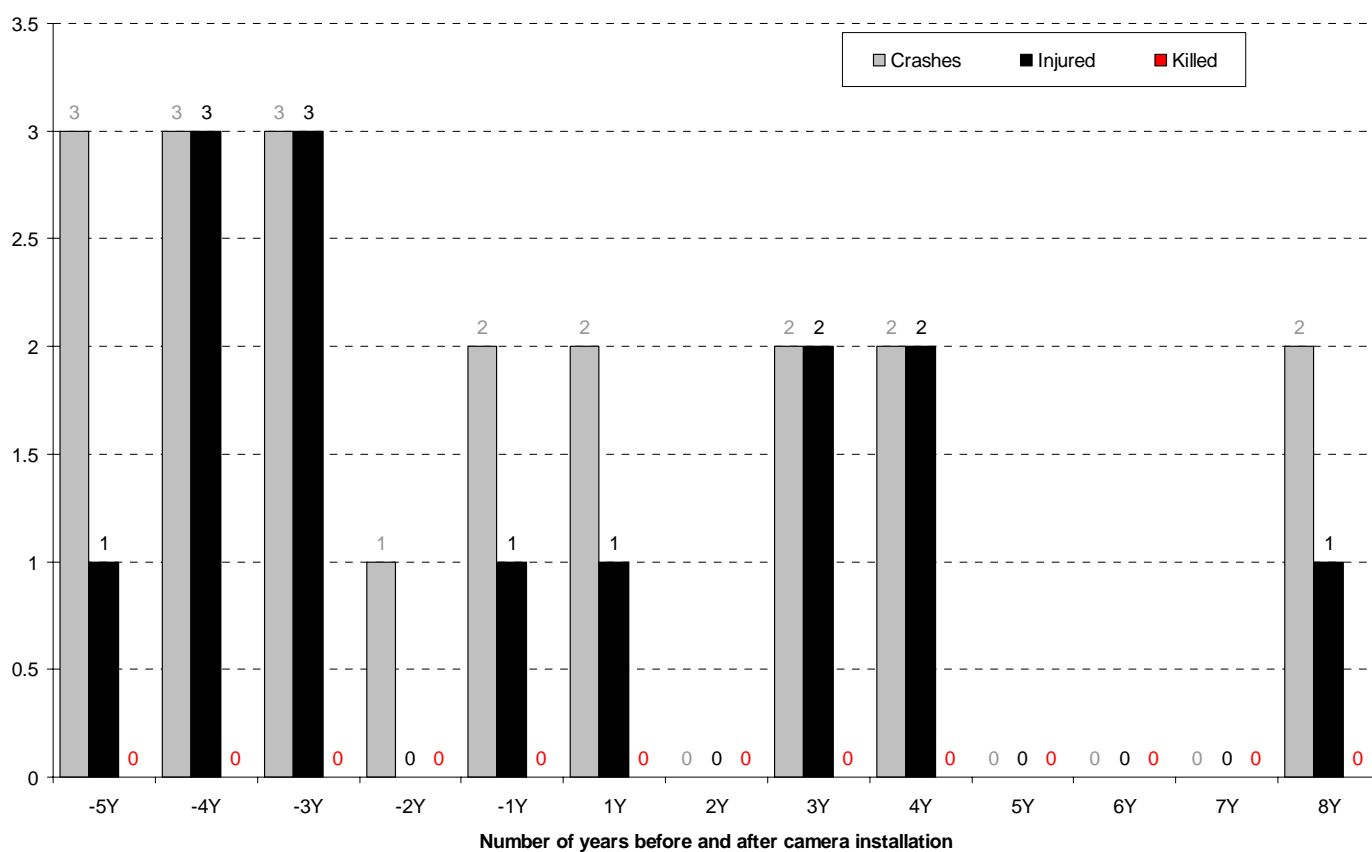
### Crashes at fixed speed camera location

Five years before – Jan 1998 to Jan 2003 - Totals				
Fatality Persons	Injury Persons	Casualty Persons	Crashes	Casualty Cost (\$M)
0	8	8	12	0.912
After (most recent five year period) – 2006 to 2011 - Totals				
Fatality Persons	Injury Persons	Casualty Persons	Crashes	Casualty Cost (\$M)
0	3	3	4	0.342

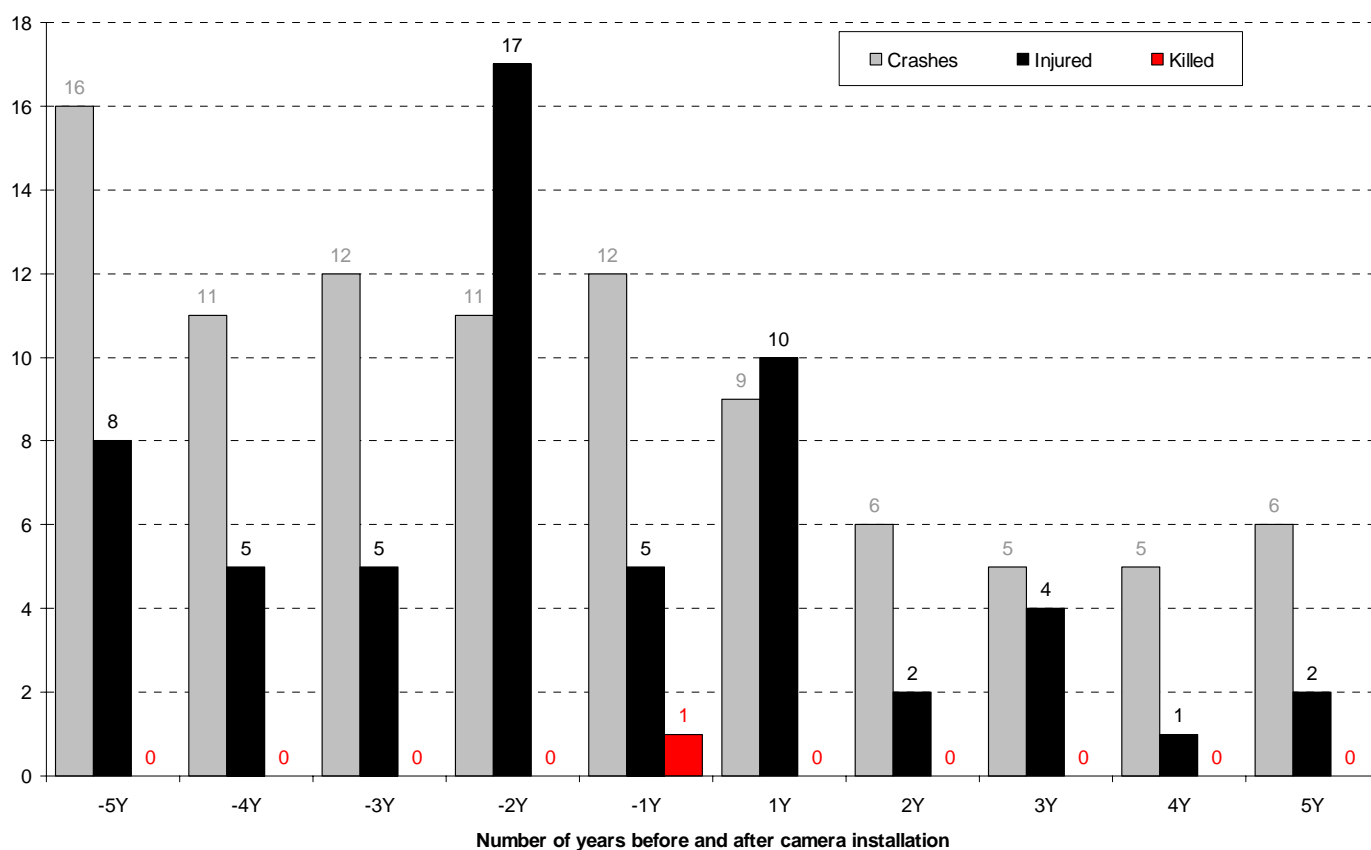
### Crashes at fixed speed camera location

Five years before – Mar 2001 to Feb 2006 - Totals				
Fatality Persons	Injury Persons	Casualty Persons	Crashes	Casualty Cost (\$M)
1	40	41	62	10.394
After (most recent five year period) – 2006 to 2011 - Totals				
Fatality Persons	Injury Persons	Casualty Persons	Crashes	Casualty Cost (\$M)
0	19	19	31	2.166

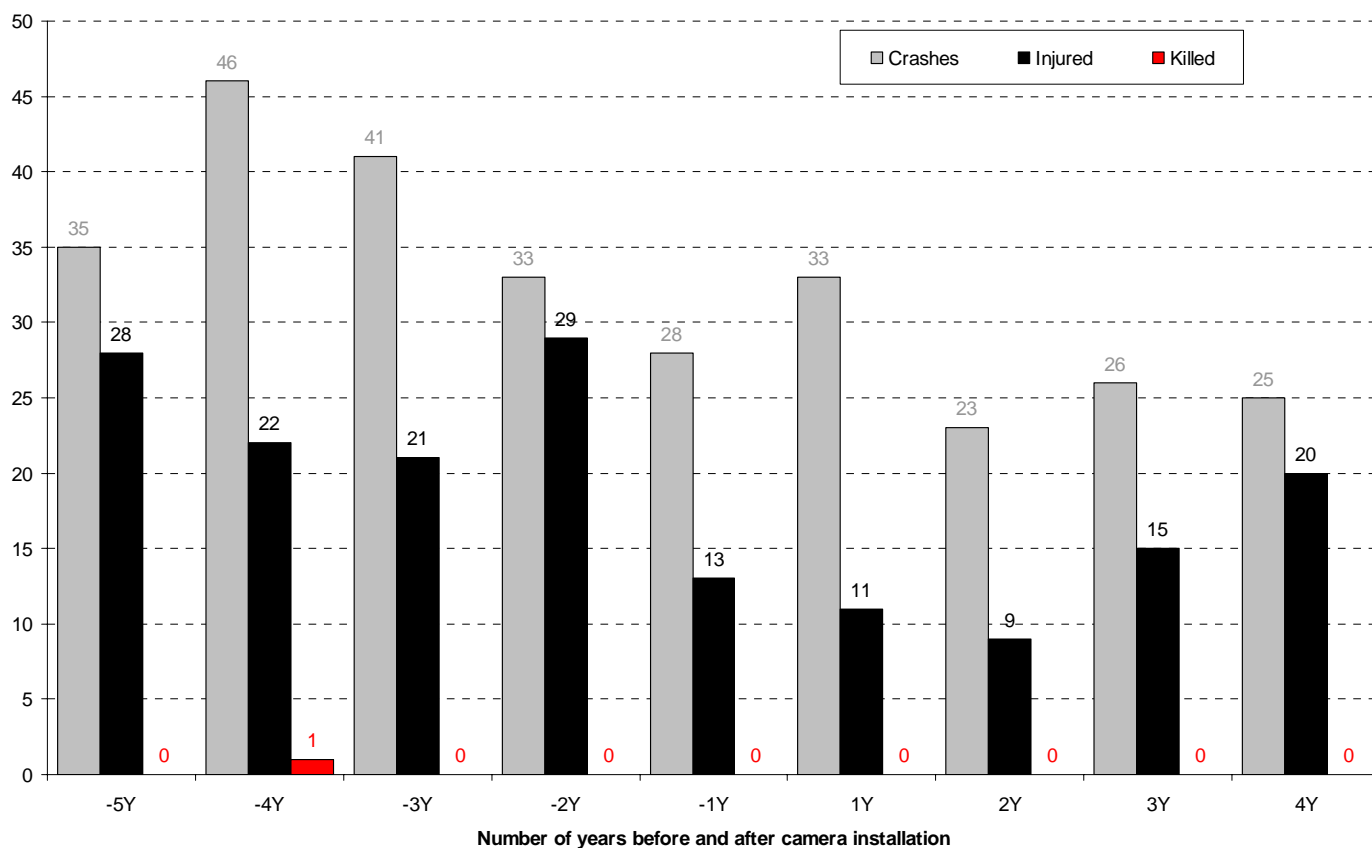
### Crashes at fixed speed camera location

Five years before – Apr 2002 to Apr 2007 - Totals				
Fatality Persons	Injury Persons	Casualty Persons	Crashes	Casualty Cost (\$M)
1	113	114	183	18.716
After (most recent four year period) – 2007 to 2011 - Totals				
Fatality Persons	Injury Persons	Casualty Persons	Crashes	Casualty Cost (\$M)
0	55	55	107	6.27

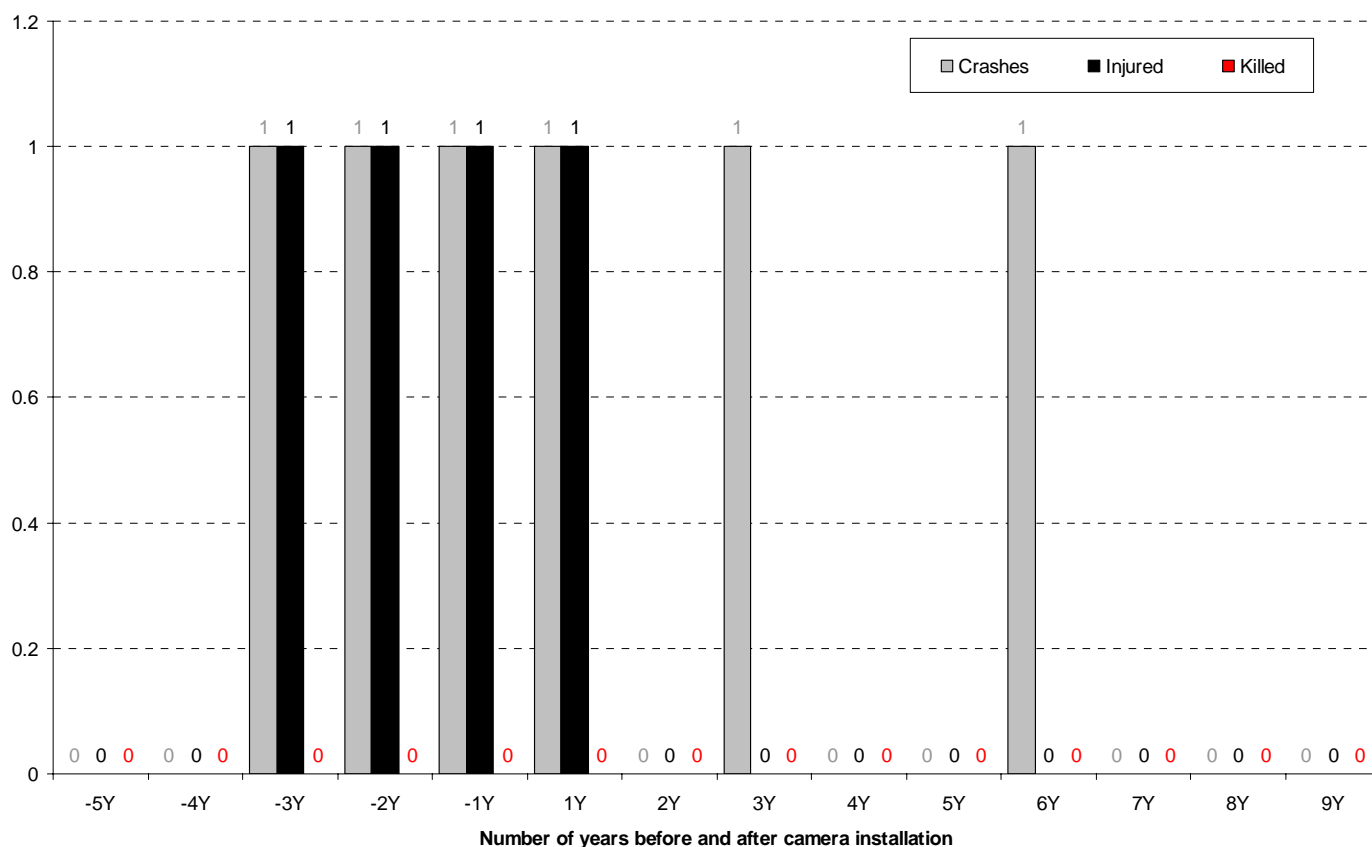
### Crashes at fixed speed camera location

Five years before – Jan 1997 to Jan 2002 - Totals				
Fatality Persons	Injury Persons	Casualty Persons	Crashes	Casualty Cost (\$M)
0	3	3	3	0.342
After (most recent five year period) – 2006 to 2011 - Totals				
Fatality Persons	Injury Persons	Casualty Persons	Crashes	Casualty Cost (\$M)
0	0	0	1	0

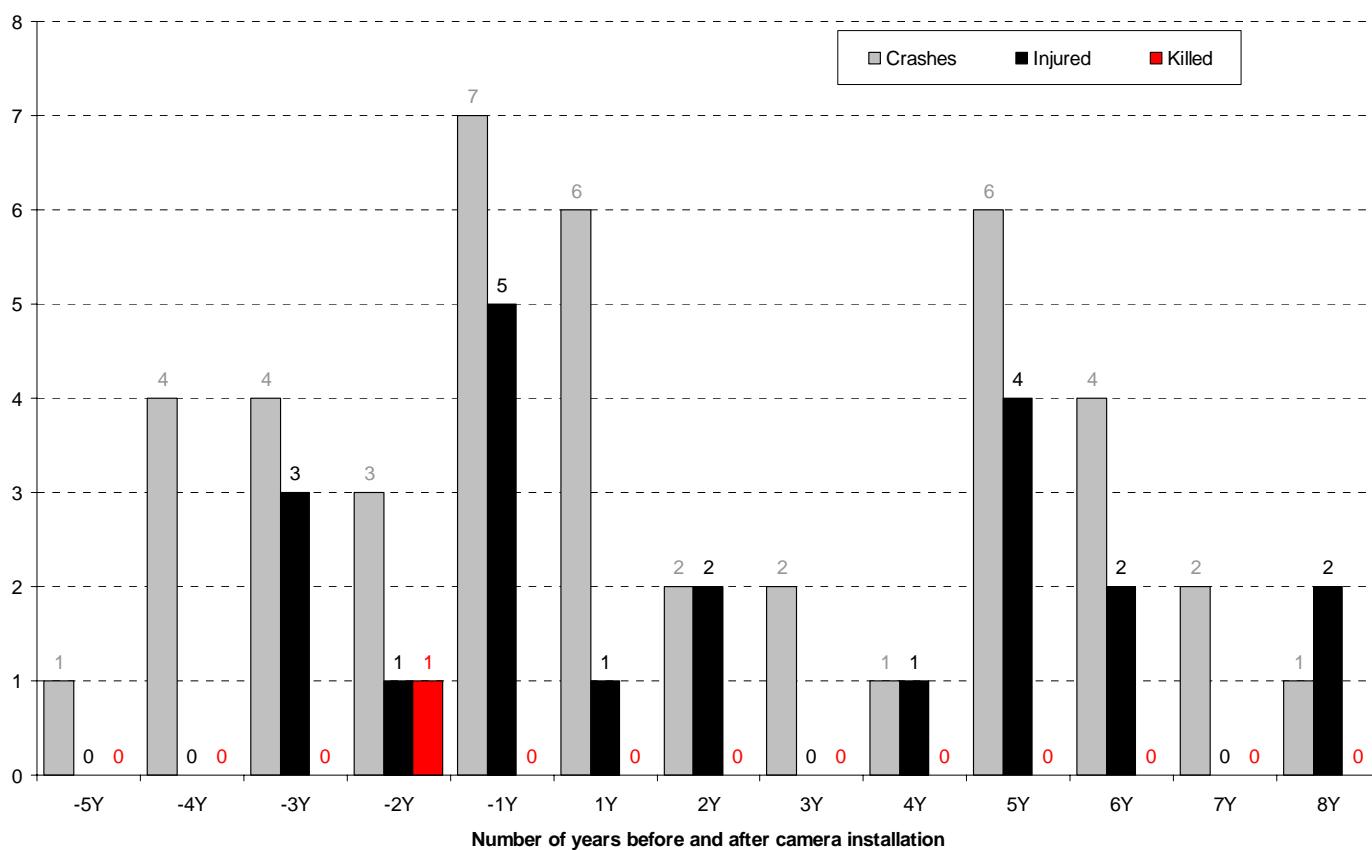
### Crashes at fixed speed camera location

Five years before – Dec 1997 to Dec 2002 - Totals				
Fatality Persons	Injury Persons	Casualty Persons	Crashes	Casualty Cost (\$M)
1	9	10	19	6.86
After (most recent five year period) – 2006 to 2011 - Totals				
Fatality Persons	Injury Persons	Casualty Persons	Crashes	Casualty Cost (\$M)
0	9	9	14	1.026

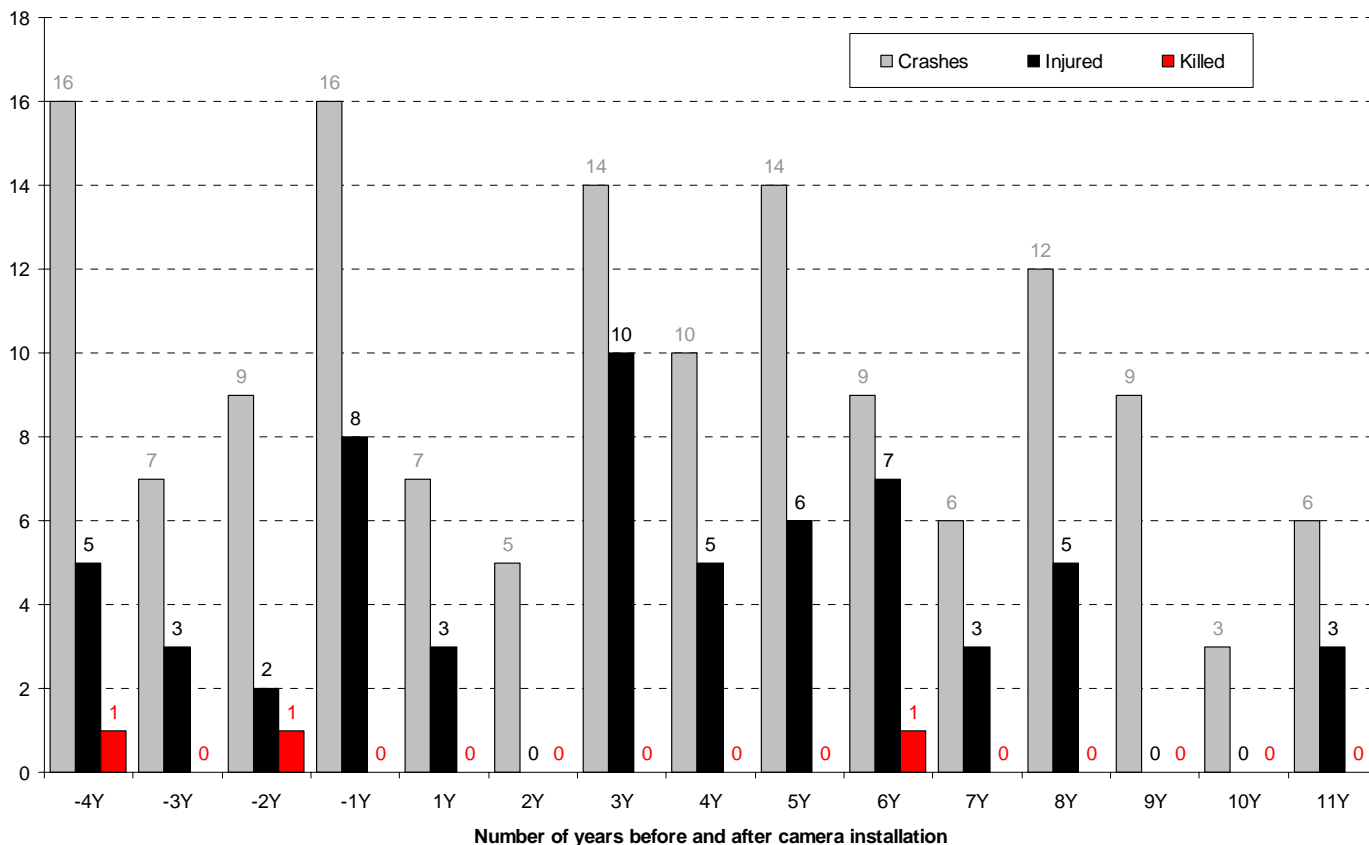
### Crashes at fixed speed camera location

Four year before – Apr 1996 to Apr 2000 (No data available for 1995) - Totals				
Fatality Persons	Injury Persons	Casualty Persons	Crashes	Casualty Cost (\$M)
2	18	20	48	13.72
After (most recent five year period) – 2006 to 2011 - Totals				
Fatality Persons	Injury Persons	Casualty Persons	Crashes	Casualty Cost (\$M)
0	11	11	36	1.254

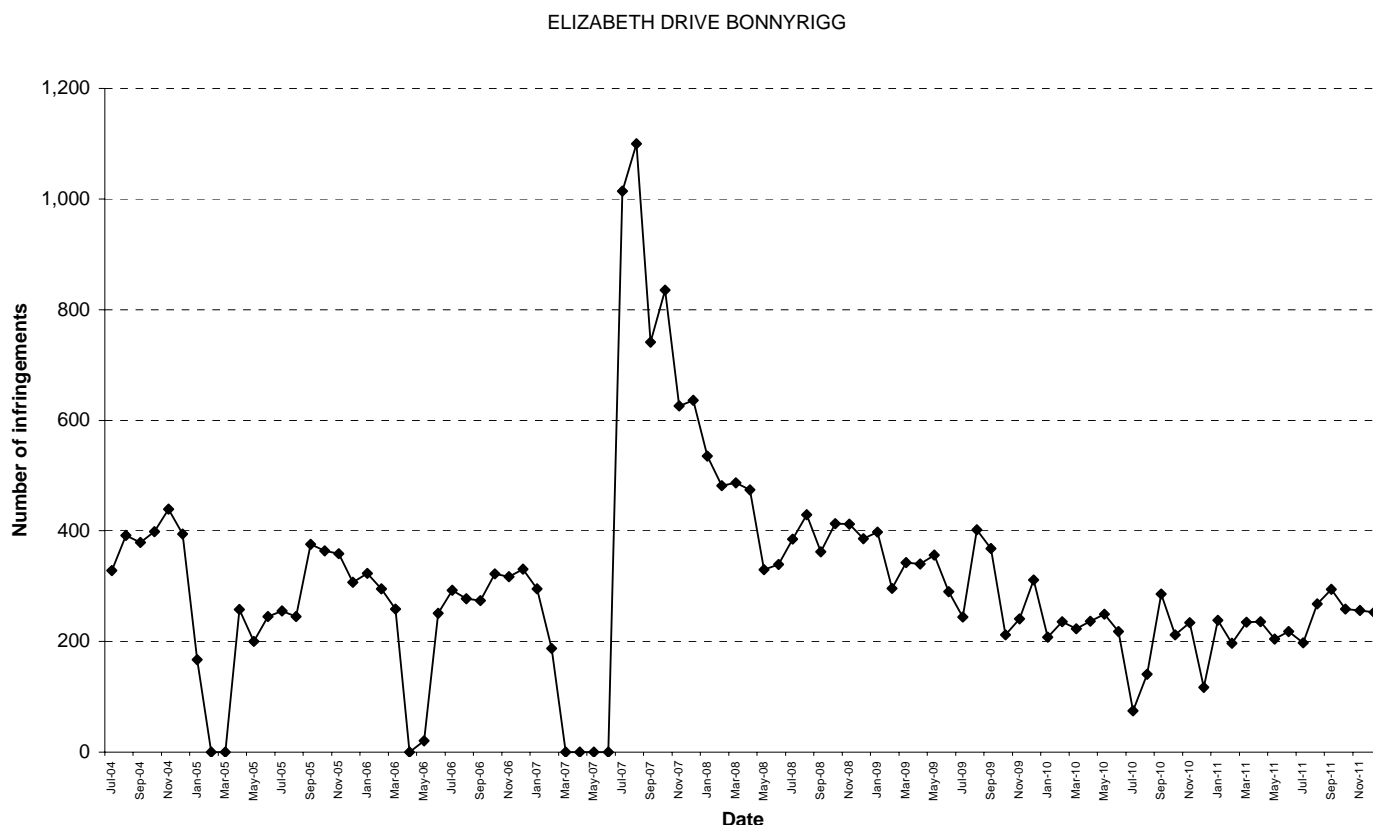
## Infringements at fixed speed camera location

The fixed speed camera on Elizabeth Drive, Bonnyrigg was installed in July 2000. There is one camera installed at this location.

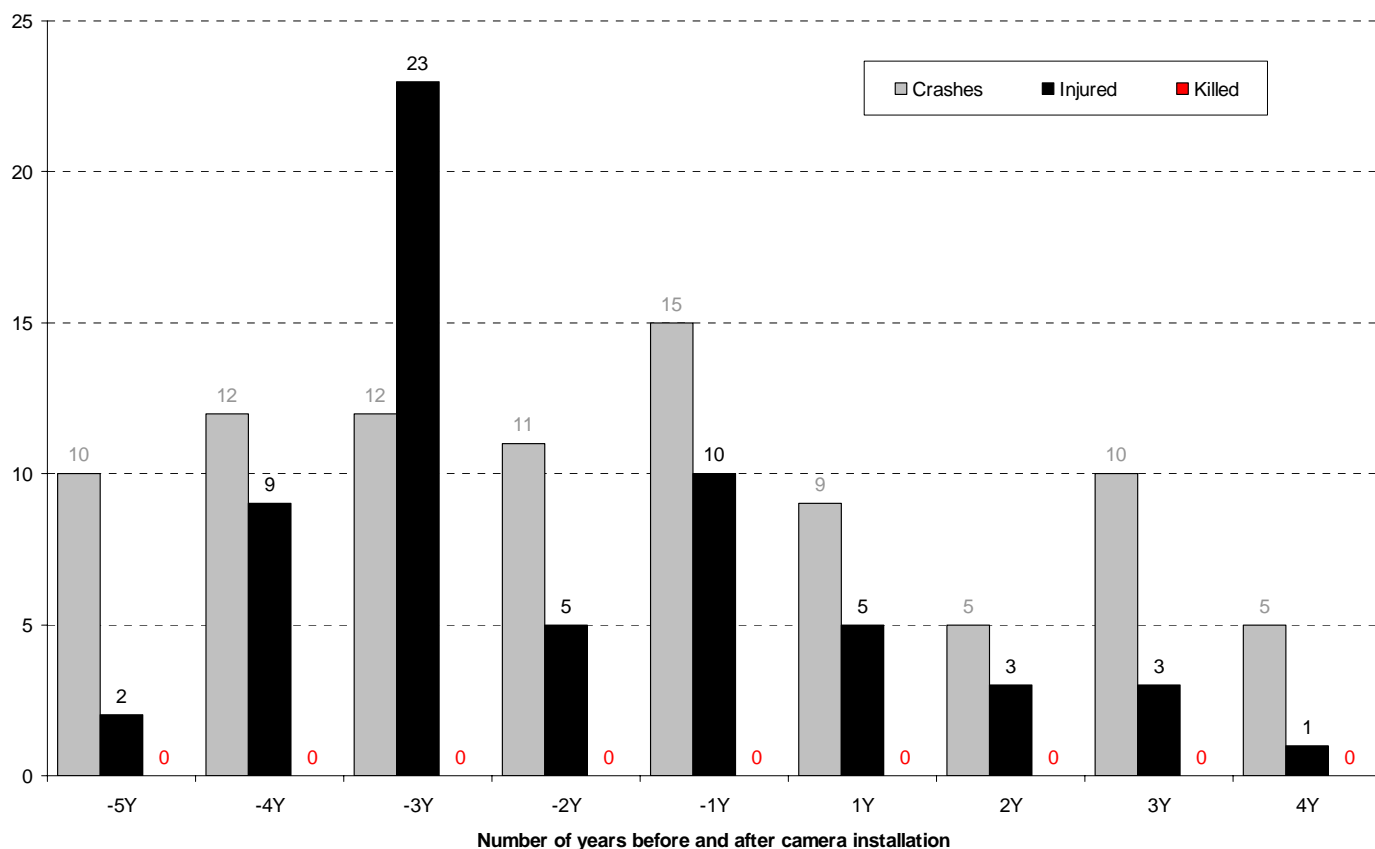
### Crashes at fixed speed camera location

Five years before – Aug 2002 to Aug 2007 - Totals				
Fatality Persons	Injury Persons	Casualty Persons	Crashes	Casualty Cost (\$M)
0	49	49	60	5.586
After (most recent four year period) – 2007 to 2011 - Totals				
Fatality Persons	Injury Persons	Casualty Persons	Crashes	Casualty Cost (\$M)
0	12	12	29	1.368

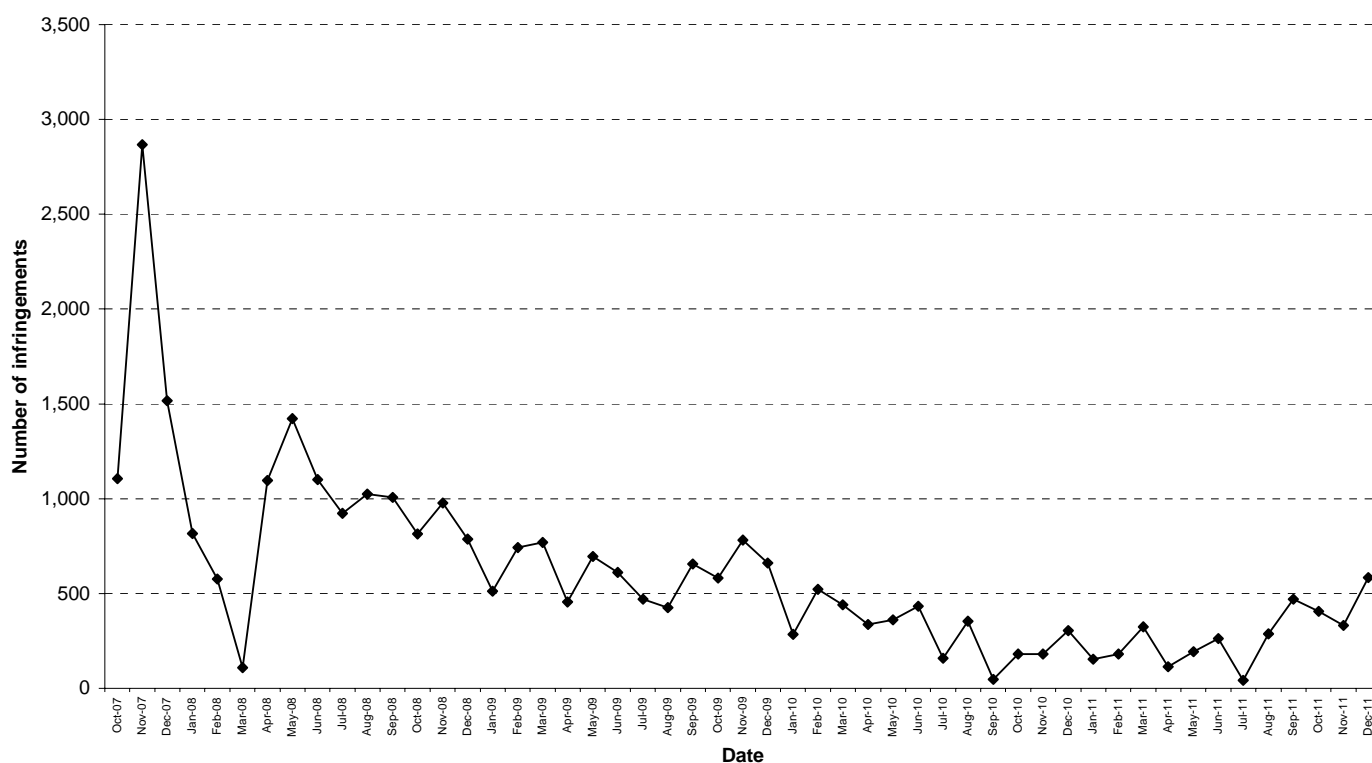
CABRAMATTA ROAD BONNYRIGG

The school zone fixed speed camera at Cabramatta Road, Bonnyrigg was installed in October 2007. There is one camera installed at this location.

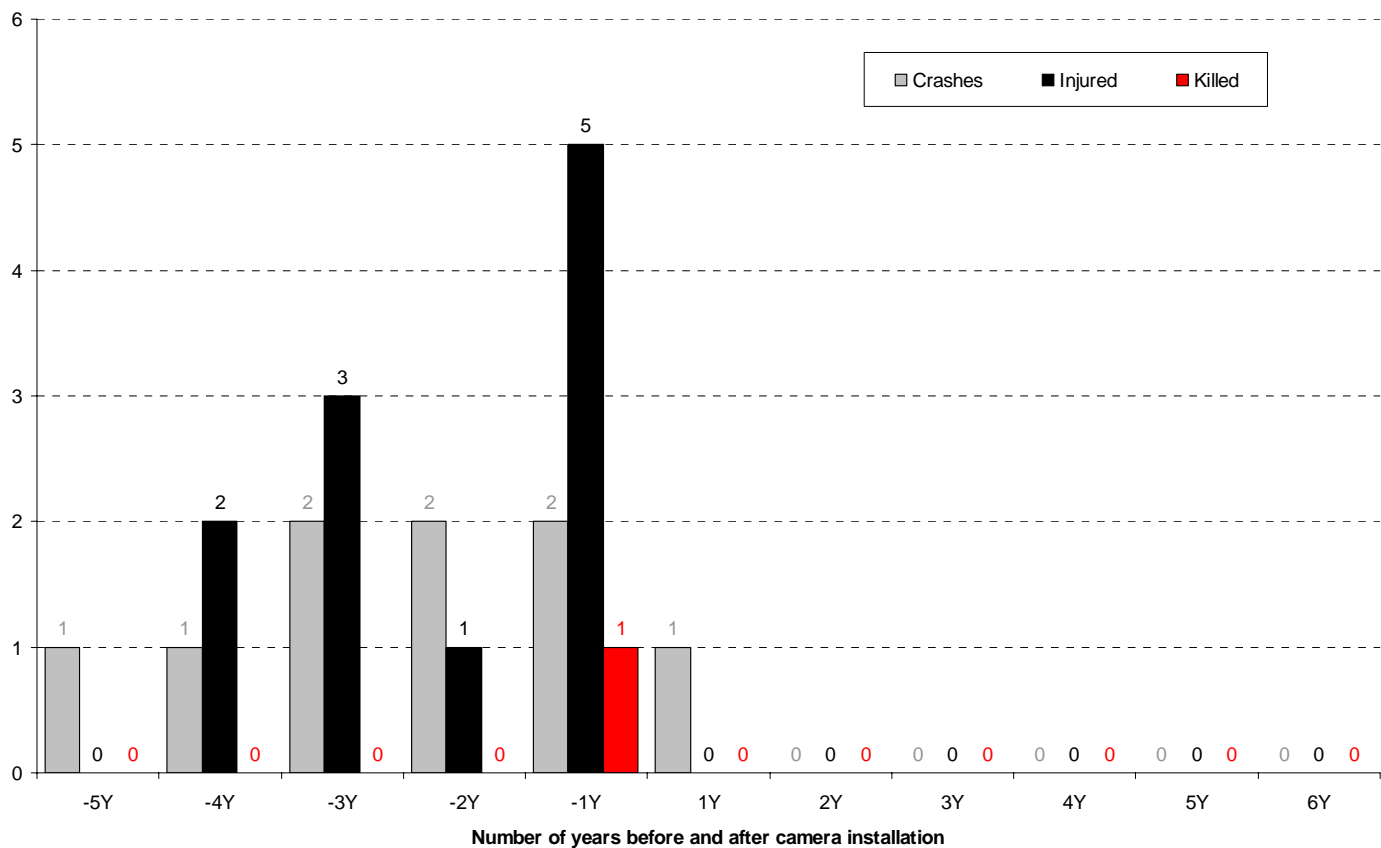
### Crashes at fixed speed camera location

Five years before – Sep 2000 to Sep 2005 - Totals				
Fatality Persons	Injury Persons	Casualty Persons	Crashes	Casualty Cost (\$M)
1	11	12	8	7.088
After (most recent five year period) – 2006 to 2011 - Totals				
Fatality Persons	Injury Persons	Casualty Persons	Crashes	Casualty Cost (\$M)
0	0	0	0	0

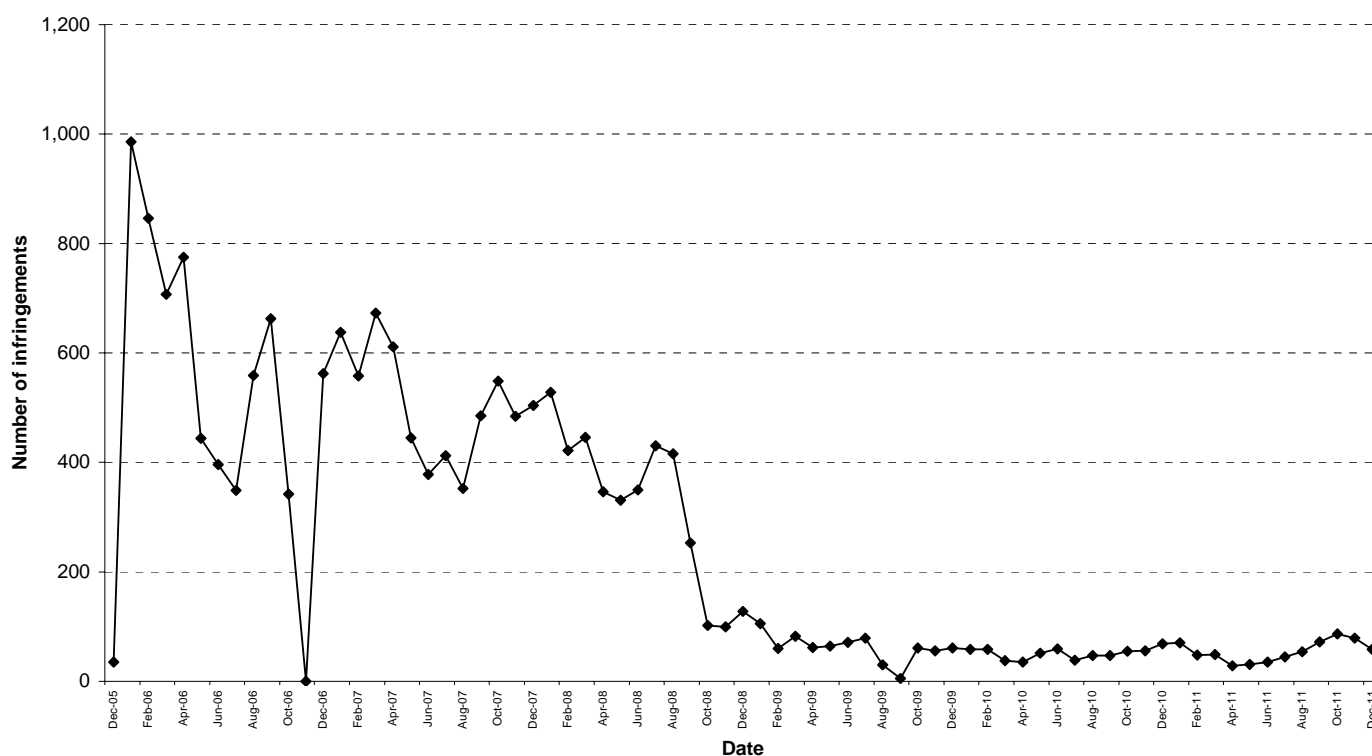
PINE CREEK WAY BONVILLE

The fixed speed camera on Pine Creek Way, Bonville was installed in December 2005. There is one camera installed at this location.

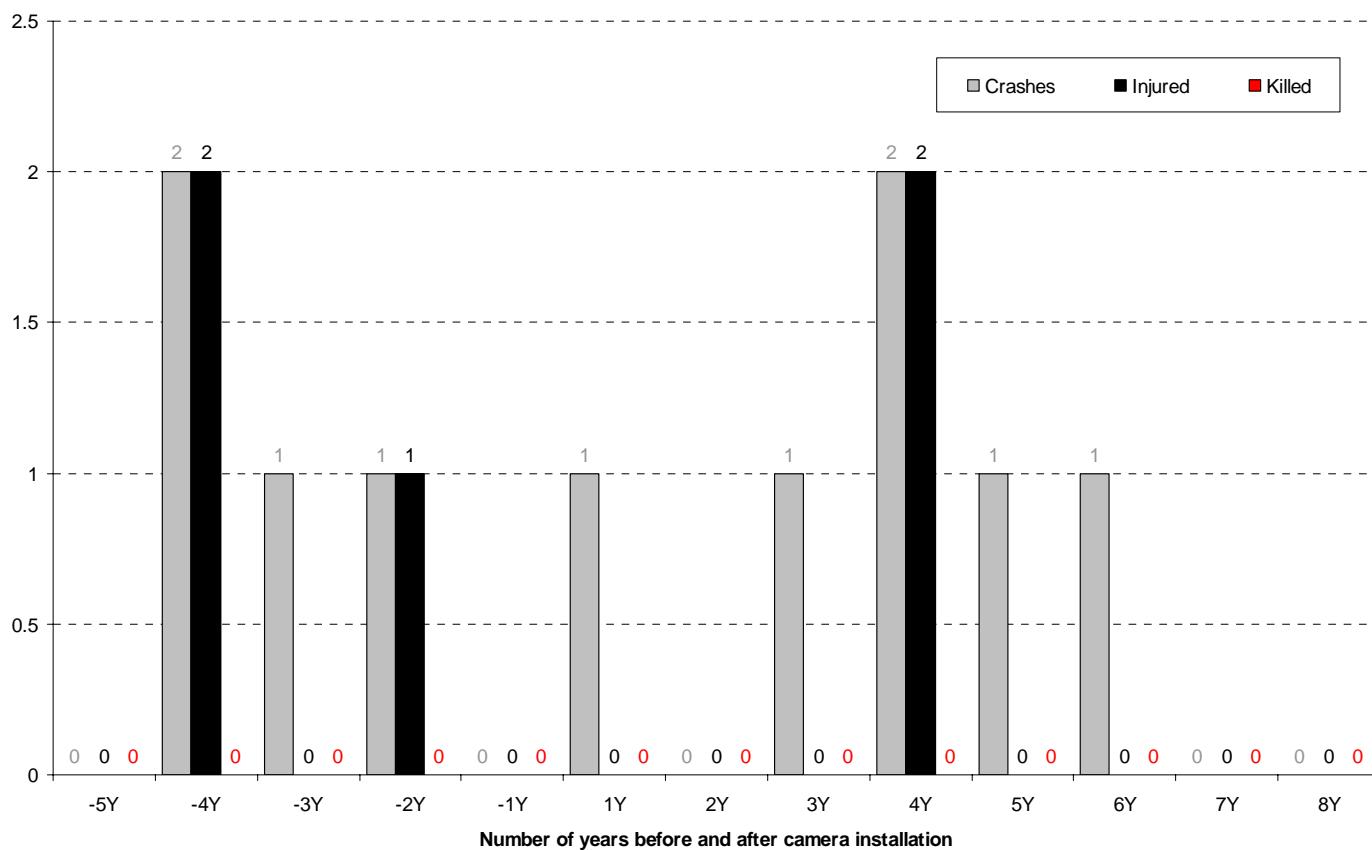
### Crashes at fixed speed camera location

Five years before – Feb 1998 to Feb 2003 - Totals				
Fatality Persons	Injury Persons	Casualty Persons	Crashes	Casualty Cost (\$M)
0	3	3	4	0.342
After (most recent five year period) – 2006 to 2011 - Totals				
Fatality Persons	Injury Persons	Casualty Persons	Crashes	Casualty Cost (\$M)
0	2	2	4	0.228
