# ANNUAL NSW SPEED CAMERA PERFORMANCE REVIEW

NSW Centre for Road Safety

JULY 2012

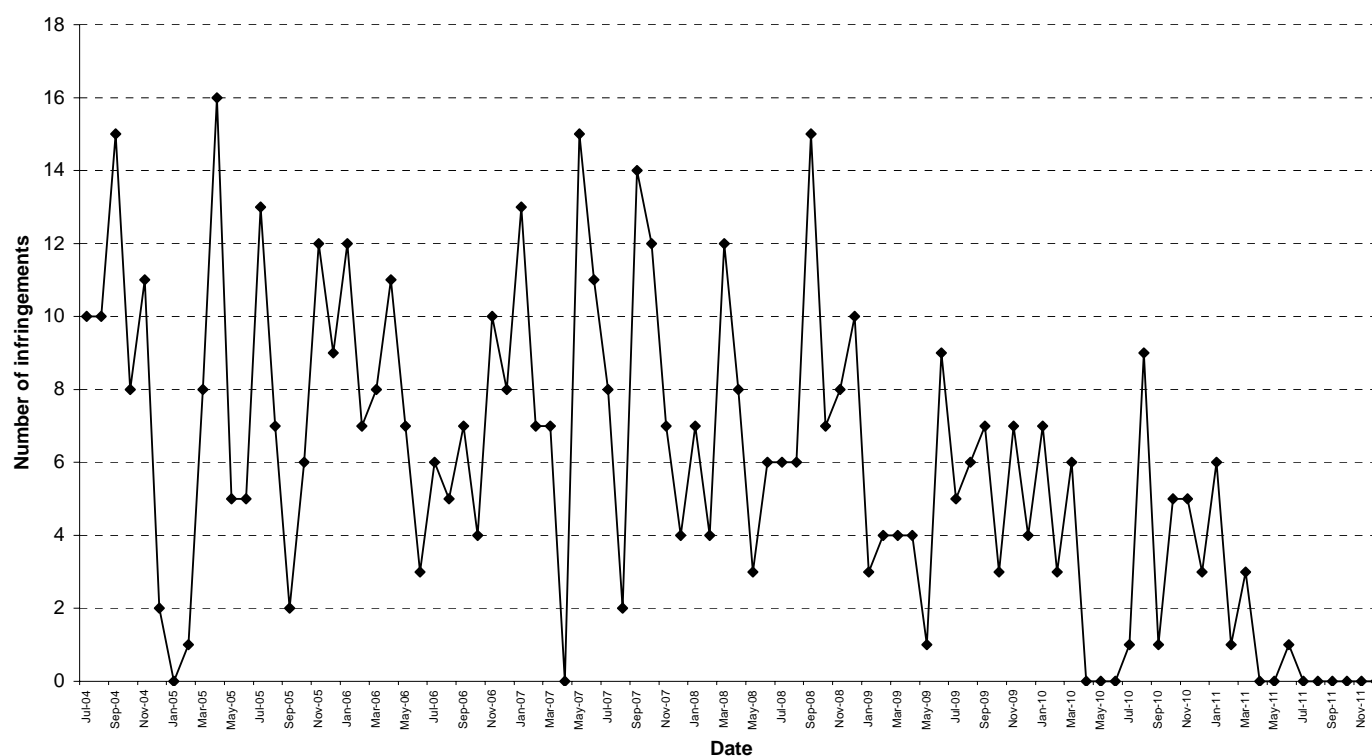
### PRINCES HIGHWAY BROGO

The fixed speed camera on the Princes Highway, Brogo was installed in May 2003. There is one camera installed at this location.

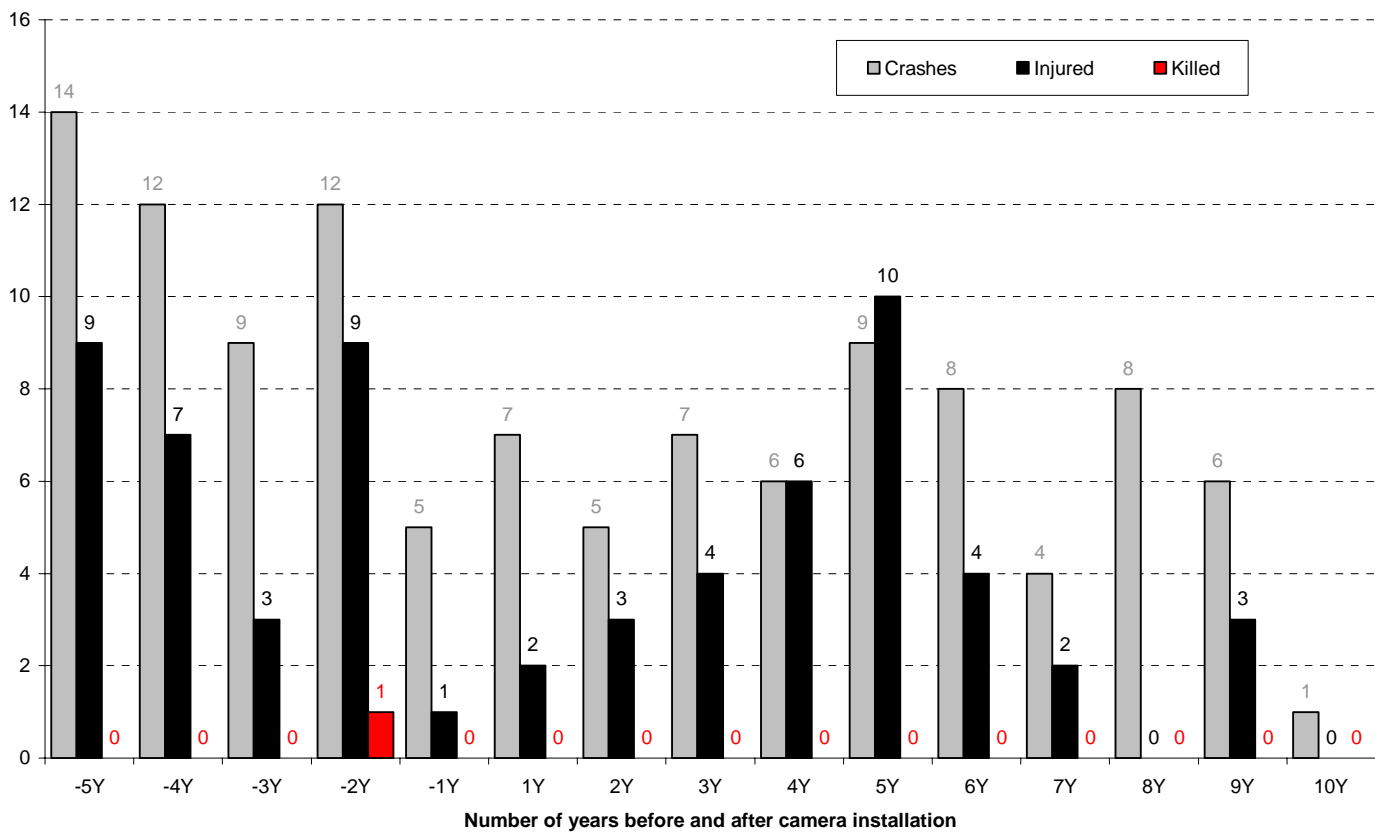
### Crashes at fixed speed camera location

Five years before – Sep 1996 to Sep 2001 - Totals				
Fatality Persons	Injury Persons	Casualty Persons	Crashes	Casualty Cost (\$M)
1	29	30	52	9.14
After (most recent five year period) – 2006 to 2011 - Totals				
Fatality Persons	Injury Persons	Casualty Persons	Crashes	Casualty Cost (\$M)
0	9	9	27	1.026

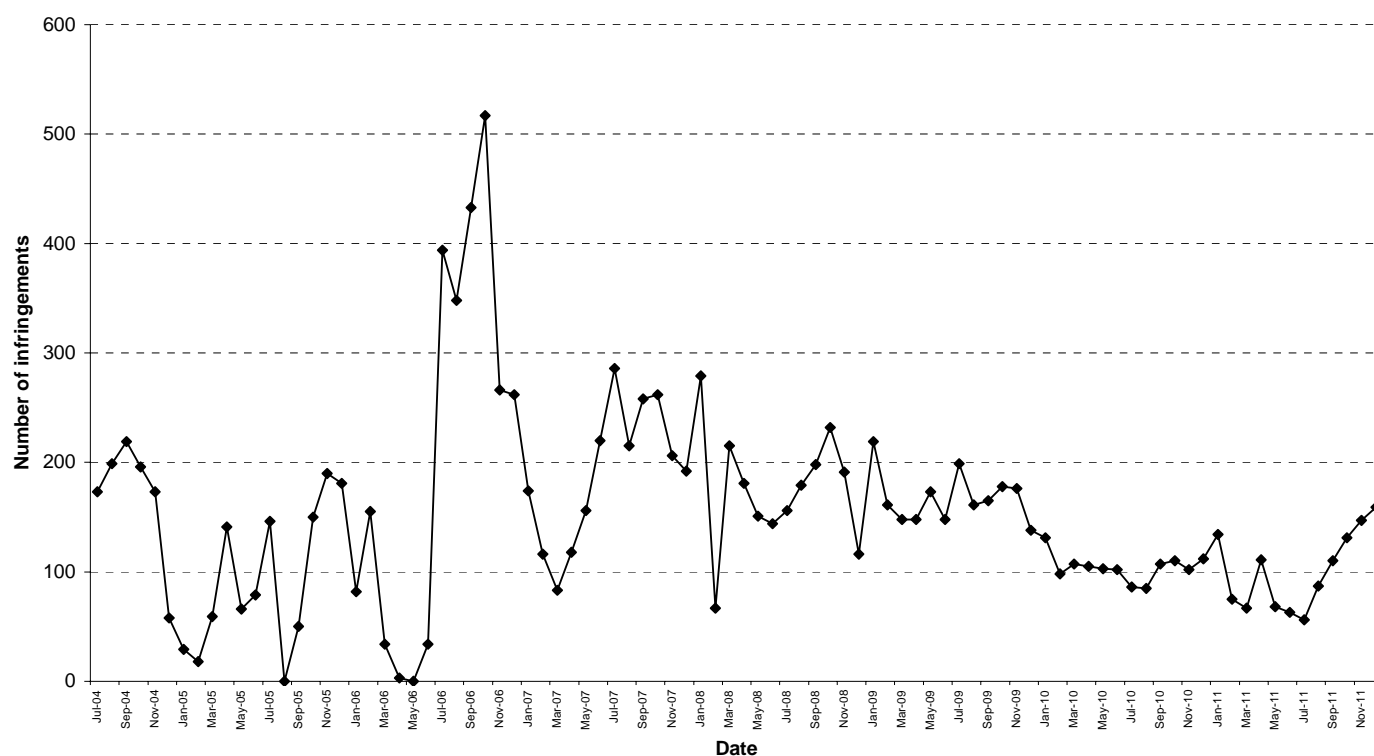
### PRINCES HIGHWAY BULLI

The fixed speed camera on the Princes Highway, Bulli was installed in December 2001. There is one camera installed at this location.

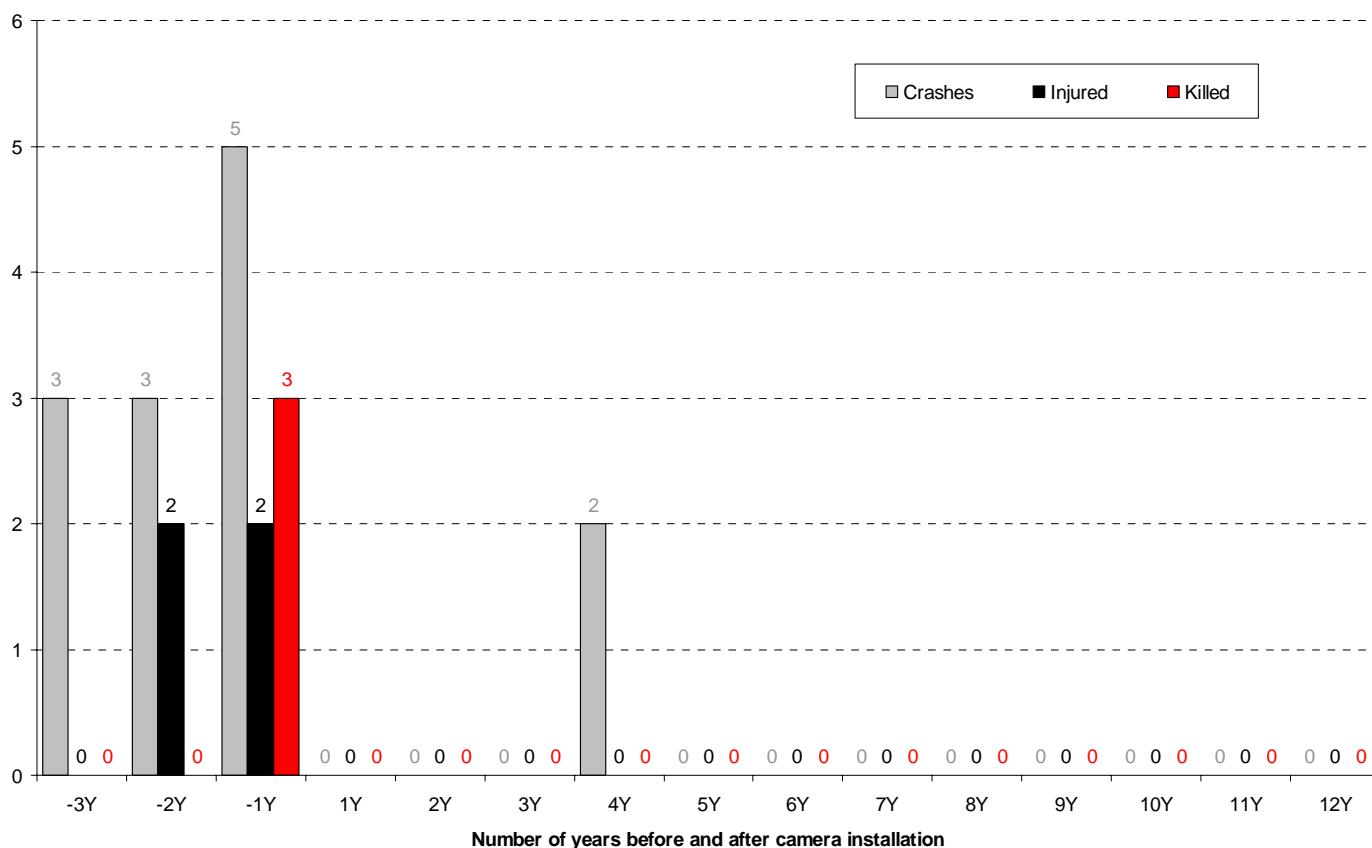
### Crashes at fixed speed camera location

Three years before – Jan 1996 to Jan 1999 (no data available for 1994 and 1995) - Totals				
Fatality Persons	Injury Persons	Casualty Persons	Crashes	Casualty Cost (\$M)
3	4	7	11	17.958
After (most recent five year period) – 2006 to 2011 - Totals				
Fatality Persons	Injury Persons	Casualty Persons	Crashes	Casualty Cost (\$M)
0	0	0	0	0

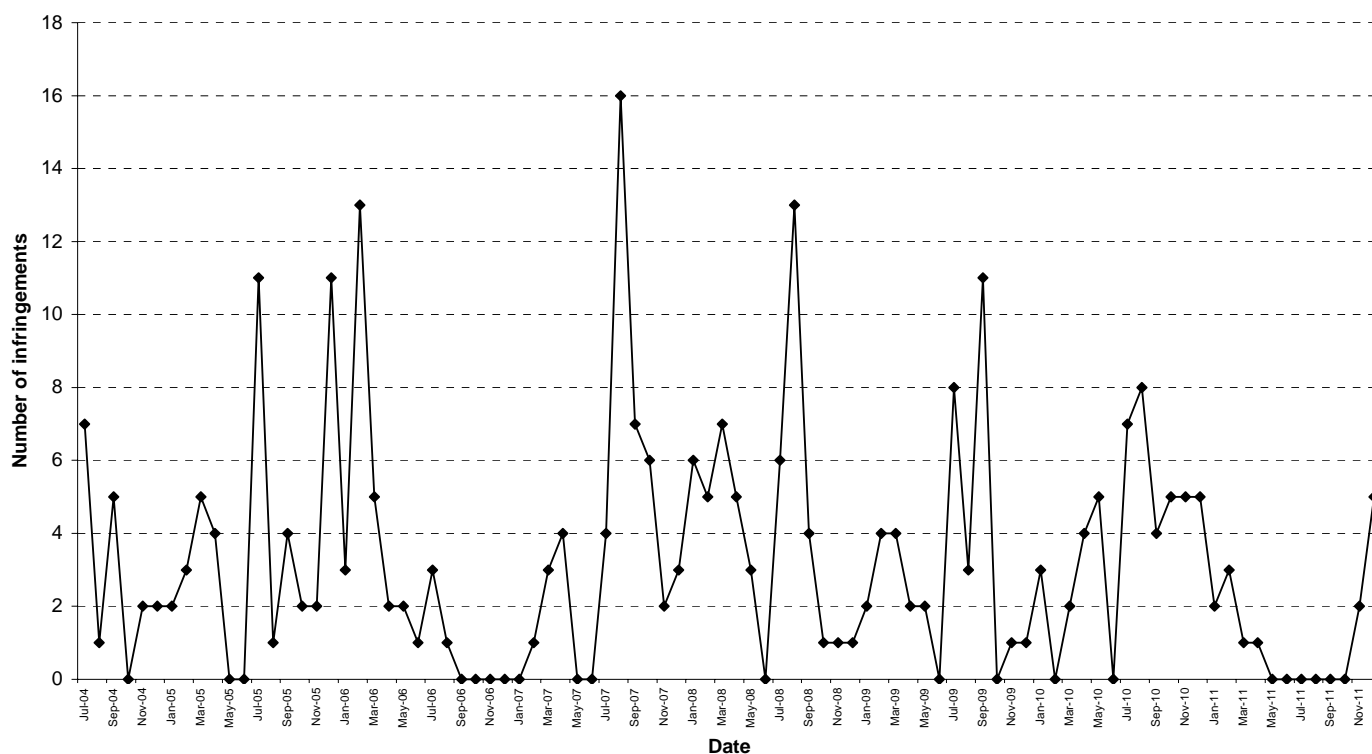
### TWEED VALLEY WAY BRRRINGBAR

The fixed speed camera on Tweed Valley Way, Burringbar was installed in April 1999. There is one camera installed at this location.

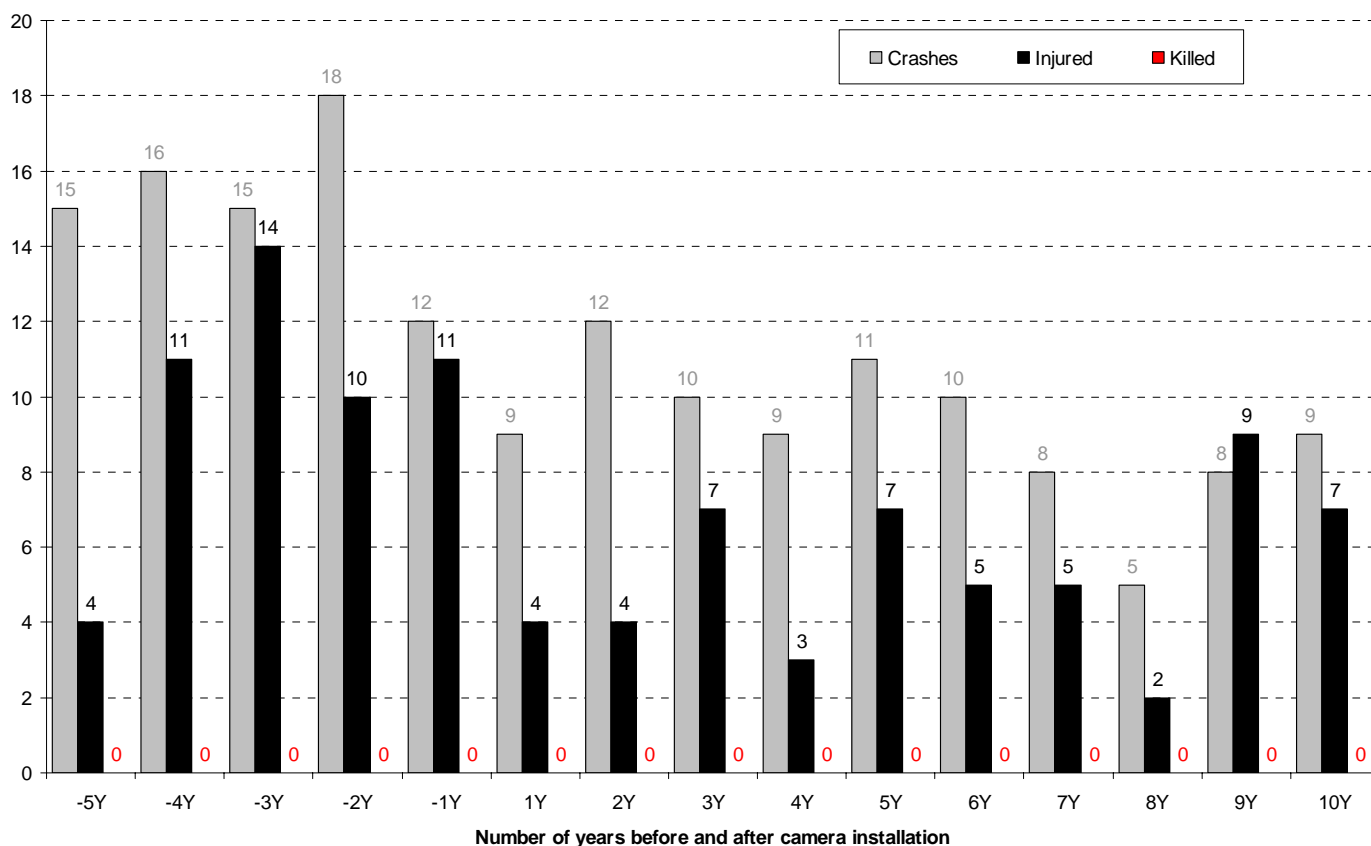
### Crashes at fixed speed camera location

Five years before – Sep 1996 to Sep 2001 - Totals				
Fatality Persons	Injury Persons	Casualty Persons	Crashes	Casualty Cost (\$M)
0	50	50	76	5.7
After (most recent five year period) – 2006 to 2011 - Totals				
Fatality Persons	Injury Persons	Casualty Persons	Crashes	Casualty Cost (\$M)
0	28	28	40	3.192

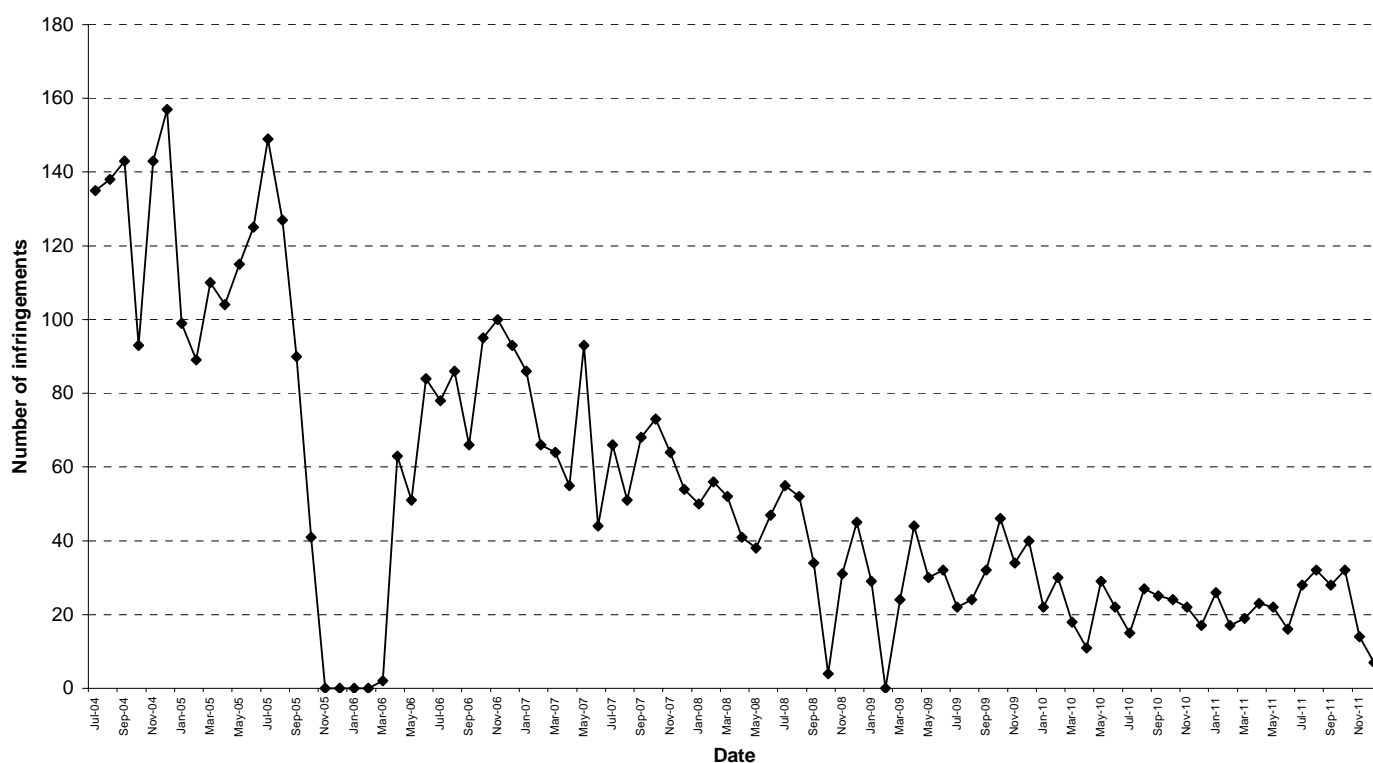
HUME HIGHWAY BURWOOD HEIGHTS

The fixed speed camera on the Hume Highway, Burwood Heights was installed in December 2001. There is one camera installed at this location.

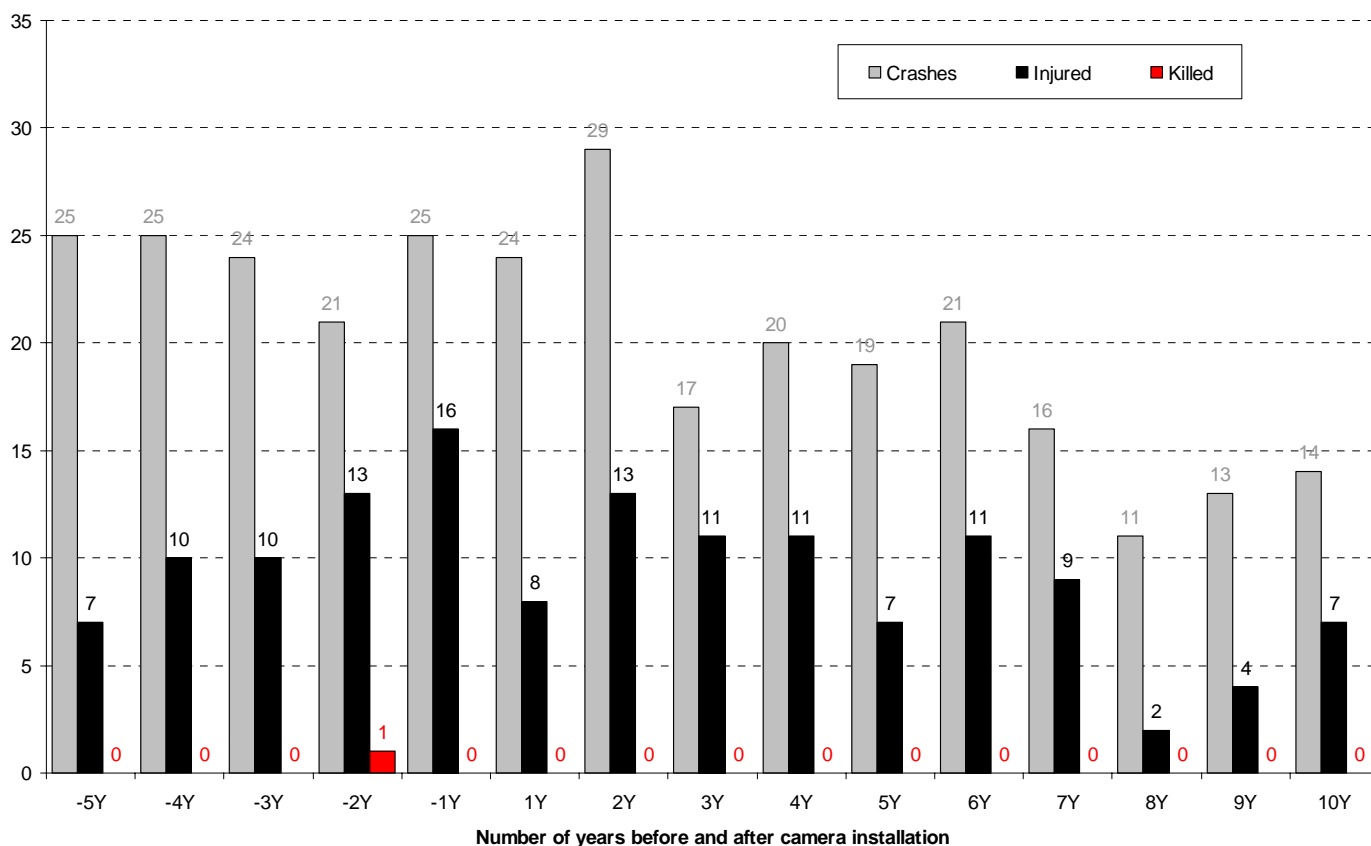
### Crashes at fixed speed camera location

Five years before – Sep 1996 to Sep 2001 - Totals				
Fatality Persons	Injury Persons	Casualty Persons	Crashes	Casualty Cost (\$M)
1	56	57	120	12.218
After (most recent five year period) – 2006 to 2011 - Totals				
Fatality Persons	Injury Persons	Casualty Persons	Crashes	Casualty Cost (\$M)
0	33	33	75	3.762

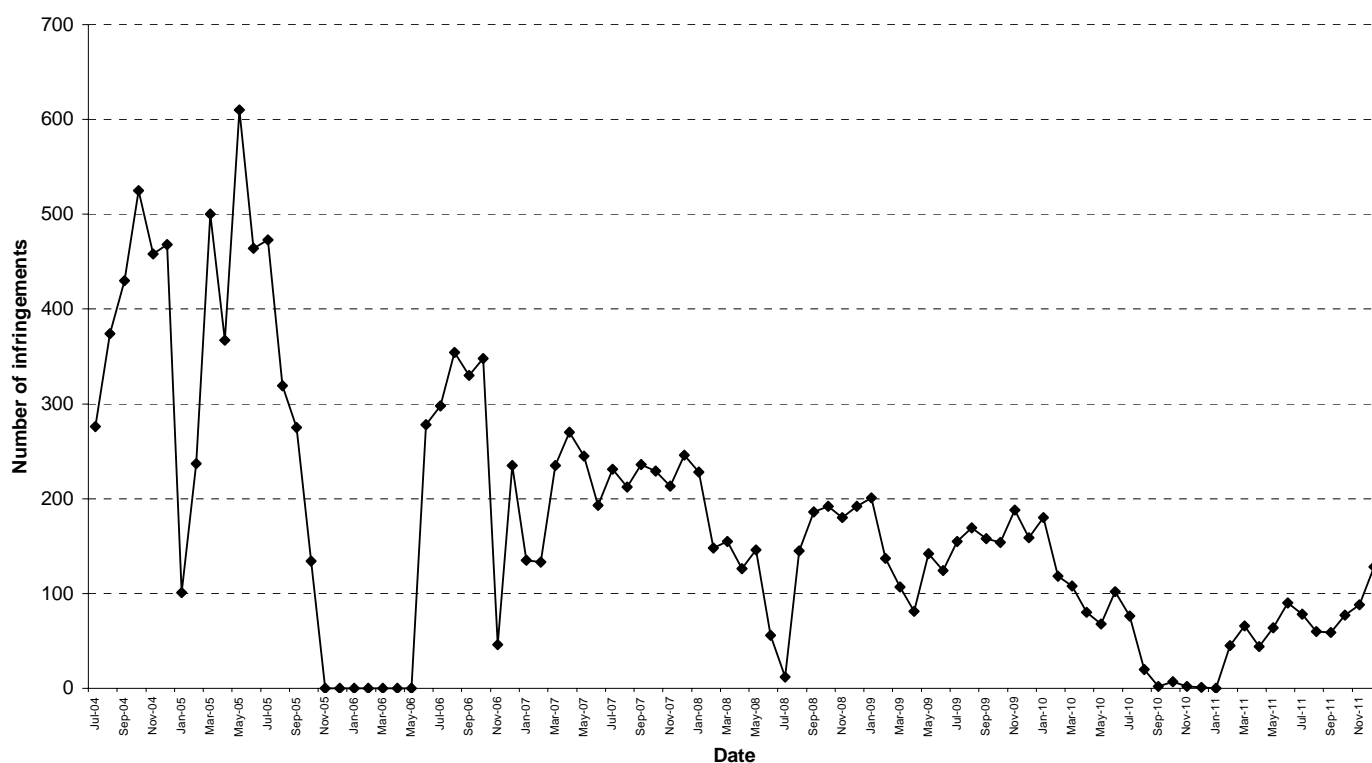
JAMES RUSE DRIVE CAMELLIA

The fixed speed camera at James Ruse Drive, Camellia was installed in December 2001. There is one camera installed at this location.

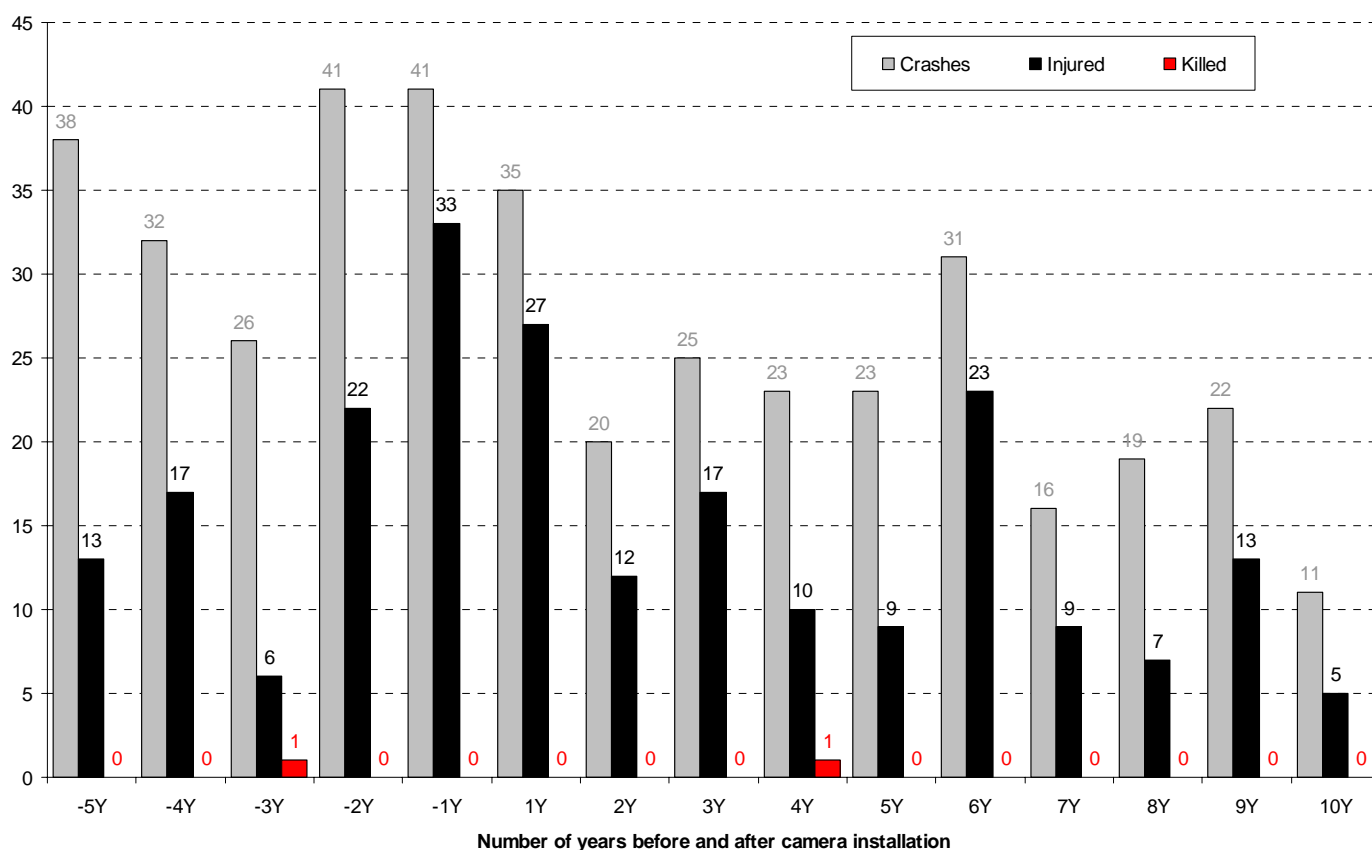
### Crashes at fixed speed camera location

Five years before – Jan 1996 to Jan 2001 - Totals				
Fatality Persons	Injury Persons	Casualty Persons	Crashes	Casualty Cost (\$M)
1	91	92	178	16.208
After (most recent five year period) – 2006 to 2011 - Totals				
Fatality Persons	Injury Persons	Casualty Persons	Crashes	Casualty Cost (\$M)
0	57	57	99	6.498

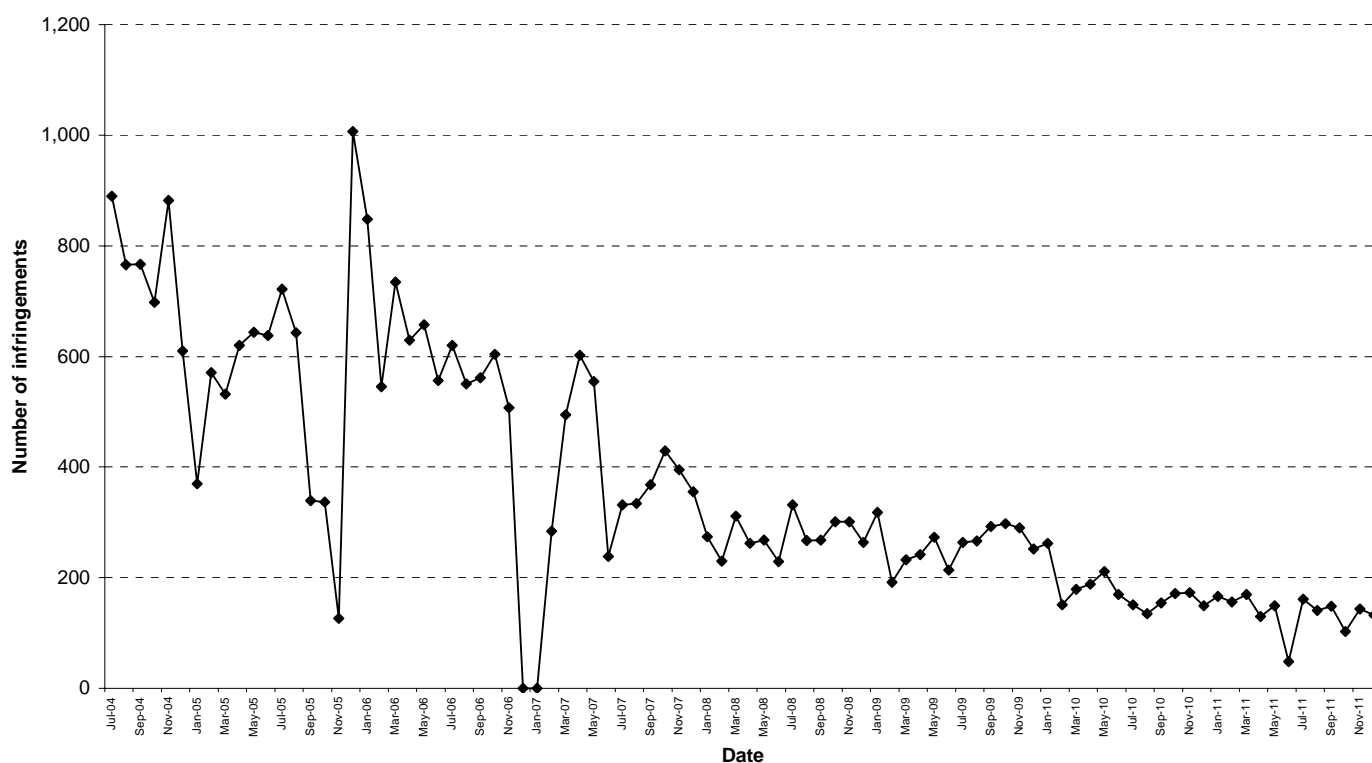
CANTERBURY ROAD CANTERBURY

The fixed speed camera at Canterbury Road, Canterbury was installed in April 2001. There is one camera installed at this location.

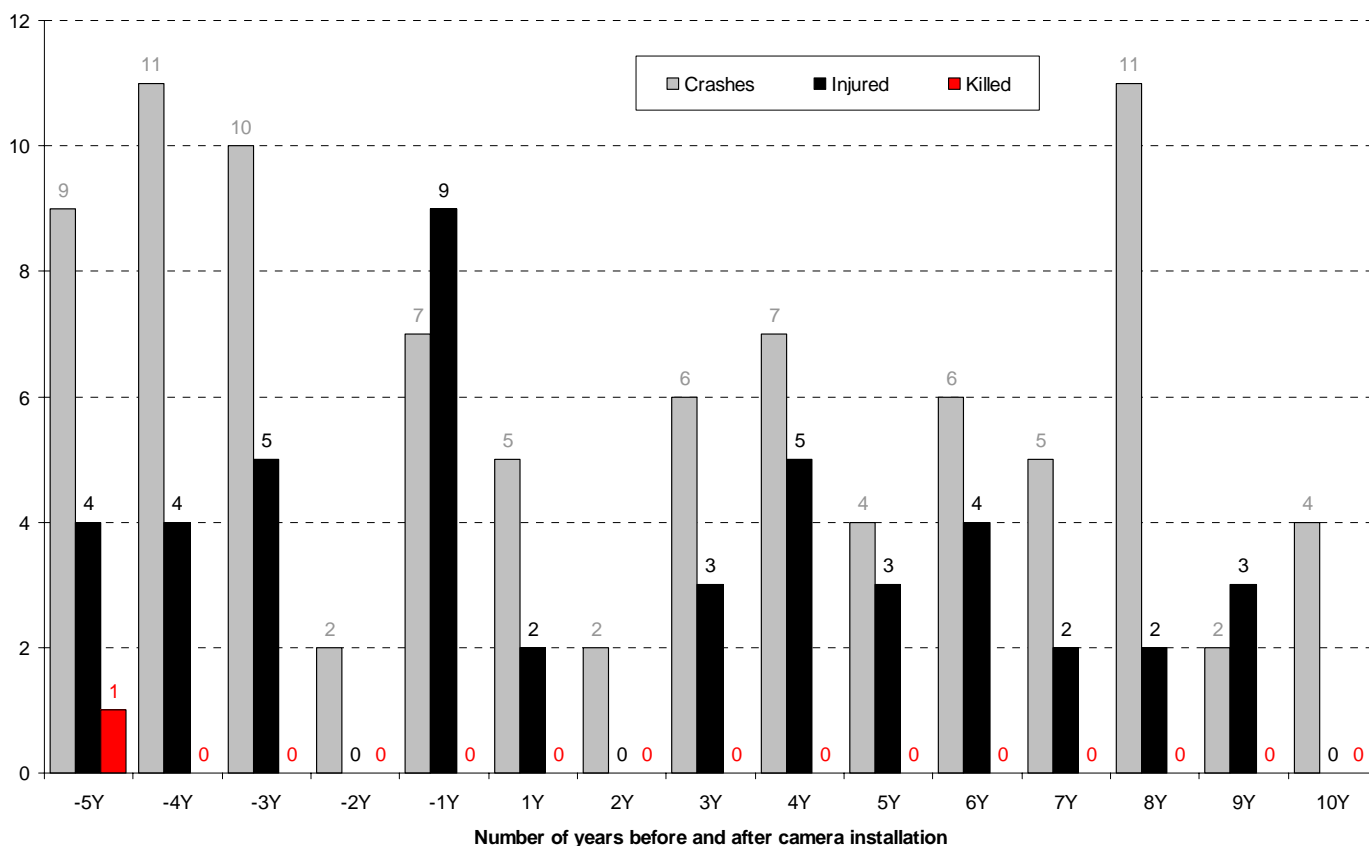
### Crashes at fixed speed camera location

Five years before – Jan 1996 to Jan 2001 - Totals				
Fatality Persons	Injury Persons	Casualty Persons	Crashes	Casualty Cost (\$M)
1	22	23	39	8.342
After (most recent five year period) – 2006 to 2011 - Totals				
Fatality Persons	Injury Persons	Casualty Persons	Crashes	Casualty Cost (\$M)
0	11	11	28	1.254

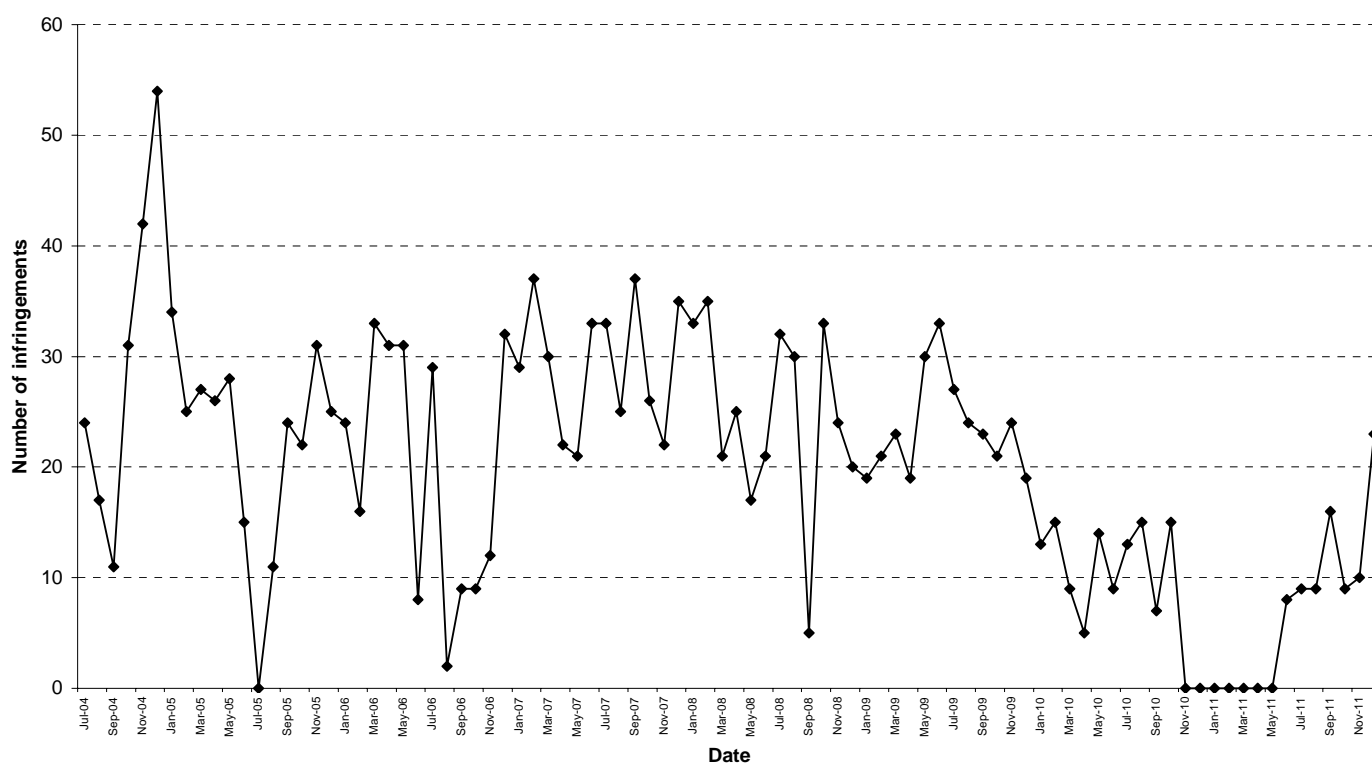
CAPTAIN COOK DRIVE CARINGBAH

The fixed speed camera at Captain Cook Drive, Caringbah was installed in April 2001. There is one camera installed at this location.

The infringement graph details the trend in infringements at this location since July 2004. Infringement data before this date are not available. No infringements were recorded at this location from November 2010 to May 2011 as a replacement camera was installed.

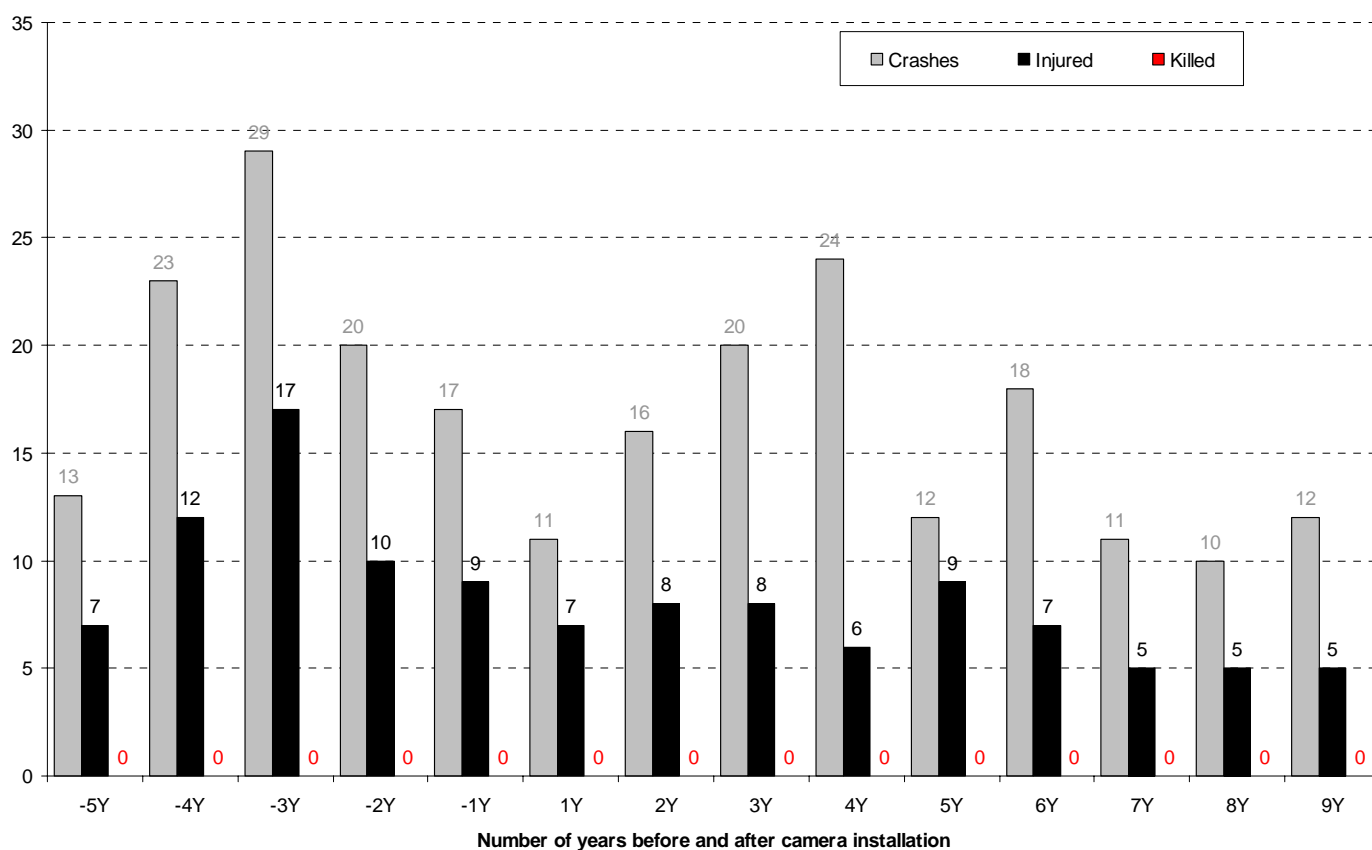
### Crashes at fixed speed camera location

Five years before – May 1997 to May 2002 - Totals				
Fatality Persons	Injury Persons	Casualty Persons	Crashes	Casualty Cost (\$M)
0	55	55	102	6.27
After (most recent five year period) – 2006 to 2011 - Totals				
Fatality Persons	Injury Persons	Casualty Persons	Crashes	Casualty Cost (\$M)
0	31	31	63	3.534

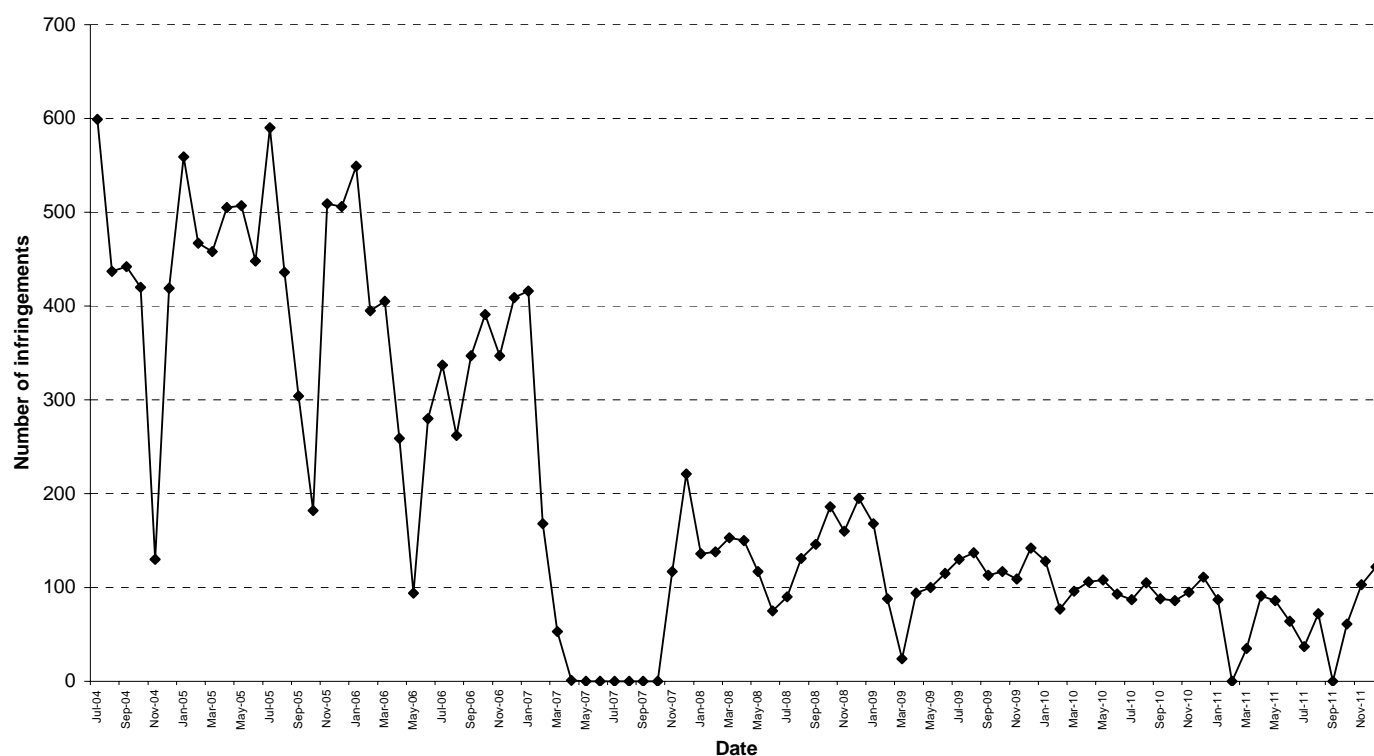
PENNANT HILLS ROAD CARLINGFORD

The fixed speed camera at Pennant Hills Road, Carlingford was installed in August 2002. There is one camera installed at this location.

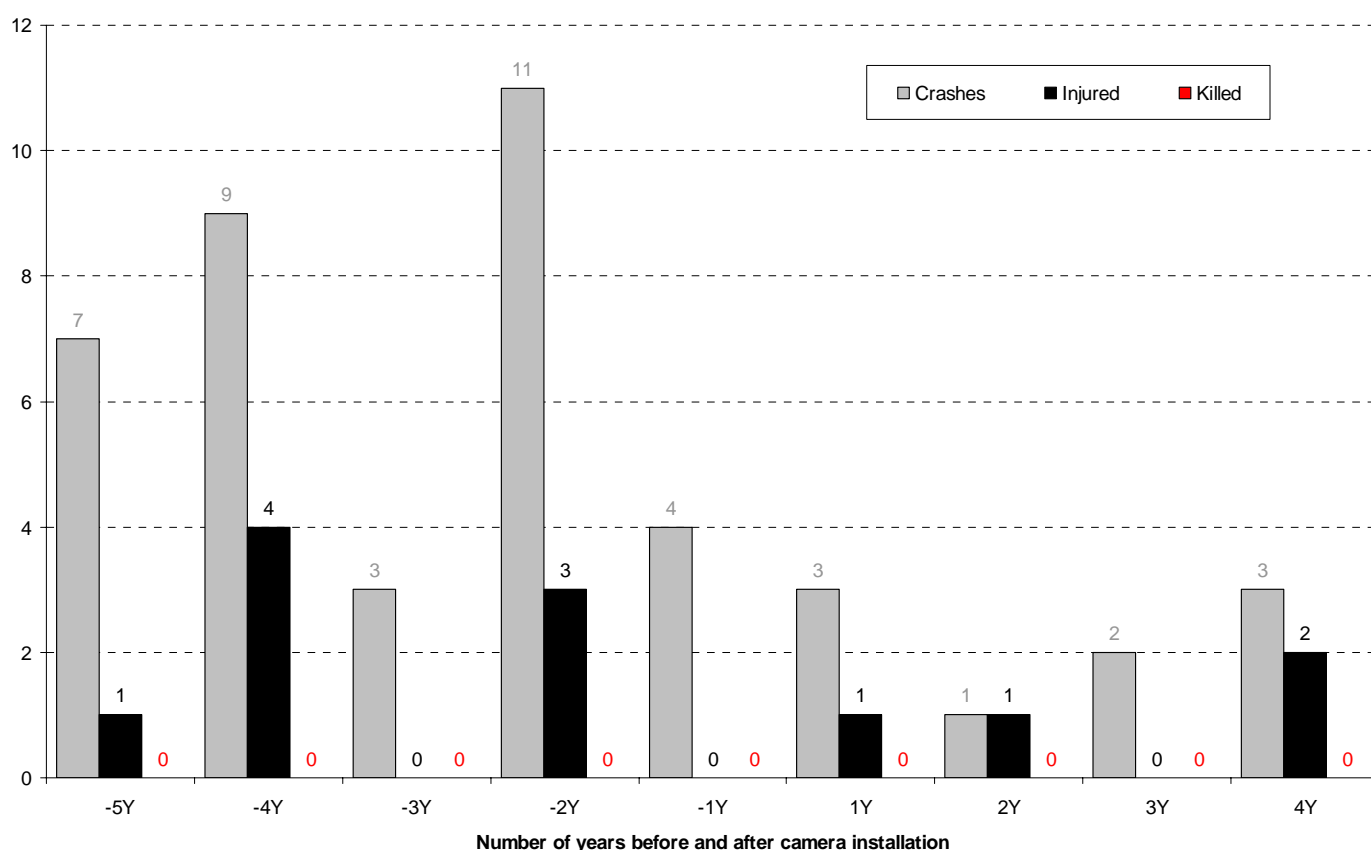
### Crashes at fixed speed camera location

Five years before – Feb 2002 to Feb 2007 - Totals				
Fatality Persons	Injury Persons	Casualty Persons	Crashes	Casualty Cost (\$M)
0	8	8	34	0.912
After (most recent four year period) – 2007 to 2011 - Totals				
Fatality Persons	Injury Persons	Casualty Persons	Crashes	Casualty Cost (\$M)
0	4	4	9	0.456

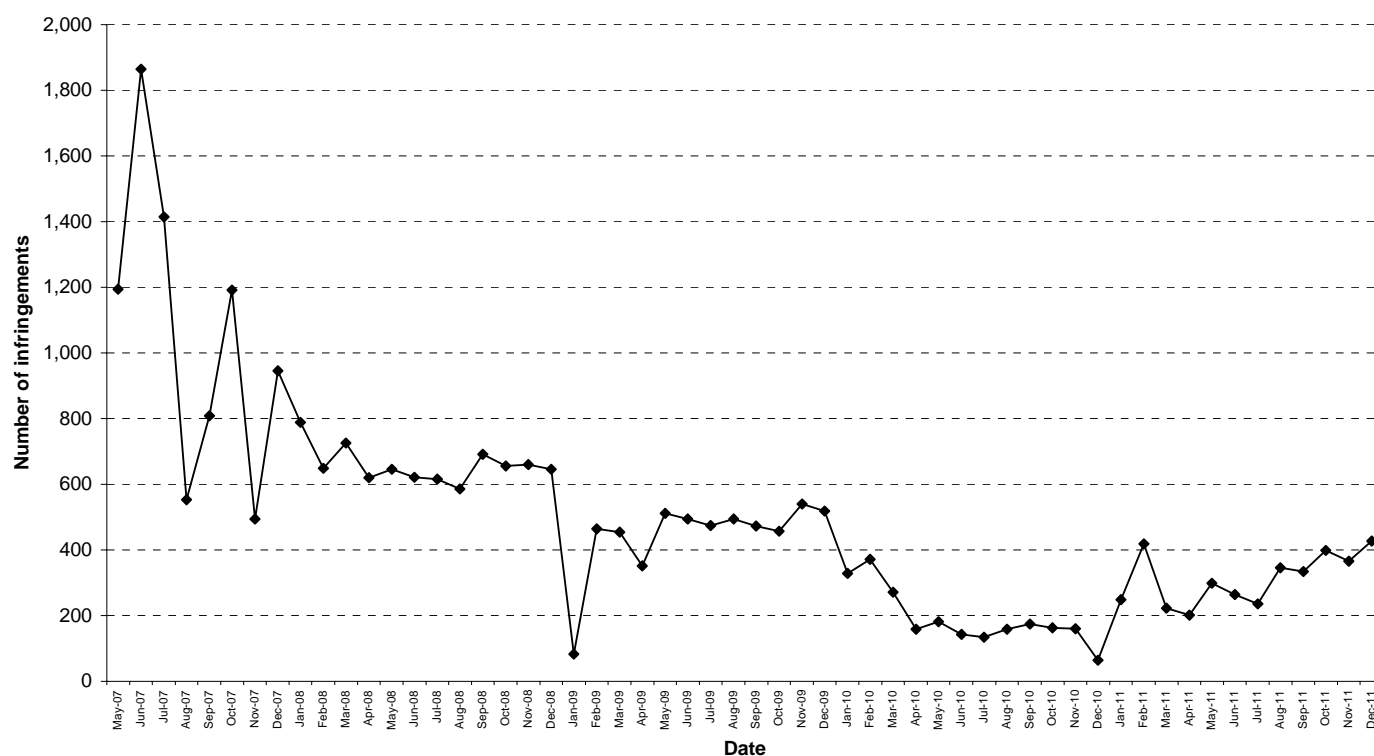
OLD NORTHERN ROAD CASTLE HILL

The school zone fixed speed camera at Old Northern Road, Castle Hill was installed in May 2007. There is one camera installed at this location.

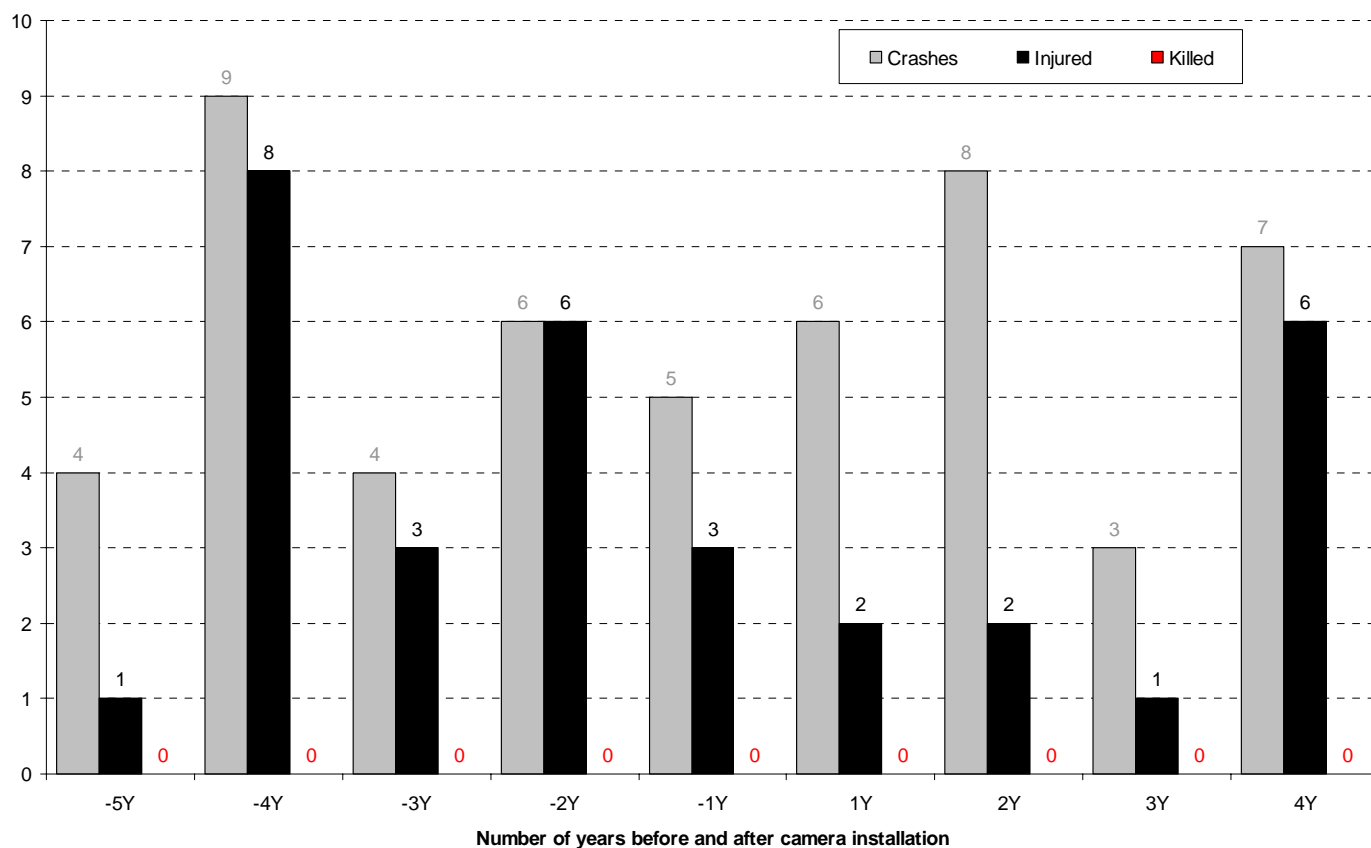
### Crashes at fixed speed camera location

Five years before – Jan 2002 to Jan 2007 - Totals				
Fatality Persons	Injury Persons	Casualty Persons	Crashes	Casualty Cost (\$M)
0	21	21	28	2.394
After (most recent four year period) – 2007 to 2011 - Totals				
Fatality Persons	Injury Persons	Casualty Persons	Crashes	Casualty Cost (\$M)
0	11	11	24	1.254

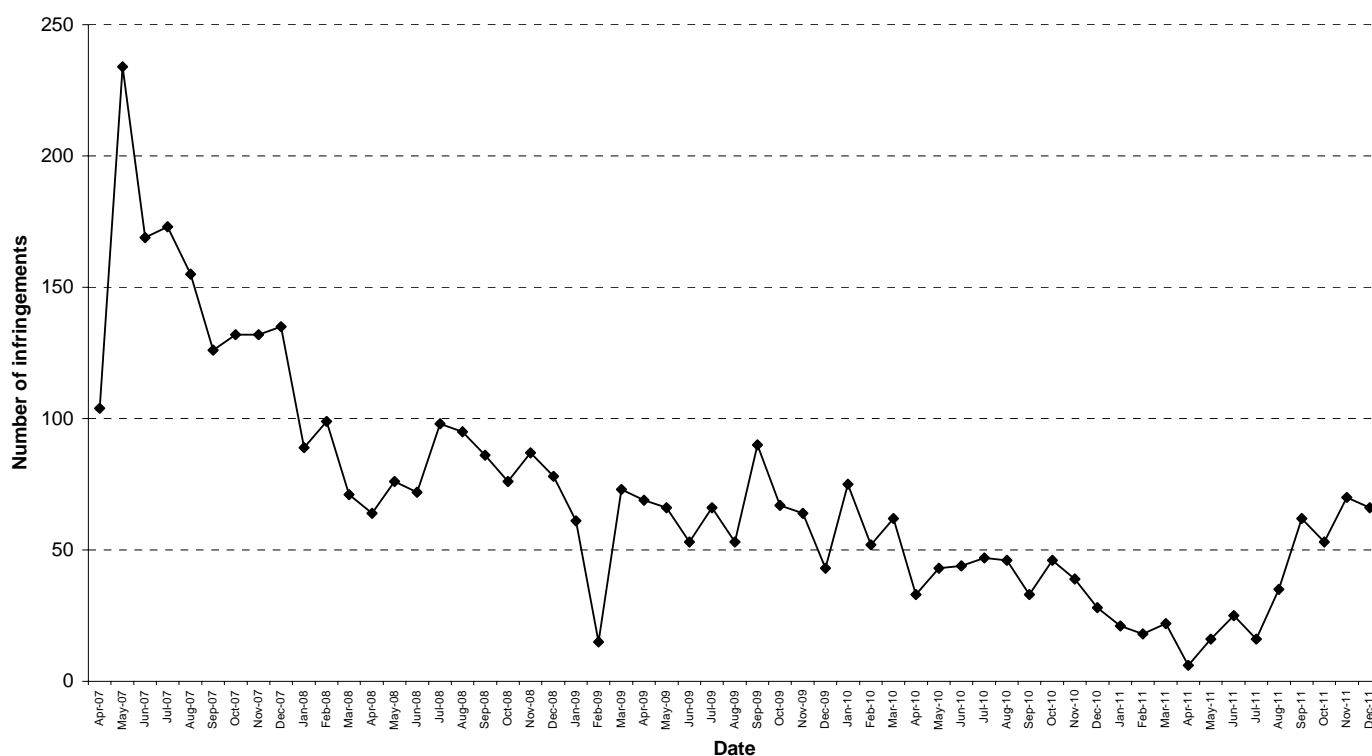
### PACIFIC HIGHWAY CHARMHAVEN

The fixed speed camera on the Pacific Highway, Charmhaven was installed in April 2007. There is one camera installed at this location.
