# ANNUAL NSW SPEED CAMERA PERFORMANCE REVIEW

NSW Centre for Road Safety

JULY 2012

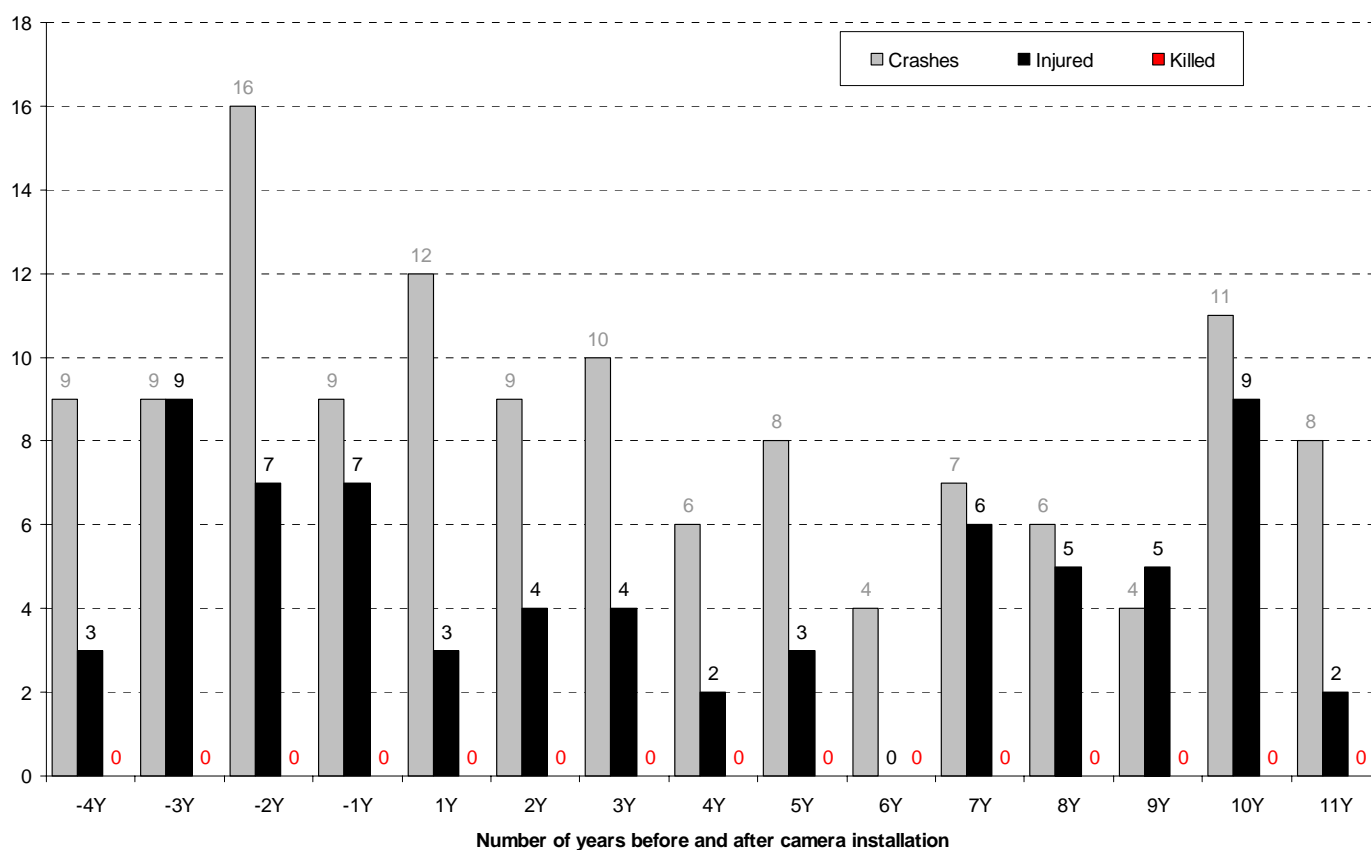
### Crashes at fixed speed camera location

Four years before – Apr 1995 to Apr 2000 (no data available for 1995) - Totals				
Fatality Persons	Injury Persons	Casualty Persons	Crashes	Casualty Cost (\$M)
0	26	26	43	2.964
After (most recent five year period) – 2006 to 2011 - Totals				
Fatality Persons	Injury Persons	Casualty Persons	Crashes	Casualty Cost (\$M)
0	27	27	36	3.078

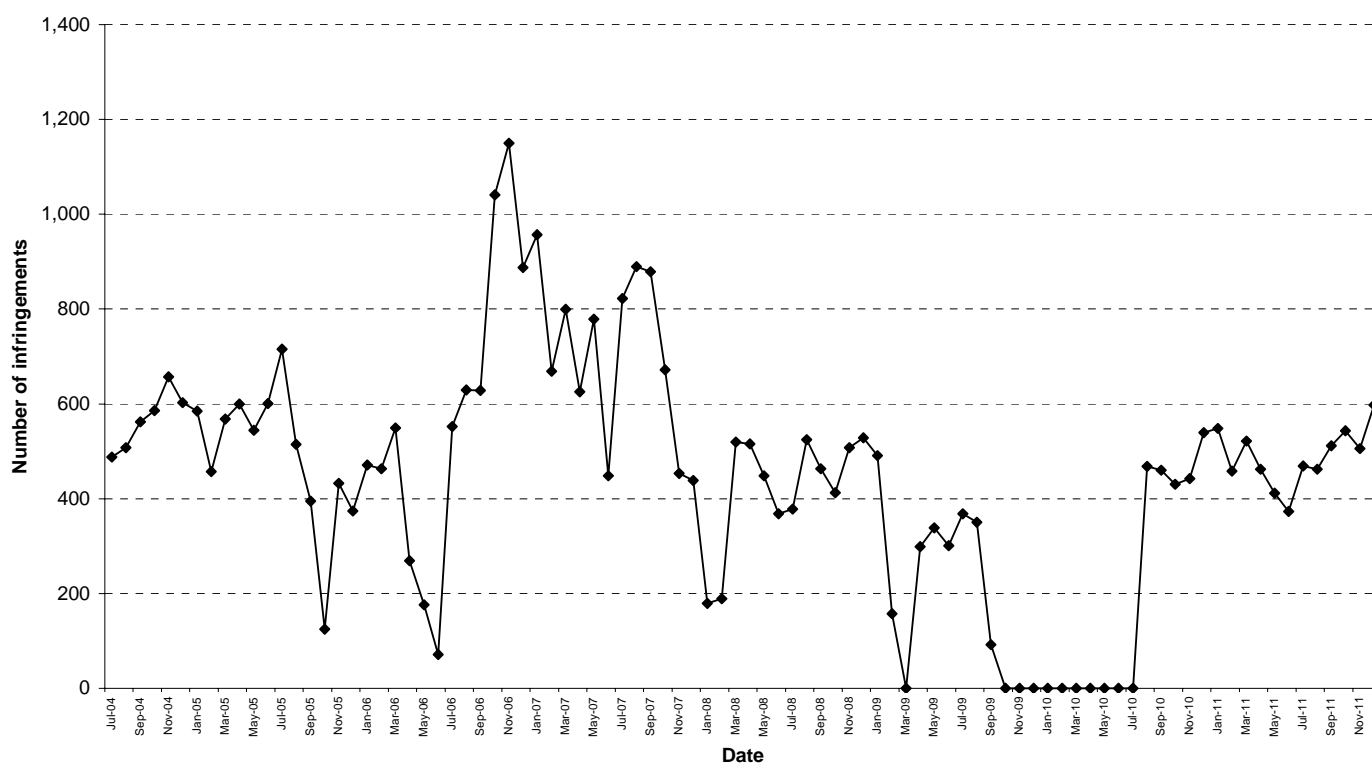
CONCORD ROAD CONCORD WEST

The fixed speed camera on Concord Road, Concord West was installed in July 2000. There is one camera installed at this location.

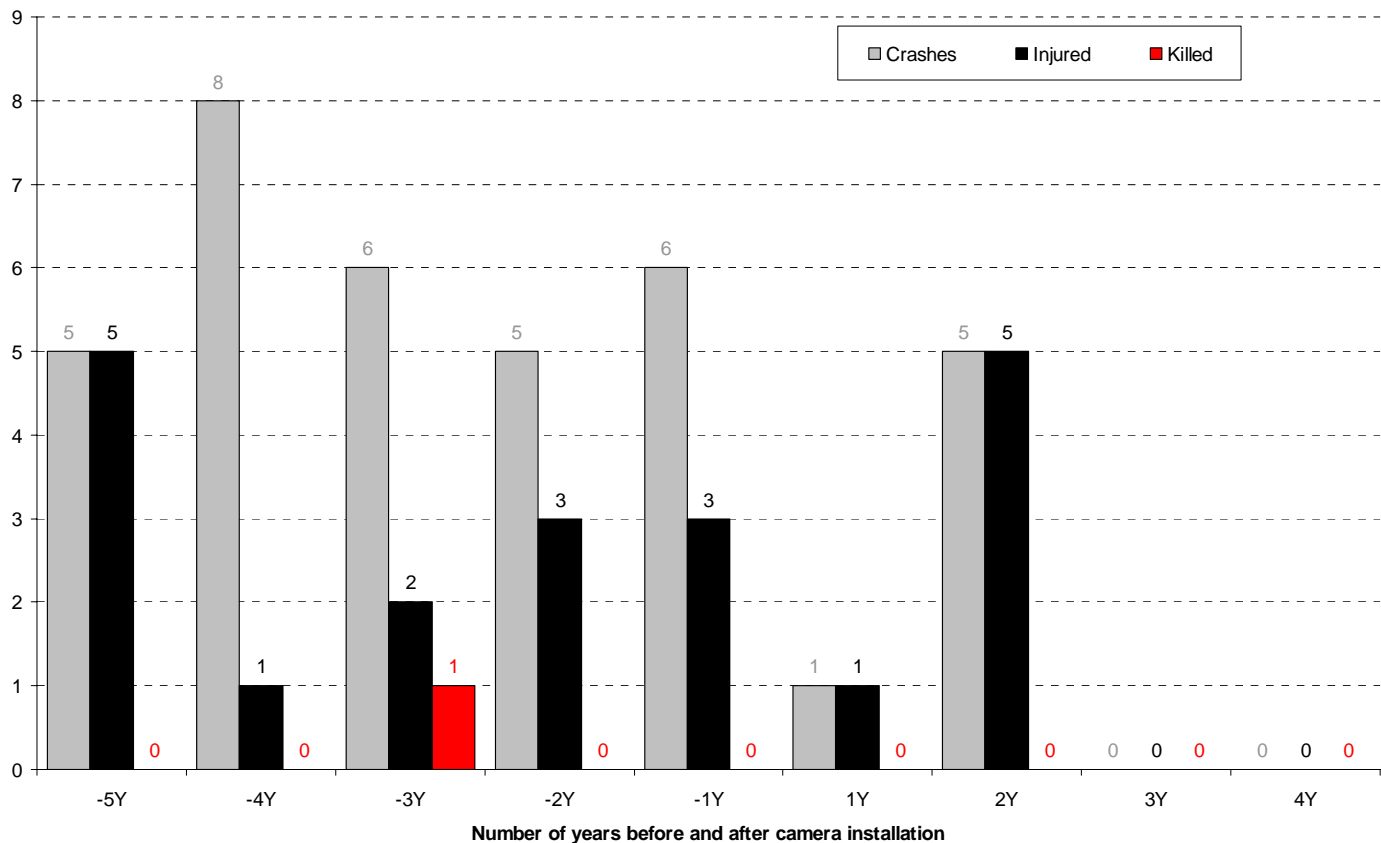
### Crashes at fixed speed camera location

Five years before – Jul 2002 to Jul 2007 - Totals				
Fatality Persons	Injury Persons	Casualty Persons	Crashes	Casualty Cost (\$M)
1	14	15	30	7.43
After (most recent four year period) – 2007 to 2011 - Totals				
Fatality Persons	Injury Persons	Casualty Persons	Crashes	Casualty Cost (\$M)
0	6	6	6	0.684

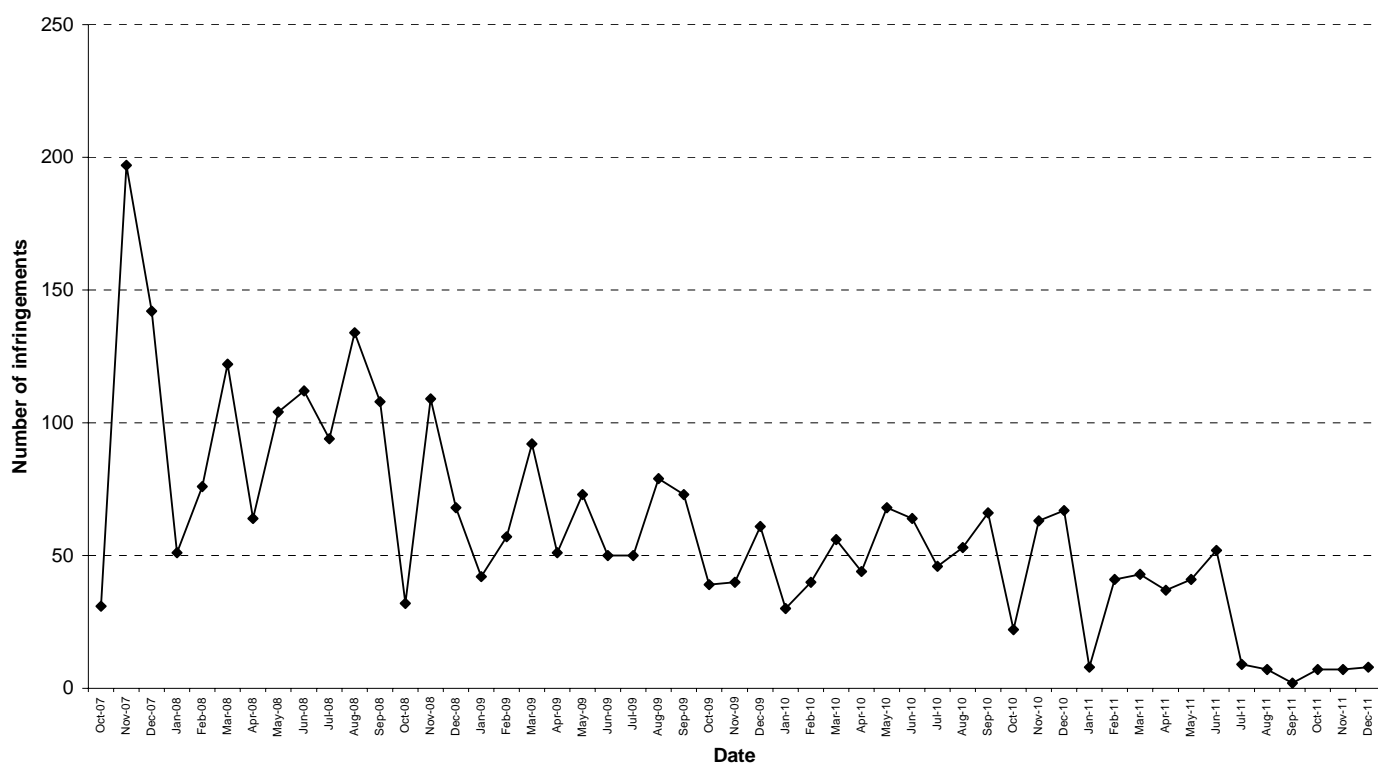
EDGAR STREET CONDELL PARK

The school zone fixed speed camera on Edgar Street, Condell Park was installed in October 2007. There is one camera installed at this location.

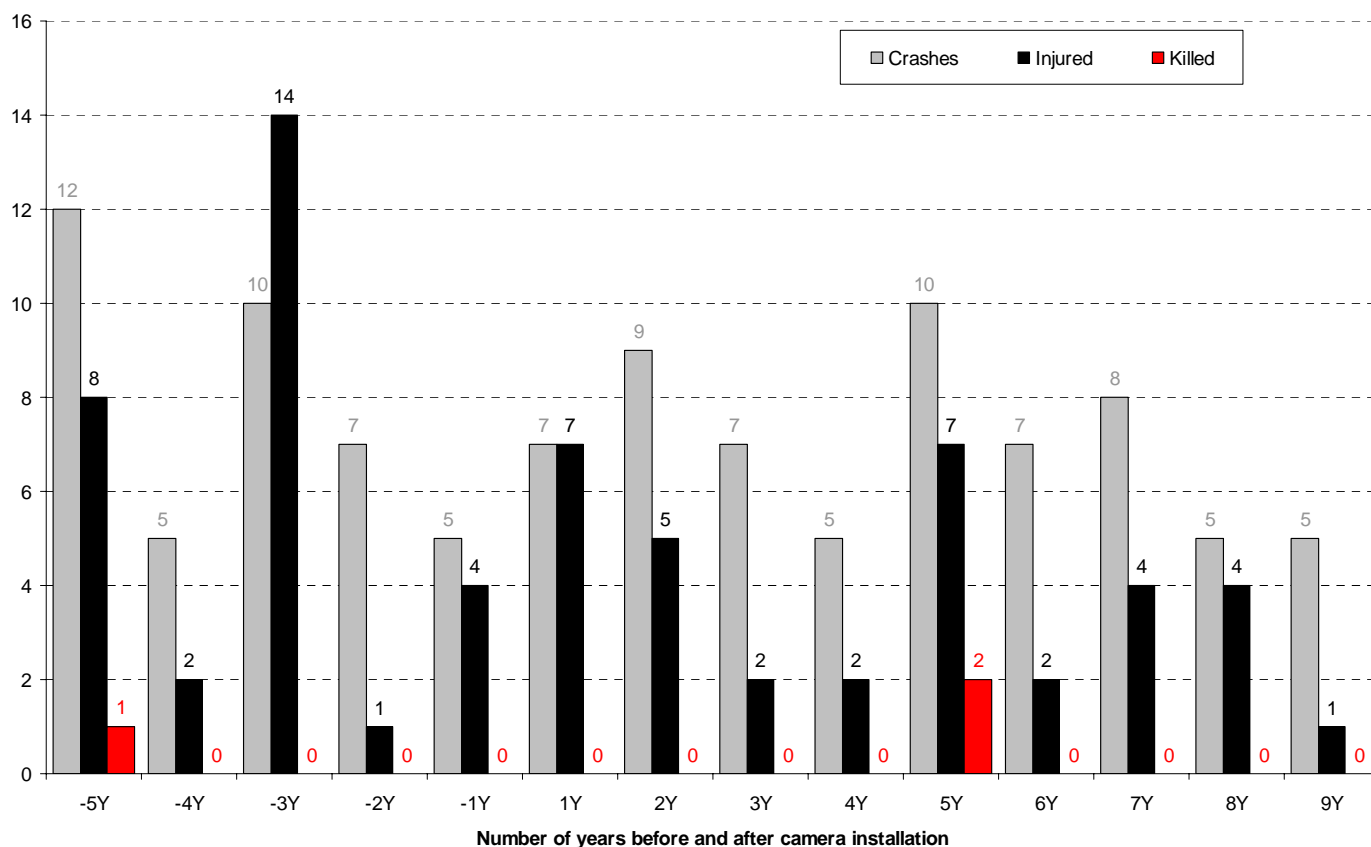
### Crashes at fixed speed camera location

Five years before – Jul 2002 to Jul 2007 - Totals				
Fatality Persons	Injury Persons	Casualty Persons	Crashes	Casualty Cost (\$M)
1	29	30	39	9.14
After (most recent five year period) – 2006 to 2011 - Totals				
Fatality Persons	Injury Persons	Casualty Persons	Crashes	Casualty Cost (\$M)
2	18	20	35	13.72

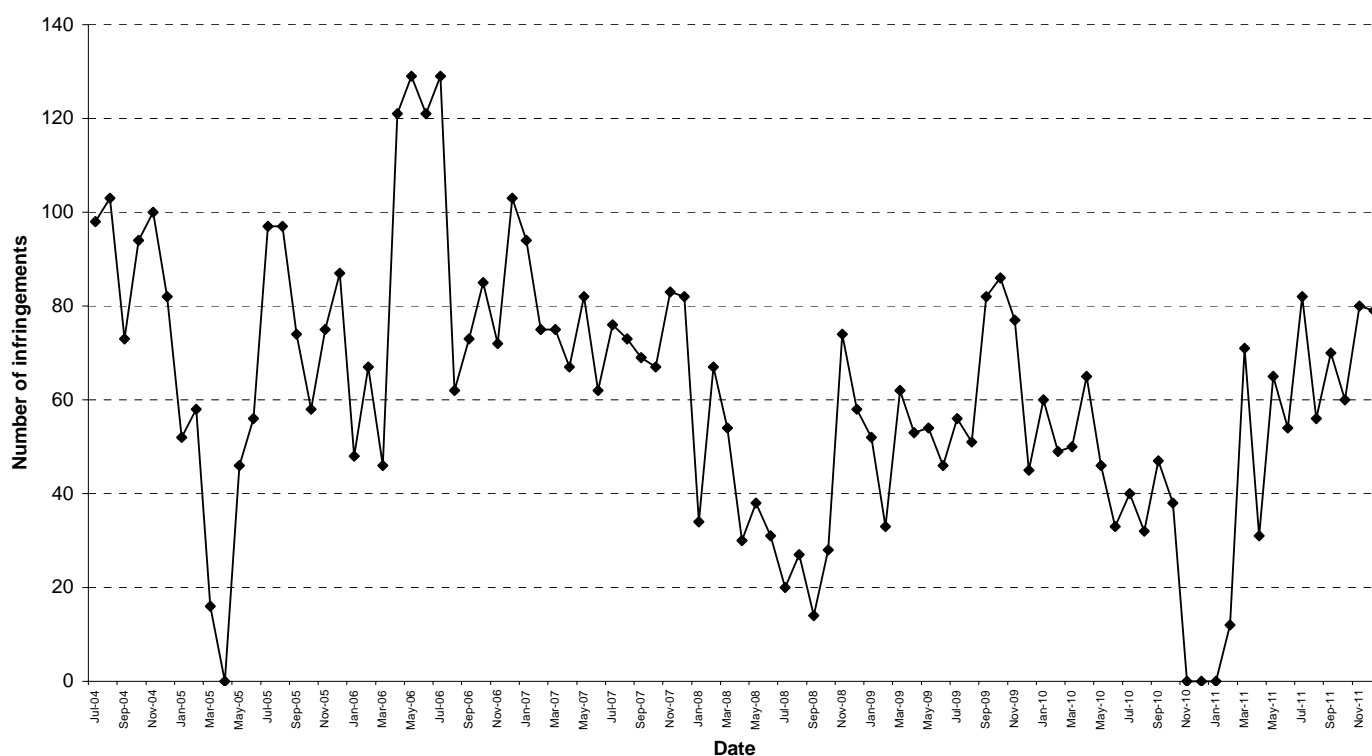
NORTHERN DISTRIBUTOR CORRIMAL

The fixed speed cameras on the Northern Distributor, Corrimal were installed in July 2002. There are two cameras installed at this location.

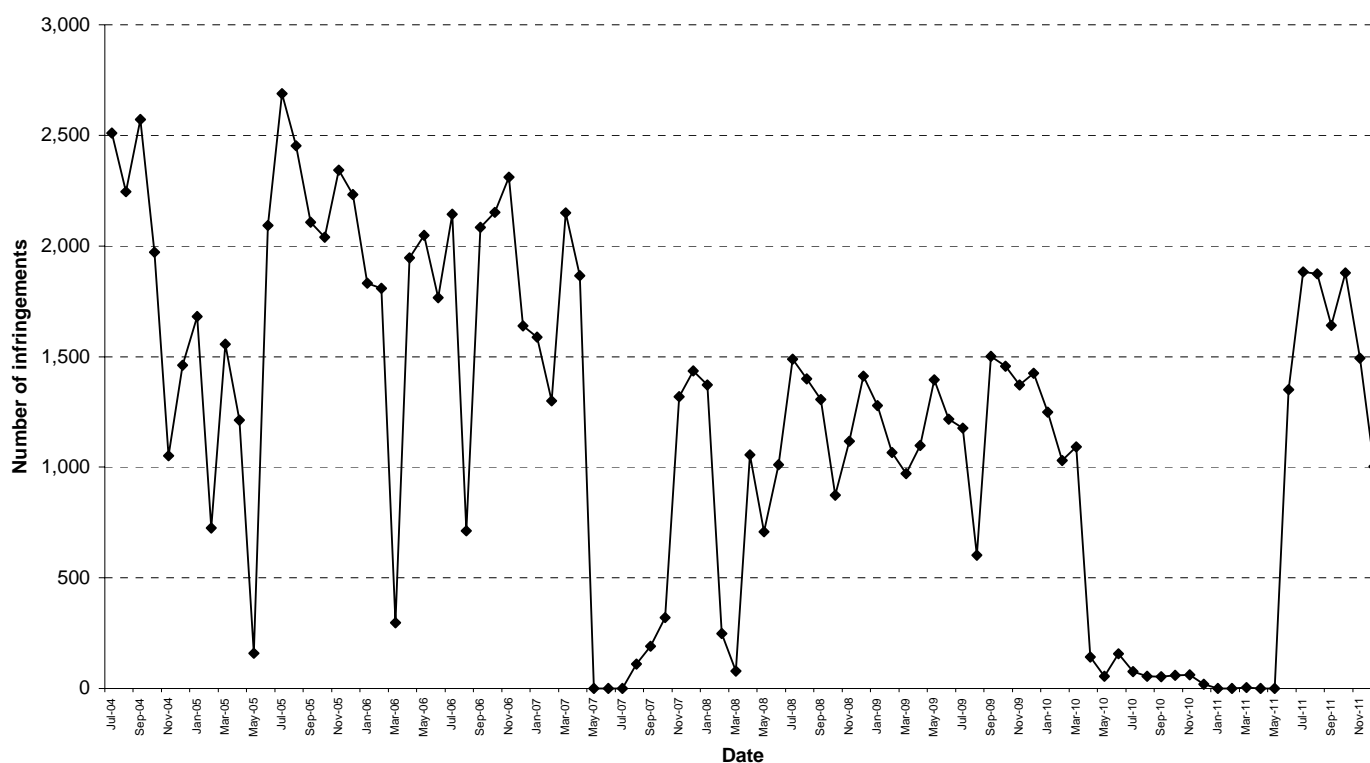
EASTERN DISTRIBUTOR DARLINGHURST

The fixed speed cameras in the Eastern Distributor, Darlinghurst were installed in June 2000 (southbound) and November 2000 (northbound). There are two speed camera installed at this location.

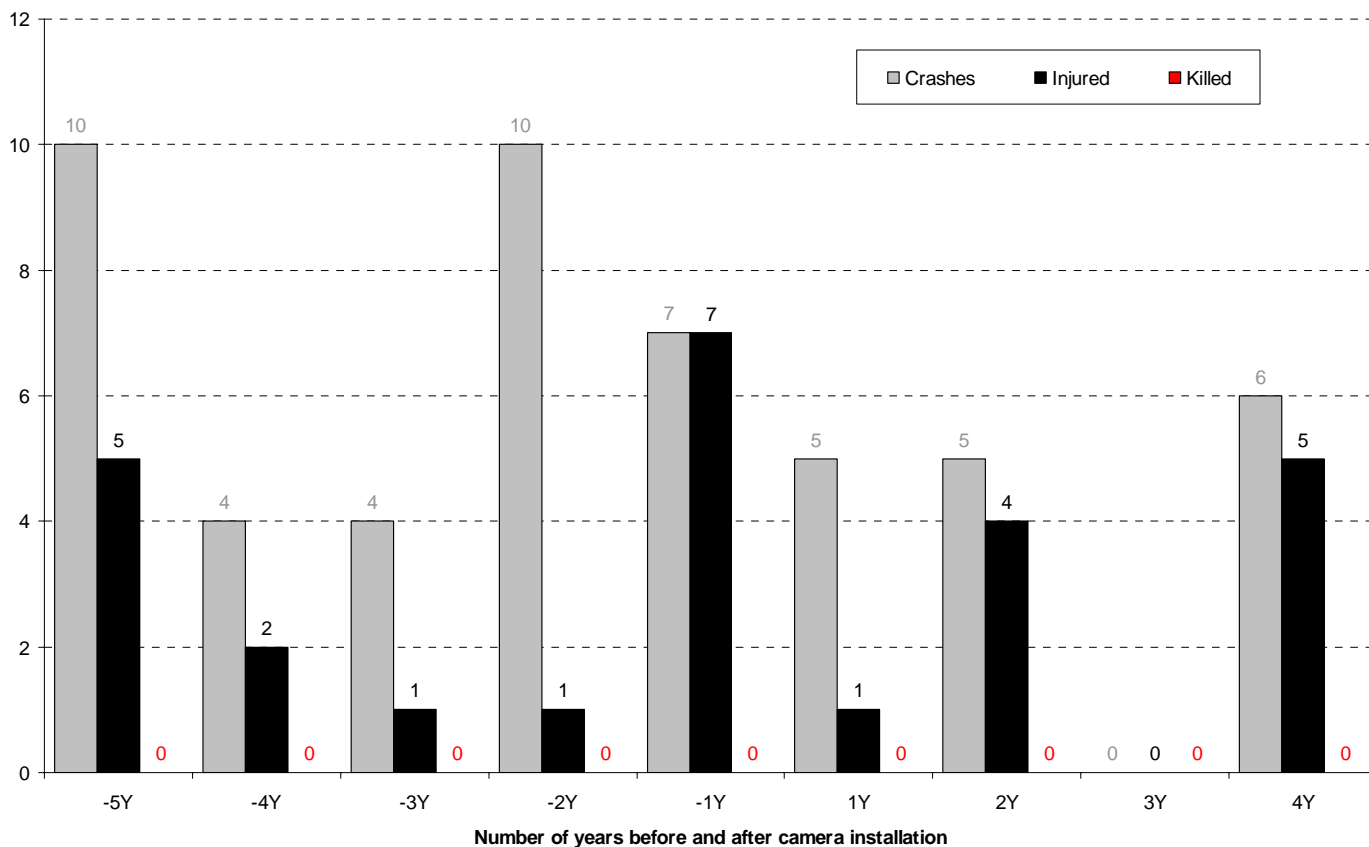
### Crashes at fixed speed camera location

Five years before – Mar 2002 to Mar 2007 - Totals				
Fatality Persons	Injury Persons	Casualty Persons	Crashes	Casualty Cost (\$M)
0	16	16	35	1.824
After (most recent four year period) – 2007 to 2011 - Totals				
Fatality Persons	Injury Persons	Casualty Persons	Crashes	Casualty Cost (\$M)
0	10	10	16	1.14

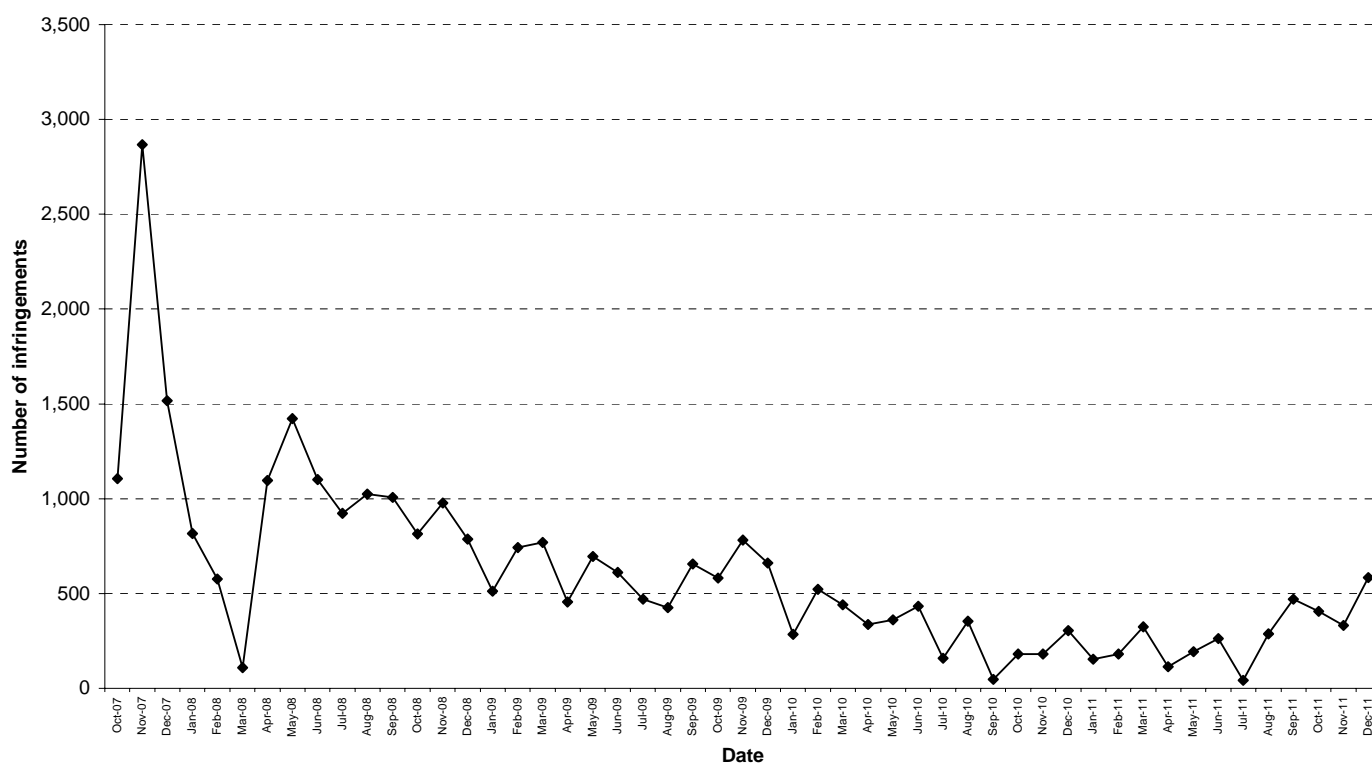
BUNNERONG ROAD EASTGARDENS/MAROUBRA

The school zone fixed speed cameras on Bunnerong Road, East Gardens/ Maroubra were installed in June 2007. There are two cameras installed at this location.

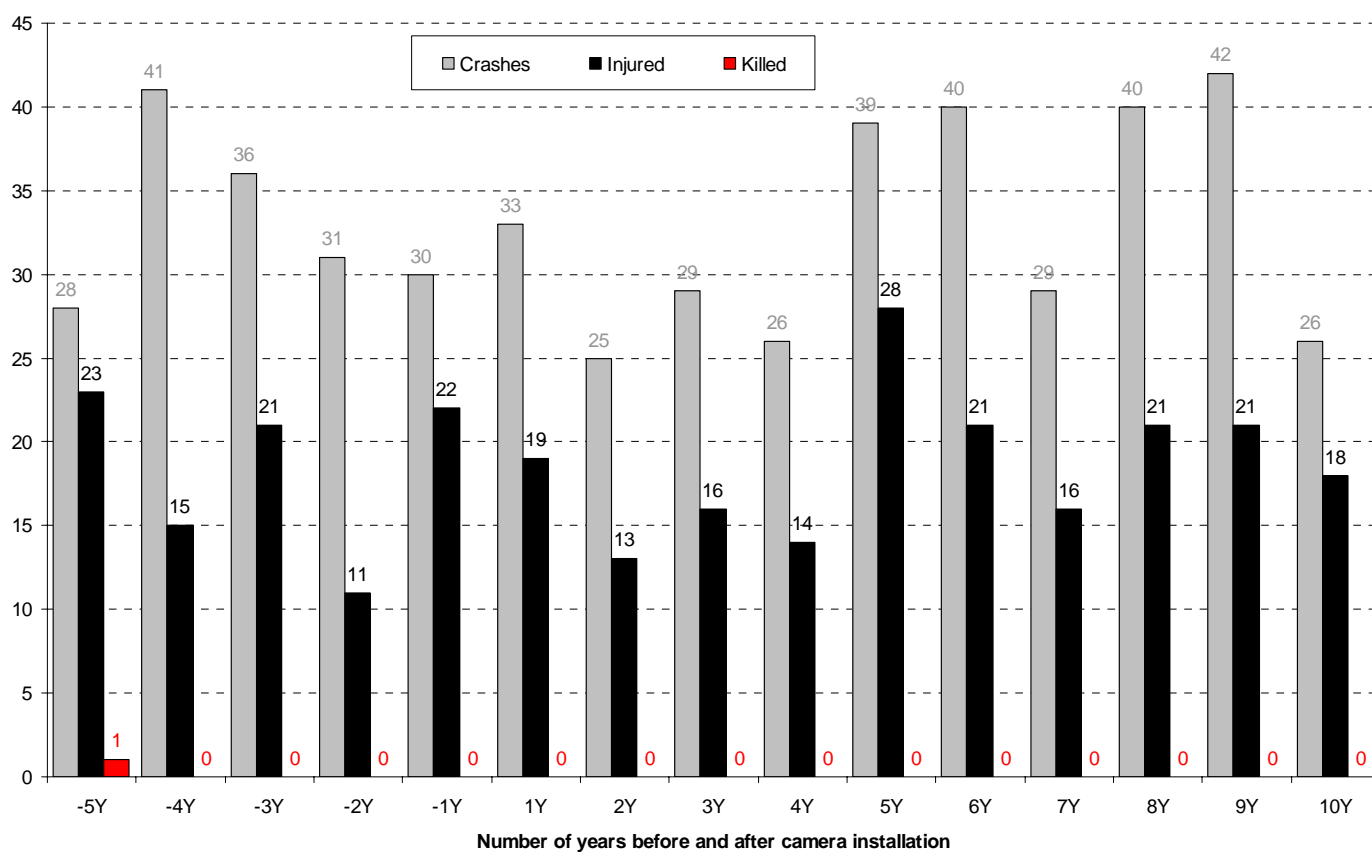
### Crashes at fixed speed camera location

Five years before – Sep 1996 to Sep 2001 - Totals				
Fatality Persons	Injury Persons	Casualty Persons	Crashes	Casualty Cost
1	92	93	166	16.322
After (most recent five year period) – 2006 to 2011 - Totals				
Fatality Persons	Injury Persons	Casualty Persons	Crashes	Casualty Cost
0	97	97	177	11.058

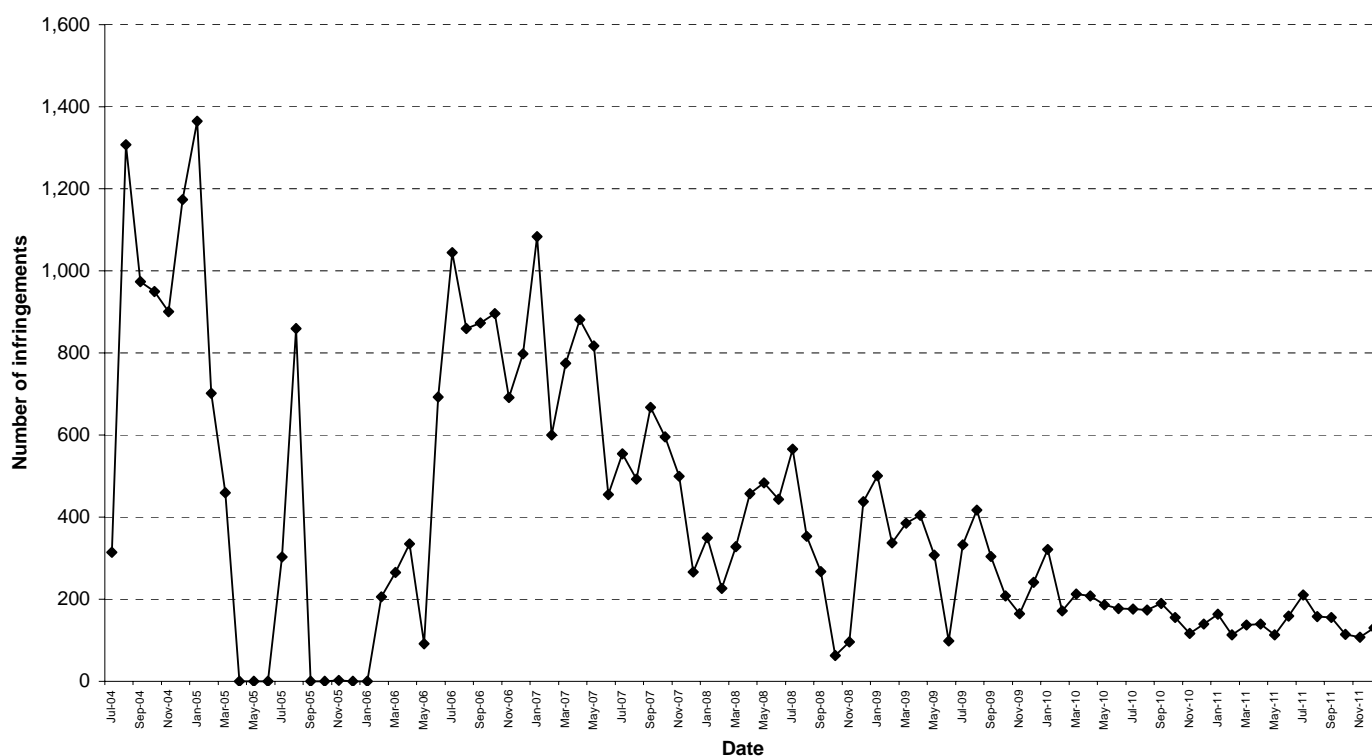
### NEW SOUTH HEAD ROAD EDGECLIFF

The fixed speed camera at New South Head Road, Edgecliff was installed in December 2001. There is one camera installed at this location.

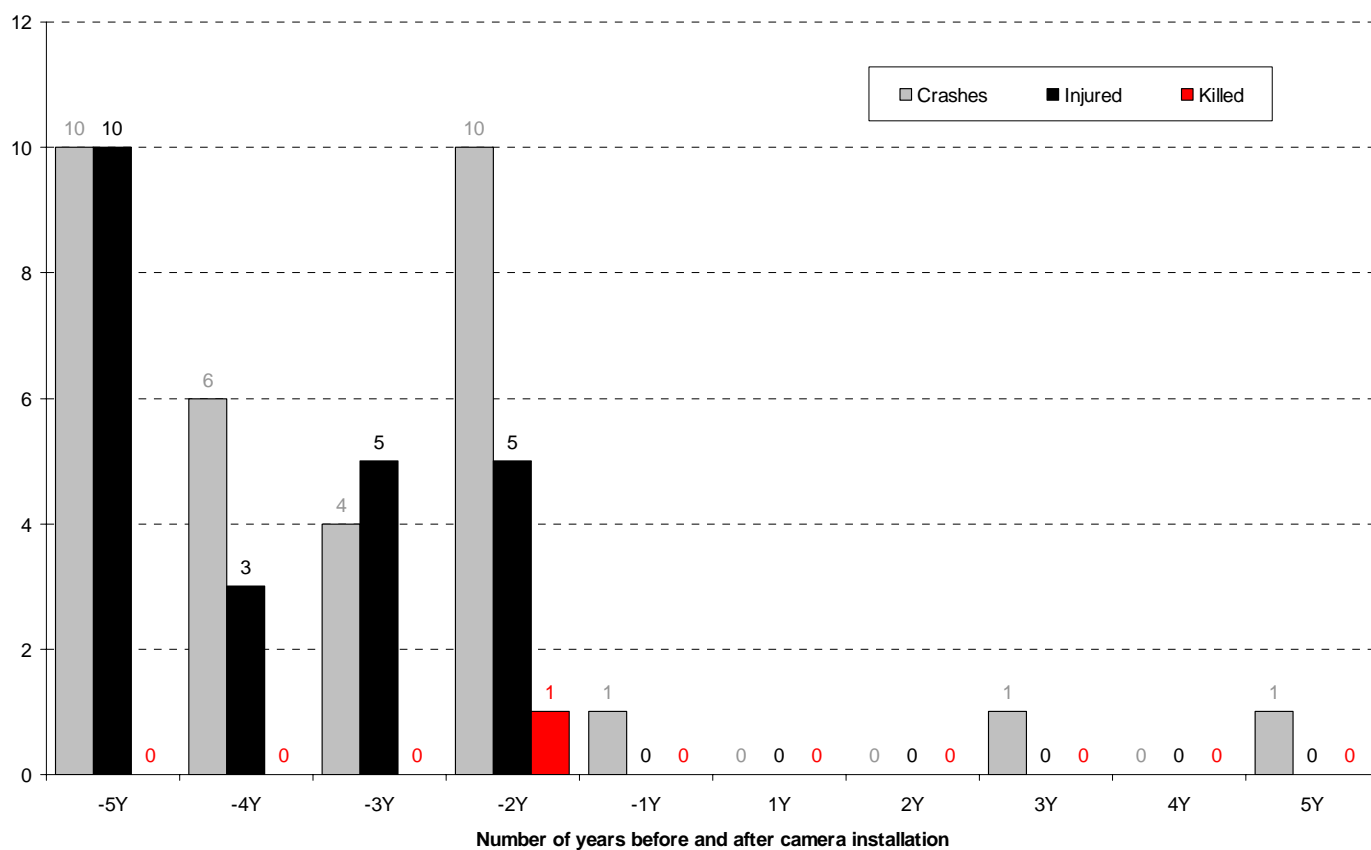
### Crashes at fixed speed camera location

Five years before – Jun 2001 to Jun 2006 - Totals				
Fatality Persons	Injury Persons	Casualty Persons	Crashes	Casualty Cost
1	23	24	31	8.456
After (most recent five year period) – 2006 to 2011 - Totals				
Fatality Persons	Injury Persons	Casualty Persons	Crashes	Casualty Cost
0	0	0	2	0

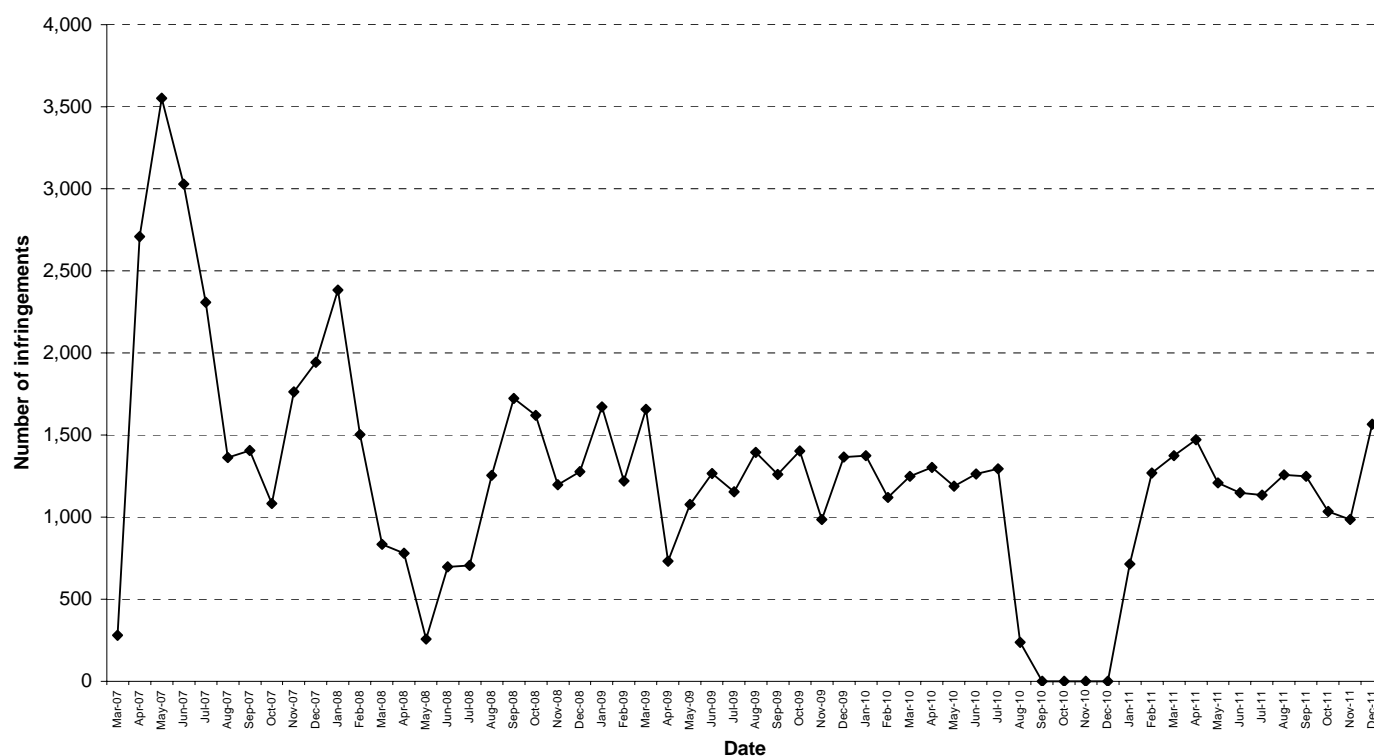
### PACIFIC HIGHWAY EWINGSDALE

The fixed speed camera on the Pacific Highway, Ewingsdale was installed in September 2006. There is one camera installed at this location.

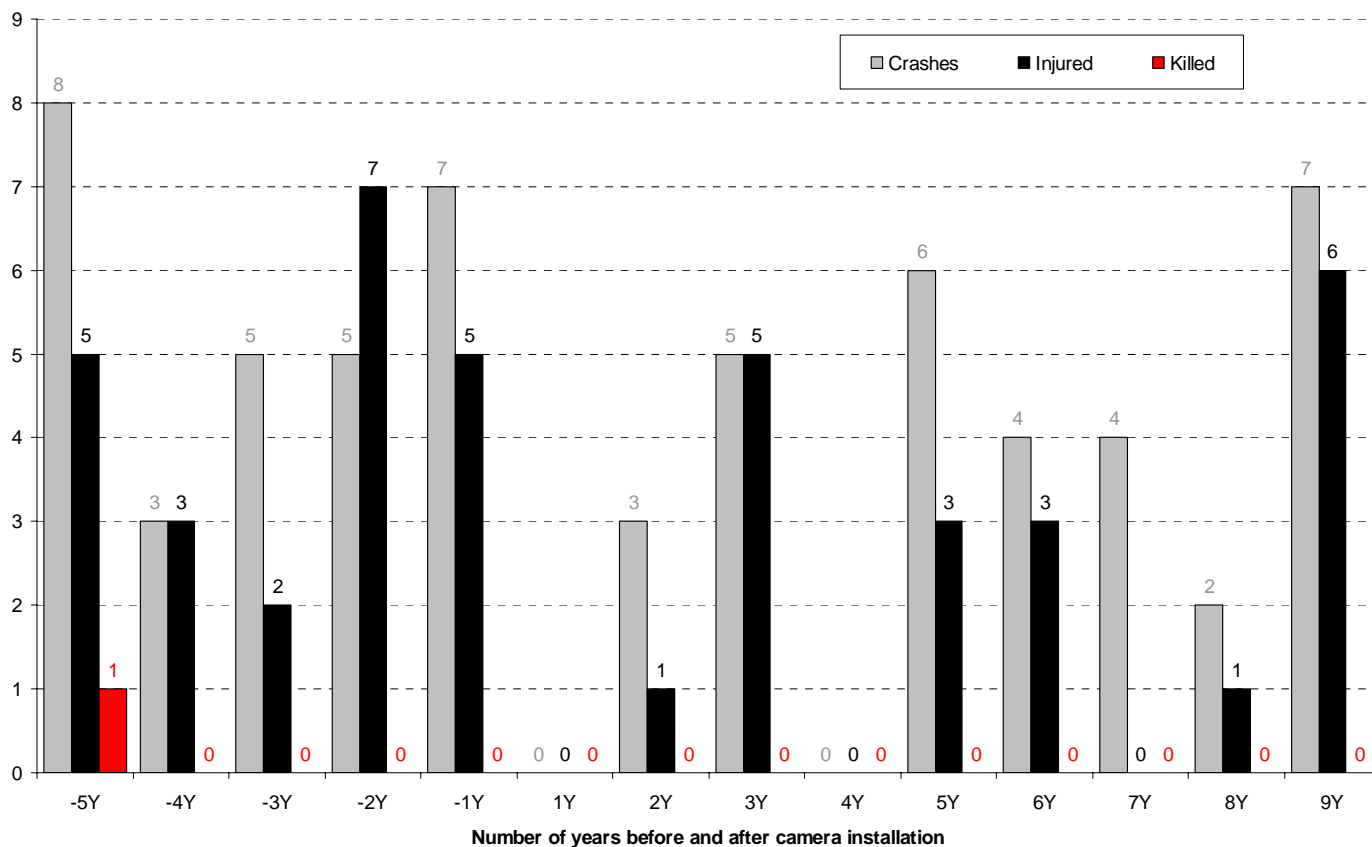
### Crashes at fixed speed camera location

Five years before – Apr 1997 to Apr 2002 - Totals				
Fatality Persons	Injury Persons	Casualty Persons	Crashes	Casualty Cost
1	22	23	28	8.342
After (most recent five year period) – 2006 to 2011 - Totals				
Fatality Persons	Injury Persons	Casualty Persons	Crashes	Casualty Cost
0	13	13	23	1.482

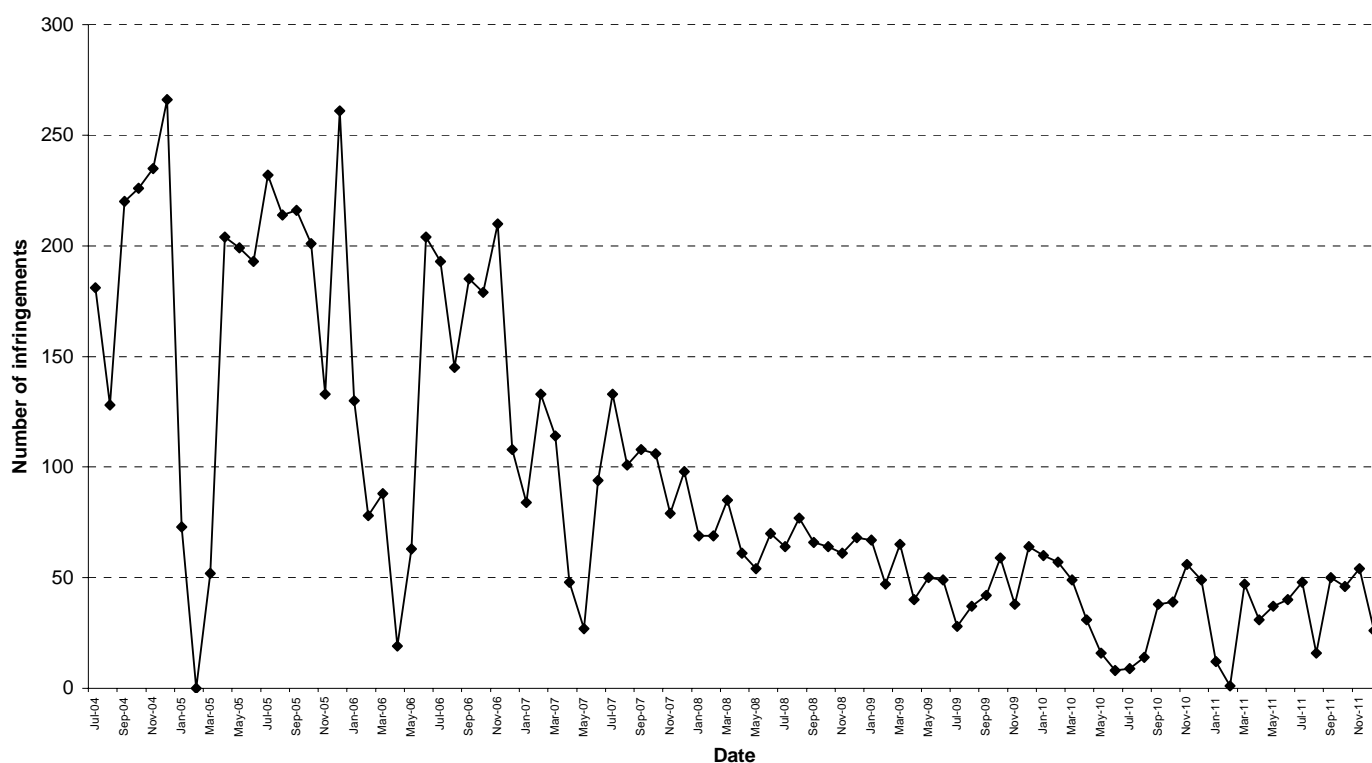
FAIRFIELD STREET FAIRFIELD EAST

## Infringements at fixed speed camera location

The fixed speed camera on Fairfield Street, Fairfield East was installed in July 2002. There is one camera installed at this location.

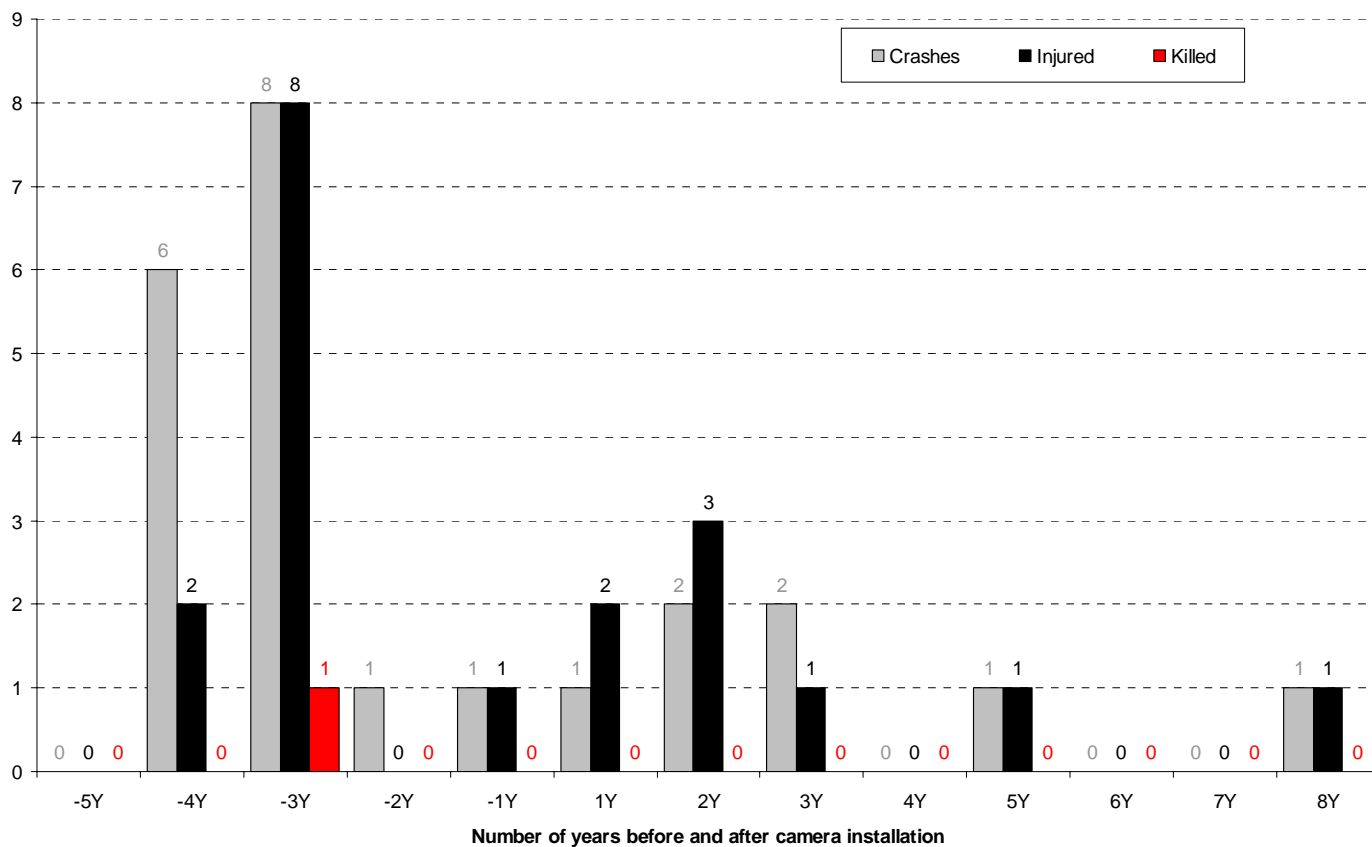
### Crashes at fixed speed camera location

Five years before – Feb 1998 to Feb 2003 - Totals				
Fatality Persons	Injury Persons	Casualty Persons	Crashes	Casualty Cost
1	11	12	16	7.088
After (most recent five year period) – 2006 to 2011 - Totals				
Fatality Persons	Injury Persons	Casualty Persons	Crashes	Casualty Cost
0	2	2	2	0.228

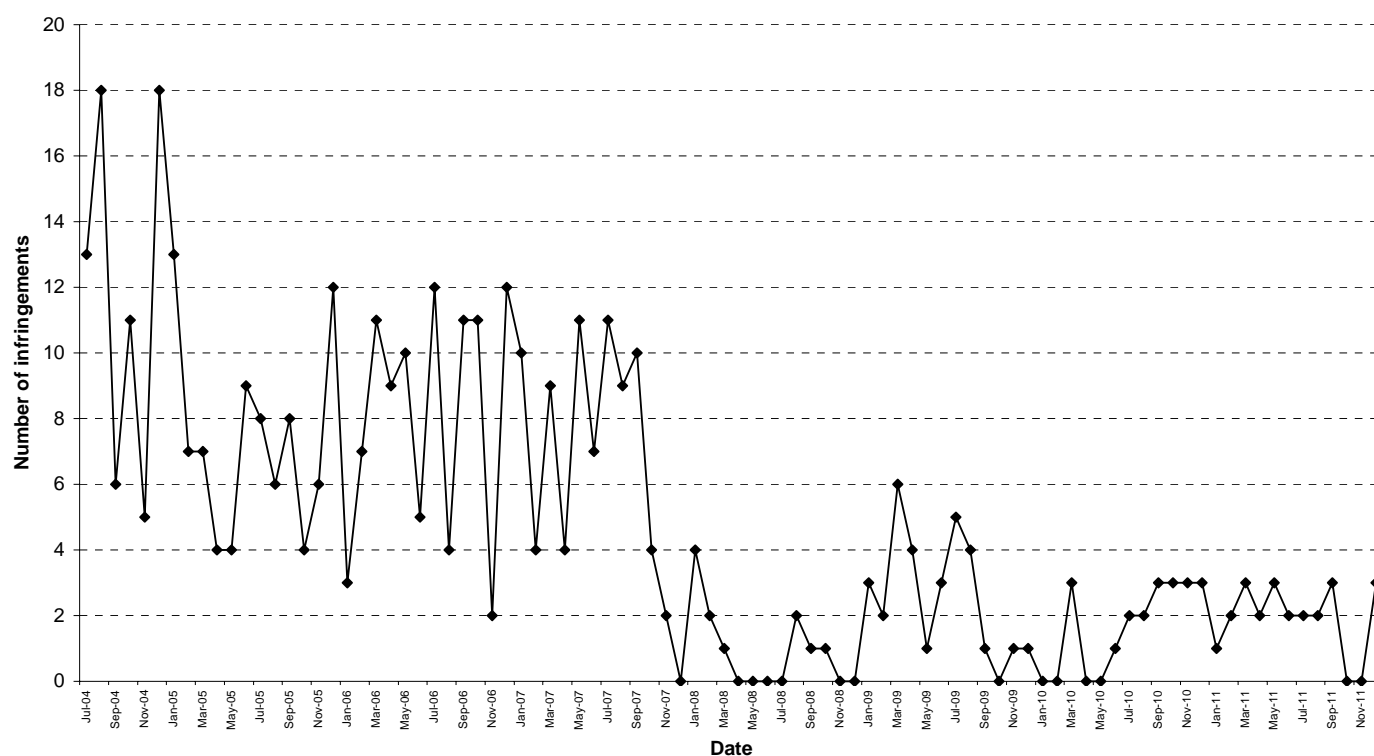
### PRINCES HIGHWAY FOXGROUND

## Infringements at fixed speed camera location

The fixed speed camera on the Princes Highway, Foxground was installed in May 2003. There is one camera installed at this location.

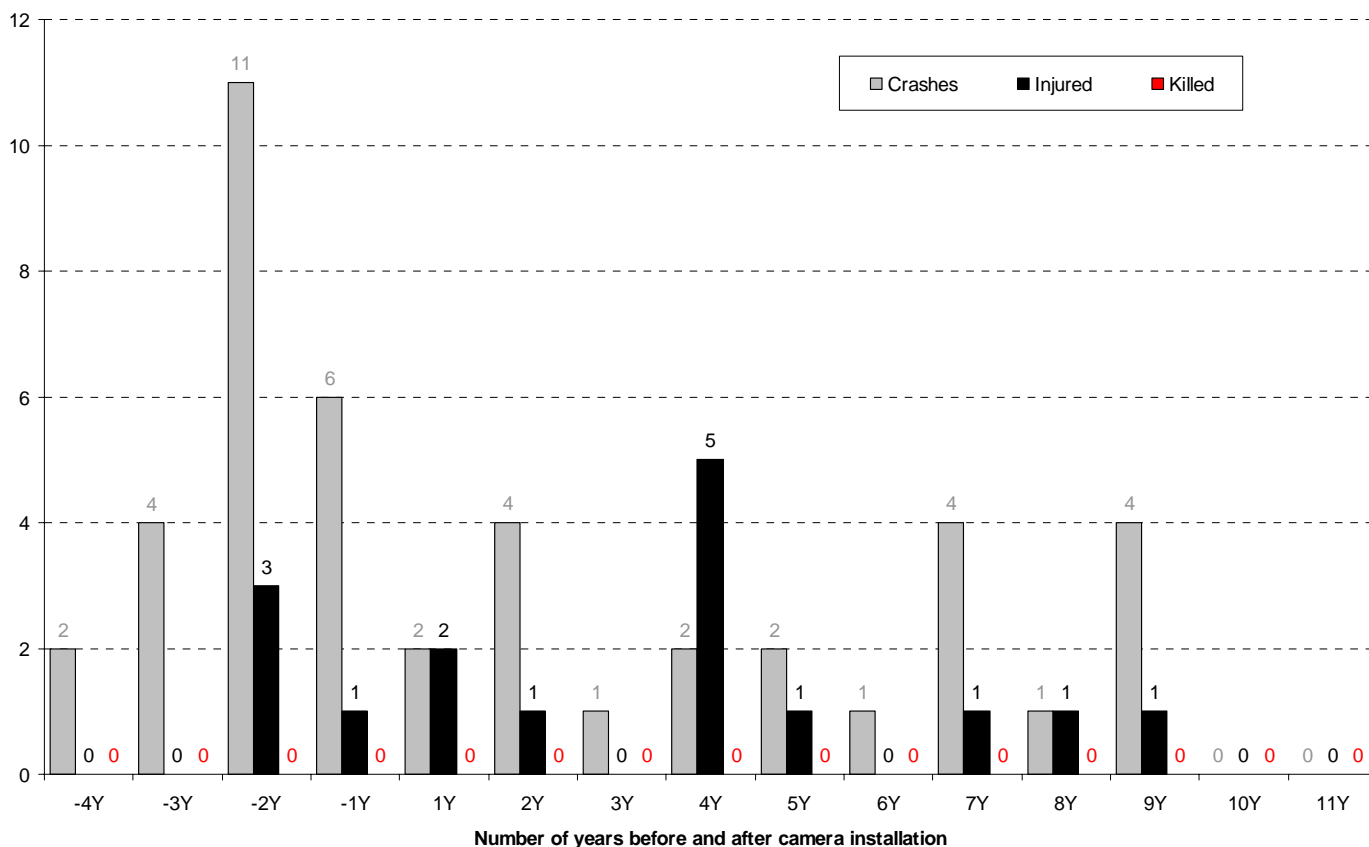
### Crashes at fixed speed camera location

Four years before – Mar 1996 to Mar 2000 (no data available for 1995) - Totals				
Fatality Persons	Injury Persons	Casualty Persons	Crashes	Casualty Cost
0	4	4	23	0.456
After (most recent five year period) – 2006 to 2011 - Totals				
Fatality Persons	Injury Persons	Casualty Persons	Crashes	Casualty Cost
0	3	3	9	0.342

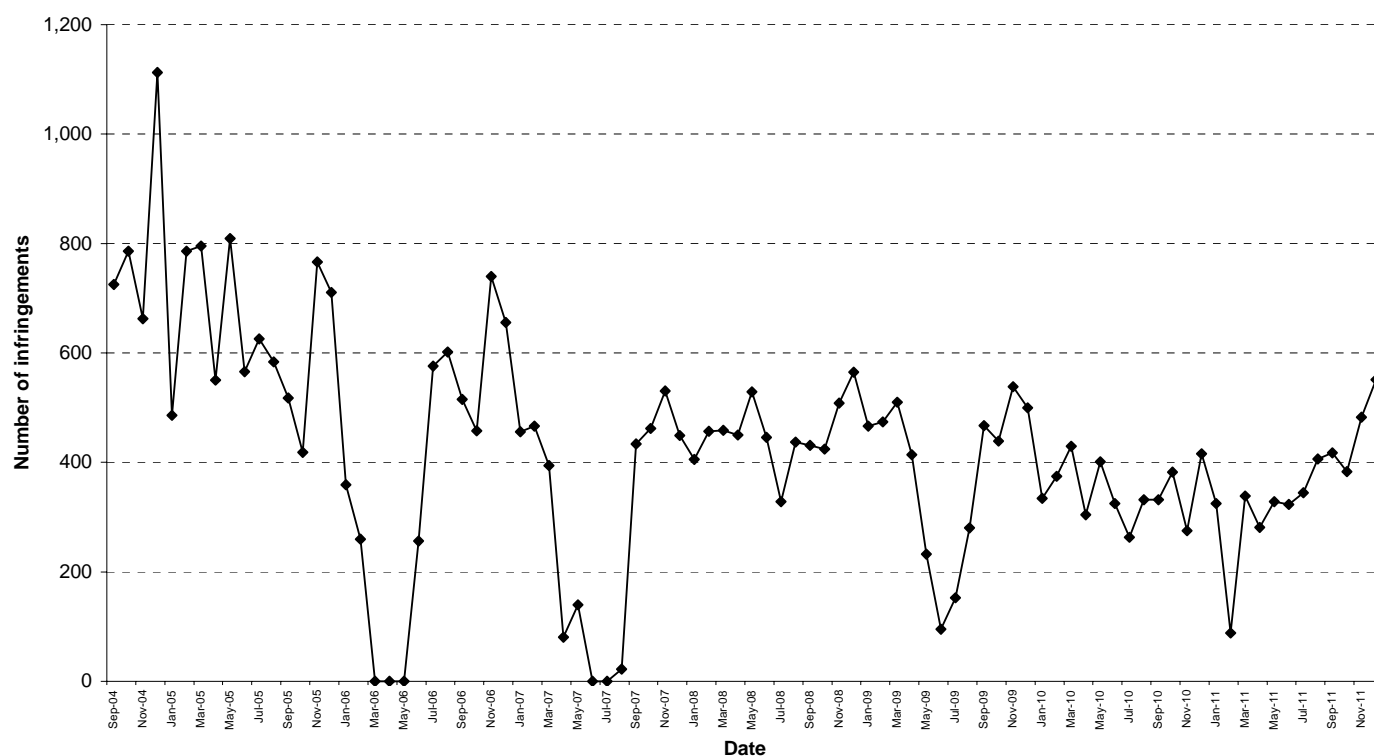
### PACIFIC HIGHWAY GATESHEAD

## Infringements at fixed speed camera location

The school zone fixed speed camera on the Pacific Highway, Gateshead was installed in May 2000. There is one camera installed at this location.
