# ANNUAL NSW SPEED CAMERA PERFORMANCE REVIEW

NSW Centre for Road Safety

JULY 2012

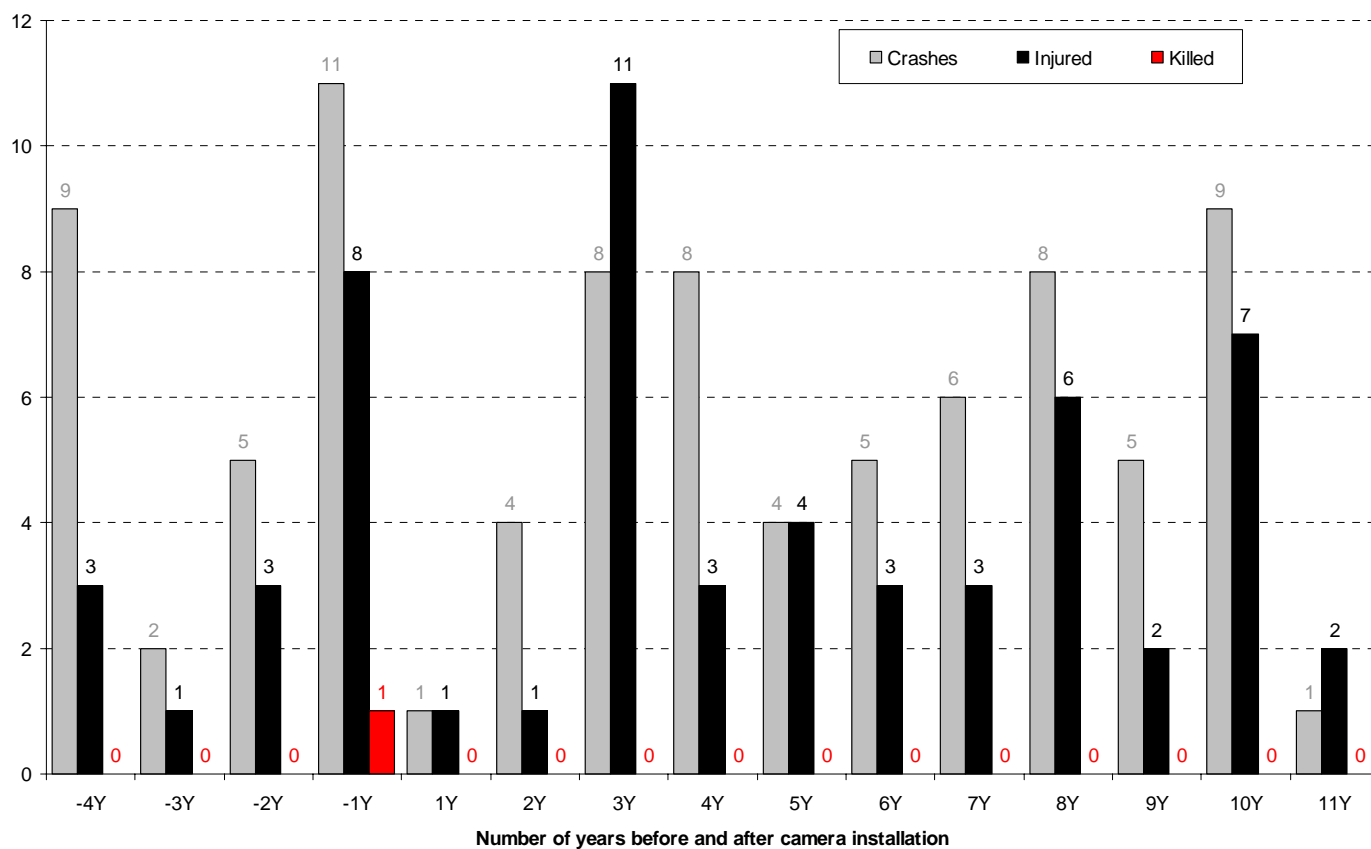
### Crashes at fixed speed camera location

Four years before – Feb 1996 to Jan 2000 (no data available for 1995) - Totals				
Fatality Persons	Injury Persons	Casualty Persons	Crashes	Casualty Cost
1	15	16	27	7.544
After (most recent five year period) – 2006 to 2011 - Totals				
Fatality Persons	Injury Persons	Casualty Persons	Crashes	Casualty Cost
0	20	20	29	2.28

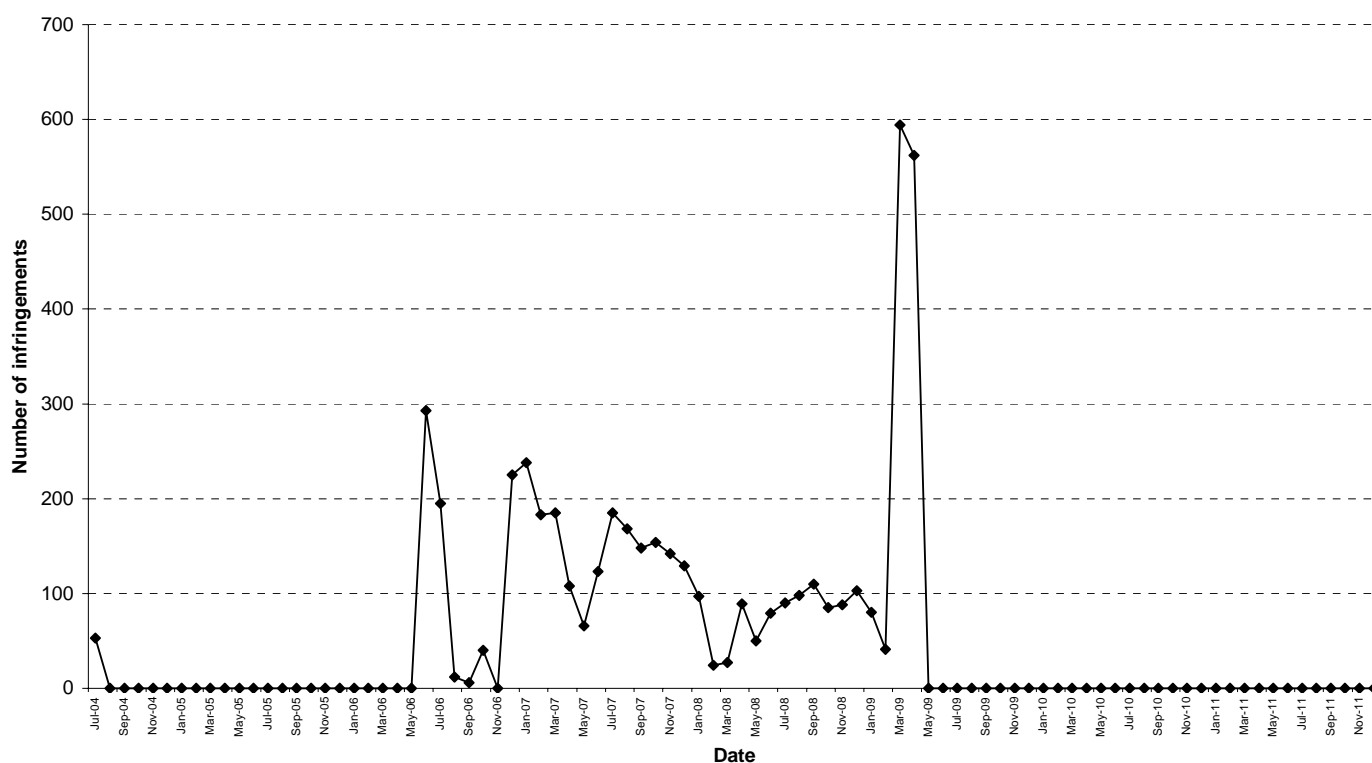
COWPASTURE ROAD GREEN VALLEY

## Infringements at fixed speed camera location

The fixed speed camera on Cowpasture Road, Green Valley was installed in May 2000. There is one camera installed at this location.

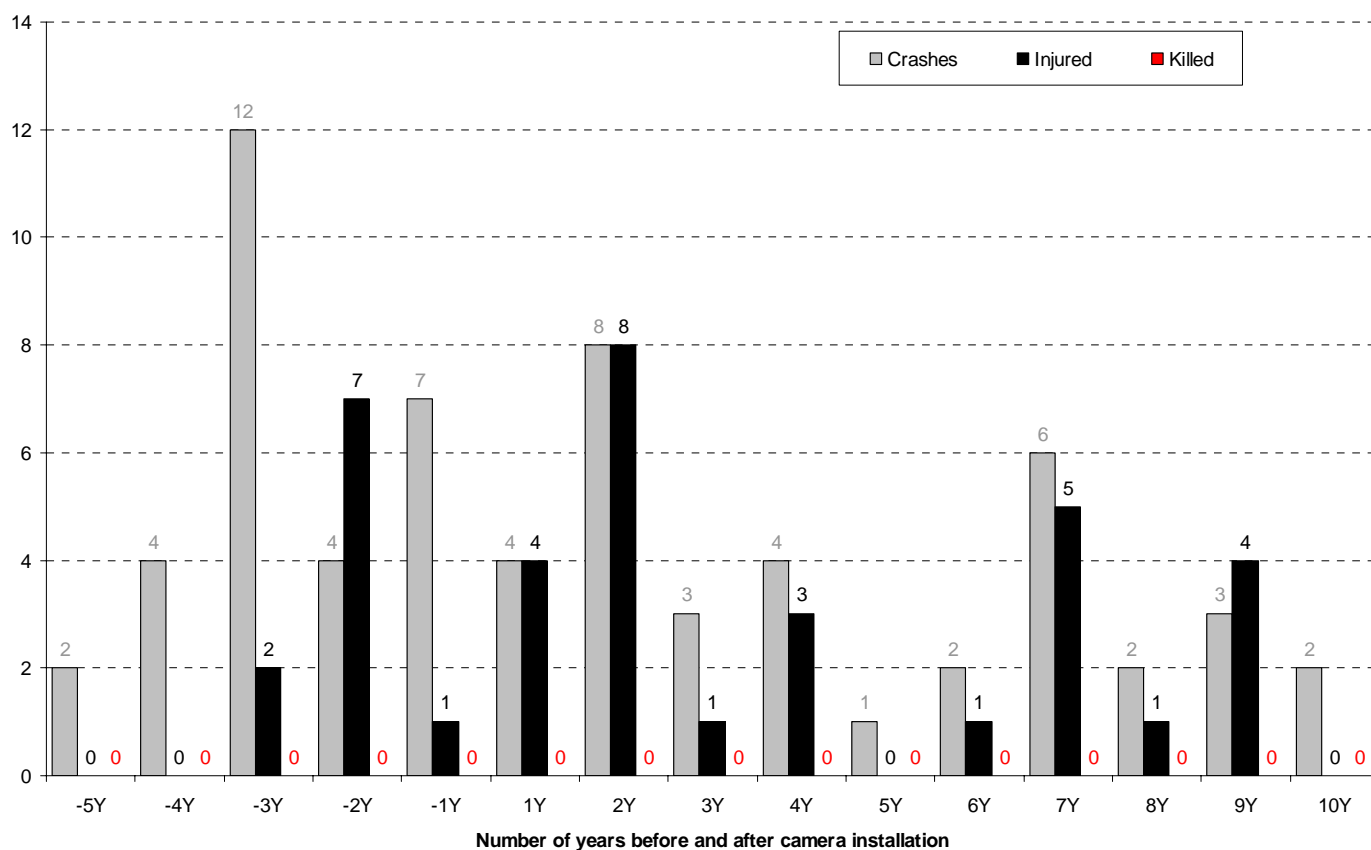
### Crashes at fixed speed camera location

Five years before – Aug 1996 to Aug 2001 - Totals				
Fatality Persons	Injury Persons	Casualty Persons	Crashes	Casualty Cost
0	15	15	29	1.71
After (most recent five year period) – 2006 to 2011 - Totals				
Fatality Persons	Injury Persons	Casualty Persons	Crashes	Casualty Cost
0	11	11	15	1.254

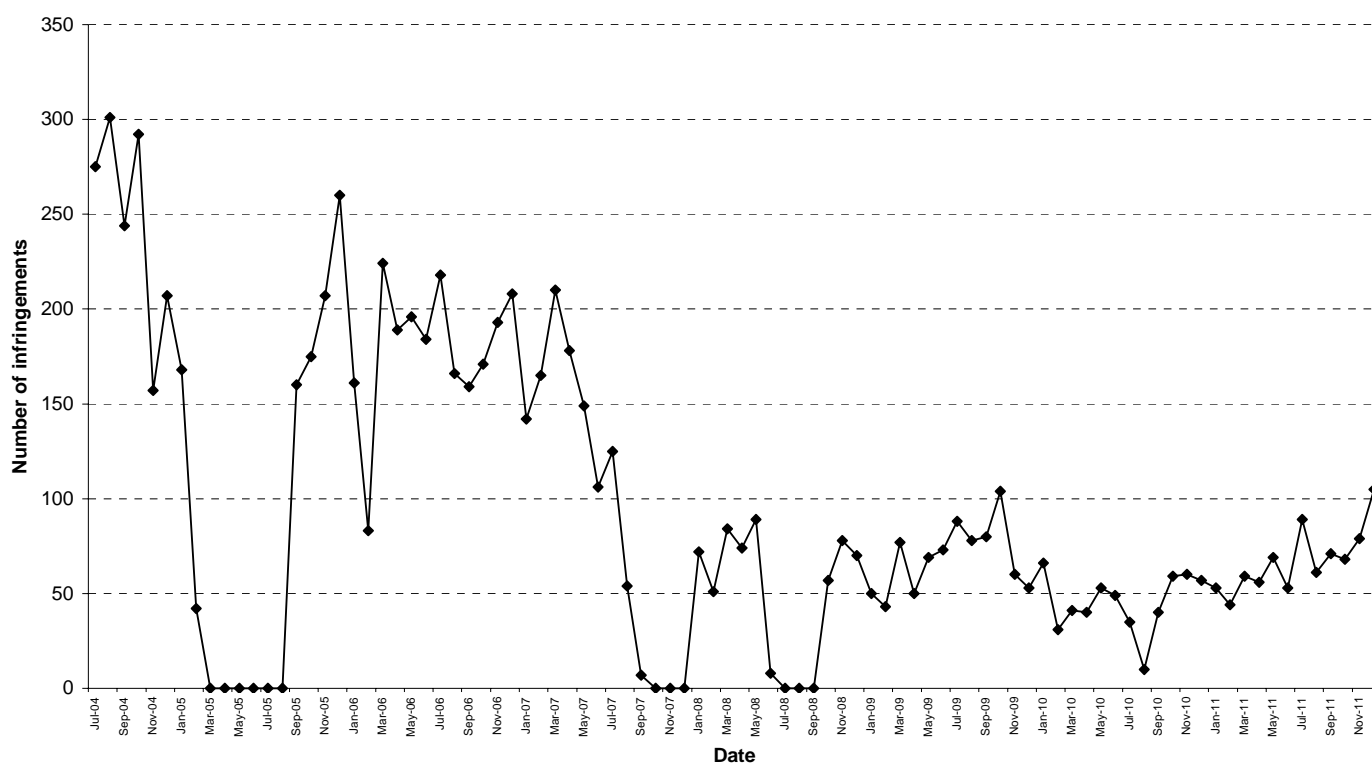
GREYSTANES ROAD GREYSTANES

## Infringements at fixed speed camera location

The fixed speed camera on Greystanes Road, Greystanes was installed in November 2001. There is one camera installed at this location.

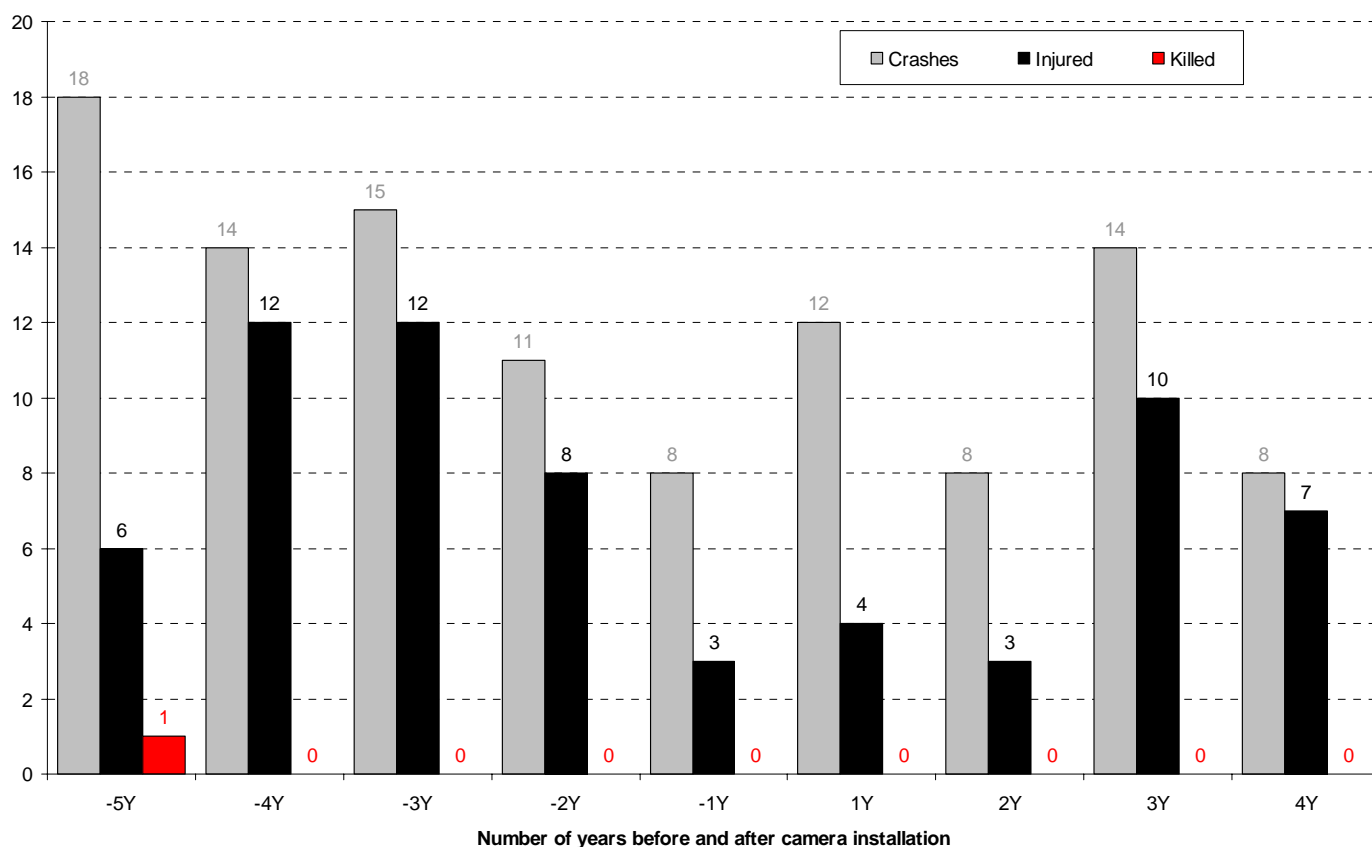
### Crashes at fixed speed camera location

Five years before – Feb 2002 to Feb 2007 - Totals				
Fatality Persons	Injury Persons	Casualty Persons	Crashes	Casualty Cost
1	41	42	66	10.508
After (most recent four year period) – 2007 to 2011 - Totals				
Fatality Persons	Injury Persons	Casualty Persons	Crashes	Casualty Cost
0	24	24	42	2.736

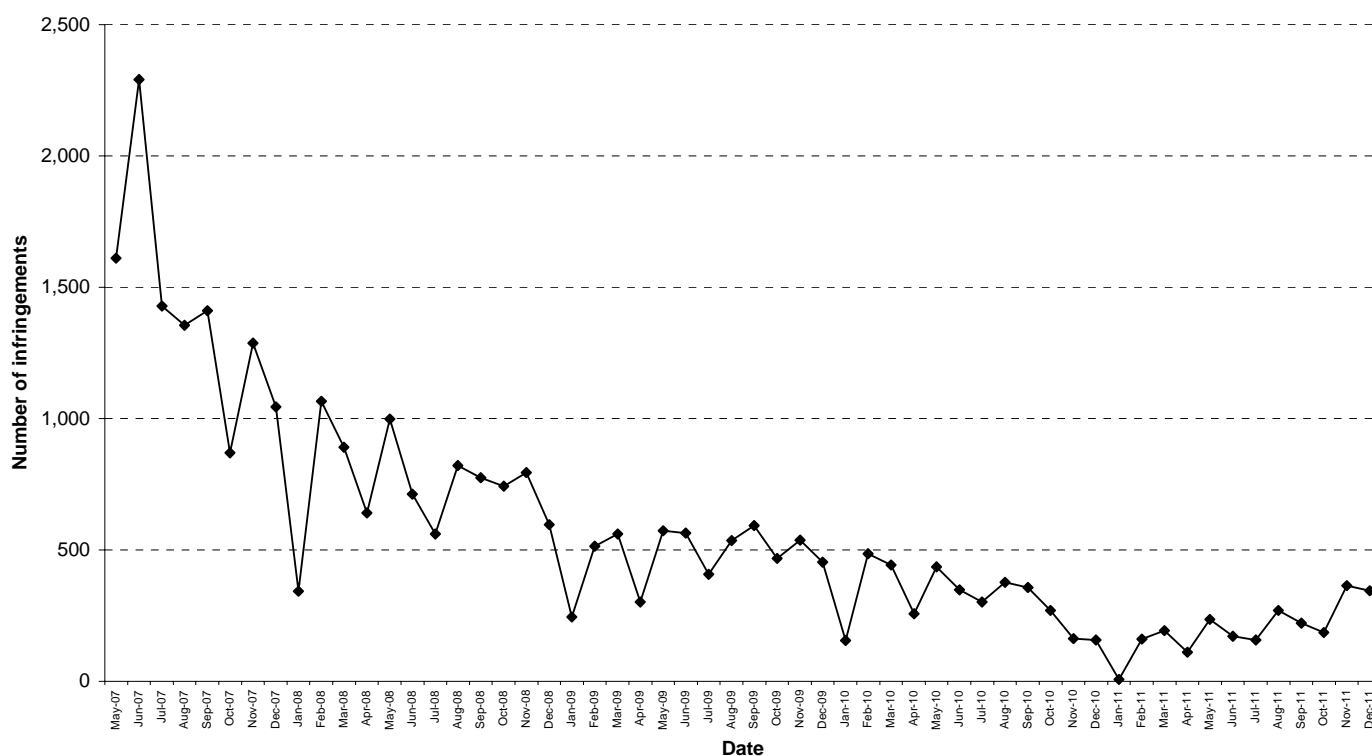
WOODVILLE ROAD GUILDFORD

## Infringements at fixed speed camera location

The school zone fixed speed cameras on Woodville Road, Guildford were installed in May 2007. There are two cameras installed at this location.

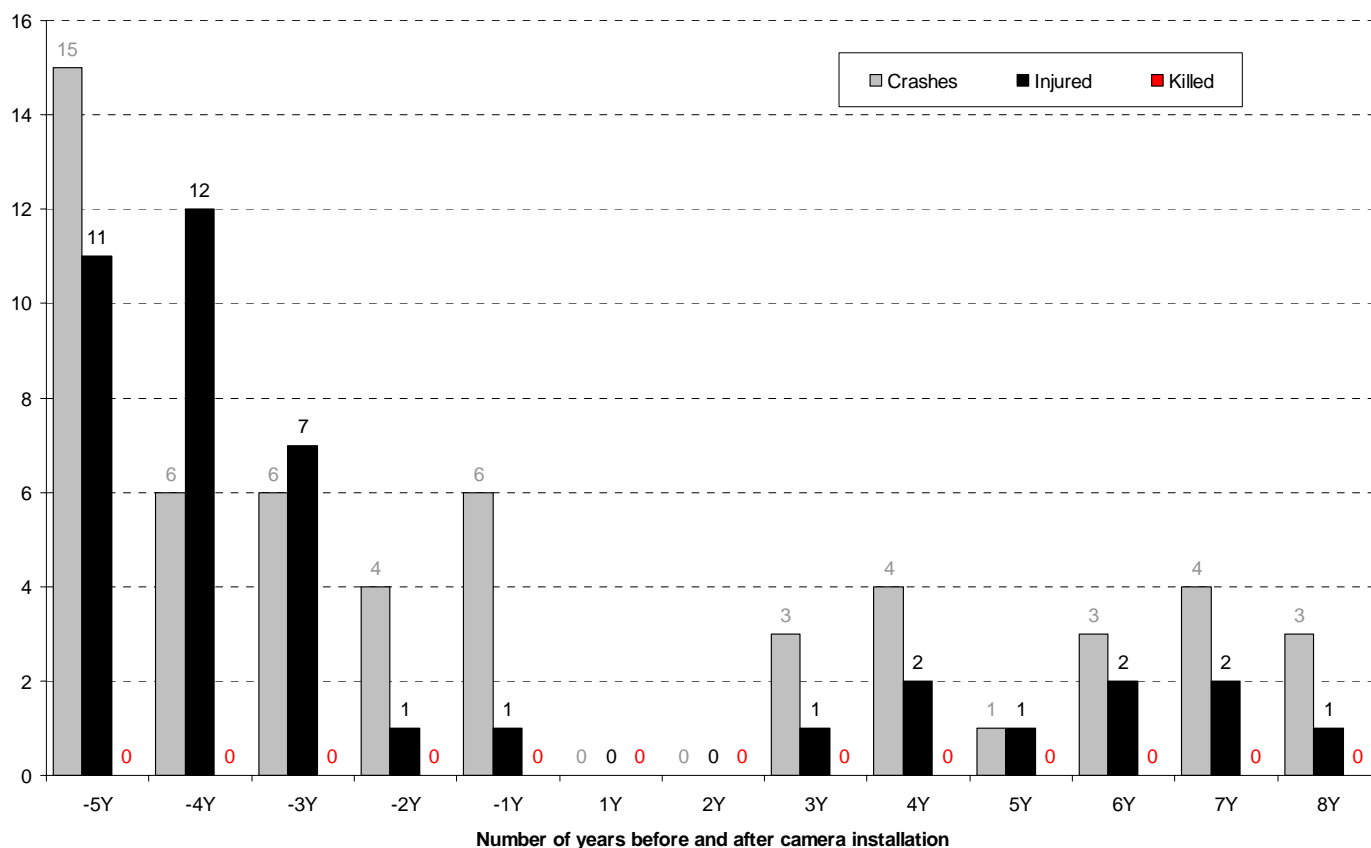
### Crashes at fixed speed camera location

Five years before – May 1998 to May 2003 - Totals				
Fatality Persons	Injury Persons	Casualty Persons	Crashes	Casualty Cost
0	32	32	37	3,648
After (most recent five year period) – 2006 to 2011 - Totals				
Fatality Persons	Injury Persons	Casualty Persons	Crashes	Casualty Cost
0	8	8	15	0.912

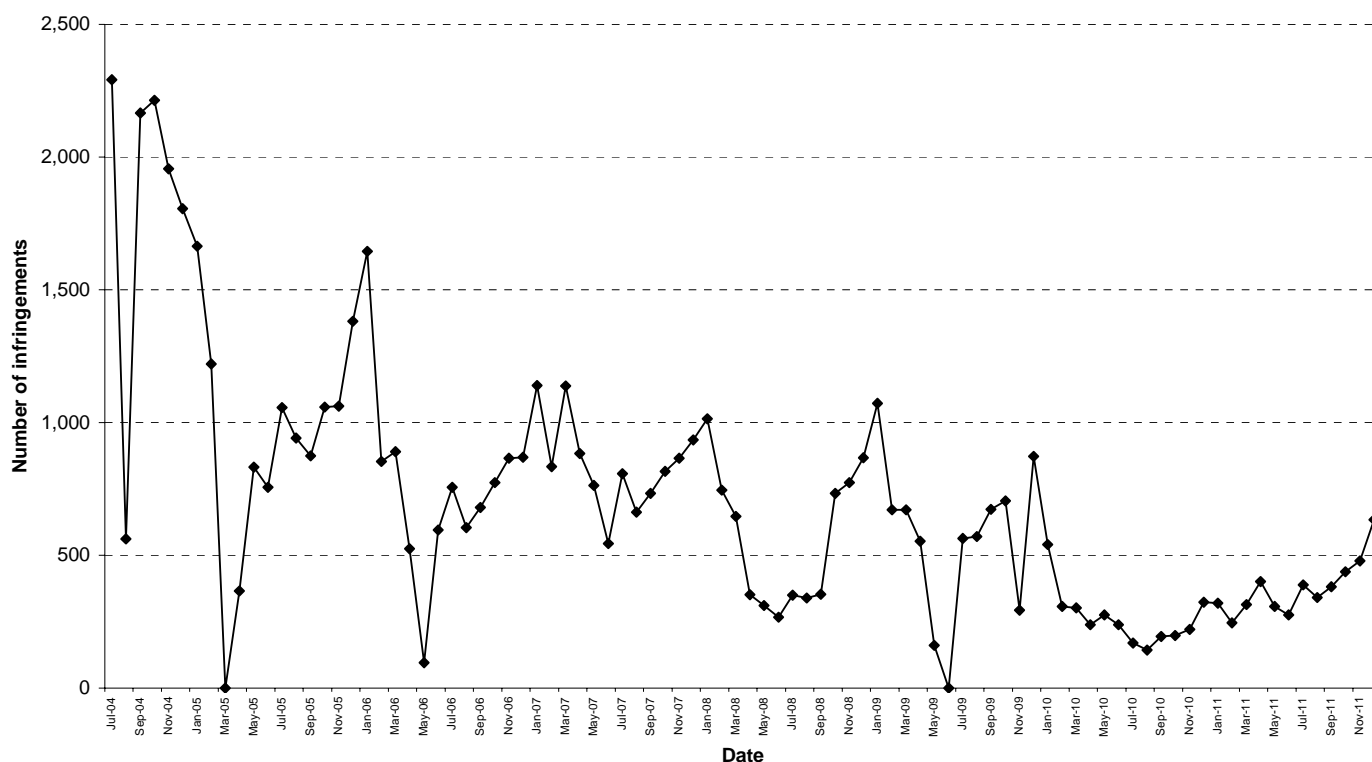
F6 SOUTHERN FREEWAY GWYNNEVILLE NORTHBOUND

## Infringements at fixed speed camera location

The fixed speed camera on the Southern Freeway, Gwynneville (northbound) was installed in August 2003. There is one camera installed at this location.

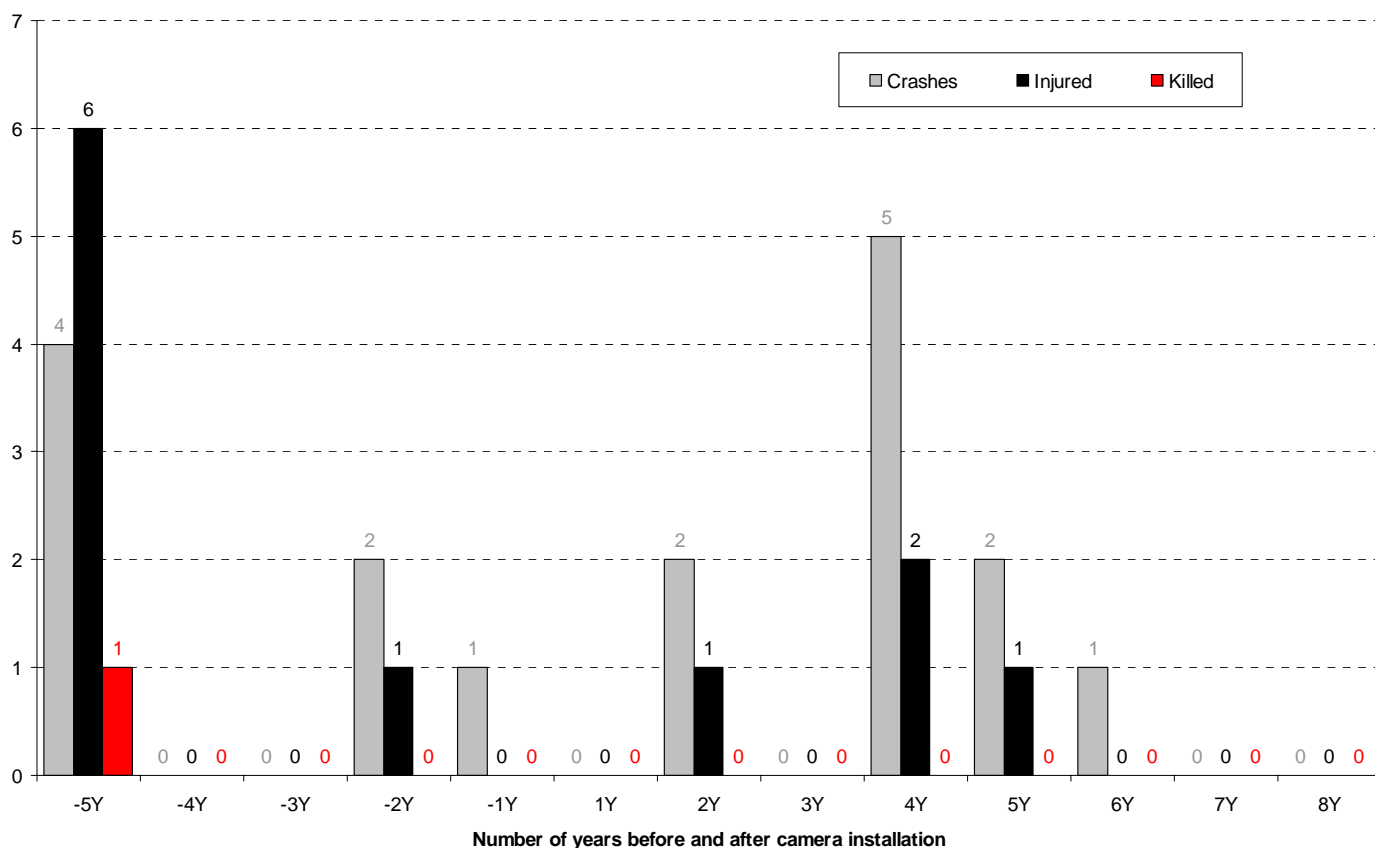
### Crashes at fixed speed camera location

Five years before – May 1998 to May 2003 - Totals				
Fatality Persons	Injury Persons	Casualty Persons	Crashes	Casualty Cost
1	7	8	7	6.632
After (most recent five year period) – 2006 to 2011 - Totals				
Fatality Persons	Injury Persons	Casualty Persons	Crashes	Casualty Cost
0	3	3	8	0.342

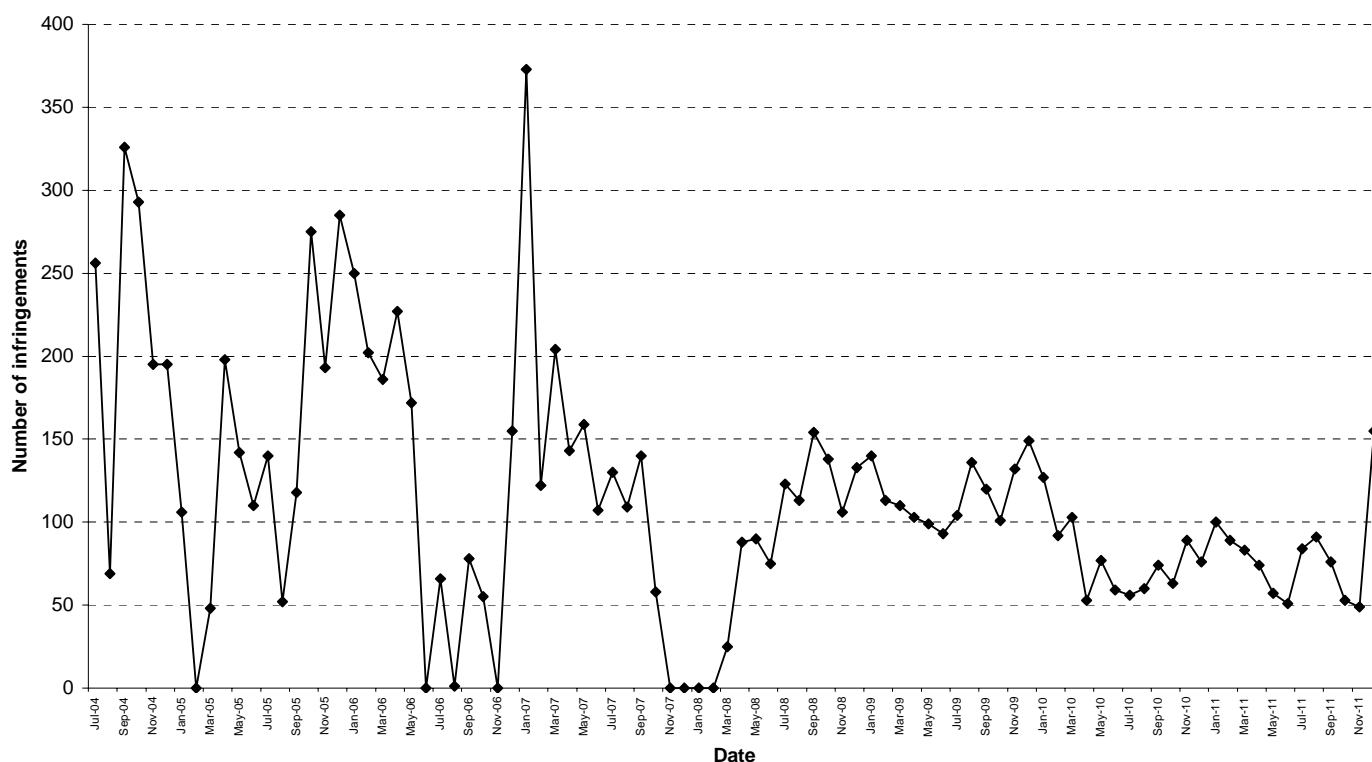
F6 SOUTHERN FREEWAY GWYNNEVILLE SOUTHBOUND

## Infringements at fixed speed camera location

The fixed speed camera on the Southern Freeway, Gwynneville (southbound) was installed in August 2003. There is one camera installed at this location.

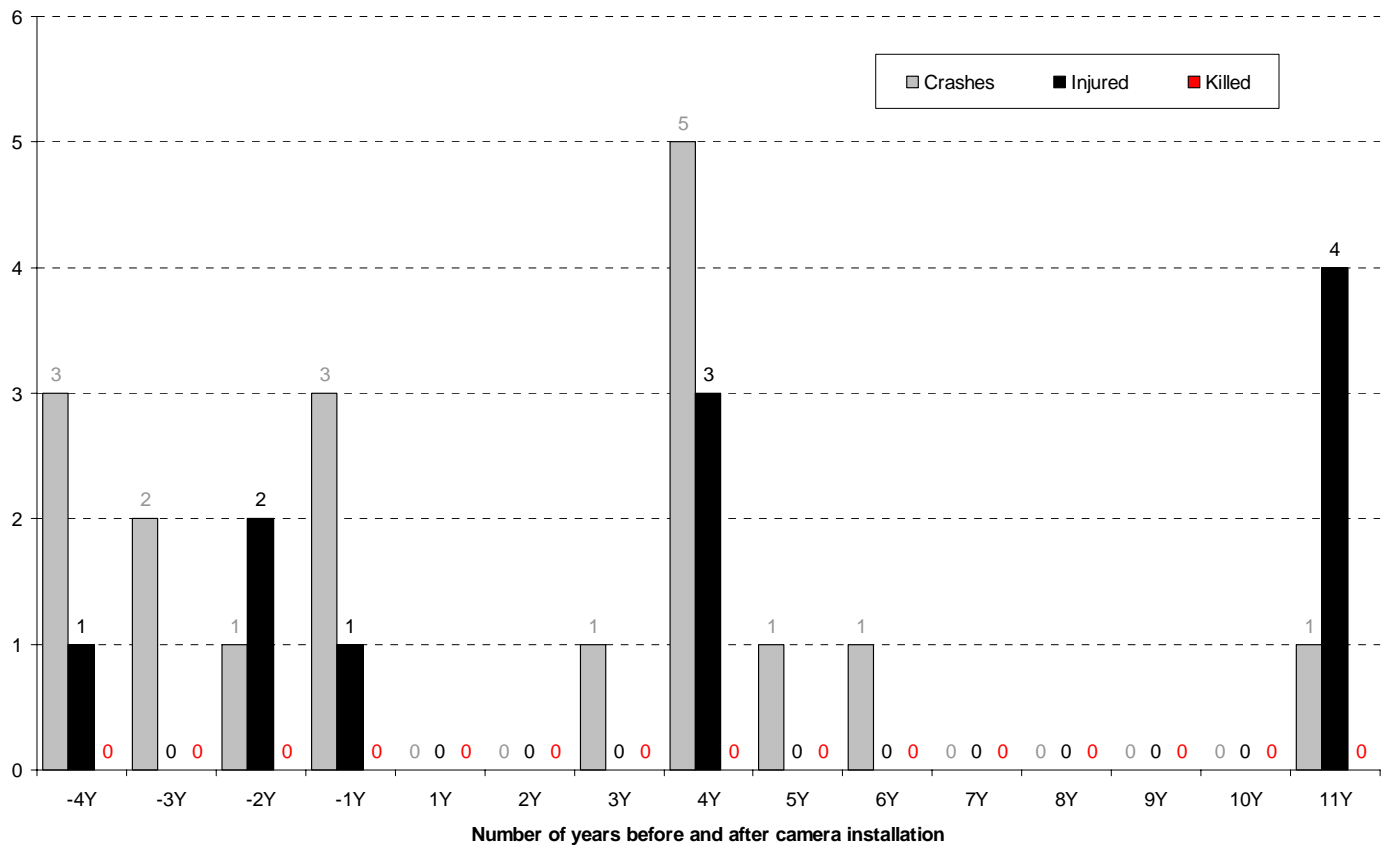
### Crashes at fixed speed camera location

Four years before – Sep 1996 to Sep 2000 (no data available for 1995) - Totals				
Fatality Persons	Injury Persons	Casualty Persons	Crashes	Casualty Cost
0	4	4	9	0.456
After (most recent five year period) – 2006 to 2011 - Totals				
Fatality Persons	Injury Persons	Casualty Persons	Crashes	Casualty Cost
0	4	4	1	0.456

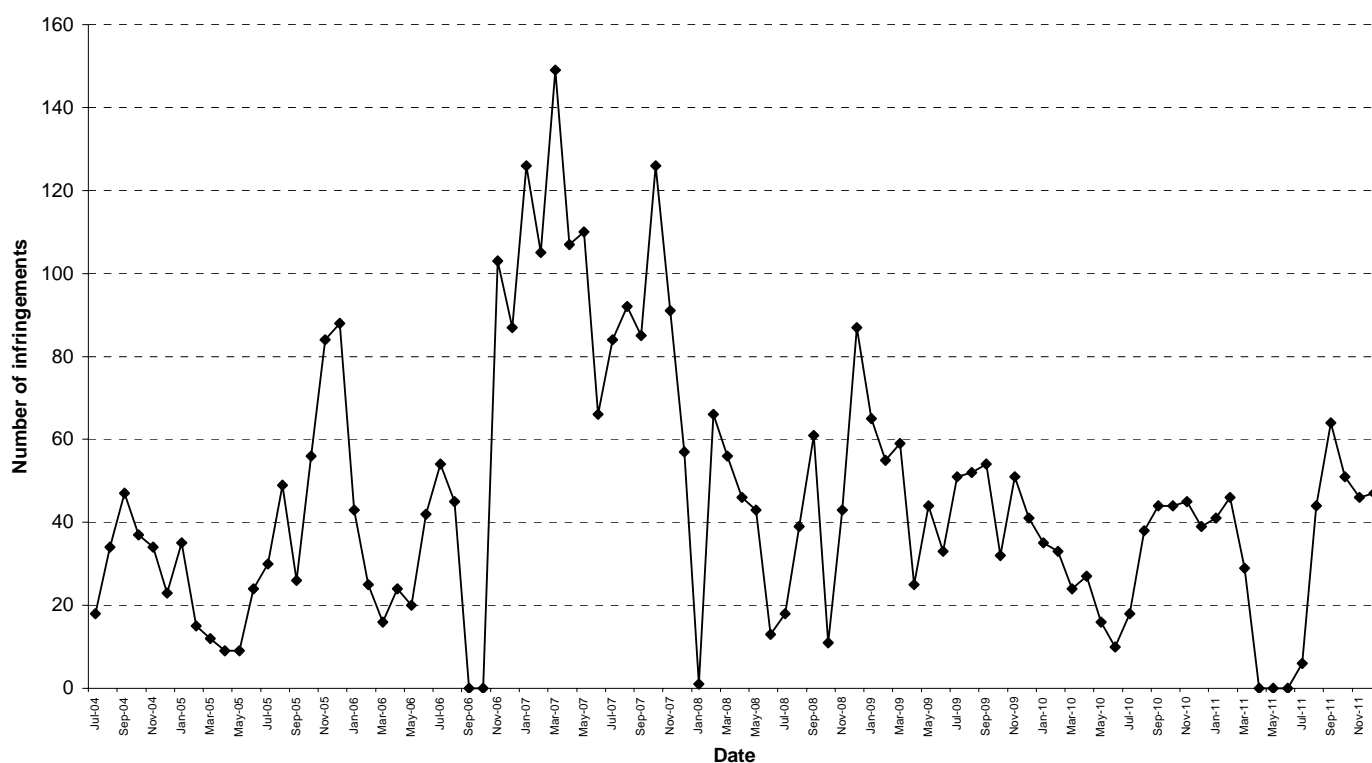
GREAT WESTERN HIGHWAY HARTLEY

## Infringements at fixed speed camera location

The fixed speed camera on the Great Western Highway, Hartley was installed in December 2000. There is one camera installed at this location.

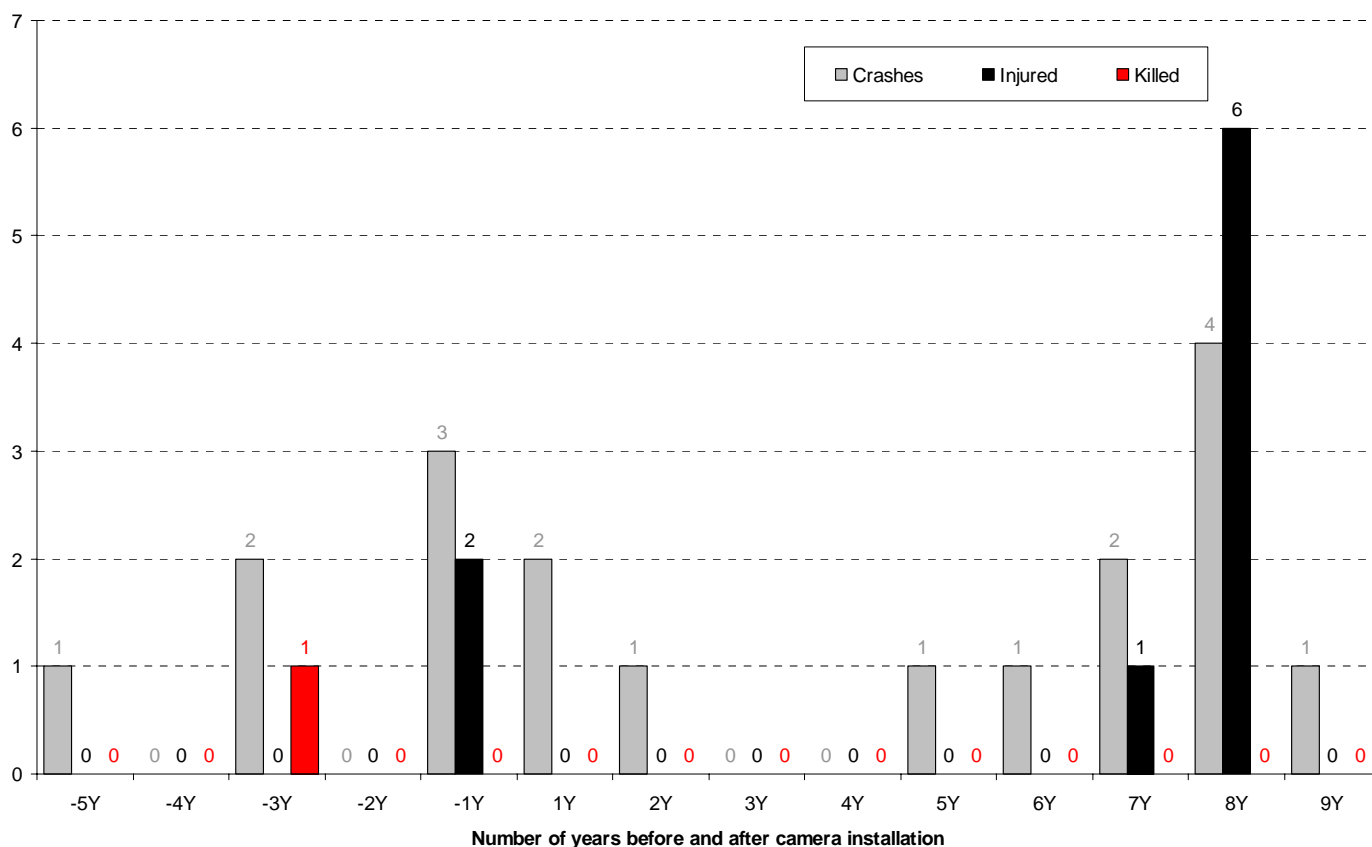
### Crashes at fixed speed camera location

Five years before – Aug 1997 to Aug 2002 - Totals				
Fatality Persons	Injury Persons	Casualty Persons	Crashes	Casualty Cost
1	2	3	6	6.062
After (most recent five year period) – 2006 to 2011 - Totals				
Fatality Persons	Injury Persons	Casualty Persons	Crashes	Casualty Cost
0	7	7	9	0.798

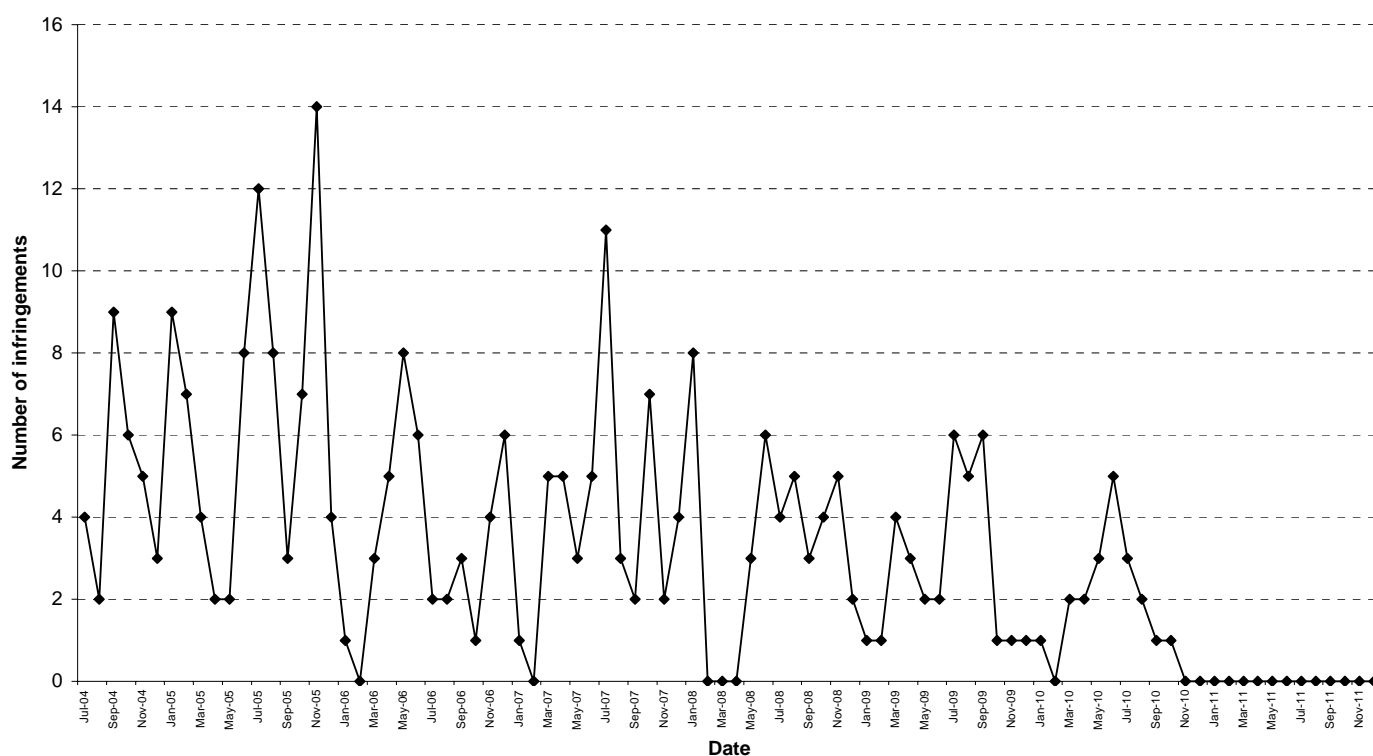
### PACIFIC HIGHWAY HUNGRY HEAD

## Infringements at fixed speed camera location

The fixed speed camera on the Pacific Highway, Hungry Head was installed in November 2002. There is one camera installed at this location.

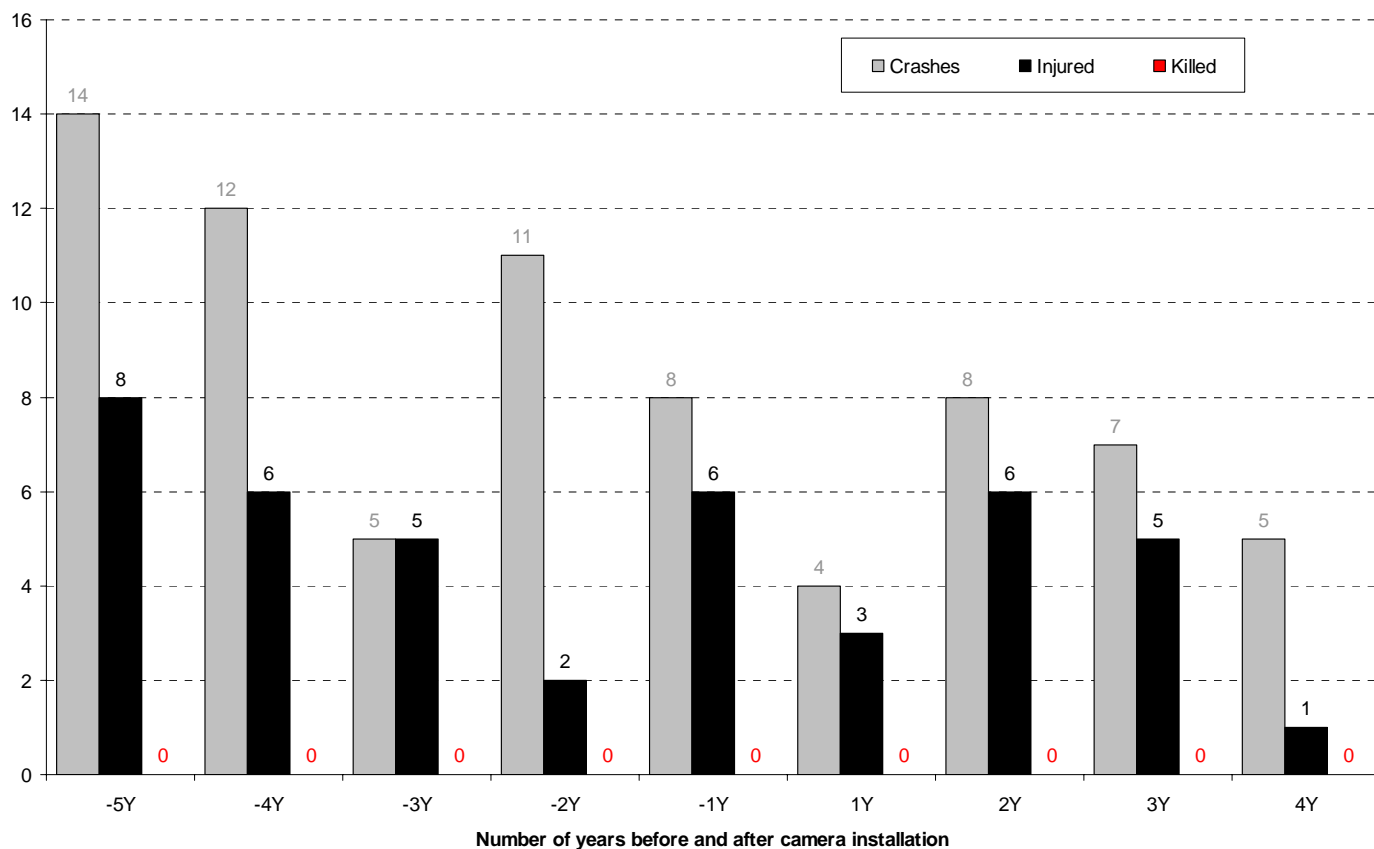
### Crashes at fixed speed camera location

Five years before – Jul 2002 to Jul 2007 - Totals				
Fatality Persons	Injury Persons	Casualty Persons	Crashes	Casualty Cost
0	27	27	50	3.078
After (most recent four year period) – 2007 to 2011 - Totals				
Fatality Persons	Injury Persons	Casualty Persons	Crashes	Casualty Cost
0	15	15	24	1.71

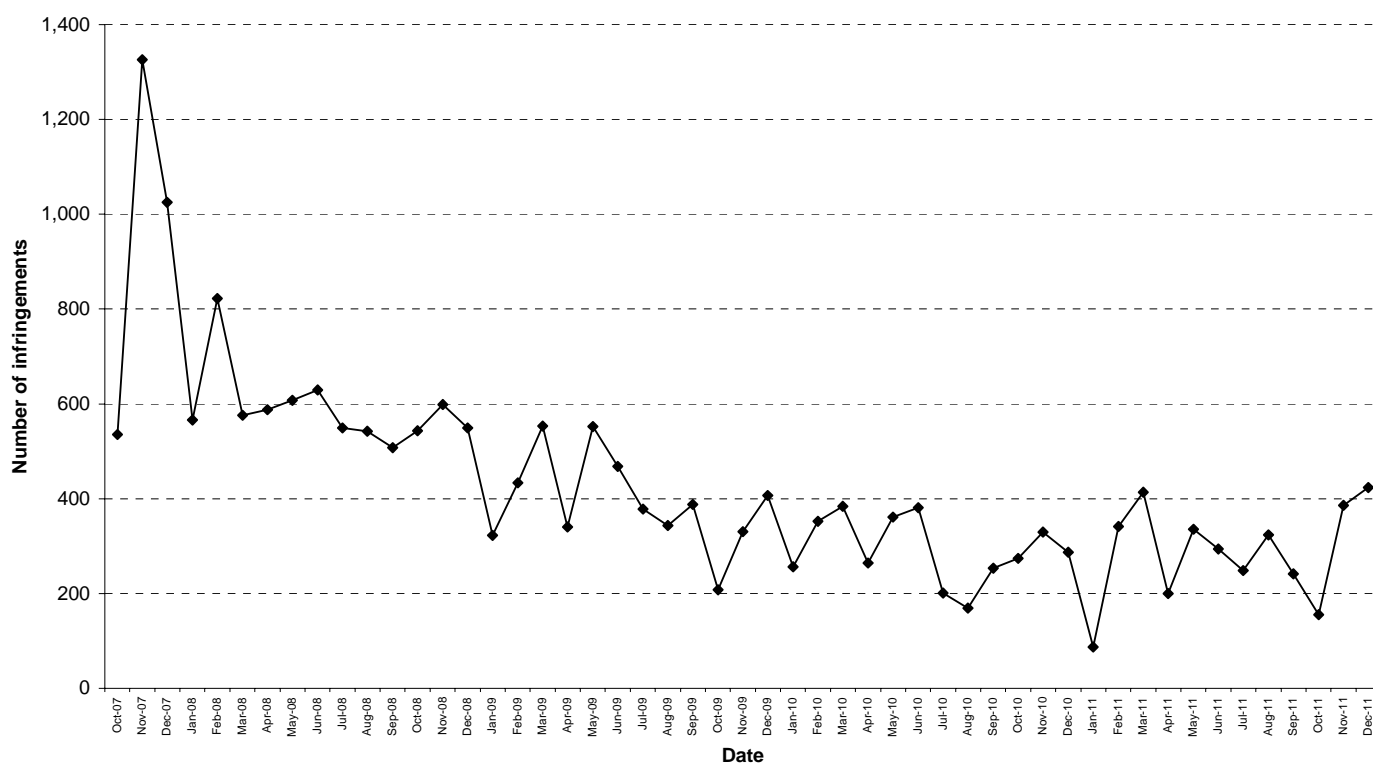
FOREST ROAD HURSTVILLE

## Infringements at fixed speed camera location

The school zone fixed speed camera on Forest Road, Hurstville was installed in October 2007. There is one camera installed at this location.

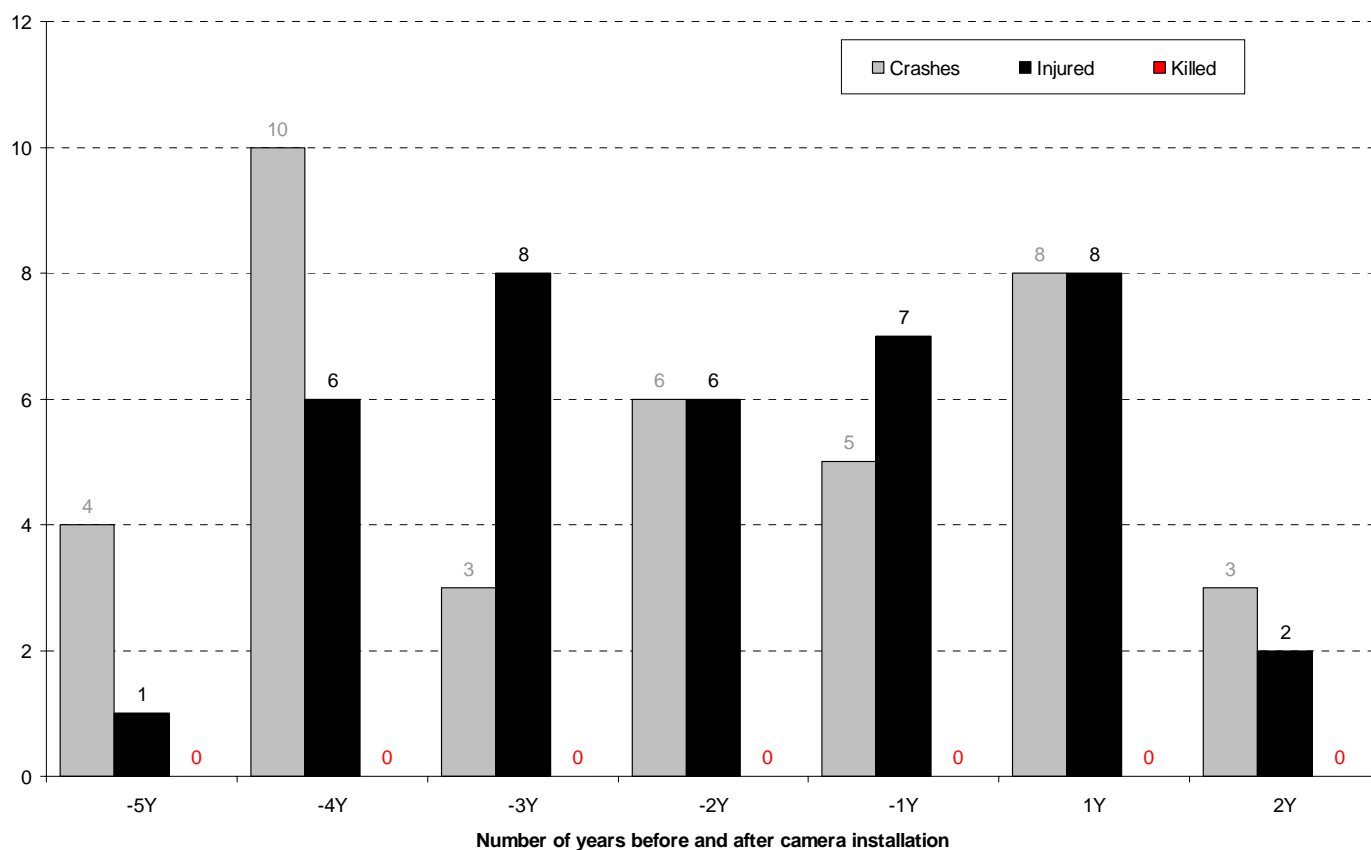
### Crashes at fixed speed camera location

Five years before – Oct 2003 to Oct 2008 - Totals				
Fatality Persons	Injury Persons	Casualty Persons	Crashes	Casualty Cost
0	28	28	28	3.192
After (most recent two year period) – 2009 to 2011 - Totals				
Fatality Persons	Injury Persons	Casualty Persons	Crashes	Casualty Cost
0	10	10	11	1.14

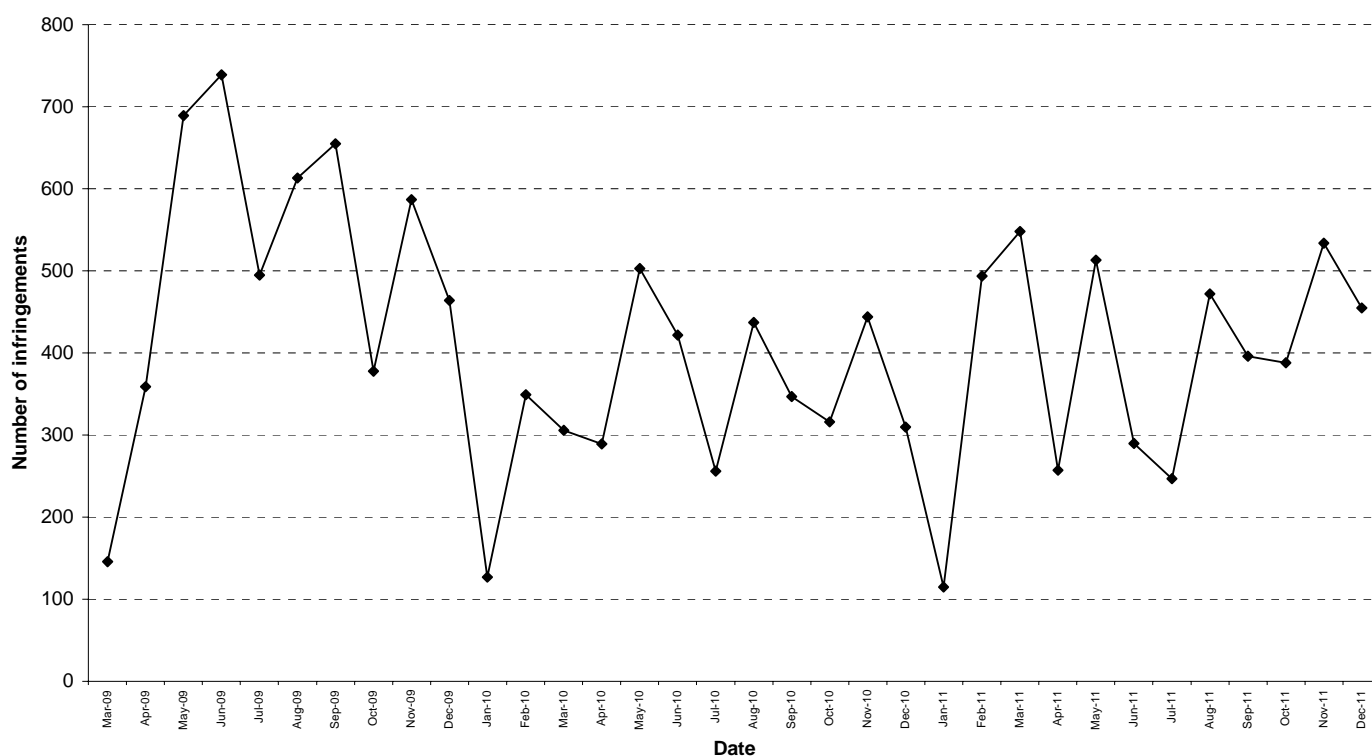
### PARKER STREET KINGSWOOD

## Infringements at fixed speed camera location

The school zone fixed speed cameras at Parker Street, Kingswood were installed in January 2009. There are two cameras installed at this location.

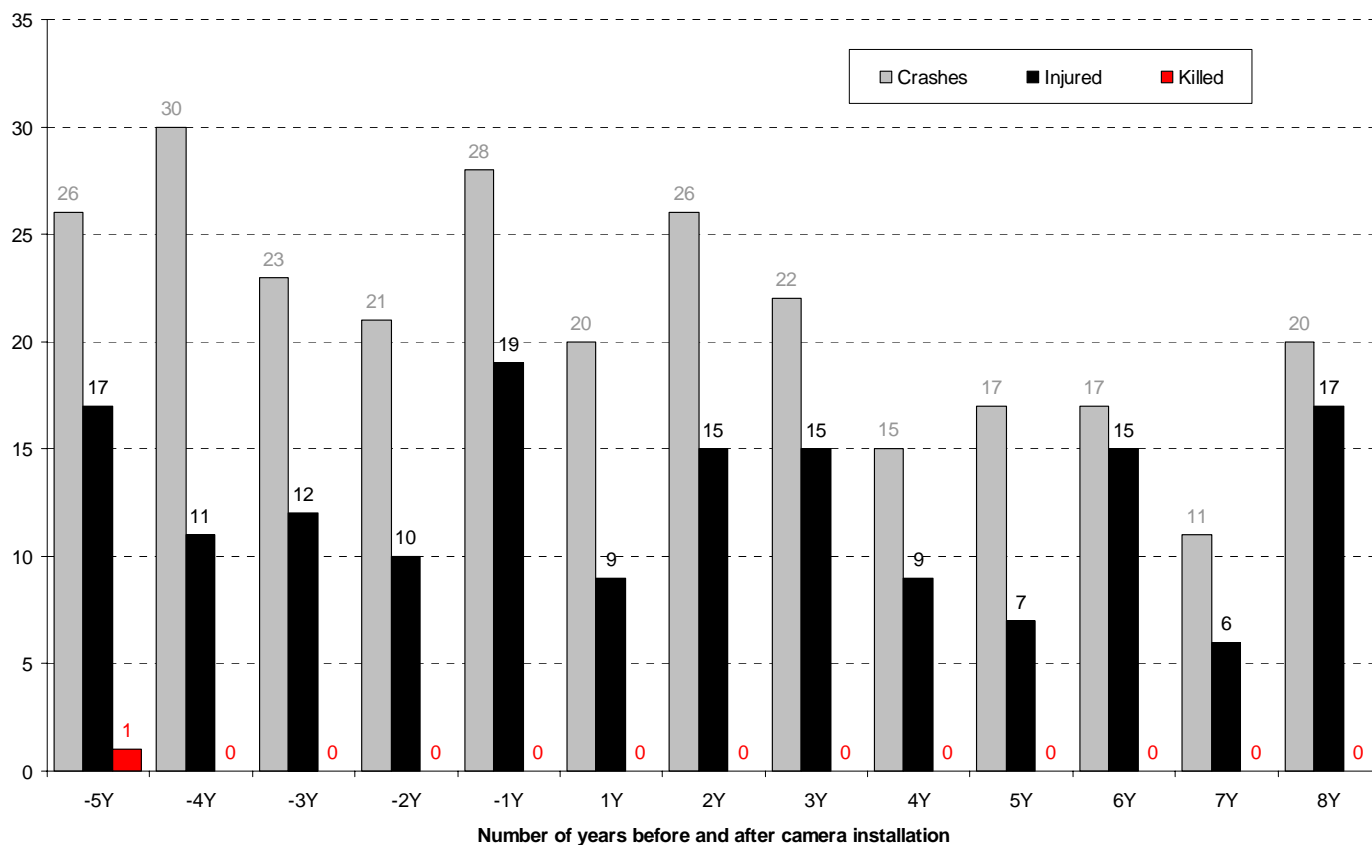
### Crashes at fixed speed camera location

Five years before – Apr 1998 to Apr 2003 - Totals				
Fatality Persons	Injury Persons	Casualty Persons	Crashes	Casualty Cost
1	69	70	128	13.7
After (most recent five year period) – 2006 to 2011 - Totals				
Fatality Persons	Injury Persons	Casualty Persons	Crashes	Casualty Cost
0	54	54	80	6.156
