# ANNUAL NSW SPEED CAMERA PERFORMANCE REVIEW

NSW Centre for Road Safety

JULY 2012

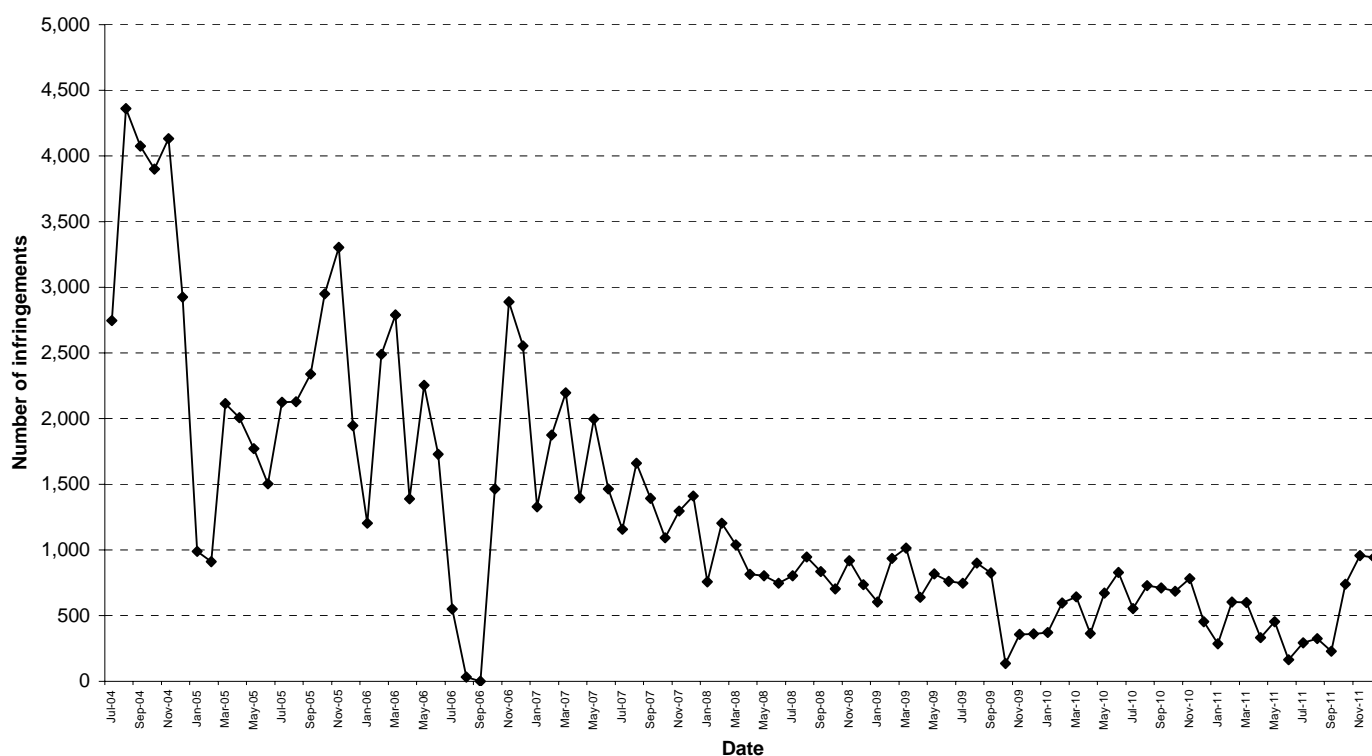
### PRINCES HIGHWAY KOGARAH

## Infringements at fixed speed camera location

The school zone fixed speed cameras on the Princes Highway, Kogarah were installed in July 2003. There are two cameras installed at this location.

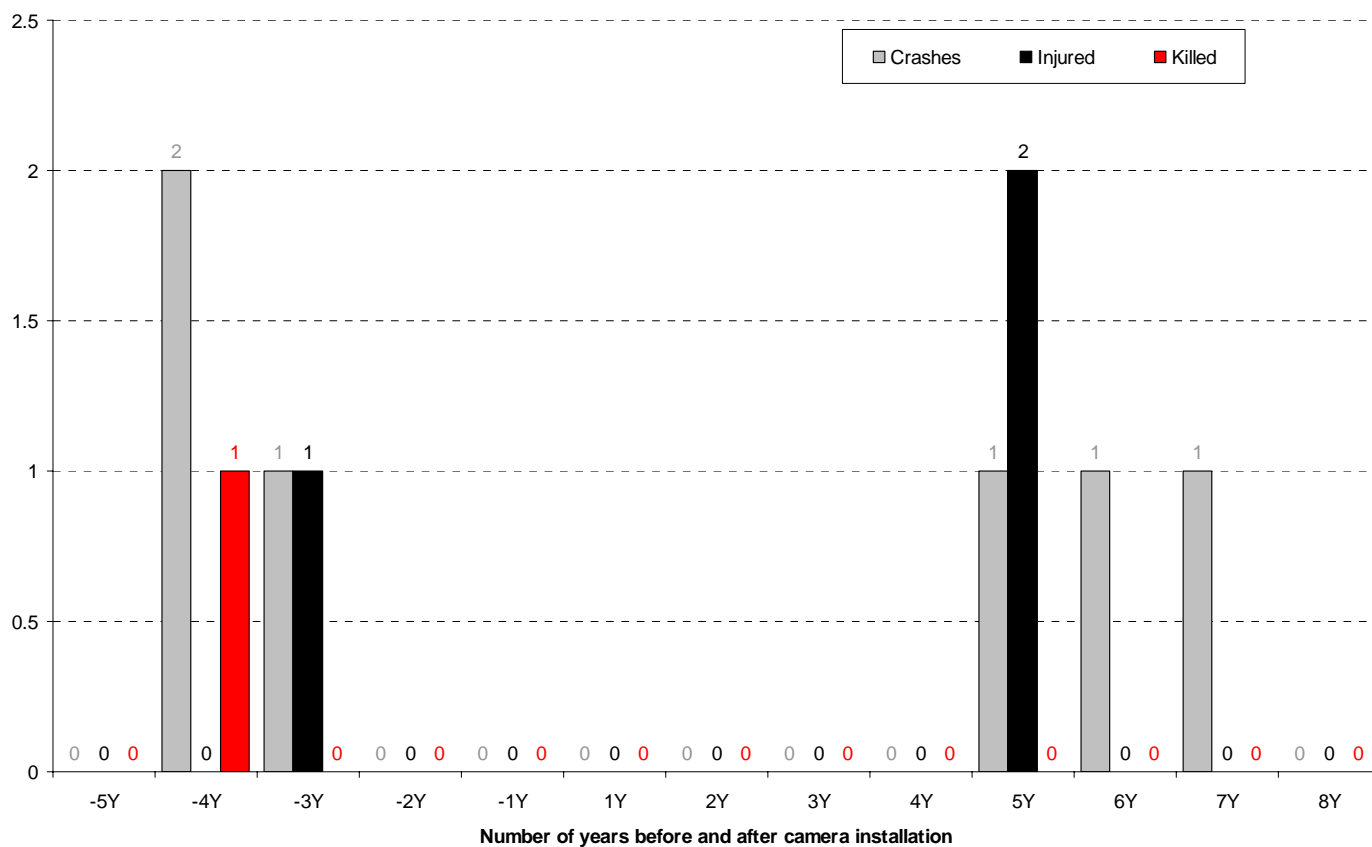
### Crashes at fixed speed camera location

Five years before – Jan 1998 to Jan 2003 - Totals				
Fatality Persons	Injury Persons	Casualty Persons	Crashes	Casualty Cost
1	1	2	3	5.948
After (most recent five year period) – 2006 to 2011 - Totals				
Fatality Persons	Injury Persons	Casualty Persons	Crashes	Casualty Cost
0	2	2	3	0.228

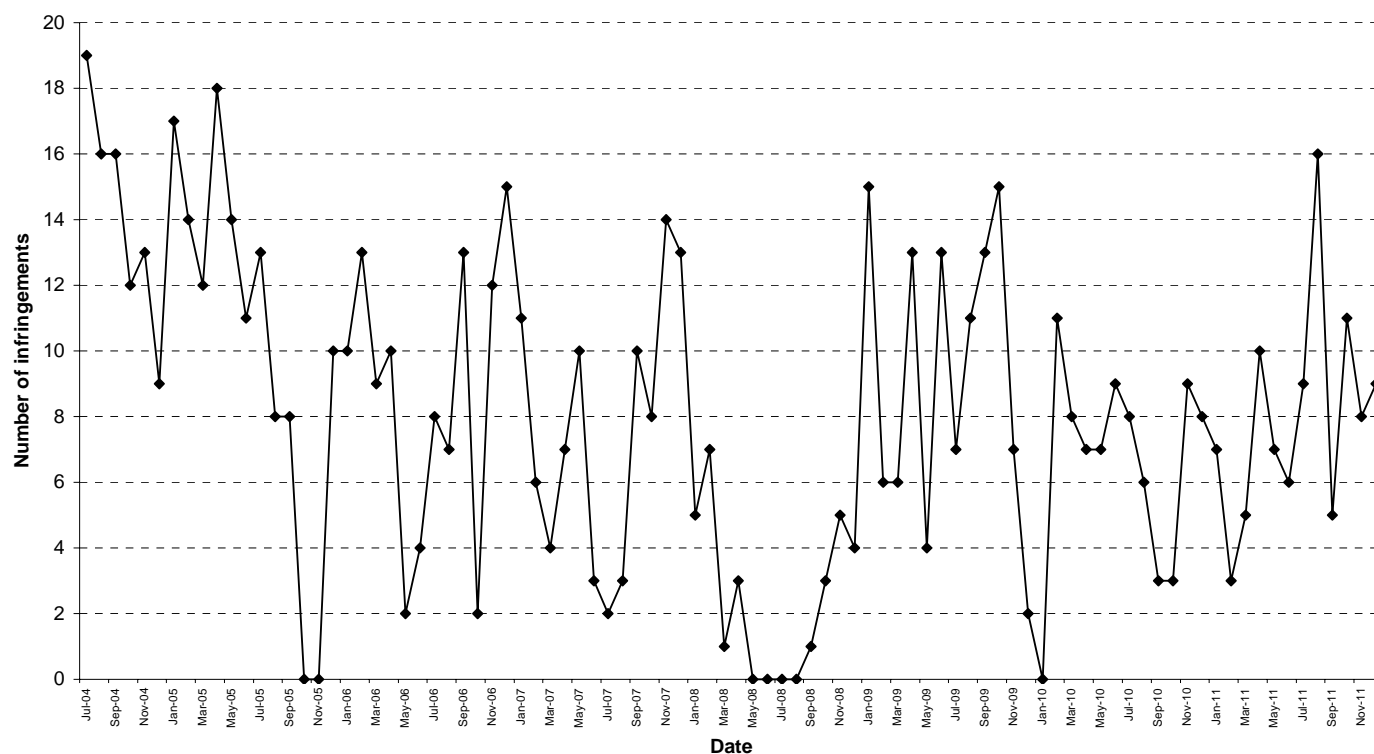
### NEW ENGLAND HIGHWAY KOOTINGAL

## Infringements at fixed speed camera location

The fixed speed camera on the New England Highway, Kootingal was installed in April 2003. There is one camera installed at this location.

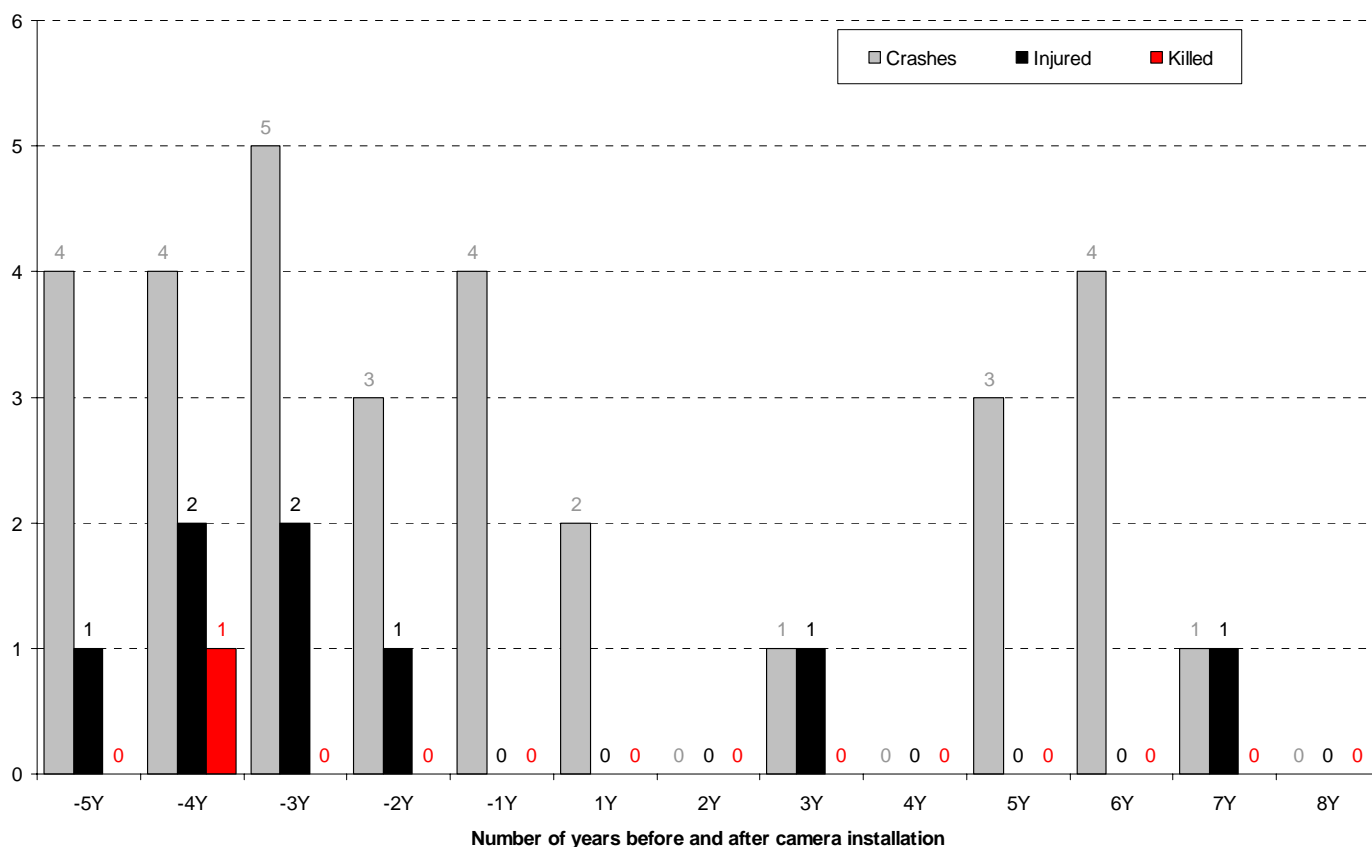
### Crashes at fixed speed camera location

Five years before – Nov 1997 to Nov 2002 - Totals				
Fatality Persons	Injury Persons	Casualty Persons	Crashes	Casualty Cost
1	6	7	20	6.518
After (most recent five year period) – 2006 to 2011 - Totals				
Fatality Persons	Injury Persons	Casualty Persons	Crashes	Casualty Cost
0	1	1	8	0.114

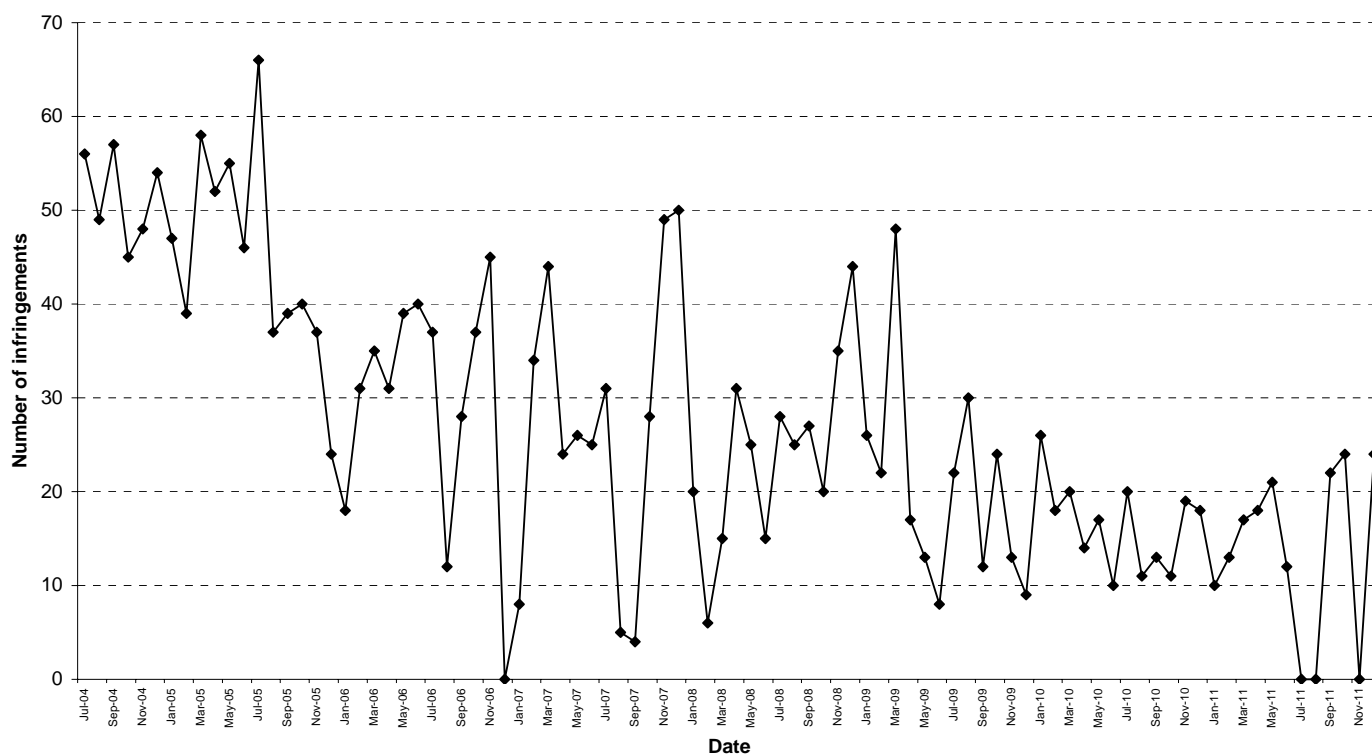
### PACIFIC HIGHWAY KORORA

## Infringements at fixed speed camera location

The fixed speed camera on the Pacific Highway, Korora was installed in February 2003. There is one camera installed at this location.

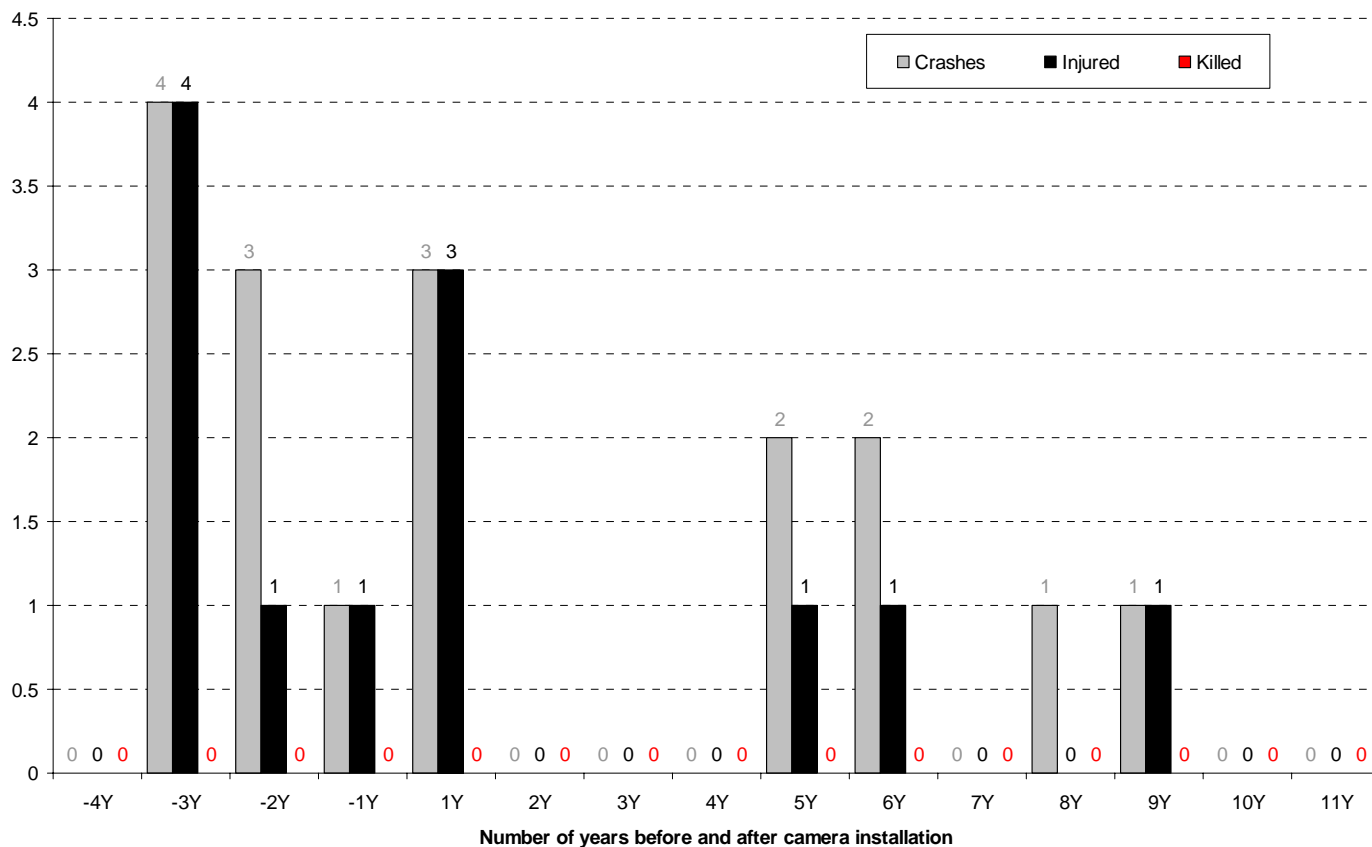
### Crashes at fixed speed camera location

Four years before – Feb 2006 to Feb 2000 (no data available for 1995) - Totals				
Fatality Persons	Injury Persons	Casualty Persons	Crashes	Casualty Cost
0	6	6	8	0.684
After (most recent five year period) – 2006 to 2011 - Totals				
Fatality Persons	Injury Persons	Casualty Persons	Crashes	Casualty Cost
0	1	1	2	0.114

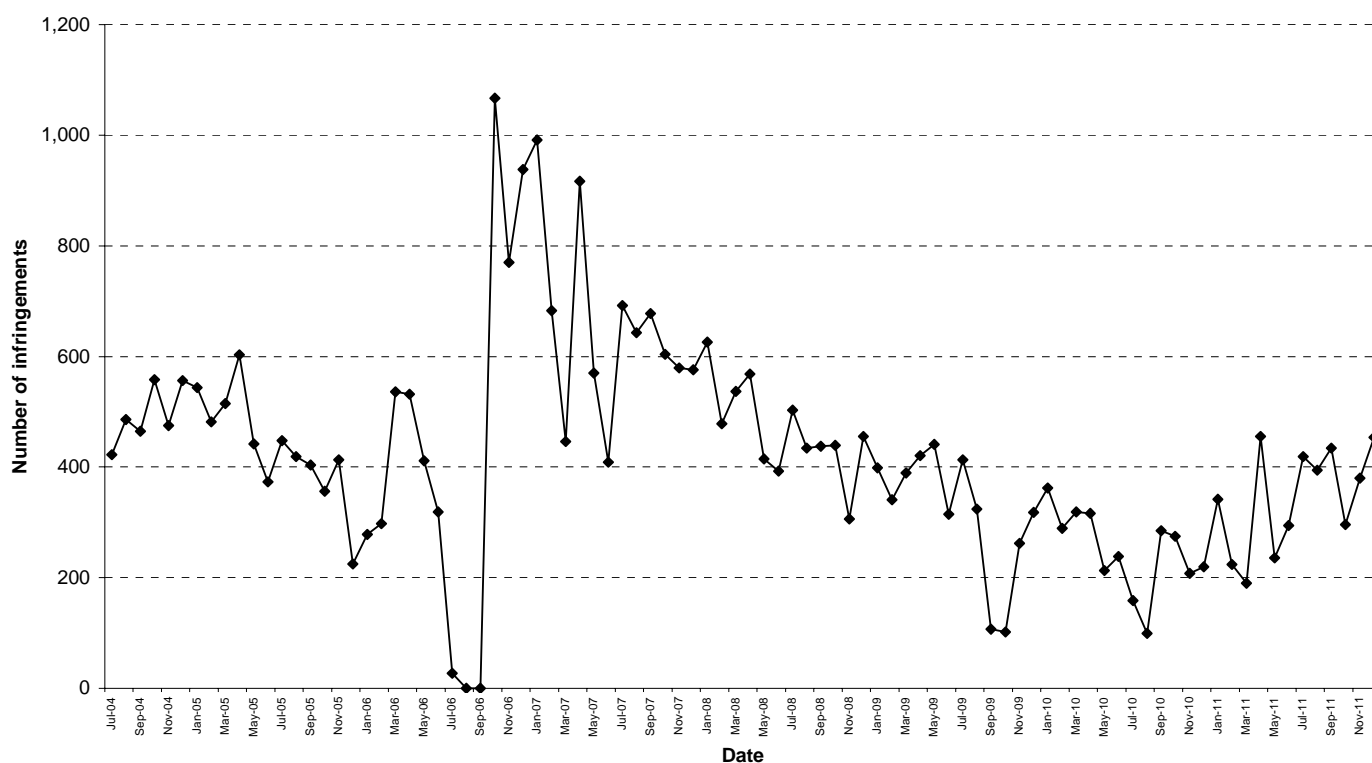
BELLS LINE OF ROAD KURRAJONG

## Infringements at fixed speed camera location

The fixed speed camera on the Bells Line of Road, Kurrajong was installed in May 2000. There is one camera installed at this location.

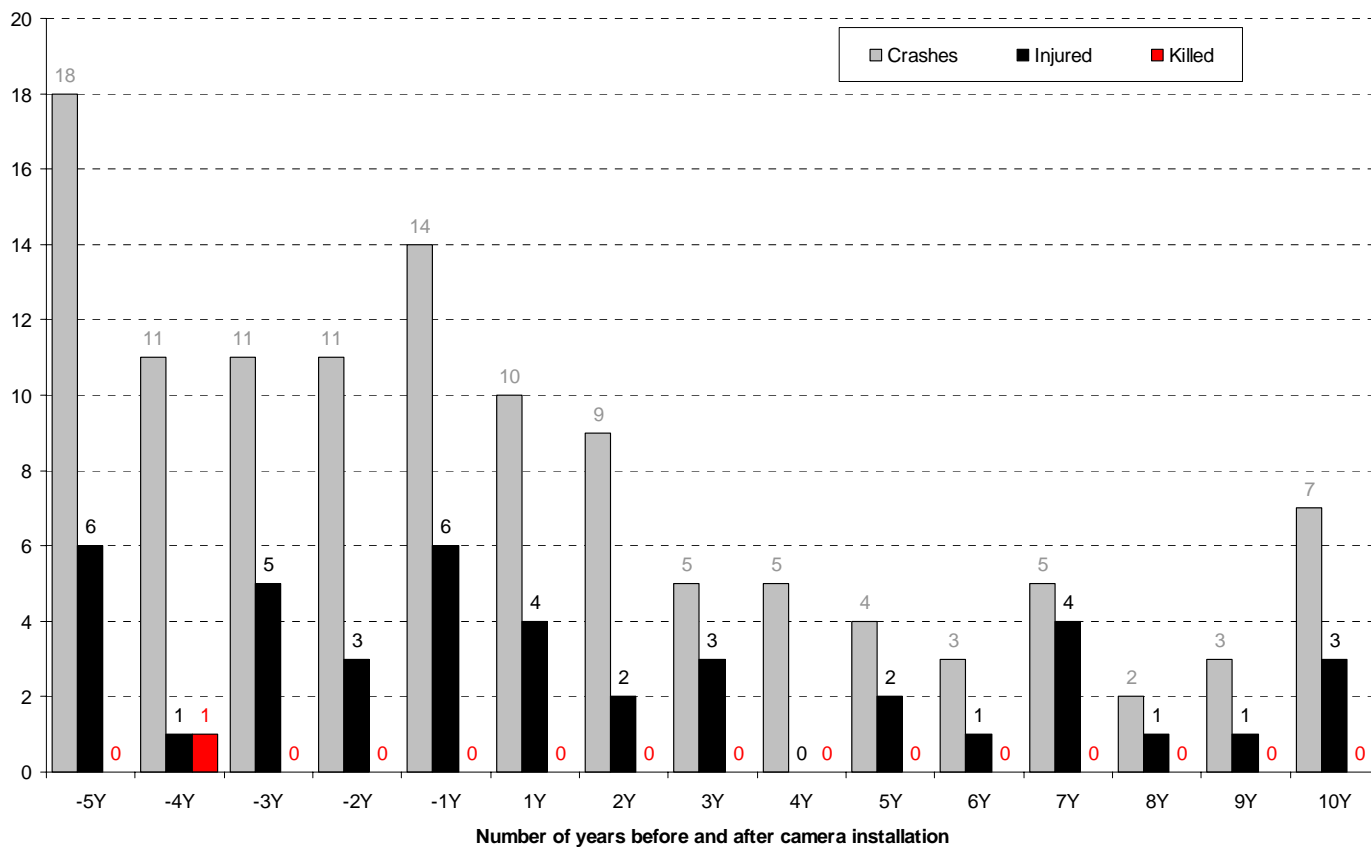
### Crashes at fixed speed camera location

Five years before – September 1996 – September 2001 - Totals				
Fatality Persons	Injury Persons	Casualty Persons	Crashes	Casualty Cost (\$M)
1	21	22	65	8.228
After (most recent five year period) – 2006 to 2011 - Totals				
Fatality Persons	Injury Persons	Casualty Persons	Crashes	Casualty Cost (\$M)
0	10	10	20	1.14

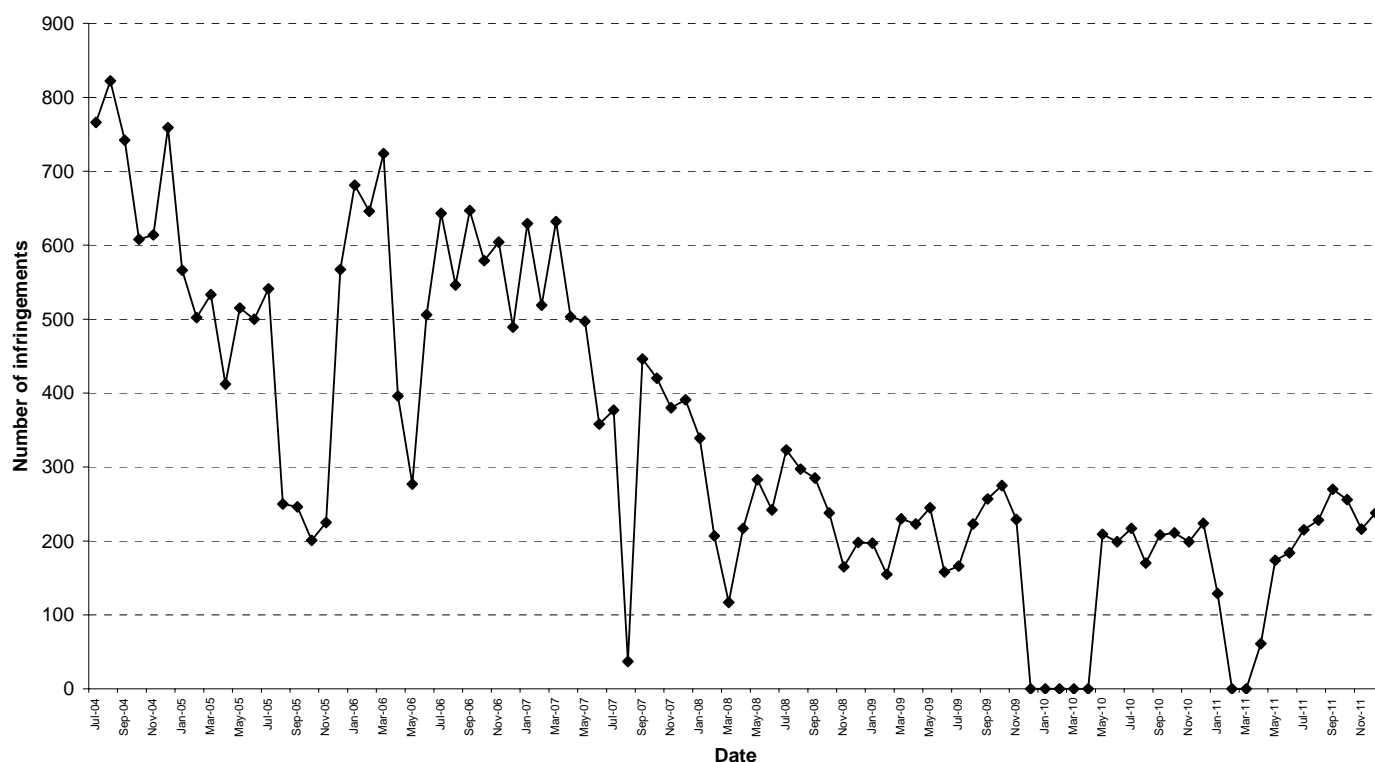
CENTENNIAL AVENUE LANE COVE

## Infringements at fixed speed camera location

The fixed speed camera on Centennial Avenue, Lane Cove was installed in December 2001. There is one speed camera installed at this location.

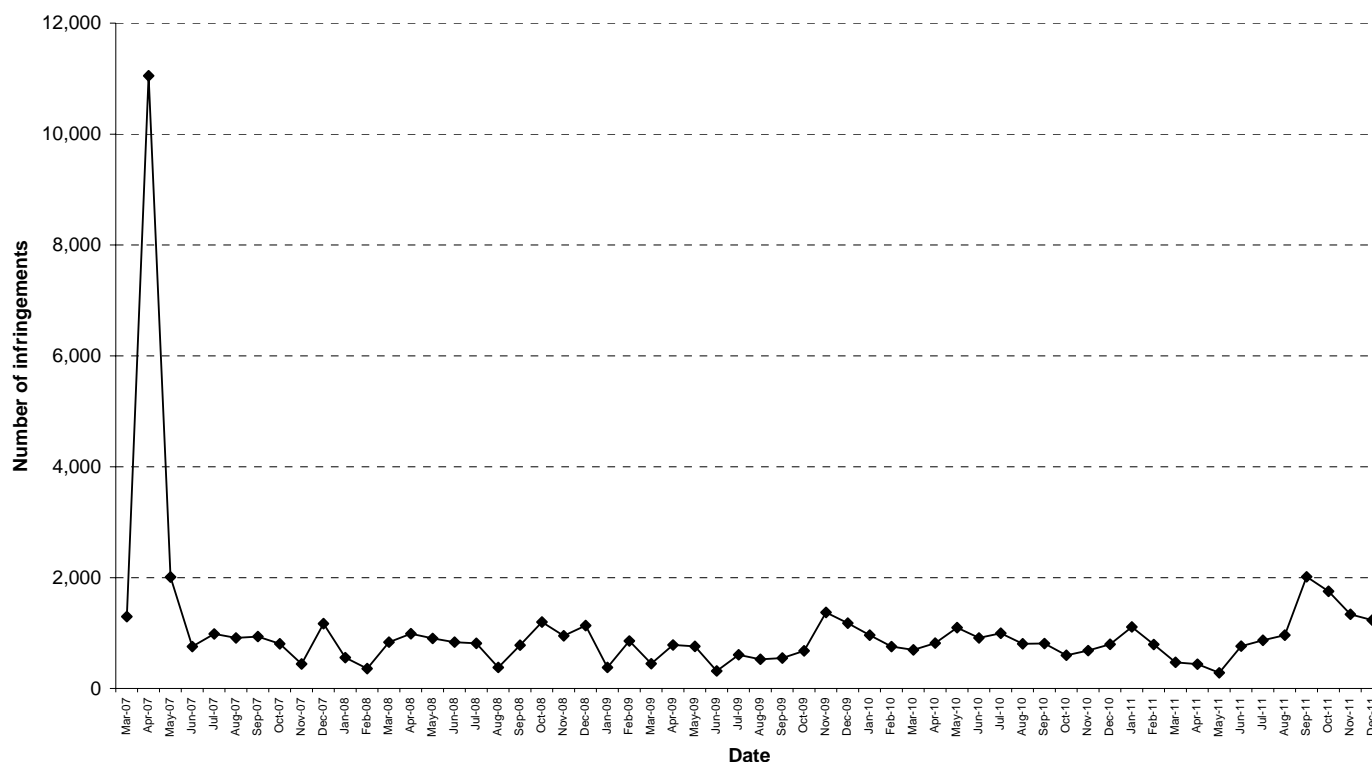
LANE COVE TUNNEL LANE COVE

## Infringements at fixed speed camera location

The fixed speed cameras in the Lane Cove Tunnel were installed in March 2007. There are two speed cameras installed at this location.

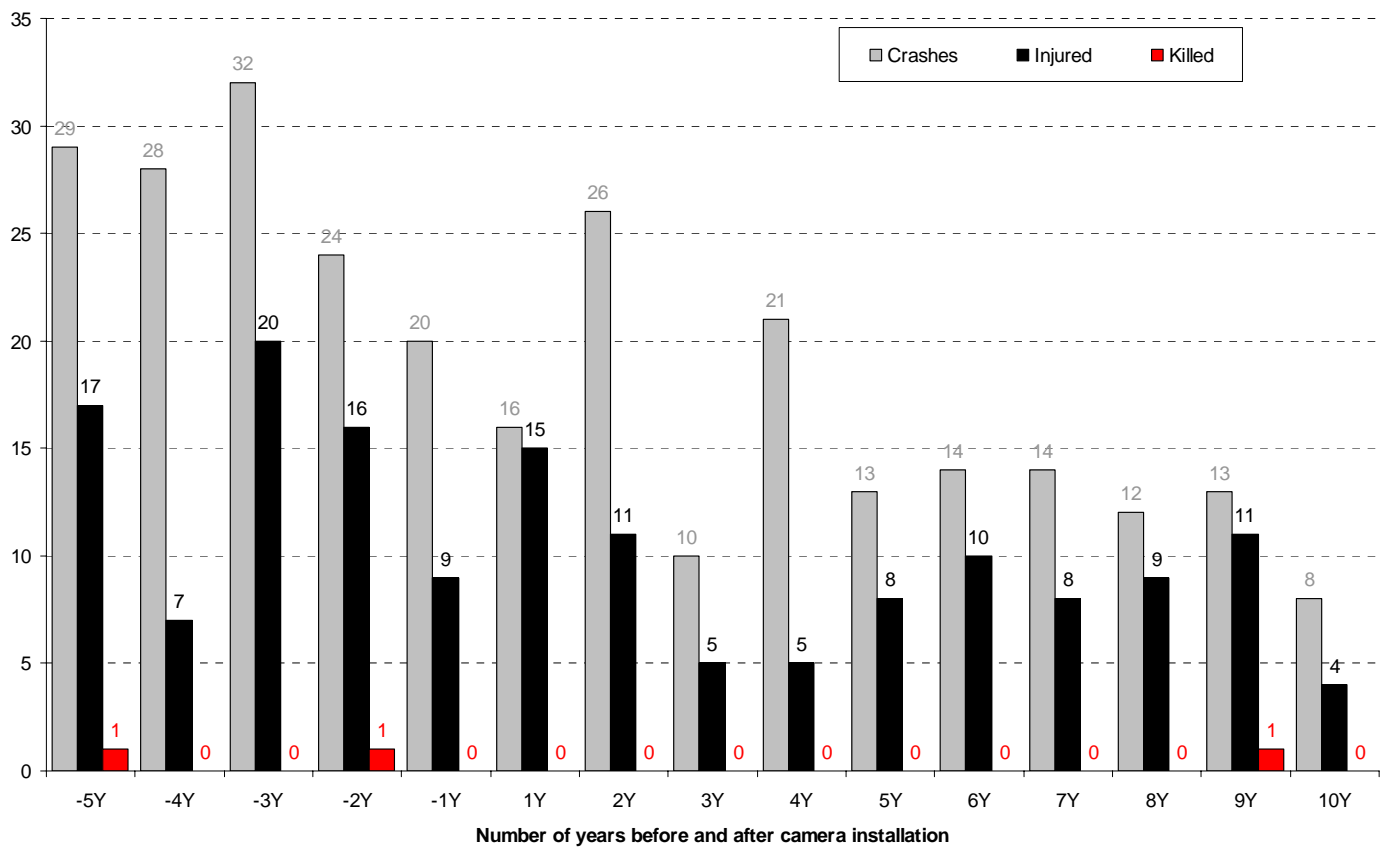
### Crashes at fixed speed camera location

Five years before – September 1996 – September 2001 - Totals				
Fatality Persons	Injury Persons	Casualty Persons	Crashes	Casualty Cost (\$M)
2	69	71	133	19.534
After (most recent five year period) – 2006 to 2011 - Totals				
Fatality Persons	Injury Persons	Casualty Persons	Crashes	Casualty Cost (\$M)
1	42	43	61	10.622

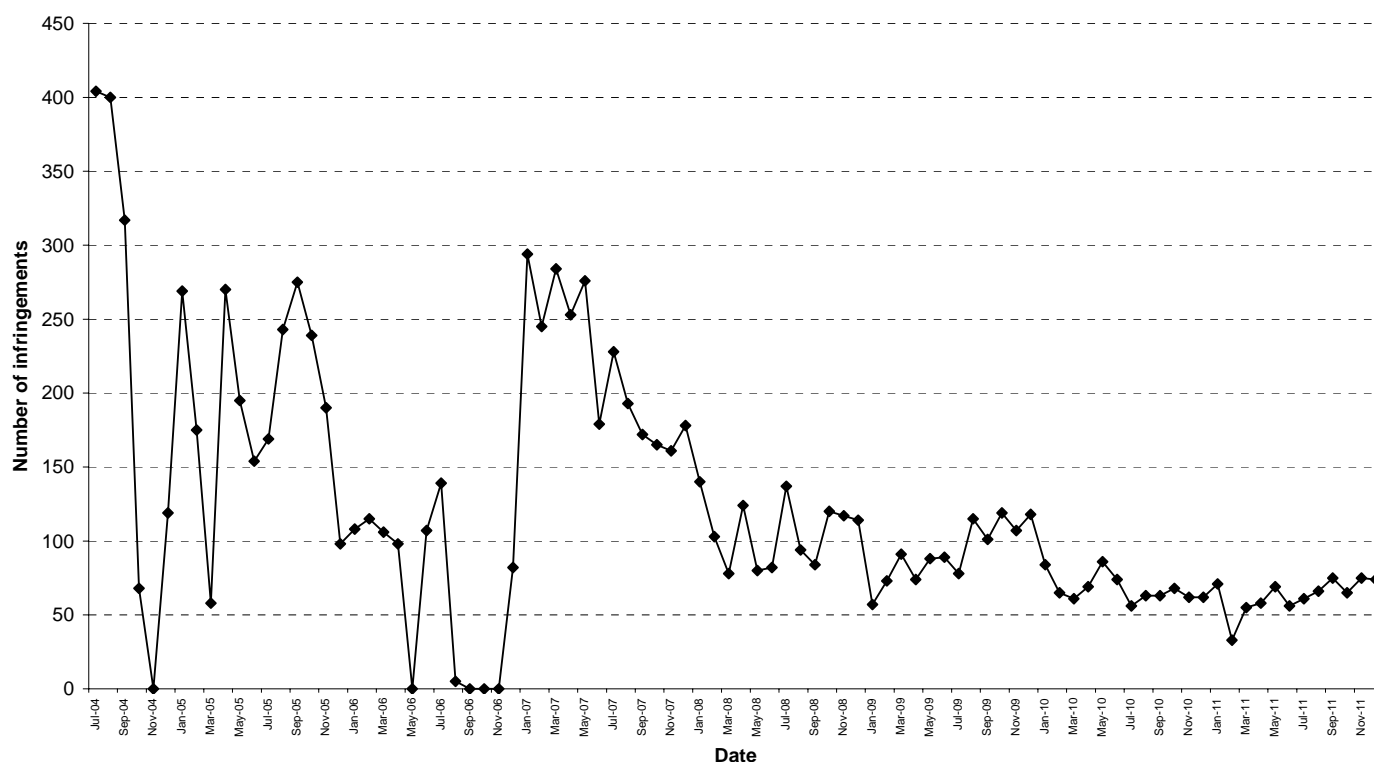
HUME HIGHWAY LANSVALE

## Infringements at fixed speed camera location

The fixed speed camera on the Hume Highway, Lansvale was installed in December 2001. There is one speed camera installed at this location.

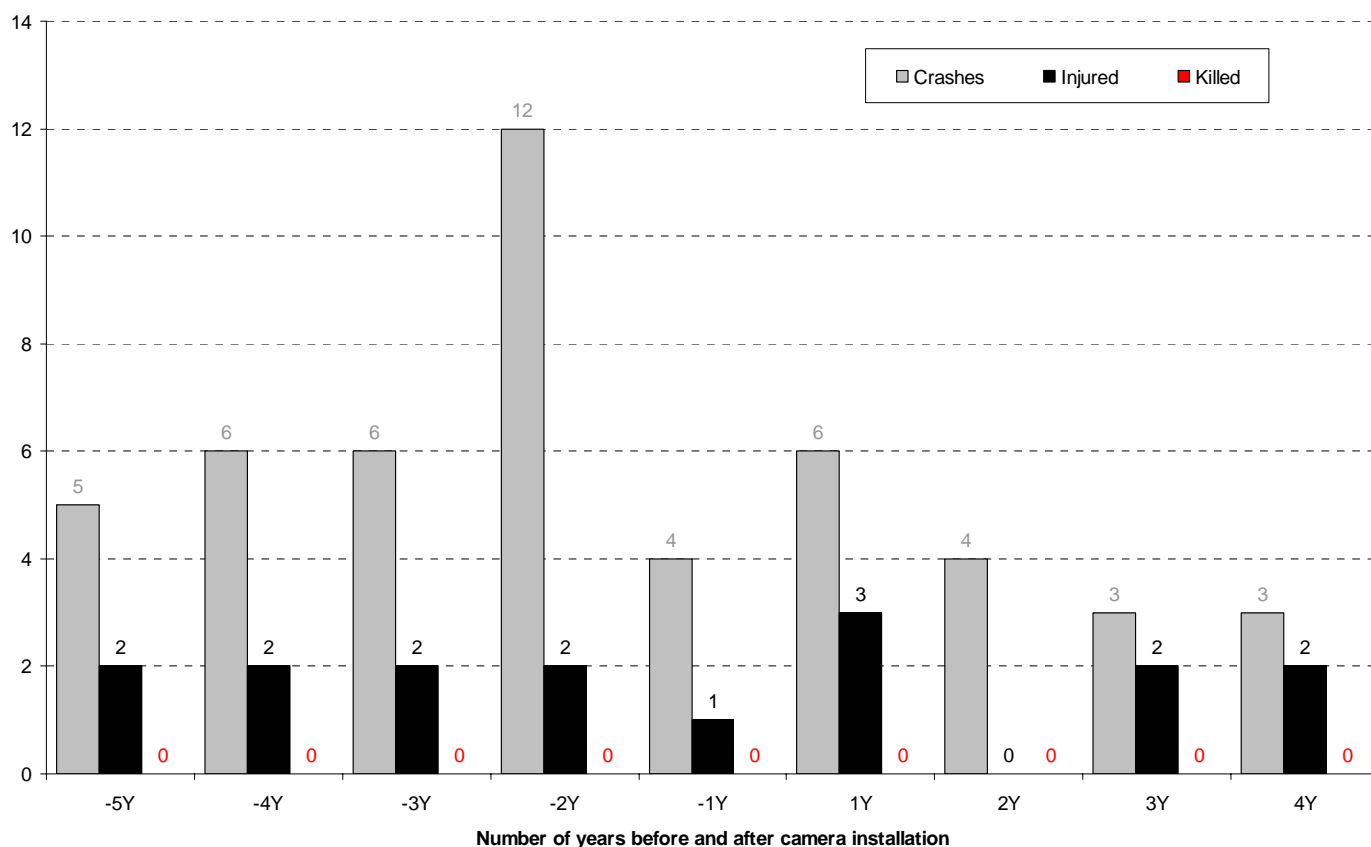
### Crashes at fixed speed camera location

Five years before – April 2002 – April 2007- Totals				
Fatality Persons	Injury Persons	Casualty Persons	Crashes	Casualty Cost (\$M)
0	9	9	33	1.026
After (most recent four year period) – 2007 to 2011 - Totals				
Fatality Persons	Injury Persons	Casualty Persons	Crashes	Casualty Cost (\$M)
0	7	7	16	0.798

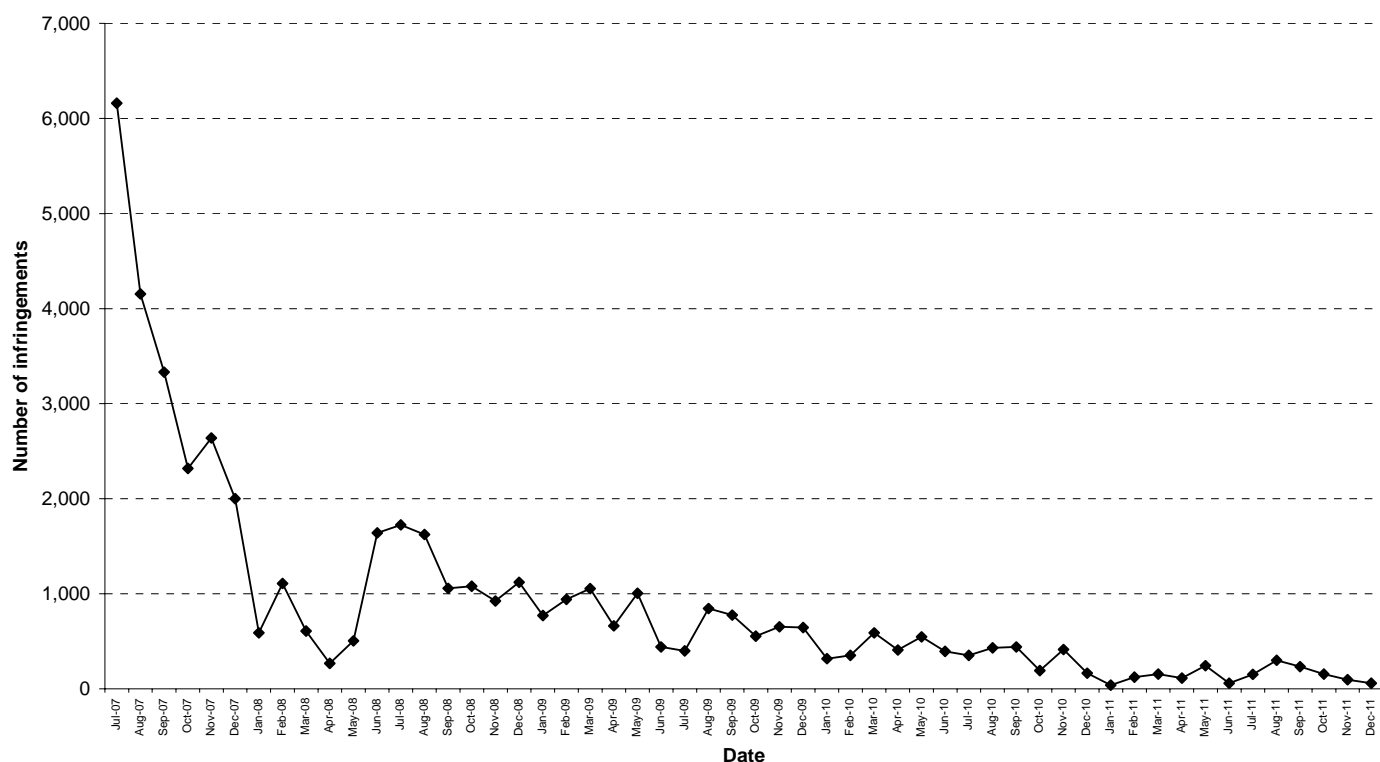
PACIFIC HIGHWAY LINDFIELD

## Infringements at fixed speed camera location

The school zone fixed speed cameras on the Pacific Highway, Lindfield were installed in July 2007. There are two speed cameras installed at this location.

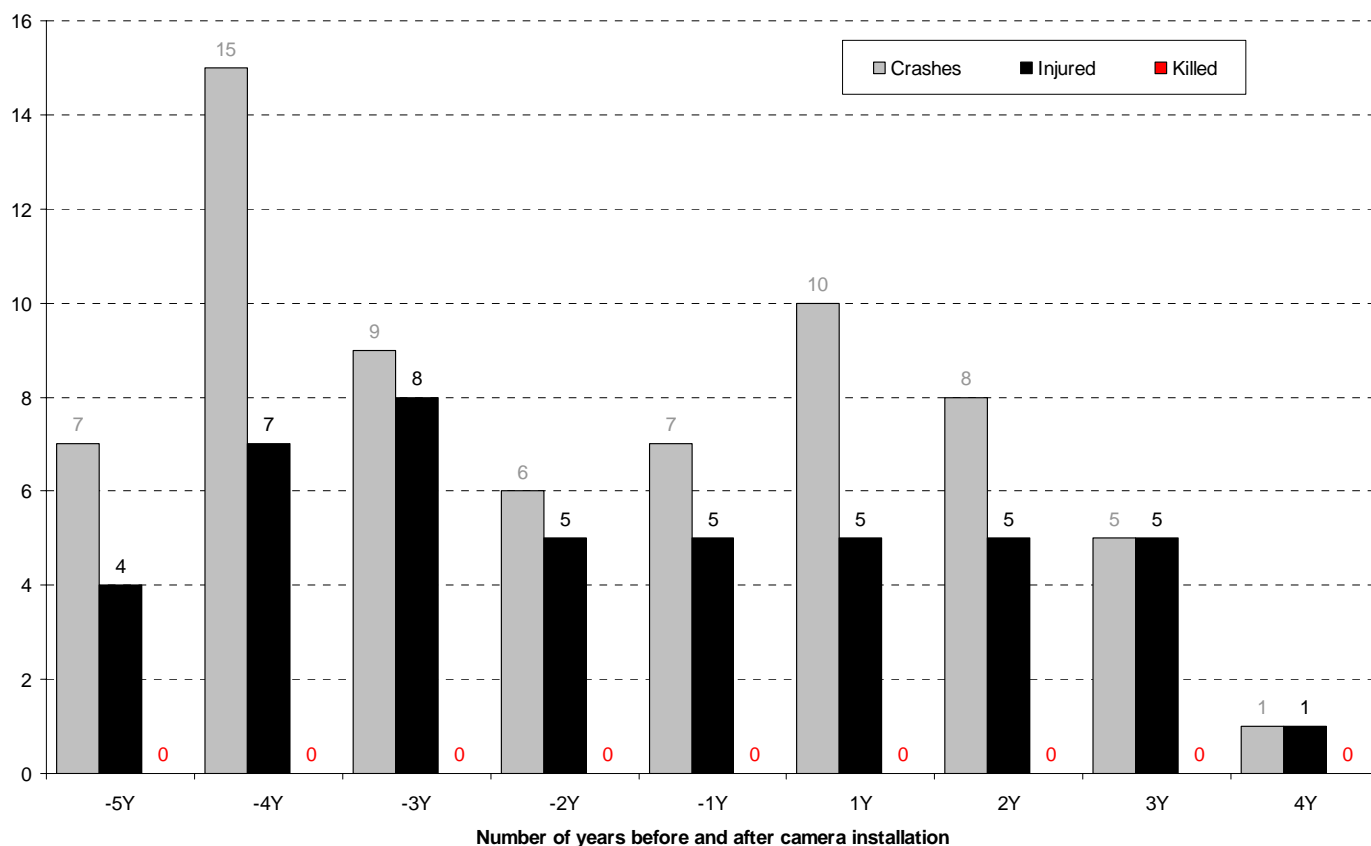
### Crashes at fixed speed camera location

Five years before – August 2002 – August 2007 - Totals				
Fatality Persons	Injury Persons	Casualty Persons	Crashes	Casualty Cost (\$M)
0	29	29	44	3.306
After (most recent four year period) – 2007 to 2011 - Totals				
Fatality Persons	Injury Persons	Casualty Persons	Crashes	Casualty Cost (\$M)
0	16	16	24	1.824

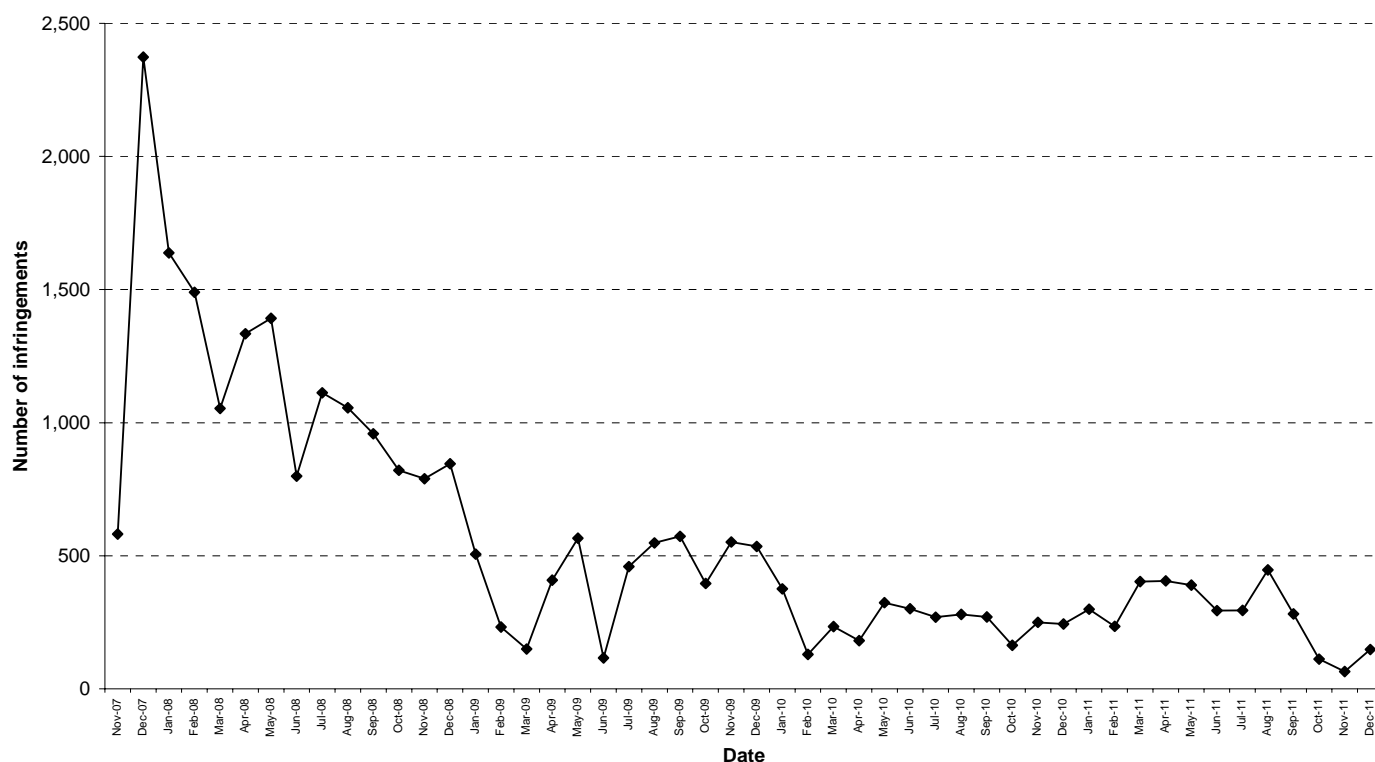
BIGGE STREET LIVERPOOL

## Infringements at fixed speed camera location

The school zone fixed speed camera on Bigge St, Liverpool was installed in November 2007. There is one speed camera installed at this location.

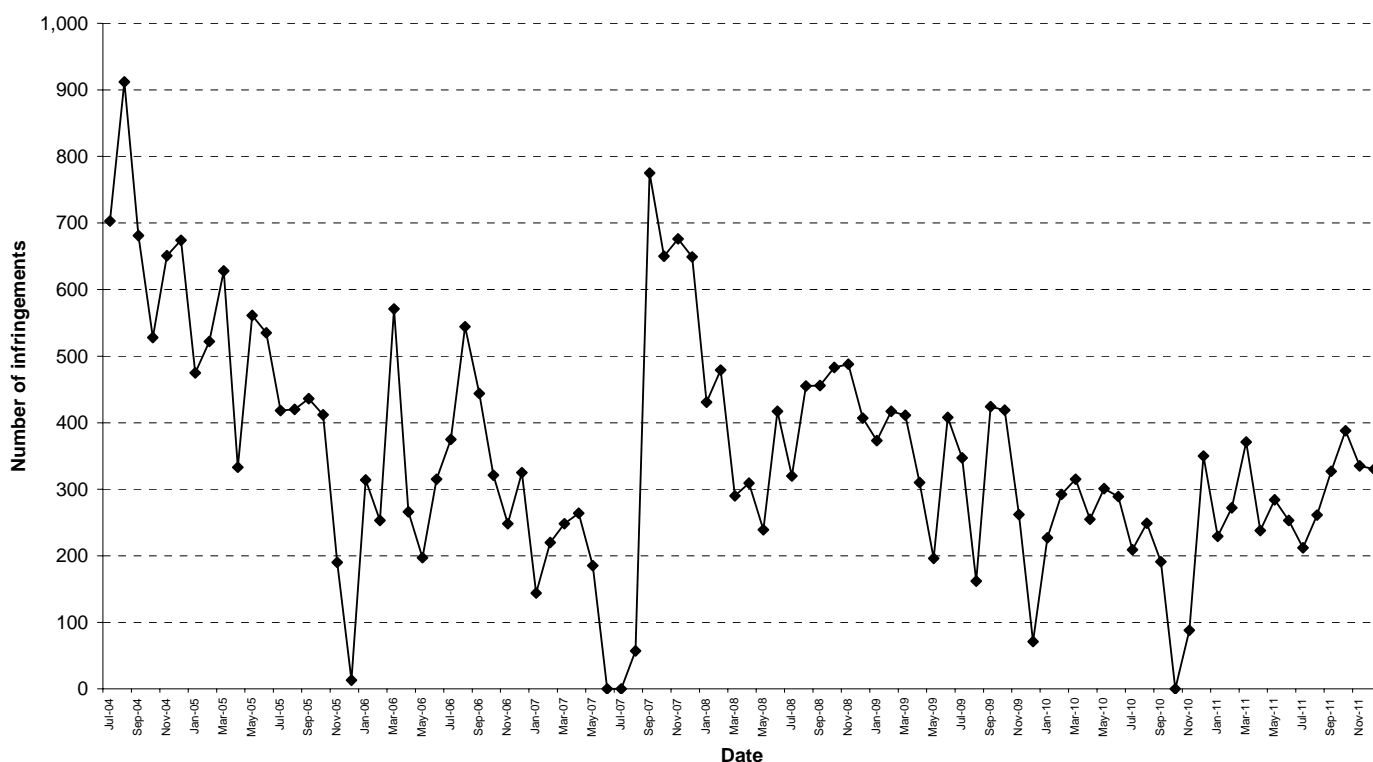
NEW ENGLAND HIGHWAY LOCHINVAR

## Infringements at fixed speed camera location

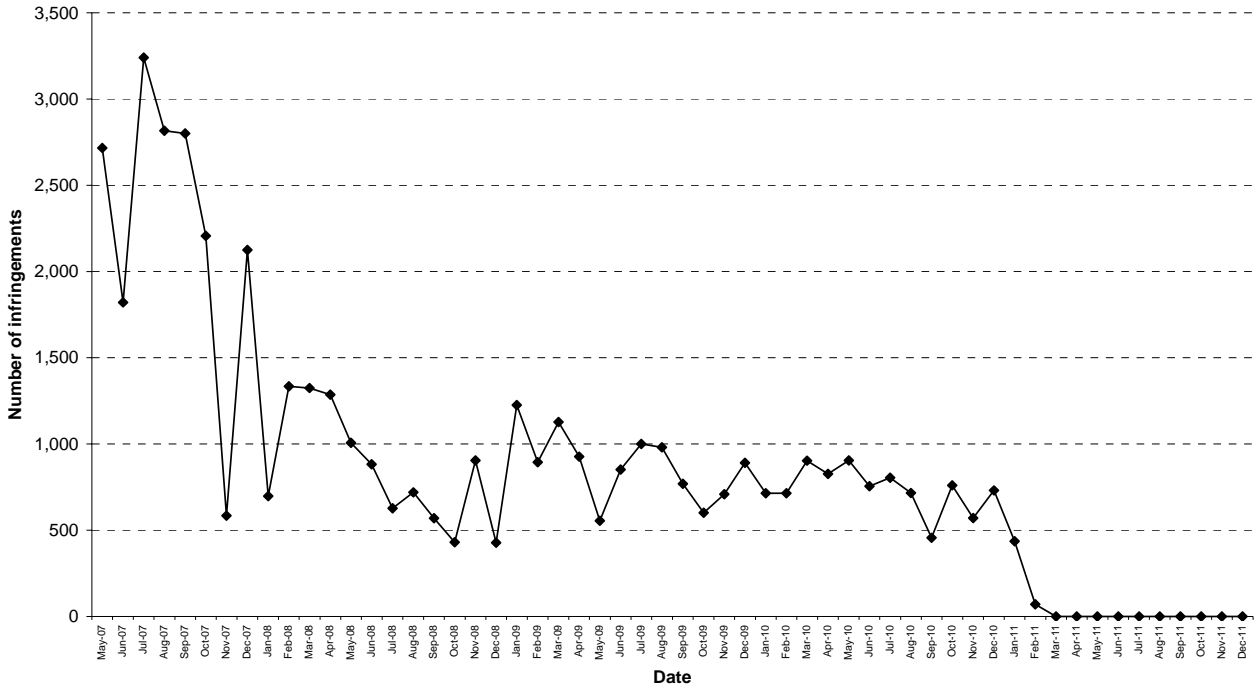
M2 MOTORWAY NORTH EPPING

## Infringements at fixed speed camera location

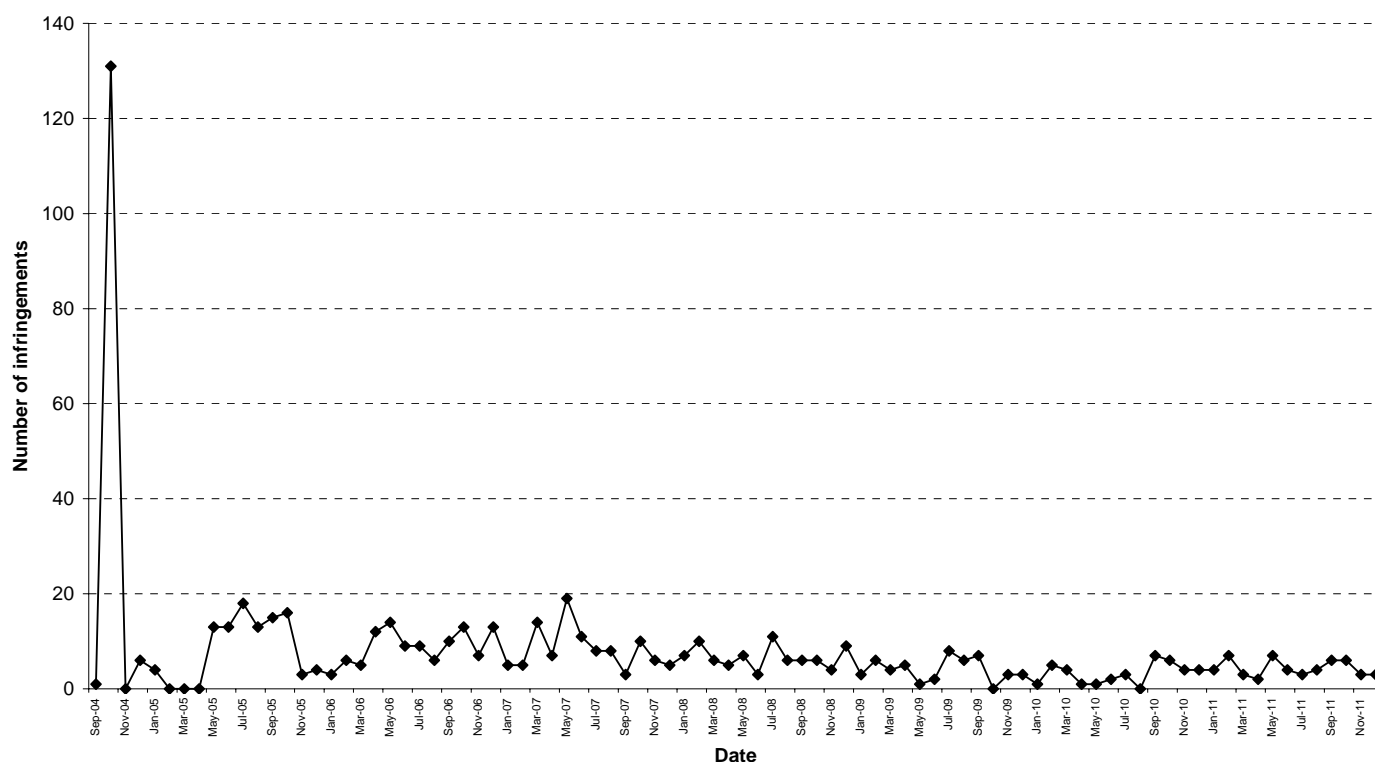
PACIFIC HIGHWAY MACKSVILLE

## Infringements at fixed speed camera location

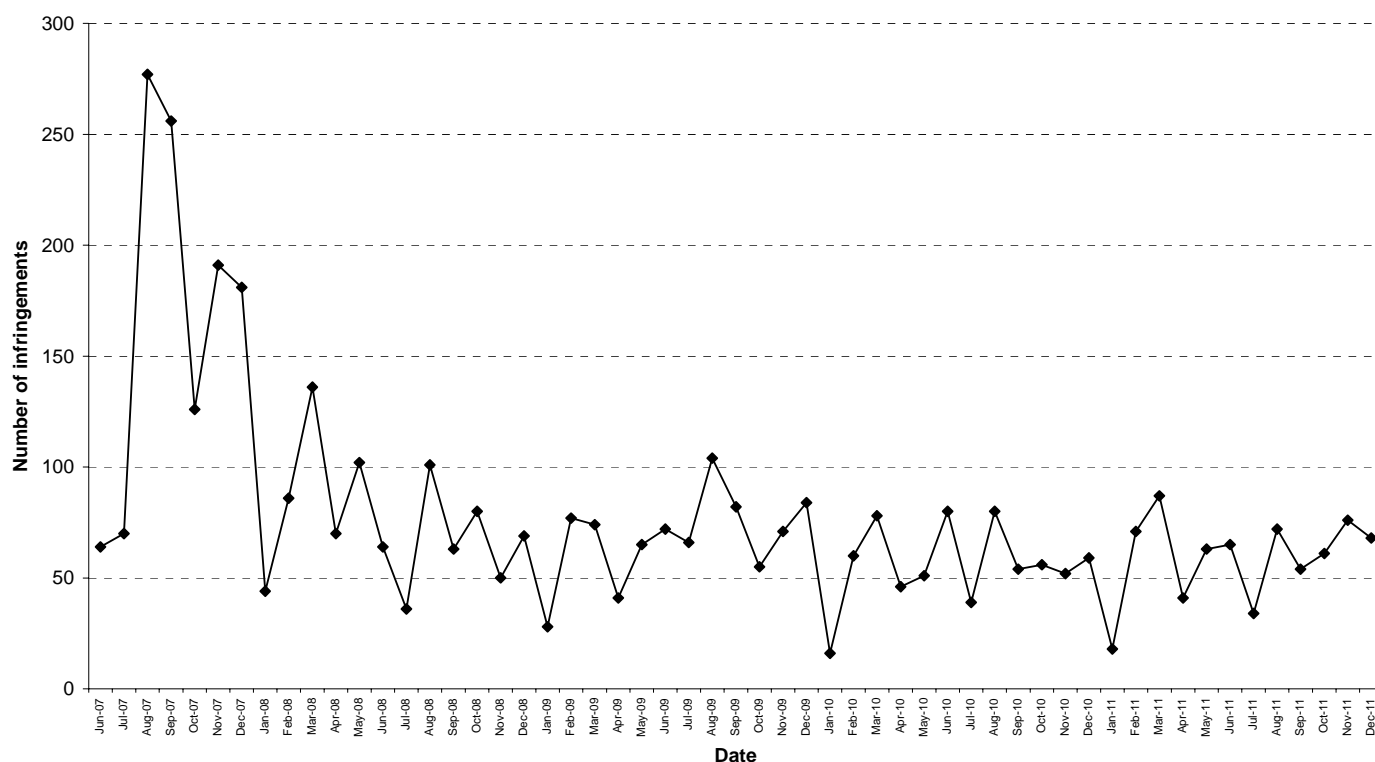
MALABAR ROAD MAROUBRA

## Infringements at fixed speed camera location
