# ANNUAL NSW SPEED CAMERA PERFORMANCE REVIEW

NSW Centre for Road Safety

JULY 2012

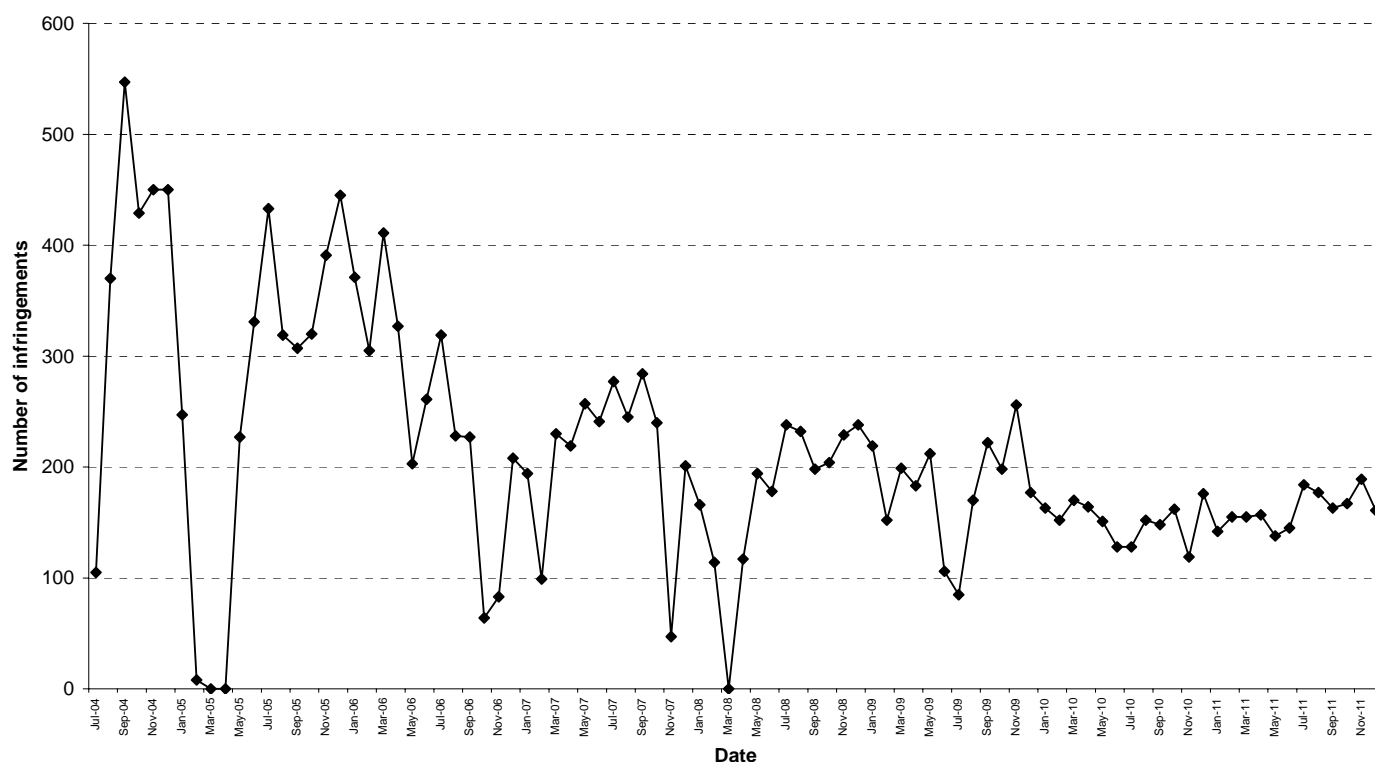
PACIFIC HIGHWAY MAYFIELD WEST

## Infringements at fixed speed camera location

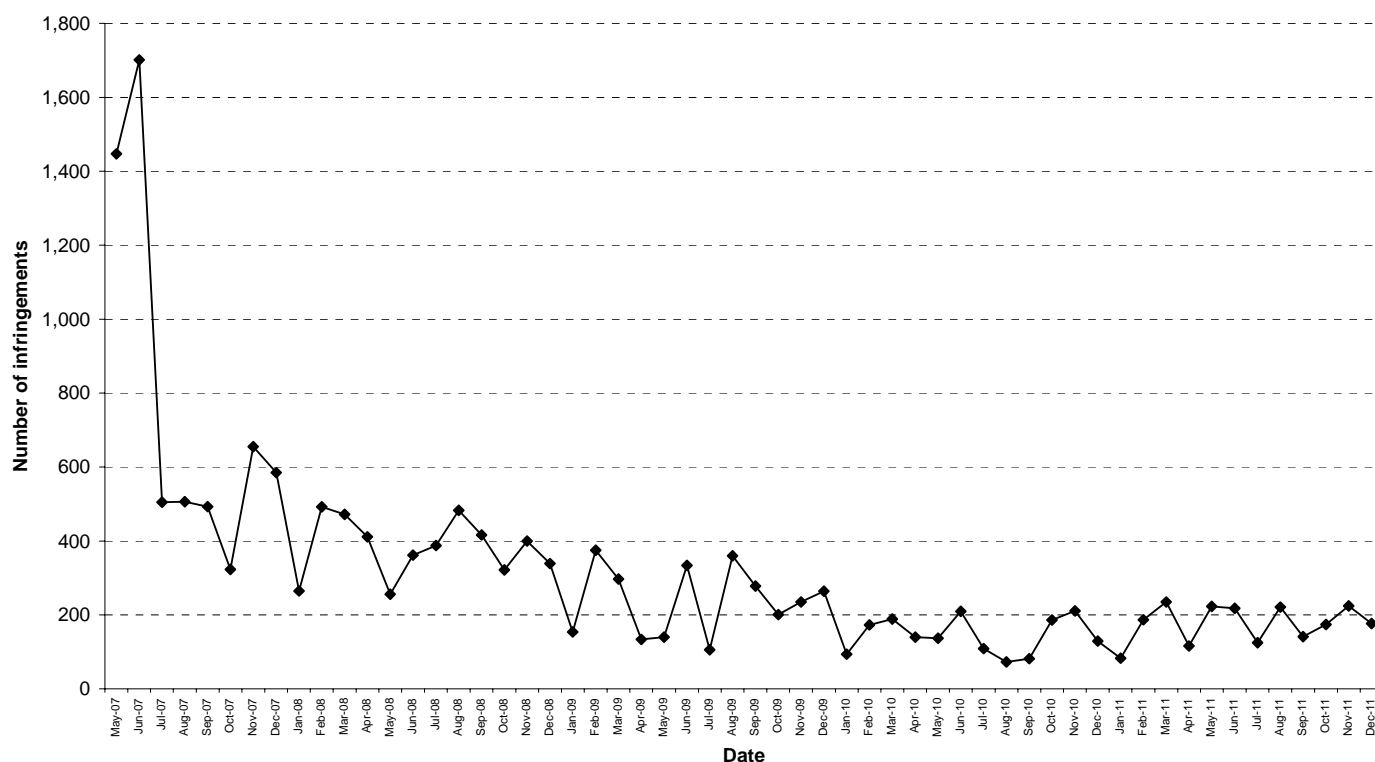
MERRYLANDS ROAD MERRYLANDS

## Infringements at fixed speed camera location

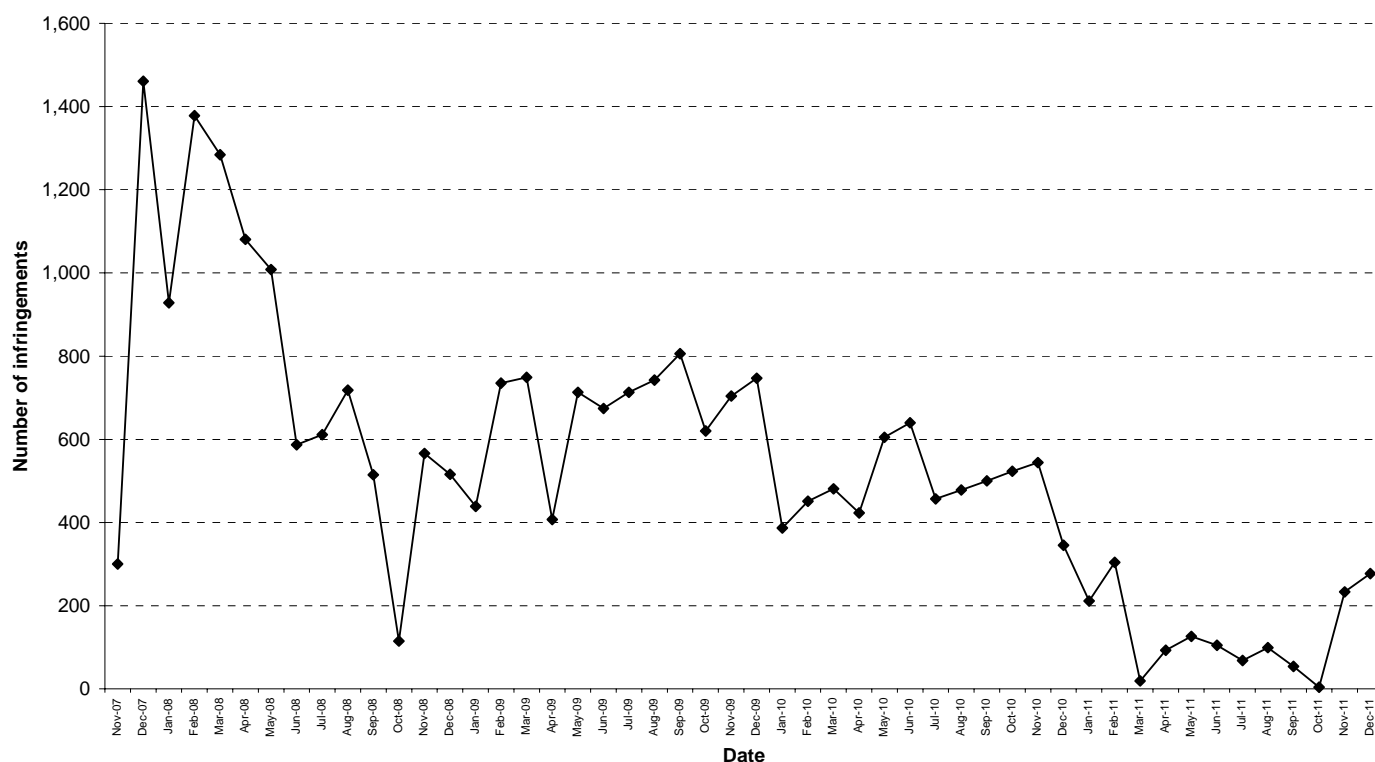
KINGSWAY MIRANDA

## Infringements at fixed speed camera location

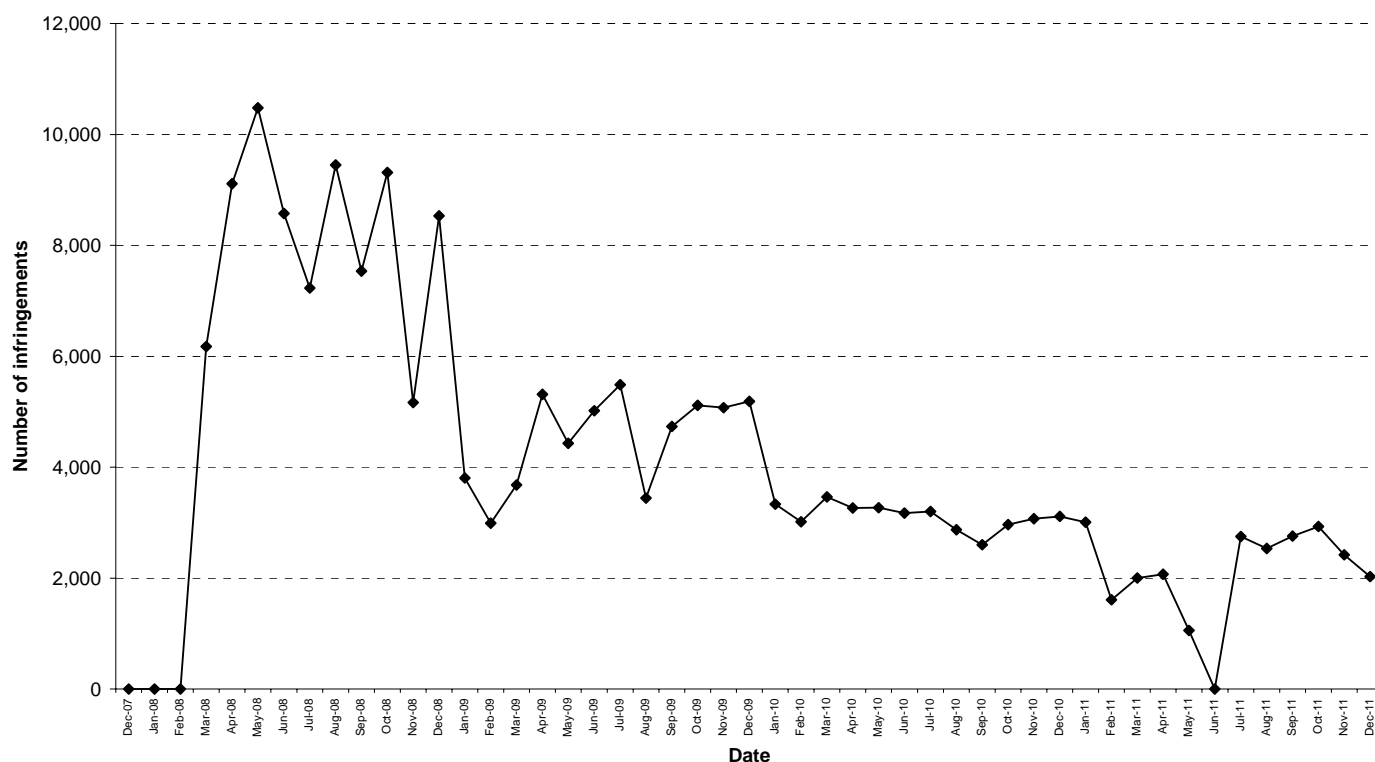
CLEVELAND STREET MOORE PARK

## Infringements at fixed speed camera location

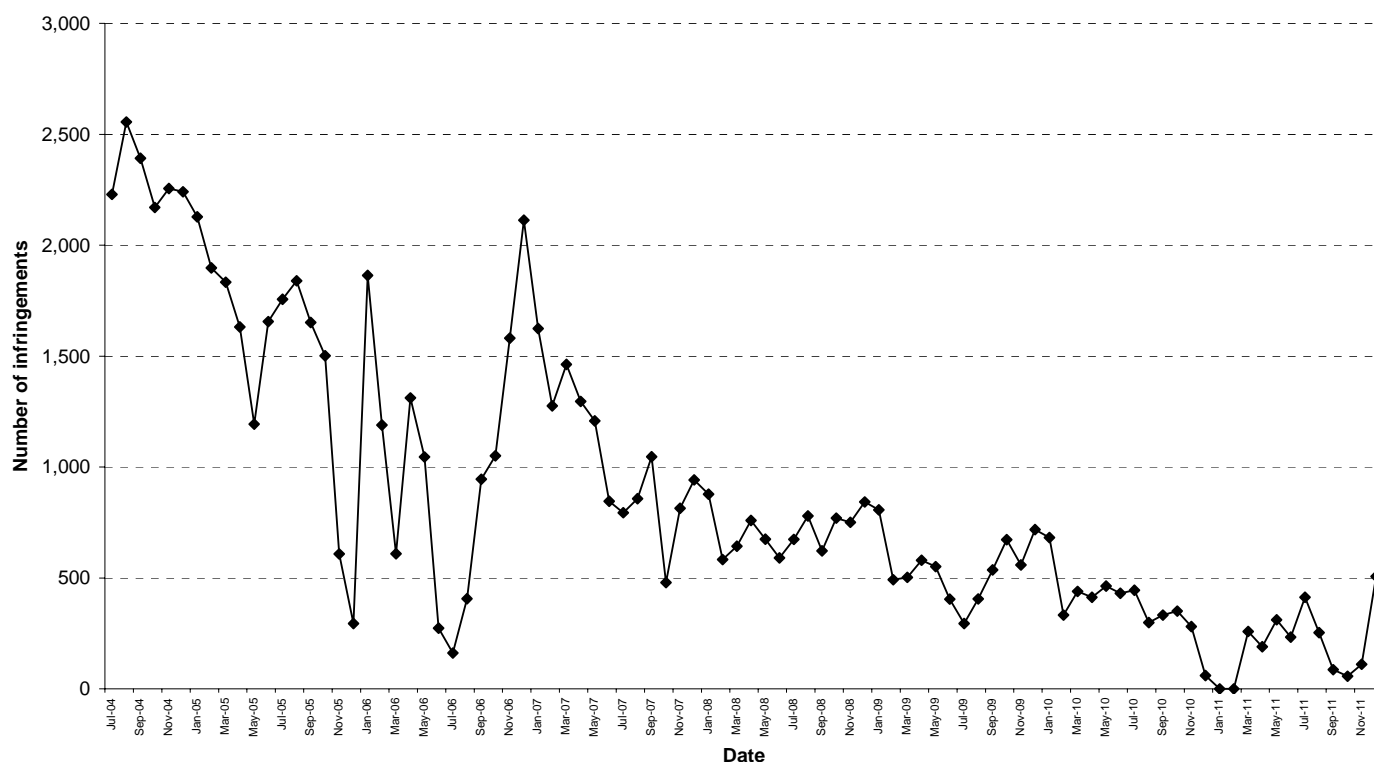
MACPHERSON STREET MOSMAN

## Infringements at fixed speed camera location

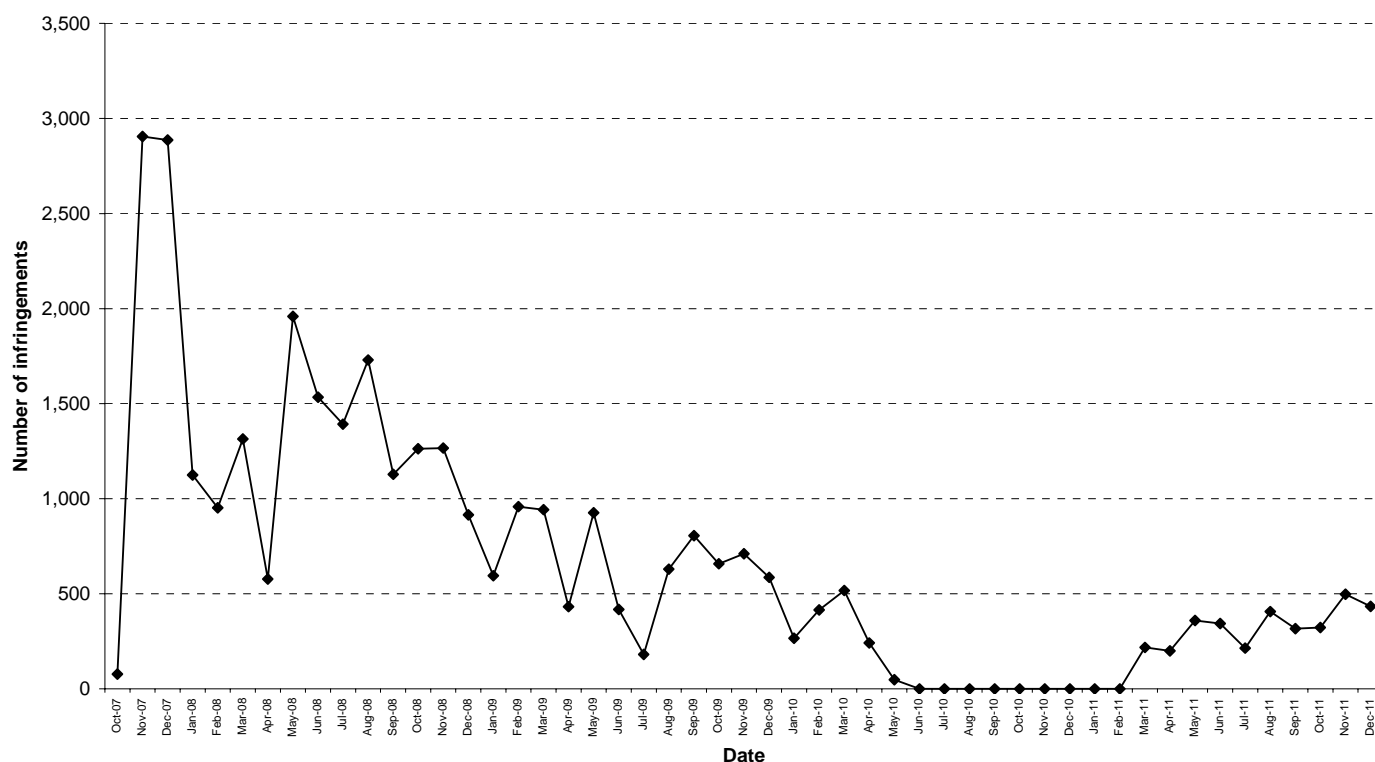
PITTWATER ROAD NARRABEEN

## Infringements at fixed speed camera location

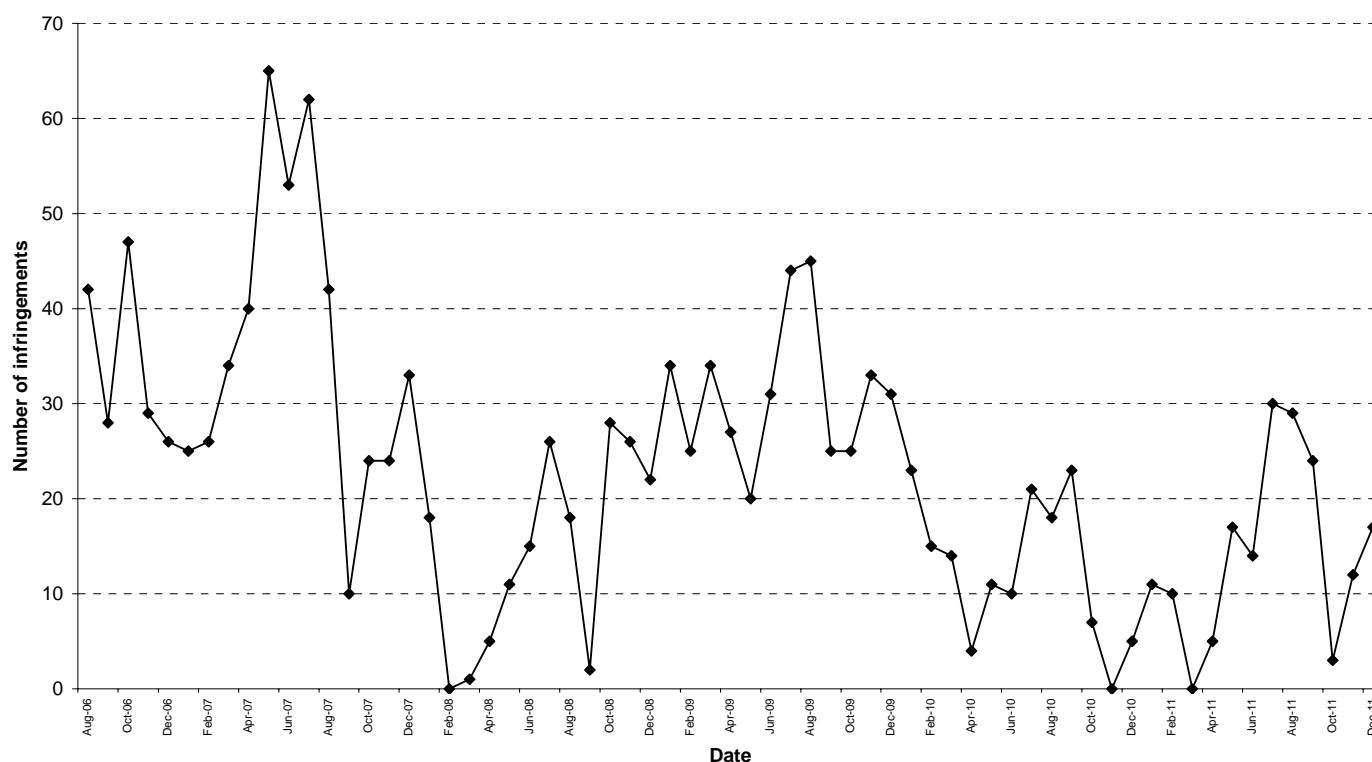
PACIFIC HIGHWAY NEW ITALY

## Infringements at fixed speed camera location

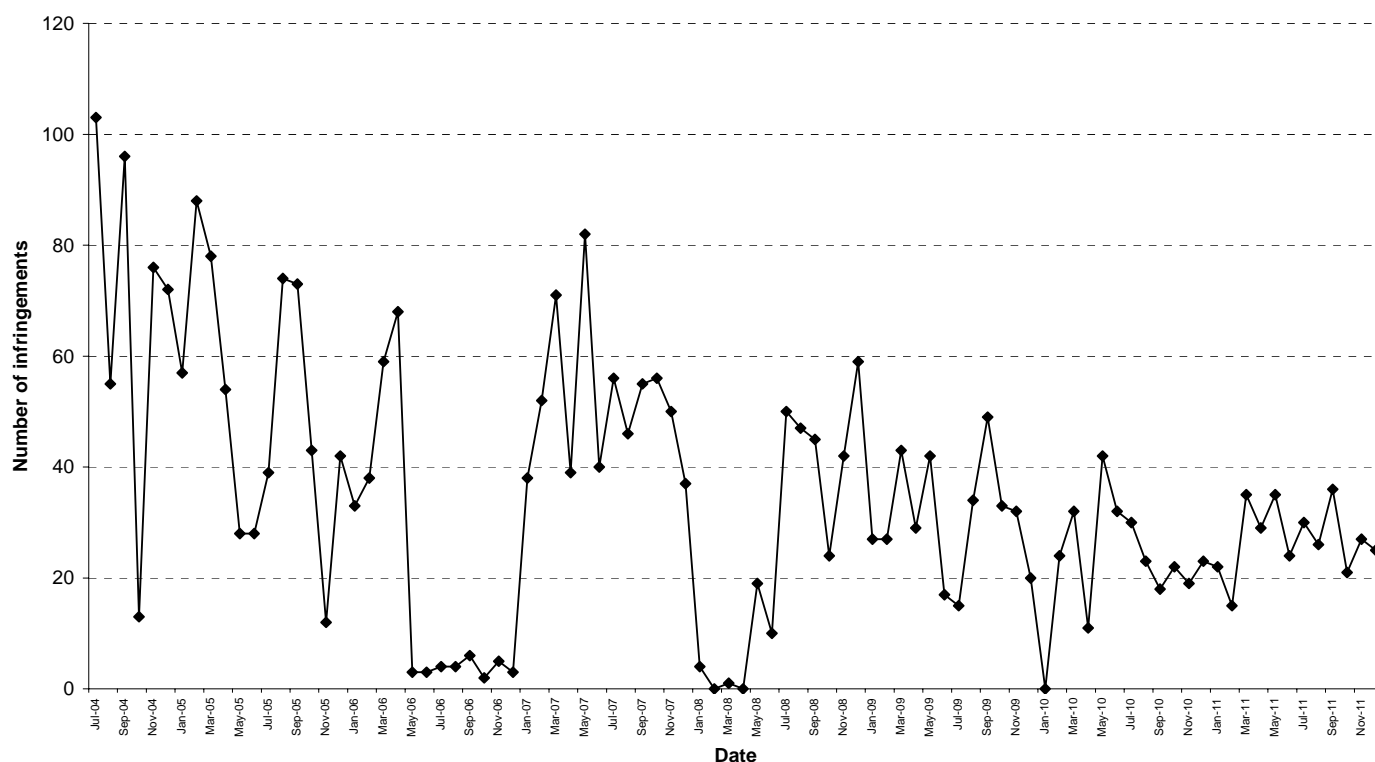
PACIFIC HIGHWAY NORDS WHARF

## Infringements at fixed speed camera location

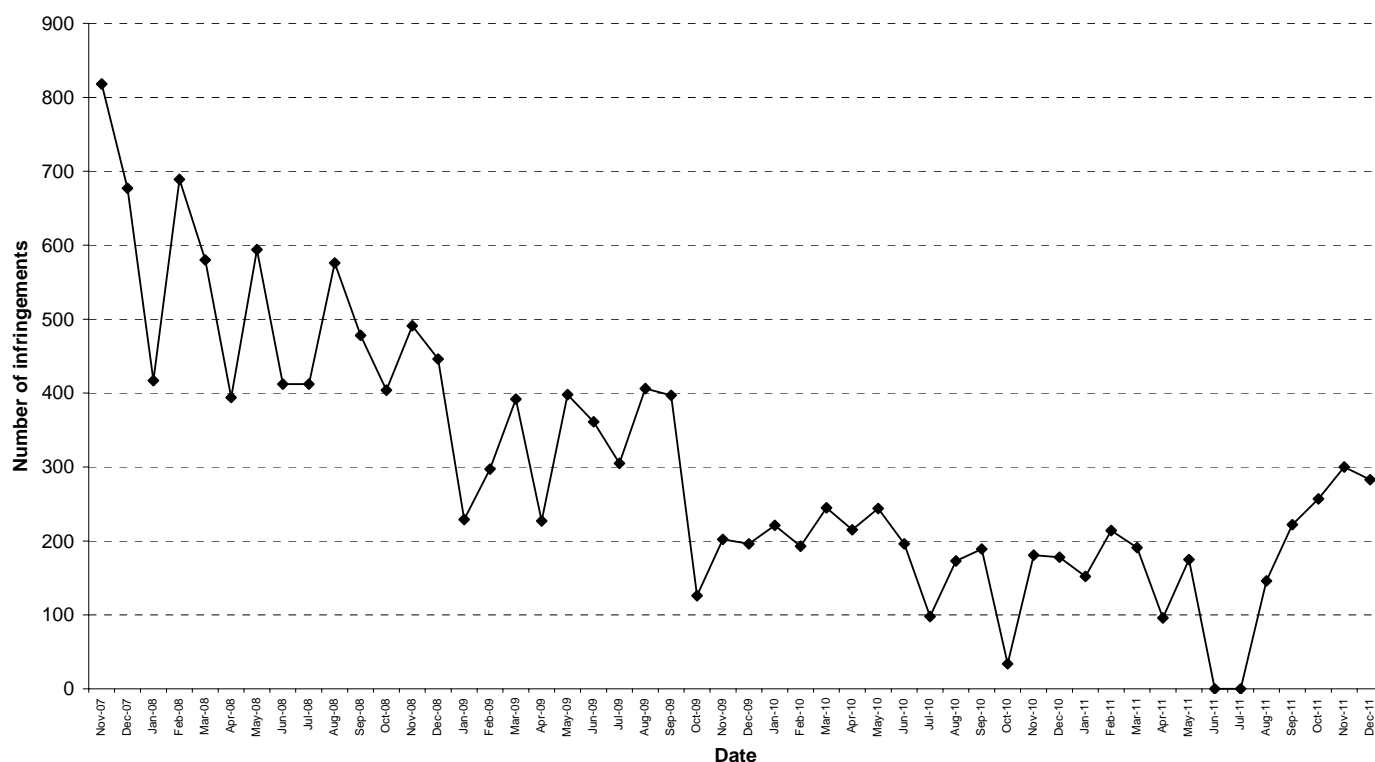
HARBORD ROAD NORTH CURL CURL

## Infringements at fixed speed camera location

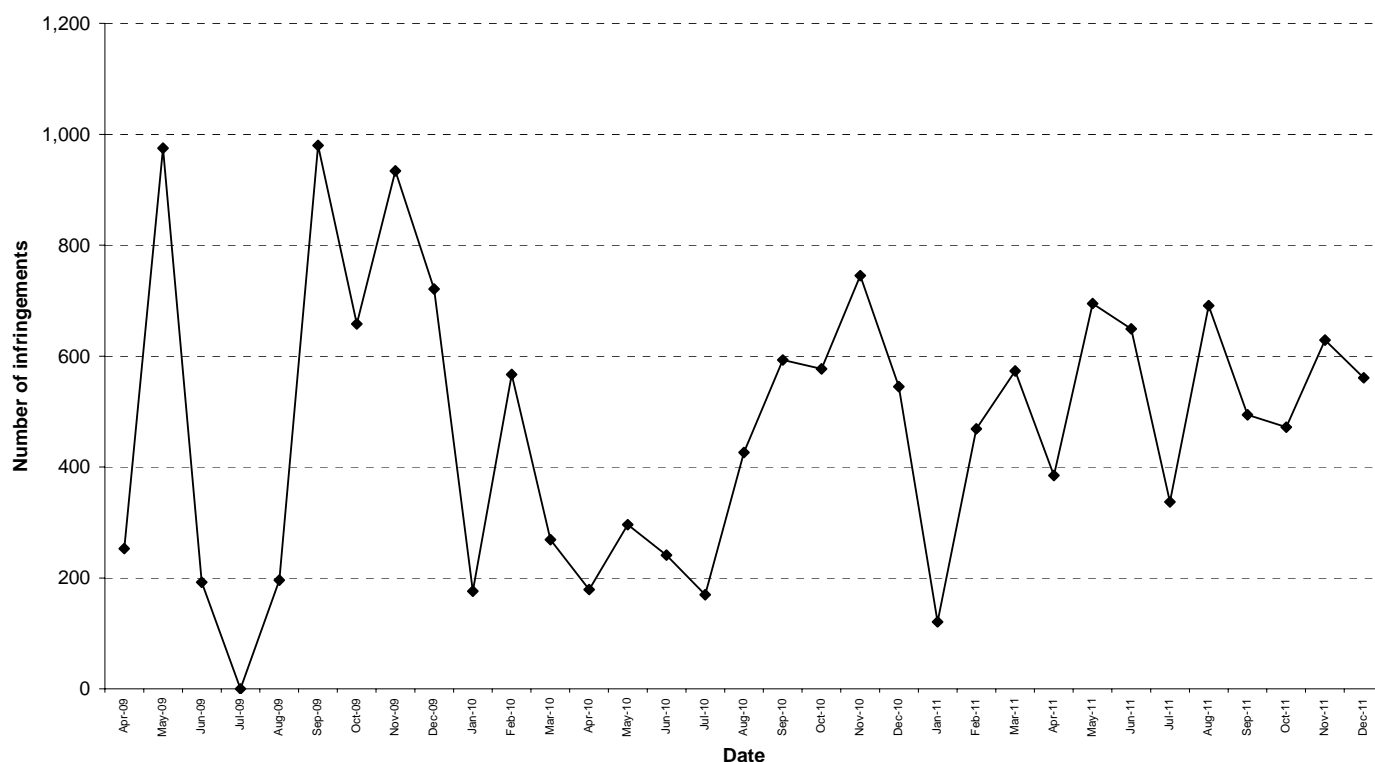
PITTWATER ROAD NORTH NARRABEEN

## Infringements at fixed speed camera location

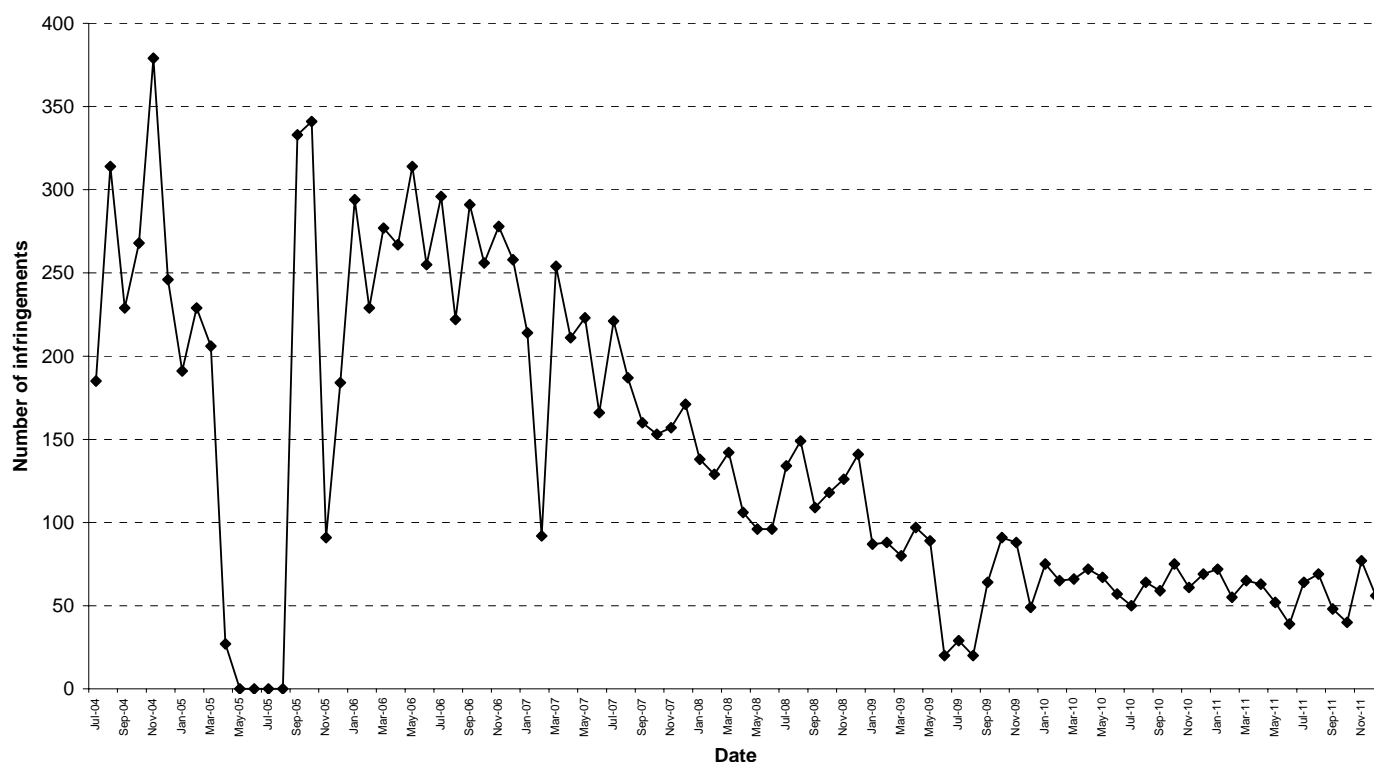
PENNANT HILLS RD NORTH PARRAMATTA

## Infringements at fixed speed camera location

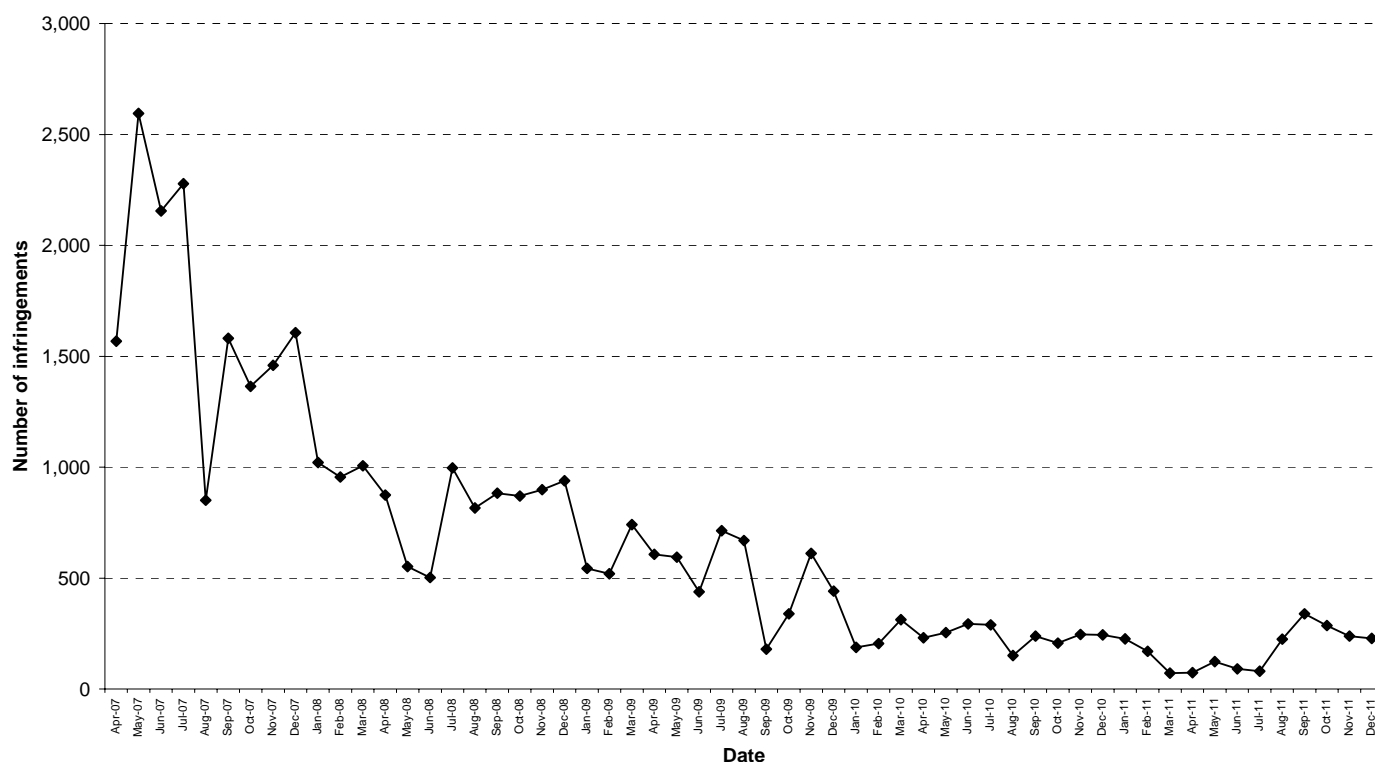
PENNANT HILLS ROAD NTH PARRAMATTA / OATLANDS

## Infringements at fixed speed camera location

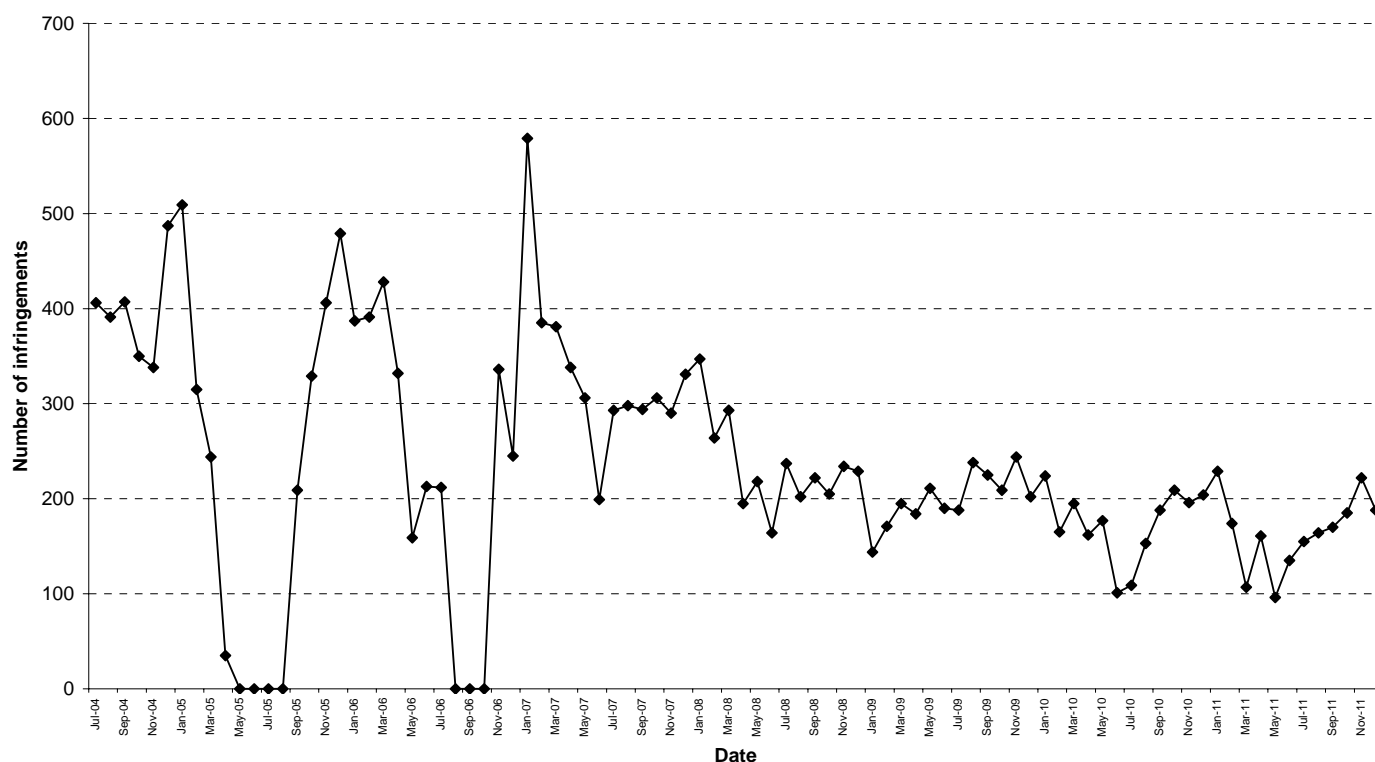
PRINCES HIGHWAY WOLLONGONG

## Infringements at fixed speed camera location

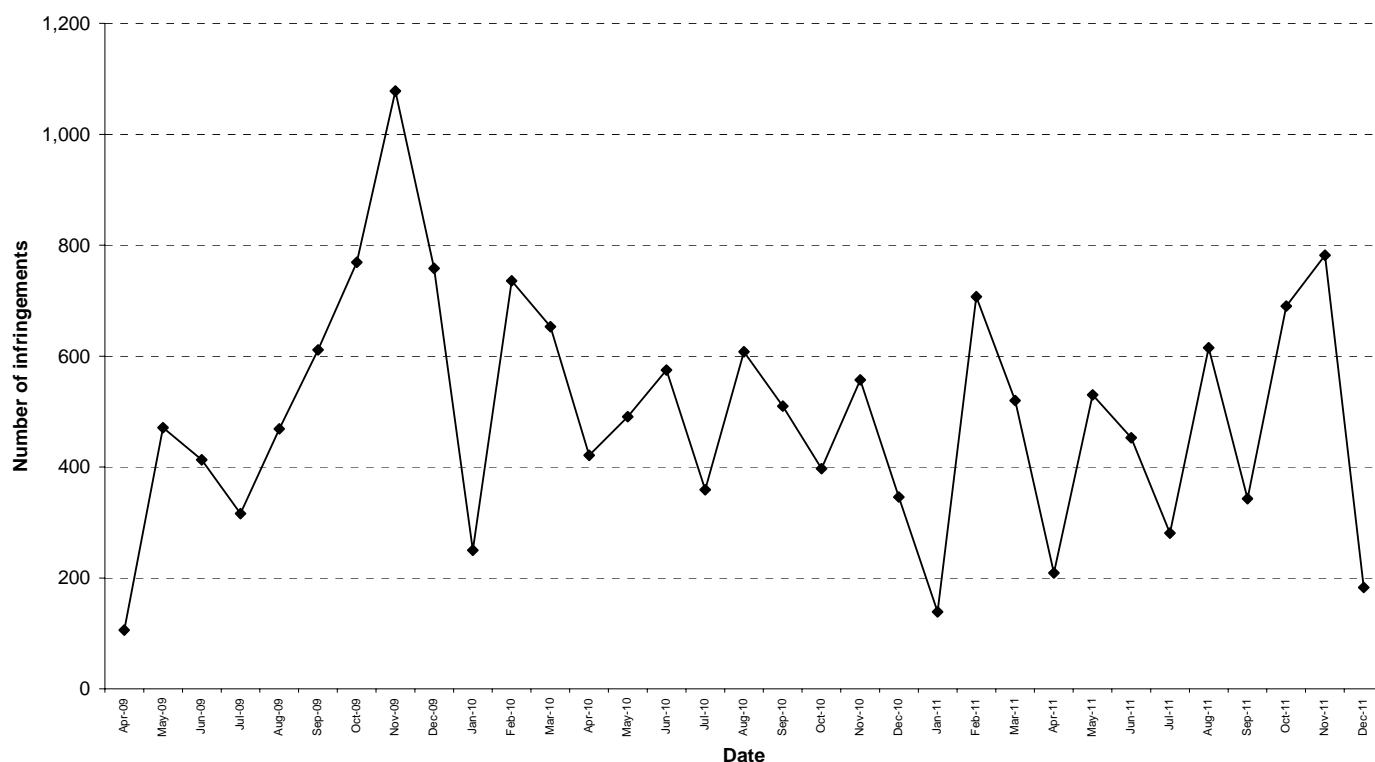
WOODVILLE ROAD OLD GUILDFORD / CHESTER HILL

## Infringements at fixed speed camera location

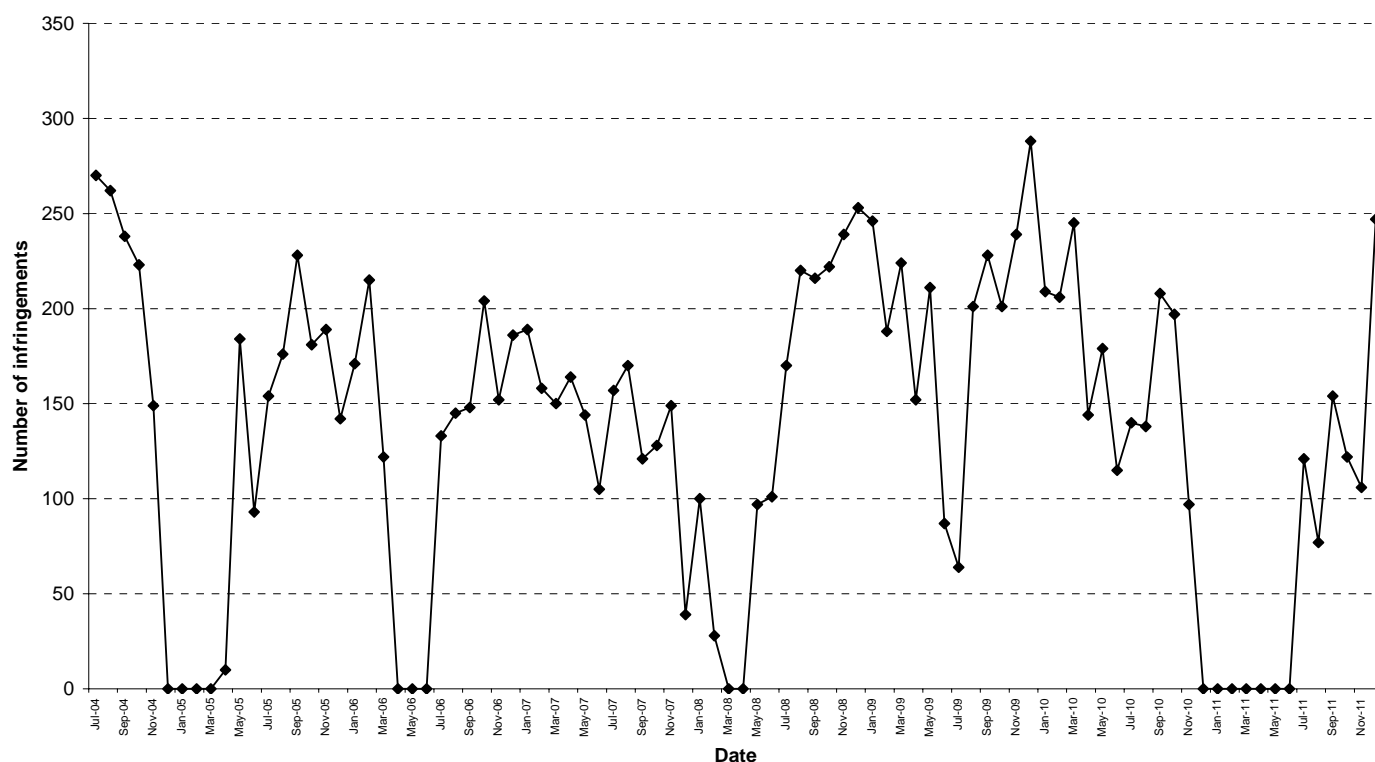
F3 FREEWAY OURIMBAH

## Infringements at fixed speed camera location

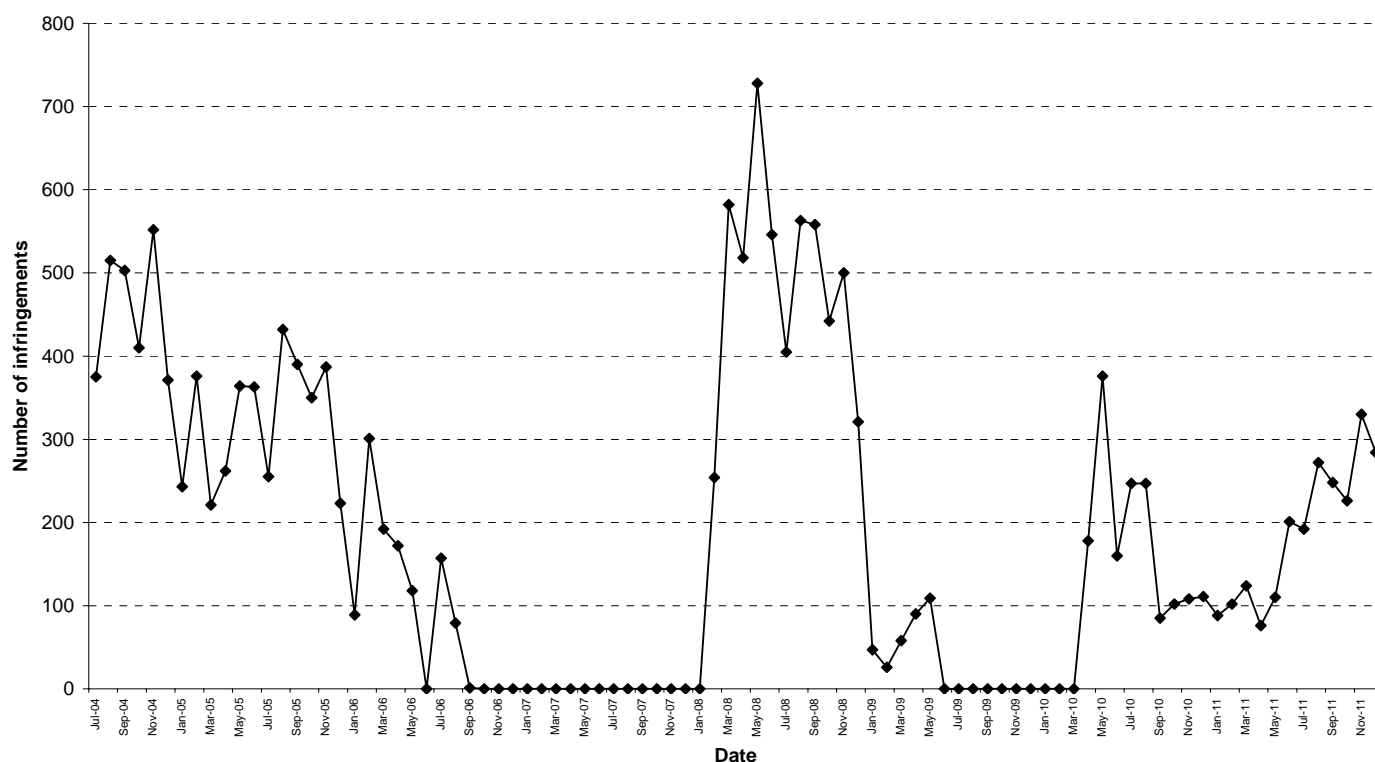
PACIFIC HIGHWAY OURIMBAH

## Infringements at fixed speed camera location

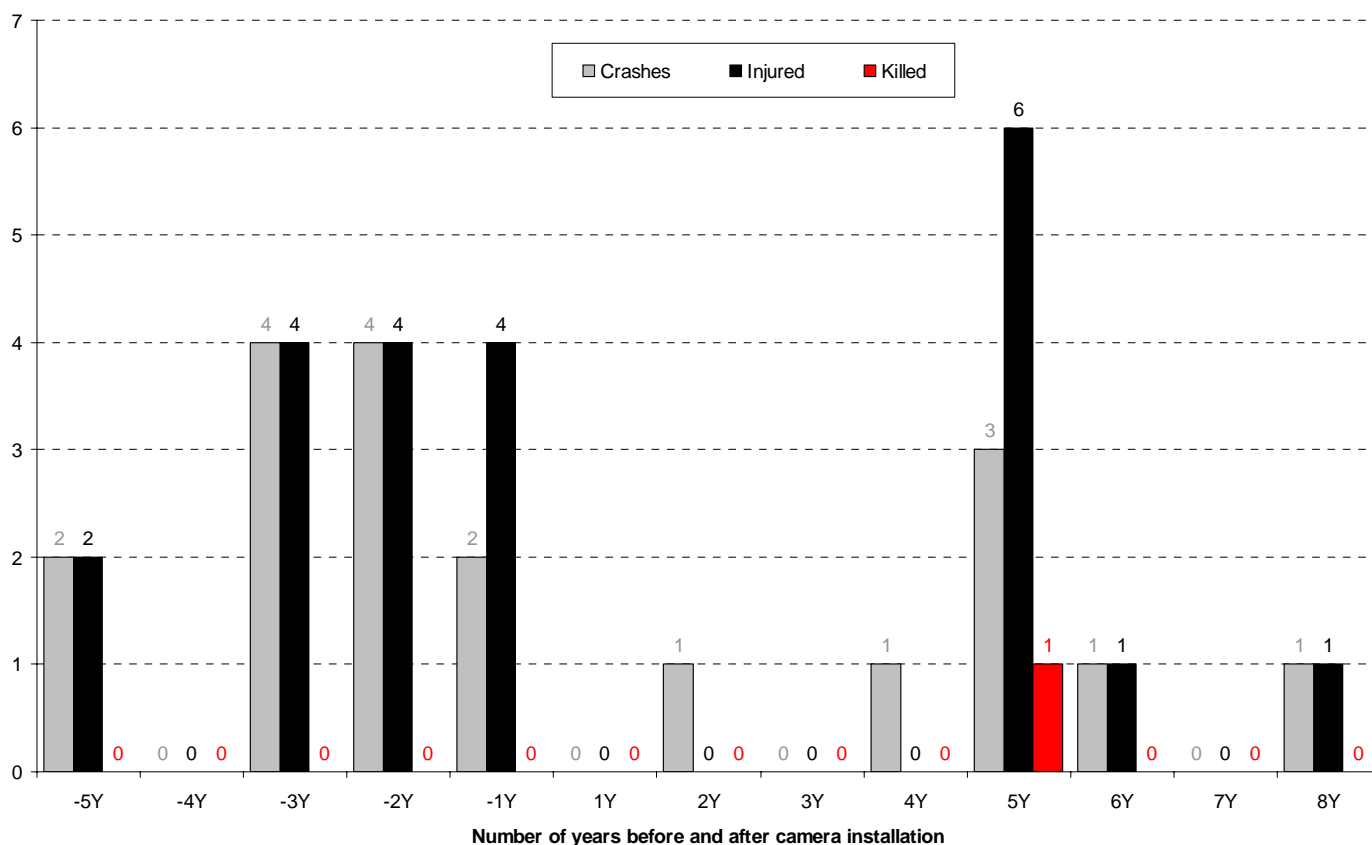
### Crashes at fixed speed camera location

Five years before – November 1997- November 2002 - Totals				
Fatality Persons	Injury Persons	Casualty Persons	Crashes	Casualty Cost (\$M)
0	14	14	12	1.596
After (most recent five year period) – 2006 to 2011 - Totals				
Fatality Persons	Injury Persons	Casualty Persons	Crashes	Casualty Cost (\$M)
1	8	9	6	6.746

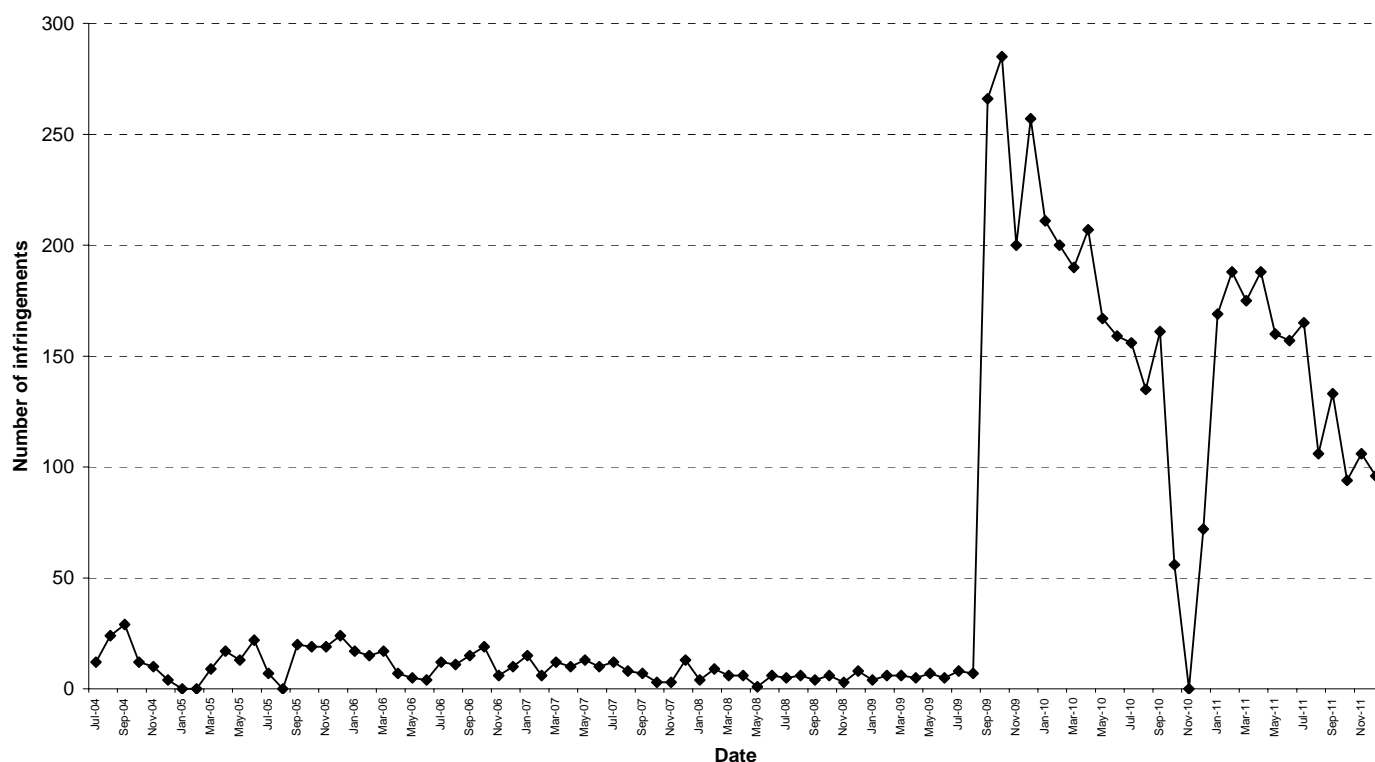
PACIFIC HIGHWAY WARDELL

## Infringements at fixed speed camera location

The fixed speed camera on the Pacific Highway, Wardell was installed in February 2002. There is one camera installed at this location.

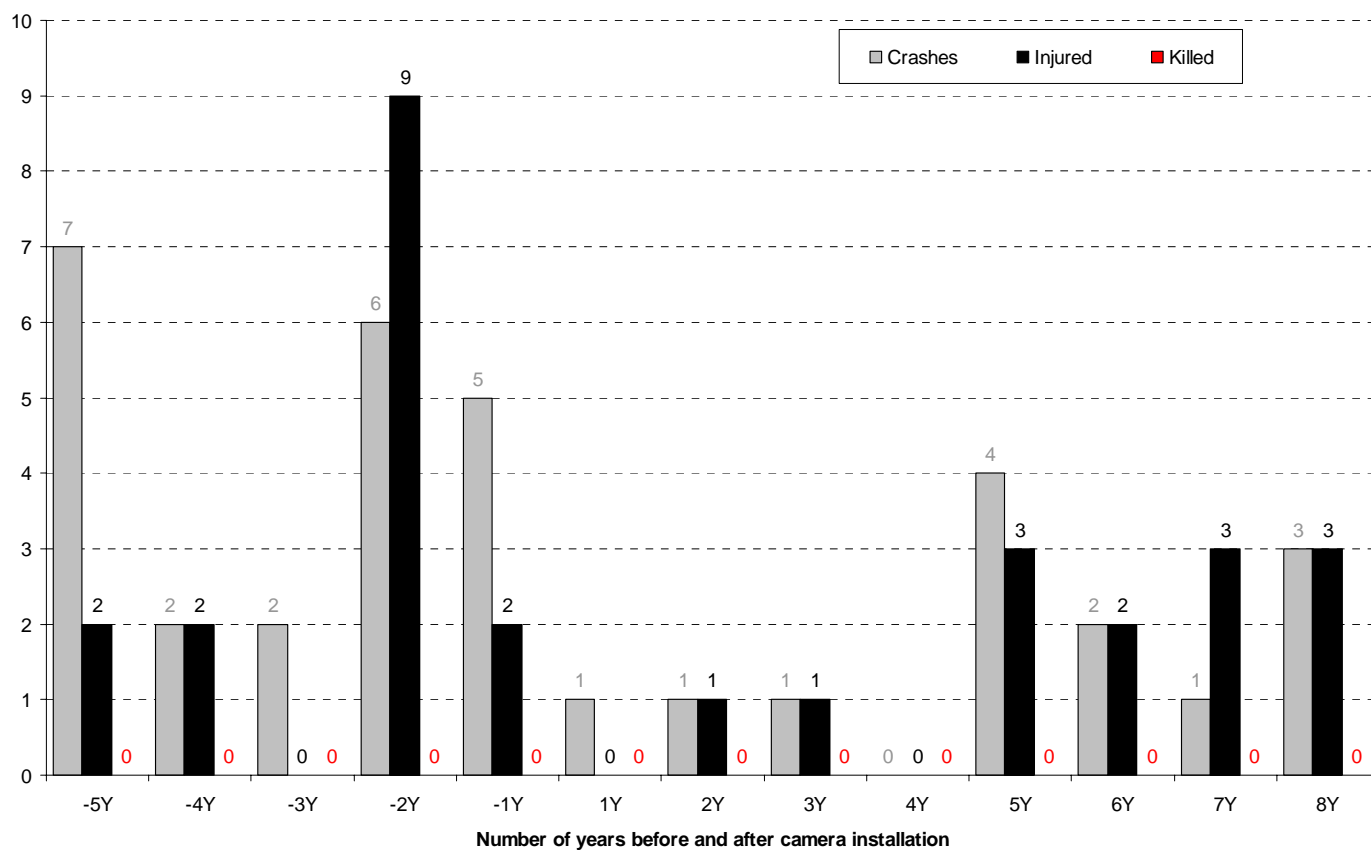
### Crashes at fixed speed camera location

Five years before – February 1998 – February 2003 - Totals				
Fatality Persons	Injury Persons	Casualty Persons	Crashes	Casualty Cost (\$M)
0	15	15	22	1.71
After (most recent five year period) – 2006 to 2011 - Totals				
Fatality Persons	Injury Persons	Casualty Persons	Crashes	Casualty Cost (\$M)
0	11	11	10	1.254

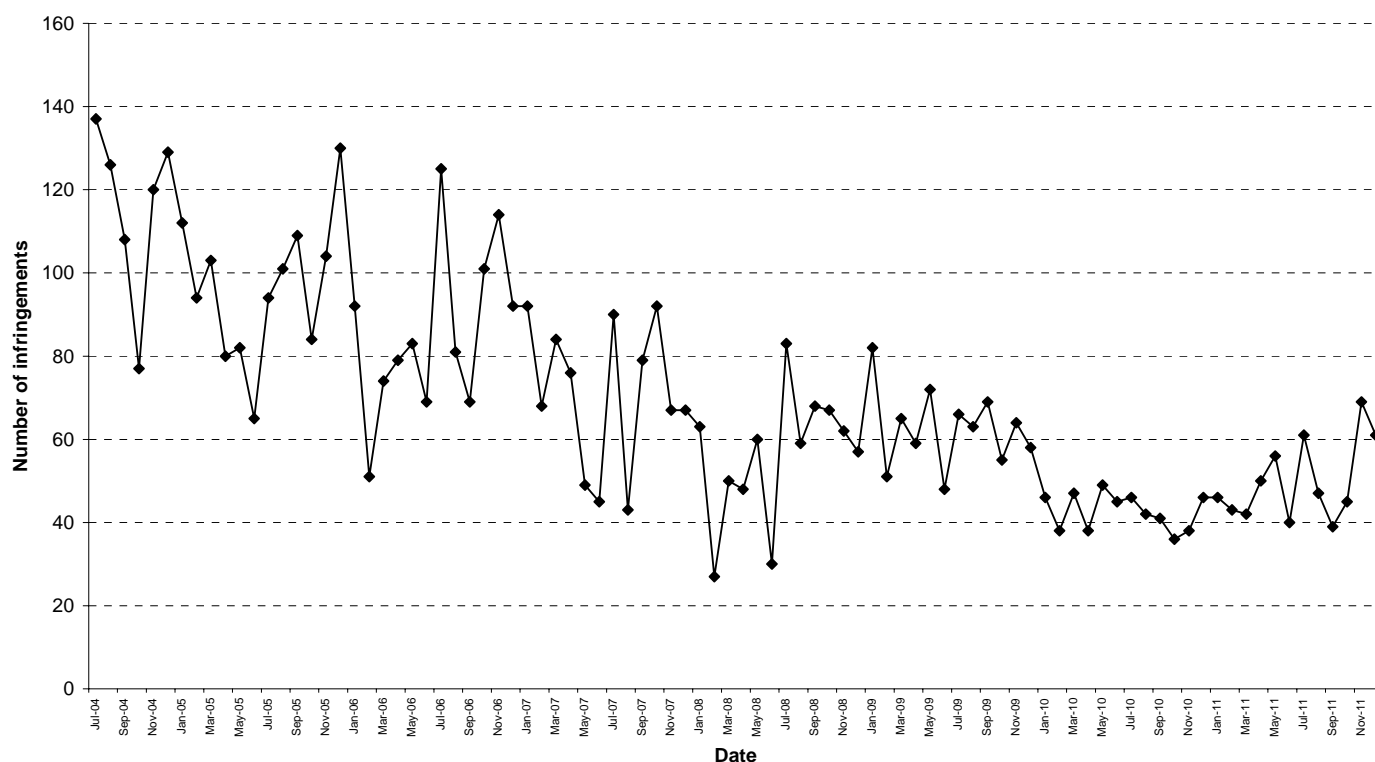
NORTHCLIFFE DRIVE WARRAWONG

## Infringements at fixed speed camera location

The fixed speed camera on Northcliffe Drive, Warrawong was installed in May 2003. There is one camera installed at this location.

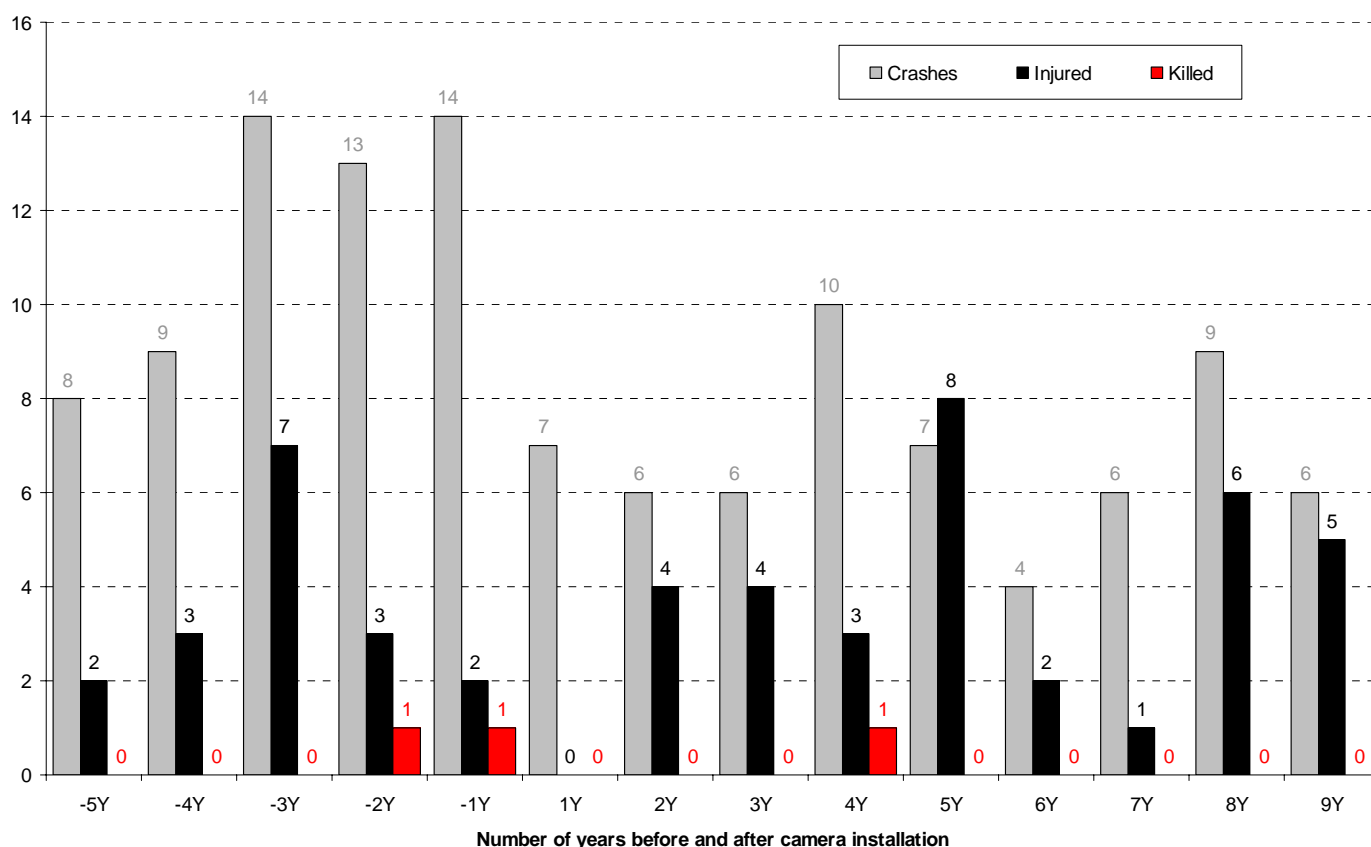
### Crashes at fixed speed camera location

Five years before – April 1997 – April 2002- Totals				
Fatality Persons	Injury Persons	Casualty Persons	Crashes	Casualty Cost (\$M)
2	17	19	58	13.606
After (most recent five year period) – 2006 to 2011 - Totals				
Fatality Persons	Injury Persons	Casualty Persons	Crashes	Casualty Cost (\$M)
0	22	22	32	2.508
